**US Army Corps
of Engineers**

Mount St. Helens Eruption

The Challenge to Restore and Protect

October 1981

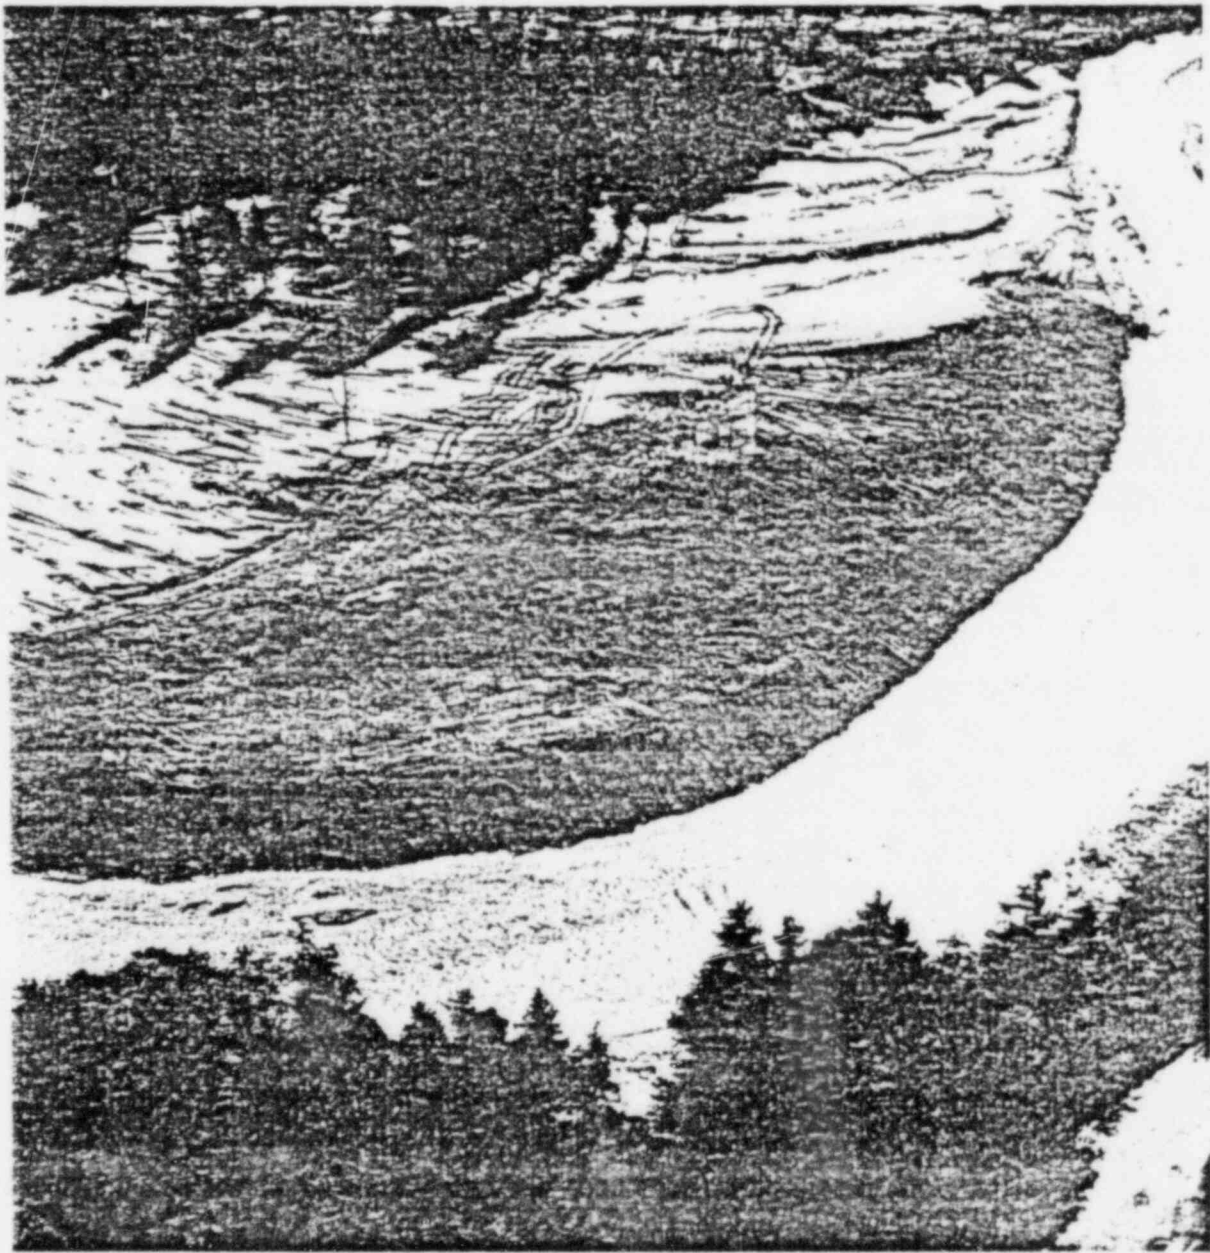
Typical bank stabilization work on the Toutle River.

Much of the mudflow material deposited in the main Toutle River valley below the north and south forks was left in heavy layers along the narrow valley. Because the Toutle River falls rapidly, future flows would erode this material at an accelerated rate with subsequent deposition in areas excavated downstream in the Cowlitz and Columbia rivers. Therefore, a plan was undertaken for stabilizing several reaches of the Toutle River by channelizing the river through the mudflow material to minimize erosion. Although this program was only partially effective in some areas, observations have concluded that it did reduce significantly the impacts of erosion of mudflow sediments downstream during the winter of 1980-1981. Continued channelization in the spring of 1981 was directed toward minimizing the impact of river flows until natural vegetation and other measures could stabilize the shoreline material.

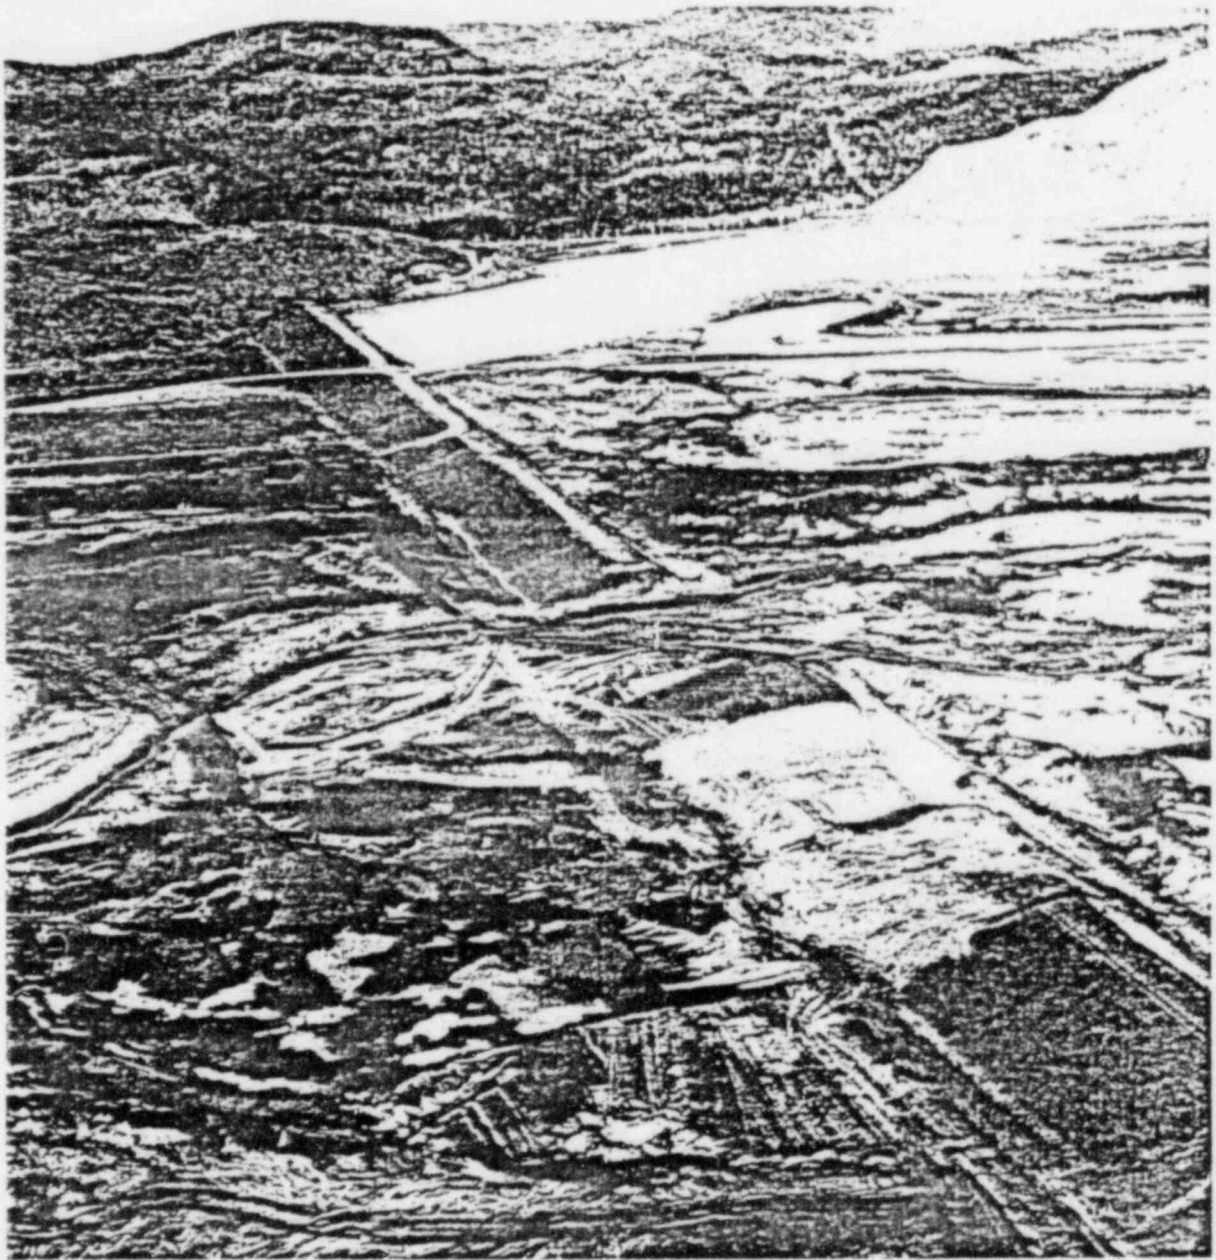
North Fork Toutle River debris retaining structure showing breached spillway caused by flood waters. New spillway under construction in foreground.

Both debris dams withstood several high flows during the fall and winter of 1980. In December 1980, however, a large freshet destroyed one of two spillways on the north fork structure. It was restored by a separate contract for \$2,118,500 to Mountain Engineering and Construction, Bozeman, Mont., in January and February 1981. The new spillway was constructed of roller compacted concrete adjacent to the damaged spillway, and the entire structure was raised five feet. In addition, a contract was awarded in January 1981 to Claterbos Construction, Astoria, Ore., for \$37.8 million for excavation of sediments deposited behind the north fork dam. This contract provides for removal of 15,000 to 80,000 yards per day. A total of about eight million cubic yards had been excavated by August 1981. It is anticipated that both debris dams will be valuable tools in controlling future sediment transport downstream to the Toutle and Cowlitz River channels. They will also ultimately provide benefits by reducing sediment deposition in the Columbia River navigation channel.

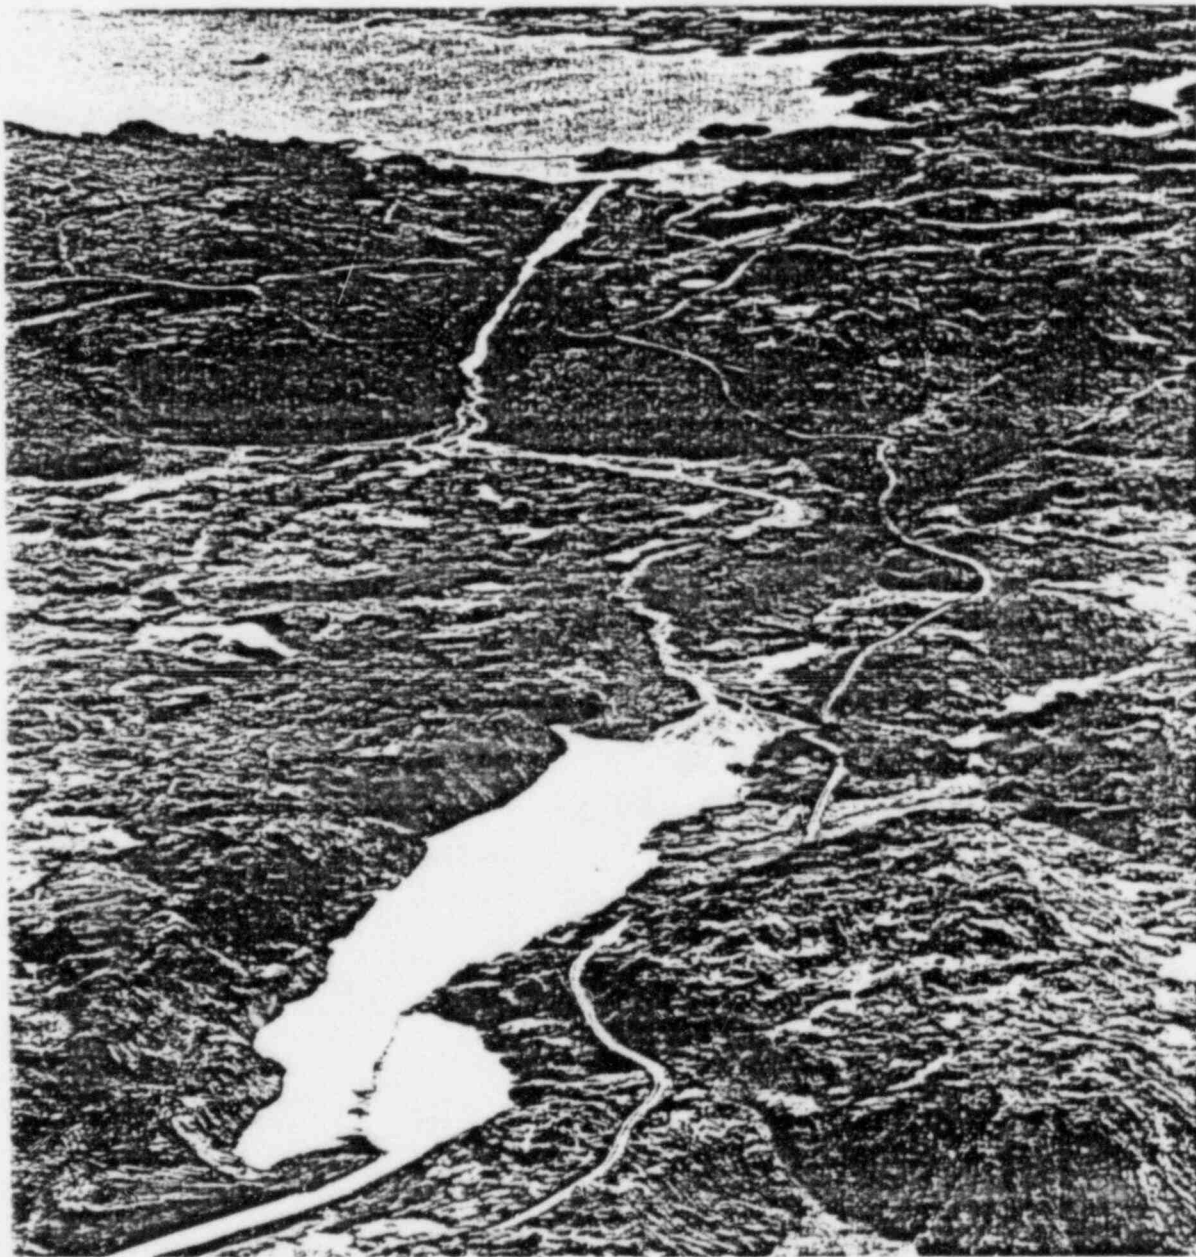
Outlet channel releasing water from Coldwater Lake. Released water collects in lower ponding before draining downstream.

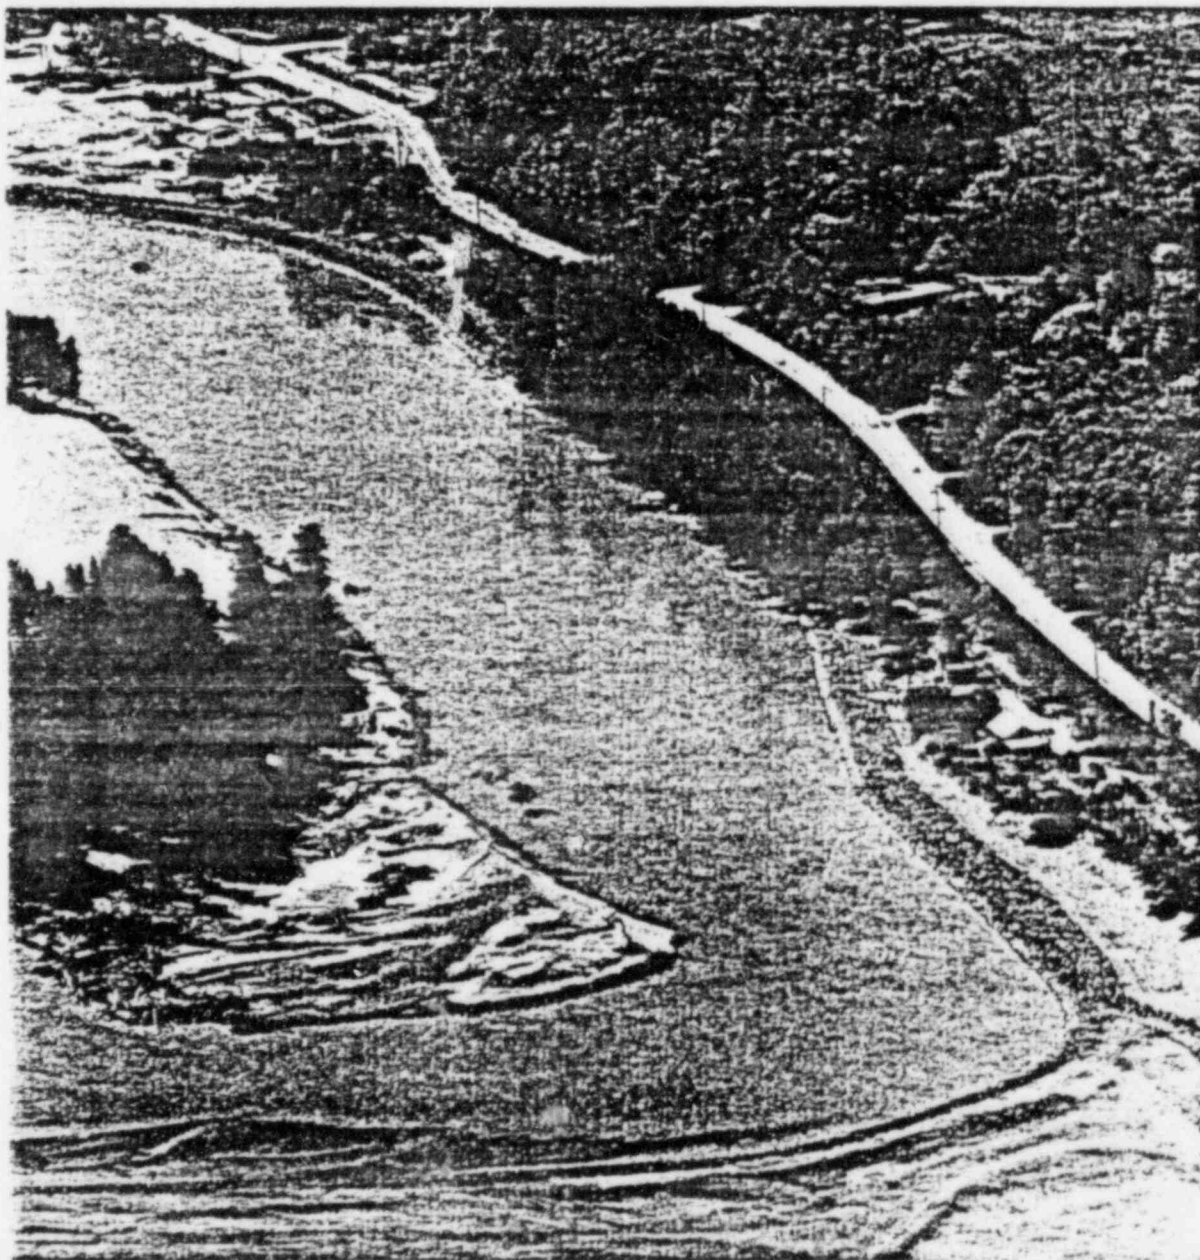
Bank stabilization on the Cowlitz River.

Several areas on the Cowlitz River developed serious erosion problems as the river channel adjusted from the impact of massive infill. Bank protection work was undertaken where erosion problems threatened to cause substantial losses to developed property. Two small projects at River Mile 13 and 13.5 were accomplished in the months of April and May 1981. Overall cost of the work was about \$700,000. Other areas of erosion are developing and are under observation. Pending availability of funds and the severity of those erosion problems, additional corrective measures may be taken.
