Helpful hints for  
handling wire and cable  
insulated with  
**KAPTON<sup>®</sup>**  
POLYIMIDE FILM

# 1 KAPTON® Polyimide Film— The Aerospace Industry Standard for Wire and Cable Insulation

NRC INFORMATION NOTICE NO. 88-XX: IMPROPER APPLICATION OF KAPTON ELECTRICAL INSULATION

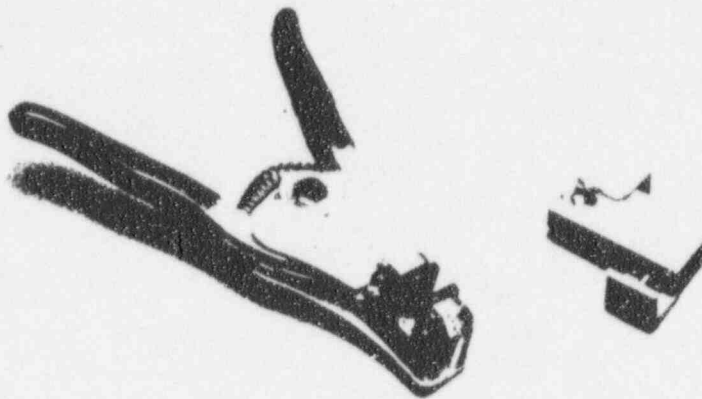
The Reon end stripper, Model R-720A (right) and The Ideal Custom Stripmaster (left) can both be used for stripping wire insulated with KAPTON. The Reon R-720, which is similar in appearance, cut with 3 cutters, is used for cutting cable jackets of KAPTON.

The most common precision stripping tool for single wires insulated with KAPTON is the "Ideal Custom Stripmaster®". It is important to use the correct Part Numbers as shown in Table I. These tools have been carefully designed to remove insulation of KAPTON quickly and completely. These tools are manufactured by Ideal Industries and are available by **special order through your ideal electrical distributor. (They are not listed in the Ideal catalog.)** If you have difficulty in obtaining the correct strippers or cutting blades for KAPTON, contact:

- Use the Reon Model R-720 Outer Jacket Cutter. **These are distributed only by direct factory sales.** For orders and inquiries, contact:

- Nick the jacket slightly over one-half the jacket thickness.
- Flex the cable at the nick (approximately 45°). The jacket should separate all around the circumference.
- Grasp the slug with a rubber gripper pad and pull it off, using firm and steady pull.

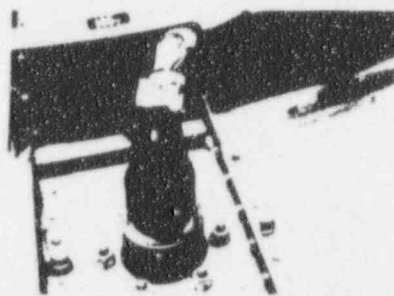
Strain relief devices are often provided to stabilize and protect wires leading from a connector.

■ **Connector Strain Relief:** Strain relief supports are provided by the designer on certain connectors where experience shows they are necessary to prevent broken wires and side loads on the connectors. They are usually in the form of a support on the back shell of the connector. It is important that the strain relief supports be reinstalled where intended after maintenance, and that the wire be properly routed and supported by them.

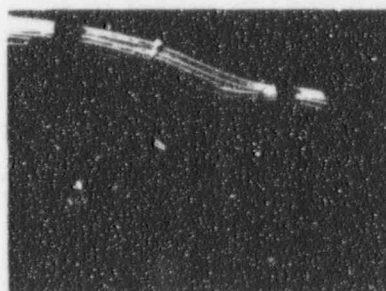
A well-routed harness is tied securely, has gentle bends, and is supported and protected at structural cutouts.

■ **Routing and Tying:** Harnesses should be routed and supported well so they will stay in position and not contact installed equipment or structural cutouts. Supports should provide stand-off capability, particularly where crossing other harnesses or lines at right angles. Breakouts should be gentle and well supported. Ties should be spaced close enough to hold the harness together, preventing splicing where the harness bends.
