**Millstone Nuclear Power Station Unit 3  
Response to Request for Additional Information On Erosion of Cement from the  
Underlying Porous Concrete Drainage System, Millstone 3**

Millstone Nuclear Station Unit 3  
Response to Request For Additional Information On Erosion of Cement From The  
Underlying Porous Concrete Drainage System, Millstone 3

178-92/M295F-R

**ALDEN RESEARCH LABORATORY, INC.**

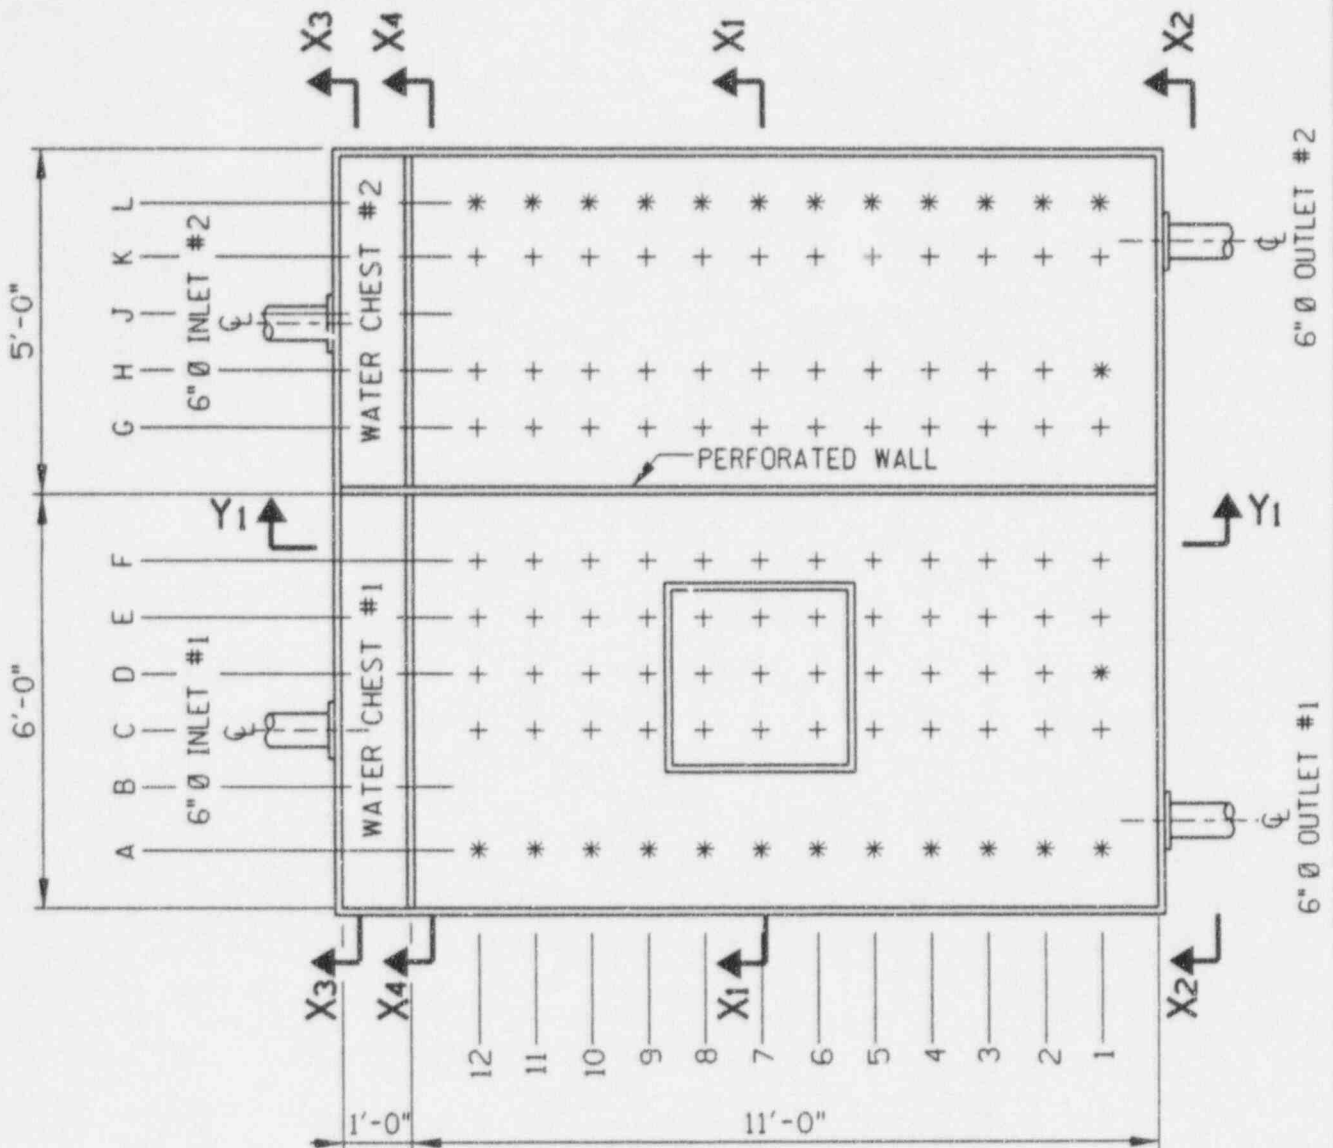
FIGURE 1a

PLAN VIEW

+ - INDICATES THE LOCATION OF 6" Ø CORE BORES.

<b>Northeast Utilities System</b>			
										FOR MILLSTONE NUCLEAR POWER STATION UNIT 3			
										TITLE			
										POUROUS CONCRETE MOCK-UP TEST			
										TESTING MOLD - PHASE III			
BY		K.FULLER		CHKD.		APP.		APP.					
DATE		8-6-96		DATE		DATE		DATE					
SCALE		N.T.S		DWG. NO.									
P.A.*													
MF	P.A.*	NO.	DATE	REVISIONS	BY	CHK.	APP.	APP.

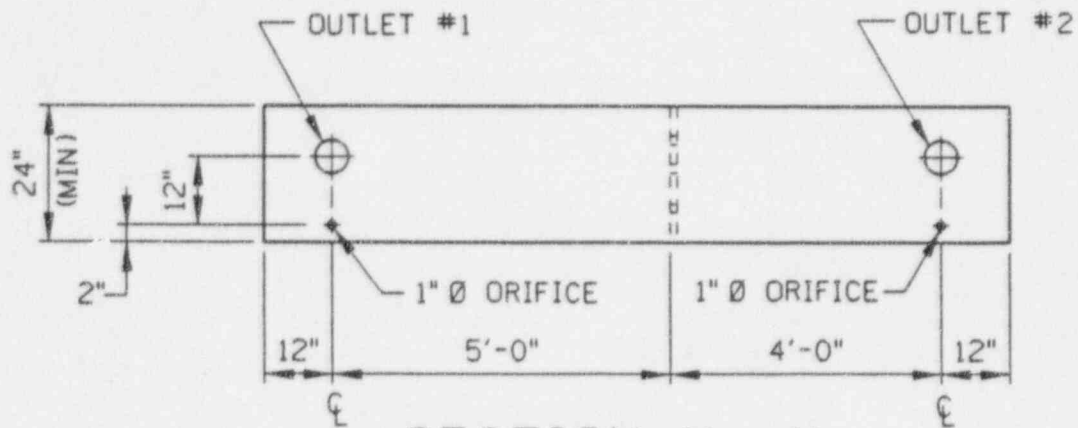
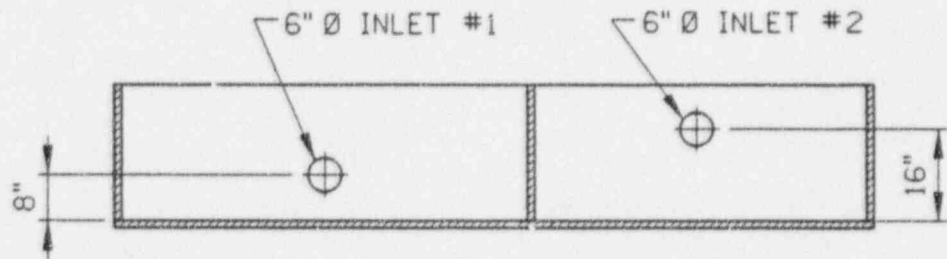
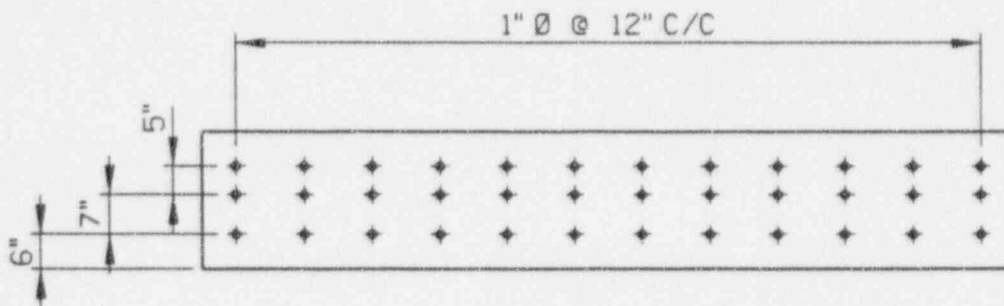
SECTION X<sub>2</sub>-X<sub>2</sub>

SECTION X<sub>3</sub>-X<sub>3</sub>

SECTION Y<sub>1</sub>-Y<sub>1</sub> (ELEVATION)  
PERFORATED WALL

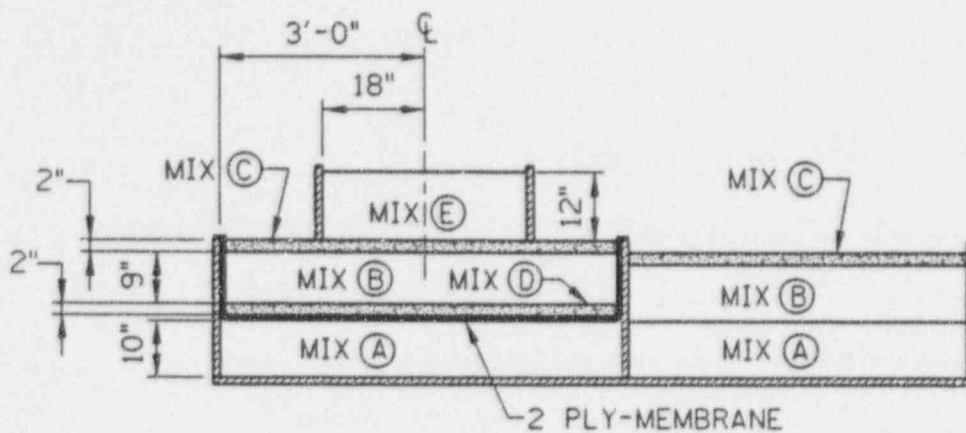
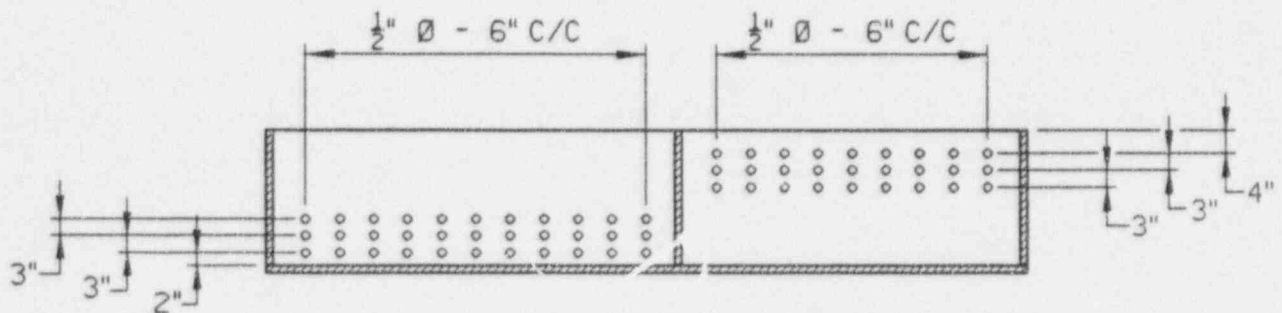
<b>Northeast Utilities System</b> FOR MILLSTONE NUCLEAR POWER STATION UNIT 3			
										TITLE <b>POURIOUS CONCRETE MOCK-UP TEST          TESTING MOLD - PHASE III</b>			
										BY K. FULLER DATE 8-6-96 SCALE N.T.S.	CHKD. DATE DWG. NO.	APP. DATE	APP. DATE
										<b>FIGURE 1c</b>

SECTION X<sub>1</sub> - X<sub>1</sub>

SECTION X<sub>4</sub> - X<sub>4</sub>

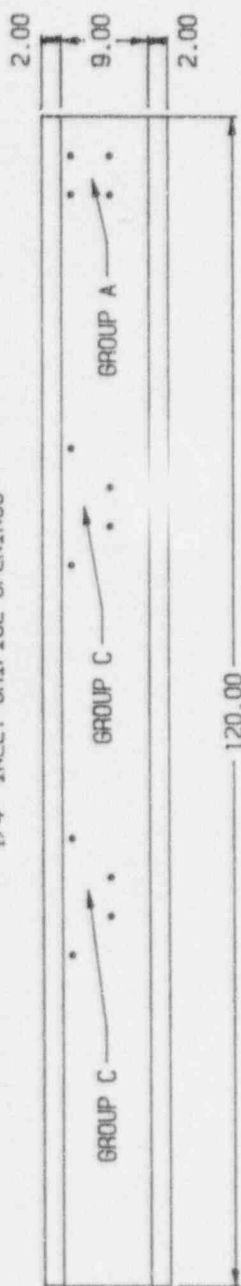
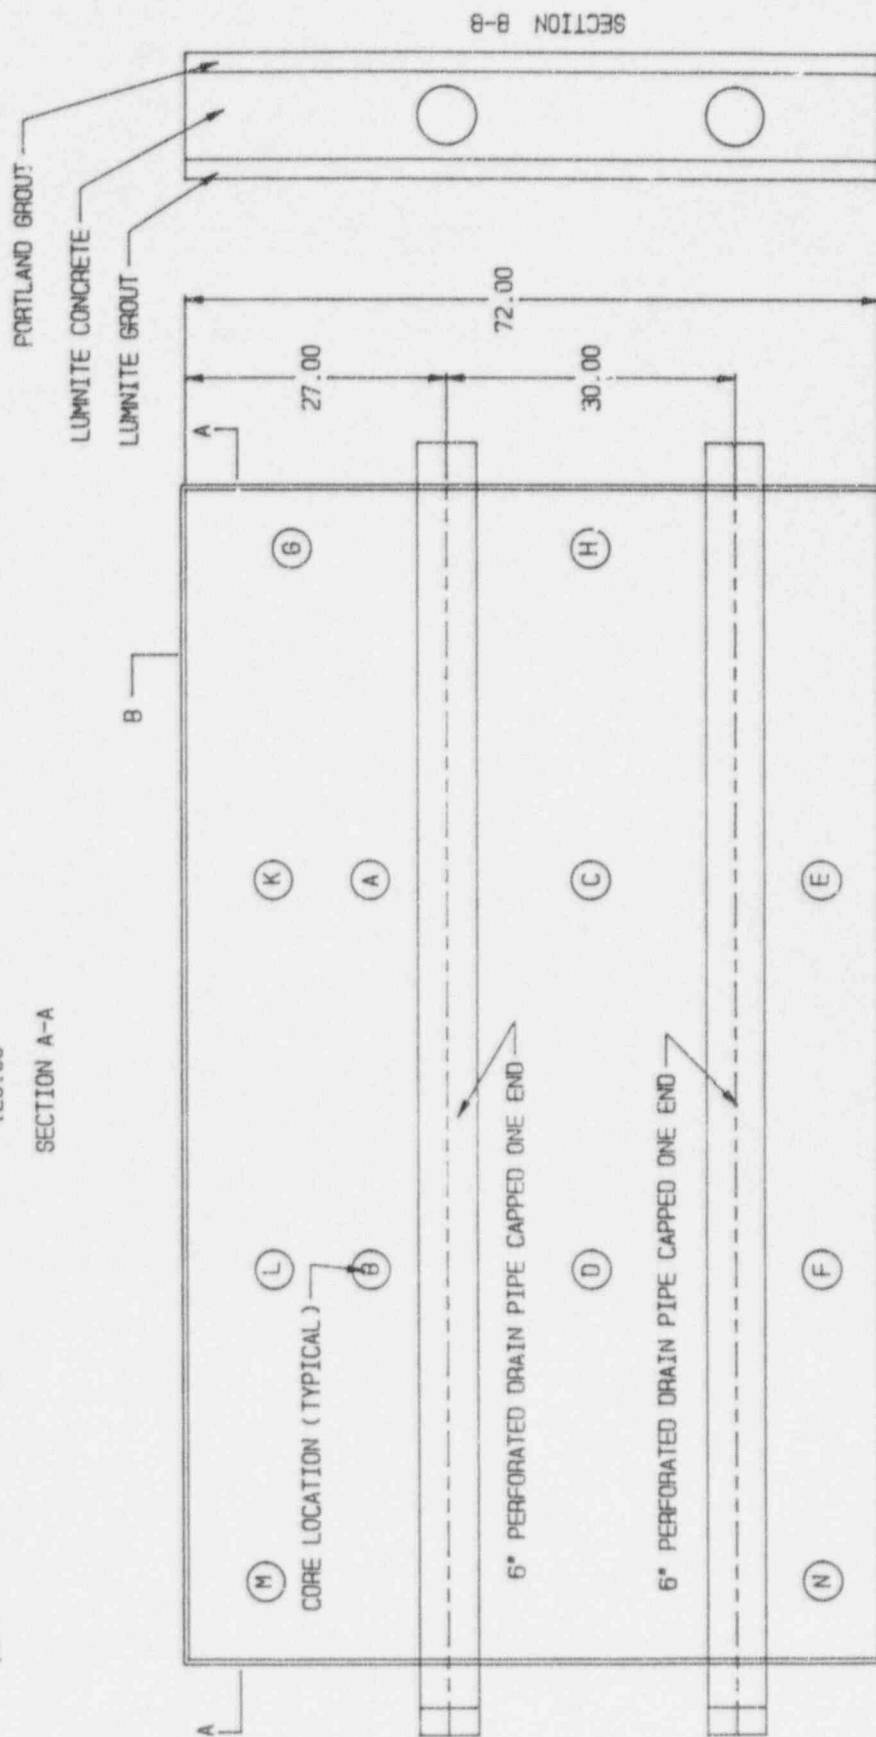
FIGURE 1 SINGLE LAYER SLAB PLAN VIEW

# 1/4" INLET DRIFICE OPENINGS

## SECTION A-A

## SECTION B-B

At the conclusion of the 8 hour tests, both slabs were tested for 30 days introducing water through all holes shown in Figures 1 and 2. The rate of flow through the slabs was measured during the test period. The average flow through the single layer mold was 50 gpm. There was a decreasing trend in flow from a high of about 64 gpm to a low of 40 gpm. The average flow through the double layer mold was 140 gpm, and there was no trend of increasing or decreasing flow. No material was found in the water discharging from either mold.

After the 30 day test period, twelve (12) 4 inch diameter cores were taken from each slab at the locations shown in Figures 1 and 2. Eight (8) of the cores were broken in compression and four (4) cores were split in the longitudinal direction. The coring operation was successful in the single layer slab. The compression tests of the single layer slab cores ranged from a high of 600 psi to a low of 440 psi with the average for 7 test of 520 psi. This average strength is

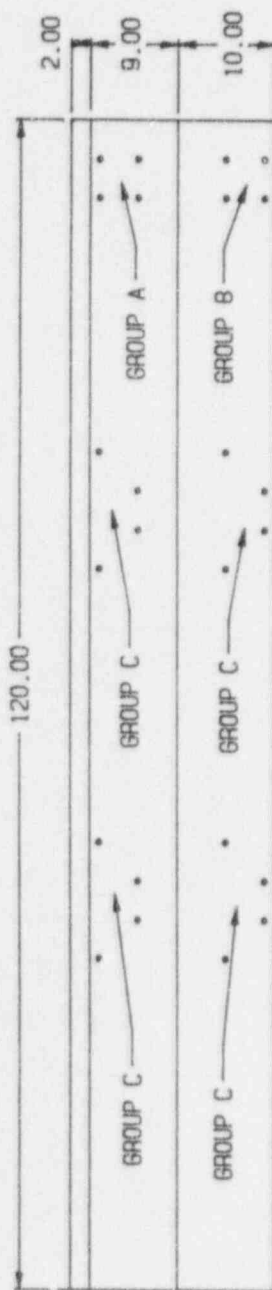
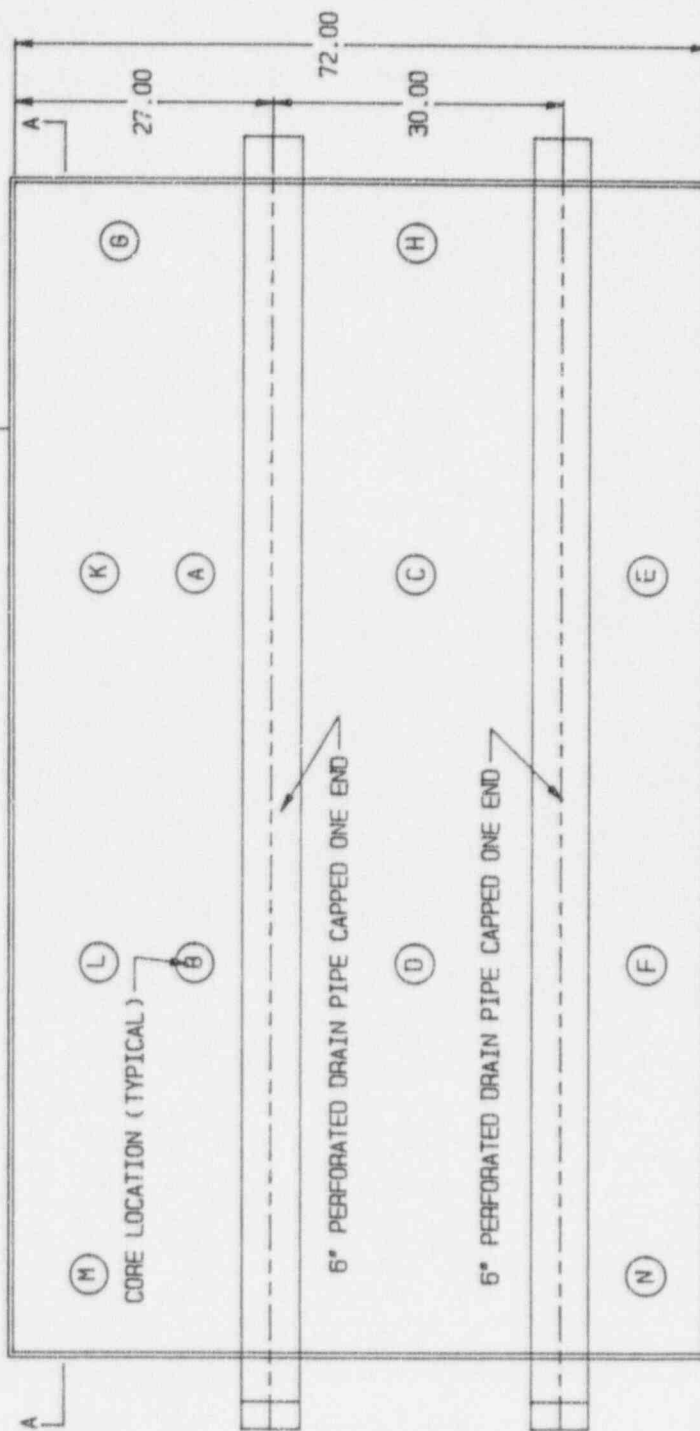
FIGURE 2 DOUBLE LAYER SLAB PLAN VIEW

# 1/4" INLET ORIFICE OPENINGS

## SECTION A-A

PORTLAND CONCRETE  
LUMINITE CONCRETE  
LUMINITE GROUT

SECTION B-B

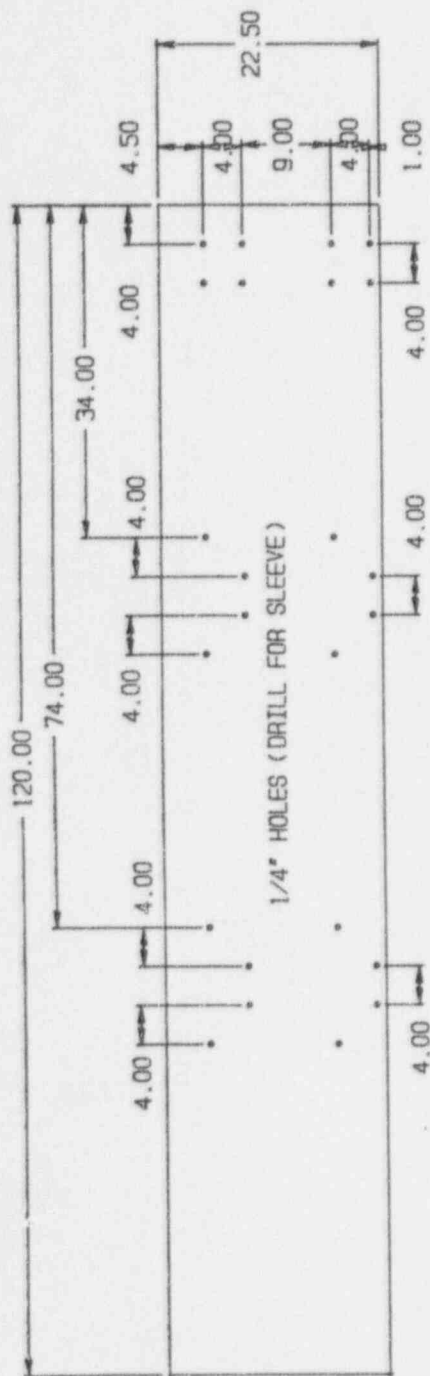
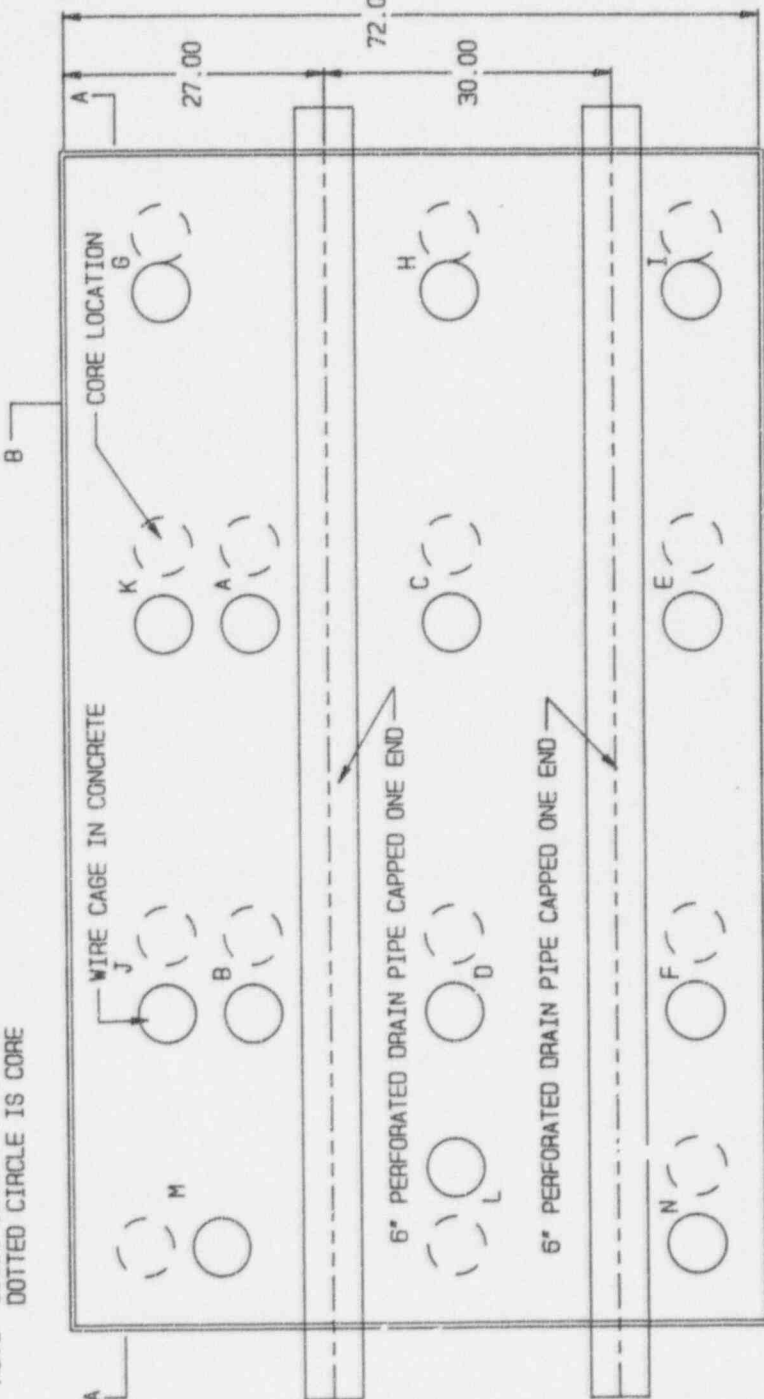
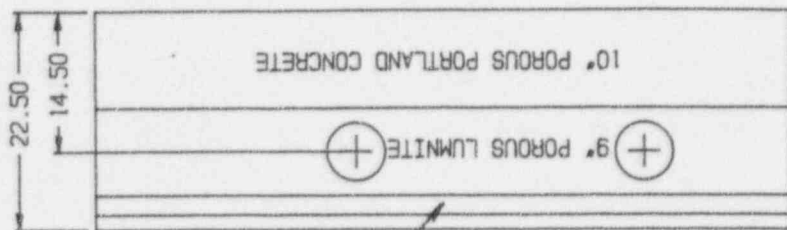
FIGURE 1 MOLD A SHOWING CAGE AND CORE LOCATIONS

# 1/4" INLET ORIFICE OPENINGS

NOTE SOLID CIRCLE IS CAGE  
DOTTED CIRCLE IS CORE

## SECTION A-A

## SECTION B-B

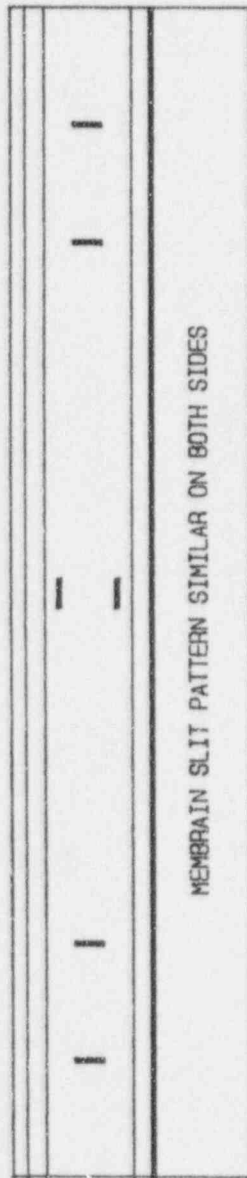
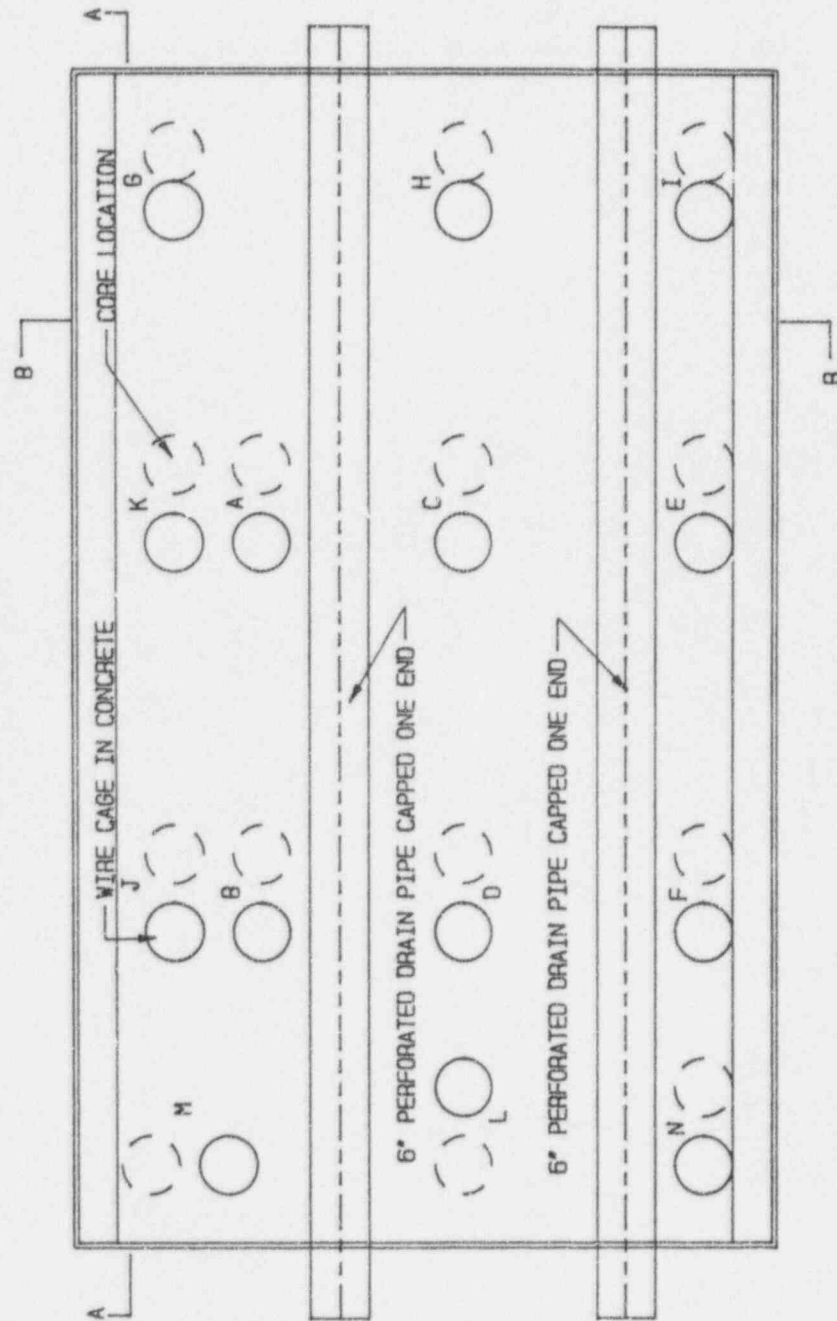
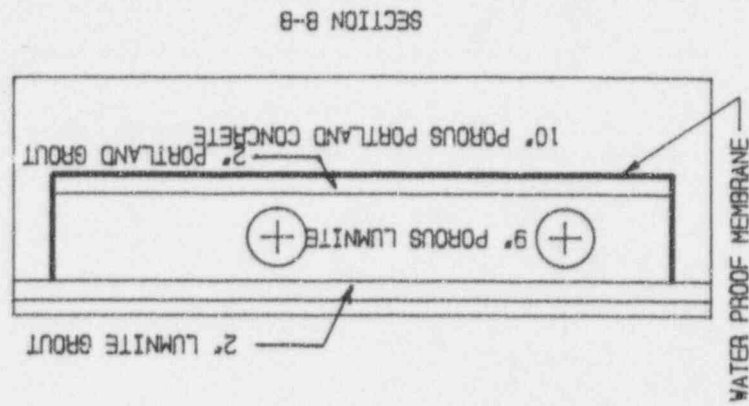
FIGURE 5 MOLD B SHOWING LOCATION OF SLITS IN MEMBRANE

SECTION A-A SHOWING SLITS IN MEMBRAN

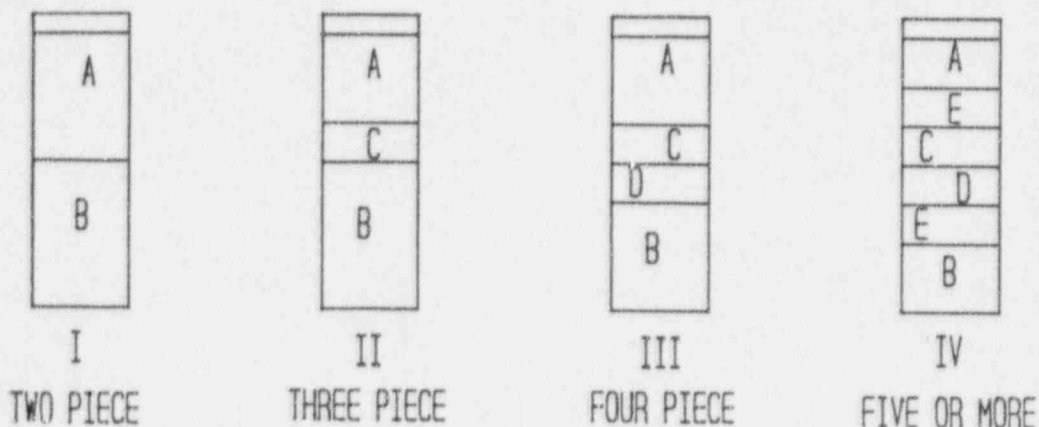
## MOLD A

## CORE BORING LOG

## CORE SAMPLE TYPE

(1) WATER DEPTH WITH WATER RUNNING

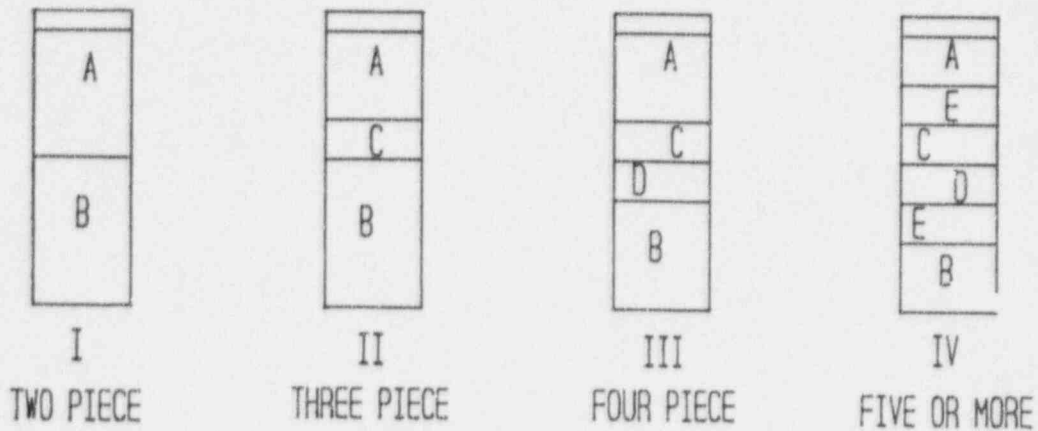
MOLD B

## CORE BORING LOG

## CORE SAMPLE TYPE

(1) WATER DEPTH WITH WATER RUNNING

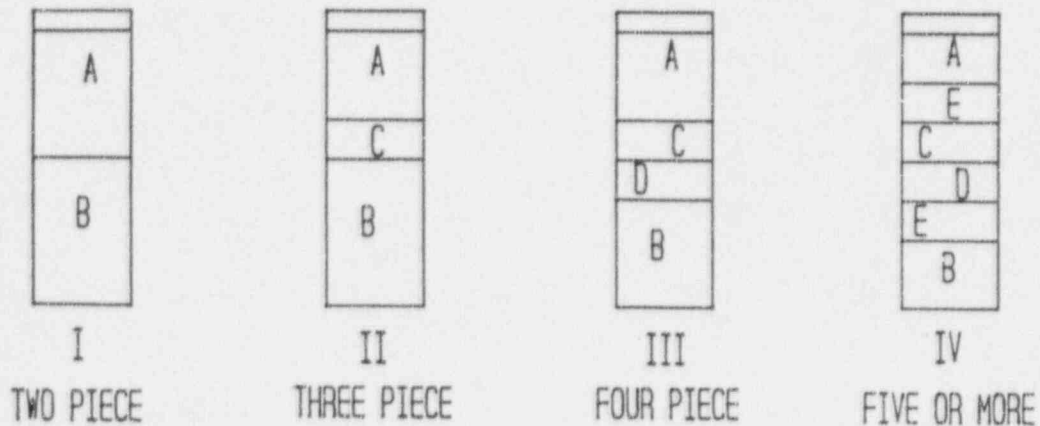
MOLD C

G3  
CORE BORING LOG

CORE SAMPLE TYPE

(1) WATER DEPTH WITH WATER RUNNING

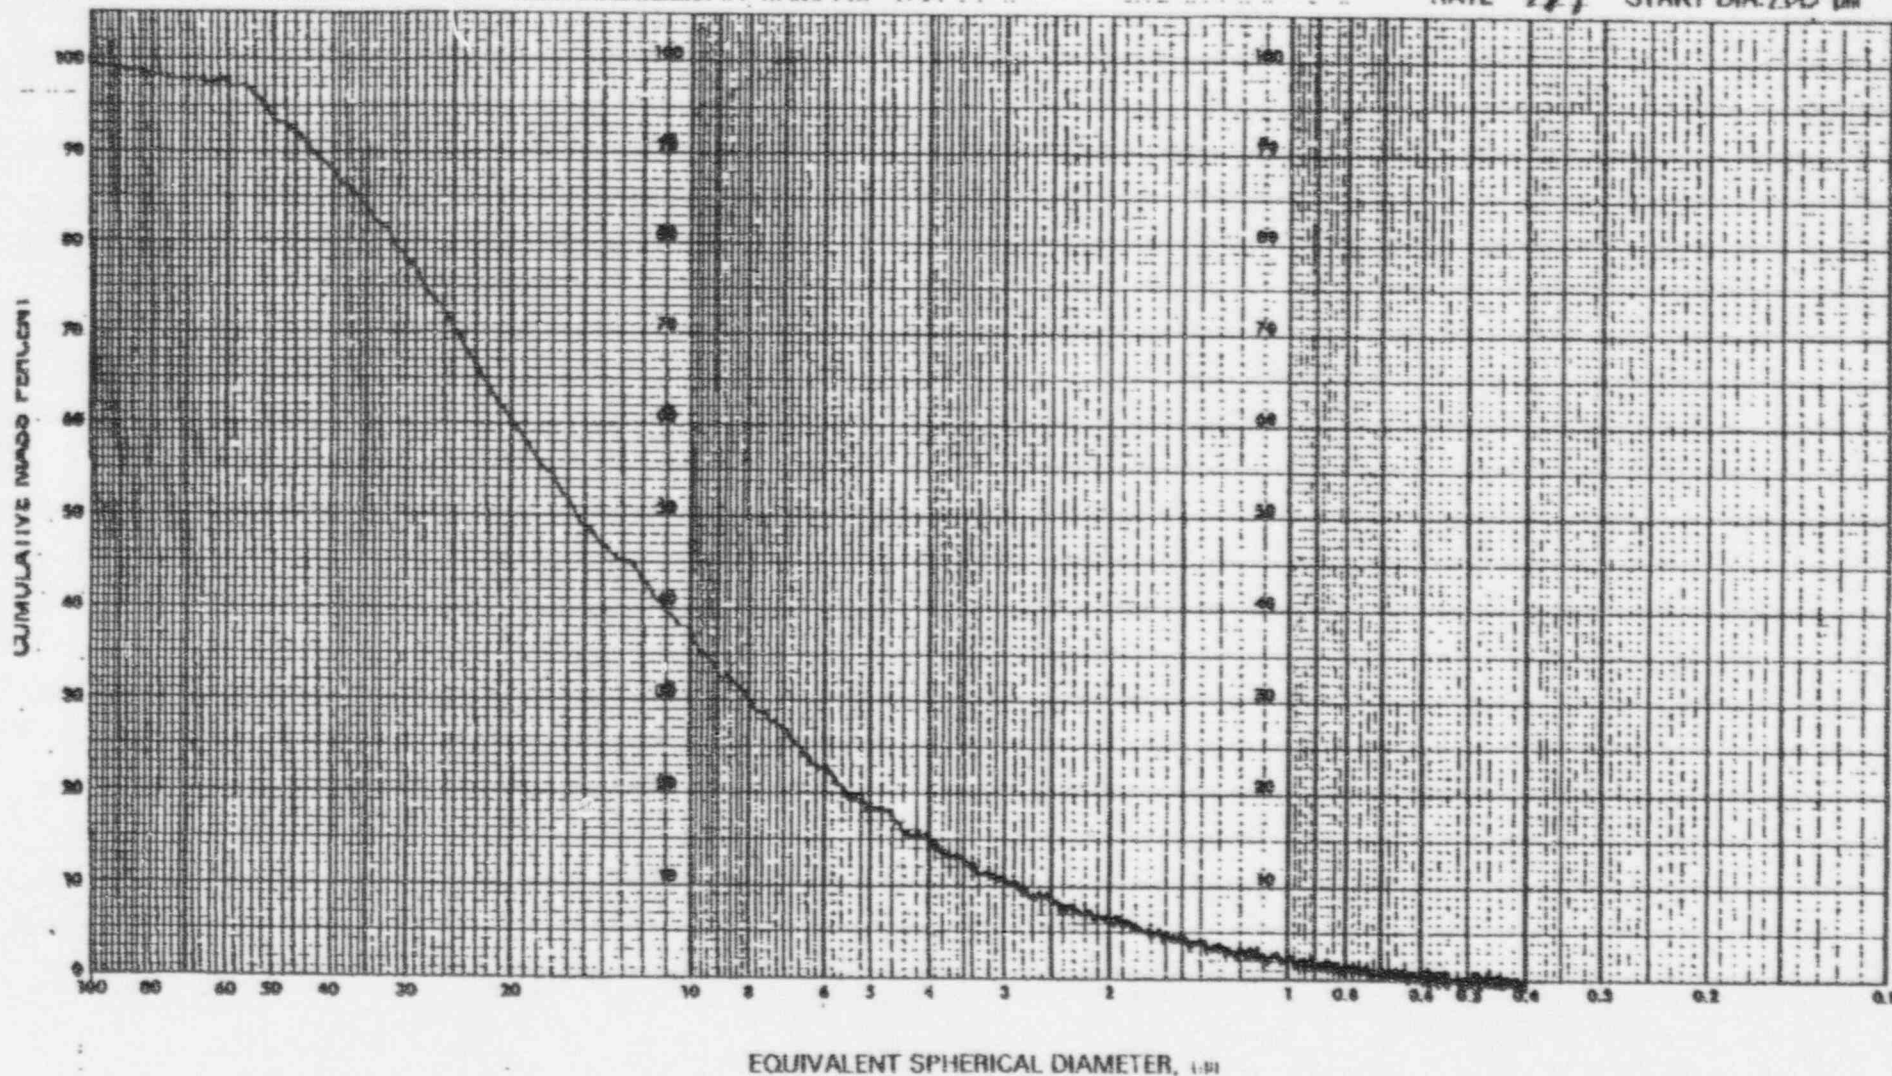
PARTIC TE DISTRIBUTION
