# Low-Velocity Impact Testing of Solid Steel Billet onto Concrete Pads

A Summary of Twelve Drop Tests Conducted February 1996  
at Lawrence Livermore National Laboratory

March 1997

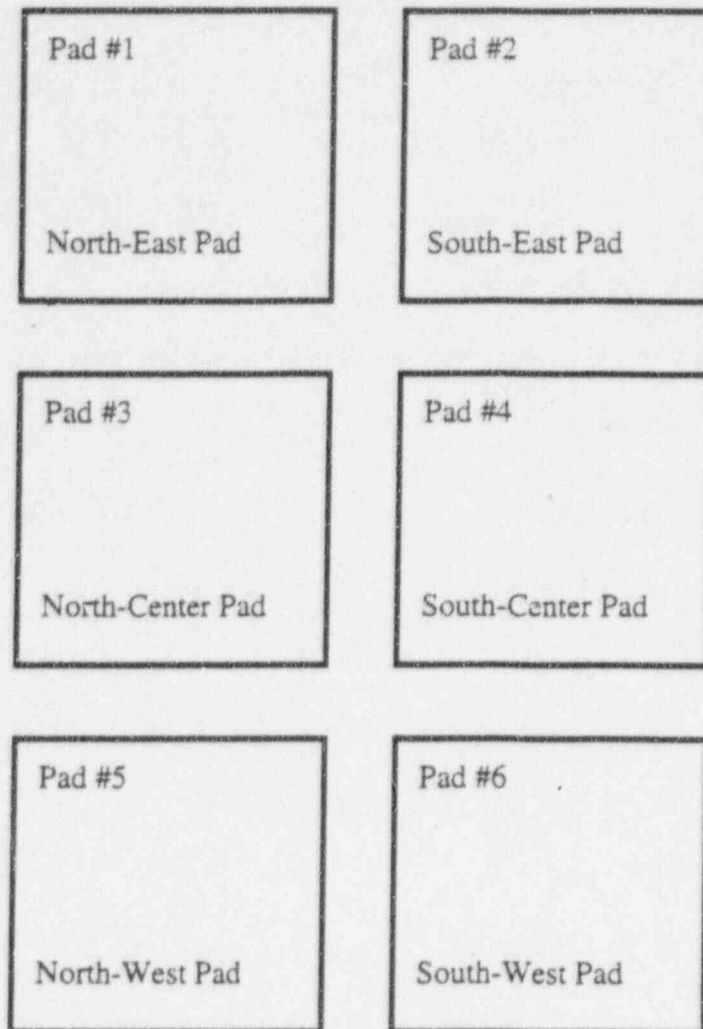
Figure 1. Labeling and Numbering of Concrete Pads

The length and width of the square pads was 10', the pad thicknesses were 12", the thickness of the concrete cap (from the top and bottom surfaces of the pad to the edge of the rebar) was 1", the rebar diameter was 3/8", and the rebar pitch (top and bottom, two way) was 18". The reinforcing steel was deformed billet steel conforming to ASTM A 615, Grade 60, where the nominal yield strength of the rebar was 60 ksi. The pads were numbered 1 through 6, as shown in Figure 1.

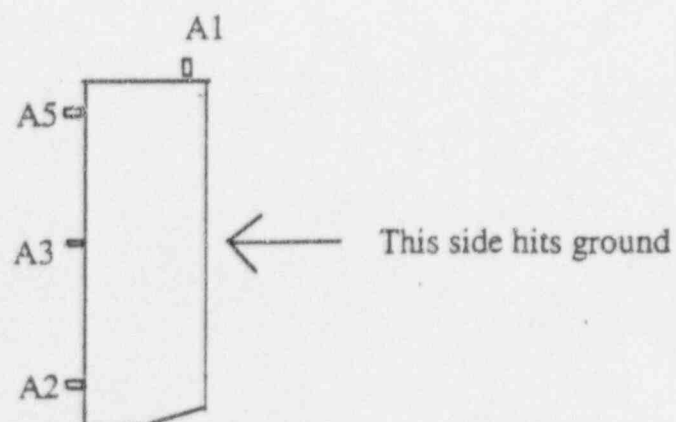
Figure 2. Accelerometer Channel Locations

The instrumentation used is described in detail in the Engineering Test Plan;<sup>3</sup> Endevco brand piezoelectric accelerometers were used, together with Endevco mounting blocks as needed. A 100-Khz 6-pole Bessel analog antialias filter was used. Figure 2 shows the locations and channel numbers of the accelerometers.

## End Drop Channel Locations

## Side Drop Channel Locations

## Tipover Channel Locations

The locations for all of the accelerometers were prepared, as previously noted, by machining flat locations and drilling mounting holes. The hole configuration for the accelerometer connected to Channel A4 during the side-drop (see Figure 2) was directly impacted during the two end-drops. In order to protect the machined holes, a small plate (1/16" thick, 1.25" diameter) was bolted to the connection location with high-strength bolts. This arrangement protruded from the bottom surface of the billet about 1/8". One bolt dug into the concrete slightly, and failed in shear just inside the hole. The other hole remained usable during the side-drops. A small amount of Eastman 910 glue was used to attach the accelerator mounting block to the hole with the damaged bolt. The results from that channel location appear to be unaffected by this mounting procedure. There were no major difficulties with the accelerometers.

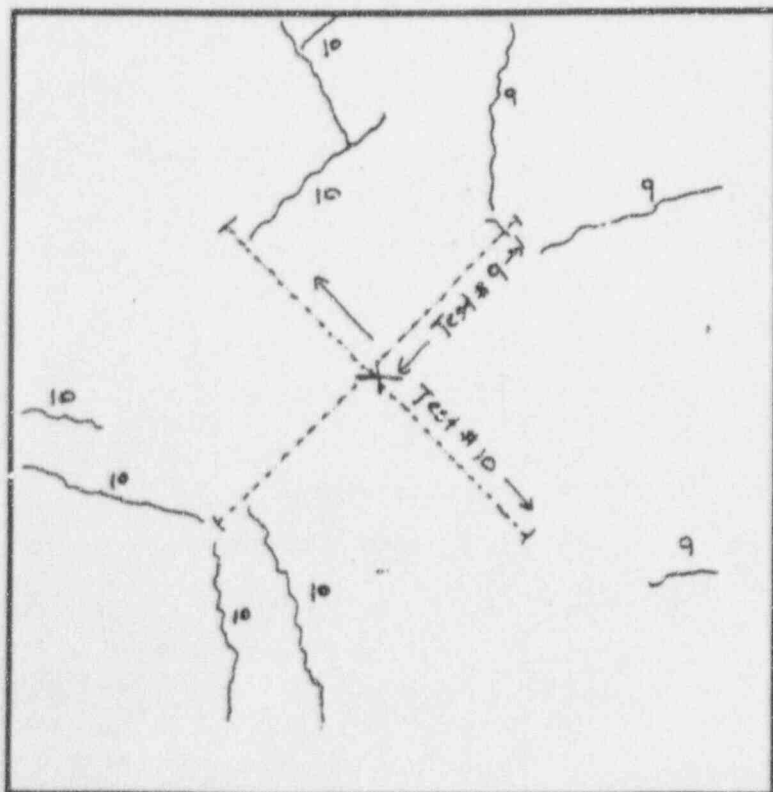
**Pad 2**

Cracking appears minor.  
Footprint from drop #10 is  
difficult to see. It can be  
seen at the ends, and in the  
region near the ends. Fairly  
uniform width of visible  
footprint from Test #9,  
about 1 to 1.5" width.

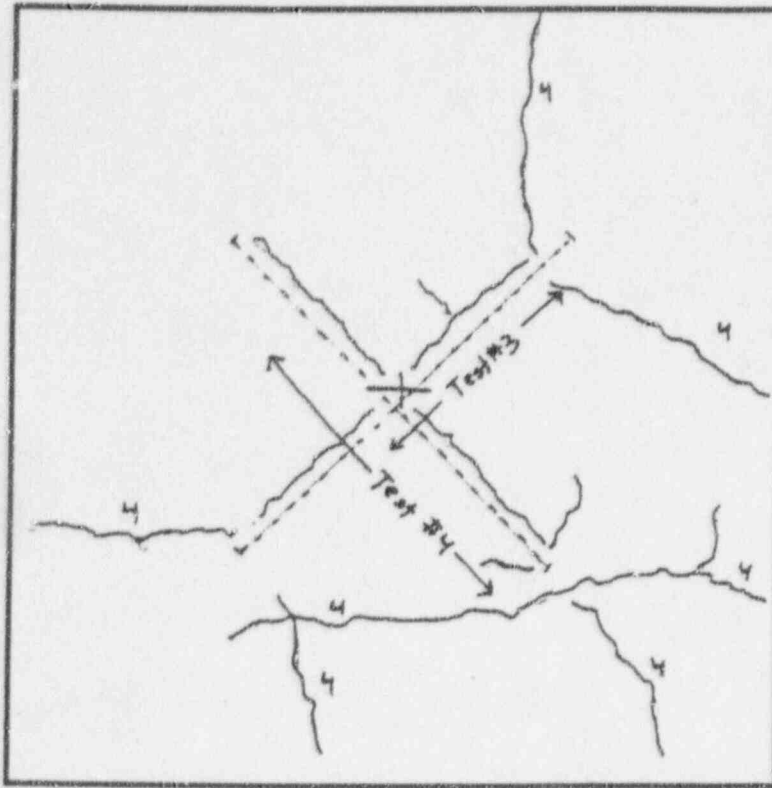
Figure 3. Crack Patterns on Concrete (continued)

**Pad 3**

Lots of cracks, nevertheless cracking appears minor. No crack openings in top surface of concrete. Some openings on sides.

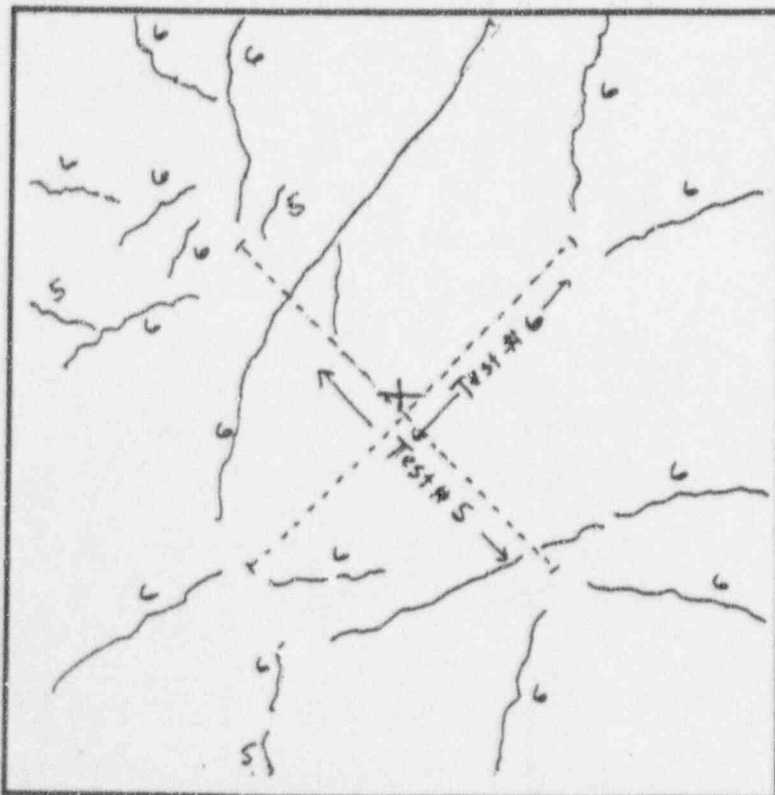
**Pad 4**

Heavily cracked pad. Some visible crack openings both top and sides. Nearly all cracking occurs after Test #6. Footprint from Test #5 difficult to see, but is clearly not uniform. Footprint from Test #6 is visible and not uniform.

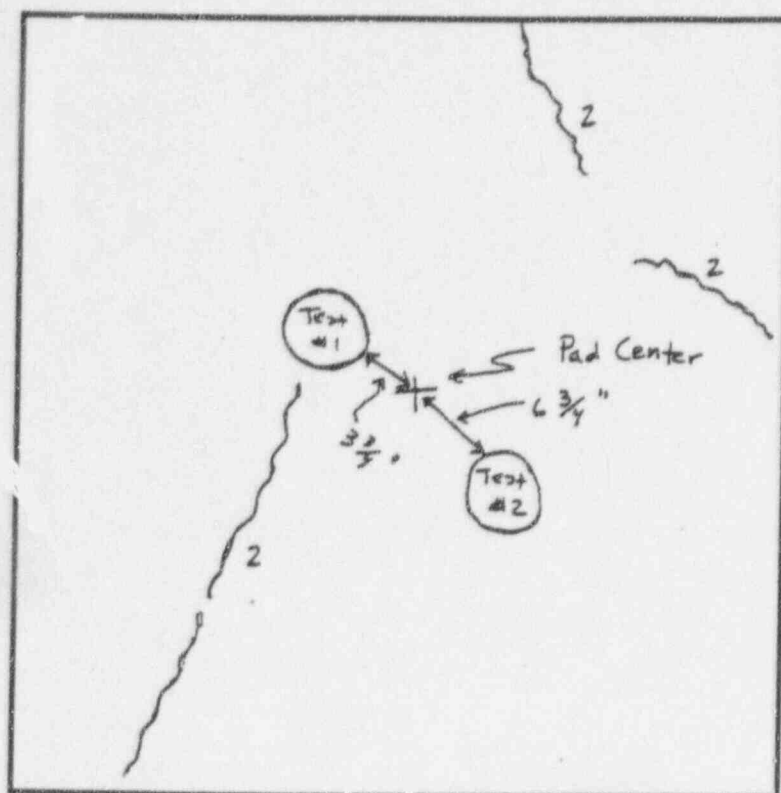
Figure 3. Crack Patterns on Concrete (continued)

**Pad 5**

No cracking on top surface for Test #1. Some on sides. Minimal cracking on top surface for Test #2, indicating likely internal damage resulting from Test #1. Crack openings visible (roughly 1/8") on sides only, none on top surface.

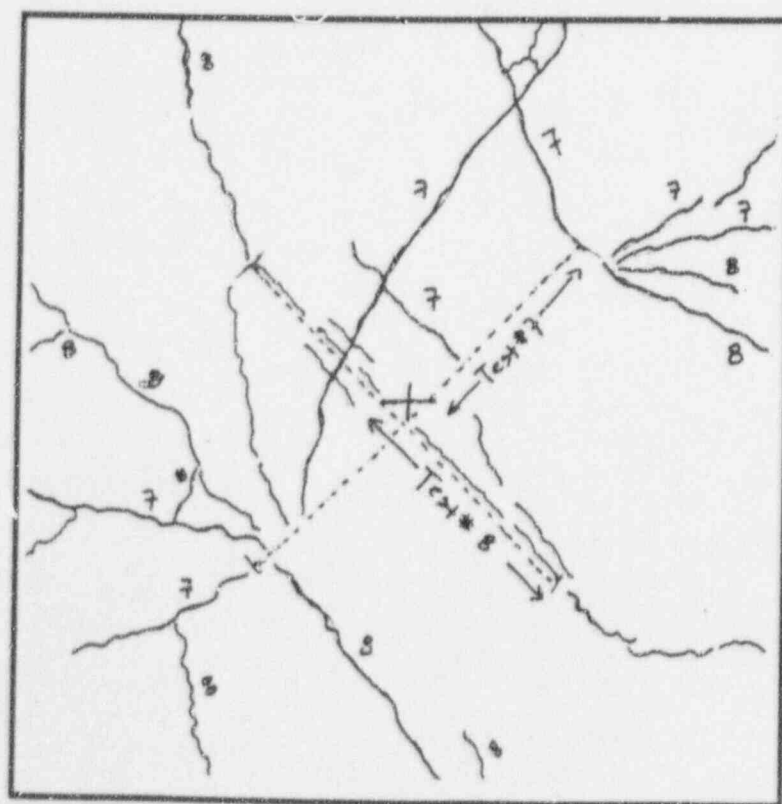
**Pad 6**

Substantial cracking, top and sides. Visible crack openings on both top and sides of pad. Footprint of billet difficult to see from Test #7, easier to see from Test #8. Neither footprint is uniform in width.

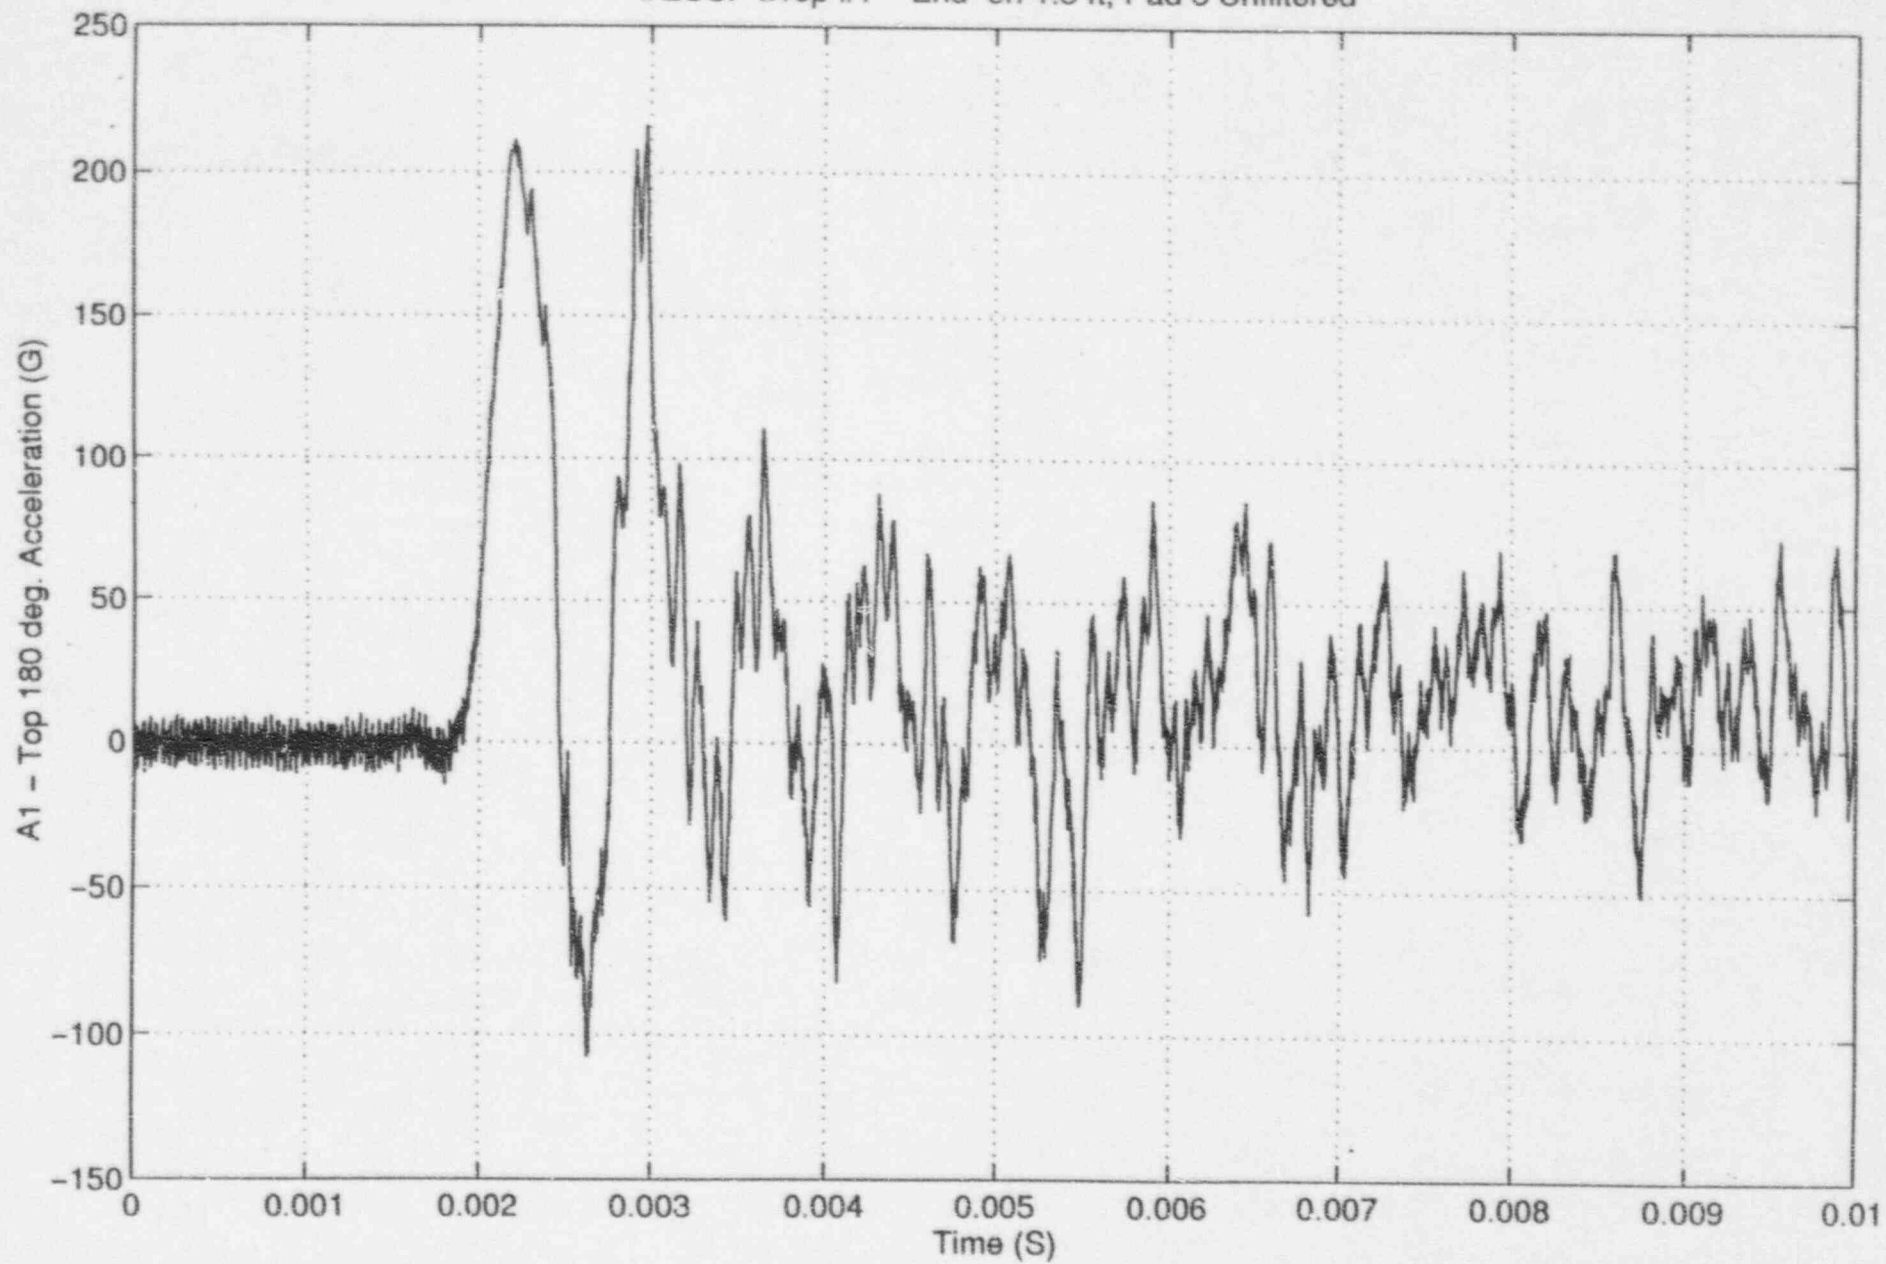
FESSP Drop #1 - End-on 1.5 ft, Pad 5 Unfiltered

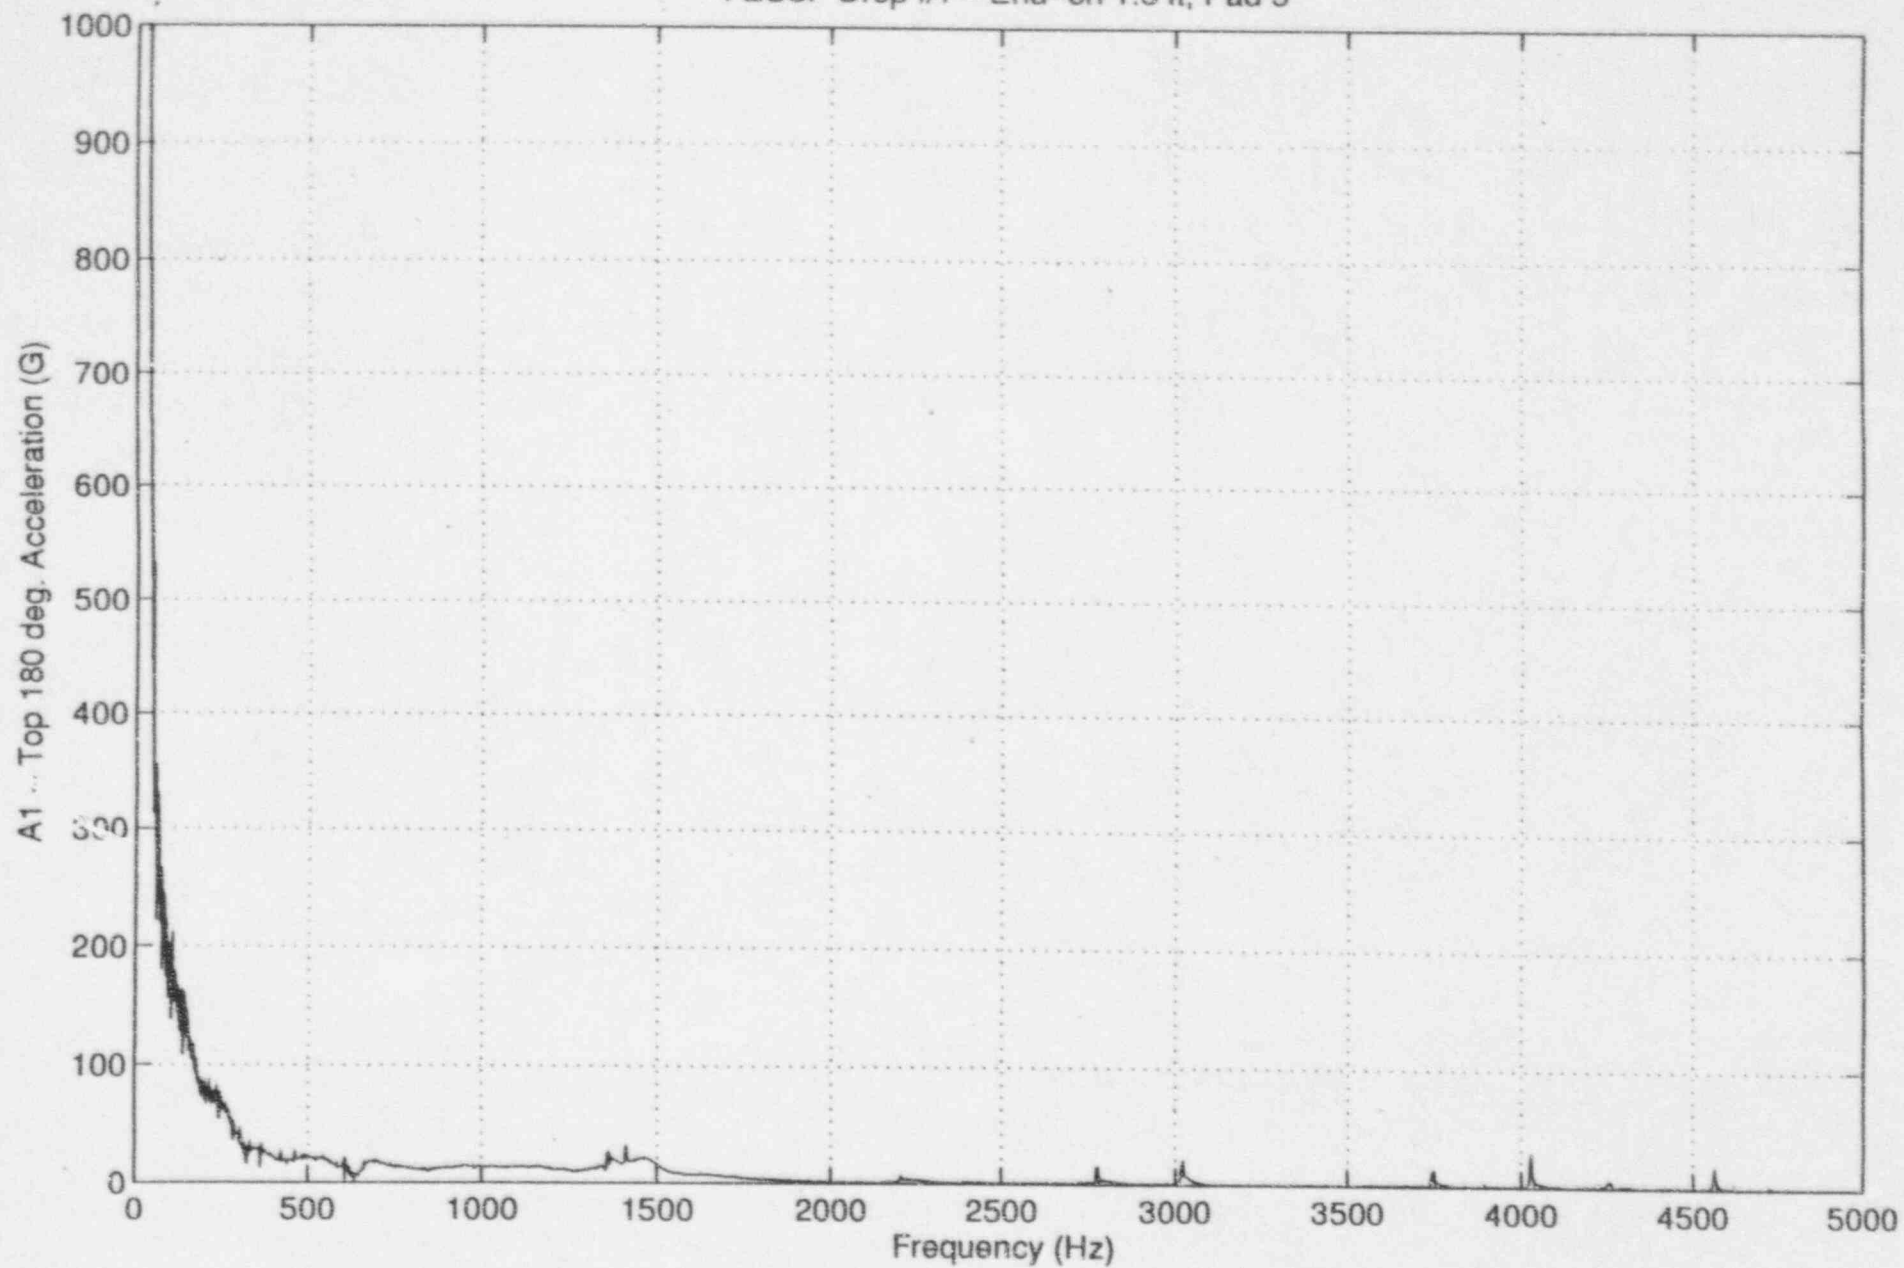
FESSP Drop #1 - End-on 1.5 ft, Pad 5
