# **PWR STEAM GENERATOR INSPECTION GUIDELINES**

**JULY 1985  
REVISION 1**

**PREPARED BY  
THE EPRI NDE CENTER**

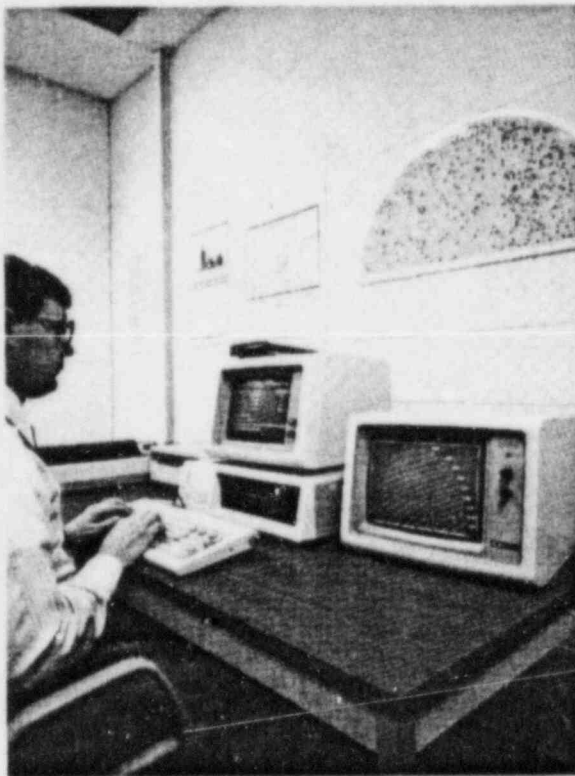
TUBAN

The TUBAN and DECIDE systems are shown in Figure 4-38.
