Heavy-Section Steel Technology Program Quarterly Progress Report for January-March 1978

Prepared for the U.S. Nuclear Regulatory Commission
Office of Nuclear Regulatory Research
Under Interagency Agreements DOE 40-551-75 and 40-552-75

OAK RIDGE NATIONAL LABORATORY
OPERATED BY UNION CARBIDE CORPORATION • FOR THE DEPARTMENT OF ENERGY

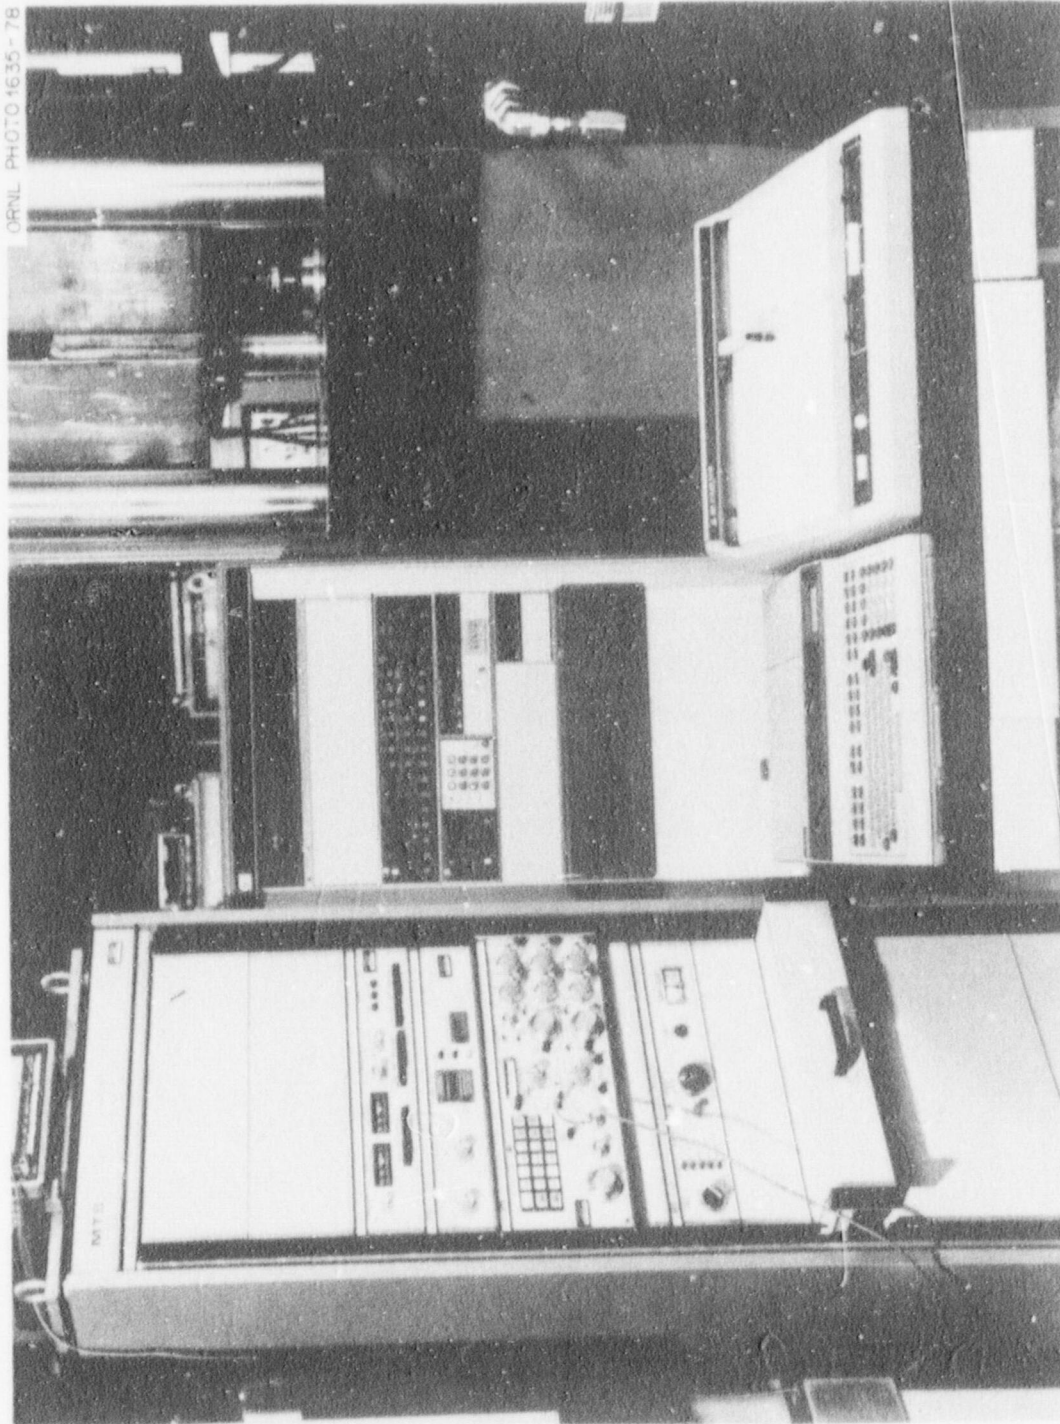
ORNL PHOTO 1635-78

Fig. 4.2. Fracture test data acquisition and processing system.

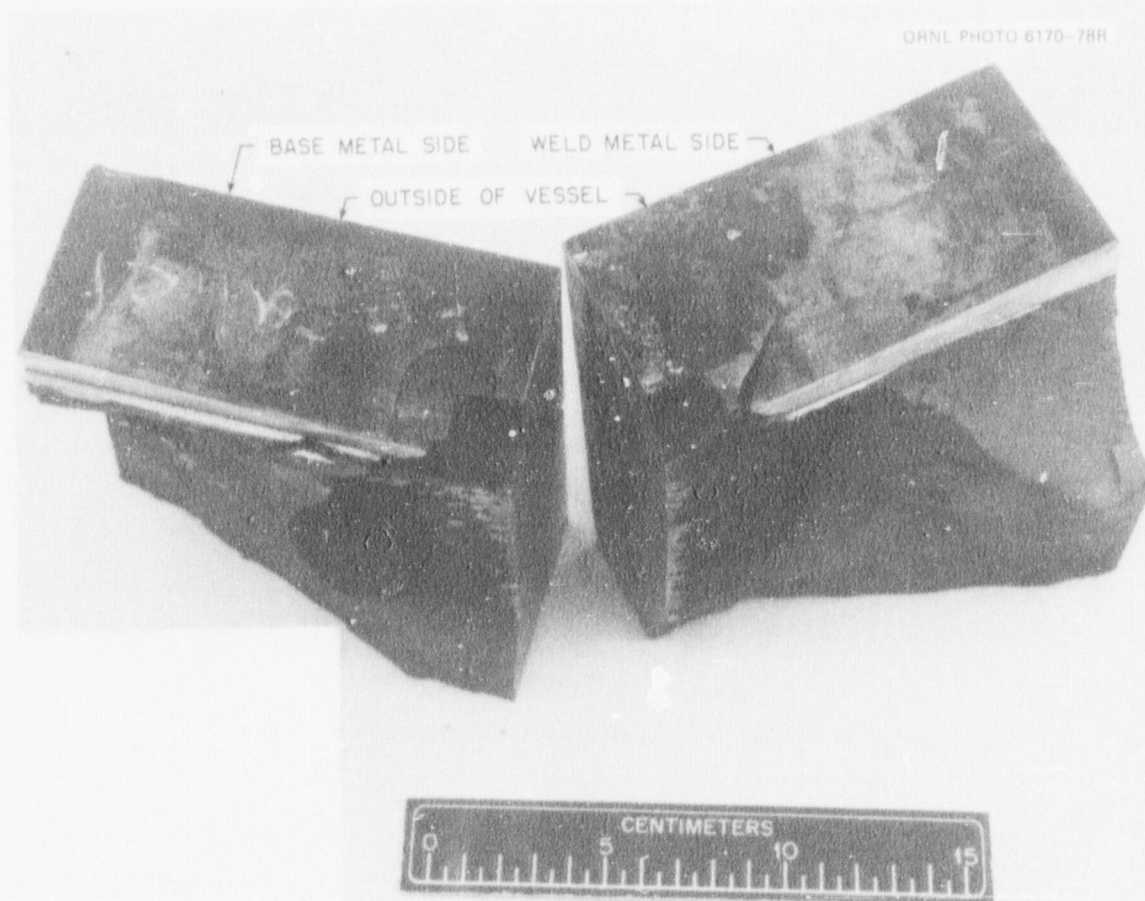
Fig. 5.4. V-7B fracture surfaces in slab Q exposed by splitting the chilled slab.

Segments J, K, and L (Fig. 5.1) fell in two pieces, since they were completely fractured during the test. Segments C, M, and Q were chilled in liquid nitrogen and broken open to expose the fracture surfaces. The two segments including the crack tips at both ends of the flaw (C and Q) are shown in Figs. 5.3 and 5.4, respectively. The visual examination of these pieces confirms the location of the crack front determined ultrasonically by K. K. Klindt.¹ It also appears that the crack extension lies entirely in the base metal in some regions, in weld metal in others, and in the HAZ only at crossover points. Figure 5.4 shows that the crack front curvature conforms to the interface of the weld and base metal. The location of the crack extension surfaces relative to the three types of metal (base, HAZ, and weld) will be determined by additional metallographic examination.
