**SALEM GENERATING STATION  
DOCKET NOS.: 50-272 AND 50-311  
RE-INITIATION OF SECTION 7 CONSULTATION  
PILOT SONAR STUDIES SUMMARY REPORT**

**Pilot Study Summary Report**  
**Salem Generating Station**  
**Circulating Water System Intake Unit 1 & Unit 2**  
**PSEG Nuclear, Hancocks Bridge, NJ**  
**May 2020**

**Pilot Study Summary Report Salem Generating Station Circulating Water  
System Intake Unit 1 & Unit 2**

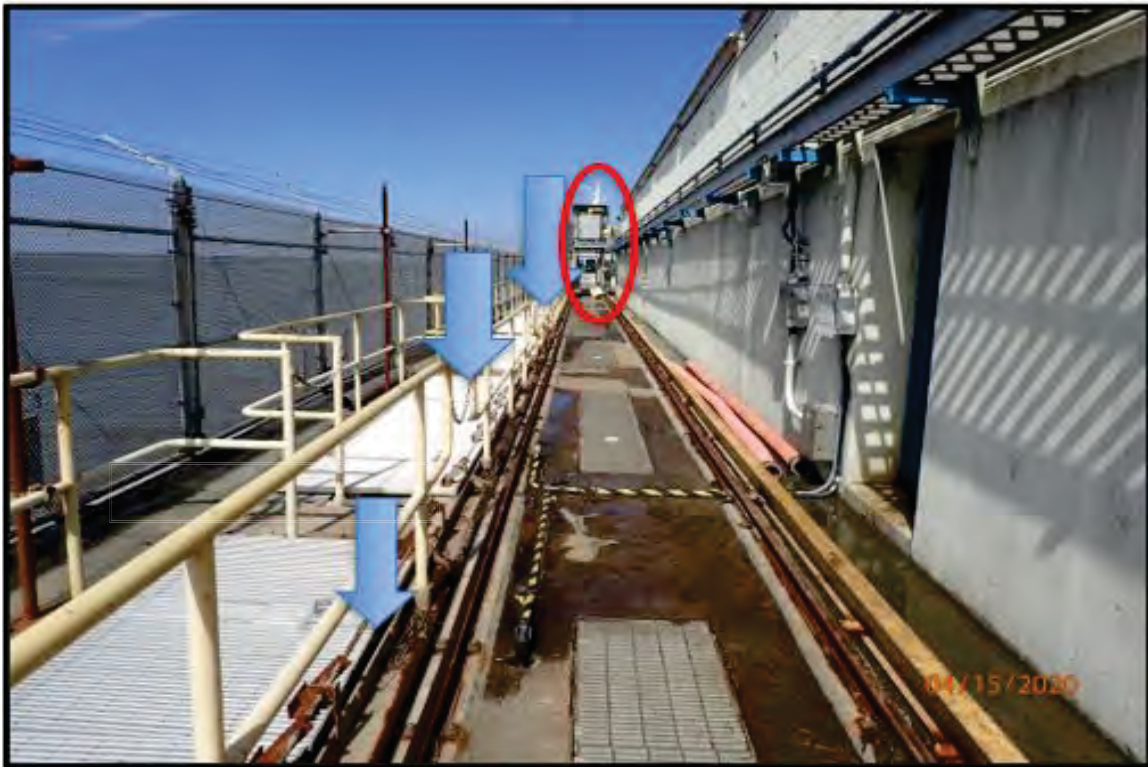
Photo 3: Topside view of intake bays at the CWS intake. Arrows show the general location of trash rack bars. Hatches are opened to clean via trash rake. Circle is trash rake on rail system. Day 2, Unit 2 area.

Day 2 (April 15, 2020) consisted of securing the ARIS system onto a pan and tilt mounted to a 28-ft long ladder bracket at Unit 2, in Bays 22A and 21B. Acoustic images were collected immediately upon deployment, which was done opportunistically during the refueling outage at Unit 2 and between crane and dive operations at the intakes. Refer to **Photos 3-6**.

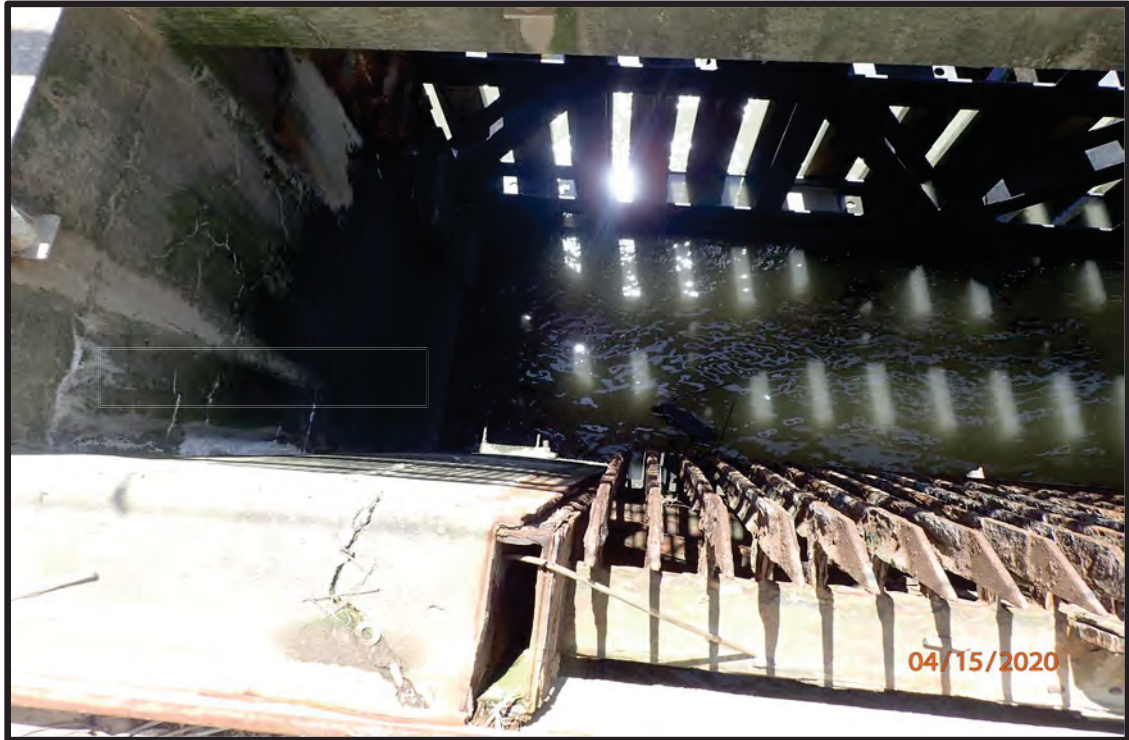
Photo 5: Looking into open hatch at 22A at Unit 2. Trash bars are to the right.

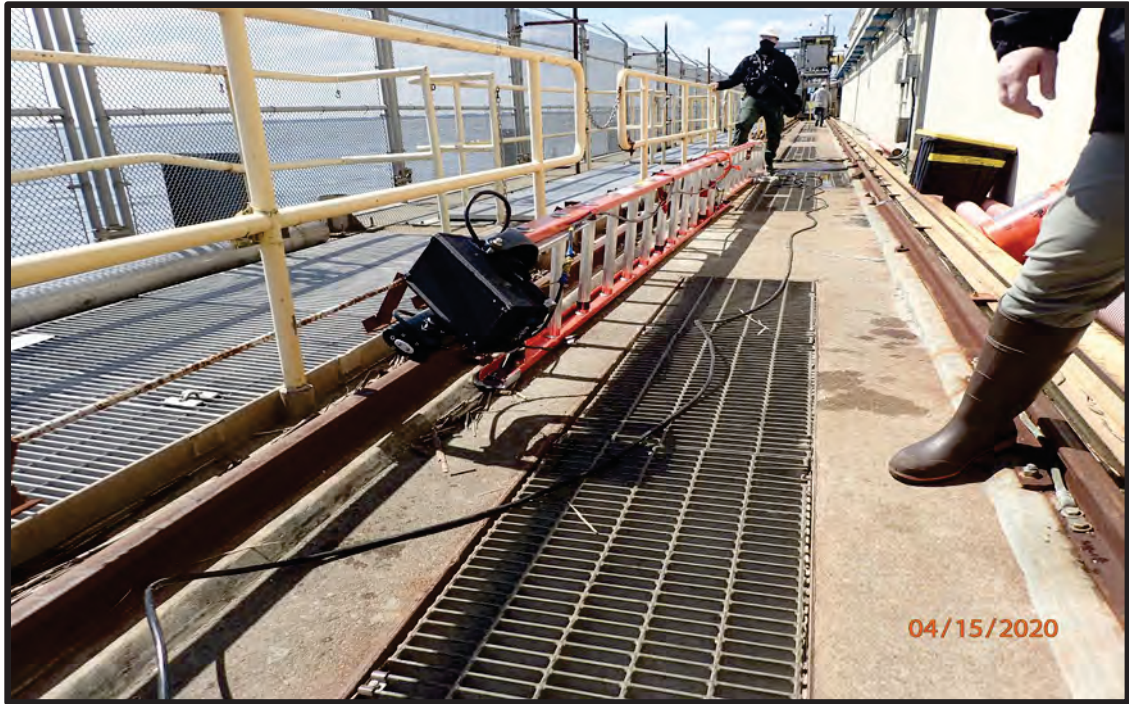
Photo 6: ARIS sonar with AR2 pan and tilt mounted on a ladder bracket prior to placement into bay.

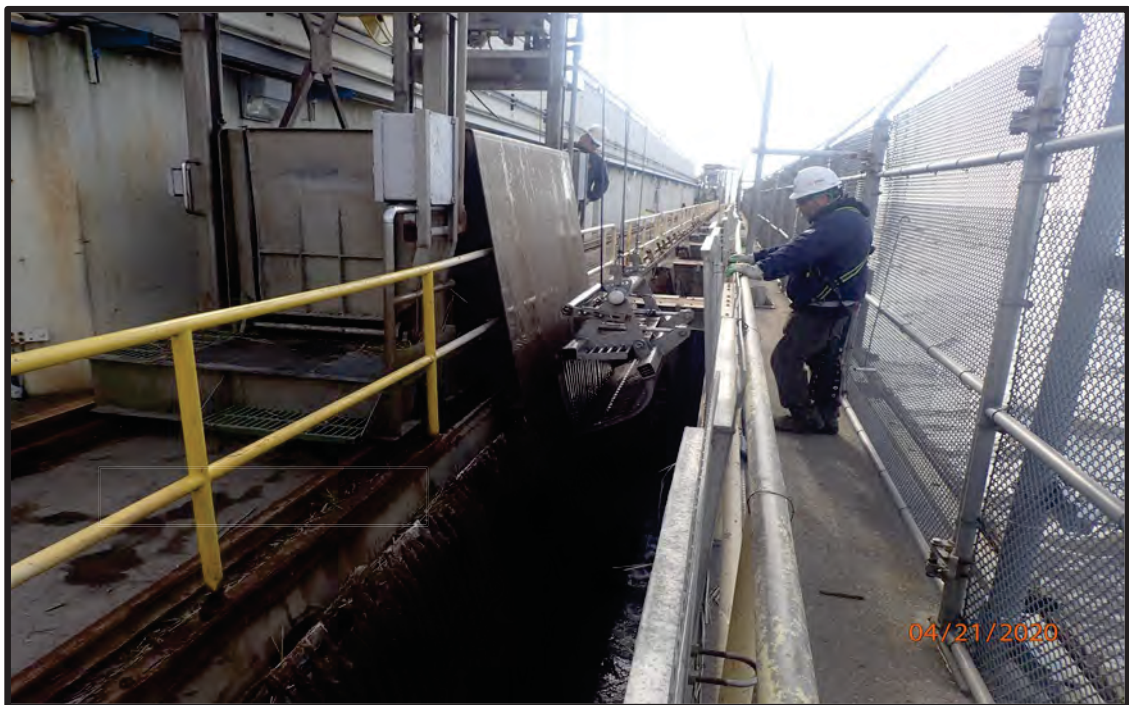
Photo 7: Trash rake operations at Unit 1; Day 3 prior to sonar testing.

Day 3 (April 21, 2020) continued the use of the ARIS system utilizing the same bracket configuration as Day 2. Imaging was conducted at Unit 1, at Bays 13A and 13B with circulating water pumps in full service. Refer to **Photos 7-10**.

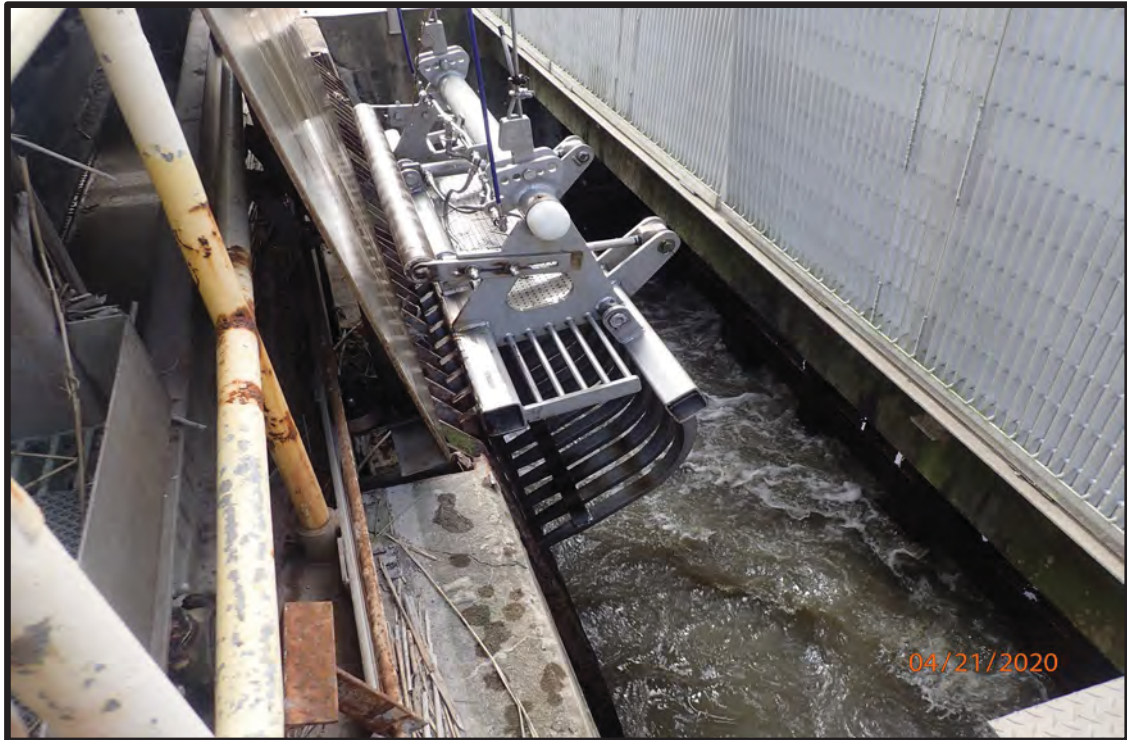
Photo 8: Trash rake being lowered into the water. Notice upwelling and turbulent flow prior to cleaning attempts.

Of additional note, trash rake operations and turbulent water flow were observed during the acoustic survey performed at Unit 1. At one-point, turbulent flow pushed the rake free of the trash rack and the rake collided with the ARIS sonar and bracket. Acoustic images using the ARIS were collected of the trash rack, but it was not possible to secure the bracket for viewing below the rake. It was also noted that two (2) Atlantic sturgeon were collected during raking operations on the same day of the survey.

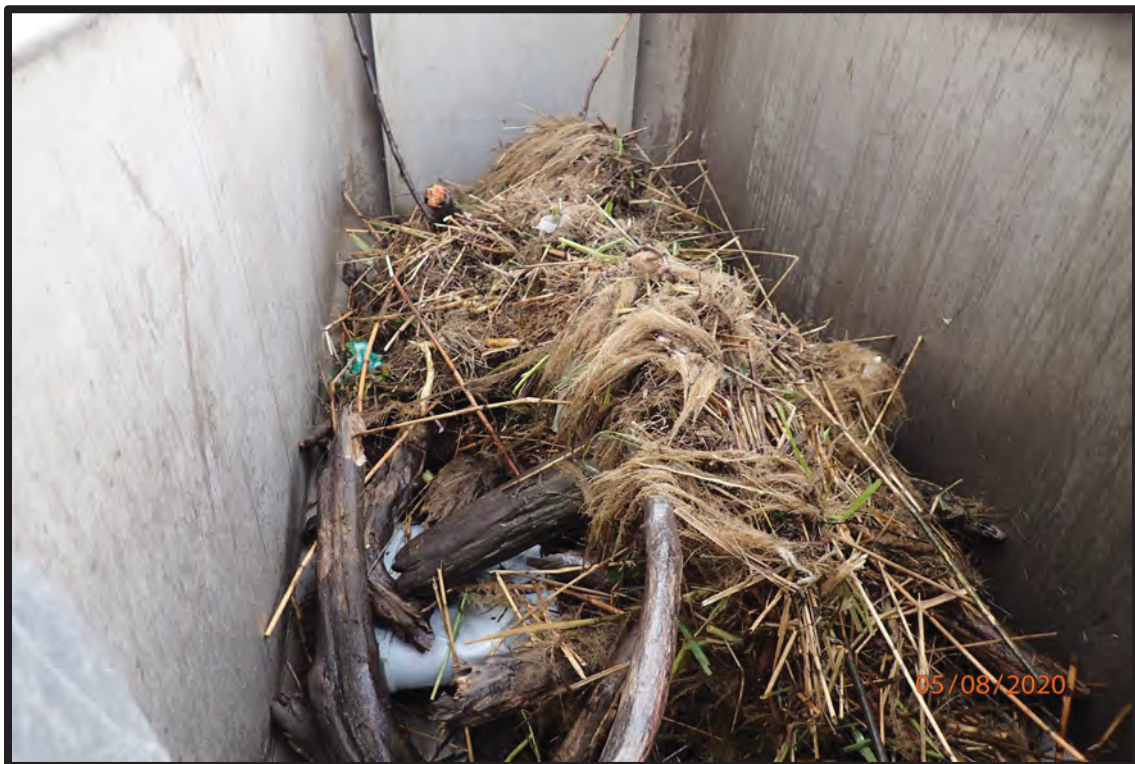
Photo 9: Typical detritus/debris collected during trash bar cleaning operations.

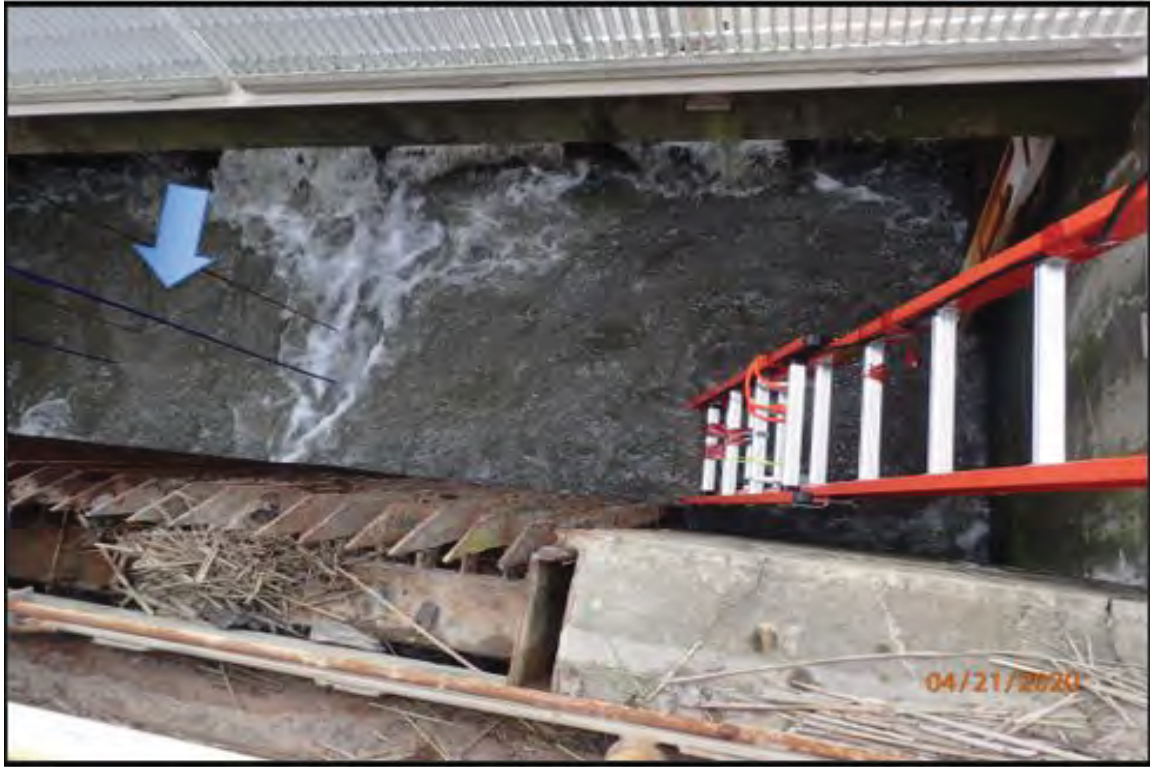
**Photo 10:** Sonar deployed at Unit 1 - 13B. Strong velocities affected ladder position. Sonar was able to collect data and observed biofouling and fish activity in the area of the trash bars. Arrow added to show localized flow after rake operations initiated.

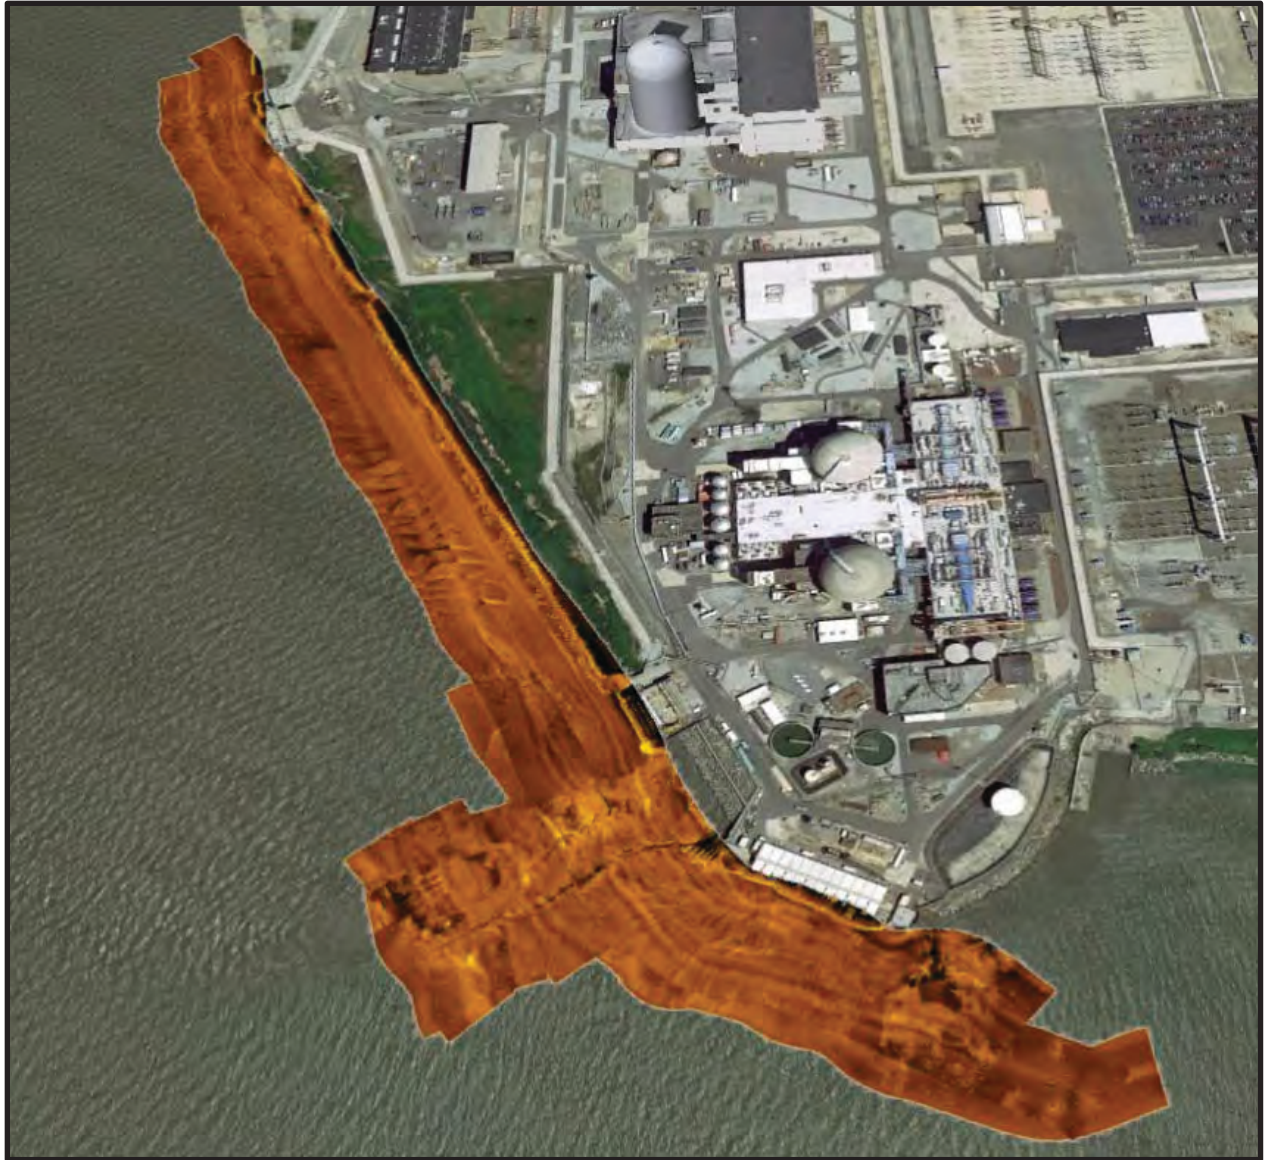
Figure 4.2: Sonar mosaic showing the area surveyed on April 17, 2020.

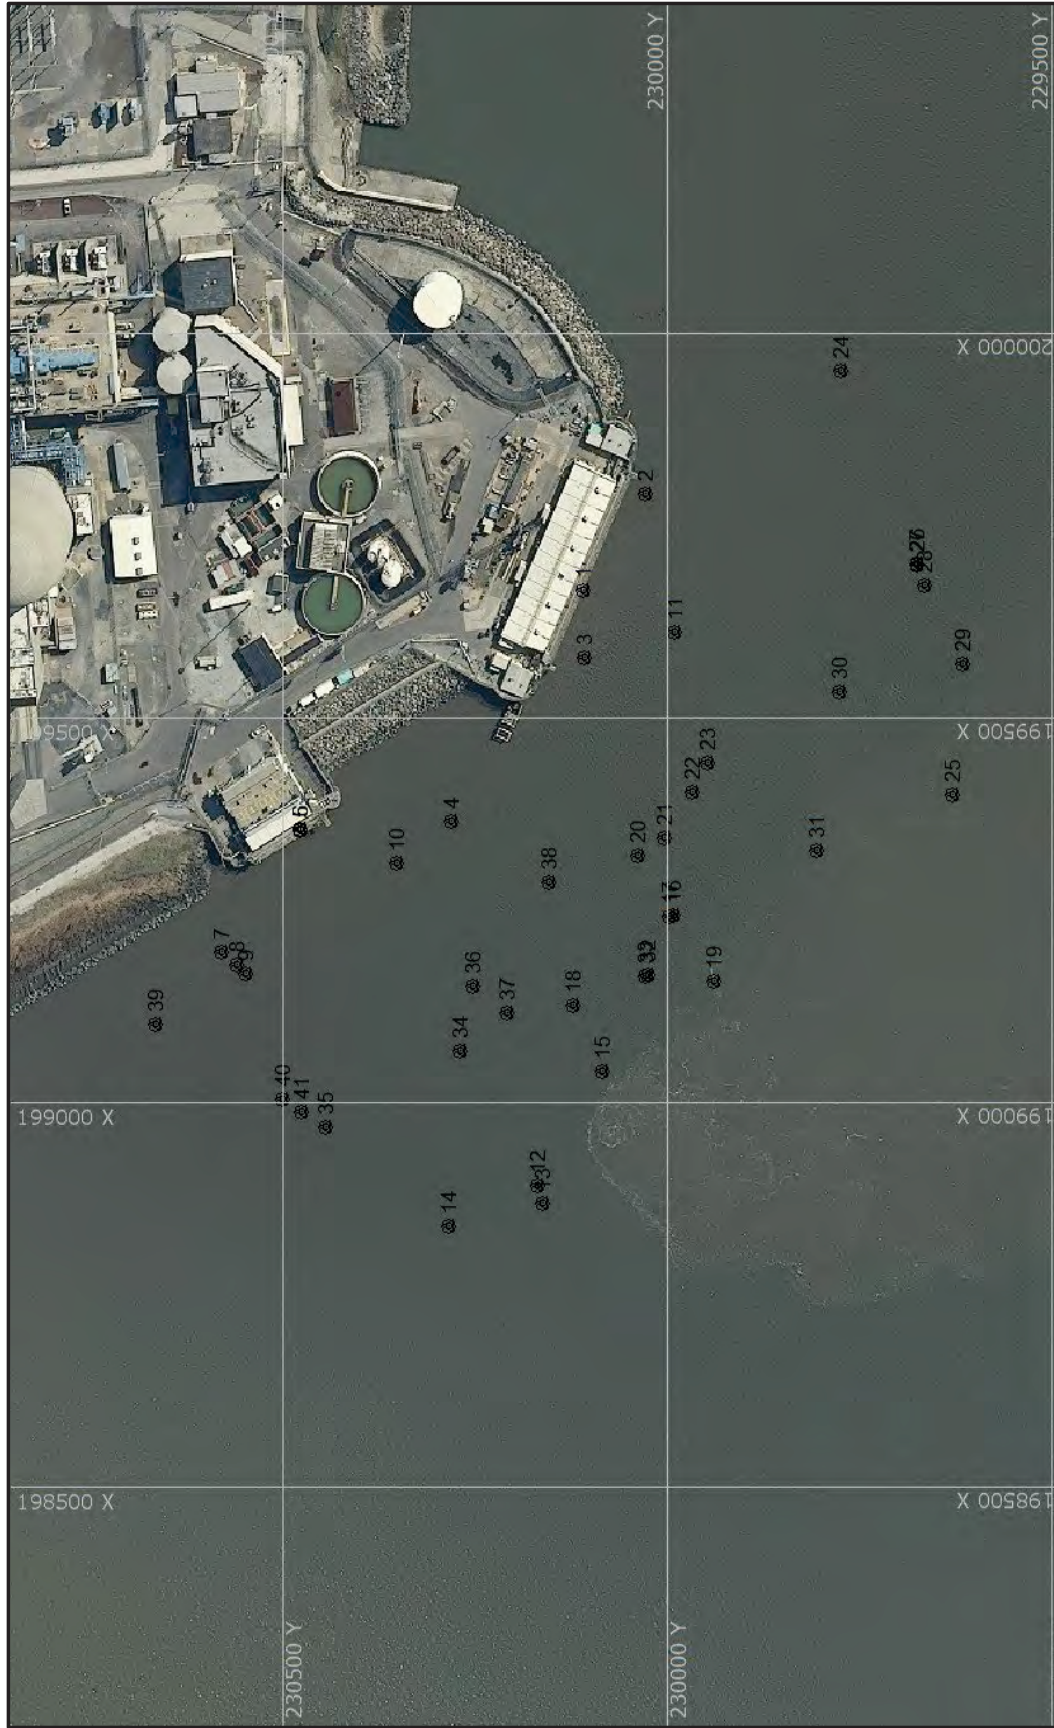
Possible sturgeon targets were scattered throughout the survey area (**Fig. 4.6**) and were not densely aggregated, as has been observed in other areas of the Delaware River (Comer et al., 2013). One possible sturgeon target was located close (0.83 m) to the CWS trash rack and two were close (1.17 and 2.17 m) to the SWS trash rack, but otherwise they did not show a particular association with structures, including the 48-inch screen wash water discharge pipe. With the exception of the close proximity of one sturgeon target to the CWS trash rack, no conditions that might explain the anomalous take were observed.

Figure 4.6. Locations of possible sturgeon targets in the vicinity of the Salem CWS and SWS intakes based on the side scan sonar survey conducted on April 17, 2020.
