ELECTRIC POWER
RESEARCH INSTITUTE

Materials Reliability Program Update

2020 EPRI-NRC Technical Exchange Meeting

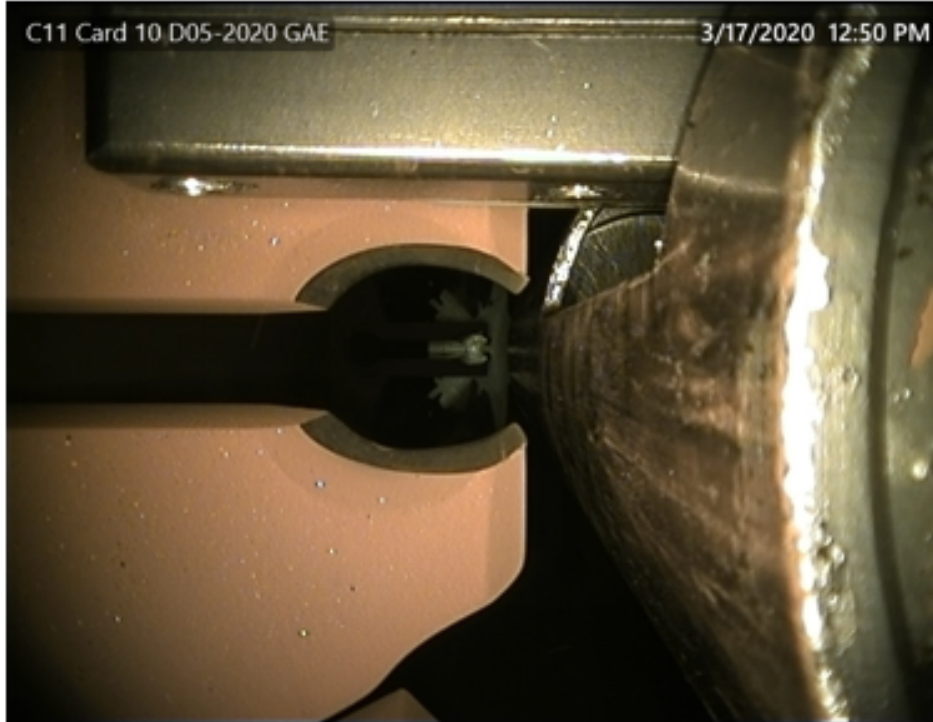
Example of ~91% Guide Card Wear

- US PWR initiated refueling outage in March 2020
 - PWR unit has operated for 29.6 EFPY (33.2 years)
- MRP-227-A inspections performed for guide card wear per industry interim guidance in MRP 2018-007 and WCAP-17451-P
- PWR unit has 17x17AS design CRGTs (ref.NSAL-17-1)
- PWR unit is considered a “high-flow” plant per WCAP-17451-P
- All lifetime wear to-date is with Chrome-plate RCCAs
- Six (6) CRGTs identified with wear in the “Yellow” zone in 2020
 - All 6 will need to be reinspected and perhaps replaced within 2-3 years
- Utility performed 2020 RCCA replacement with ion-nitrided rods which accelerates the predicted future wear by a factor of ≈ 3

- All observed wear occurred while using Chrome-plated RCCAs
- Utility currently plans to re-measure in fall 2021 refueling outage (18-month cycle)

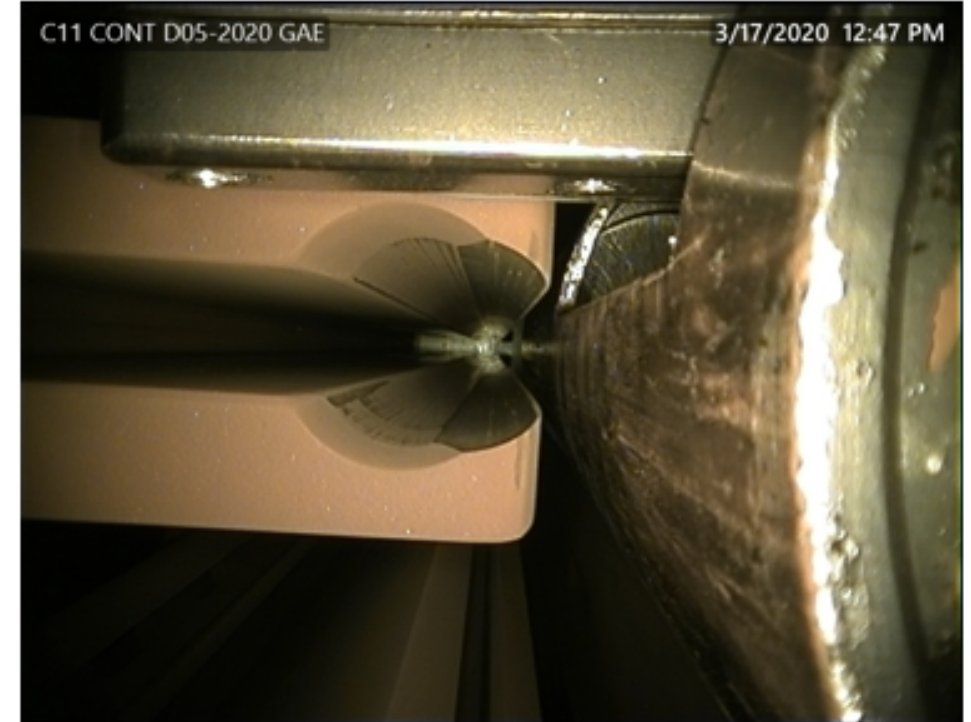
Example of ~61% Continuous Section Wear

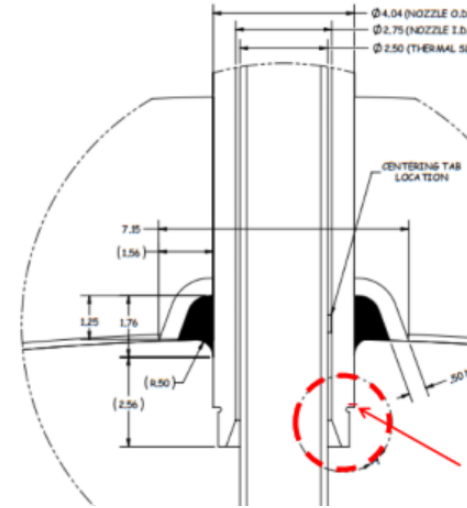
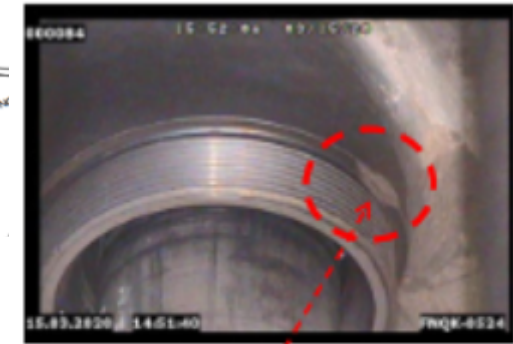
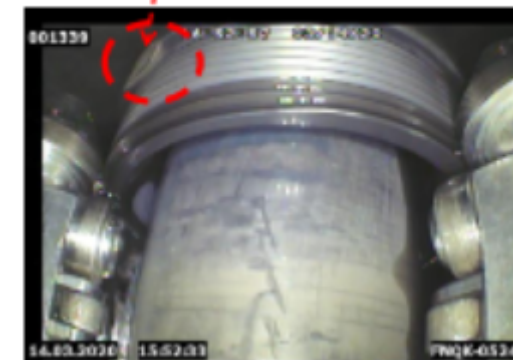
- New UT indication present in data for one nozzle, data analysis characterized as geometric in nature
- During the visual examination for thermal sleeve wear, a discernable, large “dent” was recognized on OD of CRDM (below the j-groove weld) which had the UT indication
- Determined that the “dent” was caused by equipment used during the previous outage scope where peening was applied to penetration tubes

UT results indicate a change in back-wall reflection and a typical TOFD response for an indication. Two separate images were captured for objective evidence to show geometric characteristics located on the OD.

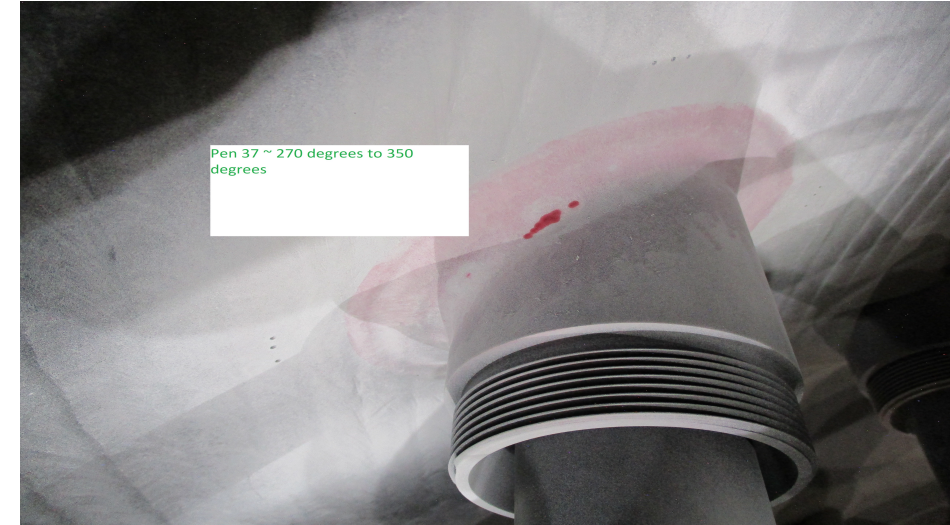
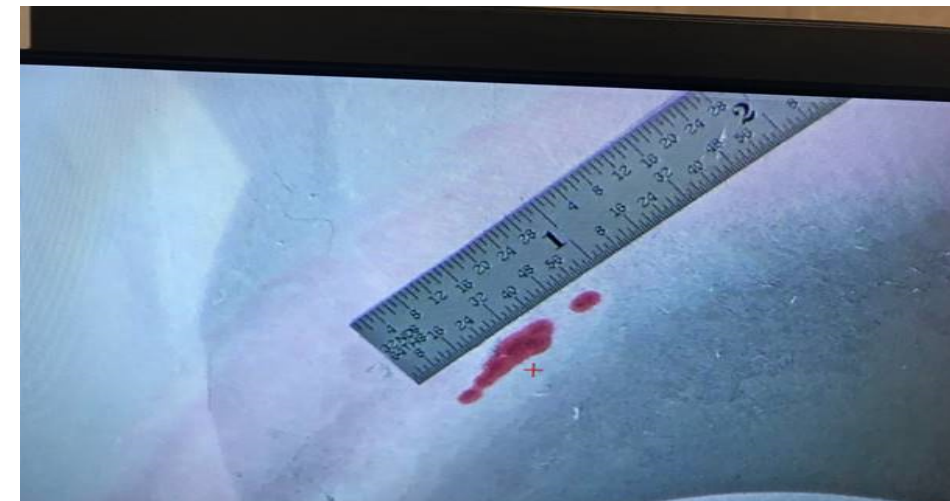
- US 3-Loop PWR
 - New UT indication present in data for one nozzle, data analysis characterized as PWSCC
 - Performed supplemental PT and confirmed surface breaking on OD
 - Embedded flaw repair mitigation technique successfully applied to component

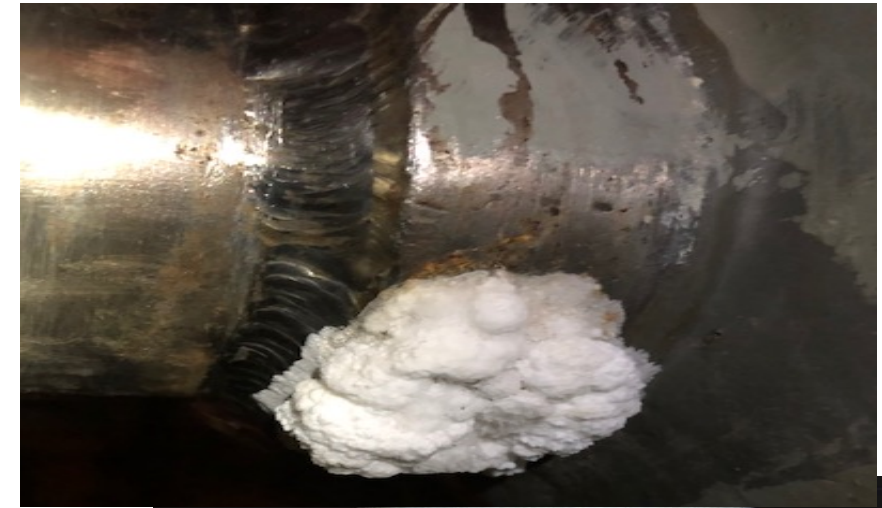
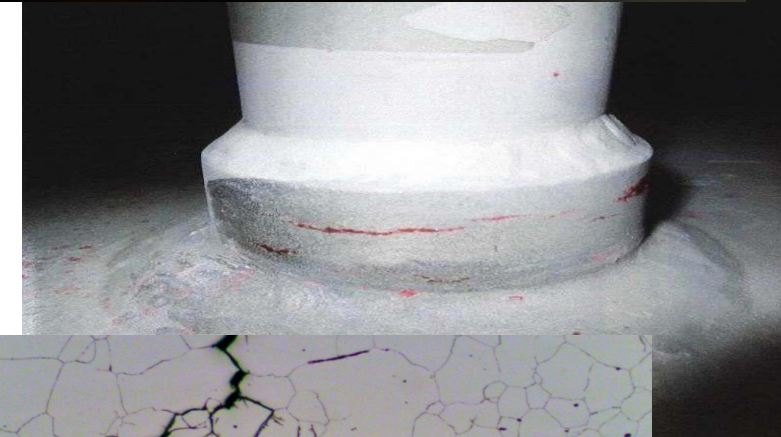
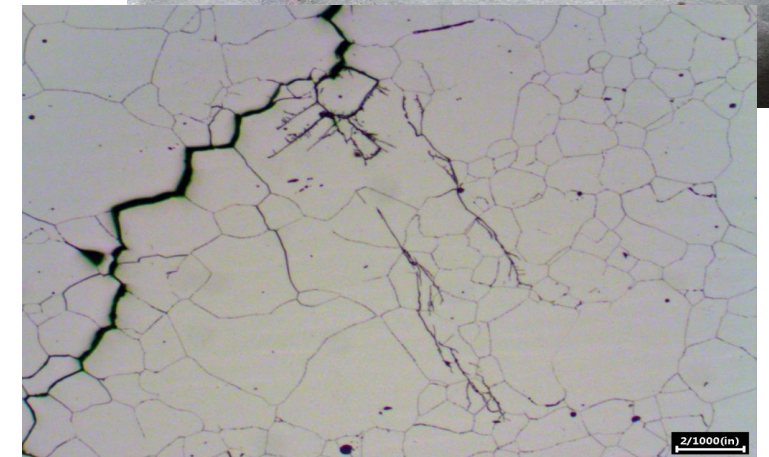
- US 4-Loop PWR
 - System walk down uncovered an active boric acid leak in a 2" nozzle
 - After surface cleaning, PT found have several circumferential indications
 - Extent of condition performed, PT and UT on all 1-inch and 2-inch nozzles
 - Replaced (4) - 2" nozzles
 - DA results – ODSCC caused by external leaking service water source containing Chlorides
