Electrical and I&C Components

Longer Term Operations

NRC Public Meeting

January 21, 2021

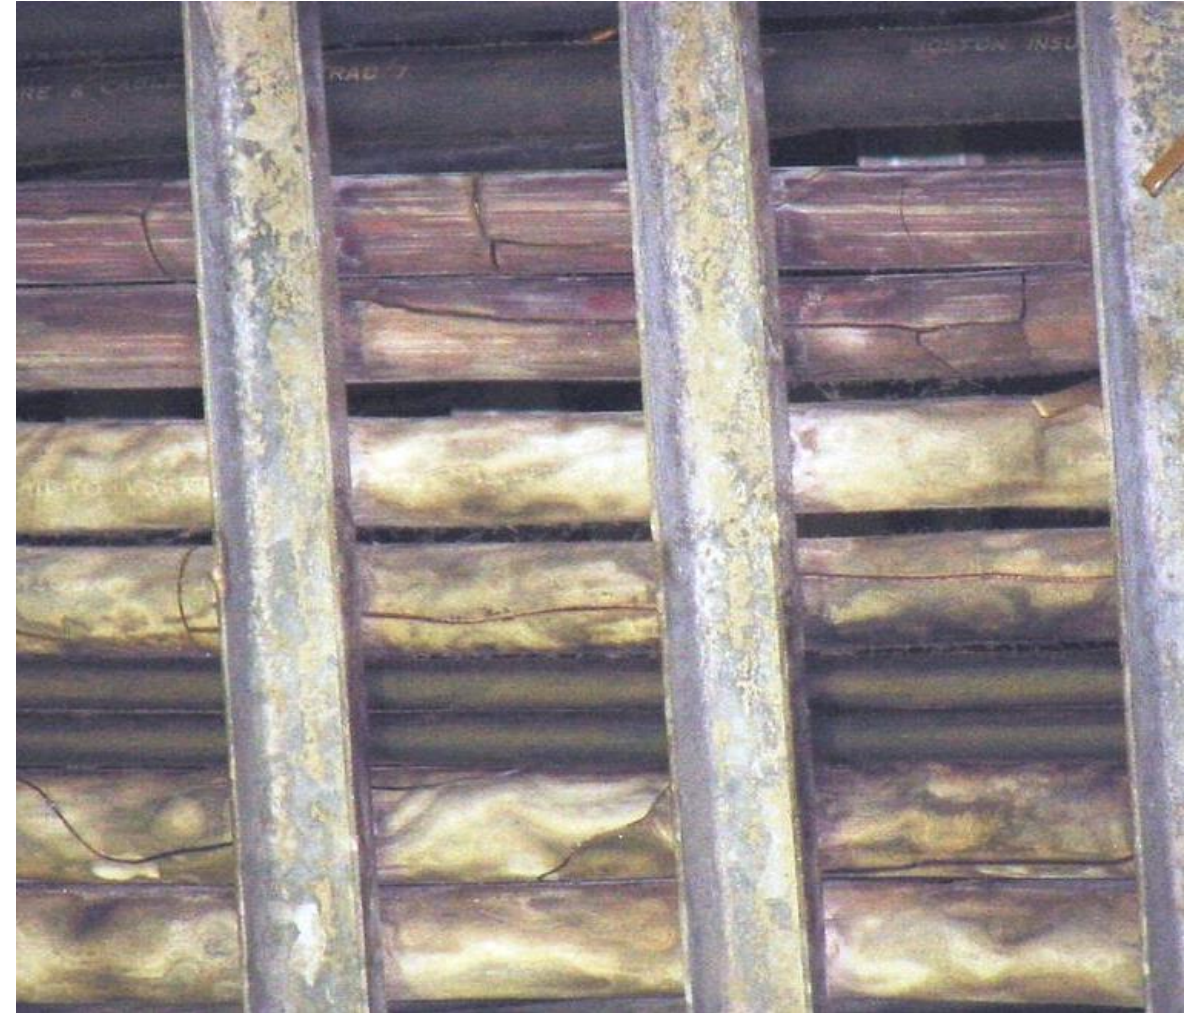
Thermal degradation showing that cables age based on both the environment and by polymer type. The cracked cable jacket is chloroprene; the black cable jacket is chloro-sulfonated polyethylene.

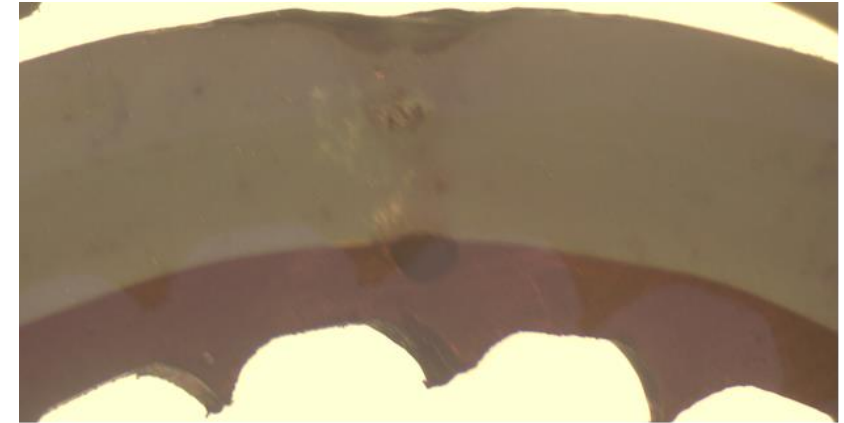
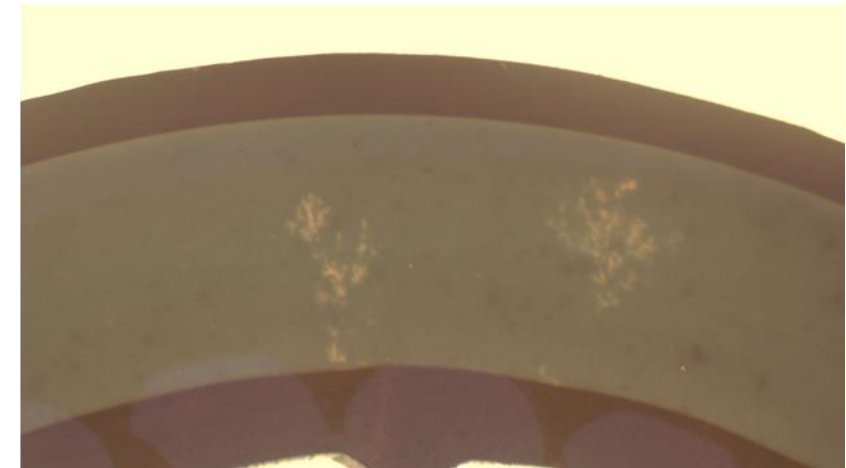
Water tree degradation of medium voltage cable insulation
