From: Strait, Kenneth A. <Kenneth.Strait@pseg.com>
Sent: Thursday, March 11, 2021 2:09 PM
To: incidental.take@noaa.gov; EndangeredSpecies Resource
Cc: jeanette.bowers@dep.nj.gov
Subject: [External_Sender] SALEM GENERATING STATION-INCIDENTAL TAKE OF STURGEON
Attachments: Sturgeon Incidental Take Report for 3102021.pdf; Sturgeon Incidental Take Report for 03102021 #2.pdf

Appendix C, Part 2A (Sturgeon)

Site of Collection: PSEG Salem Generating Station; Salem Circ-water trash basket

STURGEON DATA COLLECTION FORM

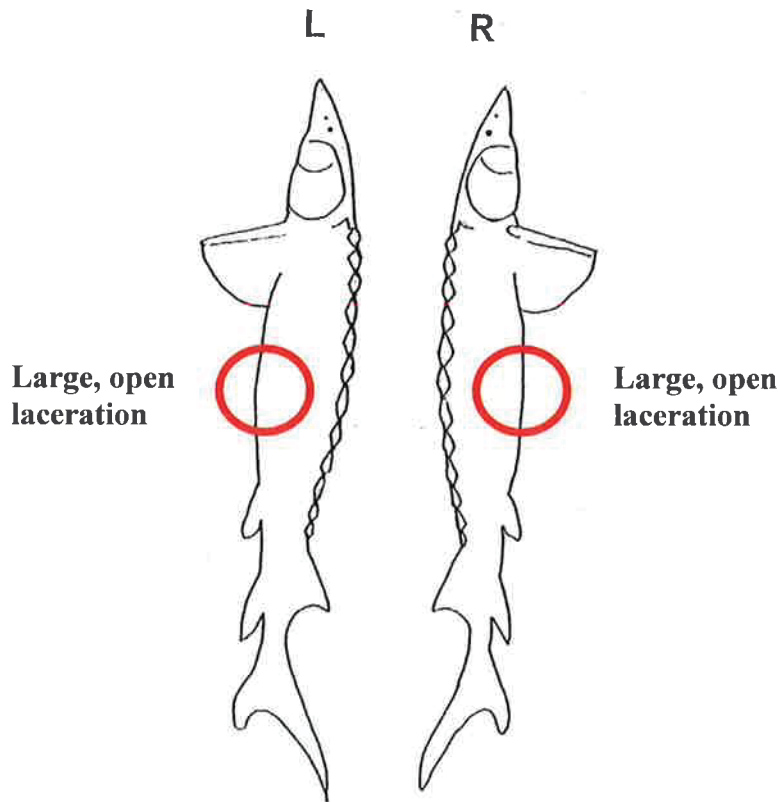
Describe any wounds / abnormalities (note tar or oil, gear or debris entanglement, propeller damage, etc.). **Please note if no wounds / abnormalities are found. Specimen was severely decomposed at the time of collection, as indicated by missing eyes, degraded dorsal, anal, and caudal fins, and exposed areas of bone on the head. A large, open ventral laceration exposing flesh and internal organs was located approximately mid-torso (refer to diagram above).**

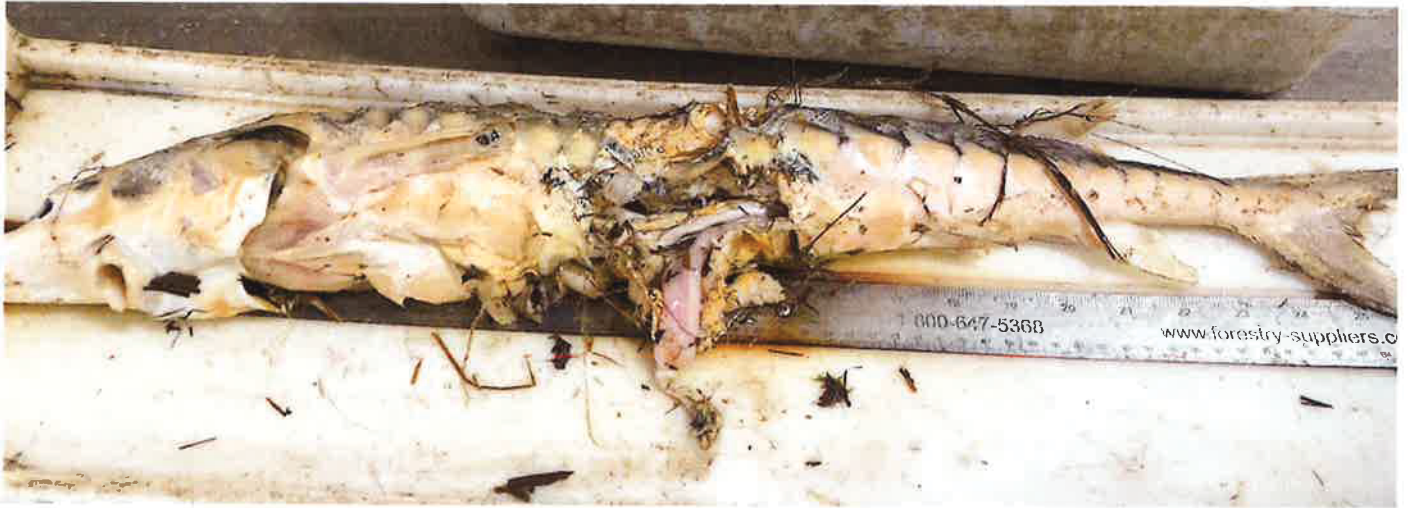
A dorsolateral view showing the size and condition of the deceased Atlantic sturgeon (*Acipenser oxyrinchus*), retrieved at approximately 09:30am on 03/10/2021 from the Salem Circulating Water Intake trash collection basket by Salem Yard Crew personnel during routine trash rack cleaning at Salem Nuclear Generating Station (03/10/2021).

Comments: A deceased and severely decomposed Atlantic sturgeon was collected from the Salem Circulating Water Intake Structure during routine trash rack cleaning on 03/10/21, at 09:30am. After positive identification was made by Environmental Consulting Services personnel, the specimen was measured, photographed, and inspected for tags. No evidence of external tags was found, and no existing PIT tags were indicated. A pelvic fin clip was also collected for future DNA analysis. Upon completion of processing, the specimen was placed on ice and prepared for transport back to the ECSI main office, where it will be stored under refrigeration, awaiting direction on further disposition. The fin clip sample has been stored in refrigeration and will be held for aggregated shipment to a designated laboratory.

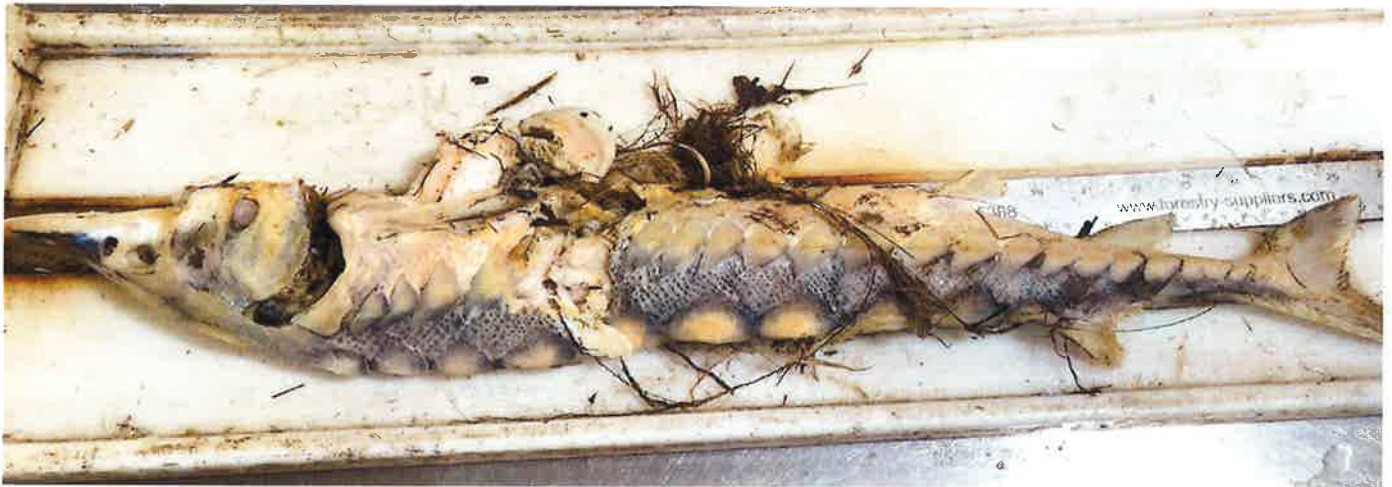
A dorsolateral view of the right side of the specimen, showing evidence of severe decomposition, particularly in the area of the head and on all the major fins. An existing large, open laceration exposing flesh and internal organs, was located at approximately mid-torso on the carcass (03/10/2021).

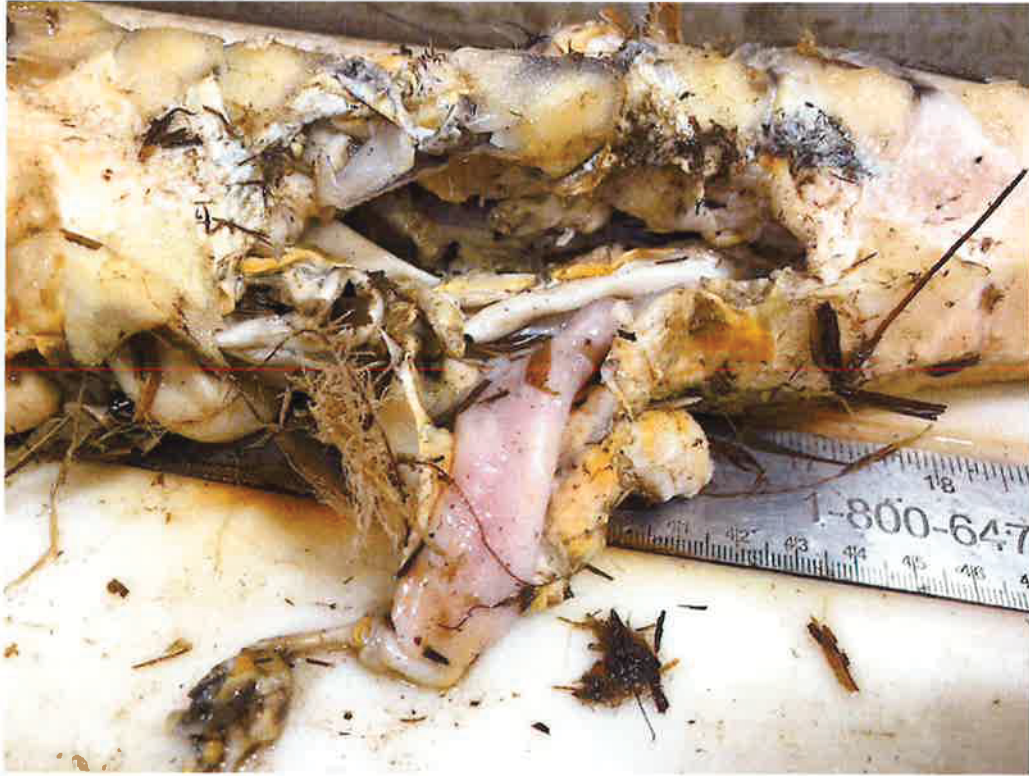
A close-up view of the ventral laceration described in the previous image (03/10/2021).

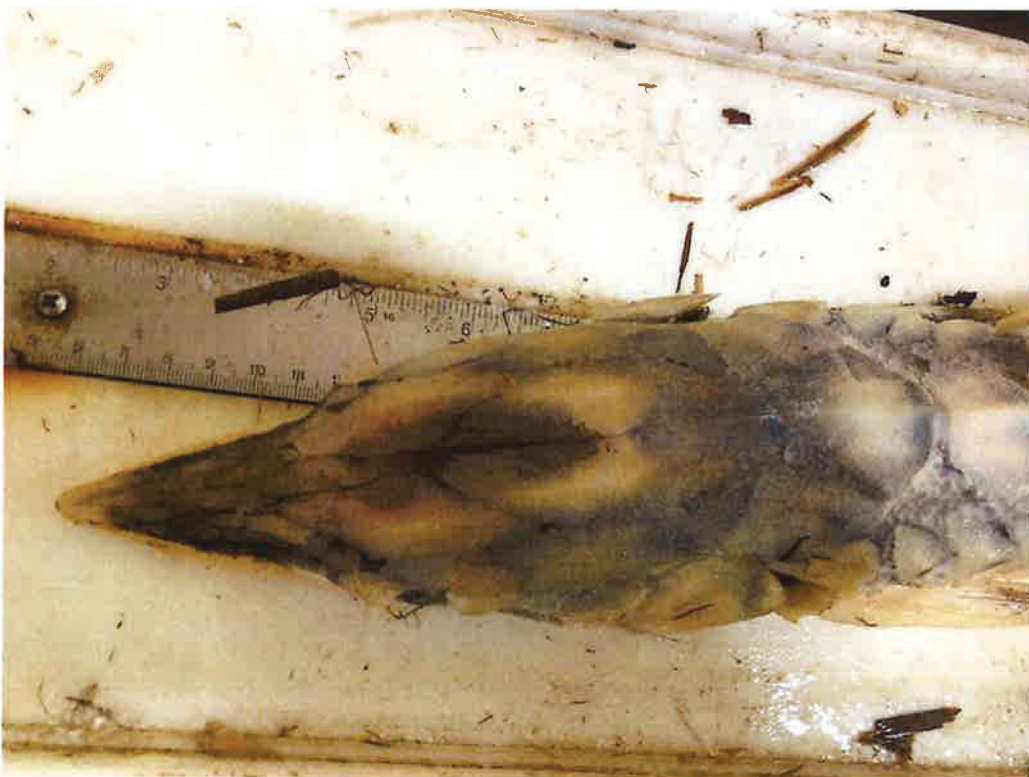
A close-up view of the head, showing the characteristic elongated rostrum, as well as evidence of the effects of prolonged decomposition (03/10/2021).

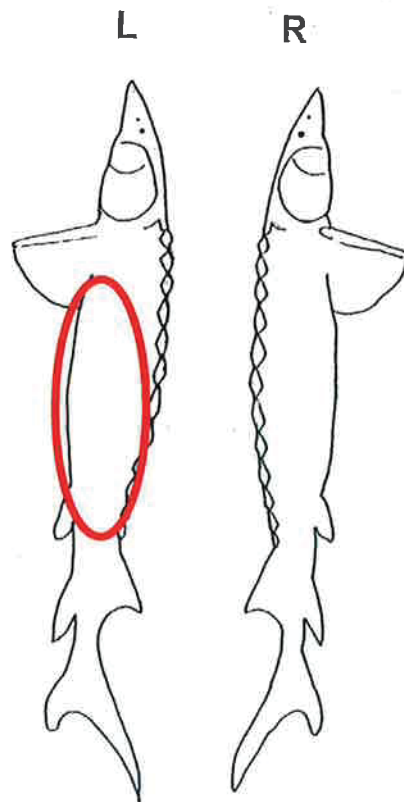
Evidence of surface bruising and slight decomposition on left side of torso.

Describe any wounds / abnormalities (note tar or oil, gear or debris entanglement, propeller damage, etc.). **Please note if no wounds / abnormalities are found. Specimen was deceased at the time of collection, with evidence of surface bruising and slight decomposition observed on the left side of the torso. No additional wounds or damage was observed that would indicate a cause of death (refer to diagram above).**

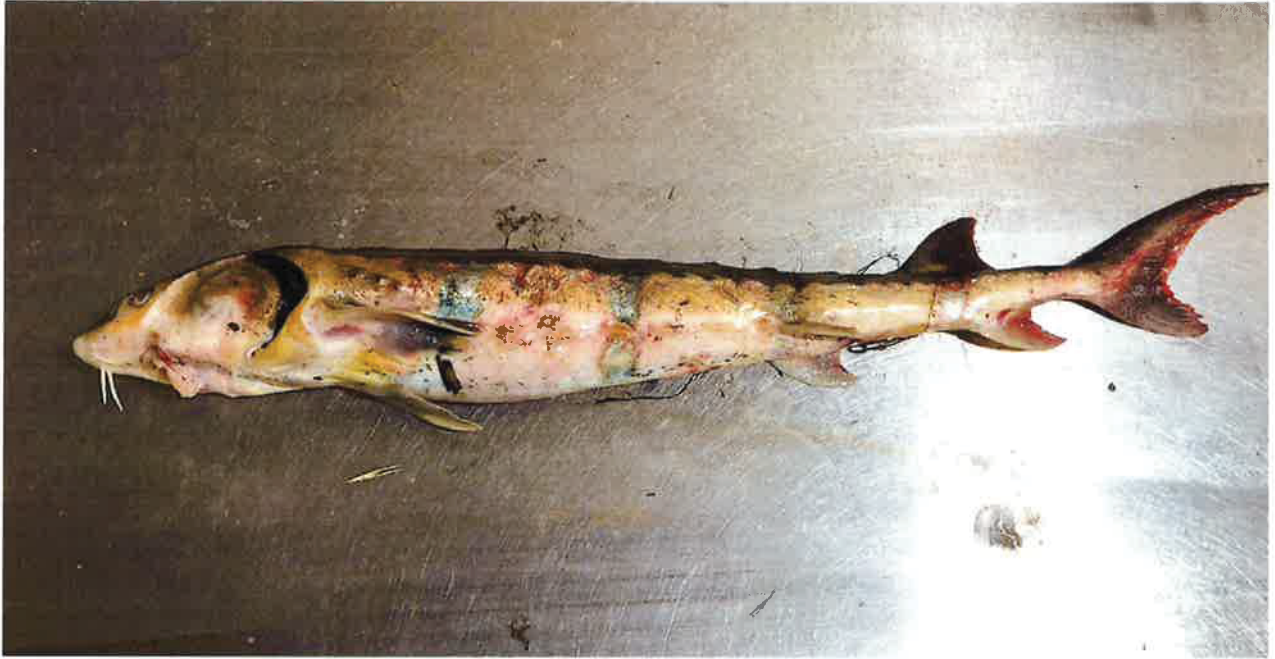
A dorsolateral view showing the size and condition of the deceased shortnose sturgeon (*Acipenser brevirostrum*), retrieved at approximately 14:45pm on 03/10/2021 from the Salem Circulating Water Intake trash collection basket by Salem Yard Crew personnel during routine trash rack cleaning at Salem Nuclear Generating Station (03/10/2021).

Comments: A deceased shortnose sturgeon was collected from the Salem Circulating Water Intake Structure during routine trash rack cleaning on 03/10/21, at 14:45pm. After positive identification was made by Environmental Consulting Services personnel, the specimen was measured, photographed, and inspected for tags. No evidence of external tags was found, and no existing PIT tags were indicated. A pelvic fin clip was also collected for future DNA analysis. Upon completion of processing, the specimen was placed on ice and prepared for transport back to the ECSI main office, where it will be stored under refrigeration, awaiting direction on further disposition. The fin clip sample has been stored in refrigeration and will be held for aggregated shipment to a designated laboratory.

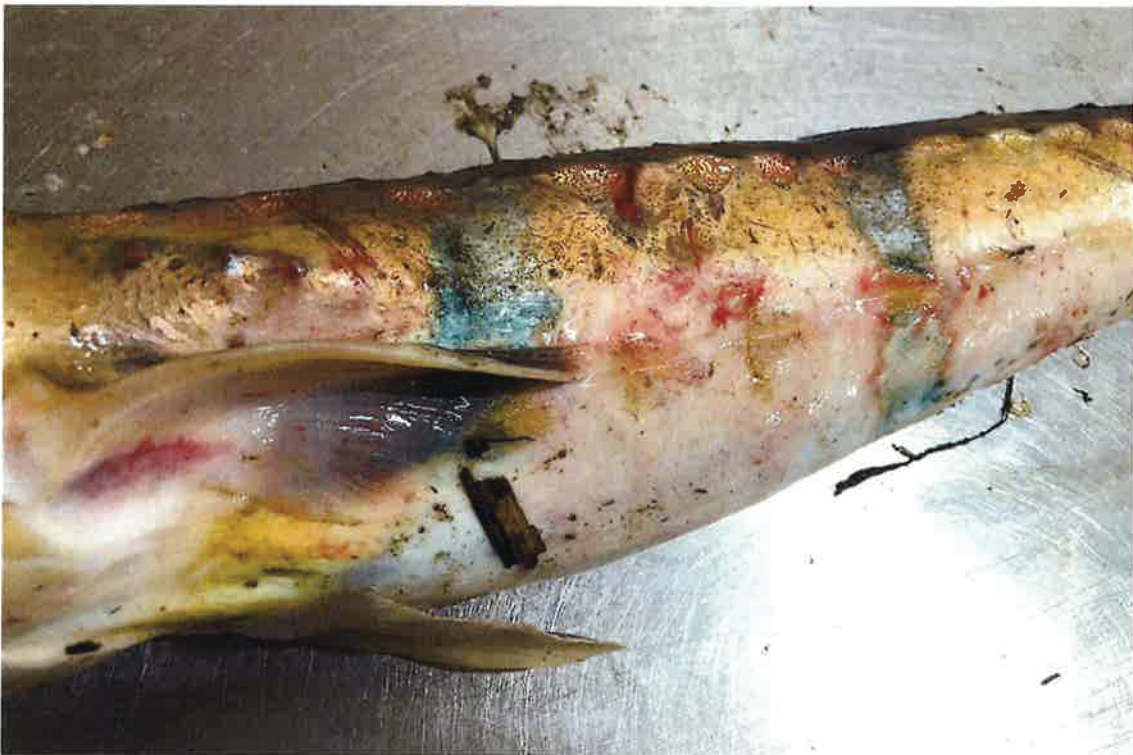
A close-up view of the surface bruising and slight decomposition observed on the left side of the torso of the specimen (03/10/2021).

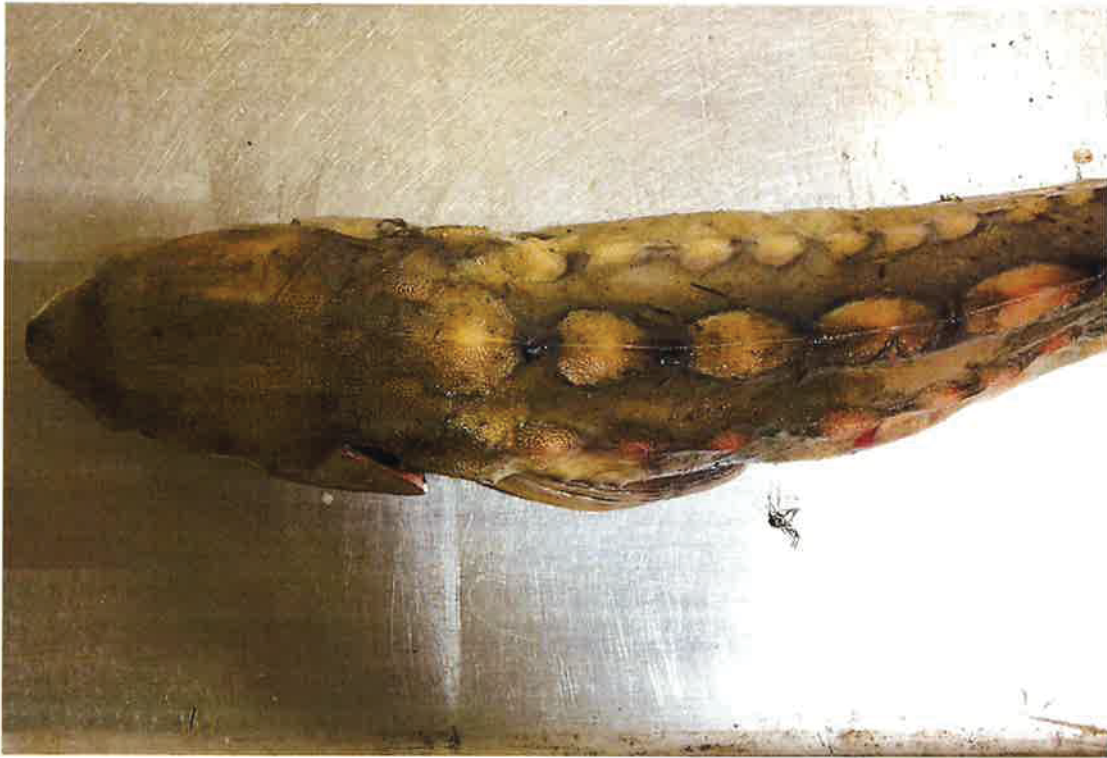
A dorsal view of the specimen, showing the characteristic shortened rostrum (03/10/2021)

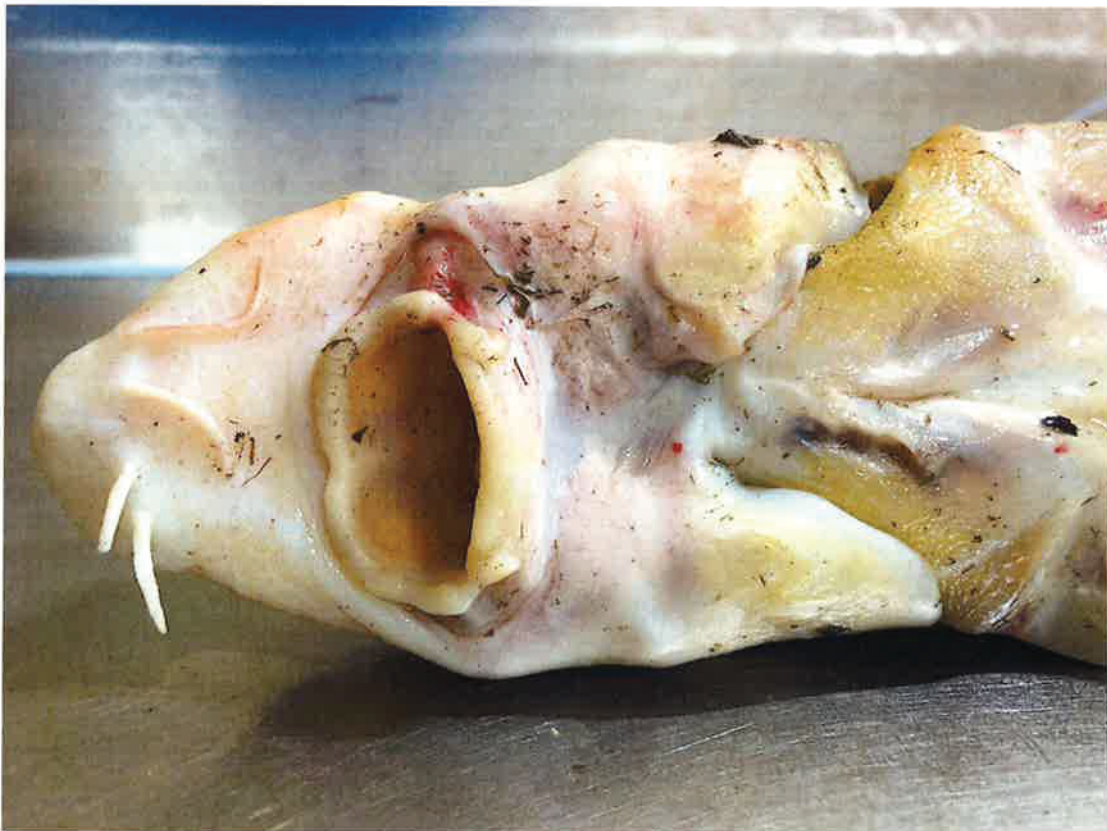
A ventral view of the head showing the shortened rostrum and the characteristic large mouth (03/10/2021)
