HEAF CABLE FRAGILITY TESTING AT THE SOLAR FURNACE AT THE NATIONAL SOLAR THERMAL TEST FACILITY

Experimental Results

Sandia National Laboratories

SAND2021-11327

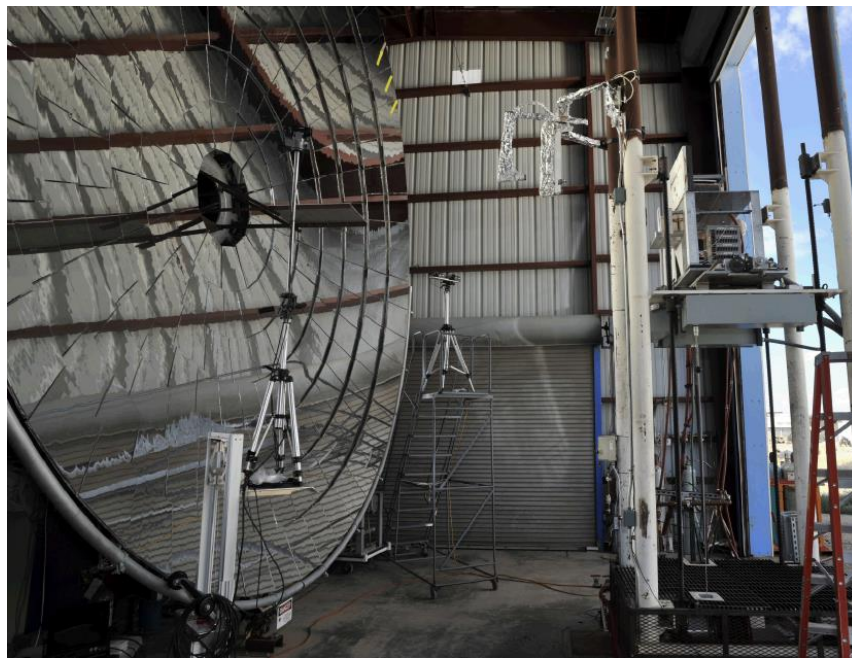
Figure 1-5: Parabolic Dish at the Solar Furnace

The fragility test series were performed at the Solar Furnace at the National Solar Thermal Test Facility at Sandia National Laboratories in Albuquerque, New Mexico. The Solar Furnace concentrates sunlight to generate intense thermal environments reaching $6 \text{ MW}/\text{m}^2$ on a spot roughly $\sim 5 \text{ cm}$ in diameter. Figure 1-4 and Figure 1-5 show the components of the solar furnace that reflect the sun and focus the sunlight onto the test article. A heliostat uses flat mirrors with a total reflective surface area of 55 m^2 to reflect the sunlight through an attenuator onto a large reflective parabolic dish. The parabolic dish concentrates the sunlight with 228 individually aligned mirrors [2].

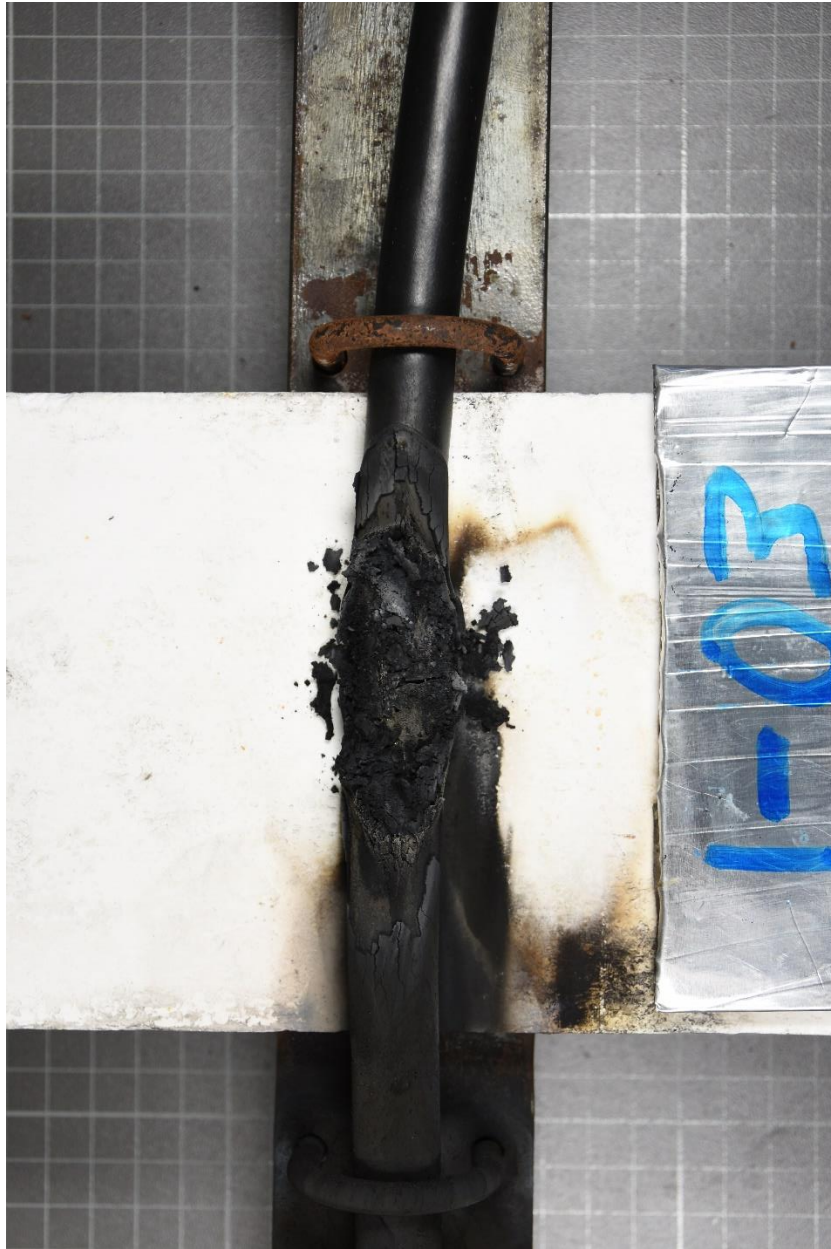
Figure 3-9: Test 1-03 Post-test Photo (1)

Figure 3-9 and Figure 3-10 show the target cable after the exposure profile. As shown, the insulated wires under the jacket were exposed during this test.

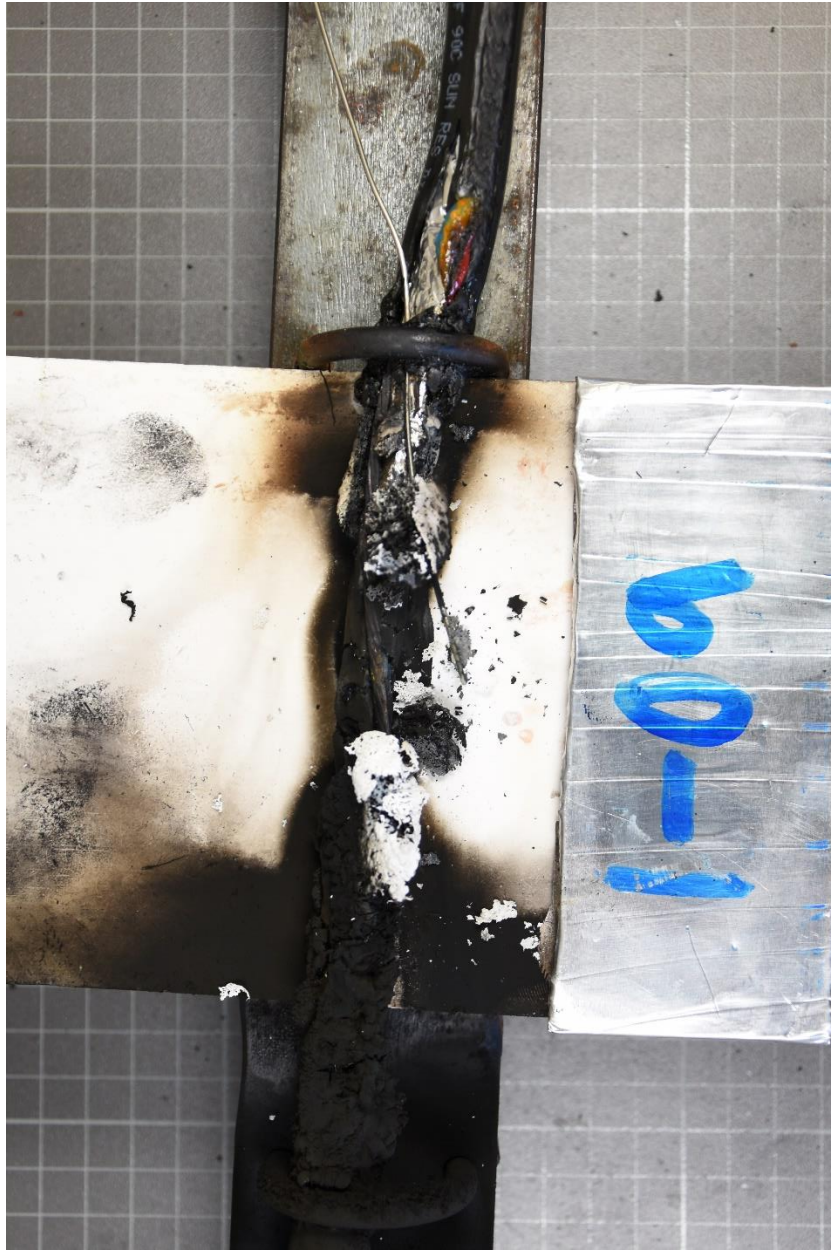
Figure 3-36: Test 1-09 Post-test Photo (1)

Figure 3-36 and Figure 3-37 show the target cable after the exposure profile. As shown, the insulated wires under the jacket were exposed during this test. Also, it appears that there is damage to the insulation, exposing bare wire.

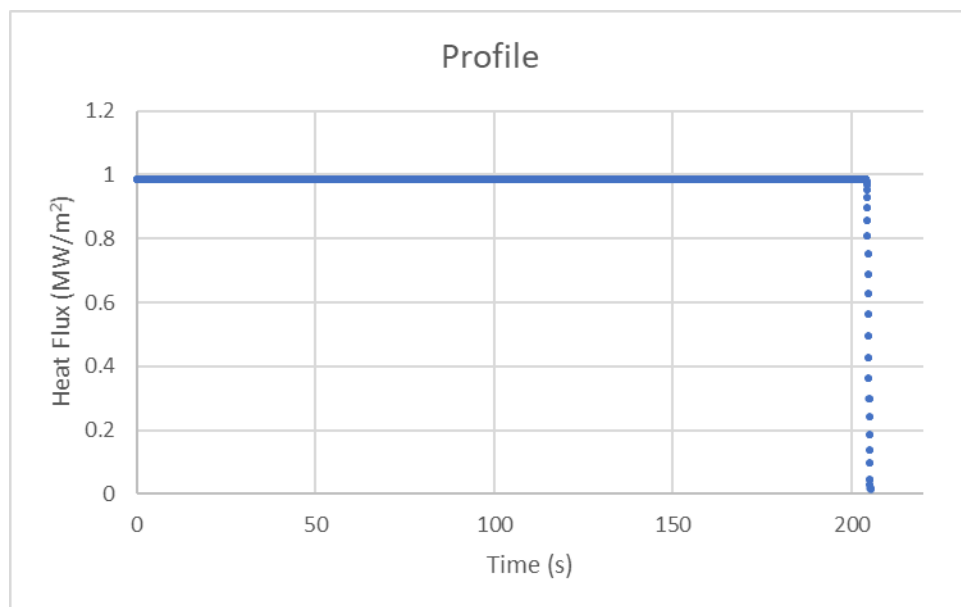
Figure 3-38: Test 1-10 Heat Flux Profile

Figure 3-38 and Figure 3-39 show the heat flux profile and total energy for which the cable target was exposed. As shown, a constant heat flux of 1 MW/m^2 was applied for a longer duration to evaluate electrical failure of the cable. The cable target was exposed to a total of approximately 202 MJ/m^2 .

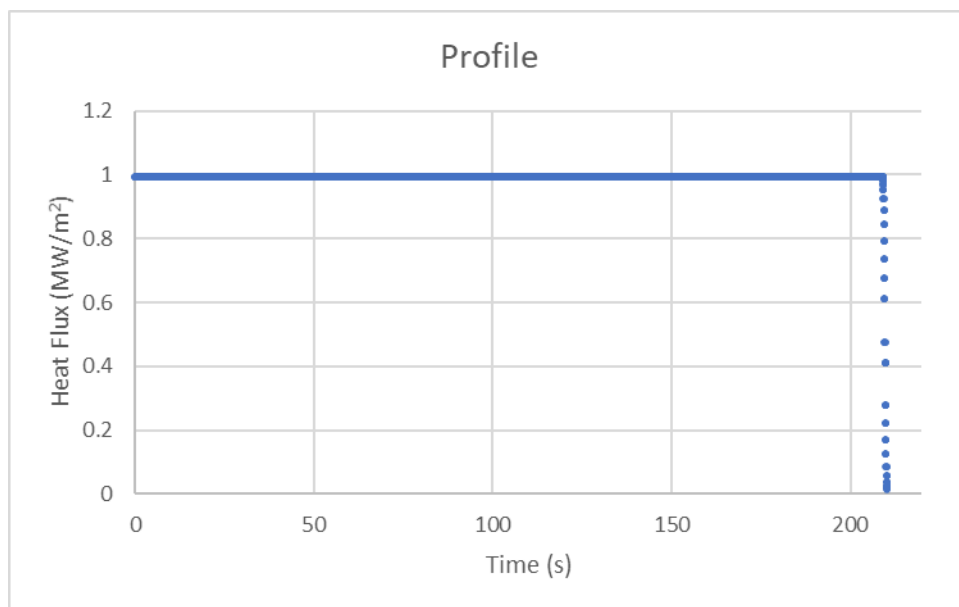
Figure 3-43: Test 1-11 Heat Flux Profile

Figure 3-43 and Figure 3-44 show the heat flux profile and total energy for which the cable target was exposed. As shown, a constant heat flux of 1 MW/m^2 was applied for a longer duration to evaluate the sub-jacket temperature of the cable. The cable target was exposed to a total of approximately 208 MJ/m^2 .

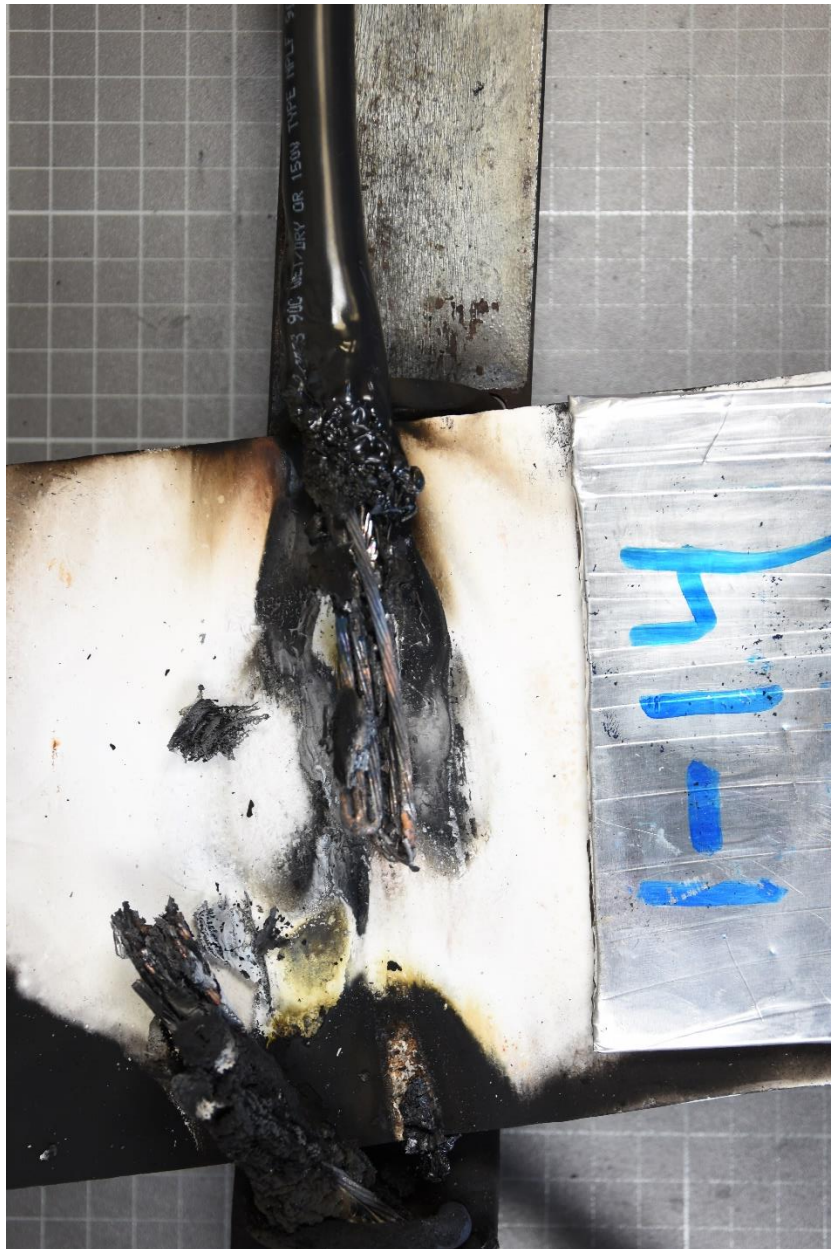
Figure 3-58: Test 1-14 Post-test Photo

Figure 3-58 shows the target cable after the exposure profile. As shown, the jacket and insulation are completely ablated, and the inner wires were separated. The cables were severed during the test exposure.

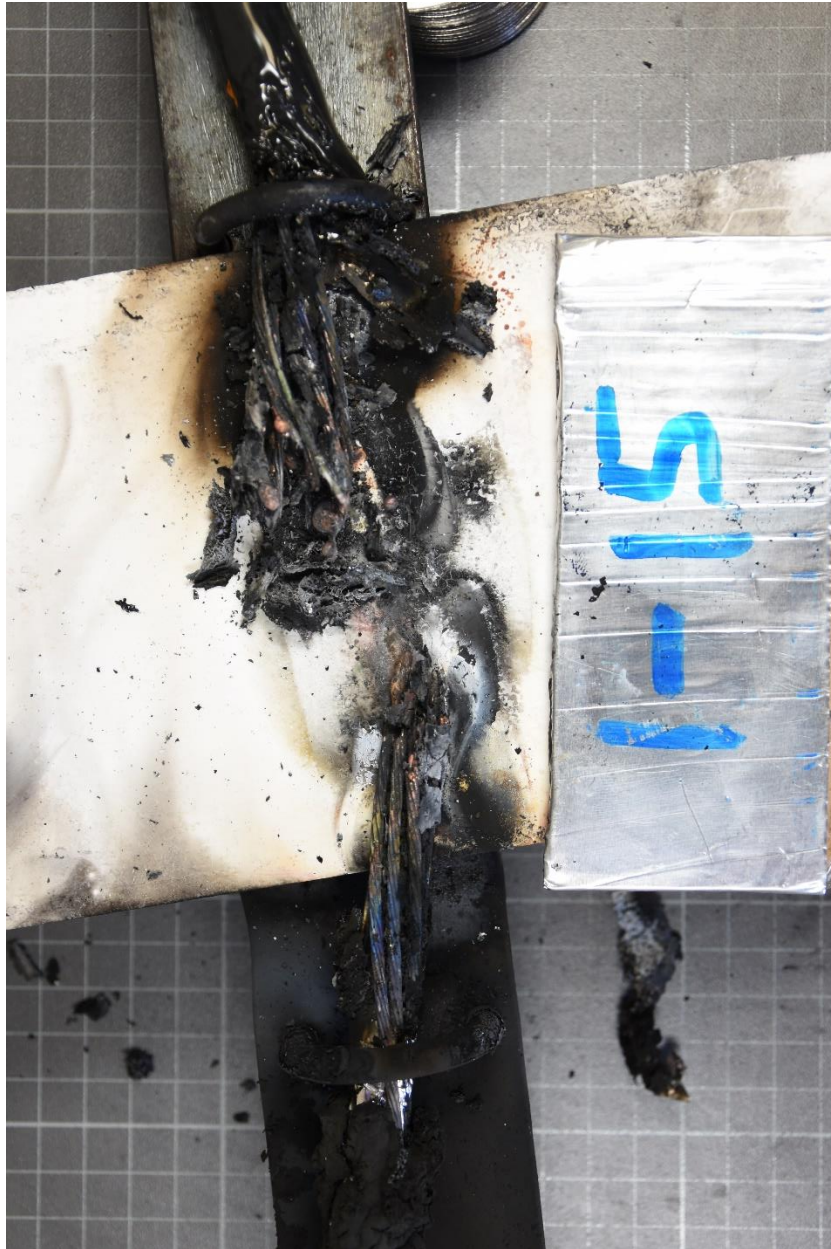
Figure 3-62: Test 1-15 Post-test Photo

Figure 3-62 shows the target cable after the exposure profile. As shown, the jacket and insulation are completely ablated, and the inner wires were separated. The cables were severed during the test exposure.

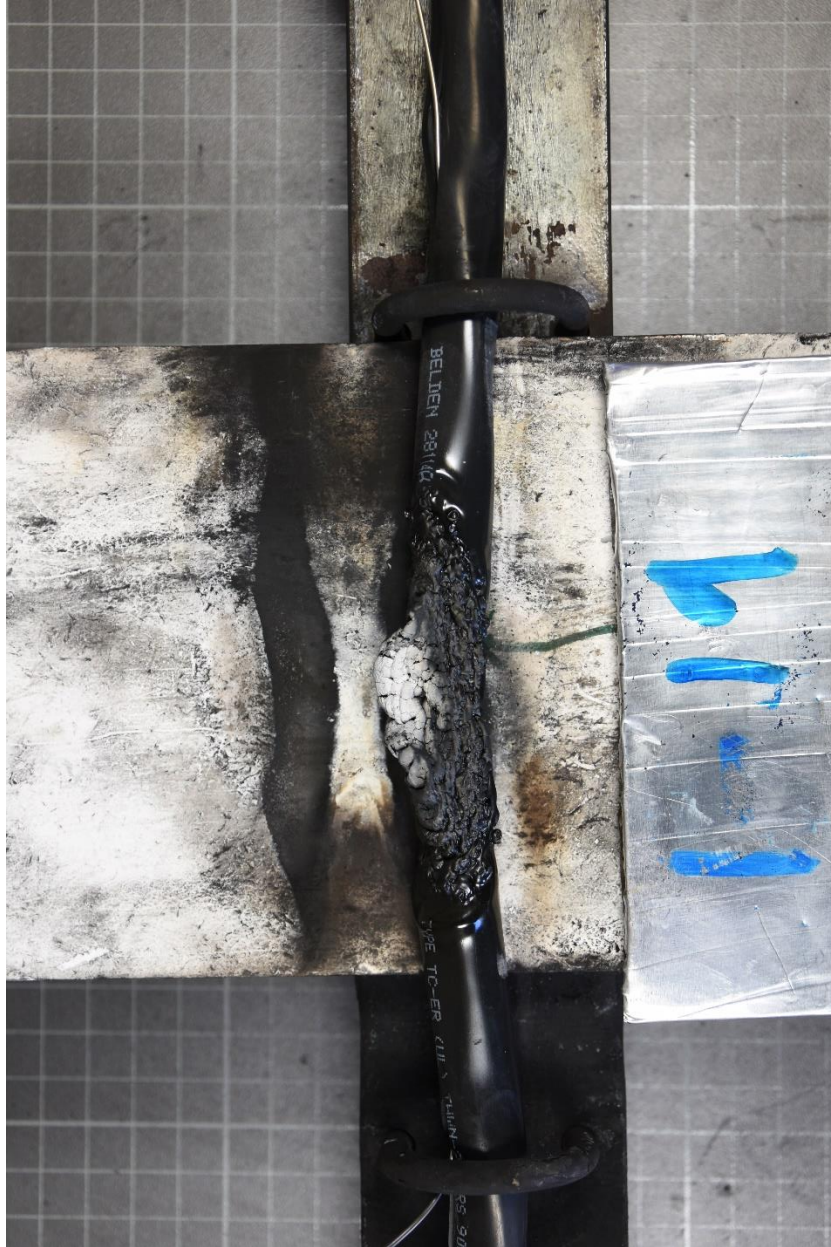
Figure 3-81: Test 1-19 Post-test Photo (1)

Figure 3-81 and Figure 3-82 show the target cable after the exposure profile. As shown, surface damage to the jacket is present. However, the insulated wires were not exposed during this test.

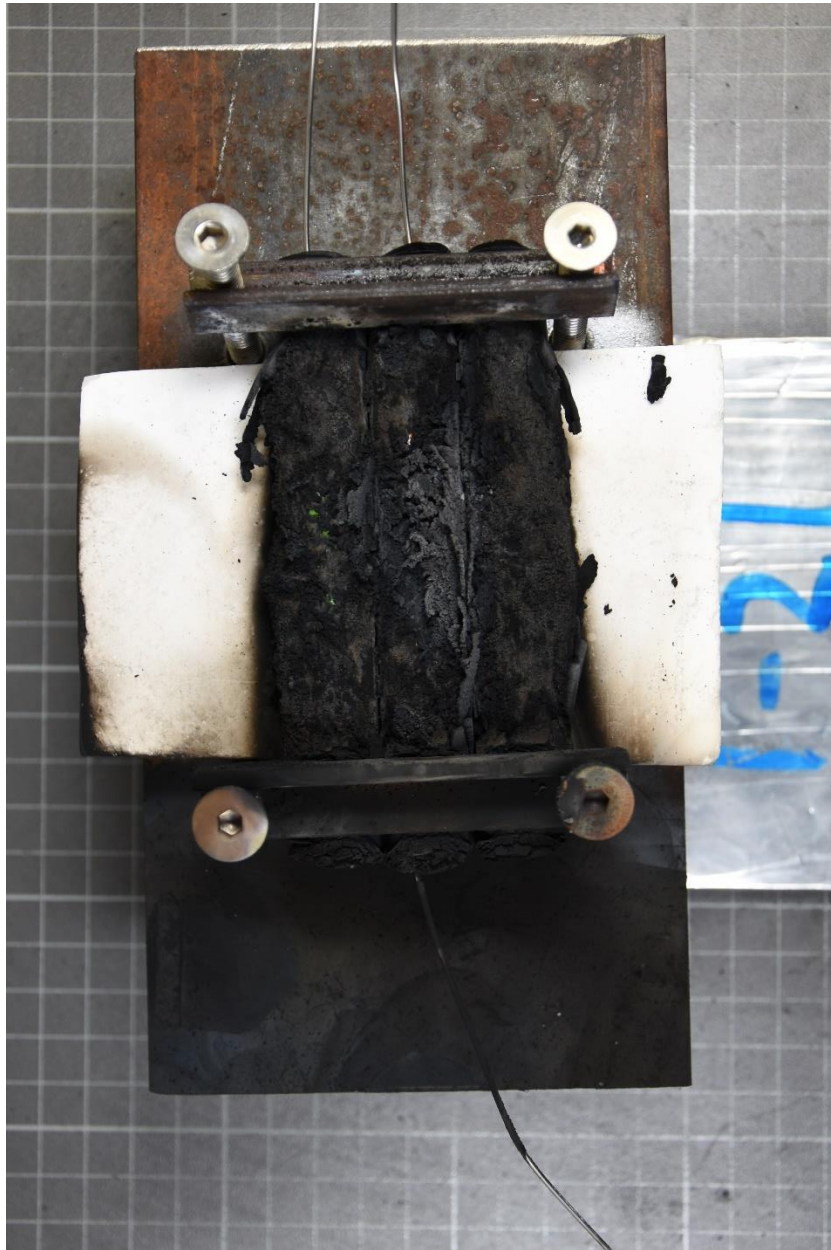
Figure 3-91: Test 1-21 Post-test Photo (1)

Figure 3-91 and Figure 3-92 show the target cable after the exposure profile. As shown, the insulated wires under the jacket were exposed during this test.

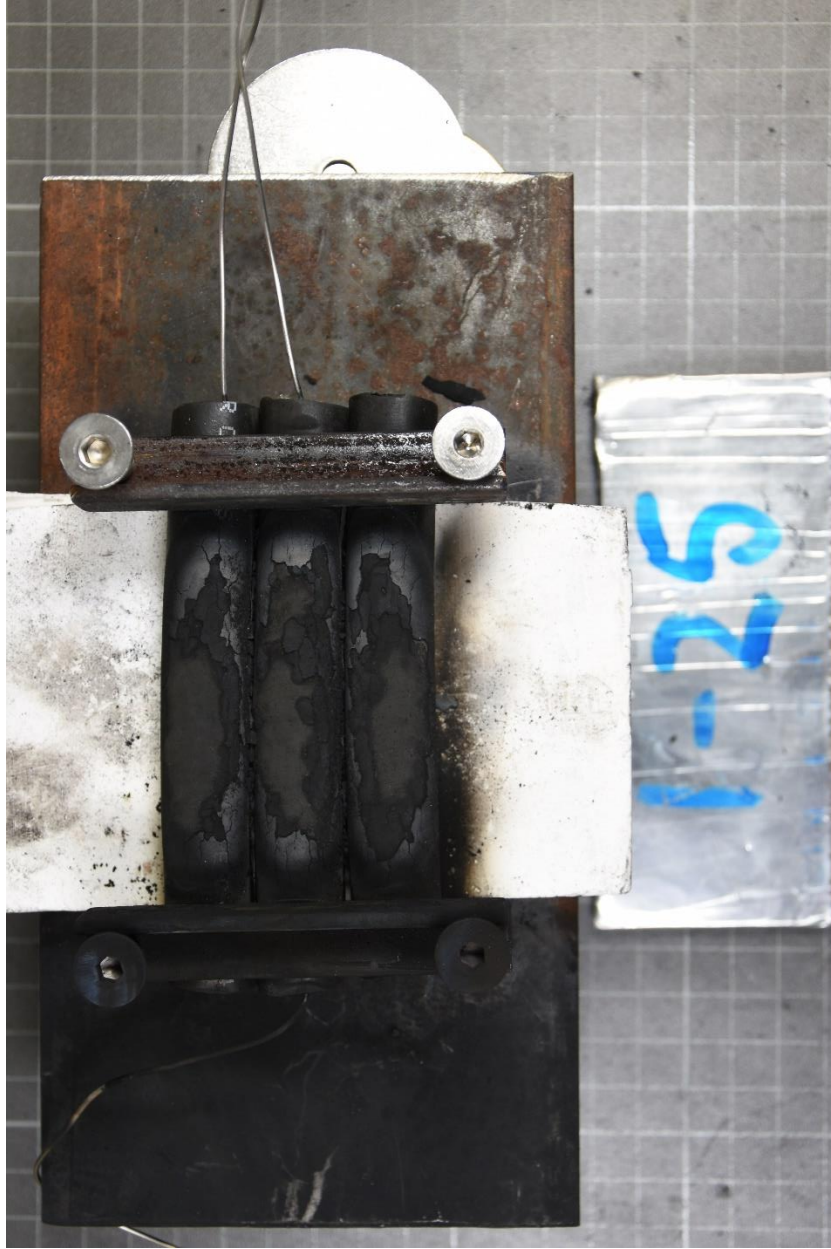
Figure 3-114: Test 1-25 Post-test Photo (1)

Figure 3-114 and Figure 3-115 show the target cable after the exposure profile. As shown, surface damage to the jacket is present. However, the insulated wires were not exposed during this test.

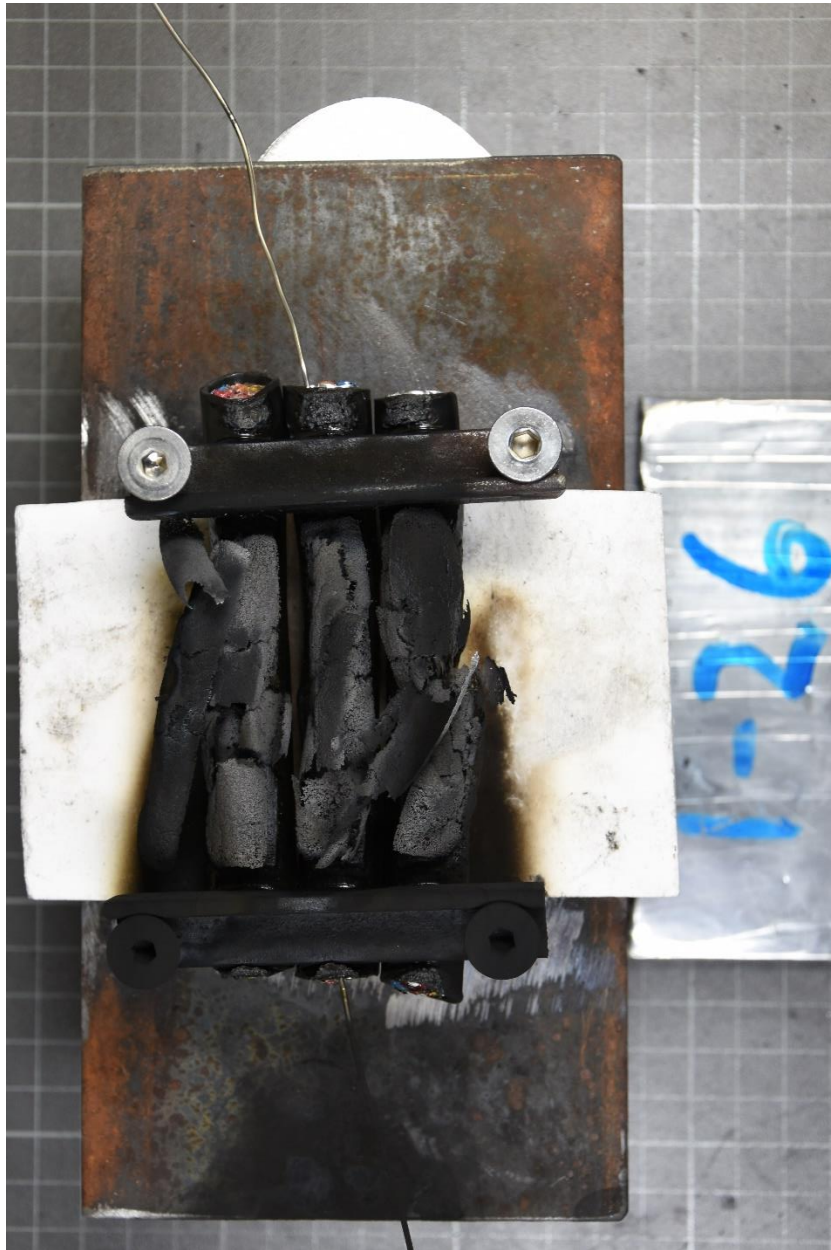
Figure 3-120: Test 1-26 Post-test Photo (1)

Figure 3-120 and Figure 3-121 show the target cable after the exposure profile. As shown, the insulated wires under the jacket were exposed during this test.

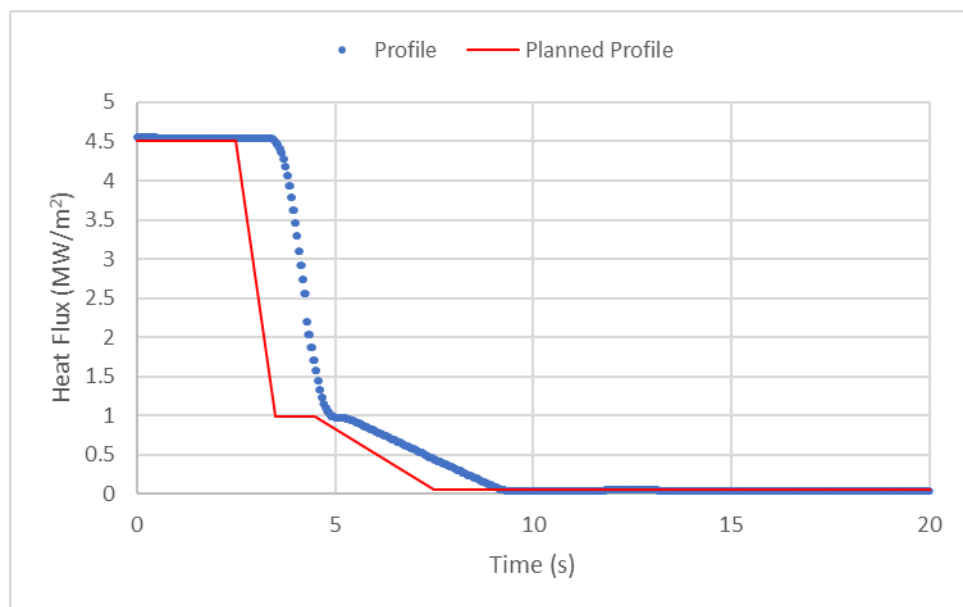
Figure 3-165: Test 1-34 Heat Flux Profile

Figure 3-165 and Figure 3-166 show the heat flux profile and total energy for which the cable target was exposed. As shown, the heat flux remained at the primary magnitude slightly longer than planned, which resulted in additional energy delivered to the cable. The cable target was exposed to a total of approximately 25 MJ/m².
