# Historical Site Assessment for Fort Calhoun Station

*Technical Support Document (TSD) No. 20-001*

*Radiation Safety & Control Services, Inc.*

*Created on: February 14, 2020*

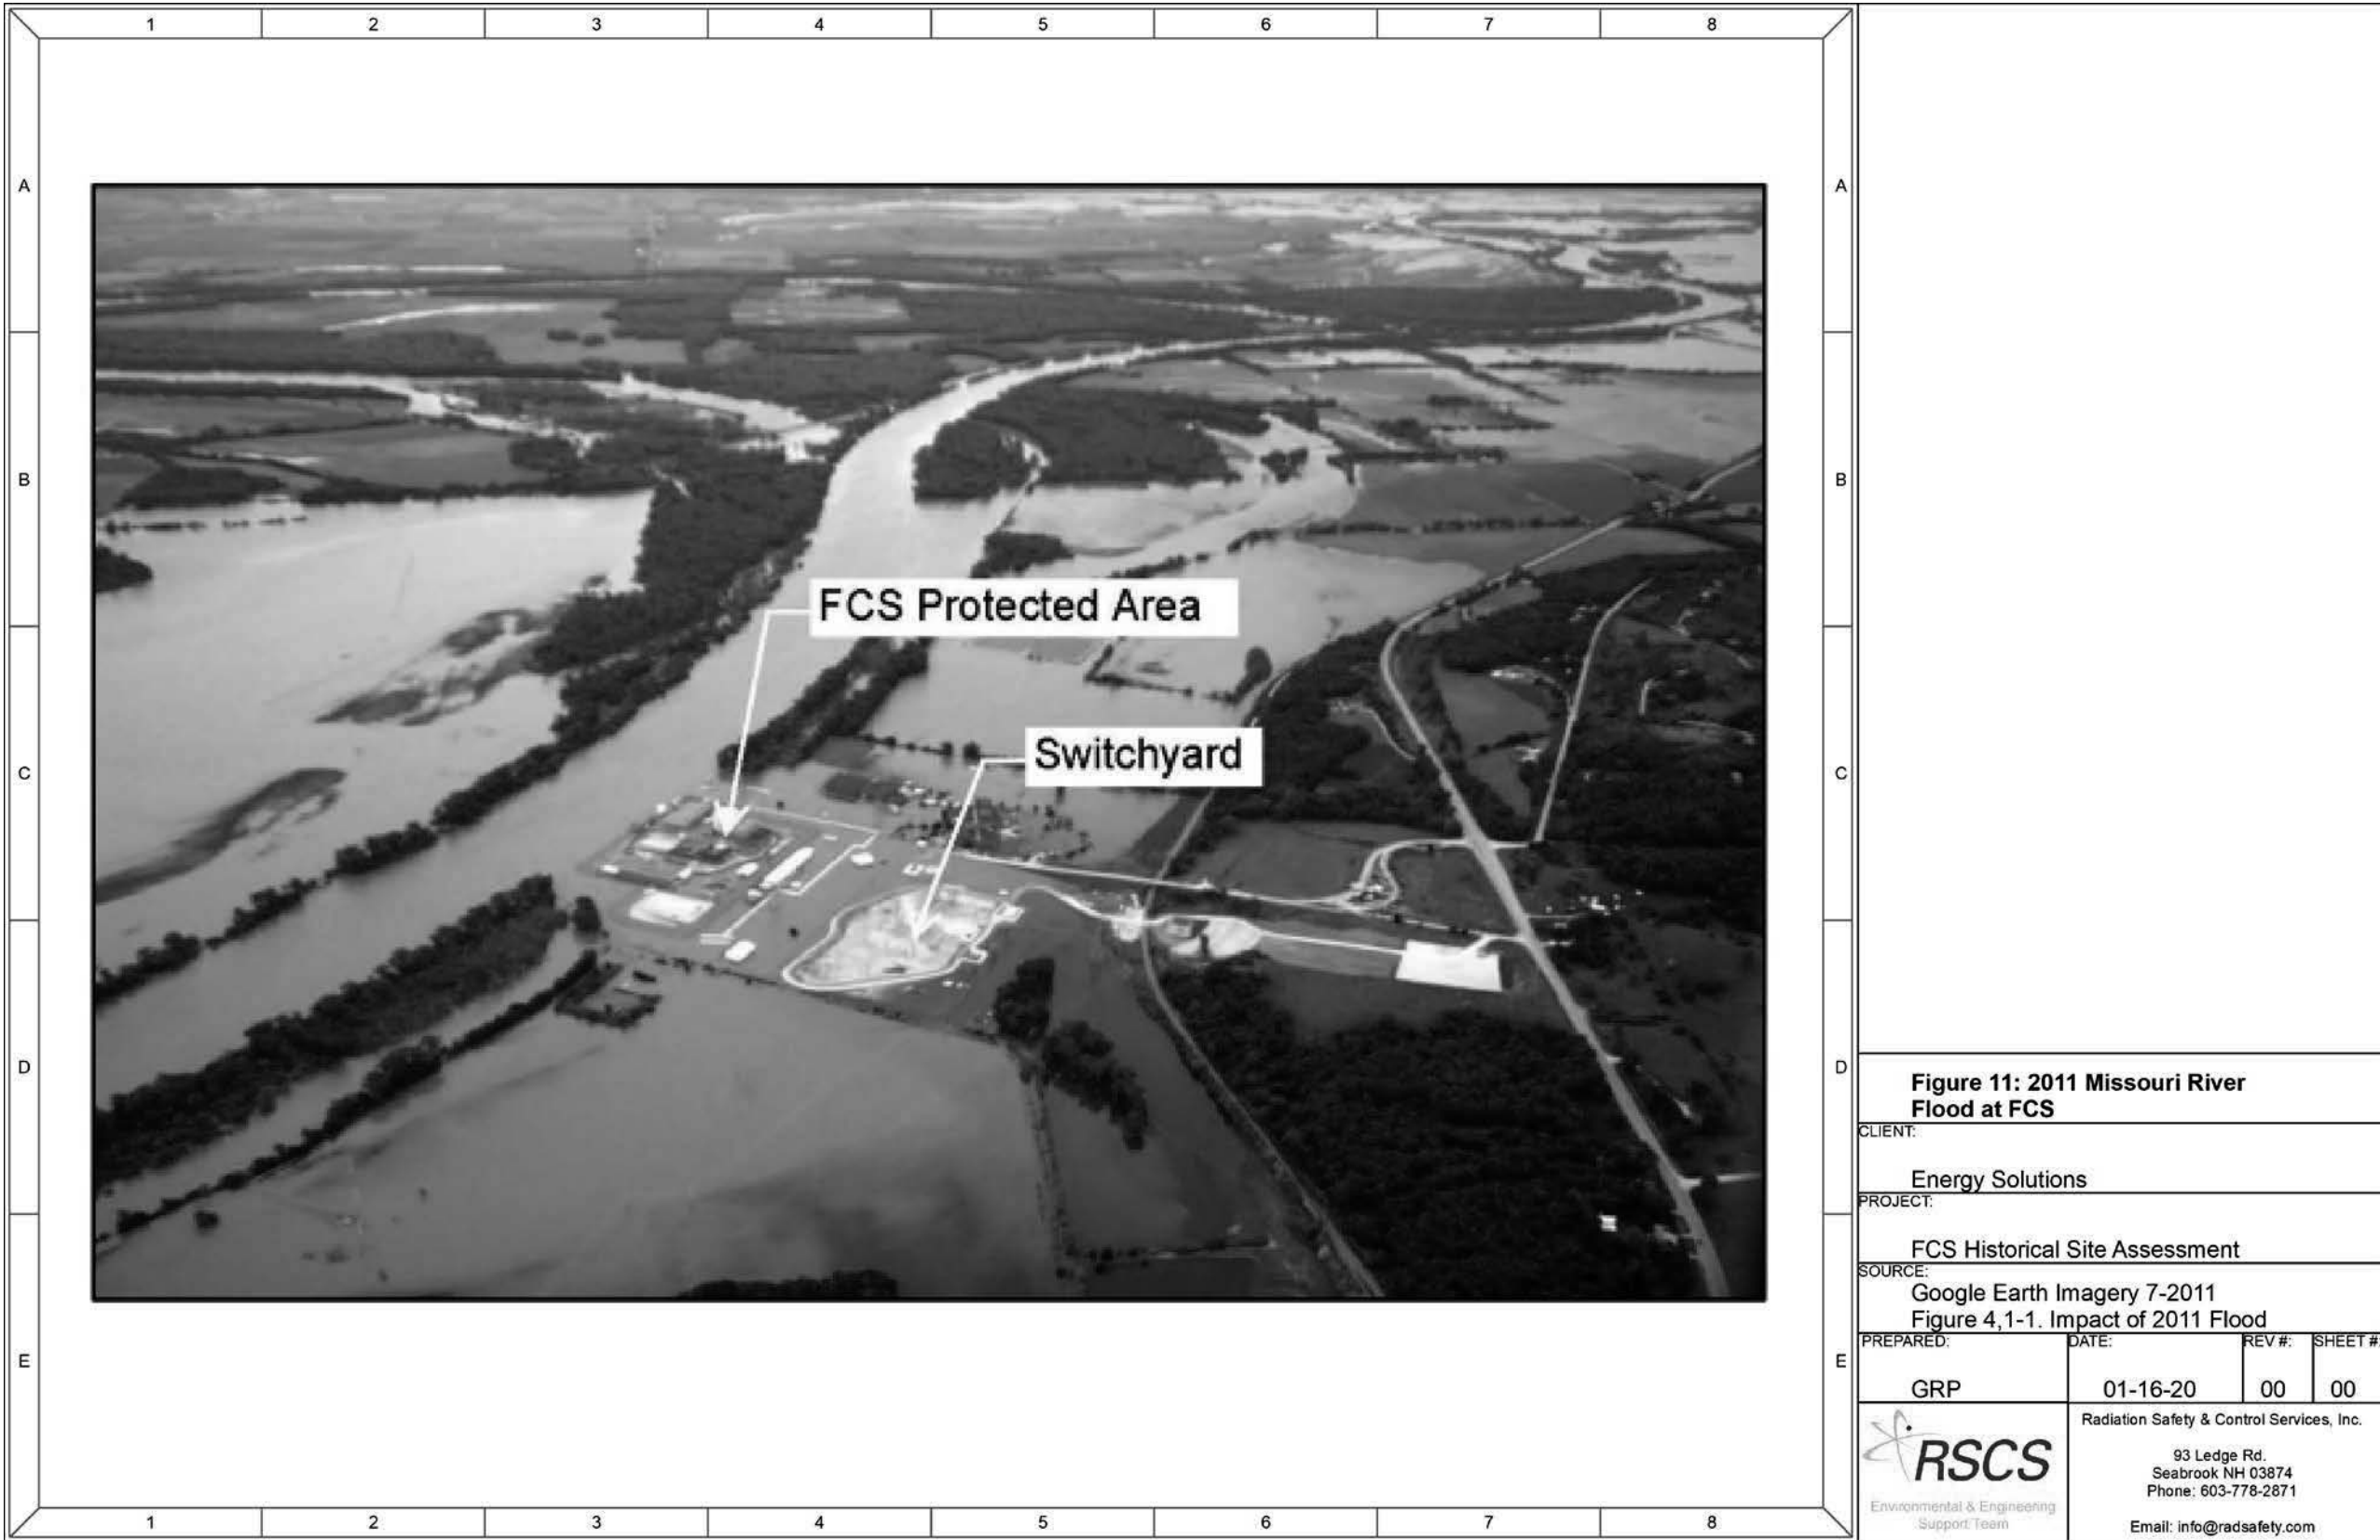
Figure 11: 2011 Missouri River Flood at FCS

Several flood events of the adjacent Missouri River have historically impacted the FCS site. The most significant flooding occurred in 2011 when flood waters covered most of the site for several months (Figure 11). During the 2011 flooding event, a soil berm was constructed around the Switchyard to protect the transformers and equipment in the yard

and the area around the PA was diked with sandbags (Figure 11). Likewise, FCS constructed aqua berms and raised walkways to protect the plant components in the PA.
