# **REPORT ON HIGH ENERGY ARCING FAULT EXPERIMENTS**

## **Experimental Results from Low- Voltage Switchgear Enclosures**

# Report on High Energy Arcing Fault Experiments

## Experimental Results from Low-Voltage Switchgear Enclosures

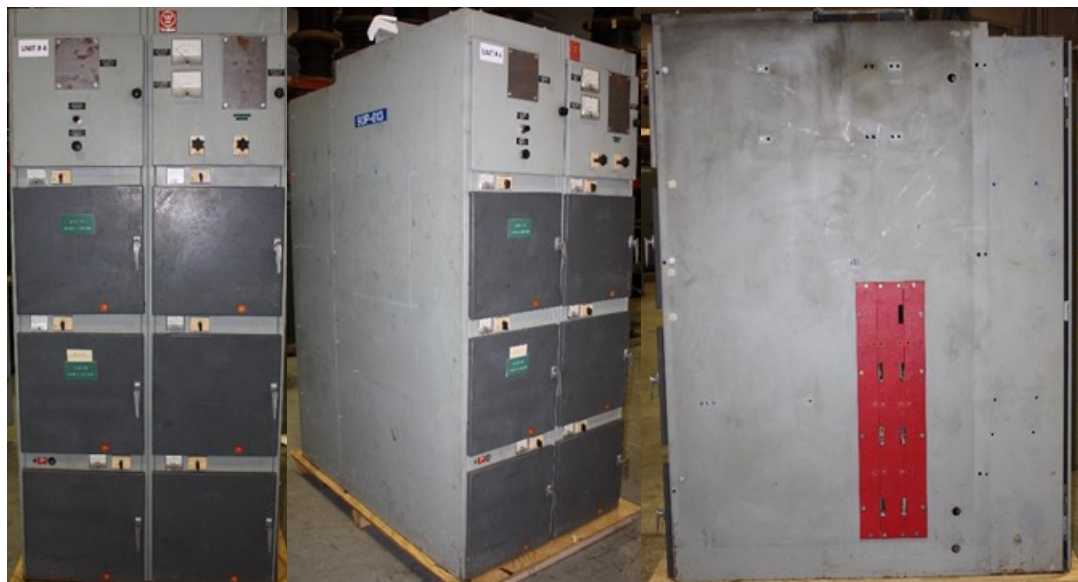
**Fig. 5.** Photo of DS switchgear. (front (left); side and front (center); opposite side (right)).

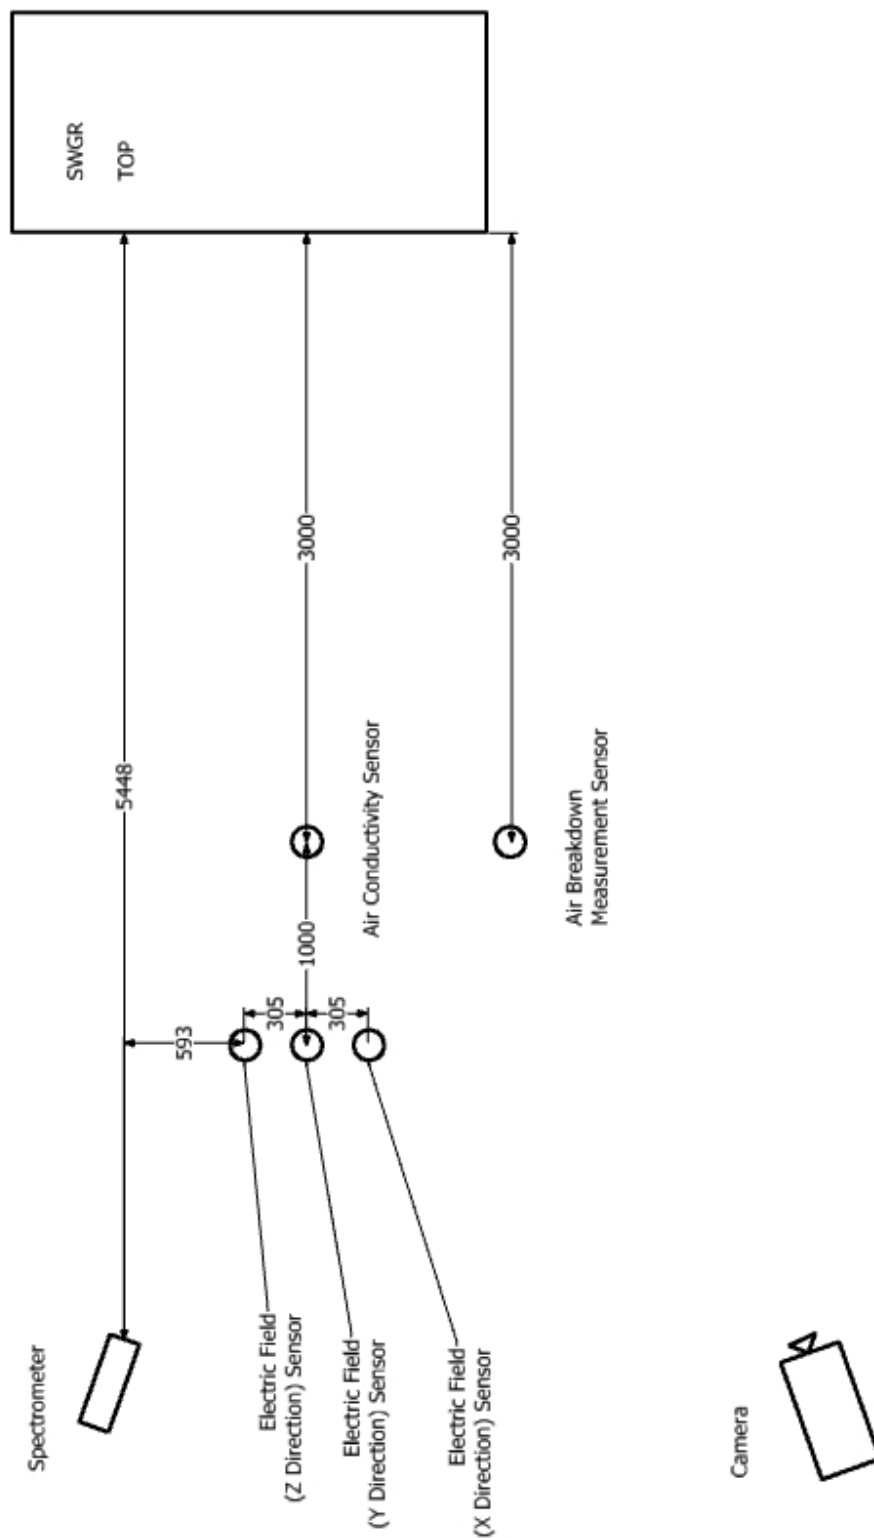
**Fig. 6.** Plan view of SNL instrumentation locations (note that locations are approximate, and instruments used varied by experiment. Illustration is not to scale). See details in Appendix A.2.

A variety of measurement equipment was used during the low-voltage DS switchgear experiments. Table 2 lists the measurement devices and the measurement that each device provides. The instruments were arranged around the cell. A general configuration is shown in Fig. 6 followed by a photograph of the configuration in Fig. 7. A brief description of each device follows. Thermal, pressure, electromagnetic, conductivity, and electrical measurements were made using a variety of instruments and techniques. This section provides an overview of each, along with the methods and locations of measurement.

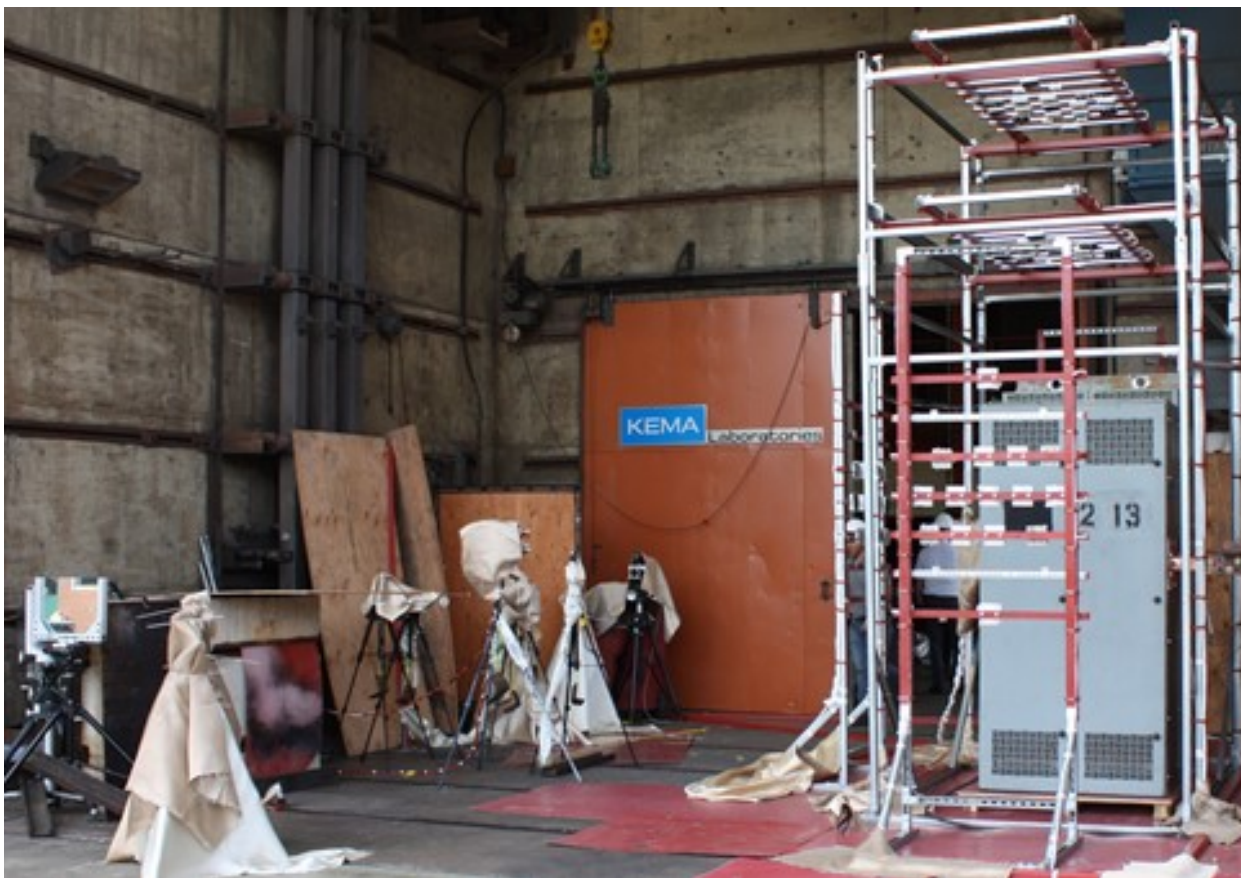
**Fig. 7.** Photograph of instrumentation cluster (from Left-to-right, air breakdown, radiometer, d-dot, air conductivity, high speed IR and visible videography)

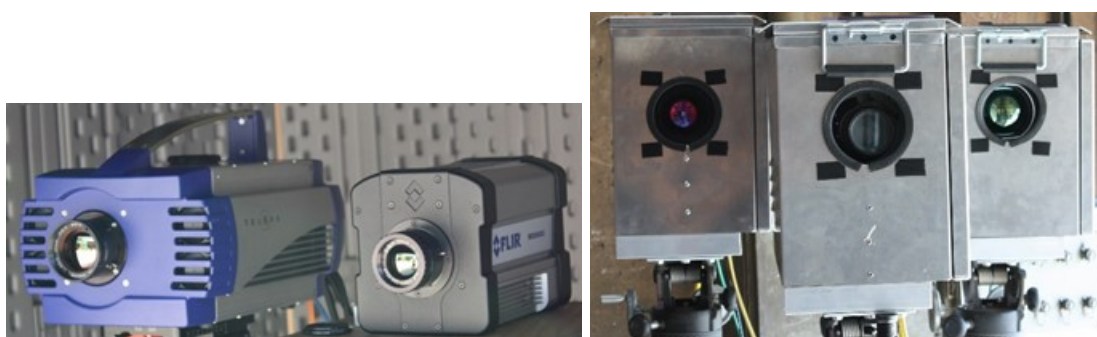
**Fig. 8.** Thermal imagers (NIST thermal imaging cameras located approximately 26.5 m from test device (let), SNL imaging cameras located approximately 27 m from test device (right), from left to right (thermal, high speed visible, thermal))

Up to four thermal imaging cameras were used per experiment. Two of the cameras were supplied by NIST, while the other two were provided by SNL. The camera settings ranged in frame-rate, thermal calibration range, and resolution. The cameras were also placed in different locations. The NIST cameras were located outside the test cell approximately 26.5 m from and orthogonal to the KEMA cell roll up door opening. The SNL cameras were located outside of the cell and were housed within a mechanically ventilated metal enclosure. The thermal imagers used in this series are shown in Fig. 8, with courtyard locations shown in Fig. 9 and Fig. 10.

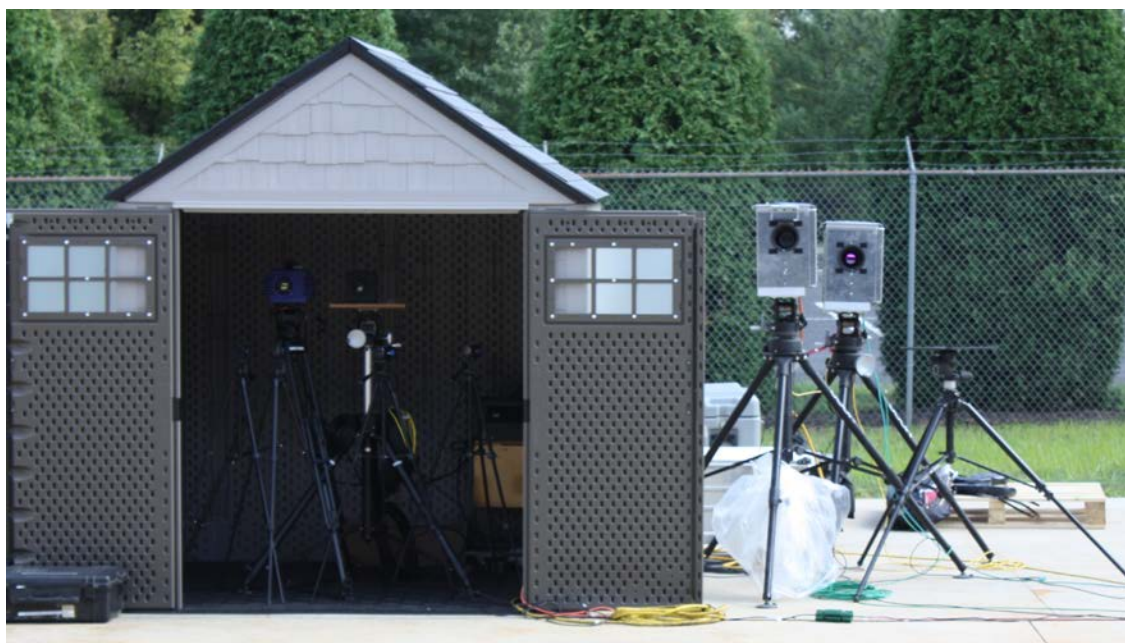
**Fig. 9.** Thermal imagers and high speed imagers are located in the courtyard. Four NIST cameras are in structure, approximately 26.5 m from the test device. Two SNL cameras are located outside the structure, approximately 27.0 m from the test device.

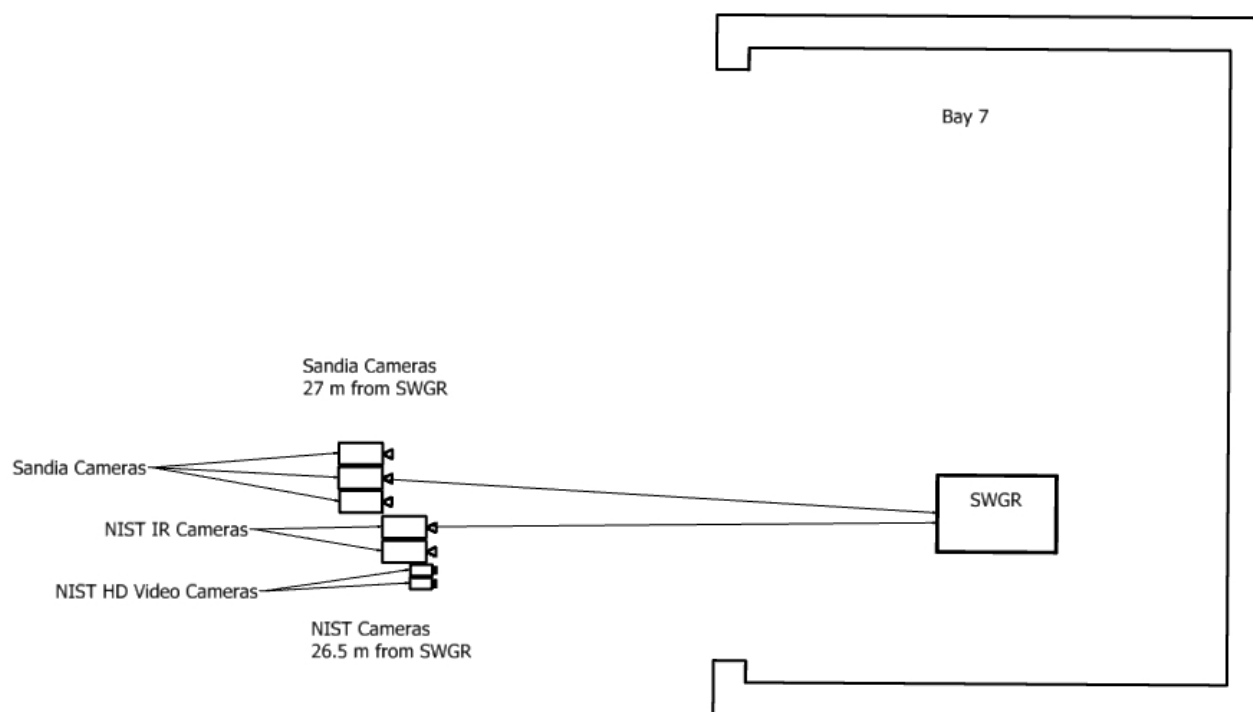
**Fig. 10.** Plan view of NIST and SNL camera locations (not to scale).

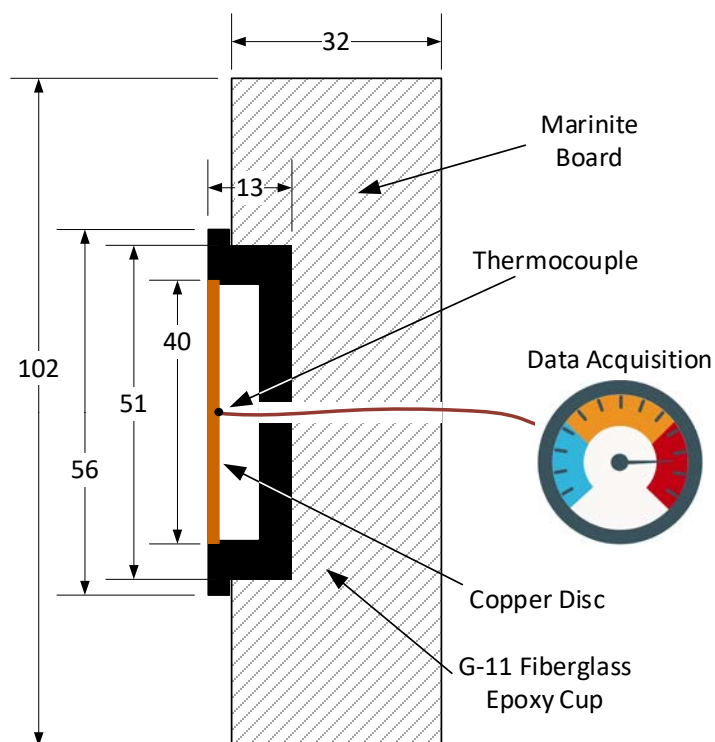
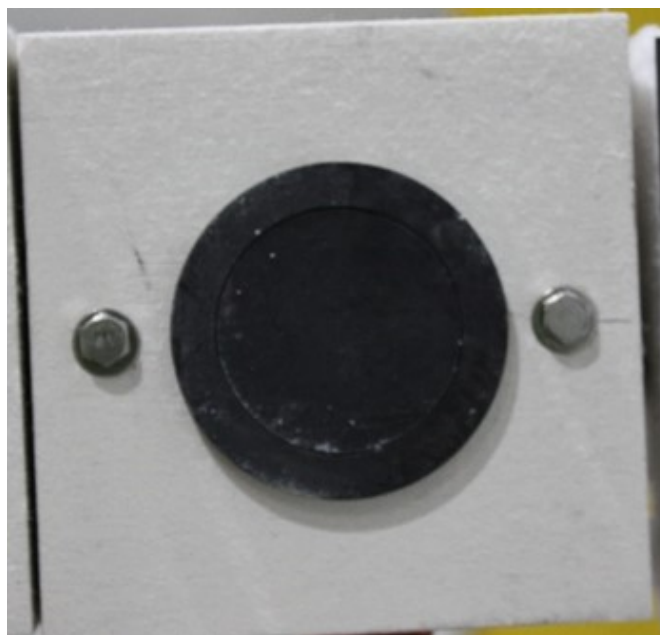
**Fig. 12.** Cross-section of ASTM Slug (top) nominal dimensions in millimeters, photo of device being prepared in the field (bottom). Note that the two bolts on each side of the device are used for mounting to the DIN rail of the instrumentation rack.

Incident energy was measured using slug calorimeters described in ASTM F1959 [20] and shown in Fig. 12. These instruments are customarily used to measure radiant energy and determine the arc flash hazard to personnel in the area of electrical enclosures. Due to the characteristics of the HEAF phenomena, which can result in convective arc jets, the calorimeters are reacting to convective heat transfer in addition to radiant heat transfer. ASTM slug calorimeters consist of a copper disc with an approximate thickness of  $1.6 \text{ mm}$  ( $0.063 \text{ in}$ ) and diameter of  $40 \text{ mm}$  ( $1.6 \text{ in}$ ). An iron-constantan thermocouple (Type J), composed of two  $0.255 \text{ mm}$  ( $0.01 \text{ in}$ ) nominal diameter (30 AWG) wires, is soldered to in the back of the copper disc

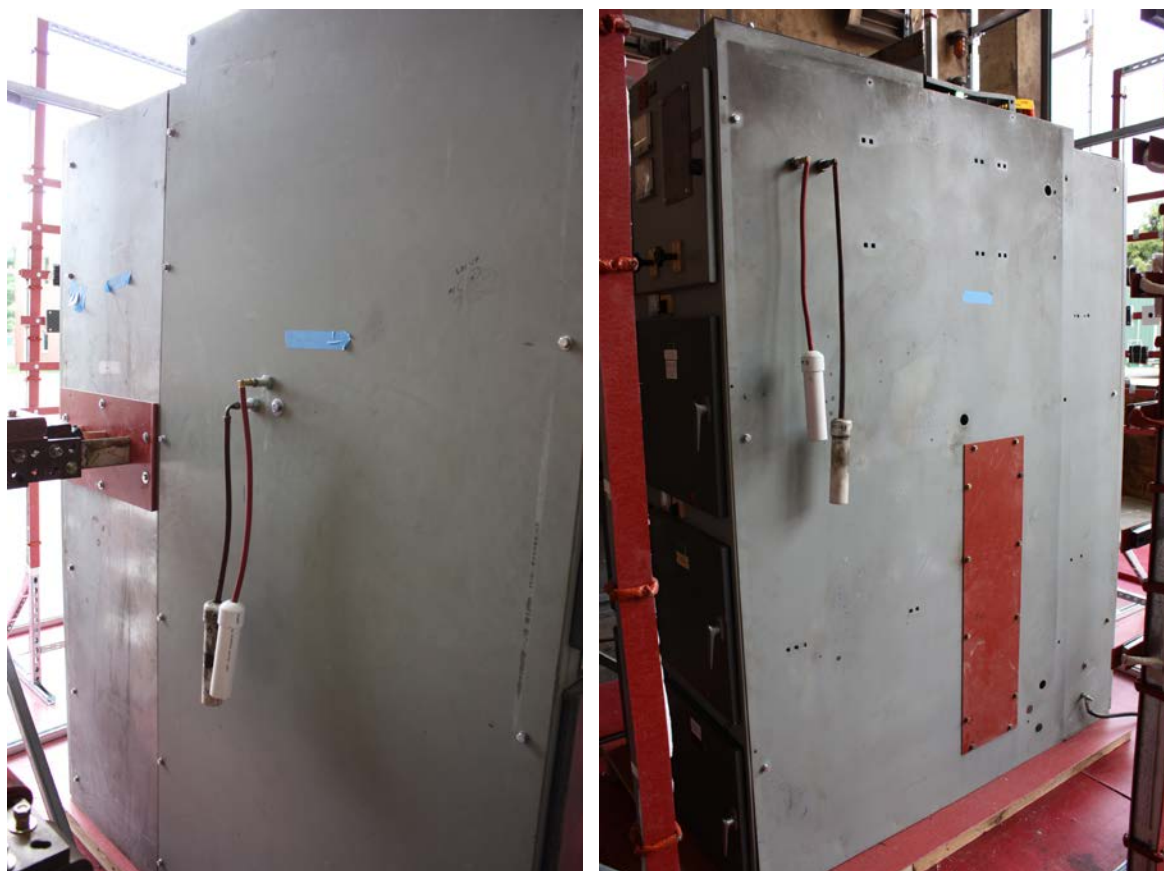
**Fig. 15.** Photos of pressure measurement locations (PT3 and PT4 (left); PT1 and PT2 (right)).

The assembly for measuring pressure consisted of a through-bolt that was installed in a hole drilled in the metal cladding of the electrical switchgear enclosure. A 90-degree fitting was connected to the through-bolt on one end, and a pressure hose was connected to the other. The opposite end of the pressure hose was connected to the pressure transducer, which was housed within a white PVC tube for mechanical protection. Within the PVC tube, the Mu-metal was installed. The electrical connection from the transducer exited the PVC tube and was routed to the data collection cart. Prior to the experiments, additional thermal protection was added to the electrical cable by surrounding it with ceramic fiber thermal insulation and secured with fiberglass tape. The configuration is shown in Fig. 15 and Fig. 16. Two general locations were selected. At each location, transducers of different nominal ranges were used. One ranged from 0 kPa (0 psia) to 207 kPa (30 psia), while the other ranged from 0 kPa (0 psia) to 345 kPa (50 psia). Pressure transducers labeled PT3 and PT4 measured the primary cable connection compartment pressure where the arc was initiated, while transducers PT1 and PT2 measured pressure in the breaker cubicle.

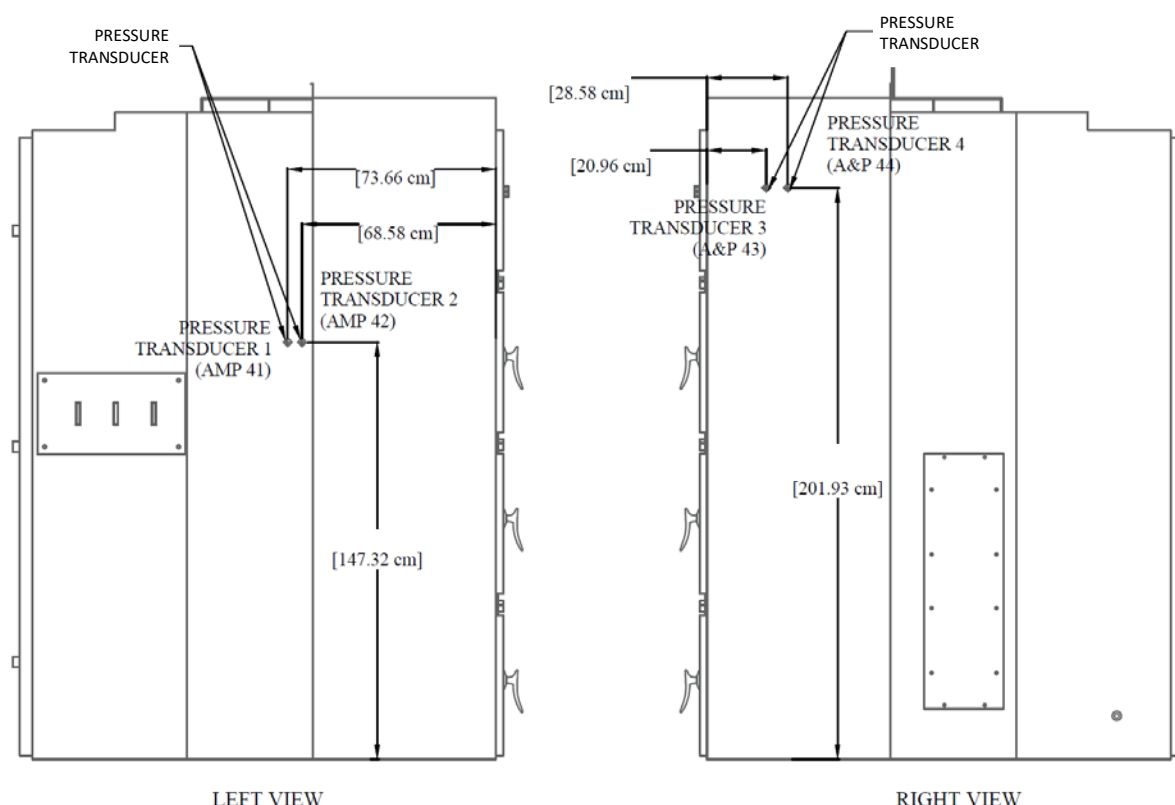
**Fig. 16.** Drawings showing locations of pressure sensor devices.

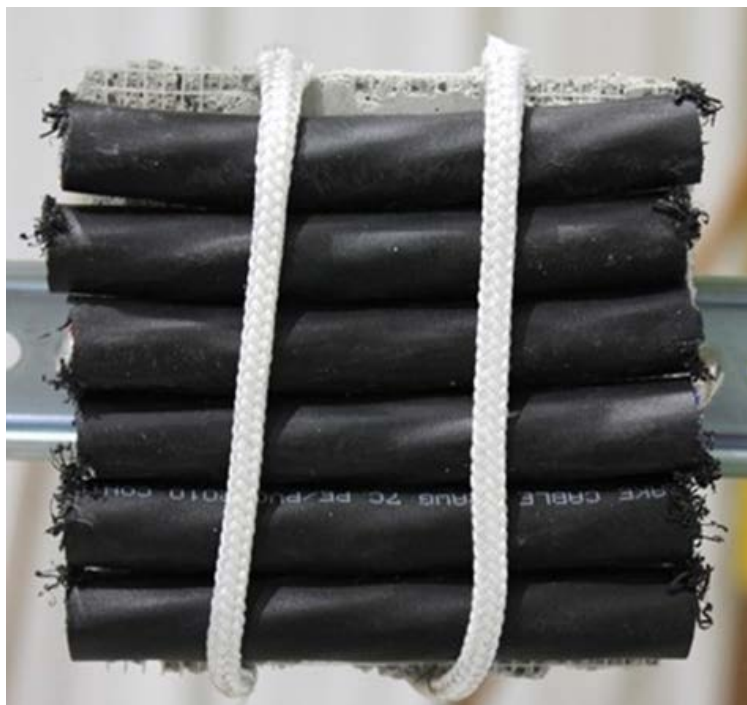
**Fig. 17.** Cable coupon constructed of seven conductor PE / PVC control cable (Cable 900). Front view.

The cable coupons were constructed using six or eight segments of cable, approximately 100 mm (4 in) long. The cables were affixed to a square piece of fiberglass reinforced cement board (“Durock™”), measuring approximately 100 mm (4 in) square and nominally 13 mm (0.5 in) thick, using steel wire protected with a glass braid sheath. The wire was also used to connect the cable coupon to the horizontal steel DIN rail. Descriptions and specifications of the cables are listed in Table 4 and Table 5. Face and side views of a typical cable coupon are presented in Fig. 17 and Fig. 18.

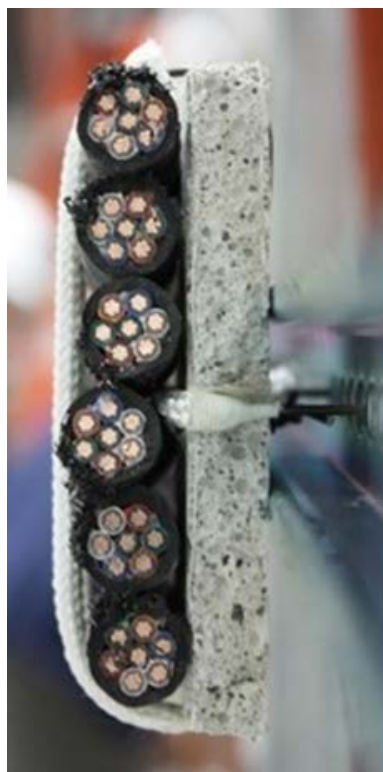
**Fig. 18.** Cable coupon constructed of seven conductor PE / PVC control cable (Cable 900). Side view.

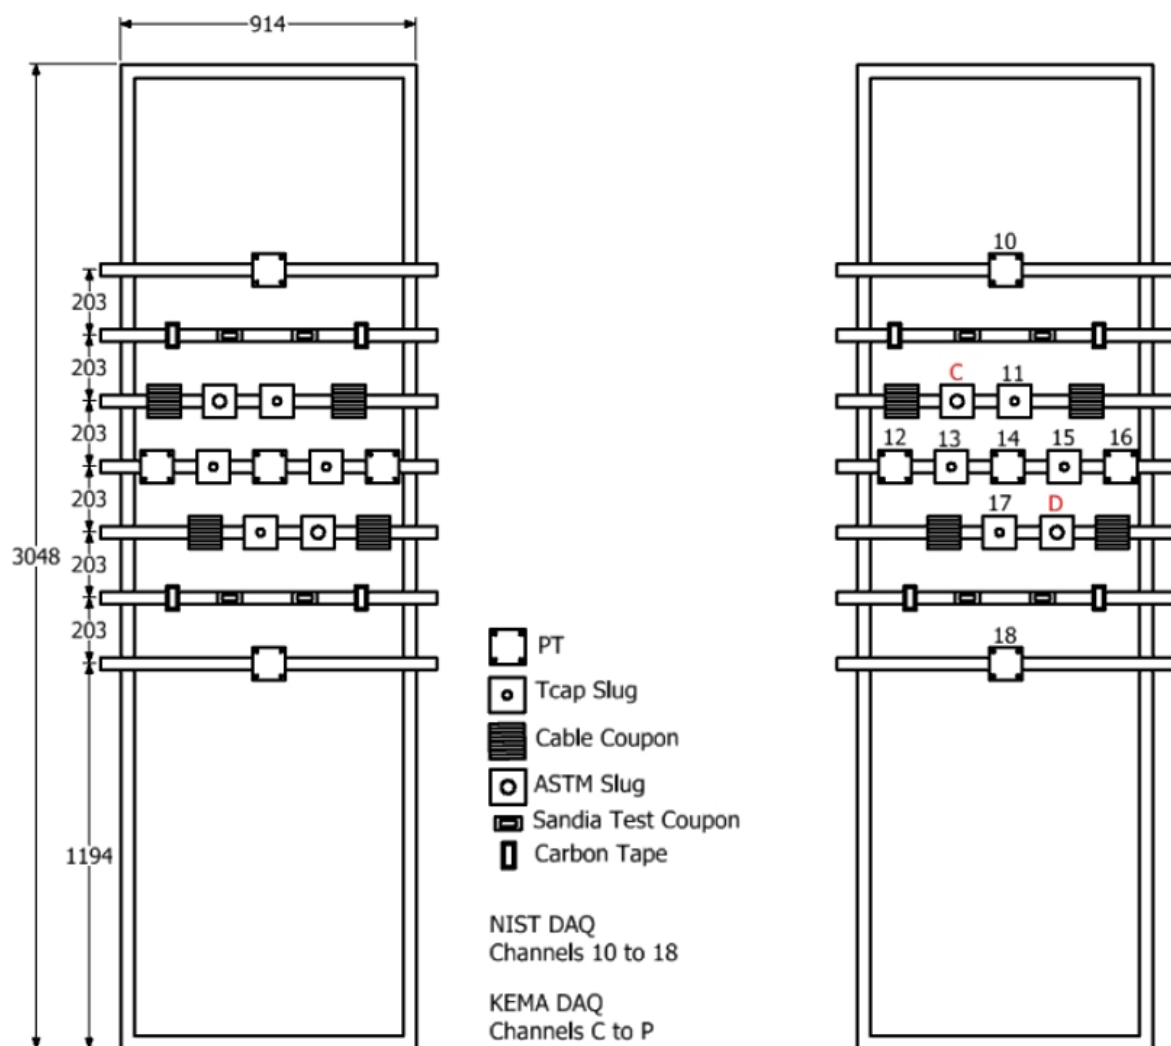
**Fig. 25.** Illustration of Vertical Instrumentation Rack 2 with data acquisition channels. Dimensions in mm  $\pm$  5 mm.

The majority of the thermal instrumentation devices were located on instrument racks with the faces of the instruments located approximately 0.91 m (3.00 ft) from the exterior sides of the metal clad enclosure. Two instrument racks were also located horizontally above the electrical enclosure (Rack 4 and Rack 5), supported by a reconfigurable steel structure. The sensors on Rack 4 were located approximately 0.91 m (3.00 ft) from the top of the enclosure, while the sensors on Rack 5 were located approximately 1.83 m (6.00 ft) from the the top of the enclosure. The location of the upper horizontal rack was horizontally offset by approximately 102 mm (4.0 in) from the lower rack to reduce shadowing from the sensors below. The instrumentation rack configuration for Test 2-13A through Test 2-13G is shown in Fig. 19 and Fig. 20. The instrumentation rack configuration for Test 2-18A and Test 2-13B is shown in Fig. 21 and Fig. 22. Details of the instrument locations are shown in Fig. 23 through Fig. 29, with a photograph showing the instrumentation racks around the test devices during setup in Fig. 30 and Fig. 31. The expanded uncertainty in the measurement of the distances from the instrumentation racks to the electrical enclosure is  $\pm 13$  mm (0.5 in) with a coverage factor of 2 and an estimated confidence interval of 95 percent.

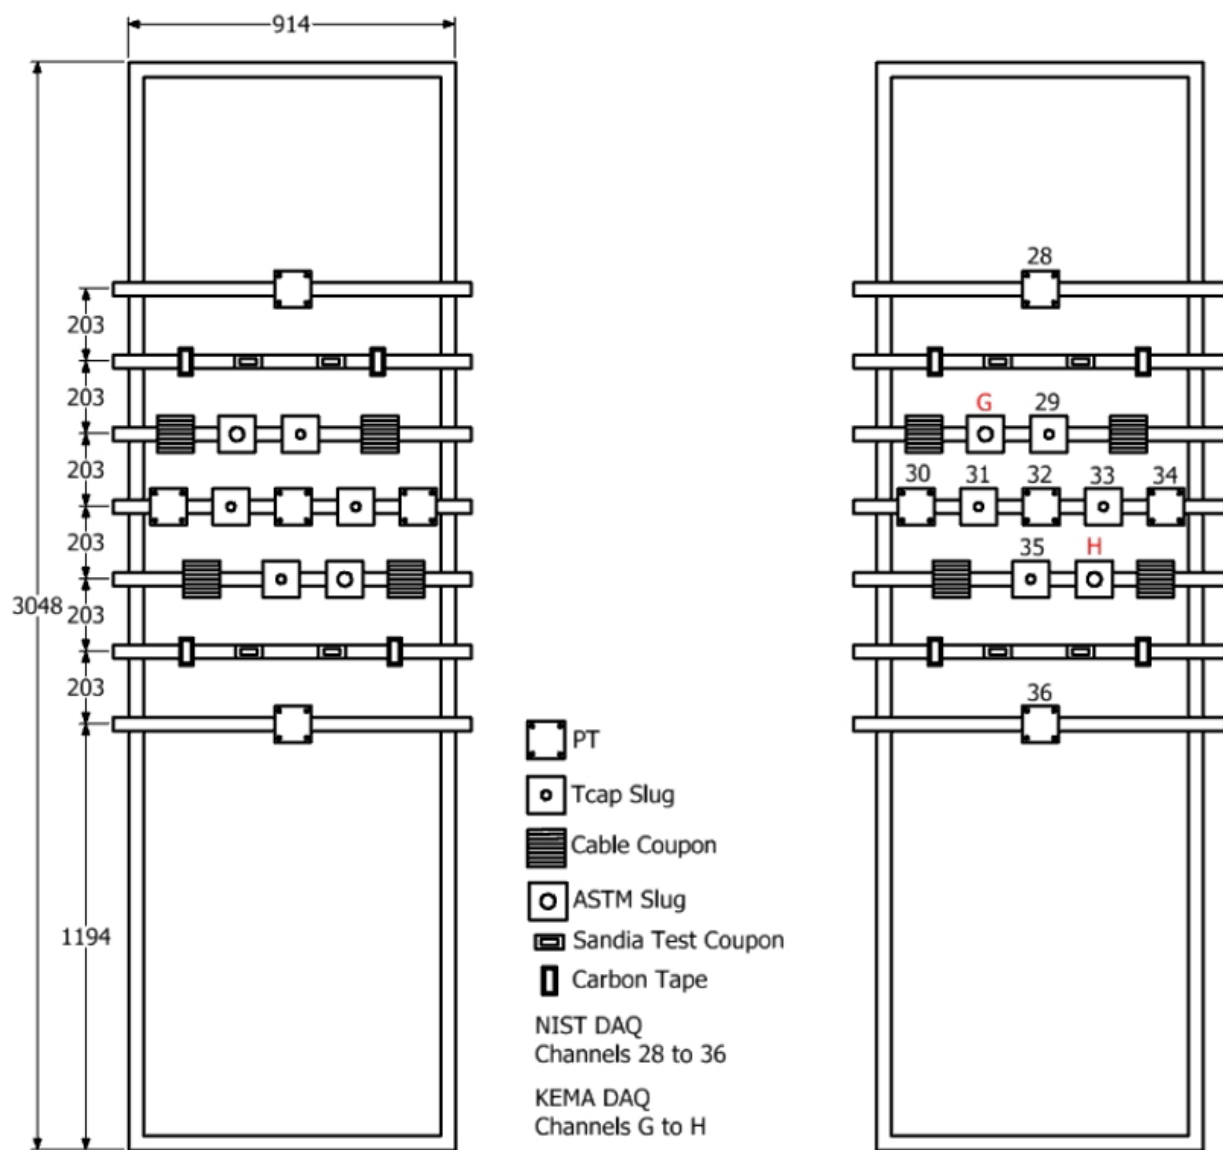
**Fig. 27.** Illustration of Horizontal Instrumentation Rack 4 with data acquisition channels. Dimensions in mm  $\pm$  5 mm. Rack was installed so that the sensors are located approximately 0.91 m (3.00 ft) from the top of the enclosure metal cladding.

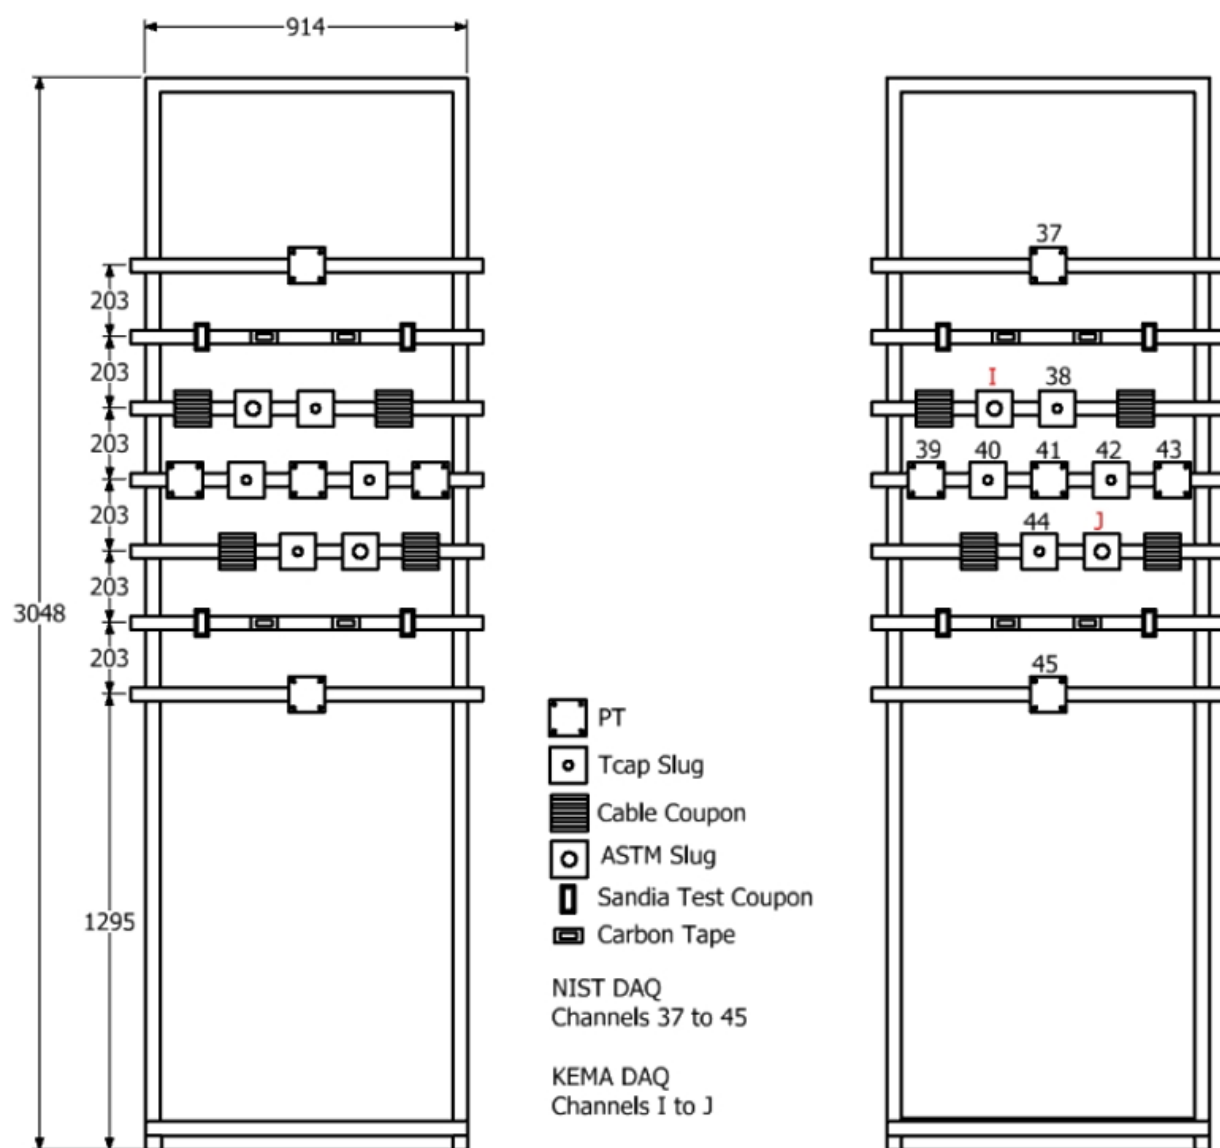
**Fig. 28.** Illustration of Horizontal Instrumentation Rack 5 with data acquisition channels. Dimensions in mm  $\pm$  5 mm. Rack was installed so that the sensors are located approximately 1.83 m (6.00 ft) from the top of the enclosure metal cladding.

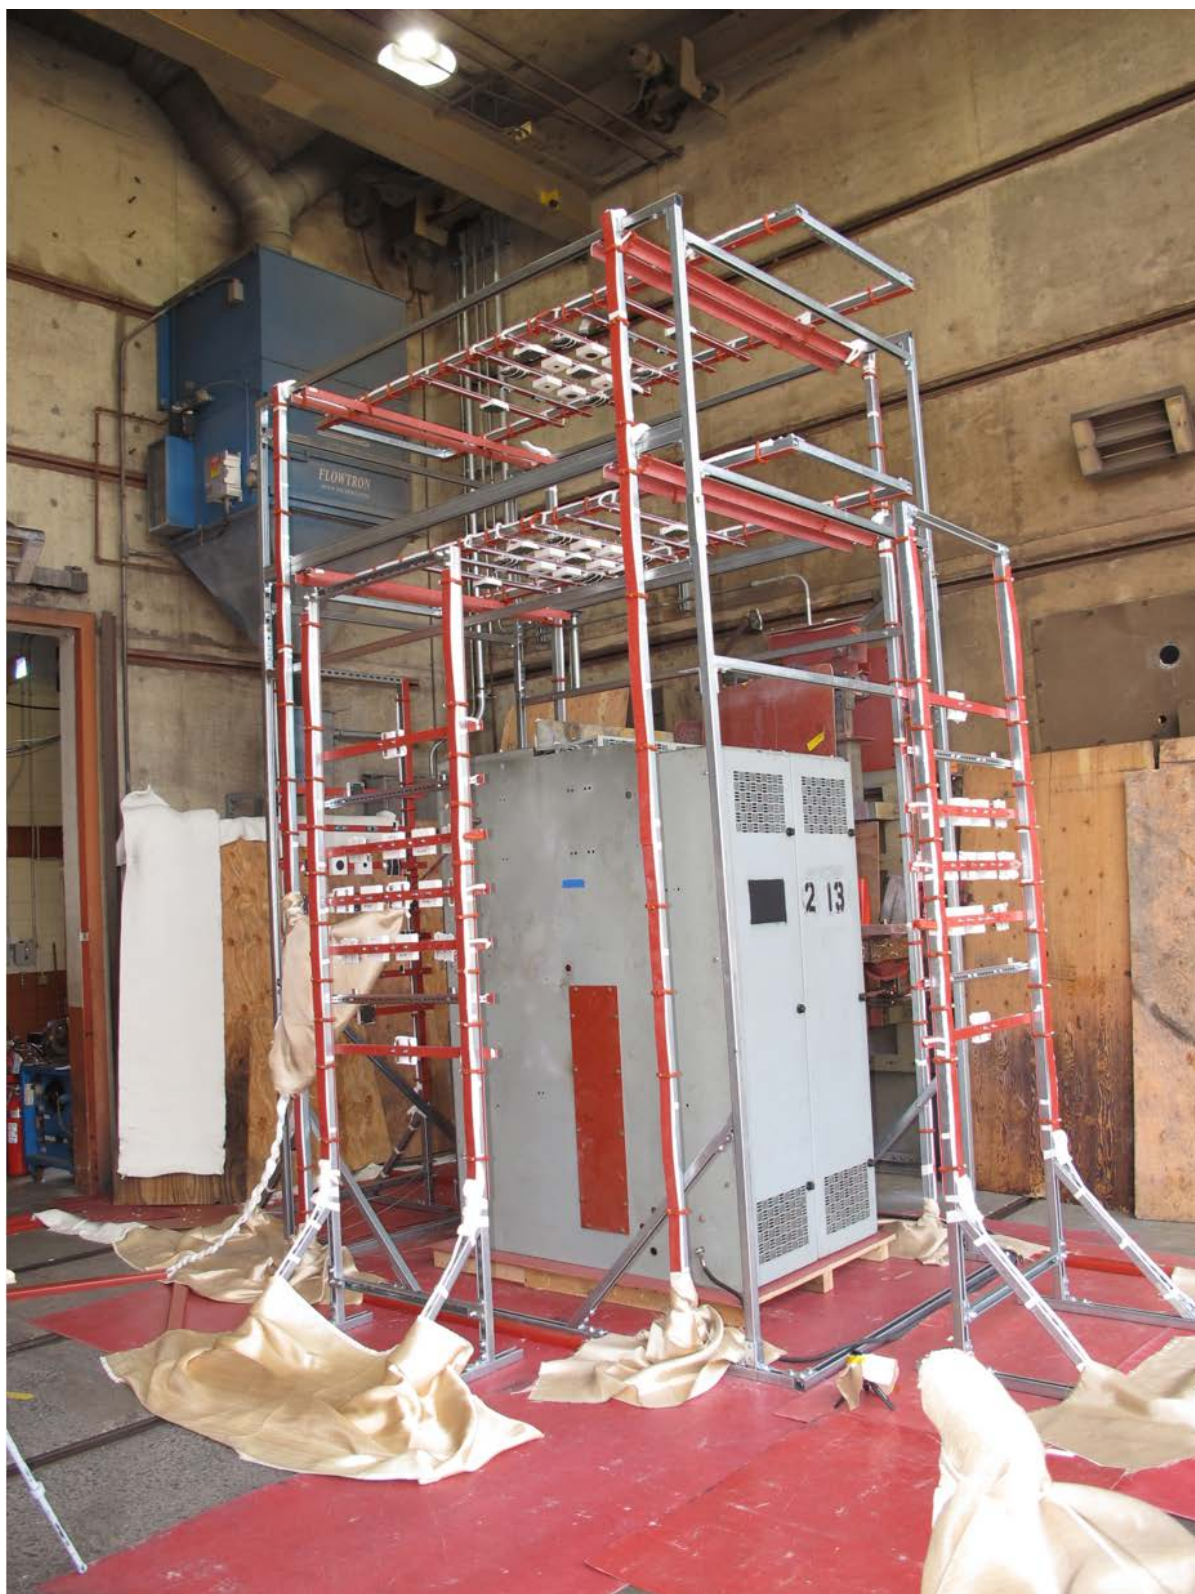
**Fig. 30.** Photo of Instrumentation Racks for Test 2-13A through Test 2-13G.

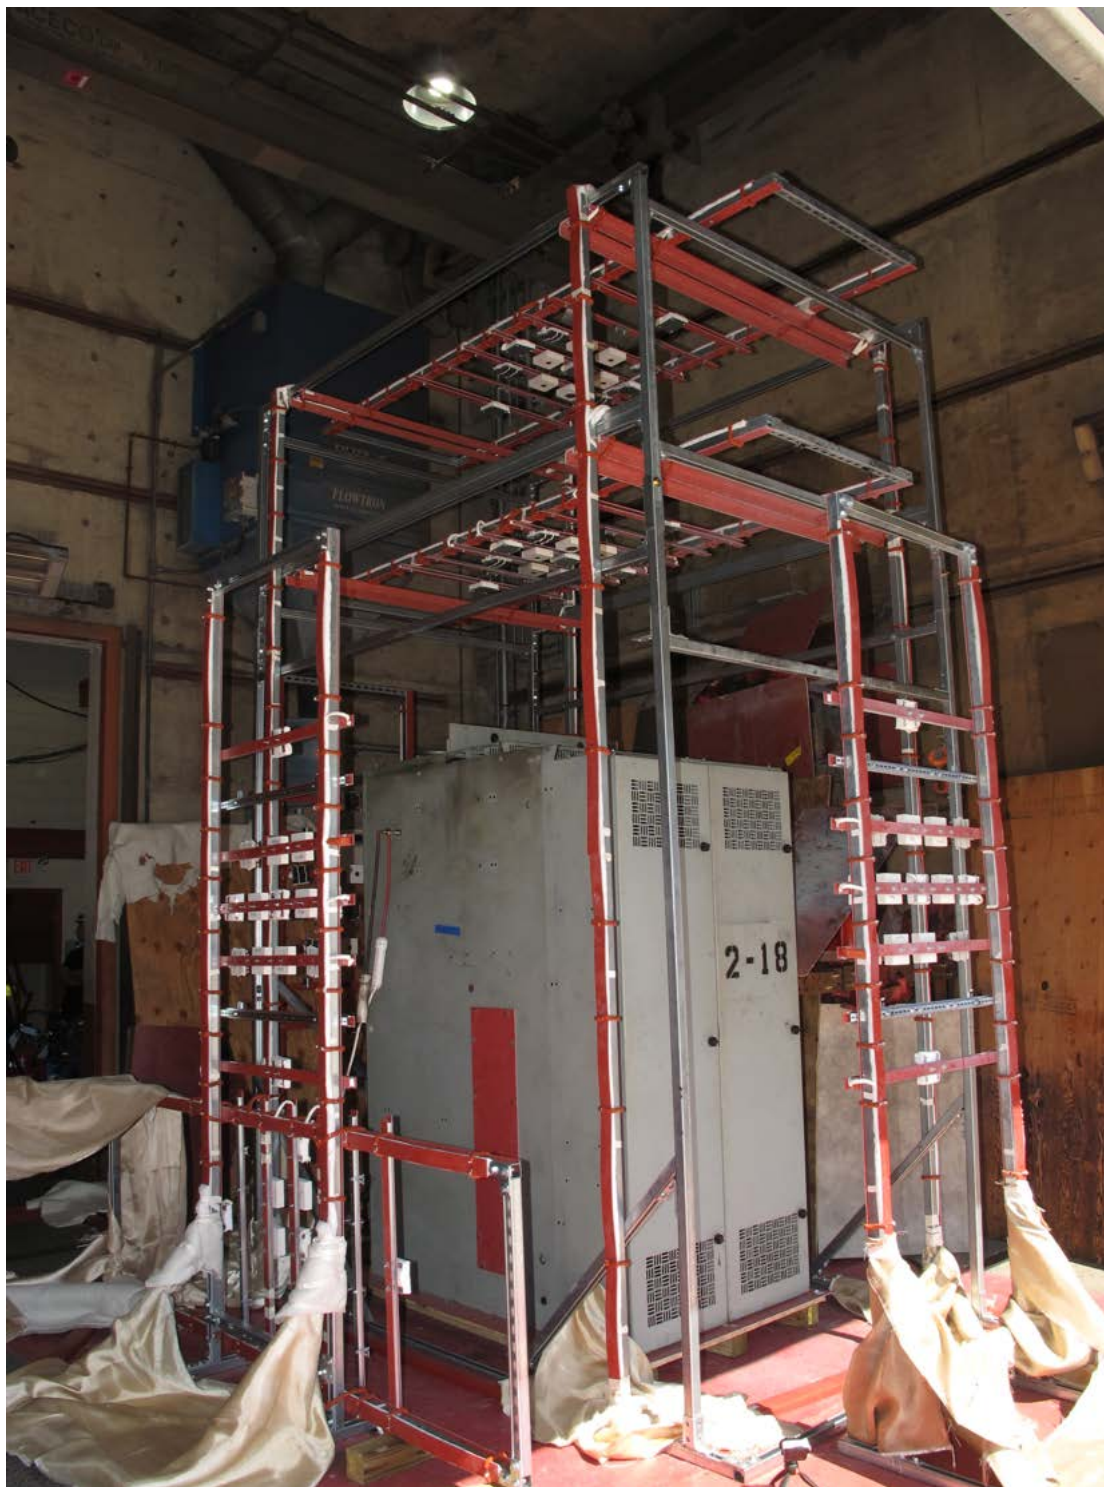
**Fig. 31.** Photo of Instrumentation Racks for Test 2-18A Test 2-18B.

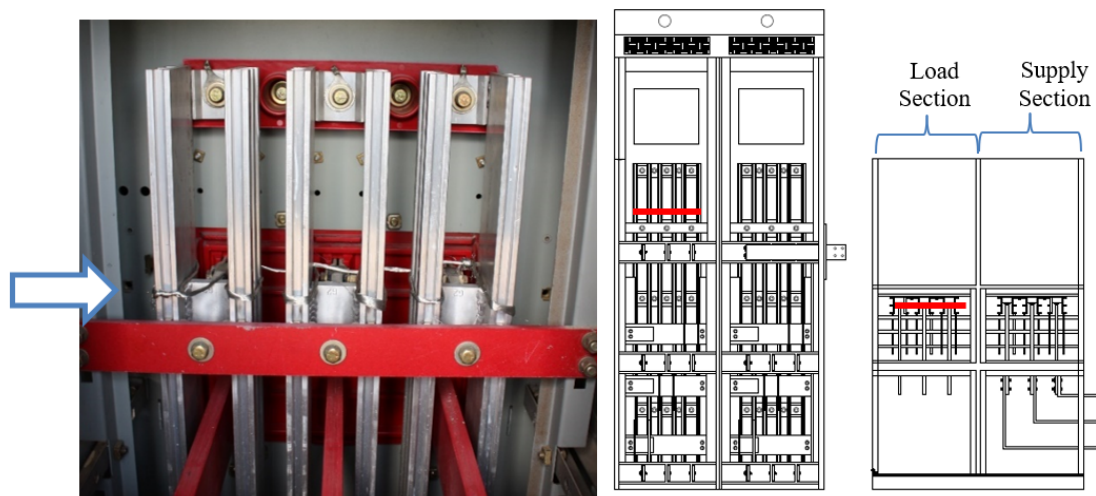
**Fig. 32.** Shorting wire location Test 2-13A (Phases left-to-right: A-B-C), photo of arc initiation point (left), elevation view (center), plan view (right). Shorting location shown in red on illustrations.

The arc was located near the top of the main bus bar in the load section of the switchgear. The arcing wire installed on the bus and marked up illustrations of the arc wire location is presented in Fig. 32.

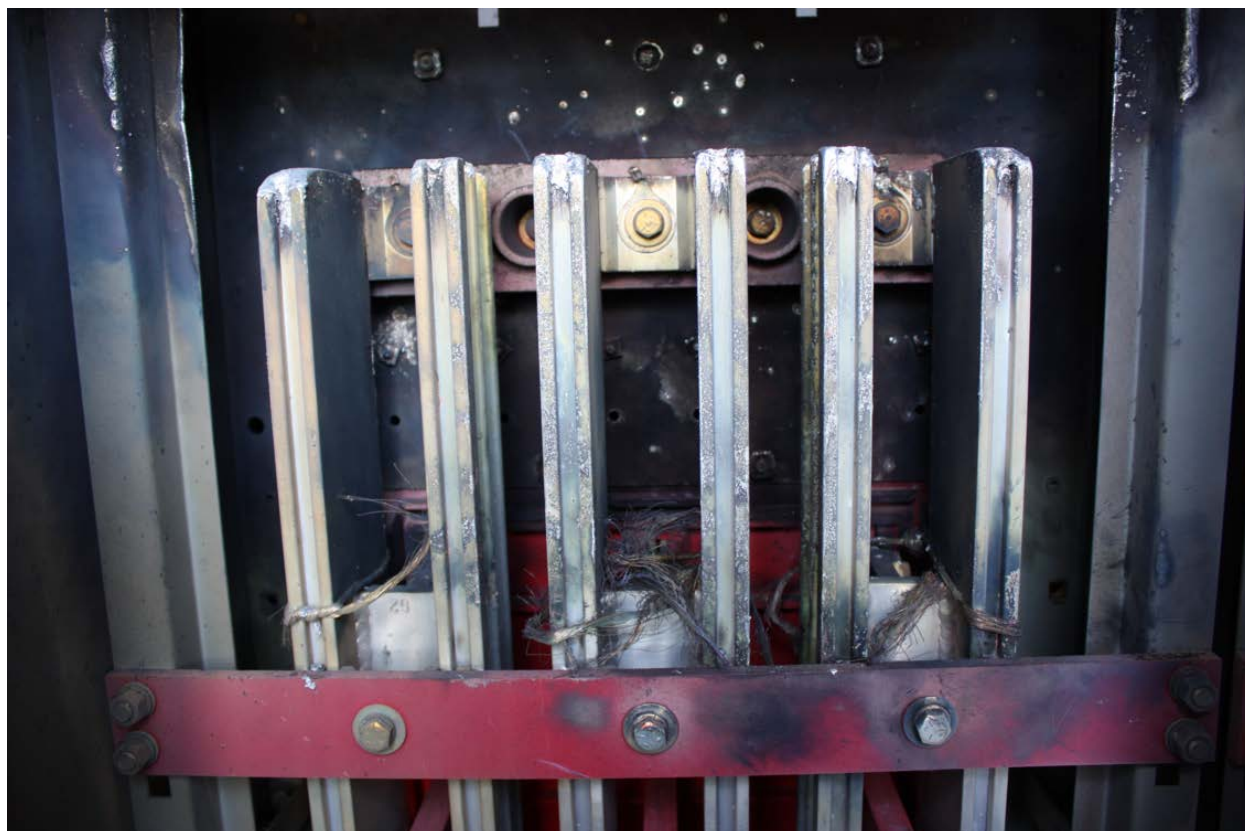
Photograph of the enclosure following the experiment is presented in Fig. 34. The enclosure did not experience a breach.

**Fig. 34.** Enclosure Post-Test 2-13A.

The experiment did not arc for the planned 2.0 s. Arcing on all three phases was intermittent for the first 500 ms with a 368 ms phase of no arcing and a brief 62 ms of arcing occurring on phase B and C only. The arcing wire successfully initiated the arc, and the arc moved towards the top of the bars as predicted but it likely extinguished at the top of the bars. There was minimal degradation to the bars themselves and minimal impact on the enclosure and instrument stands.

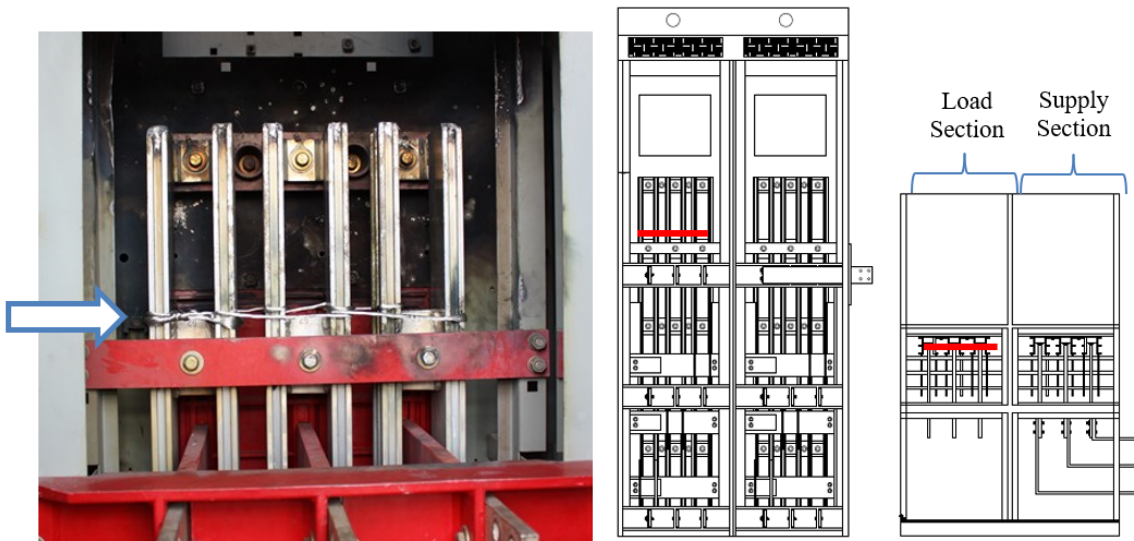
**Fig. 36.** Shorting wire location Test 2-13B (Phases left-to-right: A-B-C), photo of arc initiation point (left), elevation view (center), Plan View (right). Shorting location shown in red on illustrations.

The switchgear used in Test 2-13A was used again in this experiment. The gear was tested for sufficient insulation resistance between phases and found to be functional. The arc was located near the top of the main bus bar in the load section of the switchgear. Two 10 AWG bare stranded conductors were used to initiate the arc. The arcing wire installed on the bus and marked up illustrations of the arc wire location is presented in Fig. 36.
