# **REPORT ON HIGH ENERGY ARCING FAULT EXPERIMENTS**

## **Experimental Results from Low- Voltage Switchgear Enclosures**

# Report on High Energy Arcing Fault Experiments

## Experimental Results from Low-Voltage Switchgear Enclosures

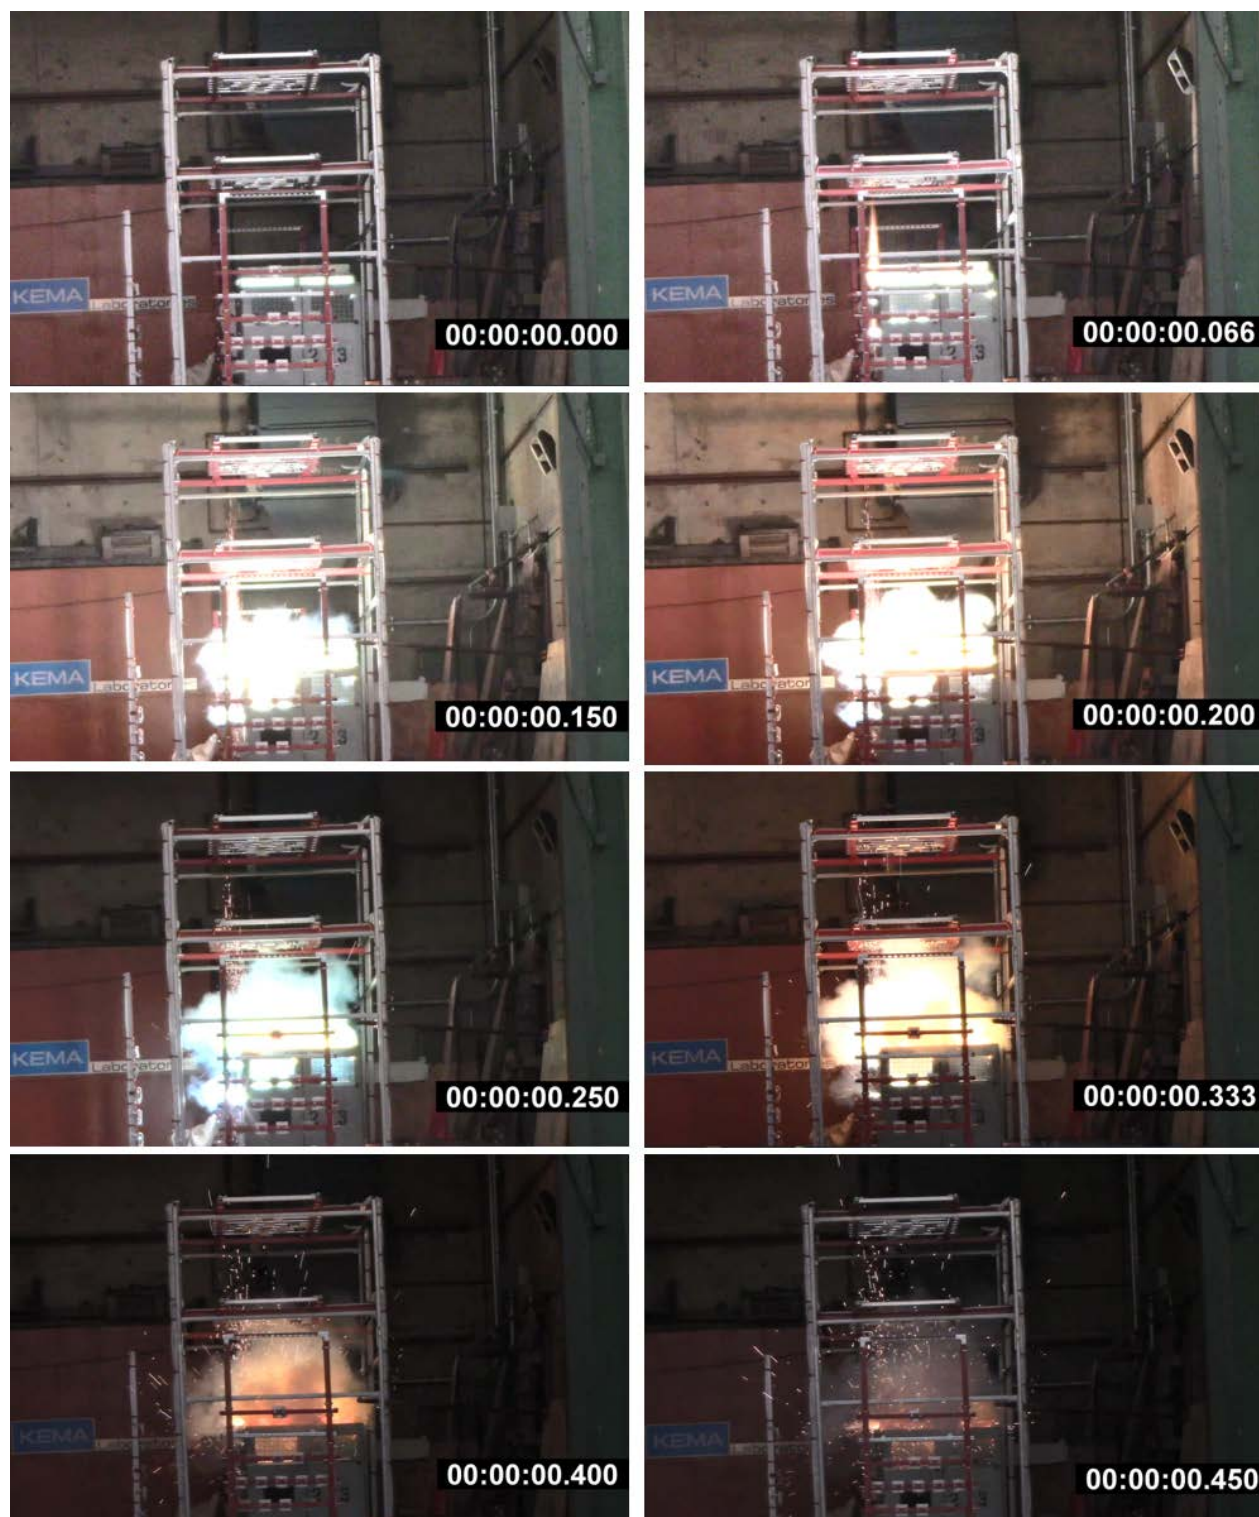
**Fig. 37.** Sequence of Images from Test 2-13B (image time stamps are in seconds).

<b>Time (ms)</b>	<b>Observation</b>
<b>0</b>	Initial light observed in top rear louver
<b>66</b>	Particle ejecta reaches first instrument rack immediately above enclosure
<b>150</b>	Particle ejecta reaches second instrument rack above enclosure
<b>200</b>	Luminescent flash zone reaches first instrument rack immediately above enclosure
<b>250</b>	Particle ejecta continue to be vertically oriented and localized to left side of load vertical section
<b>333</b>	Particle ejecta stream observed on left and right side of switchgear.
<b>400</b>	Luminescent intensity diminishing
<b>450</b>	Last particle ejecta at arc extinguishment
<b>358 000</b>	NIST data acquisition ends

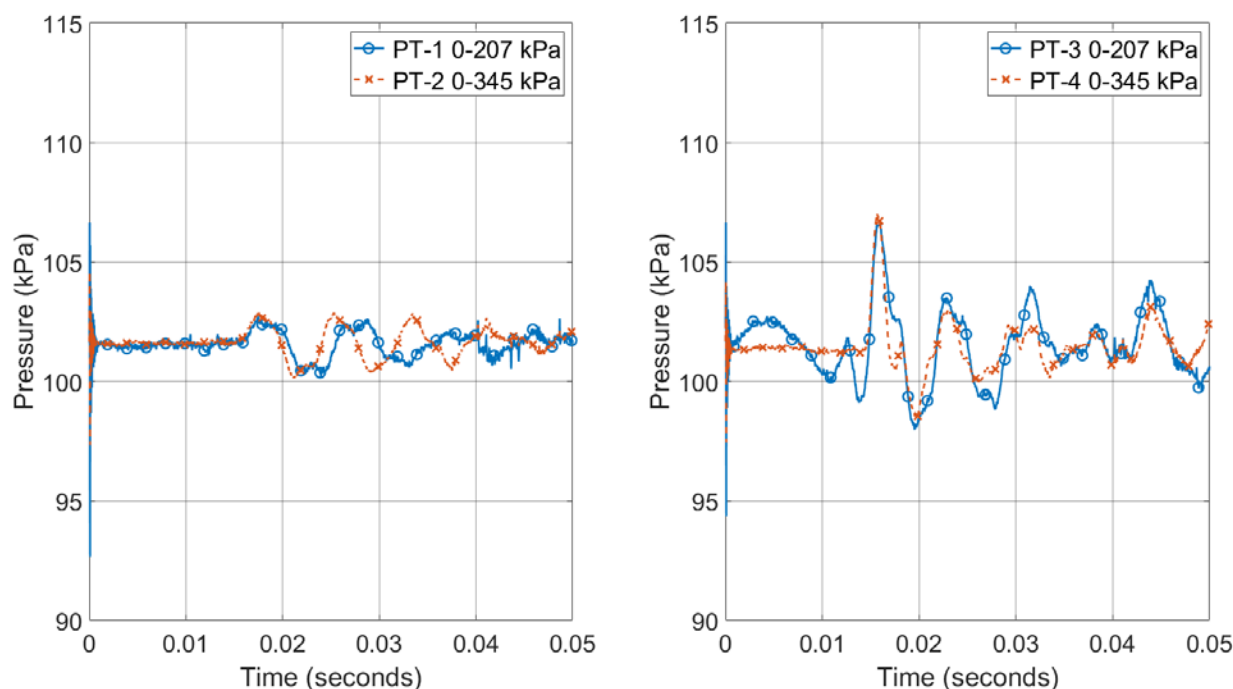
**Fig. 39.** Pressure measurements from Test 2-13B (breaker compartment (left); Main bus [arcing compartment] (right). Measurement uncertainty  $\pm 3$  percent.

The pressure profiles for the first two tenths of a second are shown in Fig. 39. After the initial pressure spike, the pressure rapidly decays to a relative steady state. The peak pressure is higher in the primary cable connection compartment as would be expected since this is the compartment where the arc is initiated. The maximum change in pressure in the main bus compartment is approximately 5 kPa (0.7 psi) above ambient at its peak. The maximum change in pressure in the breaker compartment is approximately 3 kPa (0.4 psi) above ambient. The 0 kPa to 207 kPa (0 psia to 30 psia) and 0 kPa to 345 kPa (0 psia to 50 psia) transducer recordings at a specific location were consistent.

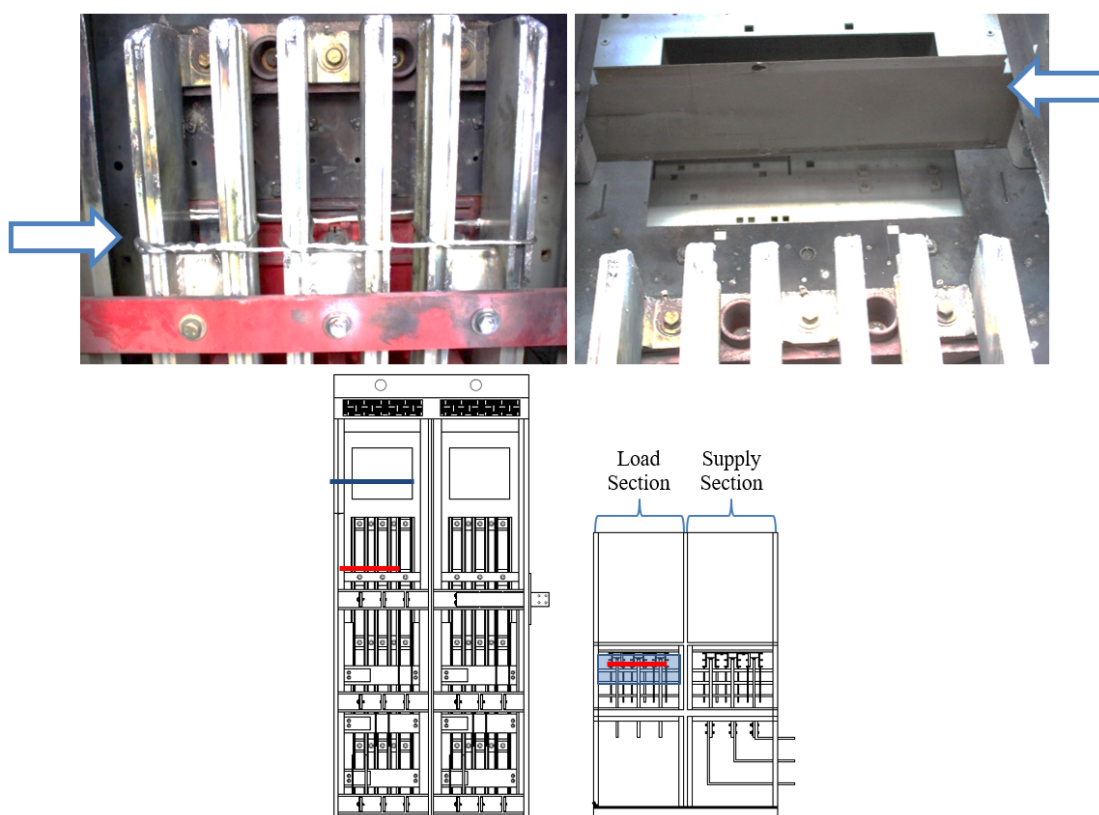
**Fig. 40.** Shorting Wire Location Test 2-13C (Phases left-to-right: A-B-C) (top left); grounding plate (top right); illustration of shorting wire (red) and grounding plate (blue) locations (bottom left) elevation view and plan view (bottom right).

The switchgear used in Tests 2-13A and 2-13B was used again in this experiment. The gear was tested for sufficient insulation resistance between phases and found to be functional. The arc was located near the top of the main bus bar in the load section of the switchgear. A single 10 AWG bare stranded conductors were used to initiate the arc. Due to the previous two experiments not maintaining the arc for the planned arc duration, a shorting plate was added near the top of the vertical main bus bars to allow for arc attachment and reduce the likelihood self-extinguishment. The grounding place was approximately 18 cm (7 in) above the top of the vertical main bus bars. This distance was selected based on available attachment points within the switchgear and discussion with the NRC/RES – EPRI HEAF working group and their review of applicable drawings. The arcing wire installed on the bus, ground plate, and marked up illustrations of the arc wire location is presented in Fig. 40.

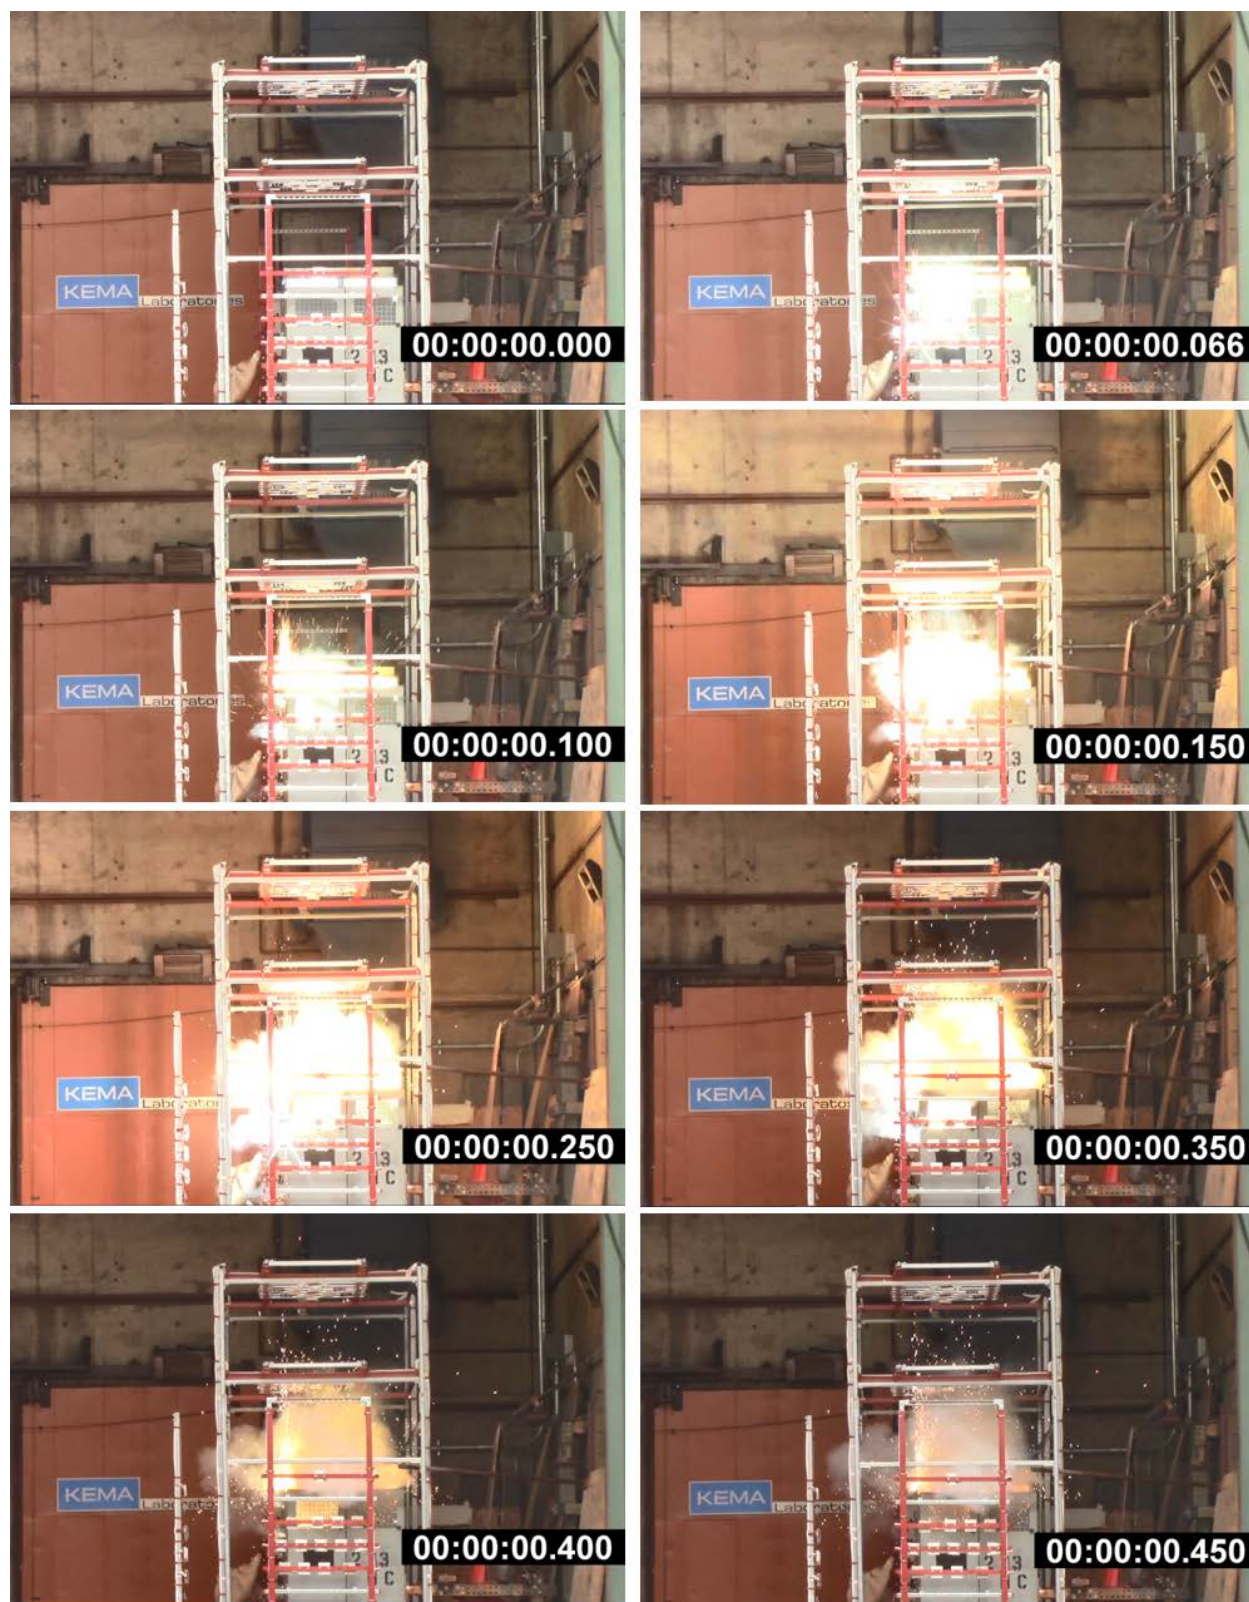
**Fig. 41.** Sequence of Images from Test 2-13C (image time stamps are in seconds).

<b>Time (ms)</b>	<b>Observation</b>
<b>0</b>	Initial light observed in top rear louver
<b>66</b>	Initial particle ejecta observed
<b>100</b>	Particle ejecta reaches first instrument rack immediately above enclosure
<b>150</b>	Luminescent flash zone reaches first instrument rack immediately above enclosure
<b>250</b>	Luminescent flash zone expands horizontally
<b>350</b>	Particle ejecta reaches second instrument rack above enclosure
<b>400</b>	Luminescent flash zone intensity diminishing
<b>450</b>	Last particle ejecta at arc extinguishment
<b>686 500</b>	NIST data acquisition ends

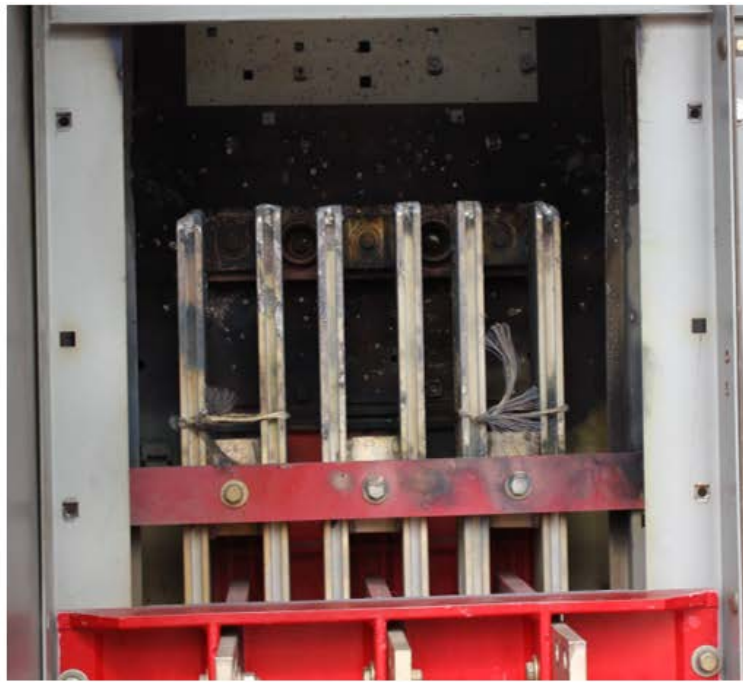
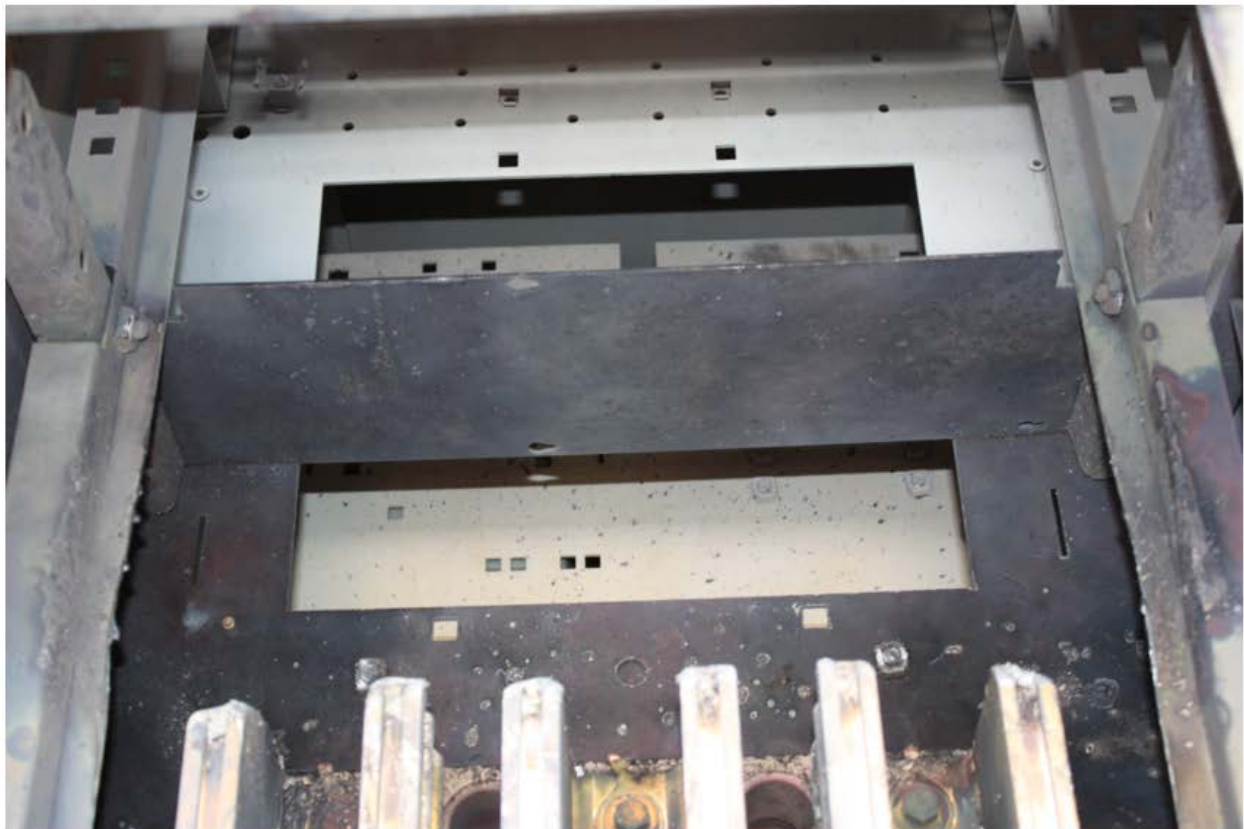
Photographs of the enclosure following the experiment is presented in Fig. 42. The enclosure did not experience a breach.

**Fig. 42.** Enclosure Post-Test 2-13C. Top photo showing top of vertical main buses. Bottom photo.

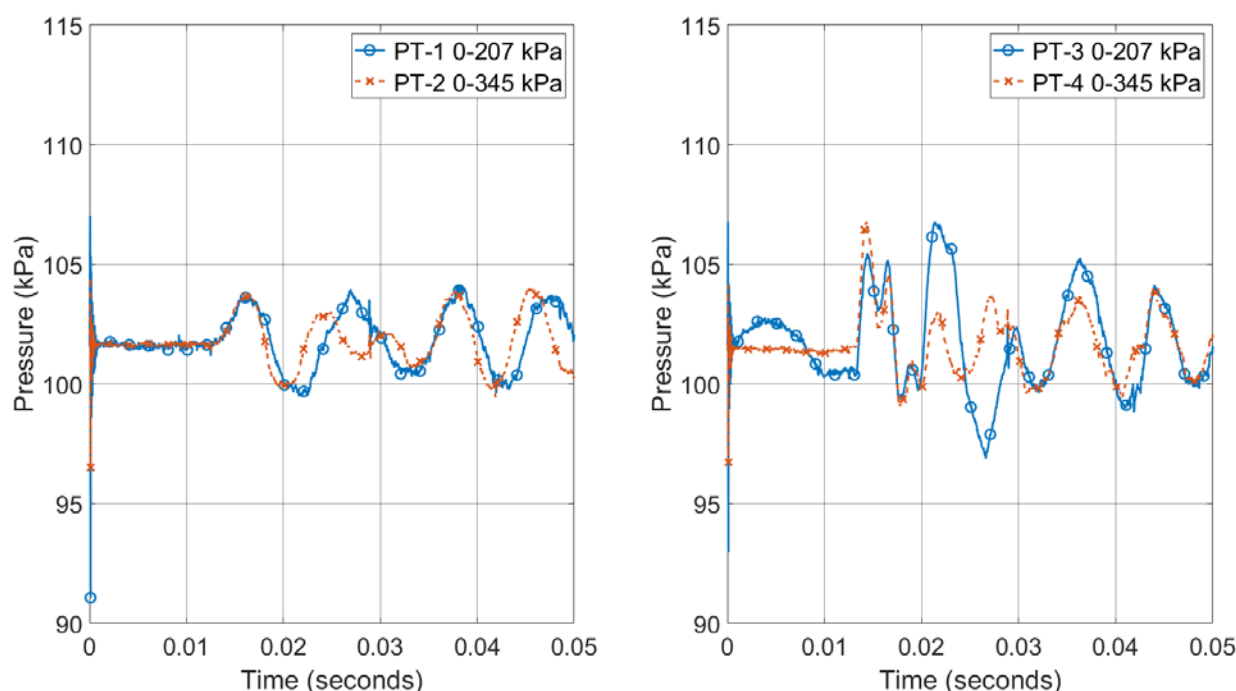
**Fig. 43.** Pressure measurements from Test 2-13C (breaker compartment (left); Main bus [arcing compartment] (right). Measurement uncertainty ± 3 percent.

The pressure profiles for the first two tenths of a second are shown in Fig. 43. After the initial pressure spike, the pressure rapidly decays to a relative steady state. The peak pressure is higher in the primary cable connection compartment as would be expected since this is the compartment where the arc is initiated. The maximum change in pressure in the main bus compartment is approximately 5 kPa (0.7 psi) above ambient at its peak. The maximum change in pressure in the breaker compartment is approximately 3 kPa (0.4 psi) above ambient. The 0 kPa to 207 kPa (0 psia to 30 psia) and 0 kPa to 345 kPa (0 psia to 50 psia) transducer recordings at a specific location were consistent.

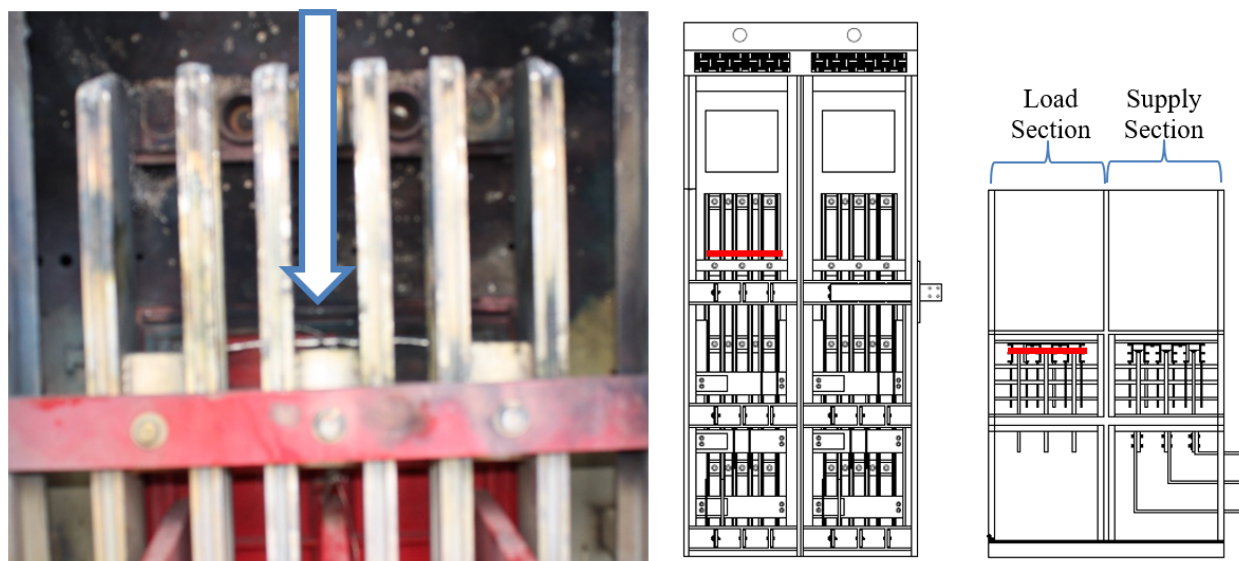
**Fig. 44.** Shorting Wire Location Test 2-13D (Phases left-to-right: A-B-C), photo of arc initiation point (left), elevation view (center), plan view (right). Shorting location shown in red on illustrations.

The switchgear used in Tests 2-13A, 2-13B, and 2-13C was used again in this experiment. The gear was tested for sufficient insulation resistance between phases and found to be functional. The arcing wire was located around the copper breaker stabs in the main bus section at the top load breaker in the load breaker vertical section. All three phases were shorted with the shorting wire. Switchgear enclosure was connected to neutral. Generator neutral was tied to ground via impedance. A single 10 AWG bare stranded conductors were used to initiate the arc. The arcing wire installed on the bus and marked up illustrations of the arc wire location is presented in Fig. 44.

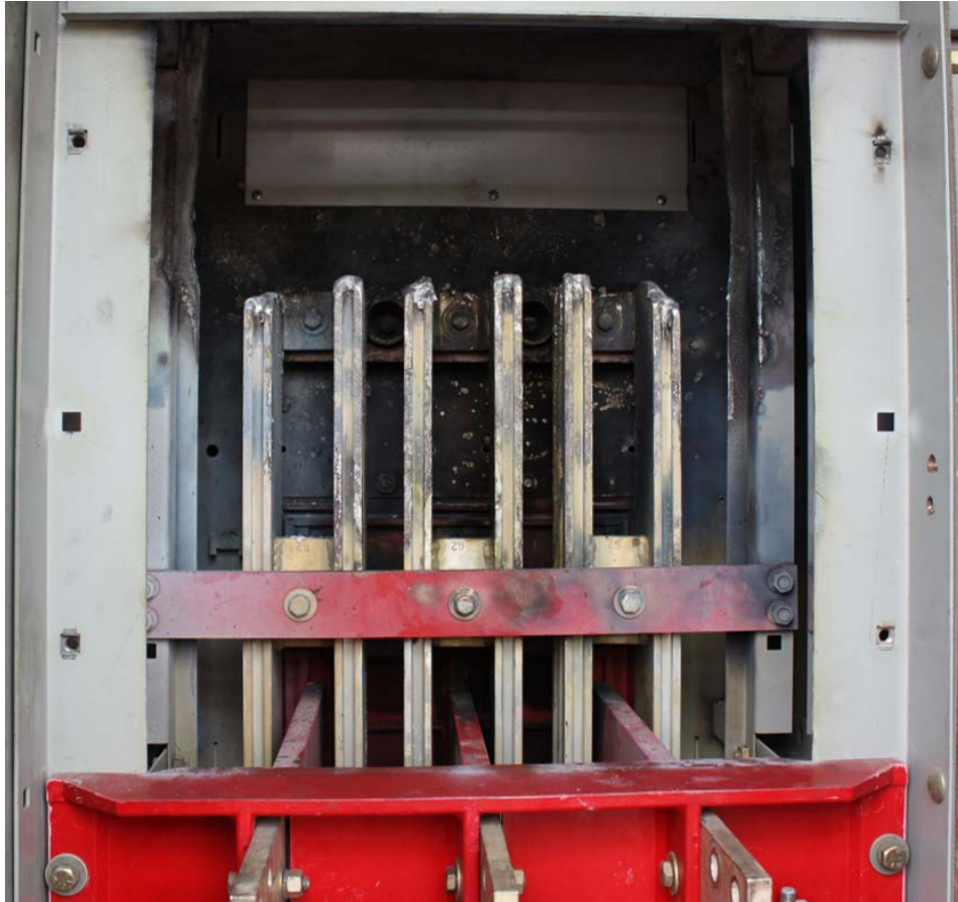
Photographs of the enclosure following the experiment are presented in Fig. 46 and Fig. 47. The enclosure did not experience a breach.

**Fig. 46.** Enclosure Post-Test 2-13D.

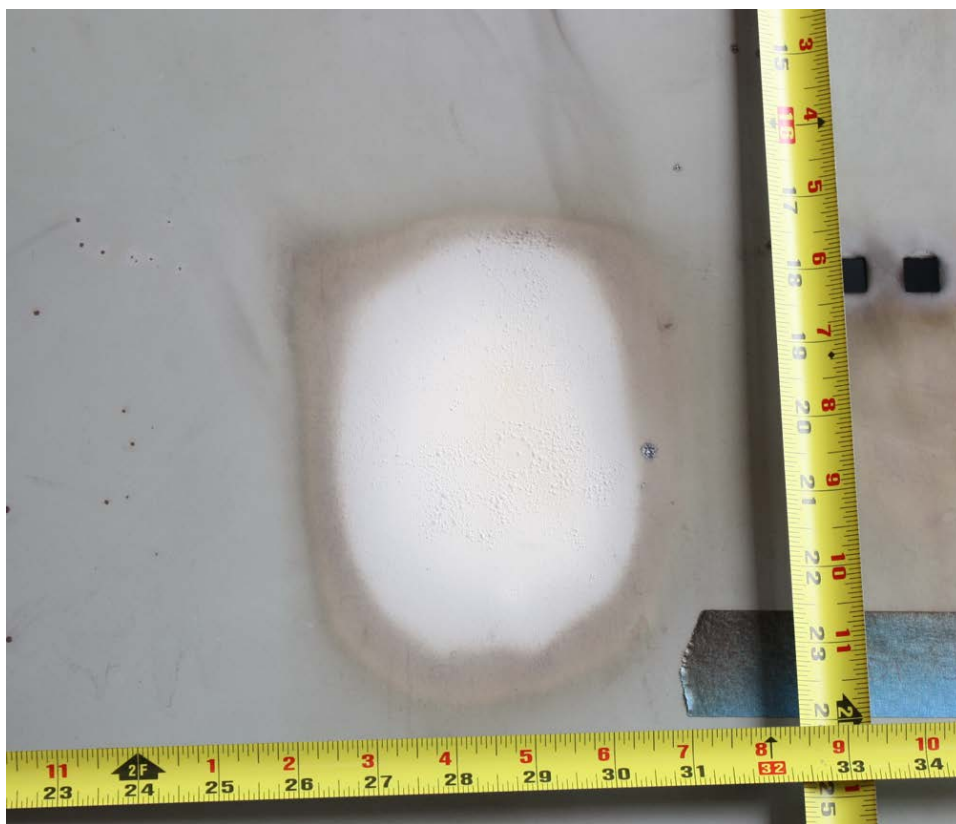
**Fig. 47.** Thermal heating on external of load section enclosure adjacent to top of vertical bus bars.

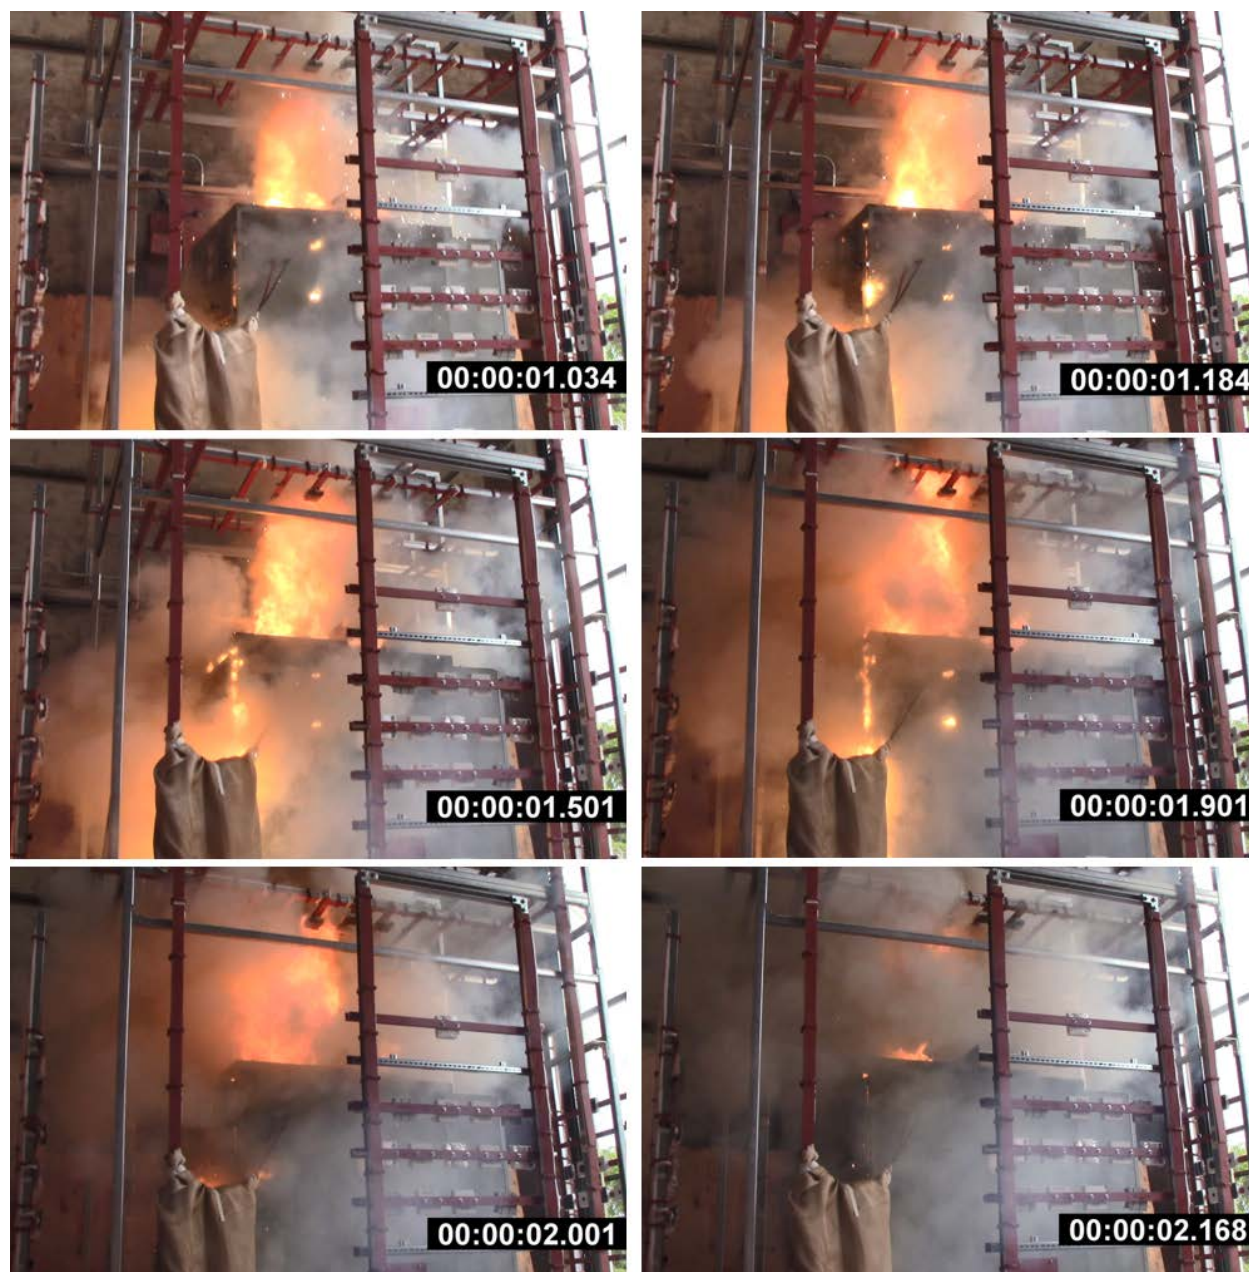
**Fig. 51.** Sequence of Images from second half of Test 2-13E (image time stamps are in seconds).

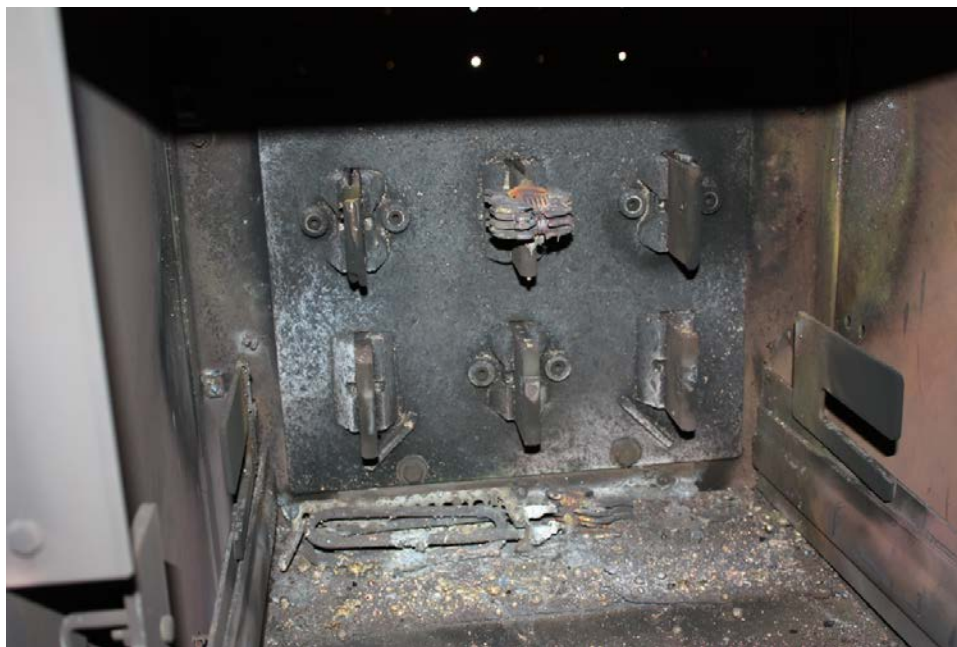
**Fig. 52.** Switchgear stabs post-experiment.

Photographs of the enclosure following the experiment are presented in Fig. 52, Fig. 53, and Fig. 54. The enclosure did not experience a breach.

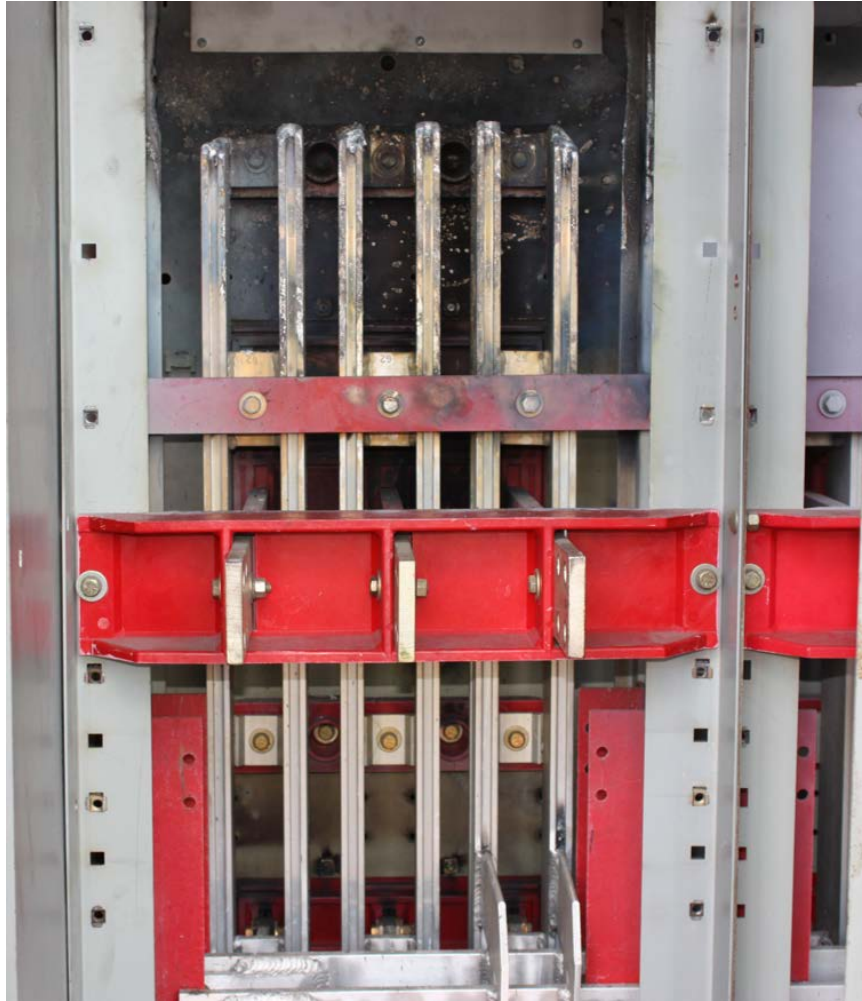
**Fig. 54.** Main bus bar post-experiment.

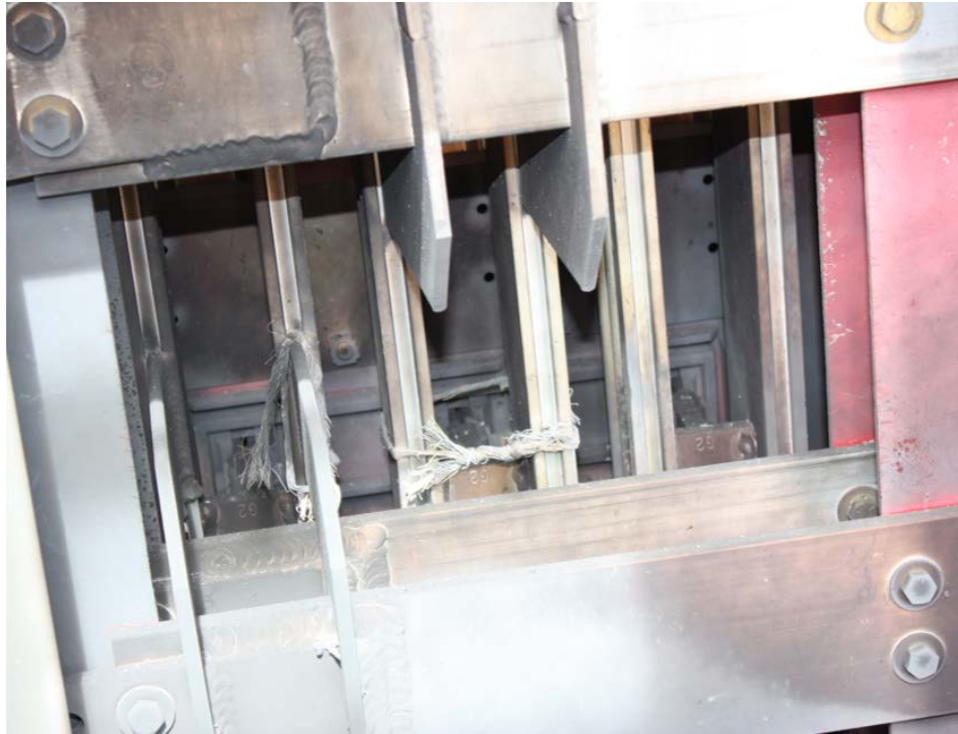
Photographs of the enclosure following the experiment are presented in Fig. 58 and Fig. 59. The enclosure did not experience a breach.

**Fig. 58.** Enclosure Post-Test 2-13F.

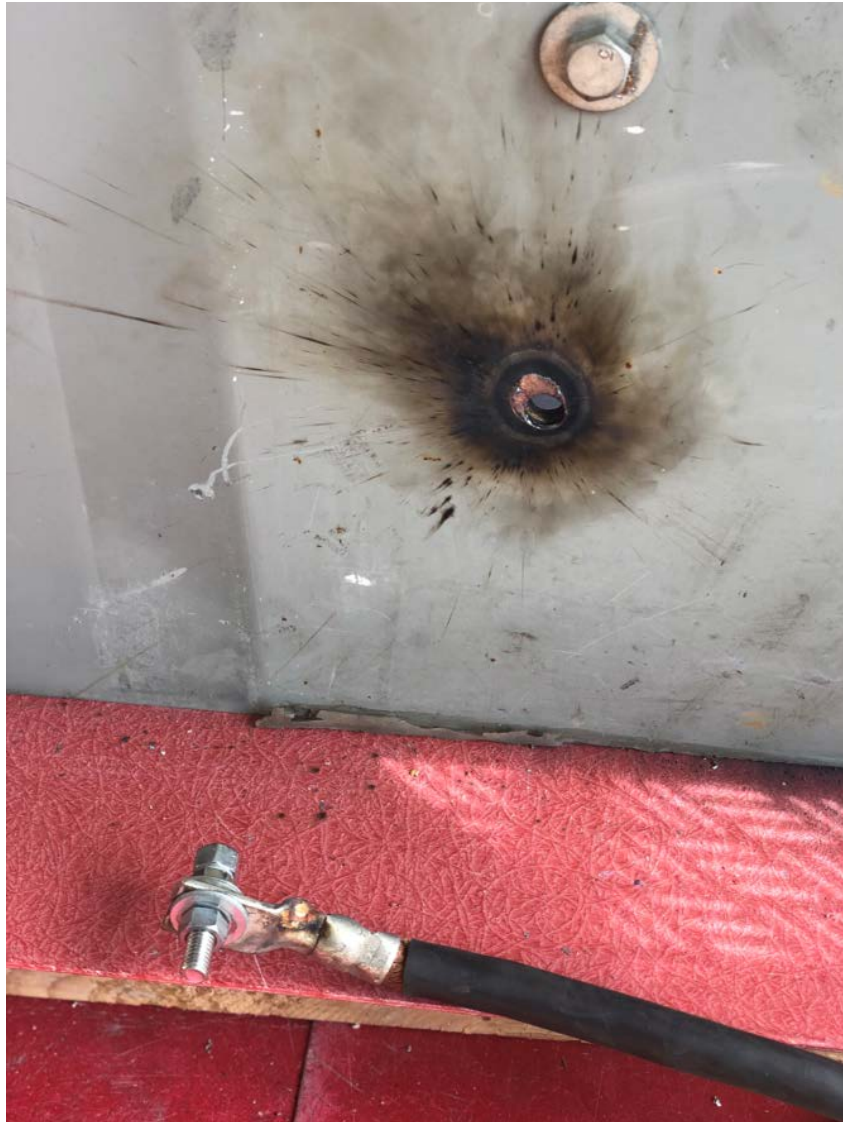
**Fig. 59.** Post-experiment image of enclosure grounding cable disconnected from enclosure due to current flow through ground circuit.

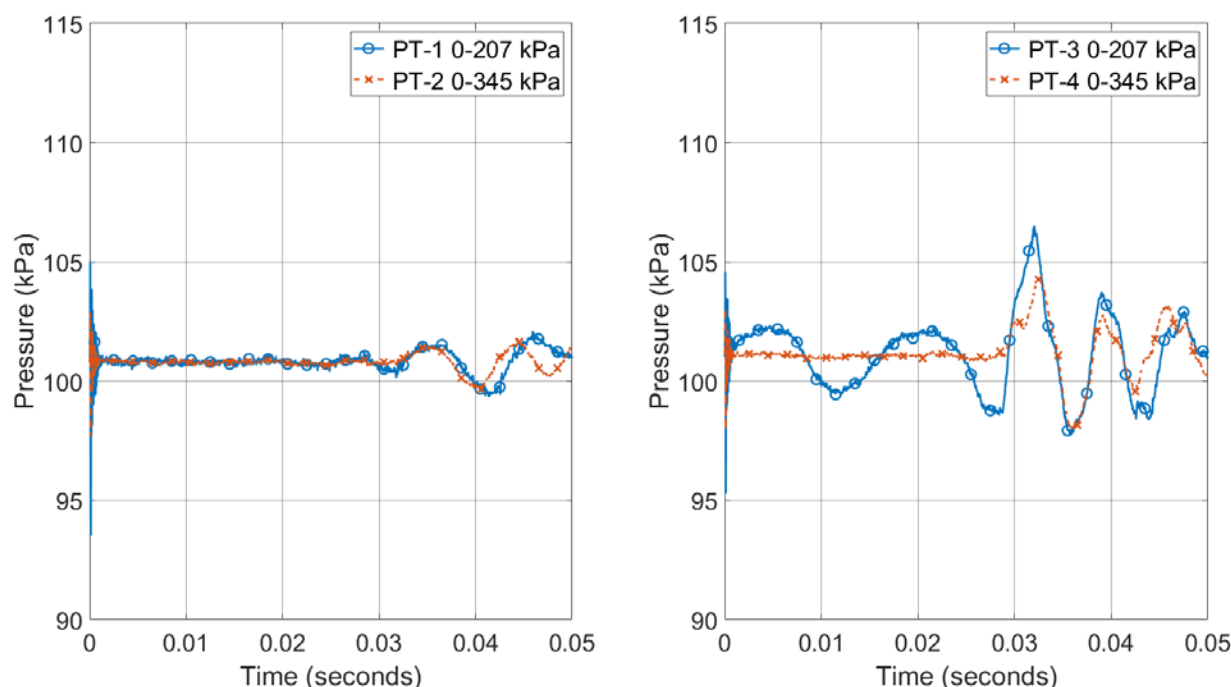
**Fig. 60.** Pressure measurements from Test 2-13F (breaker compartment (left); Main bus [arcing compartment] – (right)). Measurement uncertainty  $\pm 3$  percent.

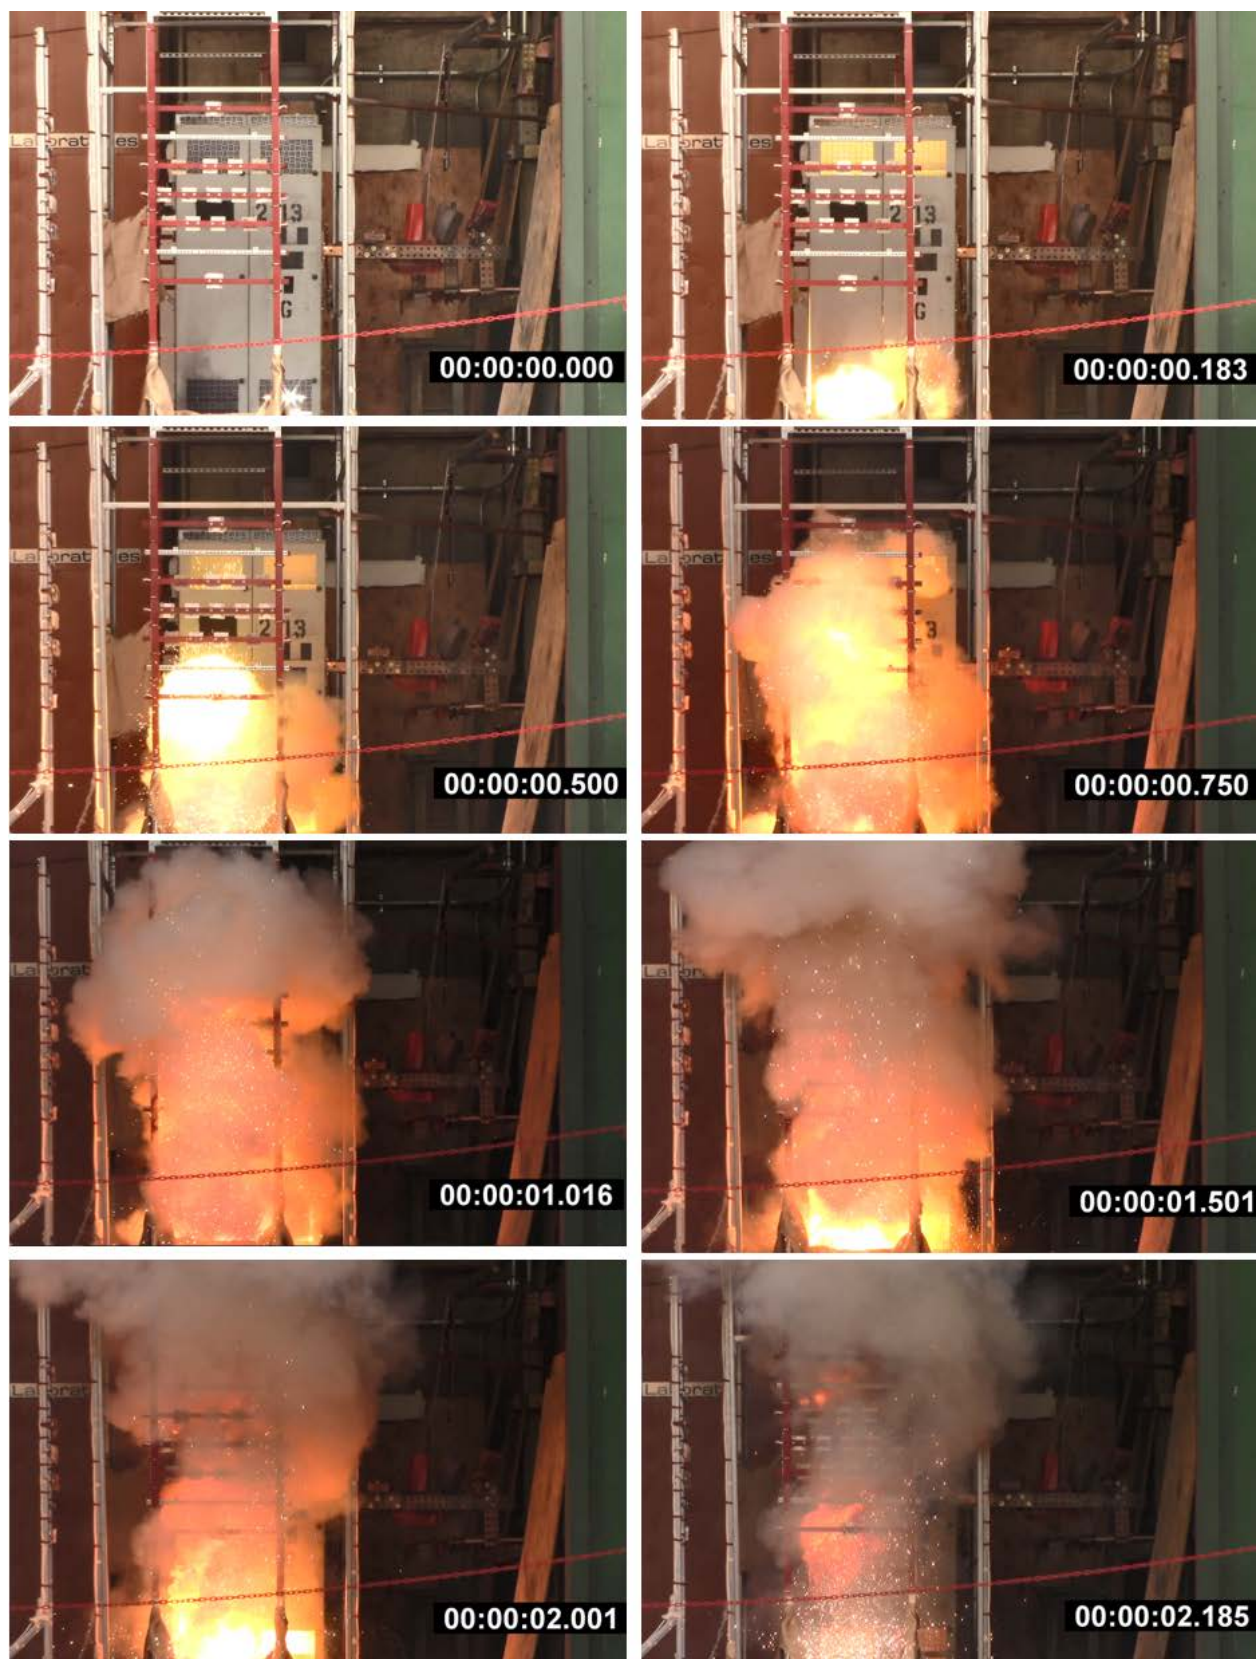
**Fig. 62.** Sequence of Images from Test 2-13G (image time stamps are in seconds).

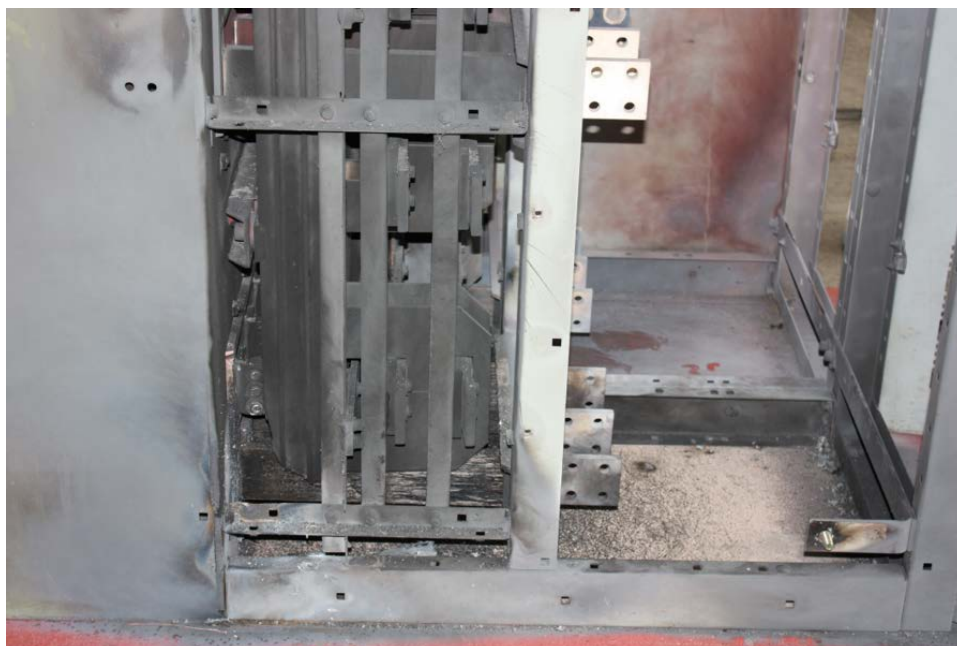
Photographs of the enclosure following the experiment is presented in Fig. 63. The enclosure did not experience a breach.

**Fig. 63.** Enclosure Post-Test 2-13G.

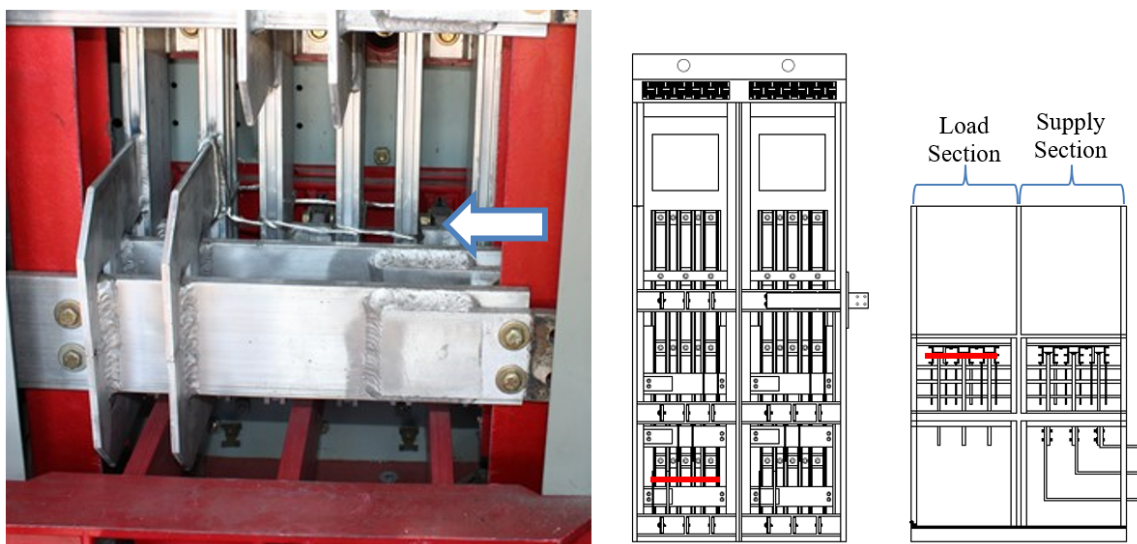
**Fig. 65.** Shorting Wire Location Test 2-18A (Phases left-to-right: A-B-C), photo of arc initiation point (left), elevation view (center), plan view (right). Shorting location shown in red on illustrations.

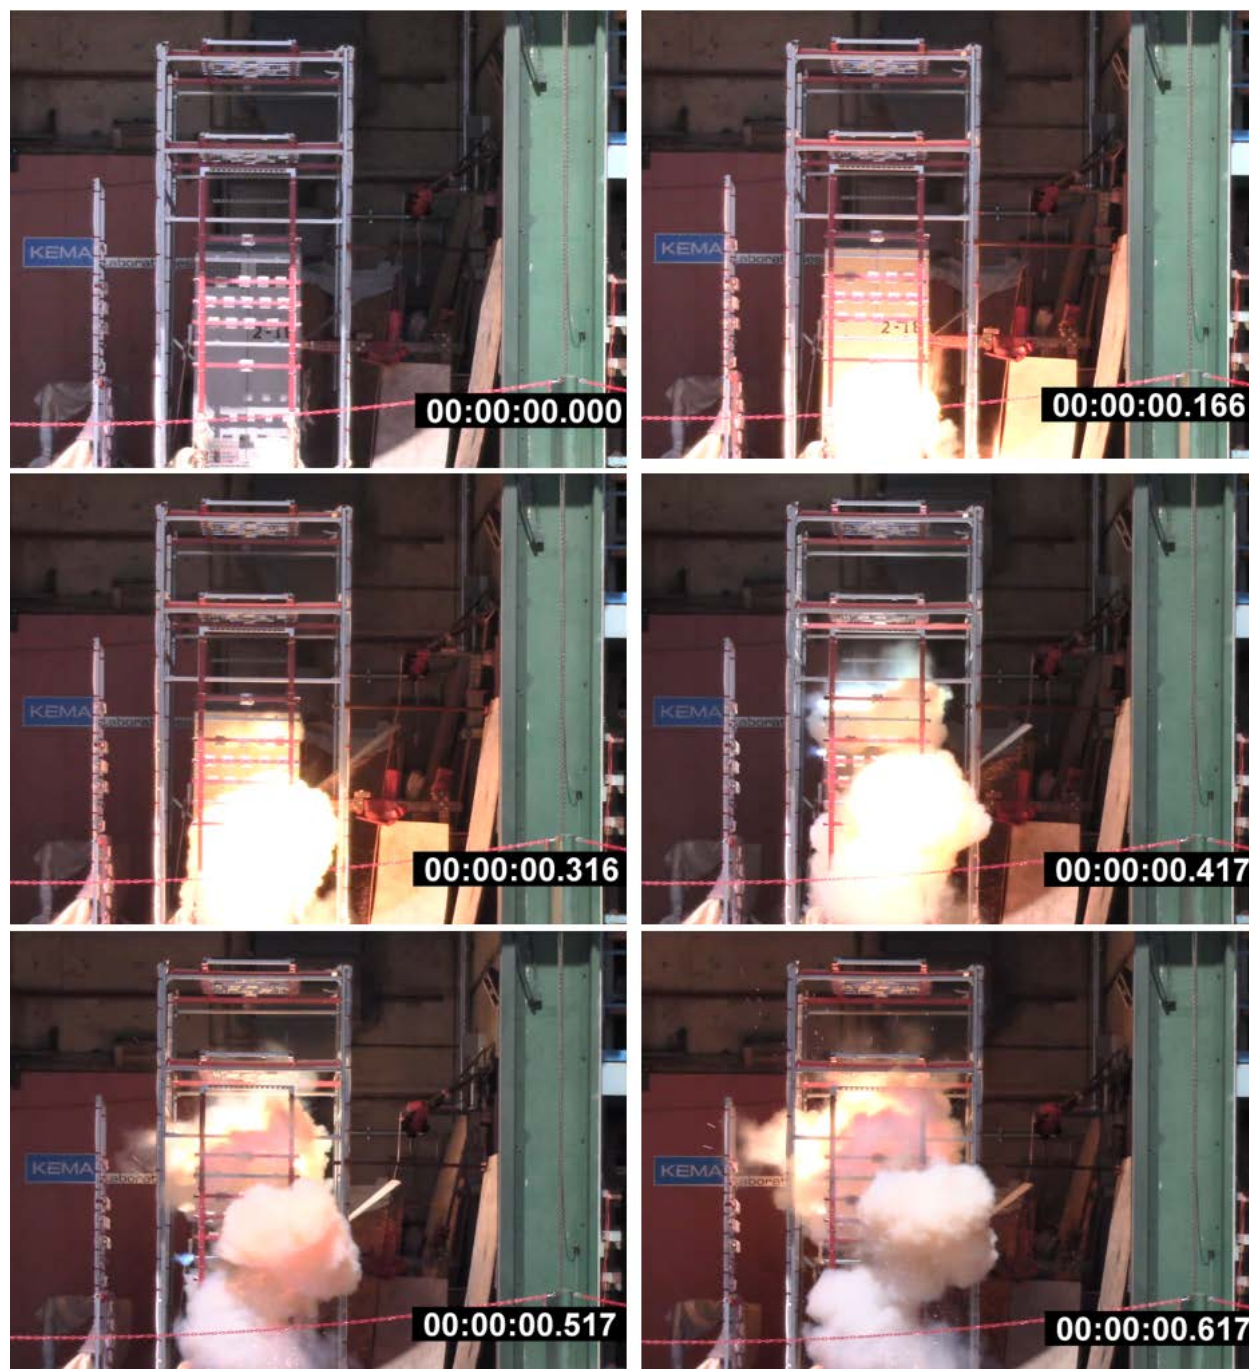
**Fig. 66.** Sequence of Images from Test 2-18A up to 0.617 s (image time stamps are in seconds).
