# **REPORT ON HIGH ENERGY ARCING FAULT EXPERIMENTS**

## **Experimental Results from Low- Voltage Switchgear Enclosures**

# Report on High Energy Arcing Fault Experiments

## Experimental Results from Low-Voltage Switchgear Enclosures

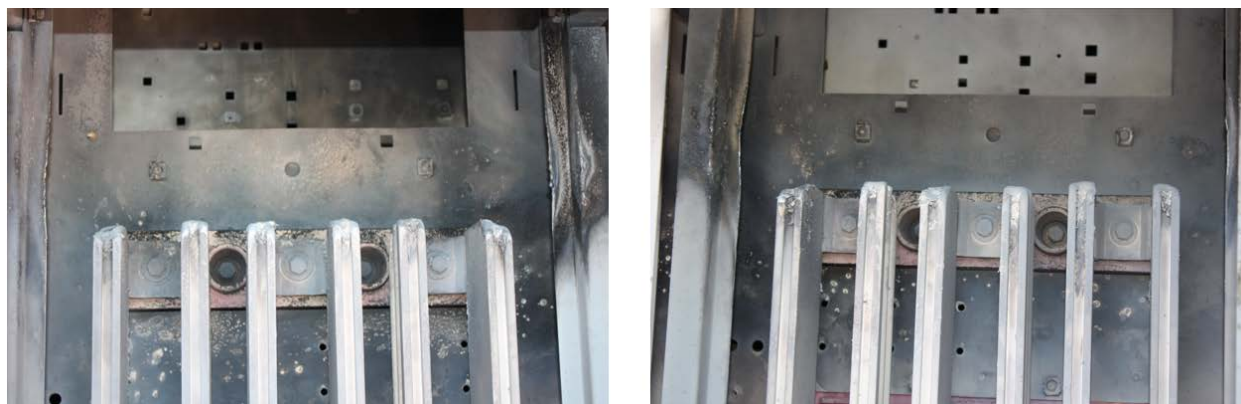
Photographs of the enclosure following the experiment are presented in Fig. 68 and Fig. 69. The enclosure did not experience a breach.

**Fig. 68.** Enclosure Post-Test 2-18A. Top of main bus, Load side (left), supply side (right).

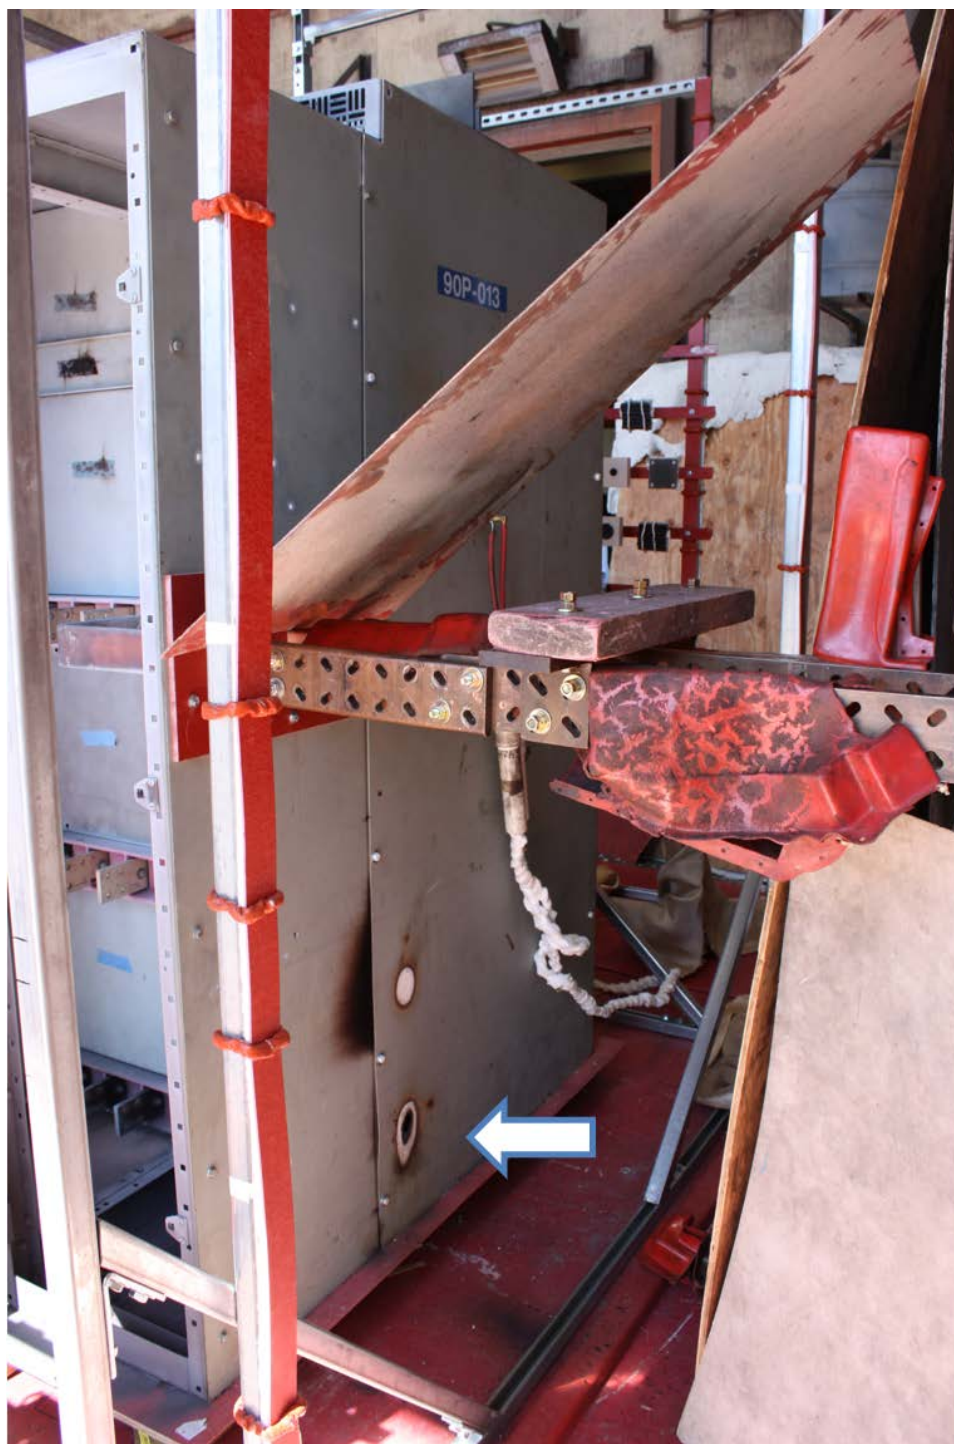
**Fig. 69.** Post-experiment image of enclosure breach and thermal effects on supply side of gear.

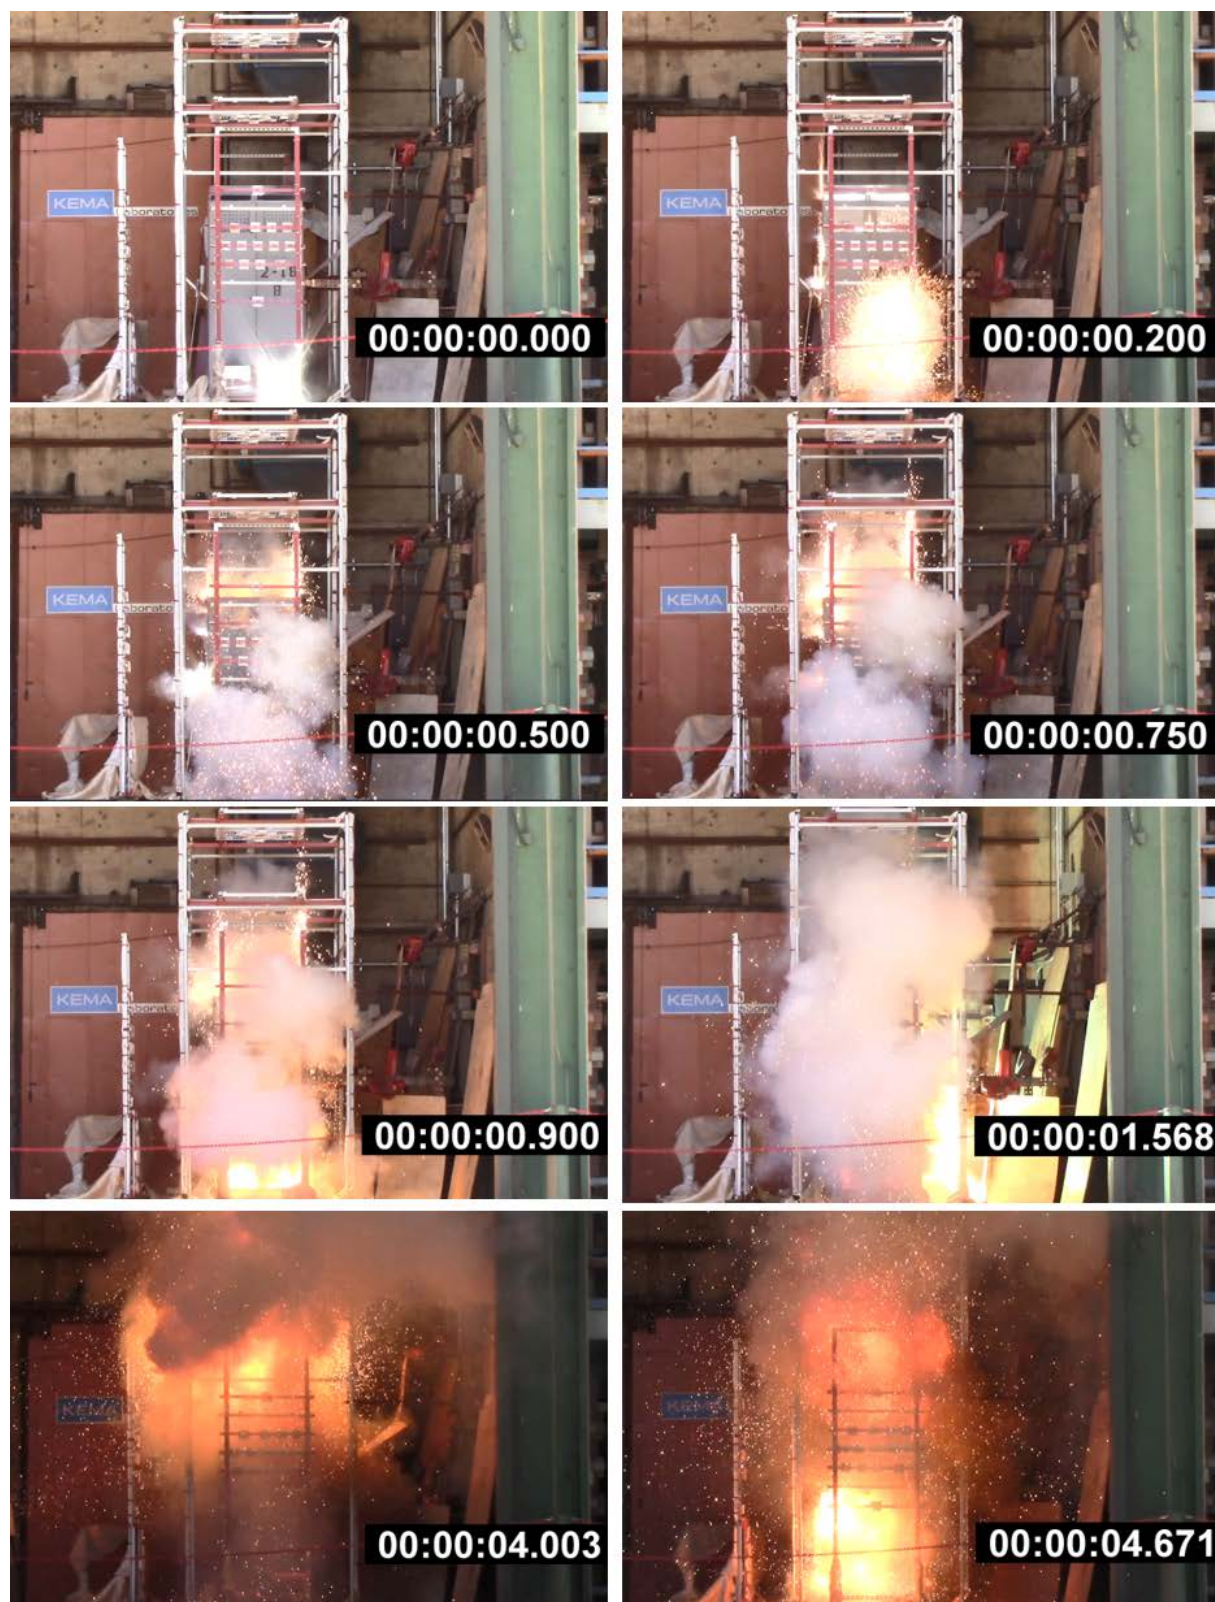
**Fig. 72.** Sequence of Images from Test 2-18B up to 4.671 s (image time stamps are in seconds).

<b>39 739</b>	Fire continues to burn in lower portion of cabinet
<b>732 700</b>	NIST data acquisition ends

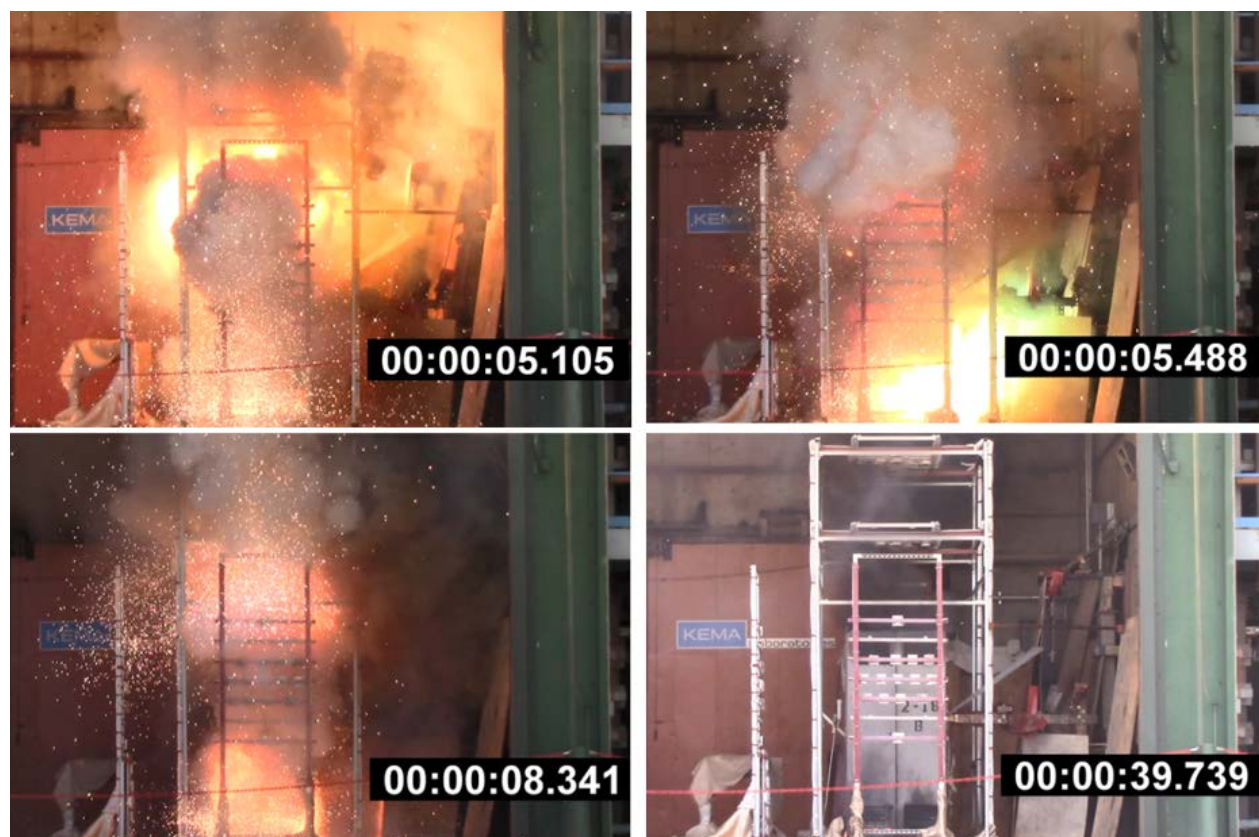
**Fig. 73.** Sequence of images from Test 2-18B from 4.671 s (image time stamps are in seconds).

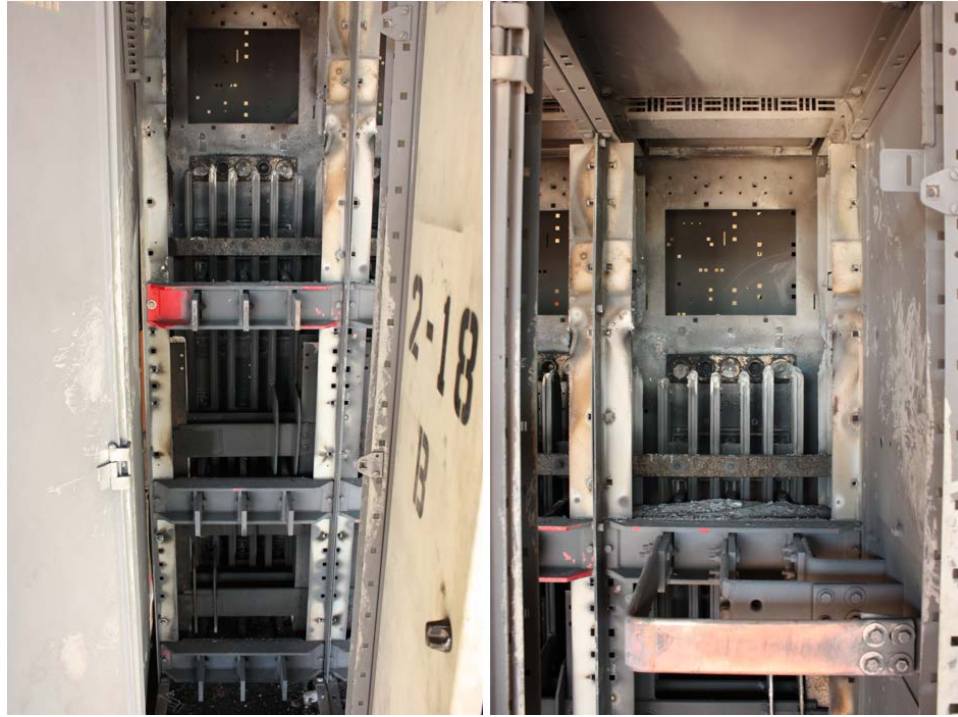
Photographs of the enclosure following the experiment are presented in Fig. 74 and Fig. 75. The enclosure did experience small breaches on the incoming (supply) side of the switchgear. There were no instruments located in this area due to the limited room and required separation distances by the incoming laboratory power conductors.

**Fig. 74.** Enclosure Post-Test 2-18B. load section (left), supply section (right)).

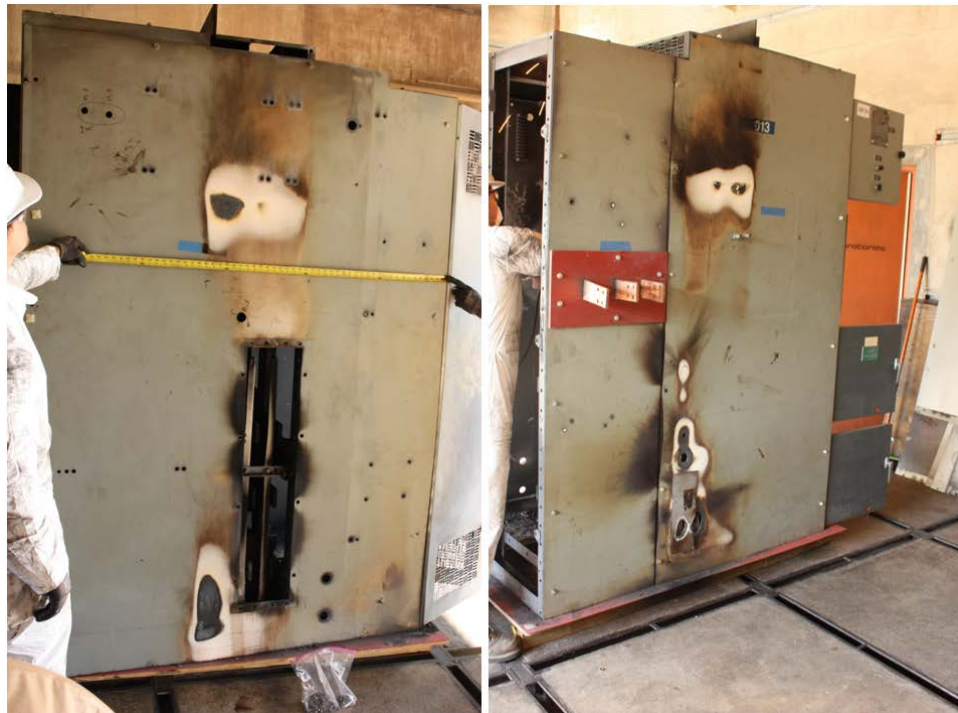
**Fig. 75.** Post-experiment image of enclosure. (load side (left), supply side (right)).

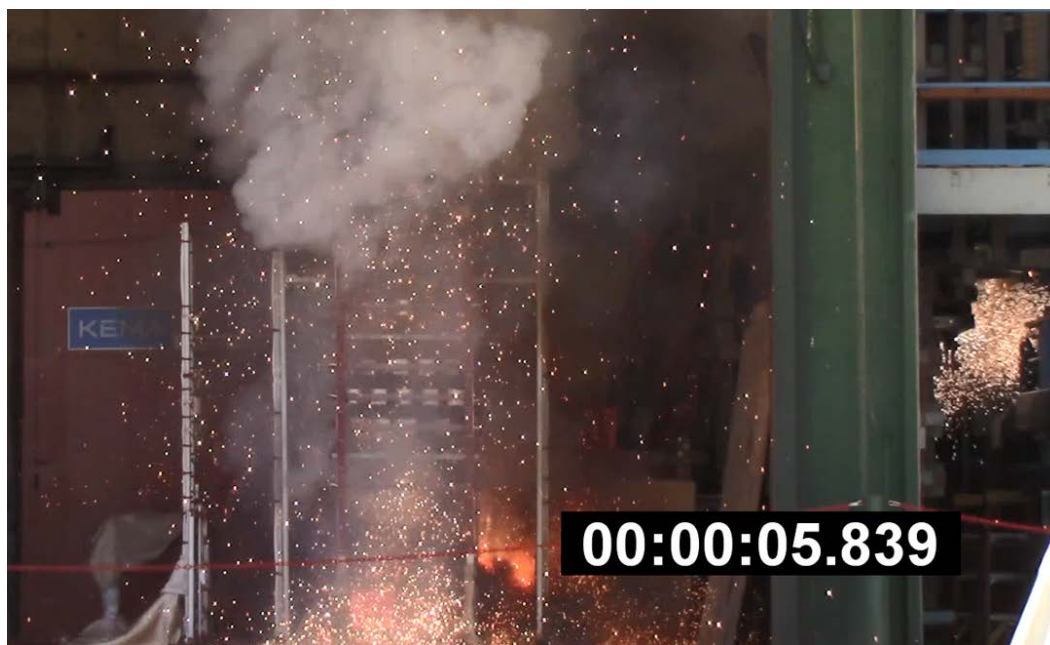
**Fig. 76.** Failure of KEMA cable connection observed as arcing occurring in Cell 8 (non-test cell).

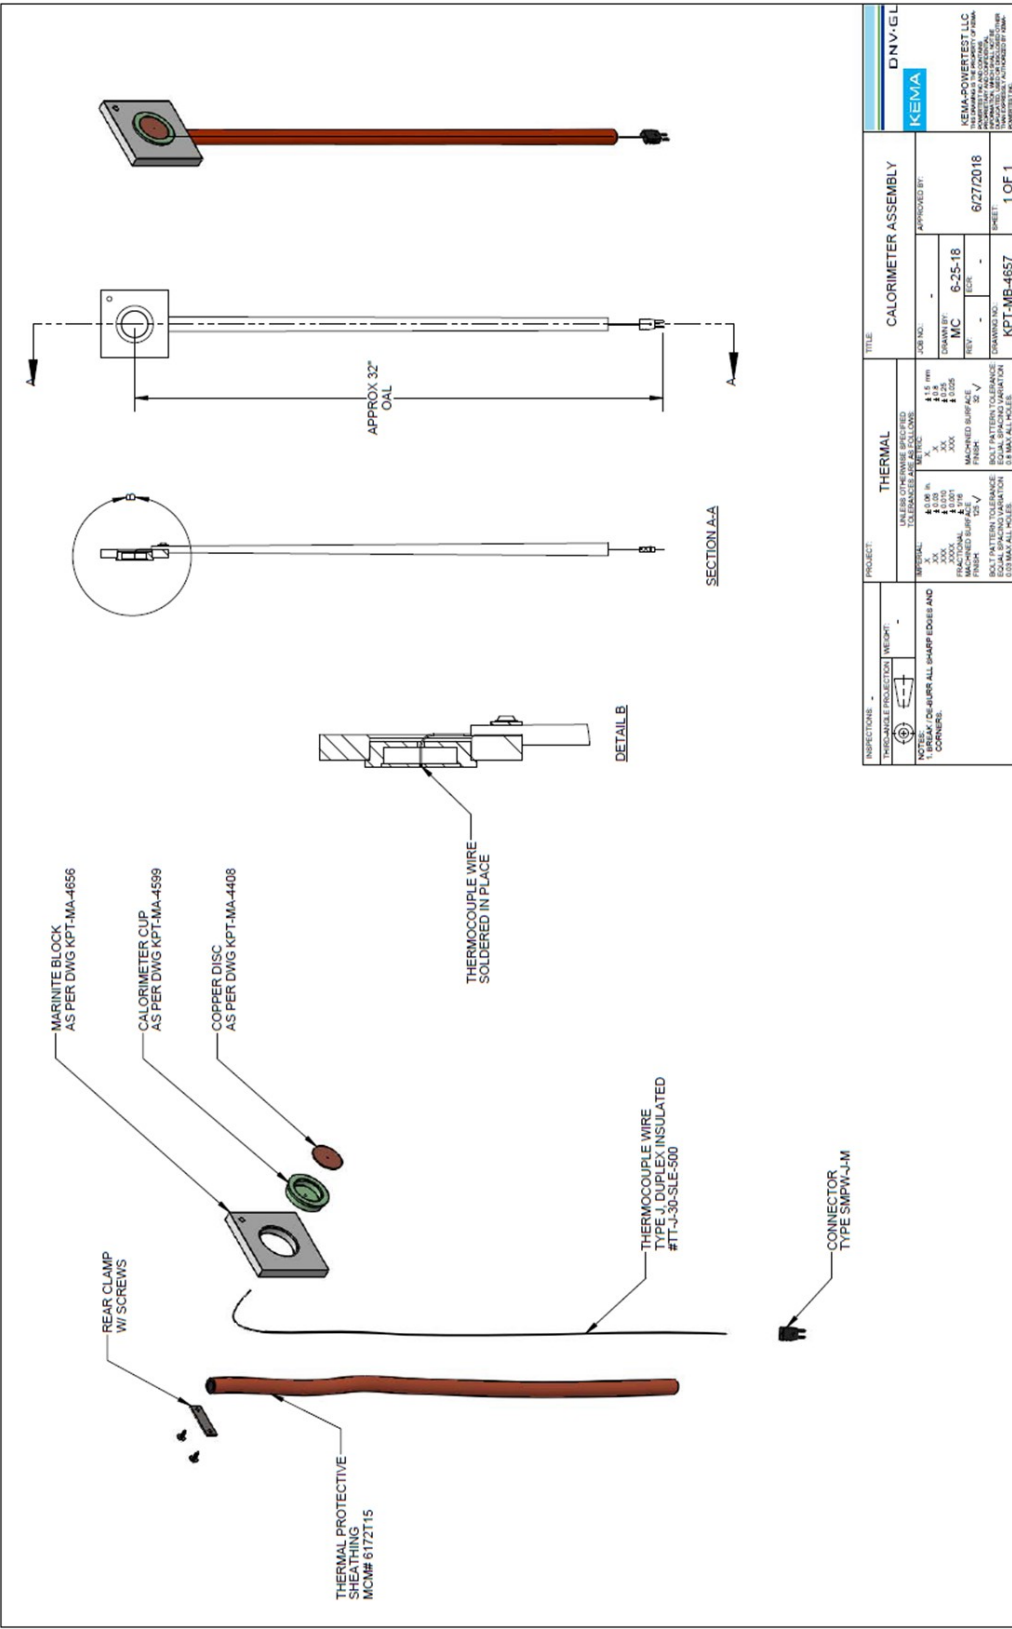
**Fig. 81.** Drawing KPT-MB-4657, ASTM Calorimeter Assembly

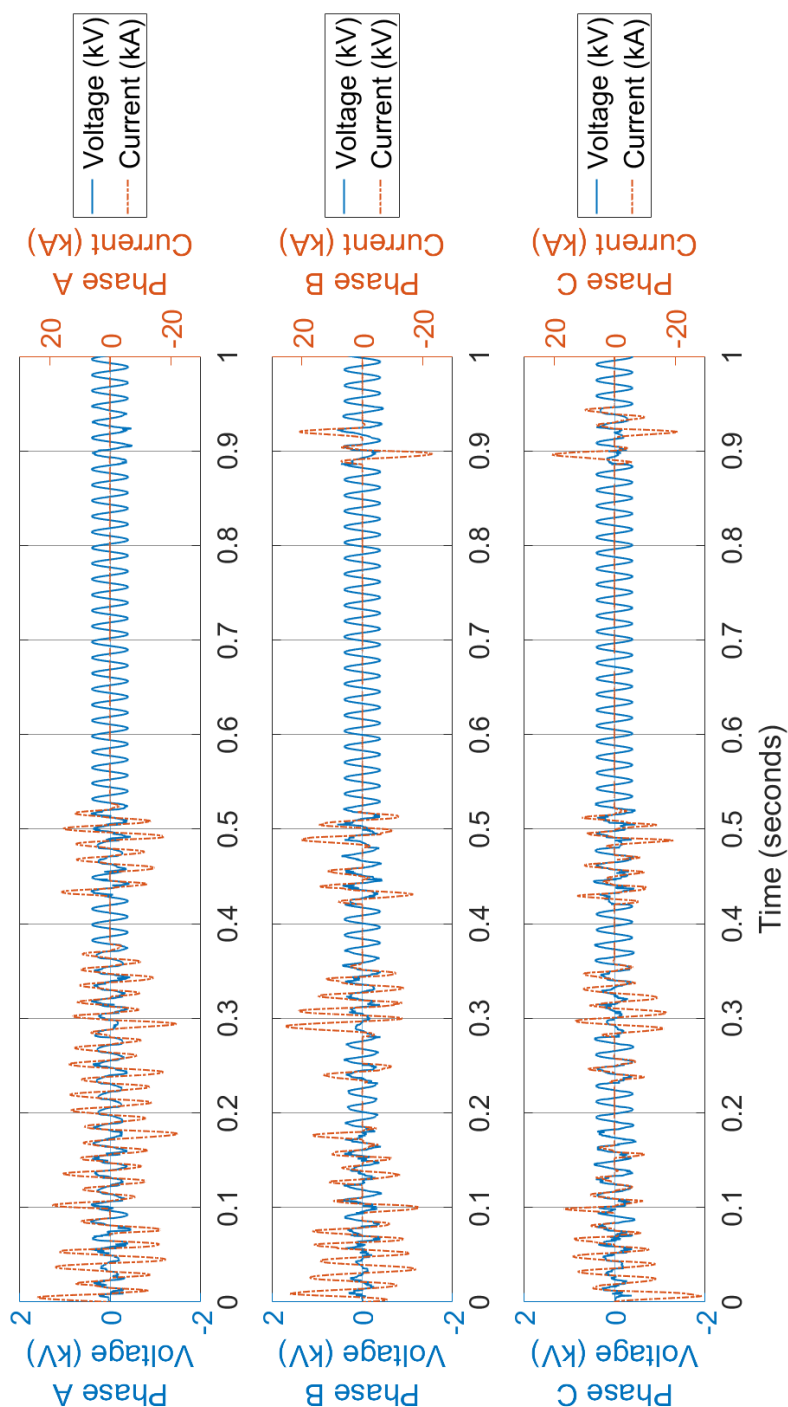
**Fig. 86.** Voltage and Current Profile during Test 2-13A. Measurement uncertainty  $\pm 3$  percent.

The voltage and current profile for the entire duration of the experiment is shown in Fig. 86. The transient region for current phases is presented in Fig. 87. Energy and power profiles are presented in Fig. 88.

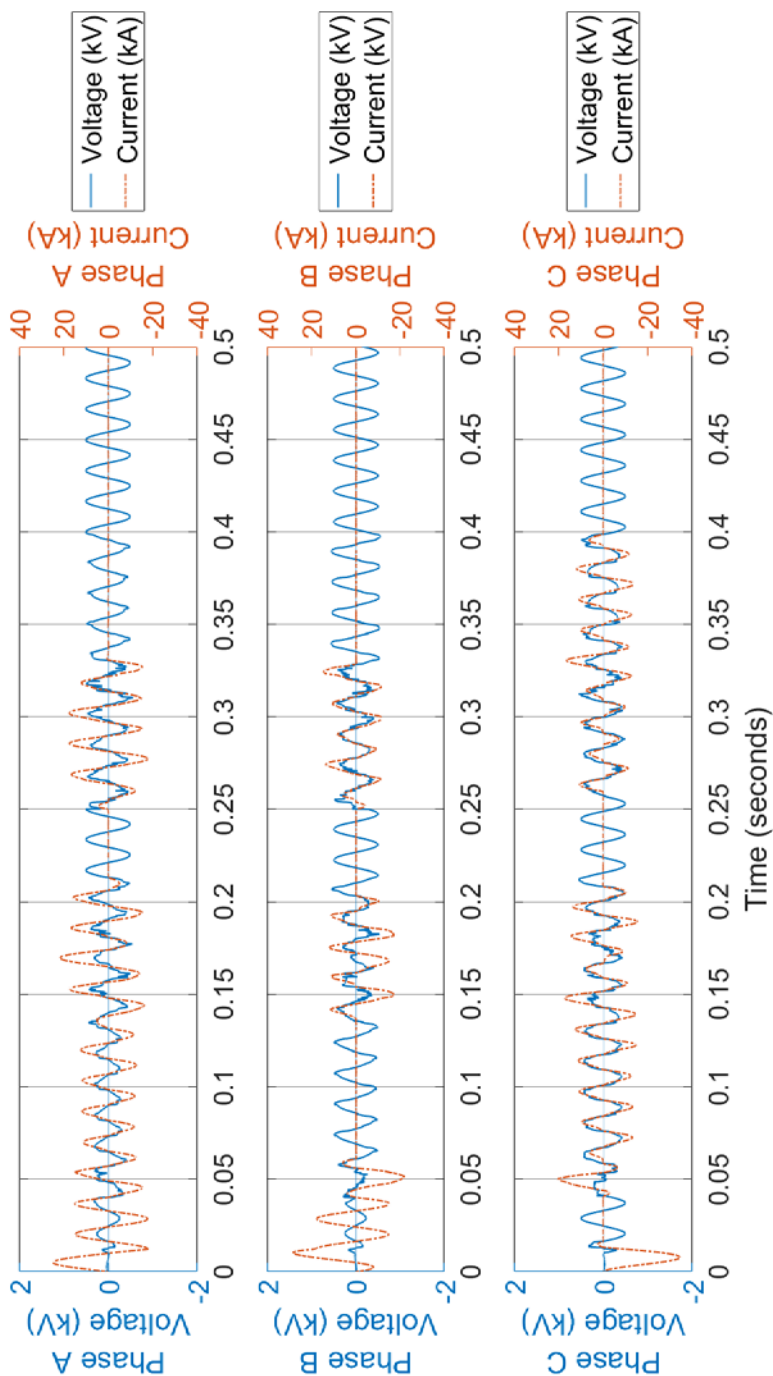
**Fig. 89.** Voltage and Current Profile during Test 2-13B. Measurement uncertainty  $\pm 3$  percent.

The voltage and current profile for the entire duration of the experiment is shown in Fig. 89. The transient region for current phases is presented in Fig. 90. Energy and power profiles are presented in Fig. 91.

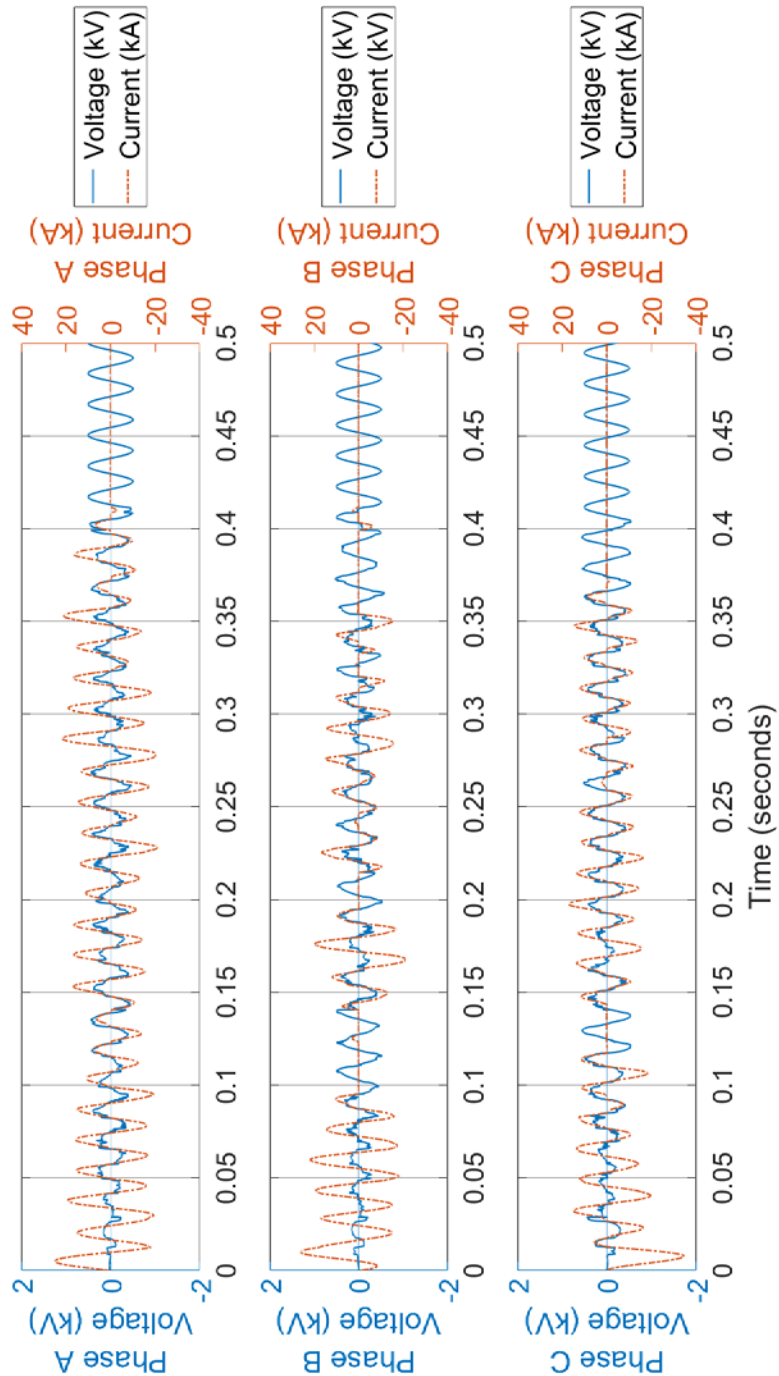
**Fig. 92.** Voltage and Current Profile during Test 2-13C. Measurement uncertainty  $\pm 3$  percent.

The voltage and current profile for the entire duration of the experiment is shown in Fig. 92. The transient region for current phases is presented in Fig. 93. Energy and power profiles are presented in Fig. 94.

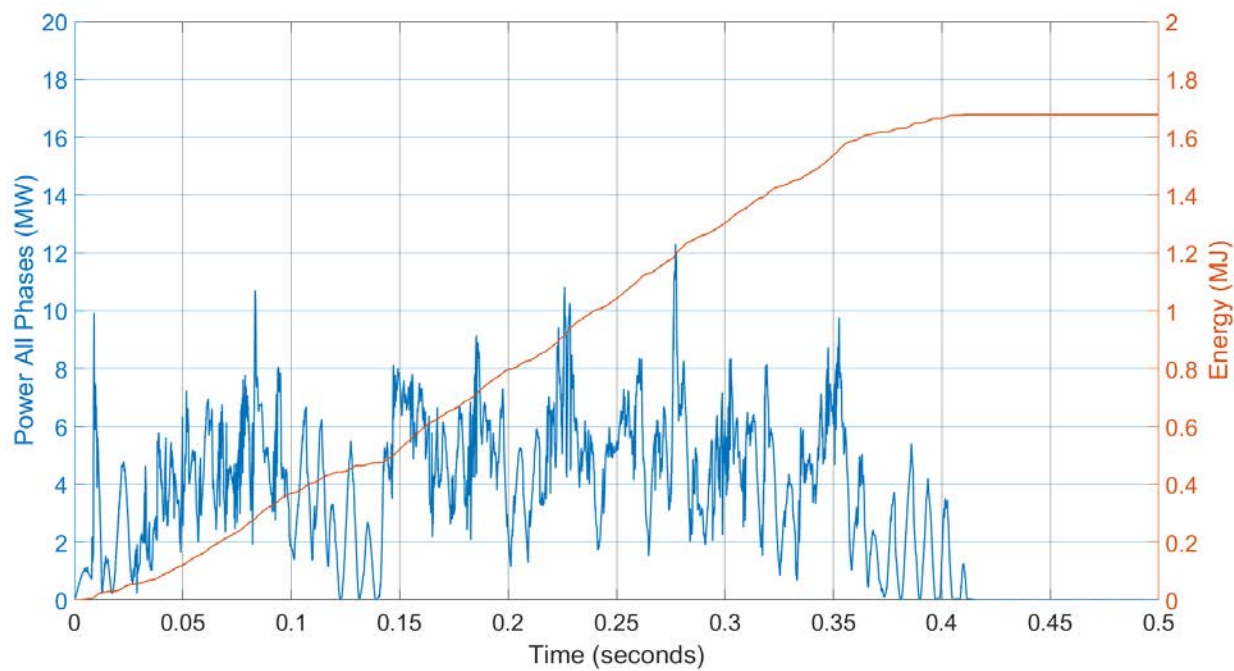
**Fig. 94.** Power and Energy for Test 2-13C. Measurement uncertainty  $\pm 3$  percent.

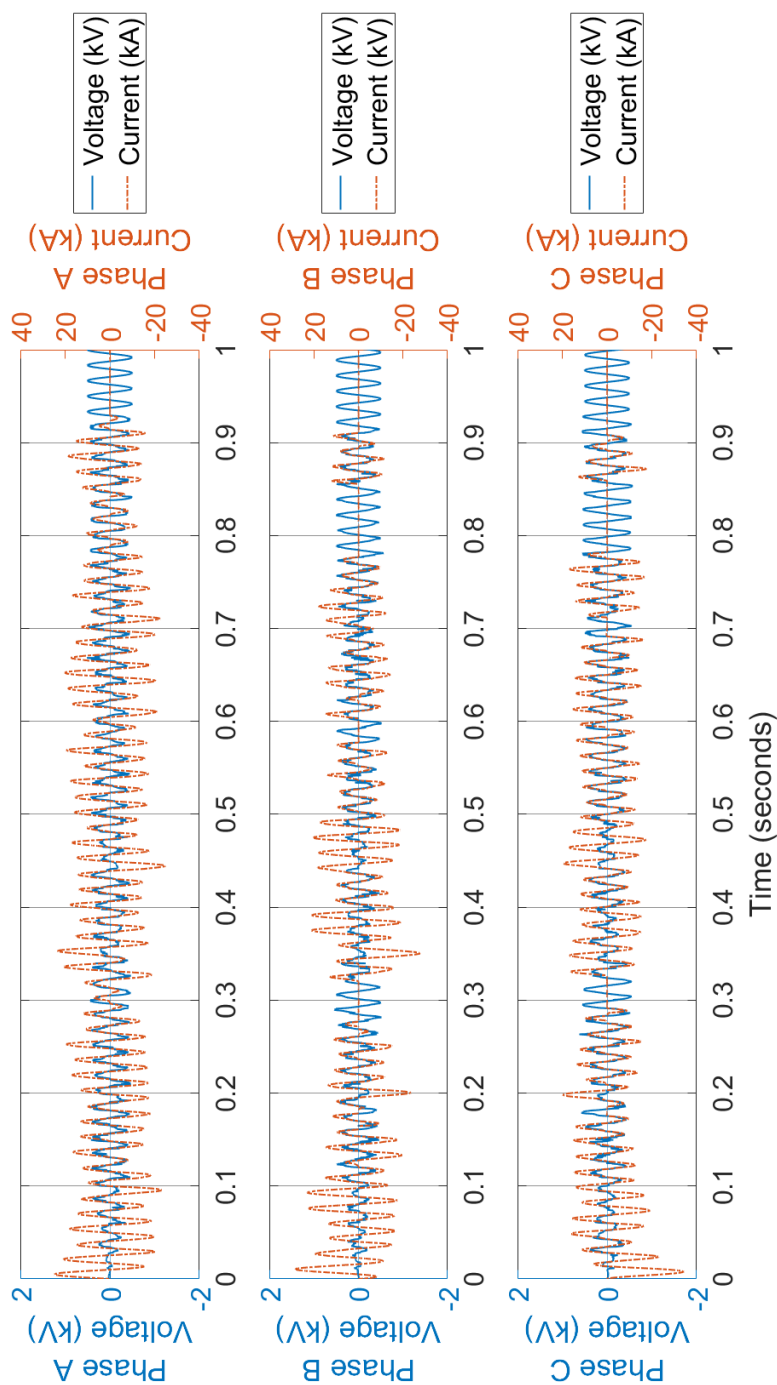
**Fig. 95.** Voltage and Current Profile during Test 2-13D. Measurement uncertainty  $\pm 3$  percent.

The voltage and current profile for the entire duration of the experiment is shown in Fig. 95. The transient region for current phases is presented in Fig. 96. Energy and power profiles are presented in Fig. 97.

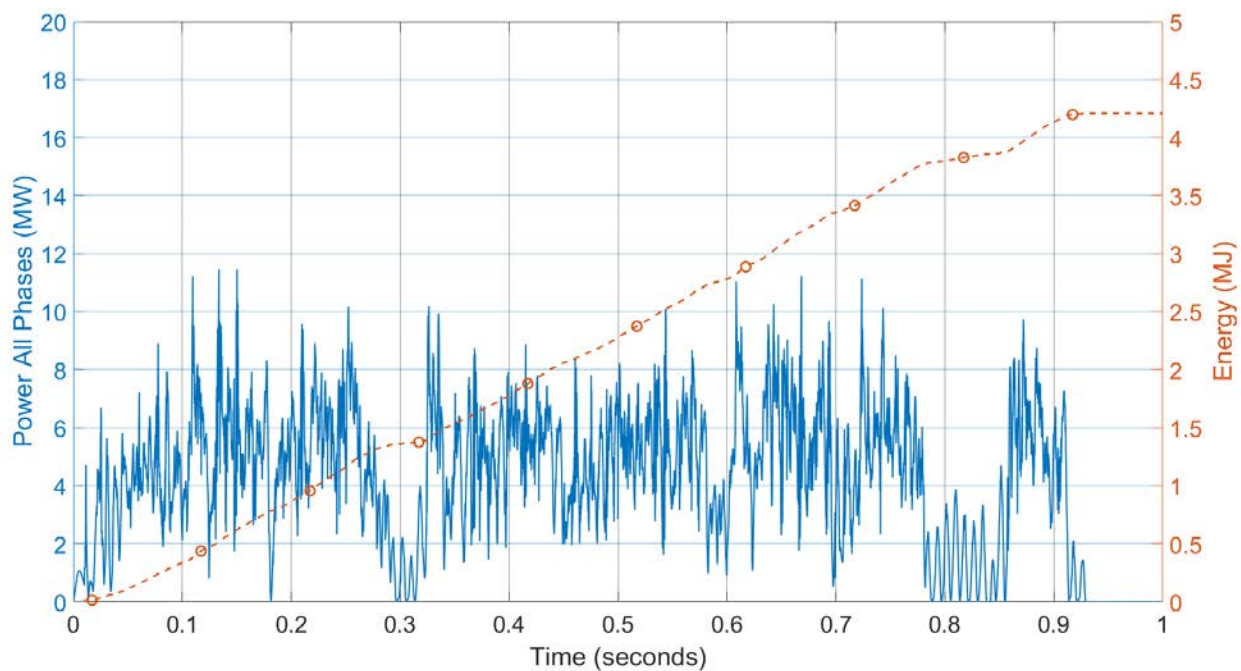
**Fig. 97.** Power and Energy for Test 2-13D. Measurement uncertainty  $\pm 3$  percent.

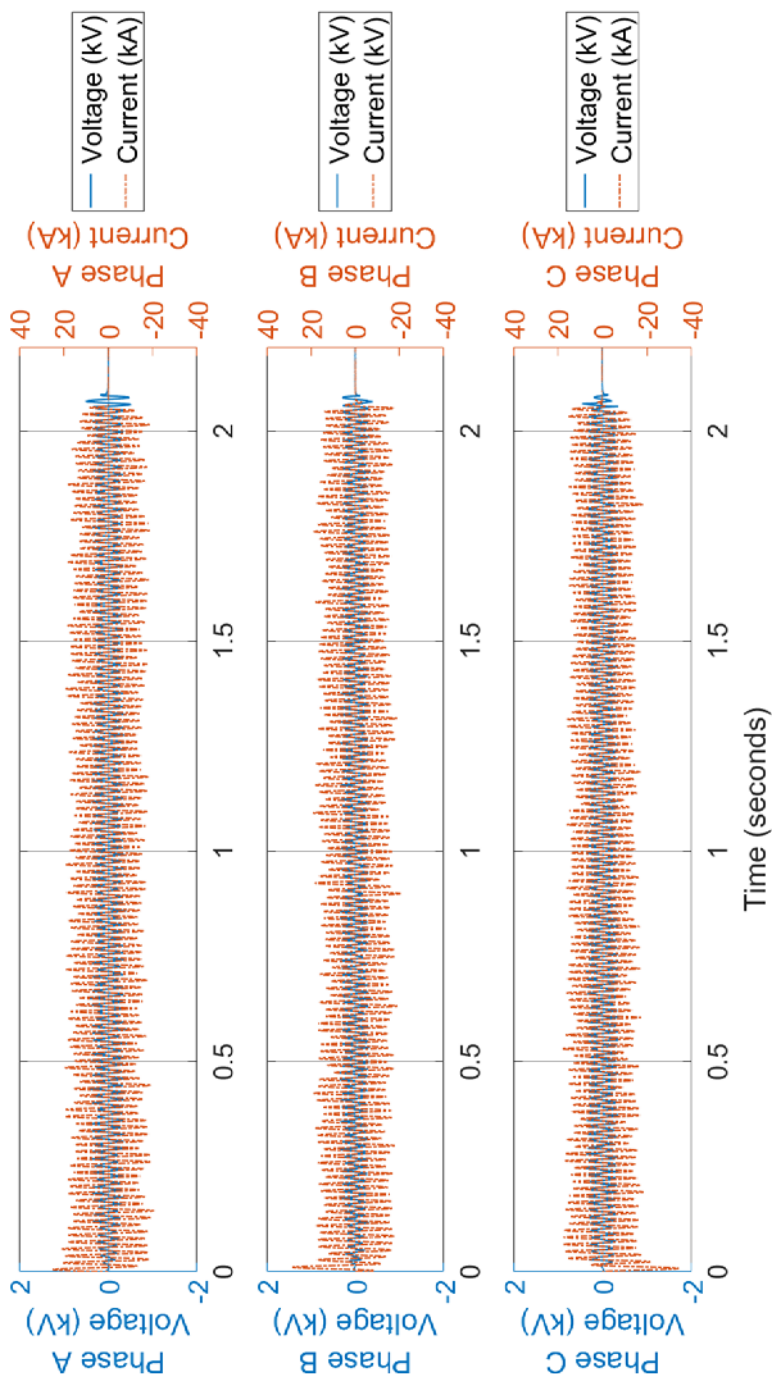
**Fig. 98.** Voltage and Current Profile during Test 2-13E. Measurement uncertainty  $\pm 3$  percent.

The voltage and current profile for the entire duration of the experiment is shown in Fig. 98. The transient region for current phases is presented in Fig. 99. Energy and power profiles are presented in Fig. 100.

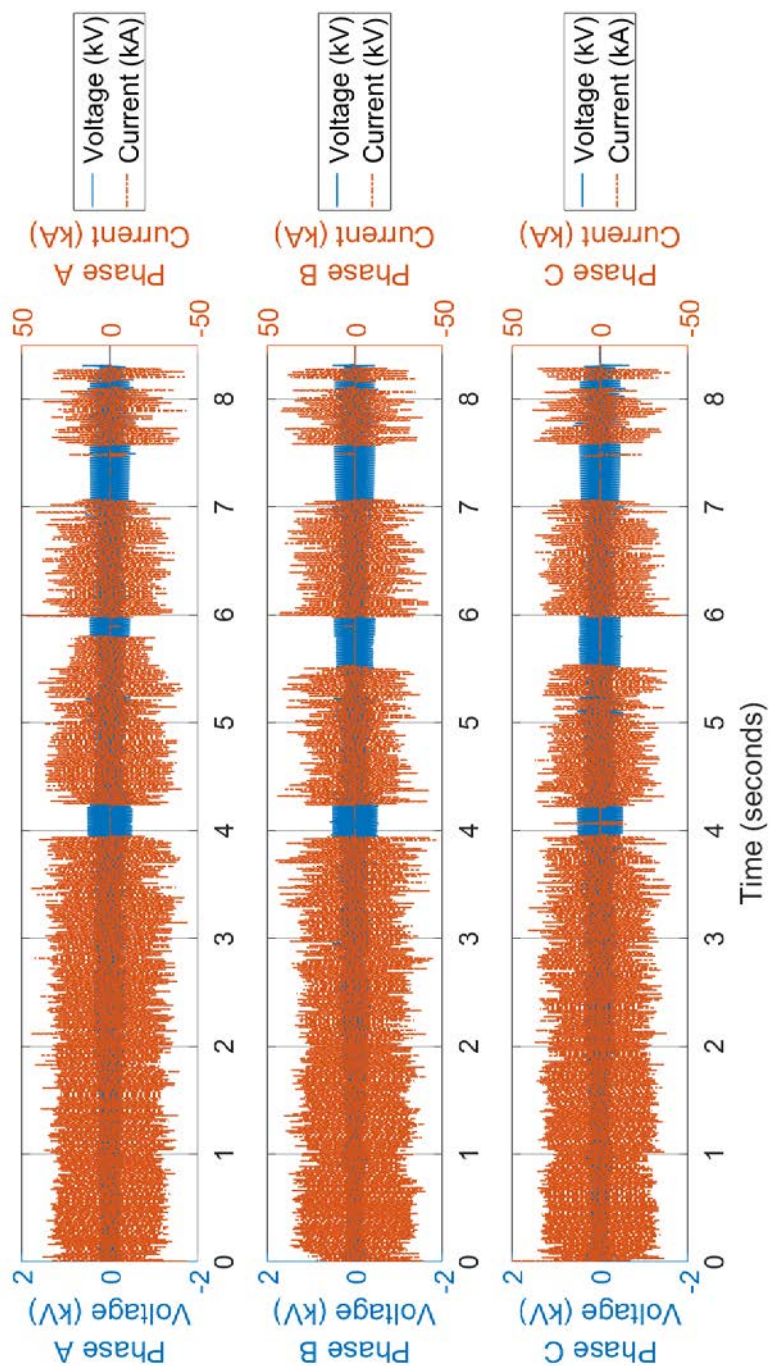
**Fig. 110.** Voltage and Current Profile during Test 2-18B. Measurement uncertainty  $\pm 3$  percent.

The voltage and current profile for the entire duration of the experiment is shown in Fig. 110. The transient region for current phases is presented in Fig. 111. Energy and power profiles are presented in Fig. 112.

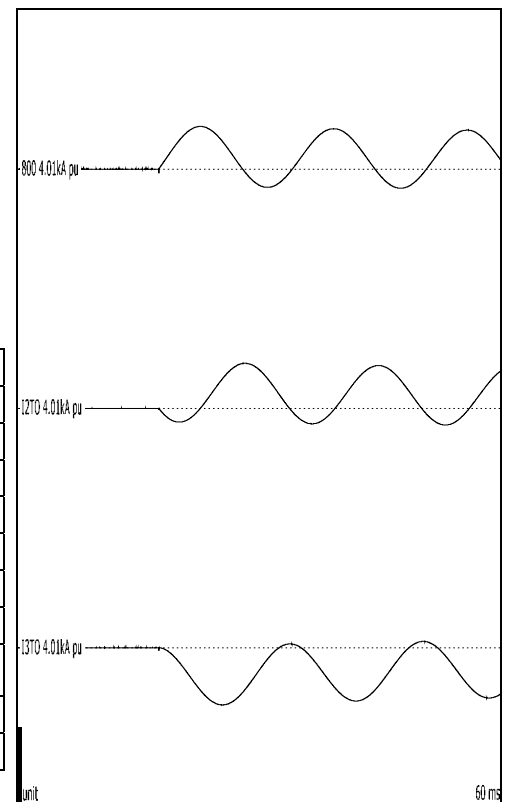
Test number: 190822-7003

Phase		A	B	C
Applied voltage, phase-to-ground	V <sub>RMS</sub>	577	577	577
Applied voltage, phase-to-phase	V <sub>RMS</sub>	999		
Making current	kA <sub>peak</sub>	2.14	2.26	-2.89
Current, a.c. component, beginning	A <sub>RMS</sub>	1064	1061	1050
Current, a.c. component, middle	A <sub>RMS</sub>	1052	1049	1039
Current, a.c. component, end	A <sub>RMS</sub>	1119	1006	985
Current, a.c. component, average	A <sub>RMS</sub>	1042	1048	1009
Current, a.c. component, three-phase average	A <sub>RMS</sub>	1033		
Duration	s	2.01	2.01	2.01
Arc energy	kJ	66.7	106	27.9

Observations: Emission of flames and gas observed. Arc wire took approximately 1.35 seconds to melt and initiate the arc.

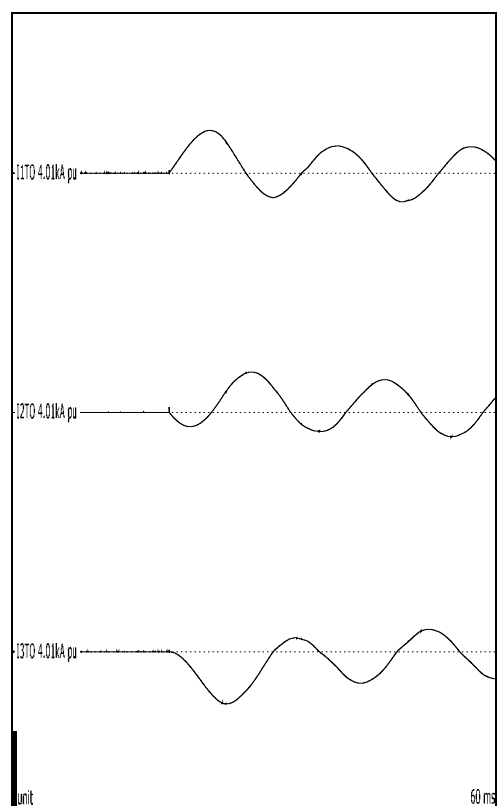
Test number: 190822-7004

Phase		A	B	C
Applied voltage, phase-to-ground	V <sub>RMS</sub>	577	577	577
Applied voltage, phase-to-phase	V <sub>RMS</sub>	999		
Making current	kA <sub>peak</sub>	2.14	2.02	-2.63
Current, a.c. component, beginning	A <sub>RMS</sub>	1056	1009	985
Current, a.c. component, middle	A <sub>RMS</sub>	1124	1035	1015
Current, a.c. component, end	A <sub>RMS</sub>	1128	1011	974
Current, a.c. component, average	A <sub>RMS</sub>	1083	1030	985
Current, a.c. component, three-phase average	A <sub>RMS</sub>	1033		
Duration	s	2.02	2.02	2.02
Arc energy	kJ	248	289	199

Observations: Emission of flames and gas observed.

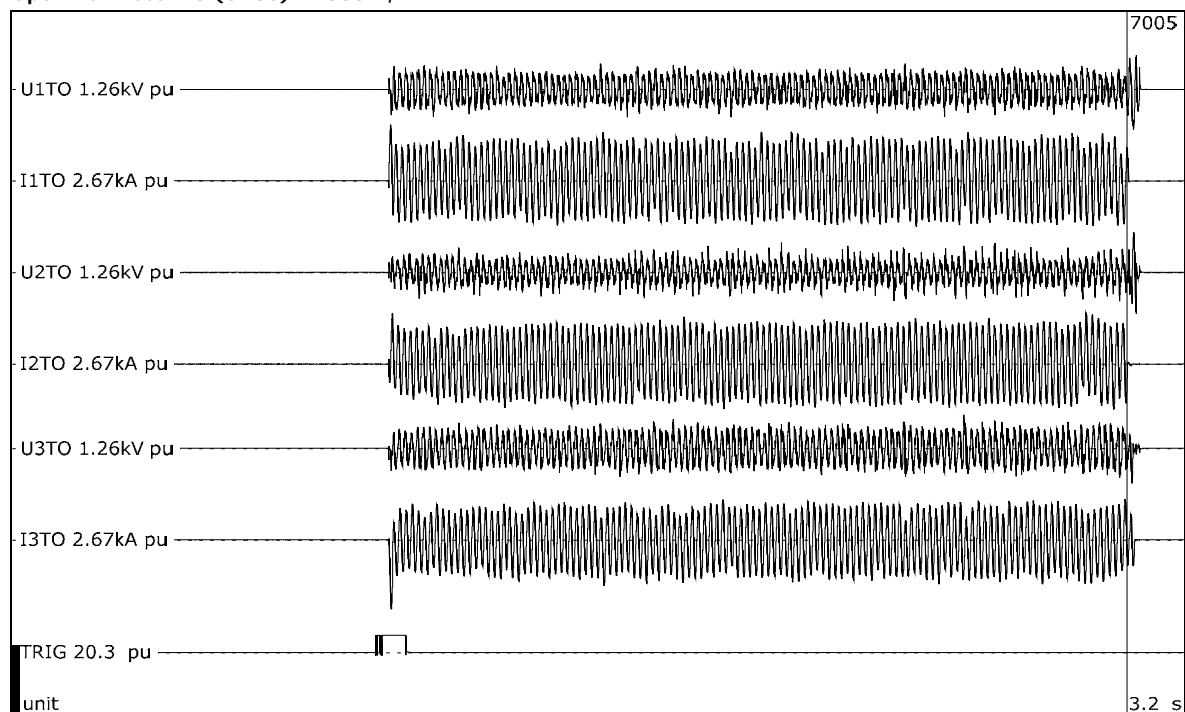
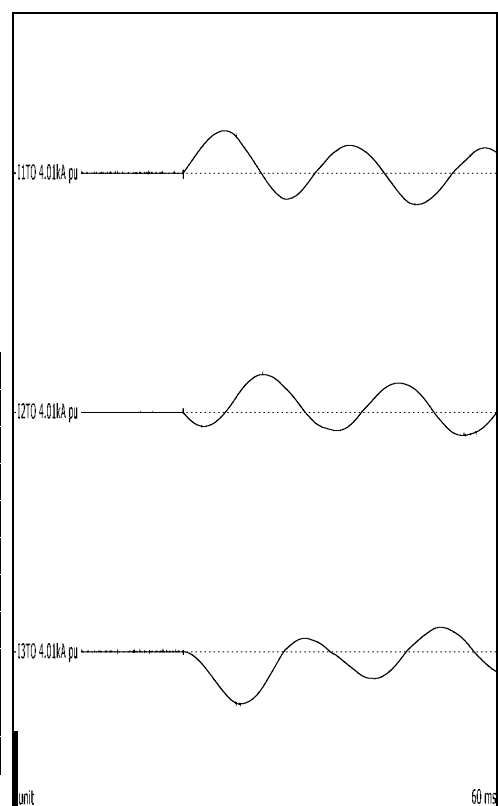
Test number: 190822-7005

Phase		A	B	C
Applied voltage, phase-to-ground	V <sub>RMS</sub>	577	577	577
Applied voltage, phase-to-phase	V <sub>RMS</sub>	999		
Making current	kA <sub>peak</sub>	2.12	1.91	-2.63
Current, a.c. component, beginning	A <sub>RMS</sub>	1088	958	949
Current, a.c. component, middle	A <sub>RMS</sub>	1173	1064	963
Current, a.c. component, end	A <sub>RMS</sub>	1000	1075	943
Current, a.c. component, average	A <sub>RMS</sub>	1080	1031	942
Current, a.c. component, three-phase average	A <sub>RMS</sub>	1018		
Duration	s	2.01	2.01	2.01
Arc energy	kJ	262	329	205

Observations: Emission of flames and gas observed.

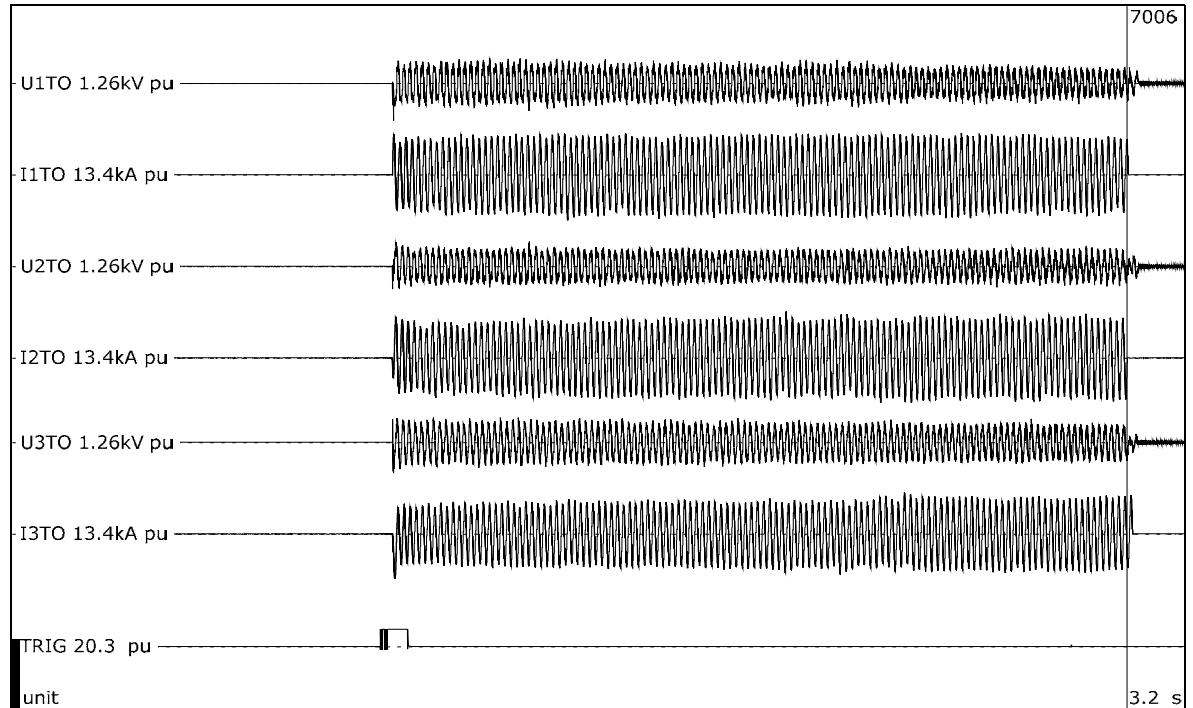
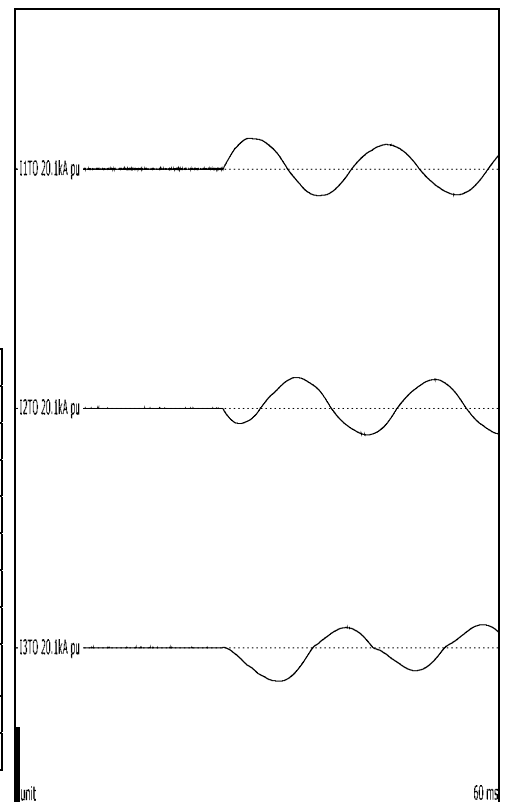
Test number: 190822-7006

Phase		A	B	C
Applied voltage, phase-to-ground	V <sub>RMS</sub>	577	577	577
Applied voltage, phase-to-phase	V <sub>RMS</sub>	999		
Making current	kA <sub>peak</sub>	7.73	7.76	-8.47
Current, a.c. component, beginning	A <sub>RMS</sub>	4812	4548	4309
Current, a.c. component, middle	A <sub>RMS</sub>	5190	5297	4487
Current, a.c. component, end	A <sub>RMS</sub>	5041	5559	4936
Current, a.c. component, average	A <sub>RMS</sub>	5193	5081	4499
Current, a.c. component, three-phase average	A <sub>RMS</sub>	4924		
Duration	s	2.00	2.00	2.00
Arc energy	kJ	1190	1960	968

Observations: Emission of flames and gas observed.

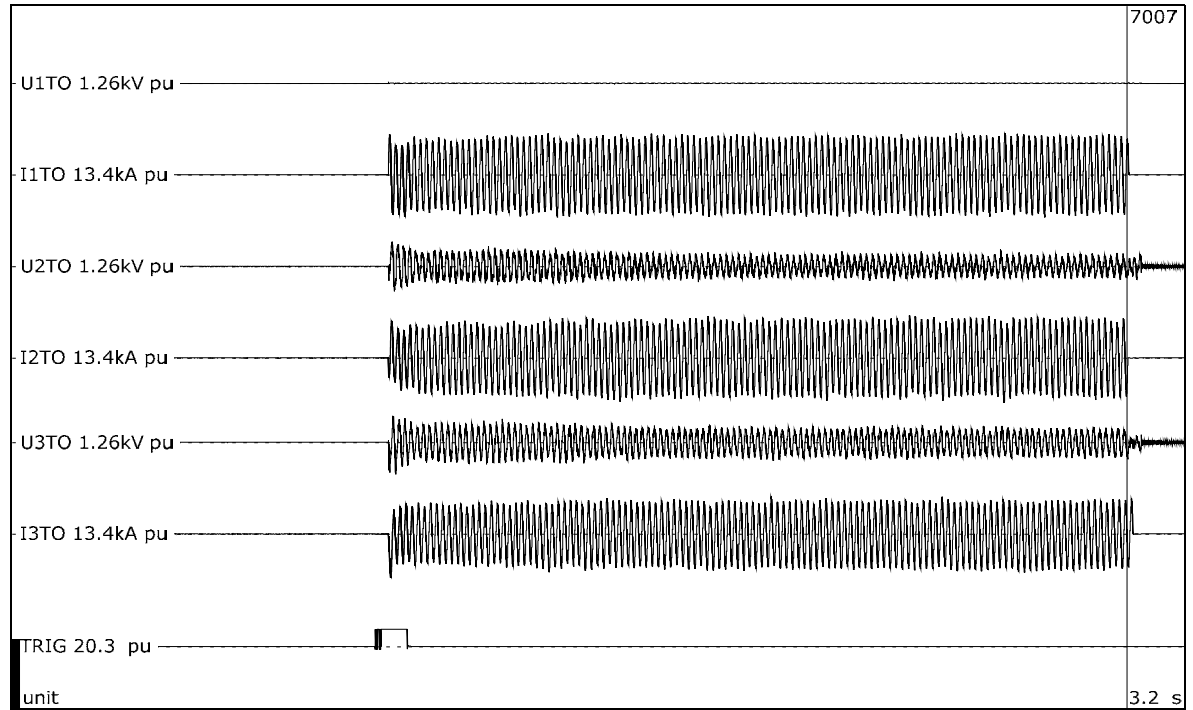
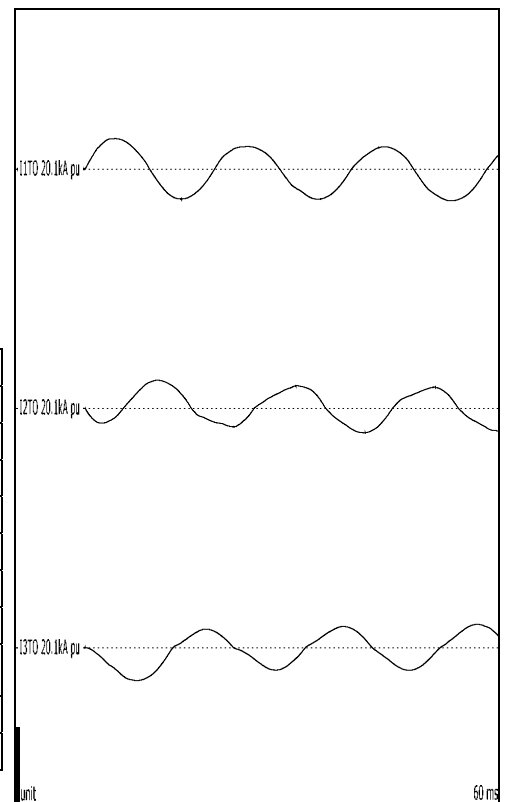
Test number: 190822-7007

Phase		A	B	C
Applied voltage, phase-to-ground	V <sub>RMS</sub>	577	577	577
Applied voltage, phase-to-phase	V <sub>RMS</sub>	999		
Making current	kA <sub>peak</sub>	7.64	7.07	-8.32
Current, a.c. component, beginning	A <sub>RMS</sub>	5011	3955	4100
Current, a.c. component, middle	A <sub>RMS</sub>	5140	5170	4313
Current, a.c. component, end	A <sub>RMS</sub>	5296	5113	4494
Current, a.c. component, average	A <sub>RMS</sub>	5179	4869	4370
Current, a.c. component, three-phase average	A <sub>RMS</sub>	4806		
Duration	s	2.01	2.01	2.01
Arc energy	kJ	21.7	1401	819

Observations: Emission of flames and gas observed.
