# **REPORT ON HIGH ENERGY ARCING FAULT EXPERIMENTS**

## **Experimental Results from Low- Voltage Switchgear Enclosures**

# Report on High Energy Arcing Fault Experiments

## Experimental Results from Low-Voltage Switchgear Enclosures

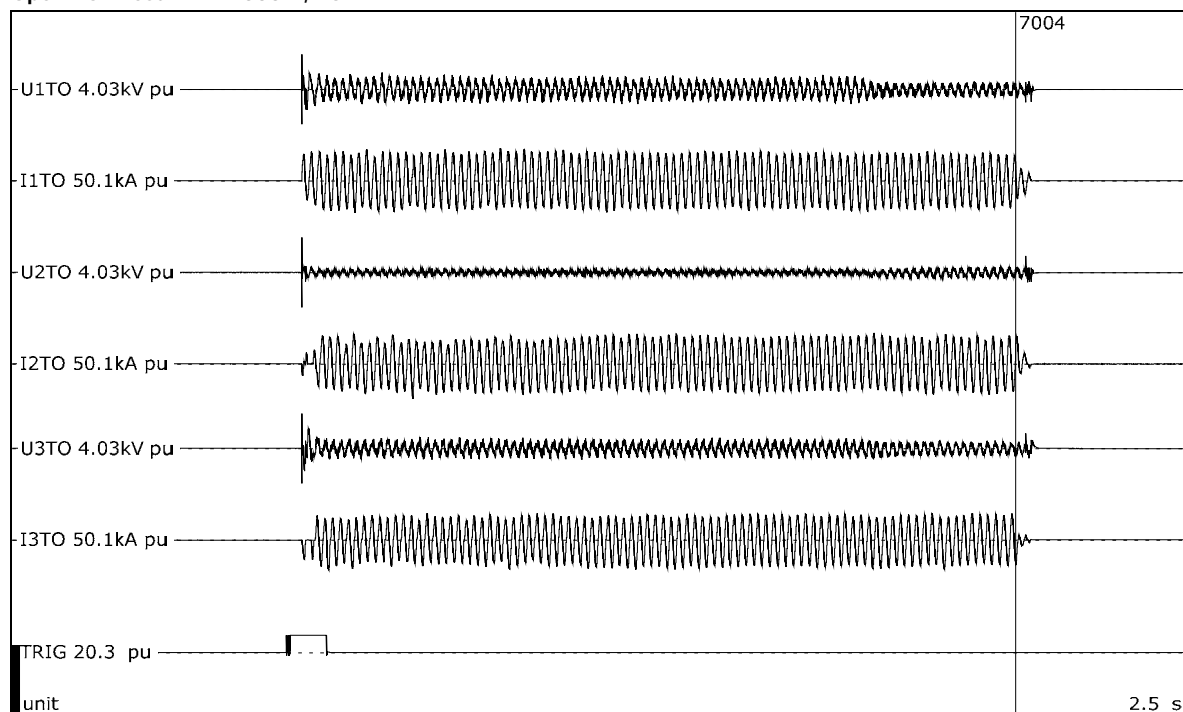
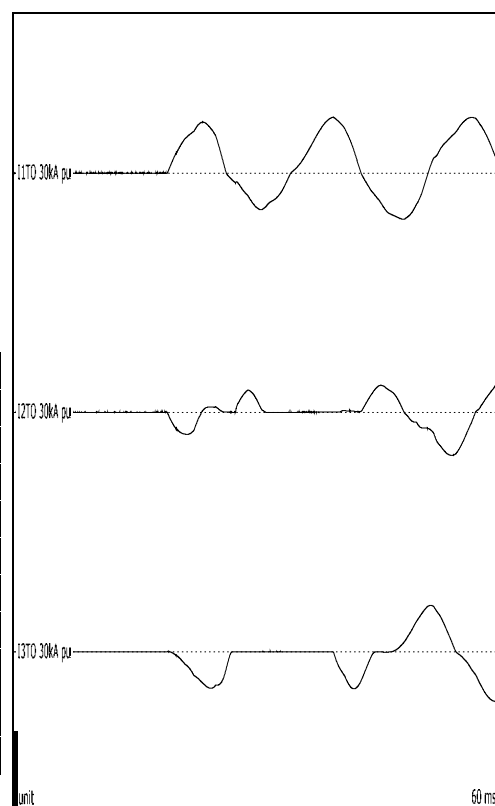
Test number: 190823-7004

Phase		A	B	C
Applied voltage, phase-to-ground	V <sub>RMS</sub>	583	583	583
Applied voltage, phase-to-phase	V <sub>RMS</sub>	1010		
Making current	kA <sub>peak</sub>	20.9	10.2	17.4
Current, a.c. component, beginning	kA <sub>RMS</sub>	14.5	13.0	12.6
Current, a.c. component, middle	kA <sub>RMS</sub>	13.9	14.0	13.0
Current, a.c. component, end	kA <sub>RMS</sub>	13.6	14.6	12.7
Current, a.c. component, average	kA <sub>RMS</sub>	13.9	12.3	11.8
Current, a.c. component, three-phase average	kA <sub>RMS</sub>	12.6		
Duration	s	1.52	1.52	1.52
Arc energy	kJ	6460	118	3655

Observations: Emission of flames and gas observed. Arc extinguished for approximately 12 ms on B & C phases before re-igniting. After this period, the arc was sustained on B & C phases for the remainder of the test.

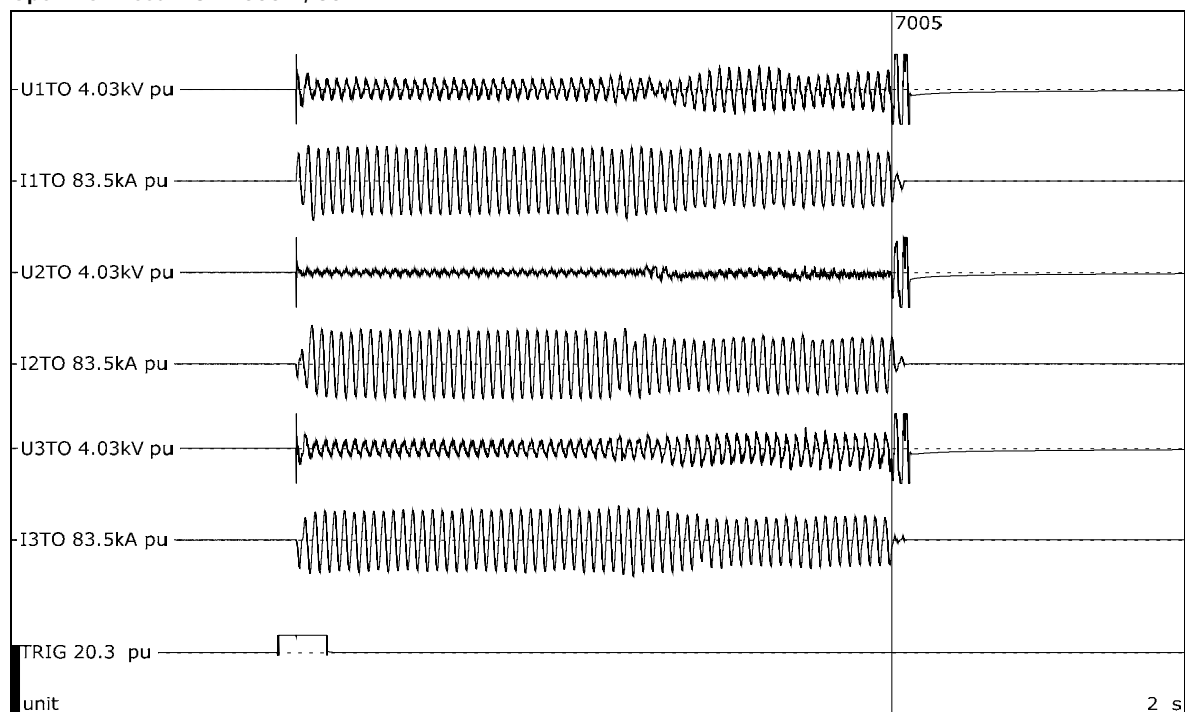
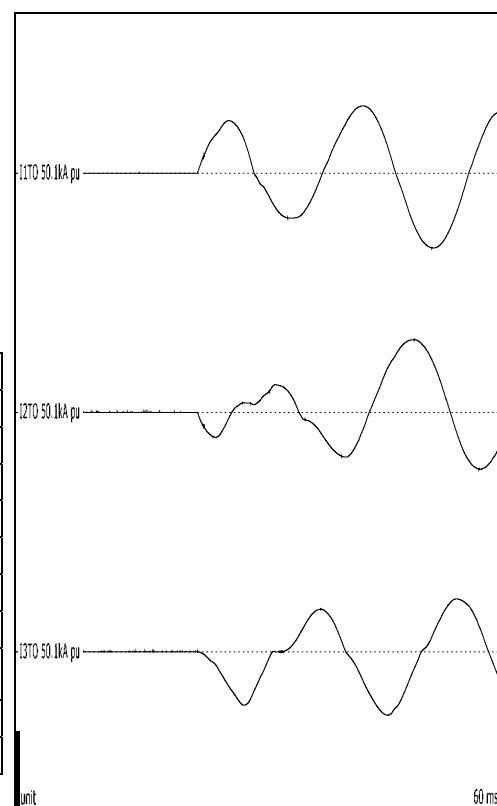
Test number: 190823-7005

Phase		A	B	C
Applied voltage, phase-to-ground	V <sub>RMS</sub>	614	614	614
Applied voltage, phase-to-phase	V <sub>RMS</sub>	1063		
Making current	kA <sub>peak</sub>	-47.0	45.7	-40.1
Current, a.c. component, beginning	kA <sub>RMS</sub>	28.8	28.0	26.0
Current, a.c. component, middle	kA <sub>RMS</sub>	27.7	28.1	26.2
Current, a.c. component, end	kA <sub>RMS</sub>	23.5	23.3	20.6
Current, a.c. component, average	kA <sub>RMS</sub>	26.1	24.8	23.9
Current, a.c. component, three-phase average	kA <sub>RMS</sub>	24.9		
Duration	s	1.01	1.01	1.01
Arc energy	MJ	10.5	1.17	7.90

Observations: Emission of flames and gas observed.

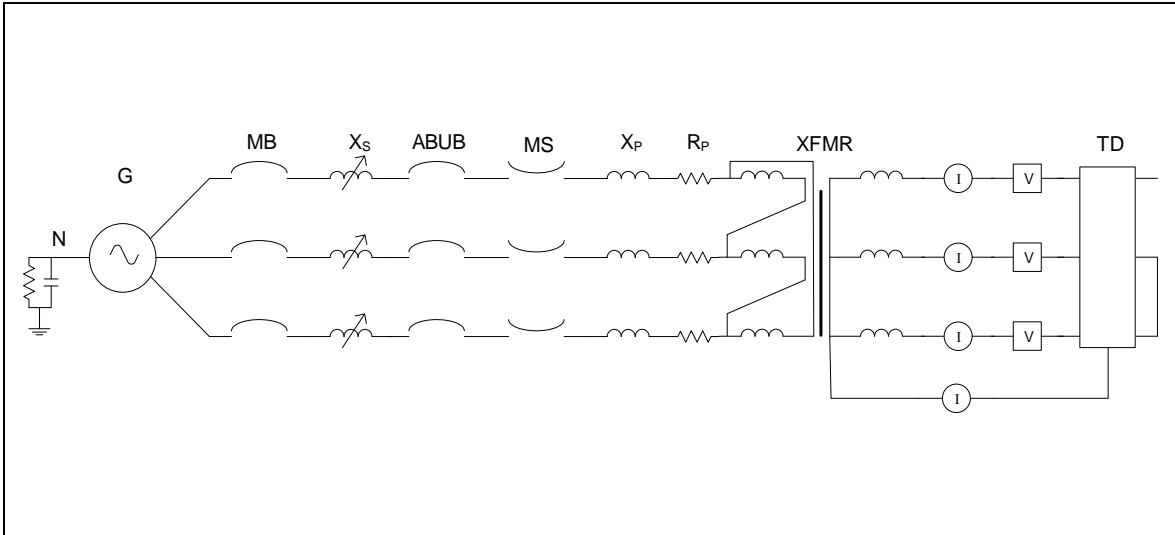
14.2 Test circuit S05

G	= Generator	ABUB	= Aux. Breaker	R	= Resistance
N	= Neutral	XFMR	= Transformer	C	= Capacitance
MB	= Main Breaker	TD	= Test Device	V	= Voltage Measurement
MS	= Make Switch	X	= Inductance	I	= Current Measurement

Supply		
Power	MVA	26.2
Frequency	Hz	60
Phase(s)		3
Voltage	V	1009
Sym. Current	kA	15
Peak current	kA	40.4
Impedance	$\Omega$	0.014

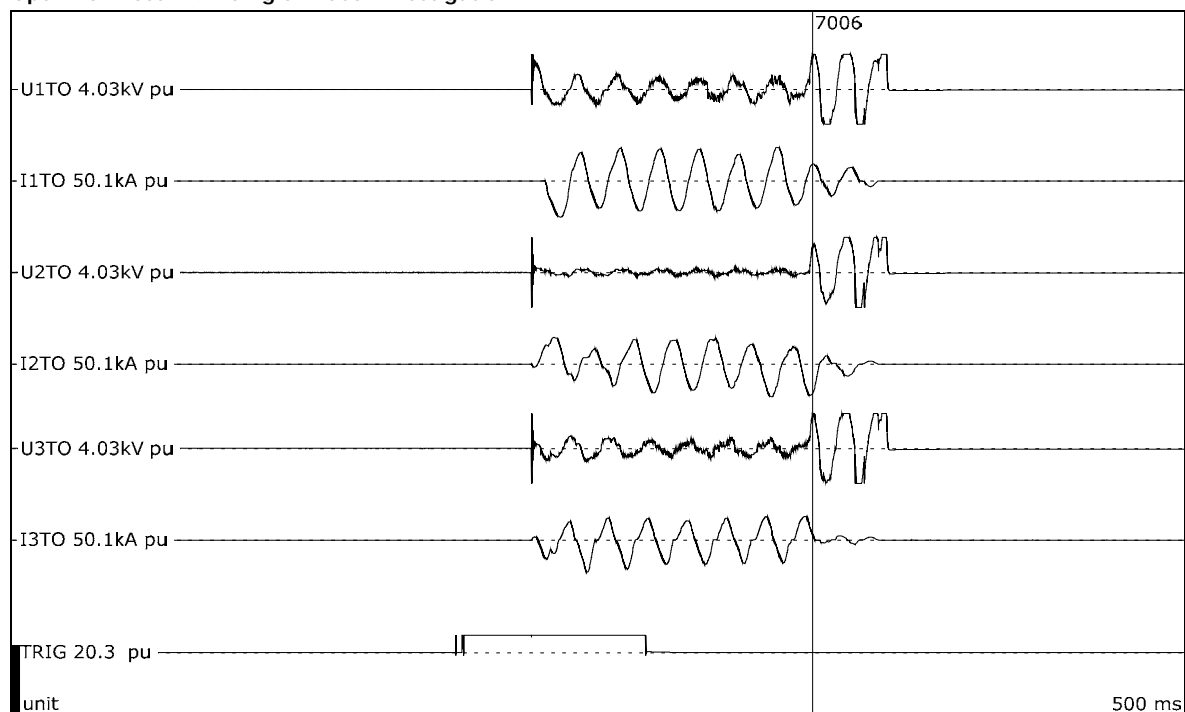
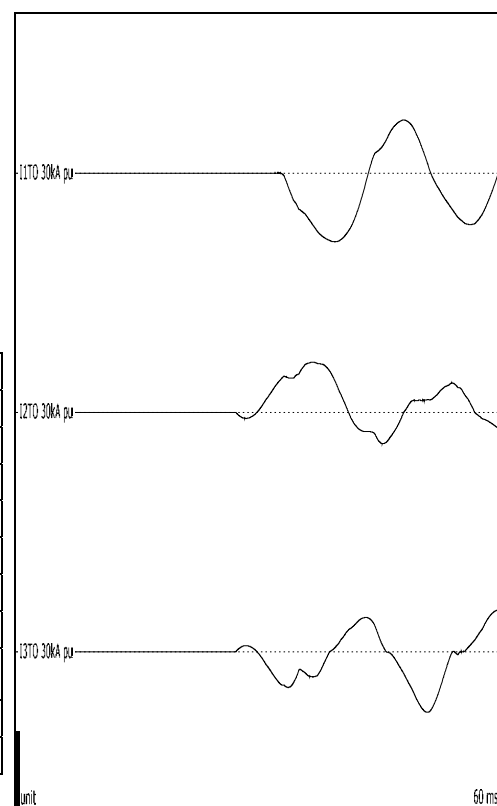
Test number: 190823-7006

Phase		A	B	C
Applied voltage, phase-to-ground	V <sub>RMS</sub>	583	583	583
Applied voltage, phase-to-phase	V <sub>RMS</sub>	1010		
Making current	kA <sub>peak</sub>	-25.9	18.8	-22.9
Current, a.c. component, beginning	kA <sub>RMS</sub>	15.1	9.44	11.2
Current, a.c. component, middle	kA <sub>RMS</sub>	15.4	12.7	11.2
Current, a.c. component, end	kA <sub>RMS</sub>	15.4	2.82	11.2
Current, a.c. component, average	kA <sub>RMS</sub>	15.2	11.7	11.9
Current, a.c. component, three-phase average	kA <sub>RMS</sub>	12.9		
Duration	s	0.114	0.120	0.117
Arc energy	kJ	758	73.0	334

Observations: Emission of flames and gas observed. Arc propagated to A-phase rod in approximately 6 ms.

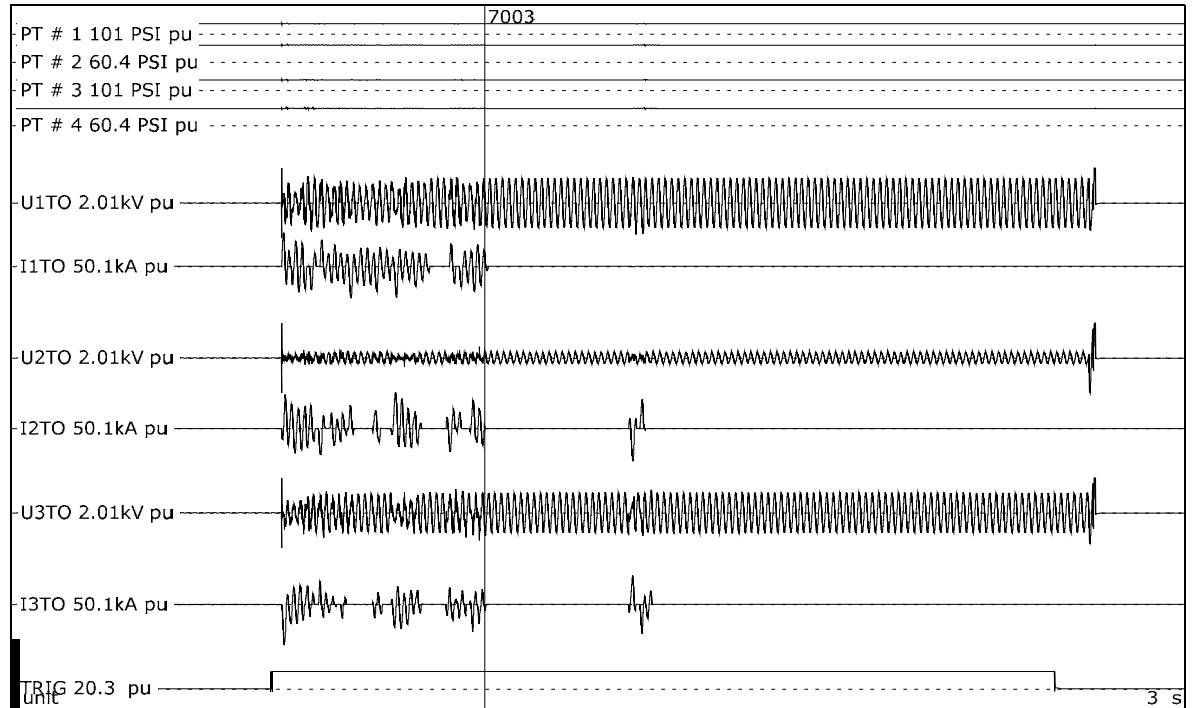
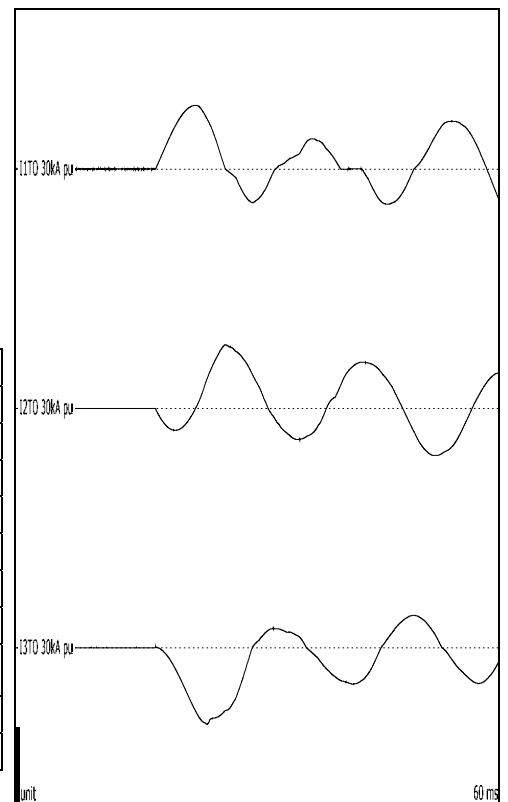
Test number: 190826-7003

Phase		A	B	C
Applied voltage, phase-to-ground	V <sub>RMS</sub>	282	282	282
Applied voltage, phase-to-phase	V <sub>RMS</sub>	488		
Making current	kA <sub>peak</sub>	24.0	23.8	-28.7
Current, a.c. component, beginning	kA <sub>RMS</sub>	10.7	11.9	10.2
Current, a.c. component, middle	kA <sub>RMS</sub>	7.52	9.15	5.89
Current, a.c. component, end	kA <sub>RMS</sub>	7.98	4.04	5.44
Current, a.c. component, average	kA <sub>RMS</sub>	8.78	9.35	7.71
Current, a.c. component, three-phase average	kA <sub>RMS</sub>	8.61		
Duration	s	0.519	0.519	0.519
Arc energy	kJ	1122	28.9	554

Observations: Emission of flames and gas observed.

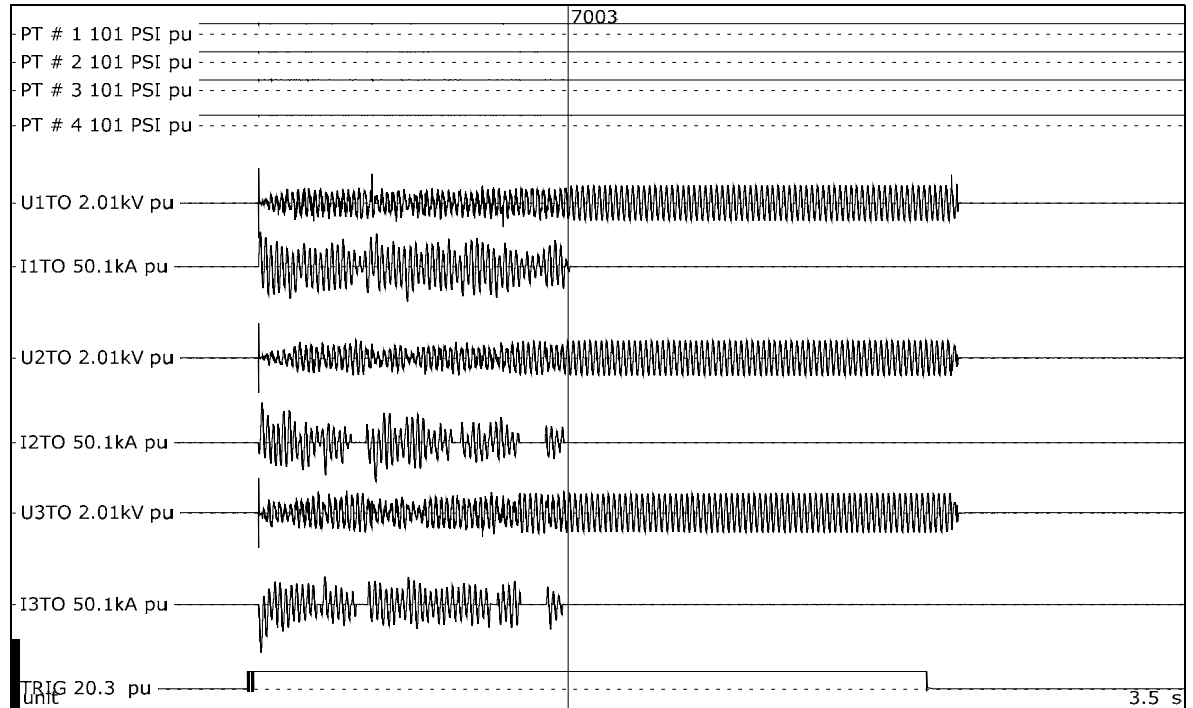
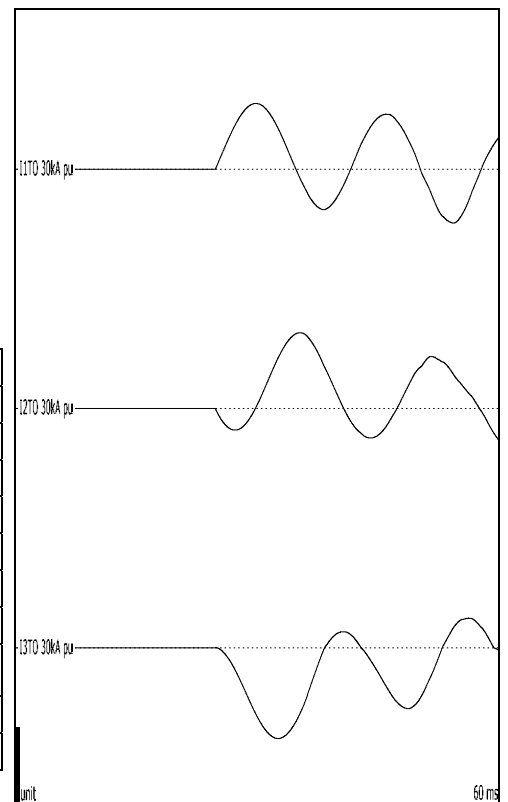
Test number: 190827-7003

Phase		A	B	C
Applied voltage, phase-to-ground	V <sub>RMS</sub>	356	356	356
Applied voltage, phase-to-phase	V <sub>RMS</sub>	617		
Making current	kA <sub>peak</sub>	24.7	28.4	-34.3
Current, a.c. component, beginning	kA <sub>RMS</sub>	13.4	13.5	12.2
Current, a.c. component, middle	kA <sub>RMS</sub>	9.05	13.7	11.8
Current, a.c. component, end	kA <sub>RMS</sub>	10.9	8.03	8.49
Current, a.c. component, average	kA <sub>RMS</sub>	11.2	10.1	9.88
Current, a.c. component, three-phase average	kA <sub>RMS</sub>	10.4		
Duration	s	0.924	0.924	0.924
Arc energy	kJ	1754	1031	1356

Observations: Emission of flames and gas observed.

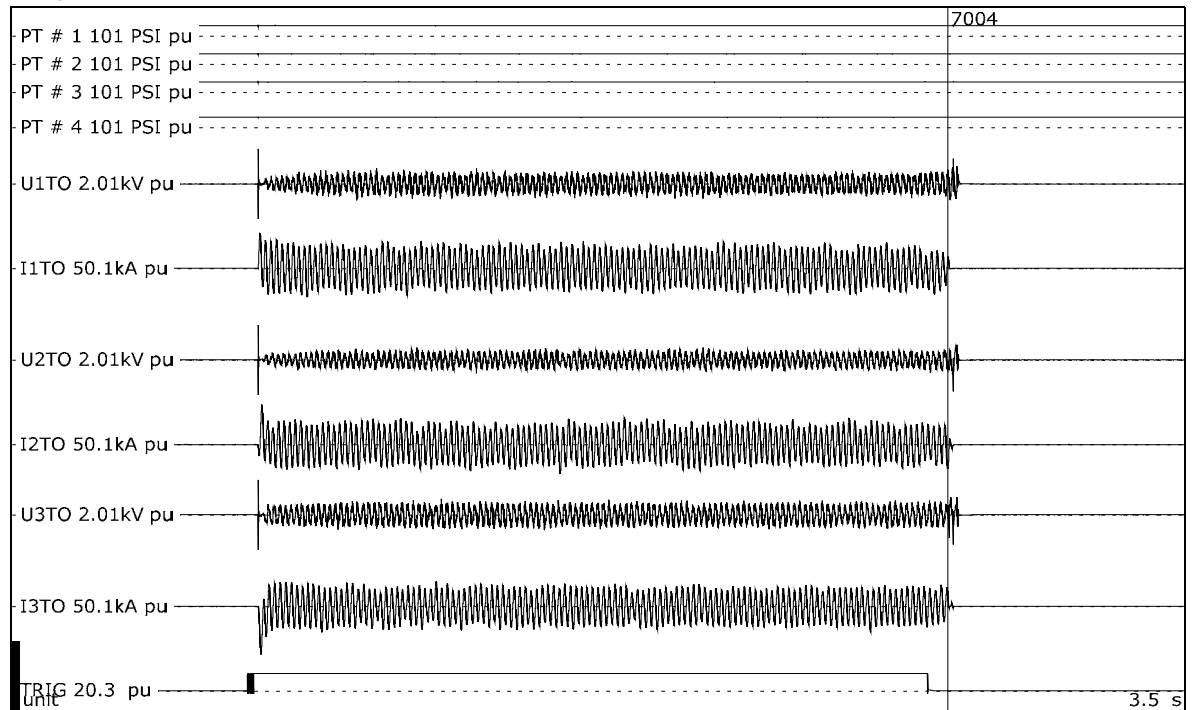
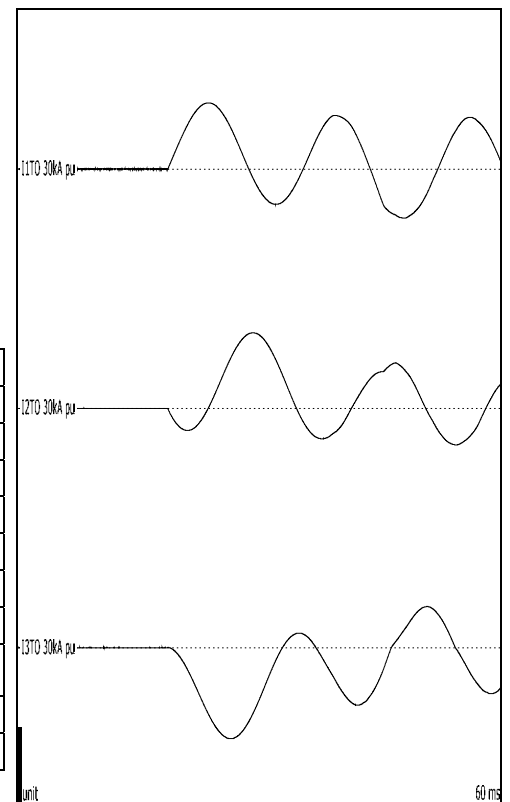
Test number: 190827-7004

Phase		A	B	C
Applied voltage, phase-to-ground	V <sub>RMS</sub>	356	356	356
Applied voltage, phase-to-phase	V <sub>RMS</sub>	617		
Making current	kA <sub>peak</sub>	24.9	28.4	-34.3
Current, a.c. component, beginning	kA <sub>RMS</sub>	12.6	13.5	11.6
Current, a.c. component, middle	kA <sub>RMS</sub>	10.4	10.5	9.79
Current, a.c. component, end	kA <sub>RMS</sub>	10.2	9.35	9.26
Current, a.c. component, average	kA <sub>RMS</sub>	11.1	10.8	10.00
Current, a.c. component, three-phase average	kA <sub>RMS</sub>	10.6		
Duration	s	2.06	2.06	2.06
Arc energy	kJ	3497	2815	3289

Observations: Emission of flames and gas observed.

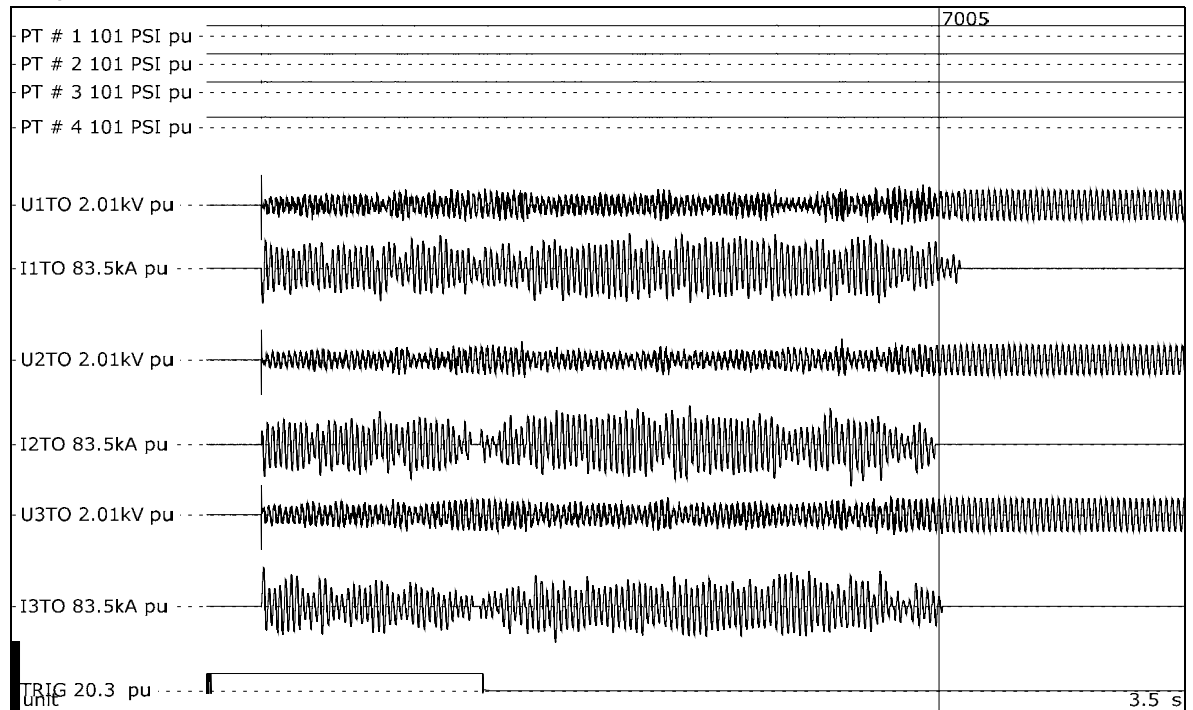
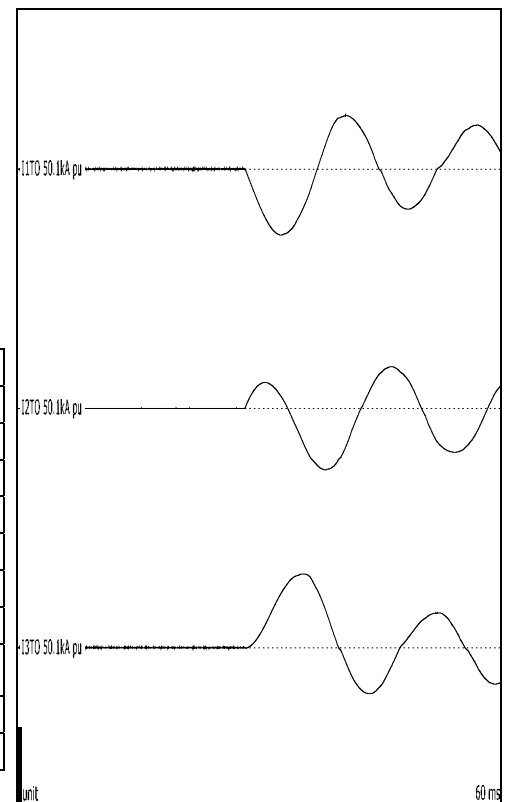
Test number: 190829-7005

Phase		A	B	C
Applied voltage, phase-to-ground	V <sub>RMS</sub>	277	277	277
Applied voltage, phase-to-phase	V <sub>RMS</sub>	480		
Making current	kA <sub>peak</sub>	-41.4	-38.5	46.2
Current, a.c. component, beginning	kA <sub>RMS</sub>	23.5	21.0	22.4
Current, a.c. component, middle	kA <sub>RMS</sub>	20.7	23.5	16.6
Current, a.c. component, end	kA <sub>RMS</sub>	15.9	18.2	12.5
Current, a.c. component, average	kA <sub>RMS</sub>	19.8	17.3	17.9
Current, a.c. component, three-phase average	kA <sub>RMS</sub>	18.3		
Duration	s	2.02	2.02	2.02
Arc energy	kJ	5925	5509	5597

Observations: Emission of flames and gas observed.

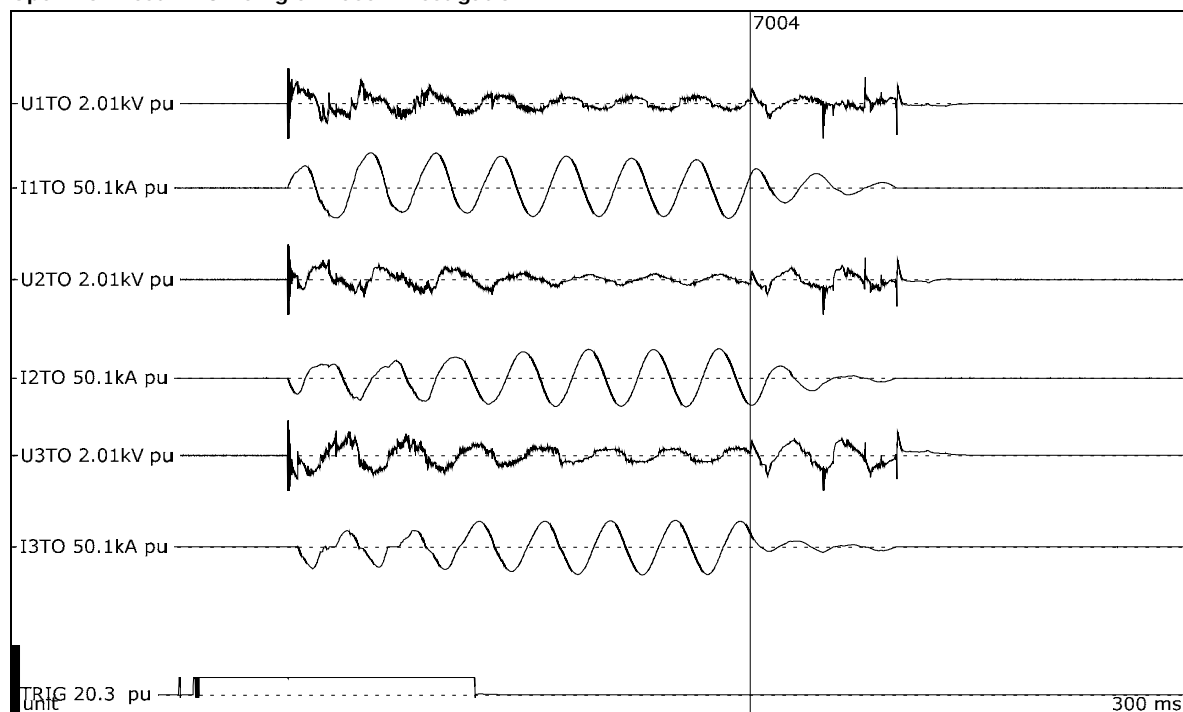
## Open Box Test # 13 - Single Phase Investigation

Observations: Emission of flames and gas observed. Arc propagation time is approximately 2.52 ms.

Minimal damage to test box observed.

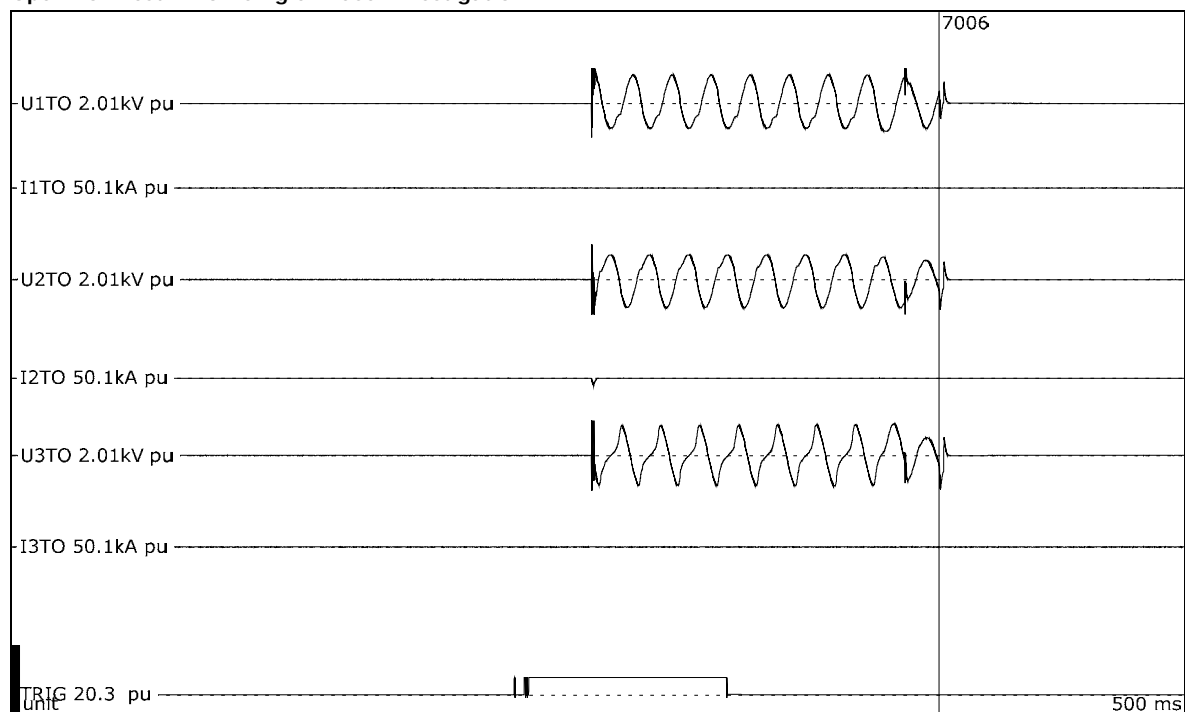
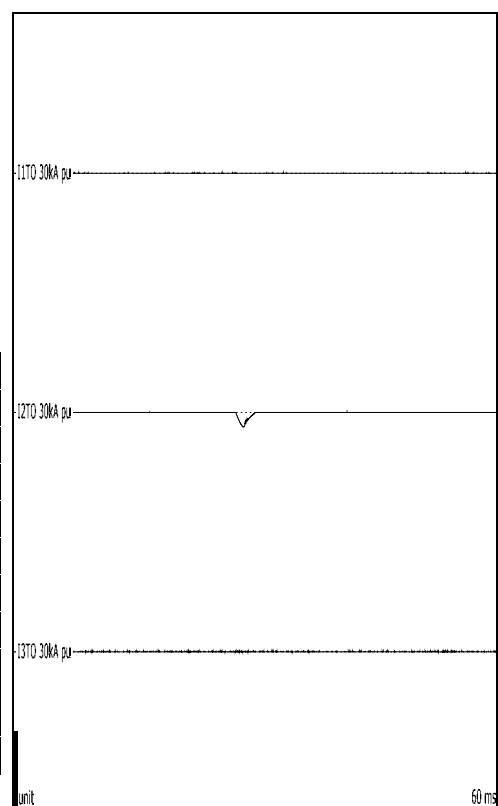
## Open Box Test # 15 - Single Phase Investigation

Observations: Small flash observed. Arc did not propagate to other phases.

Arc failed to propagate to other phases.

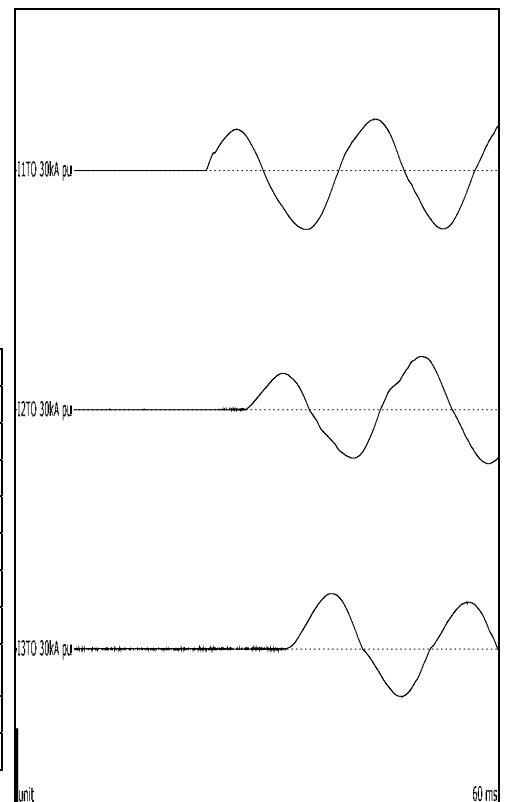
Test number: 190830-7007

Observations: Emission of flames and gas observed. Arc propagated to B-phase in approximately 4.8 ms. Arc propagated to C-phase in approximately 10 ms.

Minimal damage to test box observed.

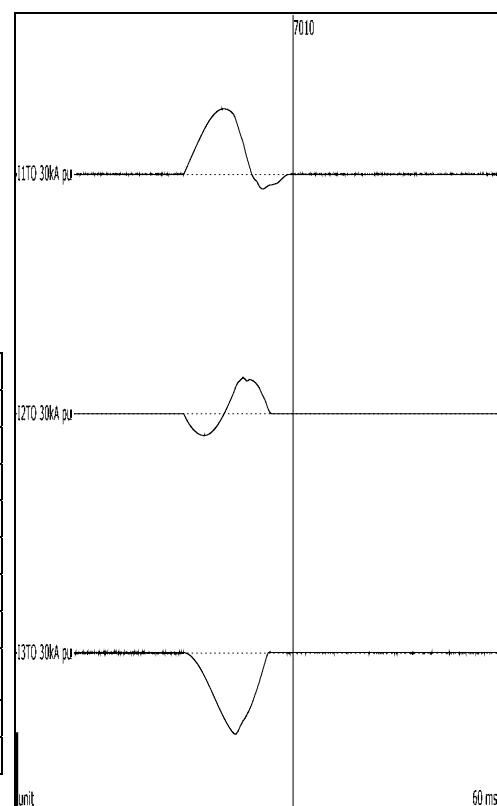
Test number: 190830-7010

Observations: Emission of flames and gas observed.

Box sustained minimal damage. Arc self-extinguished.

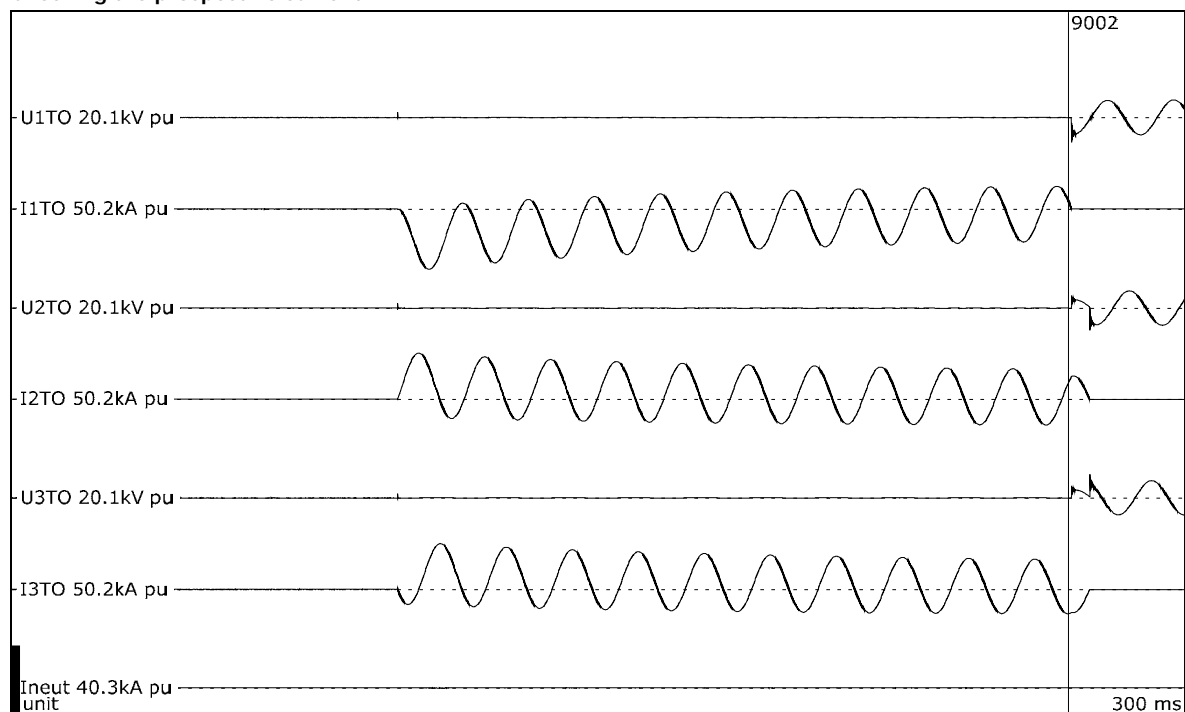
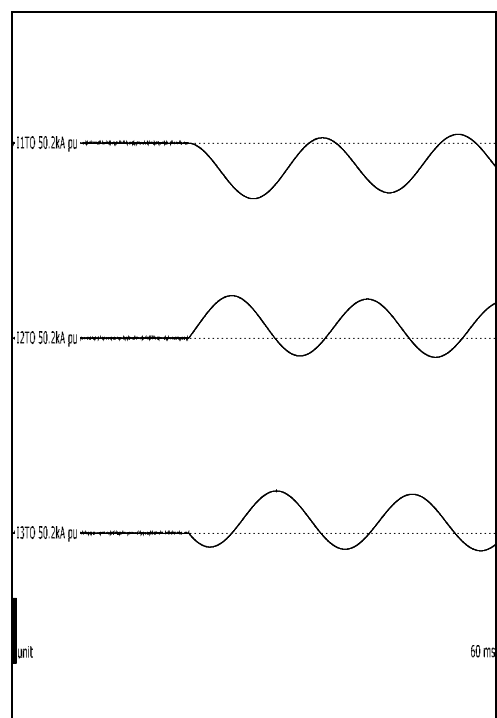
## Checking the prospective current

Phase		A	B	C
Current	kA <sub>peak</sub>	42.9	32.8	32.6
Current, a.c. component	kA <sub>RMS</sub>	15.4	15.5	15.1
Current, a.c. component, three-phase average	kA <sub>RMS</sub>	15.3		
Duration, current	s	0.171	0.171	0.171

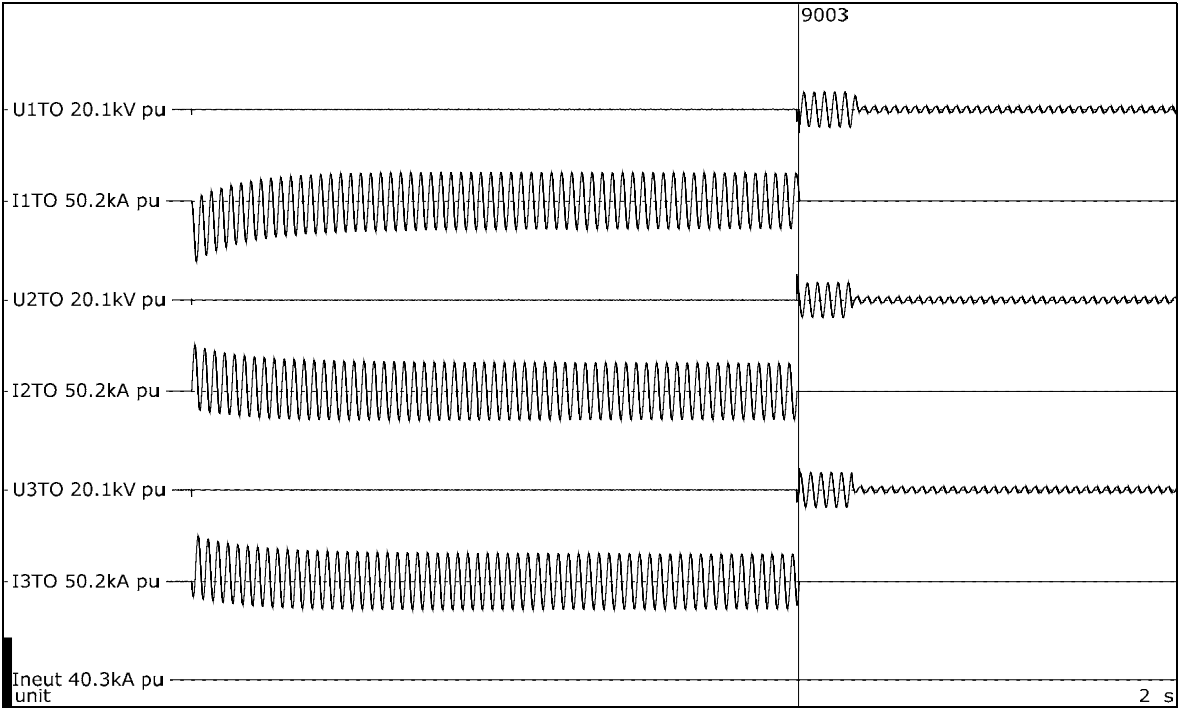
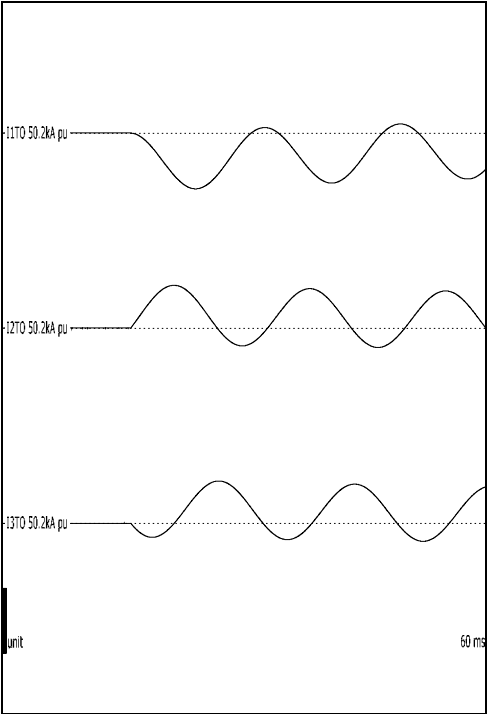
Checking the prospective current

Phase		A	B	C
Current	kA <sub>peak</sub>	43.0	33.1	32.5
Current, a.c. component	kA <sub>RMS</sub>	14.0	14.2	13.4
Current, a.c. component, three-phase average	kA <sub>RMS</sub>	13.9		
Duration, current	s	1.03	1.03	1.03

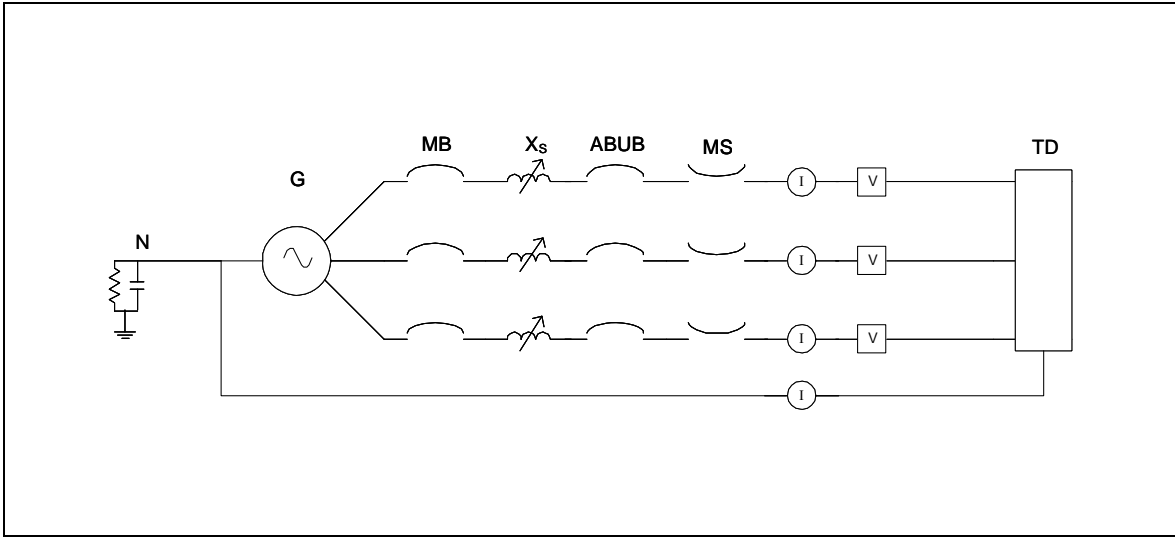
36.2 Test circuit S11

G	= Generator	ABUB	= Aux. Breaker	R	= Resistance
N	= Neutral	XFMR	= Transformer	C	= Capacitance
MB	= Main Breaker	TD	= Test Device	V	= Voltage Measurement
MS	= Make Switch	X	= Inductance	I	= Current Measurement

Supply		
Power	MVA	366
Frequency	Hz	60
Phase(s)		3
Voltage	V	6900
Sym. Current	kA	30.6
Peak current	kA	86.5
Impedance	$\Omega$	0.130

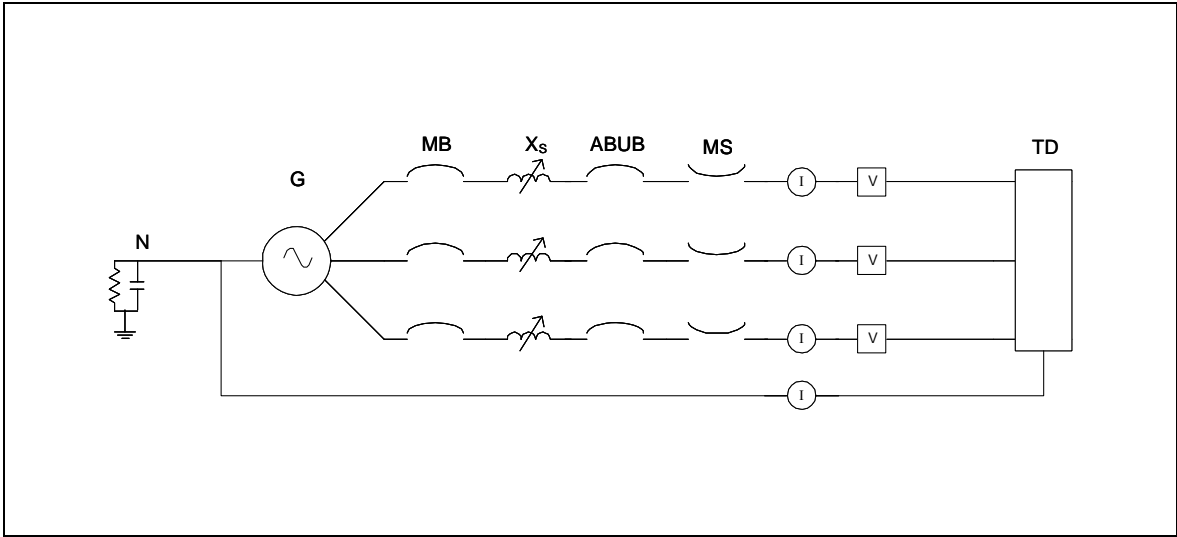
37.2 Test circuit S11

G	= Generator	ABUB	= Aux. Breaker	R	= Resistance
N	= Neutral	XFMR	= Transformer	C	= Capacitance
MB	= Main Breaker	TD	= Test Device	V	= Voltage Measurement
MS	= Make Switch	X	= Inductance	I	= Current Measurement

Supply		
Power	MVA	366
Frequency	Hz	60
Phase(s)		3
Voltage	V	6900
Sym. Current	kA	30.6
Peak current	kA	86.5
Impedance	$\Omega$	0.130

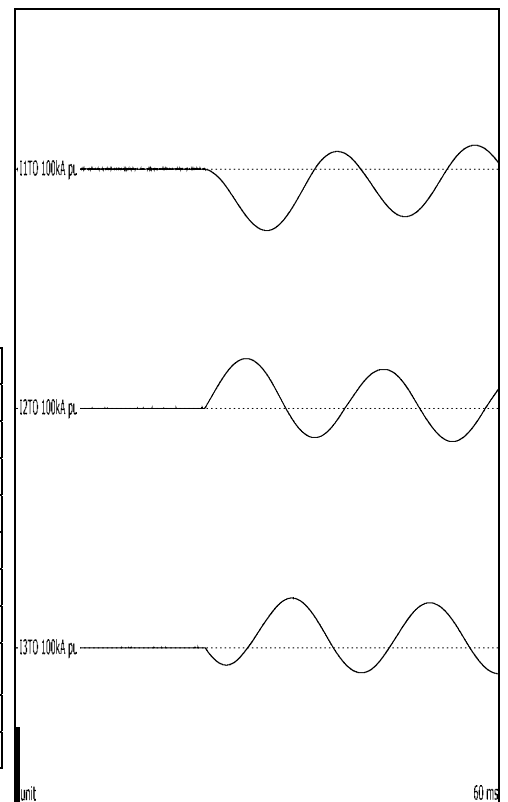
Test number: 190917-9001

Observations: Emission of flames and gas observed.

No complete burn throughs evident.

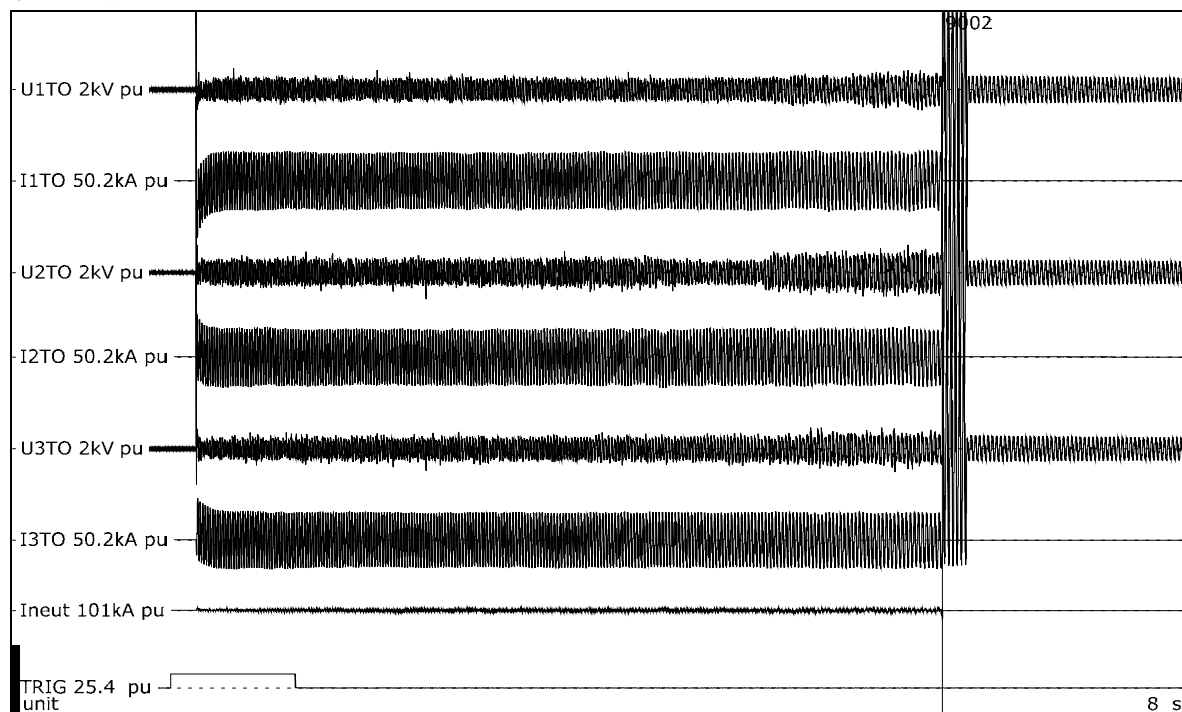
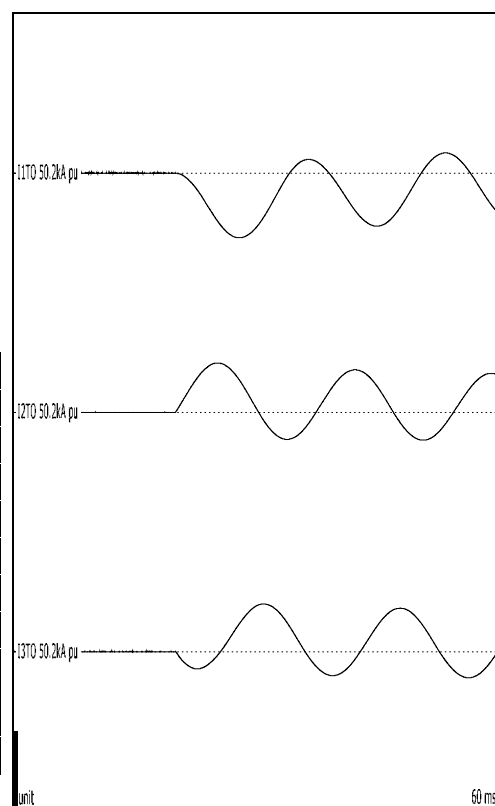
## OBMV # 4

Observations: Emission of flames and gas observed.

Bottom of box burned completely through. Large burn throughs evident on sides of box.

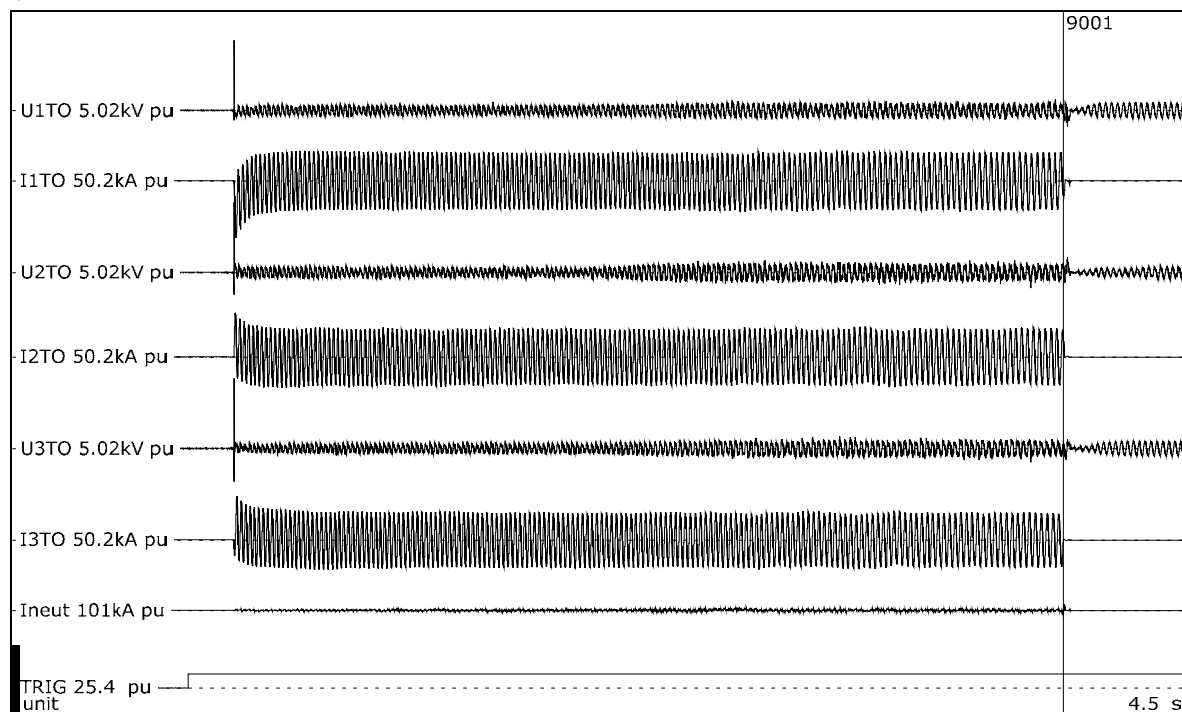
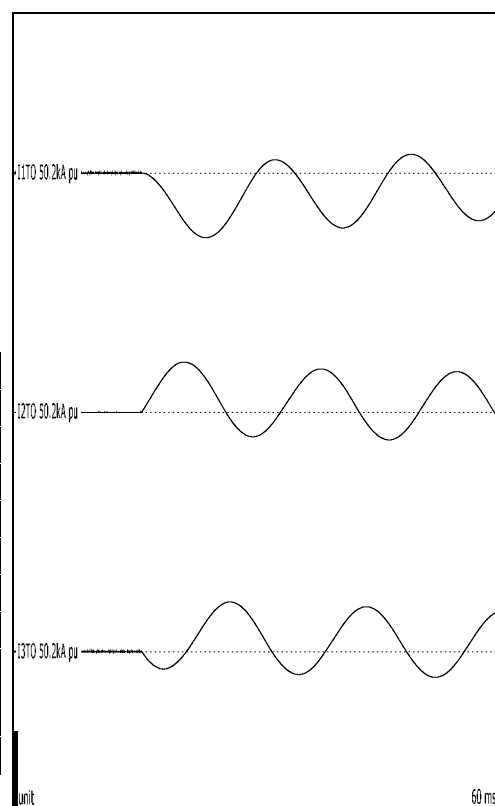
## OBMV # 1

Observations: Emission of flames and gas observed. Station timer malfunctioned during test, causing duration to be extended to 3.18 seconds.

Bottom and sides of box completely burned through. Test duration was longer than expected due to station timer malfunction.

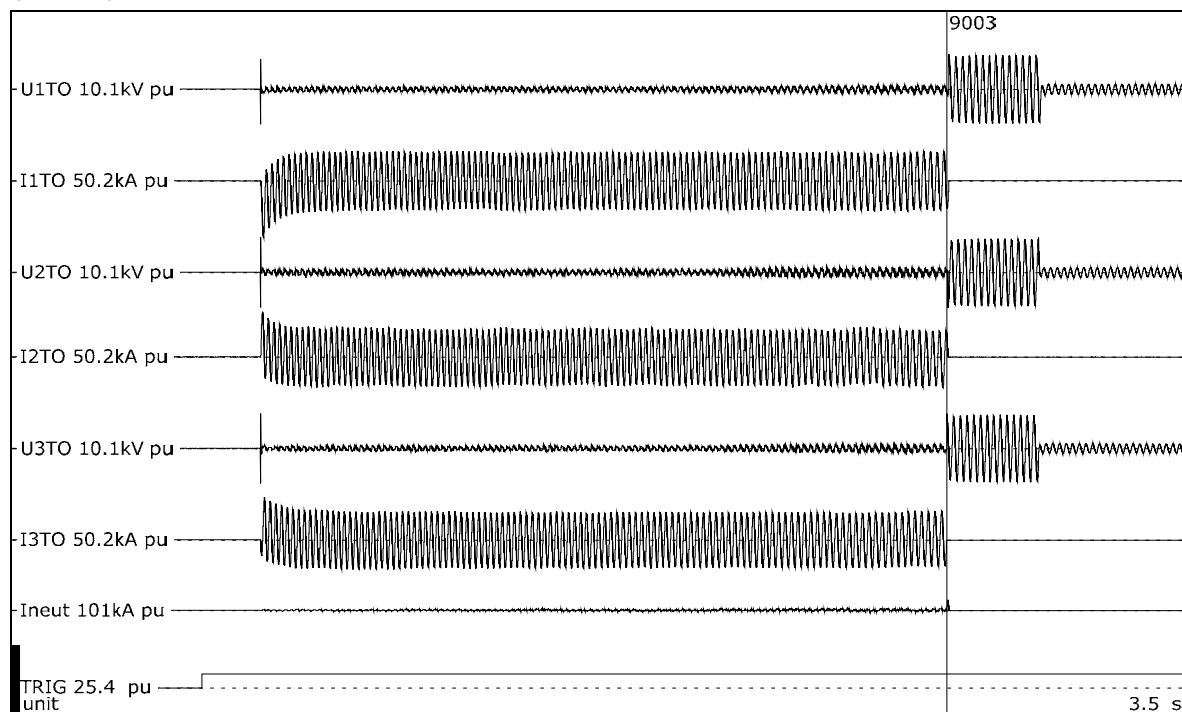
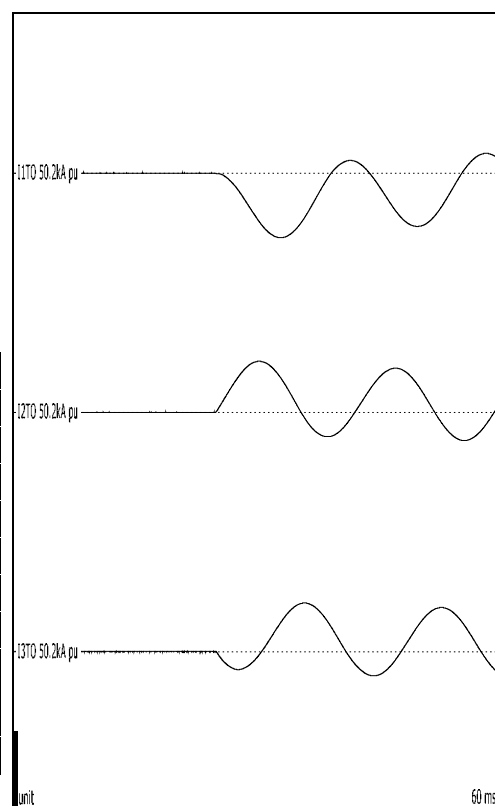
## OBMV # 6

Observations: Emission of flames and gas observed.

Bottom and sides of box completely burned through.

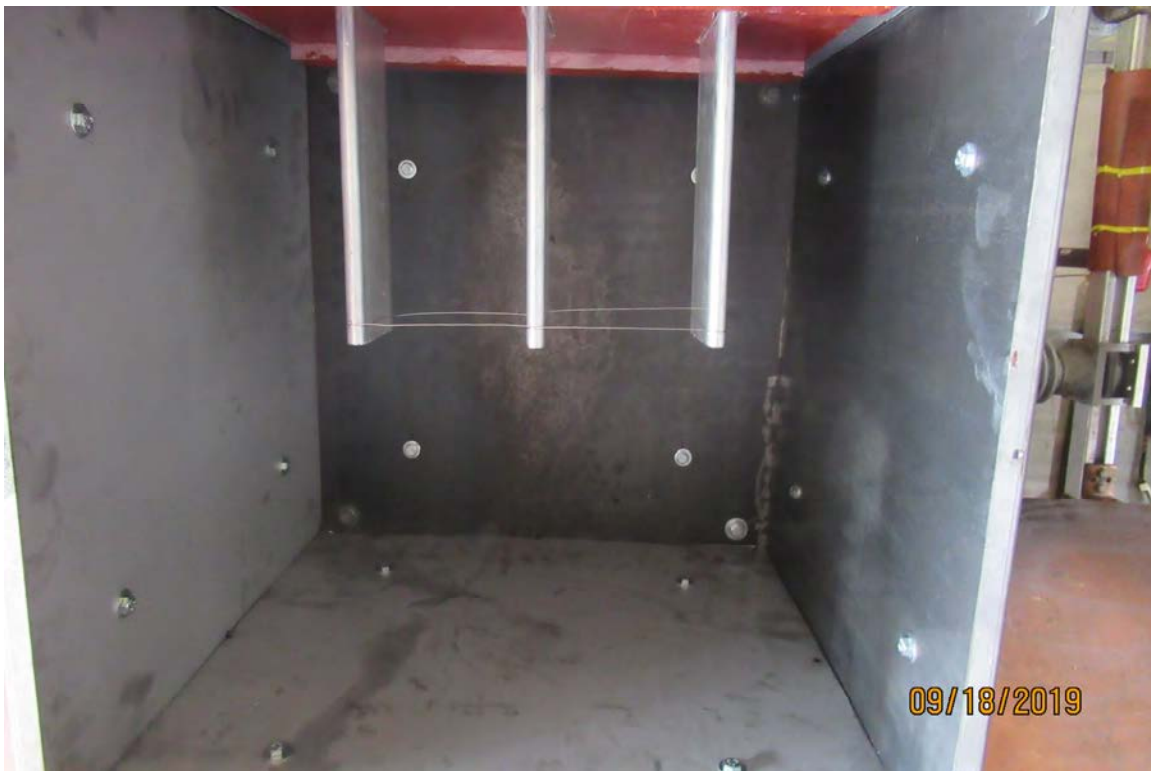
DATE:	QUOTE #:
9/18/19	245/2323
TRIAL #:	SAMPLE #:
9002	OBMV3
NOTES:

BEFORE TEST
