# **REPORT ON HIGH ENERGY ARCING FAULT EXPERIMENTS**

## **Experimental Results from Low- Voltage Switchgear Enclosures**

# Report on High Energy Arcing Fault Experiments

## Experimental Results from Low-Voltage Switchgear Enclosures

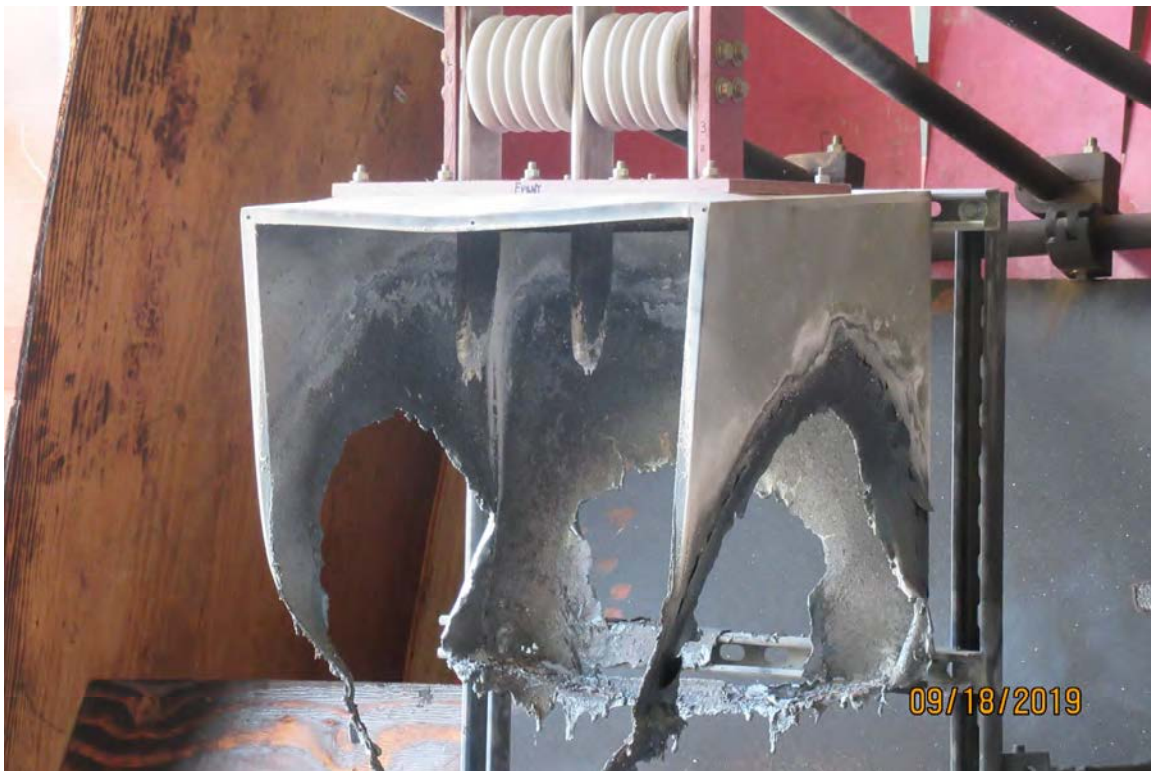
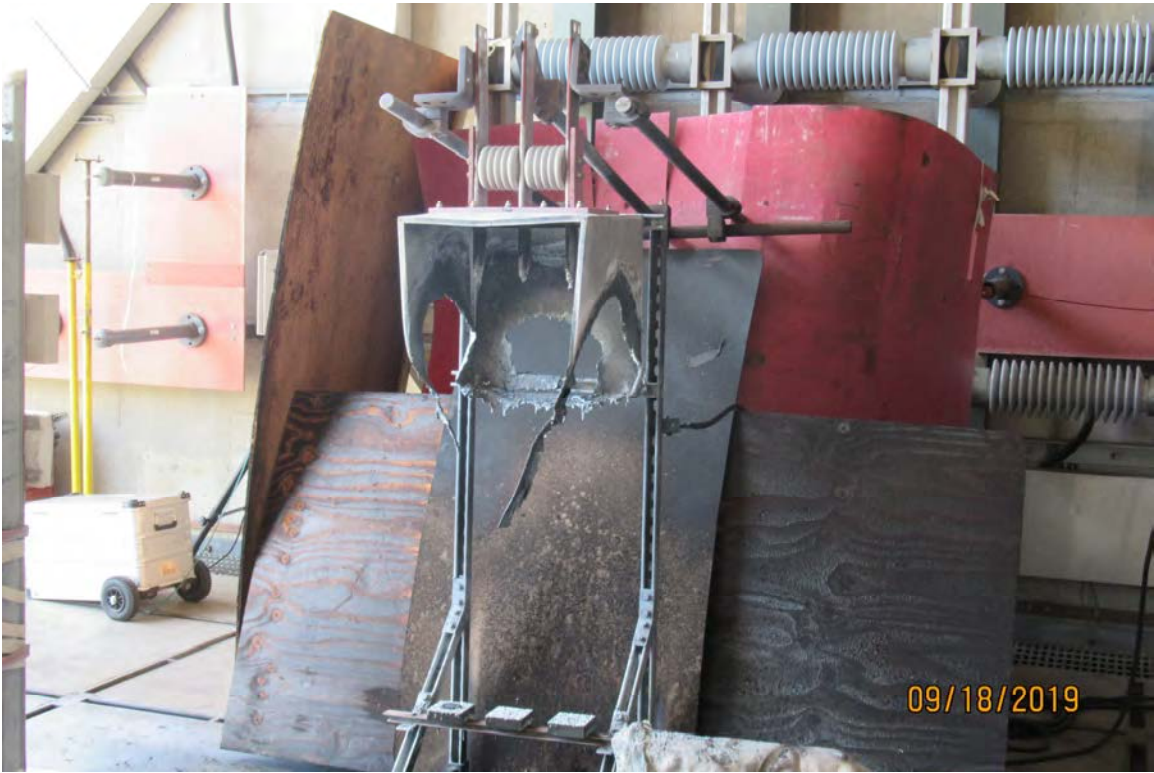
DATE:	QUOTE #:
9/18/19	24512323
TRIAL #:	SAMPLE #:
9003	03MV6
NOTES:

AFTER TEST
