NUREG-2240

# **Flood Penetration Seal Testing Protocol Research**

Office of Nuclear Regulatory Research

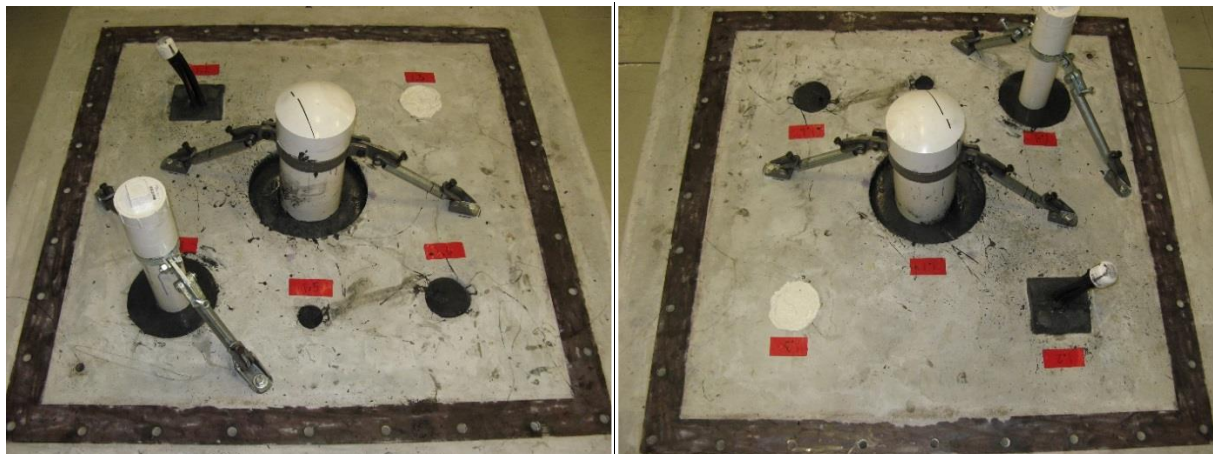
**Figure 4-10 Photos of Test Deck 1 After Seal Assembly Installation**

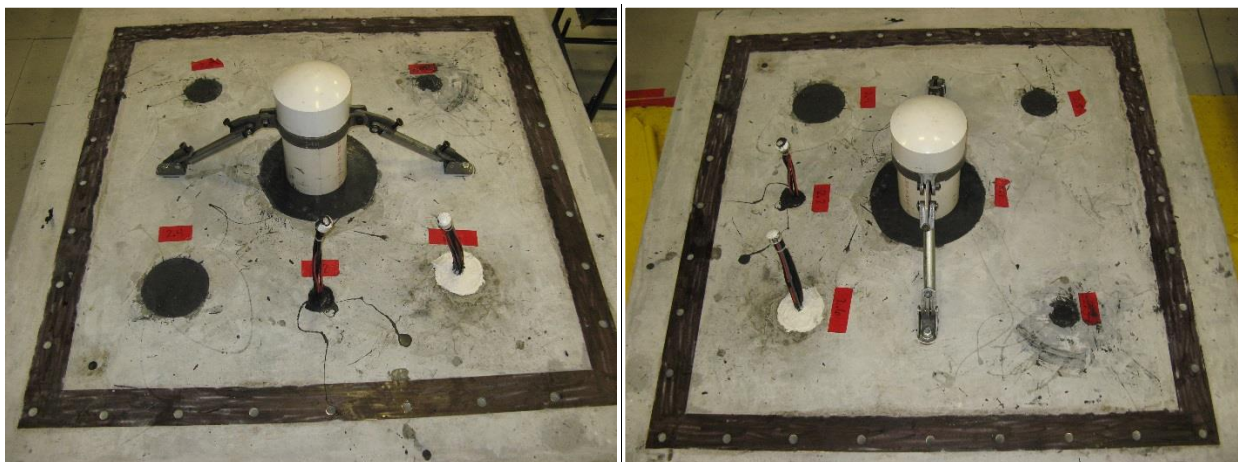
**Figure 4-13 Photos of Test Deck 2 After Seal Assembly Installation**

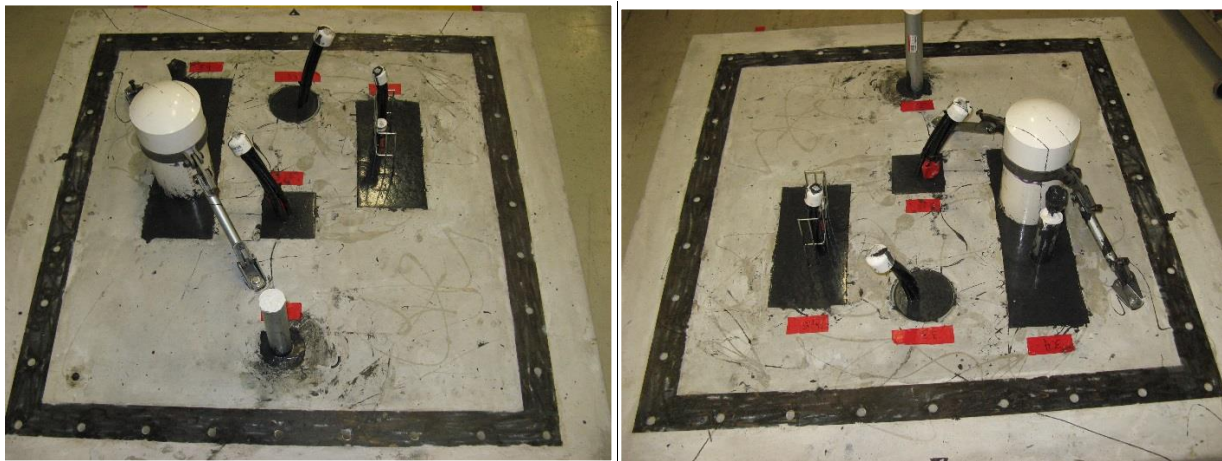
**Figure 4-16 Photos of Test Deck 3 After Seal Assembly Installation**

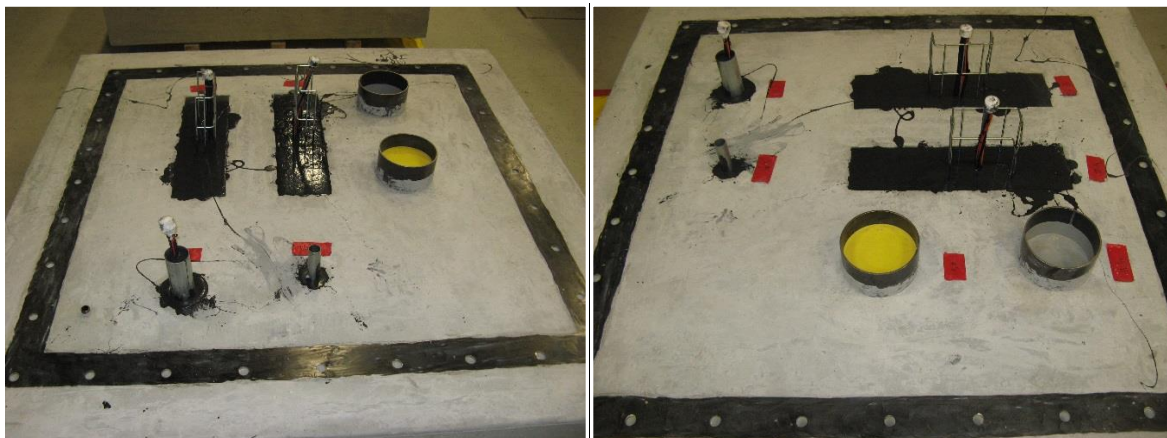
**Figure 4-18 Photos of Test Deck 4 After Seal Assembly Installation**

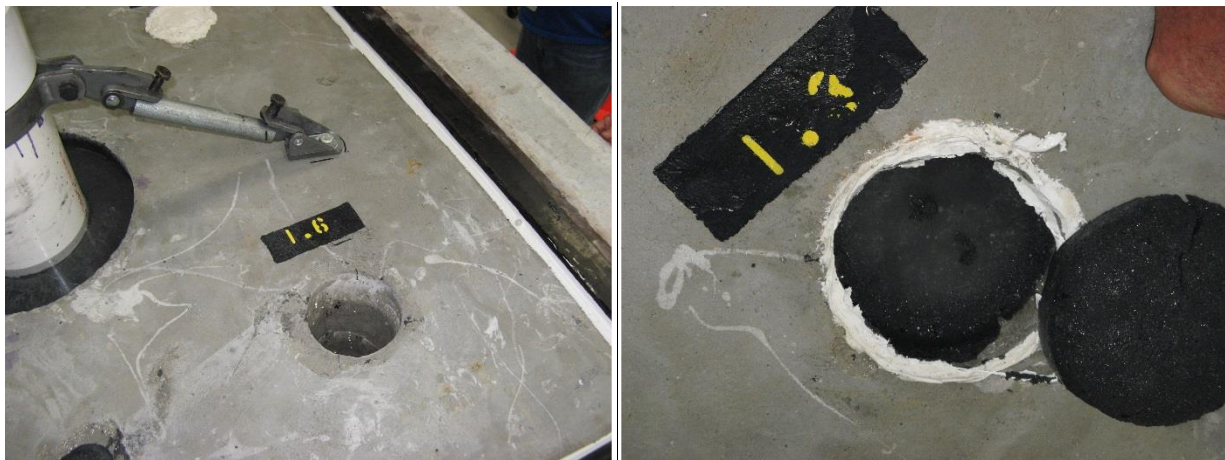
Following the termination of Test 1, visual inspections were conducted on Test Deck 1 (Figure 5-4). Penetration 1.6 was found to be completely ejected from the test deck and lodged beneath in the leakage collection system. The concrete hole into which Penetration 1.6 had been installed was open and clear of debris. Additionally, the caulk cap of Penetration 1.3 was damaged as evidenced by a large surface crack through the caulk. No damage or other notable discrepancies with the other four penetrations were observed.

Figure 5-4 Empty Penetration 1.6 (Left Photo) and Damaged Penetration 1.3 (Right Photo)

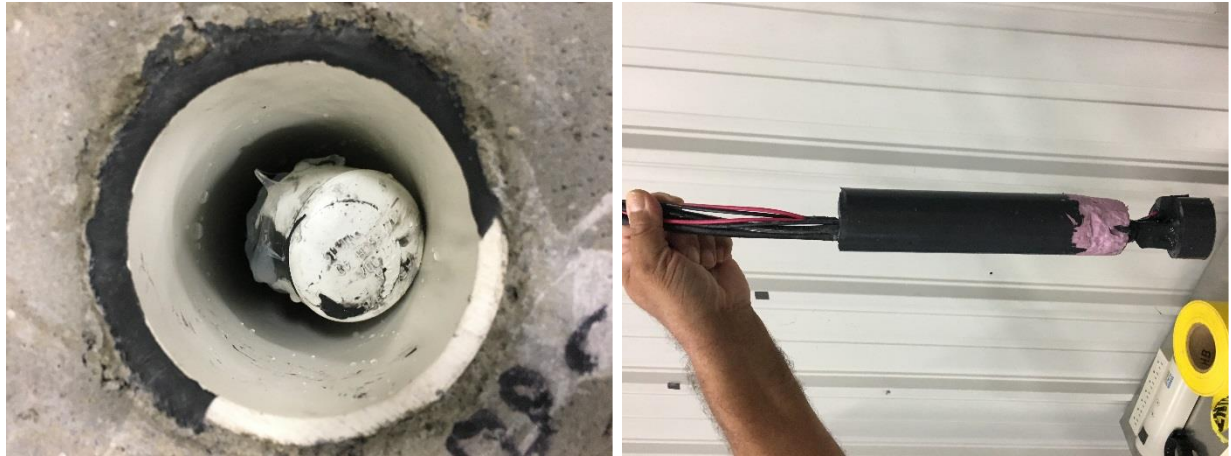
Following the termination of Test 2, visual inspections were conducted on Test Deck 2 (Figure 5-8). Penetration 2.2 was found to be completely dislodged from its sleeve within the test deck and pushed down into the leakage collection system. No damage or other notable discrepancies with the other five penetrations were observed. The lack of visible damage to Penetration 2.1 indicates that, although it experienced significant leakage during the test, it was not the source of the rapid depressurization within the water chamber, resulting in test termination.

**Figure 5-8 Top-Down View (Left Photo) of Penetration 2.2 Dislodged with its White Cable Cap Visible and Penetration 2.2 Removed (Right Photo) from the Test Deck (its White Cable Cap Not Visible)**

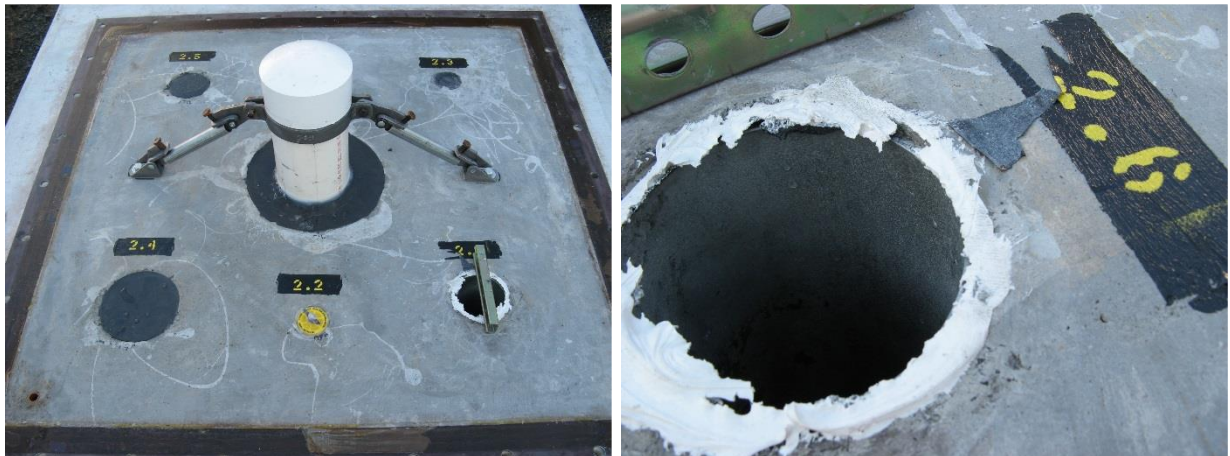
Following the termination of the pressure test, visual inspections were conducted on Test Deck 2 (Figure 5-12). The yellow object in the left photograph in Figure 5-12 is the permanent plug for Penetration 2.2. Penetration 2.6 was found to be completely dislodged from its sleeve within the test deck and pushed down into the leakage collection system. Figure 5-13 is a photograph of the ejected seal from Penetration 2.6. No damage or other notable discrepancies with the other five penetrations were observed.

**Figure 5-12 Test Deck 2 Post-Test (Left Photo) and Empty Sleeve (Right Photo) for Ejected Penetration 2.6**

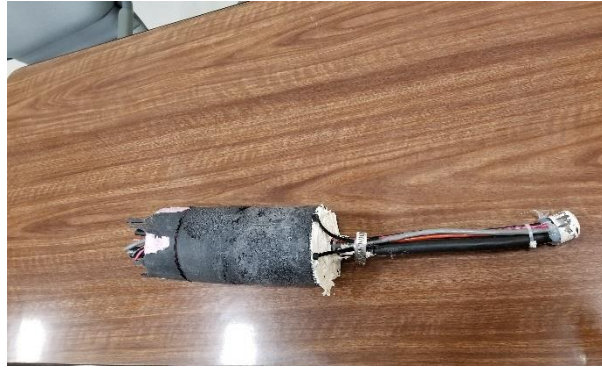
**Figure 5-13 Ejected Seal and Penetrant from Penetration 2.6**

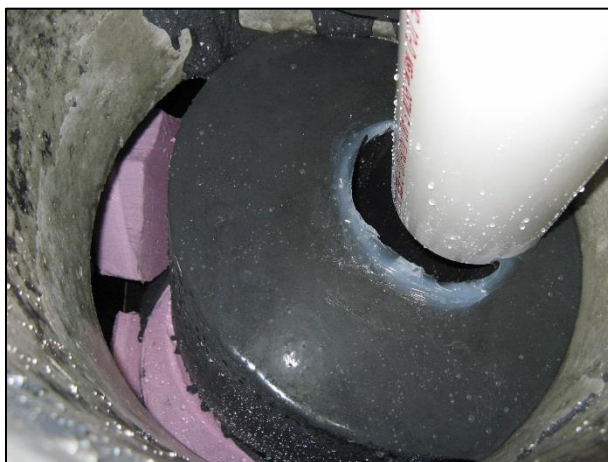
Following the termination of the pressure test, visual inspections were performed on Test Deck 5 (Figure 5-17). Penetration 5.2 was found to be completely dislodged from its installed position and pushed down into the leakage collection system. No damage or other notable discrepancies with the other five penetrations were observed.

**Figure 5-17 Dislodged Penetration 5.2**

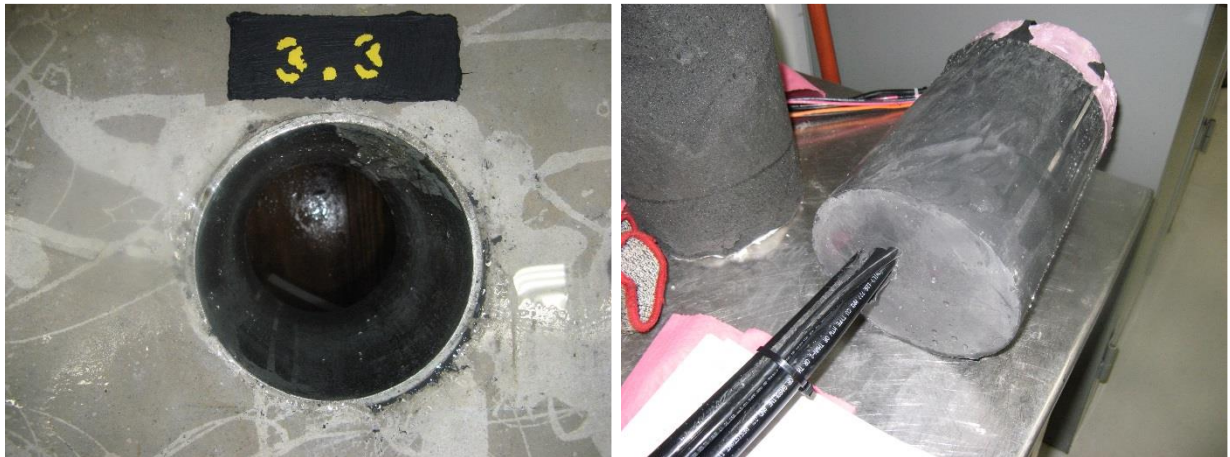
Following the termination of the test, visual inspections were conducted on Test Deck 3 (Figure 5-24). The seal in Penetration 3.3 was found to be completely dislodged from its installed position and pushed down into the leakage collection system. No damage or other notable discrepancies with the other five penetrations were observed.

**Figure 5-24 Empty Steel Sleeve for Ejected Penetration 3.3 (Left Photo) and Ejected Seal Material and Penetrants for Penetration 3.3 (Right Photo)**
