# Steam Generator Task Force/NRC Meeting

September 8, 2022

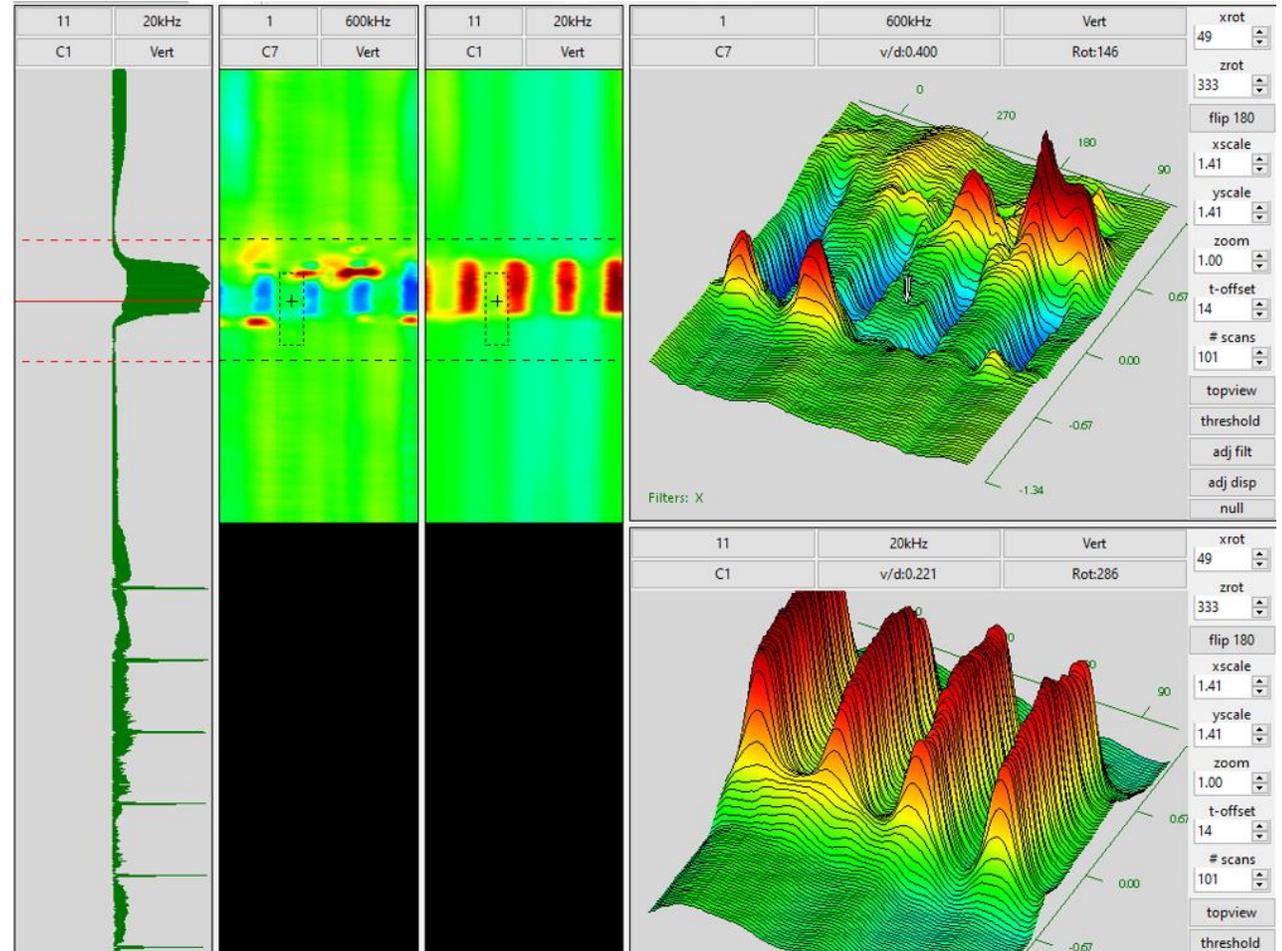
- Example of dents at quatrefoil TSP

**Note the dents are aligned with TSP contact land**

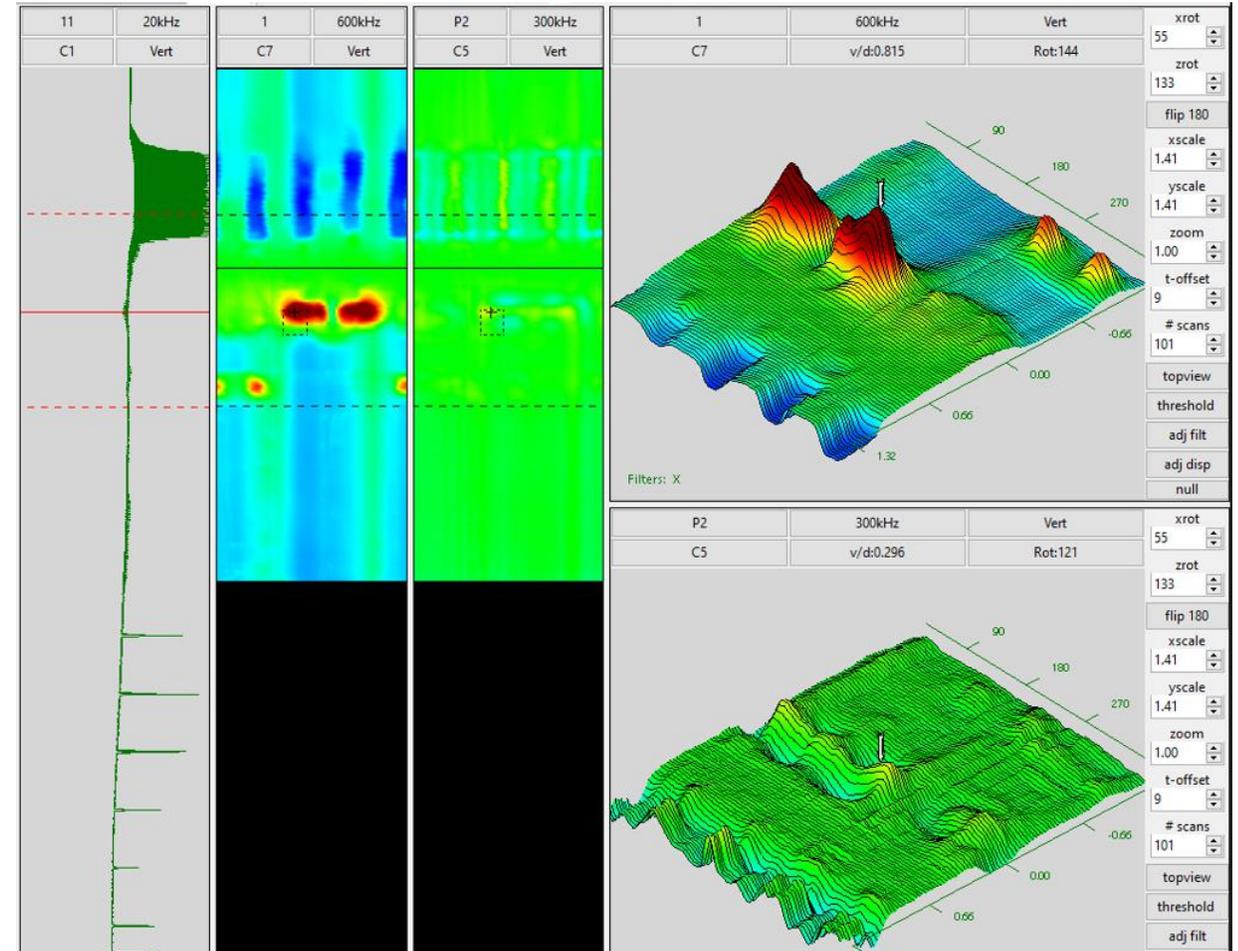
- Example of freespan dings (same plant)

Dings are aligned with the TSP contact lands with spacing coincident with TSP geometry

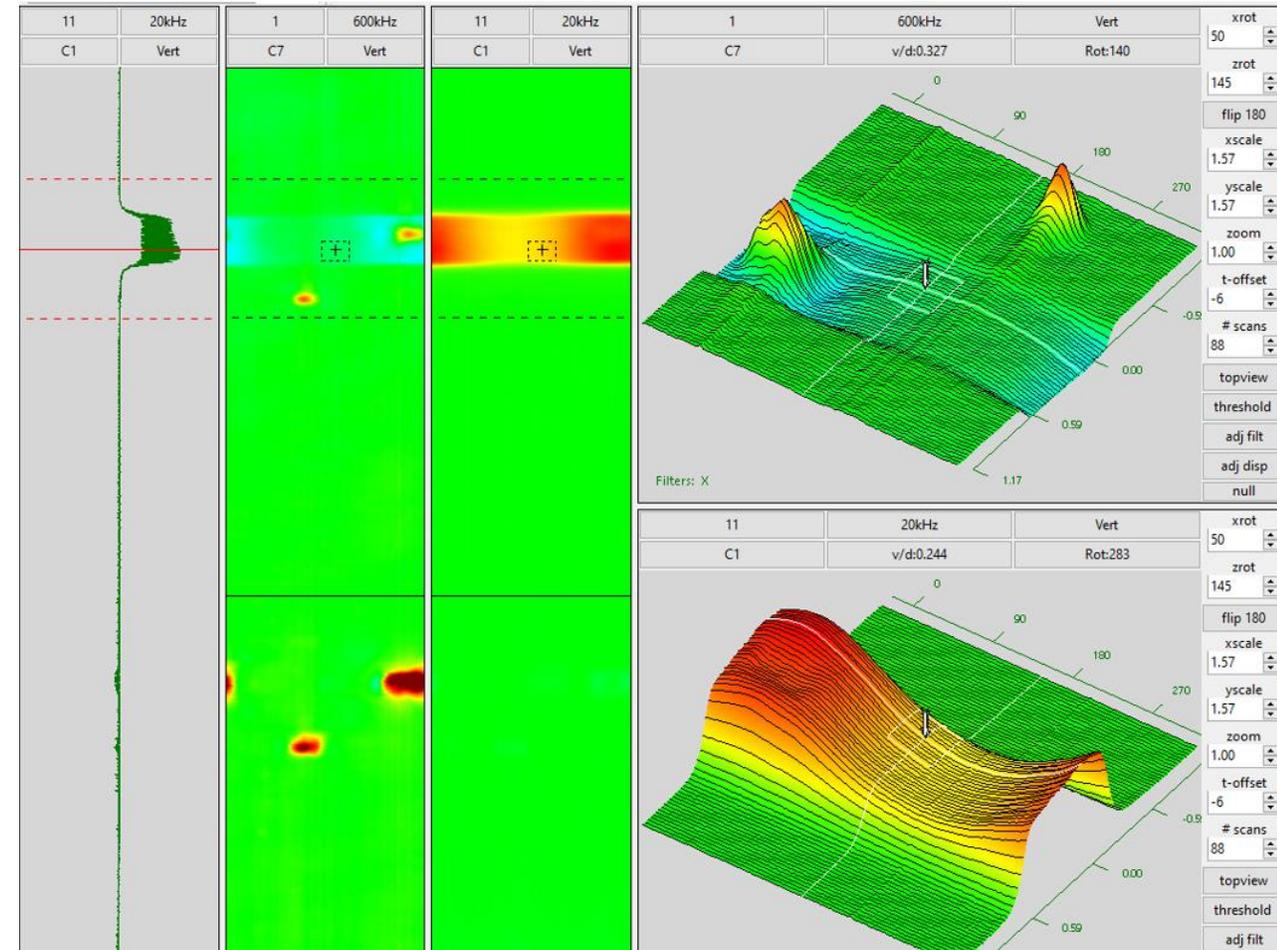
- Dents at FDB (drilled hole or octafoil design) can be generated from TSP interaction at a higher location during insertion
- Due to the tube/TSP engagement above, it is nearly impossible to get the required tube deflection at the FDB to introduce the dent during insertion
- This doesn't apply to all FDB dents, some may be due to misalignment of the FDB tube hole

**Ding angular spacing and axial spacing consistent with TSP geometry**

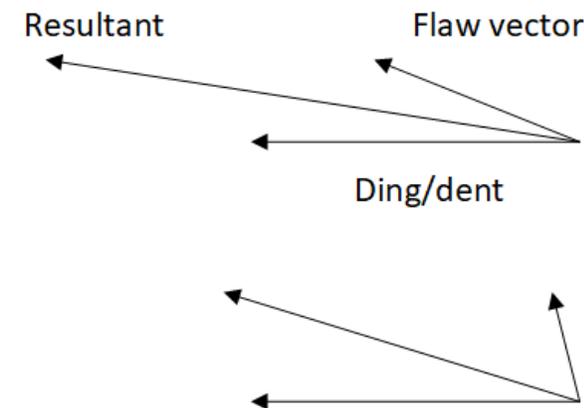
- The +Pt residual signal resides at approximately 0 degrees phase
- Simple vector addition can be used to illustrate how an ODSCC signal when combined with the ding/dent residual can produce resultant signals in the ID plane
- For equal depth ODSCC, the larger the ding, more phase suppression and the smaller the ding, less phase suppression
- If PWSCC is present, the resultant amplitude should be significantly larger than the non-flawed residual; this is not observed on in situ flaws

Note these are approximations, real ECT signals are rarely characterized by a linear vector

**Top: 60%TW PWSCC on 1.5V ding. Bottom: 60%TW ODSCC on 1.5V ding**

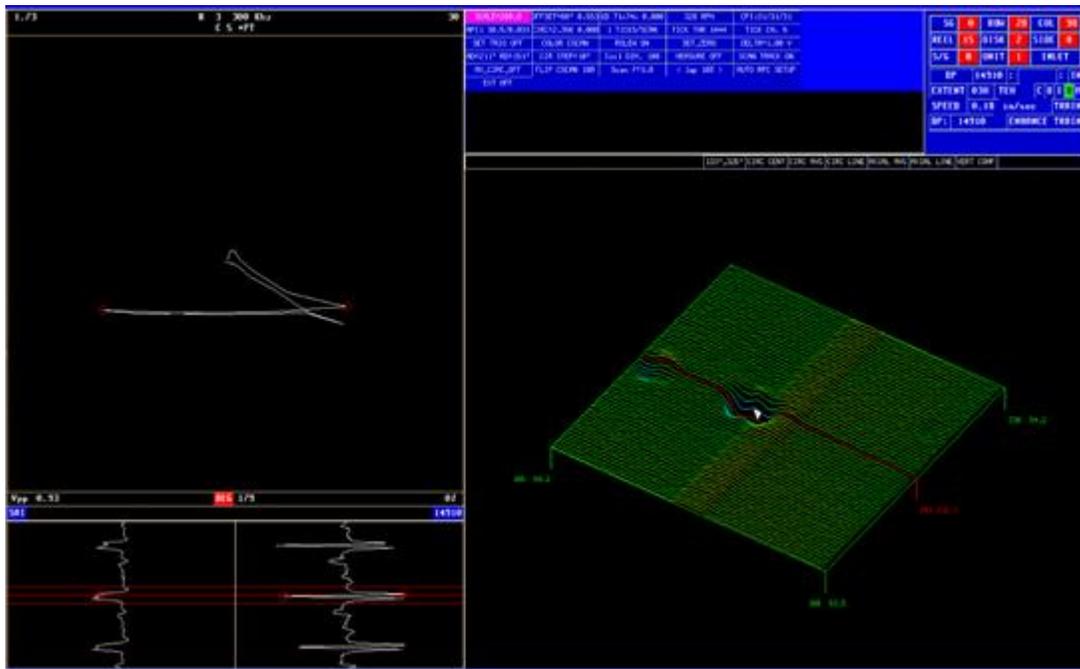
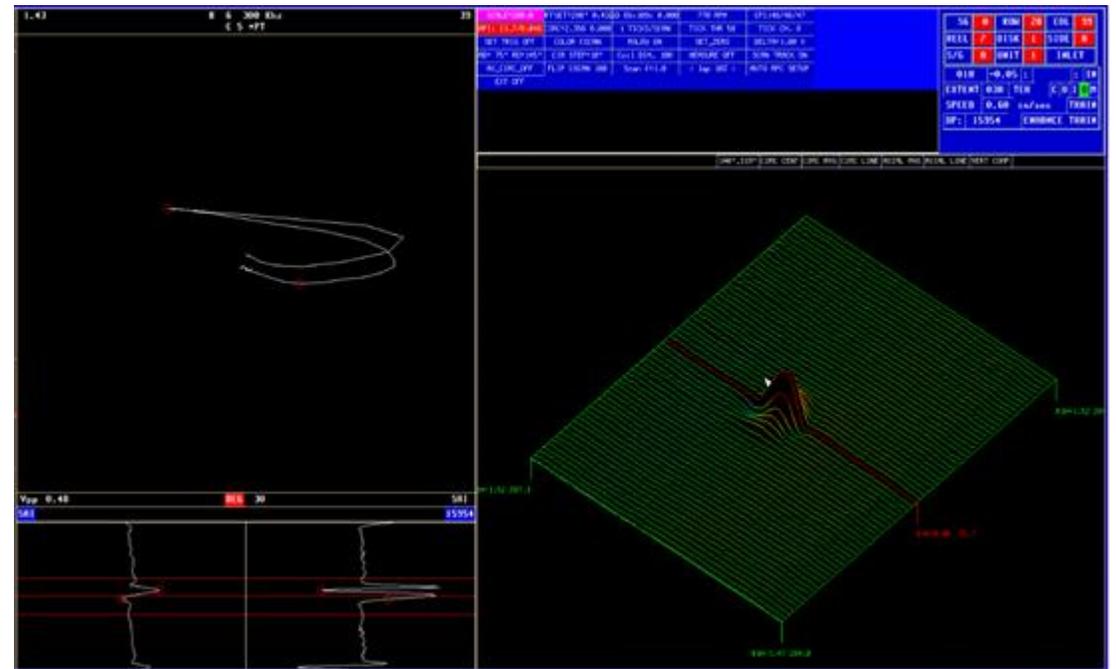
- Lab sample BOQ-28-02: 4.6V ding, 78%TW (DE), 0.23 inch long
- Pre-crack and post-crack +Pt graphics

Post crack condition more resembles a PWSCC response. Nearly identical flaw parameters as the following example but larger ding, more phase suppression

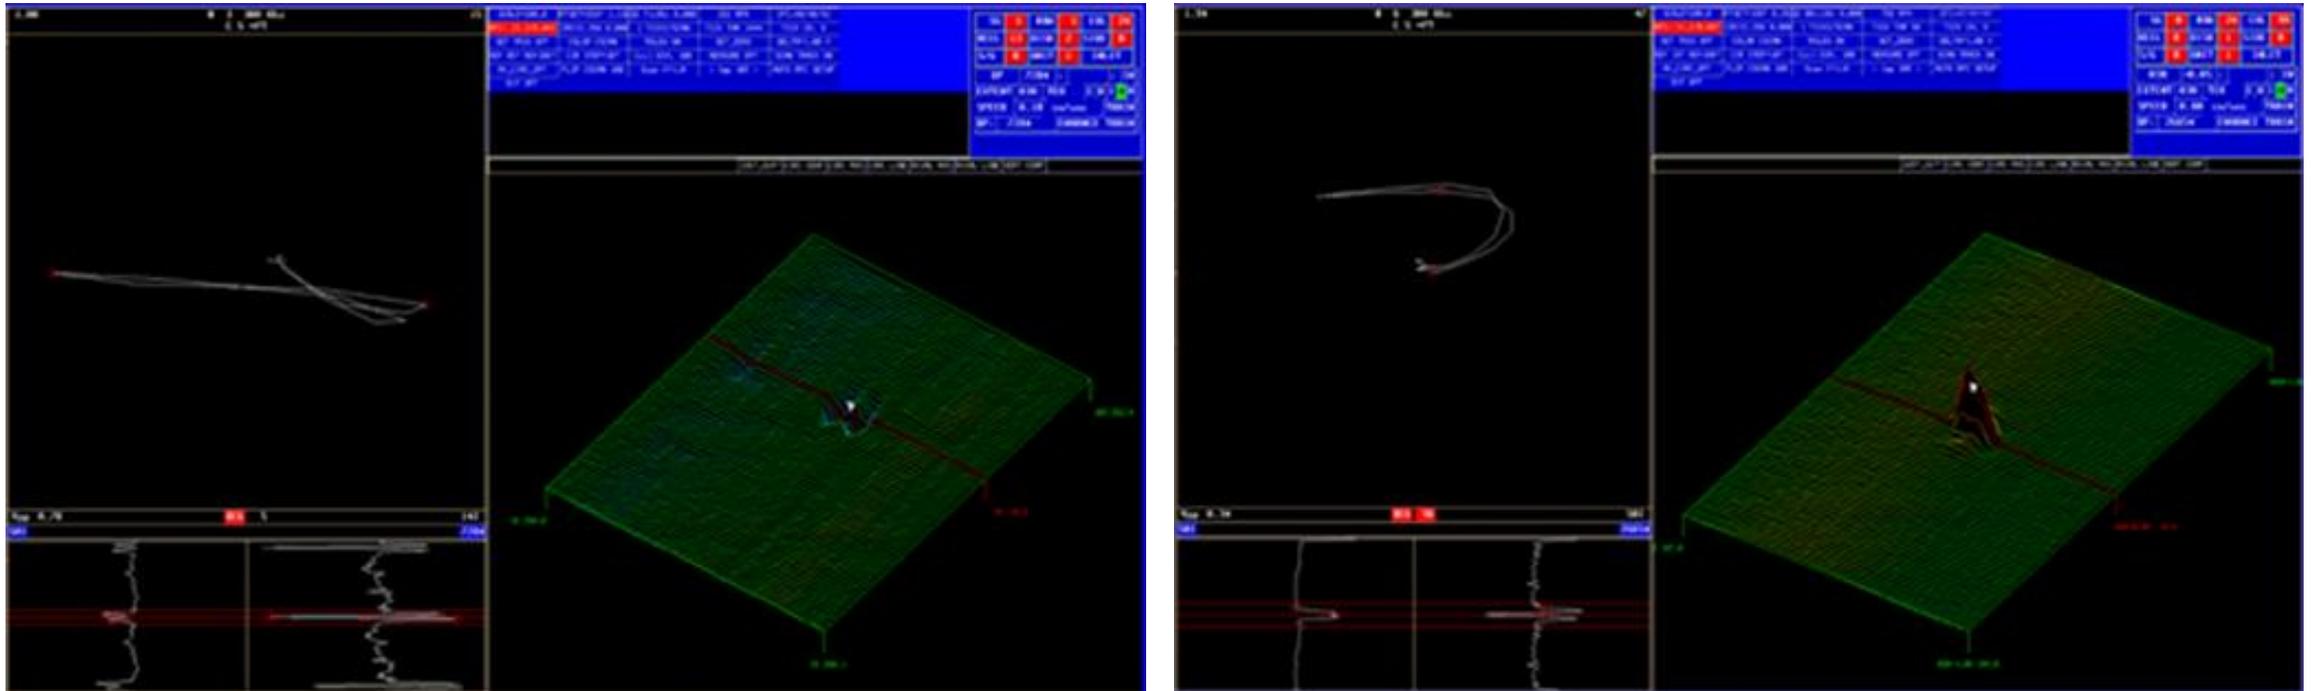
- Lab sample BOQ-24-01: 2.4V ding, 78%TW (DE), 0.25 inch long
- Pre-crack and post-crack +Pt graphic

**Note the phase suppression and unique Lissajous shape**

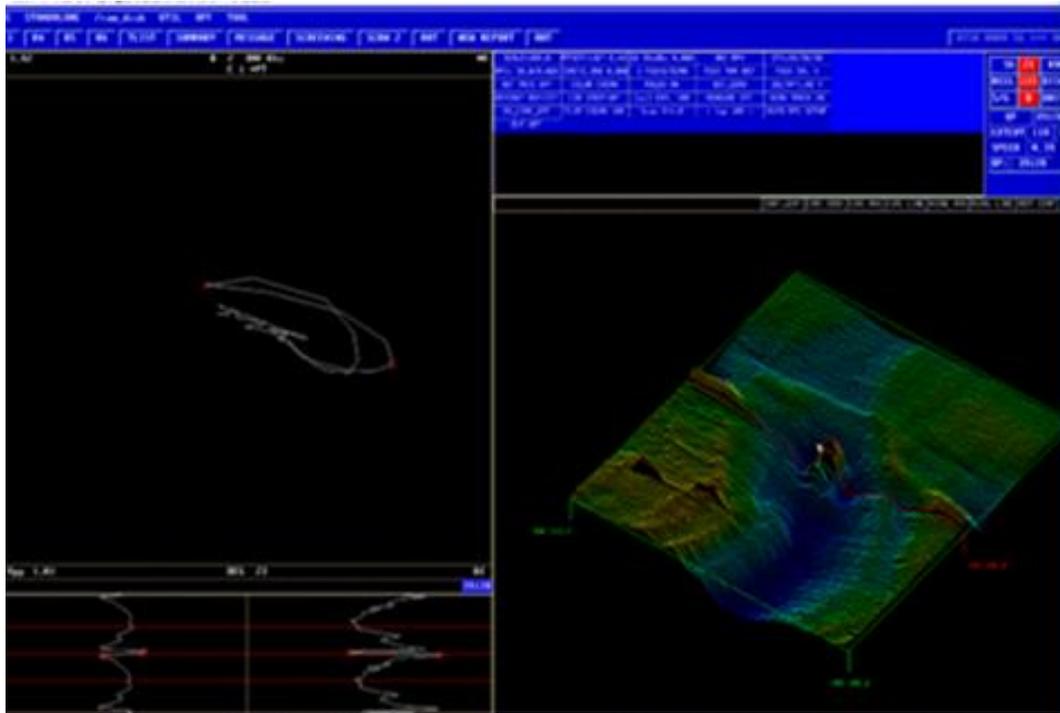
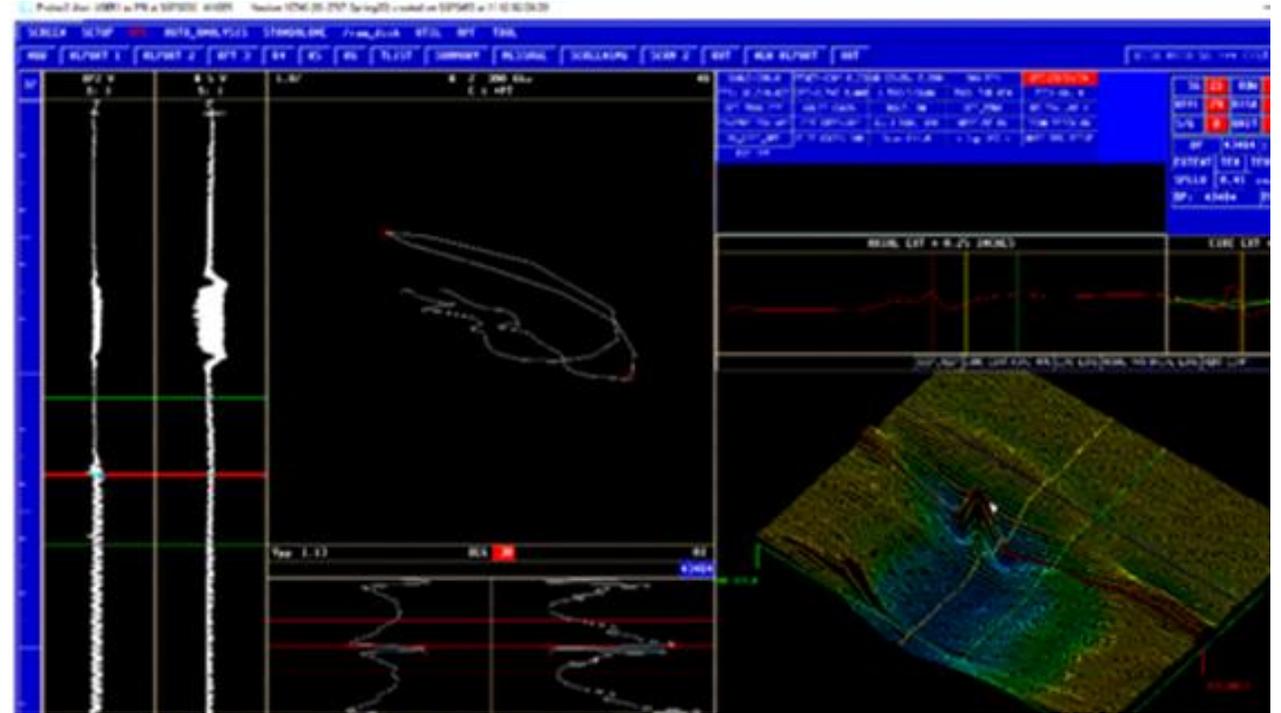
- Model D5 plant, Row 1 U-bend, axial ODSCC at 6 to 7V ding, on intrados, about 1 inch above bend tangent, in-line with TSP quatrefoil contact land
- Data Union simulation on left, plant signal on right

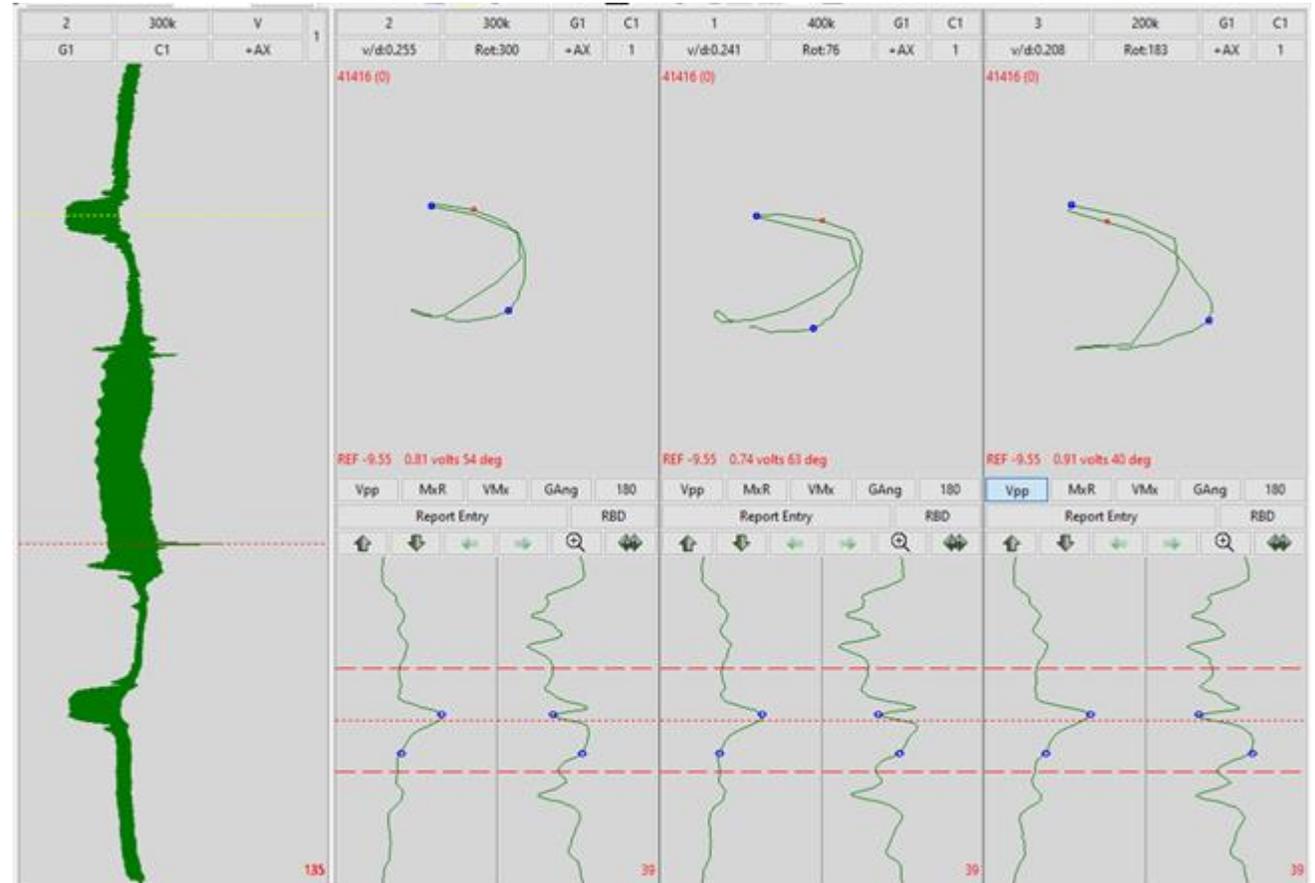
- Model 44F SG, Row 1 U-bend, axial ODSCC at ~4V ding, on intrados, about 1 inch above bend tangent, in-line with TSP contact land
- Smaller ding, lesser phase suppression
- Common factors for both plants: dings in U-bend, located on intrados, aligned with TSP contact land, located ~1 inch above bend tangent

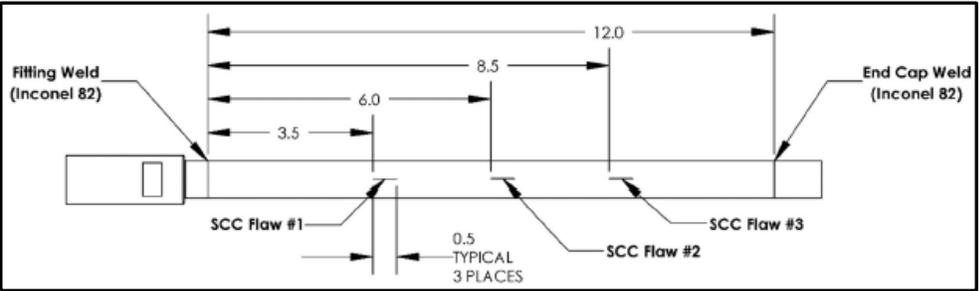
Axial Flaw Site Diagram

- Specimen Flaw Site Preparation
  - Tube specimens fabricated from 600MA steam generator tubes supplied by EPRI
  - Each tube specimen contains up to three flaw sites (either axial or circumferential), created using an arc engraver

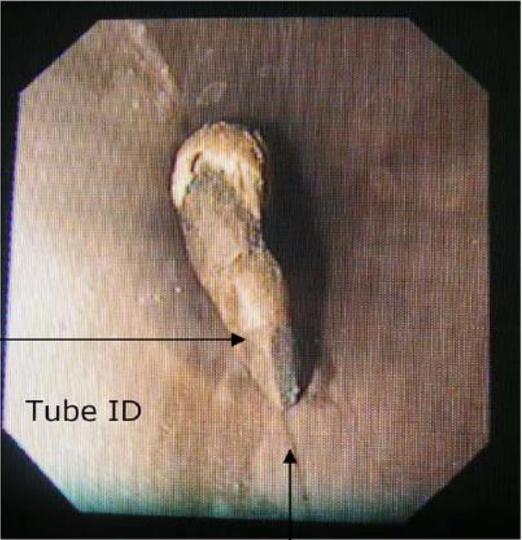
Tip of electric marker

Tube ID

starter

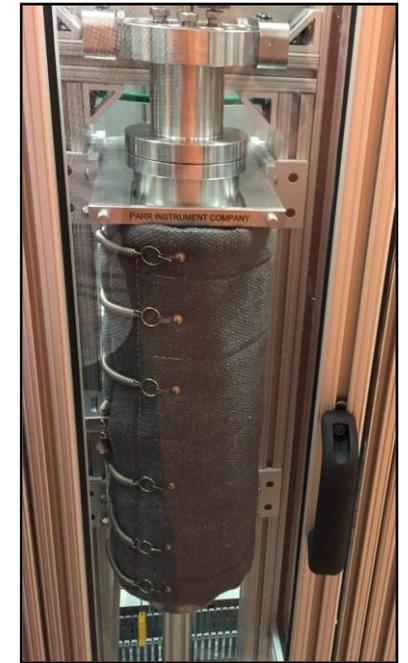
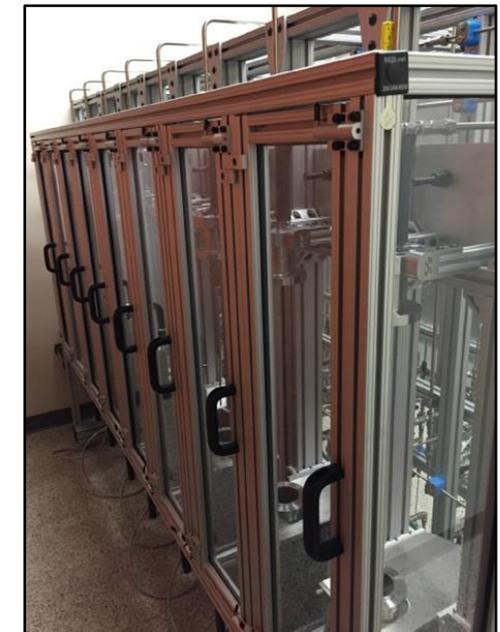
- Testing performed in heated autoclave at elevated temperature and pressure
  - Results in supersaturated steam
  - Added salts are volatilized to create doped steam conducive to corrosion
- Operating pressure chosen for volume on the opposite surface of the flaw is differentially pressurized to match the stress profile of the specific test goal

SCC Flaw Type & Location	Specimen Pressure	Specimen Environment	Vessel Pressure	Vessel Environment
OD Axial Flaw	Vessel Pressure $+1450 \pm 100$ psia	Argon	$1160 \pm 100$ psia	Doped Steam w/ $H_2$
ID Axial Flaw	$1160 \pm 100$ psia	Doped Steam w/ $H_2$	Atmospheric Pressure	Argon
OD Circumferential Flaw	Vessel Pressure $\pm 100$ psia	Argon	$1160 \pm 100$ psia	Doped Steam w/ $H_2$

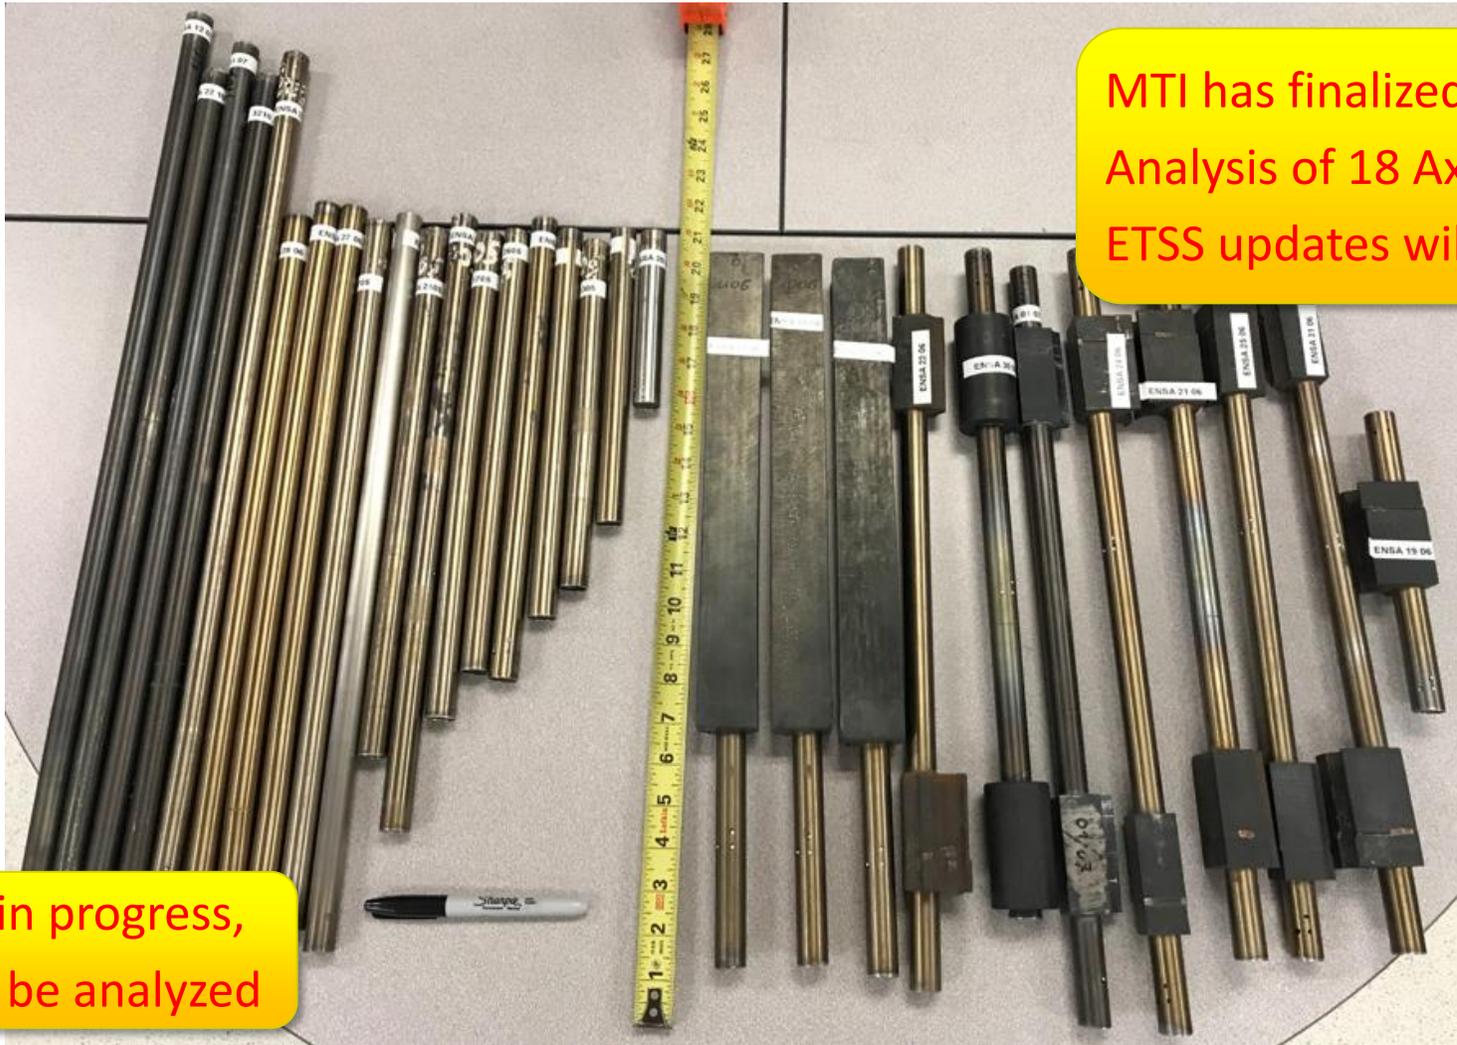
# Samples That Will Be Destructively Analyzed to Support MAPOD Calculations - Lab Cracks Available

MTI has finalized destructive Analysis of 18 Axial PWSCC Samples, ETSS updates will begin ASAP

Circ ODSCC D.E. is in progress, over 30 cracks will be analyzed

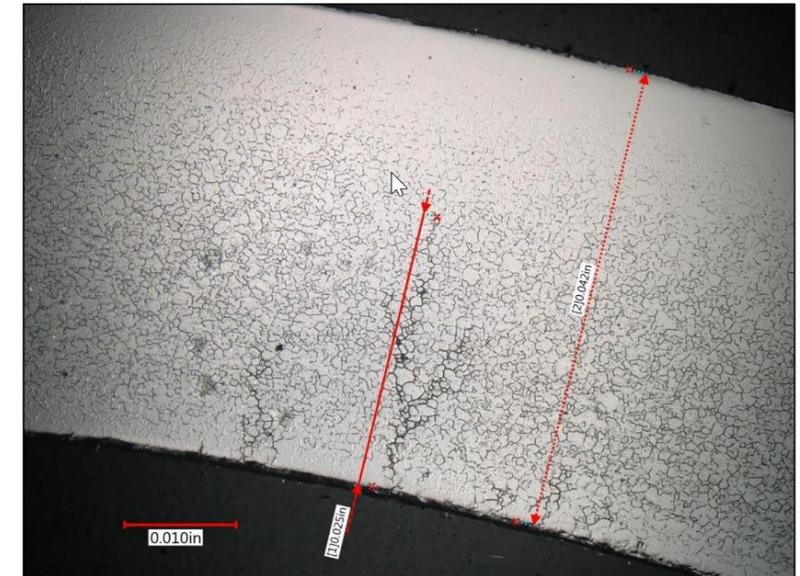
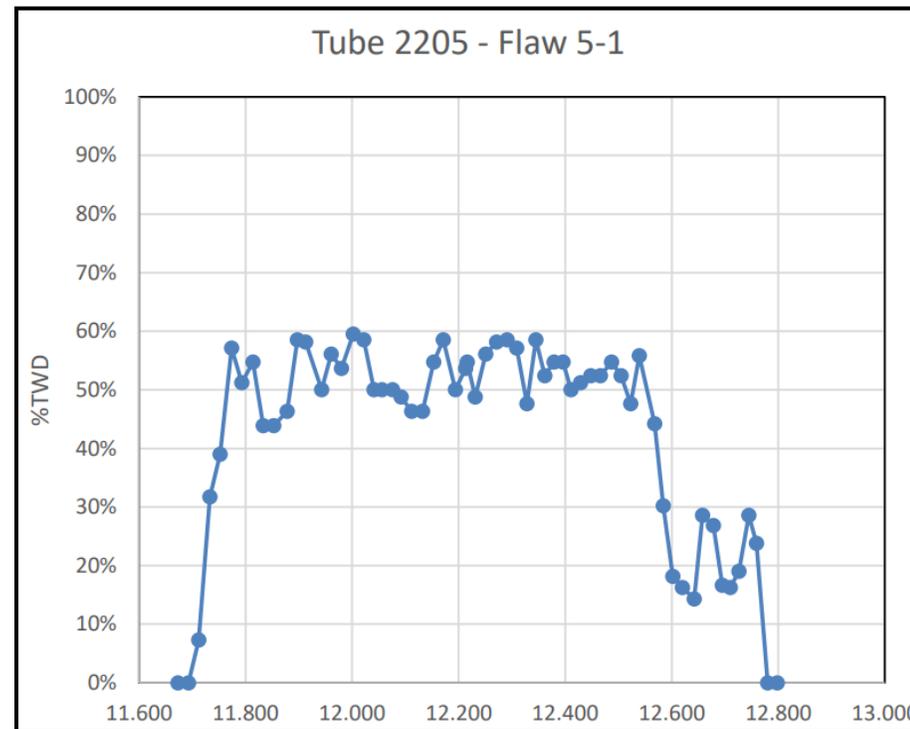
# Tube 2205 – Axial PWSCC Flaw 5-1

Final Mount Height	Wall Thickness	Depth	% Through Wall	Distance From Marked End
0.485	-	0	0%	11.673
0.505	-	0	0%	11.693
0.524	41	3	7%	11.712
0.545	41	13	32%	11.733

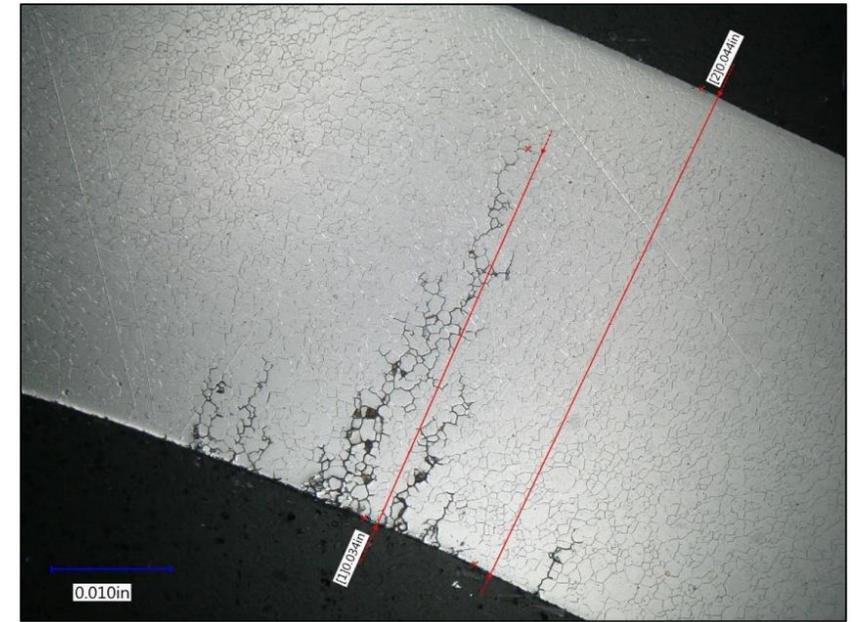
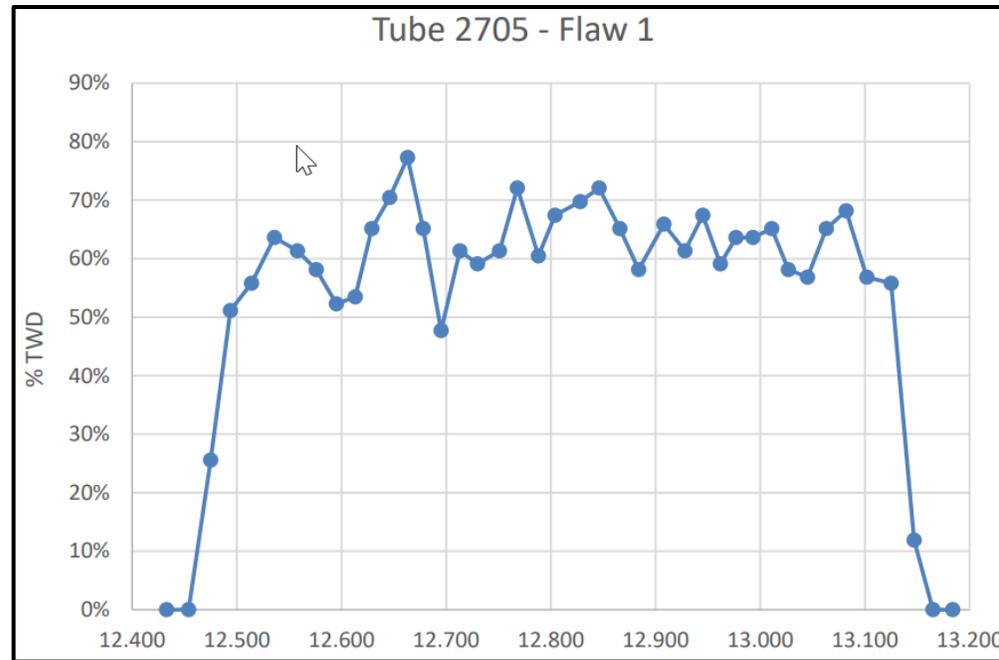
# Tube 2705 – Axial PWSCC Flaw 1

Final Mount Height	Wall Thickness mils	Depth mils	% Through Wall	Distance From Marked End
0.763	-	0	0%	12.433
0.784	-	0	0%	12.454
0.805	43	11	26%	12.475
0.824	43	22	51%	12.494

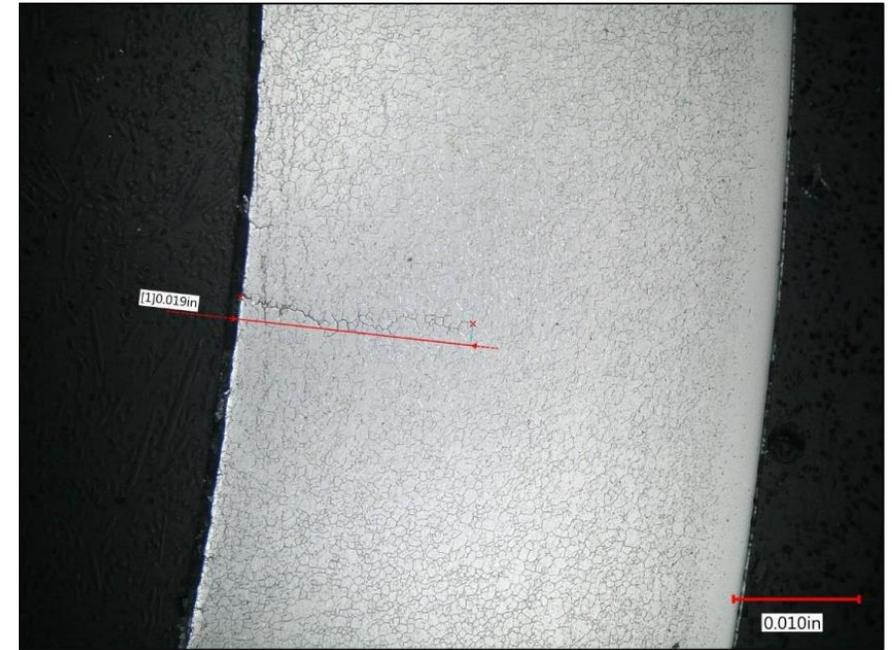
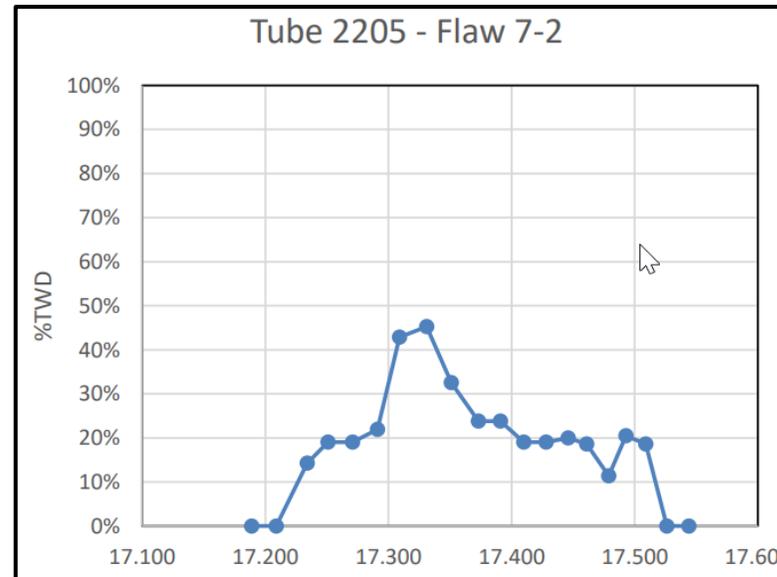
# Tube 2205 – Axial PWSCC Flaw 7-2

Final Mount Height	Wall Thickness	Depth	% Through Wall	Distance From Marked End
0.740	-	0	0%	17.189
0.760	-	0	0%	17.209
0.785	42	6	14%	17.234
0.802	42	8	19%	17.251
0.822	42	8	19%	17.271
0.842	41	9	22%	17.291
0.860	42	18	43%	17.309
0.882	42	19	<b>45%</b>	17.331
0.902	43	14	33%	17.351
0.924	42	10	24%	17.373
0.942	42	10	24%	17.391
0.961	42	8	19%	17.410
0.979	42	8	19%	17.428
0.997	45	9	20%	17.446
1.012	43	8	19%	17.461
1.030	44	5	11%	17.479
1.044	44	9	20%	17.493
1.060	43	8	19%	17.509
1.077	-	0	0%	17.526
1.095	-	0	0%	17.544

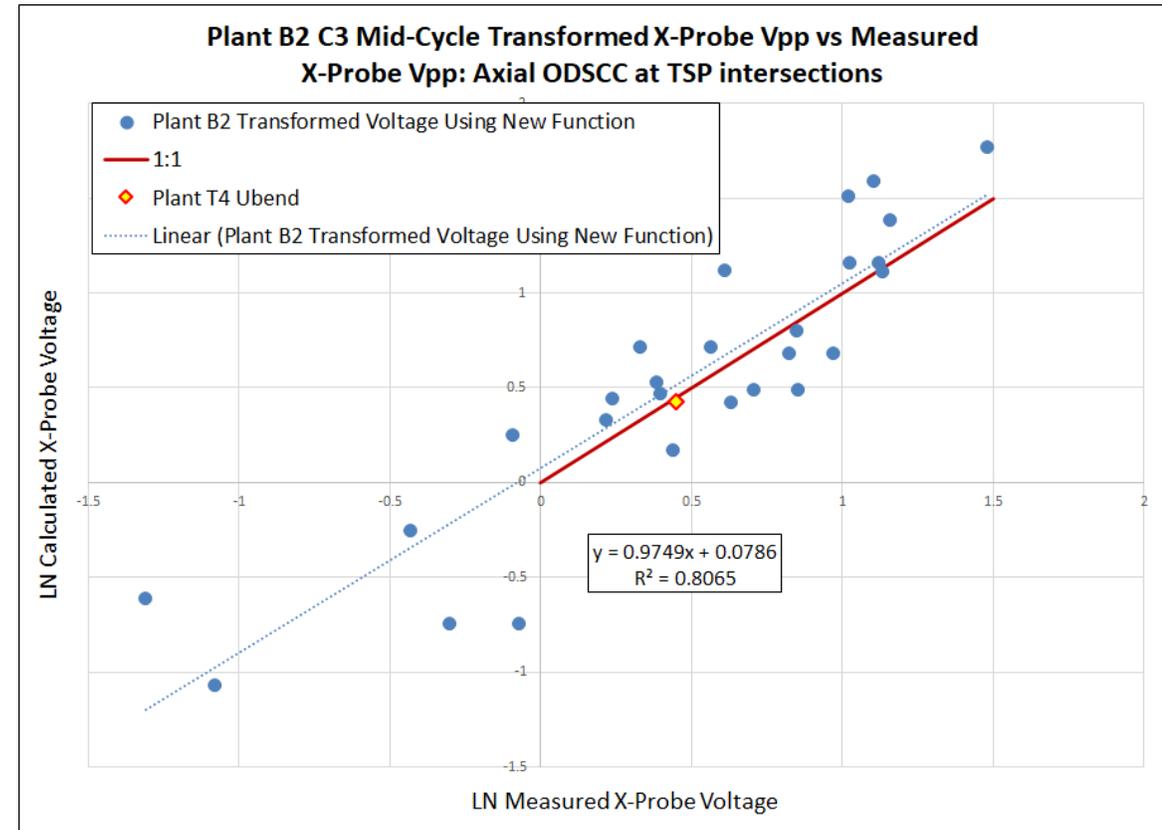
- Excellent agreement between predicted and measured array amplitudes
- Non-dented TSP and freespan locations, i.e., low noise locations

Field indication from spring 2022 falls essentially on the 1:1 line

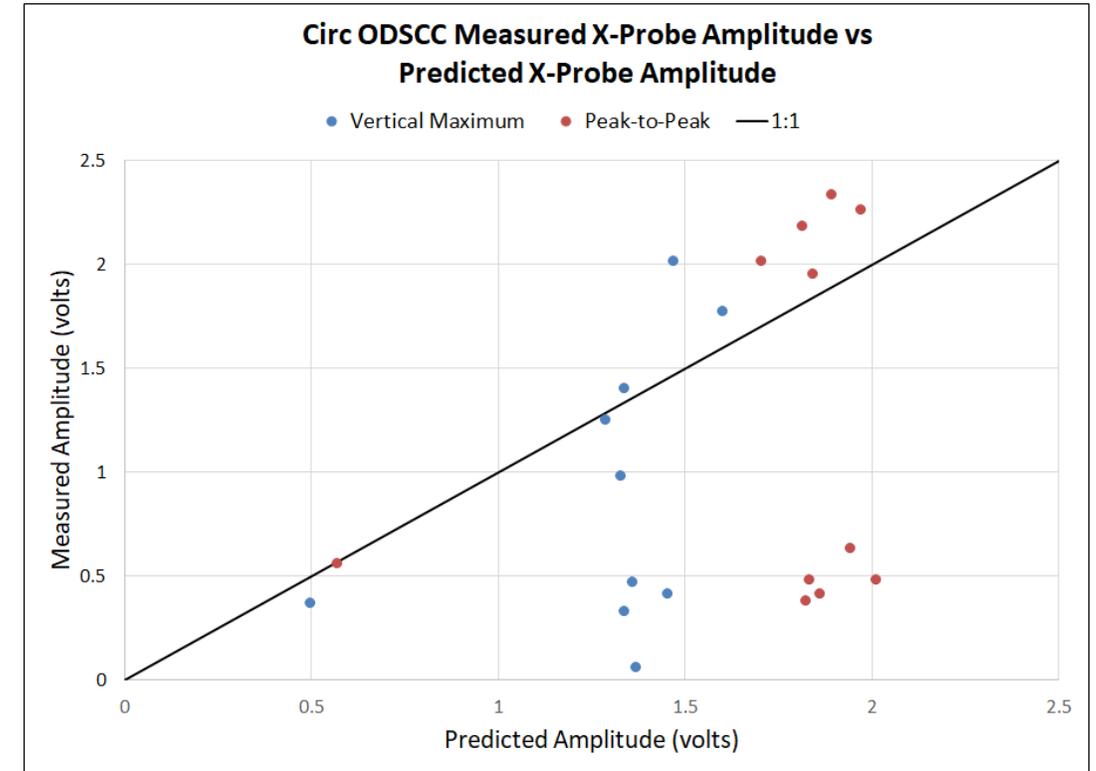
- Two distinct performances are observed; either the prediction matches the measurement, or the measurement is well less than prediction
- EPRI has associated this performance with noise characteristics between difference elevations within the expansion transition
- EPRI is addressing array probe noise monitoring protocol with Revision 9 of the Examination Guidelines
- Preliminary MAPOD modeling shows very good benchmarking for the recommended window height and noise measurement technique

**This is simply a signal-to-noise issue and research is promising**
