Decommissioning Experience in Europe

Dr.-Ing. Martin Brandauer
Principal Technical Leader

Worldwide Status and Plans for Decommissioning

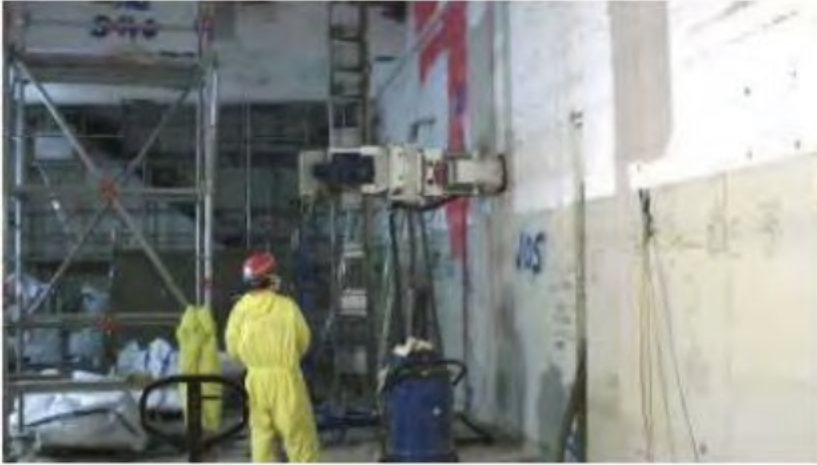
Wall decontamination

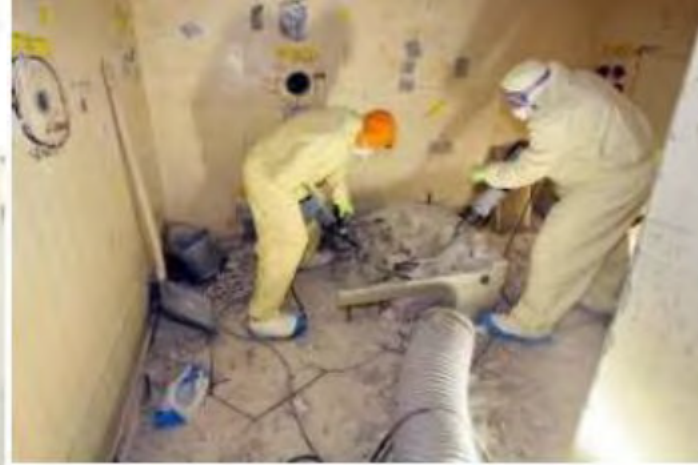
Electric handhold chiseling

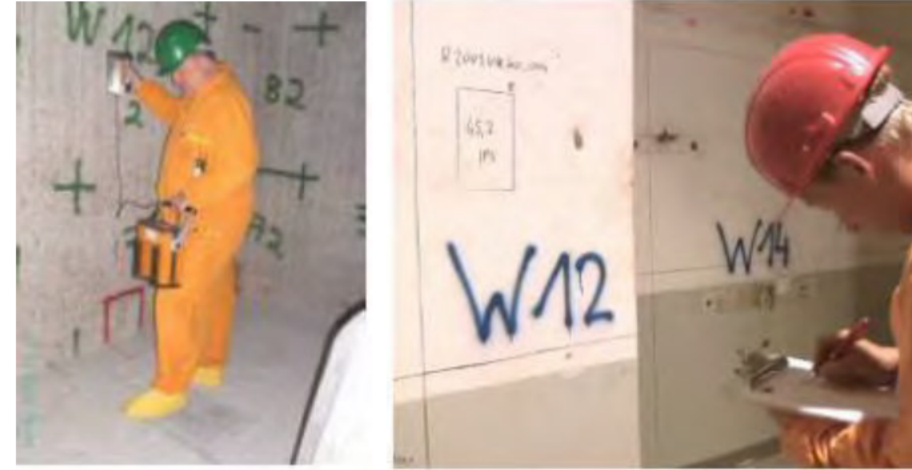
Handhold measurement and documentation

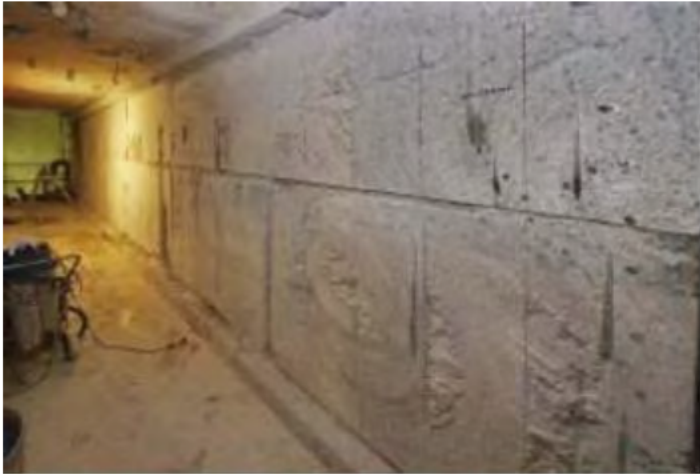
Shaved walls after decontamination

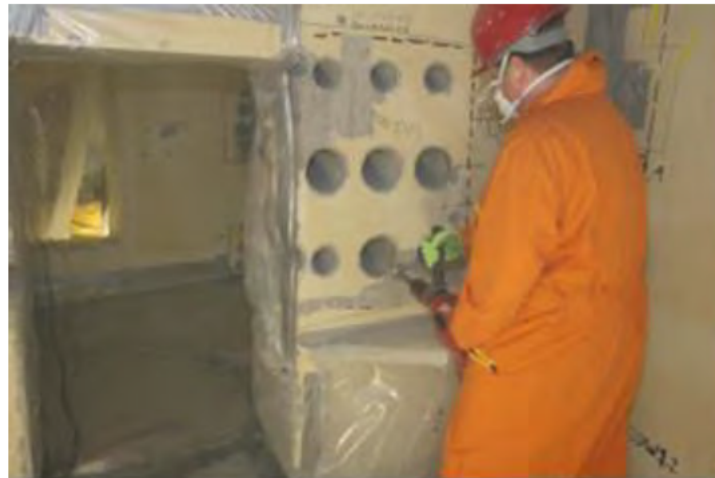
Drill out of ducts and wire shafts

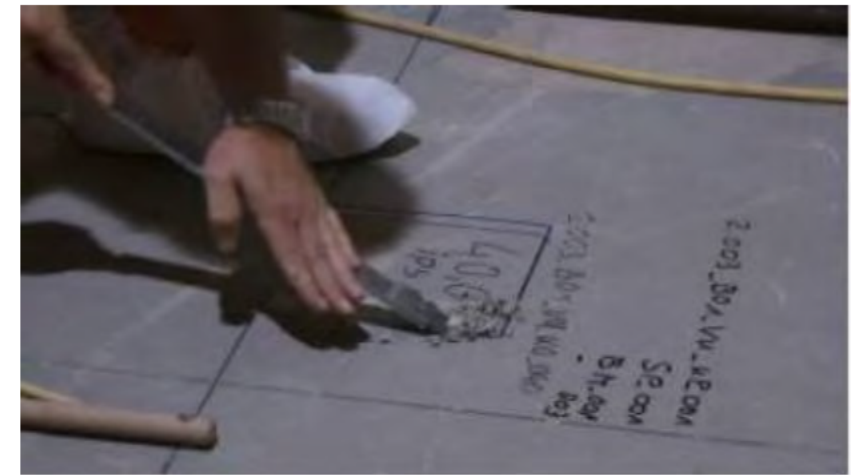
Decontamination of Residual Remains

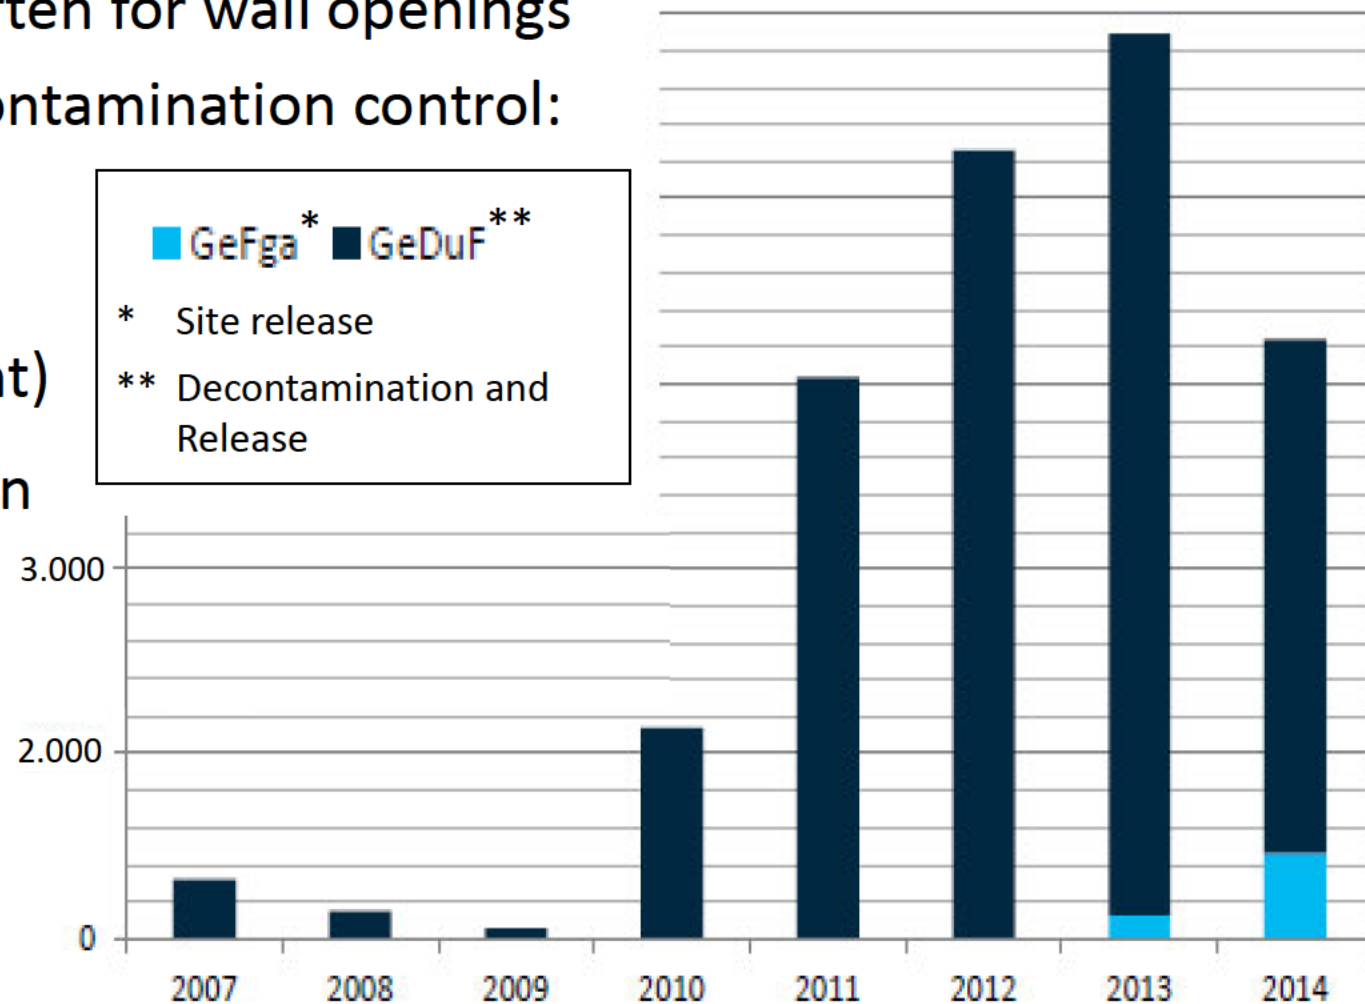
Facts from “clearance measurements” at Würgassen NPP

- Measurements with **contamination monitor** on mineral structure:
 - 26,295 decision measurements, often for wall openings
 - Preliminary investigation and decontamination control: approx. 100,000 measurements
- 12,739 measurements with **ISOCS** (typically 10 m² area per measurement)
- Collection and evaluation of more than 34,000 **material samples**
- Evaluations for the disposal of the removed material and the personnel monitoring: approximately 196,000 **laboratory analyses** conducted at Würgassen.

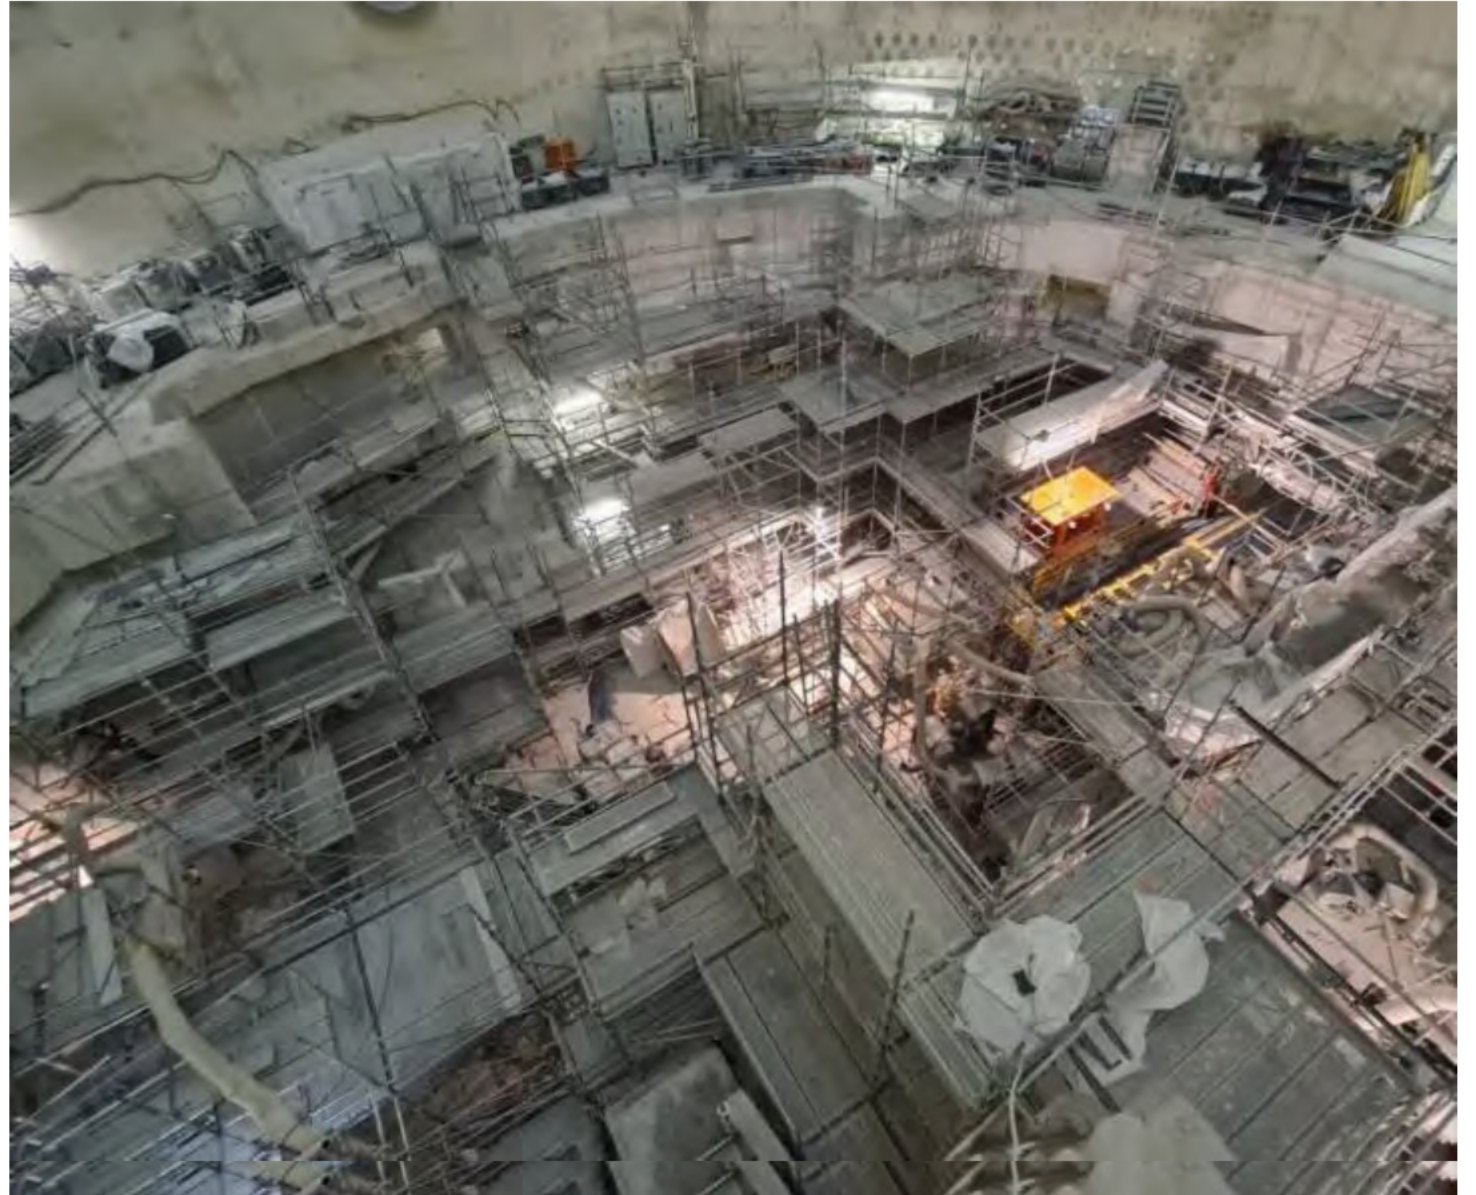
NPP Stade – Increased Decontamination Effort

- Removal of 20.000 tons of concrete due to contamination found in the reactor sump area between the concrete and the steel liner
- 1.500 pieces of about 14 metric tons each had to be removed through wire-saw cutting
- Transportation, crushing, characterization and segregation, extended project duration by 3-year

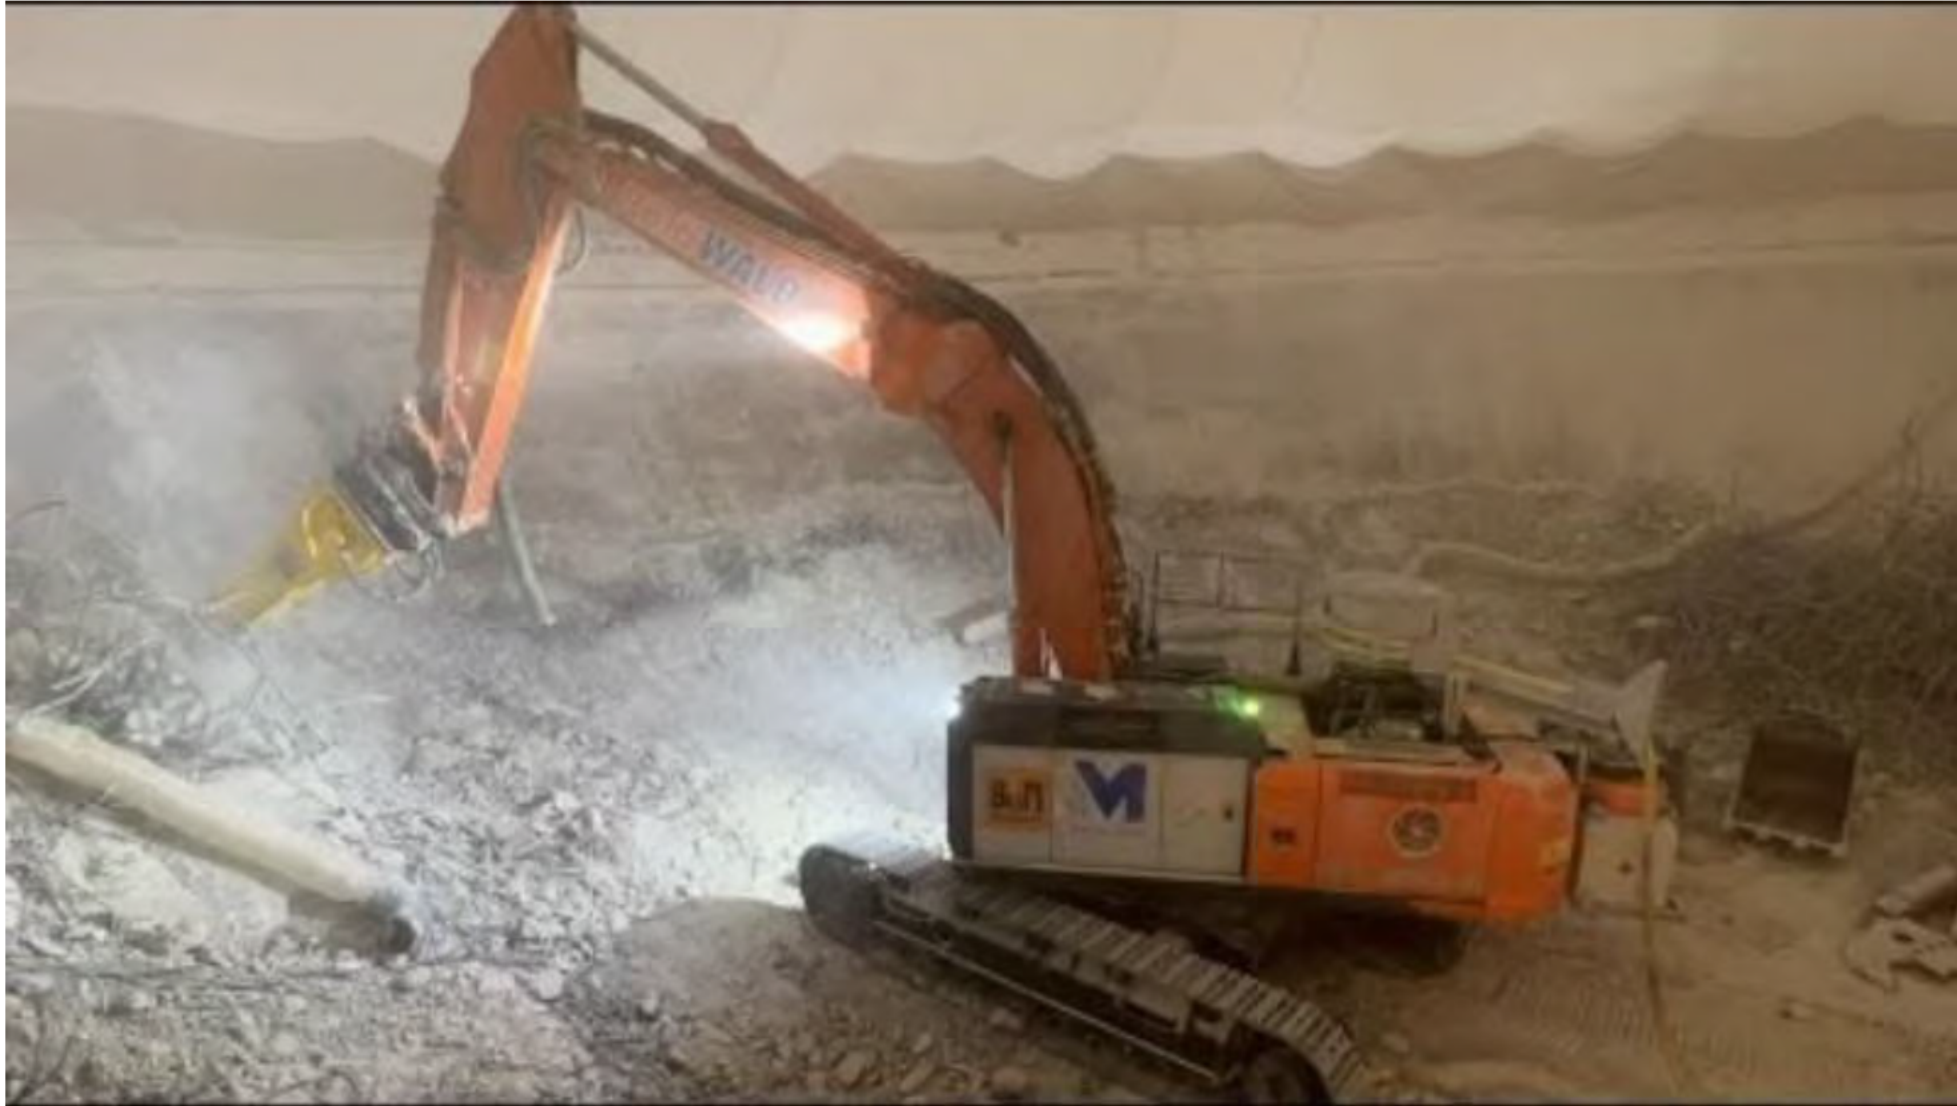
Cleanout of the Containment at Stade

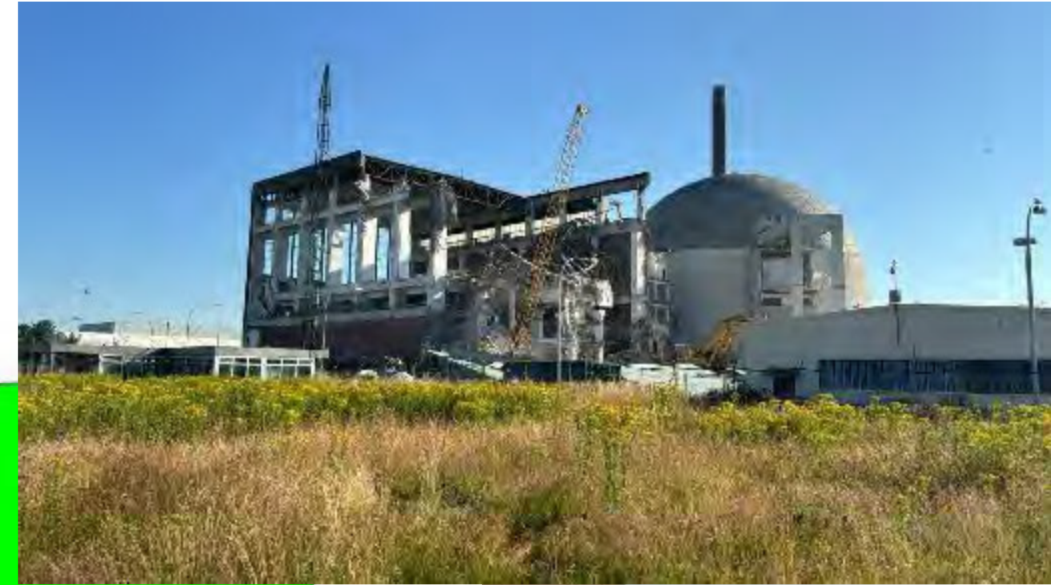
Total Initially Estimated Waste Volume* of NPP Stade

* Latest estimates show no significant changes of final Mass-%.

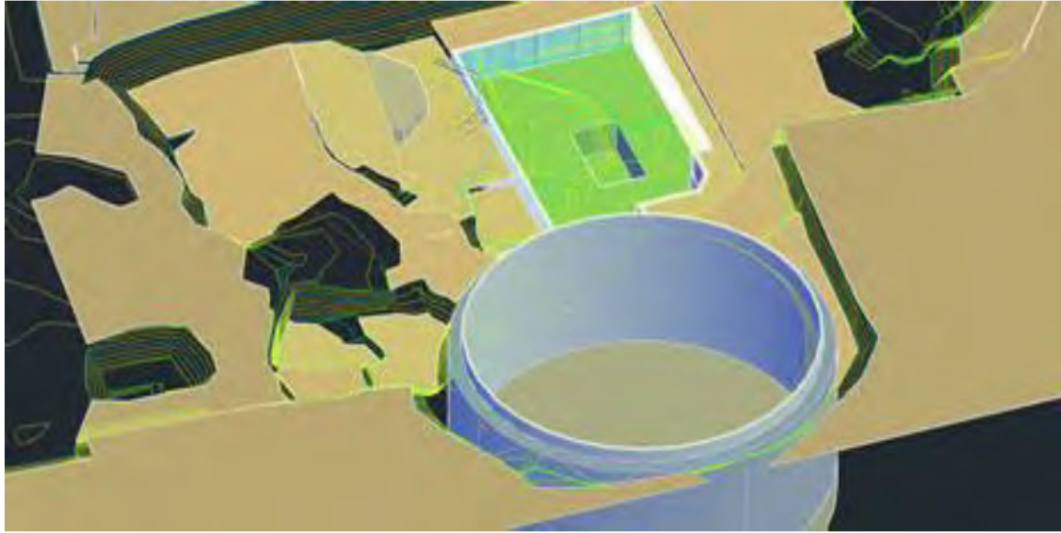
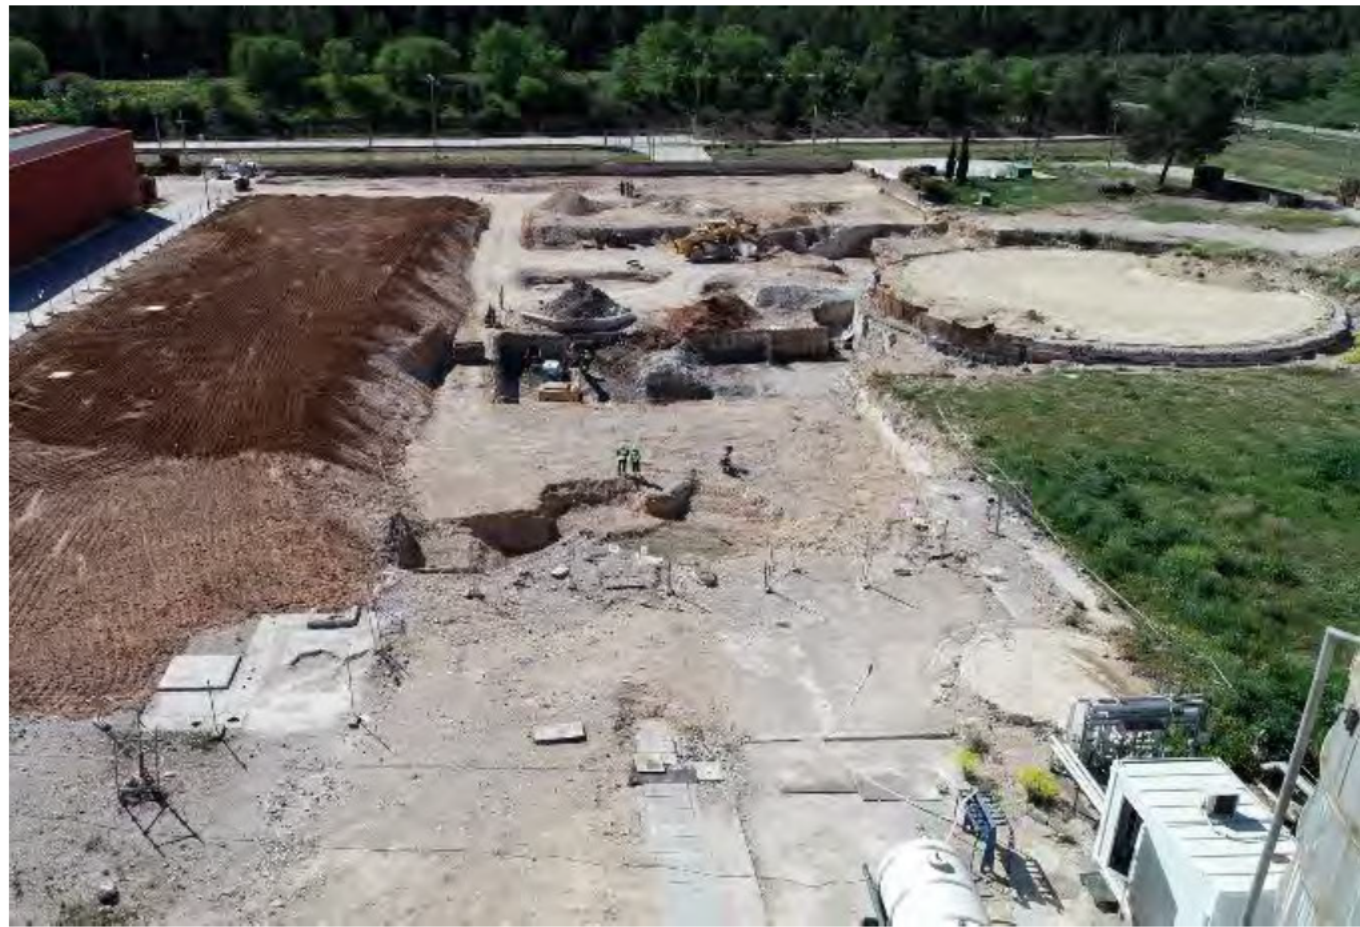
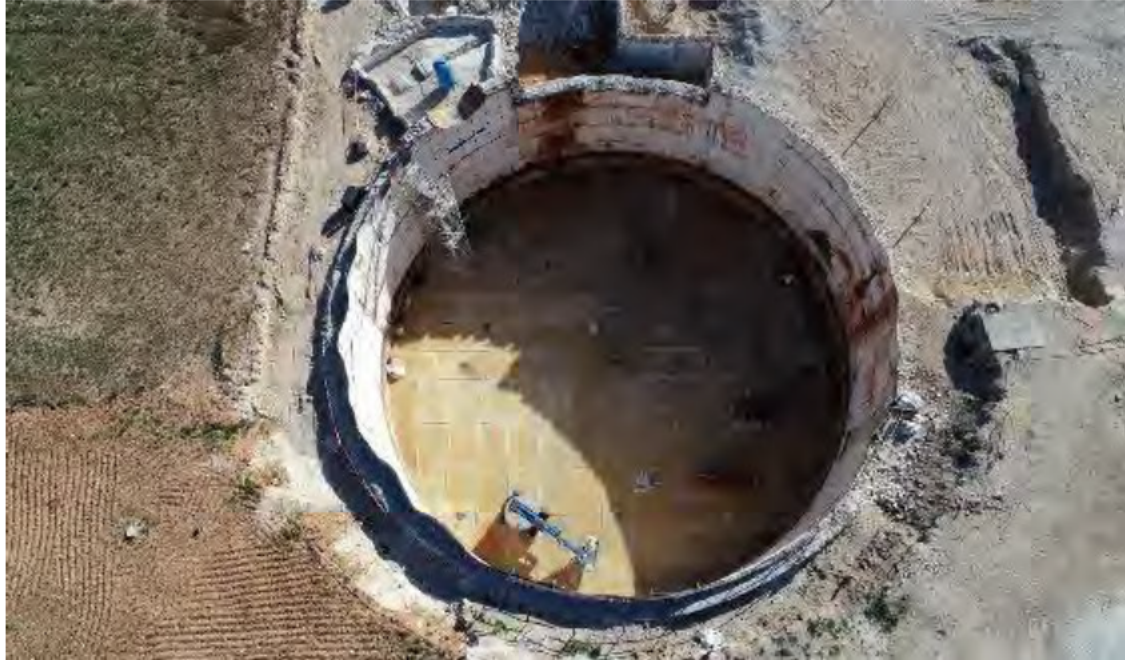
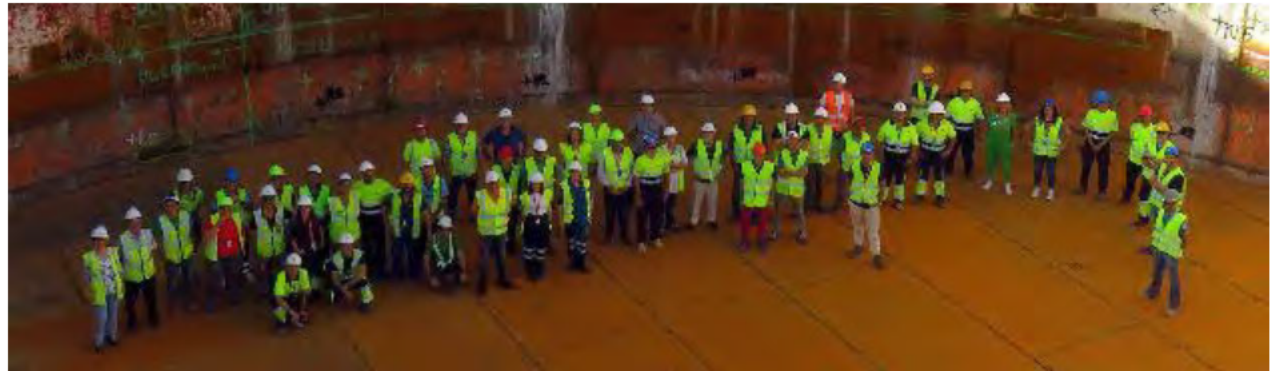
Site Restoration at CNJC
