Tube Support Plate Characterization with the Eddy Current Array (ECA) Technique

Annual NRC-Industry NDE Technical Information Exchange Meeting
Wednesday, January 22, 2025 – NRC Headquarters, Rockville, MD

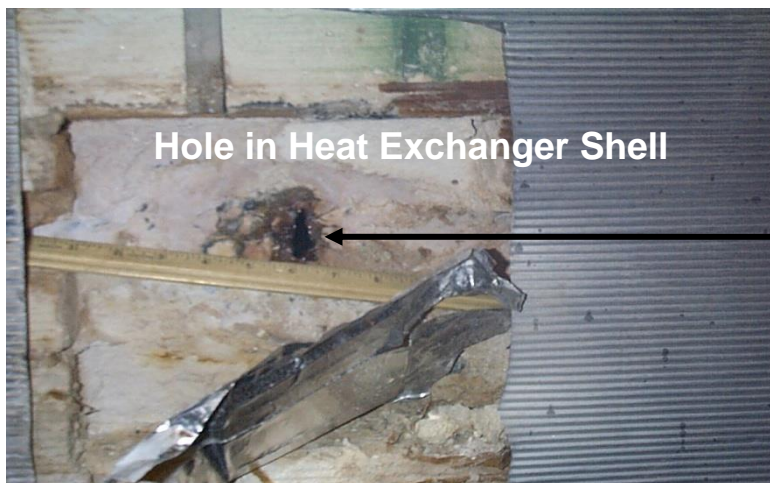
- Tube support plate (TSP) degradation occurs in feedwater heat exchangers.
- Bobbin coils can detect TSP damage but cannot characterize the extent of the damage in three critical areas;
 - **TSP Thinning**
 - **TSP Circumferential Loss**
 - **TSP Gap Opening**

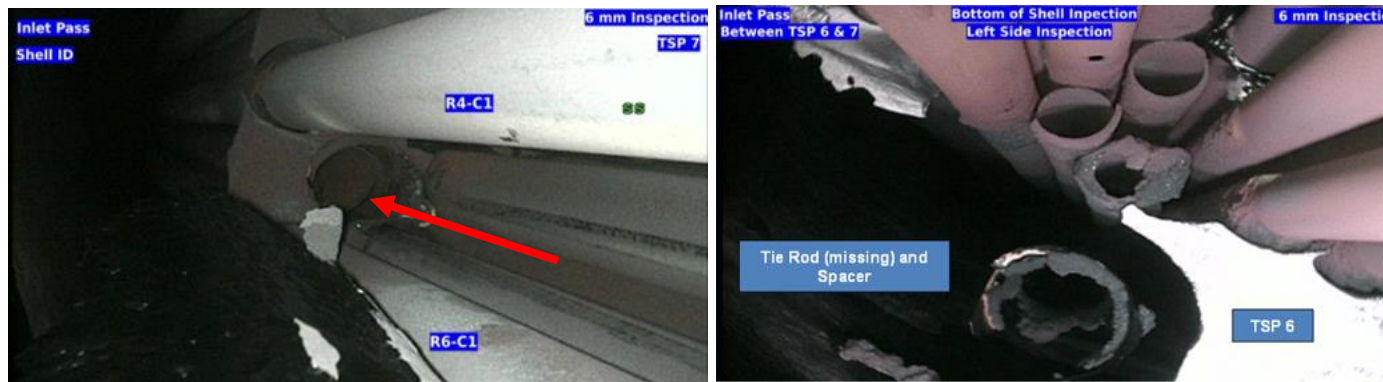
TSP Degradation

- TSP locations # 6 and #7 reflected on tube sheet map.
- Indications also found at other TSP locations.

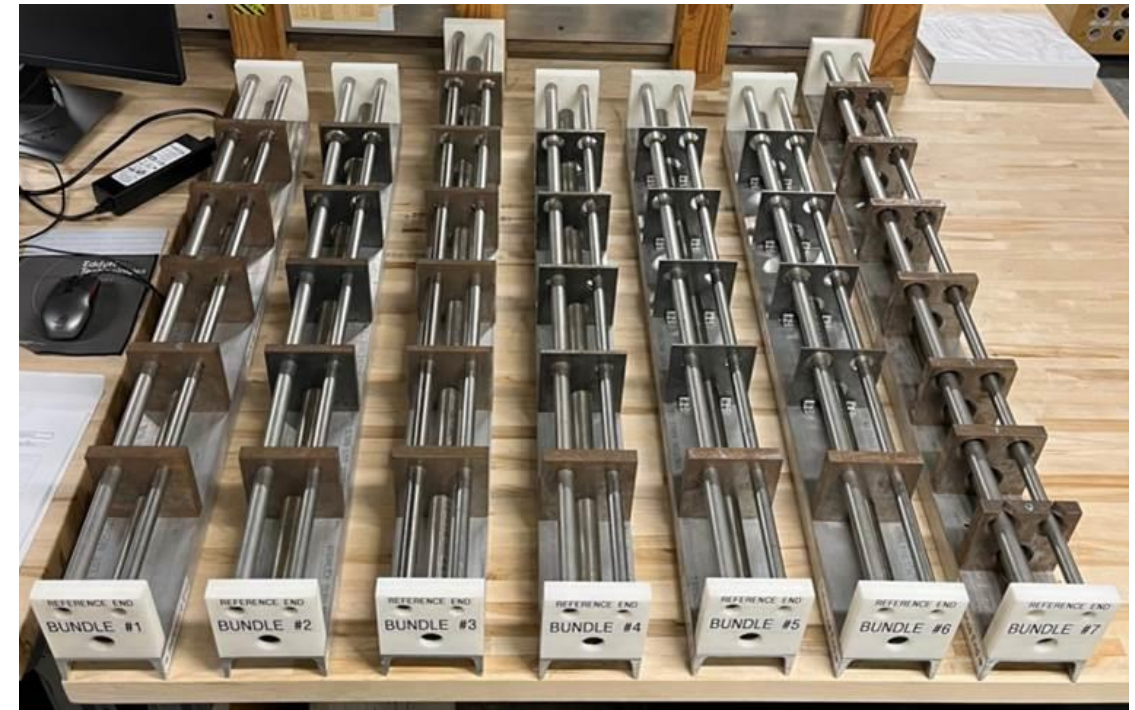
Mockups Used in the Research

- 7 mockups were fabricated.
- Mockups contain three different tube sizes set in varying levels of TSP degradation.
- Tubes include fabricated flaws: ASME pits, OD wear / thinning, OD axial and circumferential notches.
- A combination bobbin / array probe is used to investigate:
 - Tubing defects
 - TSP degradation (*Thinning, Circumferential Loss and Gap Opening*).

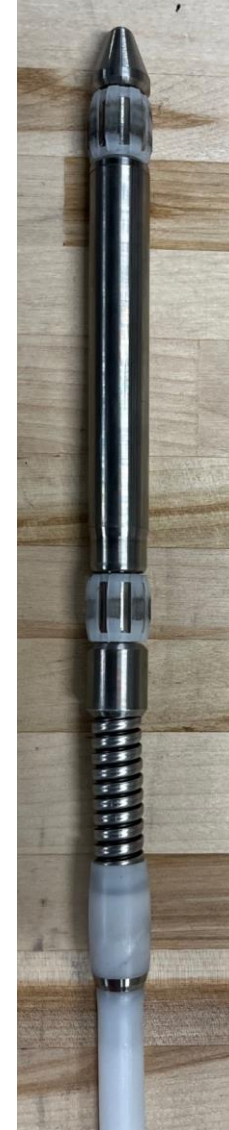
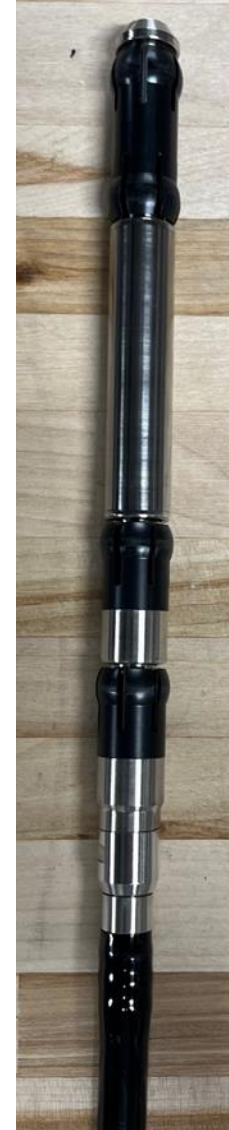
Eddy Current Array (ECA) Probes

Two ECA probes from different vendors were used to acquire data from the TSP mockups.

Each probe has three data channels:

- Bobbin Channel.
- Circ. Channel (sensitive to circumferential cracks).
- Axial Channel (sensitive to axial cracks).

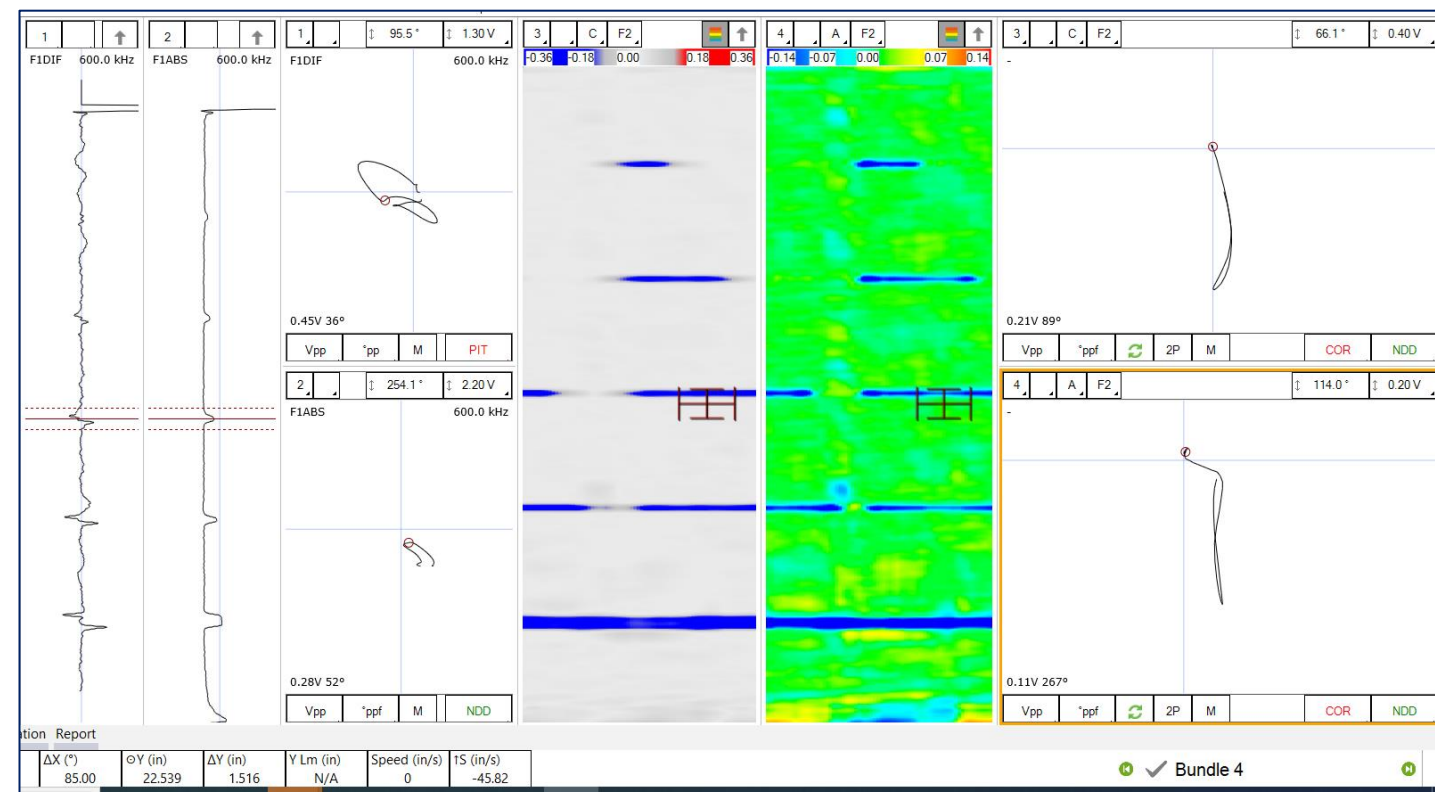
Detection and Measurement of TSP Thinning

Comparison of 0.625" and 0.250" TSP Width.

Two methods to measurement TSP thinning (encoded data or TSP amplitude-based calibration curve).

- Encoded data allows sizing of TSP thinning utilizing only the measurement cursor.
- Lissajous display utilized to characterize TSP thinning.
- Amplitude based sizing curve.

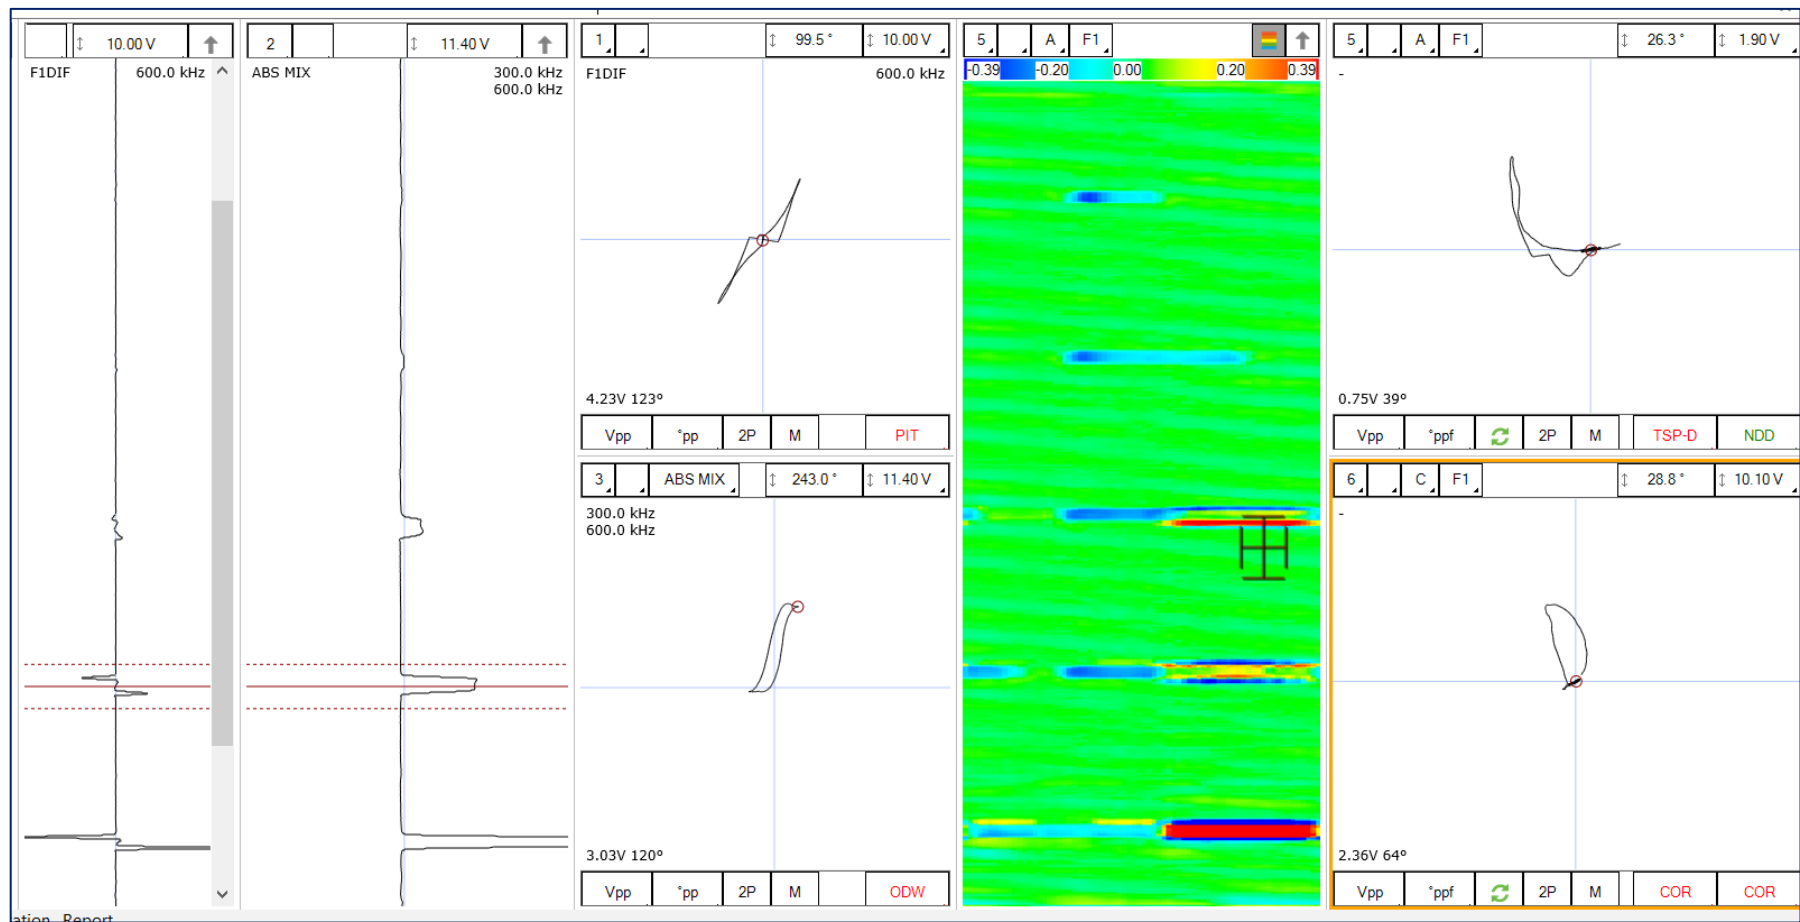
Detection of Tube Defects Under TSP

50% OD wear under TSP

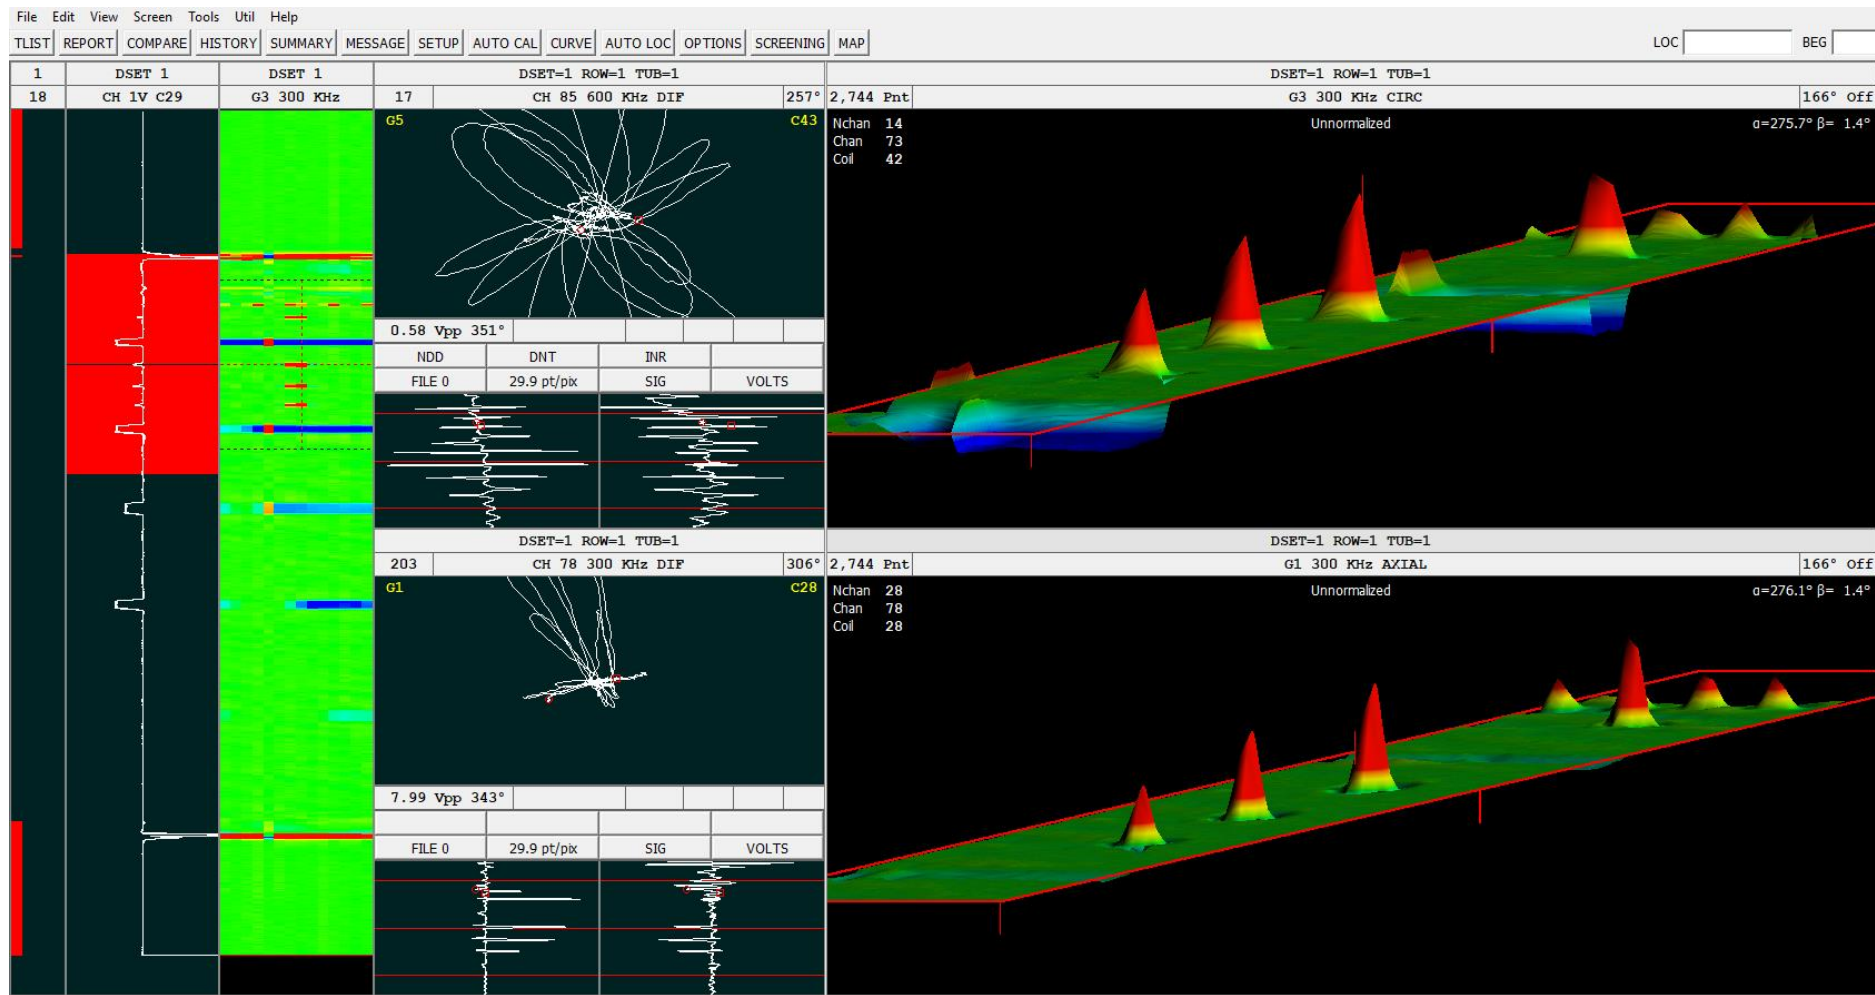
Detection of Tube Defects in Free Span Region (Probe 2)

ASME Type Standard Flaws in Circ and Axial Channels
