PNNL-SA-207447

# Nondestructive Examination of Electron Beam Welds for Nuclear Pressure Vessel Applications

2025 NDE Technical Information Exchange

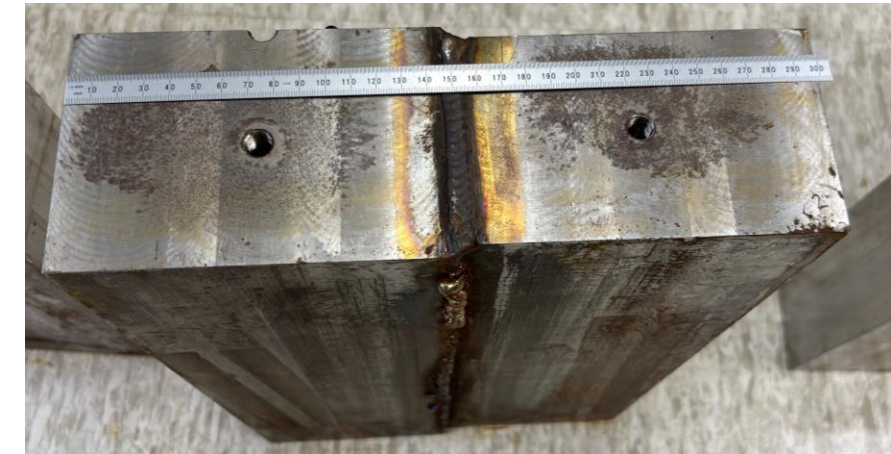
**Plate 1, as received. After the FMC scans, the plates were machined smooth to a uniform 90 mm thick**

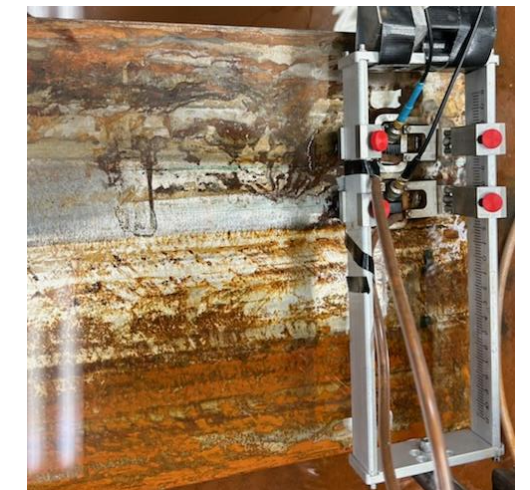
**Tandem setup**

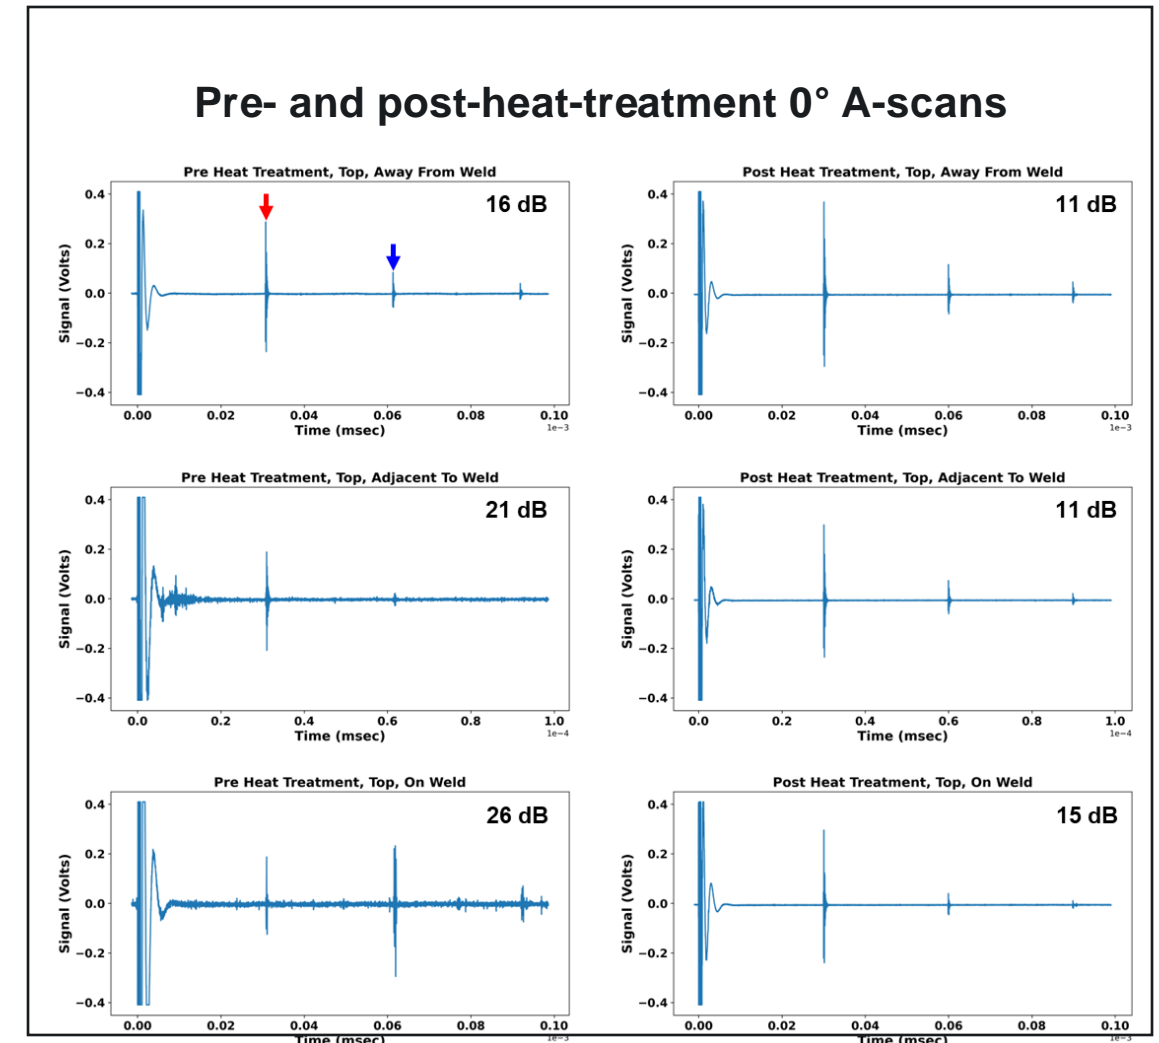
Pre (left) and post (right) heat treatment 0° A-scans taken away from the weld (top row), adjacent to the weld joint (middle row), and on the weld joint (bottom row). Attenuation measurements were made using the first two echoes (red and blue arrows; see the report).

- A section of mockup #1 (ideal weld parameters) was cut for heat treatment.
- Visual observation showed that the heat treatment changed the weld microstructure leaving a faint indication of the joint line.
- Pre- and post-heat-treatment 0° pulse-echo UT was performed.
- Results showed that the weld zone was less attenuative after heat treatment.
- Heat treatment was shown to improve ultrasonic transmission through the weld.

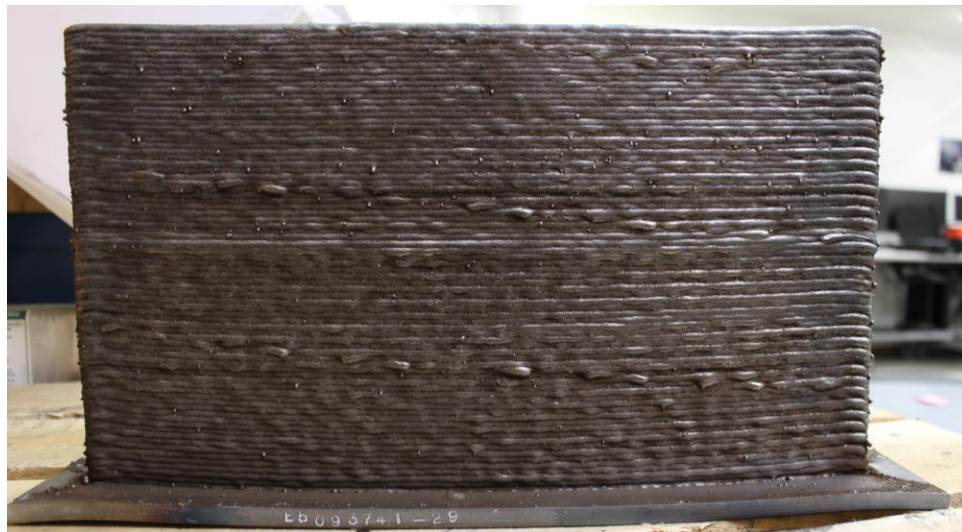
316 LSi Plate,  $\approx 16 \times 9 \times 1$  inch  
Additional 316LSi, mild steel, and Inconel 625 samples were received from Lincoln Electric.

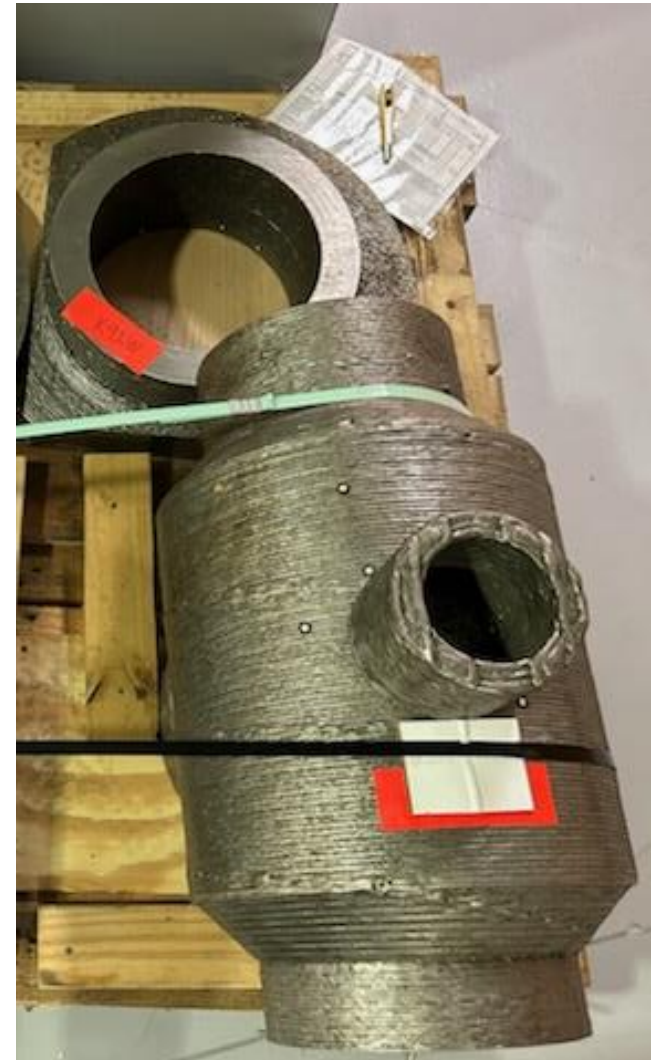
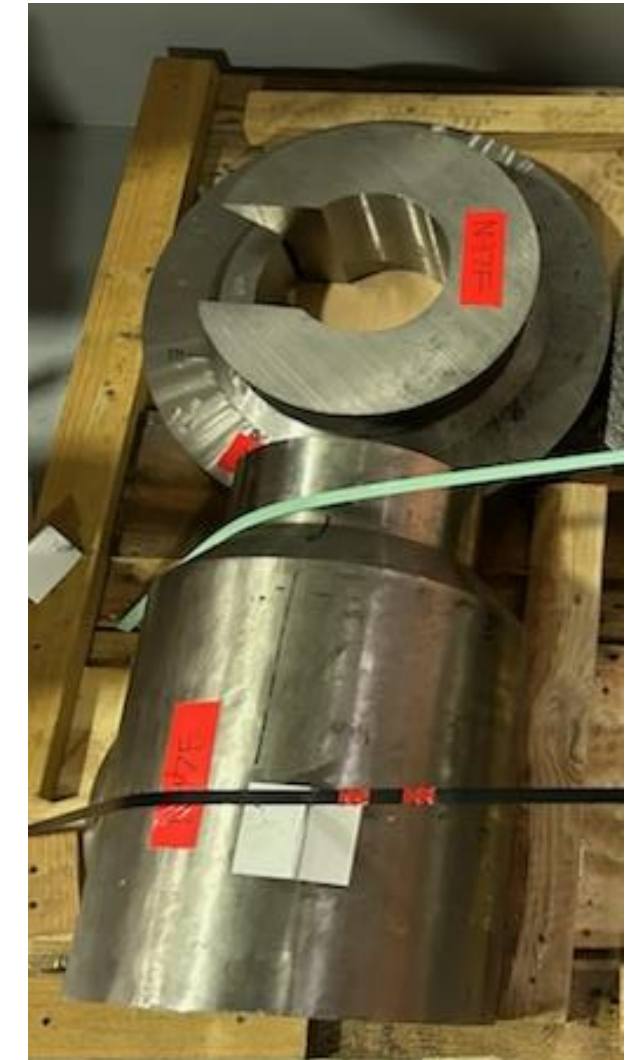
316 LSi valve bodies (up to  $\approx 4$  inch thick)  
Both have been heat treated, one was surface finished. Both have had sections cut out to test mechanical properties (work done by EPRI).

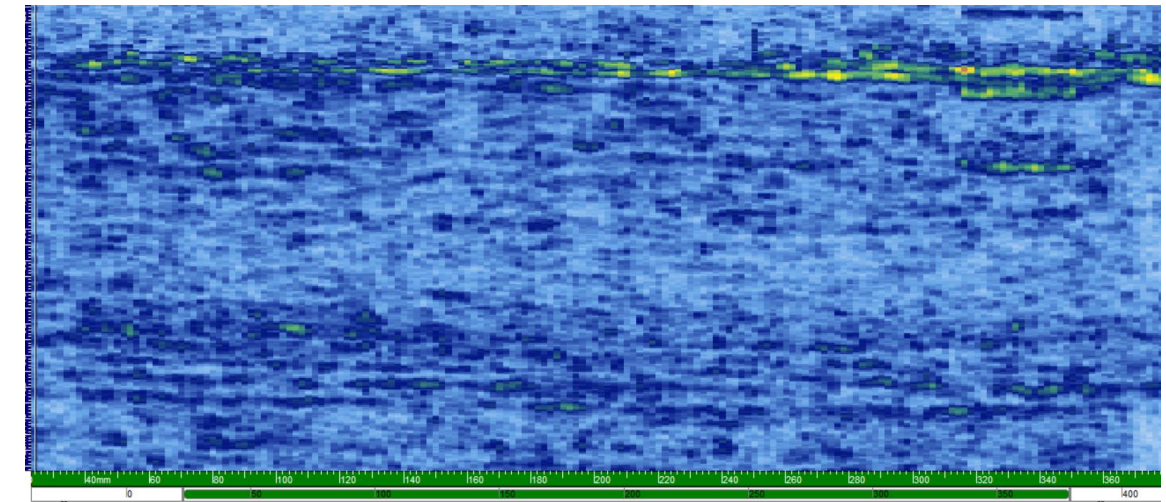
Scan from bottom of plate (full-V), 45°

- The notches were not clearly resolved in the full-V scans.
- Notch echoes observed from the top of the plate were often direct echoes from the notch tops and were not corner echoes.
- The weld pattern is apparent in the 30° scan even though the plate was machined smooth.

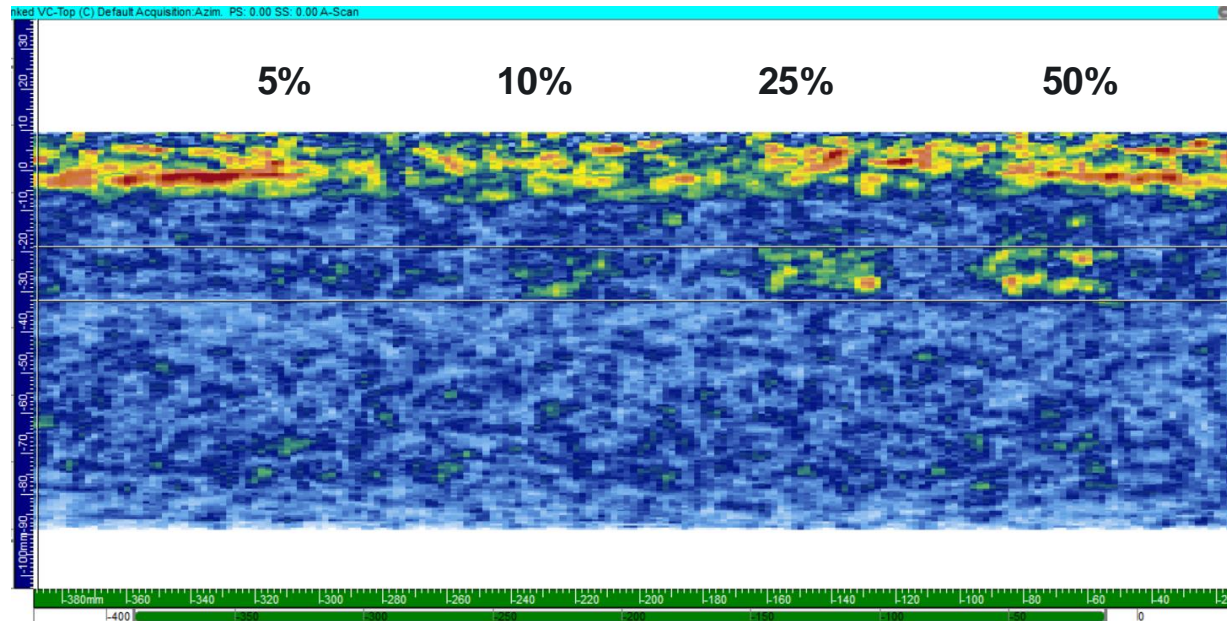
Scan from top of plate (1/2-V), longitudinal

- The notches were not clearly resolved in the full-V or the shear scans.
- Notch echoes observed from the top of the plate were often direct echoes from the notch tops and were not corner echoes.

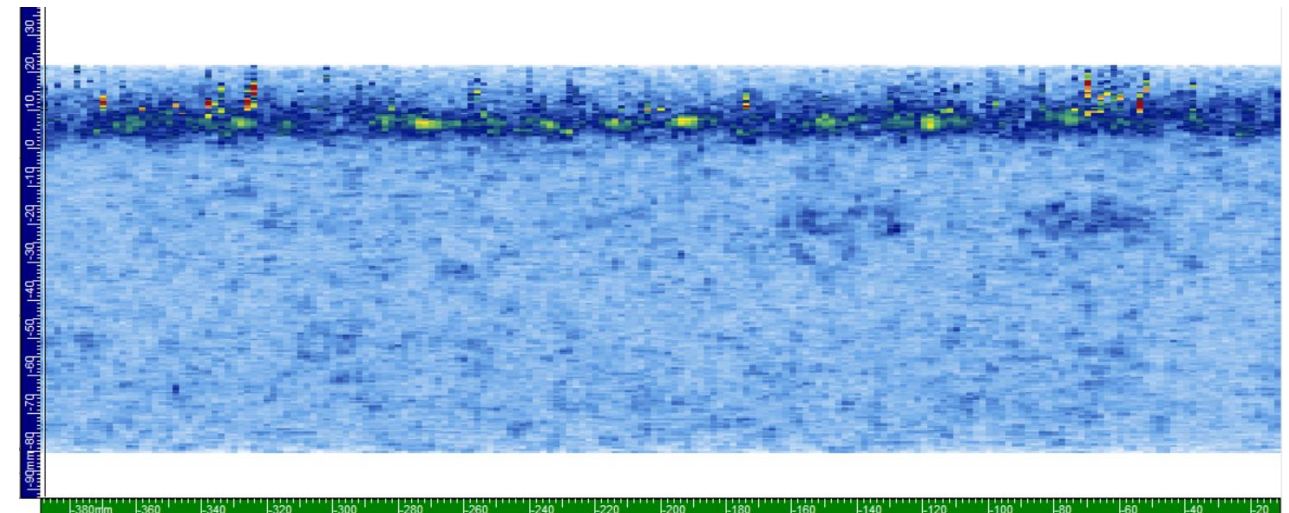
Scan from top of plate (1/2-V), shear
