Steam Generator Task Force Meeting

March 6, 2025

**EPRI Study on Significance of International Experience
with SG Tube Wear Caused by Deposits
Jim Benson**

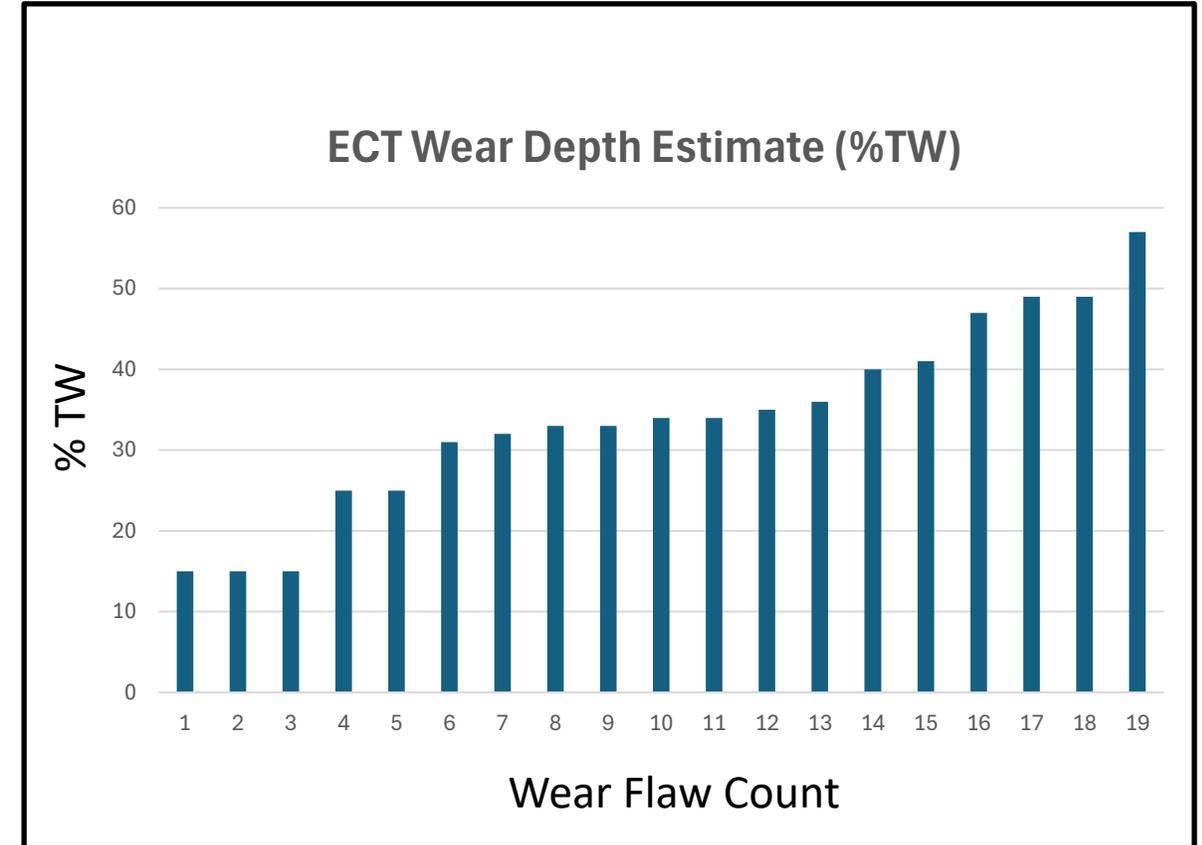
Tube Wear Believed to be from Flaked-Off SG Tube Deposits

Unit	Periodic Outage	SG	TSP*	Leg	ECT Wear Depth (%TW)
4	23	A	3		33
4	23	C	3		25
4	23	C	3		32
4	23	C	3		36
4	24	A	4	C	47
4	24	A	4	C	25
4	24	A	4	C	<20
4	24	A	3	C	33
4	24	A	3	C	40
4	24	B	4	C	49
4	24	B	3	C	<20
4	24	C	4	C	34
4	24	C	4	C	31
4	24	C	3	C	49
4	24	C	3	C	35
4	24	C	3	C	34
3	25	A	4	C	57
3	25	A	3	C	<20
3	25	B	2	H	41

* - Indications located adjacent to TSP

Note: For <20%TW indications, 15 %TW was used in this plot

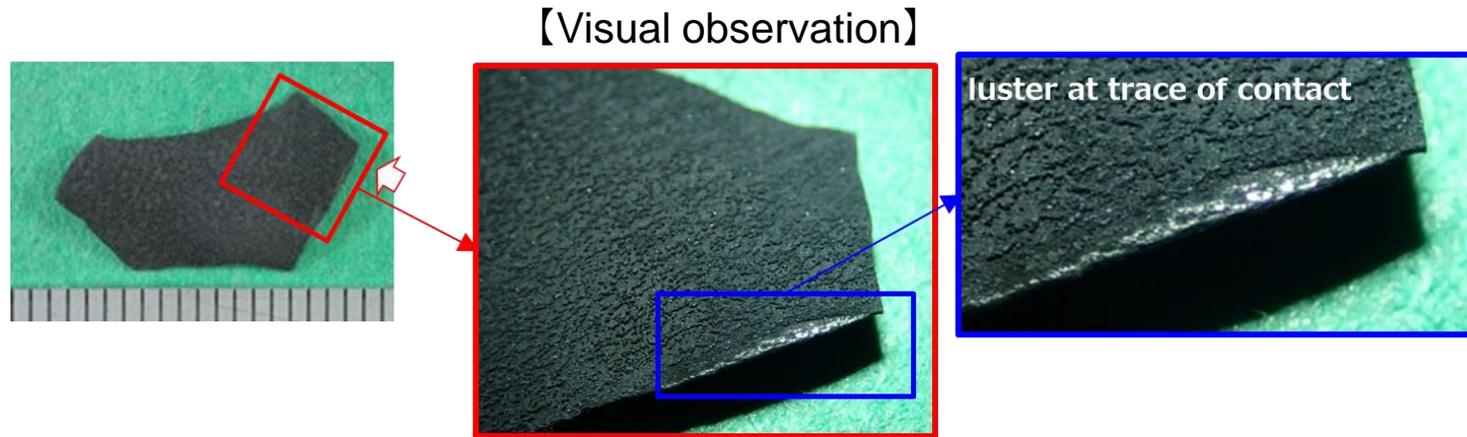
Wear Investigation (Unit 4: 24th RFO)

- Scale presumed to have caused wear was identified from samples retrieved from SG-A and SG-B. (Below figure shows scale retrieved from SG-A)
 - Area of contact with the tube was observed.
 - Components at contact area constitute the tube base material

- The application of chemical cleaning is being performed to prevent the recurrence of tube scale resulting in tube wear by making dense deposit flakes more porous
- To monitor scale buildup, it is planned to retrieve scale during every periodic outage to verify the thickness of dense scale layers and to perform wear tests on the removed scale
- Chemical cleaning application is planned if the thickness of dense scale layers exceed a predetermined limit (e.g., 0.1mm)

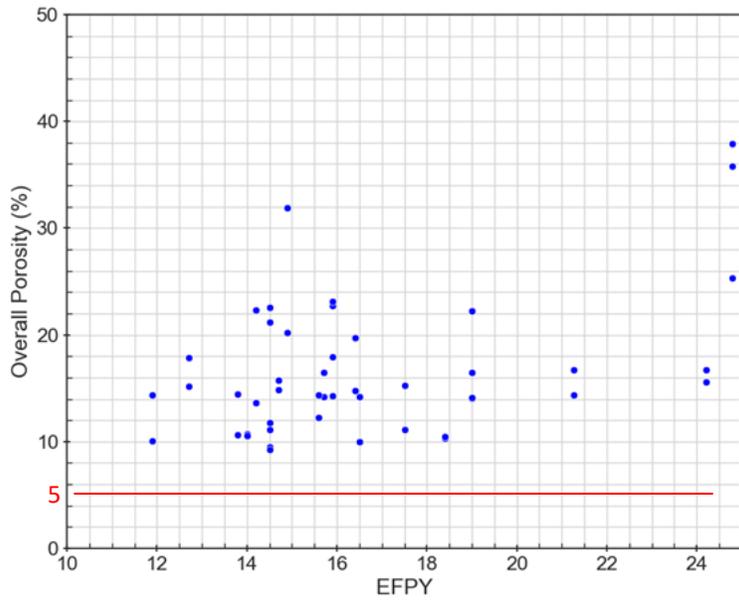
Porosity as a Function of Operating Time

- Flakes represent 15 different units

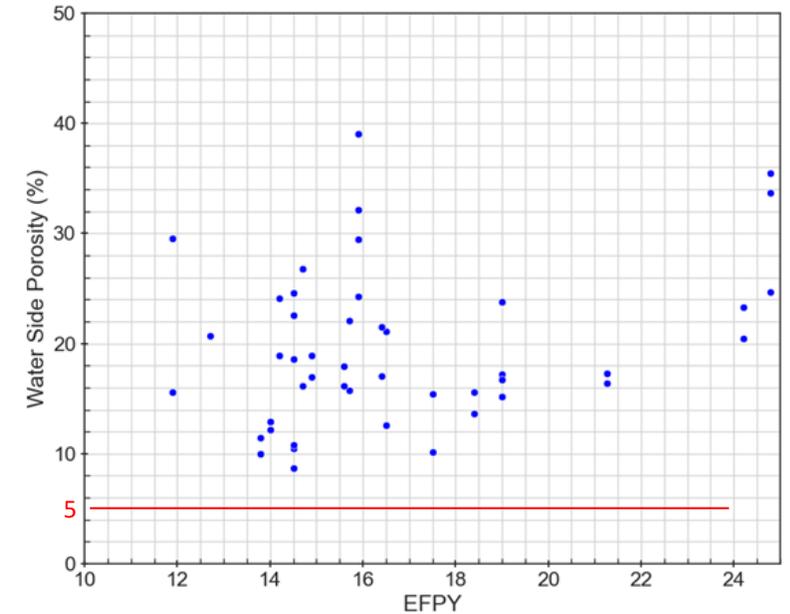
Tube Side Porosity

[Mode = 12%]

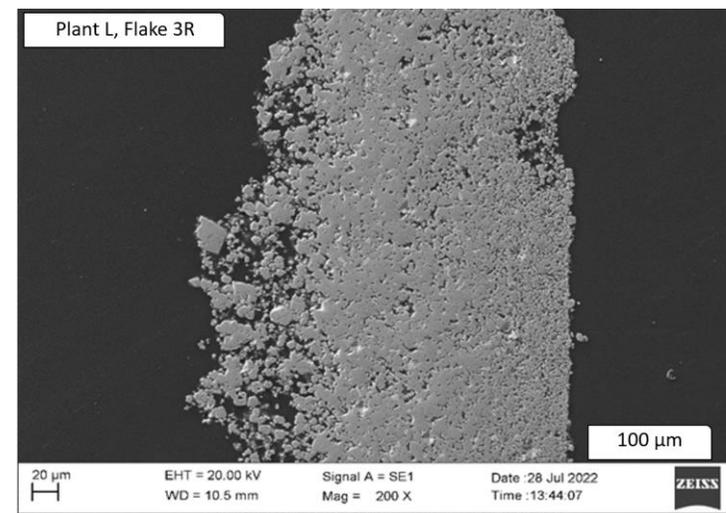
Comparison of EPRI Flake Examination Results to Utility Criterion for Potential Wear

- Of the 65 flakes examined 3 flakes had porosity values of $\leq 5\%$.
- Only 1 of the 3 flakes exceeded the utility criterion containing a dense region of ≥ 0.1 mm (100 μ m) thick:
 - **Plant I, Flake 2** was < 100 μ m total thickness, so it does not meet the utility criterion.
 - **Plant M, Flake 4** was 100 μ m total thickness, but it was not dense over the total thickness.
 - **Plant L, Flake 3R** was about 200 μ m in total thickness and was dense in about two thirds of the thickness, so it met the utility criterion.

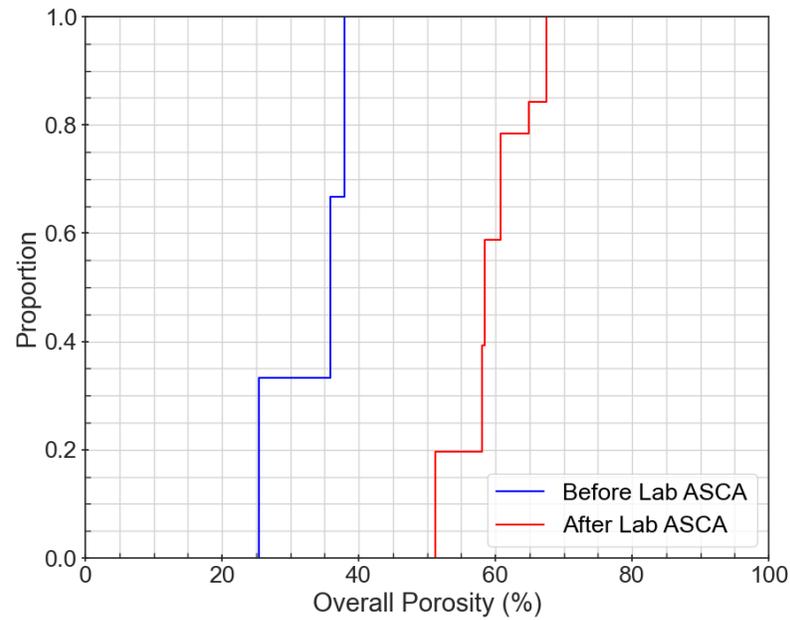
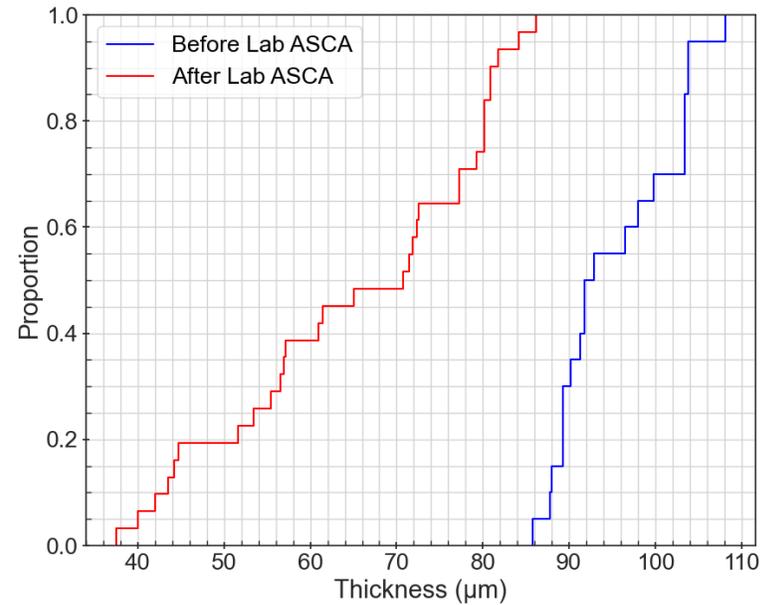
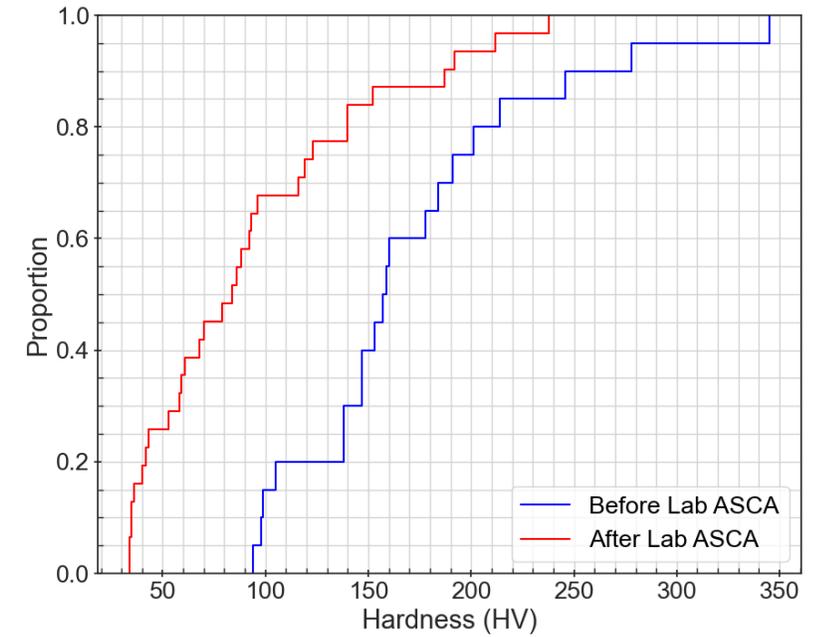
Change in Flake Attributes Following Chemical Cleaning Processes (Plant O)

Effect of Chemical Cleaning

- A possible action to mitigate the risk of tube scale fretting wear of steam generator tubes is chemical cleaning to increase the porosity of the scale.
- In 4 of 5 plants in the EPRI study, there was an increase in flake porosity following chemical cleaning.

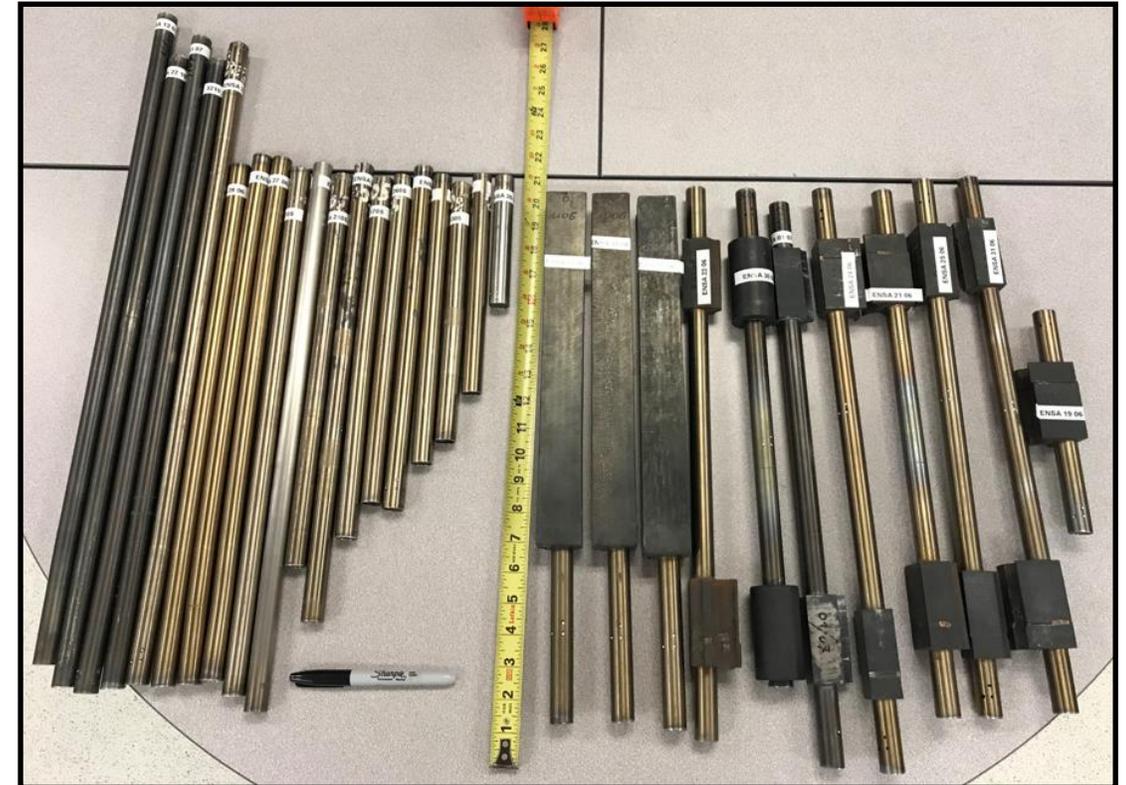
Samples Destructively Analyzed to Support ETSS Development and MAPOD Calculations - Lab Cracks Available

- Destructive analysis lab finalized report on 12 Axial PWSCC and 17 Circumferential ODSCC samples
 - Reports provided to NRC
 - Completed phases of ETSS development:
 - SGMP QA process on Metallurgical report
 - Flaw injection process including eddy current analysis of data
 - Tube integrity analysis
- Destructive analysis of Circumferential PWSCC samples ongoing, scheduled for completion this summer
- Dominion Engineering cracks fabrication
 - Destructive analysis on Axial ODSCC samples completed and report provided to NRC
 - 26 cracks ranging from 20% - 100% TW
 - Axial PWSCC and Circumferential ODSCC flaw development ongoing
