U.S. PWR Core Barrel Specimens Laboratory Evaluation

EPRI-Funded Work Scope

Laboratory Examination and Testing of 2 Core Drill Specimens (Indication #3 and Tip of Indication #4)

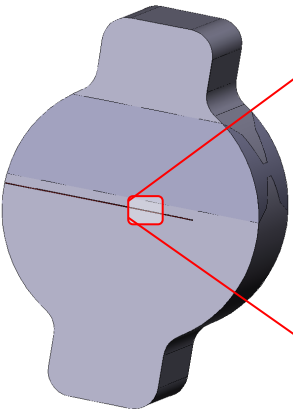
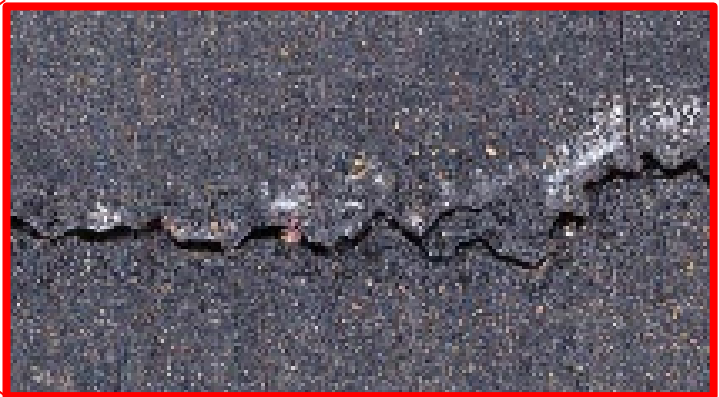
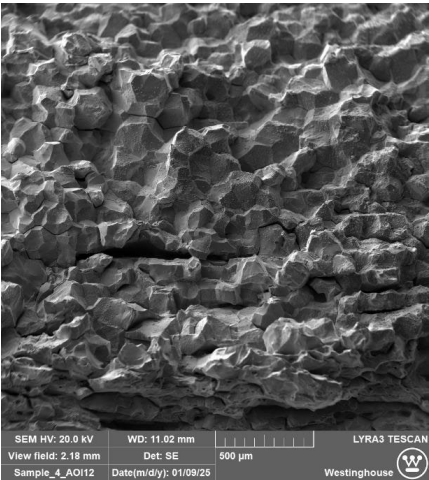
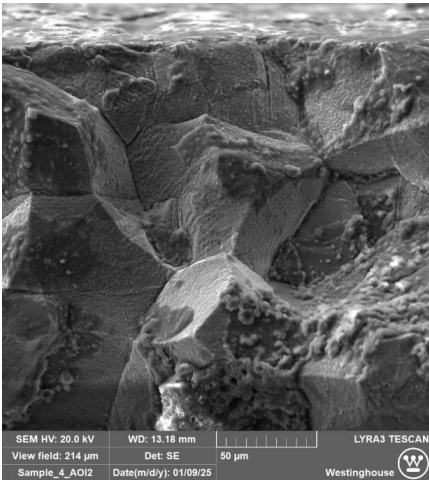
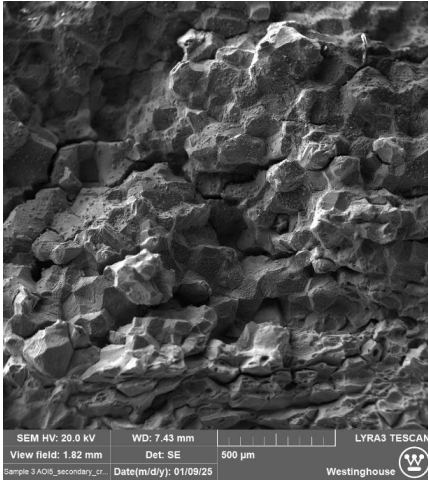
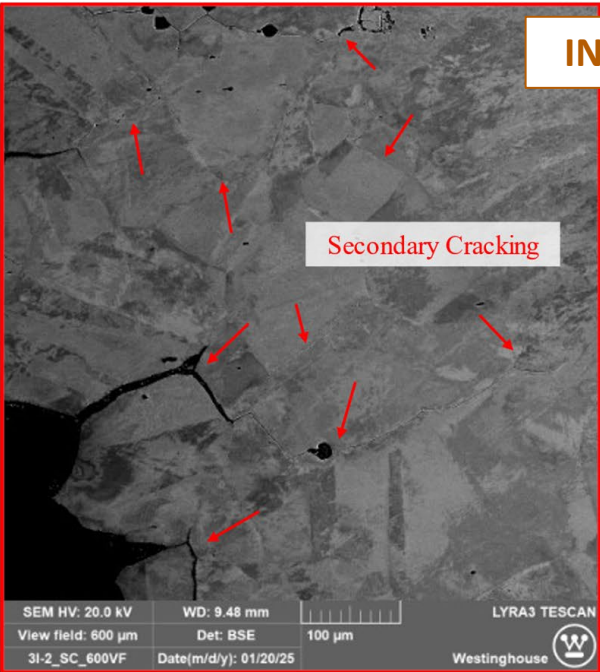
Fractography, Metallography, Microscopy

Intergranular mode of cracking, indicative of stress corrosion cracking, on all fracture faces

- **Degradation Mode**: Intergranular cracking is observed throughout the crack surface of both indications. Intergranular stress corrosion cracking (IGSCC) is the only mechanism observed.

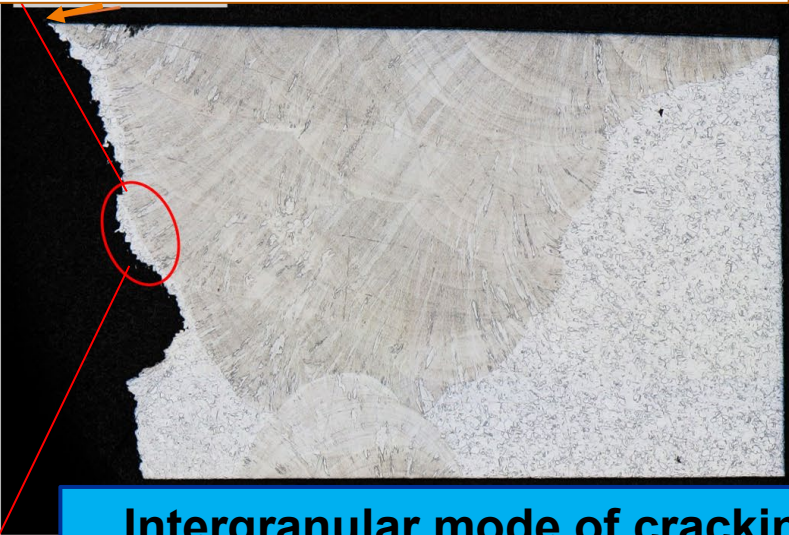
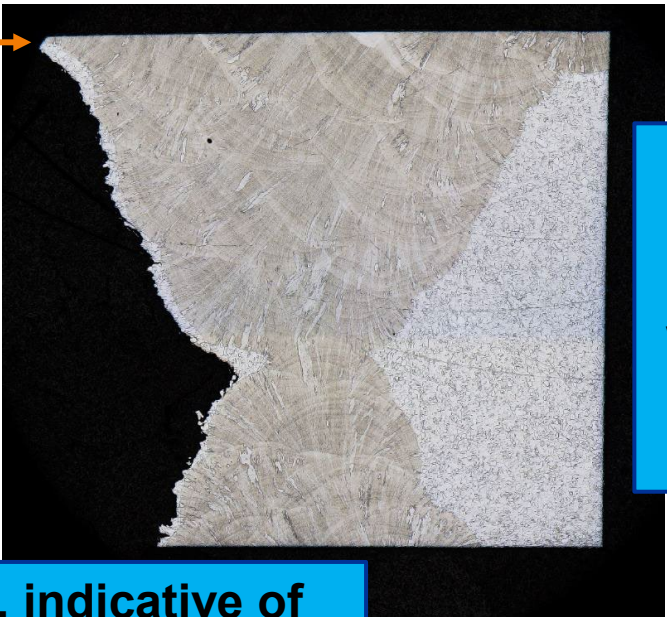
INITIATION IN THE HEAT AFFECTED ZONE (HAZ)

Crack path confined to base metal, within HAZ of the upper girth weld

- **Contributing (or Unique) Factors**:
 - IGSCC is confined to the HAZ of middle core barrel shell
 - No indication of weld repairs in the vicinity of the cracks
 - Typical carbon and sulfur levels measured for Type 304 stainless steel of this vintage
 - ASTM A262 Practice A indicates some “suspect” microstructures present in samples, notably HAZs.
 - “Suspect” is language from A262 specification, meaning HAZ is *potentially sensitized*
 - Microstructure otherwise seems typical for base metal and weld metal
 - Moderately elevated hardness in some regions (notable near root pass), but not so high as to be a significant contributor to initiation
 - Irradiation damage is not a contributing factor to the degradation

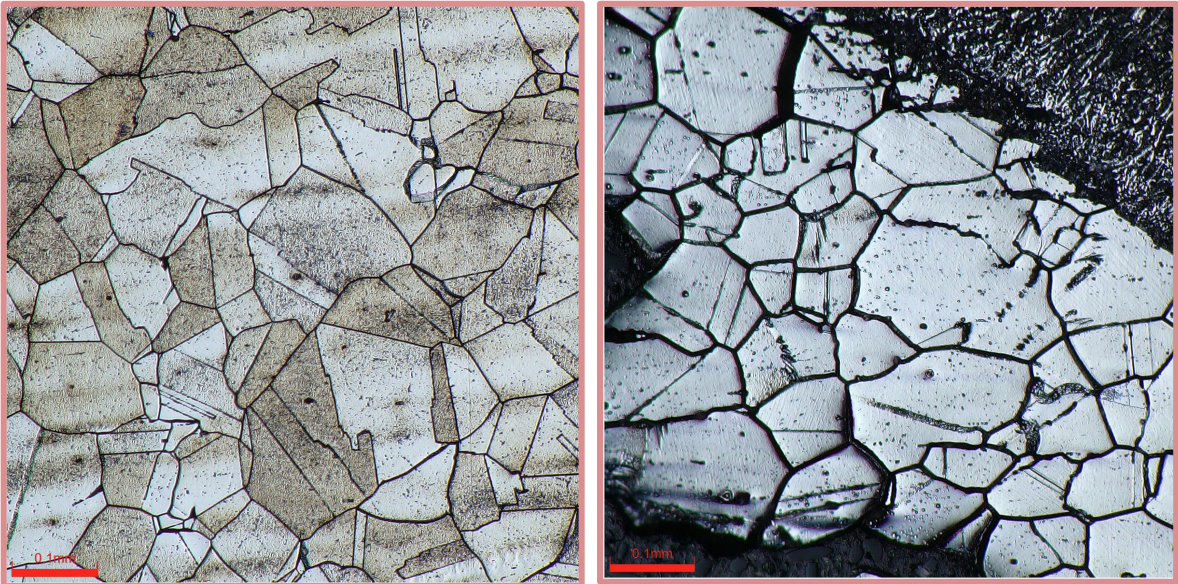
ASTM A262 Practice A Testing

- Middle cylinder plate
 - Base metal – Not sensitized (left image)
 - HAZ – Potentially sensitized (right image)
- Upper cylinder plate
 - Base metal – Potentially sensitized
 - HAZ – Potentially sensitized

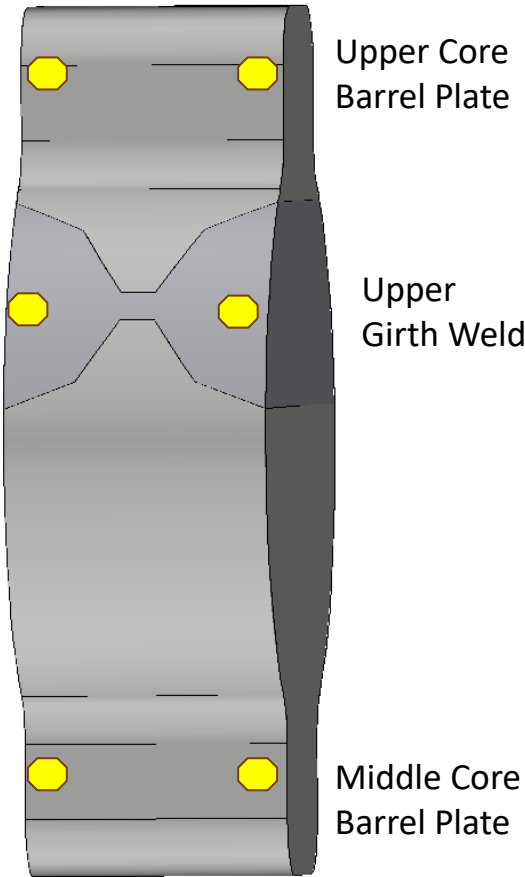
Retrospective Dosimetry Analysis

- One sample from each respective location in each Core Sample, both on ID and OD.
- Chemistry quantification supported by X-ray Fluorescence (XRF)

With irradiation damage less than 0.002 dpa, irradiation effects are considered insignificant with respect to the degradation observed
