NDE of Novel Repair/Replacement Materials

Update: 2026 NRC-EPRI TIE

George D. Connolly Engineer, EPRI, Inc.
Luke Breon Senior Technical Leader, EPRI, Inc.

21 January **2026**

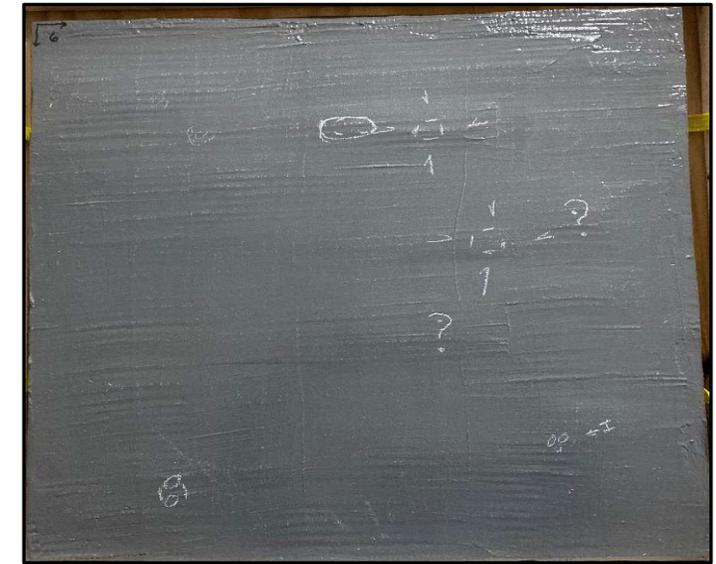
Example plate mockup from the first set

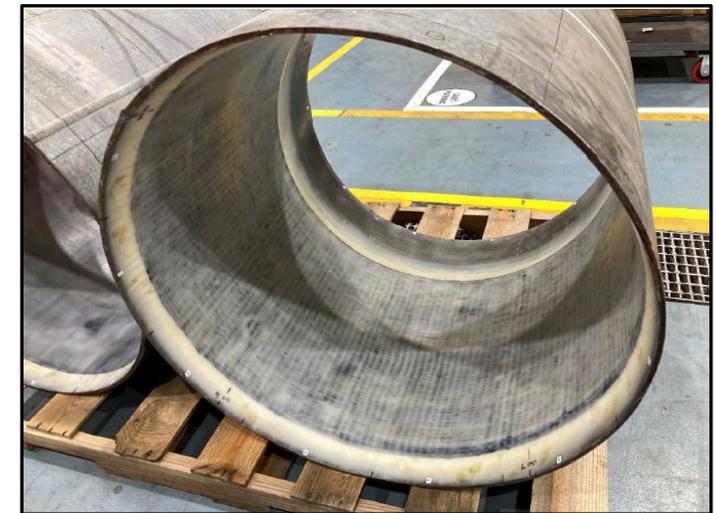
Example pipe mockup from the second set

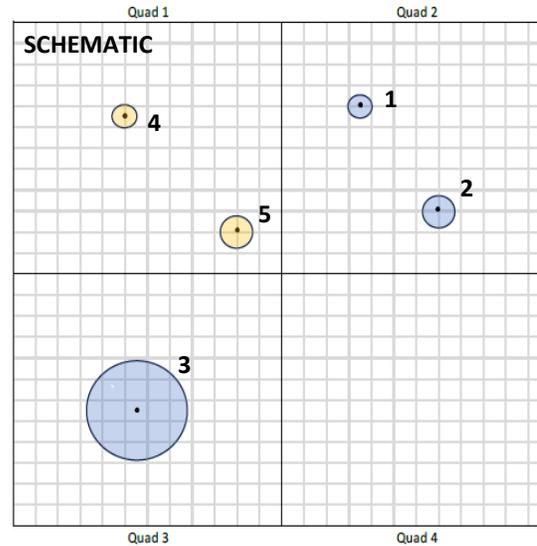
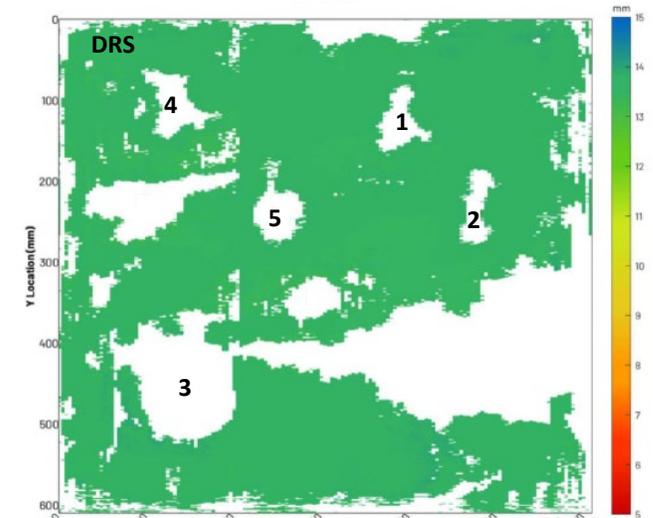
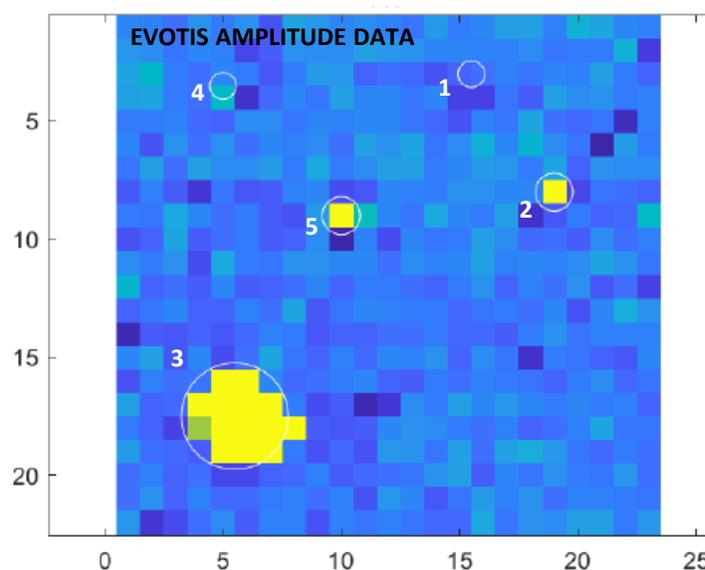
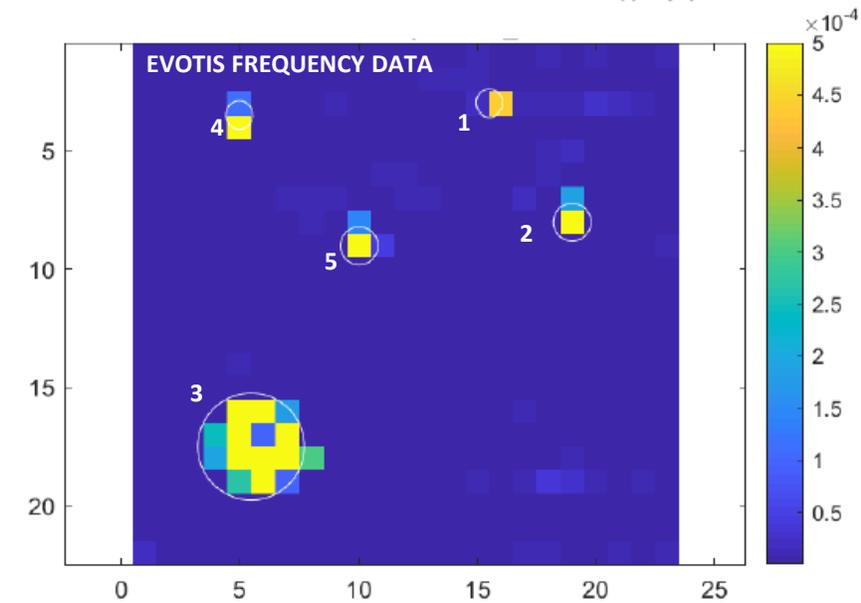
Results from single layer mockup: Tap testing and DRS

■ Structure:

- One layer of CF 2339
- One layer of FG 1210
- Thick epoxy topcoat approx. 0.125 in.

■ DRS identified additional four flaws

■ Successful detection by all applied NDE methods including conventional UT (next slide)

Schematic legend: First interface (yellow); base (blue)

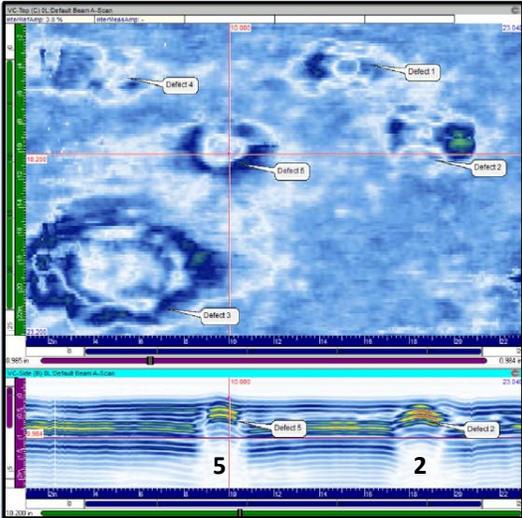
Immersion, 0.5 MHz/1''C, NF

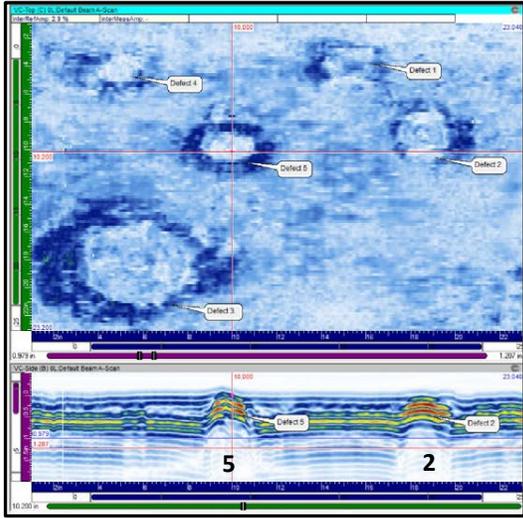
Immersion, 0.5 MHz/1''C, 1.5S

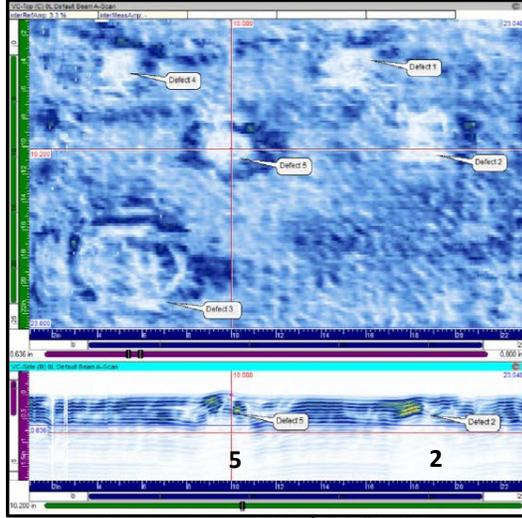
Immersion, 1 MHz/0.75''C, NF

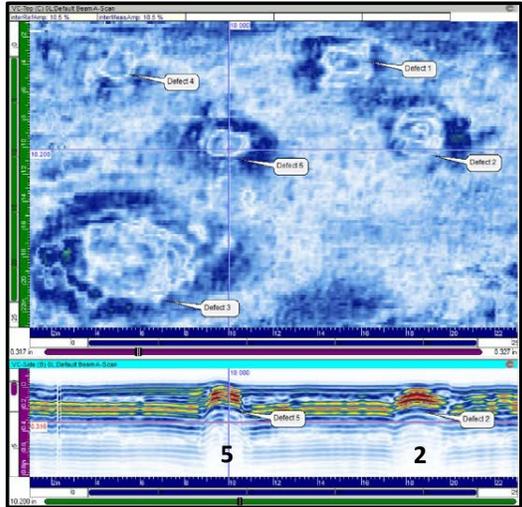
Immersion, 0.5 MHz/1''C, 1.5C

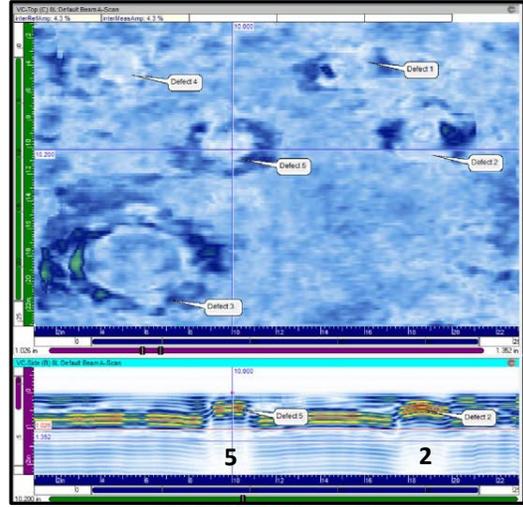
Contact, 0.5 MHz/1''C, NF

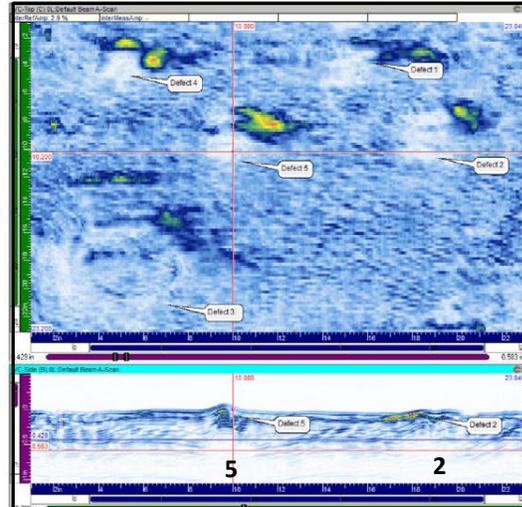
Immersion, 2.25 MHz/0.75''C, NF

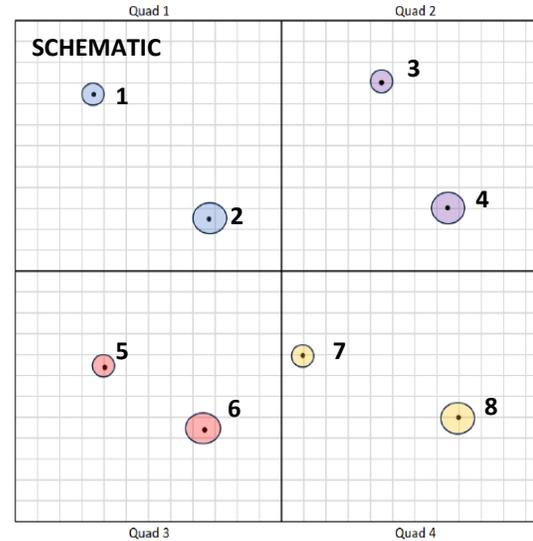
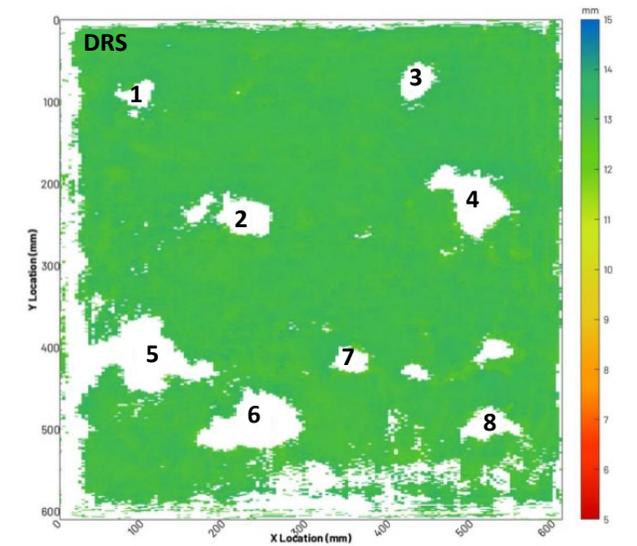
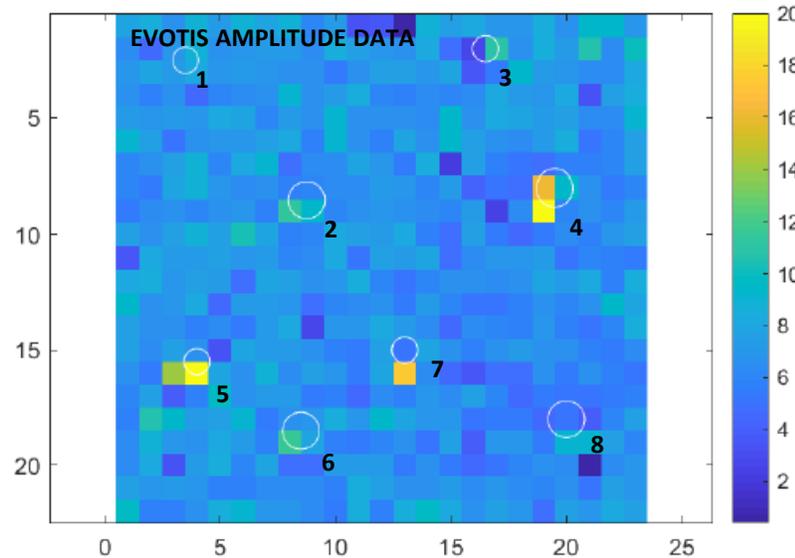
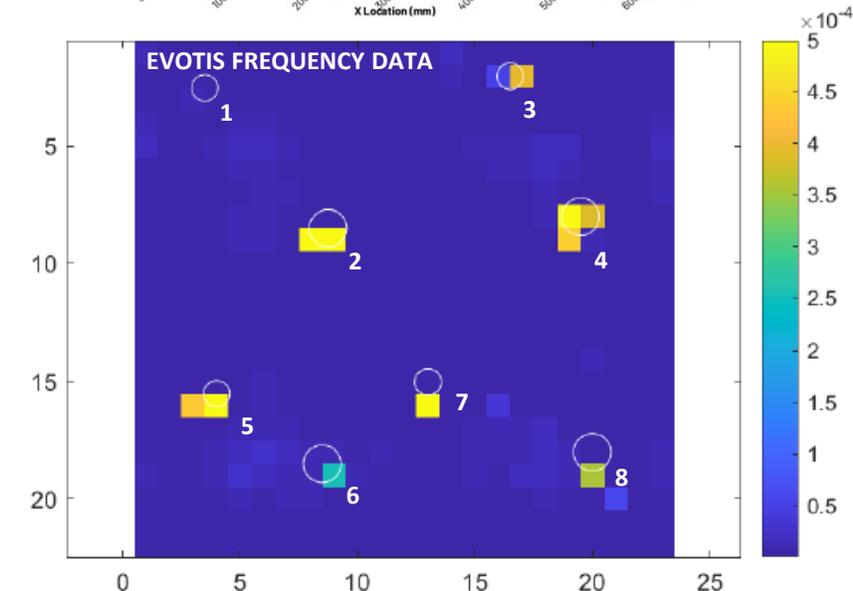
Results from multi-layer mockup: Tap testing and DRS

■ Structure:

- Five CF 2339 layers
- No FG 1210
- Thin epoxy topcoat approx. 0.050 in.

■ DRS shows successful detection of all flaws albeit with two additional flaws

- Electronic tap testing detects all flaws except the first
- Regardless of probe type, UT detection found to be more challenging (next slide)

Schematic legend: First interface (yellow); second interface (purple); third interface (pink); base (blue)

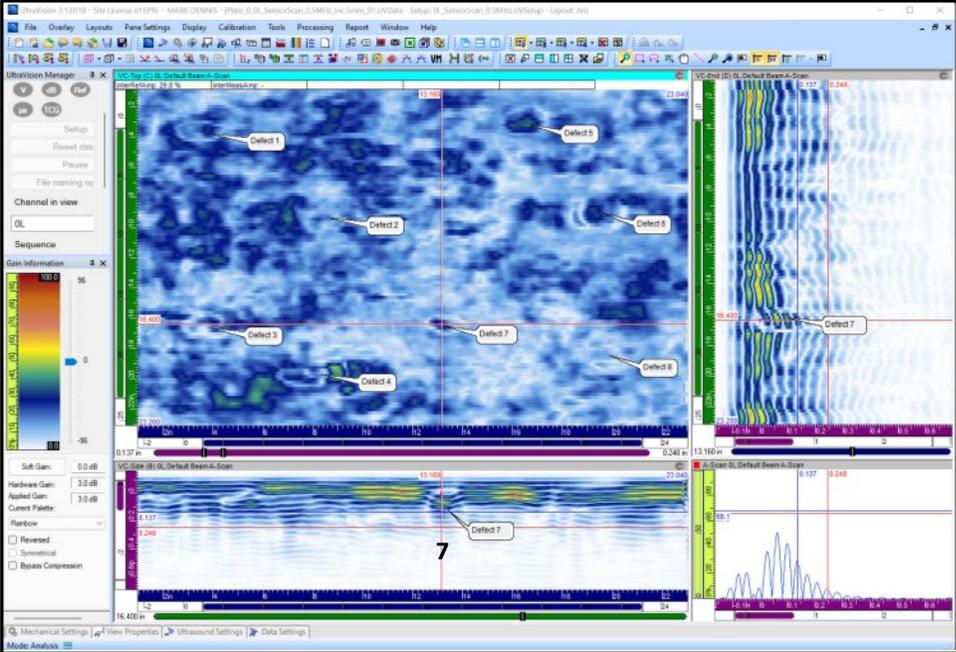
Contact, 0.5 MHz/1" C, NF

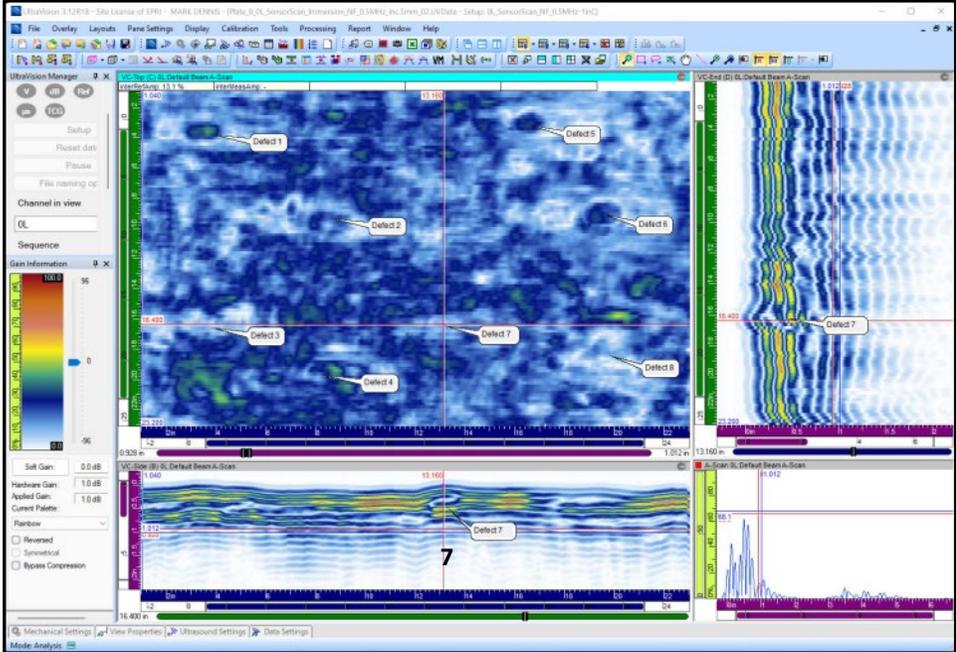
Immersion, 0.5 MHz/1" C, NF

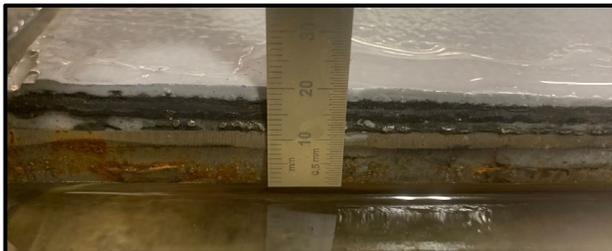
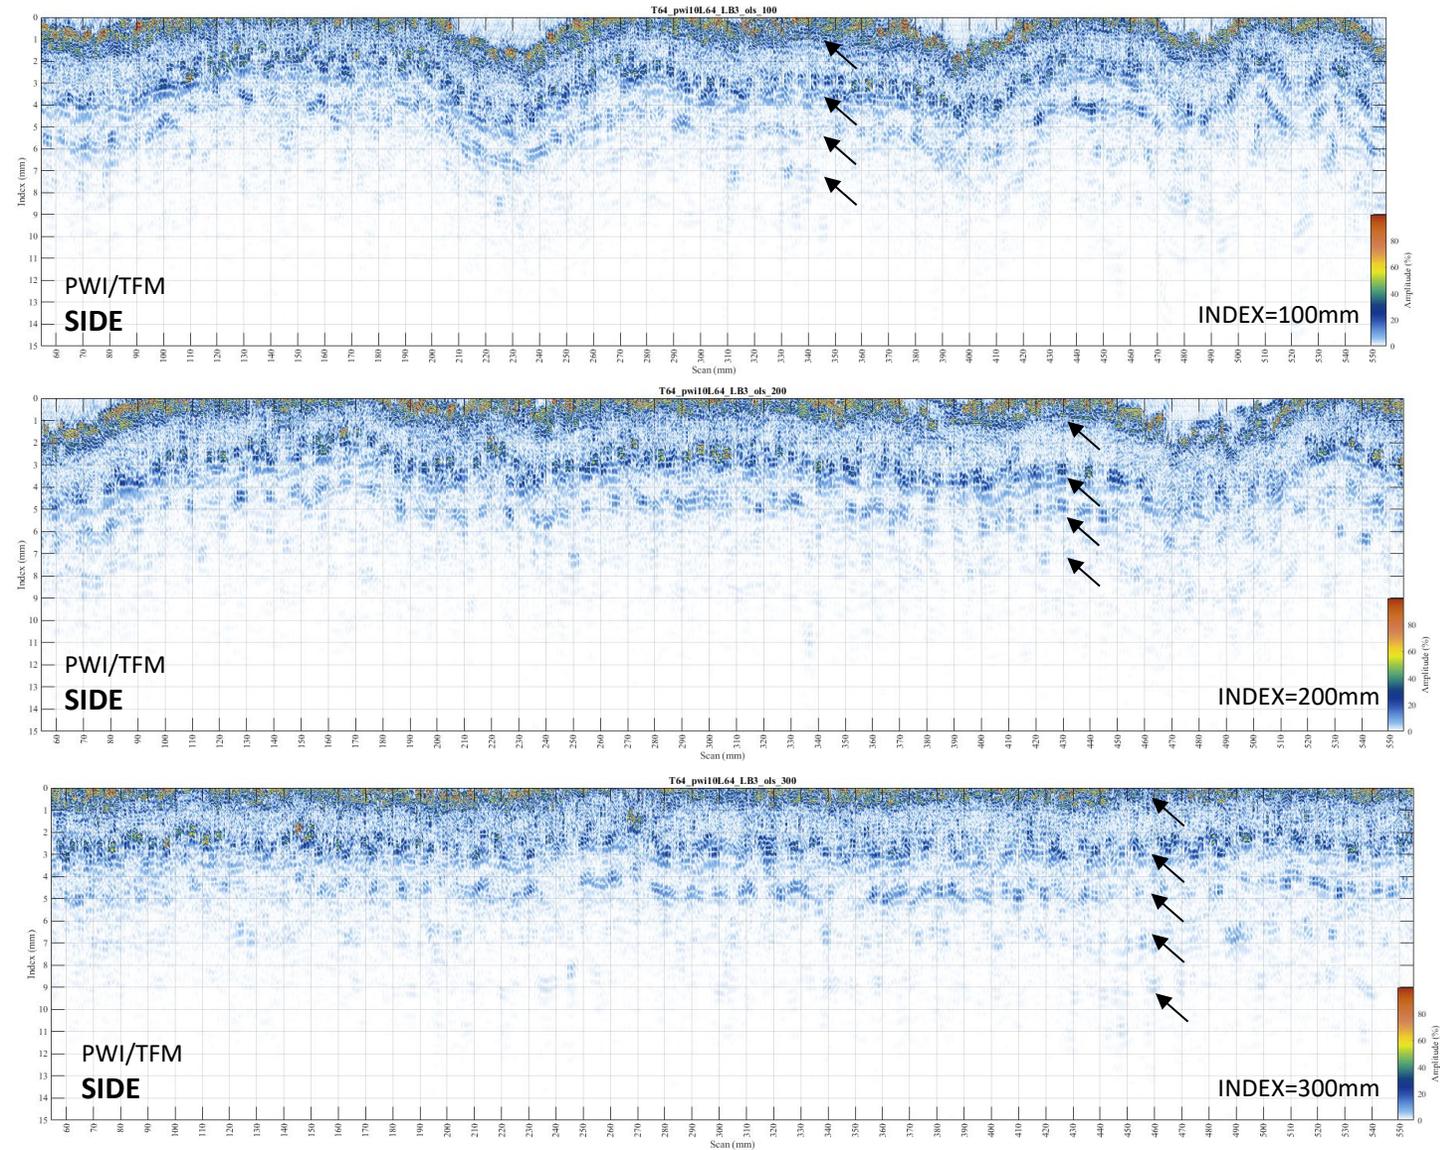
One-Line PWI/TFM at 10MHz

- Structure:
 - Epoxy layer (2mm)
 - Four laminar layers ($\approx 1.5\text{mm}$ each)
 - Steel substrate ($\approx 12\text{mm}$)
- One-line scans conducted at 100mm intervals
 - Local immersion
 - PWI/TFM (insonification angles from -20° to $+20^\circ$) at 10MHz
 - Probe oriented with aperture *in* RoI plane
- Observations:
 - Reflections from internal layers visible
 - Sensitivity to slight surface undulations, which formed rings around implanted flaws

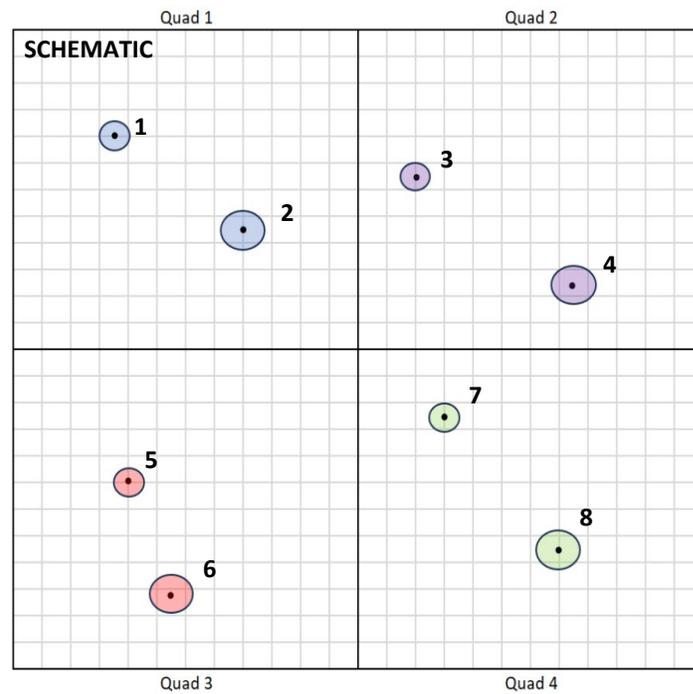
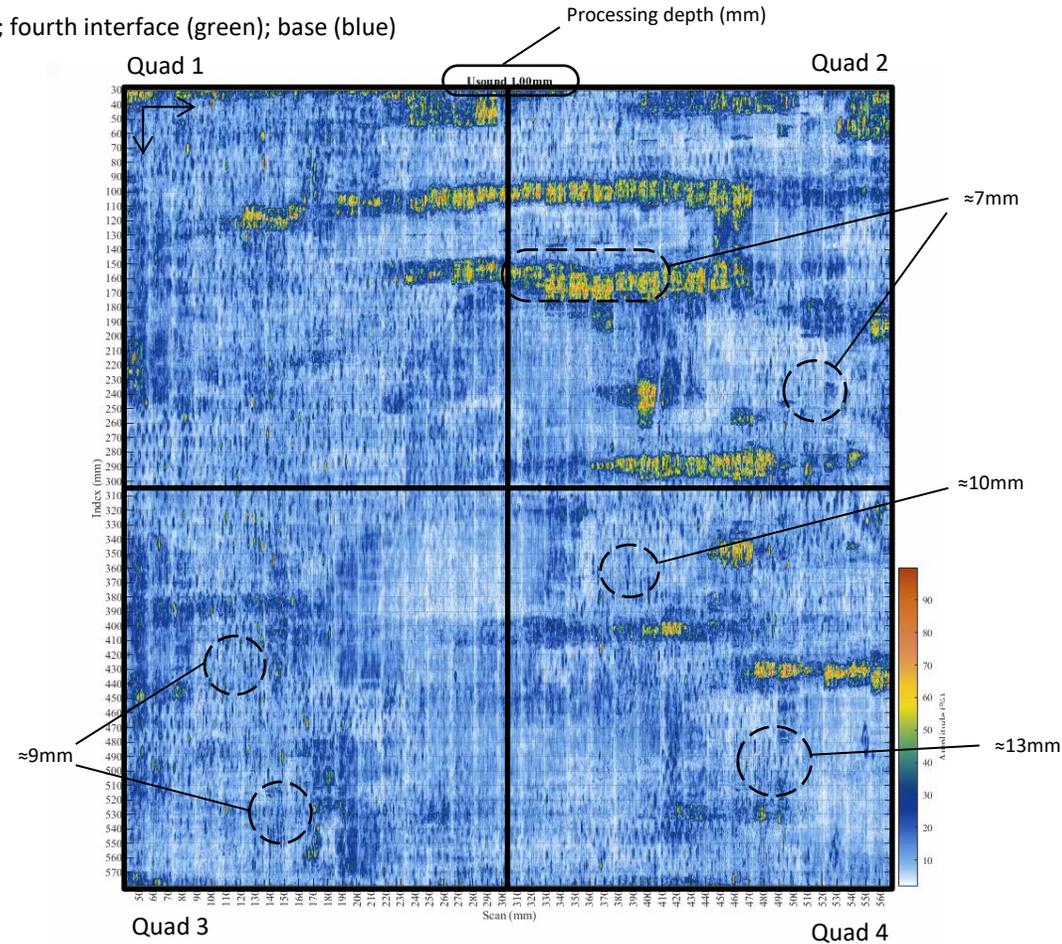
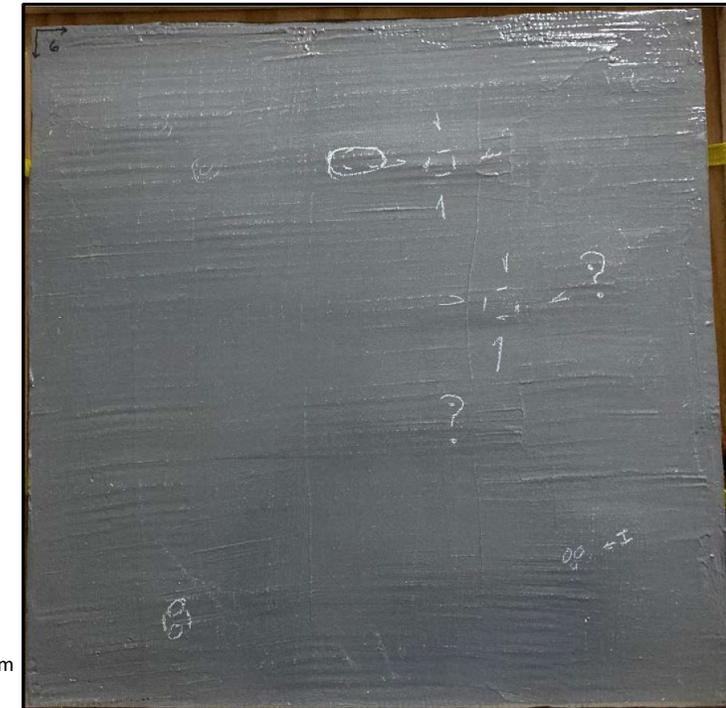
Volumetric PWI/TFM at 10MHz

- Animation shows maximum projection from specified depth to bottom of scan
- Some correspondence to schematic with knowledge of intended flaw locations

Schematic legend: second interface (purple); third interface (pink); fourth interface (green); base (blue)

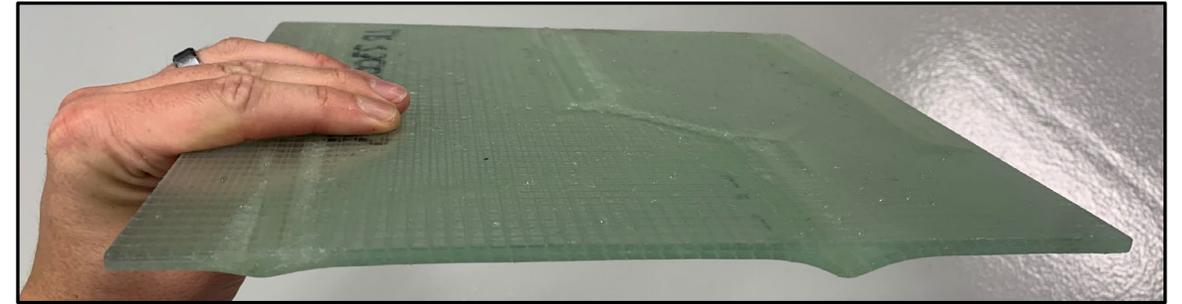
Glass fibre plate (270×245×5)mm with four $\varnothing 3\text{mm}$ glass rods to effect wrinkling

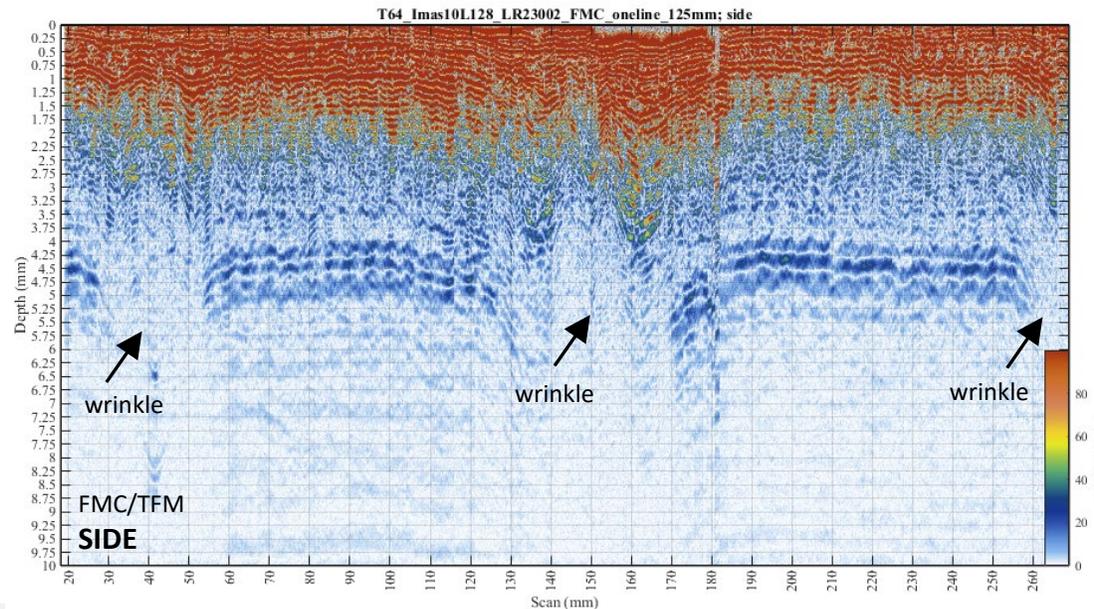
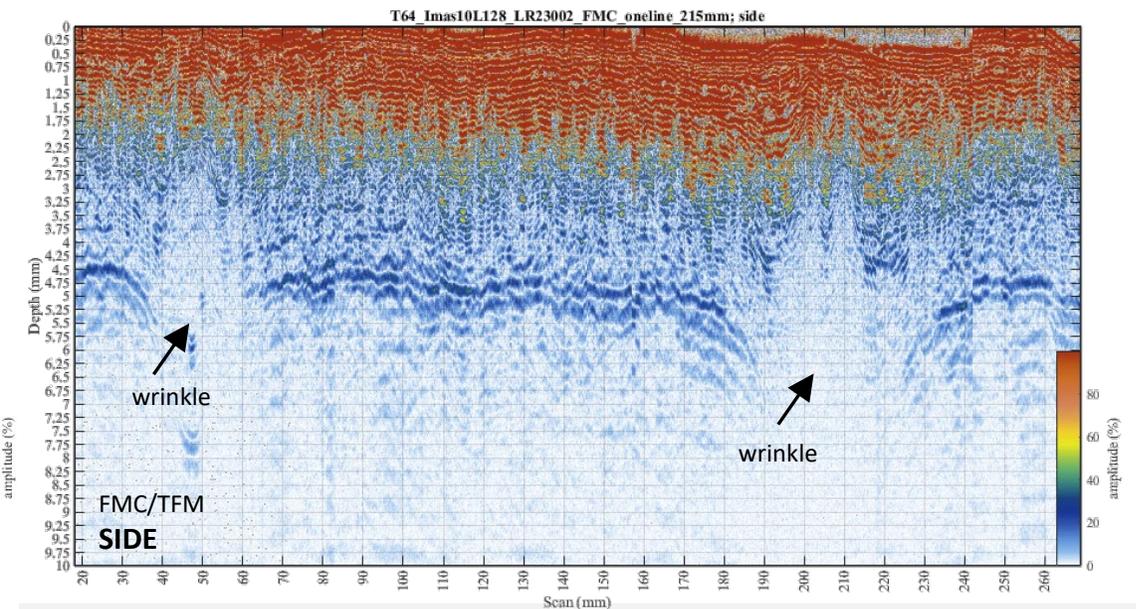
One-Line FMC/TFM at 10MHz

- One-line scans with probe oriented with aperture *in* RoI plane
 - Imasonic 10MHz phased array probe
 - 128-el (but only 64 active elements); 0.3mm pitch
 - Scan resolution: 1mm
- Backwall clearly visible at 5mm
- Wrinkles identifiable as gaps in backwall with quantifiable extent in scan direction
- Heavy top surface noise ($\approx 2\text{mm}$ thickness)

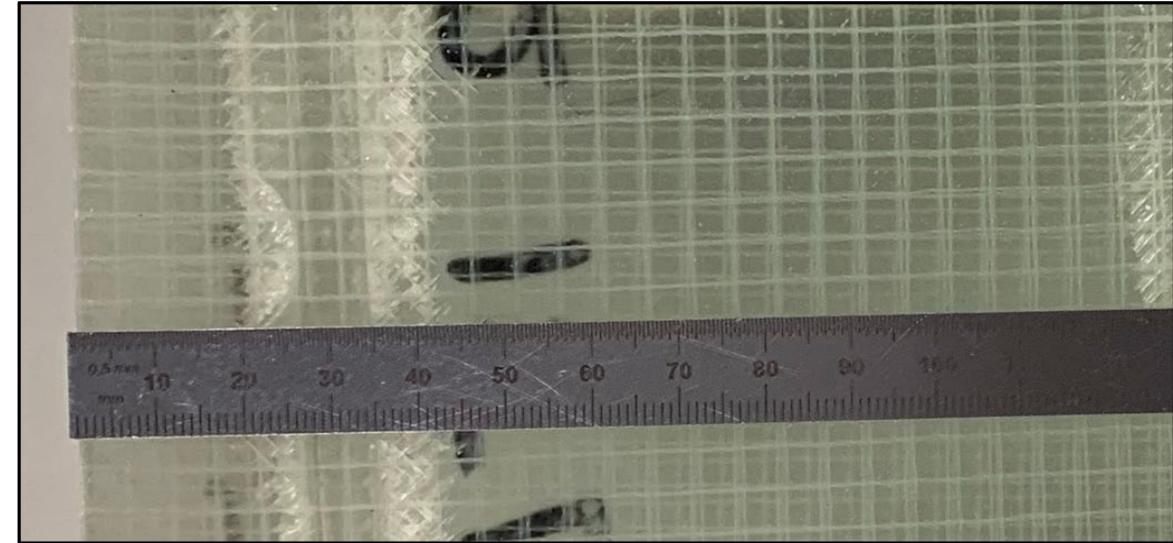
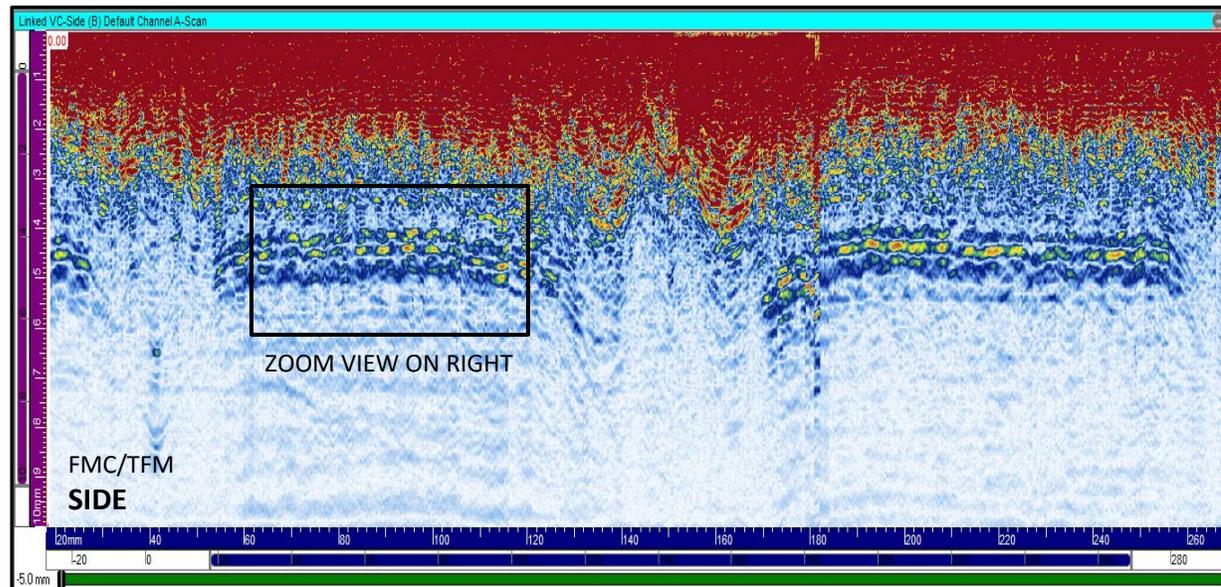
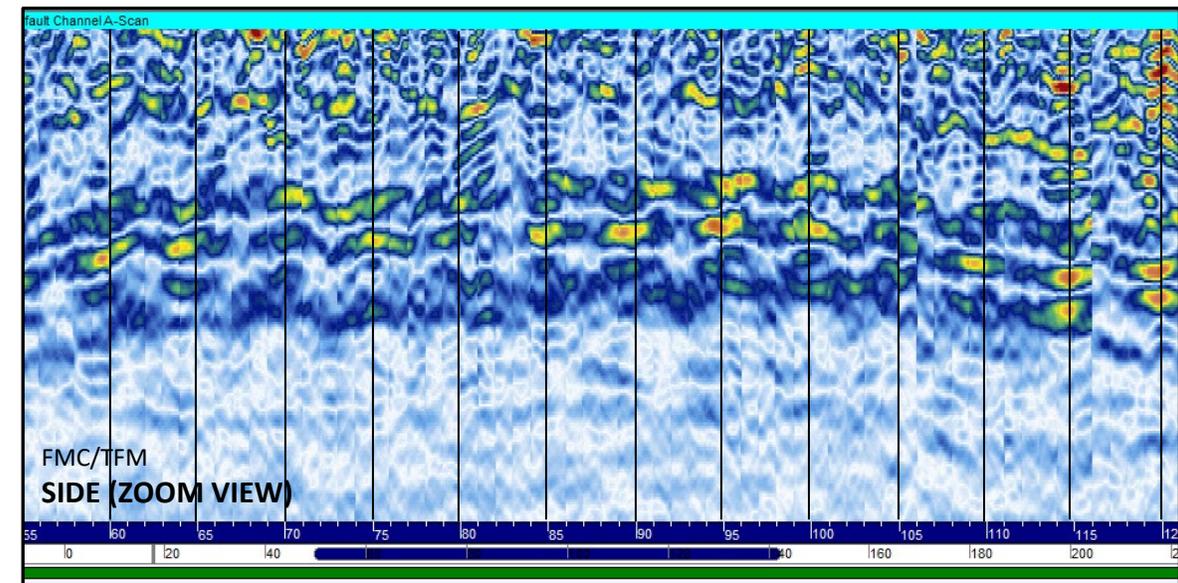
One-Line FMC/TFM at 10MHz (cont'd)

- Fibre pitch $\approx 5\text{mm}$
- Individually identifiable on bottom right zoom view
 - Added lines to indicate 5mm intervals
- But for the heavy noise at top surface, same pattern too might be visible at earlier depths

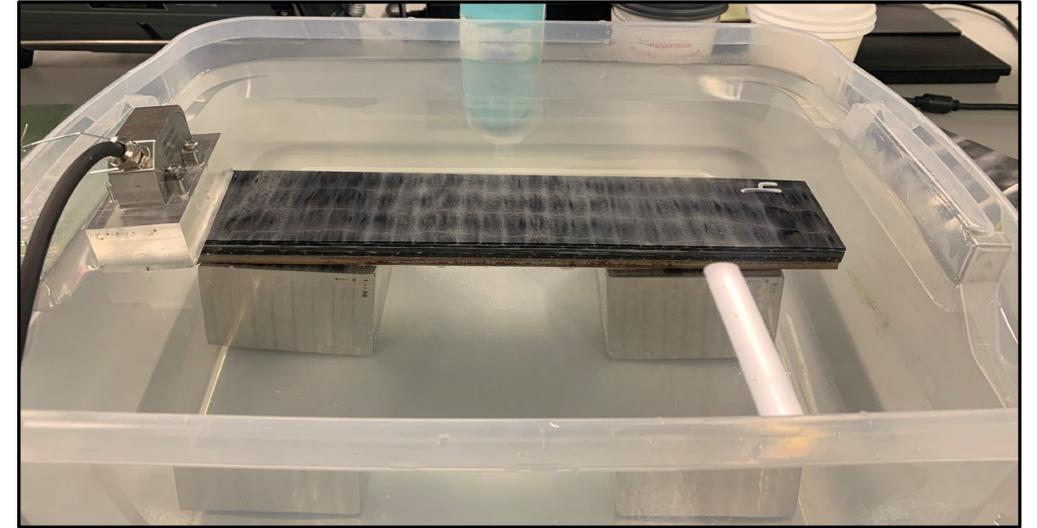
Small specimen (304×60×18)mm in immersion tank

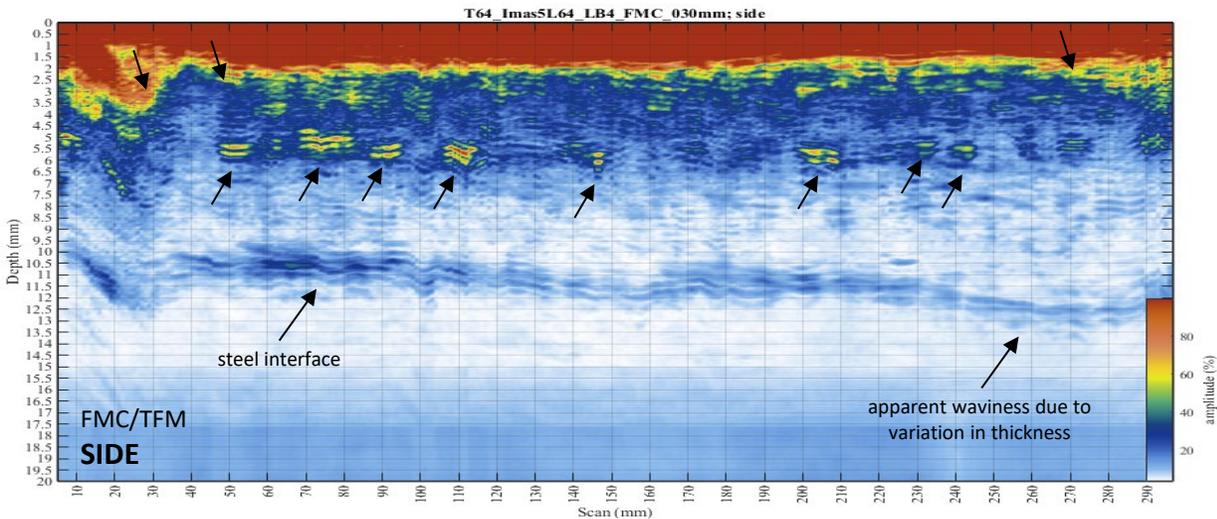
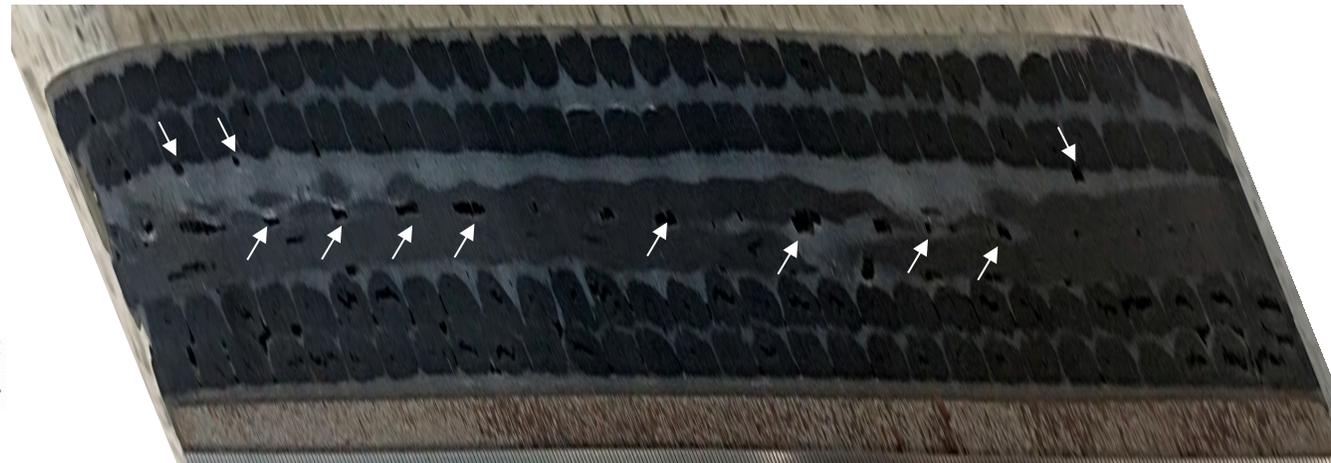
One-Line FMC/TFM at 5MHz

- Structure:
 - Six laminar layers ($\approx 12\text{mm}$)
 - Steel substrate ($\approx 7\text{mm}$)
- TFM highlights voids observed at mid-depth; some possible correspondence with the observed distribution, though the voids may not be consistent with depth
 - Steel interface is seen clearly, showing variation in height of the CFRP material
 - Unfortunately, wedge entry noise is significant
