# EPRI NDE Research for Long Term Operations

2026 NRC NDE Technical Information Exchange Meeting  
1/22/26

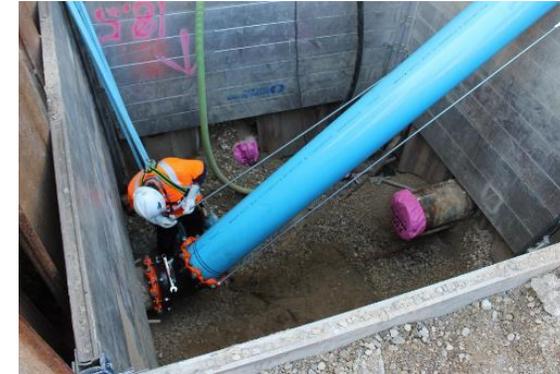
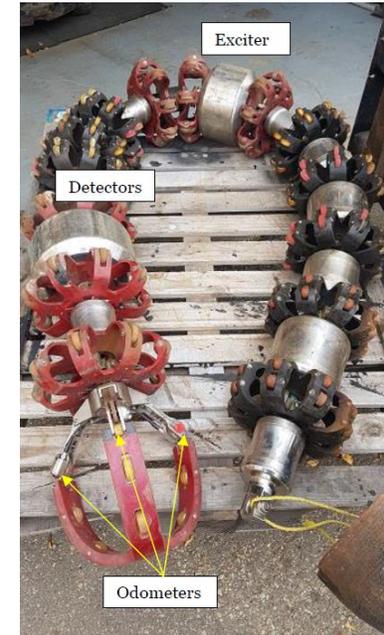
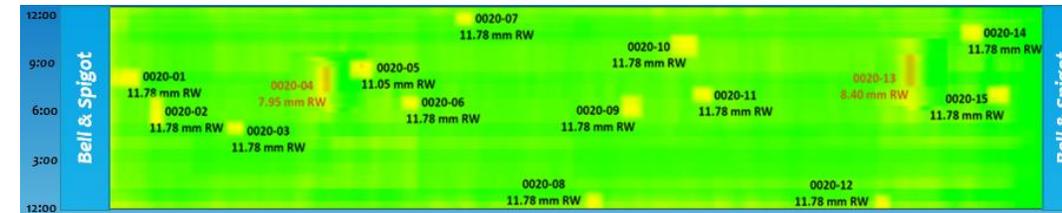
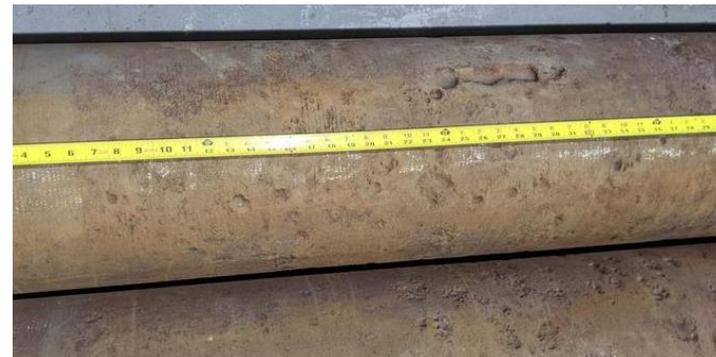
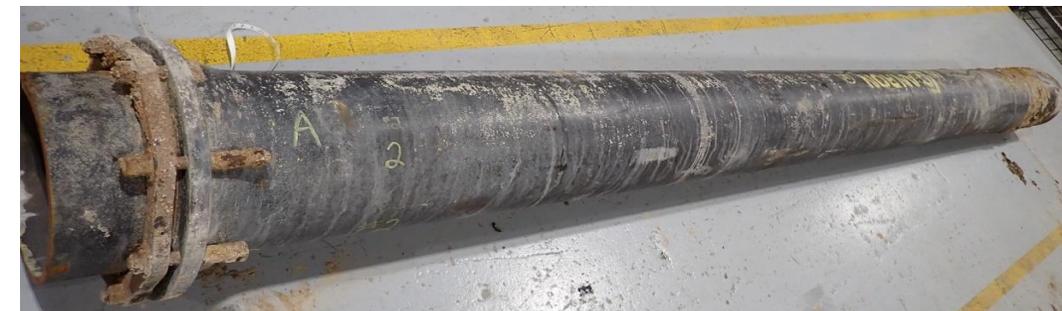
- In 2021, Bruce Power utilized the Remote Field Testing (RFT) technique to internally inspect >200 linear feet of cast iron fire water piping
- ~200 pitting indications were found across 20 pipe segments
- Pipes were abrasively blasted to reveal selective leaching degradation on both internal & external surfaces
- Successful use and application of RFT to identify extent of degradation led to proactive plans to begin replacements of susceptible portions of fire water ring header

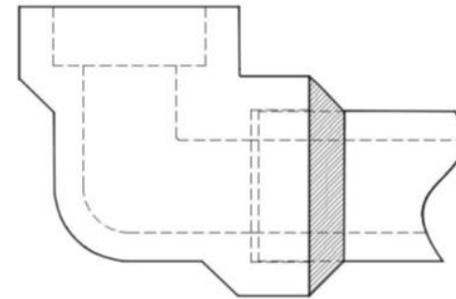
Illustration of 0.75-inch, 1-inch and 2-inch Sch.40, 80 and 160 Carbon Steel Pipe Elbow with 1:1 taper

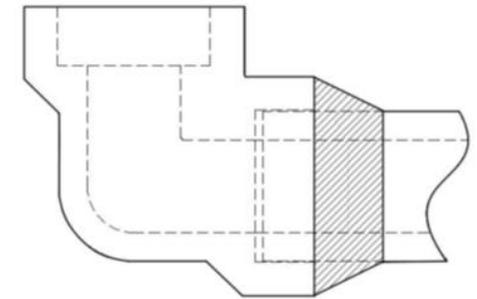
Illustration of 0.75-inch, 1-inch and 2-inch Sch.40, 80 and 160 Carbon Steel Pipe Elbow with 2:1 taper

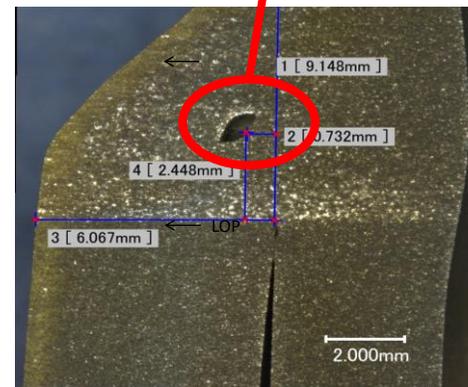
Extended Porosity

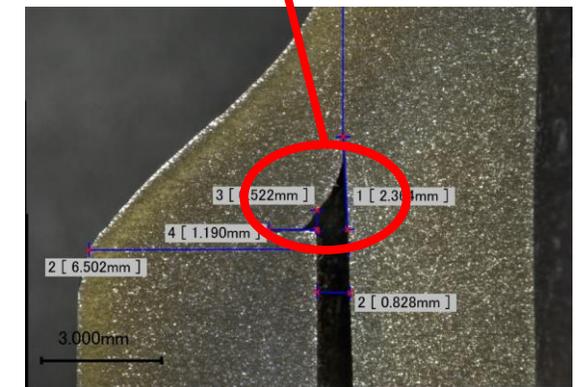
Lack of Penetration

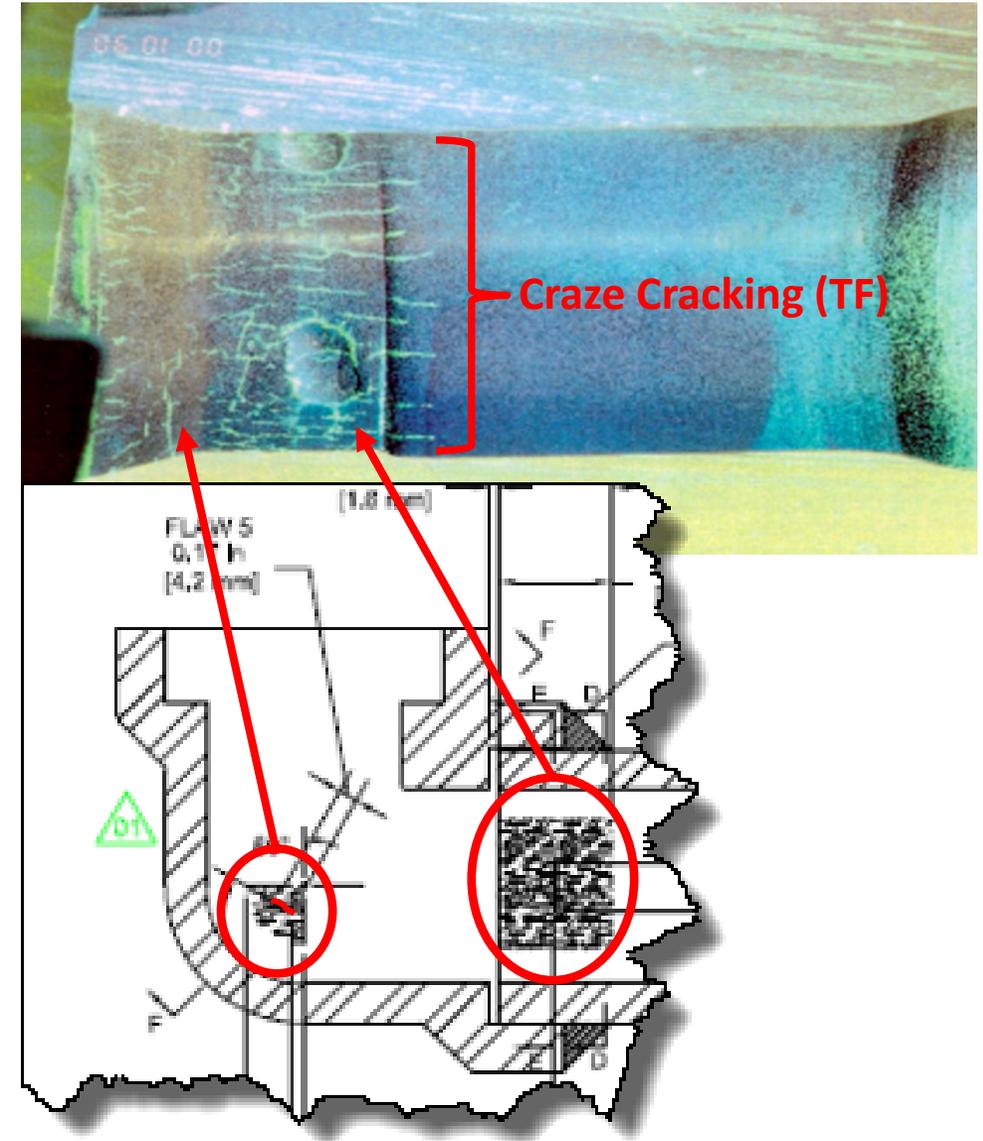
- Service induced type flaws
- May or may not involve a socket weld configuration
- Caused by concentrated stress due to large thermal “spikes”
- Only ID initiated
- Base metal flaws
- Tends to form craze cracking
- Can have singular, deeper flaw
