Idaho National Engineering Laboratory

TECHNICAL REPORT

EVALUATION OF EPRI DRAFT REPORT NP-7065 - REVIEW OF NRC/INEL GATE VALVE TEST PROGRAM

Prepared for the
U.S. NUCLEAR REGULATORY COMMISSION

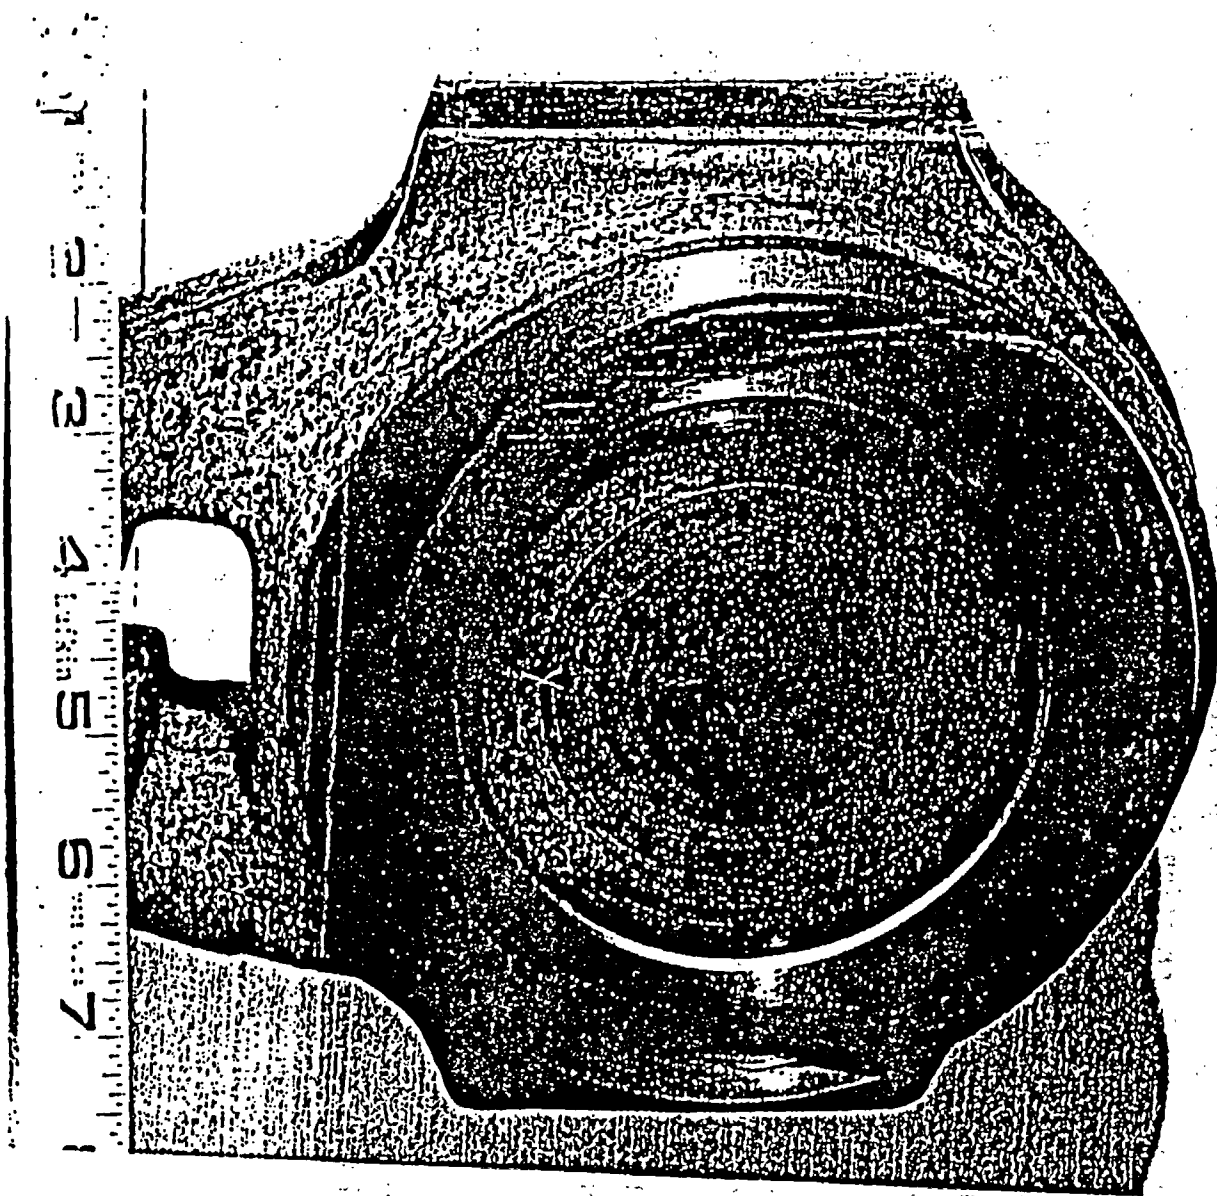
Figure 13. Photograph of the entire Valve A disc after the Phase I tests

Figures 13 and 14 are photographs of the Valve A disc taken after the Phase I tests. These photographs show the condition of the seating surface and the sharp edge discussed later in this section. The valve was manufactured for the Phase I test program by Anchor/Darling, and to quote the EPRI report, *"Anchor/Darling indicates that Valve A is similar in design features to a large population of flexible wedge gate valves they have manufactured and supplied to nuclear power plants."* Valves supplied to nuclear power plants with similar design features to Valve A would therefore be expected to perform in a similar fashion when exposed to similar conditions. Valve A performed unpredictably in the Phase I test program due to internal damage caused by the flow loadings.

After the Phase I tests and in preparation for the Phase II program, Valve A was refurbished by Crane Valve Services, Crane-Aloyco, Inc. and

redesignated Valve 1 for Phase II. The work scope for this purchase order is correctly quoted in the EPRI report on page 3-3 as follows:

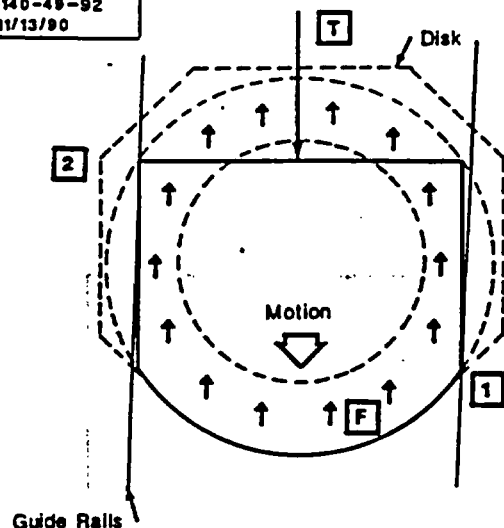
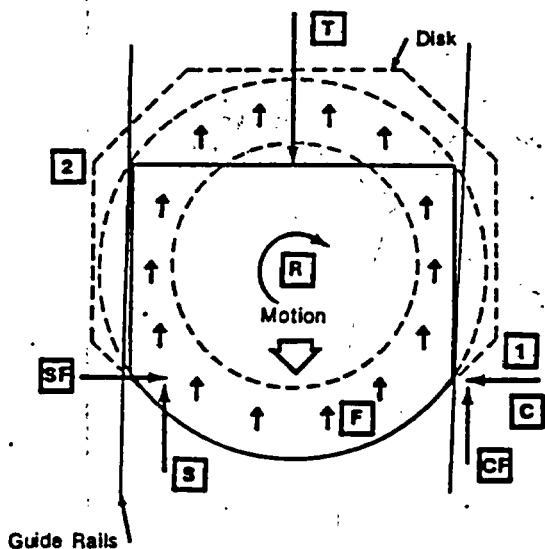
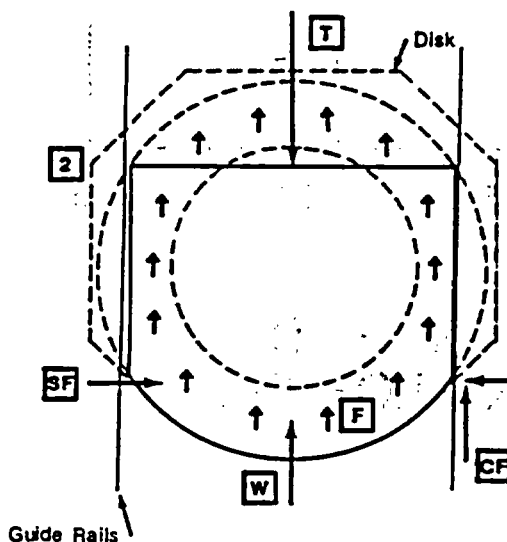
FIGURE 6-6

1. AT FLOW ISOLATION

Stem thrust [T] is opposed by disk/seat friction forces [F]. Disk is slightly rotated relative to guide rails, and contact occurs at points [1] and [2], but there are not significant reaction forces. Rotation is exagerated; actual value is less than 1°. Mechanism for disk rotation is not known, but could be slight stem misalignment, flow effects, non-uniform friction, etc.

2. APPROACHING HARD SEATING

Because of disk angular position, seat reacts disk eccentrically at first [S]. Disk rotates clockwise to align with seat [R]. Contact force [C] builds up on guide due to squeezing point [1], reacted by lateral seat friction [SF]. Additional friction at guide [CF] needs to be overcome by stem thrust

3. HARDSEATED

Disk motion is stopped, and wedging force [W] is established. Disk is sprung into guide at point [1]

HYPOTHESIZED MECHANISM FOR VALVE 2 BEHAVIOR

9. Additional testing of NRC/INEL Valve 2 or special testing to
    reproduce and explain the phenomena causing the Valve 2 unusual
    behavior is warranted. This testing should include
    investigation of unexpected disk/guide contact and should seek
    to identify the root cause of the Valve 2 behavior and explore
    potential modifications to alleviate the behavior.

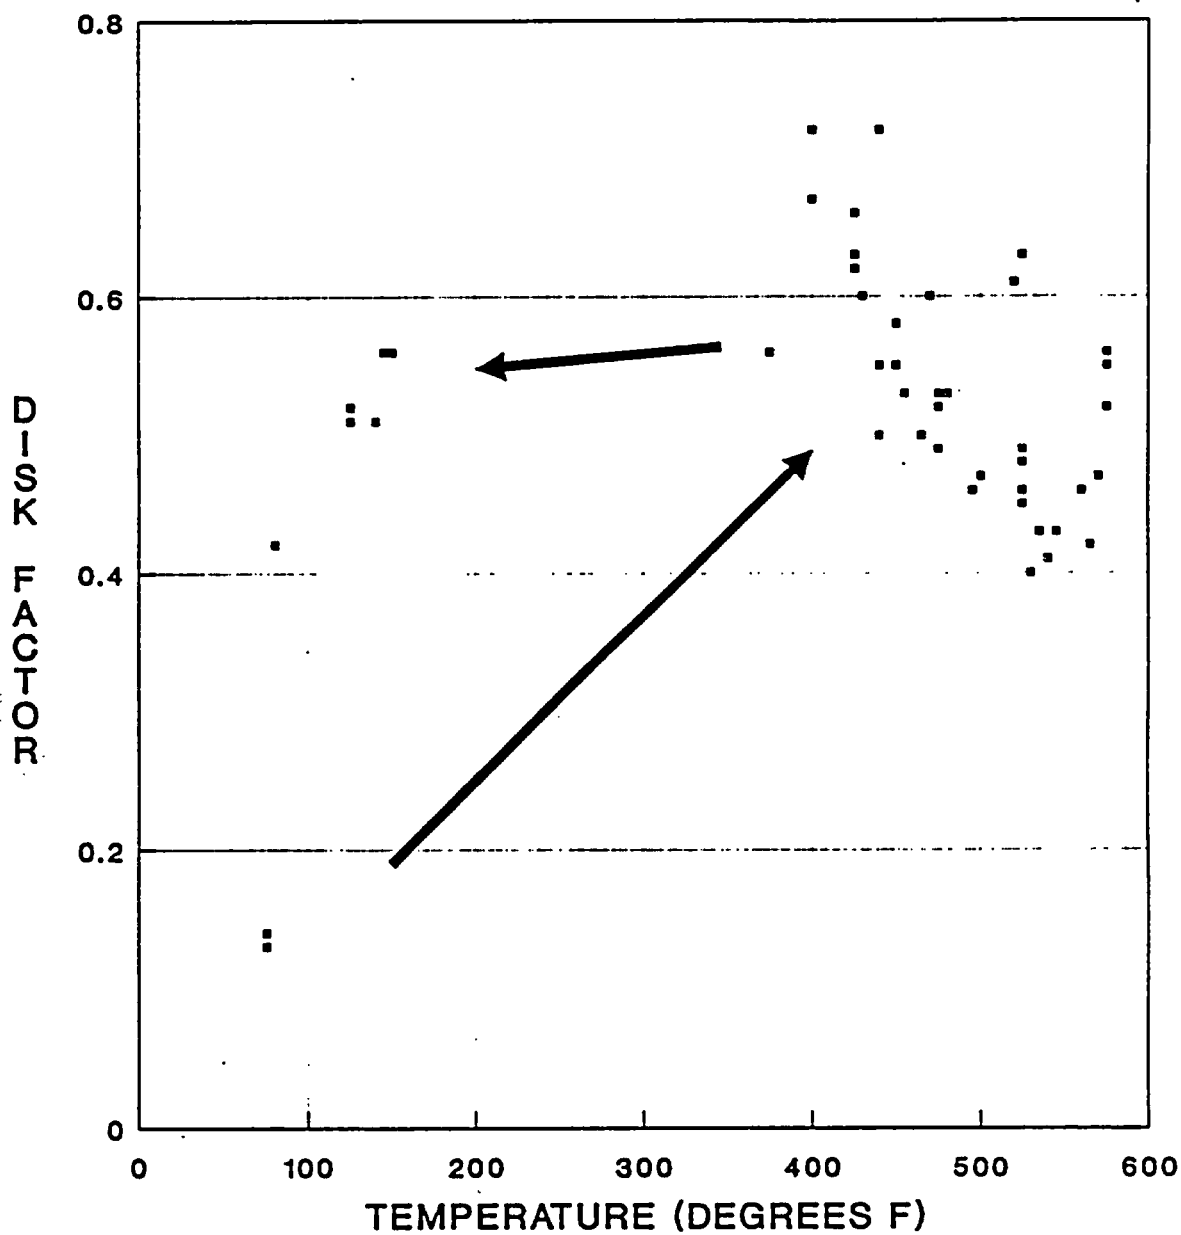
The first major observation is that on all 8 valves the initial cold no-flow strokes yielded low apparent disk factors (0.1 to 0.2). Upon initiation of hot no-flow testing, disk factor increased (to above 0.3). There was also some evidence of disk factor increasing with repeated strokes at cold temperature (see Valves 6 and A, Figures 6-21 and 6-23). In cases where cold temperature tests were conducted after hot tests (Valves A, B and 2), disk factor did not return to the initial low level but instead remained at the higher level. Figure 6-27 is a plot of disk factor (based on wedging) versus temperature covering all strokes of Valve 2, which illustrates the irreversible nature of the disk factor change.

DISK FACTOR VS TEMPERATURE
WEDGING OF VALVE #2
FIGURE 6-27

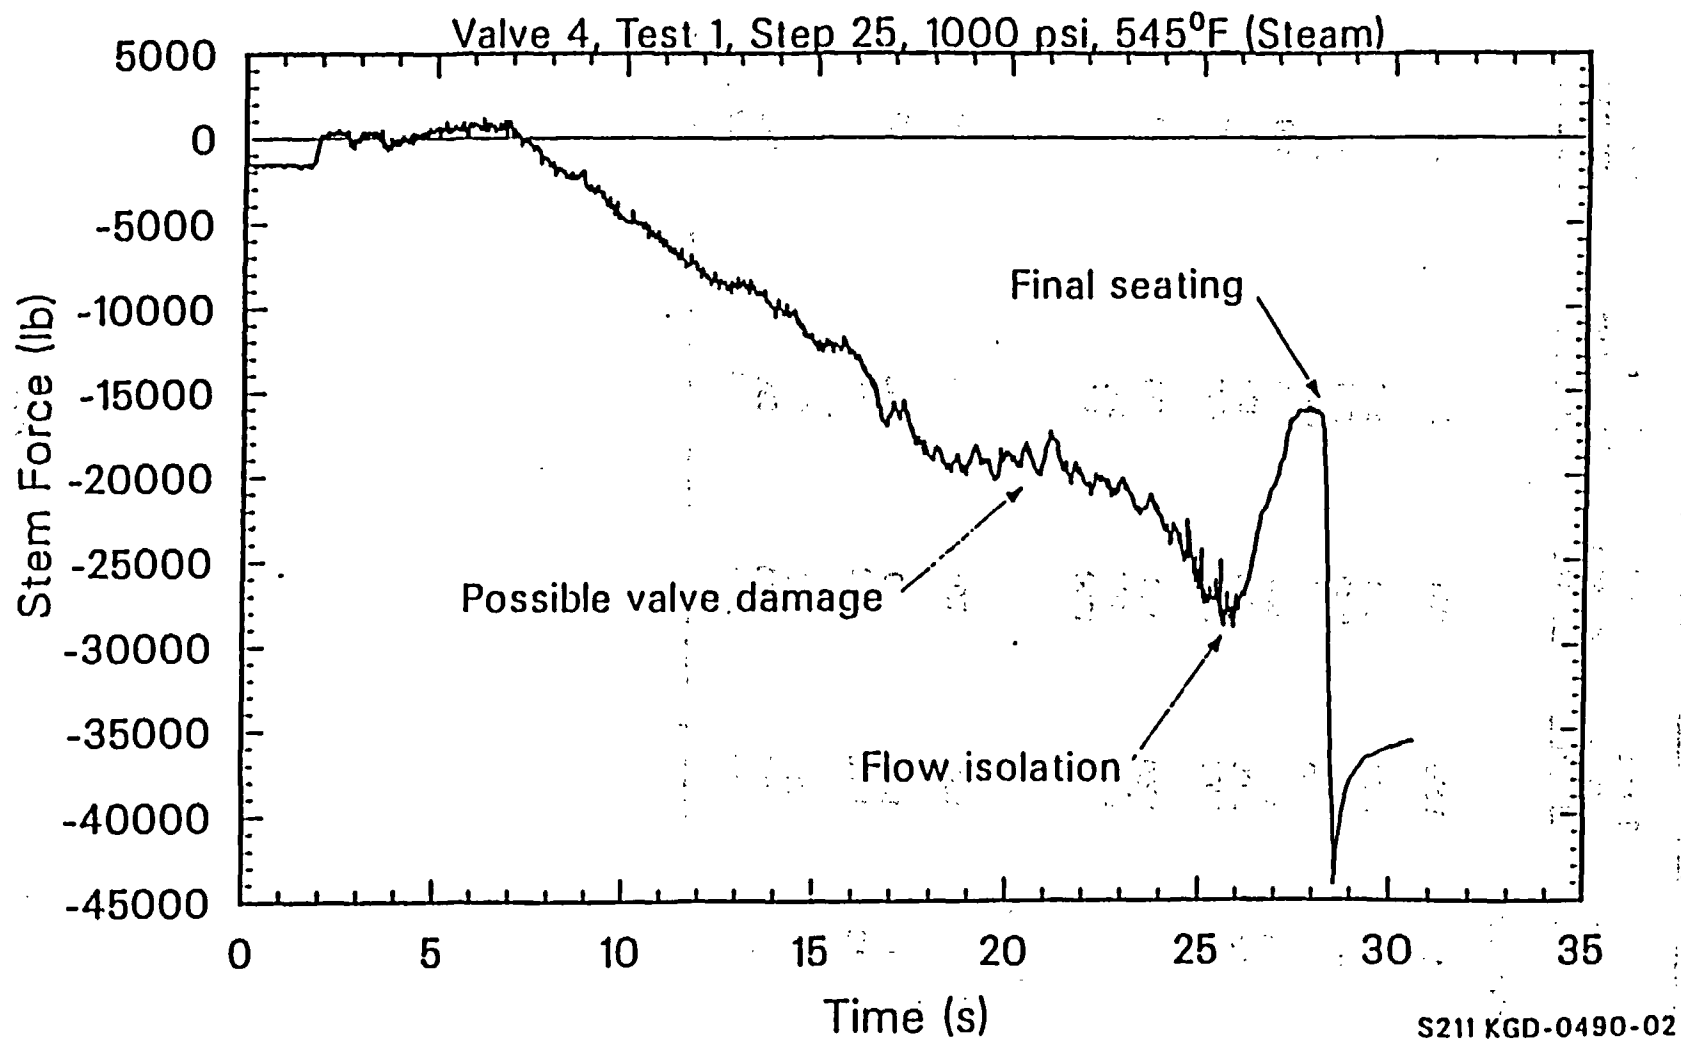
Figure 6. Valve stem force history from Phase II testing shows nonlinear performance of the valve, indicating valve damage.
