NUREG/CR-5783
BNL-NUREG-52299

Aging Assessment of the Combustion Engineering and Babcock & Wilcox Control Rod Drives

Prepared by
E. Grove, W. Gunther

Brookhaven National Laboratory

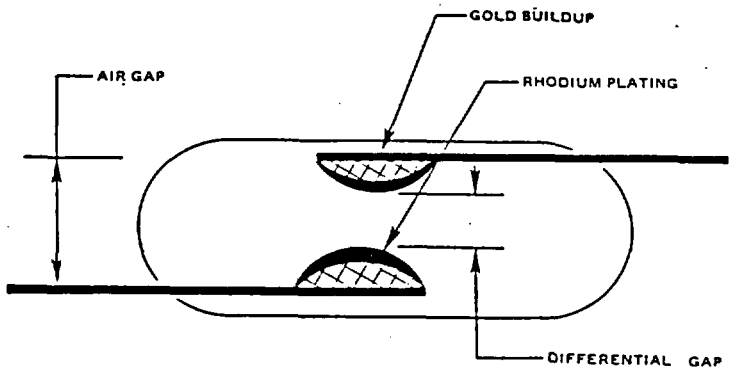
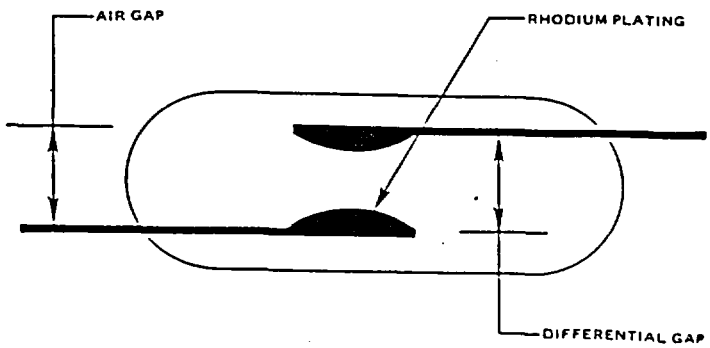
Figure 3.14 Reed Switches

The current API system uses high differential reed switches (Figure 3.14) which are completely enclosed in glass, with rhodium plated contact surfaces. During the early 1980's low differential reed switches were used which incorporated gold plating on top of the rhodium plating. The failure rate and the erratic operation of these early switches, due to the buildup of contact surface film and the low closing force required from the decreased gap, necessitated the design change. These switches were also prone to fluttering in stray magnetic fields. The high-differential switches provided a greater positive contact due to the higher closing force, thus reducing surface film buildup.

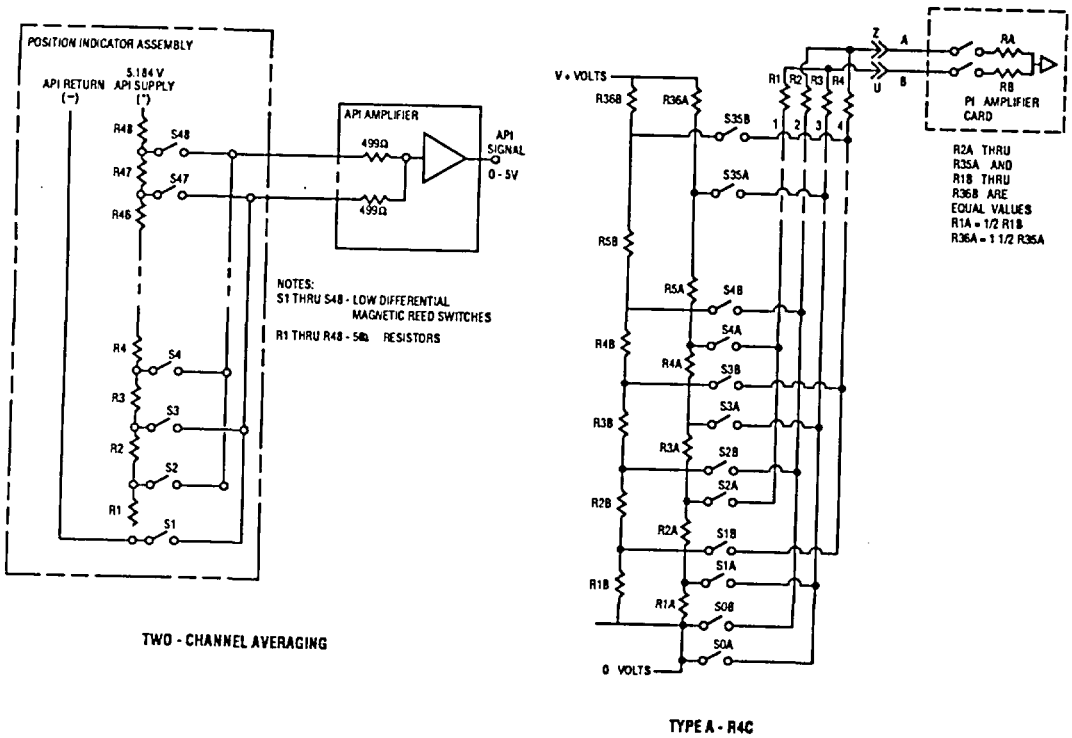
Figure 3.15 Absolute Position Indication (API)

Operating limitations also necessitated the redesign of the API system. The early Type A indicating circuits used a two channel averaging circuit. As the leadscrew moved, the reed switches closed in a 2-1-2-1 sequence. A failed open reed switch produced an erroneous dropped rod indication and initiated an automatic runback to 60% power resulting from the asymmetric fault condition. If any of the forty-eight reed switches failed, the entire assembly had to be replaced because the failed switch could not be bypassed.

The new circuit design (Type A-R4C), has two parallel sets of voltage divider circuits, comprised of 36 resistors, each connected in series. A 5 volt dc power supply is connected across the two circuits, such that 5 volts (at the top end of the circuit) represents the full-out rod position, and 0 volts (at the bottom end of the circuit), represents the full-in position for the rod. The reed switches for each circuit are offset such that they are staggered. One end of the 36 reed switches are connected at a junction between each of the resistors of the two parallel circuits. The other end (output) of the switches are alternately connected to 4 internal output signal lines. These signals are selectively averaged to form two output signals. Both circuit designs are schematically shown in Figure 3.15.

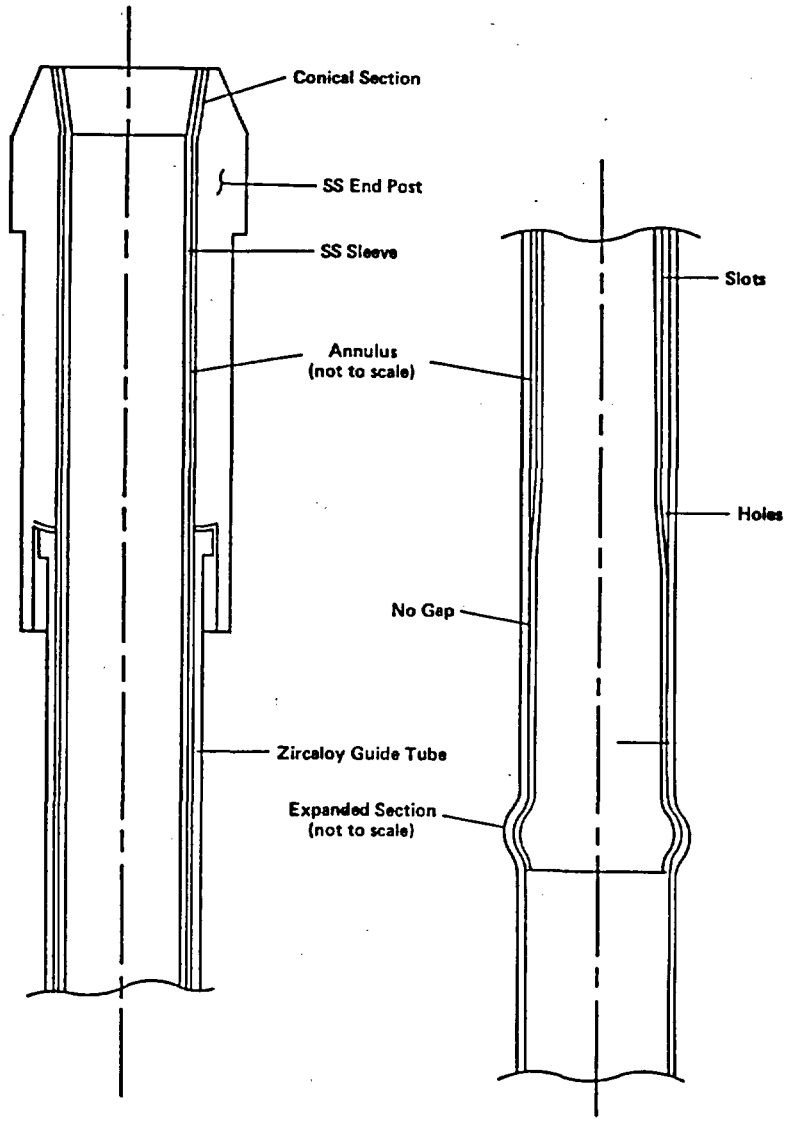
Figure 5.1 Combustion Engineering Guide Tube Sleeve

This NUREG, published early in 1980, documented the discovery of guide tube cracks at Millstone 2 after the first cycle of operation. The wear was attributed to flow induced vibration of the Inconel clad control rods rubbing against the Zircaloy guide tubes. On-site inspection revealed that the maximum wear corresponded to the location of the control rod tips when the rod was in the full out position.

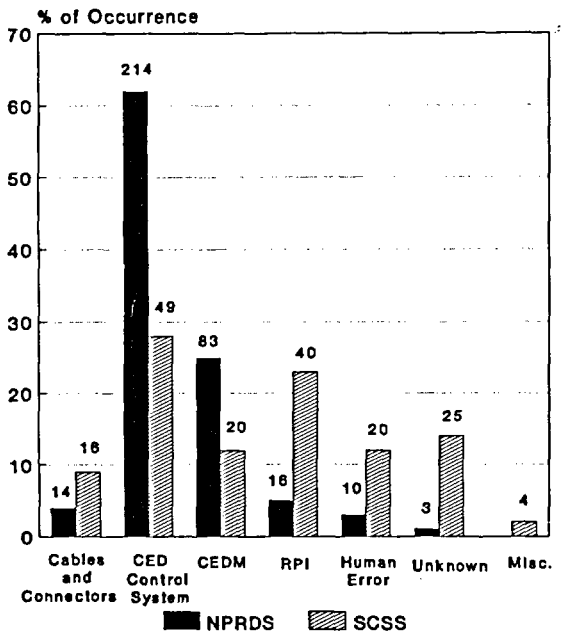
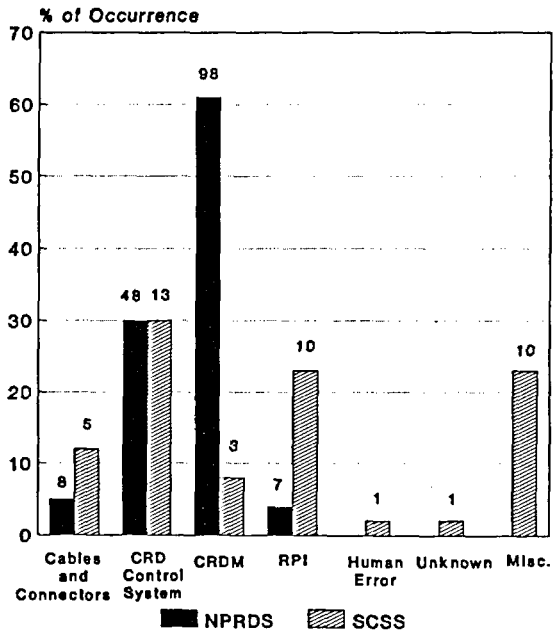
Figure 6.1 CRD Sub-systems Database Comparison

Figure 6.1 shows the failure frequencies, as reported to the SCSS and NPRDS data bases, for the B&W and CE CRD system for each category. The actual number of failures reported in each data base is also presented. For CE, the control system accounted for the majority of the failures while for B&W, degradation of the control system and the control rod drive mechanisms were the leading causes of failure.

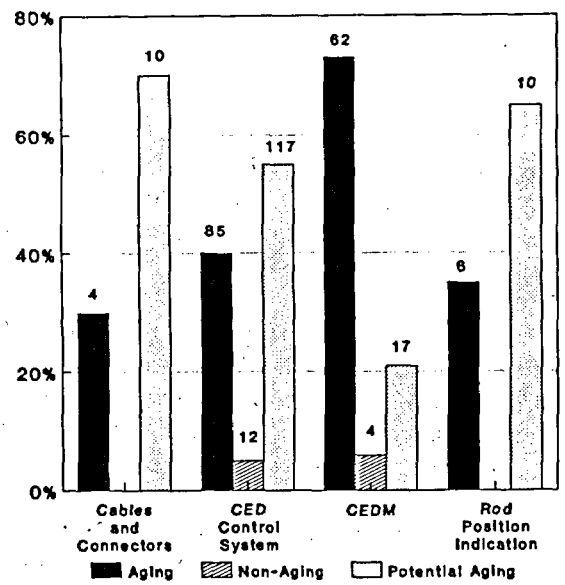
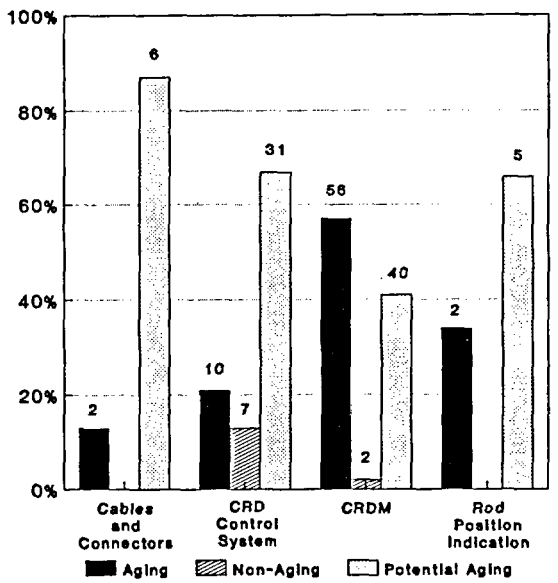
Figure 6.2 Percentage of Component Failures Attributable to Aging

As shown in Figure 6.2, the percentage of failures attributable to aging degradation varies between the individual component and sub-system. The control rod drive mechanisms for both CE and B&W experienced the greatest percentage of aging failures, primarily due to seal degradation and housing cracks. This high rate of failure corresponds with the high likelihood of aging when exposed to the operating stressors, defined in Section 4.4, and the research performed on this problem by the NRC and industry, summarized in Section 5.0.

Both B&W and CE have experienced system degradation due to aging failures of the cables and connectors (Figure 6.2). Because cables and connectors are replaceable, the root cause for many failures has not been determined and has been classified as potential aging in this study.

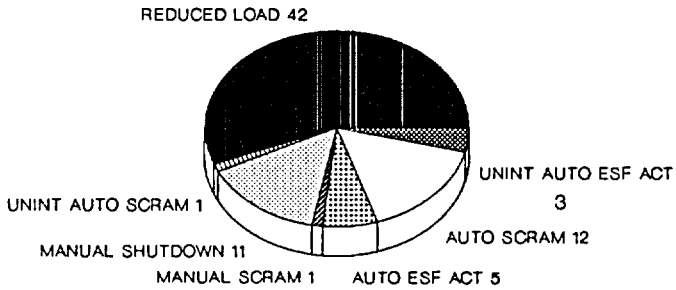
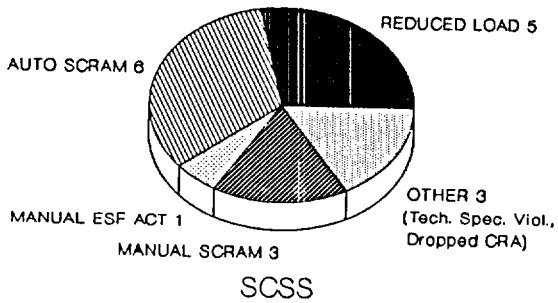
Figure 6.3 Significant Plant Effects Resulting from CRD System Degradation

Component and control rod drive sub-system failures also resulted in significant plant effects, in addition to affecting the availability and operability of the system (Figure 6.3). These effects included reduced plant loads, reactor shutdowns, manual and automatic scrams, and actuation of Engineered Safety Features (ESF).

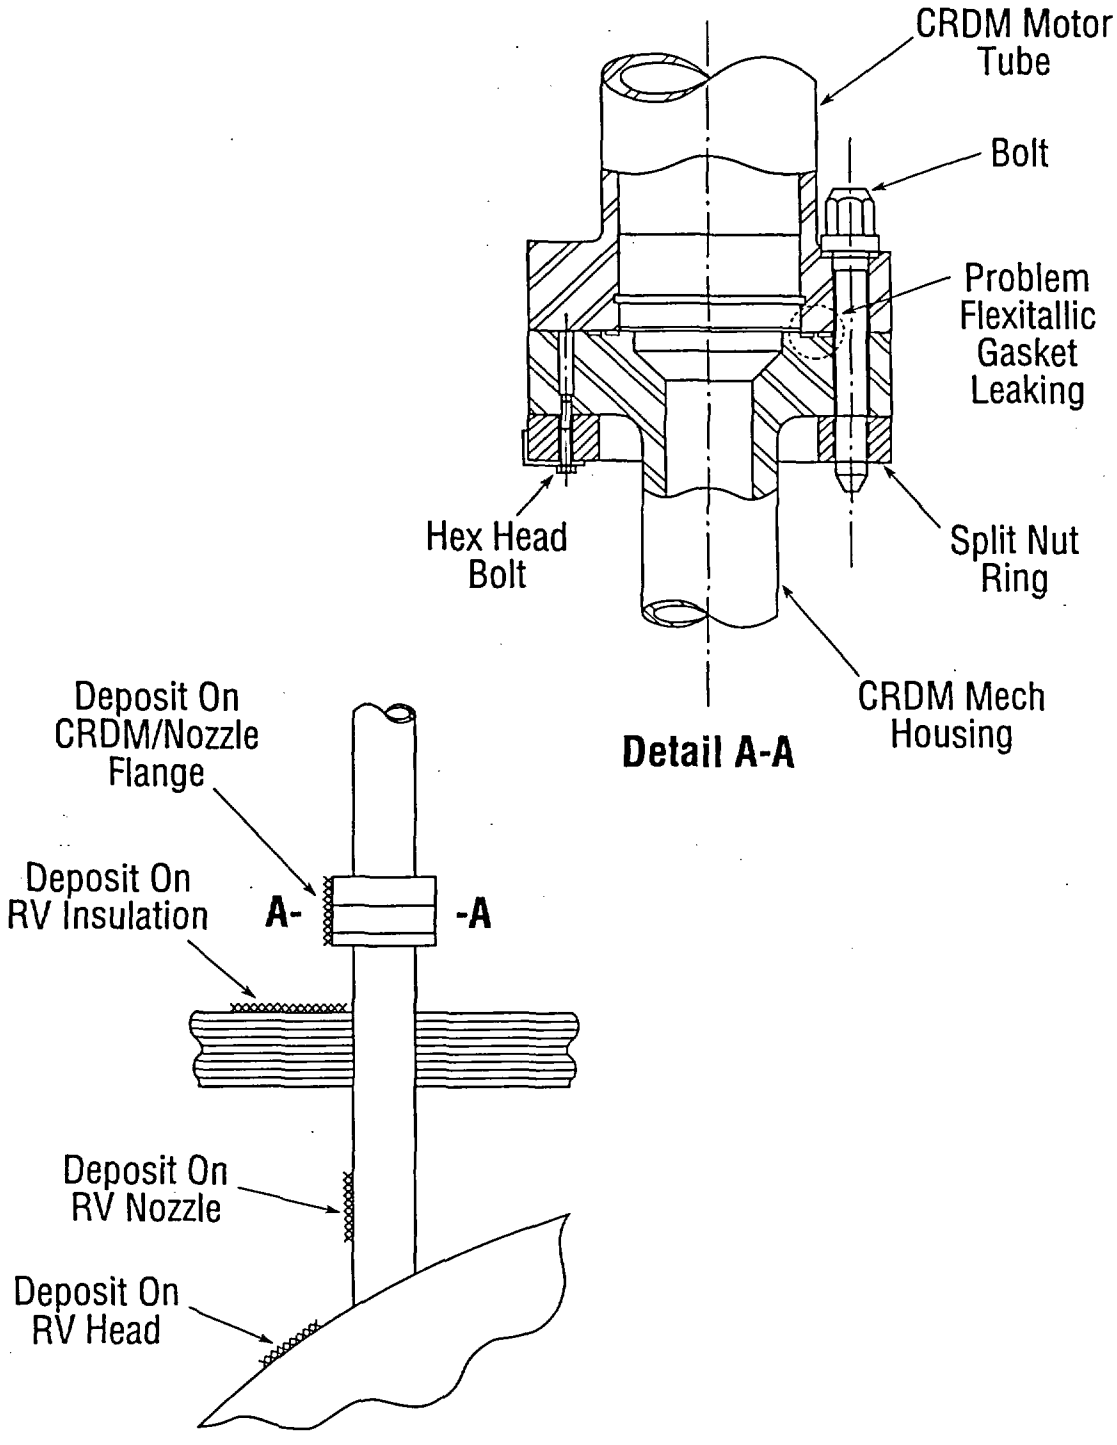
Figure 6.9 Inspection Areas for Boric Acid Deposits (B&W Plants)

Boric acid corrosion, as described in Section 4.0, is a significant potential degradation mechanism, which if uncorrected, could result in control rod drive failure. Utilities were alerted to this problem by Information Notice 86-108 (Section 5.1). This Notice, and subsequent revisions, documented leakage from CRDM seals, which was detected during an outage, but judged acceptable for continued operation

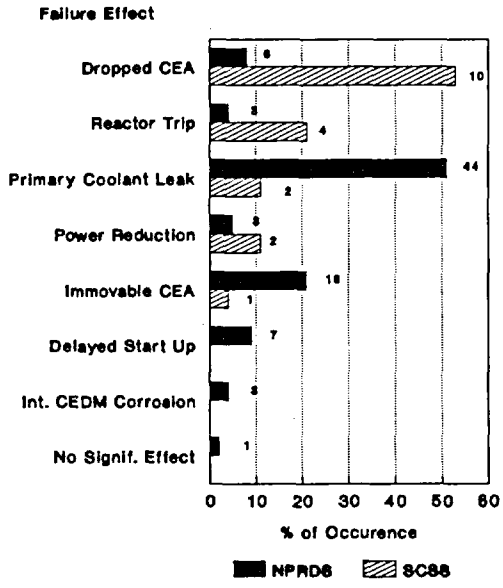
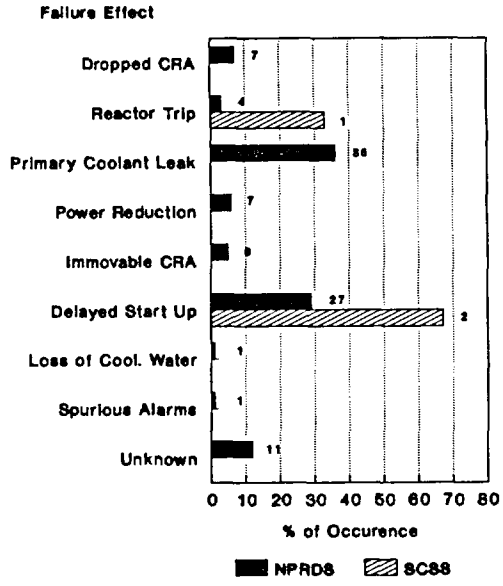
Figure 6.11 Control Rod Drive Mechanism Failure Effect

The effect of CRDM failure was dependant upon the specific failure type (Figure 6.11). Stator shorts occurring during operation typically resulted in dropped or slipped rods, and depending upon the power level at the time of the incident, and the time required to recover the rod, led to power decreases, and reactors scrams. Failures discovered during normal maintenance testing during outages delayed reactor startup for repairs.

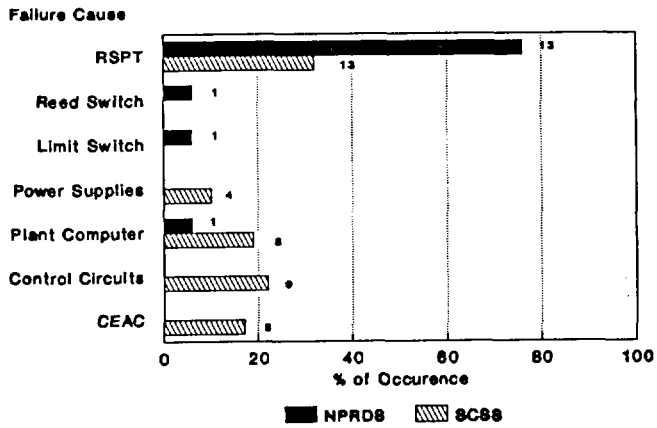
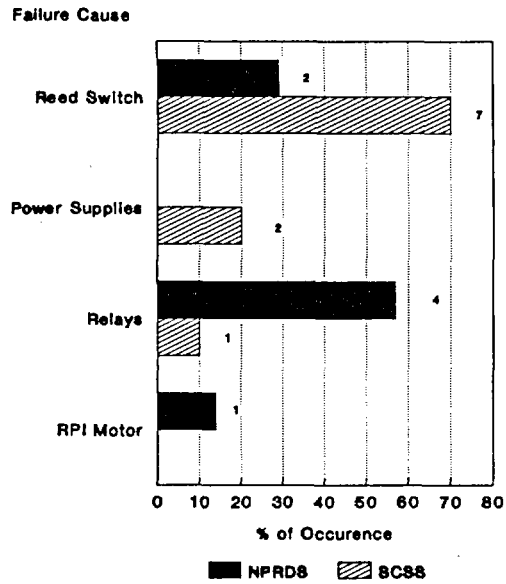
Figure 6.12 Rod Position Indication Failure Cause

As shown in Figure 6.12, reed switch failures were the main cause of system failure. Typically, failures occurred during operation, and were not immediately repairable. The failures were electrically isolated, minimizing the operational effect. The CE design incorporates redundant reed switch position transmitters and can remain operational with reed switch failures. B&W redesigned the circuitry from a two-channel design, which became inoperable when a reed switch failed, to a four-channel design which remains functional with a failure. Since the replacement of the old two-channel RPI circuitry, the B&W RPI sub-system has performed well. Not all B&W plants have a four-channel design, however.

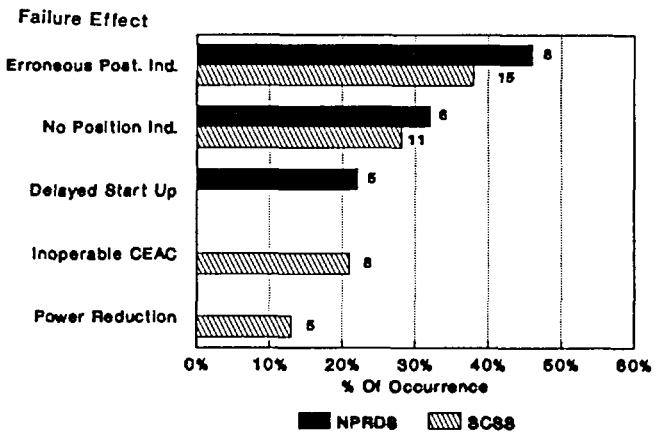
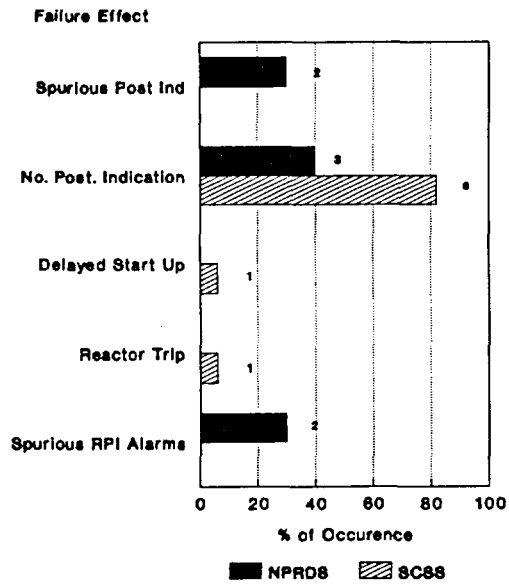
Figure 6.13 Rod Position Indication Failure Effect

The common effects of these failures were erroneous or loss of position indication signals, resulting in power reductions or a start-up delay to permit maintenance (Figure 6.13). Plant Technical Specifications require redundant position indication signals. When one system fails, power is reduced, and the operators verify the proper position every four hours until the redundancy is available.[31,32] If discovered before operation, the system will be repaired before start-up.

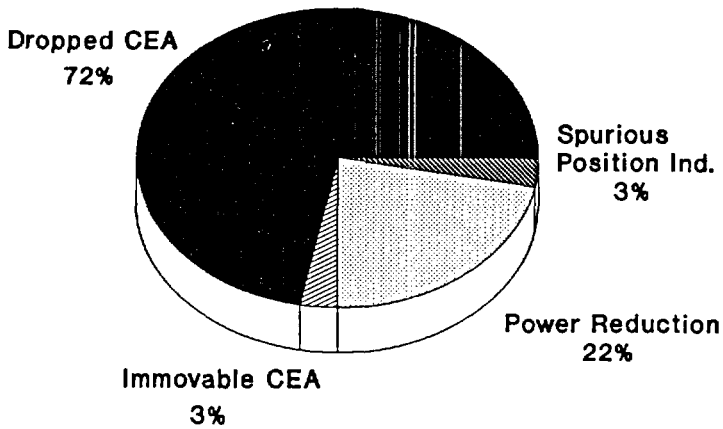
Figure 6.14 CE Control Element Drive System Unknown Failures Effect

As documented in Appendix B, a significant number of LERs documented CE Control Element Drive System failures due to unknown causes. As Figure 6.14 shows, these failures resulted in significant plant effects including dropped or immovable CEAs, spurious position indication, and reactor power reductions. Upon review of these failures, it was noted that many were similar to occurrences with known causes. However, as discussed in Section 6.1, no conclusions were made regarding the causes of these failures. Numerous incidents of dropped and slipped rods affected CE plants early in the 1980s. This problem has been ascribed to sluggish gripper operation with the older CEA Timer, which did not provide for feedback to confirm gripper operation. This allowed the weight of the CEA to be transferred to another gripper which was not correctly engaged, causing the rods to slip.

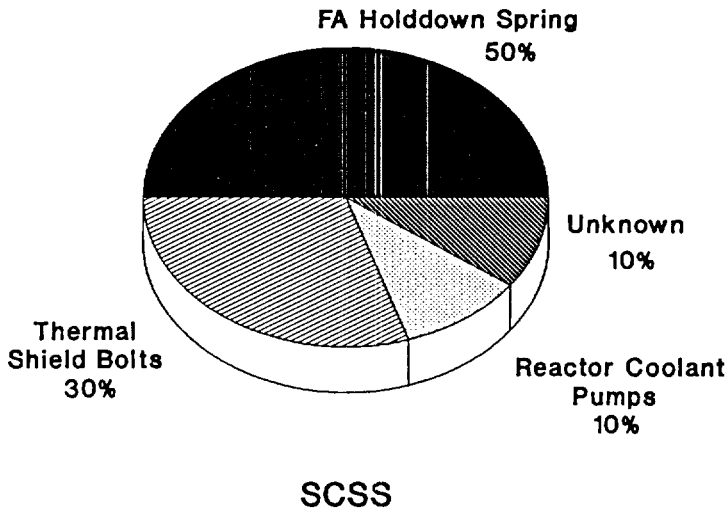
Figure 6.15 B&W Control Rod Drive System Source of Loose Parts

The design life of the CEA is specified as 10 years (13-14 EFPY). The failed CEA exceeded these limits, and was judged acceptable due to its specific exposure history. This failure highlights the need for tracking exposure of the rods, as recommended in Section 5.0, to prevent this failure from occurring.
