NUREG/CR-5555
BNL-NUREG-52232

Aging Assessment of the Westinghouse PWR Control Rod Drive System

Prepared by
W. Gunther, K. Sullivan

Brookhaven National Laboratory

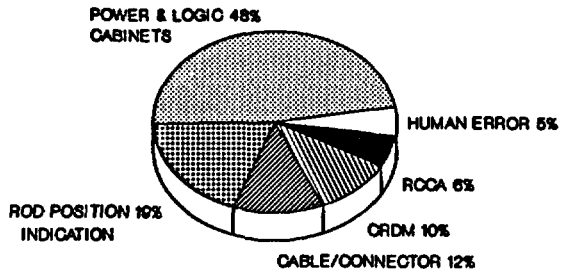
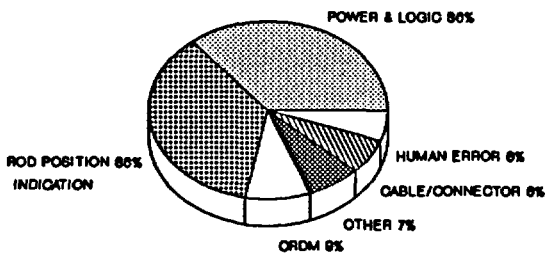
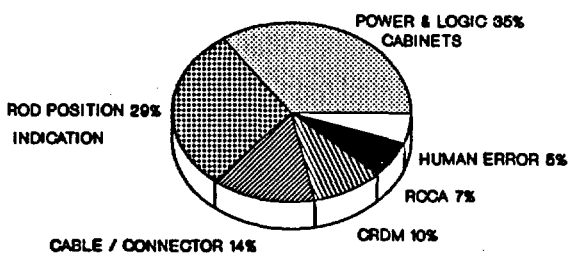
Figure 4.1 CRD failure distribution

As depicted in Figure 4.1, malfunctions within this subassembly were found to be the dominant contributors of reported failures of the CRD system. Of the 163 hardware related NPRDS failure reports reviewed during this study, 83 (51%) were attributed to failures within this subassembly. The review of NPE and LER data produced similar findings, with 51 of the 147 NPE reports (35%) and 45 of the 125 LERs (36%) relating to this subassembly.

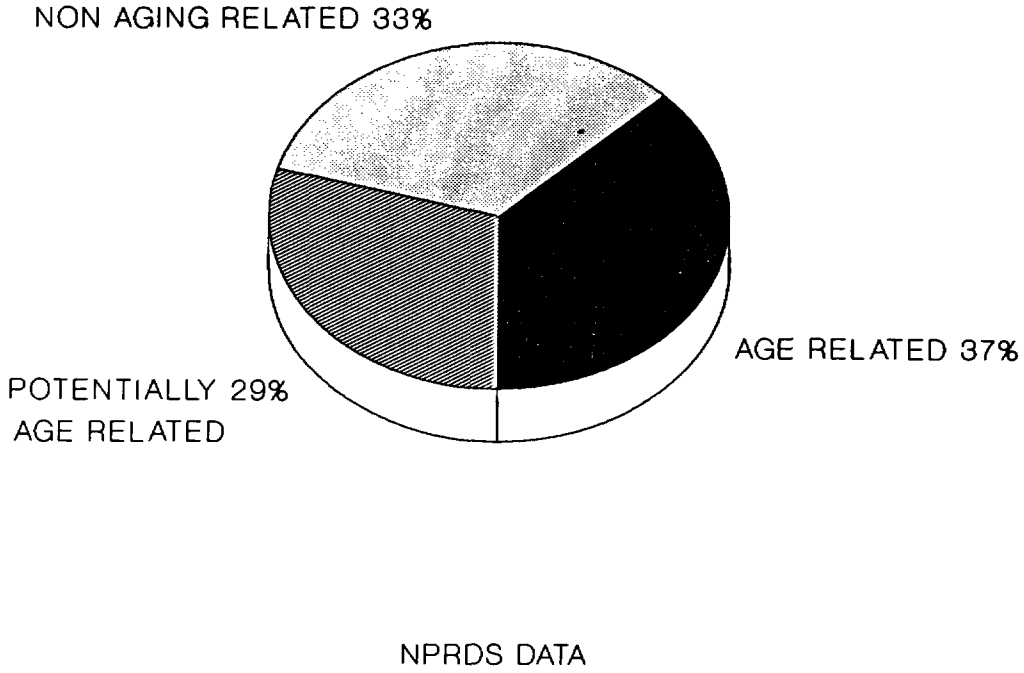
Figure 4.2 CRD system aging fraction

The data were then individually reviewed and sorted to determine the events that were age related. The results are presented in Figure 4.2, which shows that the Westinghouse CRD system is susceptible to age related degradation. A minimum of 37% of all failures fall into this category. Figure 4.2 also shows that a large fraction (29%) of reported failures could not be directly attributed to the age related degradation of components as defined in NUREG-1144, and, therefore, are categorized as "potentially age related".

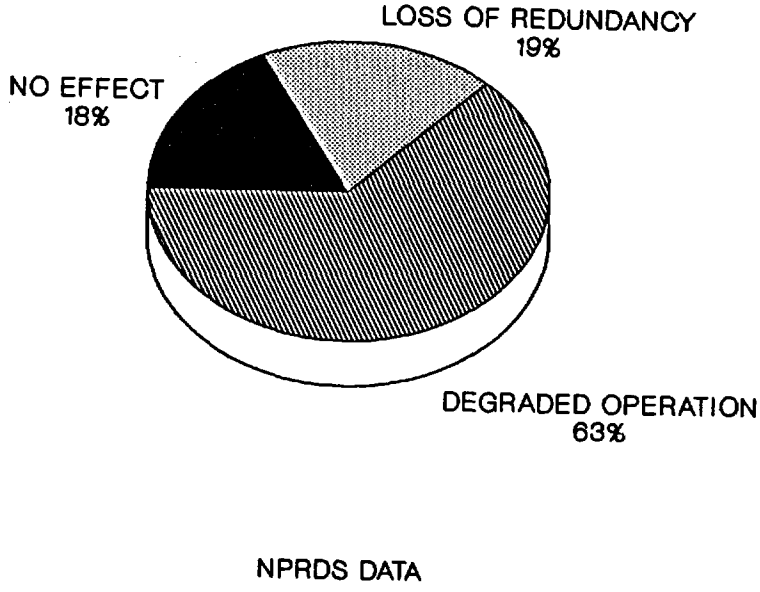
Figure 4.3 Effects of failure on CRD

An evaluation of the Westinghouse CRD system operating experience data was performed to determine the effects on system performance. Figure 4.3 shows the results of this evaluation; over half (63%) of all events reported in the NPRDS resulted in degraded system operation which, if uncorrected, could adversely affect safety.

Nineteen percent of events reported to NPRDS resulted in a loss of component redundancy (Figure 4.3). While the failure of a redundant component may not appear to adversely impact the system's operation, from a PRA standpoint it would decrease the availability in the overall system, and therefore, represents a potentially significant failure effect.

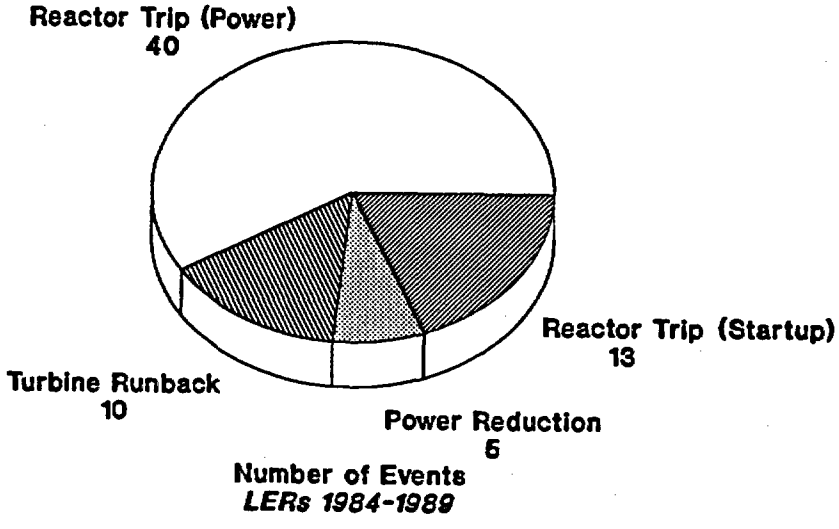
Figure 4.4 Effect of failure on plant operation

Unplanned, automatic trips challenge the operation of the plant's safety systems. Consequently, their occurrence represents a potentially significant increase in plant risk. Figure 4.4 shows the effects of failure on plant performance that were identified in the LER data. Of the 125 LERs obtained, 40 described system failures that resulted in a reactor trip from power operation. Additionally, the NPRDS data identified several important plant/system interactions. The results of this review show that a significant fraction (32%) of CRD system failures reported to the NPRDS directly affected plant performance by either an unplanned shutdown or reducing power.

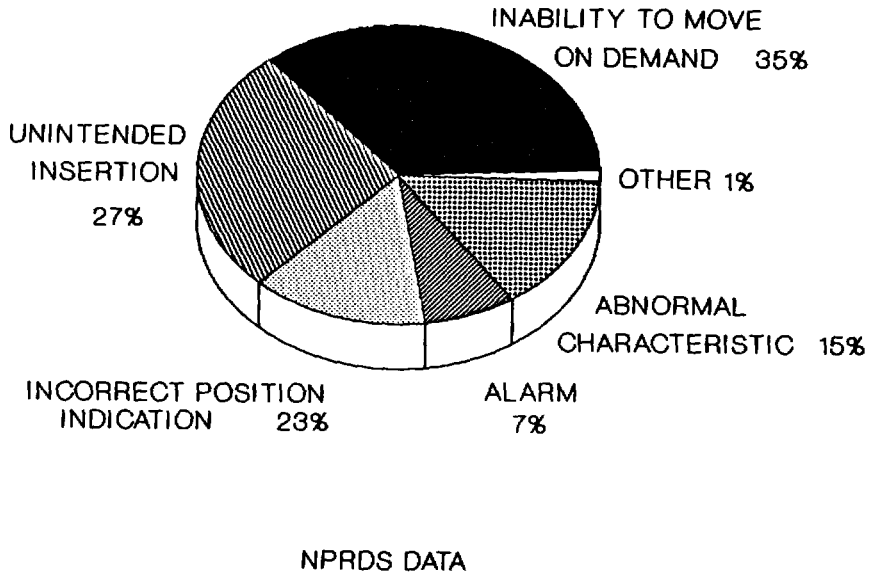
Figure 4.5 CRD system failure modes

A failure mode is a description of the basic manner in which a malfunction in the CRD system was detected. The predominant failure modes of the CRD system that were identified during the review of the NPRDS data are shown in Figure 4.5. The most frequently observed failure modes include the inability to move rods on demand (35%), and unintended rod insertion (27%). Abnormal system operating characteristics of this type are typical consequences of component malfunctions within the power and logic cabinets and are consistent with the identification of this subassembly as the leading contributor to failure of the CRD system.

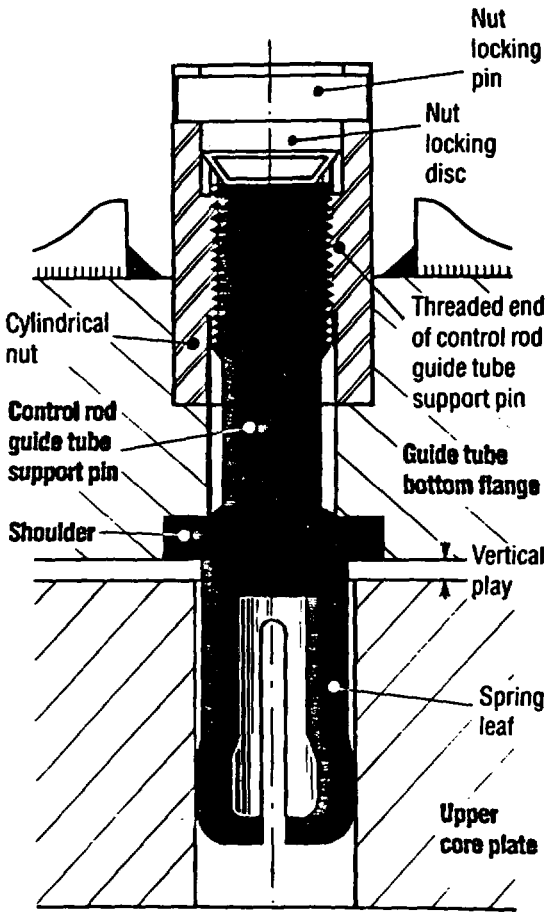
Figure 4.6 Control rod guide tube support pins

A potential consequence of a failure of the support pins is the misalignment of the guide tubes, which could prevent control rod insertion. Westinghouse does not consider this to be credible. Upper Head Injection plants (Sequoyah, McGuire, Catawba, and Watts Bar) have a special retainer welded to the bottom of the guide tube flange that prevents the support pin shoulder from dropping out of the counterbored hole in the guide tube flange.

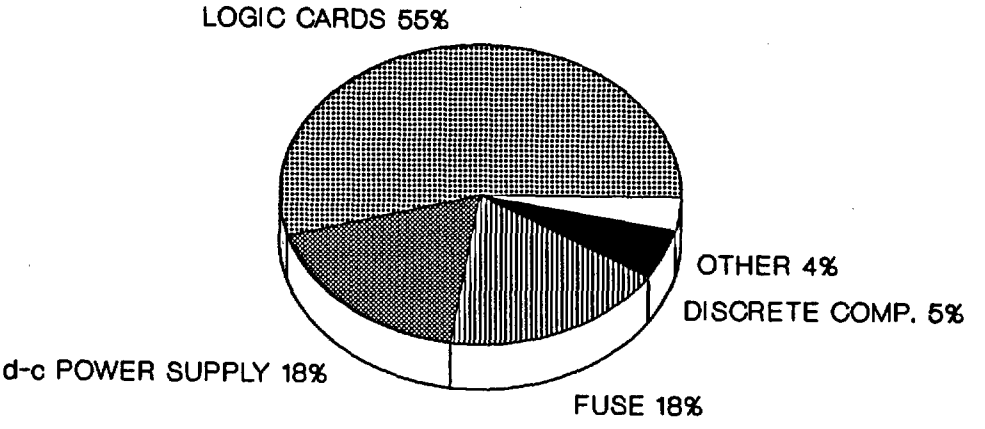
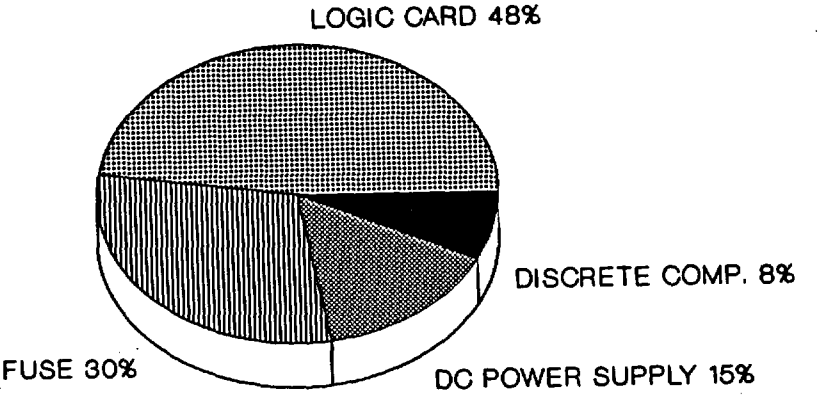
Figure 4.7 Power and logic cabinet subcomponent failures

A further review of the data was performed to evaluate the distribution of failures within the power and logic cabinets and to identify any dominant failure trends in the subcomponents. Figure 4.7 shows the results of this review; printed circuit logic cards are the most frequently failed component, followed by fuses, d-c power supplies, and discrete components. As can be seen in this figure, the distribution of subcomponent failures closely agreed for each database reviewed.

As depicted in Figure 4.7, the failure of discrete components located within the power and logic cabinets have also appeared in the data. These components are independently mounted devices such as thyristors, relays, and transformers.

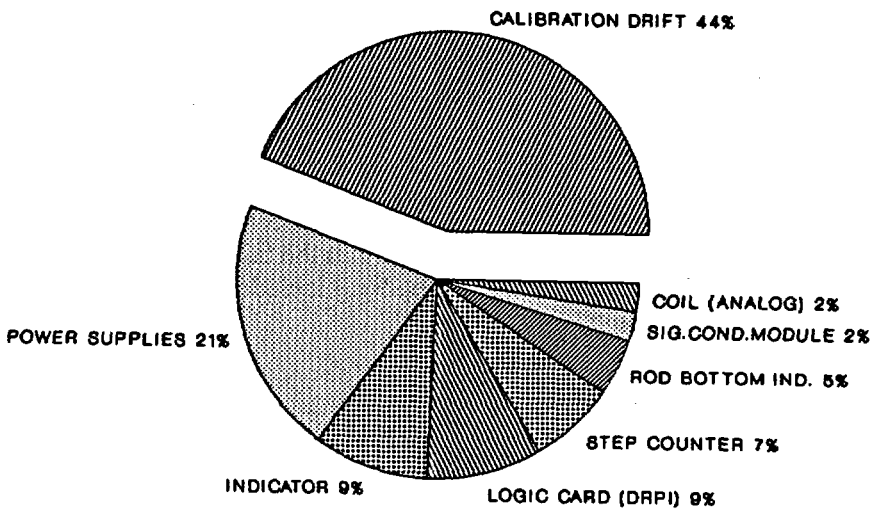
Figure 4.9 Rod position indication system failure causes (1/80 to 12/88)

The distribution of reported component failures within this subsystem is shown in Figure 4.9. As indicated in this figure, problems related to instrument calibration drift primarily involving signal conditioning modules and associated circuitry of the analog IRPI system, were the dominant contributors of failures identified in the NPE data. Additionally, the majority of analog IRPI failures occurred at a component age of greater than 10 years.

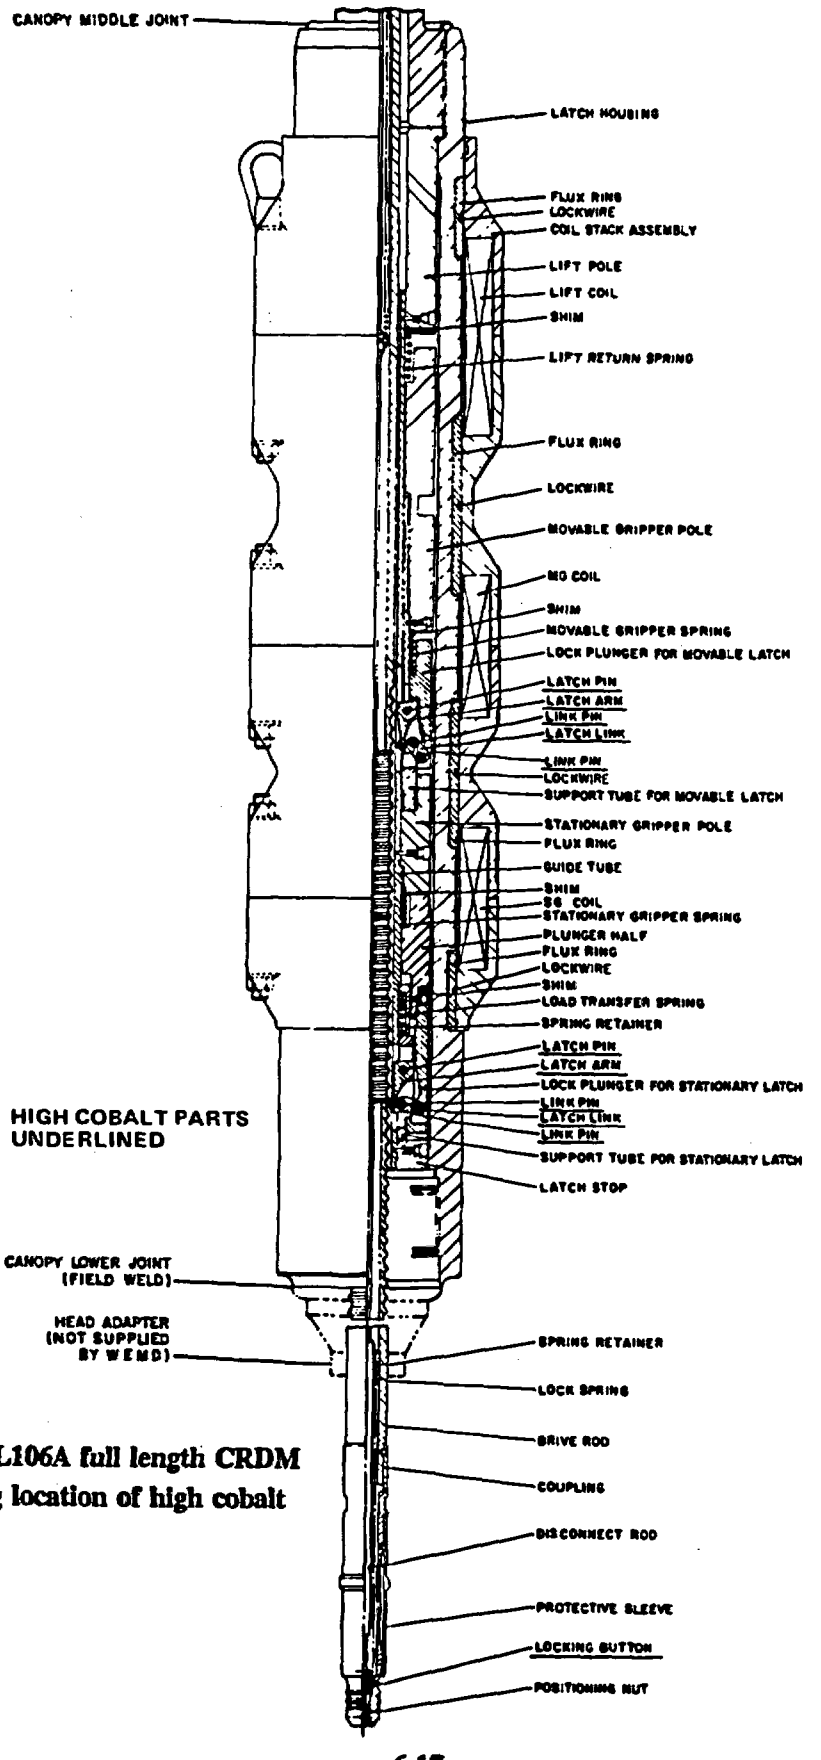
Figure 6.7 Model L106A full length CRDM showing location of high cobalt parts[19]

Programs aimed at reducing the cobalt inventory in a nuclear plant have identified the Westinghouse CRDM as one of the significant contributors due to the wear of its subcomponents[19]. As illustrated in Figure 6.7, the CRDM latch assemblies and the locking button at the base of the drive rod are the parts with a high cobalt content that are subject to wear.

Life tests have been conducted in which the wear of the high cobalt material was measured. These life tests represented 20 years of plant operation and indicated that the wear of the high cobalt material could range from 265 grams to 751 grams for 53 CRDMs. It should be noted that the life cycle testing assumed a high (conservative) number of steps over the 20 year cycle but does not include a loss of material due to corrosion.
