SHAG Test Series

Seismic Research on an Aged United States Gate Valve
and on a Piping System in the Decommissioned
Heissdampfreaktor (HDR): Appendices

Prepared by R. Steele, Jr., J. G. Arendts

Idaho National Engineering Laboratory
EG&G Idaho, Inc

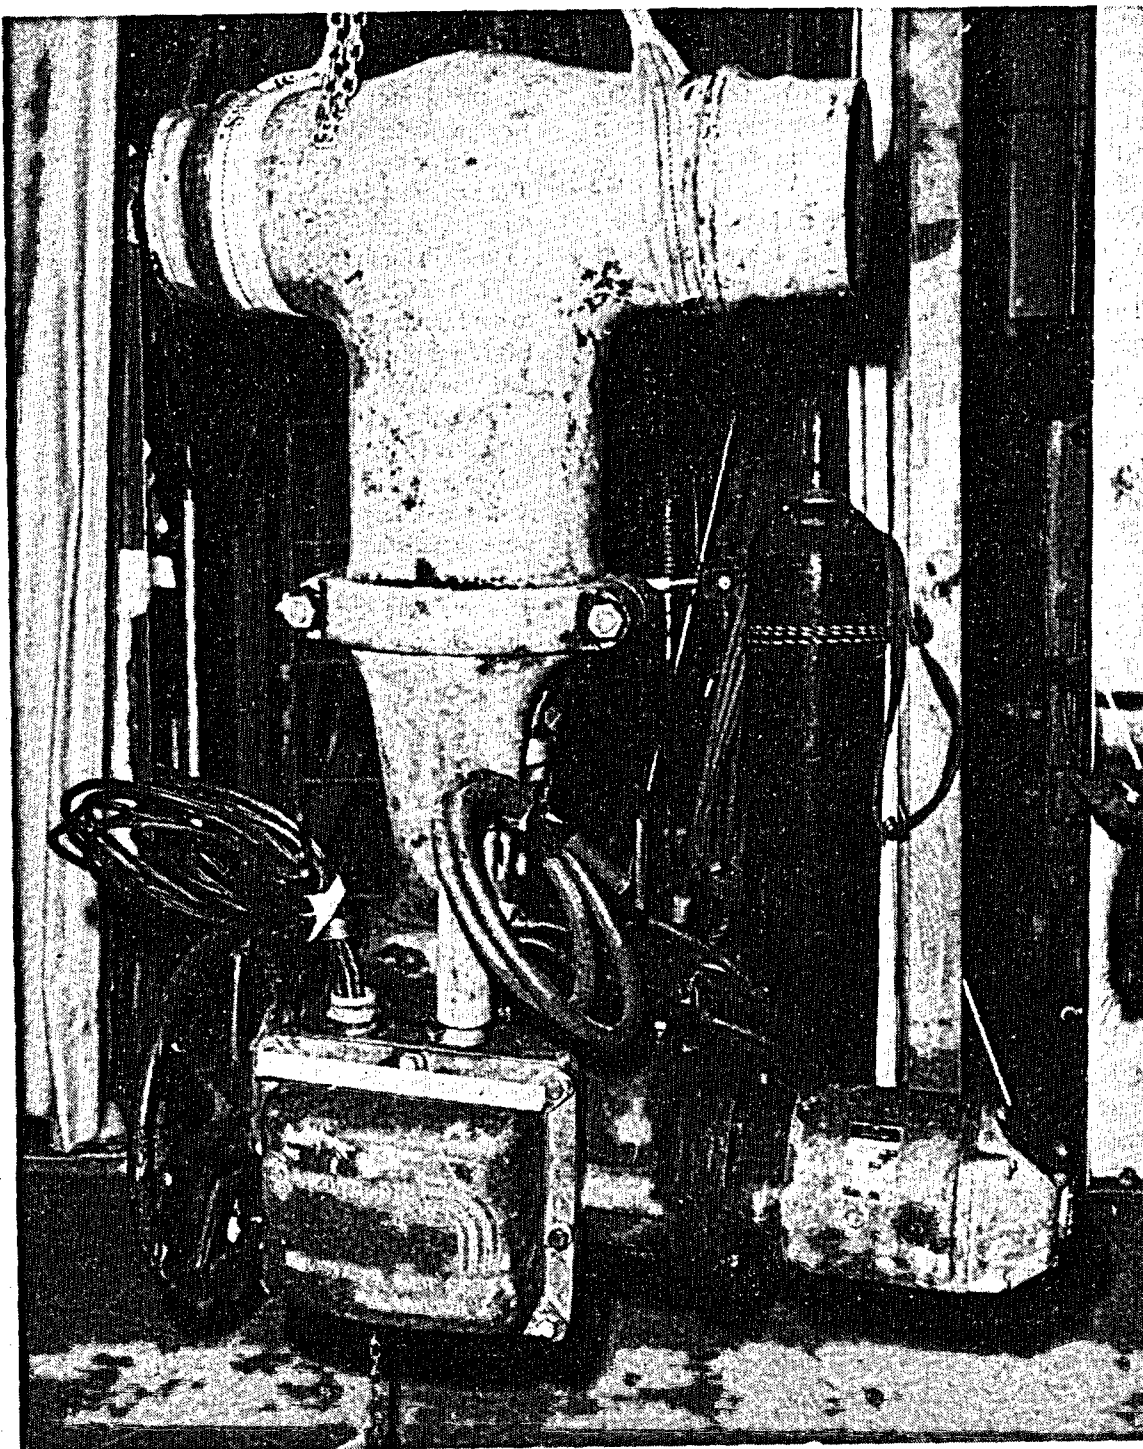
Figure A-1. Eight-inch gate valve and actuator in "as received" condition.

The valve was supplied from Shippingport with 8-in., Schedule-80 pipe stubs (safe ends) butt-welded to the valve body (see Figure A-1). One pipe stub measured 3.25-in. long; the other measured a minimum length of 1 in. A weld backing ring was found tack-welded to the inside of the 3.25-in.-long pipe-stub-to-body weld. The backing ring was removed by grinding out the tack welds. The 1-in. pipe stub was removed because it was too short to weld a flange to.

The valve was manually opened using the actuator handwheel. The valve was observed to operate smoothly. However, initial inspection of the valve assembly indicated the valve actuator handwheel handle was broken off. No other damage was observed on the outside of the valve.

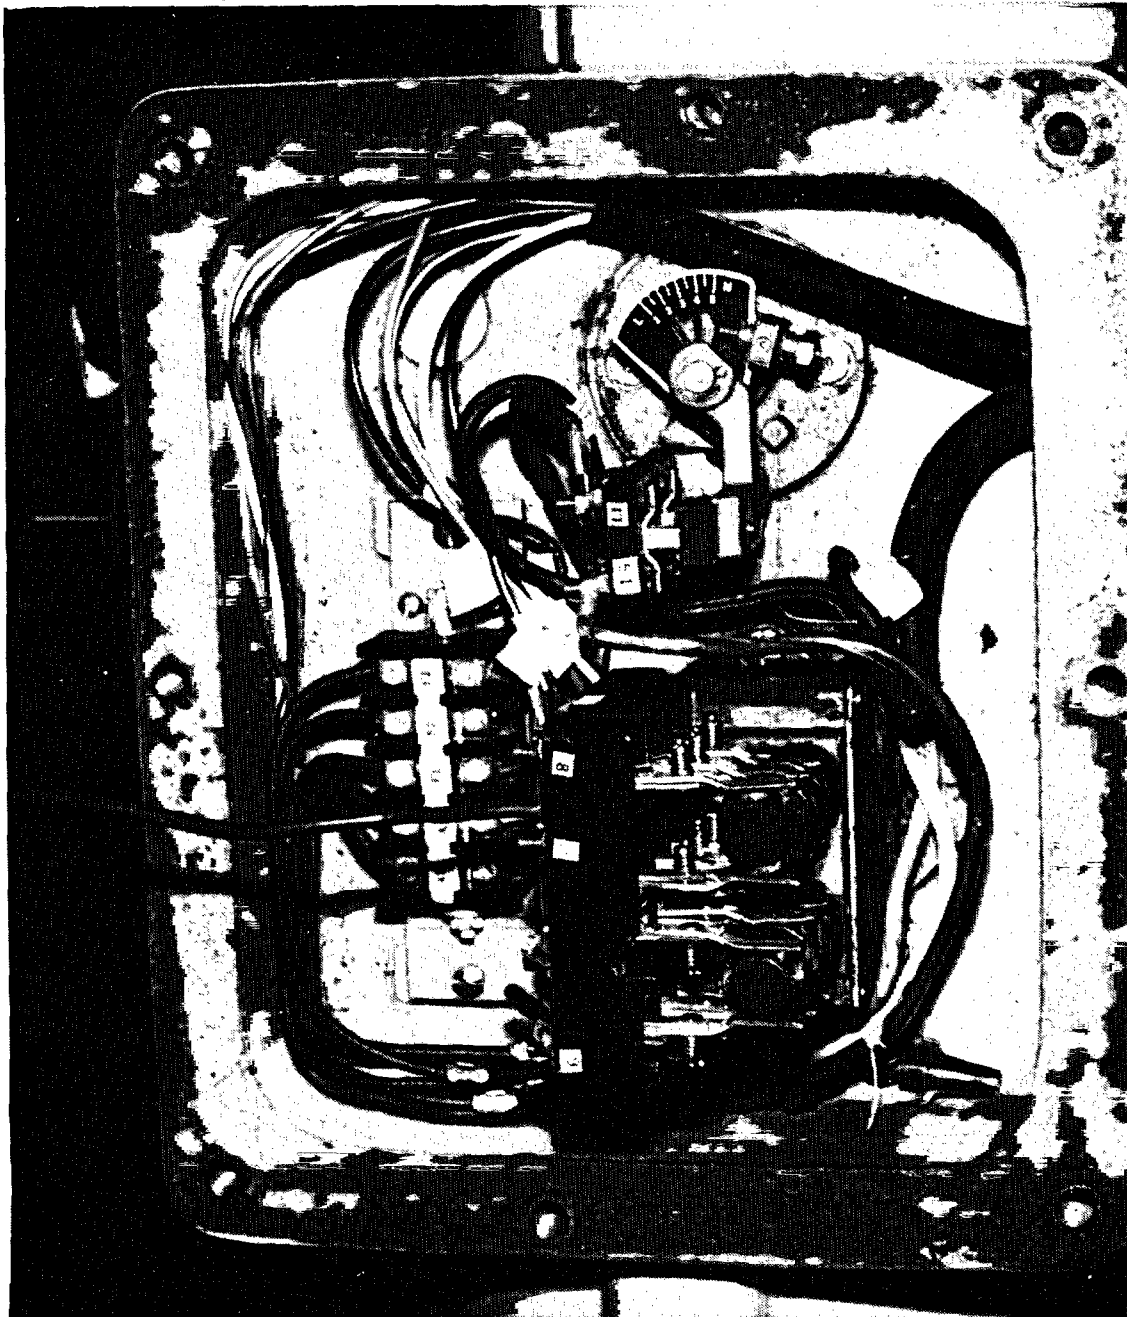
The compartment cover of the valve limit switch was opened and the components shown in Figure A-2 were visually inspected. No sign of moisture, corrosion, wear, or damage was observed. The limit switch and torque switch shaft penetration seals were also inspected. No sign of grease weepage into the limit switch compartment from the actuator housing was observed, indicating the shaft seals were satisfactory. The torque switch setting, "as received," was 2. Initial discussion with the Limitorque Corp., Lynchburg, Virginia, determined that a set point of 2 corresponds to a stem thrust load of approximately 12,000 lb. (After dynamometer testing at Lynchburg, however, old documents were found indicating that a torque switch setting of 3 was required to achieve the 12,000-lb thrust.)

Figure A-2. Limitorque actuator limit switch compartment.

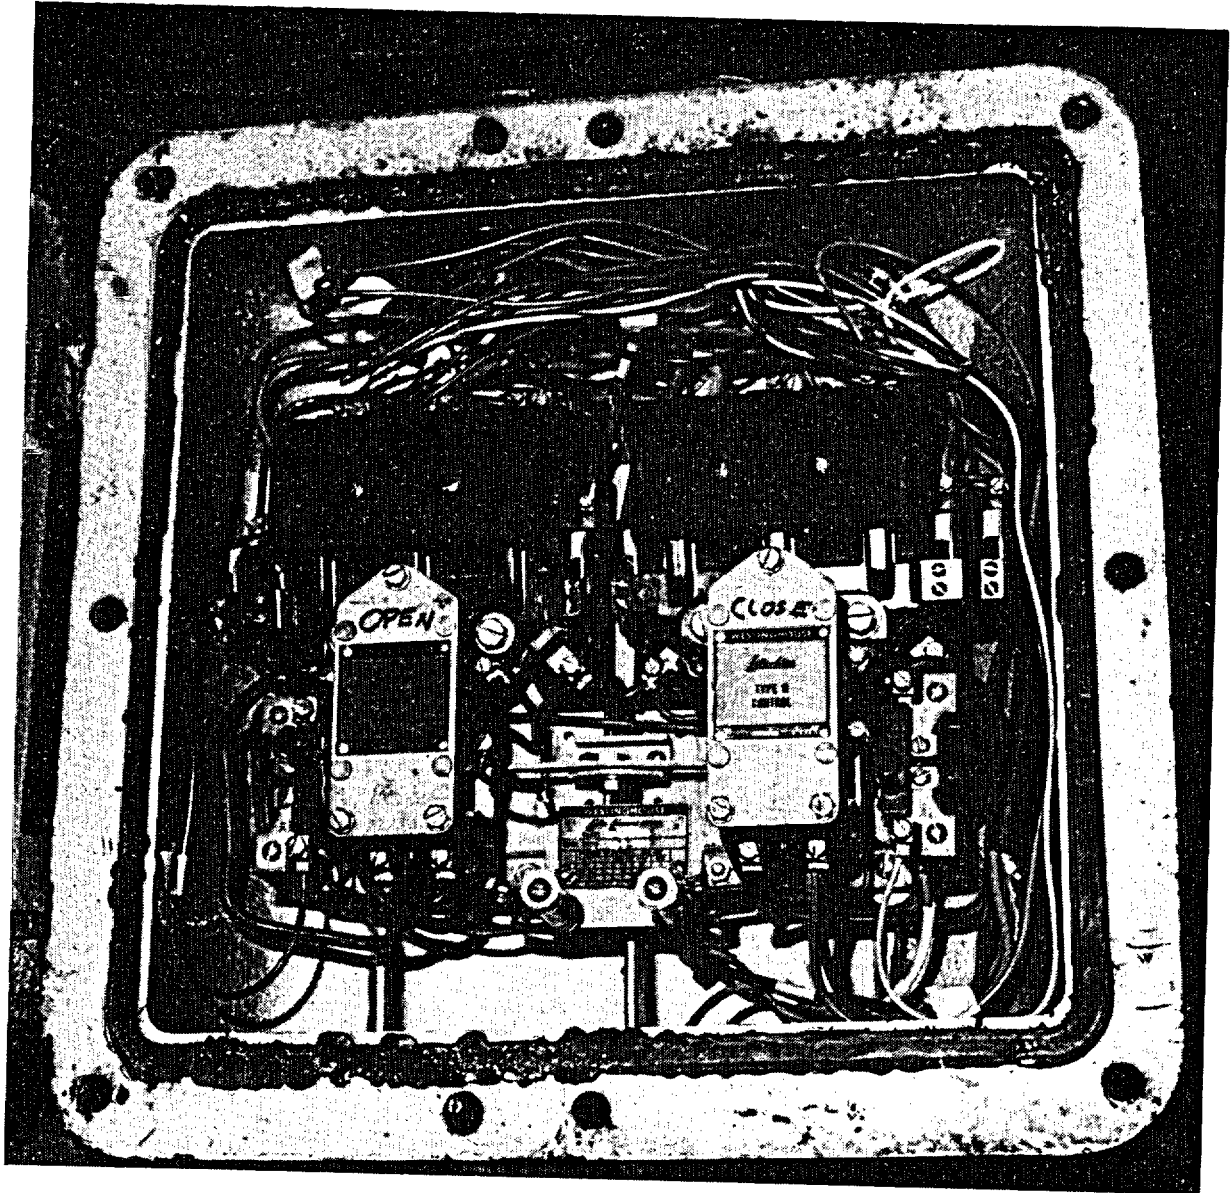
The motor controller and 3-position panel switch for the valve were shipped separately from Shippingport. The cover on the motor controller unit was removed, and the internal components shown in Figure A-3 were inspected. No evidence of moisture, corrosion, or damage was found inside the controller. One mounting screw from a terminal block or contact set was found loose in the housing and was replaced. The contact sets were operated by hand and found to operate smoothly. All circuits were resistance-checked and found satisfactory. The insulation resistance was tested at 500 V and found satisfactory. The 3-position switch was also inspected and found to be in good working condition.

Figure A-3. Limitorque actuator motor controller.

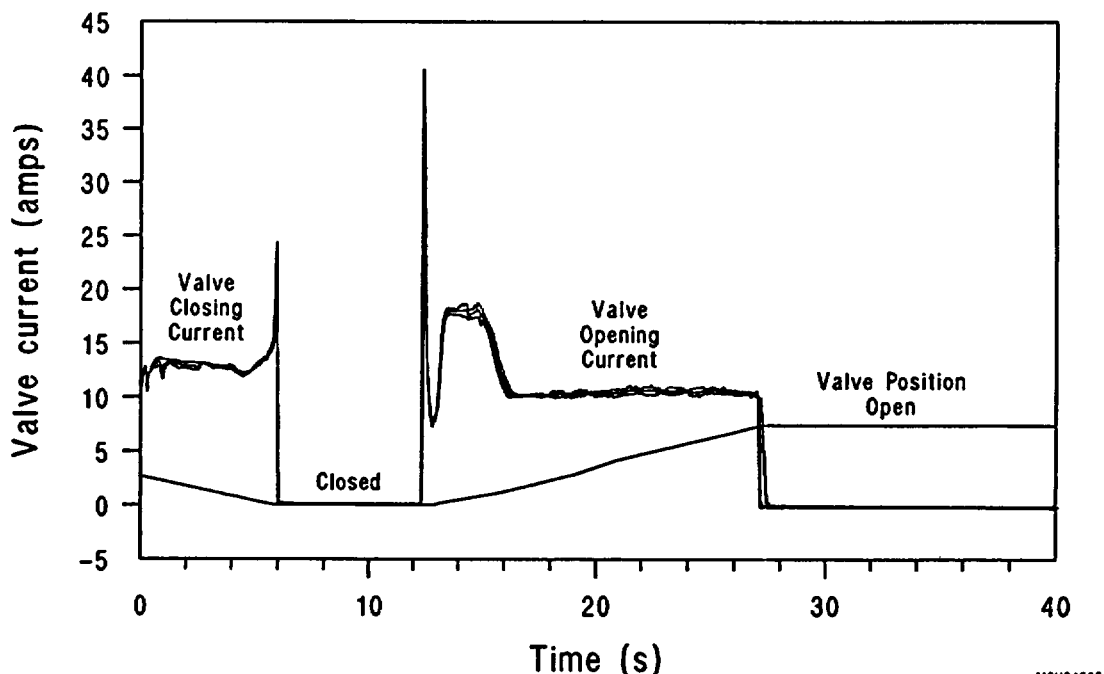
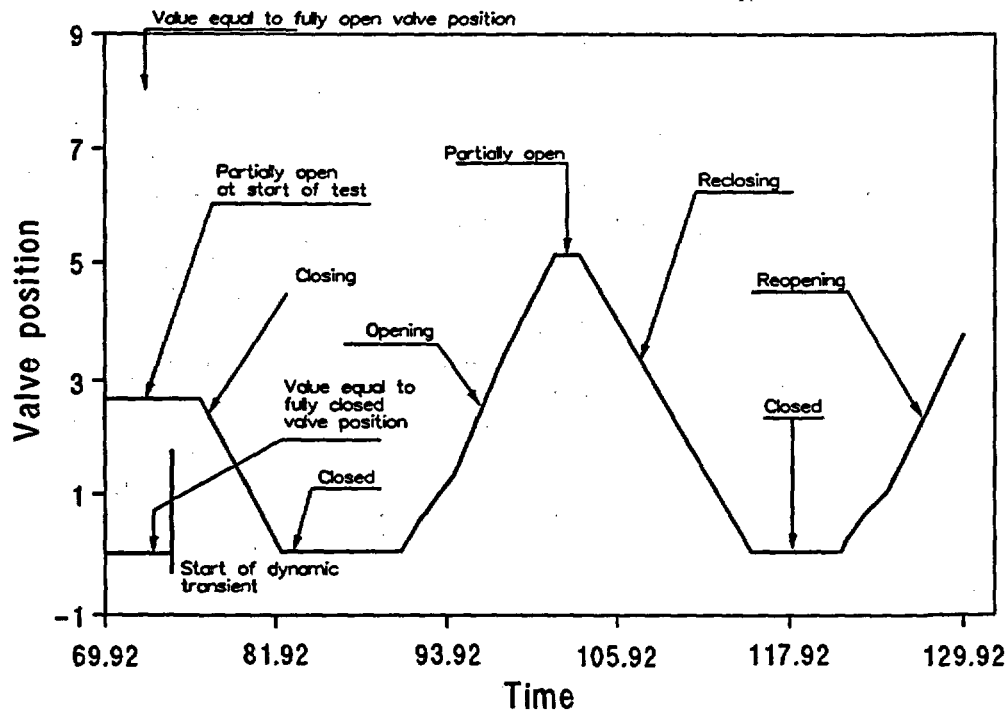
Figure A-7. Composite time histories for valve position and current.

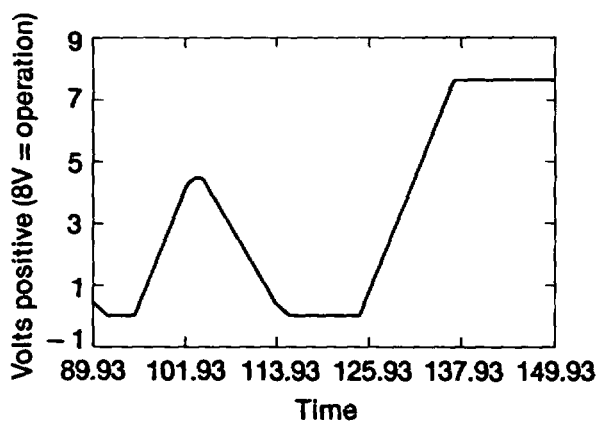
Figures A-10 and A-11 show the valve position and valve current histories for two-cycle hot test T40.52; Figures A-12 and A-13 show corresponding histories for a single-cycle hot test. Both sets of figures are typical examples showing the valve's failure to torque out on closing during hot testing.

Figure A-10. Valve position versus time during a two-cycle, elevated temperature valve test.

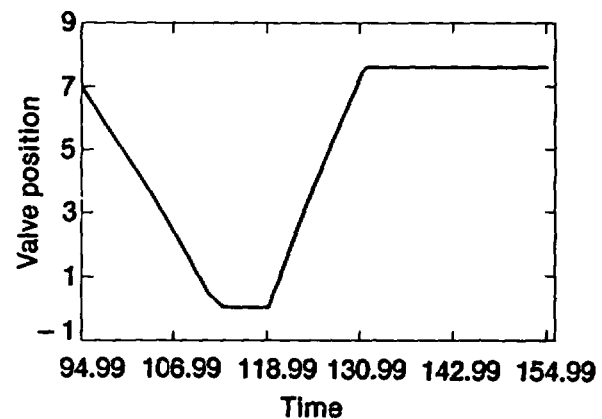
Figure A-12. Valve position versus time during a single-cycle, elevated temperature valve test.

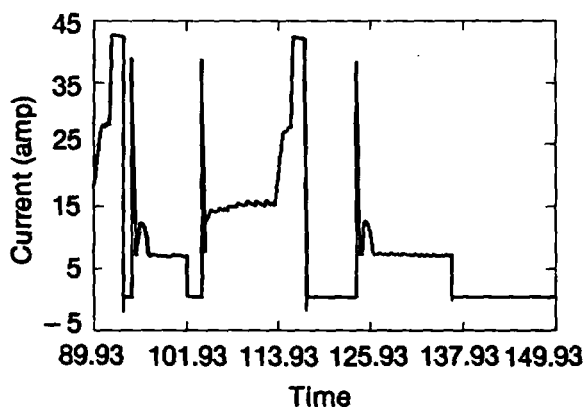
Figure A-11. Valve current versus time during a two-cycle, elevated temperature valve test.

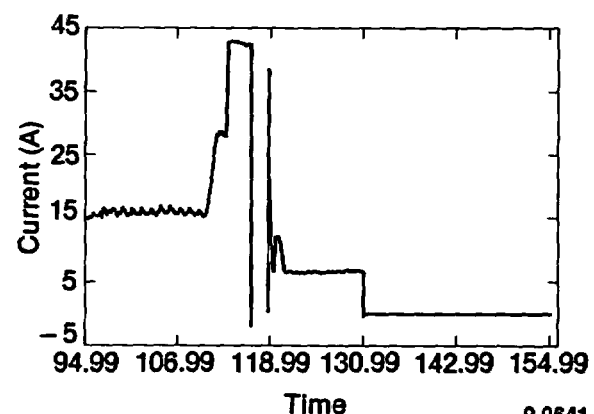
Figure A-13. Valve current versus time during a single-cycle, elevated temperature valve test.

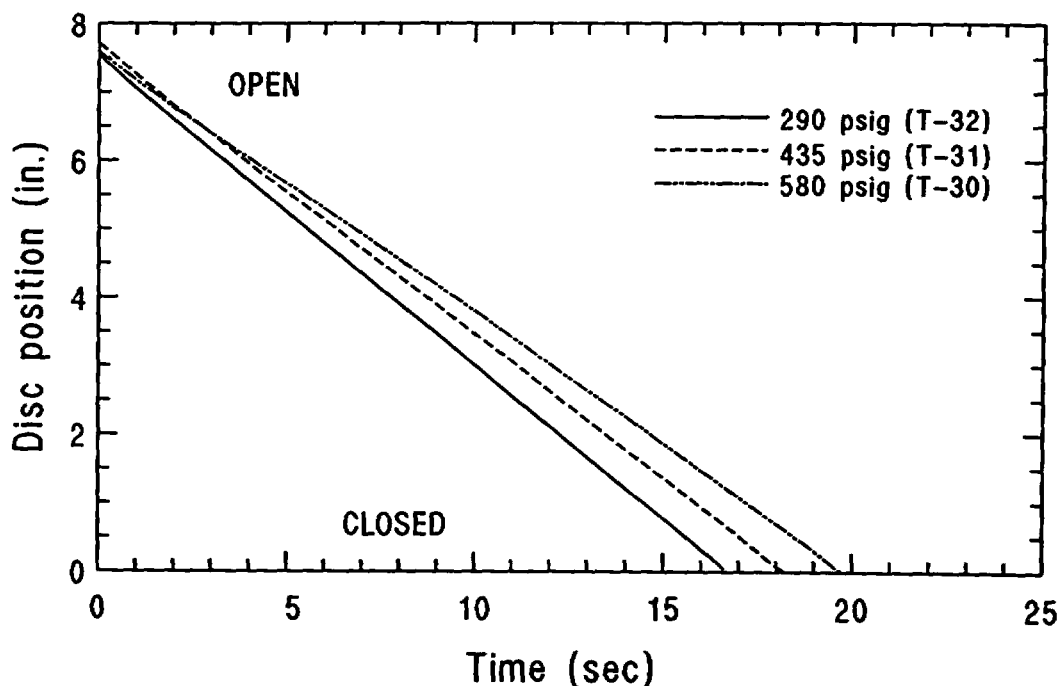
Figures A-15 and A-16 show this valve disc velocity relationship for the valve closing stroke at three pressures with and without flow. With pressure alone (no flow), the stroke time increases with pressure (Figure A-15). Note in Figure A-16 the decrease in the disc velocity, indicated by the slope of the trace, for all three pressure cases (with flow) as the disc approaches the closed position. In the cases with flow, the torque switch failed to open. The extent to which the valve remains open is increasingly greater with each increase in pressure combined with the flow load. Figure A-17 shows a 147 psig static pressure case with flow, along with the three pressure cases shown in Figure A-16. The disc velocity near closing for the

Figure A-15. Valve position during closing stroke under three different static pressure loads with no flow.

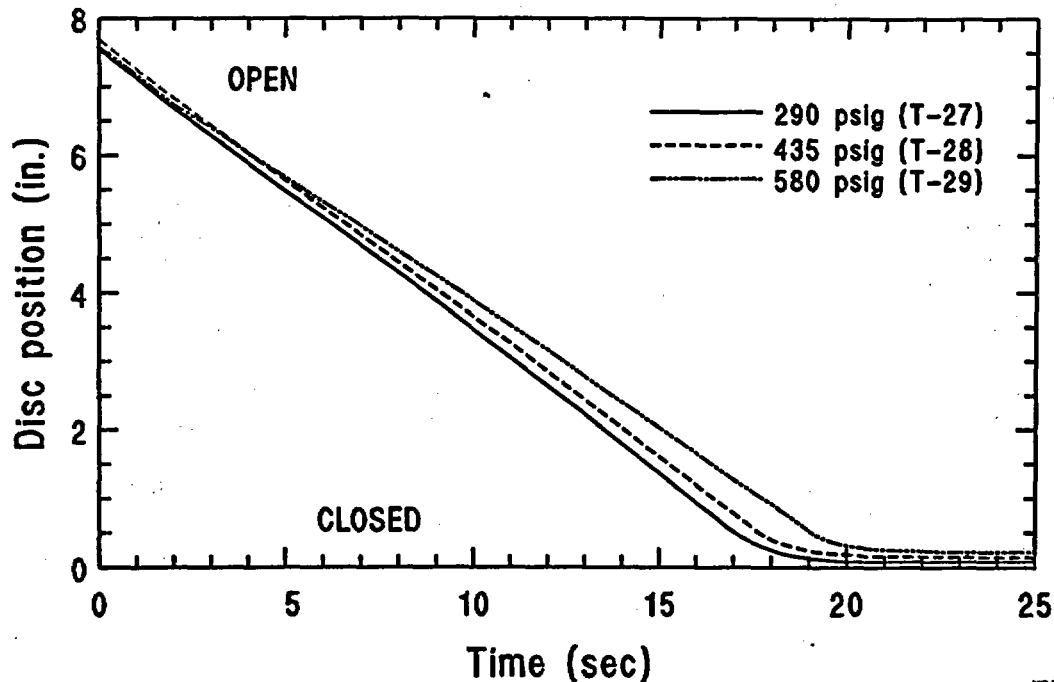
147 psig pressure case does not decrease as much as it does for the higher pressure cases. In   .. , the valve torque switch opened. The valve stem area is 2.77 square inches. The difference between the torque switch opening and failing to open is the 407 lbf reduction in the stem rejection load.

Figure A-16. Valve position during closing stroke with flow (360 gpm) under three different static pressure loads.

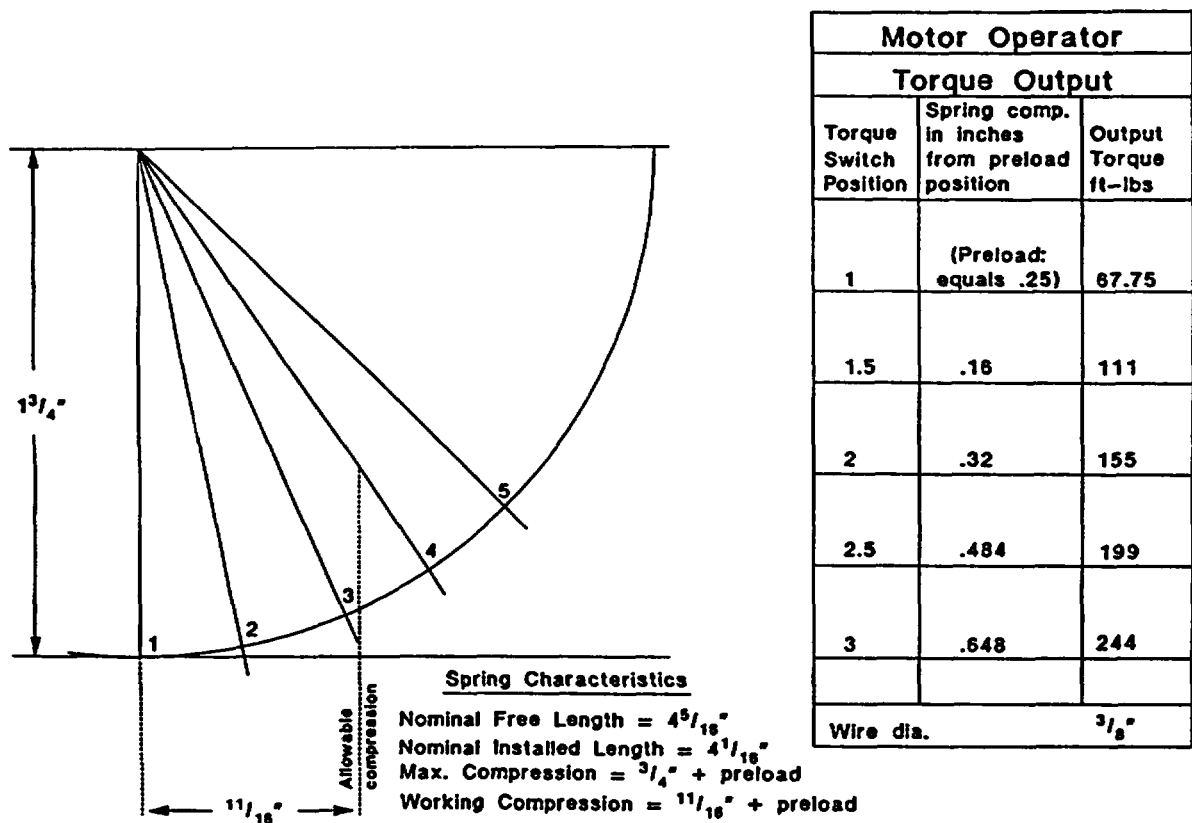
Figure A-18. Torque switch setting versus spring compression and torque output (HDR valve).

During the disassembly of the actuator to remove the old spring, it was noted that there was no preload on the old spring. The preload should have been .25 in., as can be seen in Figure A-18. The information contained in this figure was not obtained from Limitorque until after the spring testing had been completed. As shown in Figure A-18, the maximum allowed compression was 0.75 in. plus 0.25 in. preload. This explains why the new spring showed significant yielding after one inch of travel during the first test. It also shows why there was no preload on the old spring. The correct installed length for the spring is 4 1/16 in., and the old spring was slightly less than 4 in. long. This confirms the hypothesis developed during the dynamometer testing at Limitorque that the torque spring was too short, requiring a higher torque switch setting to achieve the torque output versus torque switch setting shown on Figure A-18.

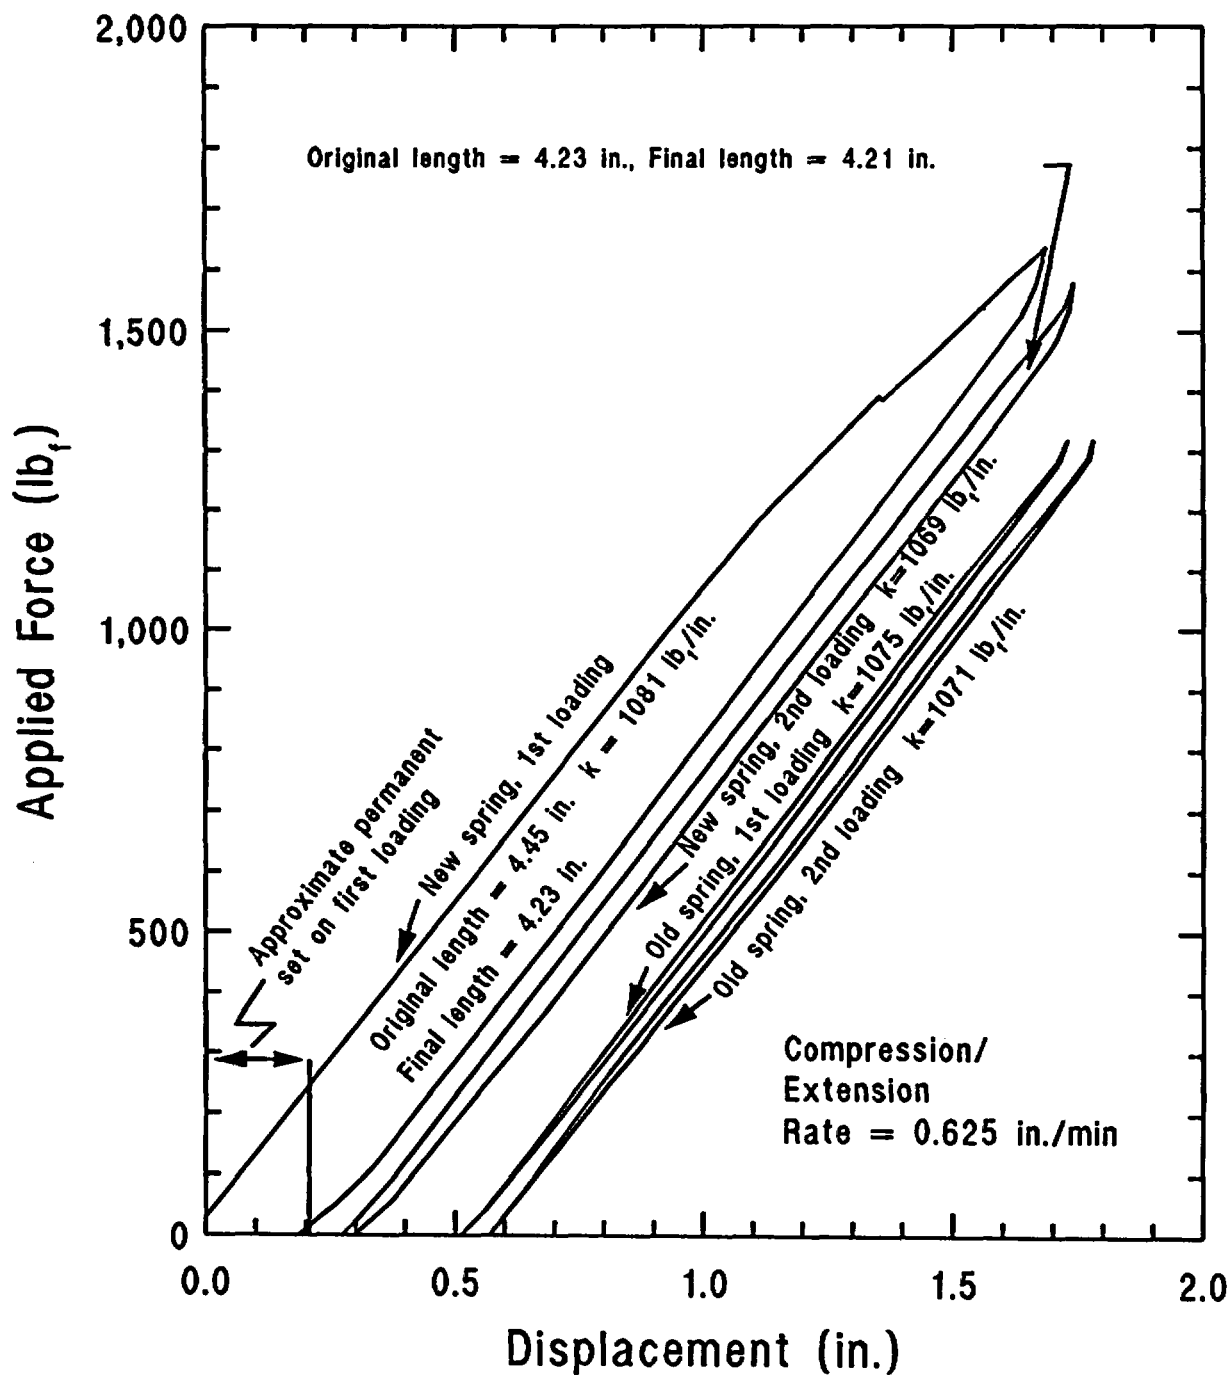
Another spring, similar to the spring in the HDR Shippingport valve assembly, was obtained from Oak Ridge National Laboratory (ORNL). This spring was removed from Shippingport valve Number 54475D with a Limitorque motor operator type SMA-1 S/N 08531A. The free length of this spring was 3.745 in. Figure A-22 shows the relationship of torque switch setting versus spring compression for the ORNL valve, as Figure A-18 does for the INEL/HDR Shippingport valve. The information obtained from Limitorque used to draw Figure A-22 specified two springs with different free lengths: 3-7/8 in. and 3-13/16 in., as shown. Limitorque did not know from the old records which of the two springs was installed in this valve. This spring is short by either slightly more than 3/16 in. or slightly more than 1/16 in., depending on which

Figure A-21. Load testing of old and new torque springs.

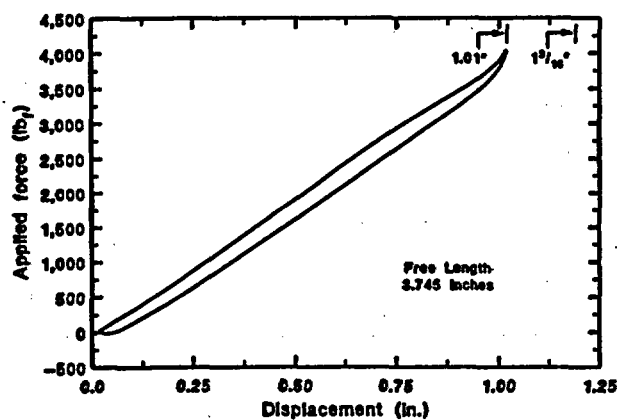
Figure A-23. Load testing of ORNL torque spring.

spring was used. Figure A-23 shows the load test for this spring. The total allowable elastic travel for this spring should be 1.188 or 1-3/16 in. plus or minus a small margin for tolerances. As can be seen from the load test, the spring went nonlinear at 1.01 in. The difference between the allowable installed travel (1.188 in.) and the load test travel (1.01 in.) provides a good indication the spring was originally 3-7/8 in. long and has nearly 3/16-in. permanent set. The ORNL valve, like the Shippingport valve, was a normally closed valve, which means the spring was normally in the compressed position for the life of service (>25 years). It is believed this near full time compression may accelerated spring aging.

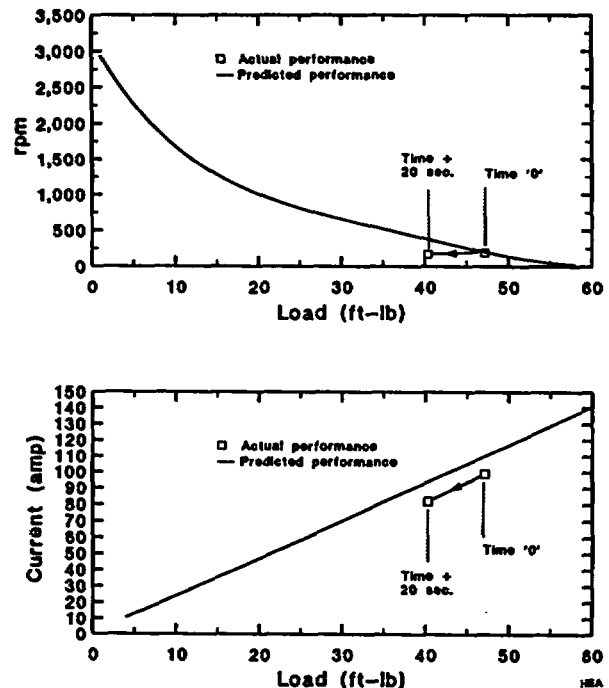
Another test was conducted to evaluate the effects of motor heating. Before the test, the motor load was adjusted to 45 ft-lb, and then the motor was cooled to ambient temperature. The motor was brought to speed without a load, and the preset load was then applied. The motor speed slowed immediately and stabilized within 2 seconds. Figure A-25 shows the results of this test. The load was applied for 20 seconds. Internal motor heating caused the motor to drop in current demand at 1 amp per second for 20 seconds. In round numbers, for each 2-amp reduction in demand, motor output is reduced by one ft-lb of torque. The motor output performance was reduced by 10 ft-lb in 20 seconds.

Figure A-25. Effects of motor heating on motor output.

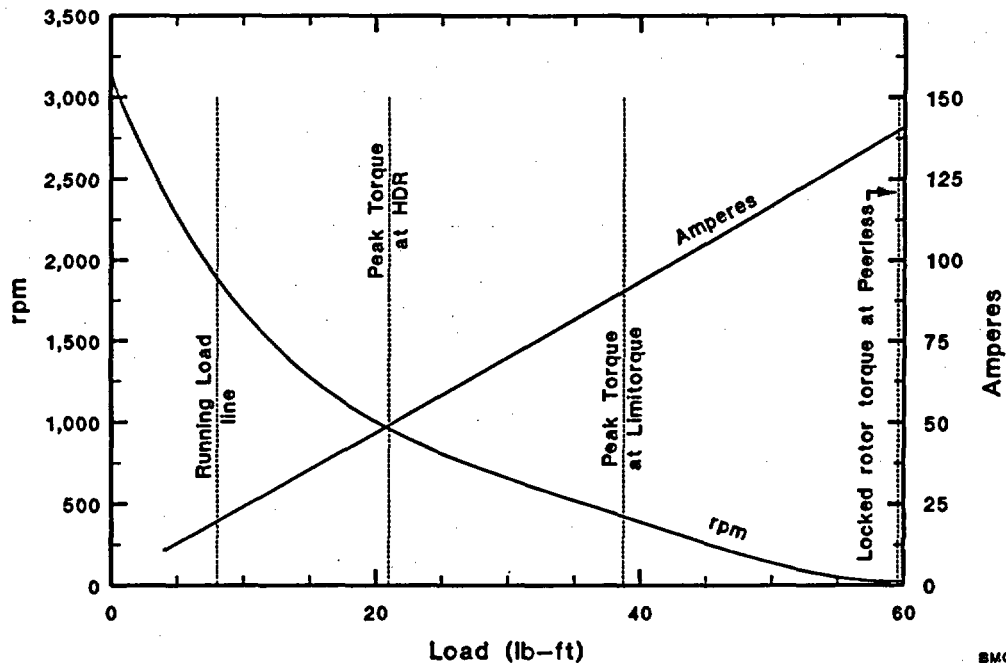
The engineers at Peerless supplied a motor performance curve for the subject motor (Figure A-26). Performance characteristics shown on this plot are similar to those shown on the one Limitorque had supplied earlier in the program (Figure A-14). Figure A-26 also shows the peak torque obtained in each of the parametric test programs.

Figure A-26. Motor performance curve obtained from Peerless Motors and peak torque values obtained during testing.

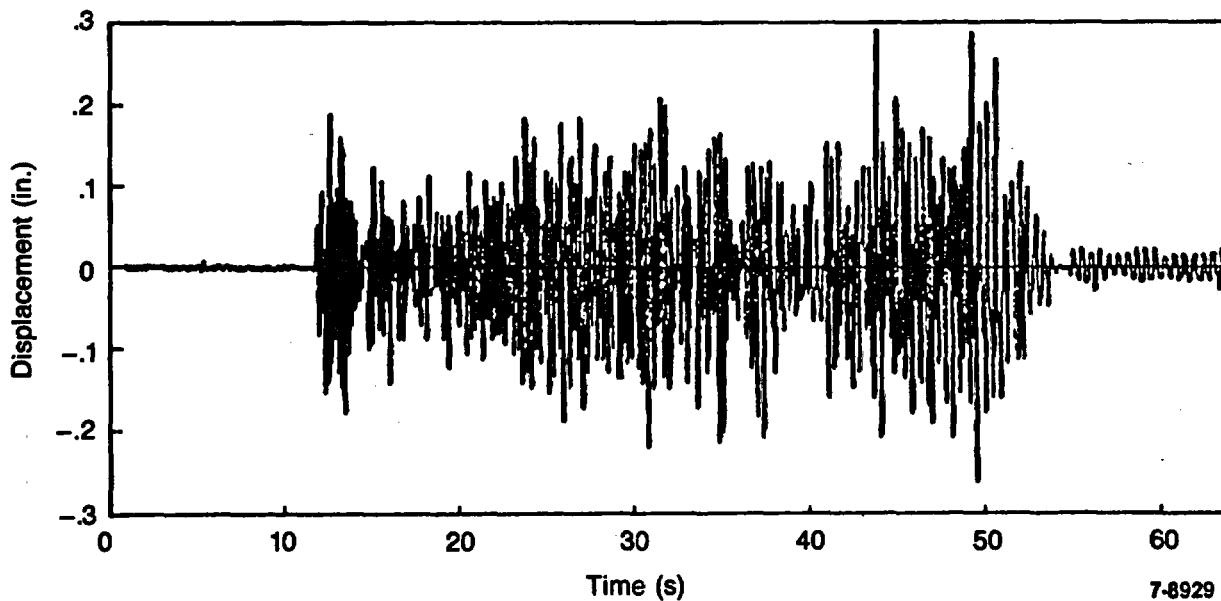
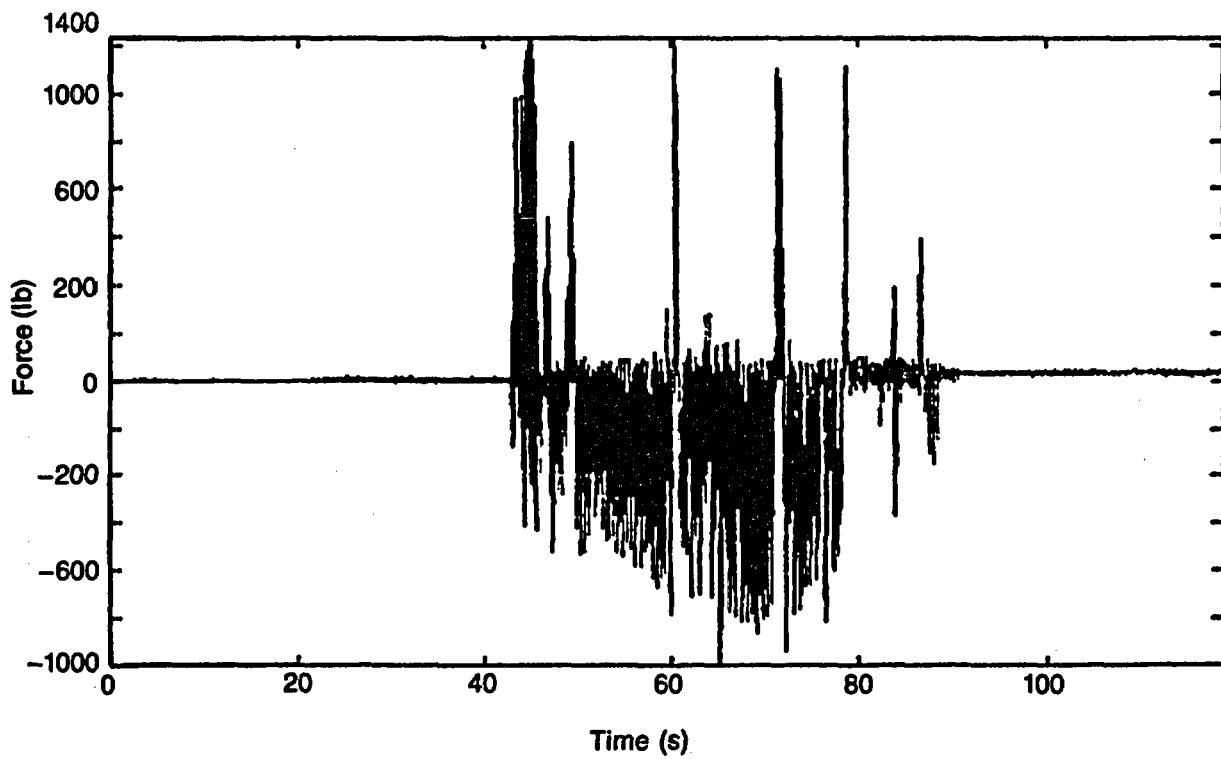
Figure C-4. Comparison of force and displacement at support location H-6. Note the erratic behavior of the snubber from 45 to 80 s. The snubber is locking up only in the negative direction throughout most of this period.

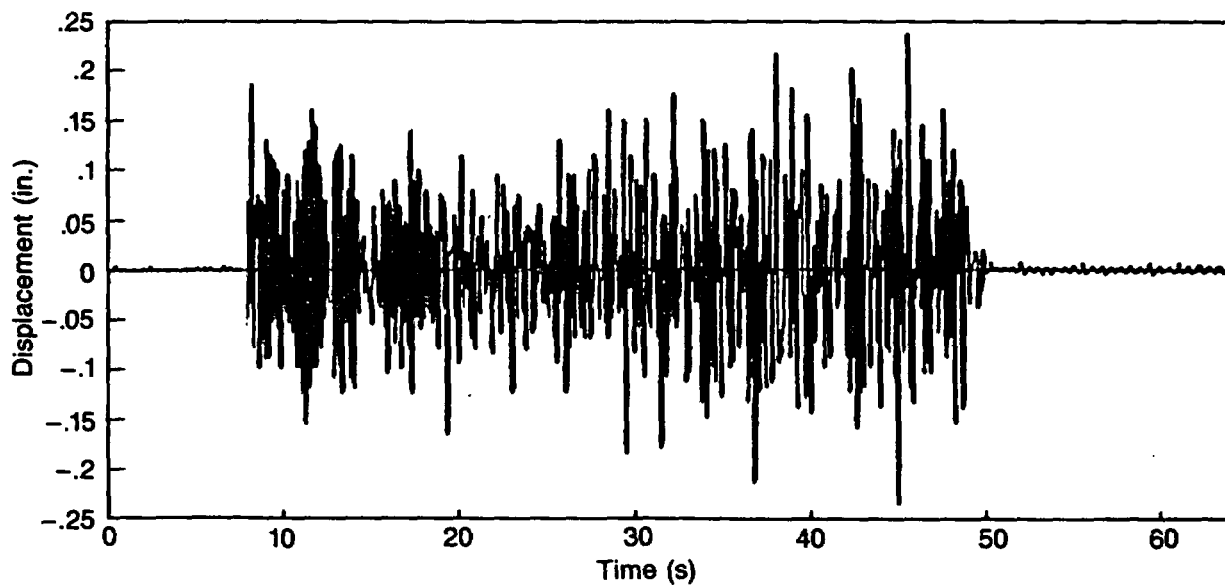
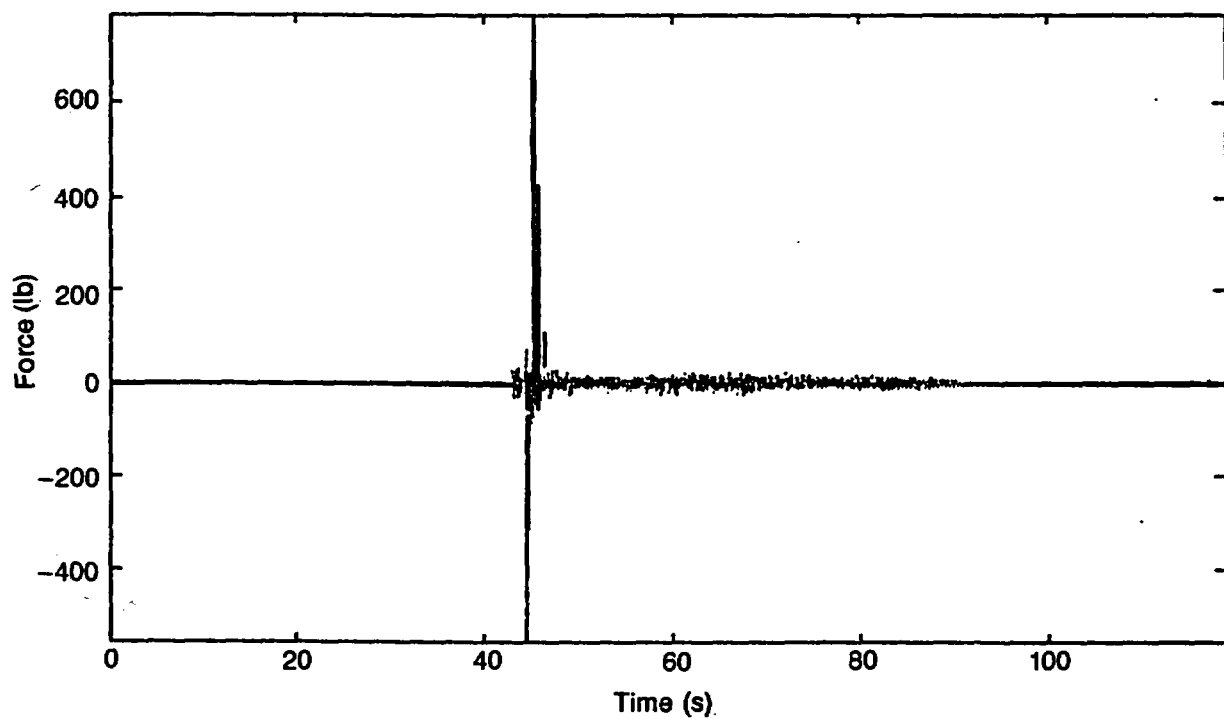
Figure C-5. Comparison of force and displacement at support location H-8. This snubber resisted motion for only 2 or 3 s.

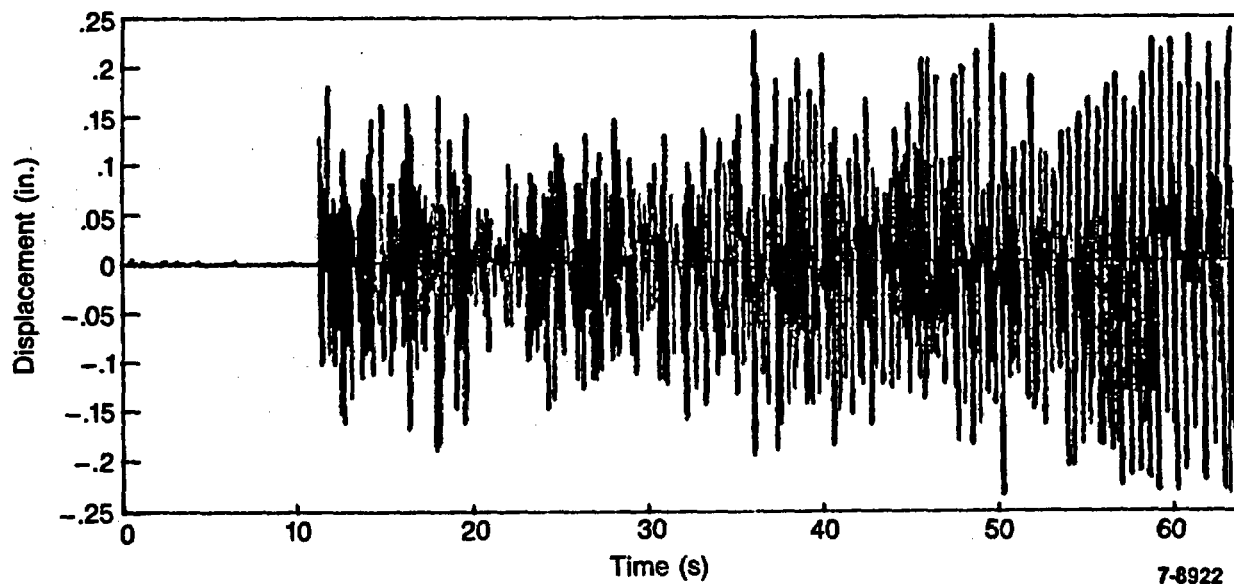
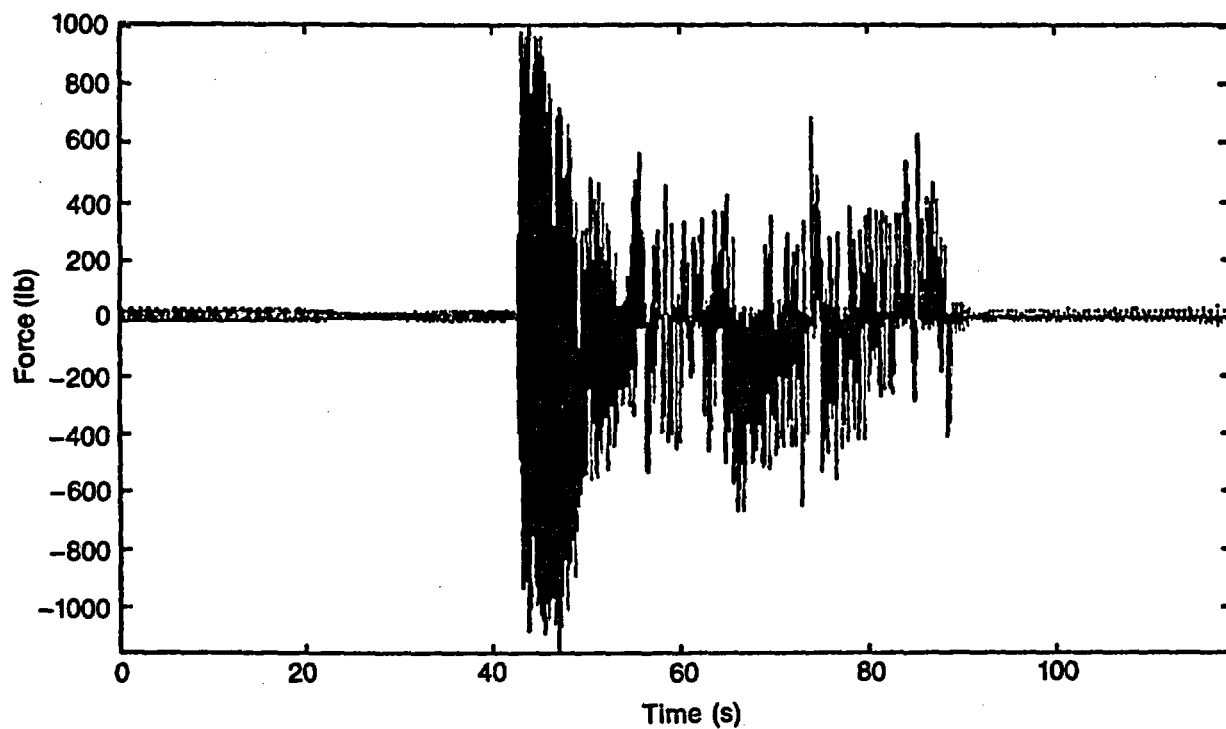
Figure C-6. Comparison of force and displacement at snubber location H-7. This snubber performed reasonably well from 40 to 80 s. Note that as the snubber performance becomes more erratic, the displacement increases.

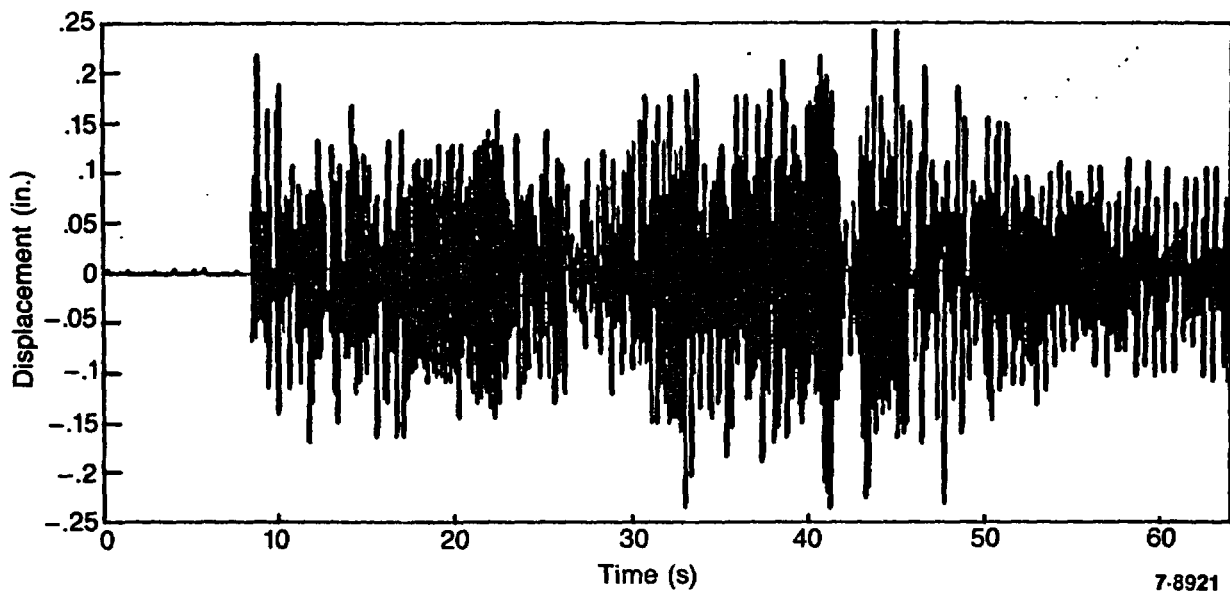
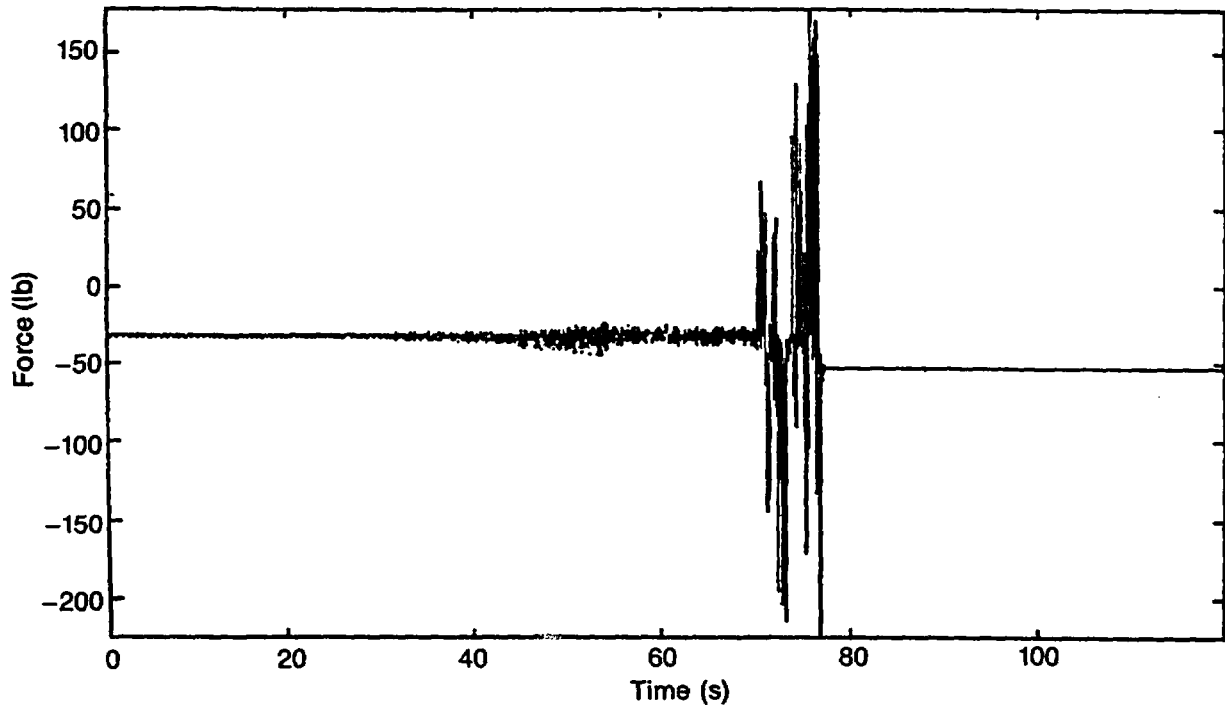
Figure C-7. Comparison of force and displacement at snubber location H-12. This snubber operated erratically for a few seconds then failed to resist motion for the remainder of the transient.
