SHAG Test Series

Seismic Research on an Aged United States Gate Valve
and on a Piping System in the Decommissioned
Heissdampfreaktor (HDR): Appendices

Prepared by R. Steele, Jr., J. G. Arendts

Idaho National Engineering Laboratory
EG&G Idaho, Inc

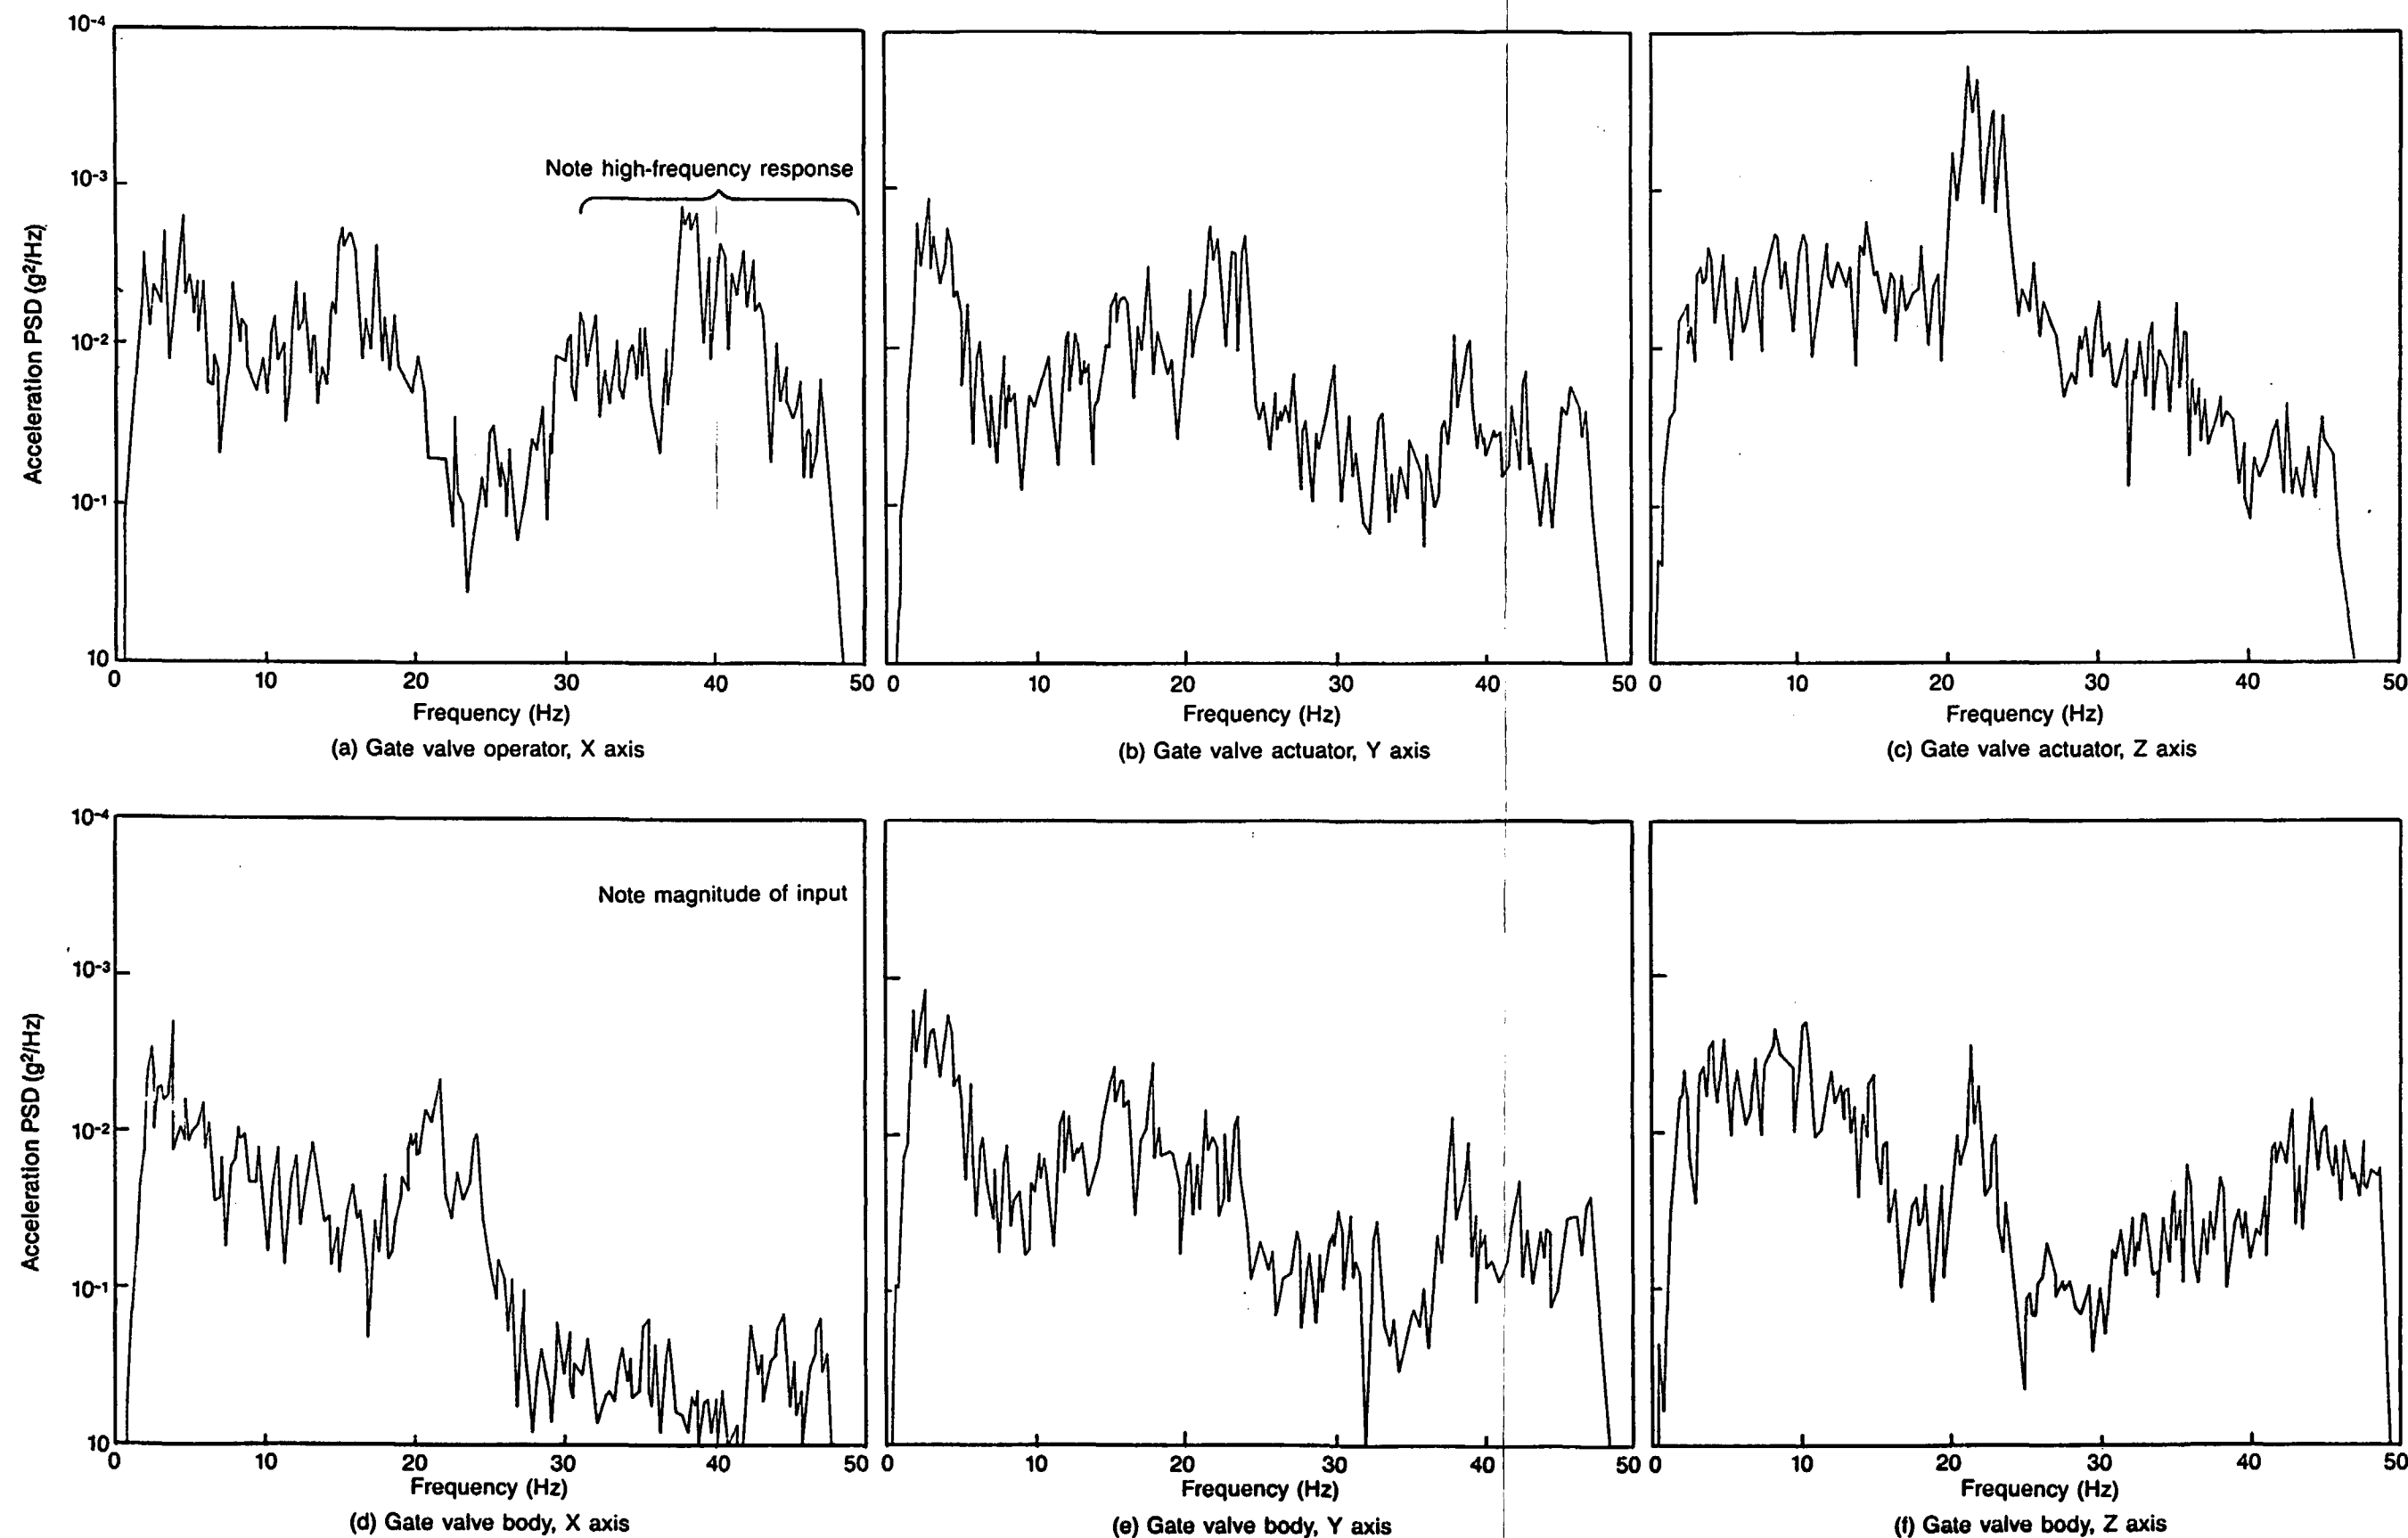
Figure E-111. Frequency domain (PSD) comparison of the gate valve body and actuator responses in the three global axes.

Both CPS valve acceleration responses exhibited significant high-frequency response and amplification, as was observed for response of the valve installed in the HDR VKL system. This is most significant in the horizontal response directions (X and Z directions), which are normal to the axes of the valve operators.

In the case of the gate valve, the greatest response and amplification occur for response in the X direction and in the higher-frequency range (35 to 45 Hz). However, for gate valve response in the Z direction, the greatest response and amplification occur in the intermediate-frequency range (20 to 30 Hz). In addition, a small degree of intermediate-frequency acceleration amplification may be observed for response parallel to the valve actuator stem axis (Y direction).

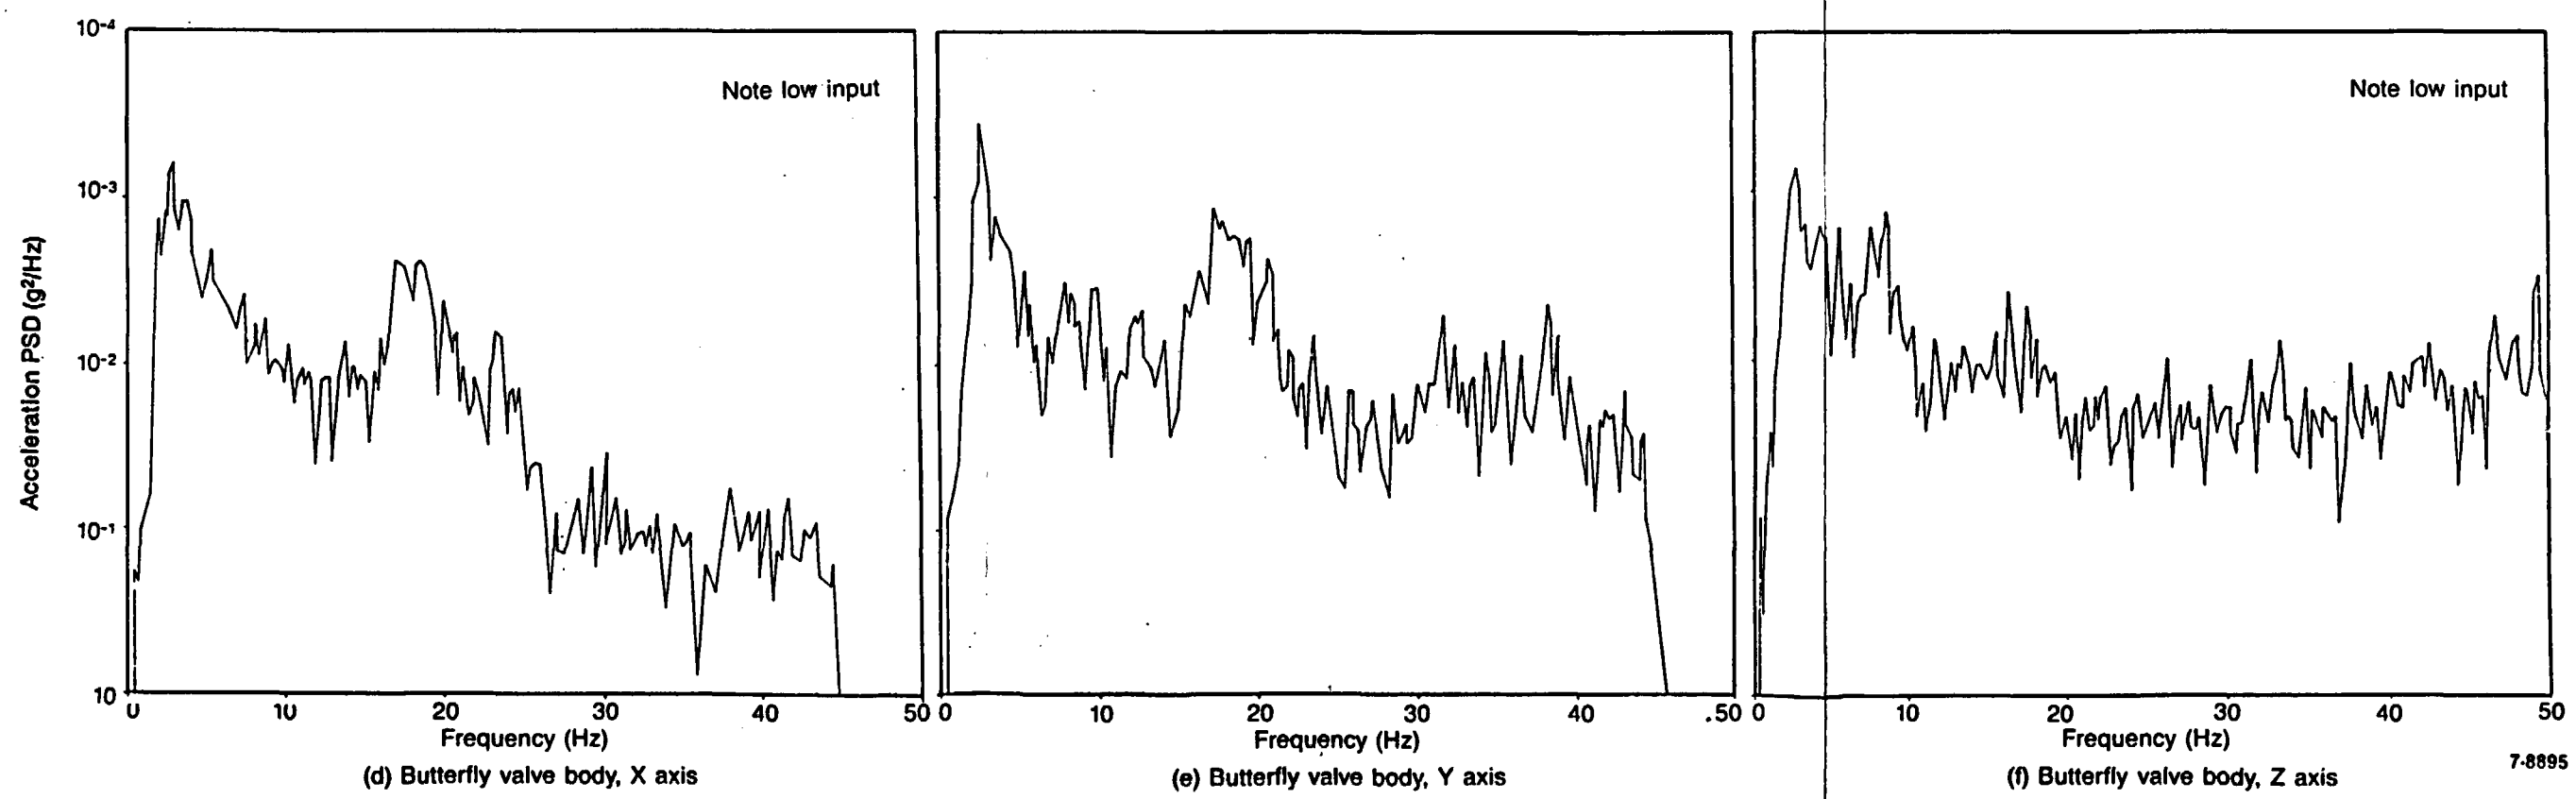
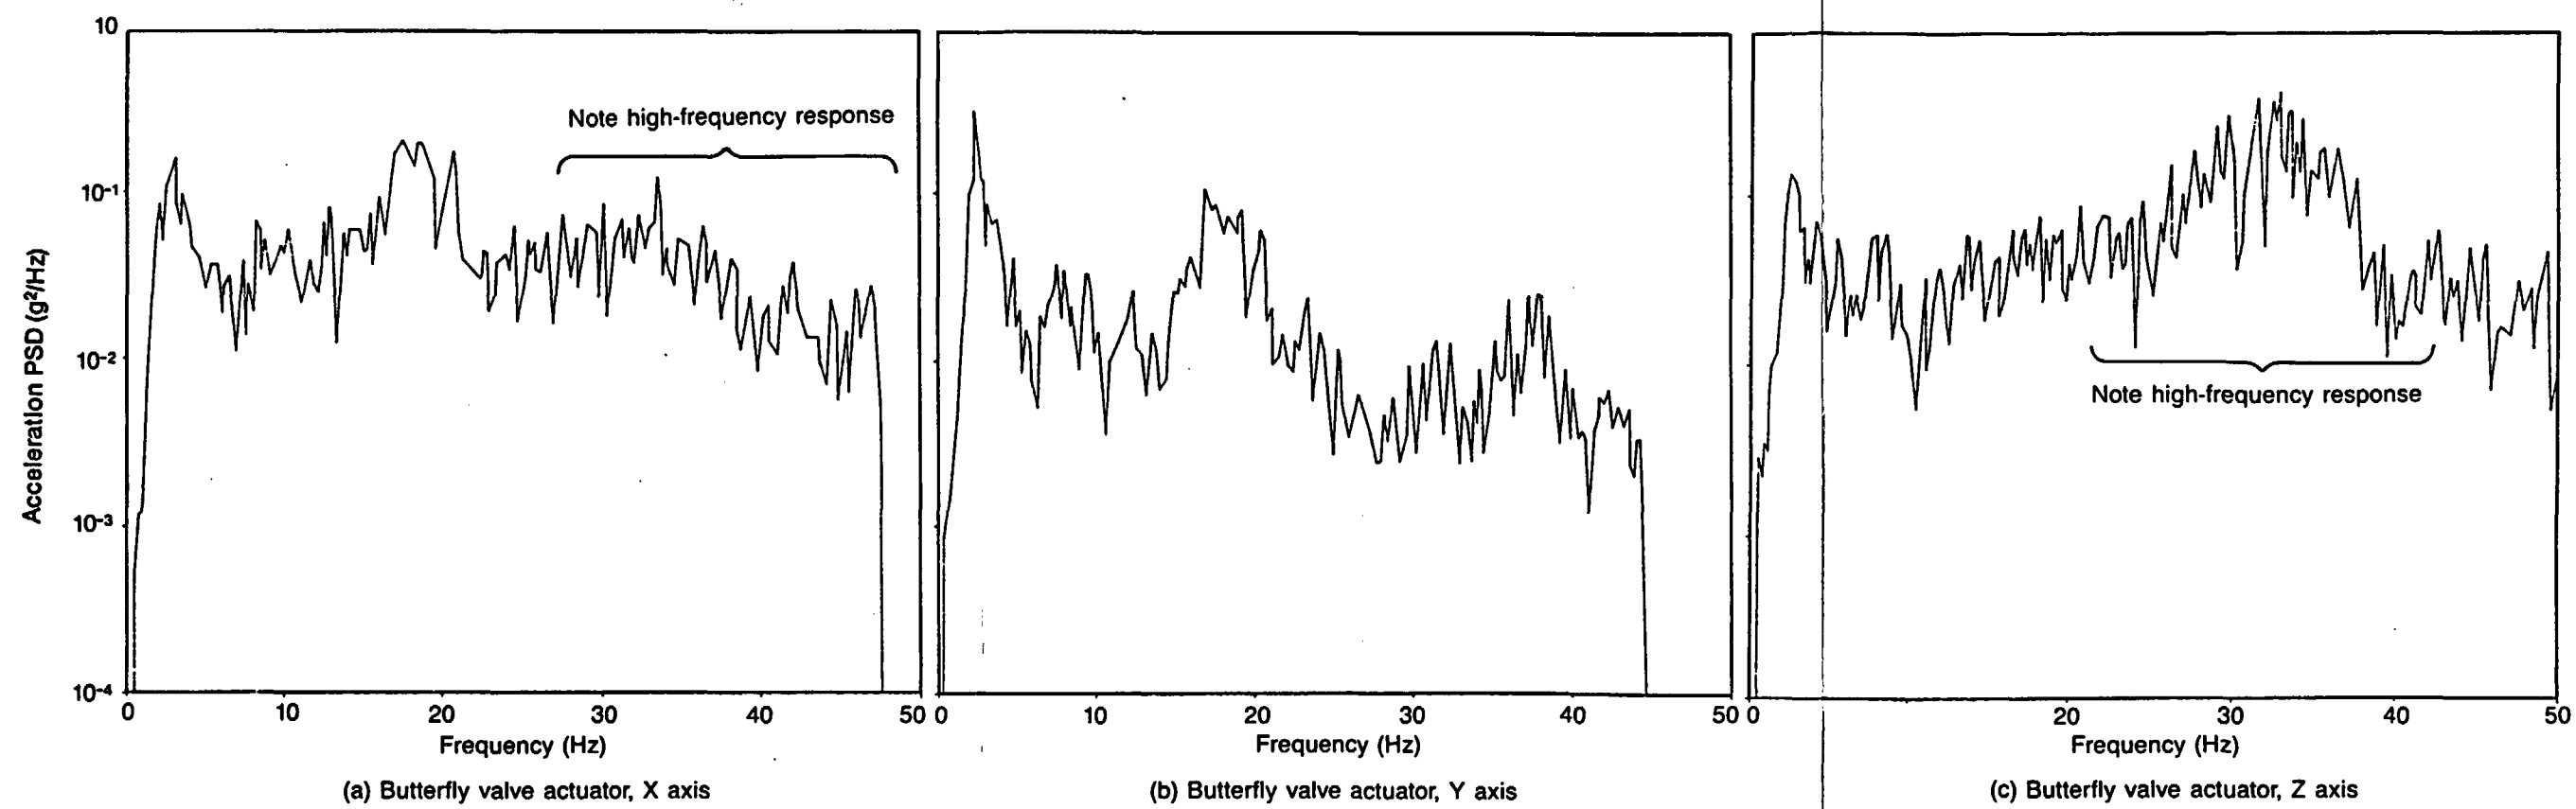
Figure E-112. Frequency domain (PSD) comparison of the butterfly valve body and actuator responses in the three global axes.

Butterfly valve results are similar to results found from the gate valve response. However, for the butterfly valve, greater response and amplification in the higher frequency range are found in the Z direction than the X direction. We note that for response in the X direction, amplification occurs across a wide-frequency range (8 to 45 Hz).
