Braidwood Station, Units 1 and 2
Facility Operating License Nos. NPF-72 and NPF-77
NRC Docket Nos. STN 50-456 and STN 50-457

Byron Station, Units 1 and 2
Facility Operating License Nos. NPF-37 and NPF-66
NRC Docket Nos. STN 50-454 and STN 50-455

Three Mile Island Nuclear Station, Unit No. 1
Facility Operating License No. DPR-50
NRC Docket No. 50-289

Subject: Initial response to NRC Bulletin 2004-01, "Inspection of Alloy 82/182/600 Materials Used in the Fabrication of Pressurizer Penetrations and Steam Space Piping Connections at Pressurized-Water Reactors"

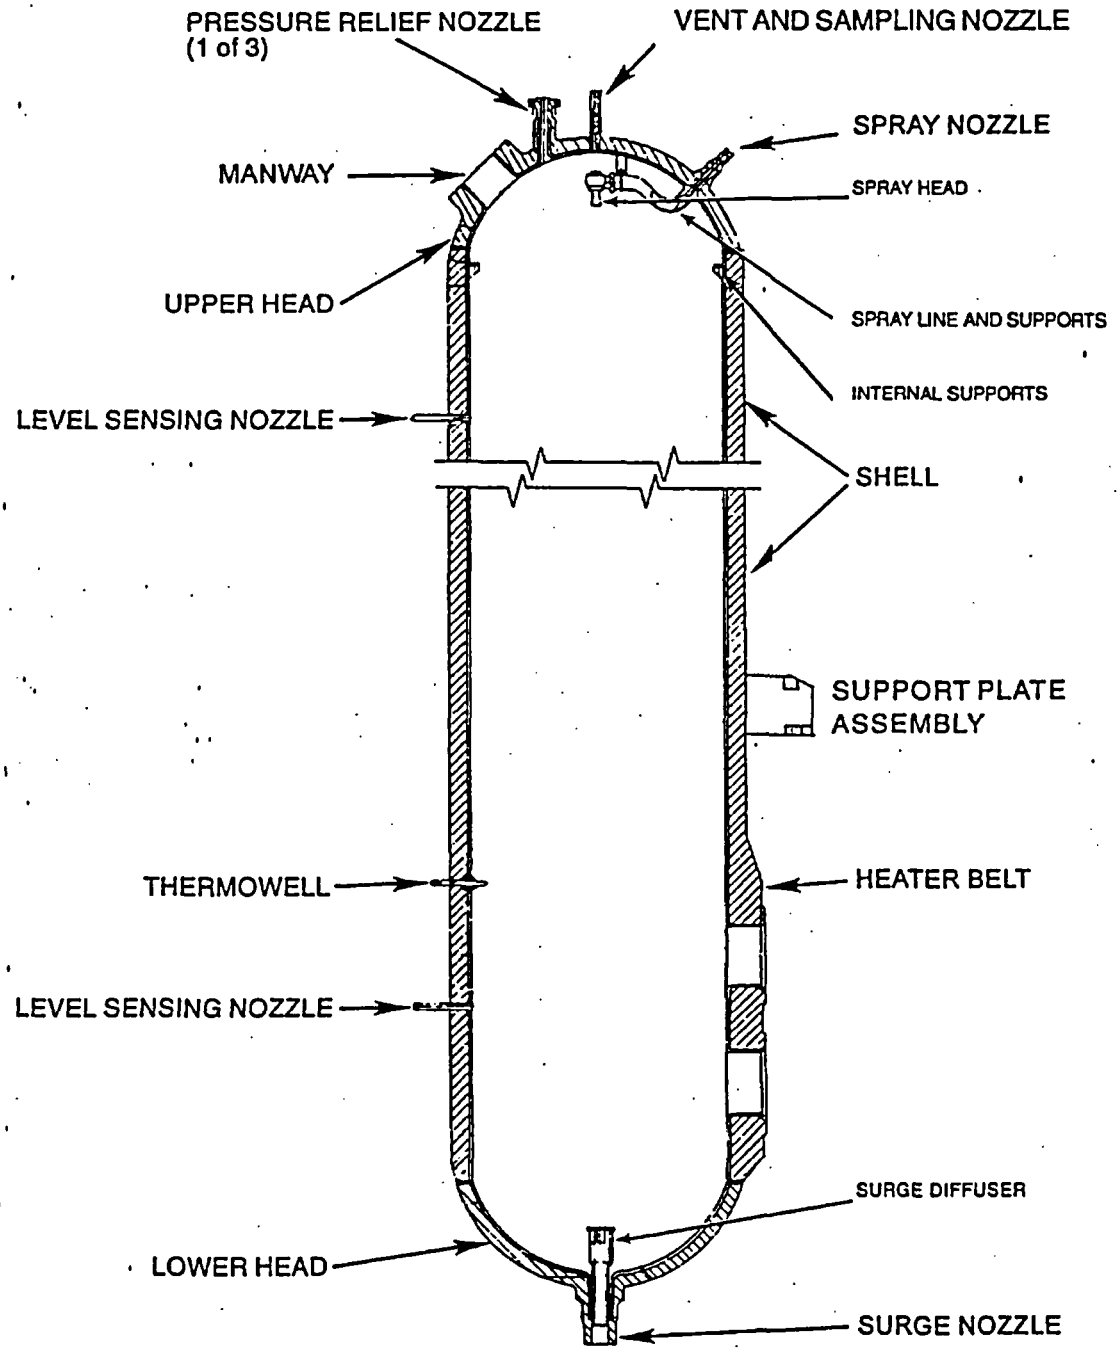
Figure 1 - The general arrangement of pressurizer penetrations at B&W 177-FA units. TMI, Unit 1 also has 36 internal stainless steel ladder rungs welded to the I.D. surface of the pressurizer vessel.

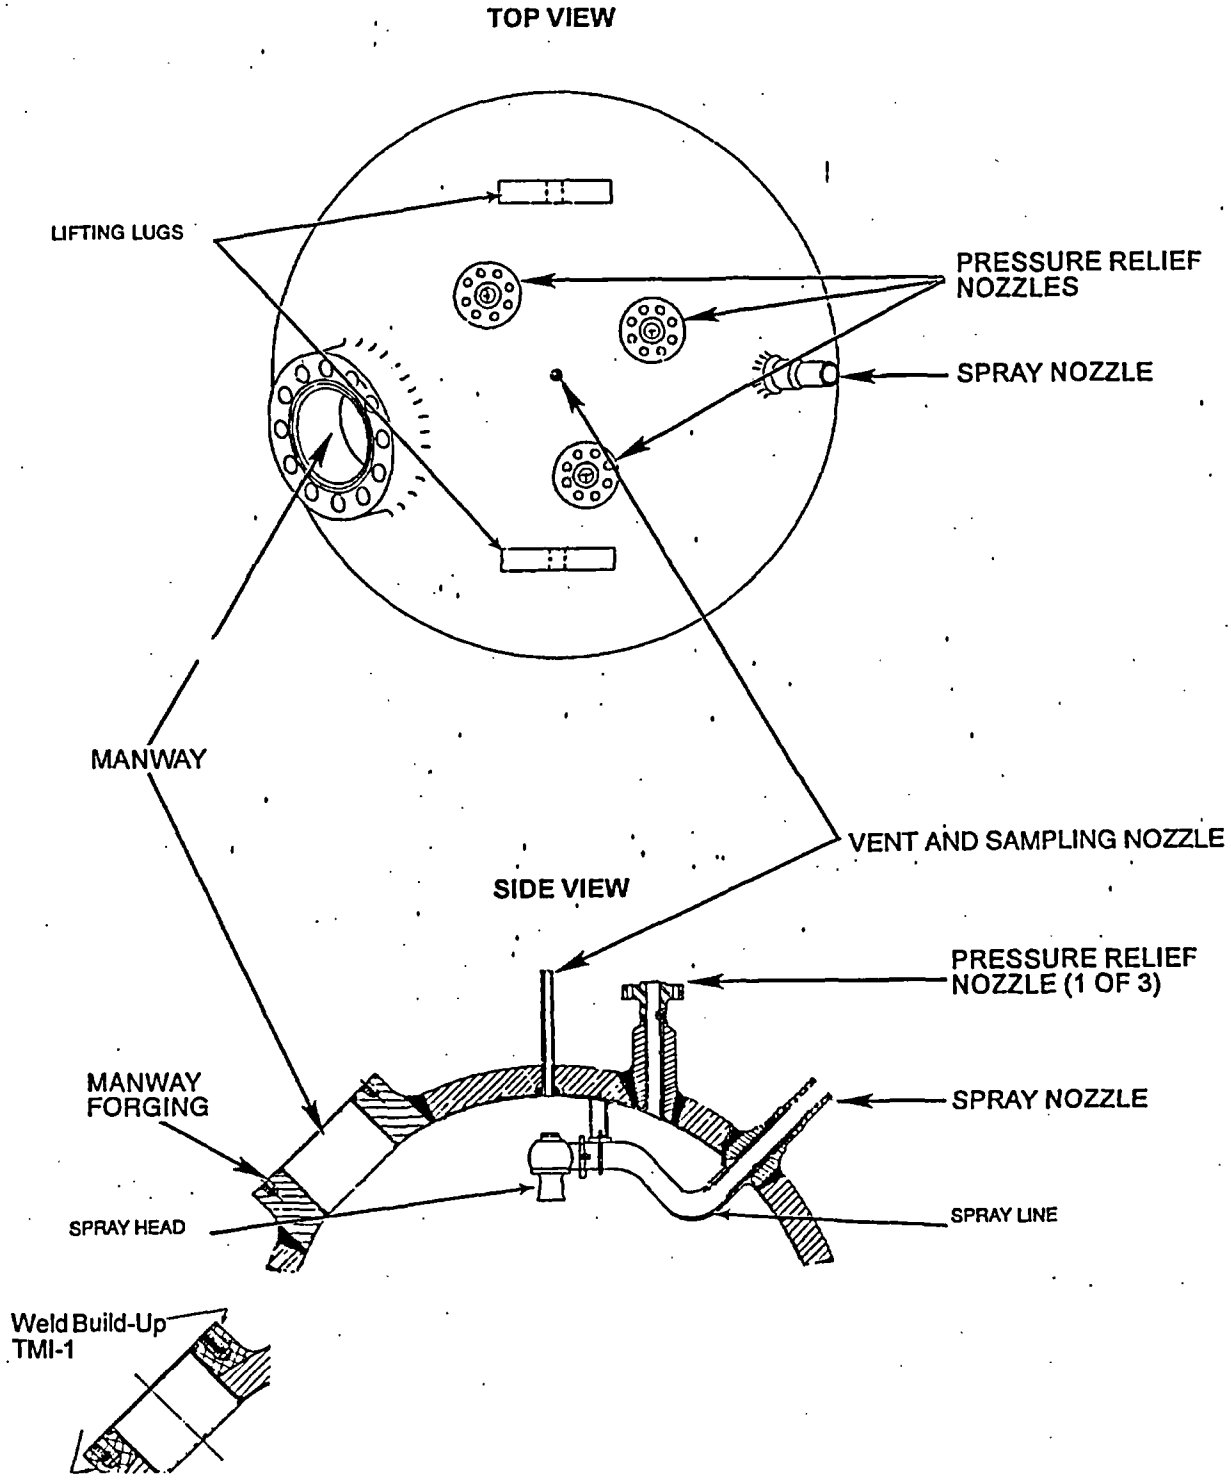
Figure 2A - Penetrations at the upper head of pressurizer vessel. Note, the manway boss was weld buildup at TMI-1, instead of a forging.

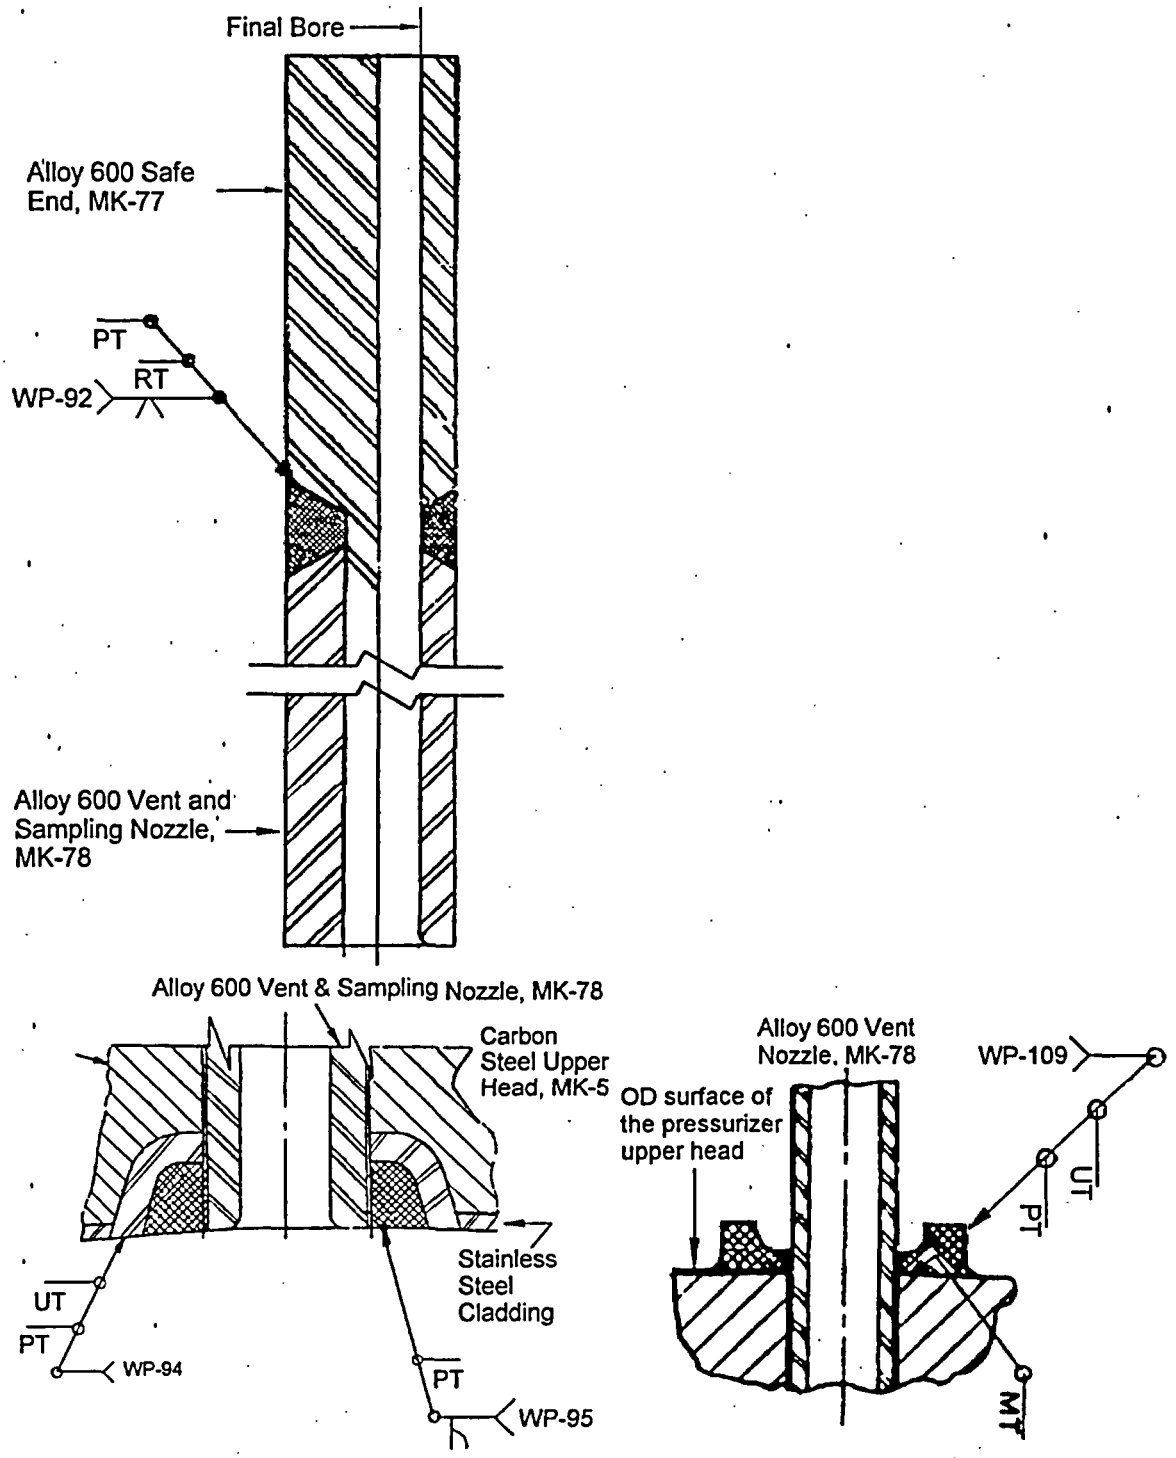
Figure 2B - Top, 1-inch Schedule 160 Alloy 600 vent to Alloy 600 safe-end weld. Bottom, detail of the 1-inch vent and sampling nozzle to pressurizer upper head J-groove weld and weld boss (not wetted by RC).

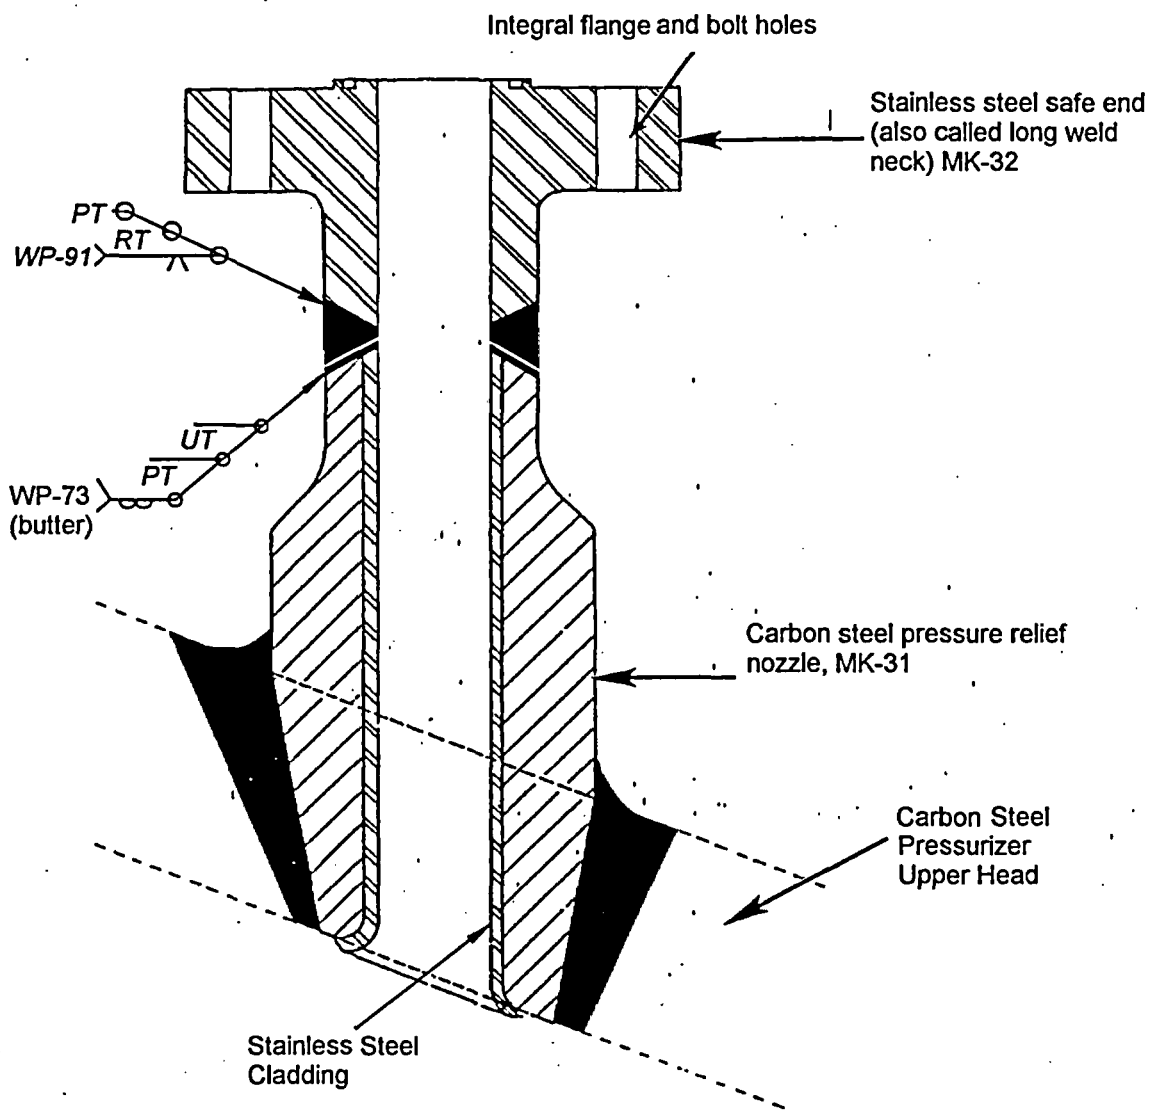
Figure 3 - Detail of the three 2½-inch pressure relief nozzle to stainless steel safe-end weld.

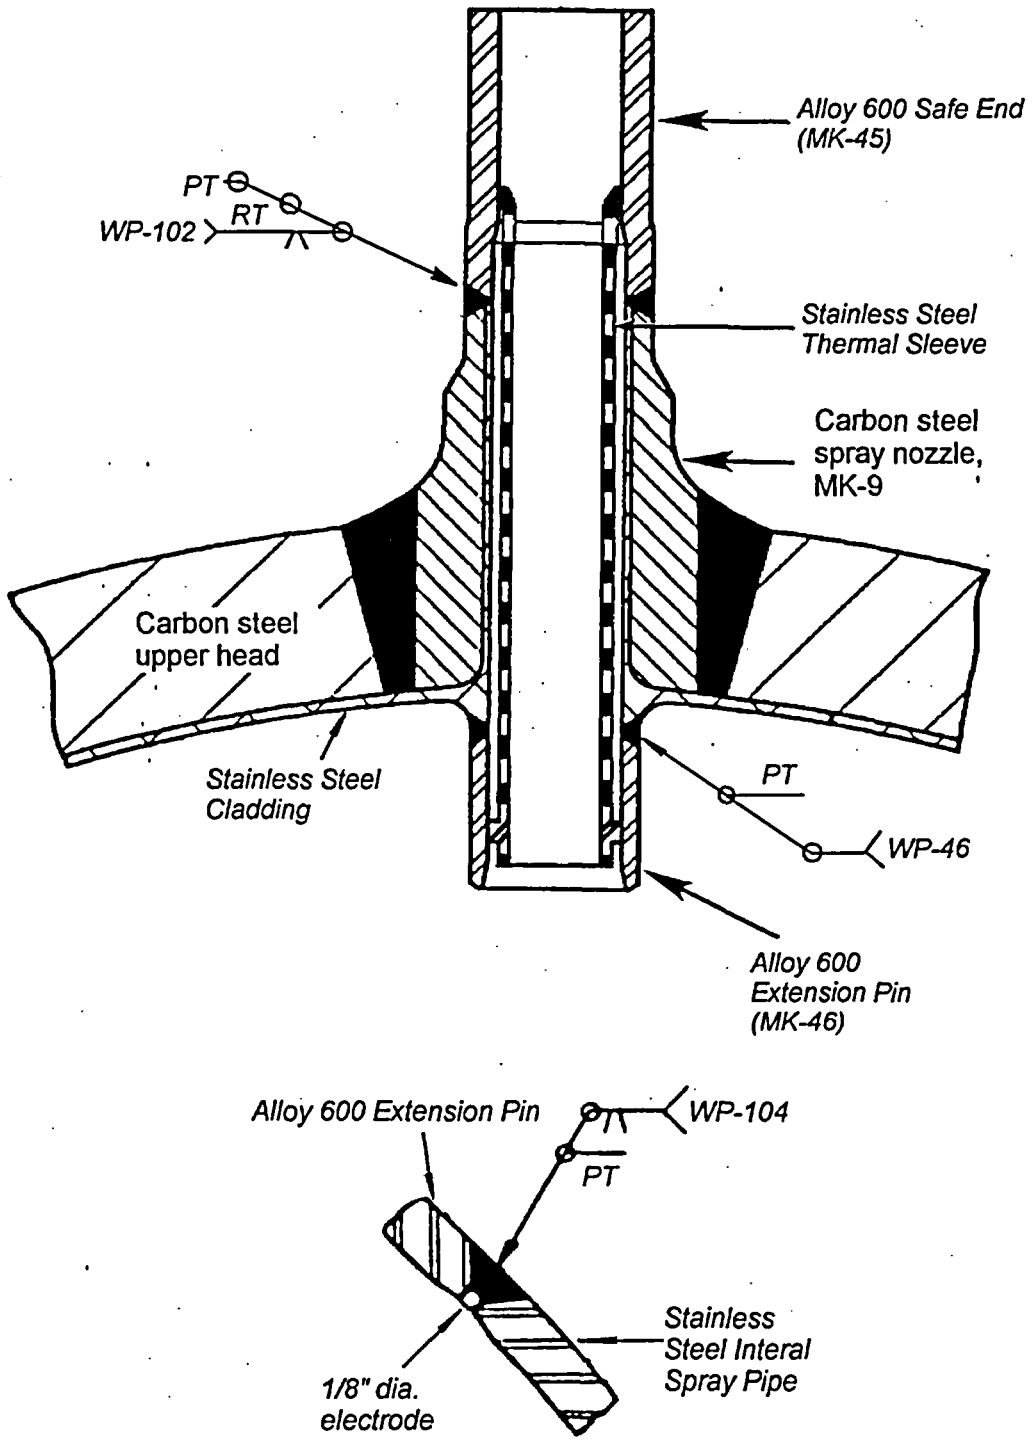
Figure 4 - Top, detail of the 4-inch spray nozzle assembly. Bottom, detail of the extension pin to the internal spray pipe weld. See Figure 5 for detail of the weld buttons for positioning the thermal sleeve.

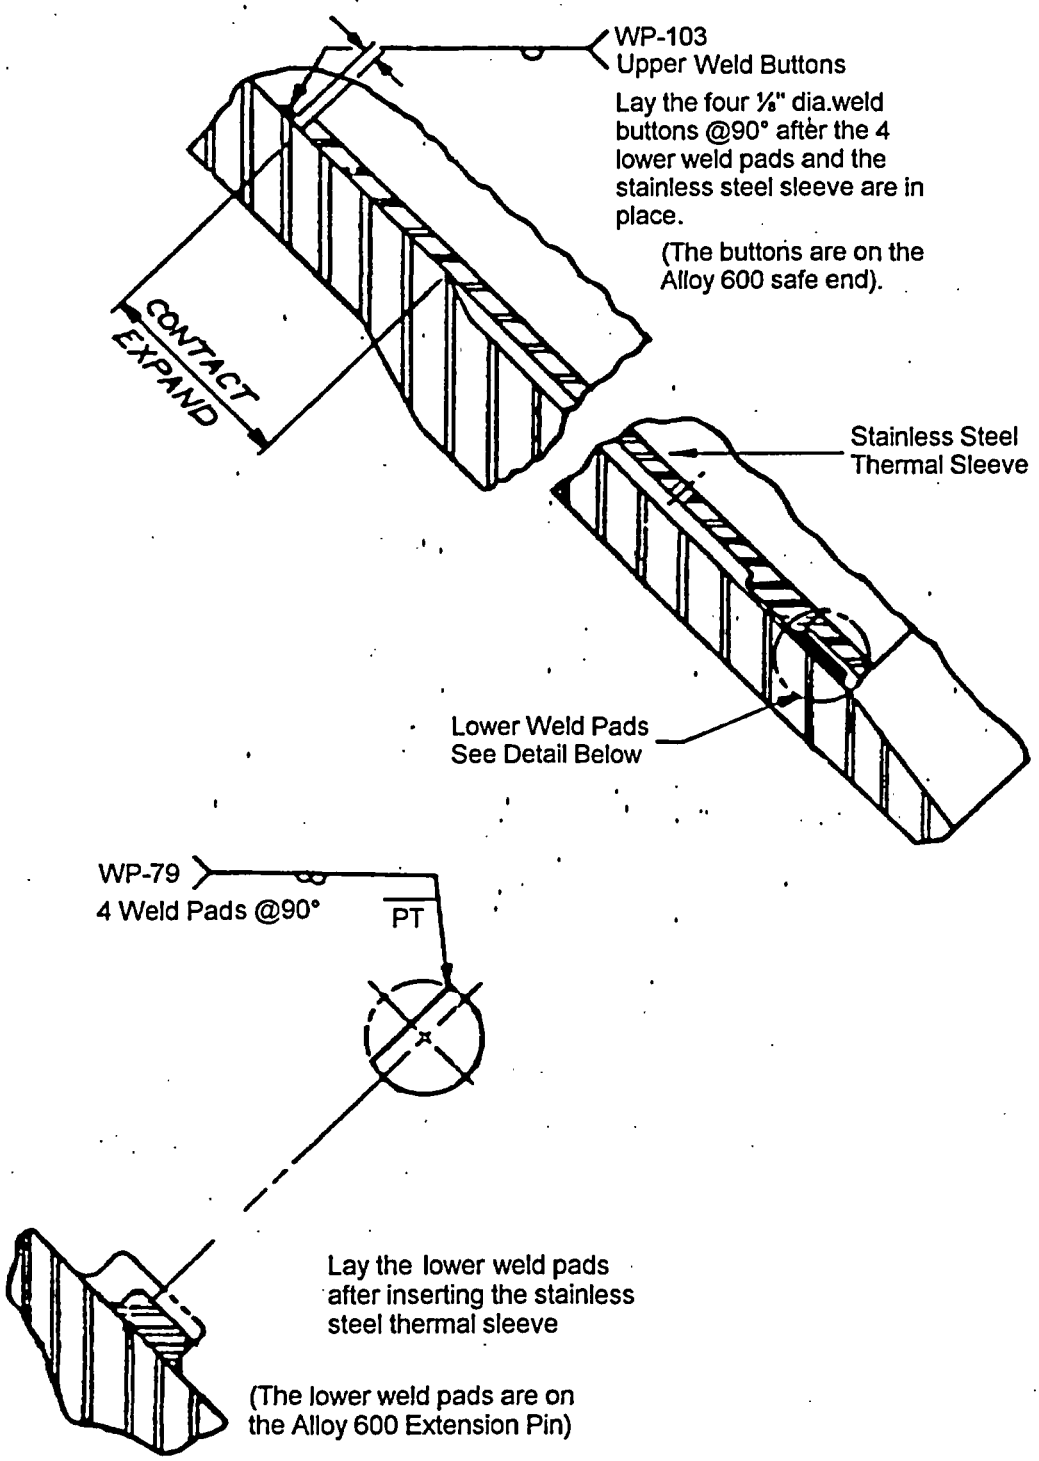
Figure 5 - Detail of the weld buttons for positioning the stainless steel thermal sleeve inside the 4-inch spray nozzle.

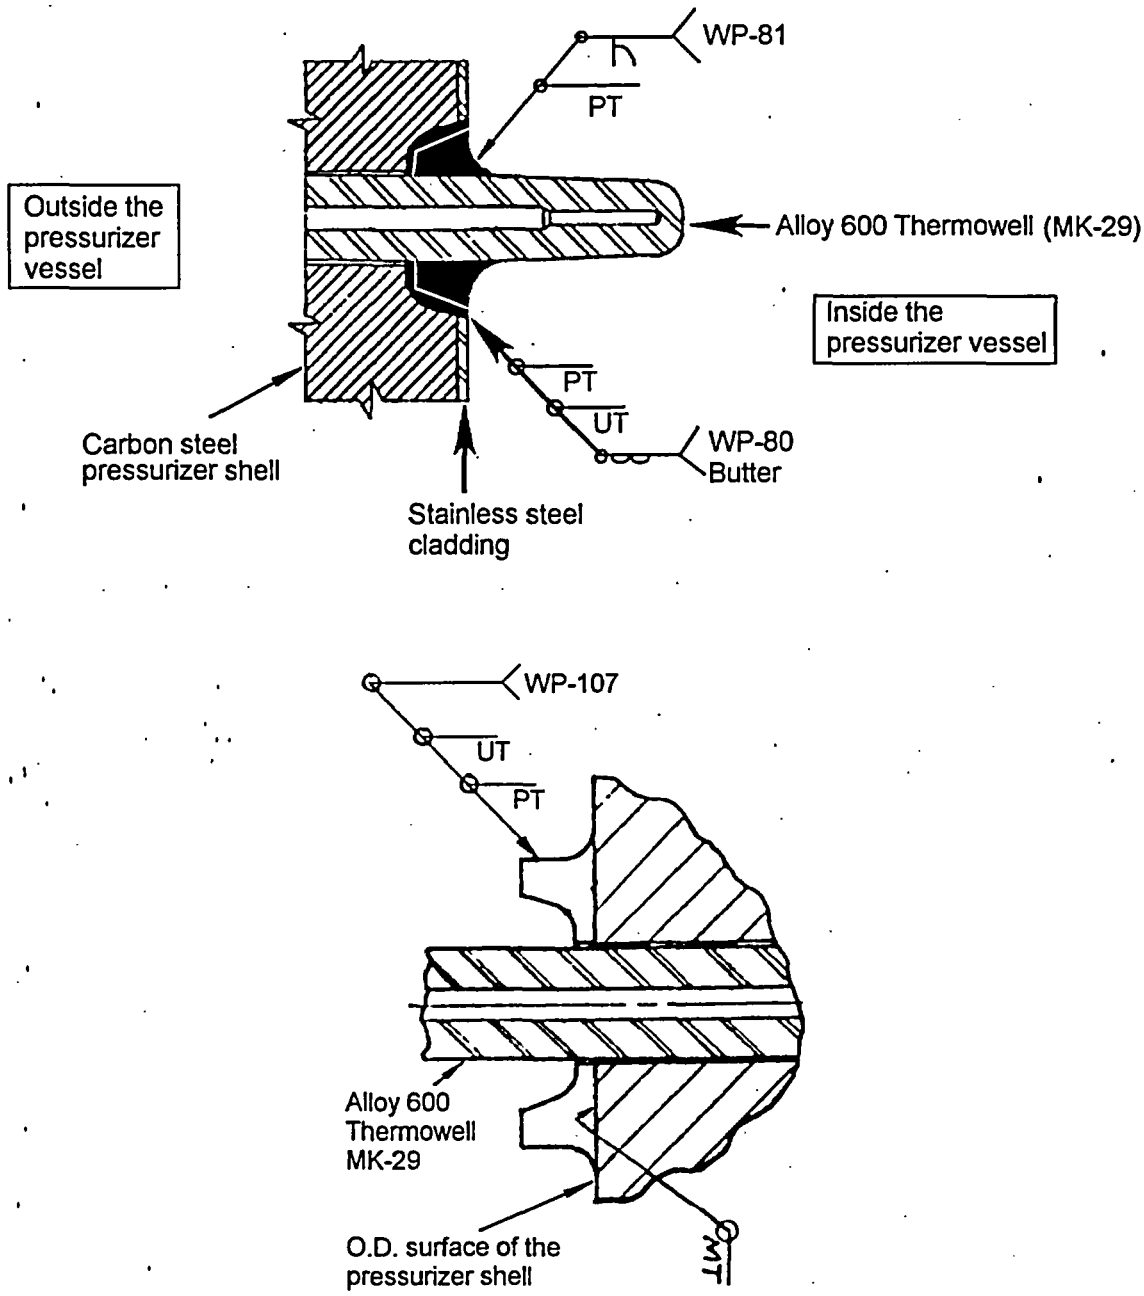
Figure 6 - Top, detail of the 1½-inch thermowell nozzle to the pressurizer shell I.D. surface J-groove weld. Bottom, detail of the weld boss (not wetted) to the pressurizer shell O.D. surface. The weld boss was intended for future welding replacement thermowell nozzle if needed.

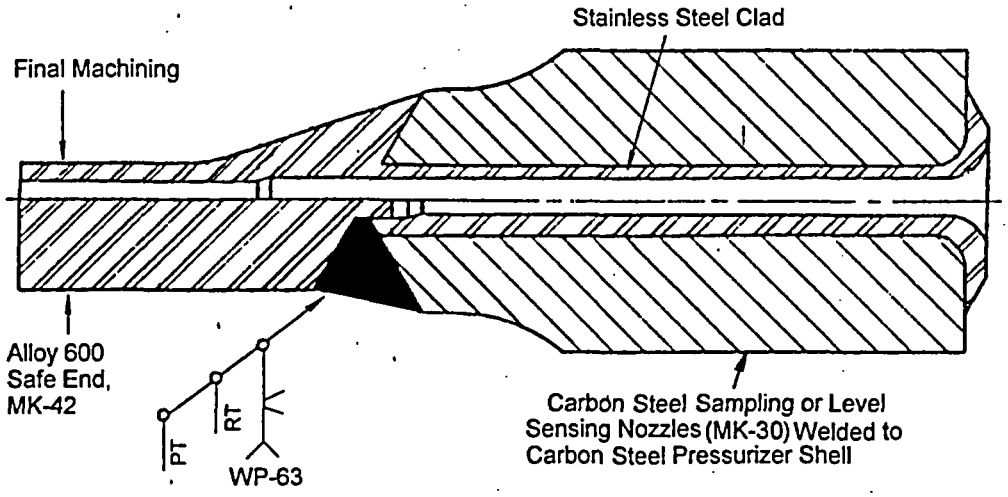
Figure 7 - Detail of the 1-inch level sensing nozzle or 1-inch sampling nozzle to Alloy 600 safe-end weld.

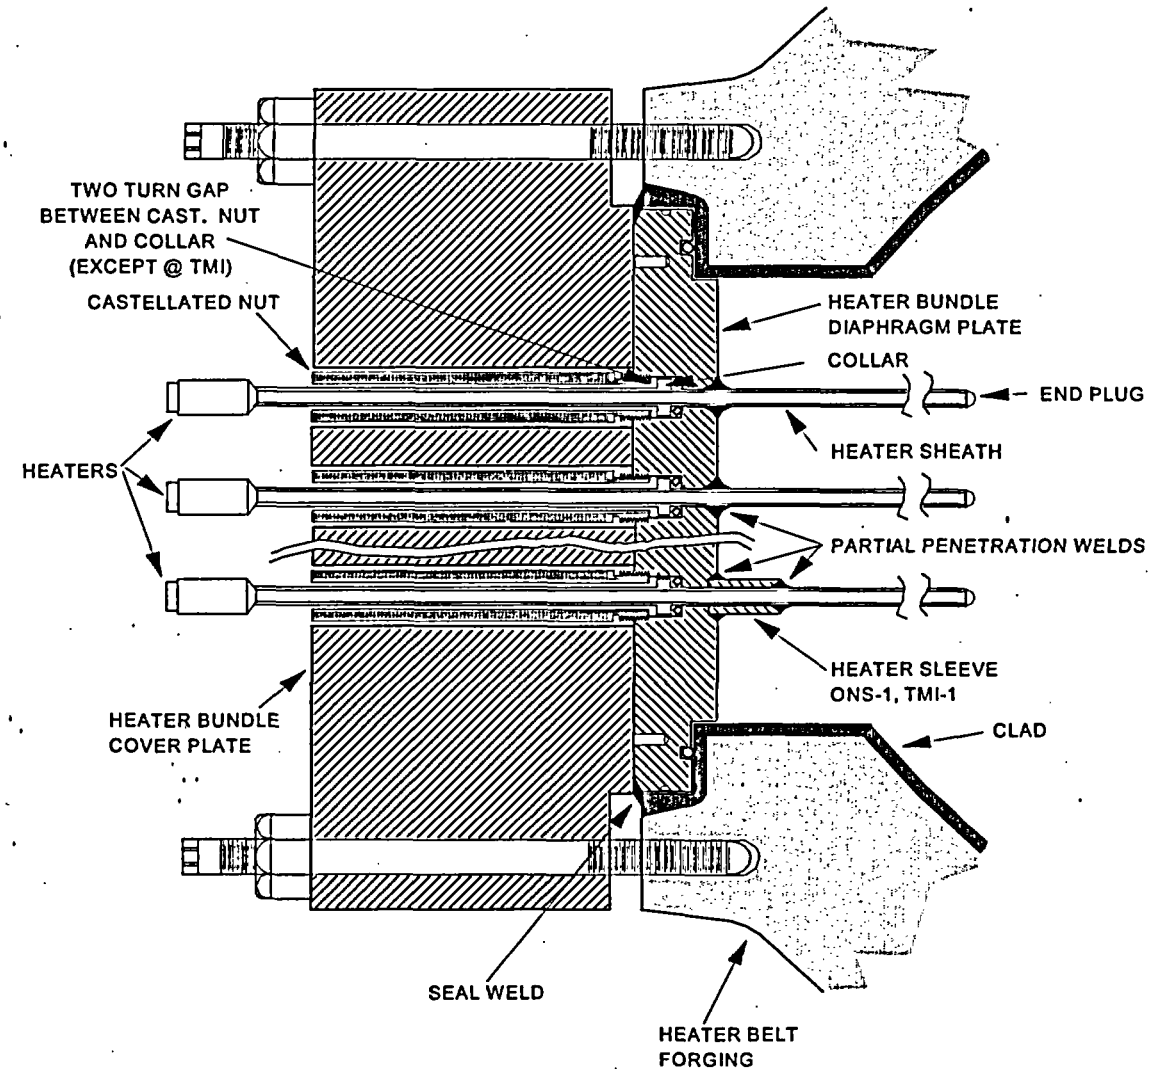
Figure 9 - Cross sectional view of the original heater bundle assembly.

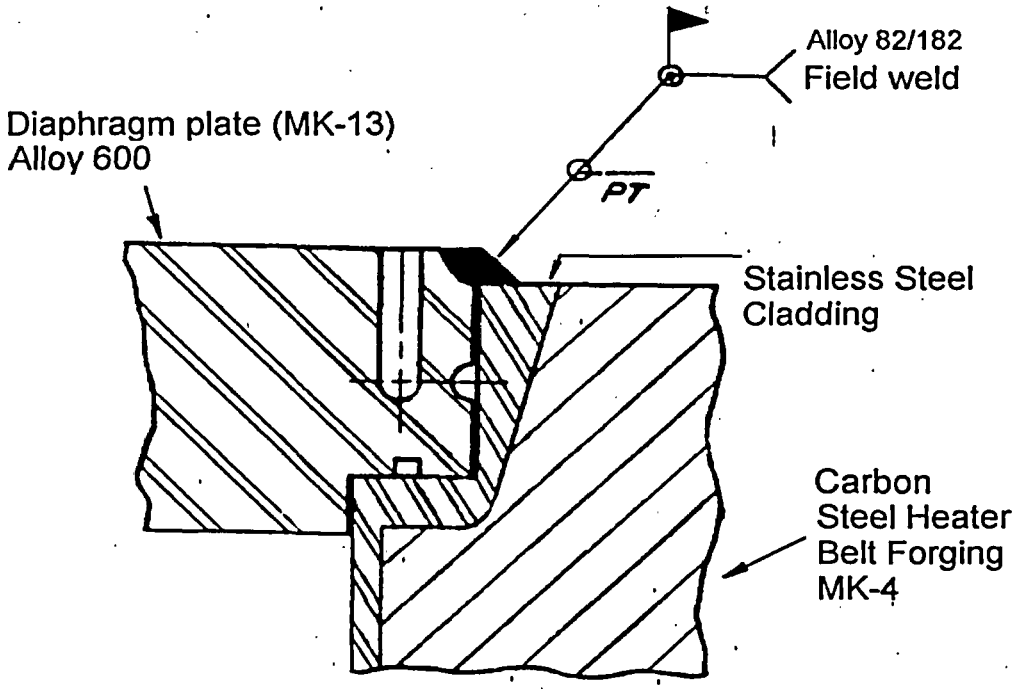
Figure 10 - Detail of the Alloy 600 diaphragm plate to stainless steel cladding seal weld (Alloy 82/182) for the original heater bundles.

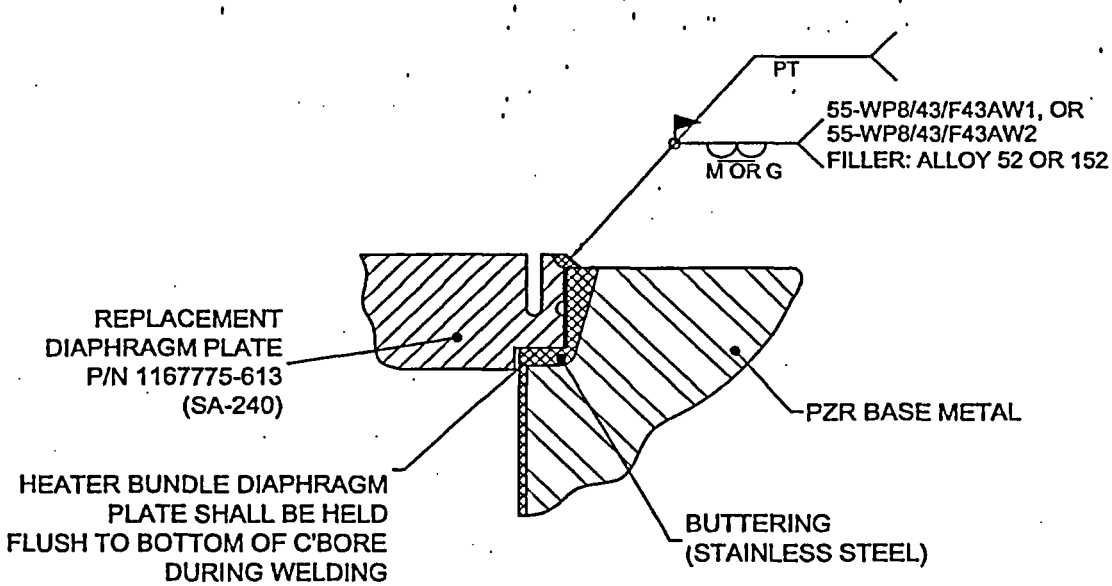
Figure 11 - Detail of the stainless steel diaphragm plate to stainless steel cladding seal weld for the replacement lower heater bundle in 2003. The weld metal is Alloy 52/152.

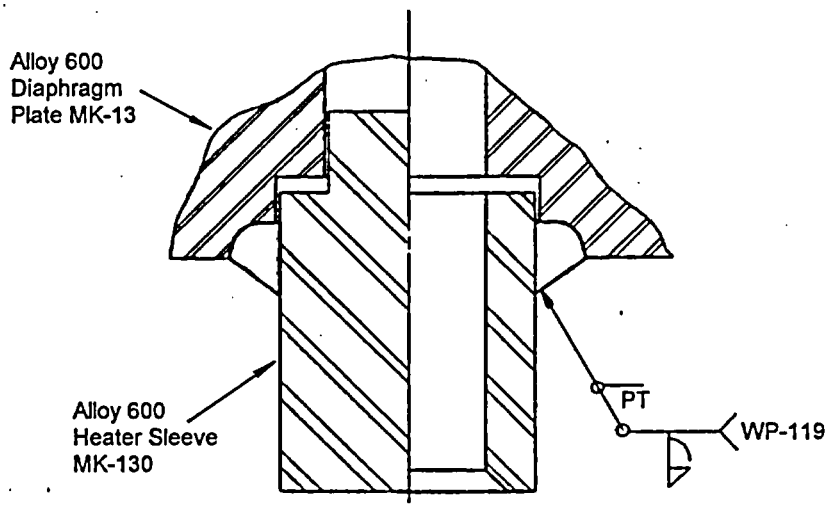
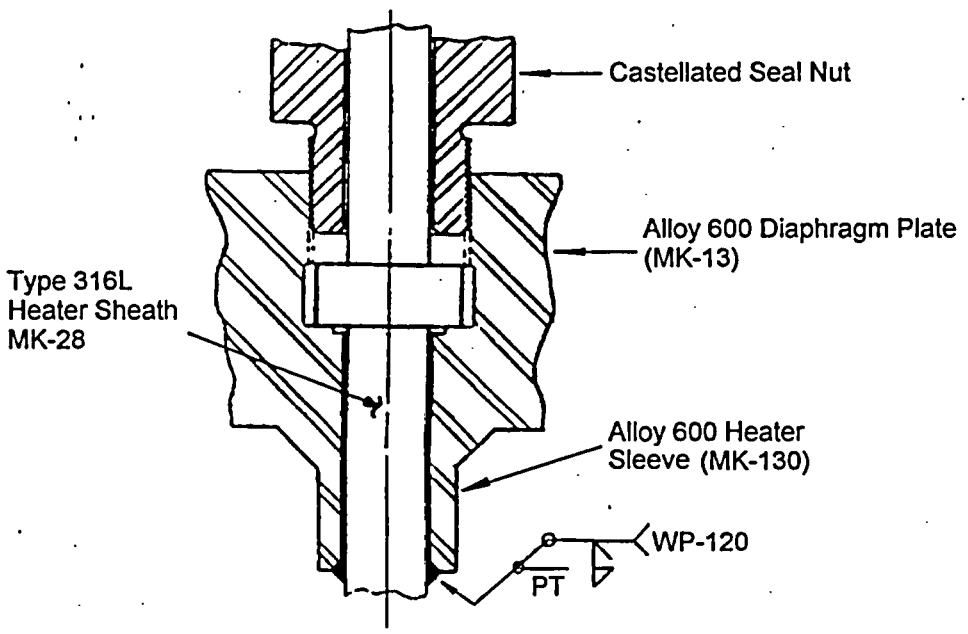
Figure 12 - Top, detail of the Alloy 600 heater sleeve to the Alloy 600 diaphragm plate weld Bottom, detail of the Type 316L heater sheath to the Alloy 600 heater sleeve.
