Steam Generator Issues

Generic Implications of TMI Tube Sever Event

January 31, 2002

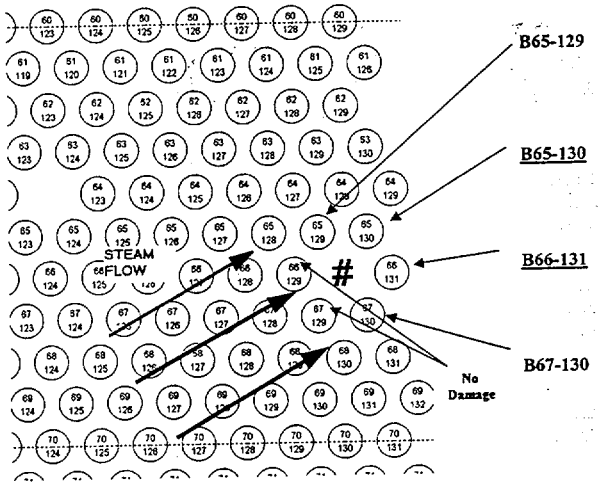
- Two severed tubes
  - B66-130, Severed at UTSF
    - Impacted 4 surrounding tubes
    - Original UTS Alloy 600 rolled plug replaced in 1997 with Alloy 690 (ribbed A-600 at bottom)
  - A2-24, Severed at 15th TSP
    - No impact on surrounding tubes
    - Westinghouse Alloy 600 rolled plugs top and bottom, re-rolled after hot functional testing
- One axial burst
  - B150-14, Opening in Top Span
    - Original UTS Alloy 600 rolled plug replaced in 1997 with Alloy 690 (ribbed A-600 at bottom)

Tubes With Damage Surrounding B66-130

- Failure scenario for B66-130
  - Tube swelled during heatup due to trapped water
  - Tube became restrained at top TSP and UTS
  - Restraint isolated top span & decreased damping
  - Tube severed due to high cycle fatigue caused by flow-induced vibration at area of high cross flow
    - Initiated at shallow OD IGA patch
- Populations with observed swelling at TMI
  - Locations where plugs were repaired without de-watering
    - Westinghouse A-600 roll plugs re-rolled in place
    - Framatome A-600 UTS roll plugs removed & replaced
