GENERAL ATOMICS'

FINAL RADIOLOGICAL SURVEY REPORT

FOR THE LINAC NORTH LAND AREA

April 2001

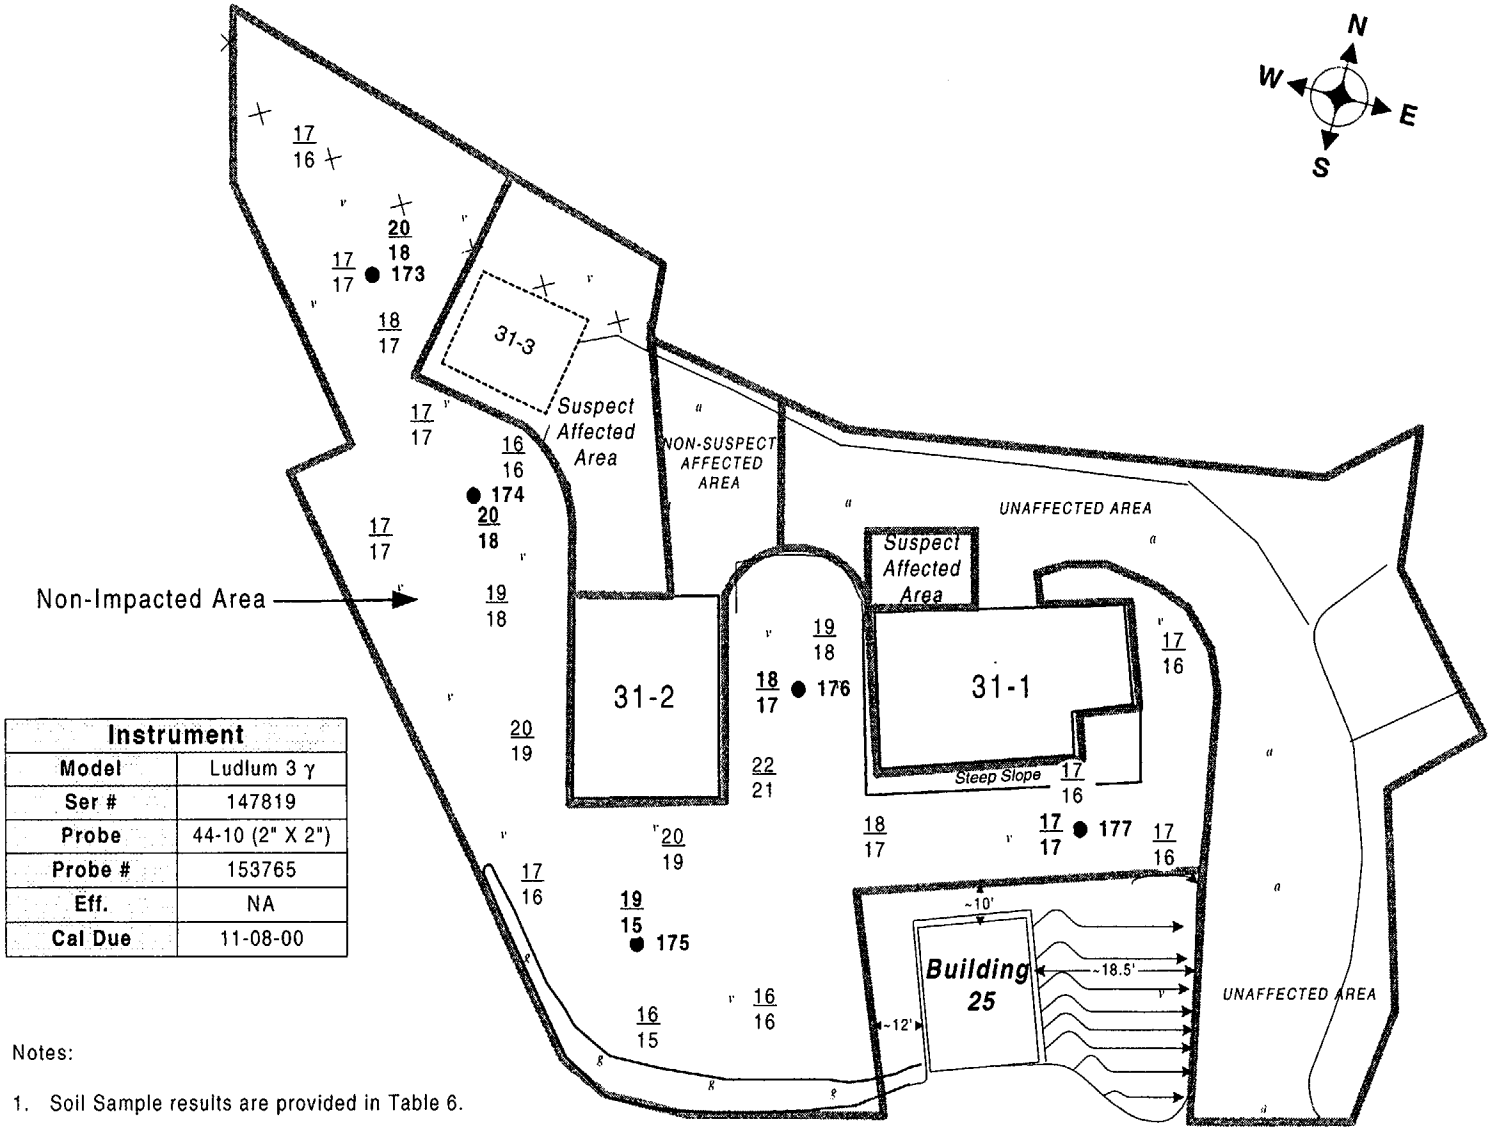
Figure 4: Non-Impacted Area Soil Sample Locations and Exposure Rate Fixed Measurement Locations and Results

Direct radiation levels were measured at 1 m from the surface at about 301 locations using a 2"x2" NaI(Tl) detector. The maximum result was 27 μR/hr, which is less than 10 μR/hr above background (~12-18 μR/hr at 1 m). Thus, all readings were less than the approved release criteria. See Figures 4, 9, 15, 18 and 24 for locations and results.

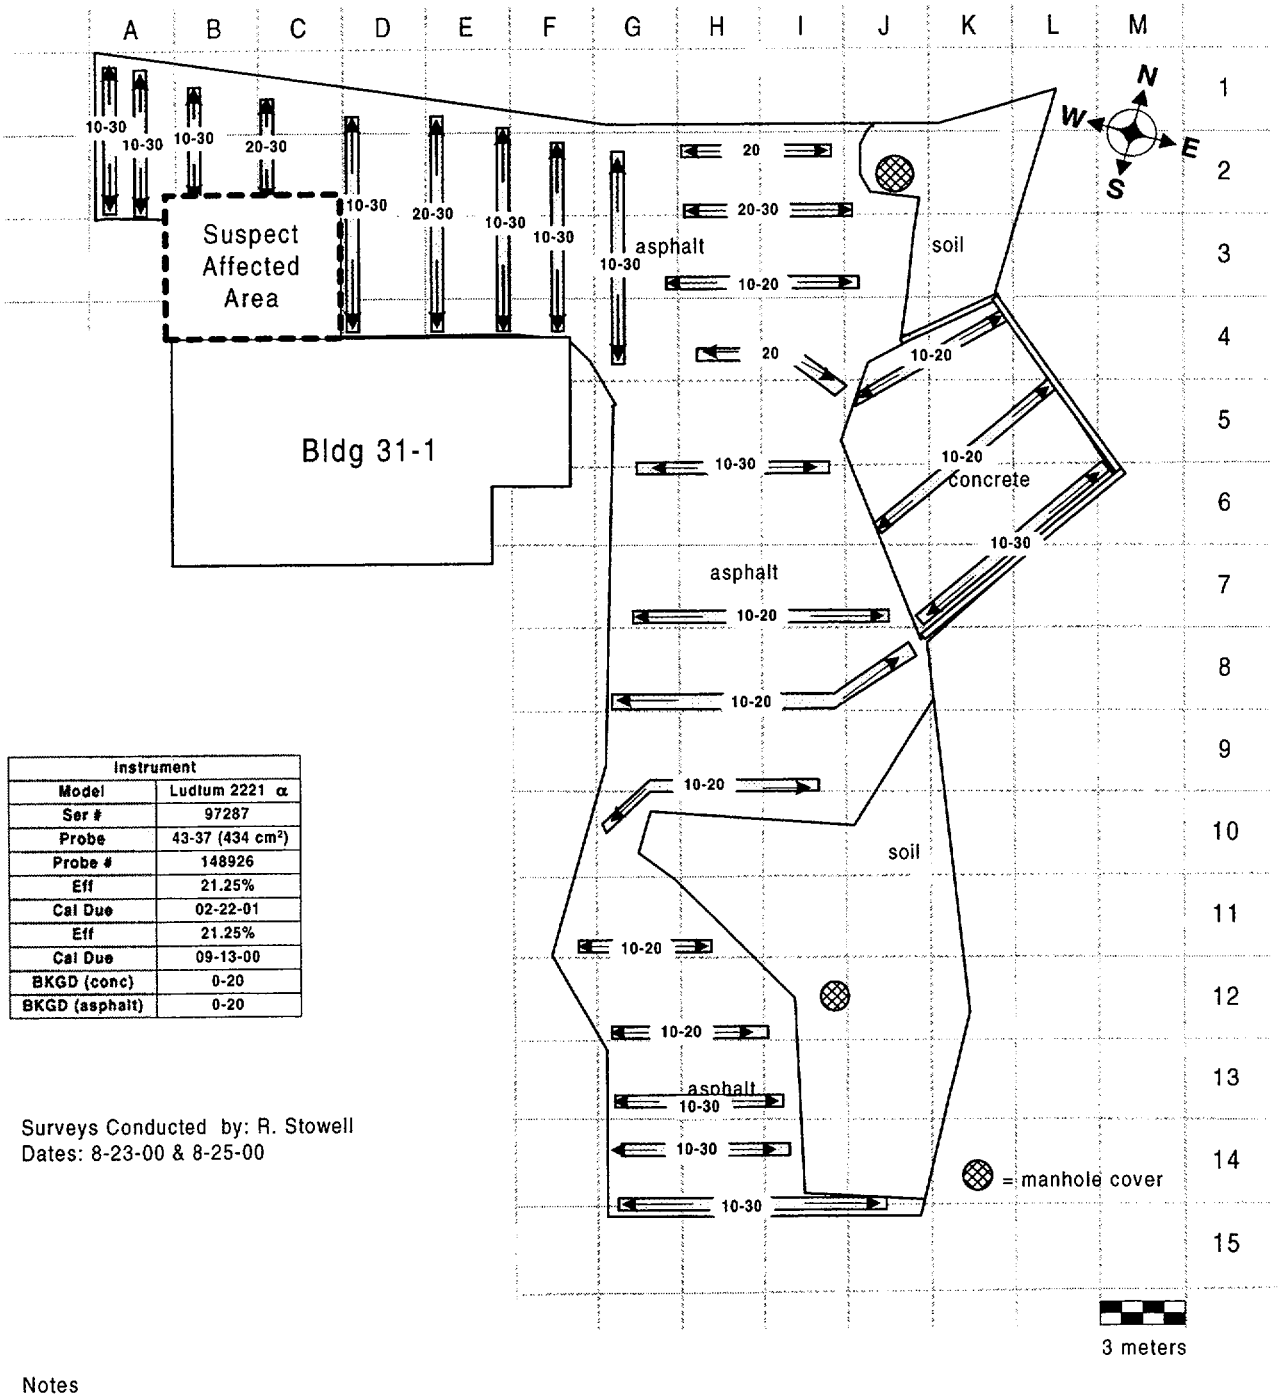
Figure 5: Unaffected Area Alpha Scan Survey Locations and Results

1. 10 % of accessible flat surface area scanned with results ranging from 10 - 30 cpm.
2. ▭ Denotes scan area.
3. ←xx-xx→ Denotes scan range in cpm.

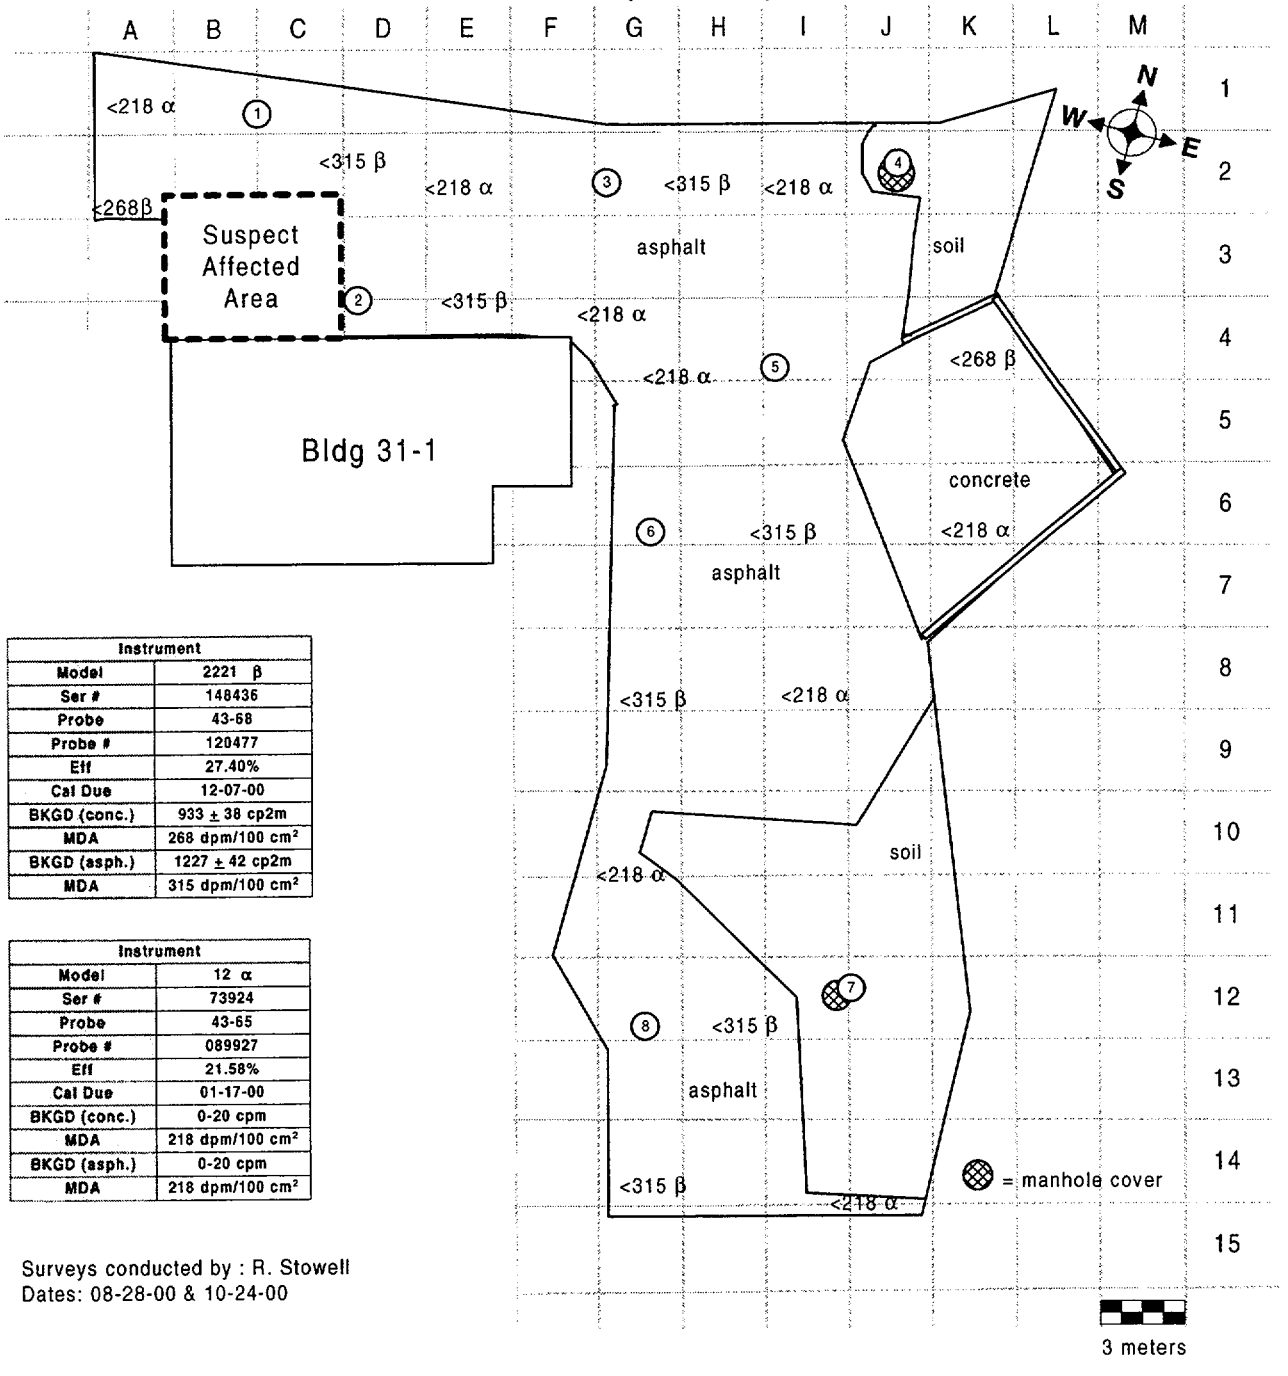
Figure 6: Unaffected Area Fixed Alpha and Fixed Beta Measurement Locations and Results and Wipe Survey Locations

There were 25 fixed α and 24 fixed β, measurements taken. All results (after any required remediation) were well below the release criteria. See Figures 6, 13, and 22 for approximate α and β measurement locations and results.

1. (X) Denotes approximate wipe location. Wipe results are provided in Table 5.
2. Fixed alpha readings (XXX α) are in dpm/100 cm² with a maximum result of <218 dpm/100cm². (MDA for asphalt and concrete)
3. Fixed Beta readings (XXX β) are in dpm/100 cm² with a maximum result of < 315 dpm/100cm² (MDA for asphalt).

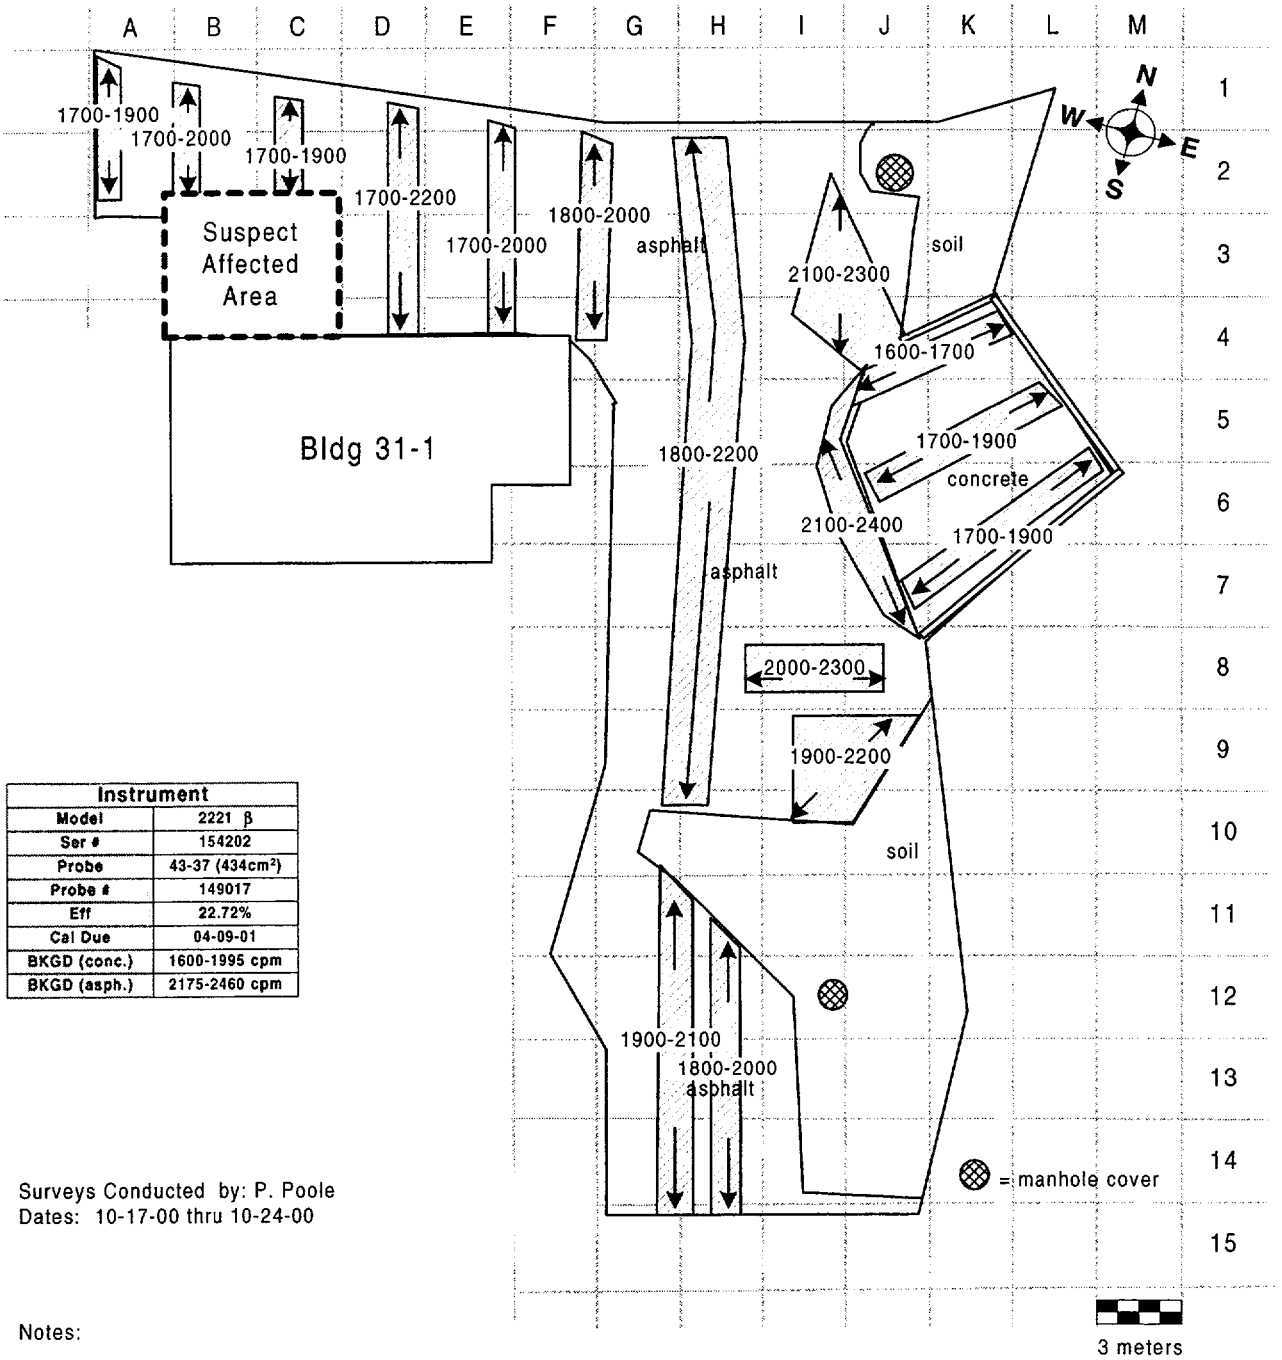
Figure 7: Unaffected Area Beta Scan Survey Locations and Results

1. 10% of flat surfaces scanned with a result of 1600 to 2400 cpm .
2. ▭ Denotes area scanned.
3. ← xxxx-xxxx → Denotes scan range in cpm.

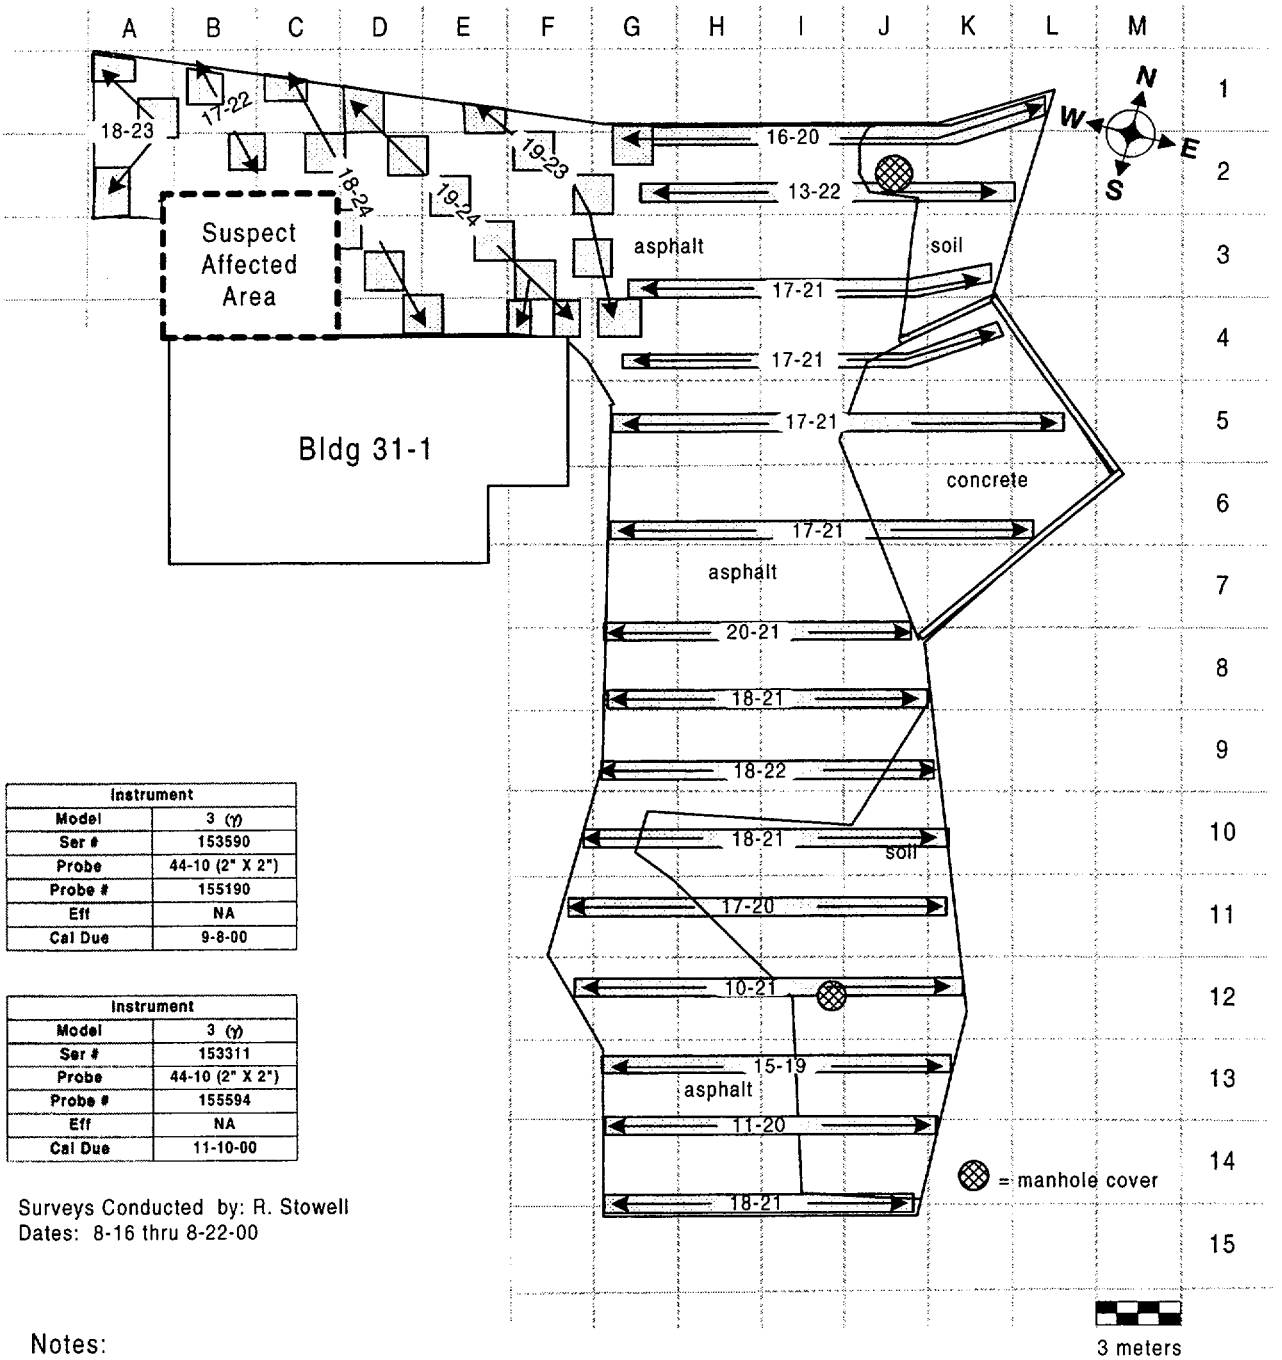
Figure 8: Unaffected Area Exposure Rate Scan Measurement Locations and Results

1. 25% of surface scanned with results ranging 10-24 µR/hr.
2. ▭ Denotes area scanned.
3. ← xx-xx → Denotes scan range in µR/hr

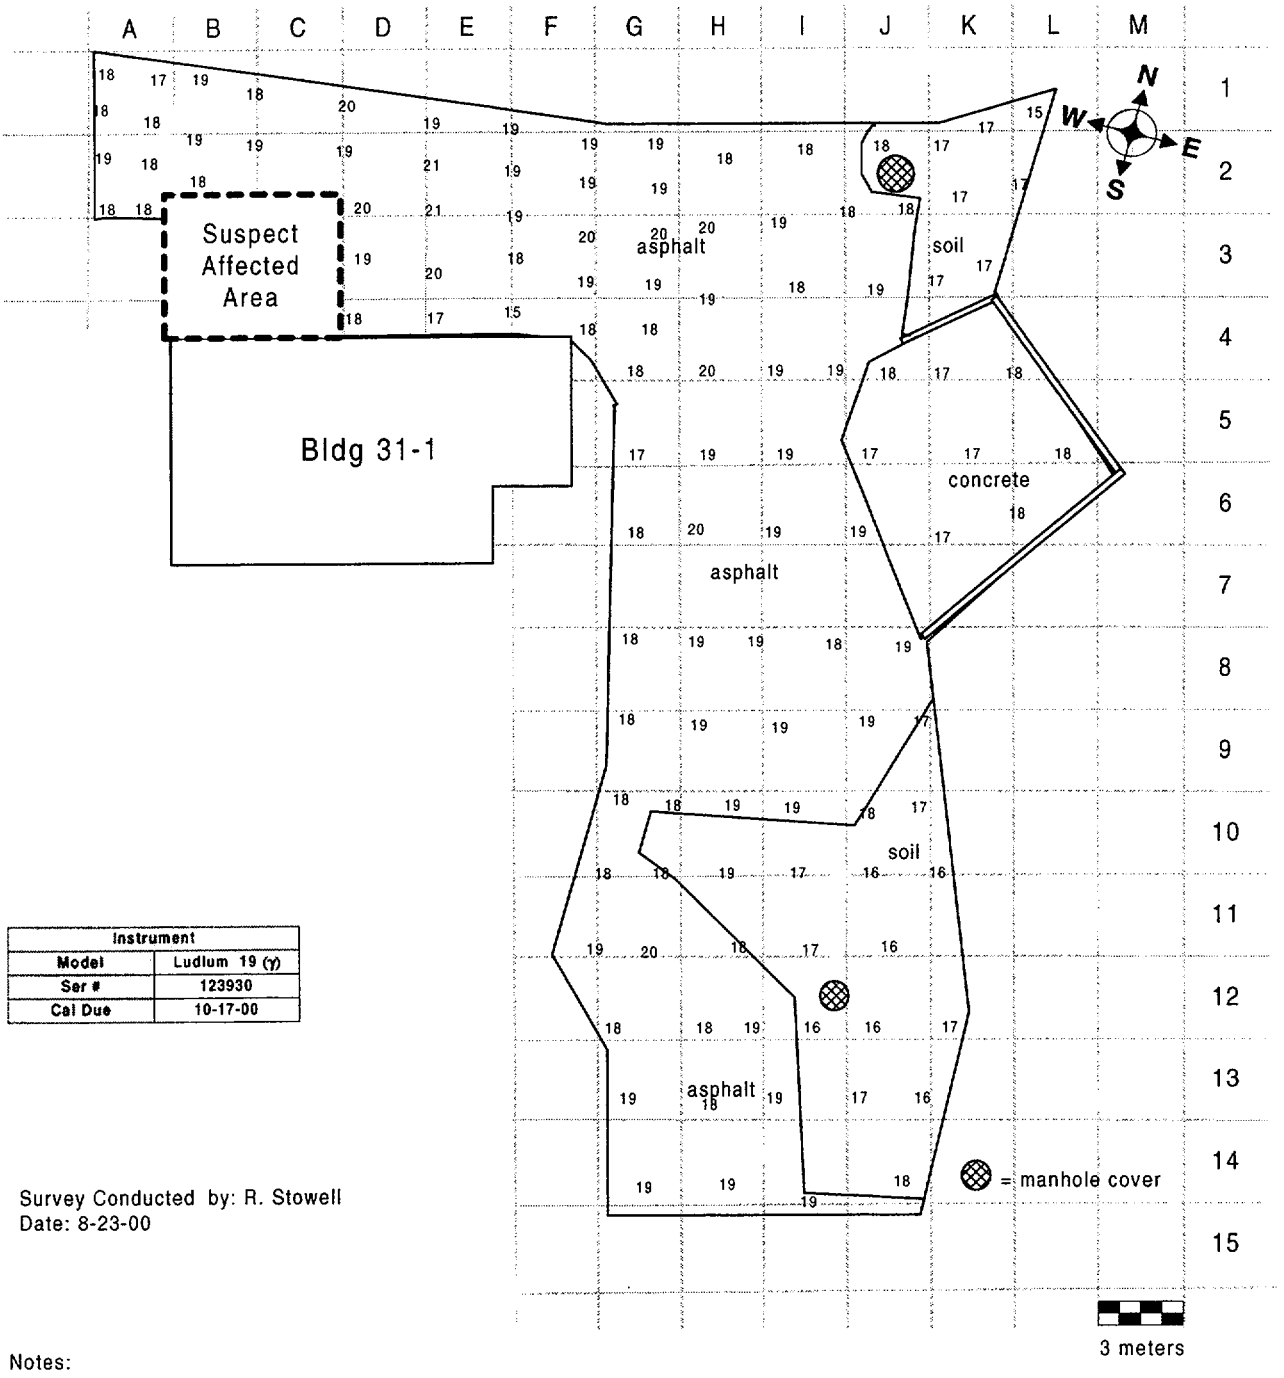
Figure 9: Unaffected Area Exposure Rate Fixed Measurement Locations and Results

2.. Results range from 15 to 21 µR/hr.

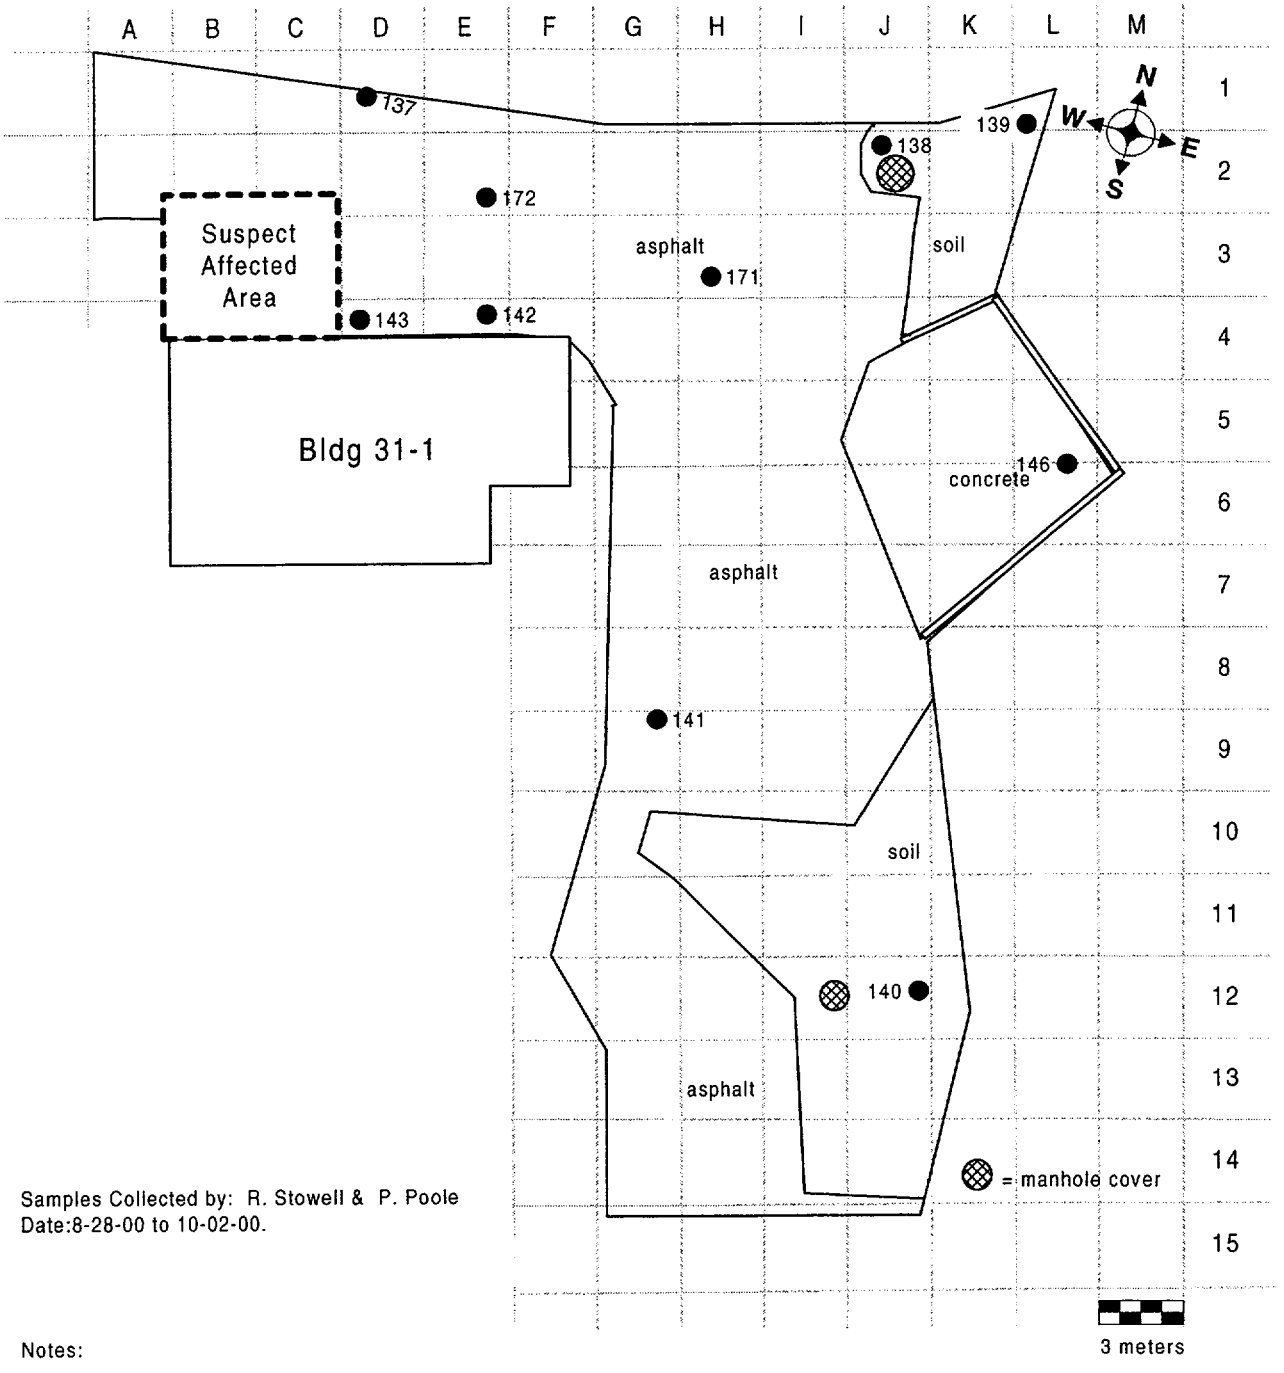
Figure 10: Unaffected Area Soil Sample Locations

1. Soil sample results are provided in Table 6.
2. ●XXX Denotes approximate soil sample location, LNLA-S-XXX.
3. ●XXXB Denotes resample at original location following remediation.
4. ●XXX/A Denotes dual sample, surface 0-6" and subsurface 6-12".
5. ▭ Denotes excavated / remediated area.
6. The original sample at this location had 98% of the limit for U-235. This area was excavated and resampled as shown.

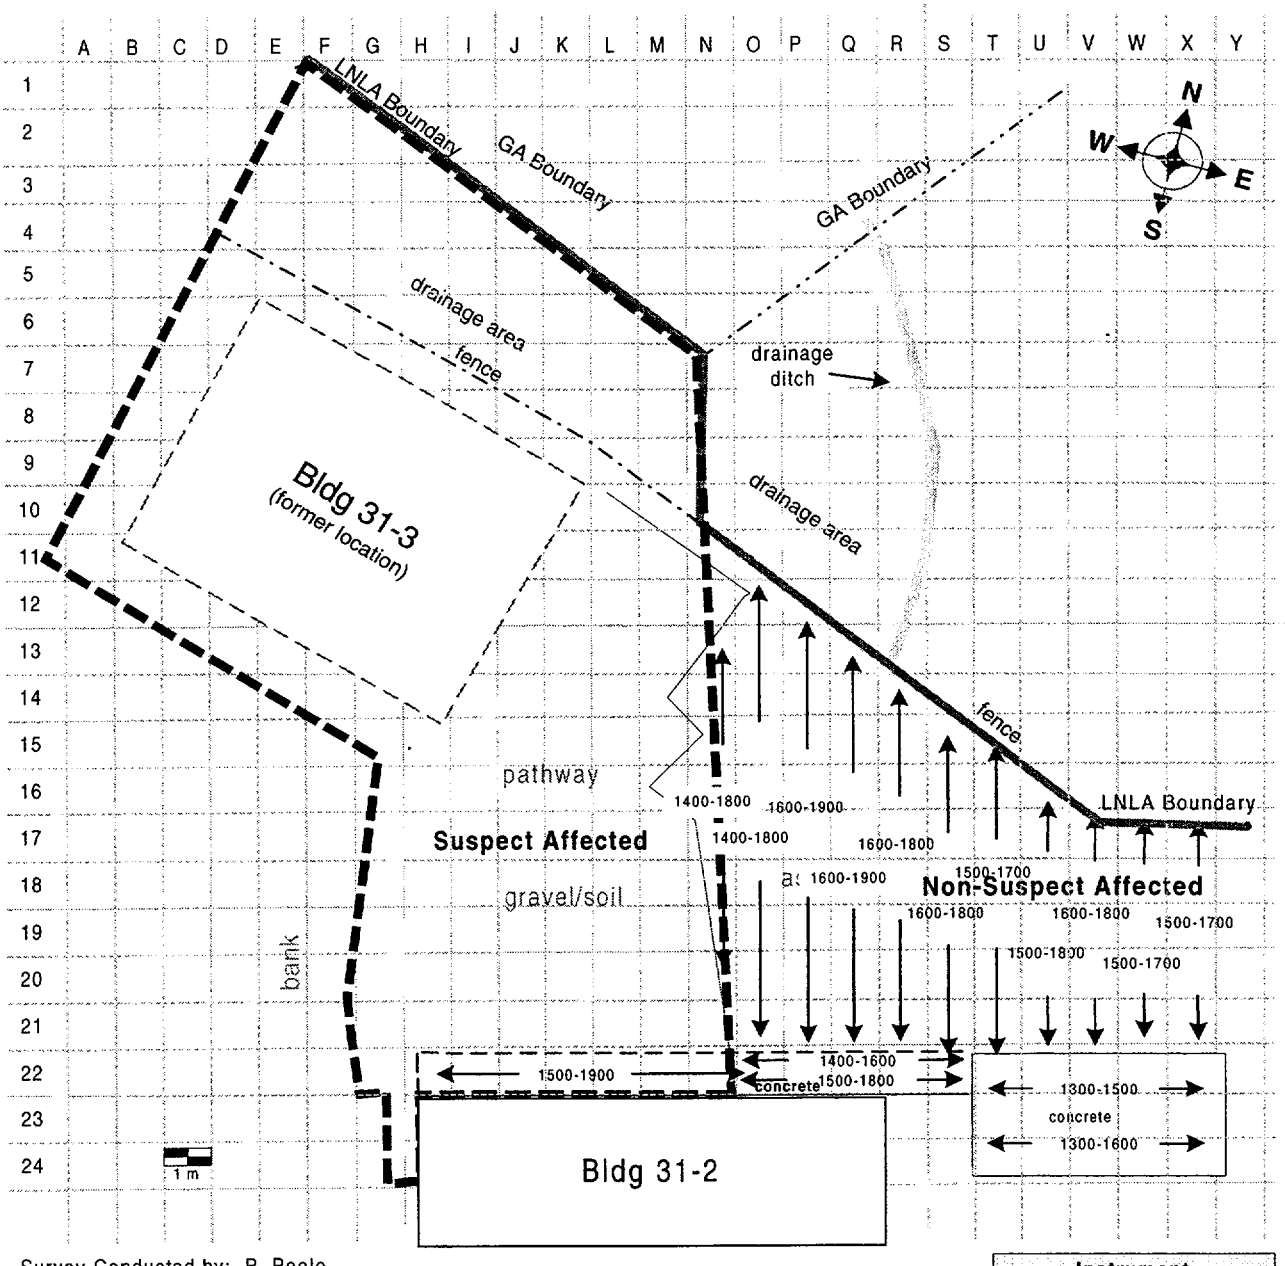
Figure 12: Affected Areas Beta Scan Locations and Results

1. 100% of available flat surfaces scanned . Results range from 1300 to 1900 cpm.
2. ← XXXX-XXXX → Denotes scan range in cpm.

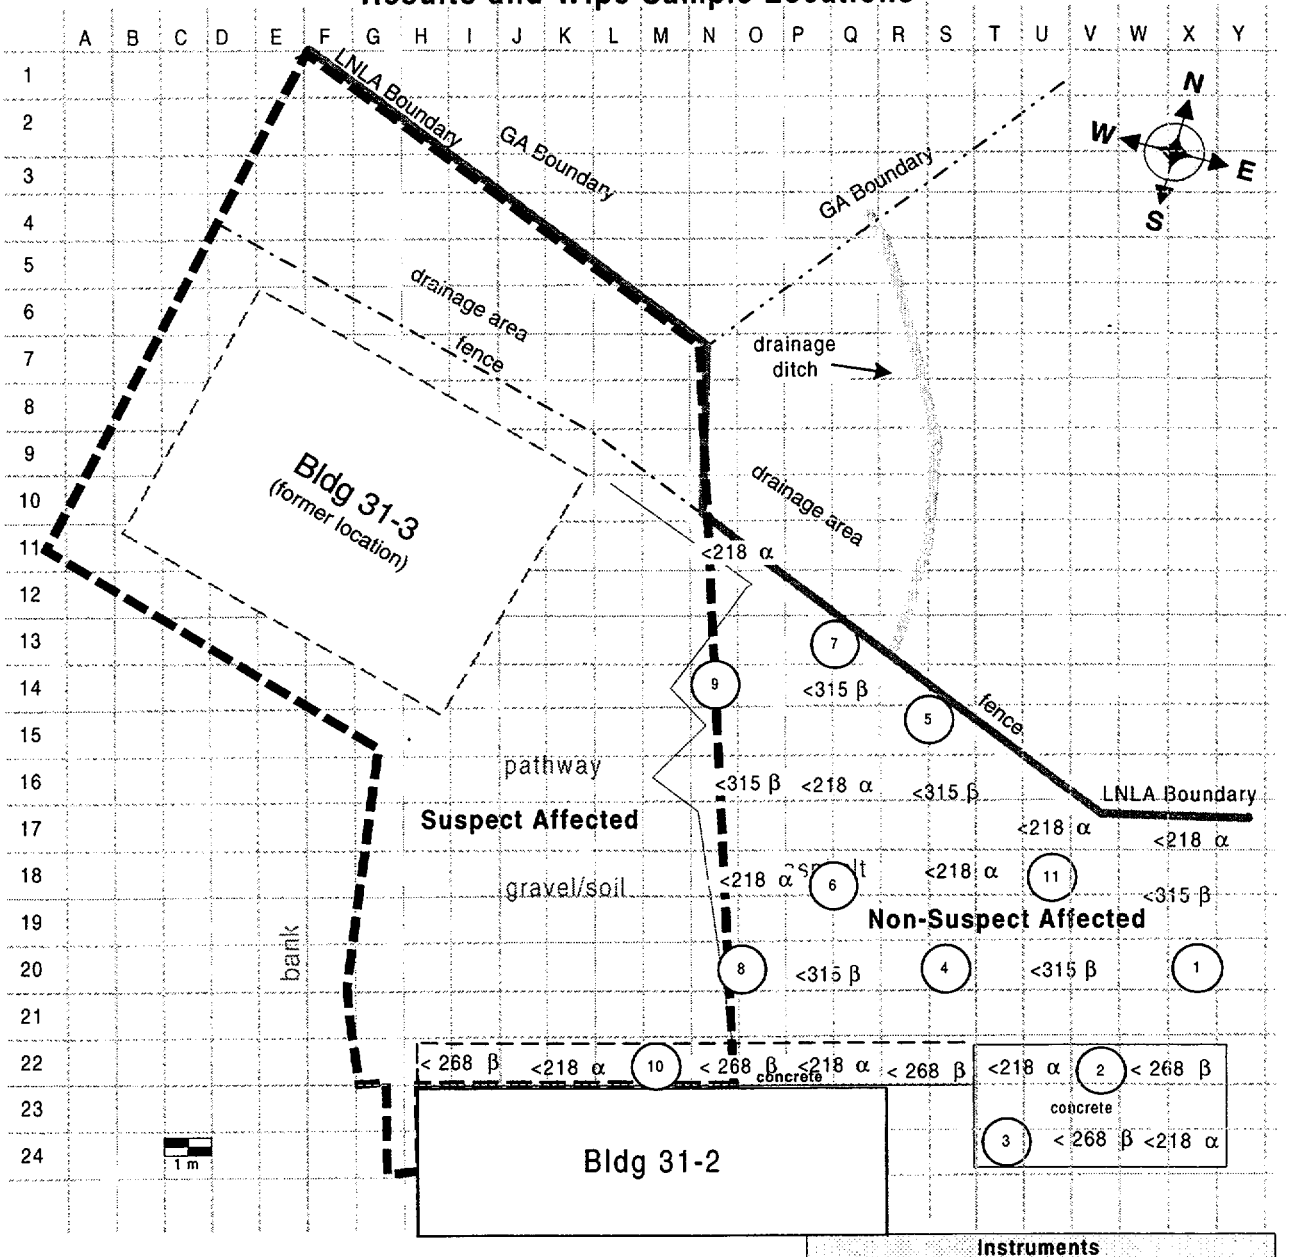
Figure 13: Affected Areas Alpha and Beta Fixed Measurement Locations and Results and Wipe Sample Locations

1. XXX β Denotes a fixed beta reading in dpm/100 cm^2. Maximum result for beta was <315 dpm/100 cm^2 (MDA for asphalt).
2. XXX α Denotes a fixed alpha reading in dpm/100 cm^2. Maximum result for alpha was <218 dpm/100 cm^2 (MDA for asphalt and concrete).
3. (XX) Denotes a wipe location. Wipe results are provided in Table 5.

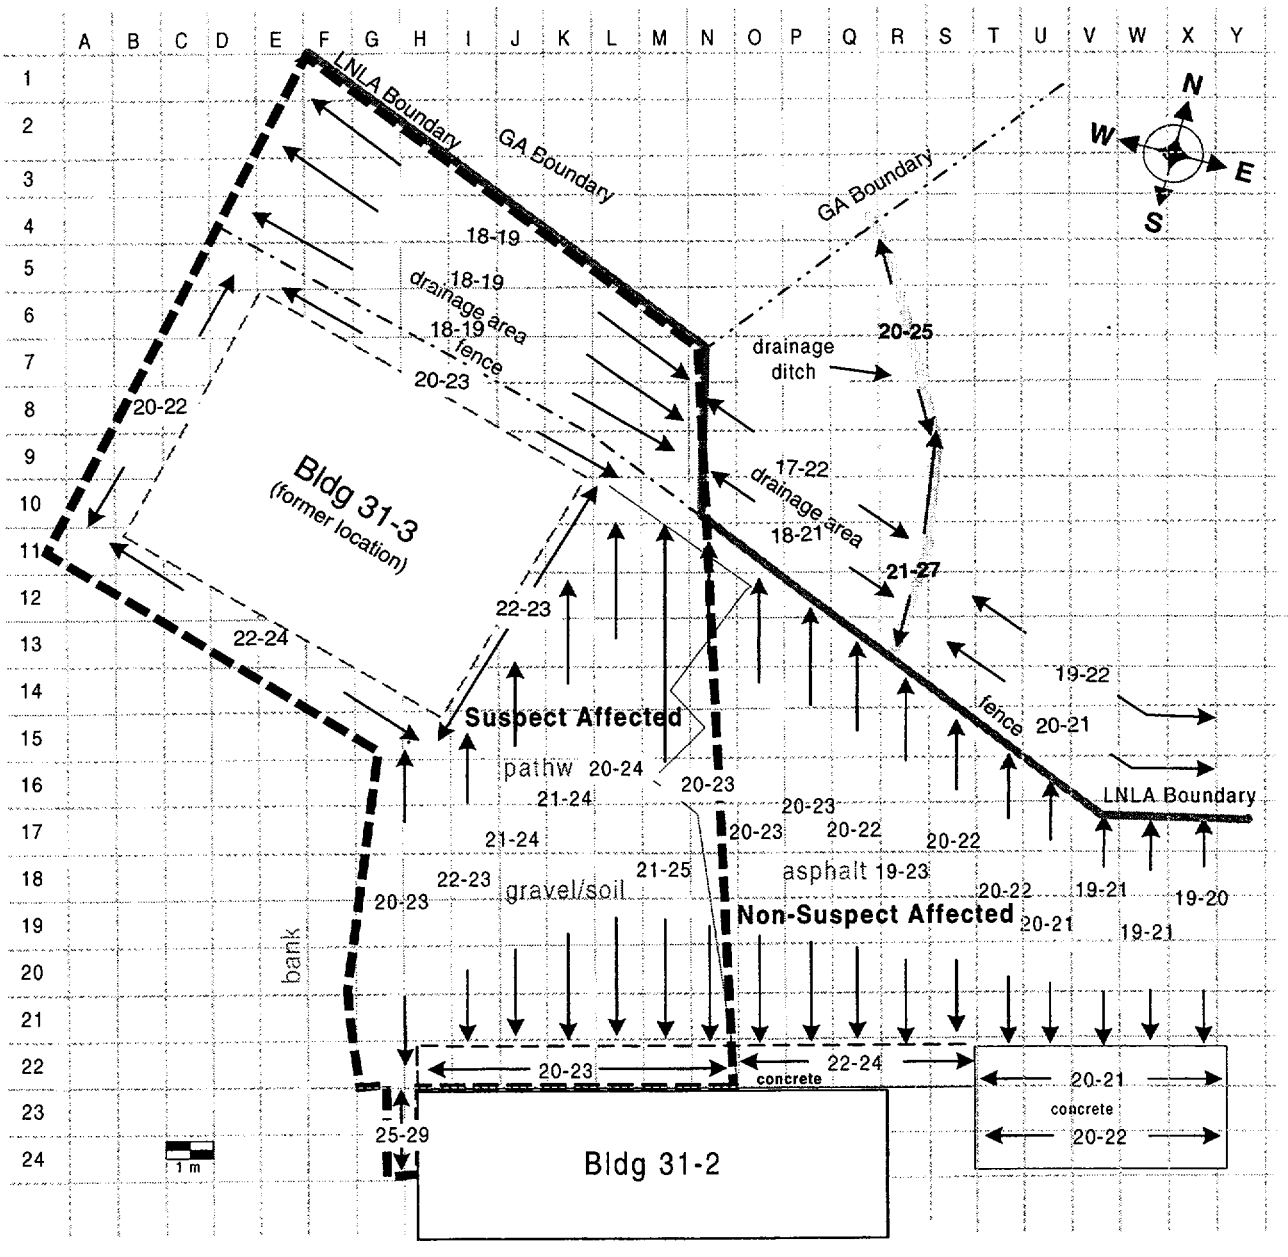
Figure 14: Affected Areas Exposure Rate Scan Locations and Results

1. Approximately 100 % of the accessible surface area scanned.
2. ← xx-xx → Denotes surface scan range in µR/hr.
3.. Scan results range from 18 to 29 µR/hr inside LNLA and 17-27 µR/hr outside LNLA.

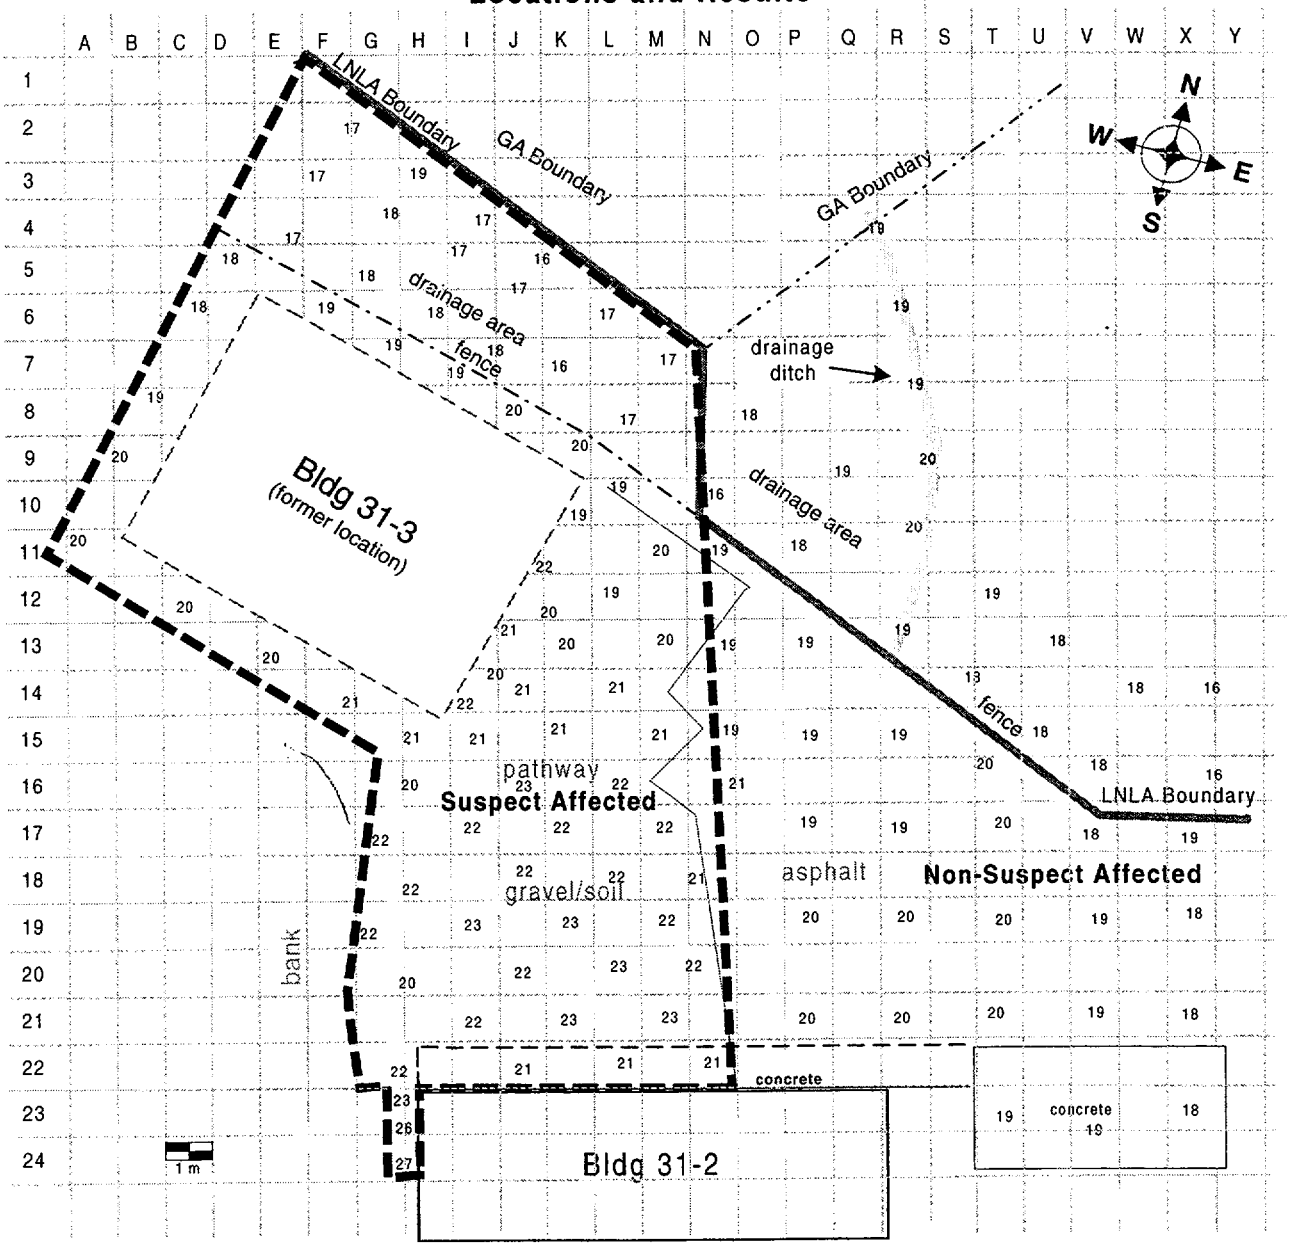
Figure 15: Affected Areas Fixed Exposure Rate Measurement Locations and Results

2. Results range from 16-27μR/hr inside LNLA Boundary and 16-20 μR/hr outside LNLA Boundary.

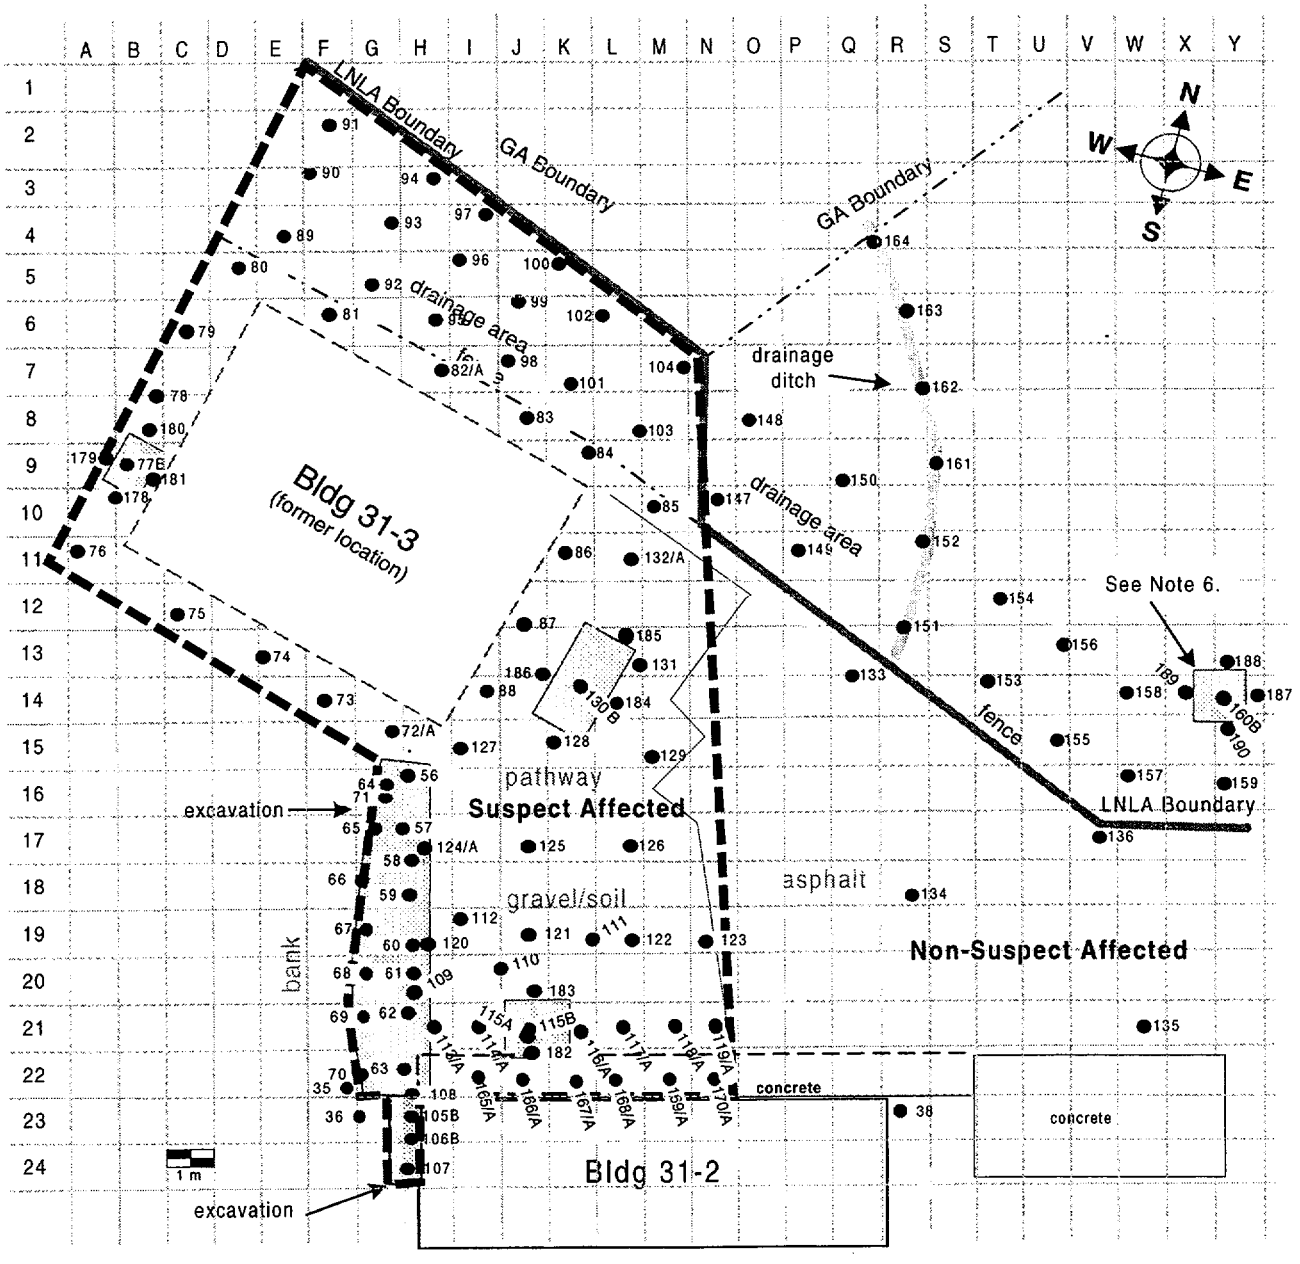
Figure 16: Affected Areas Soil Sample Locations and Remediated Areas

Elevated radiation levels were also found in the hillside area outside and immediately west of Building 31-2. Soil samples were taken and analyzed by gamma spectroscopy. Elevated levels of U-235 were identified. Uranium isotopic analyses performed by an outside laboratory on one of the contaminated soil samples identified the contaminate as enriched uranium (enriched to ~ 44-45% U-235). The U-234:U-235 ratio was measured to be 26:1. These results are provided in Appendix C. GA removed soil until soil concentrations demonstrated that the levels were below the approved release criteria. The contaminated soil was disposed of as low-level radioactive waste. The area remediated is the shaded area shown on Figure 16.

Asphalt was removed from the area north of Building 31-2 to allow soil sampling and remediation. Concrete surfaces were scabbled in areas where radioactivity was found. The shaded areas shown on Figures 16 and 19 approximates the areas of remediation. Approximately 1,152 ft^3 of contaminated material (mostly soil) was removed. The total weight of material removed was ~ 67,480 pounds. This material was packaged into 9 standard metal low specific activity (LSA) radioactive waste boxes.
