GENERAL ATOMICS'

FINAL RADIOLOGICAL SURVEY REPORT

FOR THE LINAC NORTH LAND AREA

April 2001

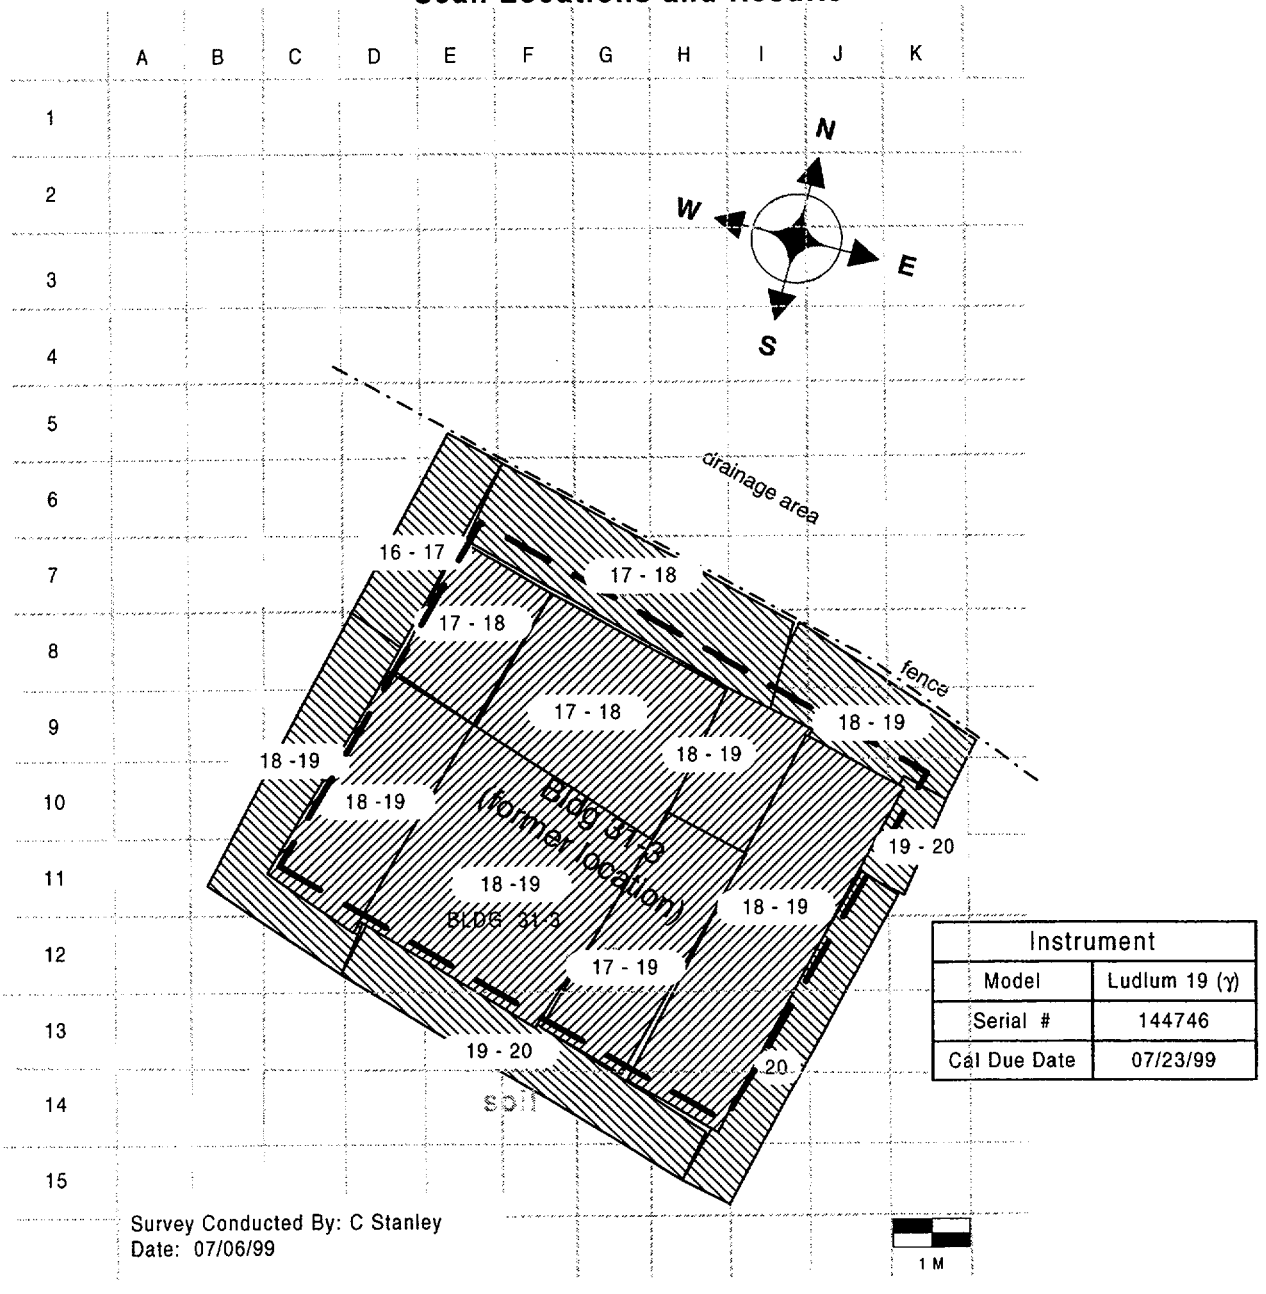
Figure 17: Building 31-3 Suspect Affected Area Exposure Rate Scan Locations and Results

1. Approximately 100% of of the accessible surface area scanned.
2. Denotes surface scan area, ranges shown in µR/hr.
3. Scan results range from 17 to 20 µR/hr.

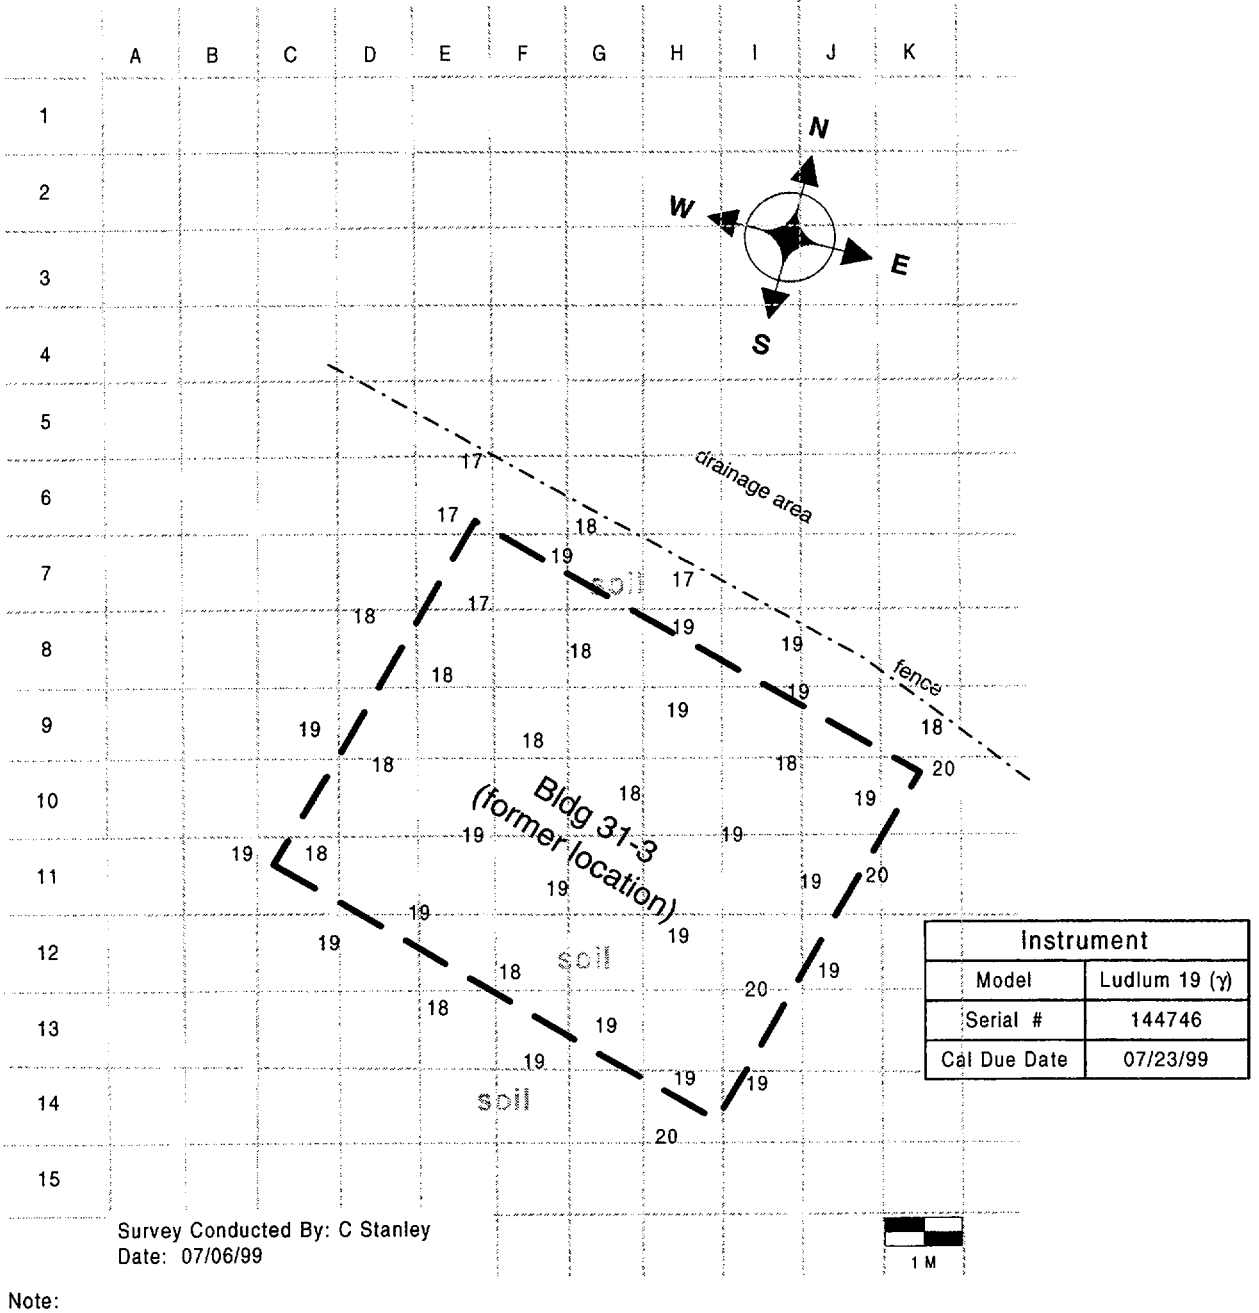
Figure 18: Building 31-3 Suspect Affected Area Exposure Rate Fixed Measurement Locations and Results

1. All readings are in µR/hr and taken at ~ 1m above the surface.
2. Results range from 17 to 20 µR/hr.

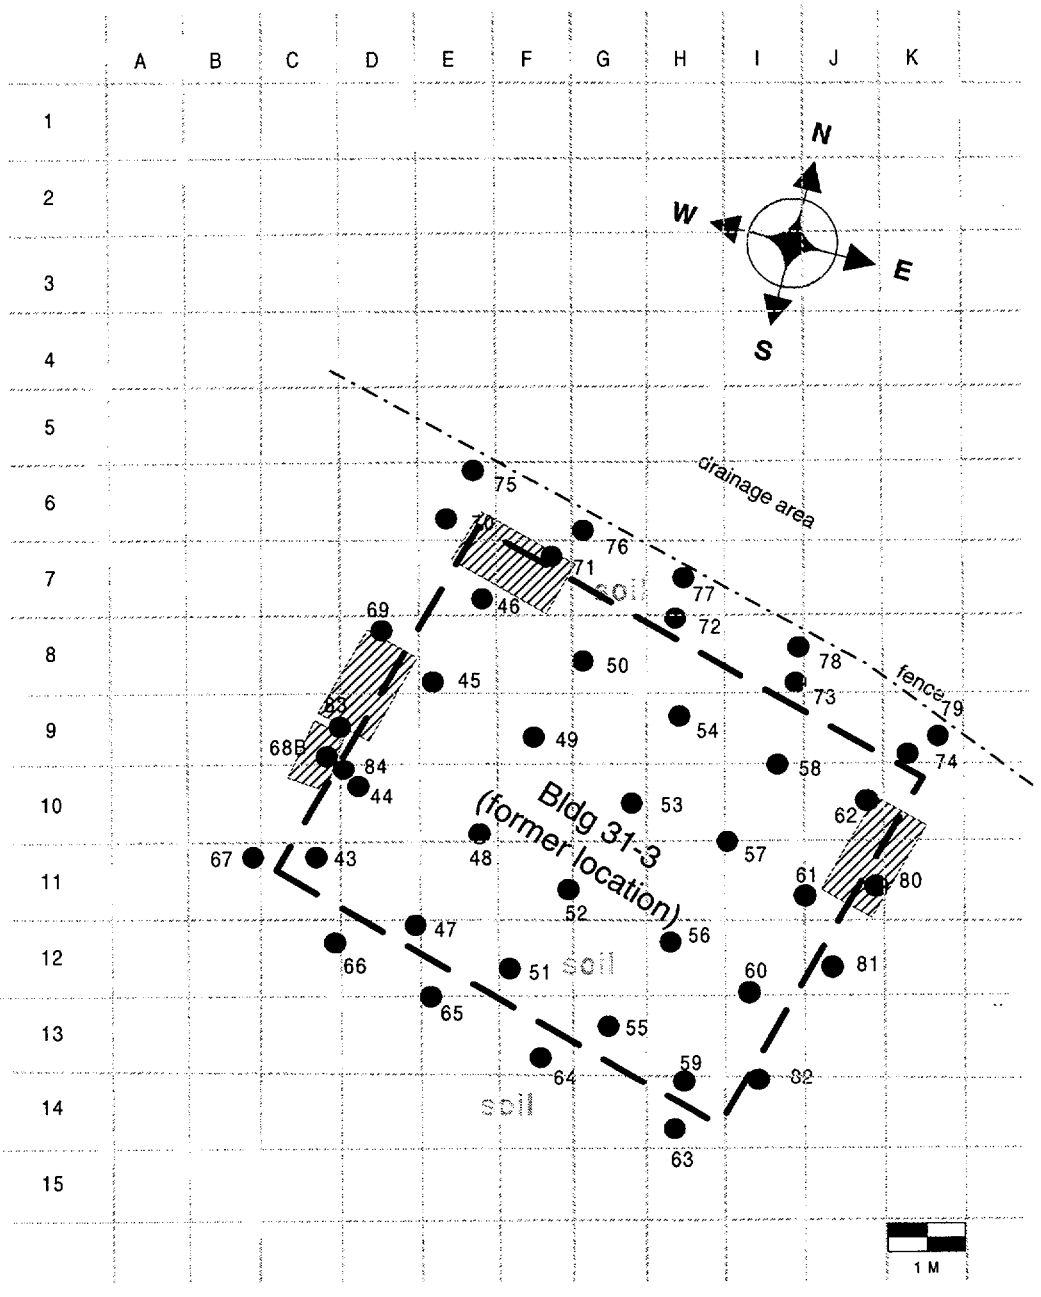
Figure 19: Building 31-3 Suspect Affected Area Soil Sample Locations and Remediated Areas

1. Soil sample results are provided in Table 6.
2. ● xx Denotes soil sample location, 31-3-XX.
3. ▨ Denotes remediated area.

Asphalt was removed from the area north of Building 31-2 to allow soil sampling and remediation. Concrete surfaces were scabbled in areas where radioactivity was found. The shaded areas shown on Figures 16 and 19 approximates the areas of remediation. Approximately 1,152 ft^3 of contaminated material (mostly soil) was removed. The total weight of material removed was ~ 67,480 pounds. This material was packaged into 9 standard metal low specific activity (LSA) radioactive waste boxes.

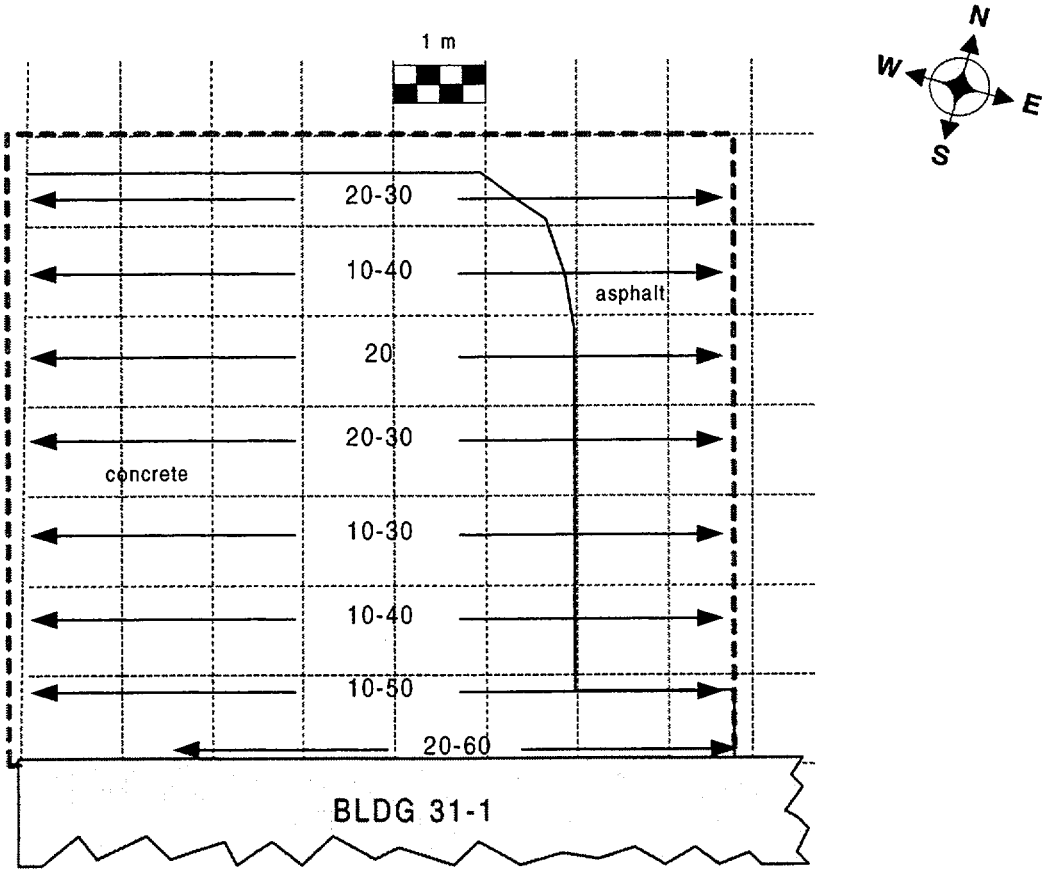
Figure 20: Suspect Affected Area Outside Building 31-1 Alpha Scan Locations and Results

1. ~100% of accessible surface area scanned with a result of 1600-2300 cpm except as noted below.
2. One small area, denoted as , had scan results of up to 6000 cpm. Contamination was identified as Co-60.
3. Subsequent investigation using a 100 cm^2 beta detector resulted in (12) two-minute fixed readings with a maximum of 3220 dpm/ 100 cm^2 with an average of 1182 dpm/100 cm^2 (below the Co-60 release criteria).
4. ← XX → Denotes scan range in cpm.
5. Denotes area where concrete was removed to access soil for sample LNLA-S-193

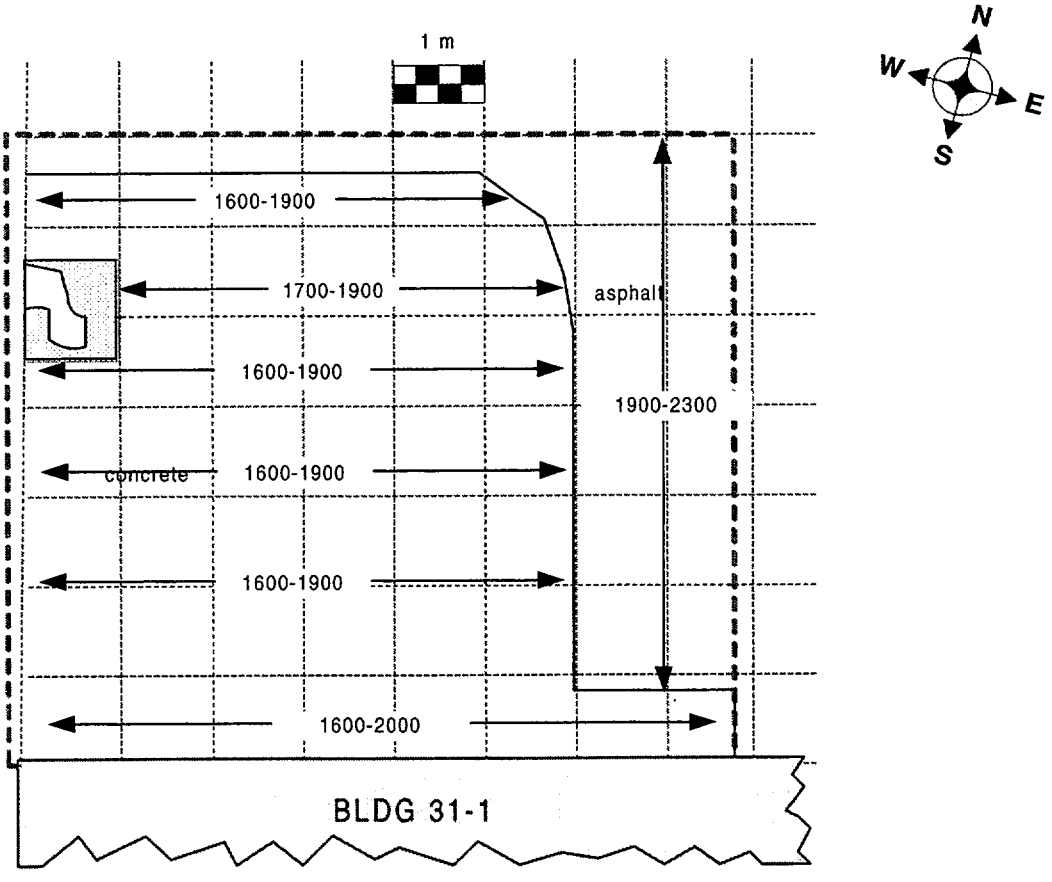
Figure 21: Suspect Affected Area Outside Building 31-1
Beta Scan Locations and Results

While scanning the concrete outside Building 31-1 for beta contamination, elevated radiation levels (~6,000 cpm) were noted in a small area of concrete (< 0.3 m^2) on the northwest concrete pad north of Building 31-1. A sample of concrete was collected and analyzed by gamma

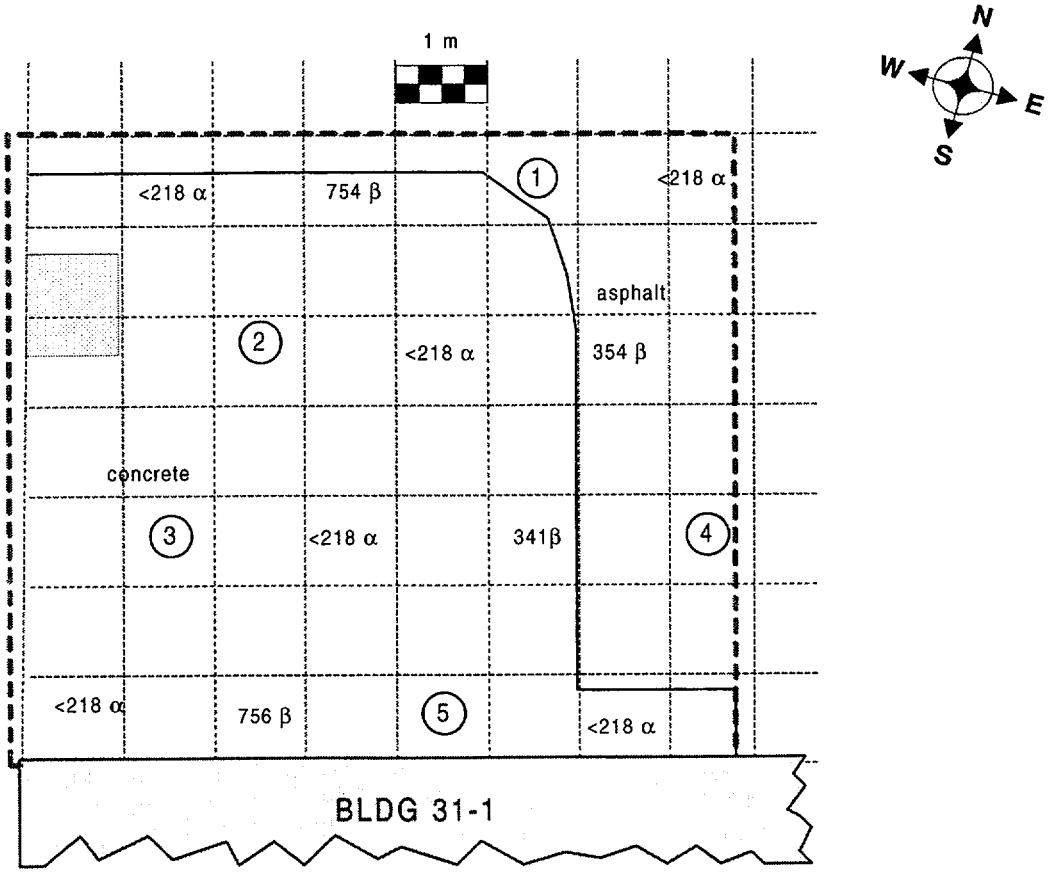
Figure 22: Suspect Affected Area Outside Building 31-1
Fixed Alpha and Beta Measurement Locations and Results and Wipe Locations

1. (X) Denotes approximate wipe location. Wipe results are provided in Table 5.
2. XX α Denotes Fixed Alpha Measurement in dpm/100 cm^2. Results were all <218 dpm/100 cm^2, (MDA for asphalt and concrete.)
3. XXX β Denotes Two Minute Fixed Beta Measurement in dpm/100 cm^2. Results ranged from 341 to 756 dpm/100 cm^2.
4. ▭ Denotes area where concrete was removed to access soil for sample LNLA-S-193.

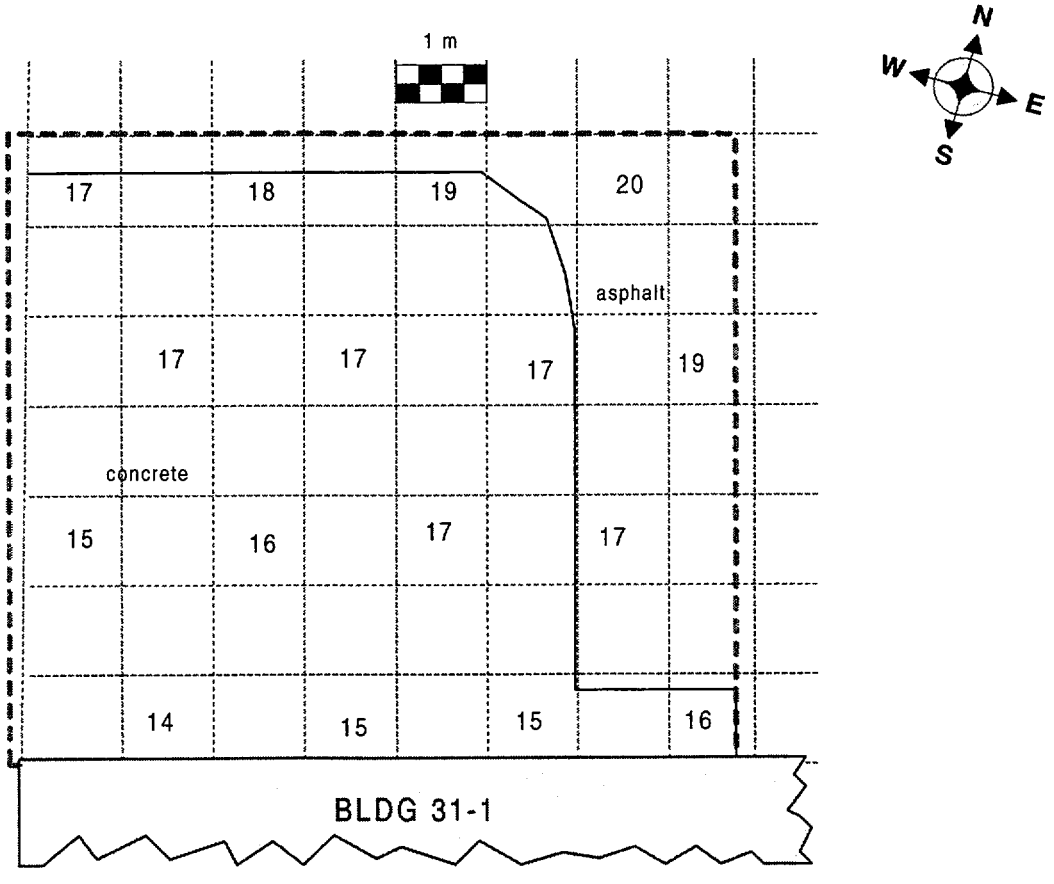
Figure 24: Suspect Affected Area Outside Building 31-1
Fixed Exposure Rate Measurement Locations and Results

1. XX Denotes reading in μR/hr taken 1 meter above the surface.
2. Results range from 14 to 20 μR/hr.

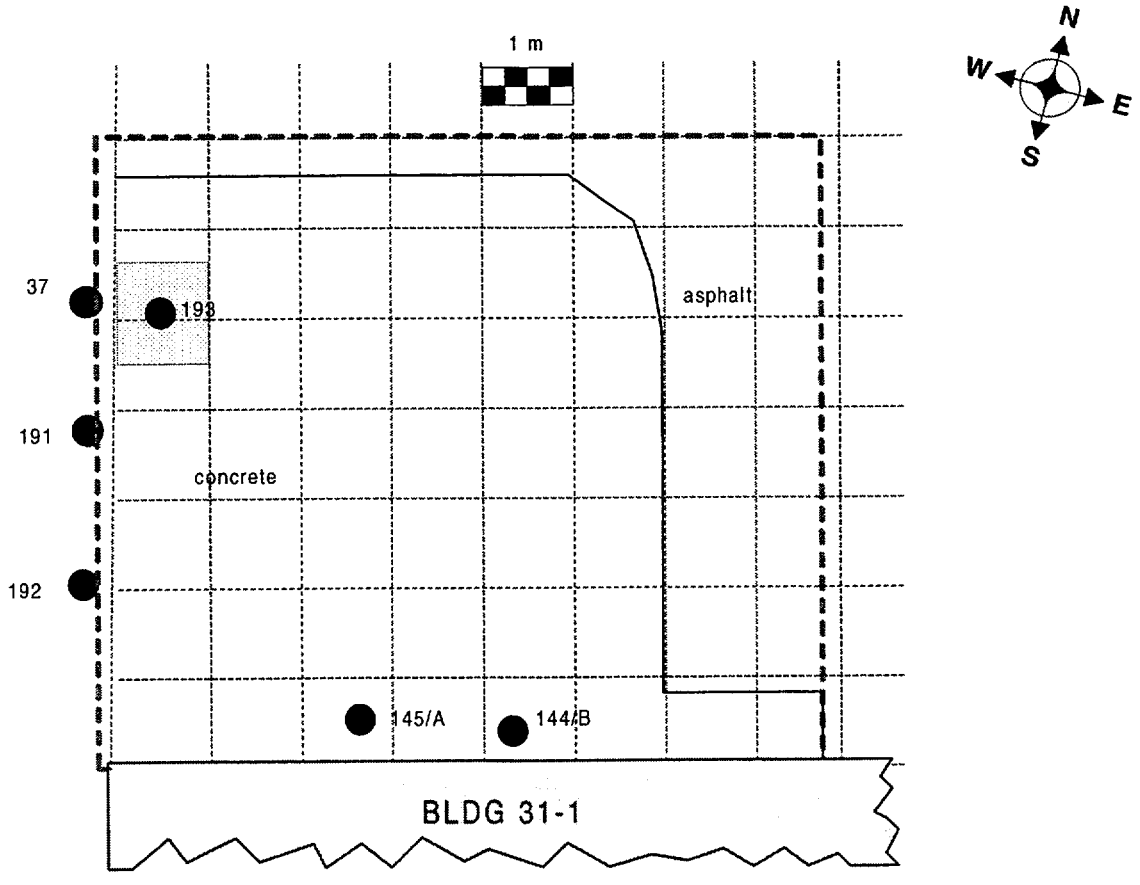
Figure 25: Suspect Affected Area Outside Building 31-1
Soil Sample Locations

1. Soil Sample results are provided in Table 6.
2. ● XXX Denotes approximate soil sample location, LNLA-S-XX.
3. XXX/A or XXX/B Denote dual samples, surface (0-6") and subsurface (6-12").
4. ▭ Denotes area where concrete was removed.

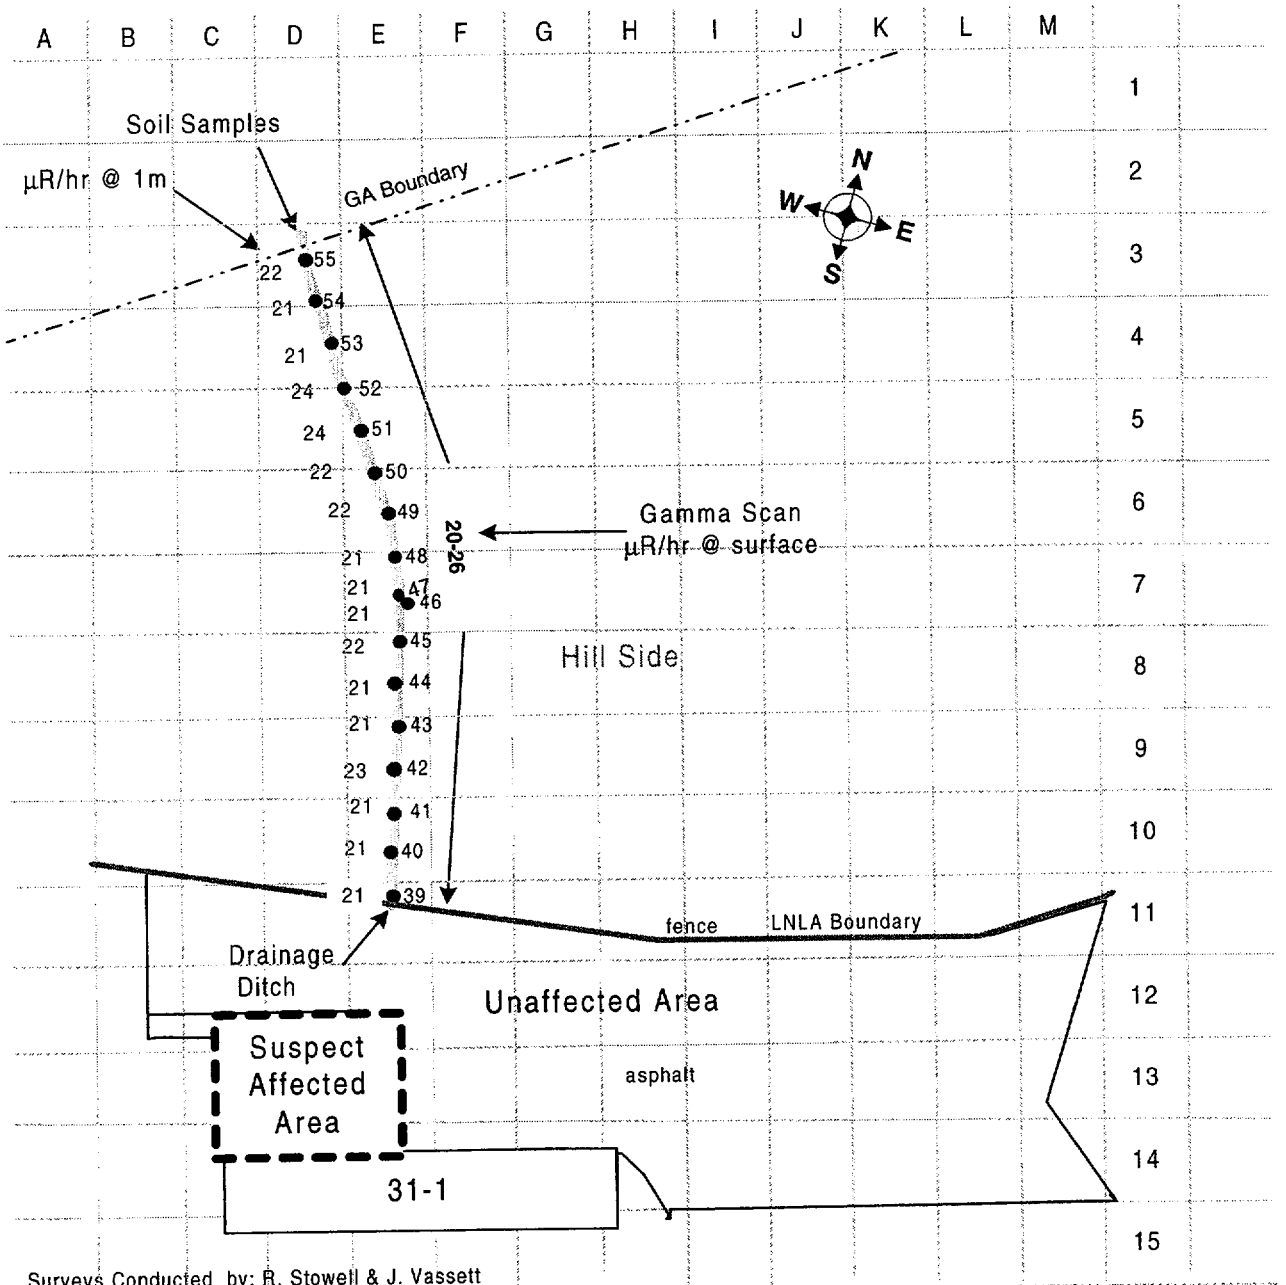
Figure 26: Unaffected Area Drainage Surveys

A total of thirty-five (35) fixed exposure rate measurements were taken at 1 meter from the surface. Eighteen (18) measurements were taken along the hillside (see Figure 15); the maximum reading was 20 μR/hr. Seventeen (17) measurements were taken along the drainage channel (see Figure 26); the maximum reading was 24 μR/hr.

1. Soil Sample results are provided in Table 6.
2. ● XX Denotes approximate soil sample location.
3. XX Denotes exposure rate measurement in µR/hr taken at ~1 meter above the surface. Results range from 21-24 µR/hr.
4. ←xx-xx→ Denotes gamma scan range in µR/hr taken in the drainage ditch at the surface. Results range from 20 -26 µR/hr.

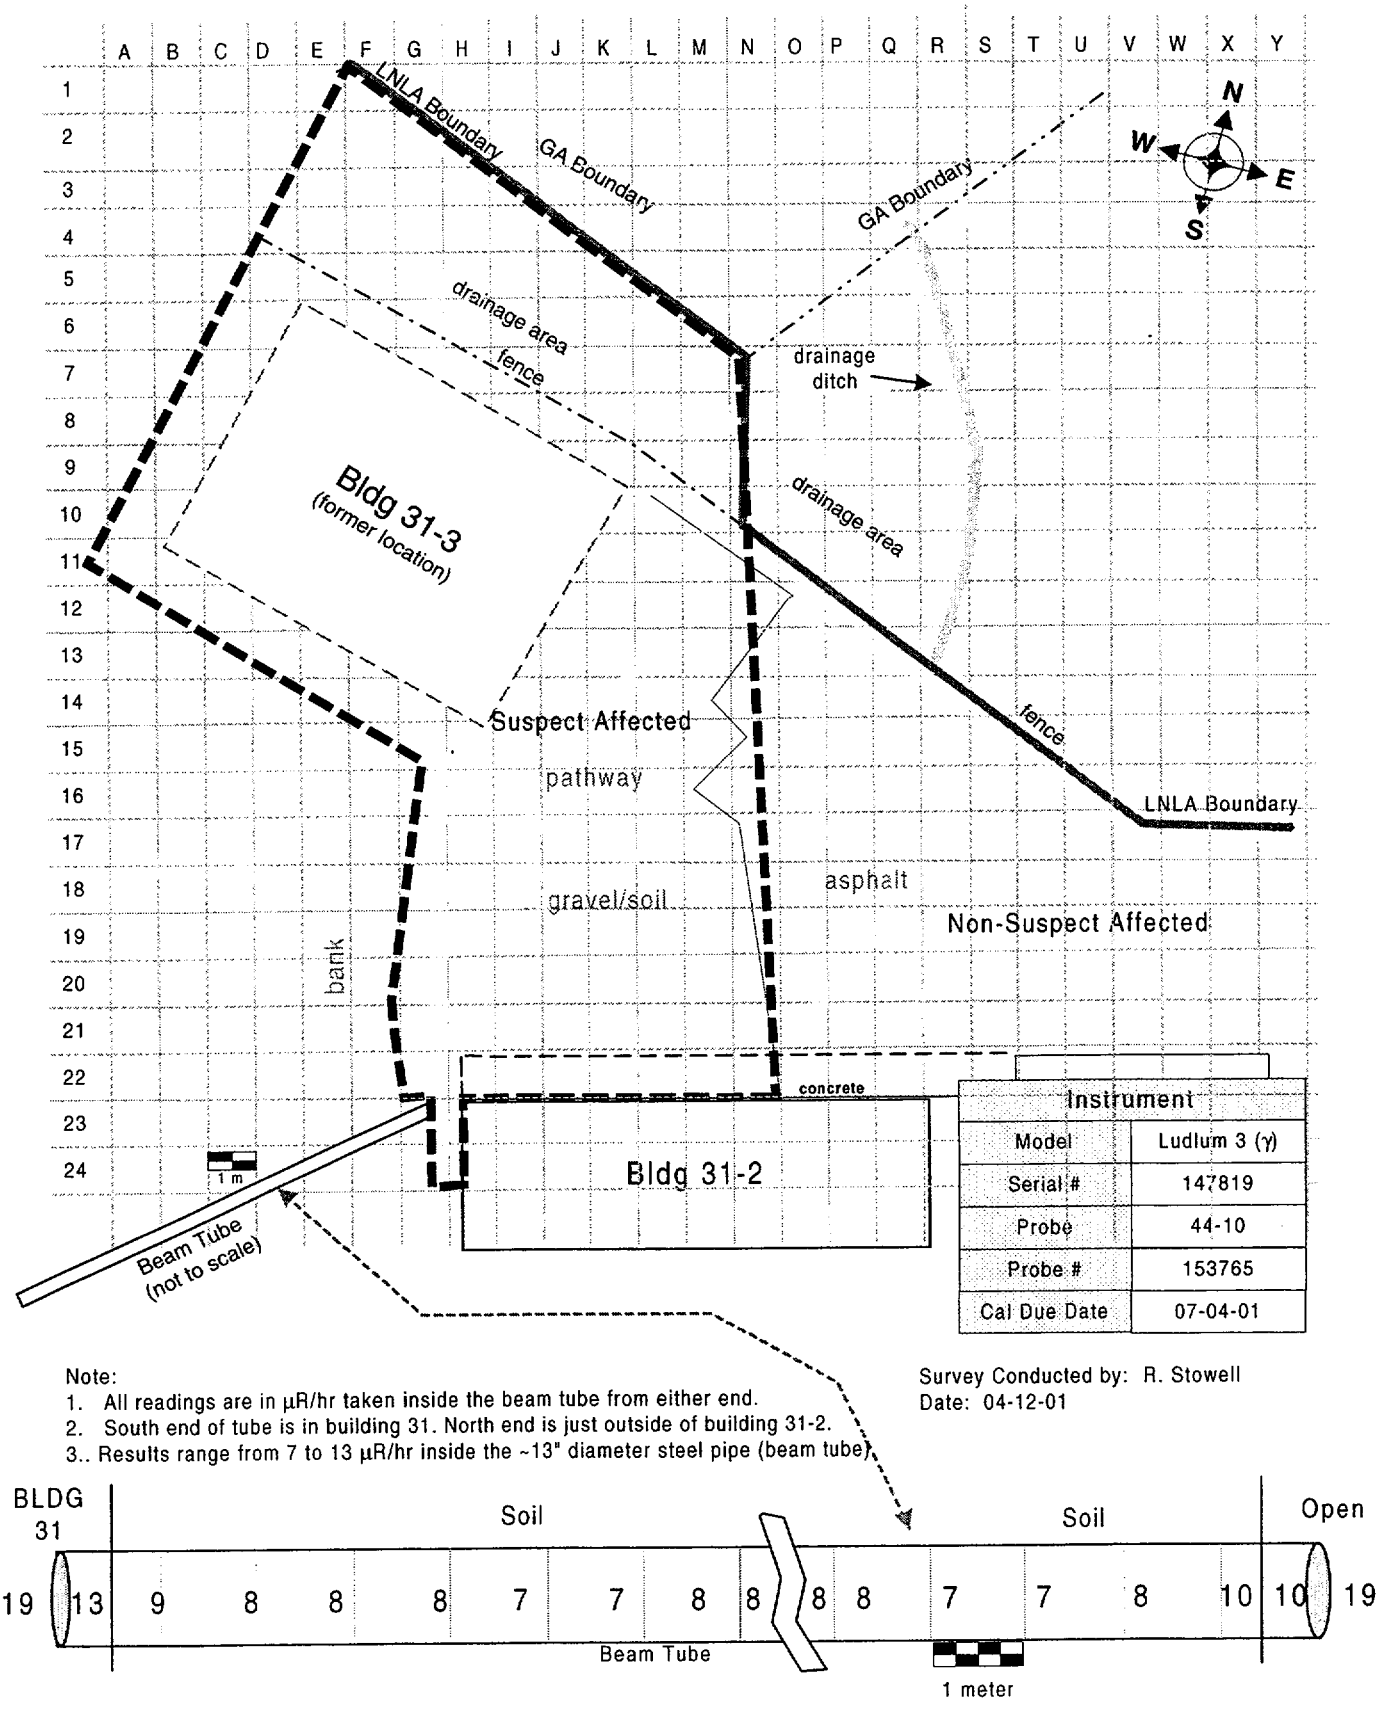
Figure 27: Beam Tube Exposure Rate Measurements

There is a beam tube that originates at Building 31, traverses (underground) the non-impacted area between Building 30 and Building 31-2, and terminates at a hillside west of Building 31-2. Approximately 7.5 m of the internal surface of this tube was surveyed with a NaI(Tl) detector from the Building 31 opening, and 5.5 m of the internal surface from the Building 31-2 opening was surveyed. The exposure rates decreased the further the detector was placed into the tube. The exposure rates were initially about ~19 μR/hr and decreased to ~ 7-8 μR/hr at a depth of one meter at both ends of the beam tube, as shown in Figure 27.

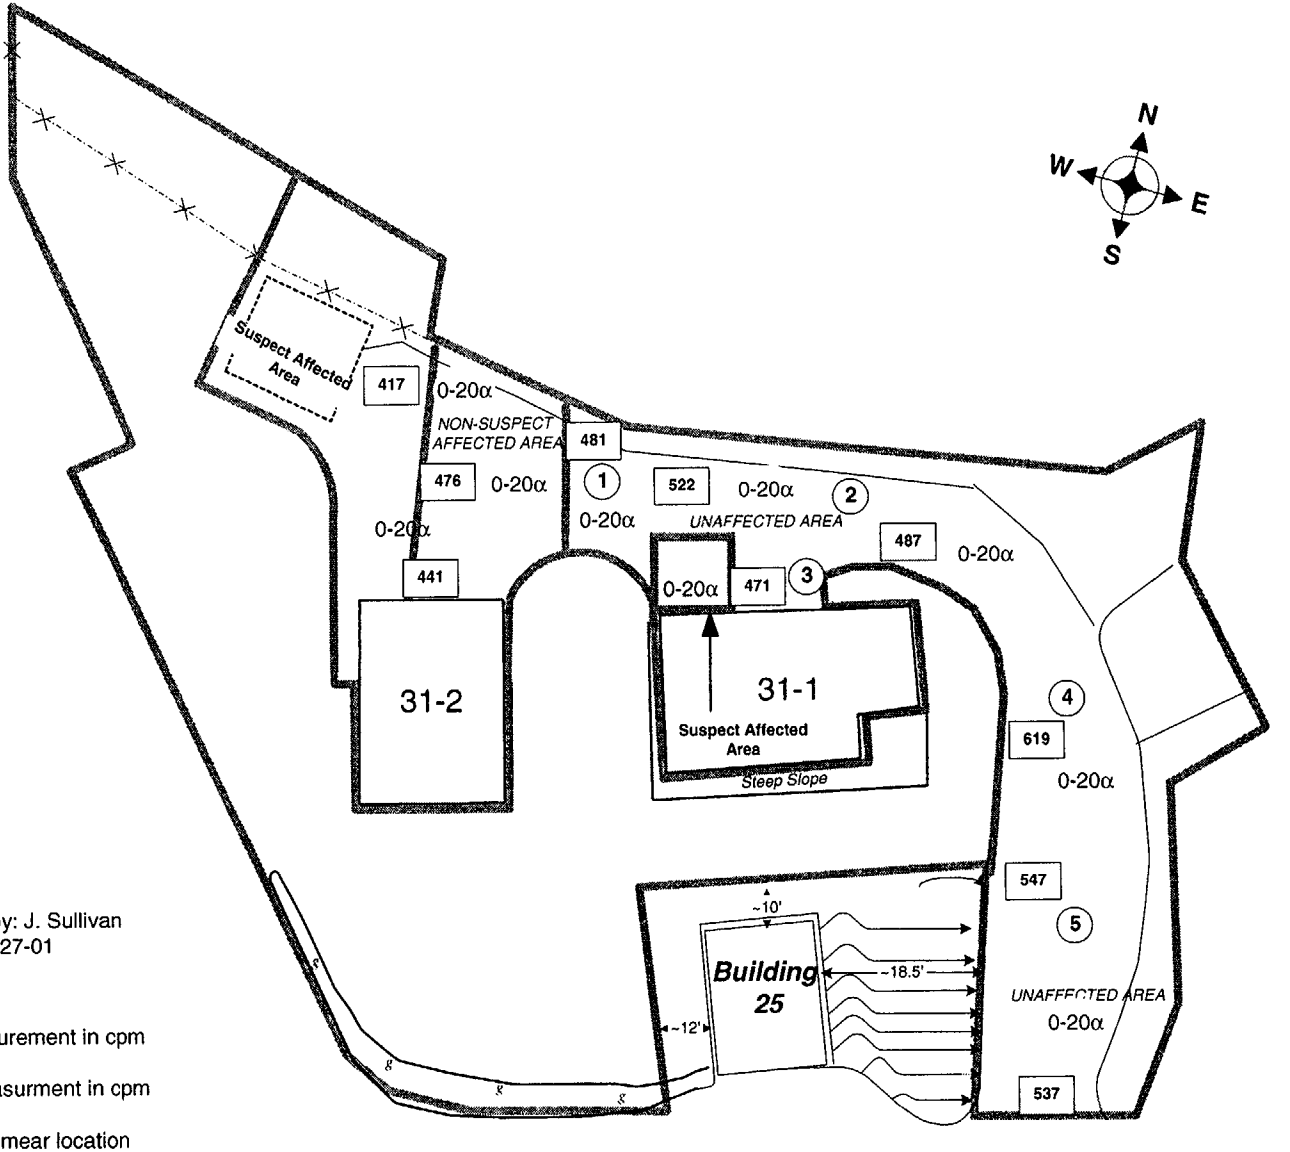
Figure 3 : Confirmatory Alpha , Beta Fixed and Smear Locations

Nine (9) 1-minute fixed alpha readings, all of which were <20 cpm (background) were taken. See Figure 3 for locations and results.

Ten (10) fixed 2-minute beta readings were, all of which were ≤ background (554 cpm on concrete and 644 cpm on asphalt for this instrument), were taken. See Figure 3 for approximate locations and results.

Five (5) swipe samples for loose surface contamination, which were < 10 pCi/100 cm^2 alpha and < 10 pCi/100 cm^2 beta activity were taken. See Figure 3 for approximate locations and Table 2 for results.

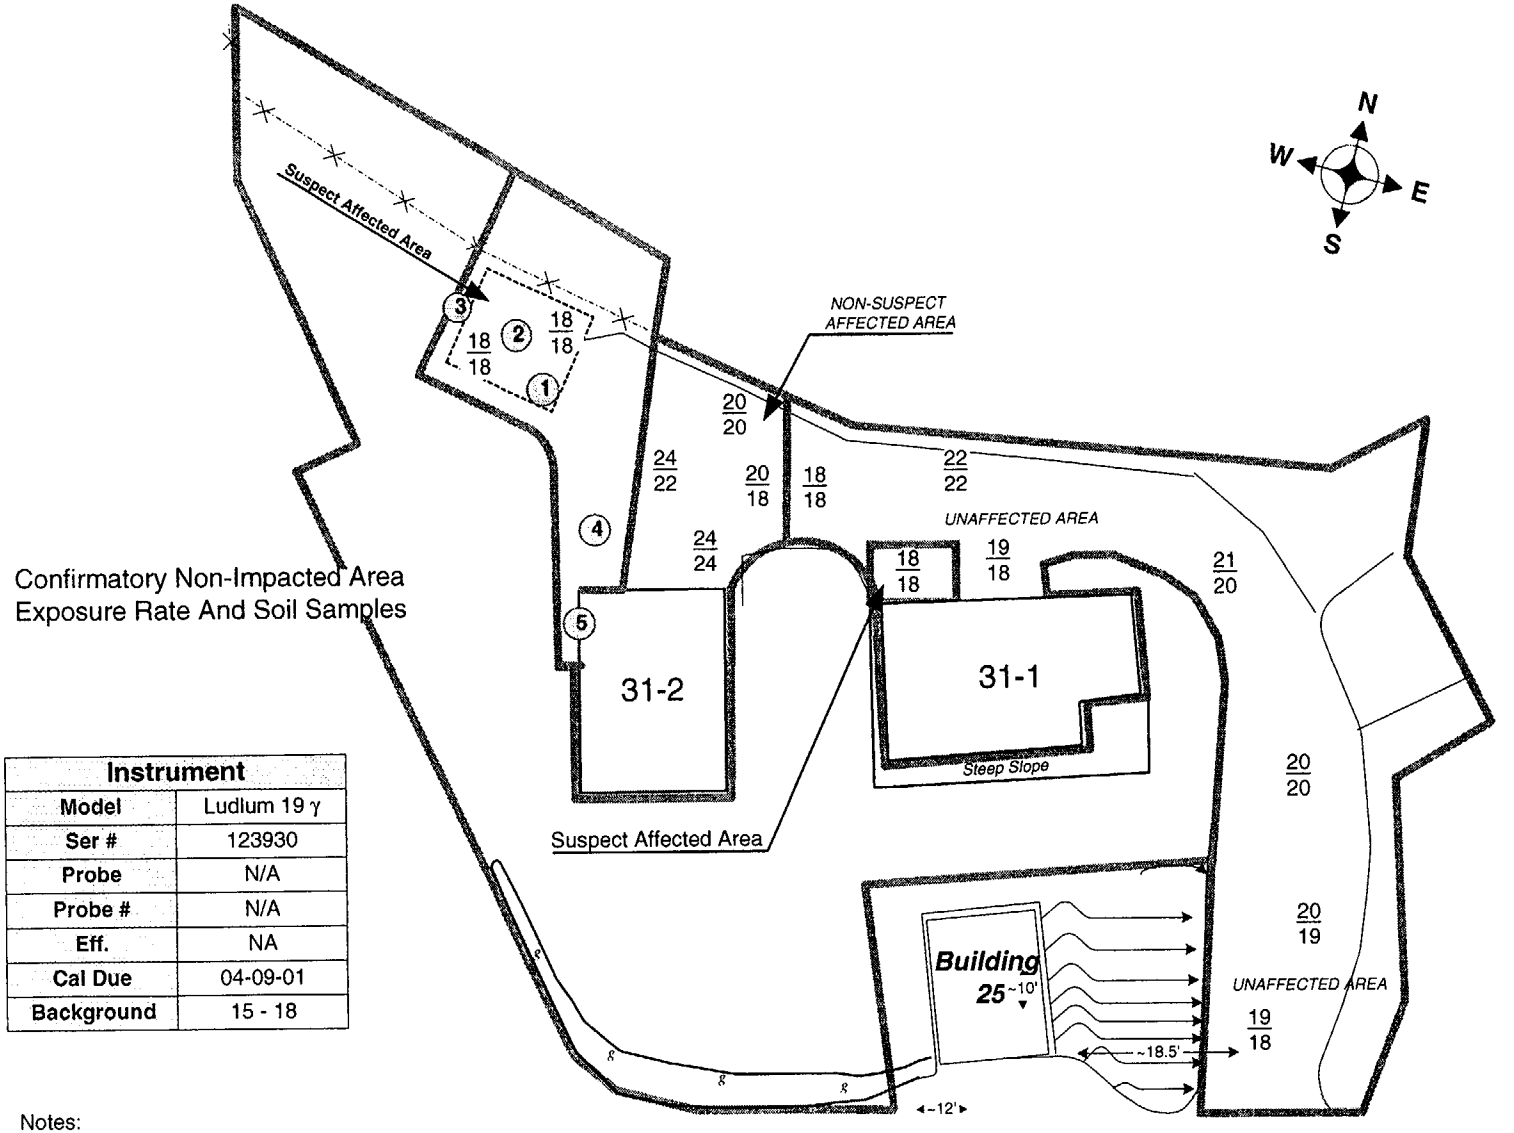
Figure 4 : Confirmatory Exposure Rate and Soil Samples

surface. The background ranged from 18-22 μR/hr. See Figure 4 for approximate locations and results.

Five (5) soil samples were collected in the area, processed and analyzed by gamma spectroscopy. See Table 1 for the results and Figure 4 for the approximate soil sample locations.
