UNITED STATES OF AMERICA
NUCLEAR REGULATORY COMMISSION

In the Matter of:	)	July 20, 2007
AmerGen Energy Company, LLC	)	Docket No. 50-219
(License Renewal for Oyster Creek Nuclear Generating Station)	)

AMERGEN'S PRE-FILED DIRECT TESTIMONY EXHIBITS

VOLUME 1 OF 2: EXHIBITS 1-19

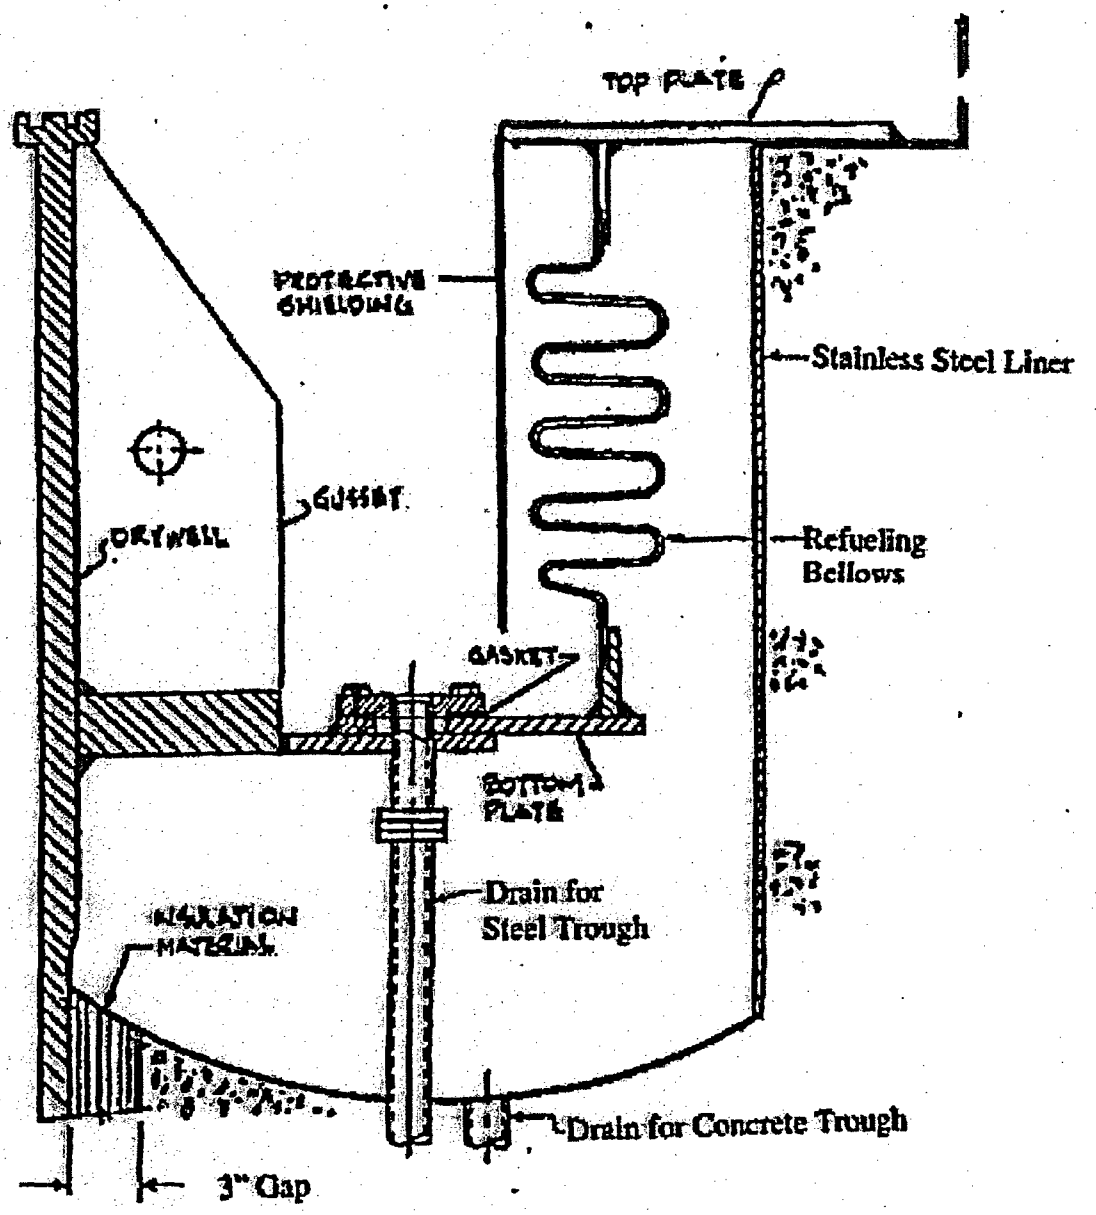
FIGURE 6 – REACTOR CAVITY TROUGH DRAIN

At the top of the Reactor Building concrete shield wall, a concrete trough is located below the reactor cavity seal to collect any water that might leak from the reactor cavity during refueling outages. This trough is equipped with a drain line designed to direct any leakage to the Reactor Building equipment drain tank and prevent it from entering the gap between the drywell shell and the Reactor Building concrete shield wall (See Figure 6).

- Replaced reactor cavity metal trough drain gasket, which was found to be leaking (See Figure 6 of Section 3 of this Enclosure).

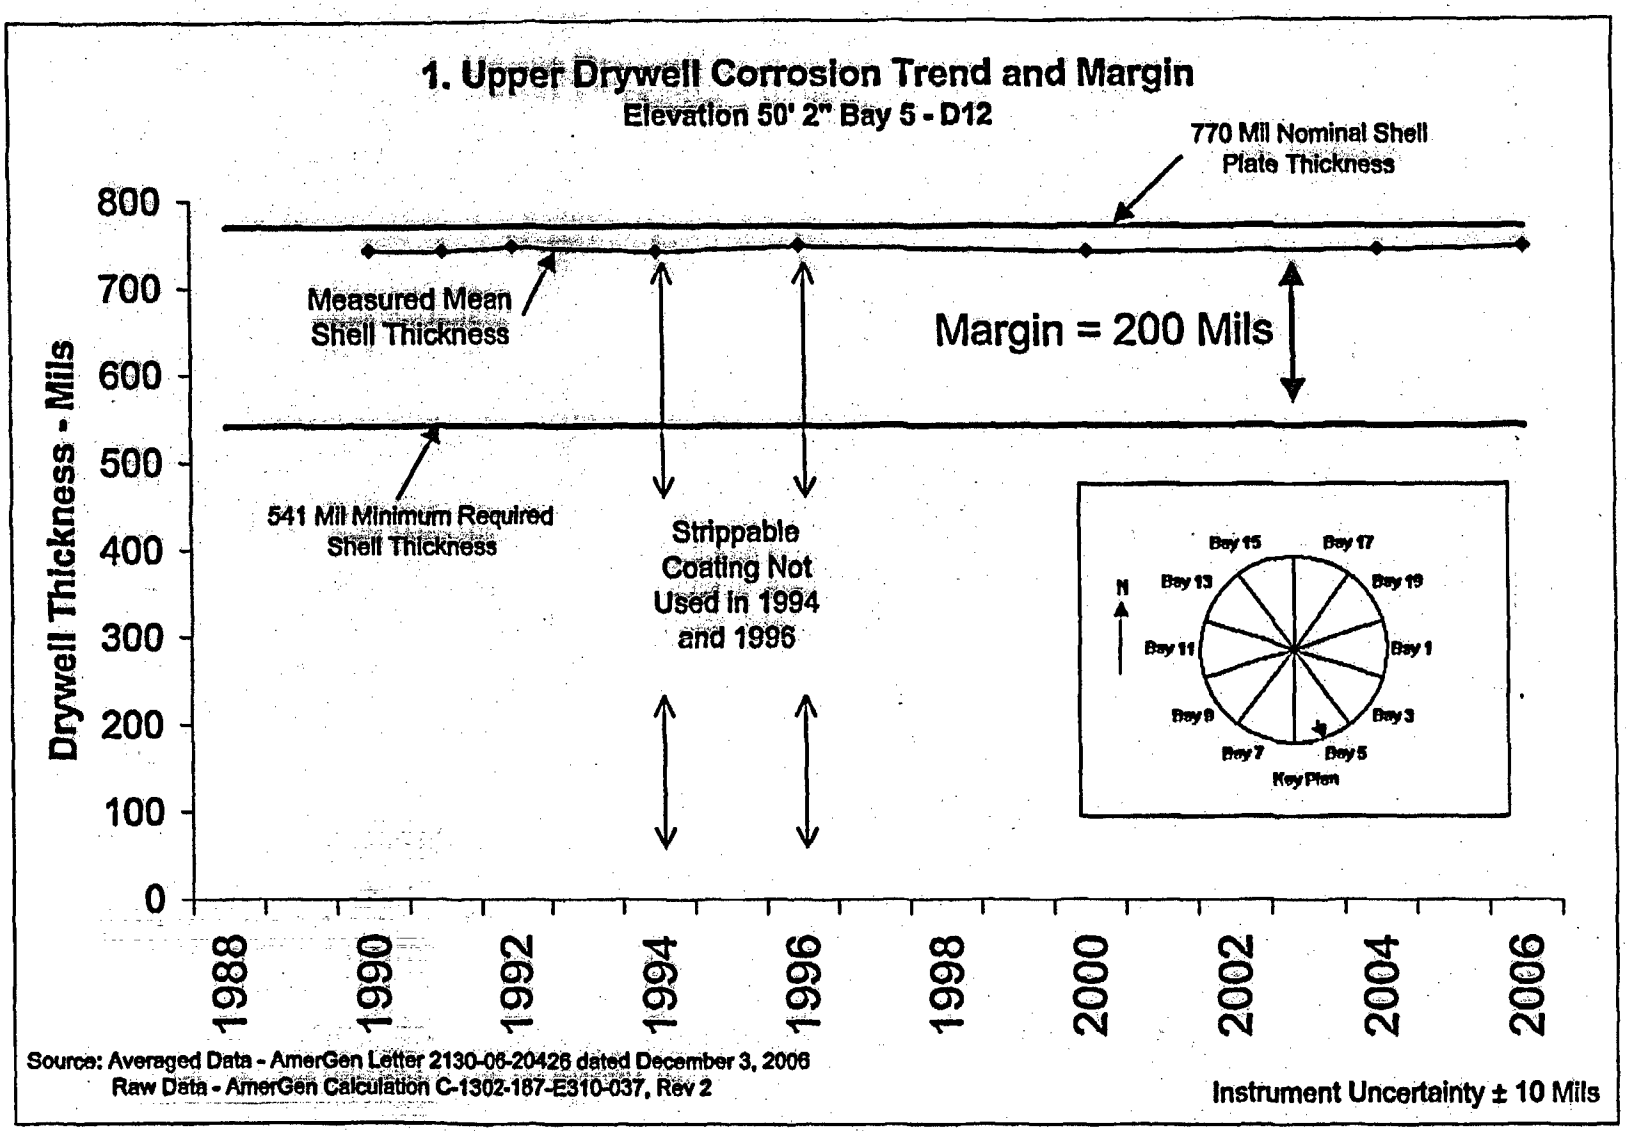
1. Upper Drywell Corrosion Trend and Margin
Elevation 50' 2" Bay 5 - D12
770 Mil Nominal Shell Plate Thickness
Measured Mean Shell Thickness
Margin = 200 Mils
541 Mil Minimum Required Shell Thickness
Strippable Coating Not Used in 1994 and 1996
Drywell Thickness - Mils
800
700
600
500
400
300
200
100
0
1988
1990
1992
1994
1996
1998
2000
2002
2004
2006
N
Bay 15
Bay 17
Bay 13
Bay 19
Bay 11
Bay 1
Bay 9
Bay 3
Bay 7
Bay 5
Key Plan
Source: Averaged Data - AmerGen Letter 2130-06-20426 dated December 3, 2006
Raw Data - AmerGen Calculation C-1302-187-E310-037, Rev 2
Instrument Uncertainty ± 10 Mils

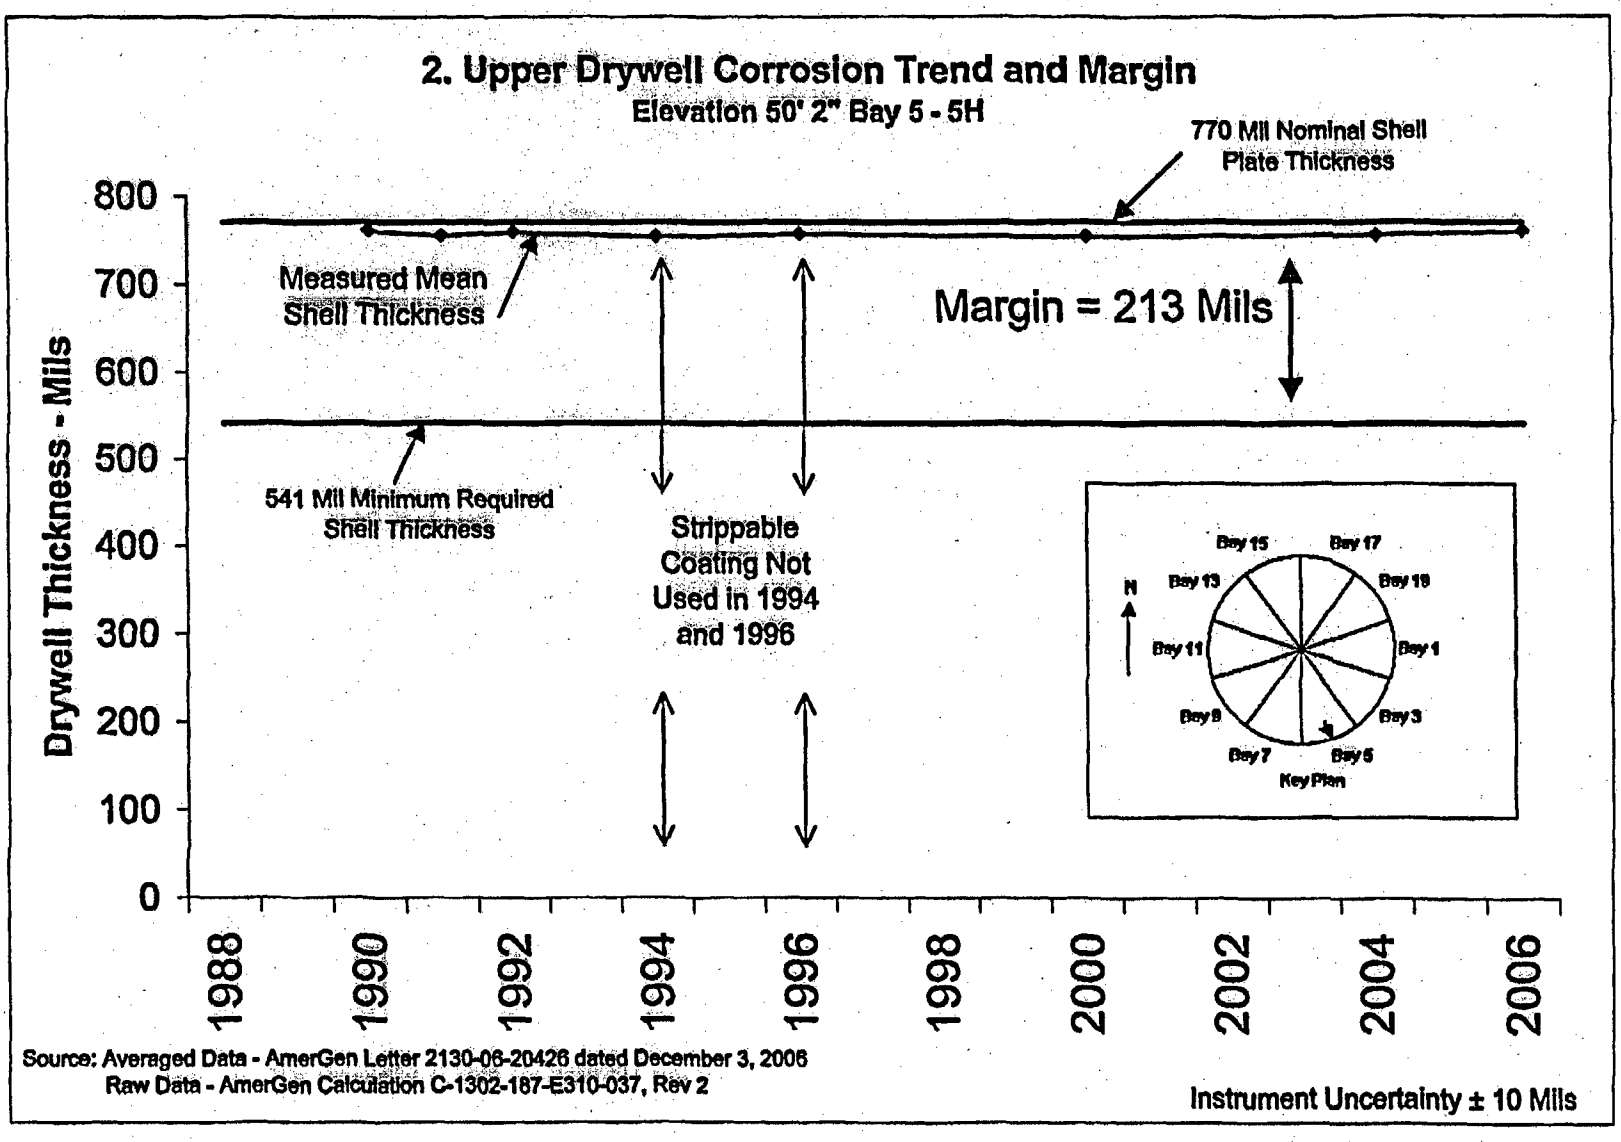
2. Upper Drywell Corrosion Trend and Margin
Elevation 50' 2" Bay 5 - 5H
770 Mil Nominal Shell Plate Thickness
Measured Mean Shell Thickness
Margin = 213 Mils
541 Mil Minimum Required Shell Thickness
Strippable Coating Not Used in 1994 and 1996
Drywell Thickness - Mils
800
700
600
500
400
300
200
100
0
1988
1990
1992
1994
1996
1998
2000
2002
2004
2006
N
Bay 15
Bay 17
Bay 13
Bay 19
Bay 11
Bay 1
Bay 9
Bay 3
Bay 7
Bay 5
Key Plan
Source: Averaged Data - AmerGen Letter 2130-06-20426 dated December 3, 2006
Raw Data - AmerGen Calculation C-1302-187-E310-037, Rev 2
Instrument Uncertainty ± 10 Mils

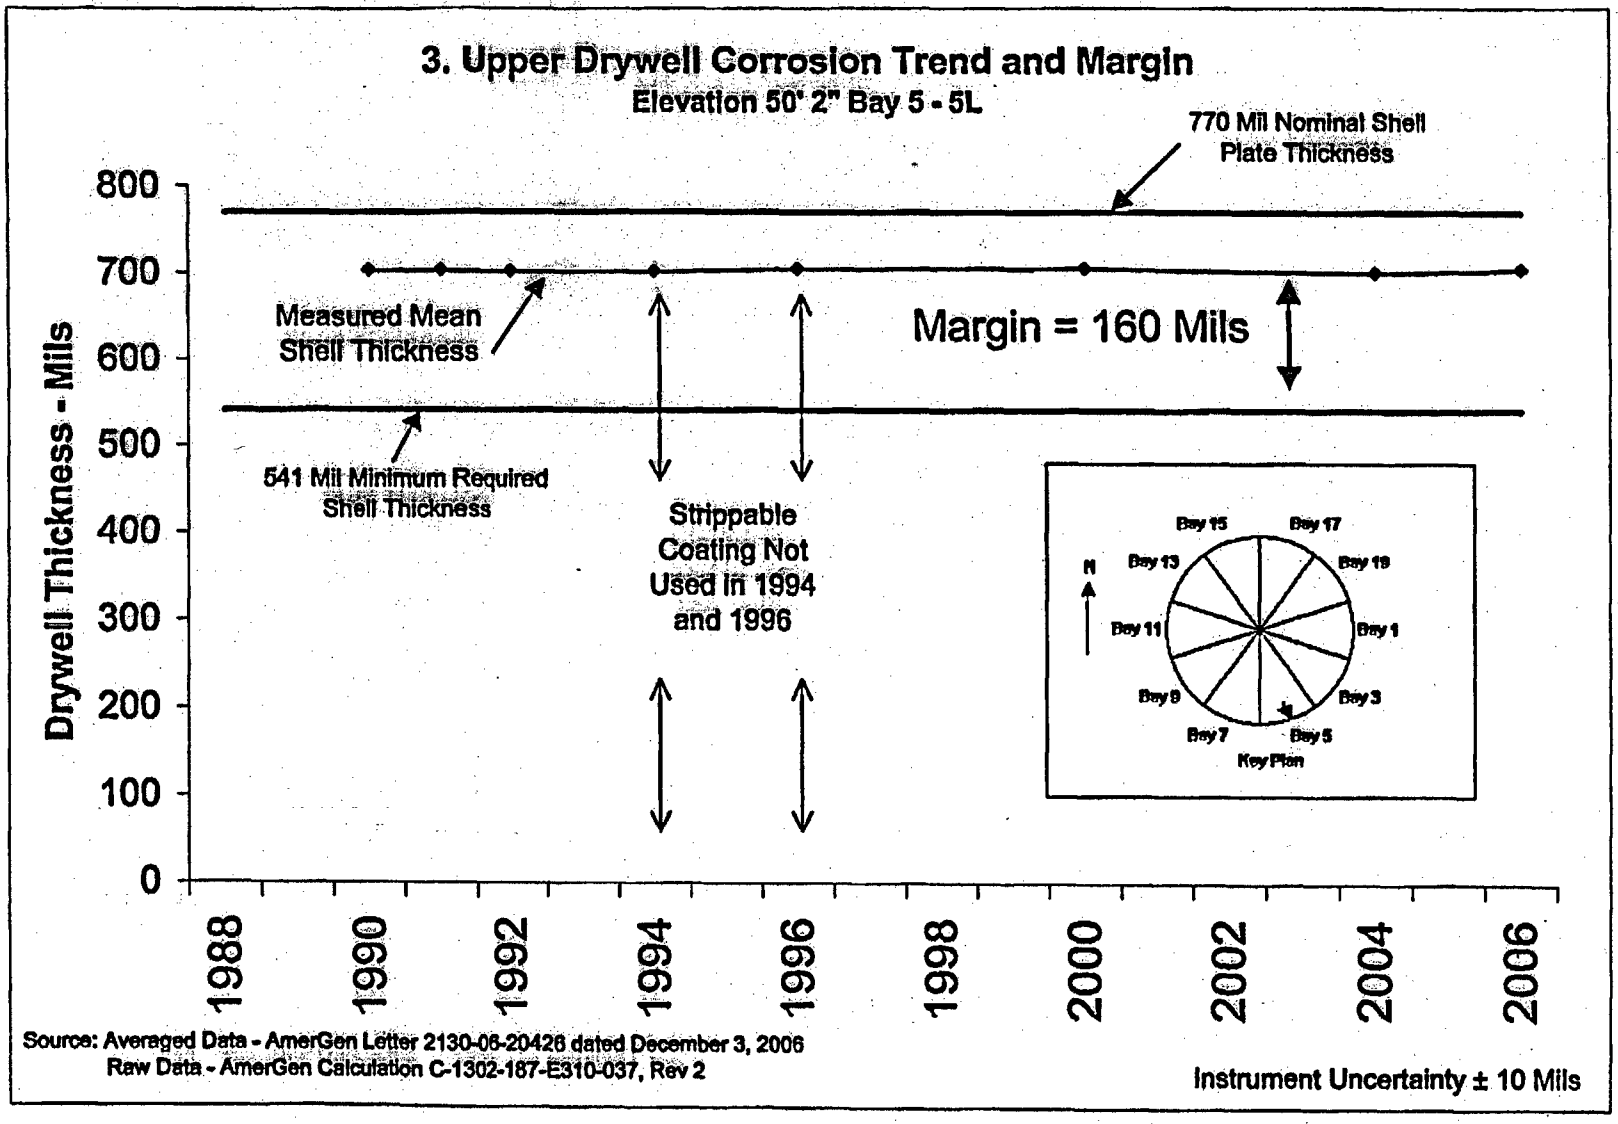
3. Upper Drywell Corrosion Trend and Margin
Elevation 50' 2" Bay 5 - 5L
770 Mil Nominal Shell Plate Thickness
Measured Mean Shell Thickness
Margin = 160 Mils
541 Mil Minimum Required Shell Thickness
Strippable Coating Not Used in 1994 and 1996
Drywell Thickness - Mils
800
700
600
500
400
300
200
100
0
1988
1990
1992
1994
1996
1998
2000
2002
2004
2006
N
Bay 15
Bay 17
Bay 13
Bay 19
Bay 11
Bay 1
Bay 9
Bay 3
Bay 7
Bay 5
Key Plan
Source: Averaged Data - AmerGen Letter 2130-06-20426 dated December 3, 2006
Raw Data - AmerGen Calculation C-1302-187-E310-037, Rev 2
Instrument Uncertainty ± 10 Mils

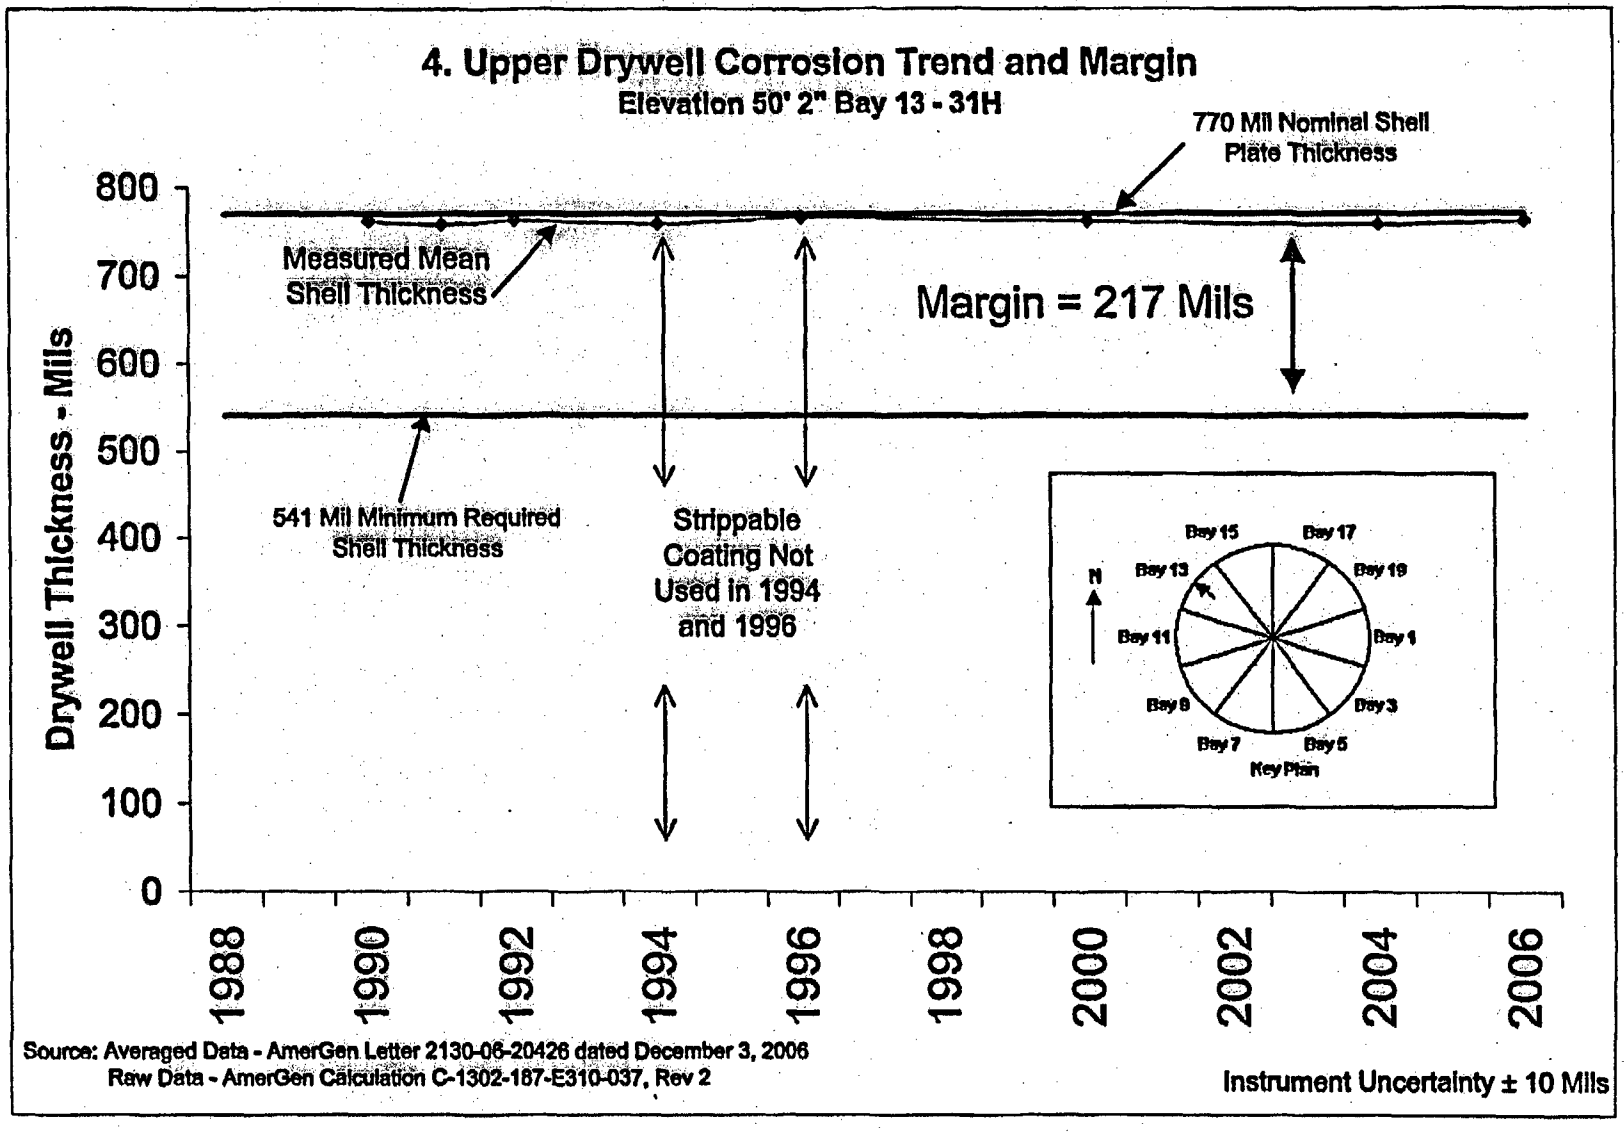
4. Upper Drywell Corrosion Trend and Margin
Elevation 50' 2" Bay 13 - 31H
770 Mil Nominal Shell Plate Thickness
Measured Mean Shell Thickness
Margin = 217 Mils
541 Mil Minimum Required Shell Thickness
Strippable Coating Not Used in 1994 and 1996
Drywell Thickness - Mils
800
700
600
500
400
300
200
100
0
1988
1990
1992
1994
1996
1998
2000
2002
2004
2006
N
Bay 15
Bay 17
Bay 13
Bay 19
Bay 11
Bay 1
Bay 9
Bay 3
Bay 7
Bay 5
Key Plan
Source: Averaged Data - AmerGen Letter 2130-06-20426 dated December 3, 2006
Raw Data - AmerGen Calculation C-1302-187-E310-037, Rev 2
Instrument Uncertainty ± 10 Mils

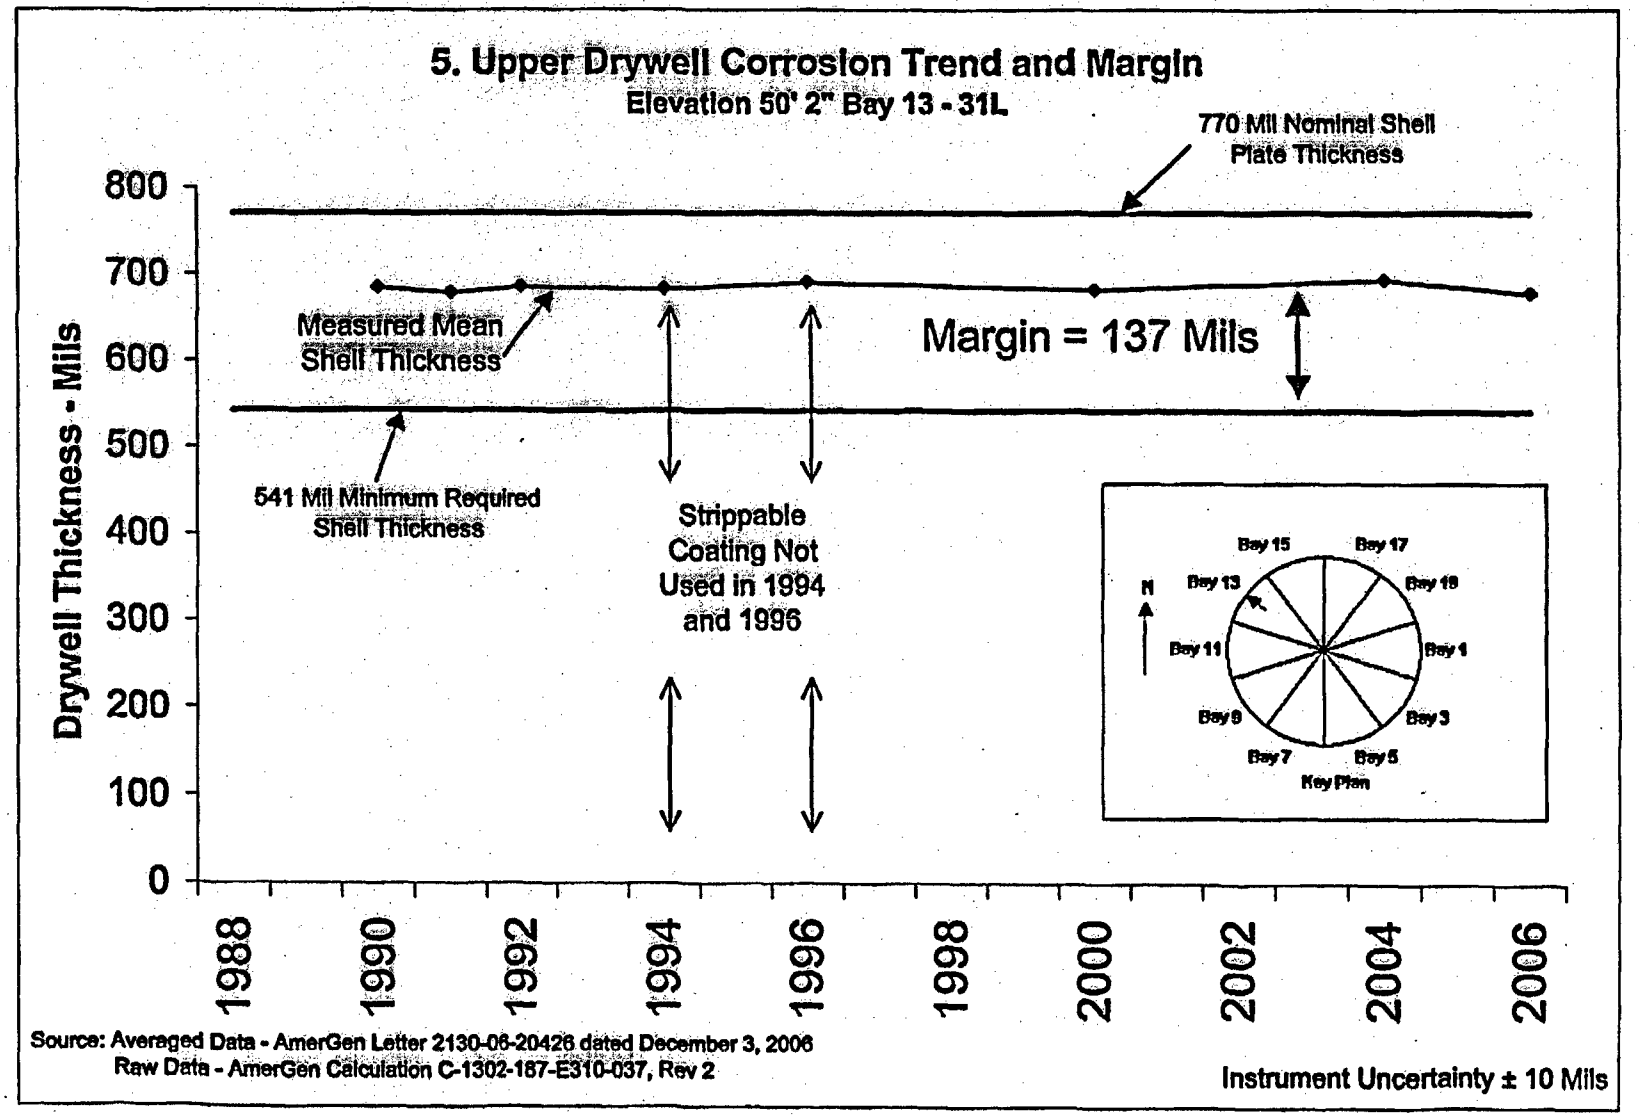
5. Upper Drywell Corrosion Trend and Margin
Elevation 50' 2" Bay 13 - 31L
770 Mil Nominal Shell Plate Thickness
Measured Mean Shell Thickness
Margin = 137 Mils
541 Mil Minimum Required Shell Thickness
Strippable Coating Not Used in 1994 and 1996
Drywell Thickness - Mils
800
700
600
500
400
300
200
100
0
1988
1990
1992
1994
1996
1998
2000
2002
2004
2006
N
Bay 15
Bay 17
Bay 13
Bay 19
Bay 11
Bay 1
Bay 9
Bay 3
Bay 7
Bay 5
Key Plan
Source: Averaged Data - AmerGen Letter 2130-06-20426 dated December 3, 2006
Raw Data - AmerGen Calculation C-1302-187-E310-037, Rev 2
Instrument Uncertainty ± 10 Mils

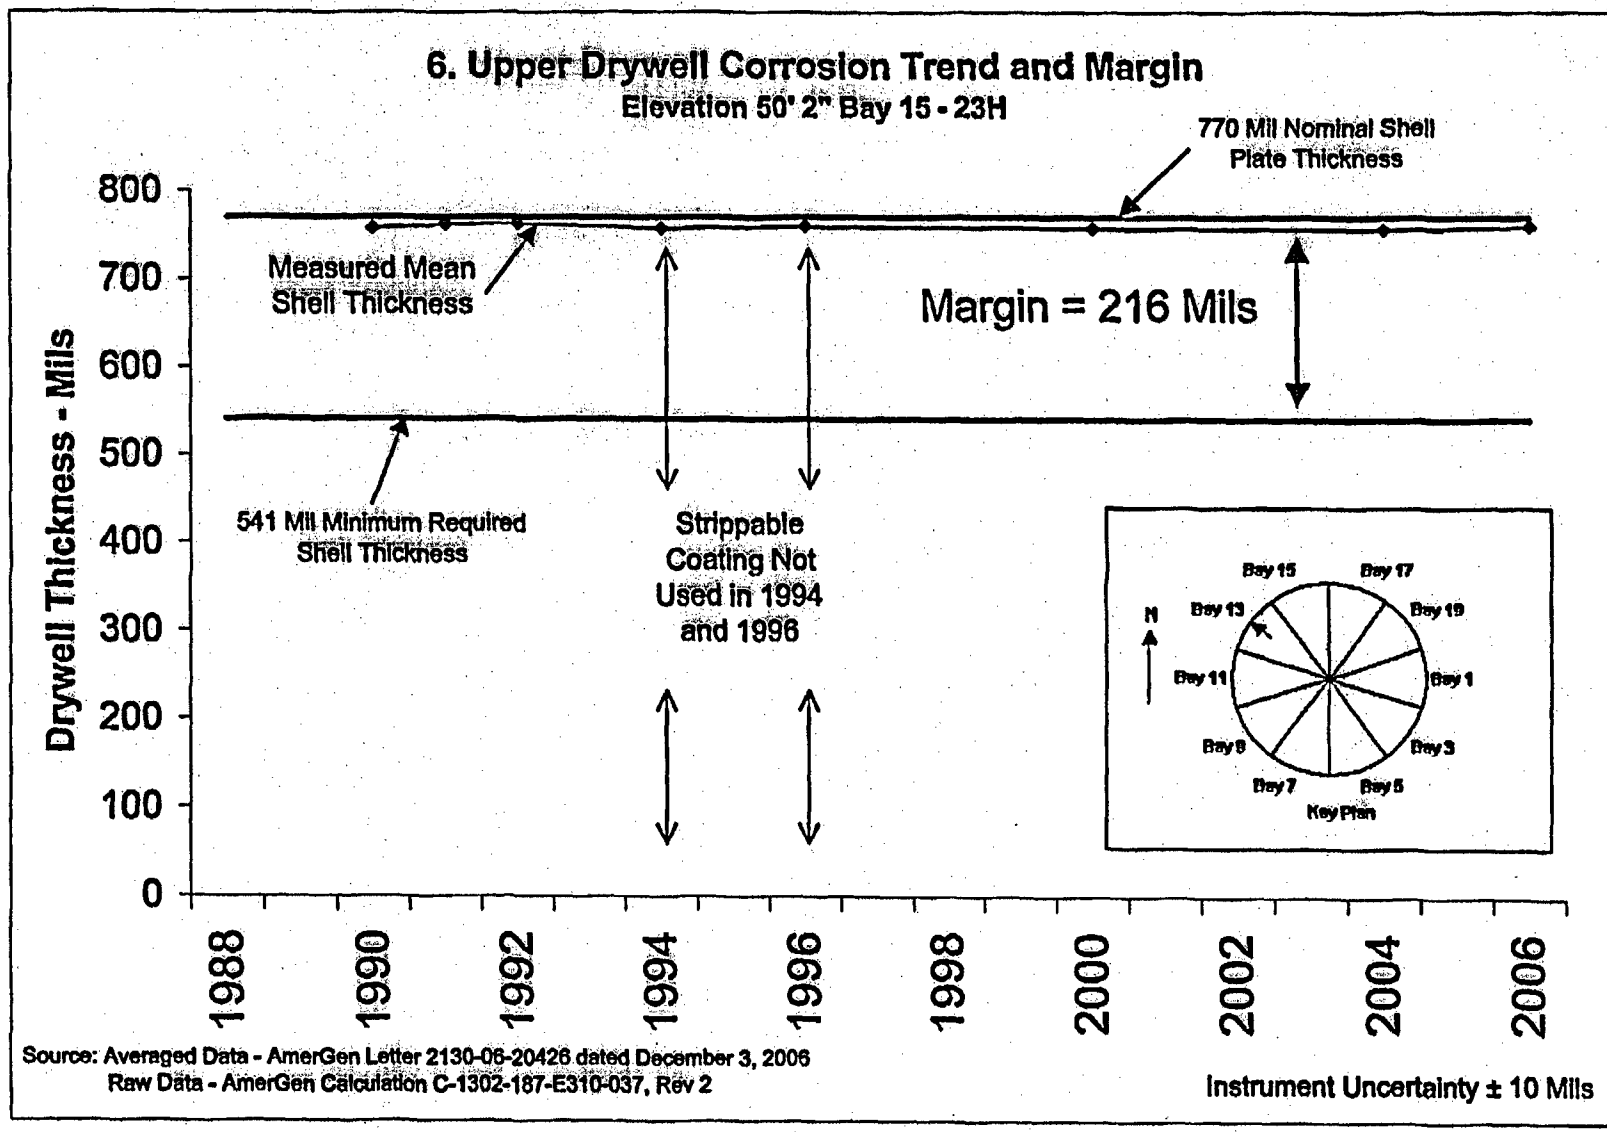
6. Upper Drywell Corrosion Trend and Margin
Elevation 50' 2" Bay 15 - 23H
770 Mil Nominal Shell Plate Thickness
Measured Mean Shell Thickness
Margin = 216 Mils
541 Mil Minimum Required Shell Thickness
Strippable Coating Not Used in 1994 and 1996
Drywell Thickness - Mils
800
700
600
500
400
300
200
100
0
1988
1990
1992
1994
1996
1998
2000
2002
2004
2006
N
Bay 15
Bay 17
Bay 13
Bay 19
Bay 11
Bay 1
Bay 9
Bay 3
Bay 7
Bay 5
Key Plan
Source: Averaged Data - AmerGen Letter 2130-06-20426 dated December 3, 2006
Raw Data - AmerGen Calculation C-1302-187-E310-037, Rev 2
Instrument Uncertainty ± 10 Mils

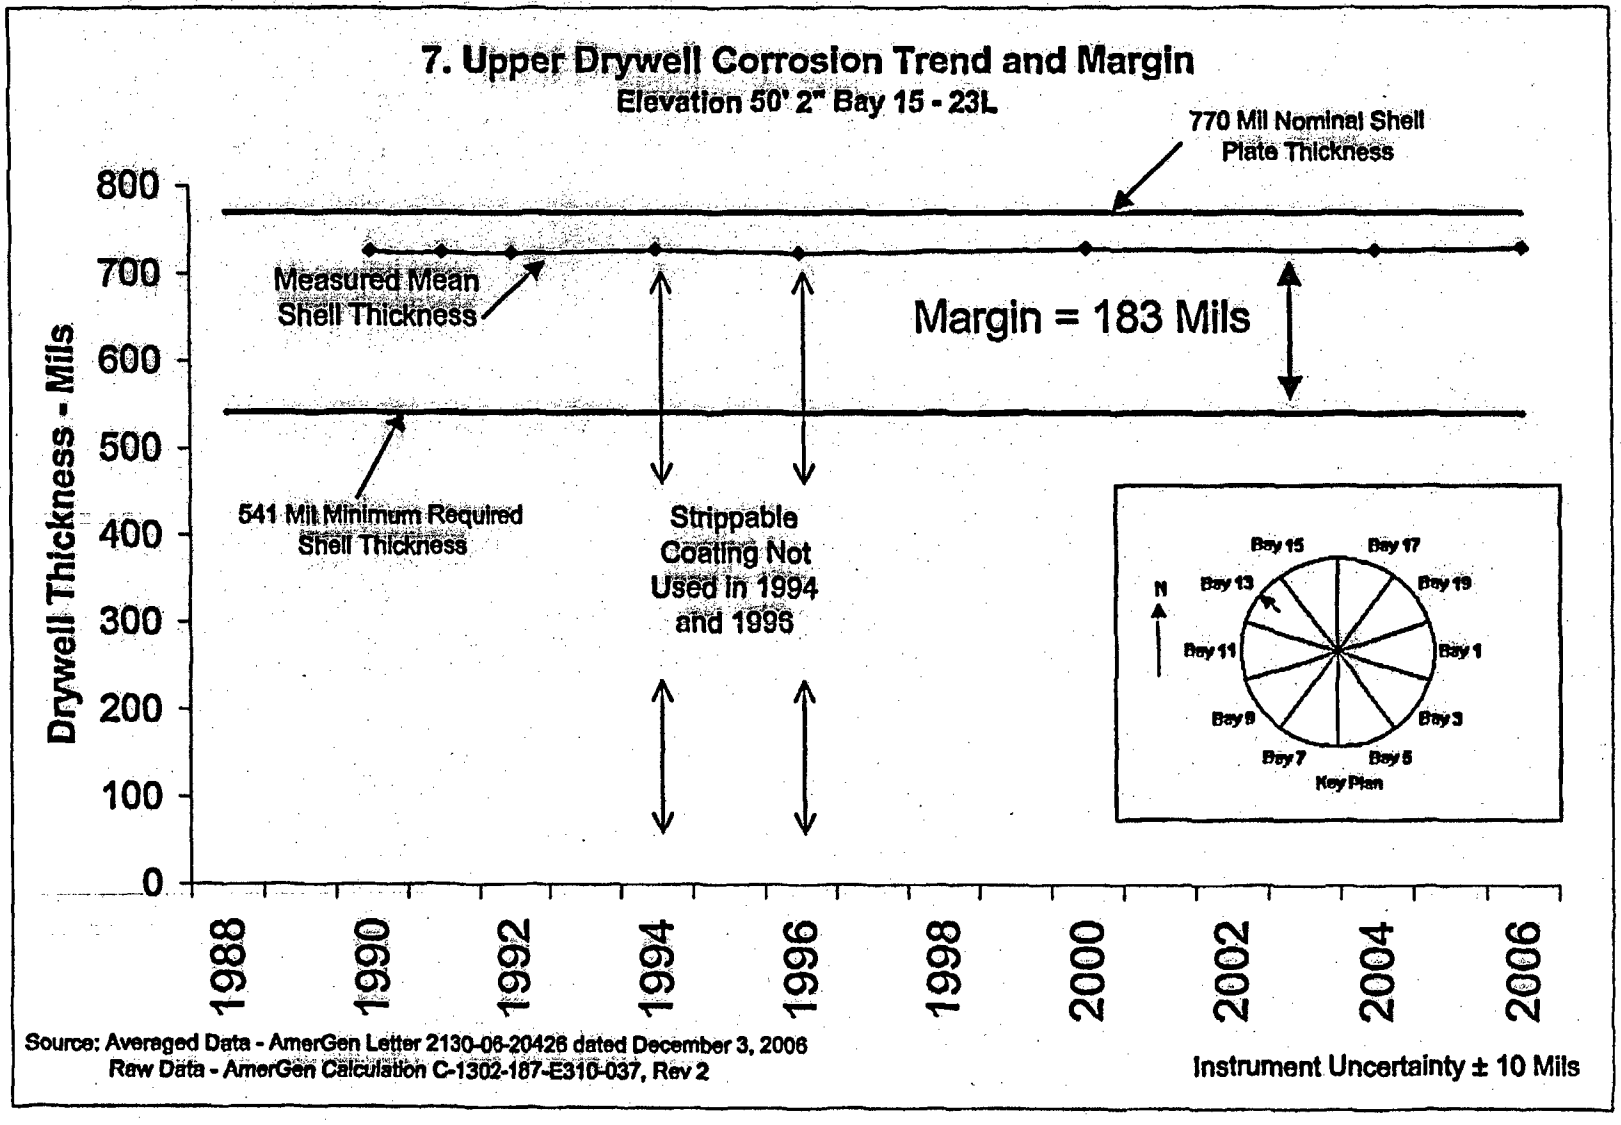
7. Upper Drywell Corrosion Trend and Margin
Elevation 50' 2" Bay 15 - 23L
770 Mil Nominal Shell Plate Thickness
Measured Mean Shell Thickness
Margin = 183 Mils
541 Mil Minimum Required Shell Thickness
Strippable Coating Not Used in 1994 and 1996
Drywell Thickness - Mils
800
700
600
500
400
300
200
100
0
1988
1990
1992
1994
1996
1998
2000
2002
2004
2006
N
Bay 15
Bay 17
Bay 13
Bay 19
Bay 11
Bay 1
Bay 9
Bay 3
Bay 7
Bay 5
Key Plan
Source: Averaged Data - AmerGen Letter 2130-06-20426 dated December 3, 2006
Raw Data - AmerGen Calculation C-1302-187-E310-037, Rev 2
Instrument Uncertainty ± 10 Mils

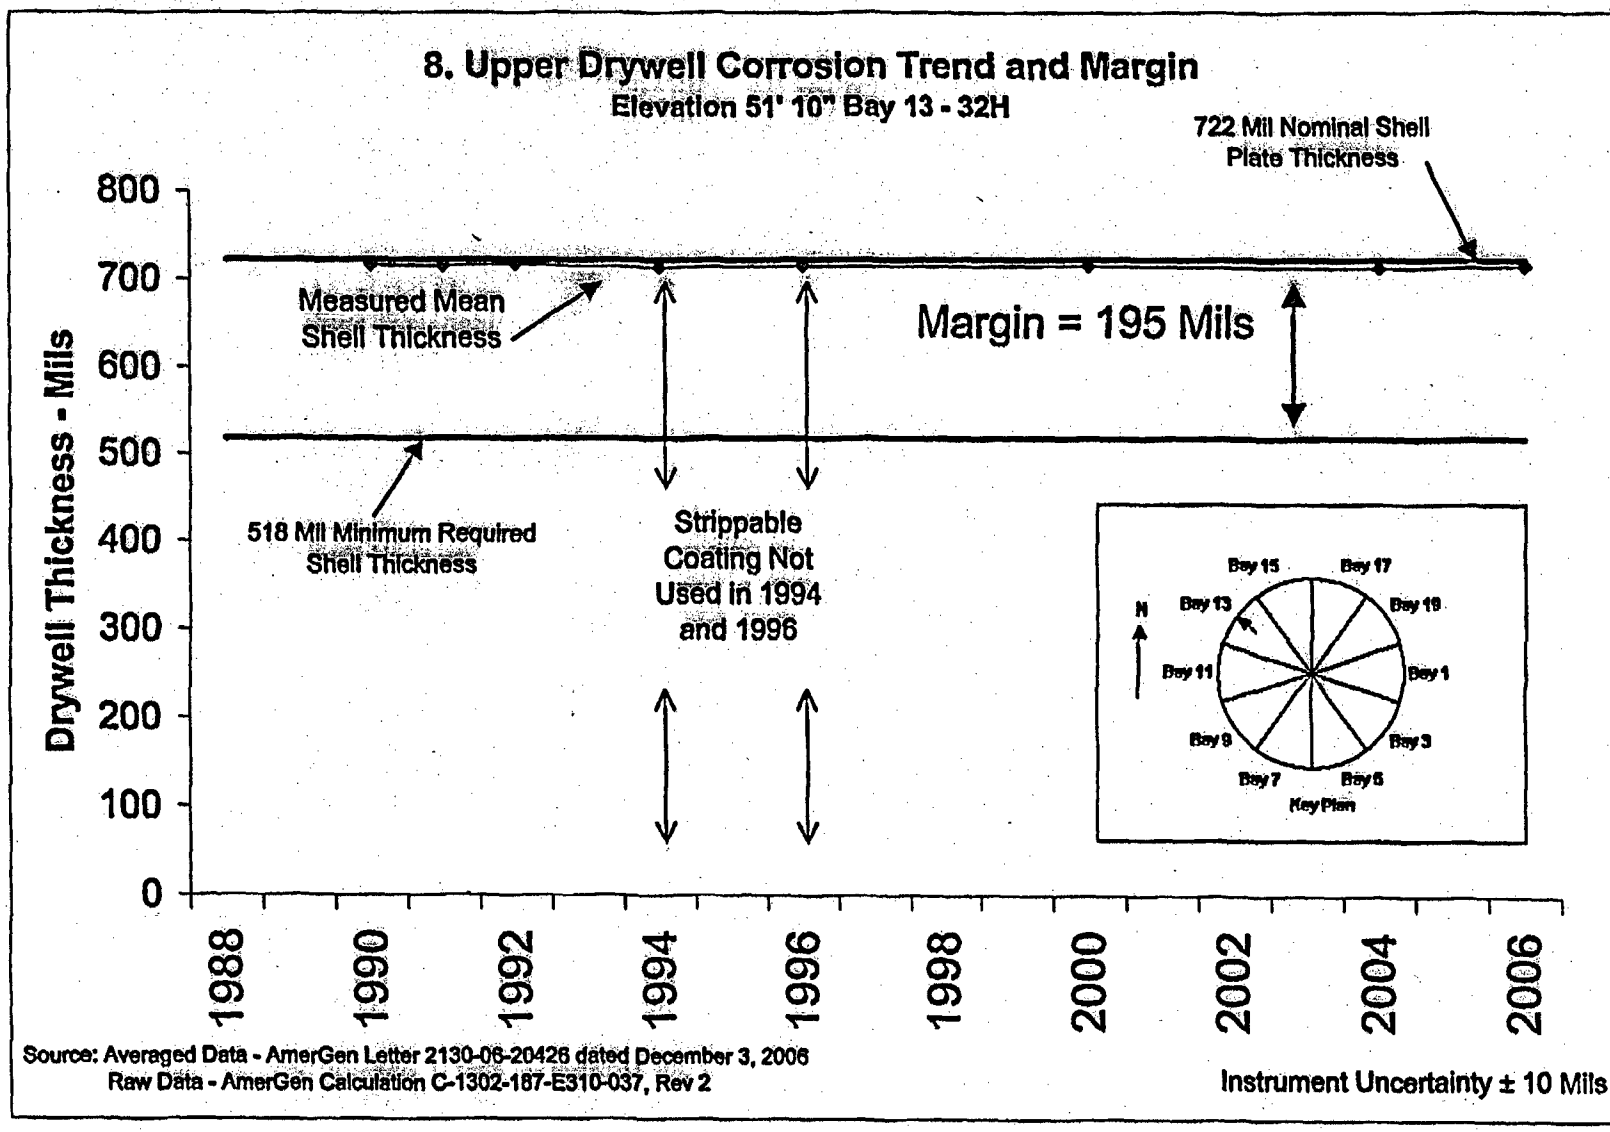
8. Upper Drywell Corrosion Trend and Margin
Elevation 51' 10" Bay 13 - 32H
722 Mil Nominal Shell Plate Thickness
Measured Mean Shell Thickness
Margin = 195 Mils
518 Mil Minimum Required Shell Thickness
Strippable Coating Not Used in 1994 and 1996
Drywell Thickness - Mils
800
700
600
500
400
300
200
100
0
1988
1990
1992
1994
1996
1998
2000
2002
2004
2006
N
Bay 15
Bay 17
Bay 13
Bay 19
Bay 11
Bay 1
Bay 9
Bay 3
Bay 7
Bay 5
Key Plan
Source: Averaged Data - AmerGen Letter 2130-06-20426 dated December 3, 2006
Raw Data - AmerGen Calculation C-1302-187-E310-037, Rev 2
Instrument Uncertainty ± 10 Mils

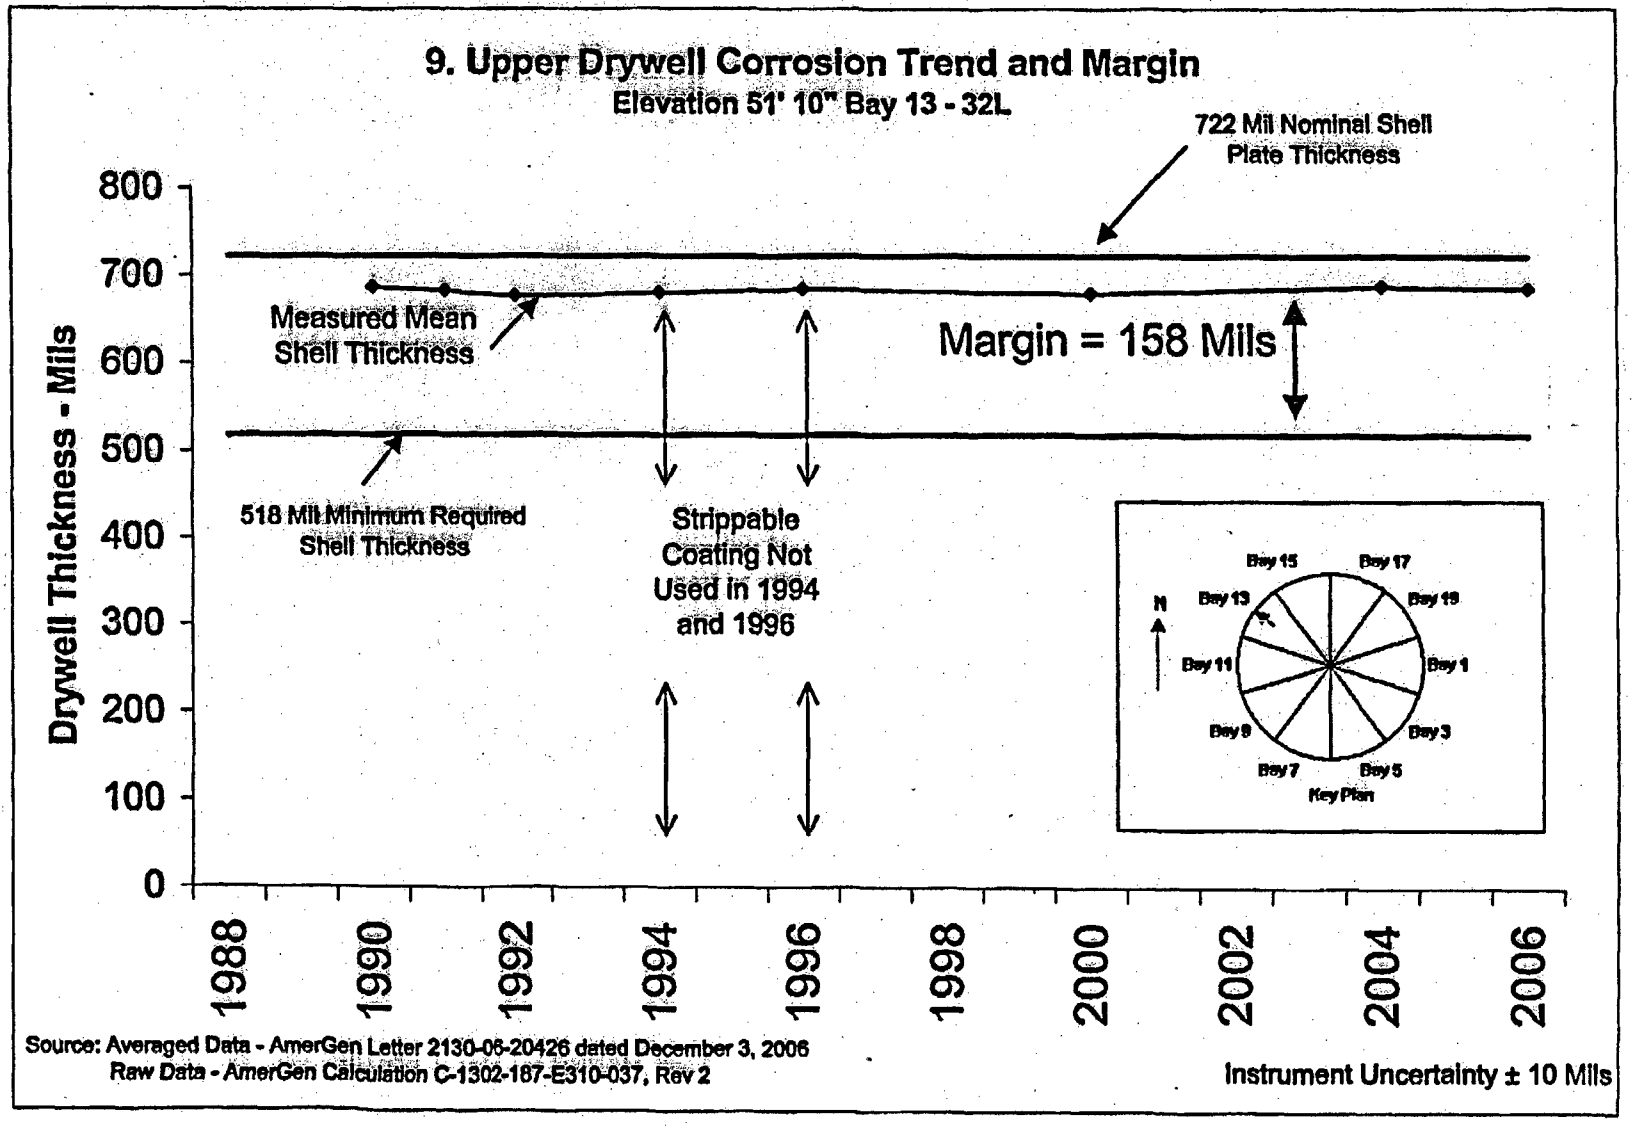
9. Upper Drywell Corrosion Trend and Margin
Elevation 51' 10" Bay 13 - 32L
722 Mil Nominal Shell Plate Thickness
Measured Mean Shell Thickness
Margin = 158 Mils
518 Mil Minimum Required Shell Thickness
Strippable Coating Not Used in 1994 and 1996
Drywell Thickness - Mils
800
700
600
500
400
300
200
100
0
1988
1990
1992
1994
1996
1998
2000
2002
2004
2006
N
Bay 15
Bay 17
Bay 13
Bay 19
Bay 11
Bay 1
Bay 9
Bay 3
Bay 7
Bay 5
Key Plan
Source: Averaged Data - AmerGen Letter 2130-06-20426 dated December 3, 2006
Raw Data - AmerGen Calculation C-1302-187-E310-037, Rev 2
Instrument Uncertainty ± 10 Mils

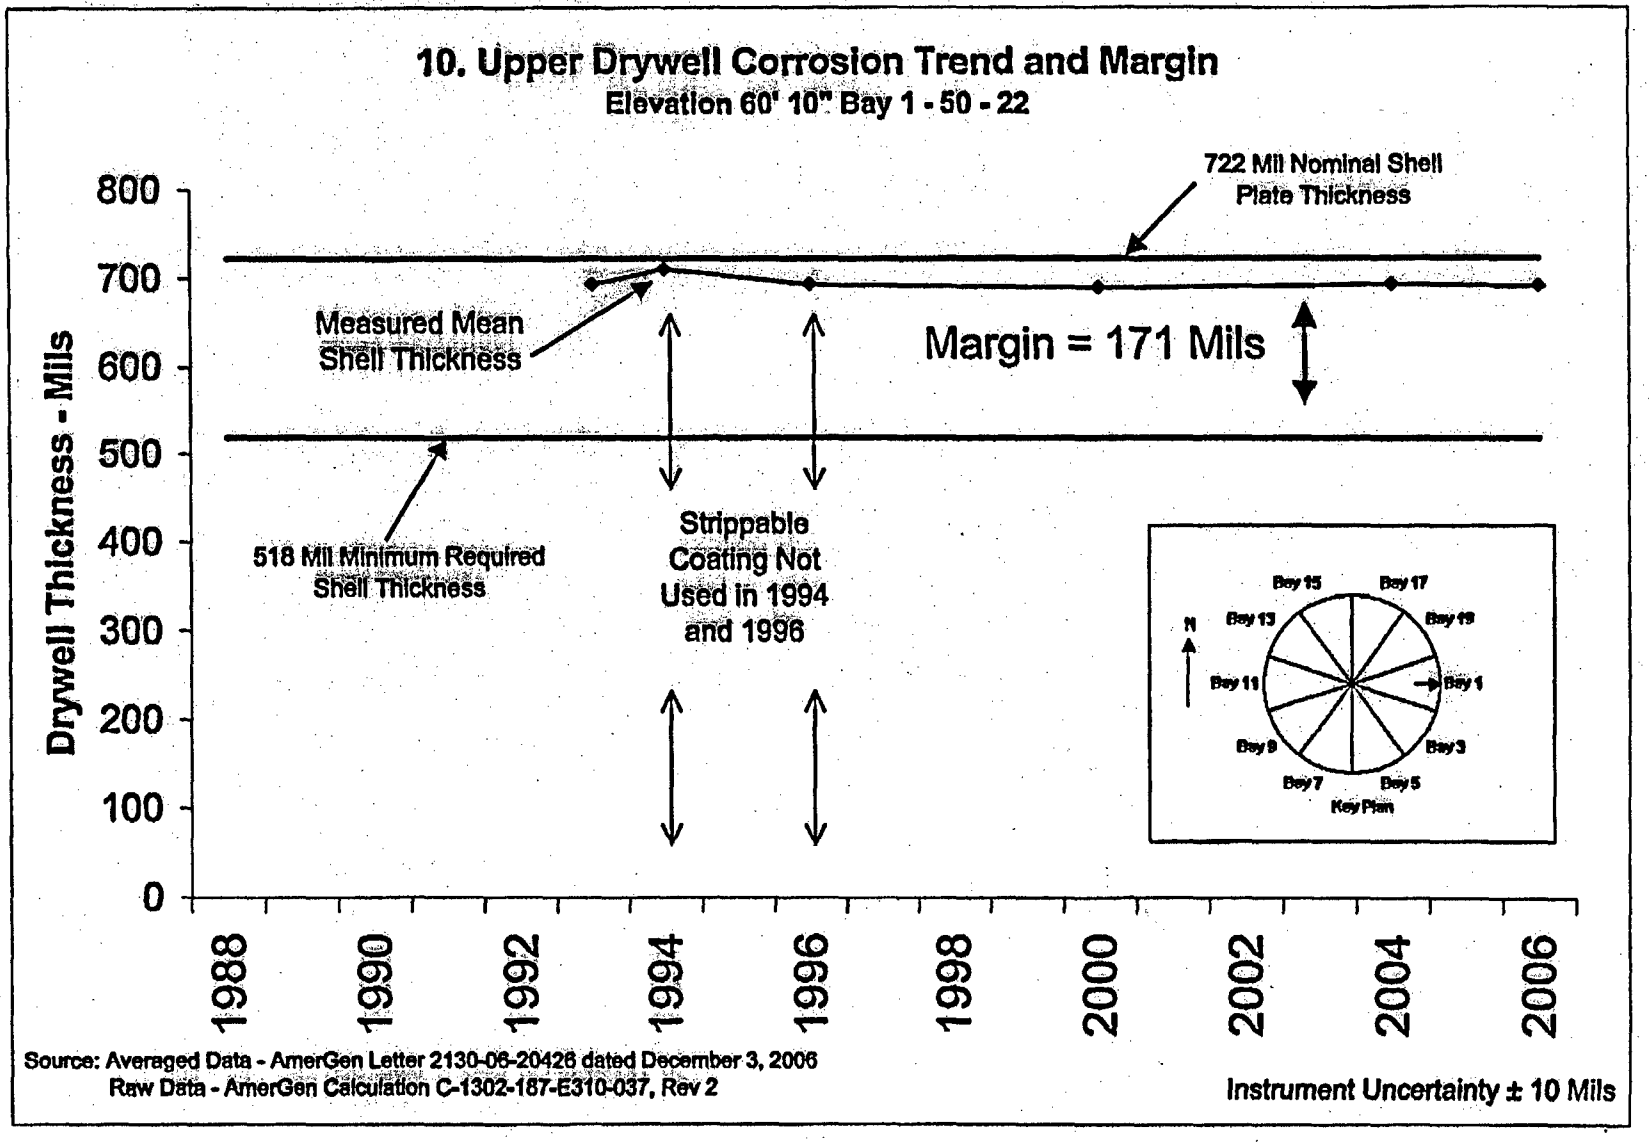
10. Upper Drywell Corrosion Trend and Margin
Elevation 60' 10" Bay 1 - 50 - 22
722 Mil Nominal Shell Plate Thickness
Measured Mean Shell Thickness
Margin = 171 Mils
518 Mil Minimum Required Shell Thickness
Strippable Coating Not Used in 1994 and 1996
Drywell Thickness - Mils
800
700
600
500
400
300
200
100
0
1988
1990
1992
1994
1996
1998
2000
2002
2004
2006
N
Bay 15
Bay 17
Bay 13
Bay 19
Bay 11
Bay 1
Bay 9
Bay 3
Bay 7
Bay 5
Key Plan
Source: Averaged Data - AmerGen Letter 2130-06-20426 dated December 3, 2006
Raw Data - AmerGen Calculation C-1302-187-E310-037, Rev 2
Instrument Uncertainty ± 10 Mils
