UNITED STATES OF AMERICA
NUCLEAR REGULATORY COMMISSION

In the Matter of:	)	July 20, 2007
AmerGen Energy Company, LLC	)	Docket No. 50-219
(License Renewal for Oyster Creek Nuclear Generating Station)	)

AMERGEN'S PRE-FILED DIRECT TESTIMONY EXHIBITS

VOLUME 1 OF 2: EXHIBITS 1-19

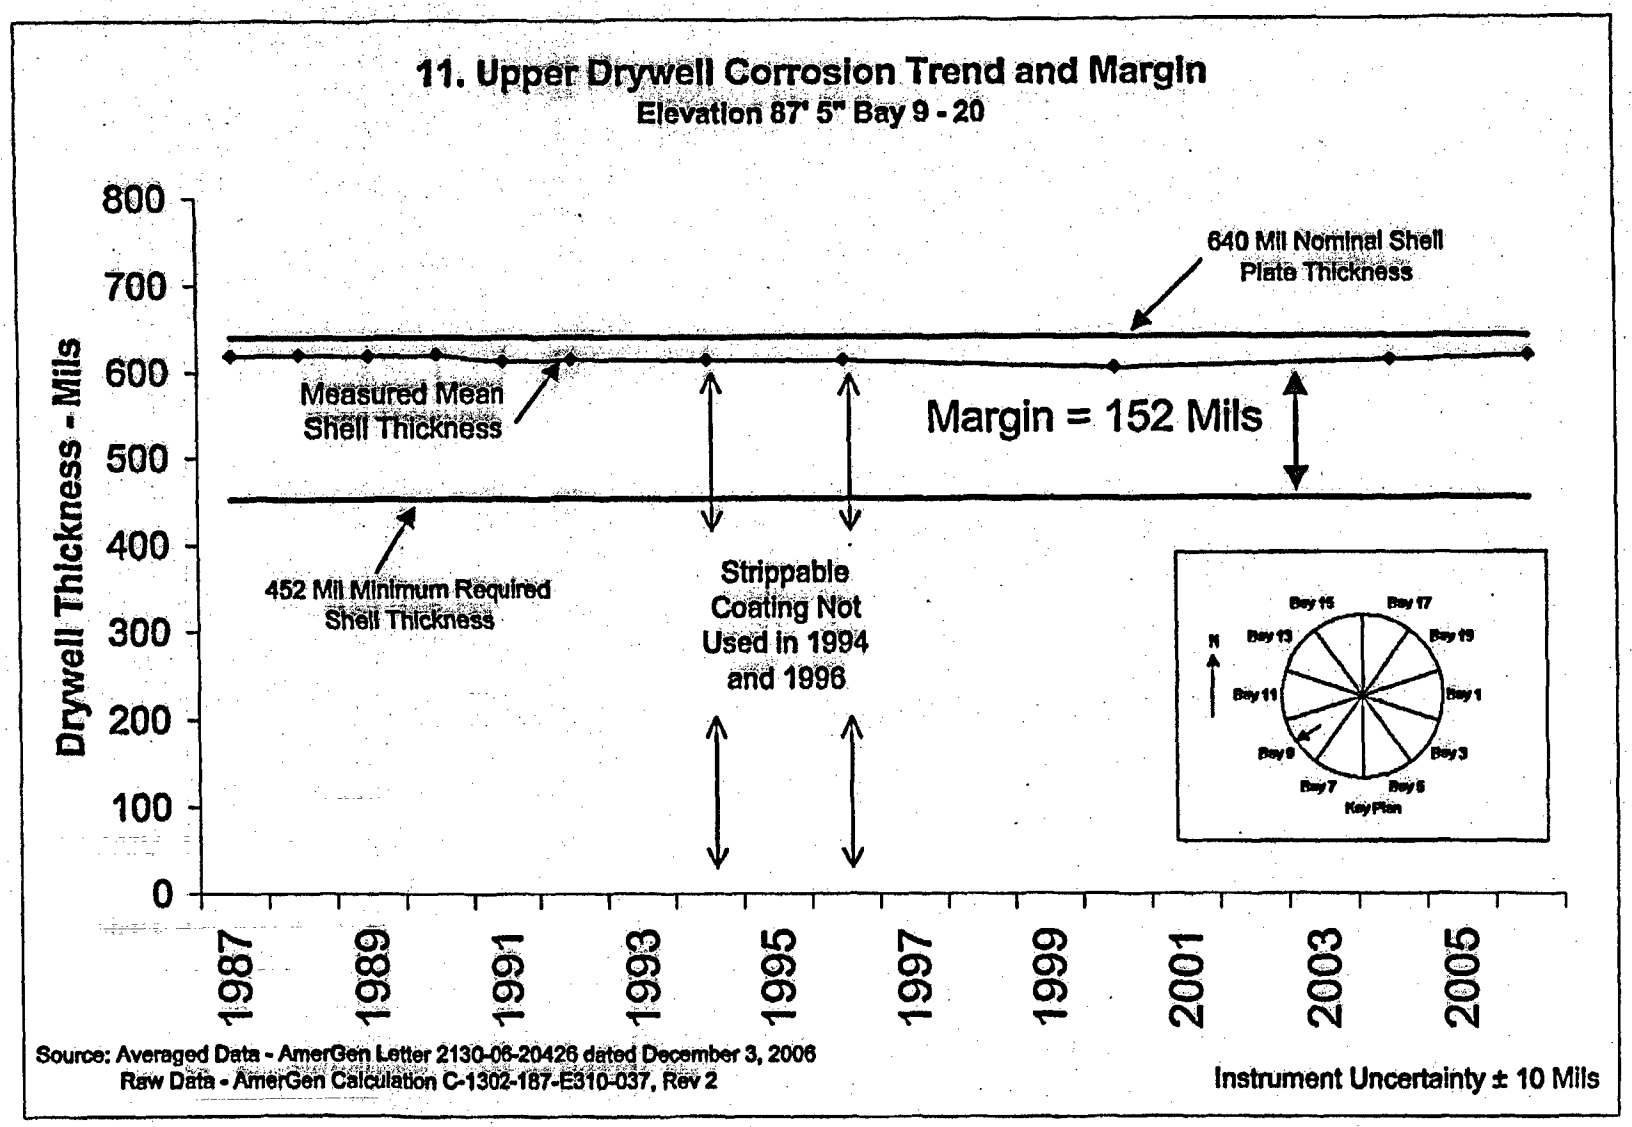
11. Upper Drywell Corrosion Trend and Margin
Elevation 87' 5" Bay 9 - 20
Drywell Thickness - Mils
800
700
600
500
400
300
200
100
0
640 Mil Nominal Shell Plate Thickness
Measured Mean Shell Thickness
Margin = 152 Mils
452 Mil Minimum Required Shell Thickness
Strippable Coating Not Used in 1994 and 1996
1987
1989
1991
1993
1995
1997
1999
2001
2003
2005
Bay 15
Bay 17
Bay 13
Bay 19
Bay 11
Bay 1
Bay 9
Bay 3
Bay 7
Bay 5
Key Plan
Source: Averaged Data - AmerGen Letter 2130-06-20426 dated December 3, 2006
Raw Data - AmerGen Calculation C-1302-187-E310-037, Rev 2
Instrument Uncertainty ± 10 Mils

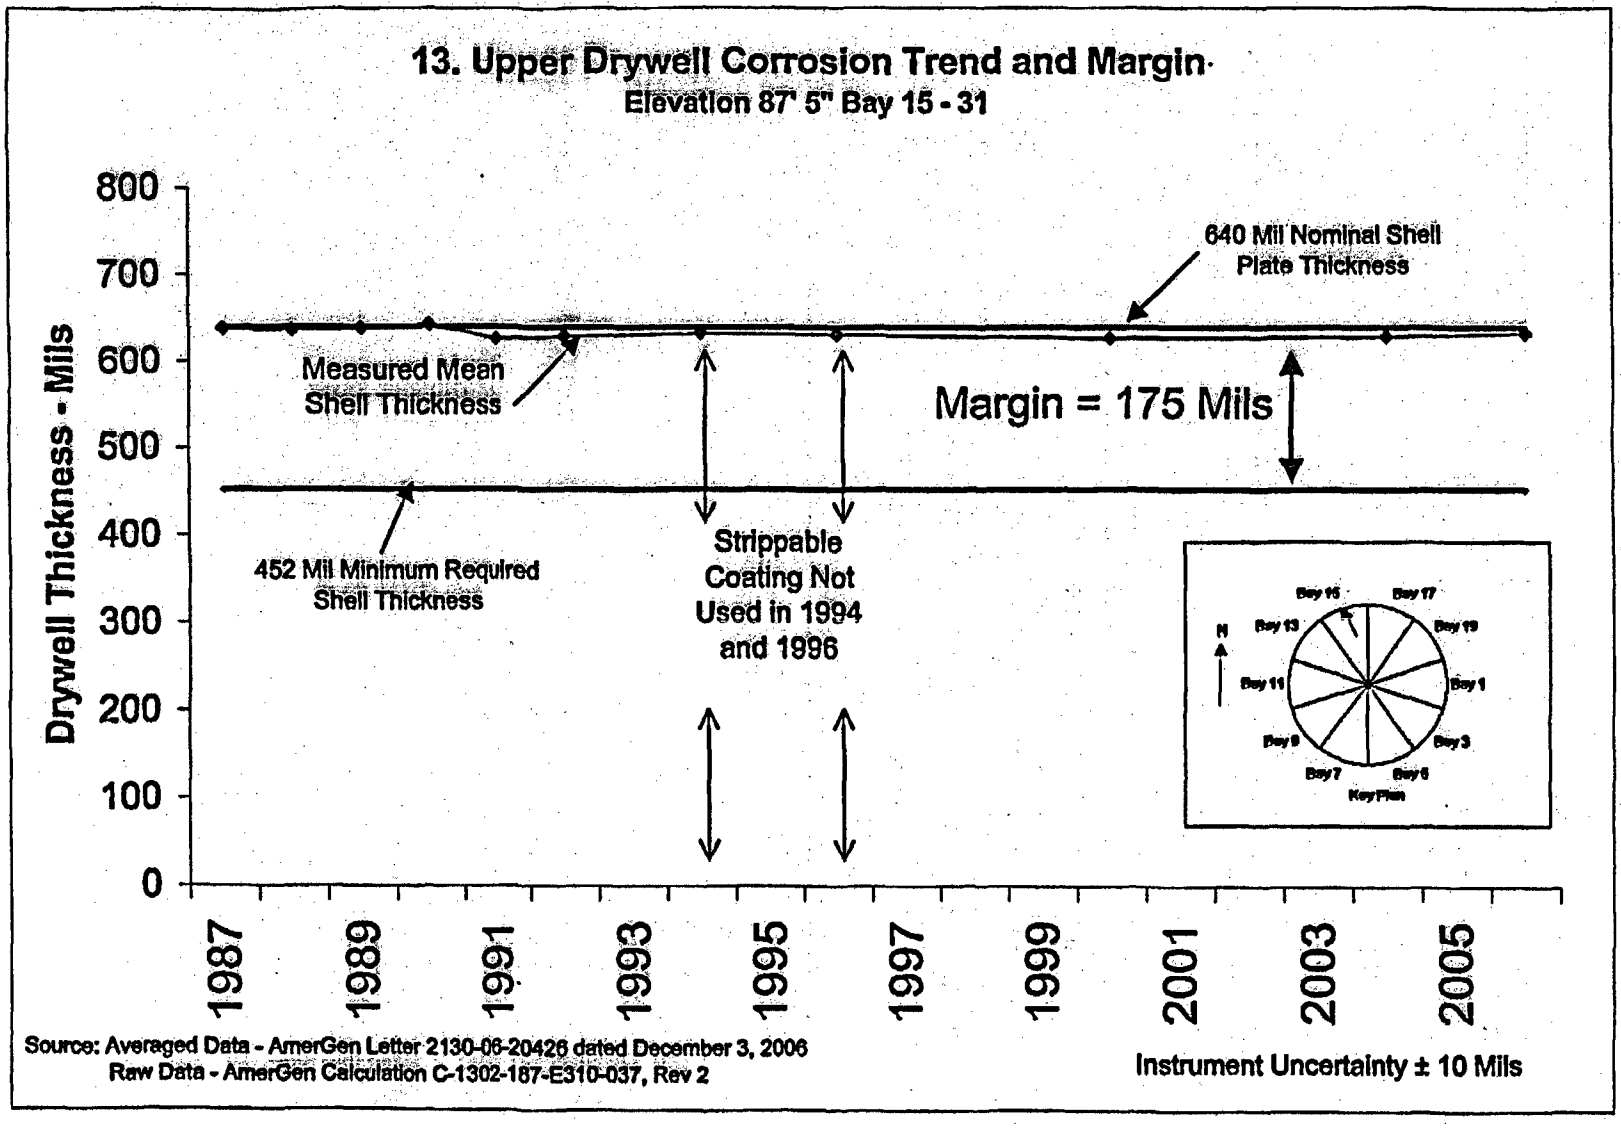
13. Upper Drywell Corrosion Trend and Margin
Elevation 87' 5" Bay 15 - 31
Drywell Thickness - Mils
800
700
600
500
400
300
200
100
0
640 Mil Nominal Shell Plate Thickness
Measured Mean Shell Thickness
Margin = 175 Mils
452 Mil Minimum Required Shell Thickness
Strippable Coating Not Used in 1994 and 1996
1987
1989
1991
1993
1995
1997
1999
2001
2003
2005
Bay 15
Bay 17
Bay 13
Bay 19
N
Bay 11
Bay 1
Bay 9
Bay 3
Bay 7
Bay 5
Key Plan
Source: Averaged Data - AmerGen Letter 2130-06-20426 dated December 3, 2006
Raw Data - AmerGen Calculation C-1302-187-E310-037, Rev 2
Instrument Uncertainty ± 10 Mils

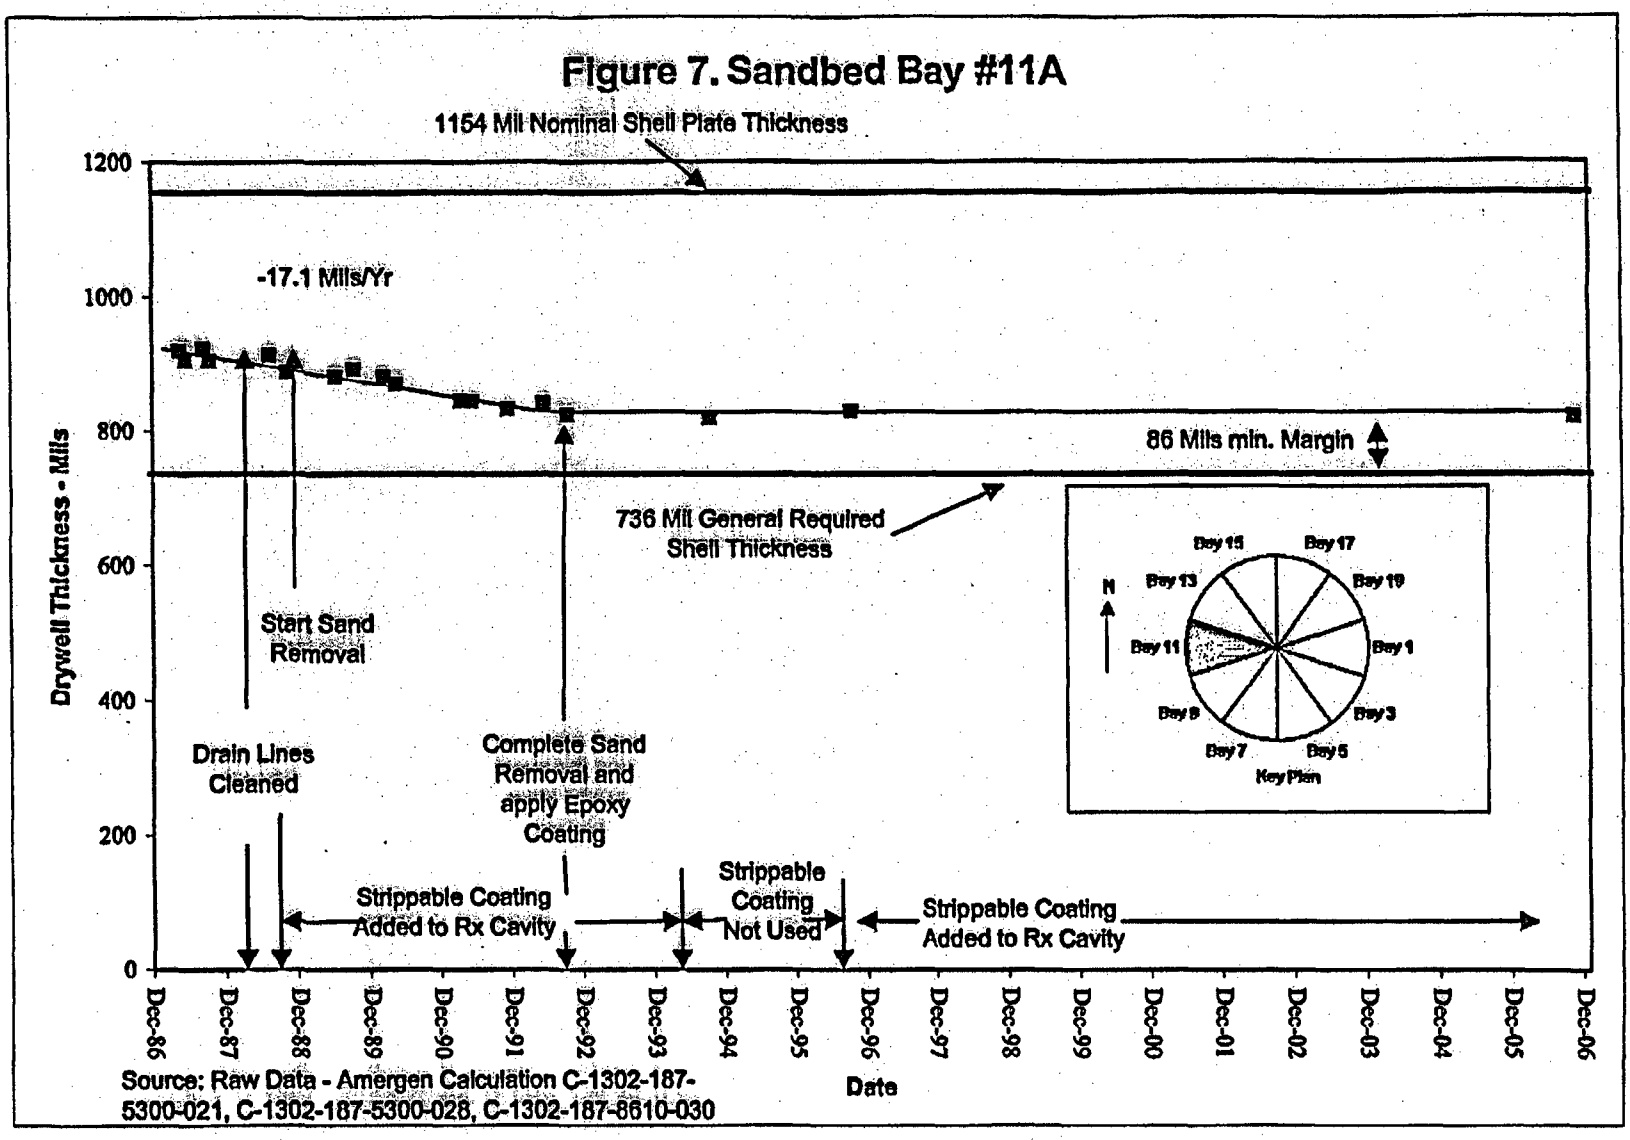
Figure 7. Sandbed Bay #11A
1154 Mil Nominal Shell Plate Thickness
-17.1 Mils/Yr
86 Mils min. Margin
736 Mil General Required Shell Thickness
Start Sand Removal
Drain Lines Cleaned
Complete Sand Removal and apply Epoxy Coating
Strippable Coating Added to Rx Cavity
Strippable Coating Not Used
Strippable Coating Added to Rx Cavity
Drywell Thickness - Mils
Date
1200
1000
800
600
400
200
0
Dec-86
Dec-87
Dec-88
Dec-89
Dec-90
Dec-91
Dec-92
Dec-93
Dec-94
Dec-95
Dec-96
Dec-97
Dec-98
Dec-99
Dec-00
Dec-01
Dec-02
Dec-03
Dec-04
Dec-05
Dec-06
N
Bay 15
Bay 17
Bay 13
Bay 19
Bay 11
Bay 1
Bay 9
Bay 3
Bay 7
Bay 5
Key Plan
Source: Raw Data - Amergen Calculation C-1302-187-5300-021, C-1302-187-5300-028, C-1302-187-8610-030

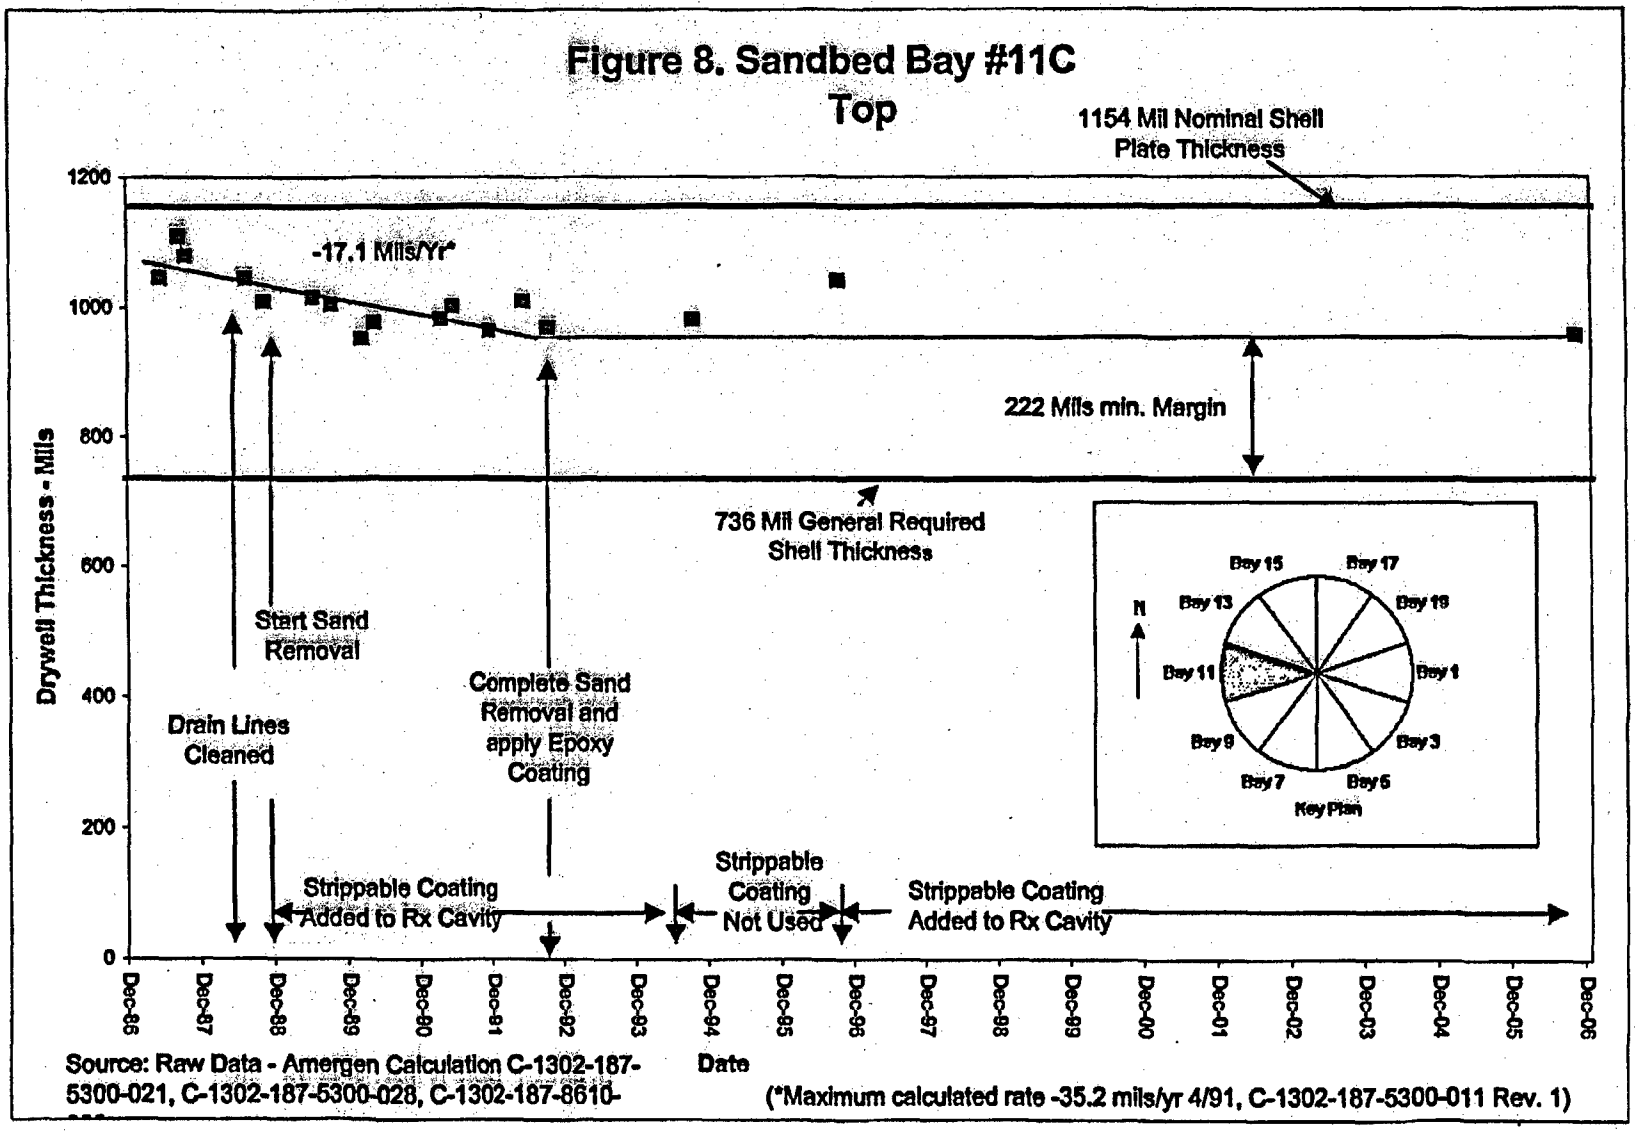
Figure 8. Sandbed Bay #11C
Top
1154 Mil Nominal Shell Plate Thickness
-17.1 Mils/Yr*
222 Mils min. Margin
736 Mil General Required Shell Thickness
Start Sand Removal
Drain Lines Cleaned
Complete Sand Removal and apply Epoxy Coating
Strippable Coating Added to Rx Cavity
Strippable Coating Not Used
Strippable Coating Added to Rx Cavity
Drywell Thickness - Mils
1200
1000
800
600
400
200
0
Dec-86
Dec-87
Dec-88
Dec-89
Dec-90
Dec-91
Dec-92
Dec-93
Dec-94
Dec-95
Dec-96
Dec-97
Dec-98
Dec-99
Dec-00
Dec-01
Dec-02
Dec-03
Dec-04
Dec-05
Dec-06
Date
N
Bay 15
Bay 17
Bay 13
Bay 19
Bay 11
Bay 1
Bay 9
Bay 3
Bay 7
Bay 5
Key Plan
Source: Raw Data - Amergen Calculation C-1302-187-5300-021, C-1302-187-5300-028, C-1302-187-8610-
(*Maximum calculated rate -35.2 mils/yr 4/91, C-1302-187-5300-011 Rev. 1)

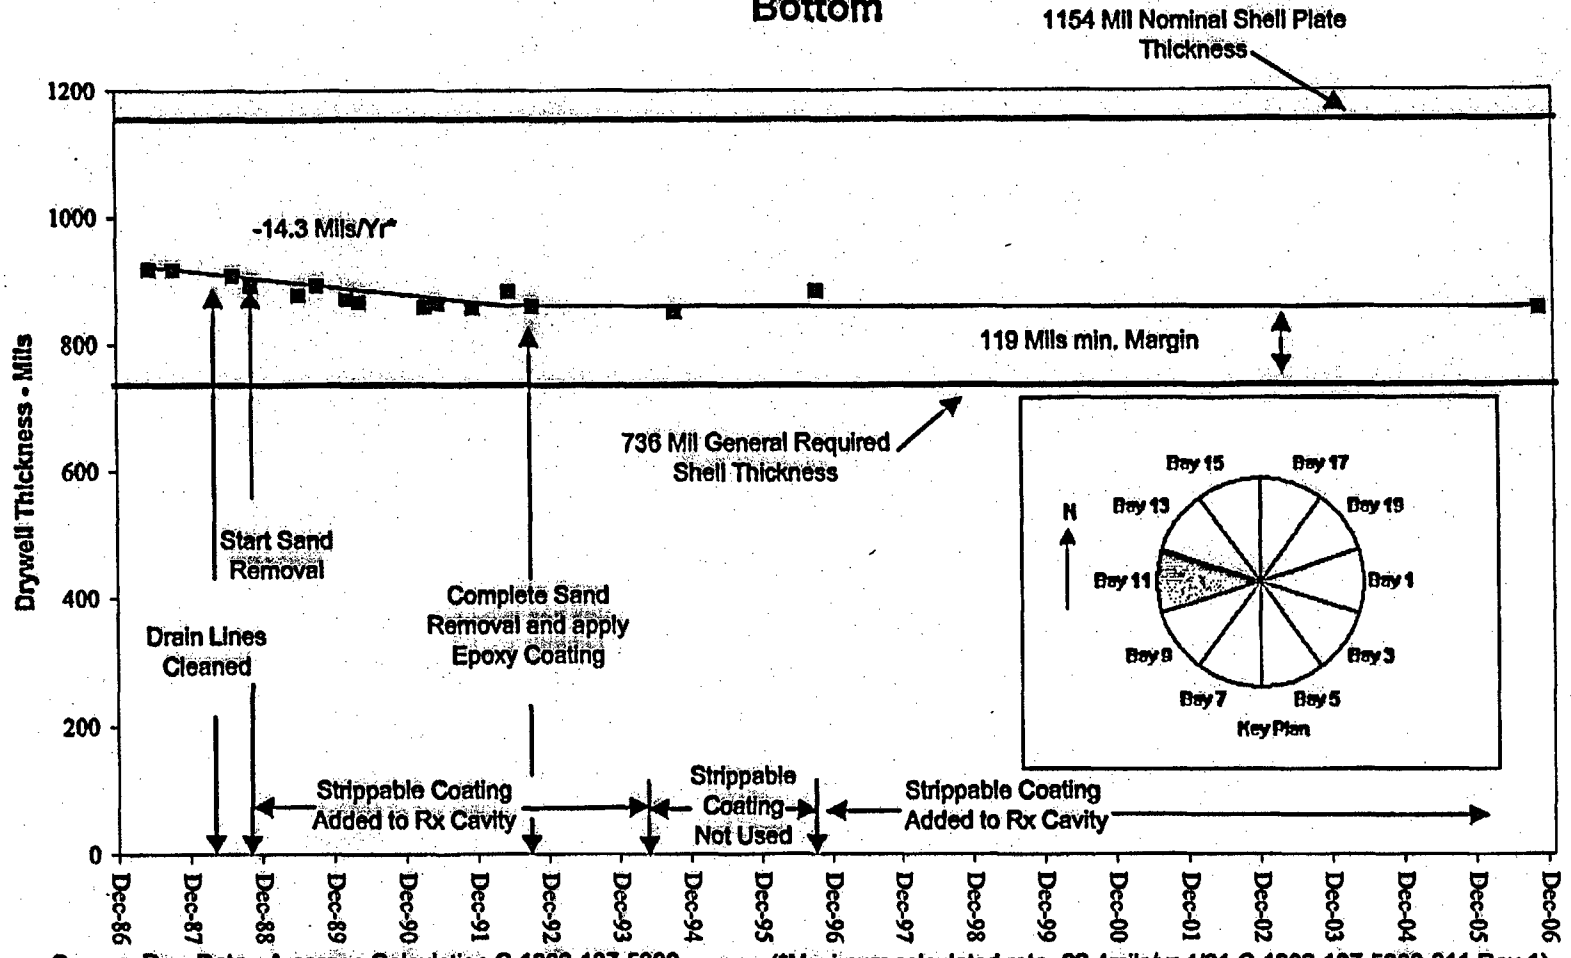
Figure 9. Sandbed Bay #11C Bottom

(*Maximum calculated rate -22.4mils/yr 4/91,C-1302-187-5300-011 Rev.1)

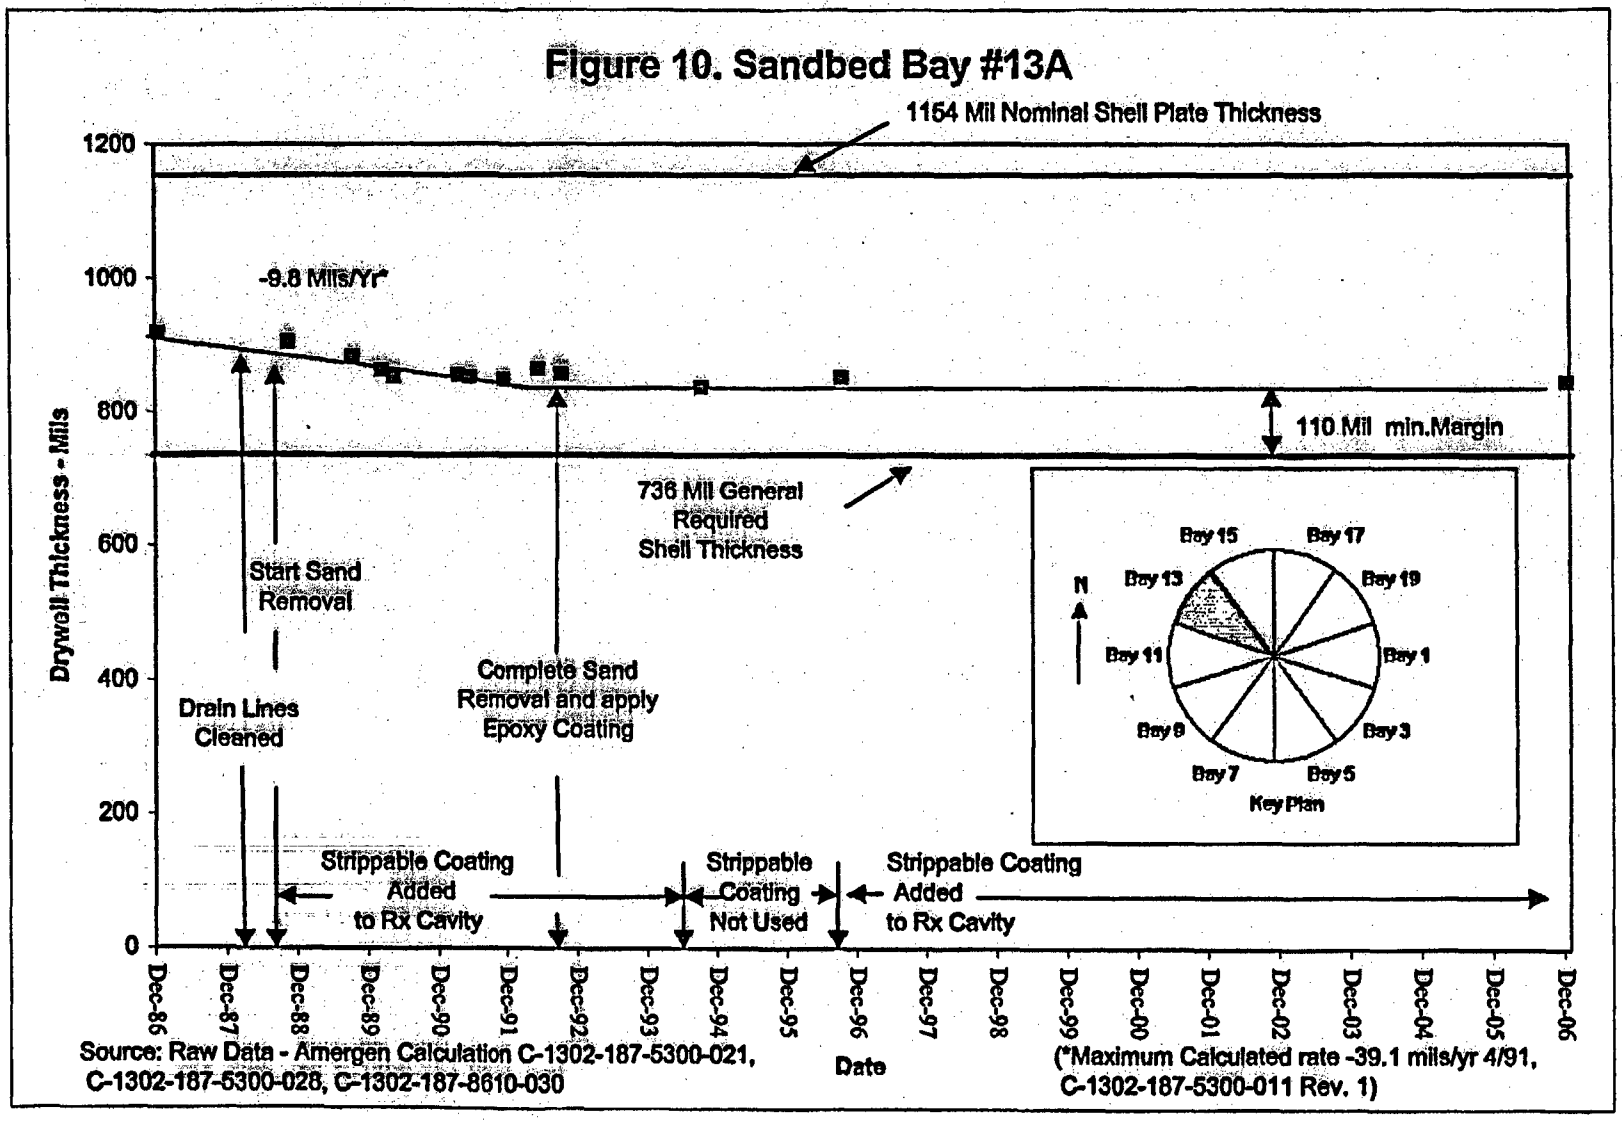
Figure 10. Sandbed Bay #13A
1154 Mil Nominal Shell Plate Thickness
1200
1000
800
600
400
200
0
Drywall Thickness - Mils
-9.8 Mils/Yr*
110 Mil min.Margin
736 Mil General
Required
Shell Thickness
Start Sand
Removal
Drain Lines
Cleaned
Complete Sand
Removal and apply
Epoxy Coating
Strippable Coating
Added
to Rx Cavity
Strippable
Coating
Not Used
Strippable Coating
Added
to Rx Cavity
N
Bay 15
Bay 17
Bay 13
Bay 19
Bay 11
Bay 1
Bay 9
Bay 3
Bay 7
Bay 5
Key Plan
Dec-86
Dec-87
Dec-88
Dec-89
Dec-90
Dec-91
Dec-92
Dec-93
Dec-94
Dec-95
Dec-96
Dec-97
Dec-98
Dec-99
Dec-00
Dec-01
Dec-02
Dec-03
Dec-04
Dec-05
Dec-06
Date
Source: Raw Data - Amergen Calculation C-1302-187-5300-021,
C-1302-187-5300-028, C-1302-187-8610-030
(*Maximum Calculated rate -39.1 mils/yr 4/91,
C-1302-187-5300-011 Rev. 1)

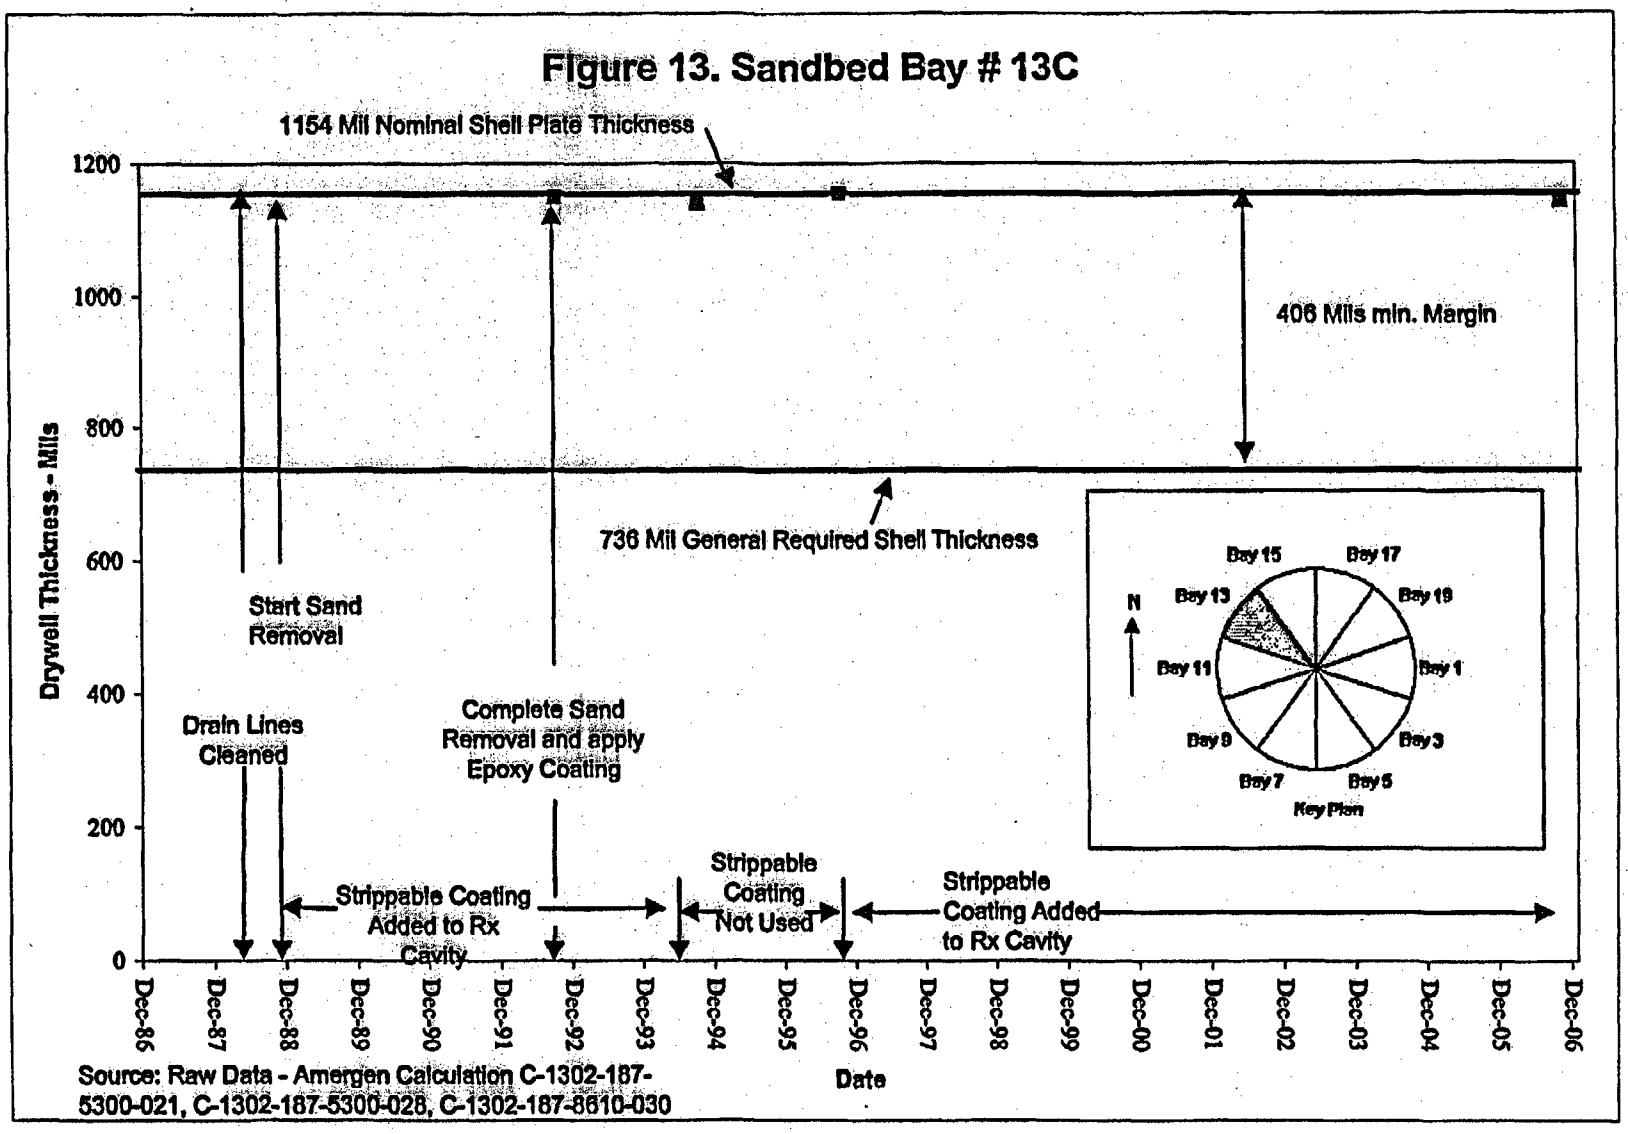
Figure 13. Sandbed Bay # 13C
1154 Mil Nominal Shell Plate Thickness
406 Mils min. Margin
736 Mil General Required Shell Thickness
Start Sand Removal
Drain Lines Cleaned
Complete Sand Removal and apply Epoxy Coating
Strippable Coating Added to Rx Cavity
Strippable Coating Not Used
Strippable Coating Added to Rx Cavity
Drywell Thickness - Mils
1200
1000
800
600
400
200
0
Dec-86
Dec-87
Dec-88
Dec-89
Dec-90
Dec-91
Dec-92
Dec-93
Dec-94
Dec-95
Dec-96
Dec-97
Dec-98
Dec-99
Dec-00
Dec-01
Dec-02
Dec-03
Dec-04
Dec-05
Dec-06
Date
N
Bay 15
Bay 17
Bay 13
Bay 19
Bay 11
Bay 1
Bay 9
Bay 3
Bay 7
Bay 5
Key Plan
Source: Raw Data - Amergen Calculation C-1302-187-5300-021, C-1302-187-5300-028, C-1302-187-8610-030

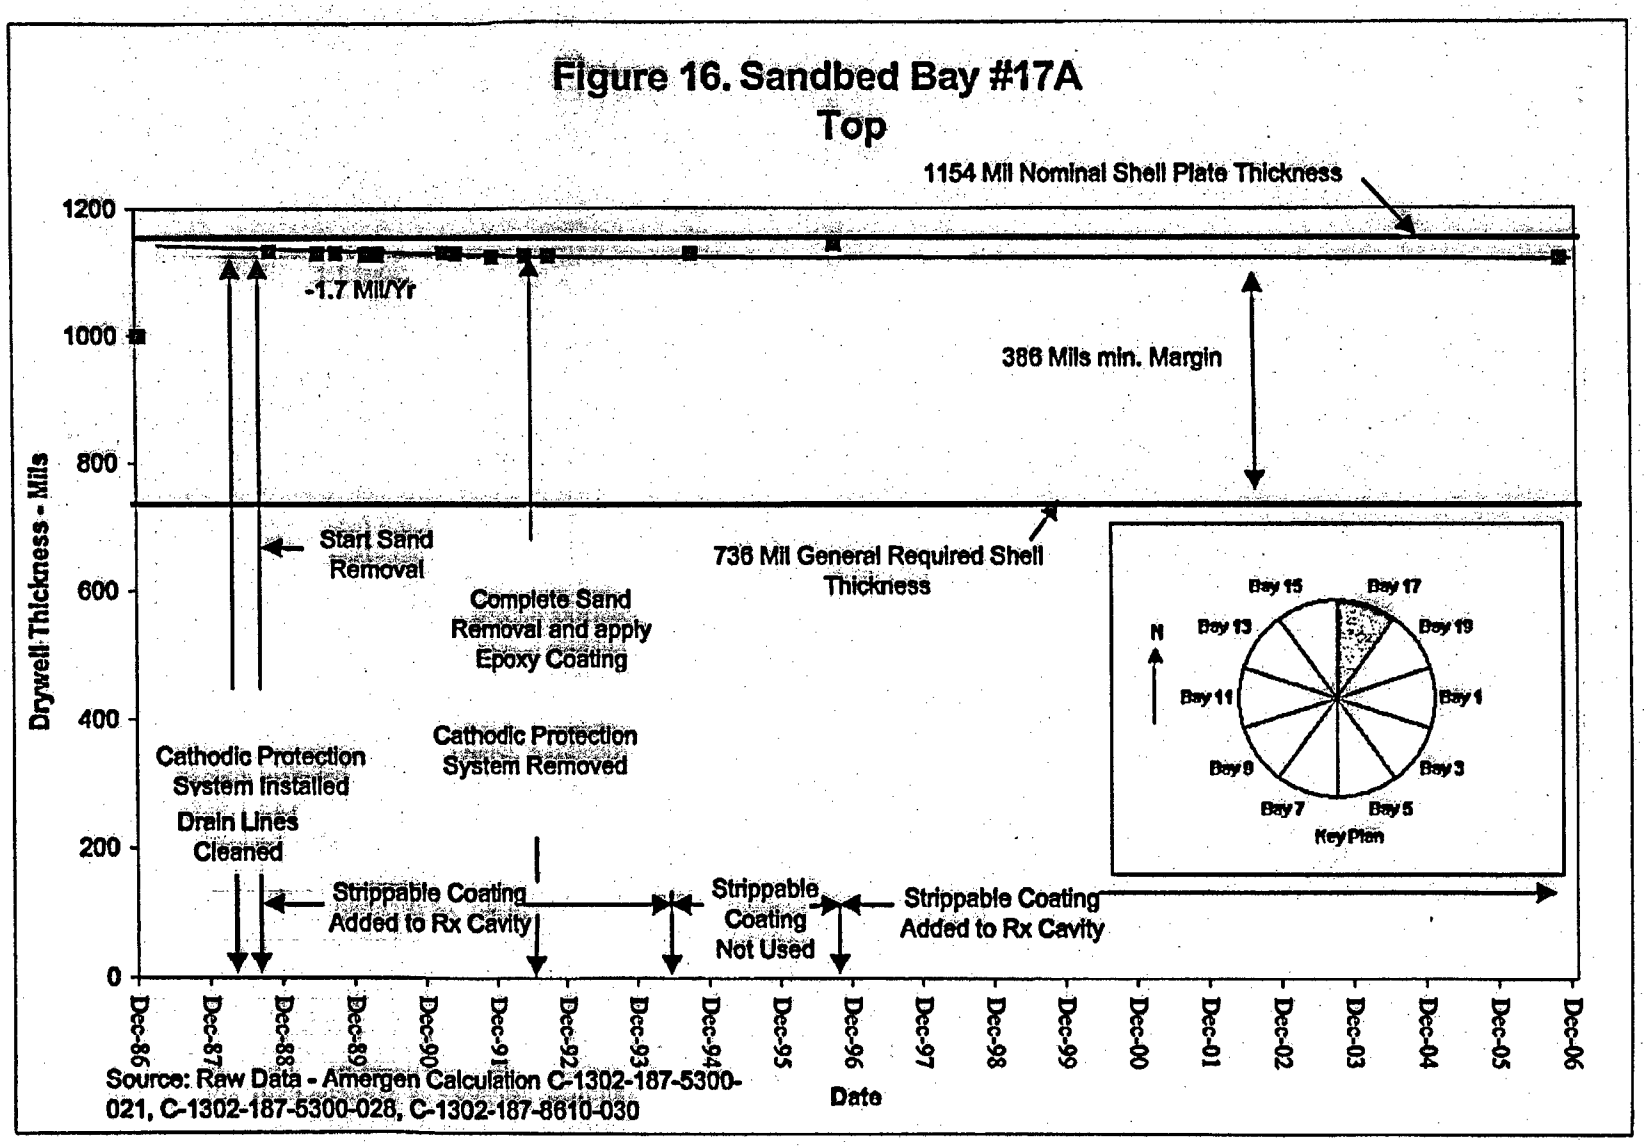
Figure 16. Sandbed Bay #17A
Top
1154 Mil Nominal Shell Plate Thickness
1200
1000
800
600
400
200
0
-1.7 Mil/Yr
386 Mils min. Margin
736 Mil General Required Shell Thickness
Drywell Thickness - Mils
Start Sand Removal
Complete Sand Removal and apply Epoxy Coating
Cathodic Protection System Installed
Drain Lines Cleaned
Cathodic Protection System Removed
Strippable Coating Added to Rx Cavity
Strippable Coating Not Used
Strippable Coating Added to Rx Cavity
N
Bay 15
Bay 17
Bay 13
Bay 19
Bay 11
Bay 1
Bay 9
Bay 3
Bay 7
Bay 5
Key Plan
Dec-86
Dec-87
Dec-88
Dec-89
Dec-90
Dec-91
Dec-92
Dec-93
Dec-94
Dec-95
Dec-96
Dec-97
Dec-98
Dec-99
Dec-00
Dec-01
Dec-02
Dec-03
Dec-04
Dec-05
Dec-06
Date
Source: Raw Data - Amergen Calculation C-1302-187-5300-021, C-1302-187-5300-028, C-1302-187-8610-030

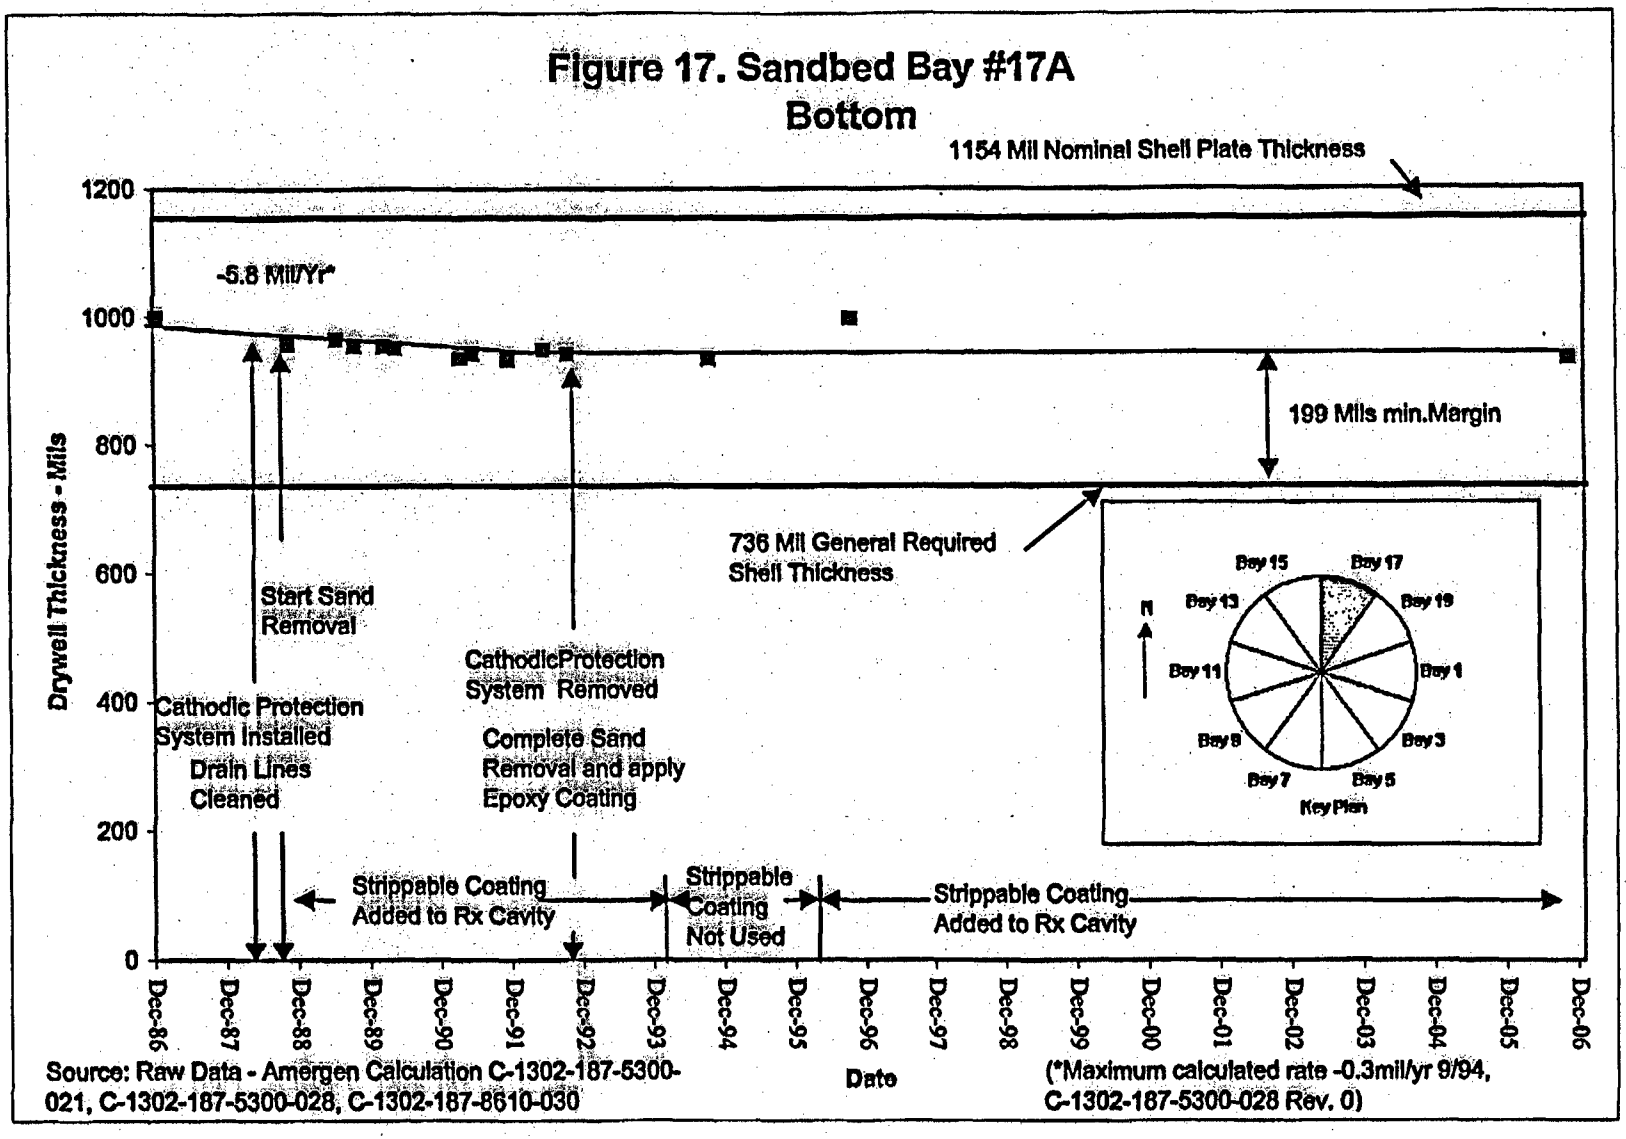
Figure 17. Sandbed Bay #17A
Bottom
1154 Mil Nominal Shell Plate Thickness
1200
1000
800
600
400
200
0
-5.8 Mil/Yr*
199 Mils min.Margin
736 Mil General Required
Shell Thickness
Drywell Thickness - Mils
Start Sand
Removal
Cathodic Protection
System Installed
Drain Lines
Cleaned
CathodicProtection
System Removed
Complete Sand
Removal and apply
Epoxy Coating
Strippable Coating
Added to Rx Cavity
Strippable
Coating
Not Used
Strippable Coating
Added to Rx Cavity
Bay 15
Bay 17
Bay 13
Bay 19
N
Bay 11
Bay 1
Bay 9
Bay 3
Bay 7
Bay 5
Key Plan
Dec-86
Dec-87
Dec-88
Dec-89
Dec-90
Dec-91
Dec-92
Dec-93
Dec-94
Dec-95
Dec-96
Dec-97
Dec-98
Dec-99
Dec-00
Dec-01
Dec-02
Dec-03
Dec-04
Dec-05
Dec-06
Date
Source: Raw Data - Amergen Calculation C-1302-187-5300-021, C-1302-187-5300-028, C-1302-187-8610-030
(*Maximum calculated rate -0.3mil/yr 9/94, C-1302-187-5300-028 Rev. 0)

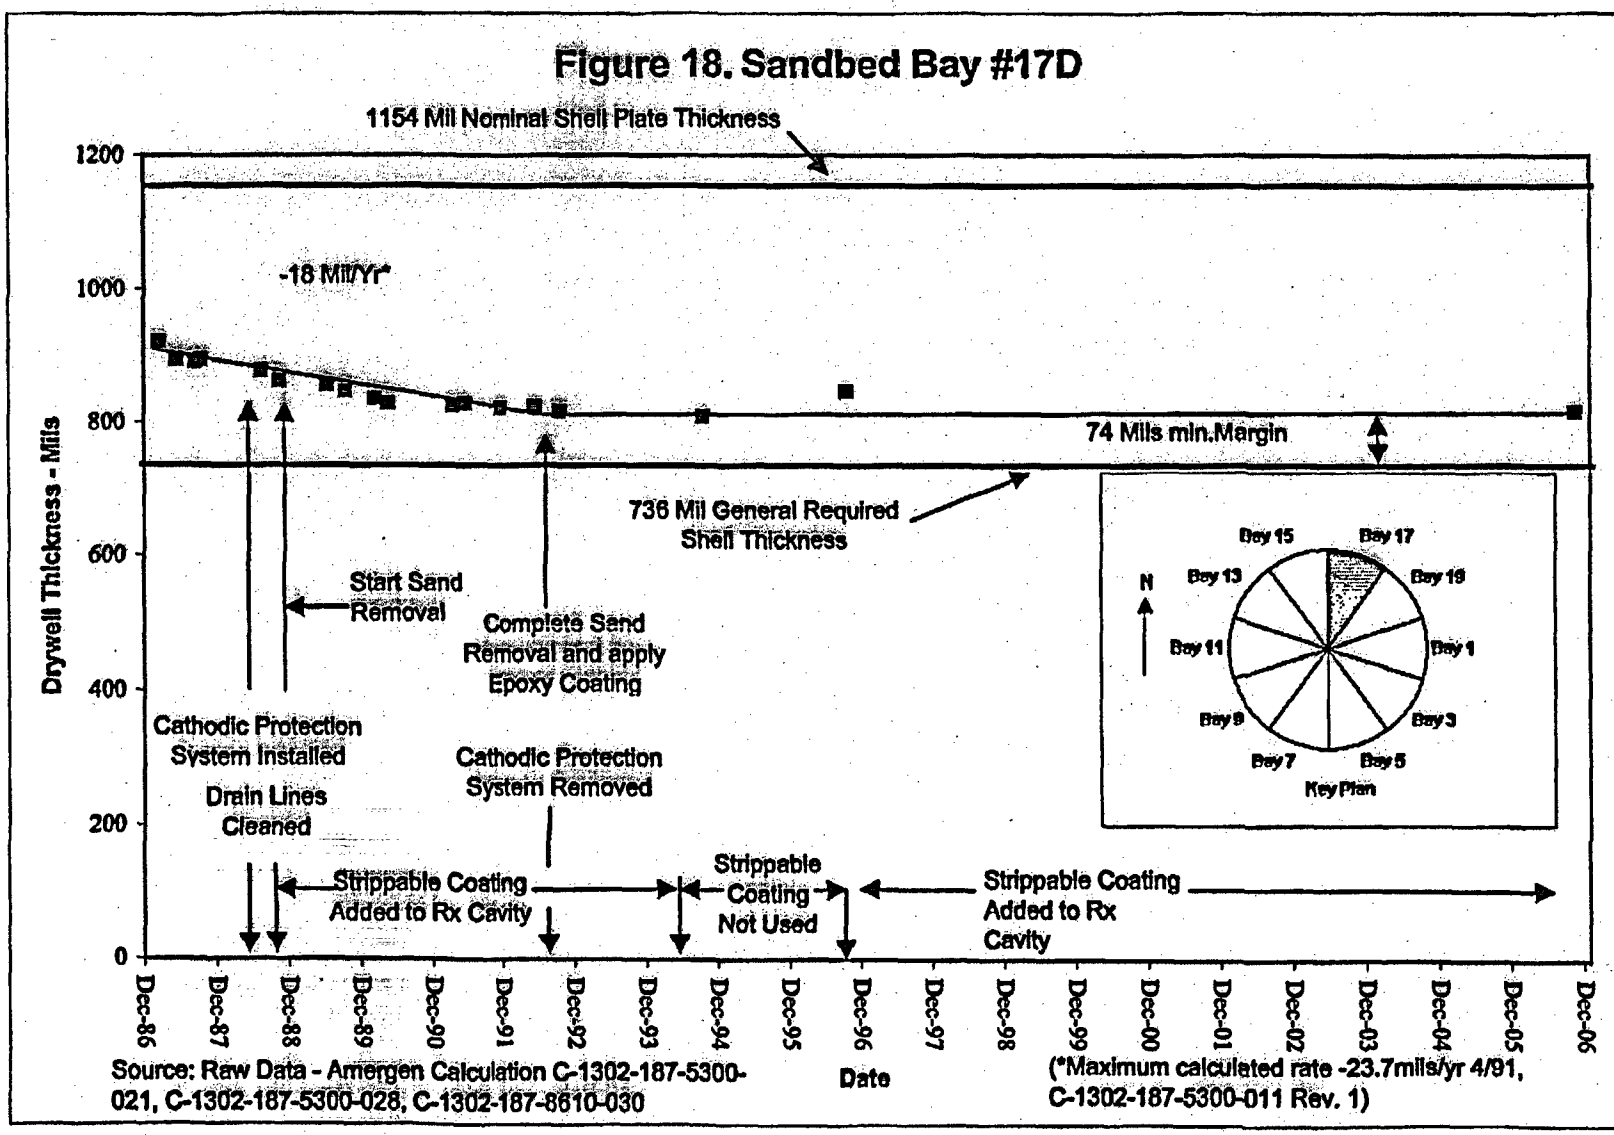
Figure 18. Sandbed Bay #17D

(*Maximum calculated rate -23.7mils/yr 4/91, C-1302-187-5300-011 Rev. 1)

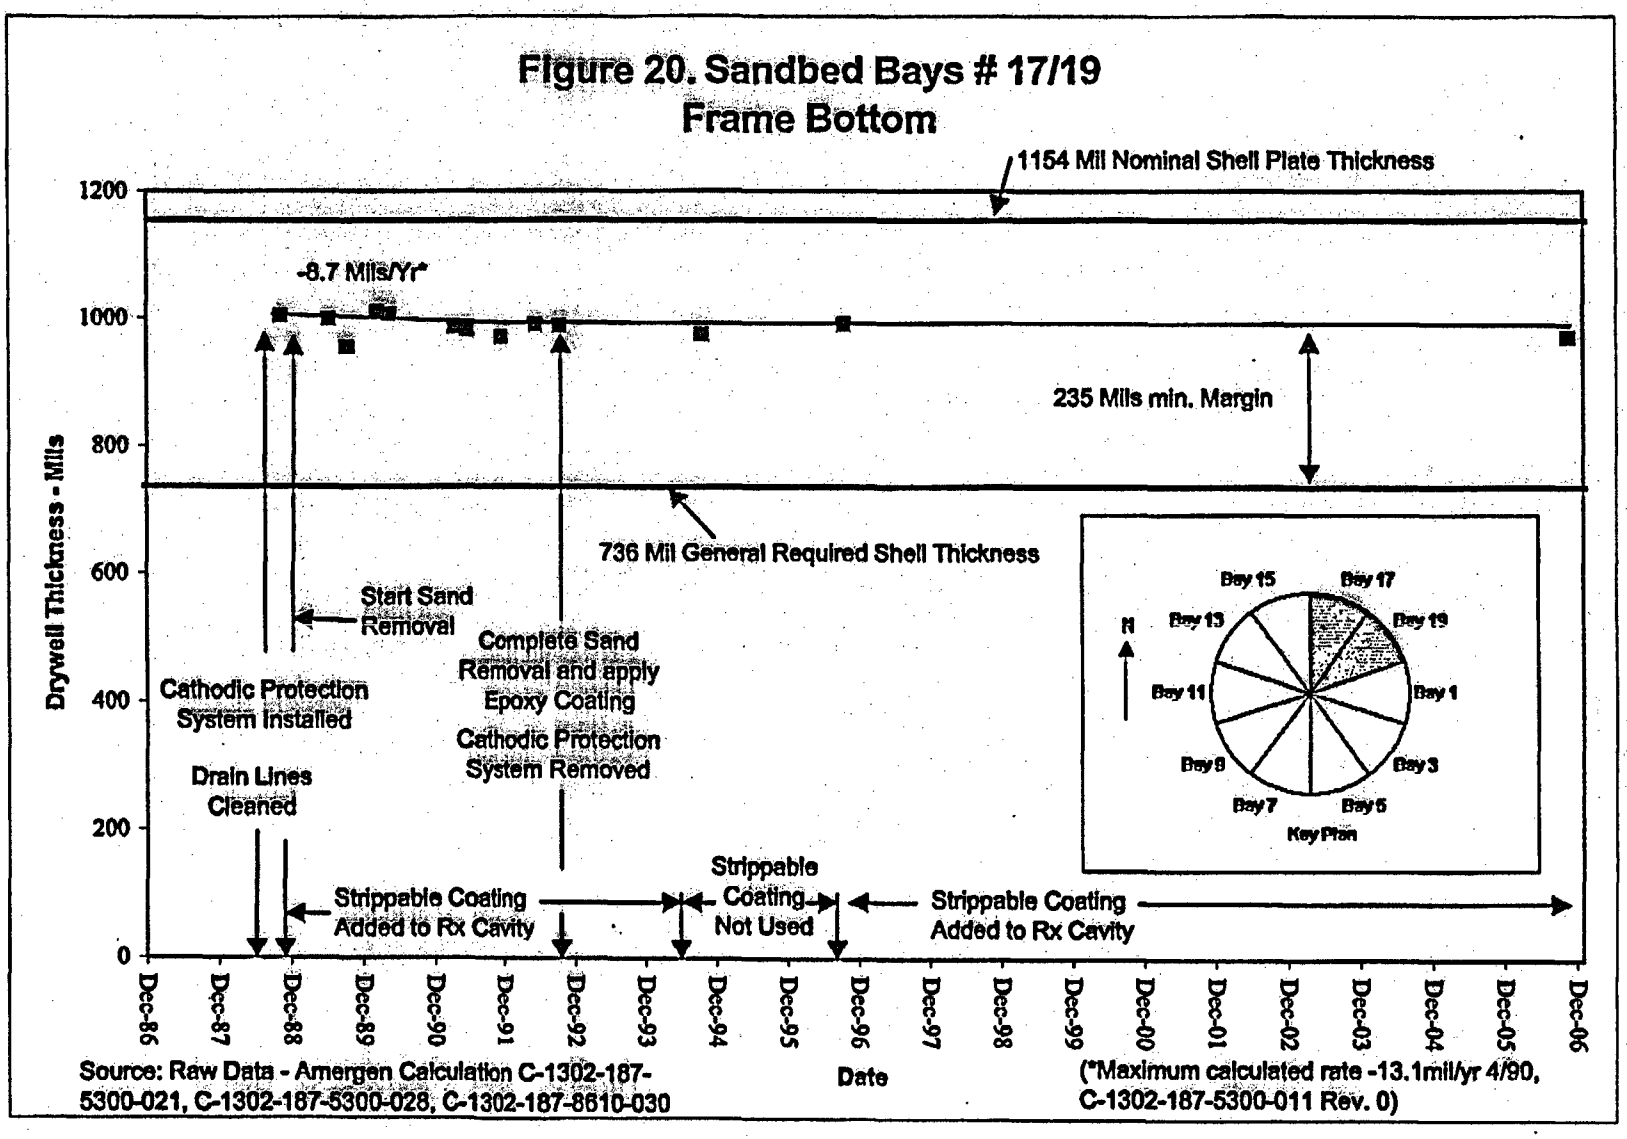
Figure 20. Sandbed Bays # 17/19
Frame Bottom
1154 Mil Nominal Shell Plate Thickness
-8.7 Mils/Yr*
235 Mils min. Margin
736 Mil General Required Shell Thickness
Drywell Thickness - Mils
1200
1000
800
600
400
200
0
Start Sand Removal
Cathodic Protection System Installed
Complete Sand Removal and apply Epoxy Coating
Cathodic Protection System Removed
Drain Lines Cleaned
Strippable Coating Added to Rx Cavity
Strippable Coating Not Used
Strippable Coating Added to Rx Cavity
Bay 15
Bay 17
Bay 13
Bay 19
N
Bay 11
Bay 1
Bay 9
Bay 3
Bay 7
Bay 5
Key Plan
Dec-86
Dec-87
Dec-88
Dec-89
Dec-90
Dec-91
Dec-92
Dec-93
Dec-94
Dec-95
Dec-96
Dec-97
Dec-98
Dec-99
Dec-00
Dec-01
Dec-02
Dec-03
Dec-04
Dec-05
Dec-06
Date
Source: Raw Data - Amergen Calculation C-1302-187-5300-021, C-1302-187-5300-028, C-1302-187-8610-030
(*Maximum calculated rate -13.1mil/yr 4/90, C-1302-187-5300-011 Rev. 0)
