UNITED STATES OF AMERICA
NUCLEAR REGULATORY COMMISSION

In the Matter of:	)	July 20, 2007
AmerGen Energy Company, LLC	)	Docket No. 50-219
(License Renewal for Oyster Creek Nuclear Generating Station)	)

AMERGEN'S PRE-FILED DIRECT TESTIMONY EXHIBITS

VOLUME 1 OF 2: EXHIBITS 1-19

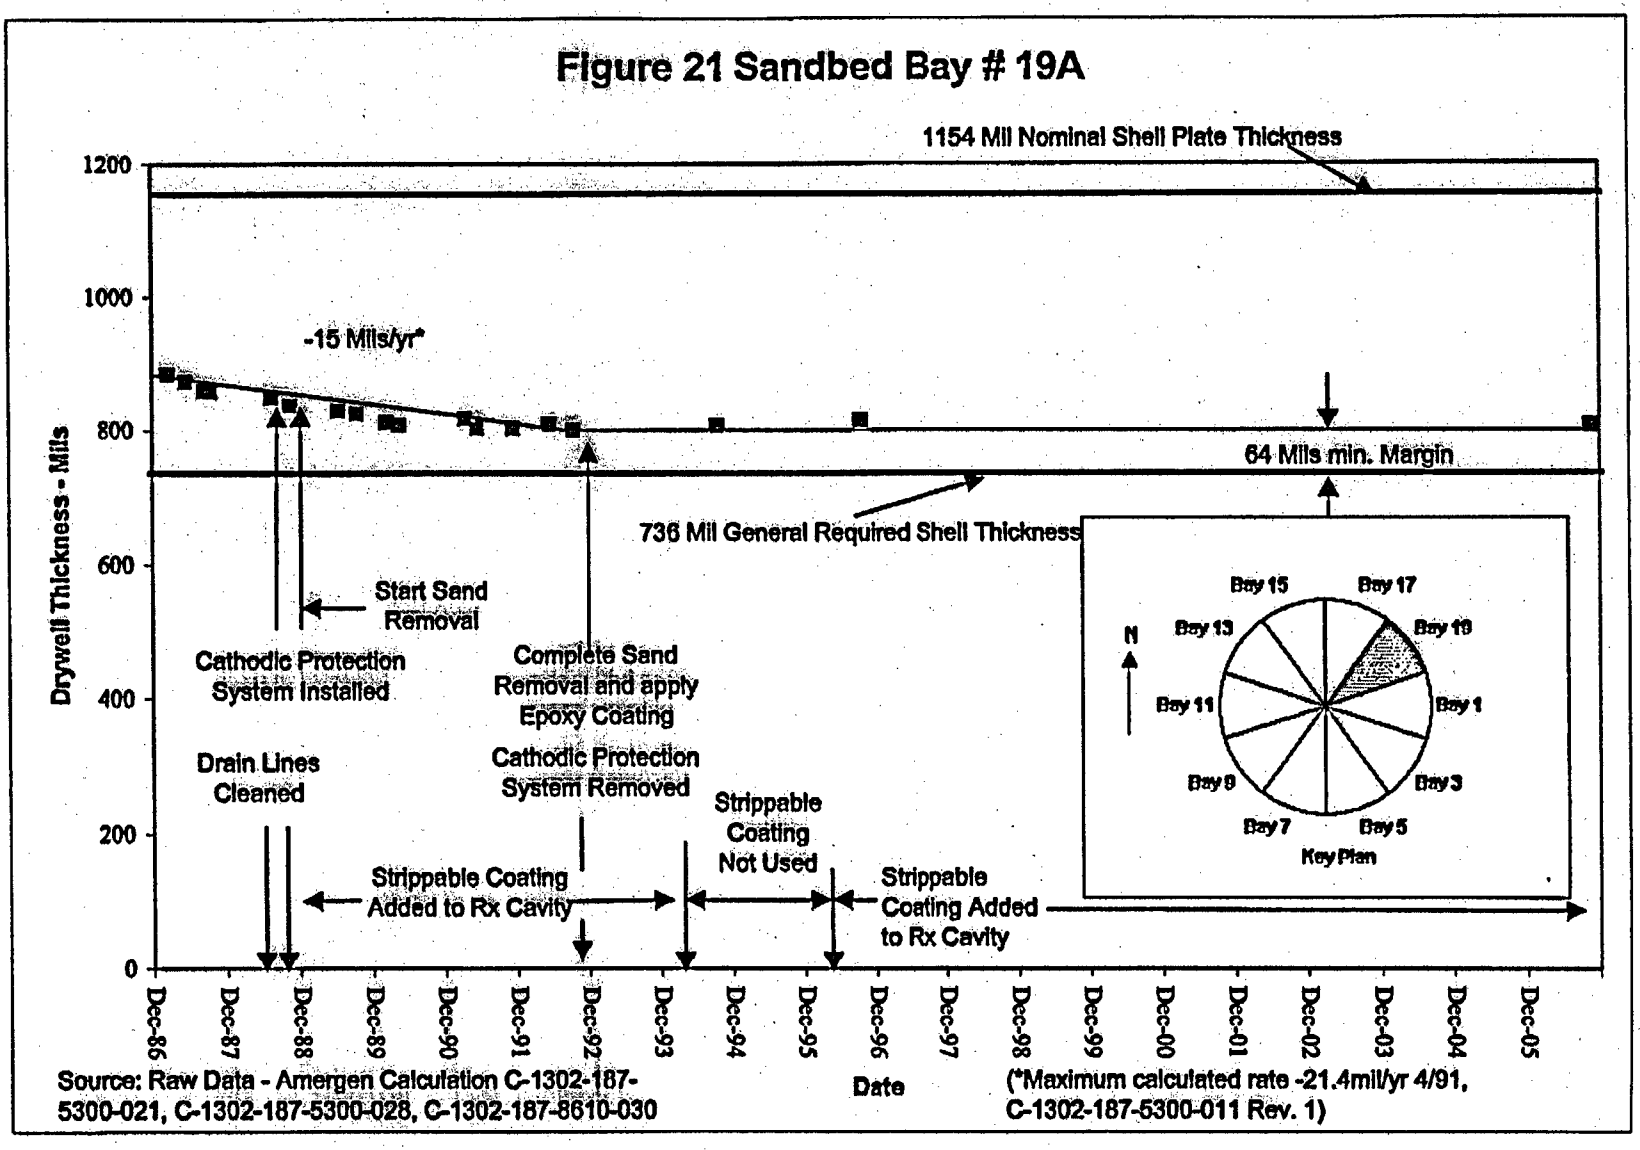
Figure 21 Sandbed Bay # 19A

(*Maximum calculated rate -21.4mil/yr 4/91, C-1302-187-5300-011 Rev. 1)

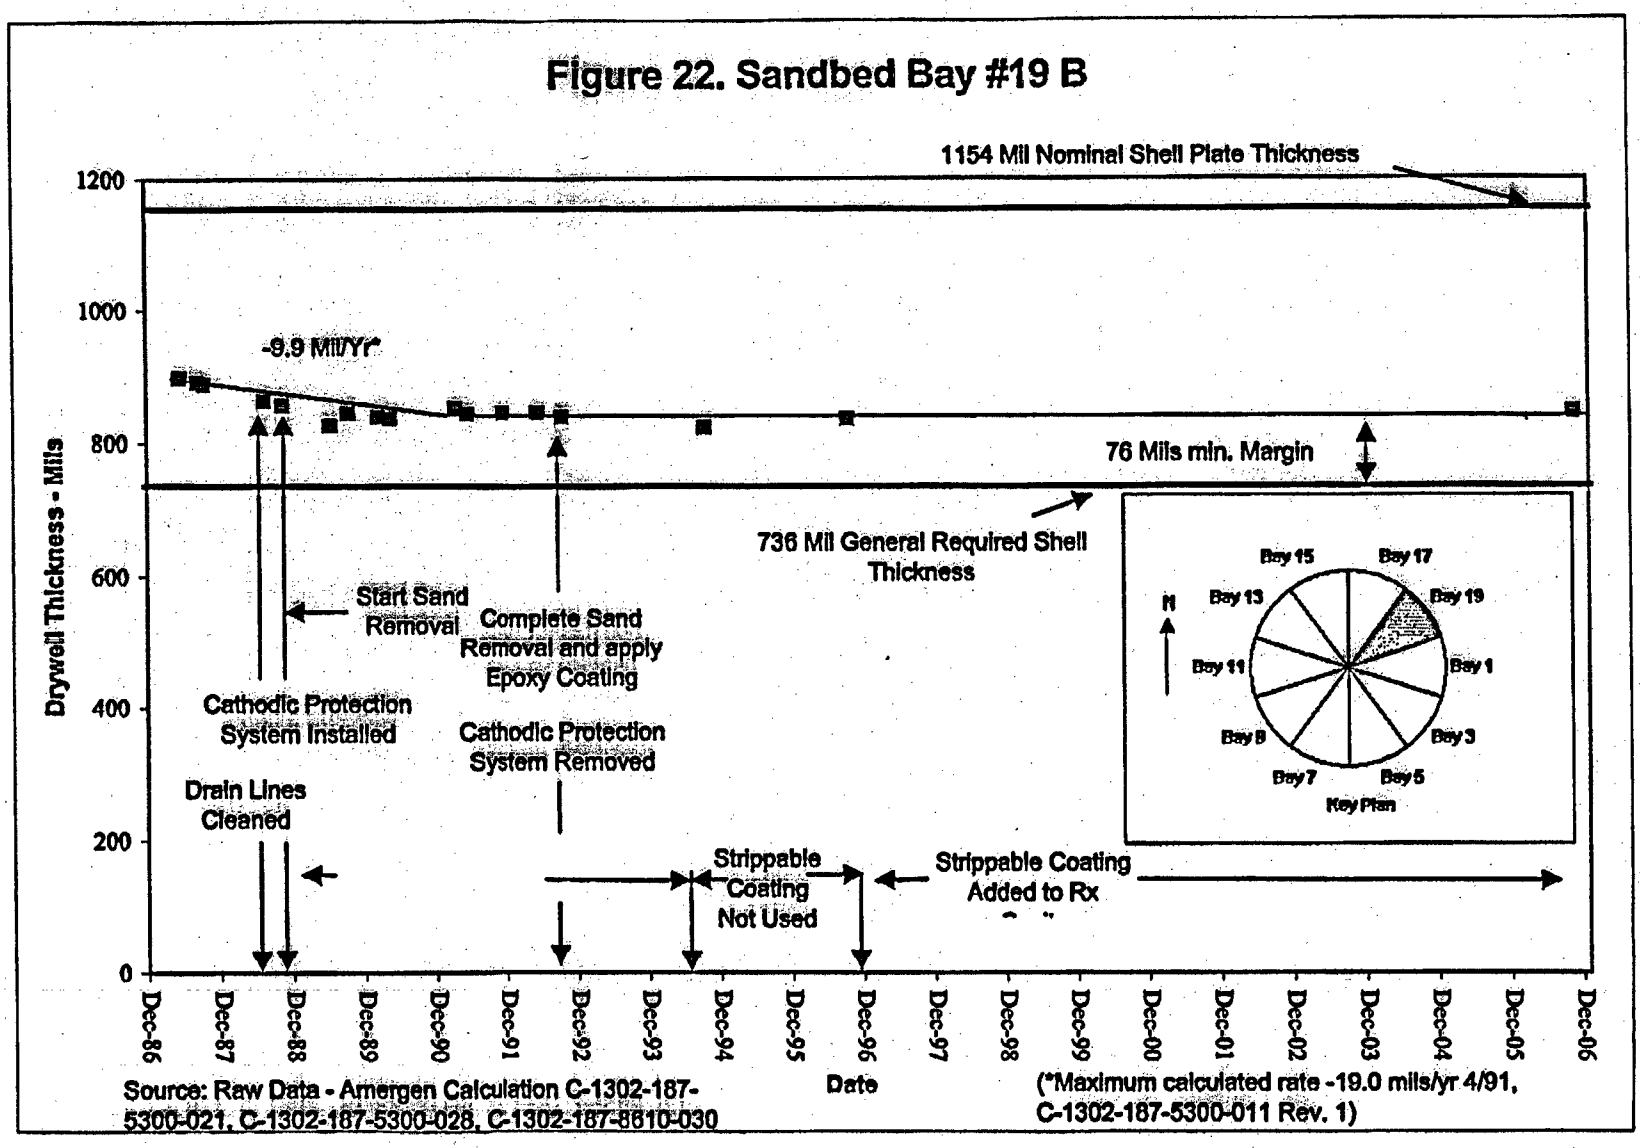
Figure 22. Sandbed Bay #19 B

(*Maximum calculated rate -19.0 mils/yr 4/91, C-1302-187-5300-011 Rev. 1)

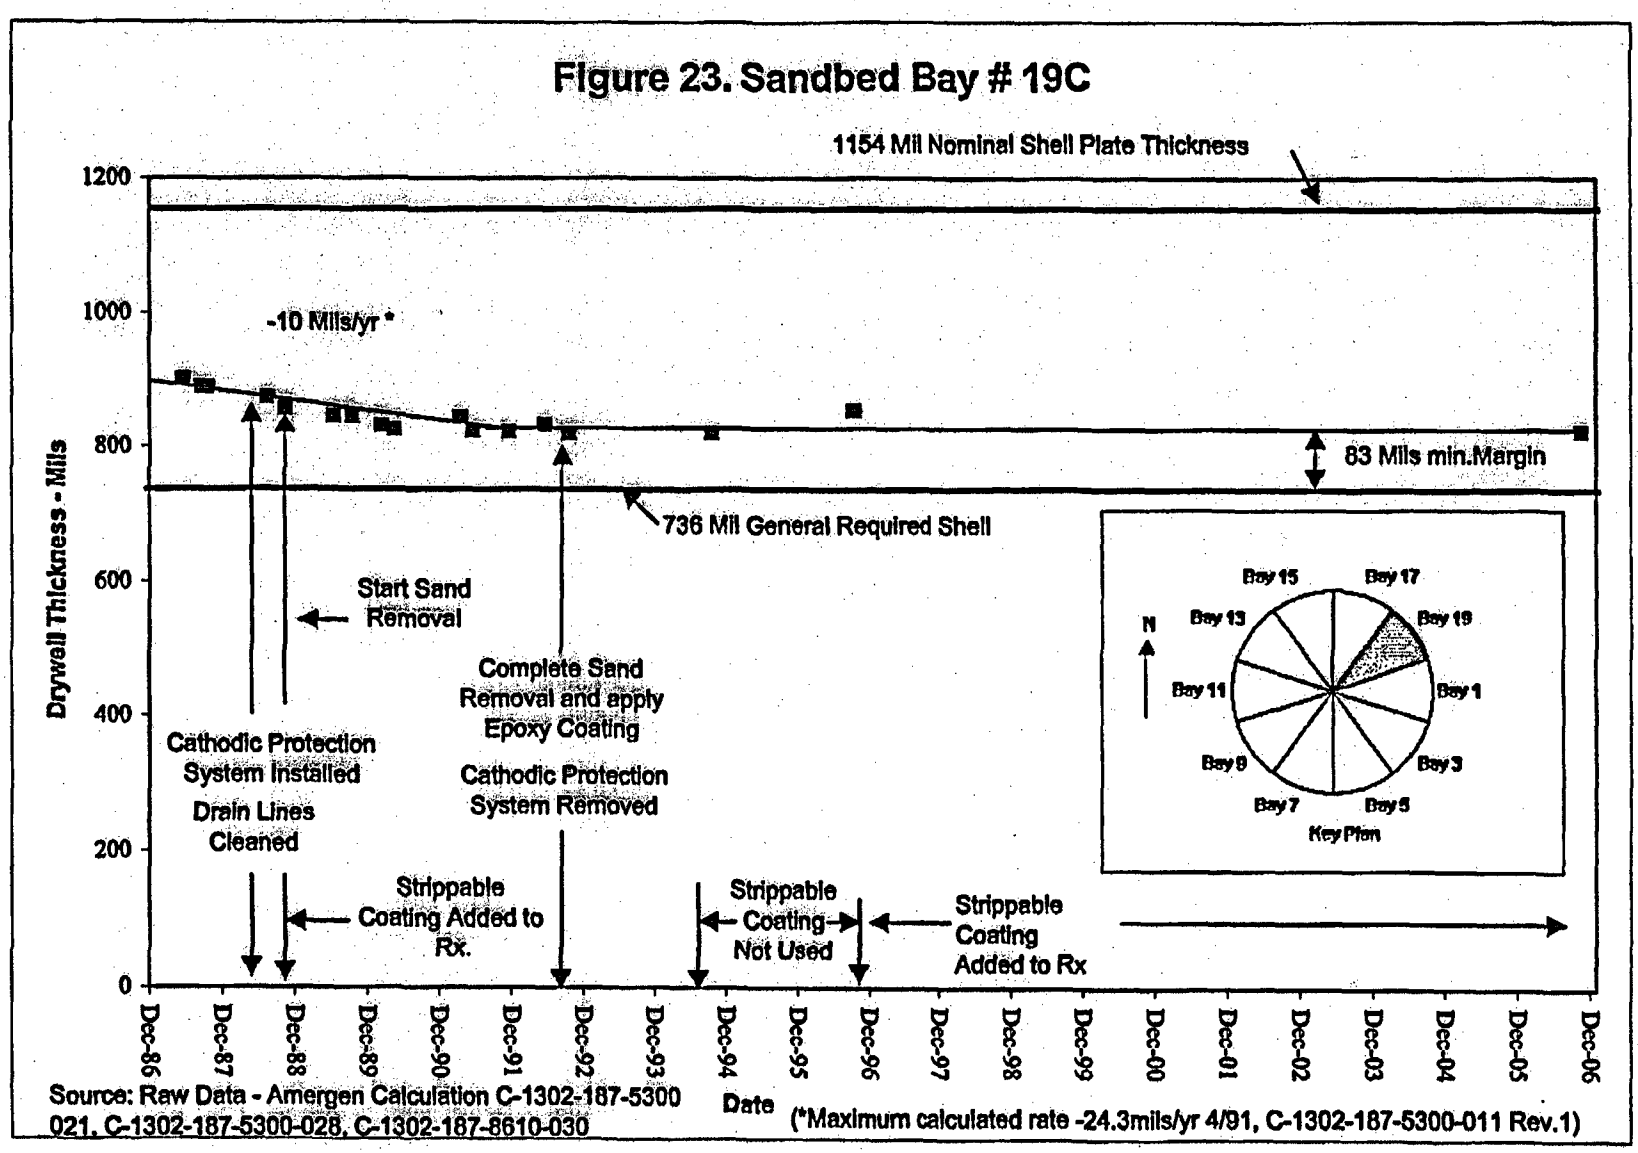
Figure 23. Sandbed Bay # 19C

(*Maximum calculated rate -24.3mils/yr 4/91, C-1302-187-5300-011 Rev.1)

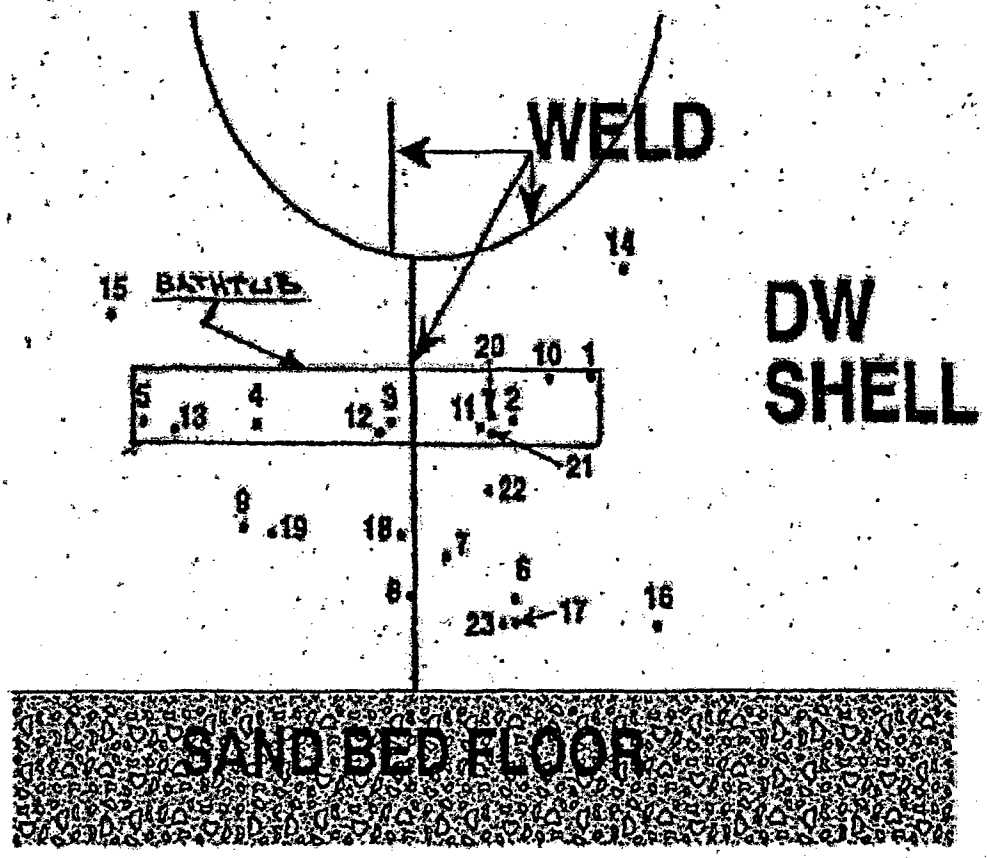
The outside surface of this bay is rough and full of dimples similar to the outside surface of a golf ball. This observation is made by the inspector who located the thinnest areas in 1992. The 2006 inspections confirmed this observation (references 3.6). This inspection focused on the thinnest areas of the drywell, even if it was very local. The shell appears to be relatively uniform in thickness except for a band of corrosion which looks like a "bathtub" ring, located 15 to 20 inches below the vent pipe reinforcement plate, i.e., weld line as shown in Figure 1-1. (Figure 1-1 is not to scale). The graphical presentation in Figure 1-1 of measured indications is extracted from Appendix D, Calculation Pages 71 to 76. Based on the inspectors observations the bathtub ring is 12 to 18 inches wide and about 75 inches long located in the center of the bay. Beyond the bathtub ring on both sides, the shell appears to be uniform in thickness at a conservative value of 0.800 inches. Above the bathtub ring the shell exhibits no corrosion since the original lead primer on the vent pipe/reinforcement plate is intact. Measurements 14 and 15 confirm that the thickness above the bathtub ring is at 1.154 inches starting at elevation 11'-00". Below the bathtub ring the shell is uniform in thickness where no abrupt changes in thicknesses are present. Figure 1-2 plots areas that are thinner than 0.736" in 2006. Figure 1-2 is to scale with respect to the distances between the readings.

1. All "Location" measurements from intersection of the DW shell and vent collar fillet welds.
2. Pit depts are average of four readings taken at 0/45°/90°/135° within 1" band surrounding ground spots. Only measured where remaining wall thk. was below 0.736".

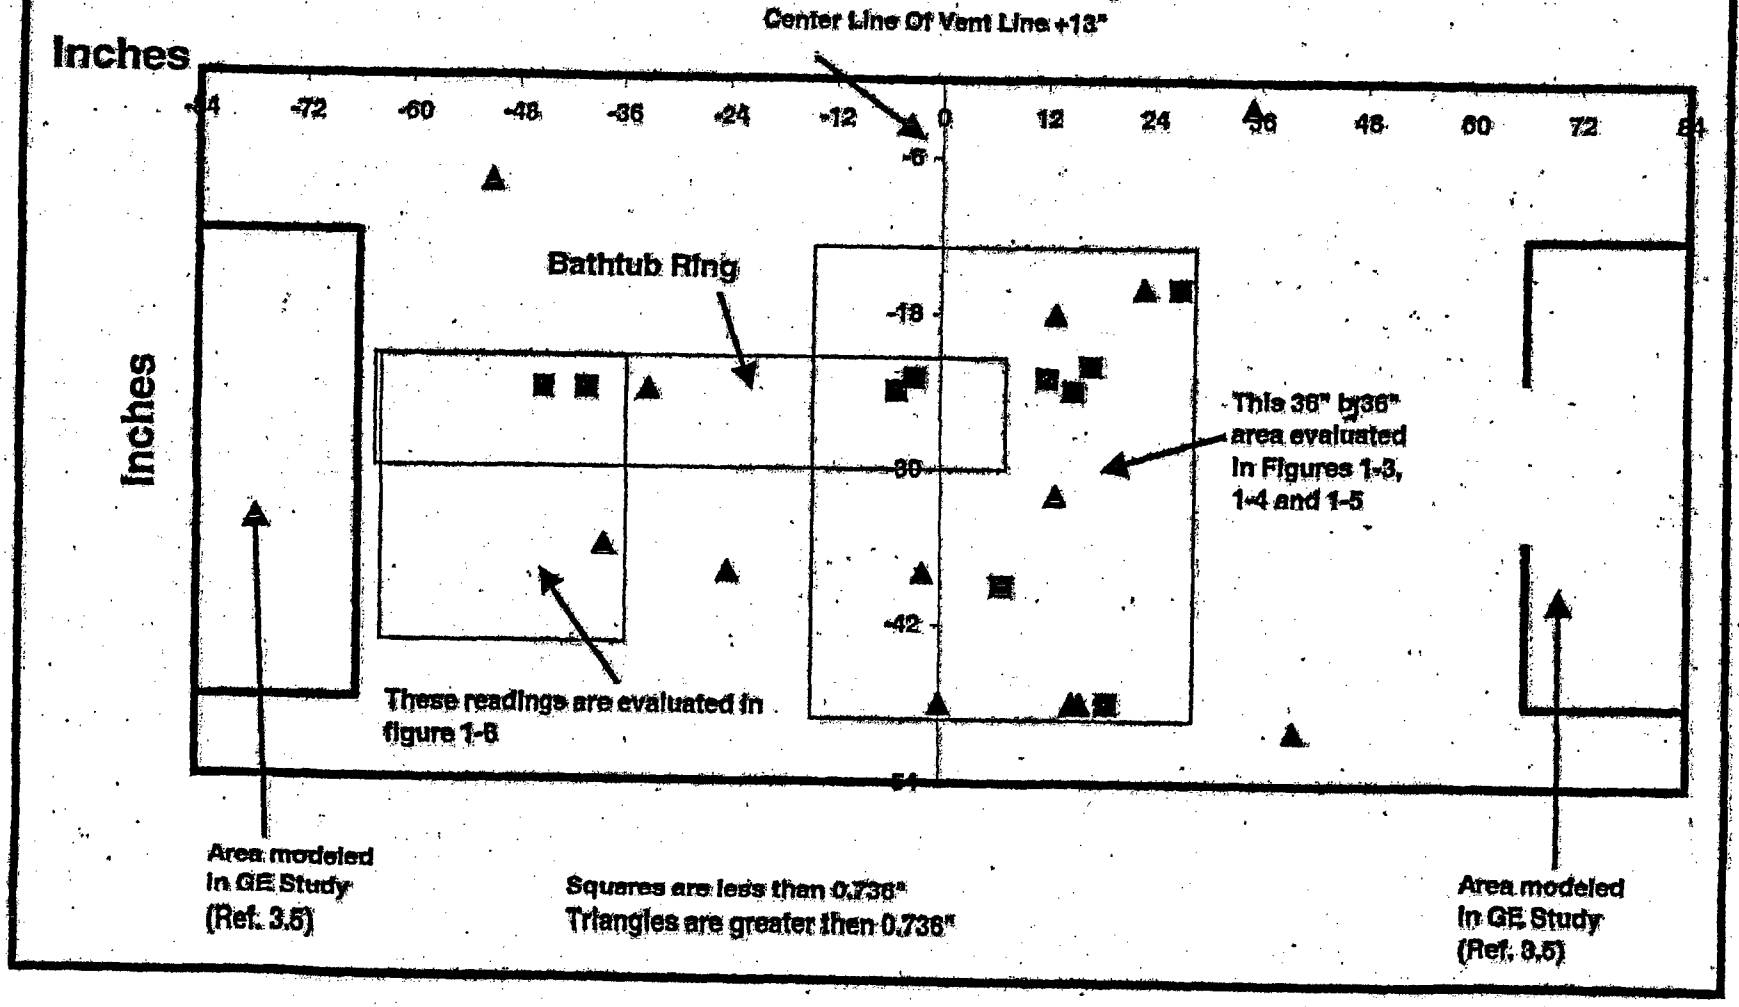
Bay 1 2006
Spatial Relationship Of Locally Thin Areas

Table 1-1 below provides individual UT readings for 1992 and 2006. These readings are the thinnest single readings within each locally thin area. All readings are confined to areas less than 2 ½" inches in diameter. Shaded readings are less than the uniform criteria of 0.736 inches and must be further evaluated. These areas and their location are shown on figure 1-2. The figure presents the areas with readings less than 0.736 inches as squares and areas with readings over 0.736 inches as triangles.

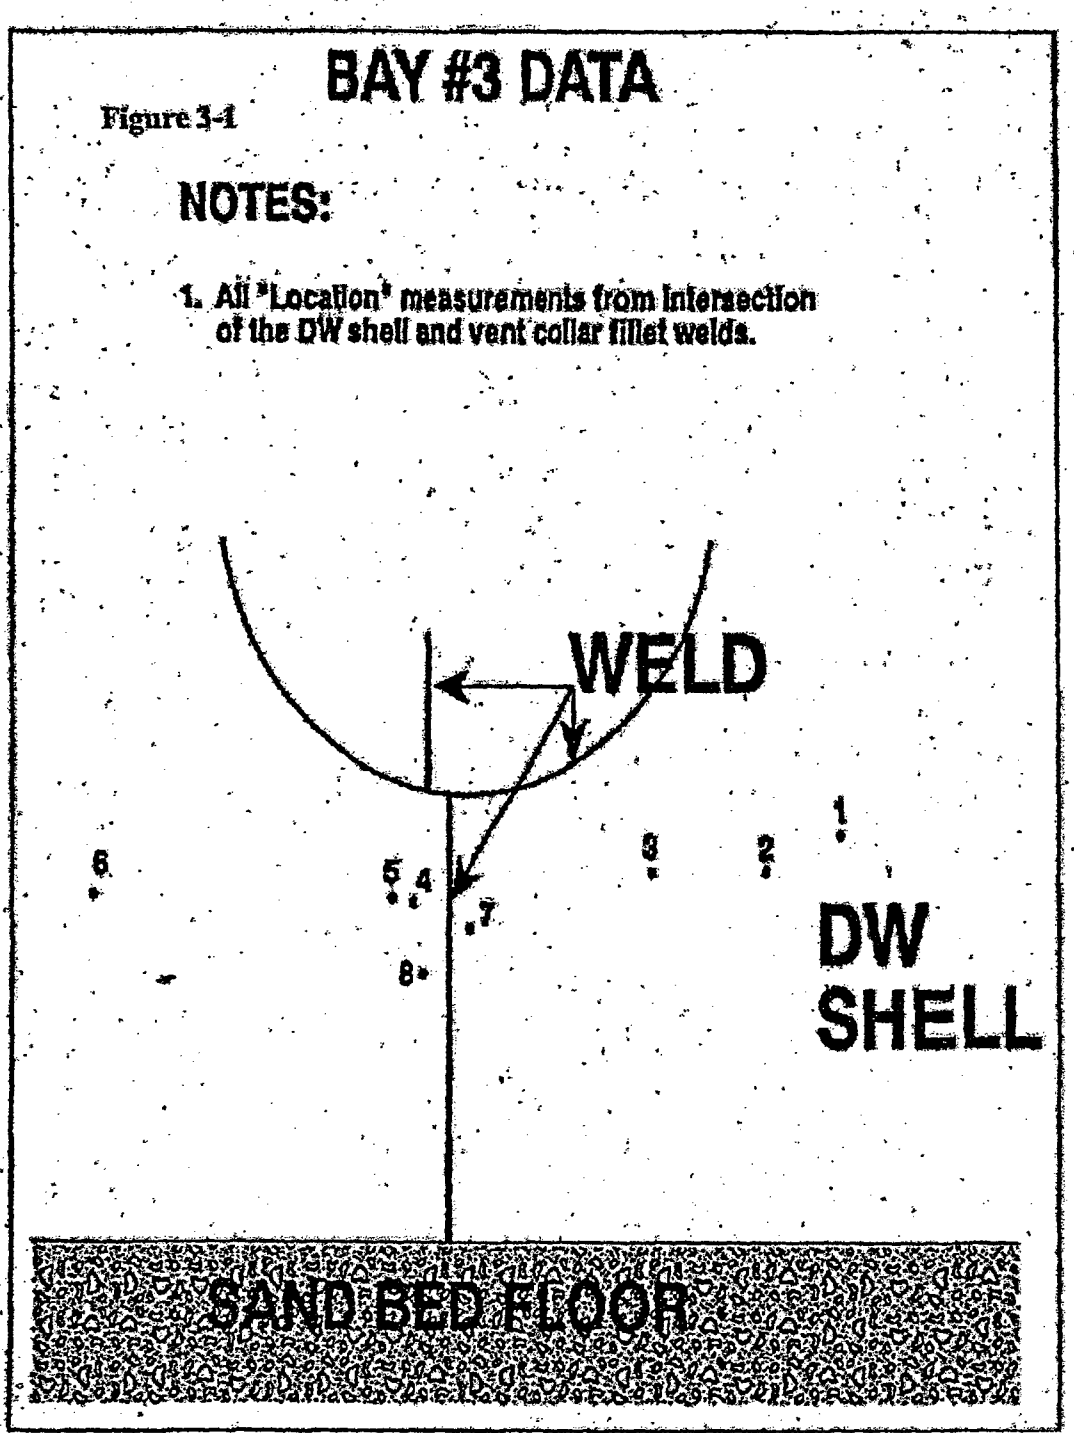
BAY #3 DATA
Figure 3-1
NOTES:
1. All "Location" measurements from intersection of the DW shell and vent collar fillet welds.
WELD
1
2
3
4
5
6
7
8
DW SHELL
SAND BED FLOOR

Eight areas were selected to represent the thinnest areas based on the visual observations of the shell surface (Table 3-1 and Fig. 3-1). These areas are a deliberate attempt to produce a minimum measurement. Table 3-1 shows measurements taken to measure the thicknesses of the drywell shell using a D-meter. The results indicate that all of the areas have thickness greater than the 0.736 inches. Therefore, the uniform criteria is met throughout the bay and it is concluded that the bay is acceptable.

It is concluded that Bay 3 is acceptable since all individual UT readings in 1992 and 2006 were greater than the uniform acceptance criteria.

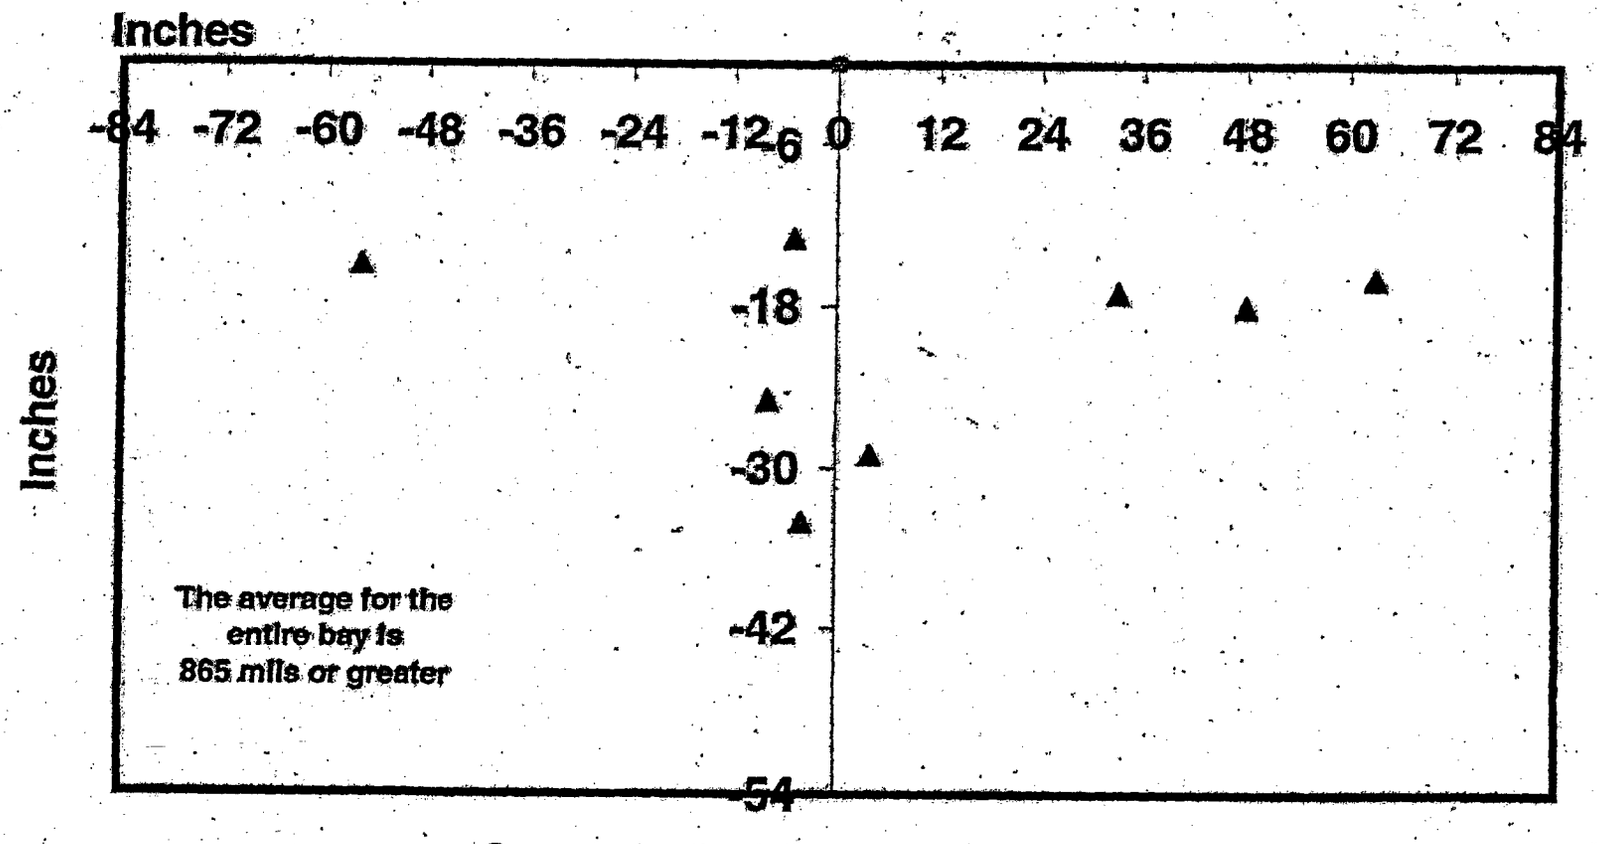
Bay 3 2006
Spatial Relationship Of Locally Thin Areas

Figure 3-2 illustrates the representative thicknesses in this bay, which is 0.865 inches or greater (refer to section 7.3.4).

Squares are less than 0.736"
Triangles are greater then 0.736"

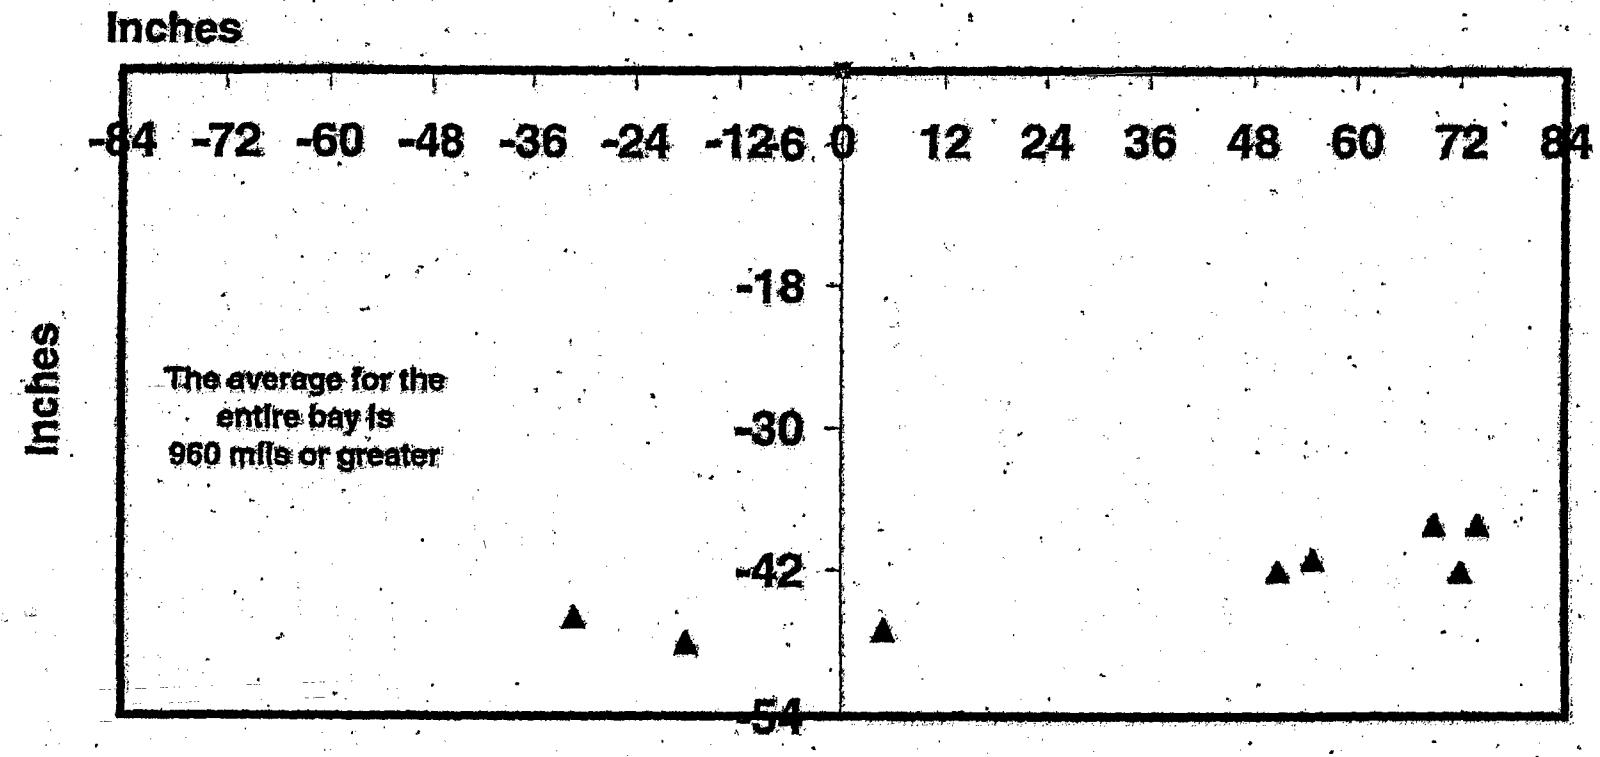
Bay 5 2006
Spatial Relationship Of Locally Thin Areas

Figure 5-2 illustrates the representative thicknesses in this bay, which is 0.960 inches or greater (refer to section 7.5.4).

Squares are less than 0.736"
Triangles are greater then 0.736"

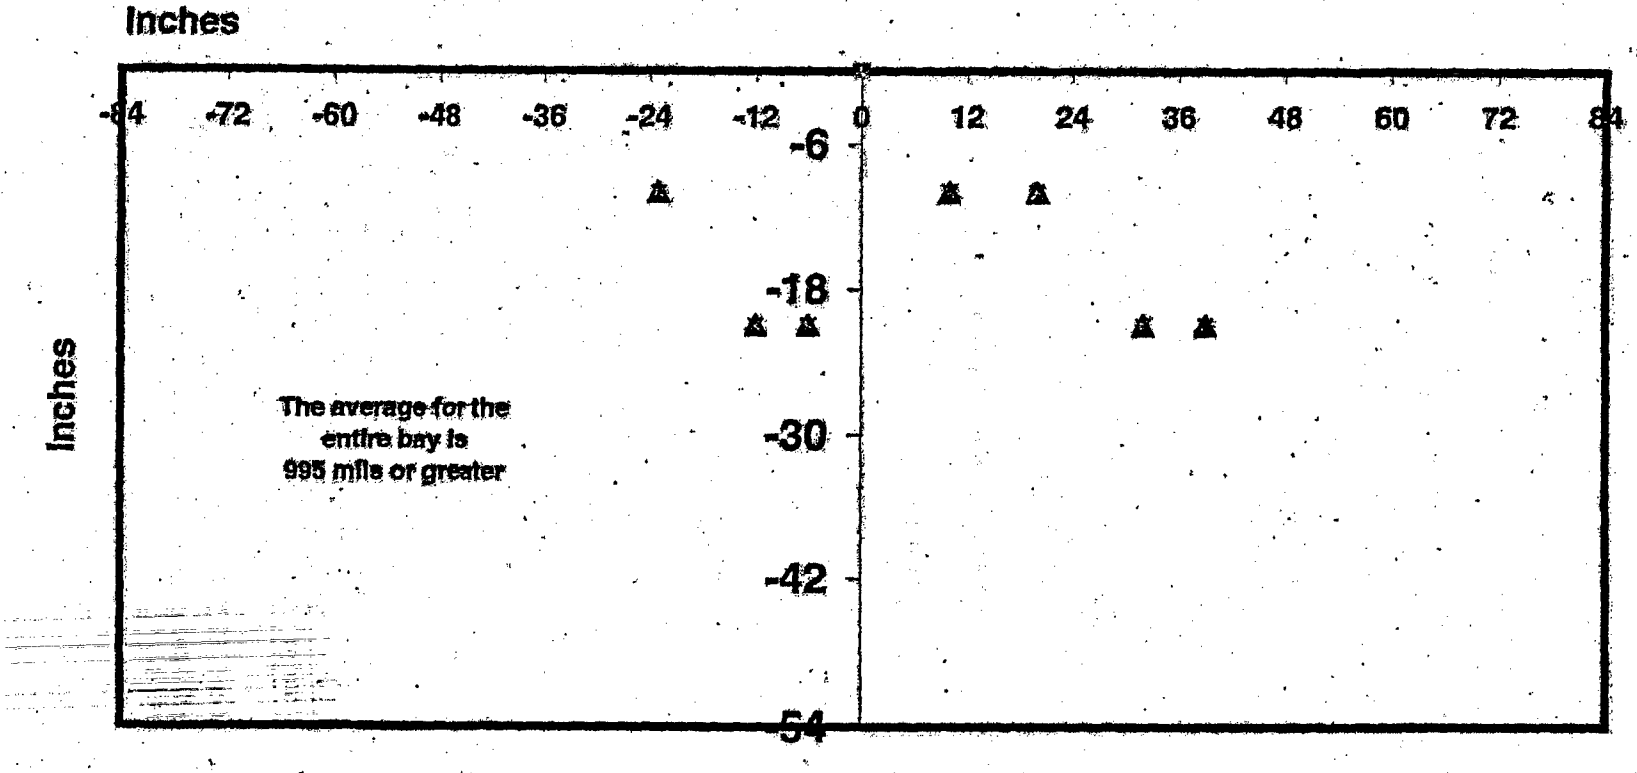
Bay 7 2006
Spatial Relationship Of Locally Thin Areas

Figure 7-2 illustrates the representative thicknesses in this bay, which is 0.995 inches or greater (refer to section 7.5.4).

Squares are less than 0.736"
Triangles are greater then 0.736"

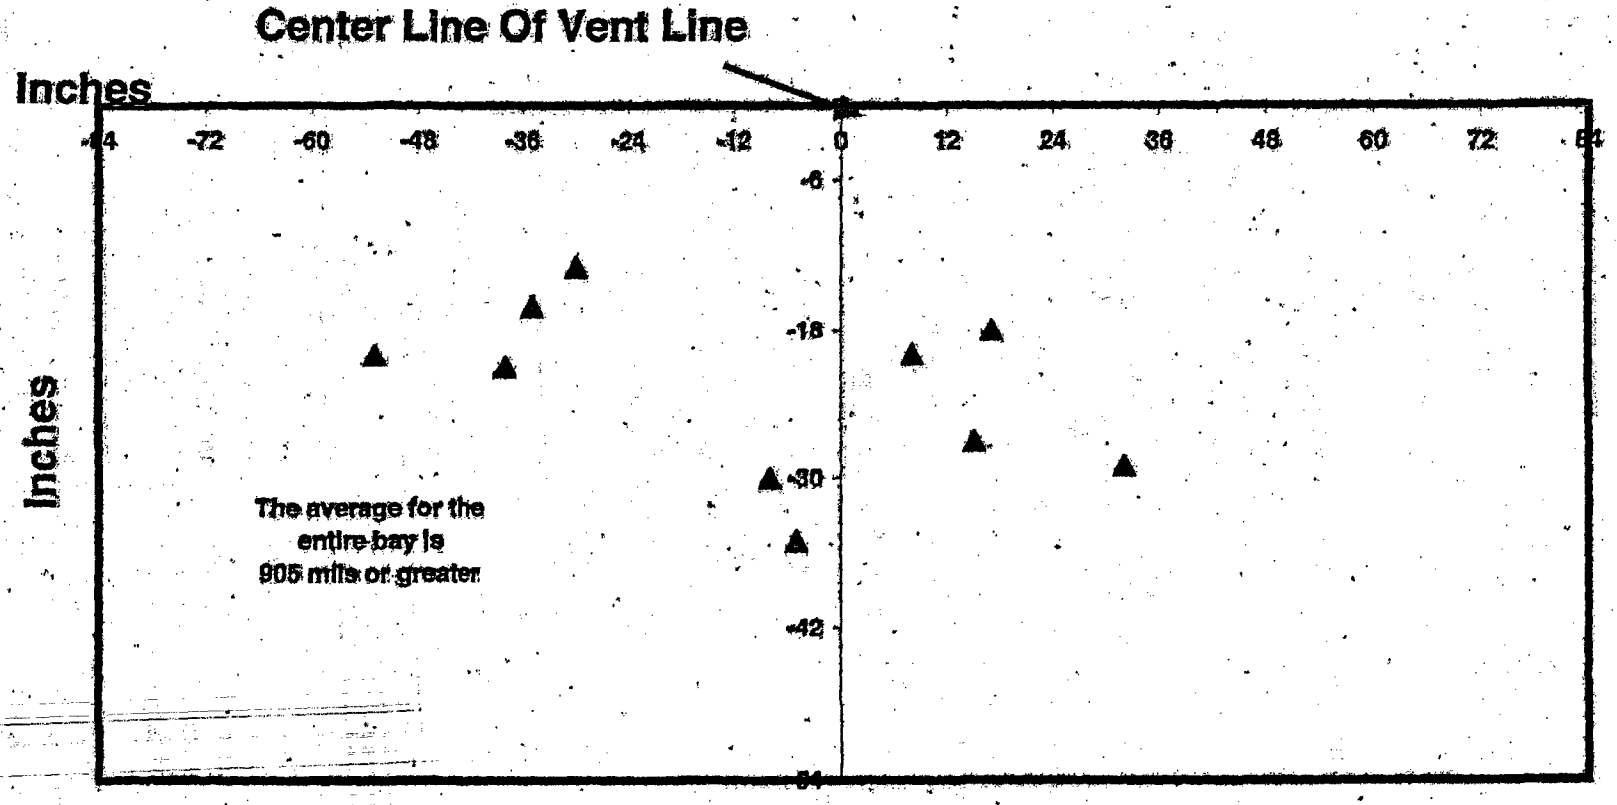
Bay 9 2006
Spatial Relationship Of Locally Thin Areas

Figure 9-2 illustrates the representative thicknesses in this bay, which is 0.905 inches or greater (refer to section 7.9.4).

Squares are less than 0.736"
Triangles are greater then 0.736"

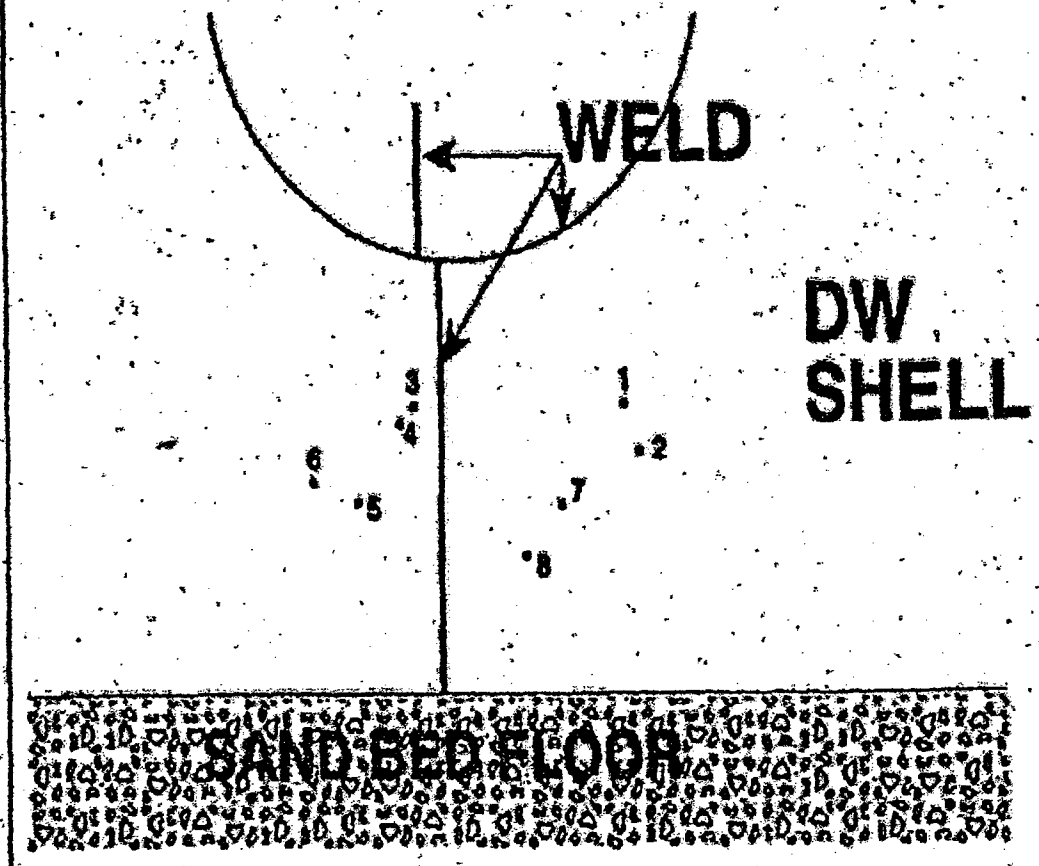
Figure 11-1

The outside surface of this bay is rough, similar to bay 1, full of uniform dimples comparable to the outside surface of a golf ball. The shell appears to be relatively uniform in thickness except for local areas at the upper right corner of Figure 11-1, located at about 10 to 12 inches below the vent pipe reinforcement plate.

1. All measurements from intersection of the DW shell (butt) and vent collar (fillet) welds.
2. Pit depths are average of four readings taken at 0/45°/90°/135° within 1" band surrounding the ground spots. This measurement was only taken when wall thickness was below 0.736".

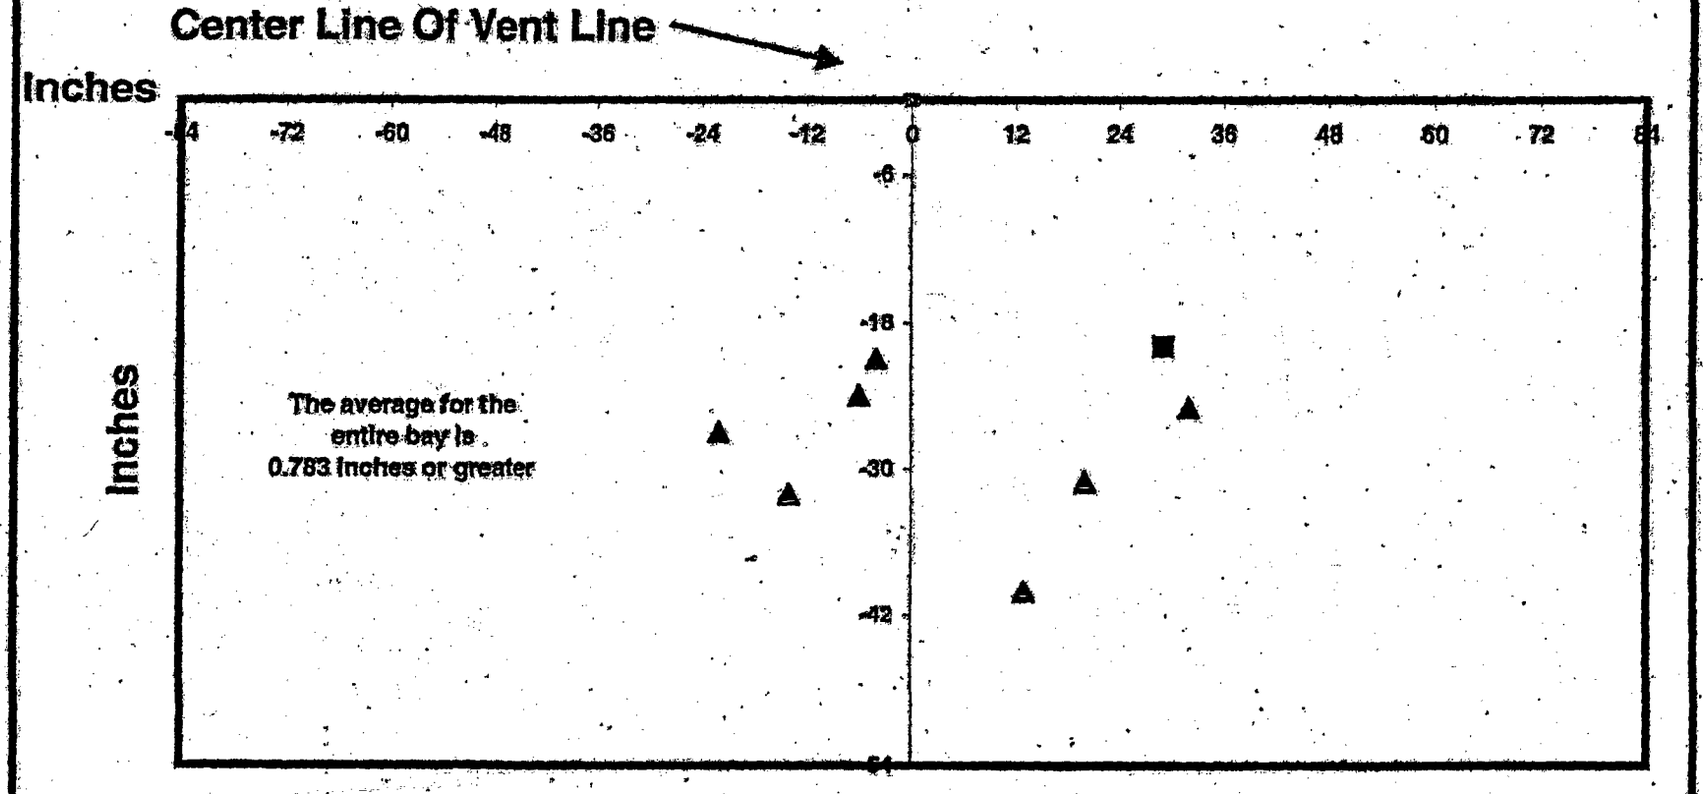
Bay 11 2006
Spatial Relationship Of Locally Thin Areas

It is concluded that Bay 11 is acceptable since all but one individual UT readings in 1992 and 2006 were greater than the uniform acceptance criteria. The calculated "Evaluation thickness" of the one remaining area is greater than then 0.763" criteria

Figure 11-2 illustrates the representative thicknesses in this bay, which is 0.783 inches or greater (refer to section 7.11.4).

Squares are less than 0.736"
Triangles are greater then 0.736"

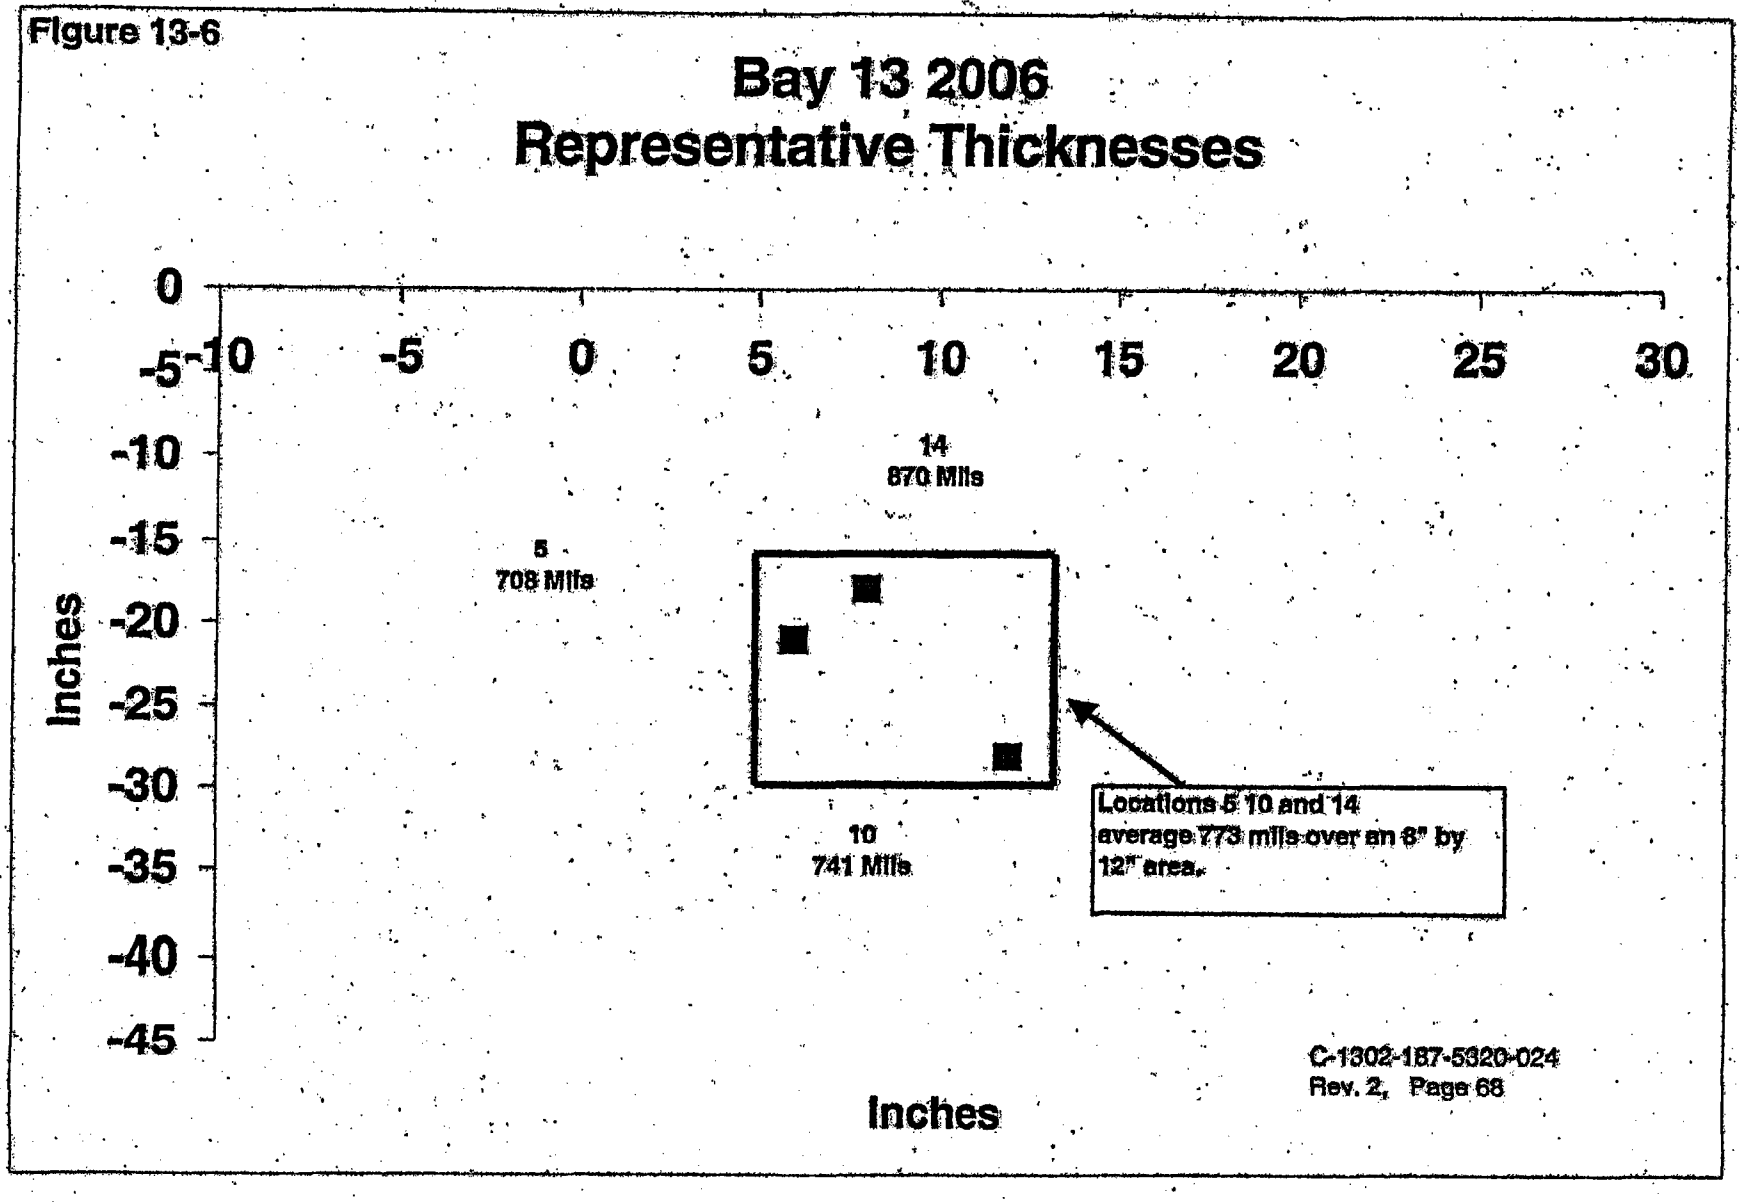
Figure 13-6

Refer to figure 13-6. Area 5 has a single reading of 0.708" in 2006. This area is next to areas 10 (0.741") and 14 (0.870"). These three areas are bounded by a 8" by 12" area. Since these single points were determined by the inspectors to be the thinnest within this area, the average of these three thicknesses is a conservative estimate of the average thickness of the area (see assumption 4.3).

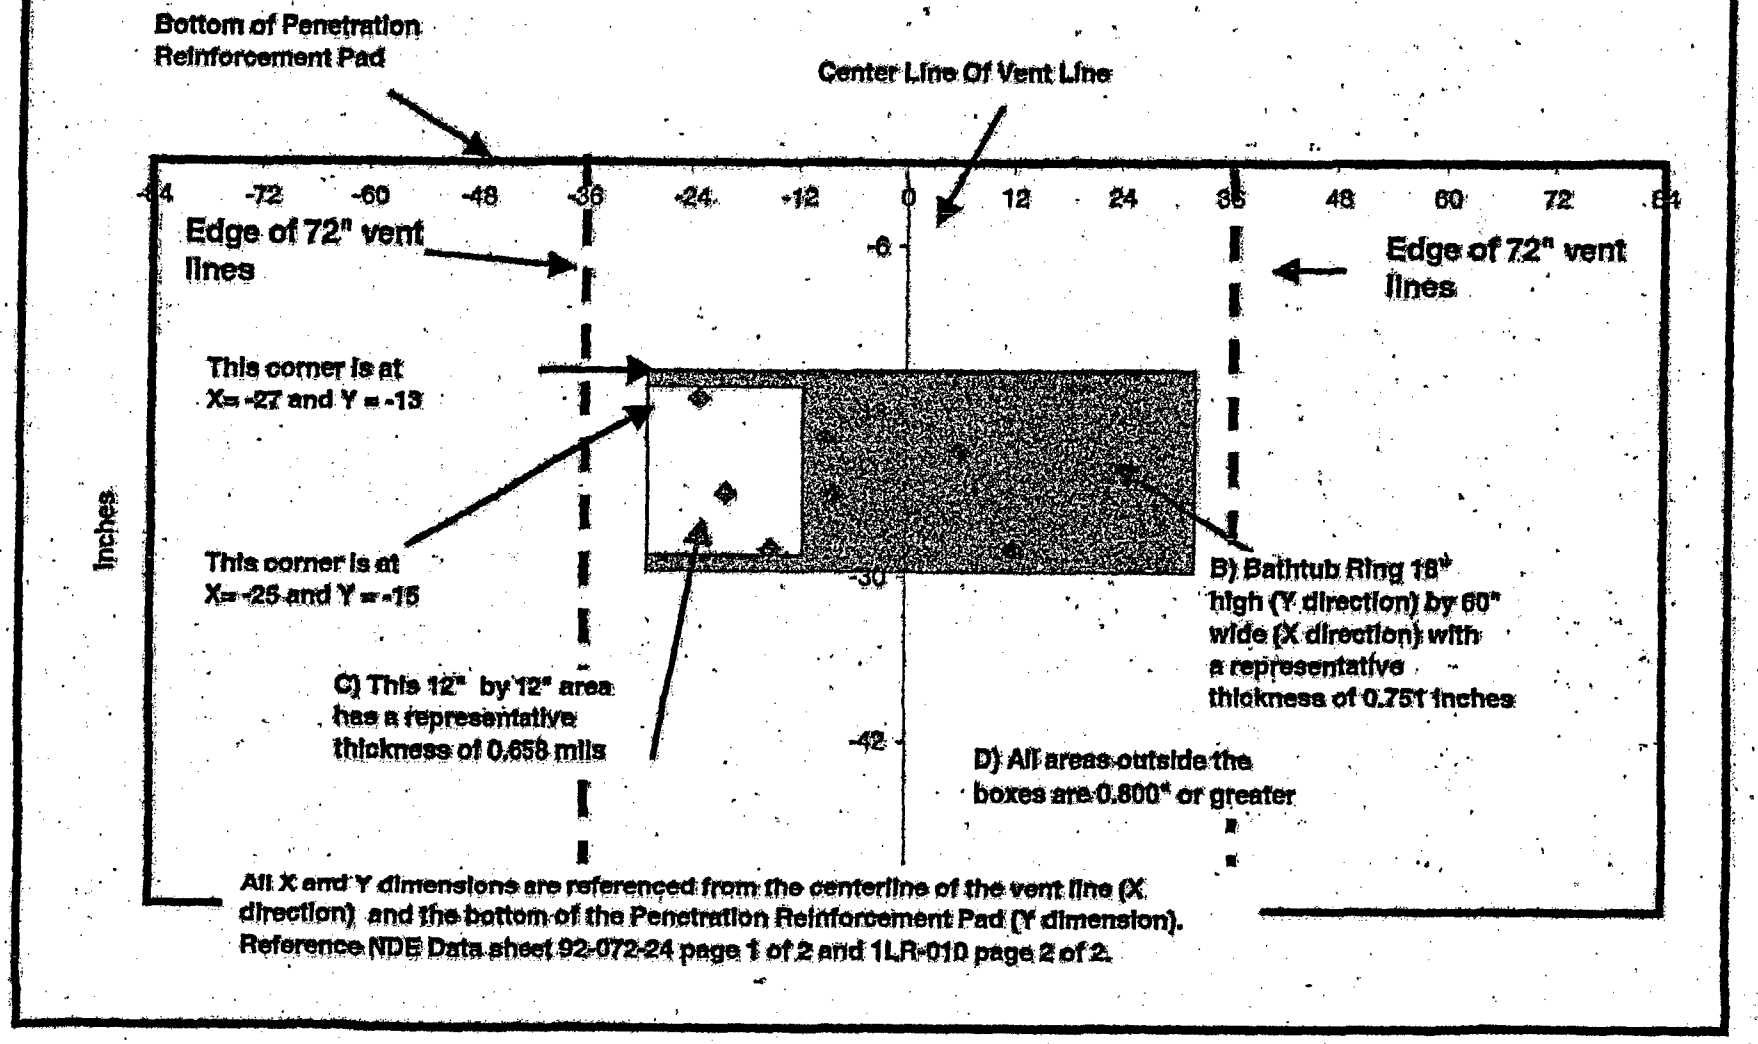
Bay 13 - 2006
Locally Thin Areas

7.13.3.3.1 Refer to figure 13-7. The locally thin area for this bay that is less than 0.737 inches is located directly under the vent line.

In addition since the majority of the vessel in this bay is thicker than 0.736", the thicker areas will reinforce the locally thin areas. For example approximately 7730 square inches of surface area in this bay (of a total of 9072 square inches) is 800 mils or thicker (refer to figure 13-7). When compared to same surface area with a thickness of 0.736" there is a total increase in volume of at least 495 cubic inches. (e .g 495 = (0.8-0.736)* 7730). This additional volume will reinforce the locally thin areas.
