UNITED STATES OF AMERICA
NUCLEAR REGULATORY COMMISSION

In the Matter of:	)	July 20, 2007
AmerGen Energy Company, LLC	)	Docket No. 50-219
(License Renewal for Oyster Creek Nuclear Generating Station)	)

AMERGEN'S PRE-FILED DIRECT TESTIMONY EXHIBITS

VOLUME 1 OF 2: EXHIBITS 1-19

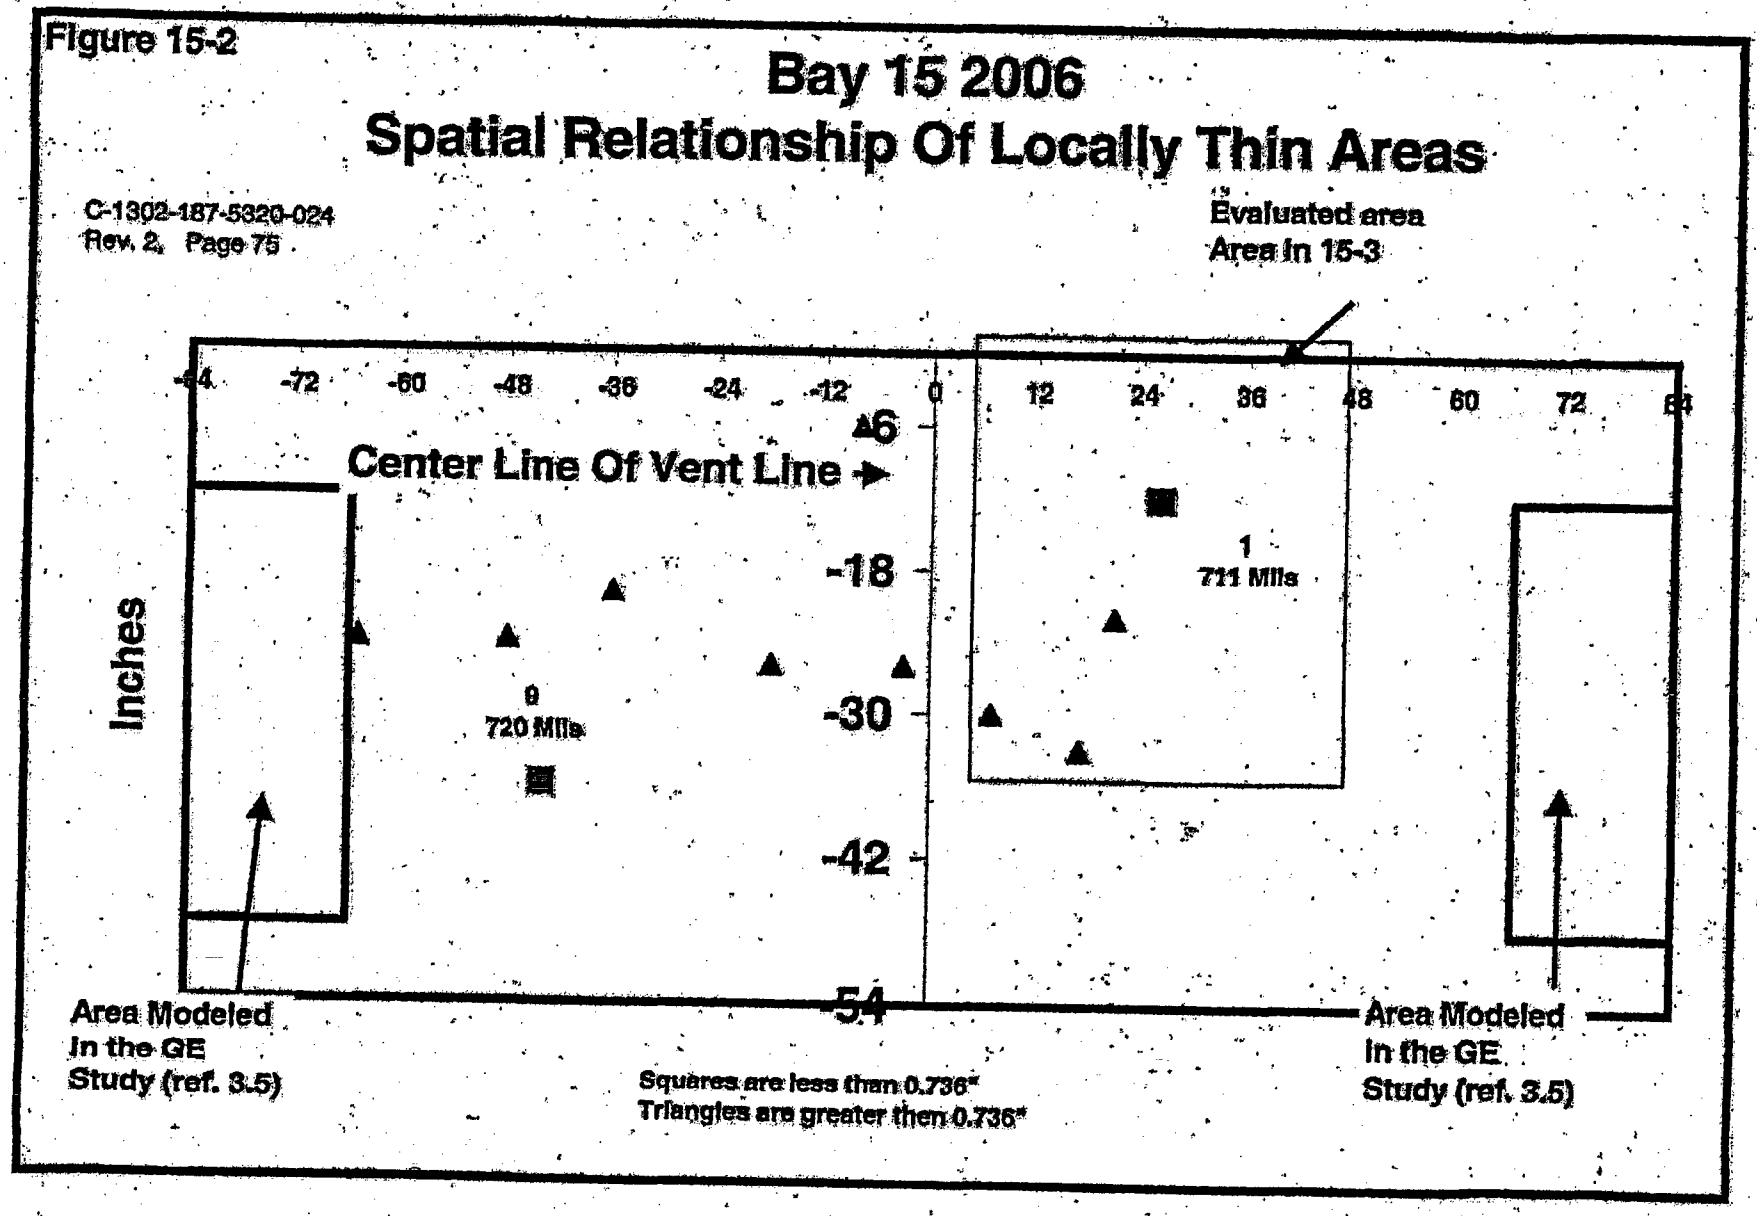
Bay 15 2006
Spatial Relationship Of Locally Thin Areas

These areas and their location are shown on figure 15-2. The figure presents the areas with readings less than 0.736 inches as squares and areas with readings over 0.736 inches as triangles.

The local buckling criteria (section 6.2) is based on sensitivity studies that placed a 36" by 36" locally thin grid on the area of the finite element model that had the highest buckling stresses. This area is located between the centerlines of the vent lines (+66" to –66 as shown in figure 15-2). Areas below the vents lines had less compressive stresses. Therefore locally thin areas located under a vent lines will have more margin than the same locally thin areas located between the centerline of the vent lines. Review of the original GE study shows that stresses under the vent line are at least 20% less then the stresses between the centerline of the vent lines. Therefore the necessary wall thickness to maintain the required safety factor for portions of the vessel under the vent lines is substantially less (by at least 20%) than the calculated required uniform thickness of 0.736".

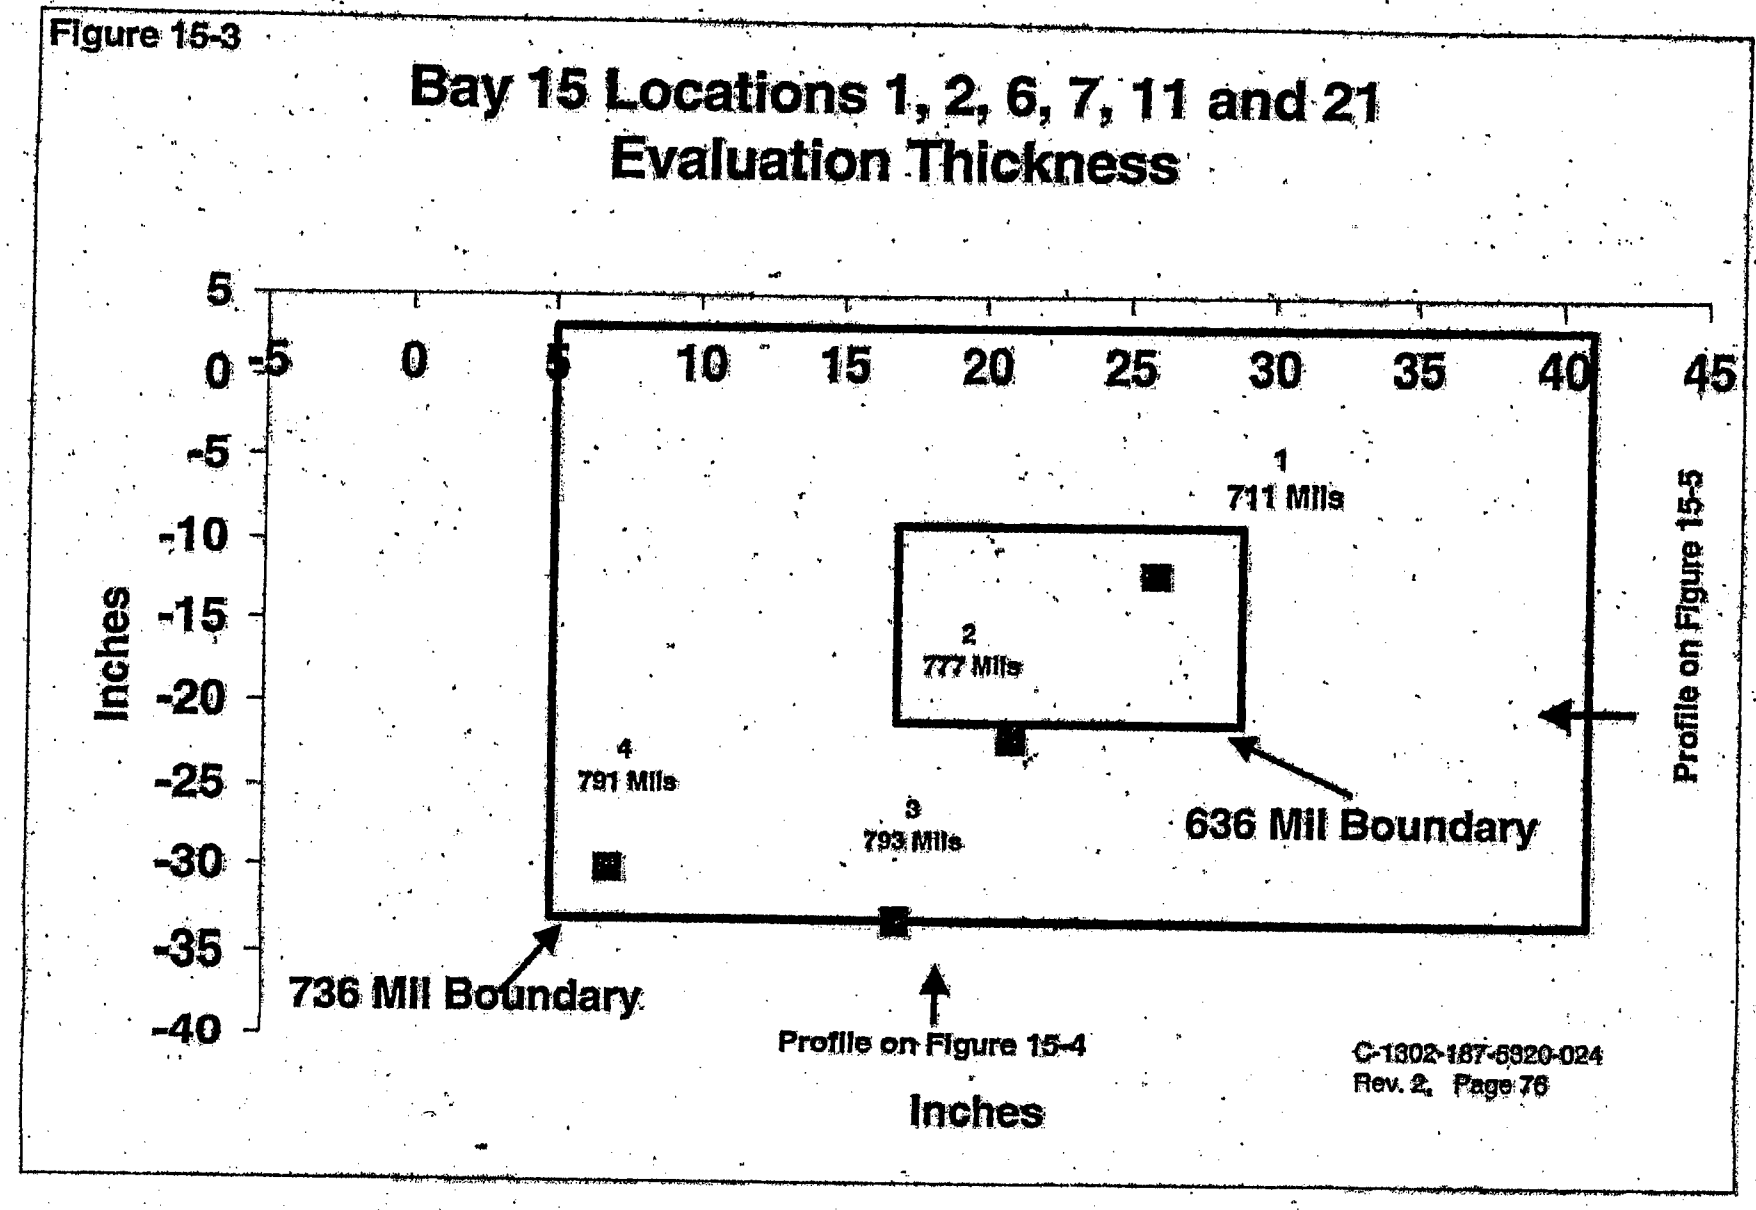
Area 1 has a single reading of 0.711" in 2006. This single point was determined by the inspectors to be the thinnest within this area. Figure 15-3 plots area 1 and all other recorded areas close by. Figure 15-3 overlays a 36" by 36" area on these locally thin areas. The center 12" by 12" of the area is overlaid on top of area 1.

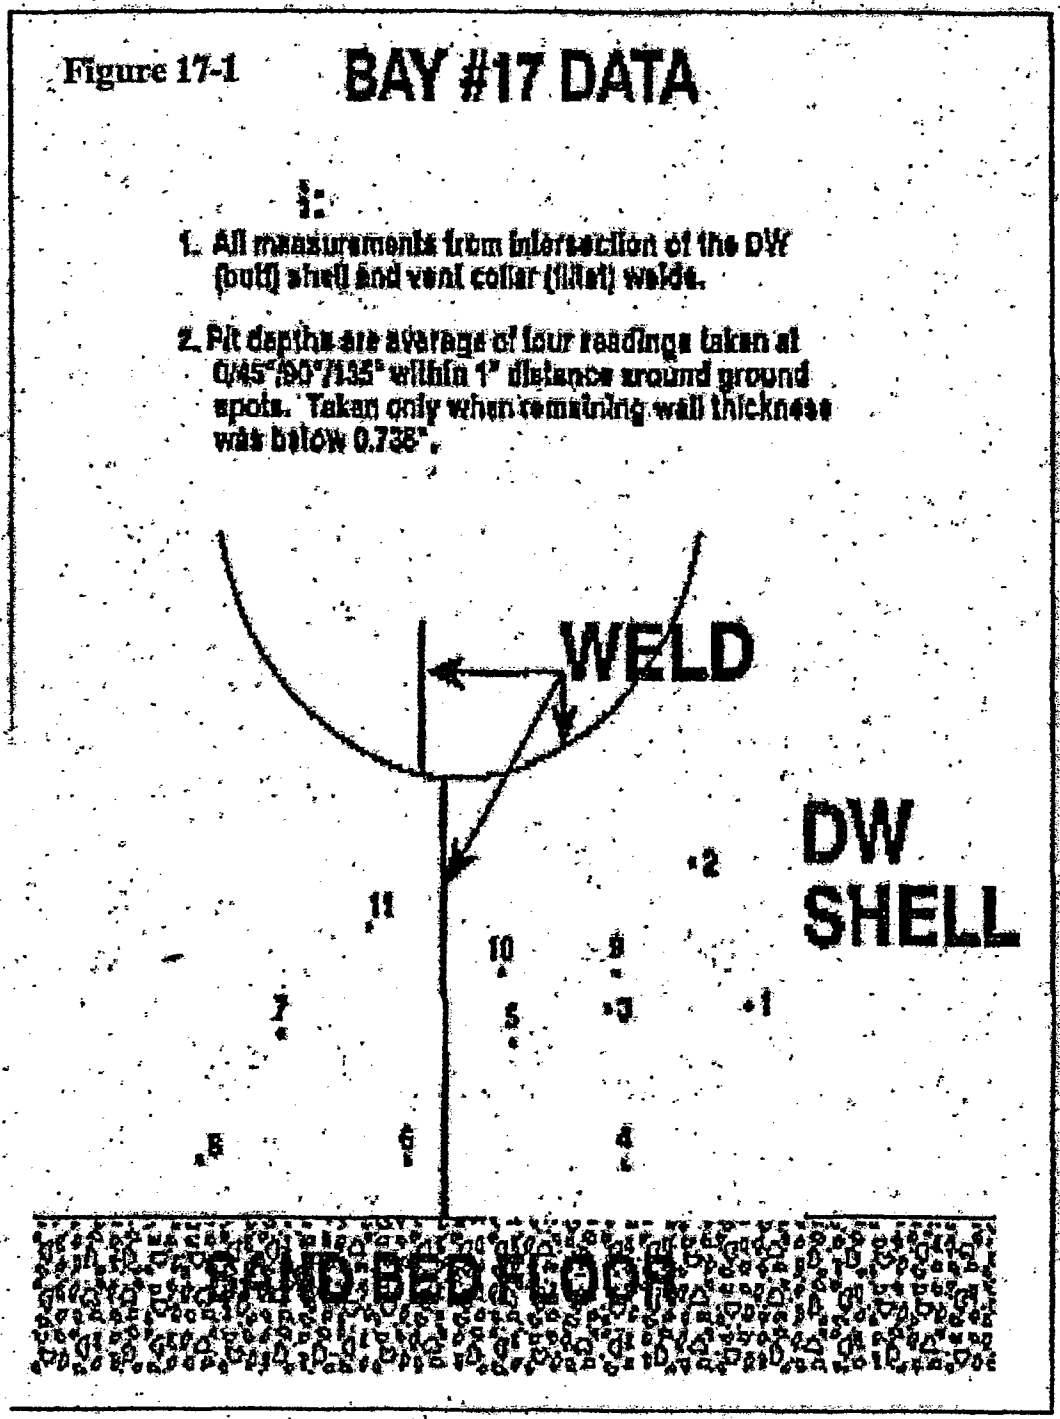
Figure 17-1

Eleven areas were selected to represent the thinnest areas based on the visual observations of the shell surface (Fig. 17-1). These areas are a deliberate attempt to produce a minimum measurement. Table 17-1 shows readings taken to measure the thinnest thicknesses of the drywell shell. The results indicate that all of the areas have thickness greater than the 0.736 inches, except one area. Area 9 as shown in Table 17-1, has a reading below 0.736 inches. Inspectors' observations indicate that this area is very deep and not more than 1 to 2 inches in diameter. The depth of area relative to its immediate surroundings was measured at 4 areas around the spot and the average is shown in Table 17-1.

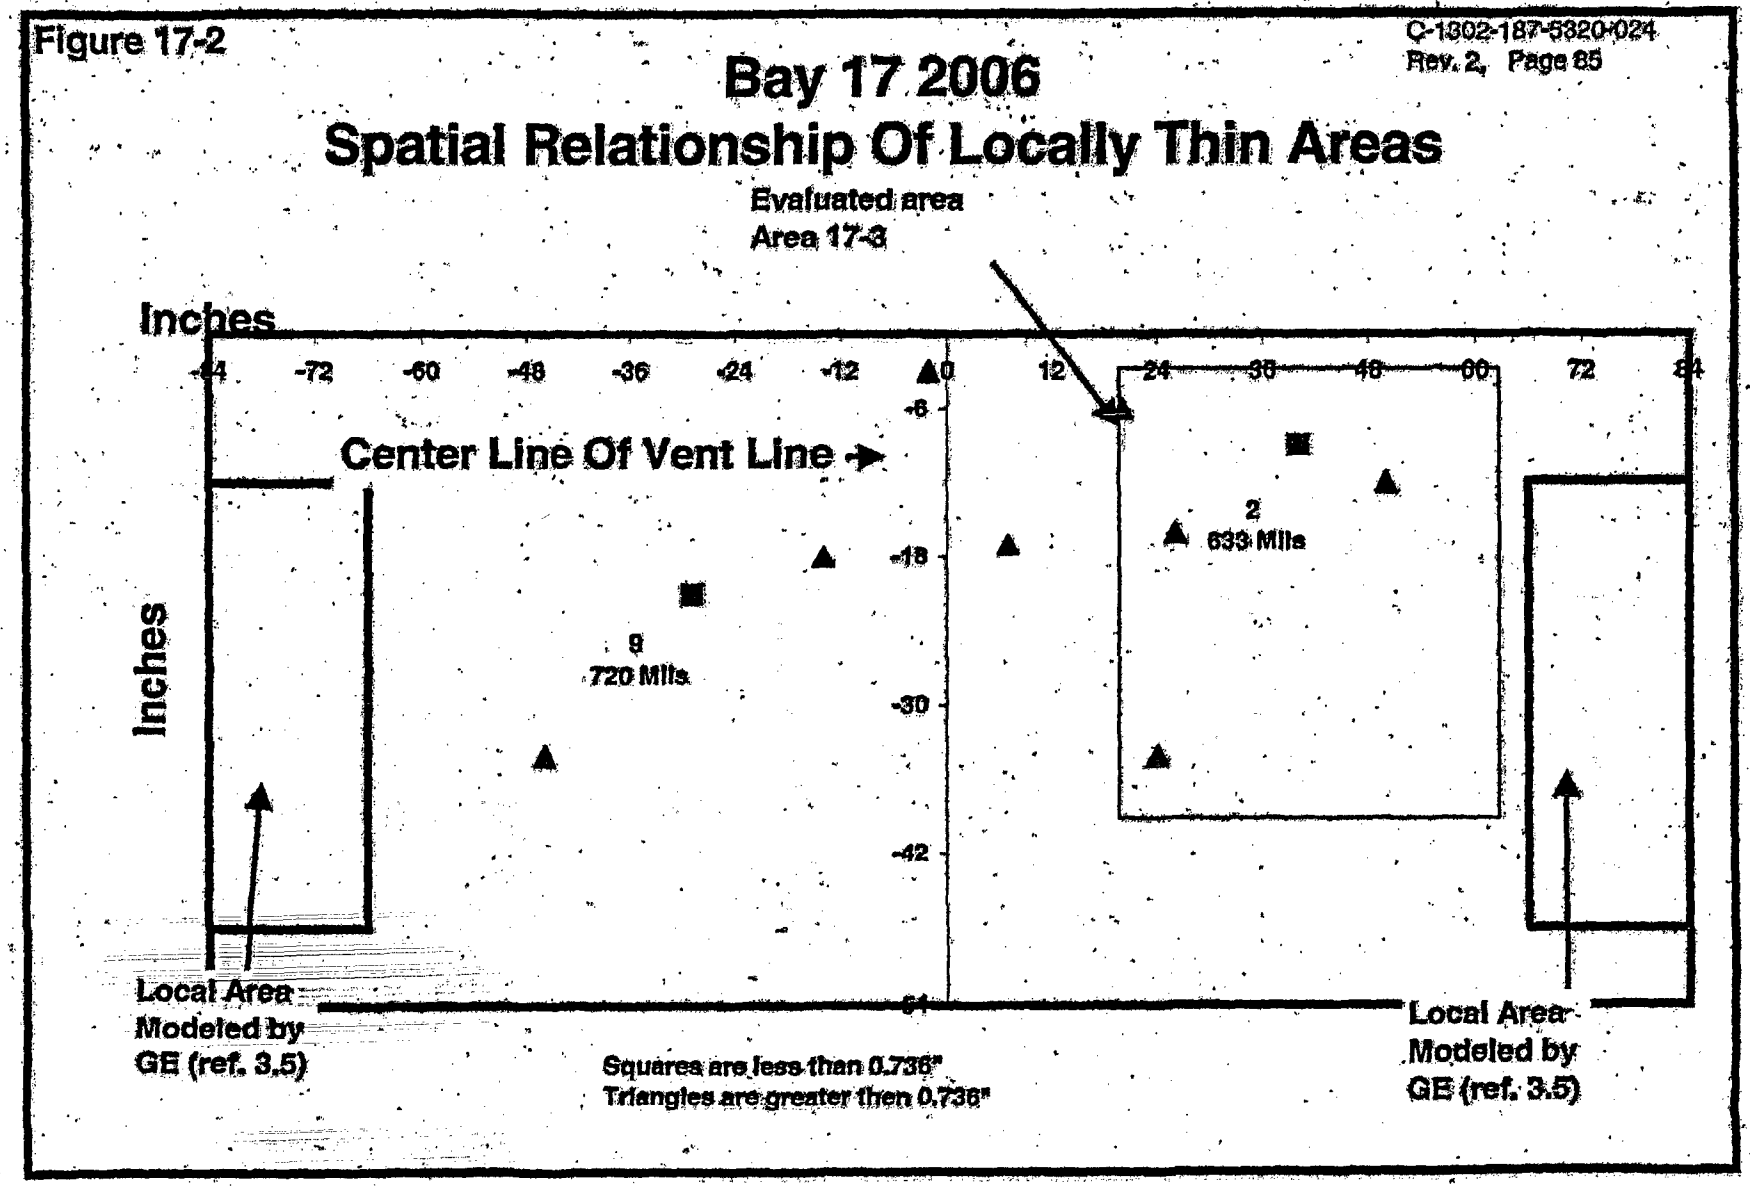
Figure 17-2

These areas and their location are shown on figure 17-2. The figure presents the areas with readings less than 0.736 inches as squares and areas with readings over 0.736 inches as triangles.

The local buckling criteria (section 6.2) is based on sensitivity studies that placed a 36" by 36" locally thin grid on the area of the finite element model that had the highest buckling stresses. This area is located between the centerlines of the vent lines (+66" to –66 as shown in figure 17-2). Areas between +20" to +56" from the vents lines had less compressive stresses. Review of the original GE study (see appendix F) shows that stresses in this region are at least 10% less then the stresses between the centerline of the vent lines. Therefore the necessary wall thickness to maintain the required safety factor for portions of the vessel under the vent lines is less (by at least 10%) than the calculated required uniform thickness of 0.736".

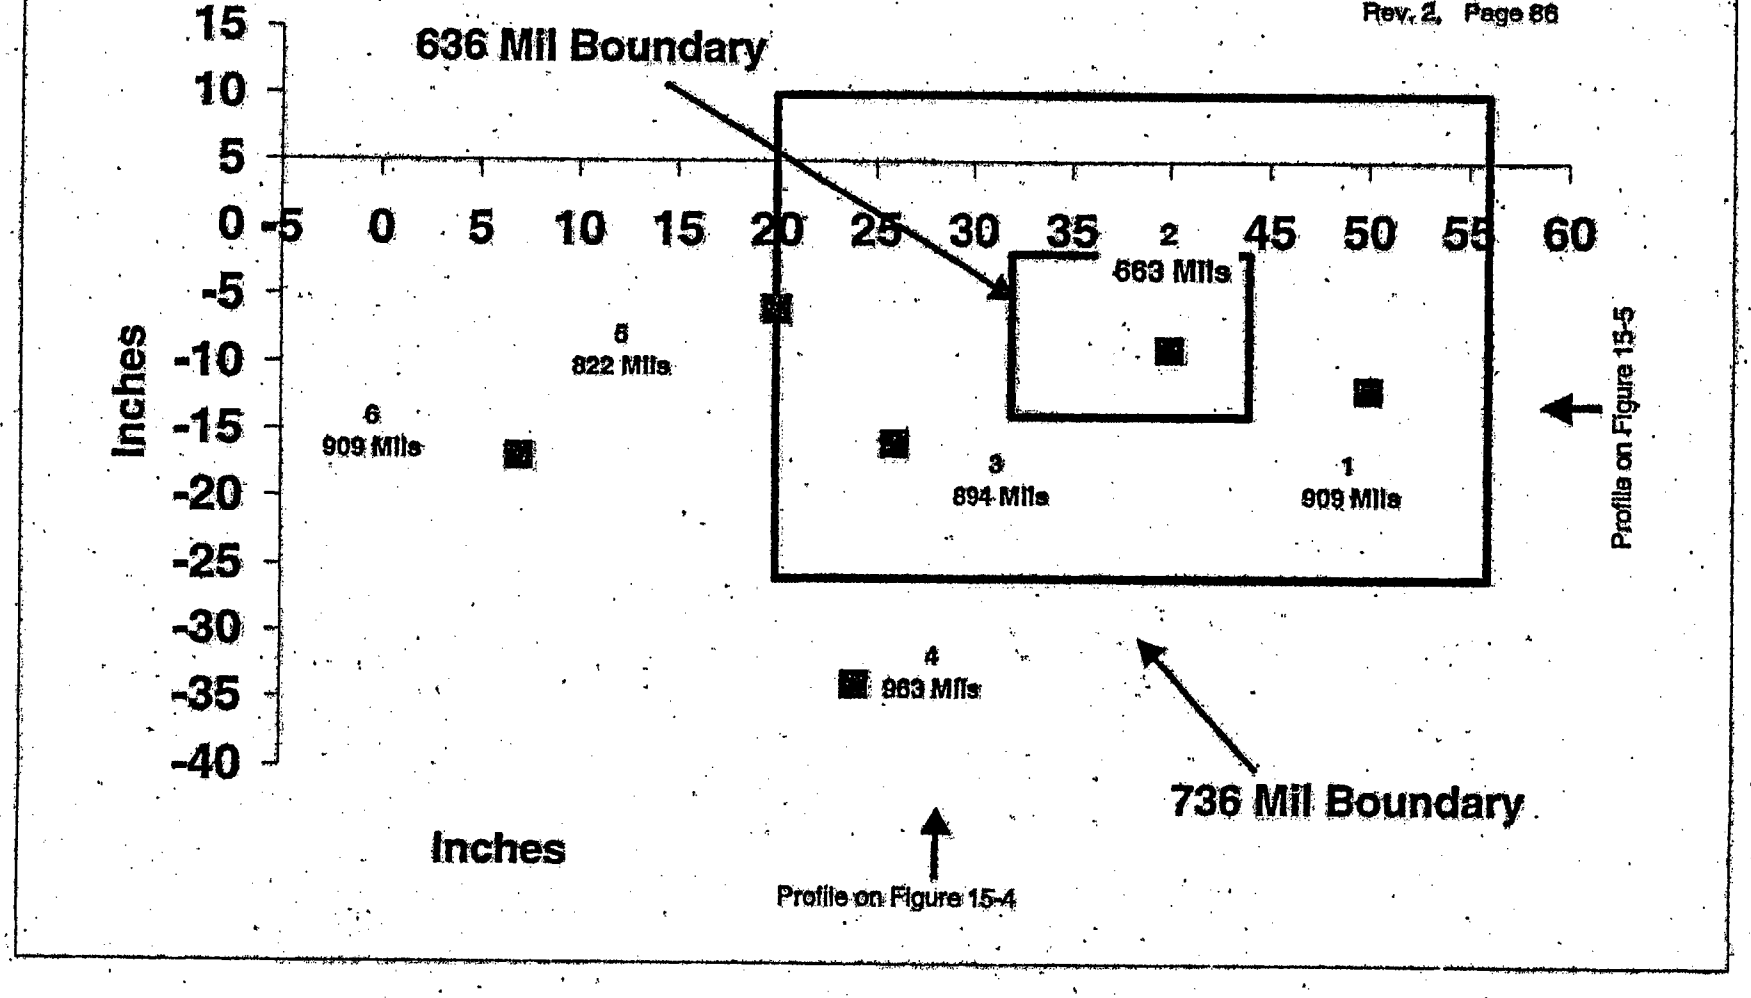
Area 2 has a single reading of 0.663" in 2006. This single point was determined by the inspectors to be the thinnest within this area. Figure 17-3 plots area 2 and all other close by areas recorded in 1992 and 2006. Figure 15-3 overlays a 36" by 36" area on these areas. The center 12" by 12" of he area is overlaid on top of area 2.

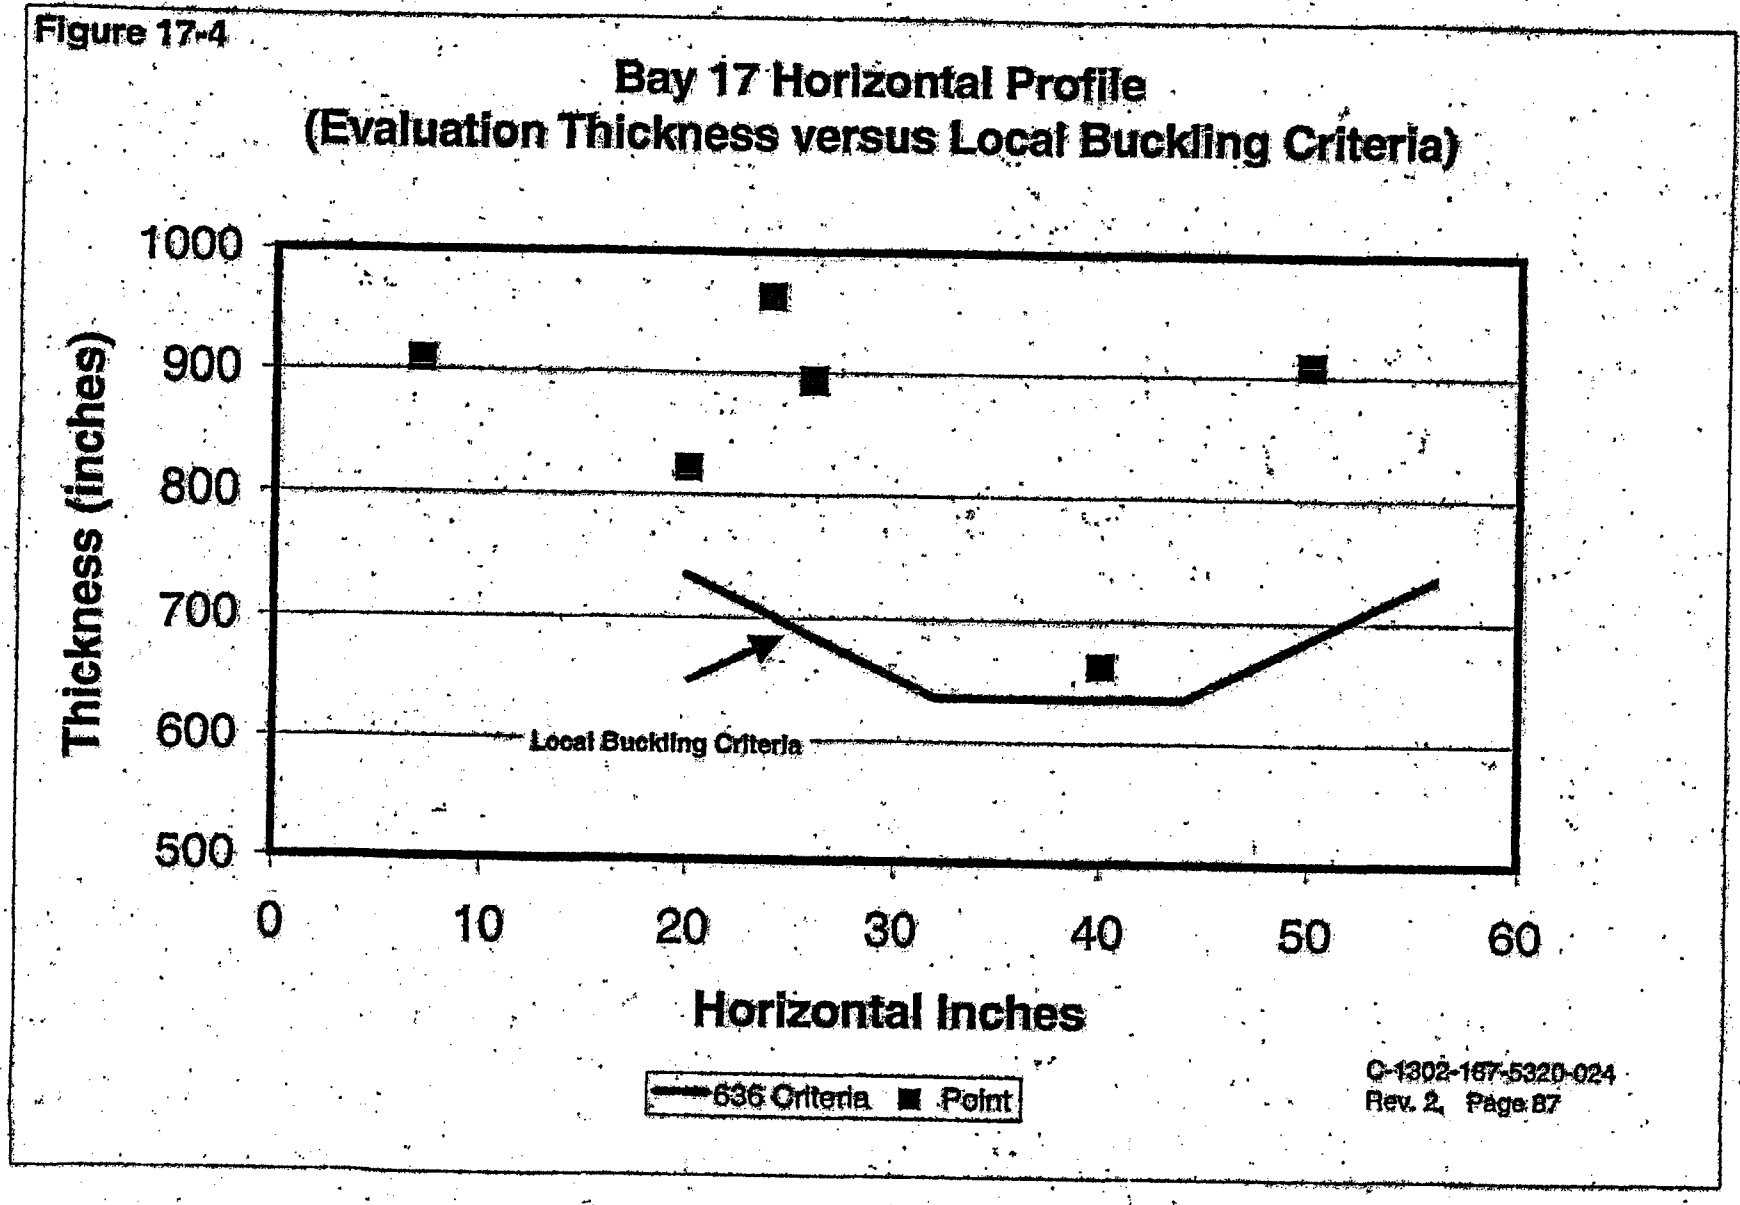
Figure 17-4 and 17-5 shows the profile of the 36" by 36" area with the single thickness overlaid on the curve depicting the acceptance criteria. Figure 17-4 shows the profile along the horizontal axis and figure 17-5 shows the profile along the vertical axis. These figures show that the local buckling criteria is met.

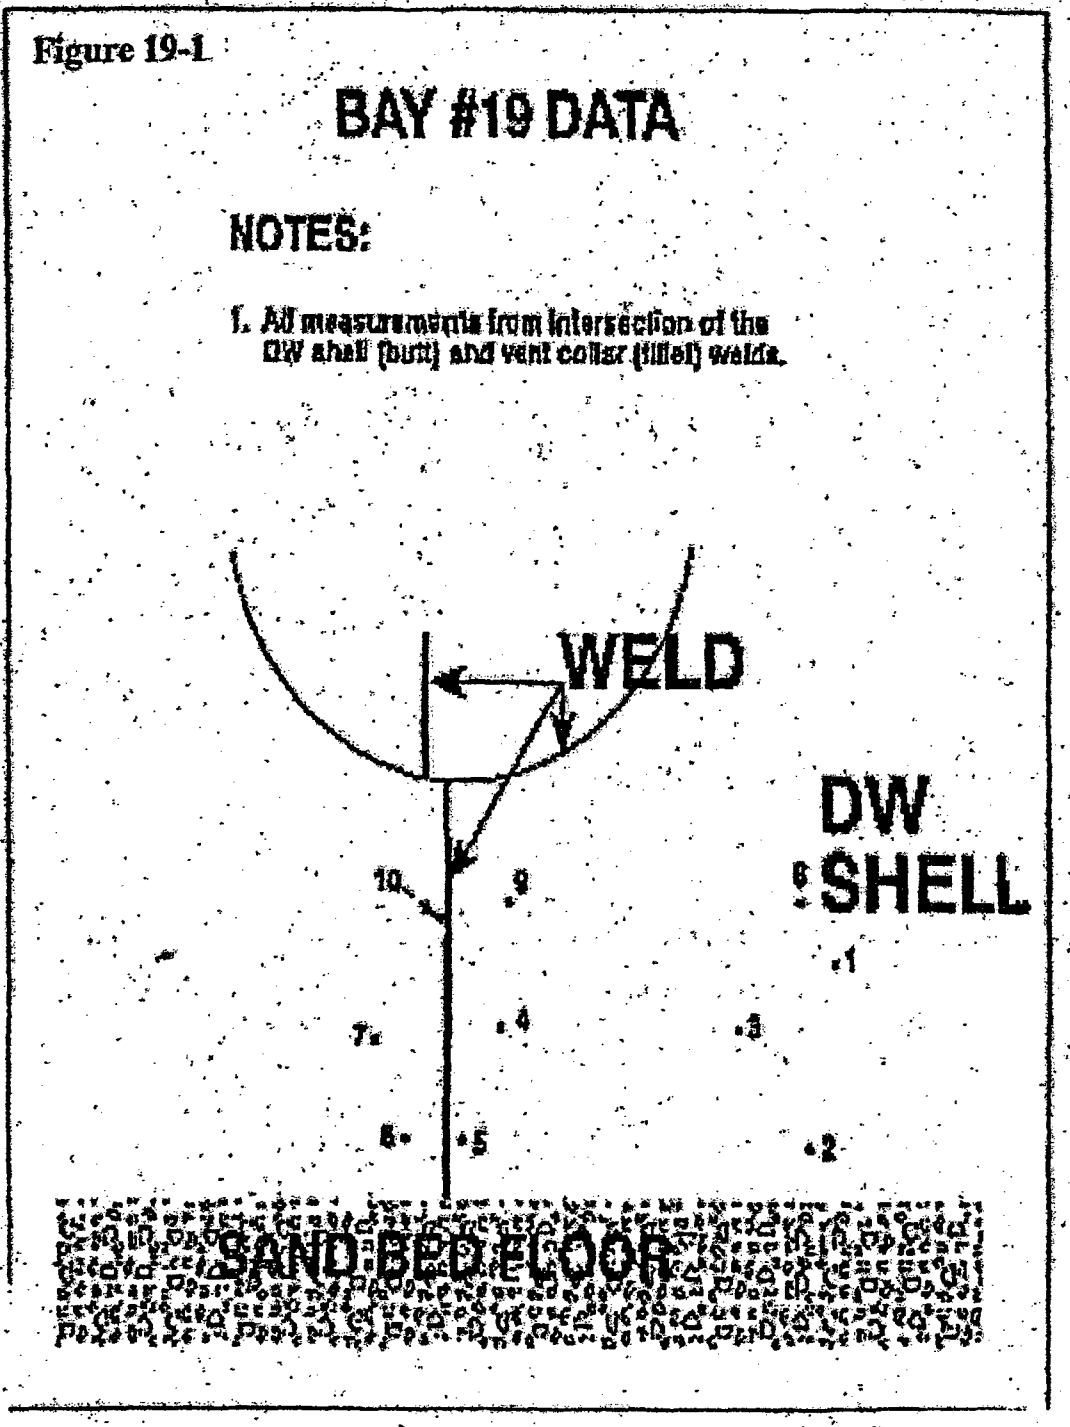
Figure 19-1

The outside surface of this bay is rough and very similar to bay 17. Areas 1 through 7 as shown in Table 19-1, were ground carefully to minimize loss of good metal. The shell surface is full of dimples comparable to the outside surface of a golf ball (references 3.6). This observation is made by the inspector who located the thinnest areas for the UT examination. The shell appears to be relatively uniform in thickness. Ten areas were selected to represent the thinnest areas based on the visual observations of the shell surface (Fig. 19-1). These areas are a deliberate attempt to produce a minimum measurement. Table 19-1 shows readings taken to measure the thinnest thicknesses of the drywell shell. The results indicate that all of the areas have thickness greater than the 0.736 inches.

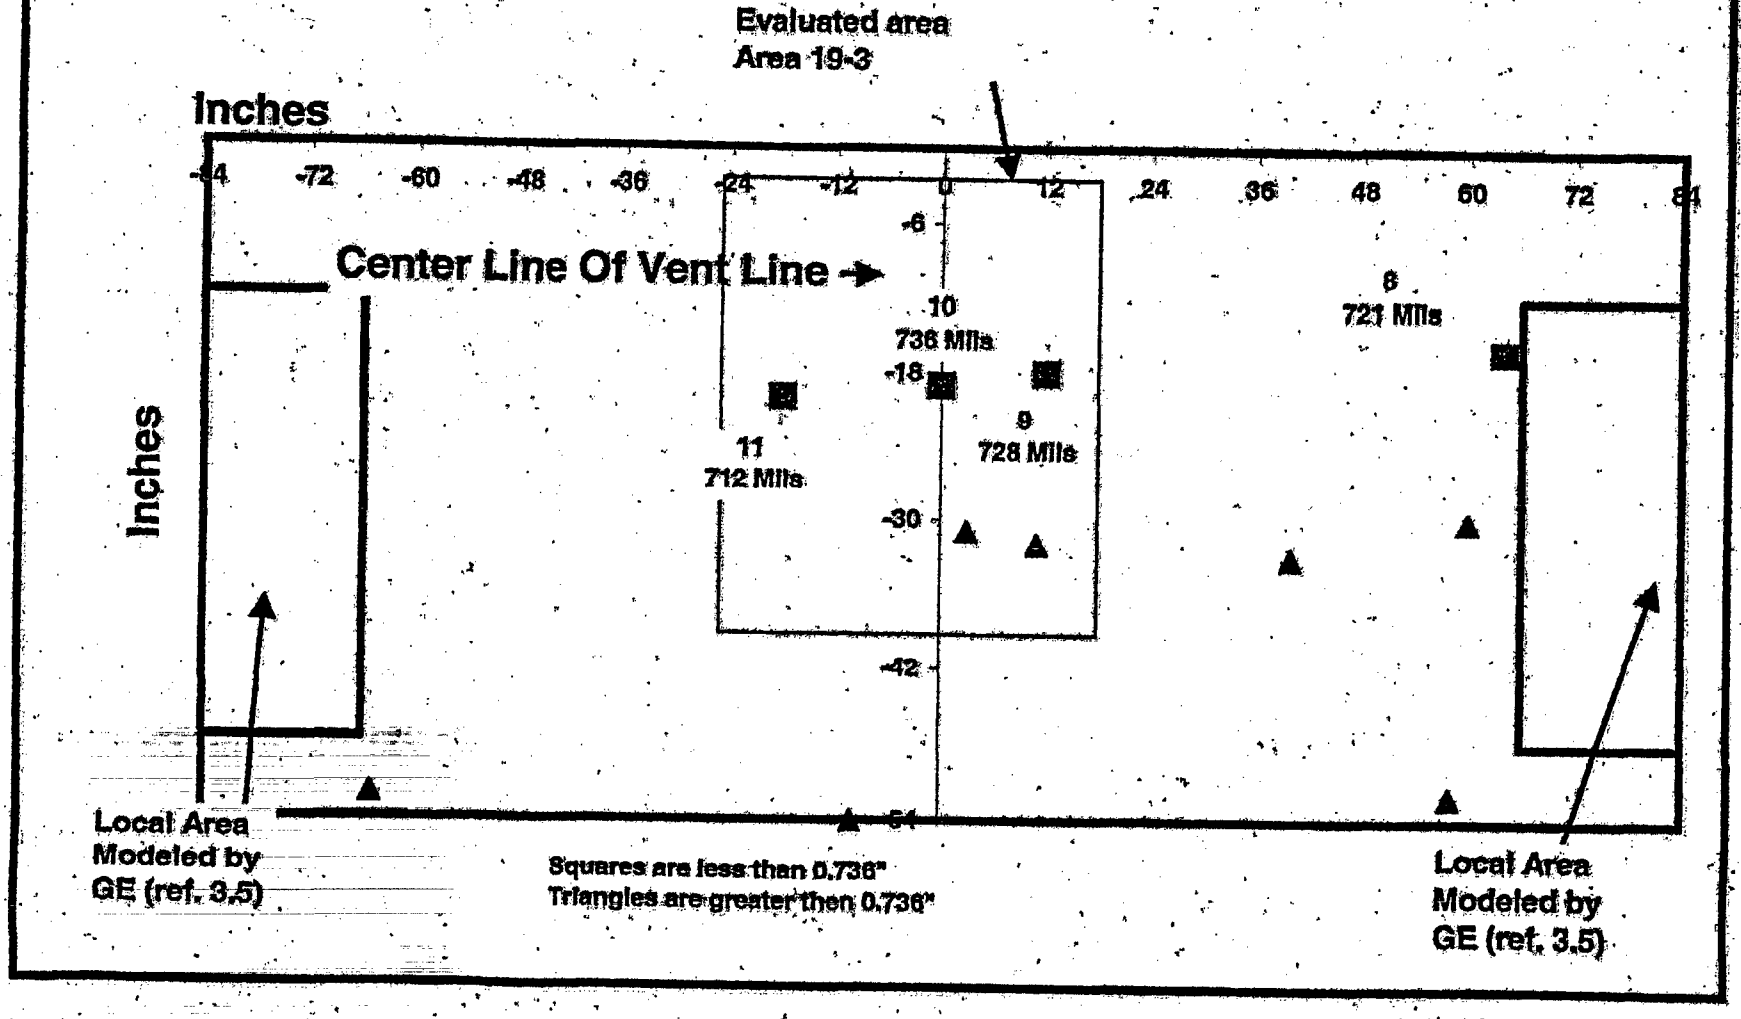
Figure 19-2

These areas and their location are shown on figure 19-2. The figure presents the areas with readings less than 0.736 inches as squares and areas with readings over 0.736 inches as triangles.

Refer to figure 19-2. Area 8 has a single reading of 0.721". This area is next to areas 1 (0.867"). These two areas are bounded by a 16" by 6" area. Since these single points were determined by the inspectors to be the thinnest within this area, the average of these two thicknesses is a conservative estimate of the average thickness of the 16" by 6" area (see assumption 4.3). The average of these three readings is 0.794", which is greater than 0.736". Therefore area 8 meets the 0.736" uniform criteria.

The local buckling criteria (section 6.2) is based on sensitivity studies that placed a 36" by 36" locally thin grid on the area of the finite element model that had the highest buckling stresses. This area is located between the centerlines of the vent lines (+66" to -66 as shown in figure 19-2). Areas below the vents lines had less compressive stresses. Therefore locally thin areas located under a vent lines will have more margin than the same locally thin areas located between the centerline of the vent lines. Review of the original GE study (see appendix F) shows that stresses under the vent line are at least 20% less then the stresses between the centerline of the vent lines. Therefore the necessary wall thickness to maintain the required safety factor for portions of the vessel under the vent lines is substantially less (by at least 20%) than the calculated required uniform thickness of 0.736".

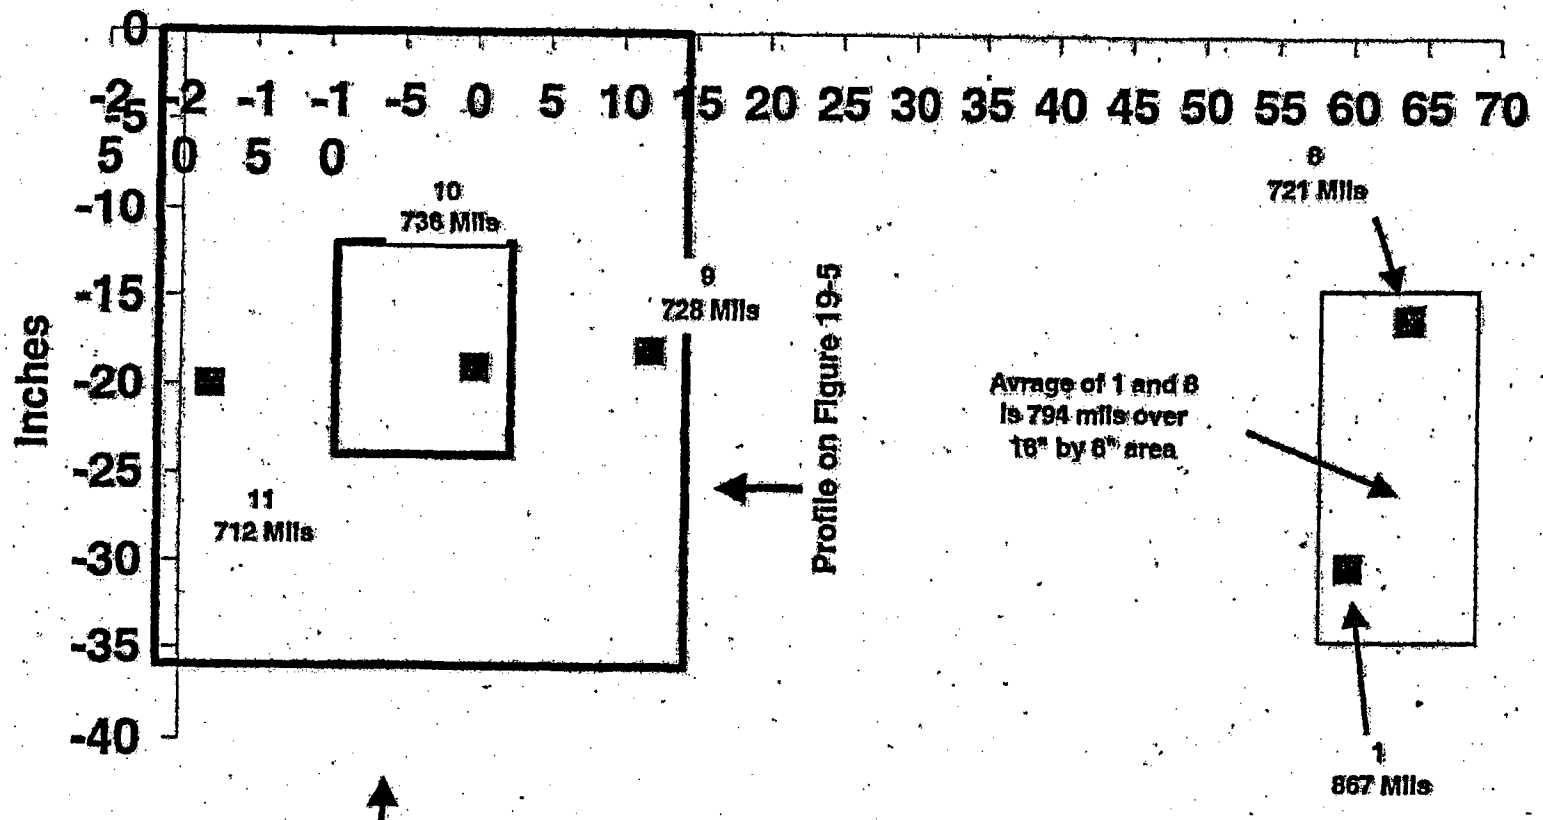
In 2006 area 9 had a single reading of 0.728 and area 11 had a single reading of 0.712". These single points were determined by the inspectors to be the thinnest within this area. Figure 19-3 plots area 9 and 11 along with area 10, which is 0.736". Figure 19-3 overlays a 36" by 36" area on these locations.

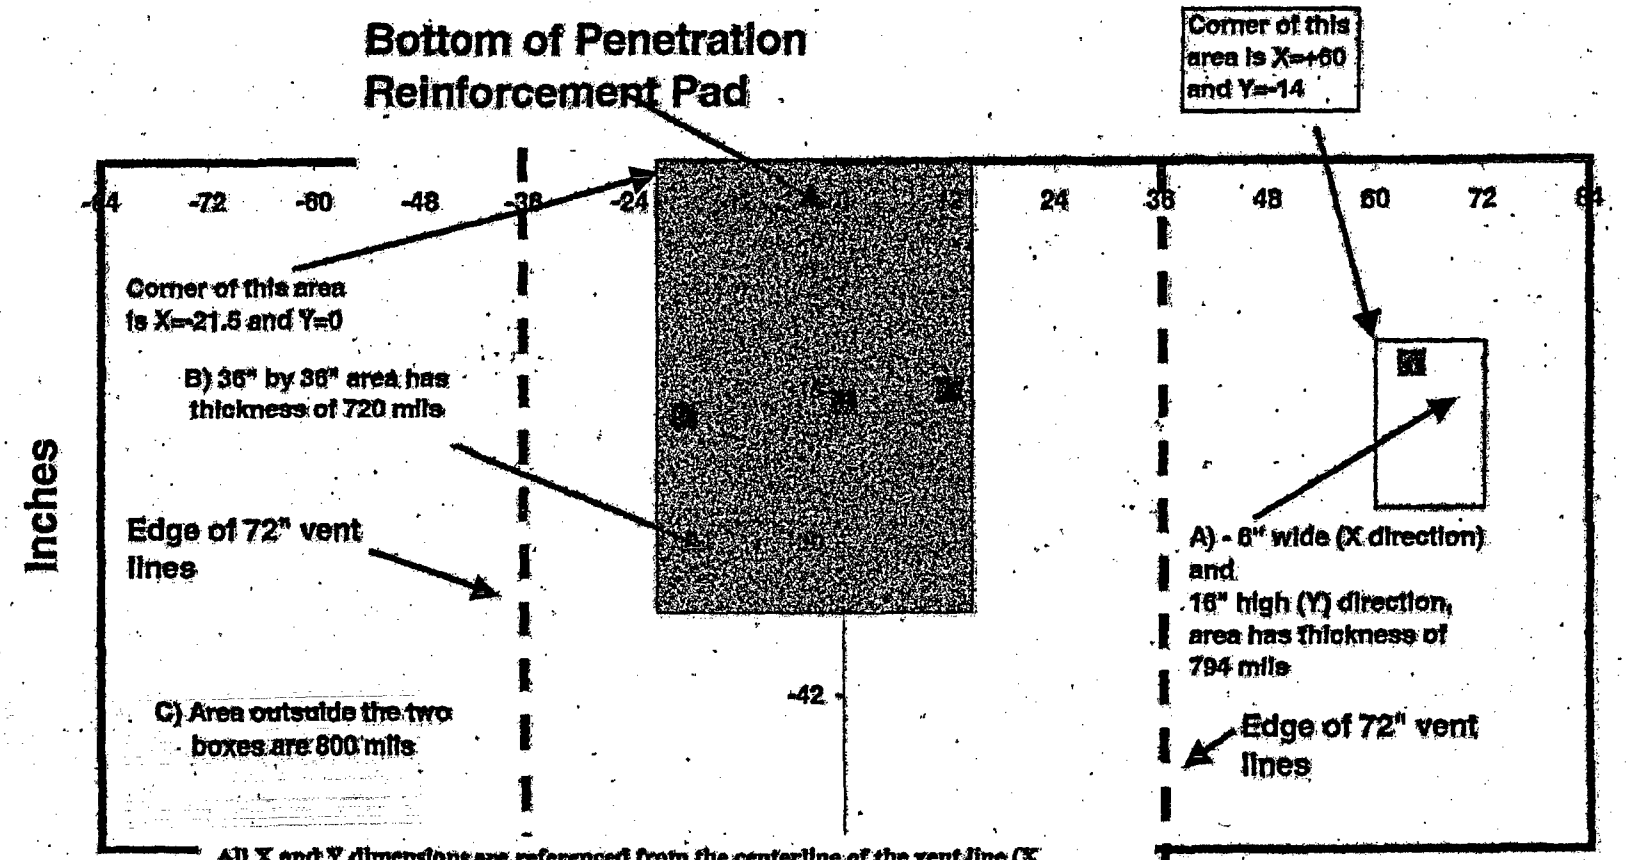
7.19.3.3.1 Refer to figure 19-7. The locally thin area for this bay that is less than 0.736 inches is located directly under the vent line.

Figure 19-7 illustrates representative areas and thicknesses in this bay as follows:

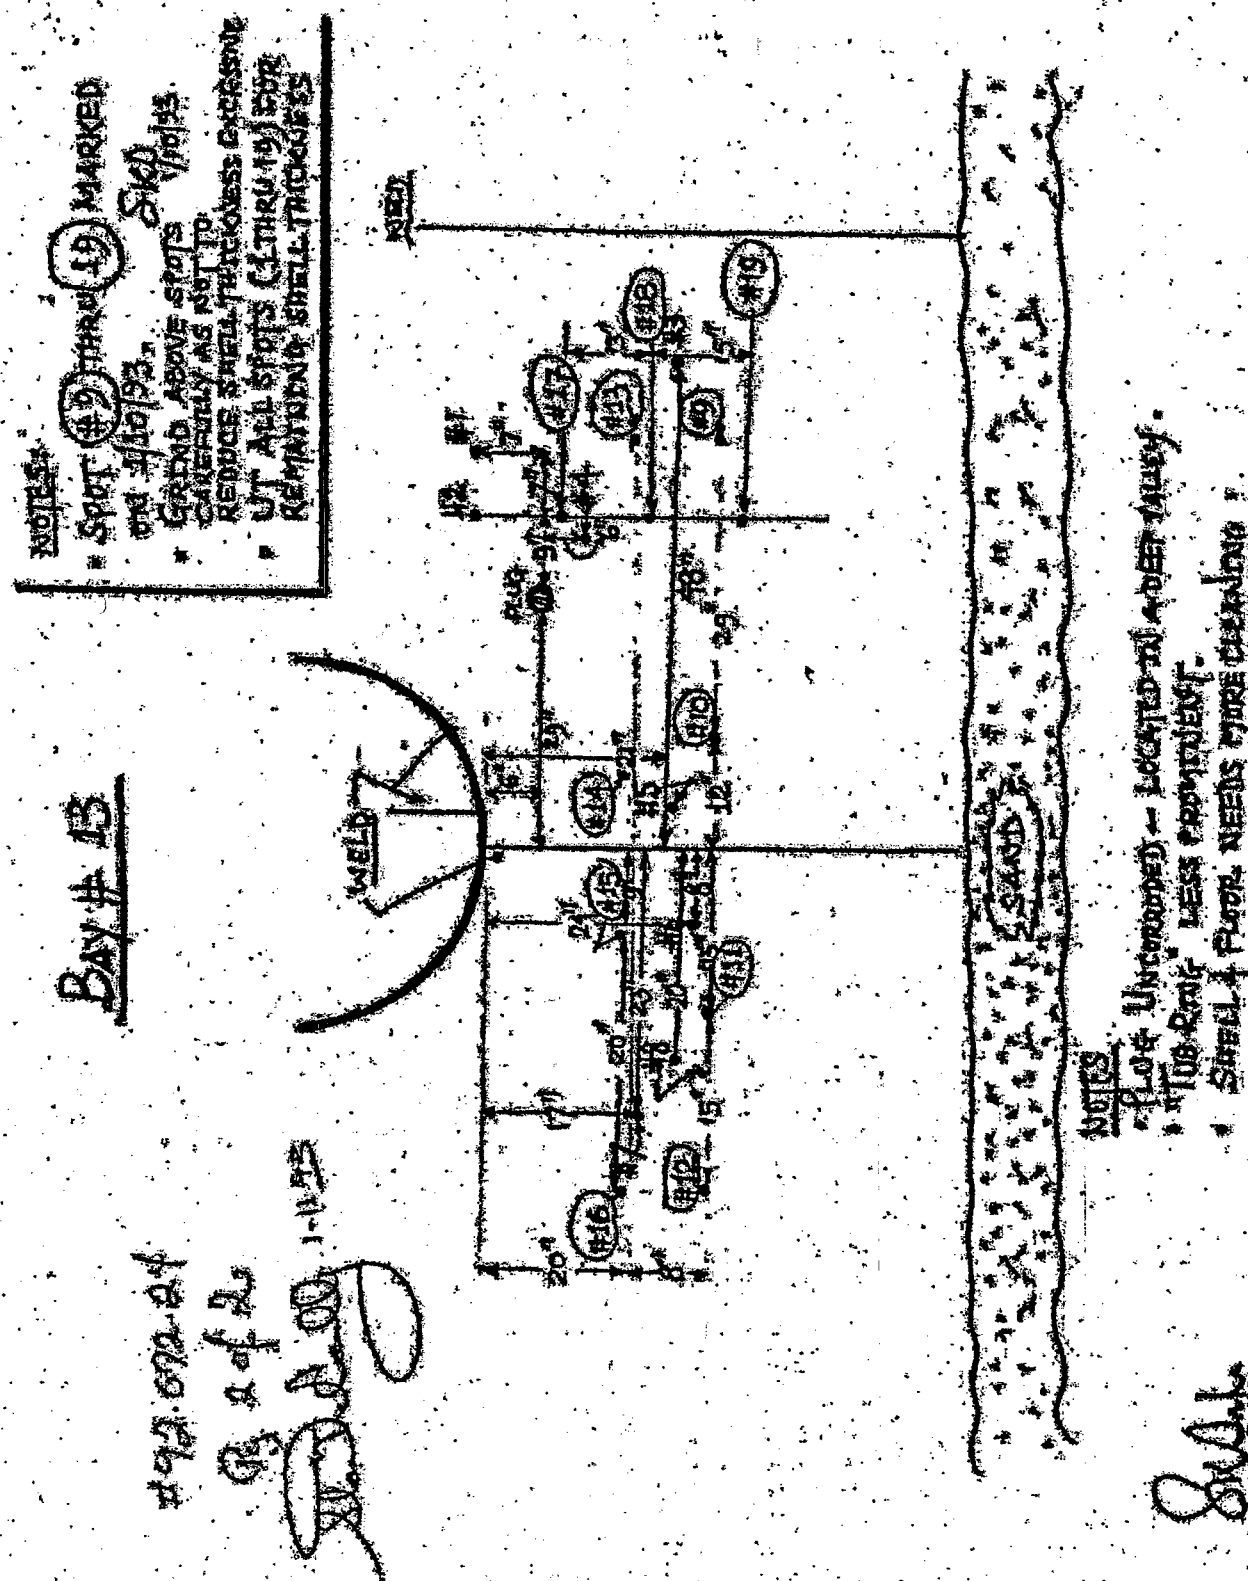
NOTES:
SPOT #2 THRU #9 MARKED ON 3/30/93.
GRIND ABOVE SPOTS CAREFULLY AS NOT TO REDUCE SHELL THICKNESS EXCESSIVE.
UT ALL SPOTS (4 THRU 19) FOR REMAINING SHELL THICKNESS
Shell 1/16/93
BAY # 13
WELD
#10
#11
#12
#13
#14
#15
#16
#17
#18
#19
SAND
NOTES:
1. Pipe Uncovered - Located in Sand Area.
2. Sub Drain Less Prominent.
3. Shell + Floor Needs More Cleaning.
