UNITED STATES OF AMERICA
NUCLEAR REGULATORY COMMISSION

In the Matter of:	)	July 20, 2007
AmerGen Energy Company, LLC	)	Docket No. 50-219
(License Renewal for Oyster Creek Nuclear Generating Station)	)

AMERGEN'S PRE-FILED DIRECT TESTIMONY EXHIBITS

VOLUME 1 OF 2: EXHIBITS 1-19

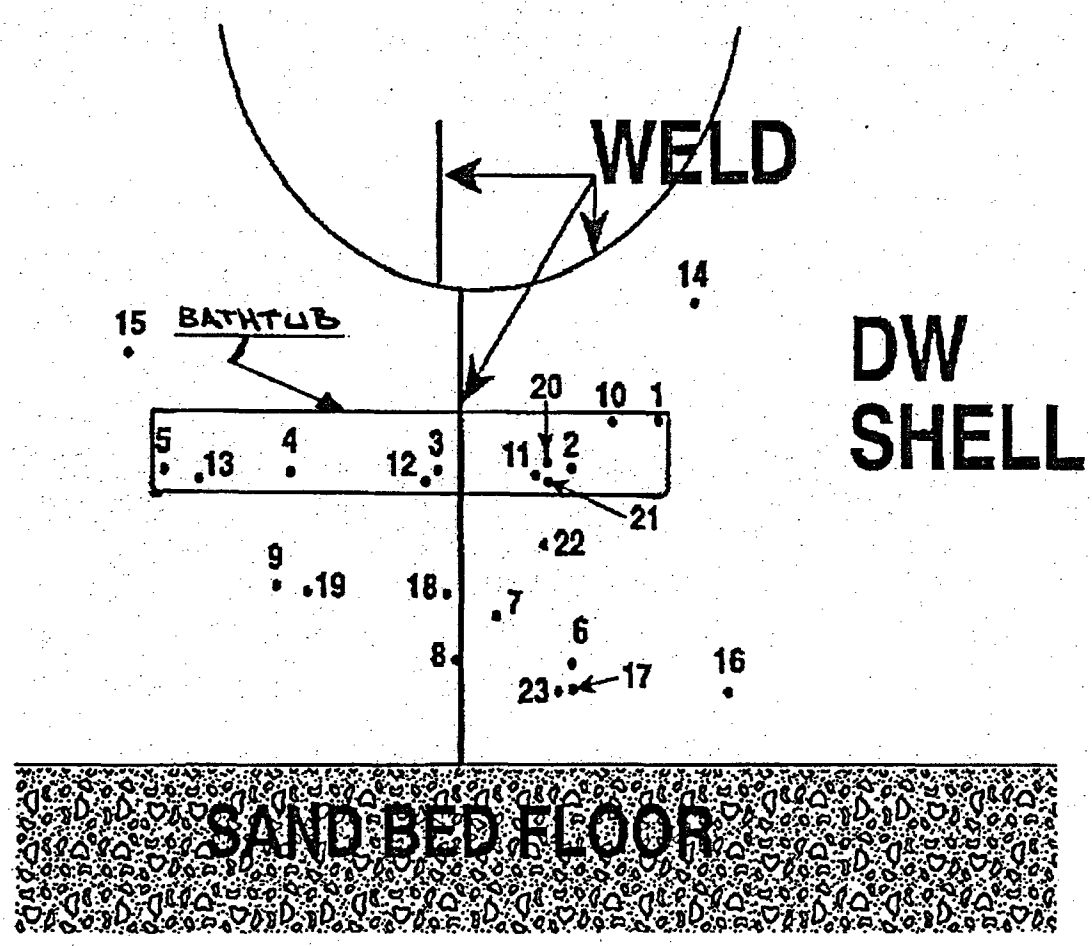
FIGURE (1)

The outside surface of this bay is rough and full of dimples similar to the outside surface of golf ball. This observation is made by the inspector who located the thinnest areas for the UT examination. This inspection focused on the thinnest areas of the drywell, even if it was very local, i.e., the inspection did not attempt to define a shell thickness suitable for structural evaluation. The shell appears to be relatively uniform in thickness except for a band of corrosion which looks like a "bathtub" ring, located 15 to 20 inches below the vent pipe reinforcement plate, i.e, weld line as shown in Figure 1. (Figure 1 and others like figures presented in this calculation are NOT TO SCALE). The bathtub ring is 12 to 18 inches wide and about 30 inches long located in the center of the bay. Beyond the bathtub ring on both sides, the shell appears to be uniform in thickness at a conservative value of 0.800 inches. Above the bathtub ring the shell exhibits no corrosion since the original lead primer on the vent pipe/reinforcement plate is intact. Measurements 14 and 15 confirm that the thickness above the bathtub ring is at 1.154 inches starting at elevation 11'-00". Below the bathtub ring the shell is uniform in thickness where no abrupt changes in thicknesses are present. Thickness measurements below the bathtub ring are all above 0.800 inches except location 7 which is very local area.

The individual measured thicknesses must also be evaluated for structural compliance. Table 1-a identifies 23 locations of UT measurements that were selected to represent the thinnest areas, except locations 14 and 15, based on visual examination. These locations are a deliberate attempt to produce a minimum measurement. Locations 14 and 15 were selected to confirm that no corrosion had taken place in the area above the bathtub ring.

Eight locations shown in Table 1-a (1, 2, 3, 5, 7, 11, 12, and 21) have measurements below 0.736 inches. Observations indicate that these locations were very deep and not more than 1 to 2 inches in diameter. The depth of each of these areas relative to its immediate surroundings was measured at 8 locations around the spot and the average is shown in Table 1-a. Using the general wall thickness acceptance criteria described earlier, the evaluation thickness for all measurements below 0.736 inches were found to be above 0.736 inches except for two locations, 2 and 11, as shown in Table 1-b. Locations 2 and 11 are in the bathtub ring and are about 4 inches apart. This area is characterized as a local area 4 x 4 inches located at about 15 to 20 inches below the vent pipe reinforcement plate with an average thickness of 0.692 inches. This thickness of 0.692 inches is 0.108 inches reduction from the conservative estimate of 0.800 inches evaluation thickness for the entire bay. In order to quantify the effect of this local region and to address structural compliance, the GE study on local effects is used (Ref. 3.5).

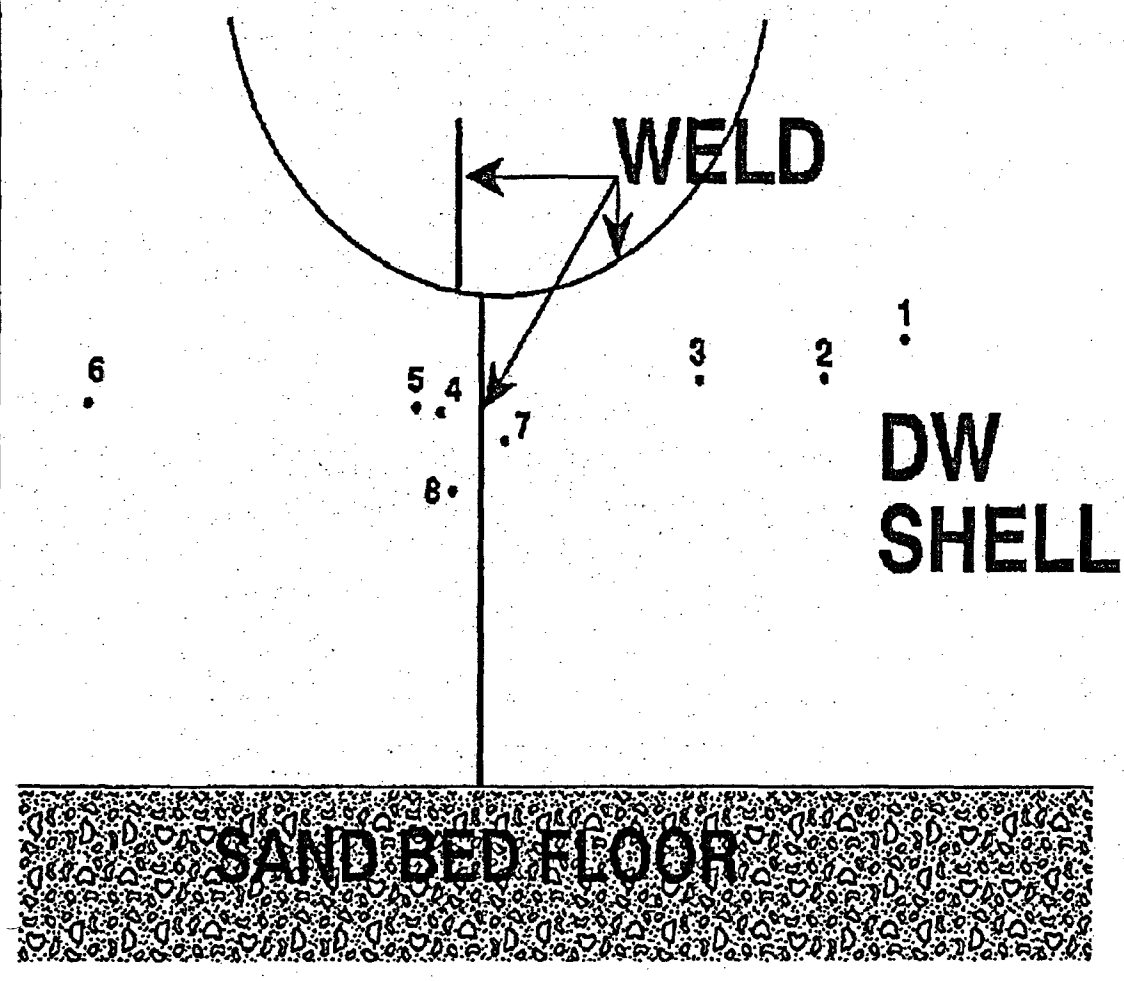
FIGURE (3)

The outside surface of this bay is rough, similar to bay one, full of dimples comparable to the outside surface of golf ball. This observation is made by the inspector who located the thinnest areas for the UT examination. The shell appears to be relatively uniform in thickness except for a bathtub ring 8 to 10 inches wide approximately 6 inches below the vent header reinforcement plate. The upper portion of the shell beyond the band exhibits no corrosion where the original red lead primer is still intact. Eight locations were selected to represent the thinnest areas based on the visual observations of the shell surface (Fig. 3). These locations are a deliberate attempt to produce a minimum measurement. Table 3 shows measurements taken to measure the thicknesses of the drywell shell using a D-meter. The results indicate that all of the areas have thickness greater than the 0.736 inches.

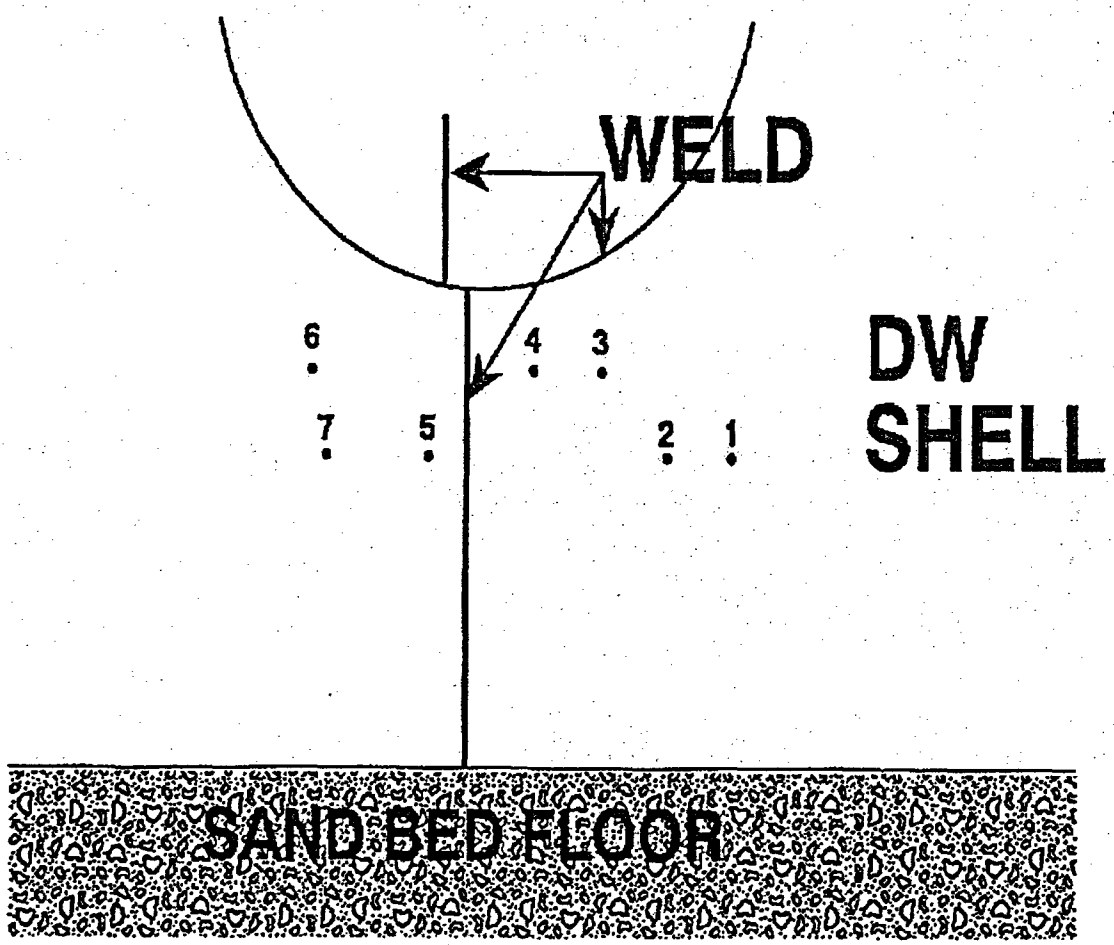
FIGURE (7)

The observation of the drywell surface for this bay showed uniform dimples in the corroded area, but they are shallow compared to those in bay 1. The bathtub ring seen in the other bays, was not very prominent in this bay. This observation is made by the inspector who located the thinnest areas for the UT examination. The shell appears to be relatively uniform in thickness. Seven locations were selected to represent the thinnest areas based on the visual observations of the shell surface (Fig. 7). These locations are a deliberate attempt to produce a minimum measurement. Table 7 shows readings taken to measure the thicknesses of the drywell shell using a D-meter. The results indicate that all of the areas have thickness greater than the 0.736 inches.

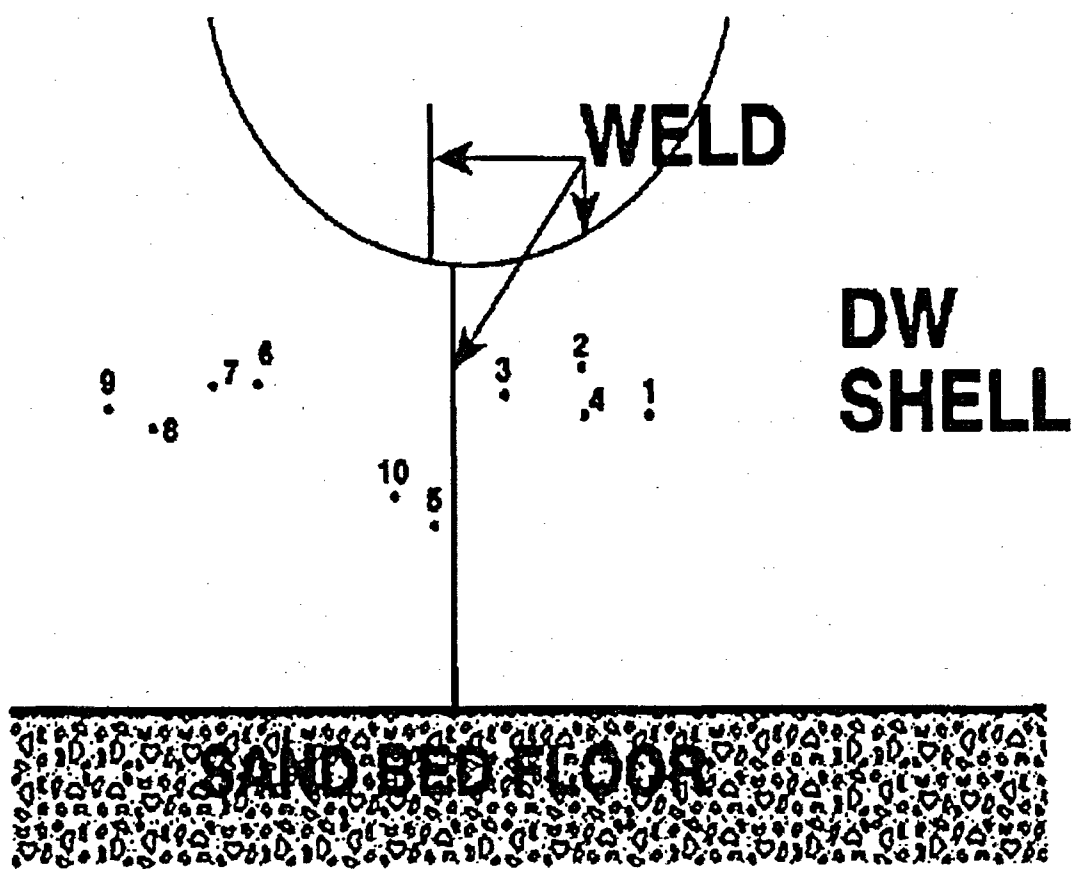
FIGURE (9)

The observation of the drywell shell for this bay was very similar to bay 7 except that the bathtub ring was more evident in this bay. The shell appears to be relatively uniform in thickness except for a bathtub ring 6 to 9 inches wide approximately 6 to 8 inches below the vent header reinforcement plate. The upper portion of the shell beyond the band exhibits no corrosion where the original red lead primer is still intact. Eight locations were selected to represent the thinnest areas based on the visual observations of the shell surface (Fig. 9). These locations are a deliberate attempt to produce a minimum measurement. Table 9 shows readings taken to measure the thicknesses of the drywell shell using a D-meter. The results indicate that all of the areas have thickness greater than the 0.736 inches.

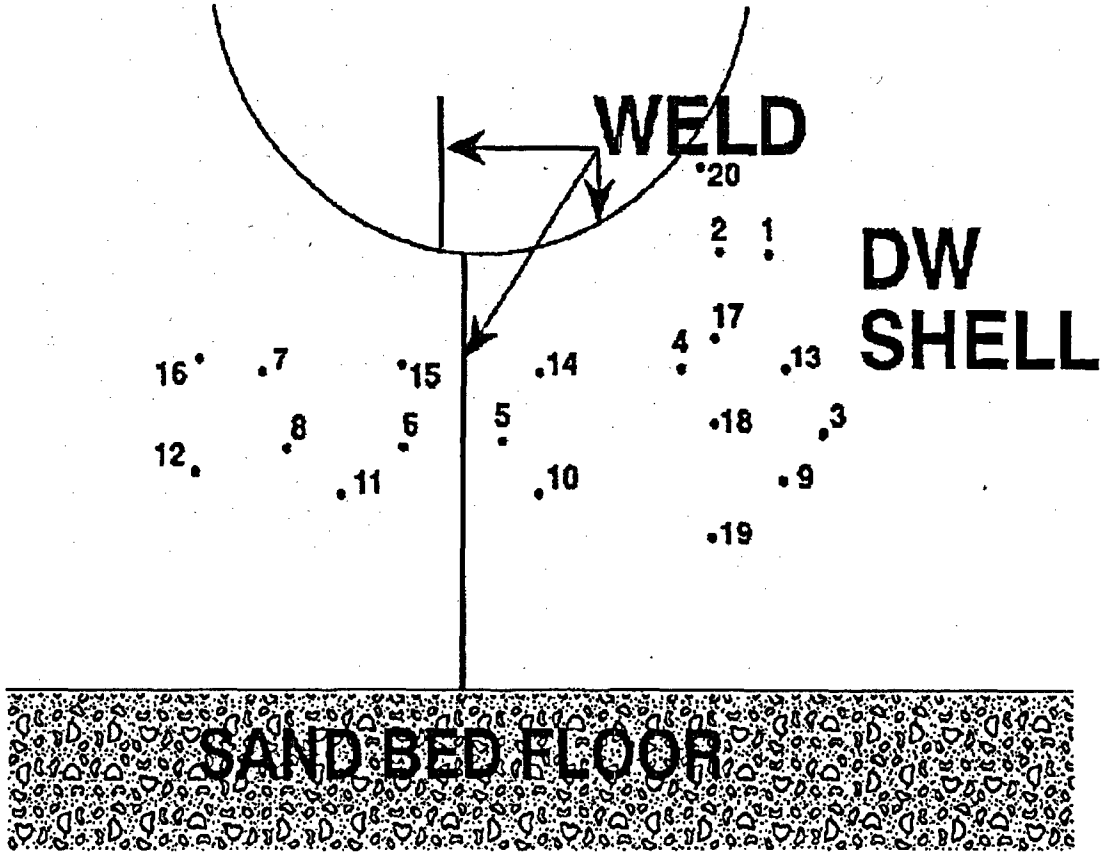
FIGURE (13)

Therefore, a conservative mean thickness of 0.800 inches is estimated to represent the evaluation thickness for this bay. Given a uniform thickness of 0.800 inches, the buckling margin for the refueling load condition is recalculated based on the GE report 9-4 (Ref. 3.3). The theoretical buckling strength from report 9-4 (ANSYS Load Factor) is a square function of plate thicknesses. Therefore, a new buckling capacity for the controlling refueling load combination is calculated to be at 13% above the ASME factor of safety of 2 as shown in Appendix B.

The individual measurements must also be evaluated for structural compliance. Table 13-a identifies 20 locations of UT measurements that were selected to represent the thinnest areas, except location 20, based on visual examination. These locations are a deliberate attempt to produce a minimum measurement. Location 20 was selected to confirm that no corrosion had taken place in the area above the bathtub ring.

Nine locations shown in Table 13-a (1, 2, 5, 6, 7, 8, 10, 11, and 15) have measurements below 0.736 inches. Observations indicate that these locations were very deep, overly ground, and not more than 1 to 2 inches in diameter. The depth of each of these areas relative to its immediate surroundings was measured at 8 locations around the spot and the average is shown in Table 13-a. Using the general wall thickness acceptance criteria described earlier, the evaluation thickness for all measurements below 0.736 inches were found to be above 0.736 inches except for two locations, 5 and 7, as shown in Table 13-b. In addition, subsequent measurements close to the locations identified above, were taken and they were all above 0.736 inches. Locations 5 and 7 are in the bathtub ring and are about 30 inches apart. These locations are characterized as local areas located at about 15 to 20 inches below the vent pipe reinforcement plate with an evaluation thicknesses of 0.735 inches and 0.677 inches. The location 5 is near to location 14 for an average value of 0.801 inches and therefore acceptable. Location 7 could conservatively exist over an area of 6 x 6 inches for a thickness of 0.677 inches. This thickness of 0.677 inches is a full 0.123 inches reduction from the conservative estimate of 0.800 inches evaluation thickness for the entire bay. In order to quantify the effect of this local region and to address structural compliance, the GE study on local effects is used (Ref. 3.5).

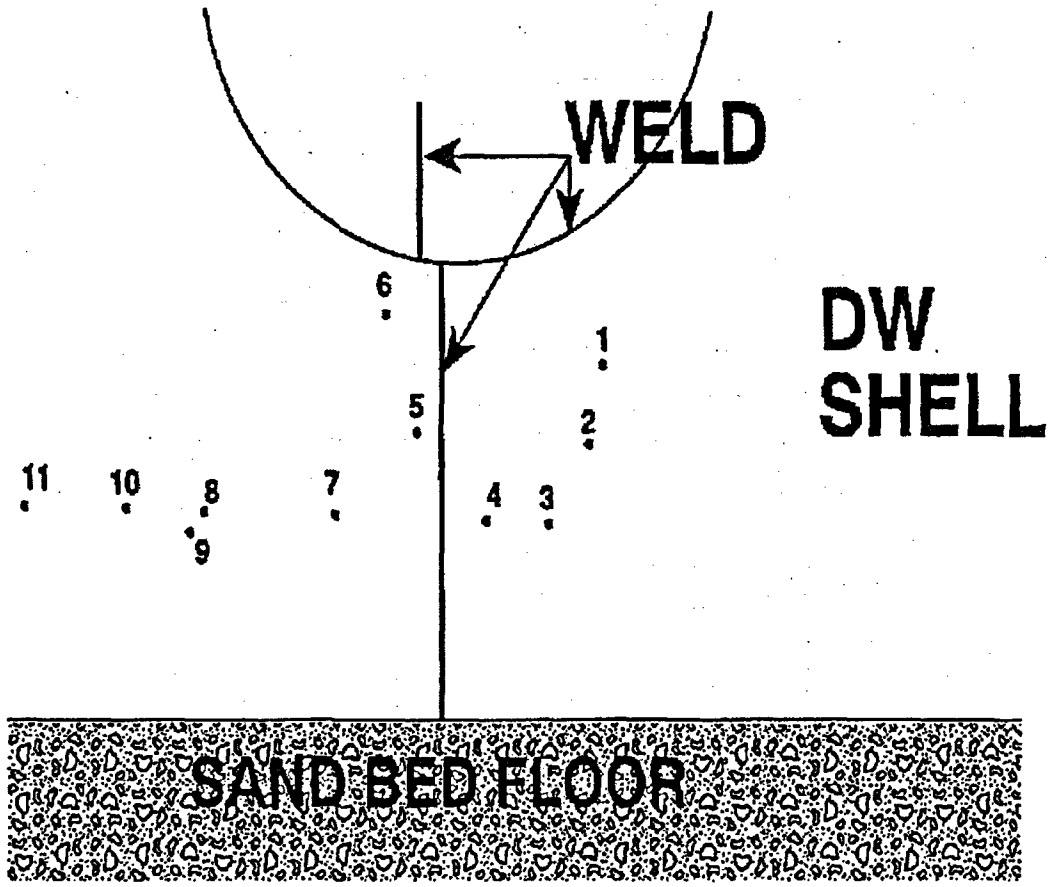
FIGURE (15)

The outside surface of this bay is rough, similar to bay 1, full of uniform dimples comparable to the outside surface of golf ball (Appendix C). The bathtub ring seen in the other bays, was not very prominent in this bay. This observation is made by the inspector who located the thinnest areas for the UT examination. The upper portion of the shell beyond the ring exhibits no corrosion where the original red lead primer is still intact. The shell appears to be relatively uniform in thickness.

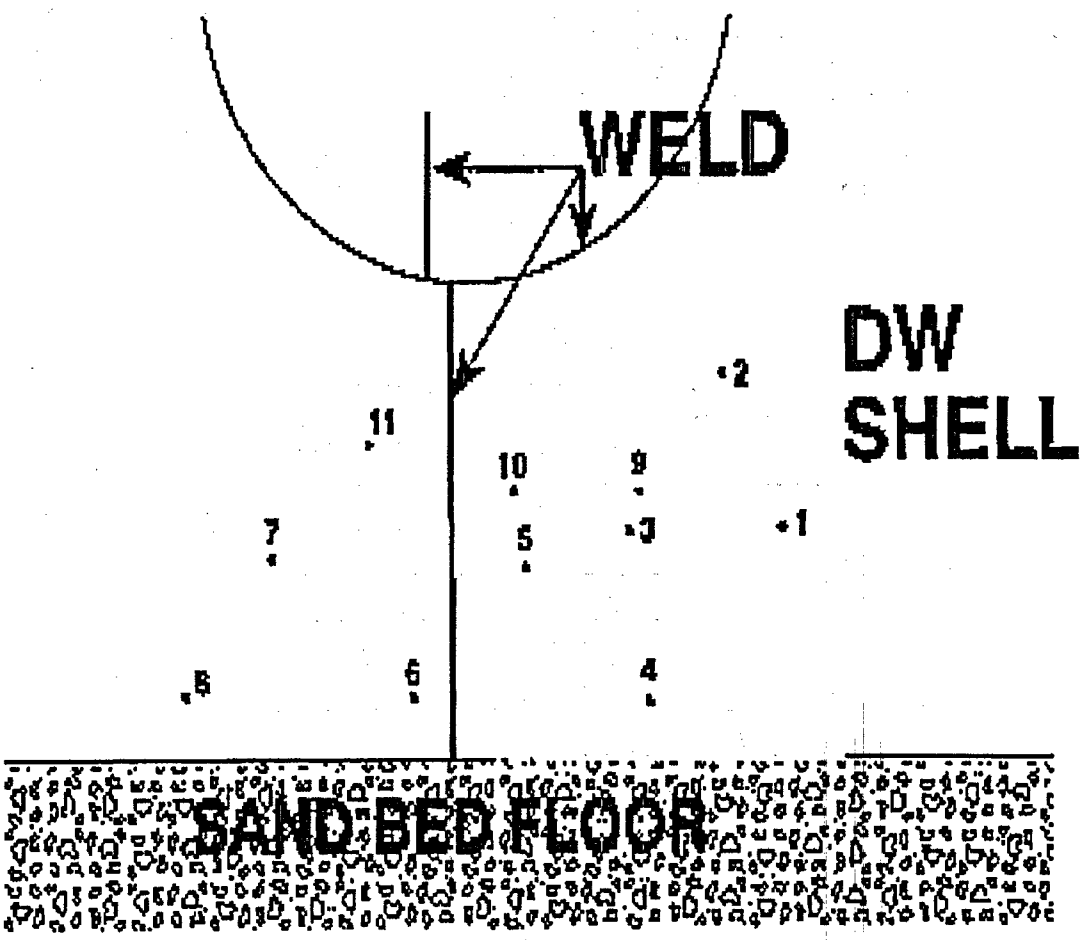
FIGURE (17)

The outside surface of this bay is rough, similar to bay 1, full of uniform dimples comparable to the outside surface of golf ball. The shell appears to be relatively uniform in thickness except for a band 8 to 10 inches wide approximately 6 inches below the vent header reinforcement plate. The upper portion of the shell beyond the band exhibits no corrosion where the original red lead primer is still intact.

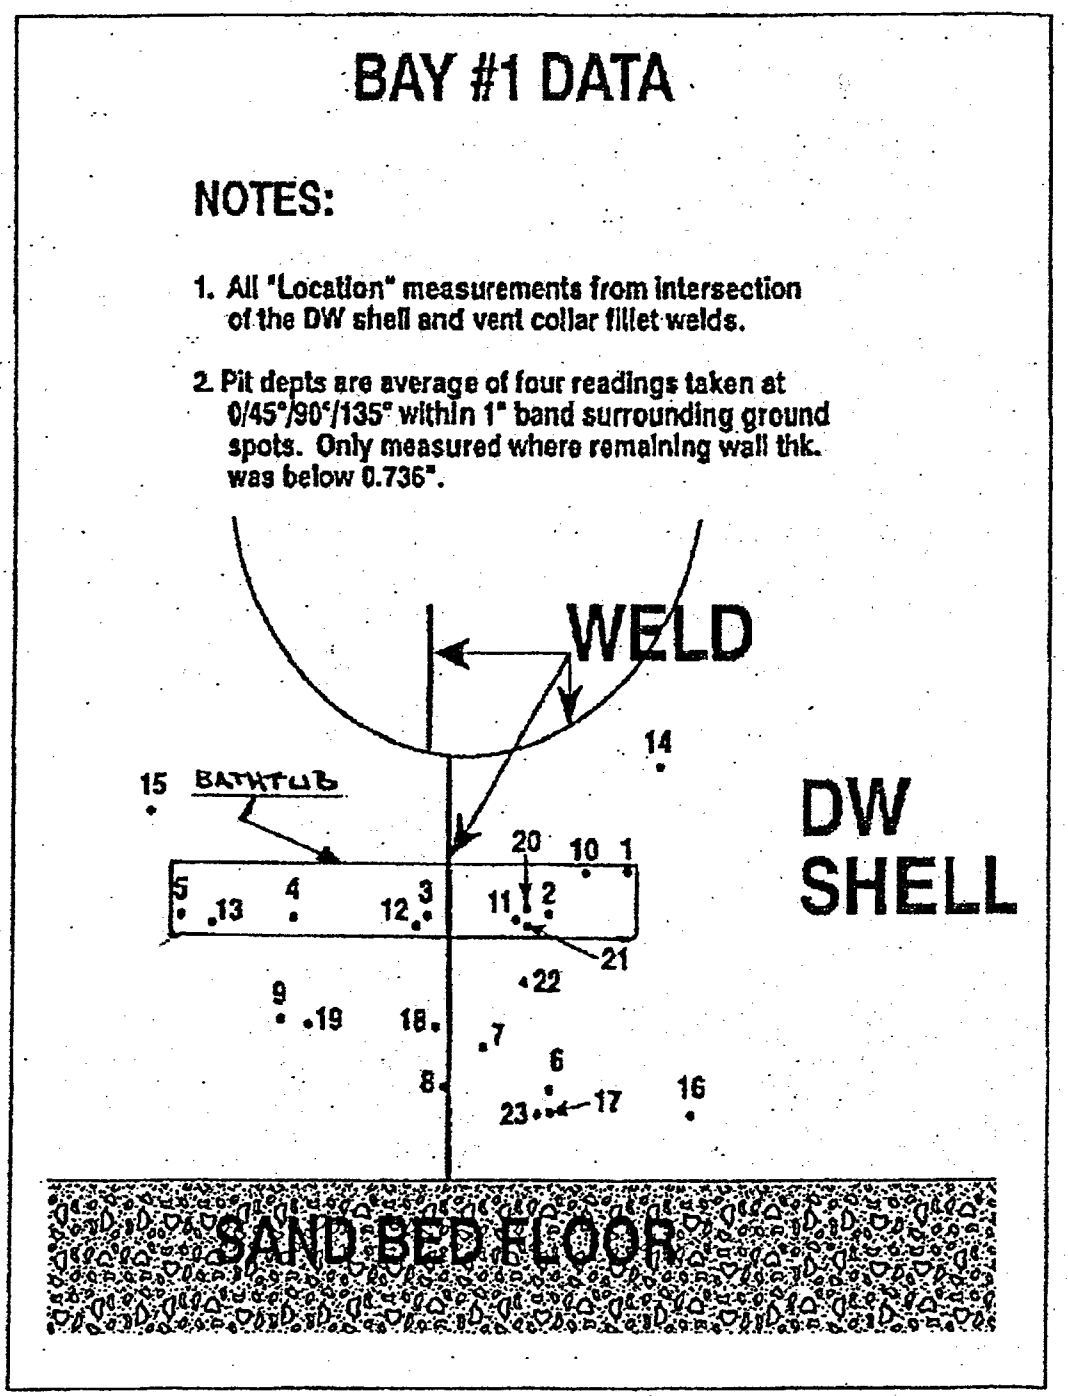
FIGURE (1)

Location	UT Measurement (1)	AVG Micrometer (2)	Mean Depth/Valley (3)	T (Evaluation) (4)=(1)+(2)-(3)	Remarks
1	0.720"	0.217"	0.200"	0.737"	Acceptable
2	0.716"	0.143"	0.200"	0.659"	Acceptable
3	0.705"	0.347"	0.200"	0.852"	Acceptable
5	0.710"	0.313"	0.200"	0.823"	Acceptable
7	0.700"	0.266"	0.200"	0.766"	Acceptable
11	0.714"	0.212"	0.200"	0.726"	Acceptable
12	0.724"	0.301"	0.200"	0.825"	Acceptable
21	0.726"	0.211"	0.200"	0.737"	Acceptable

BAY #1 DATA
NOTES:
1. All "Location" measurements from intersection of the DW shell and vent collar fillet welds.
2. Pit depts are average of four readings taken at 0/45°/90°/135° within 1" band surrounding ground spots. Only measured where remaining wall thk. was below 0.736".
WELD
DW SHELL
BATHTUB
SAND BED FLOOR
1
2
3
4
5
6
7
8
9
10
11
12
13
14
15
16
17
18
19
20
21
22
23

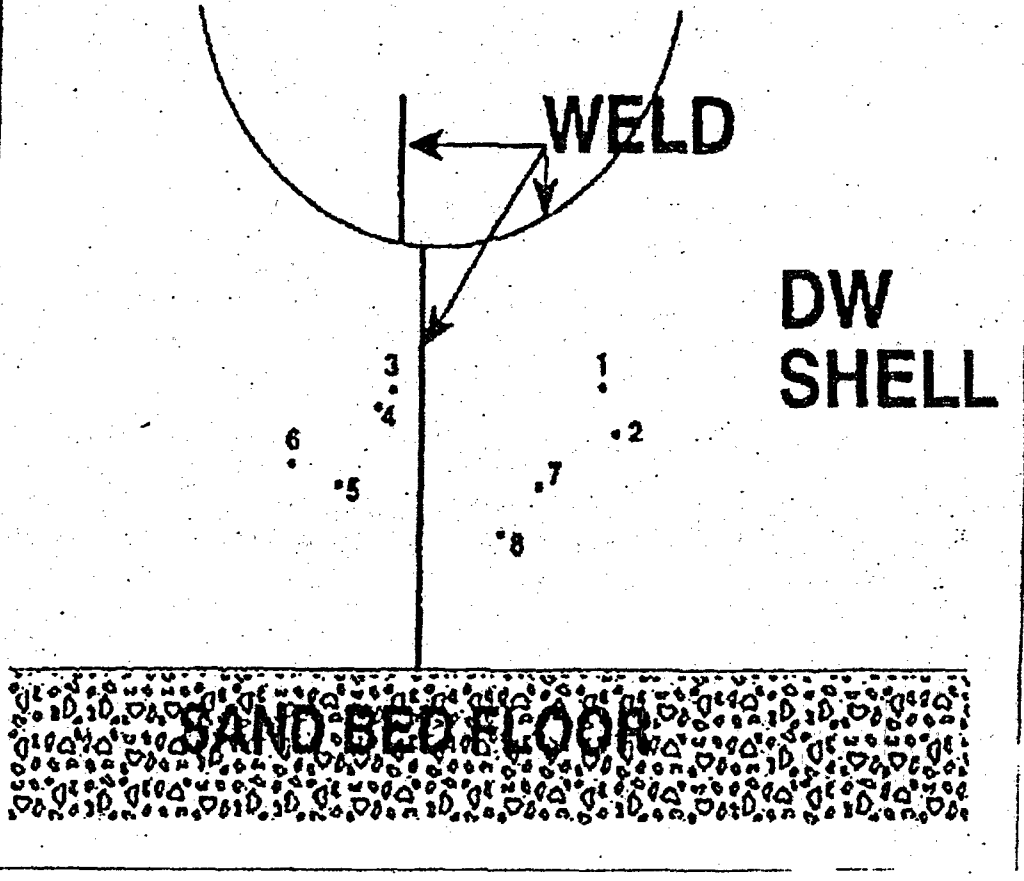
FIGURE (11)

The individual measurements must also be evaluated for compliance with the local wall thickness criteria. Table 13-b identifies 20 locations of UT measurements that were selected to represent the thinnest areas, except location 20, based on visual examination. These locations are a deliberate attempt to produce a minimum measurement. Location 20 was selected to confirm that no corrosion had taken place in the area above the bathtub ring.

Nine locations shown in Table 13-b (1, 2, 5, 6, 7, 8, 10, 11, and 15) have measurements below 0.736 inches. Inspectors observations indicate that these locations were very deep, overly ground, and not more than 1 to 2 inches in diameters. The depth of each of these areas relative to its immediate surroundings was measured at 4 locations around the spot and the average is shown in Table 13-a. Using the general wall thickness acceptance criteria described earlier, the evaluation thickness for all measurements below 0.736 inches were found to be above 0.736 inches except for two locations, 5 and 7, as shown in Table 13-b. In addition, subsequent measurements close to the locations identified above, were taken and they were all above 0.736 inches.

Based on the buckling design thickness of 0.736 inches the "as found" 6" by 6" area with a thickness of 0.673" represents a 8.6% reduction in local shell thickness and a material loss of 2.3 cubic inches. The volumetric consideration provides a quick visualization. While shell buckling depends on various parameters as discussed in References 3.3 and 3.7.

Comparison of the "as found" area of 6" x 6" with the "as analyzed" criteria of 0.636" over a 12" x 12" area, with an additional transition zone of 12", and its associated 13.5% reduction in shell wall thickness and a material loss of 72 cubic inches leads to the conclusion that the effect on the theoretical buckling load factor is negligible. Also based on the location of this 6" x 6" area, is almost directly below the vent and vent header assembly (between 20 to 26 inches to the left of the vent centerline and between 14 to 20 inches down from the vent weld line). This is in the area where buckling of the shell is limited due to the stiffening effect of the vent and vent header assembly. This effect can be clearly seen in the buckling analyses presented in References 3.3 and 3.5.

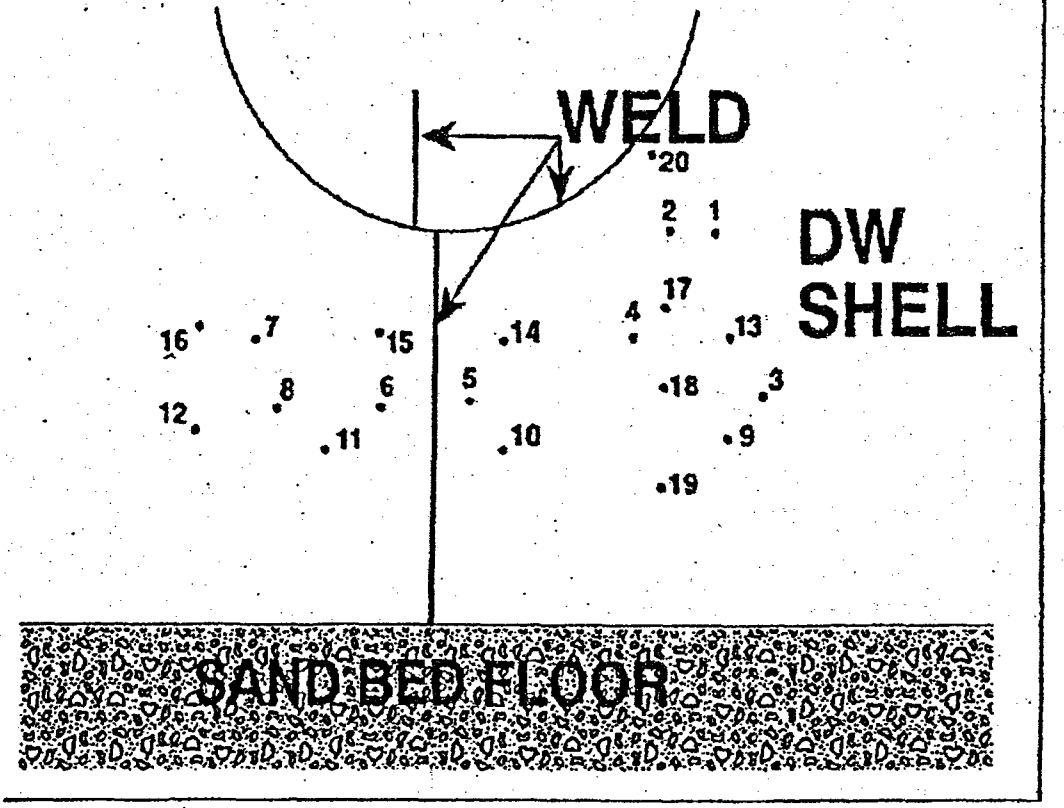
Figure (13)

1. All measurements from intersection of the DW shell (butt) and vent collar (fillet) welds.
2. Spots with suffix (e.g. 1A or 2A) were located close to the spots in question and were ground carefully to remove minimum amount of metal but adequate enough for UT.
3. Pit depths are average of four readings taken at 0/45°/90°/135° within 1" distance around ground spot. Taken only where remaining wall showed below 0.736".

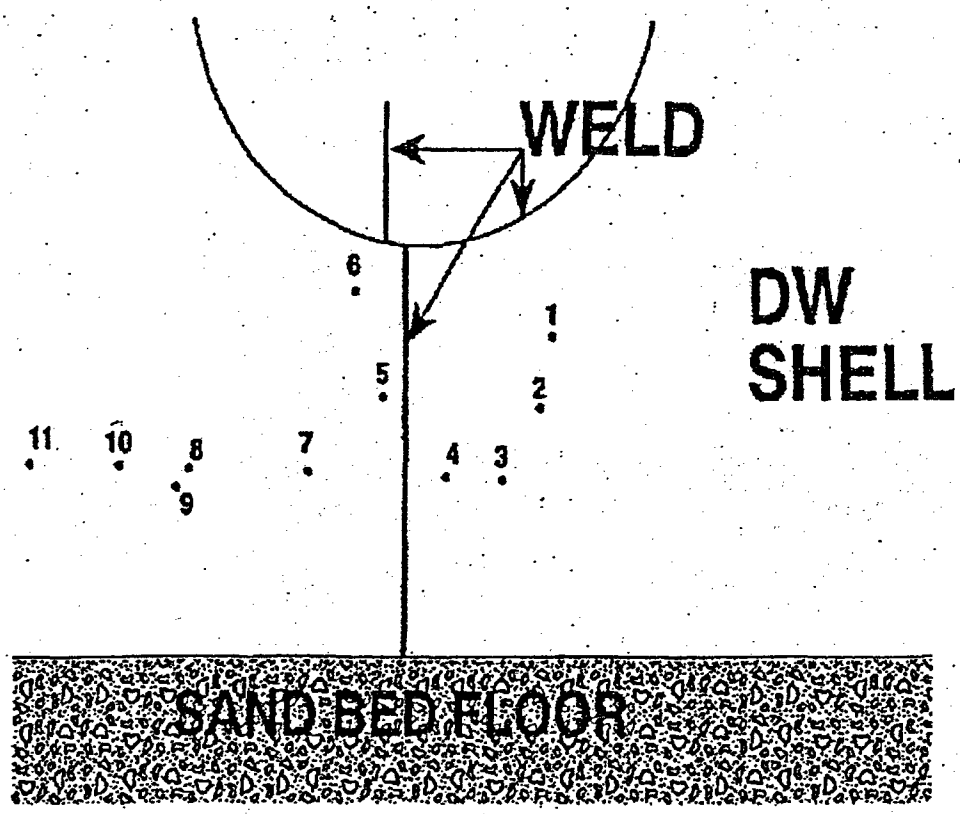
FIGURE (15)

1. All measurements from intersection of the DW shell and vent collar (fillet) welds.

2. Pit depths are average of four readings taken at 0/45°/90°/135° within 1" distance around ground spots. Taken only when remaining wall thickness shown below 0.736".

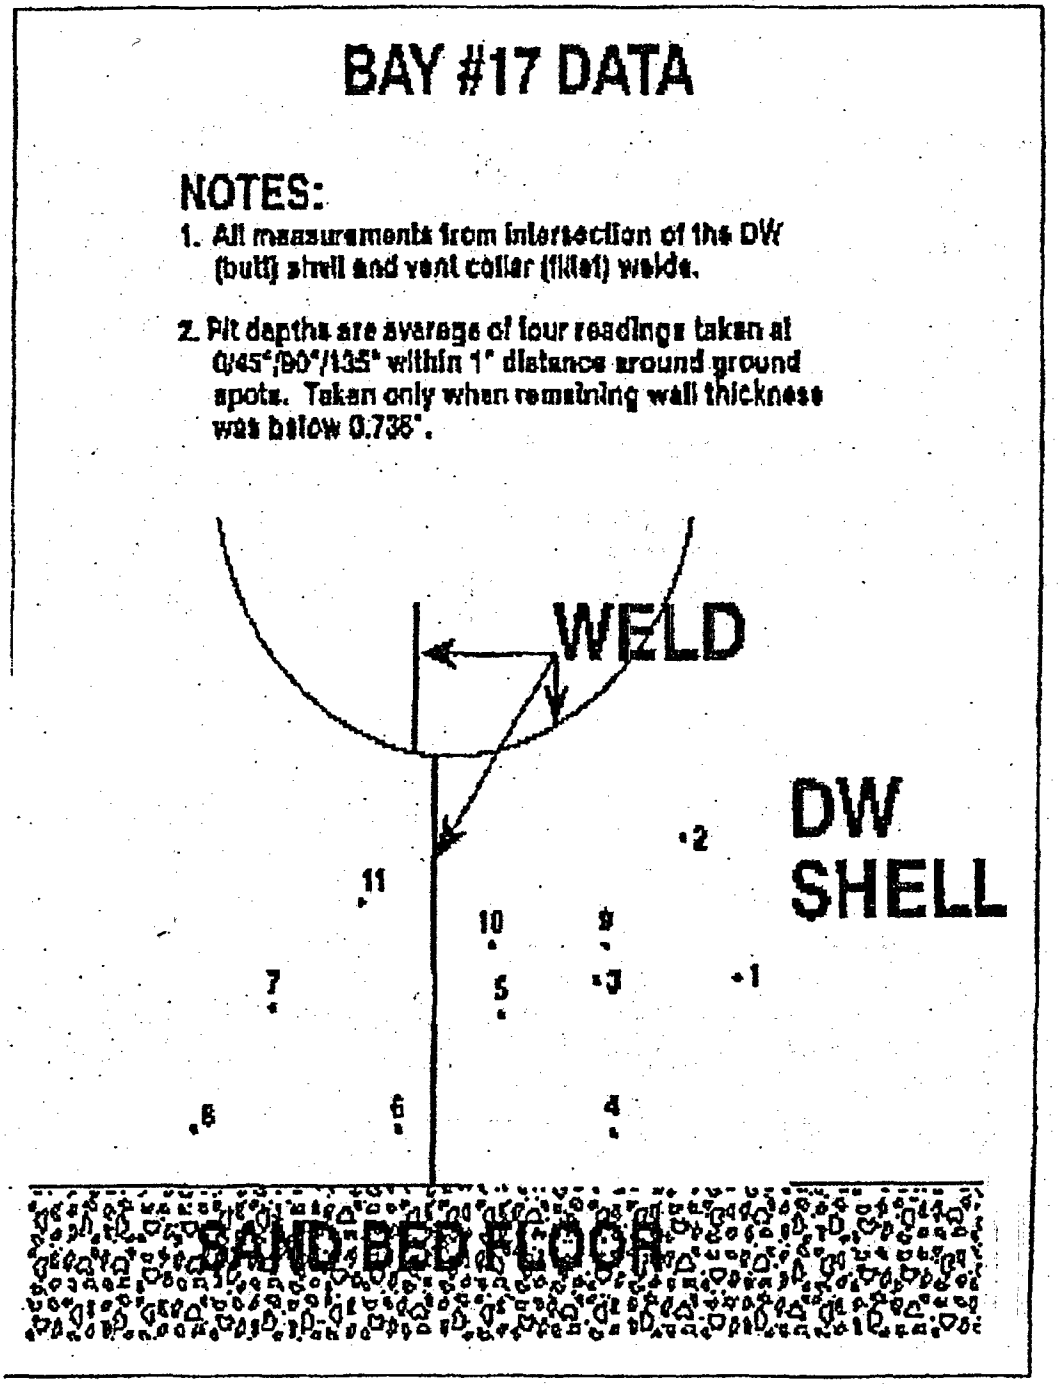
FIGURE (17)

Location	UT Measurement (1)	AVG Micrometer (2)	Mean Depth/Valley (3)	T (Evaluation) (4)=(1)+(2)-(3)	Remarks
9	0.720"	0.351"	0.200"	0.871"	Acceptable

BAY #17 DATA
NOTES:
1. All measurements from intersection of the DW (butt) shell and vent collar (fillet) welds.
2. Pit depths are average of four readings taken at 0/45°/90°/135° within 1" distance around ground spots. Taken only when remaining wall thickness was below 0.738".
WELD
DW SHELL
11
10
9
7
5
3
1
8
6
4
SAND BED FLOOR

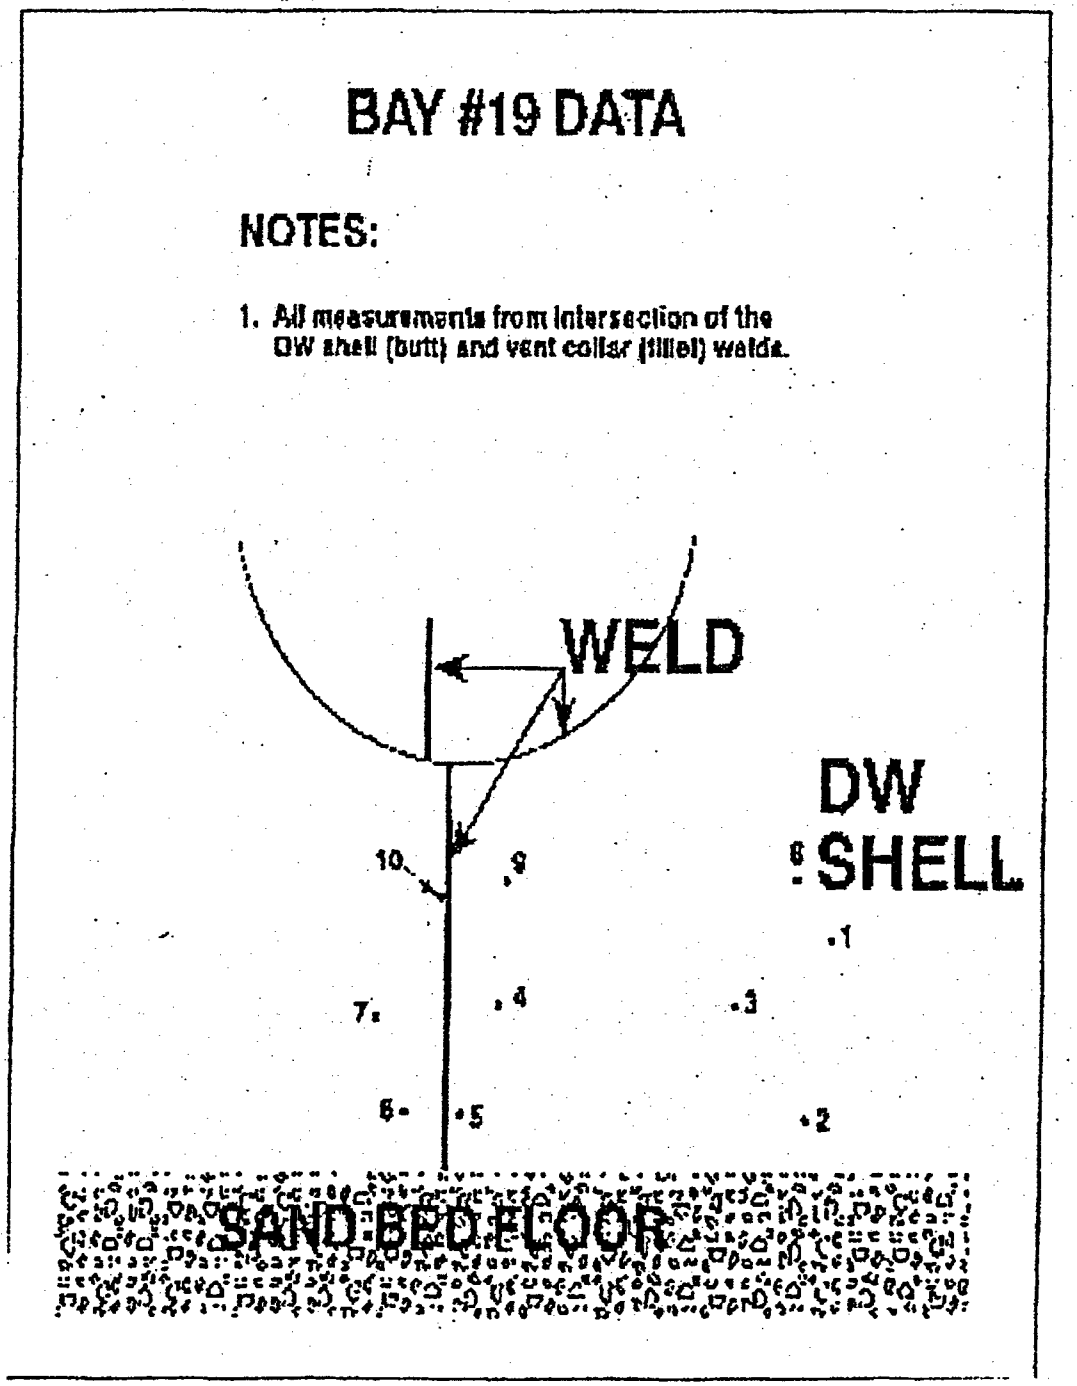
FIGURE (19)

Location	D-Meter UT Measurement (inches)	Appendix D on Calculation Page	Average Micrometer (inches)
1	0.932	109	---
2	0.924	109	---
3	0.955	109	---
4	0.940	109	---
5	0.950	109	---
6	0.860	109	---
7	0.969	109	---
8	0.753	108	---
9	0.776	108	---
10	0.790	108	---

BAY #19 DATA
NOTES:
1. All measurements from intersection of the DW shell (butt) and vent collar (fillet) welds.
WELD
DW SHELL
10
9
8
1
7
4
3
6
5
2
SAND BED FLOOR

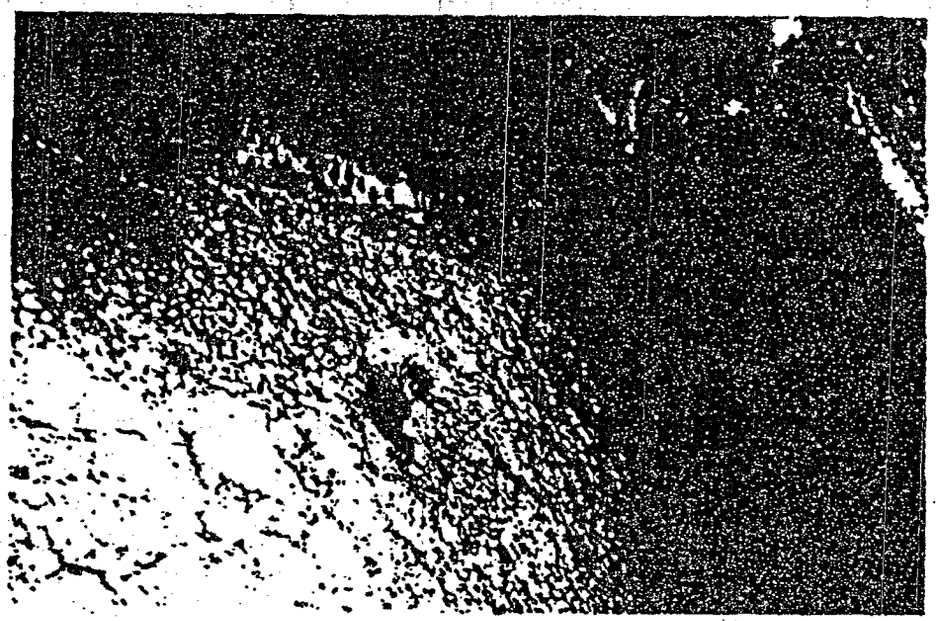
Bay #1 - Looking at the worst corroded area on shell near vent tube collar/ring. The ground spots seen here correspond to UT spot 20-21-23

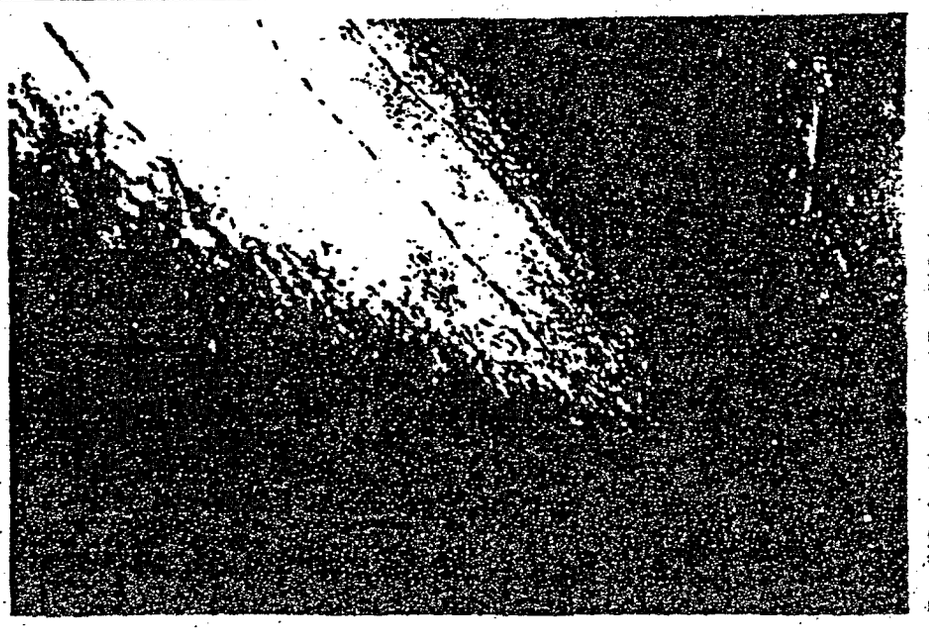
Bay #15 Looking toward Bay #13 showing portions of DW shell and concrete floor, after removal of loose debris / sand / rust. The concrete floor in this bay is one of the better ones. However - Note (1) no drainage channel and (2) cratered holes near shell corner

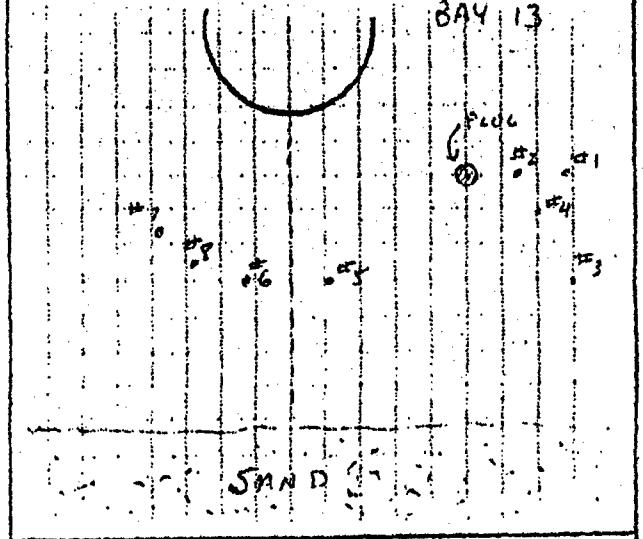
Area	Location	Thk
1	D 6" R 46"	.814"
2	D 6" R 39"	.615"
3	D 26" R 93"	.931"
4	D 12" R 35"	.914"
5	D 26" R 6"	.735"
6	D 14" L 8"	.683"
7	D 17" L 23	.632"
8	D 22" L 20"	.744"

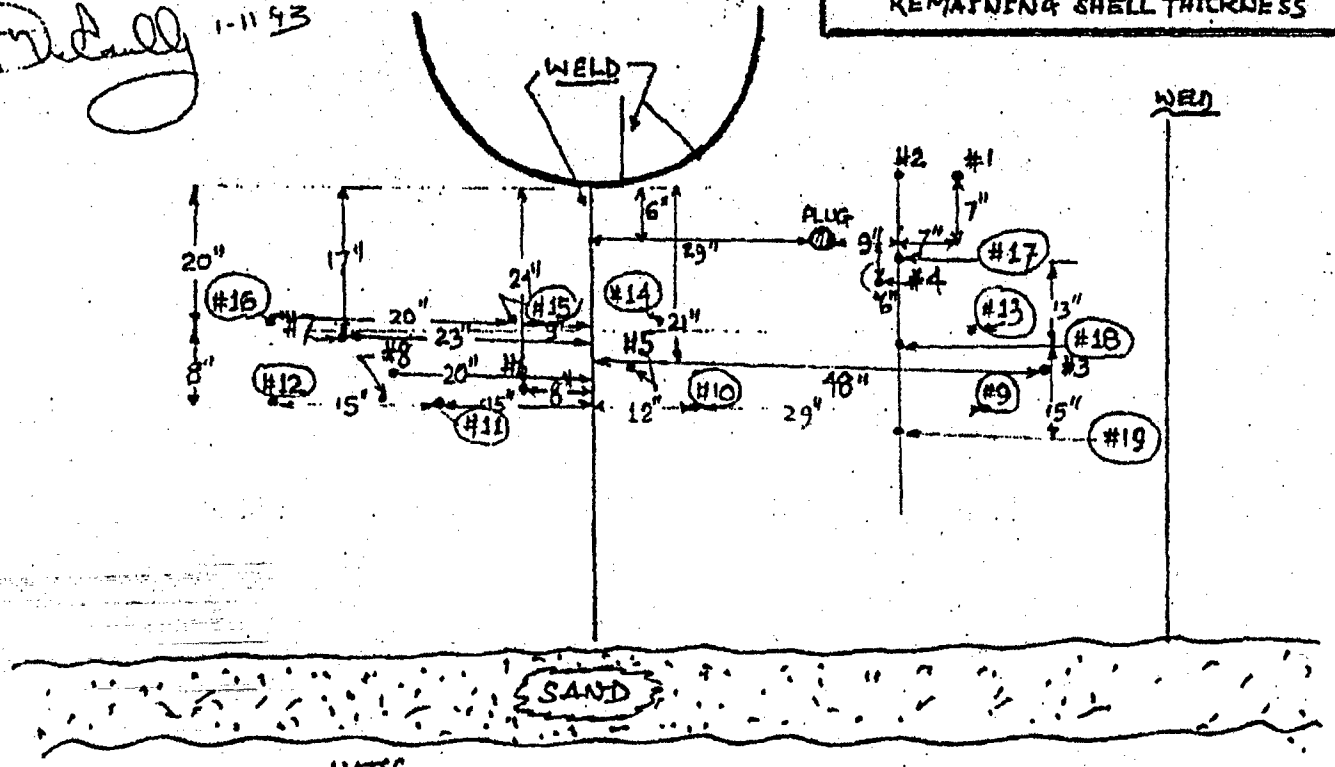
BAY # 13

NOTES
- PLUG UNCORRODED — LOCATED IN A DEEP VALLEY.
- "TUB RING" LESS PROMINENT.
- SHELL & FLOOR NEEDS MORE CLEANING.

NOTES:
- SPOT (#9) THRU (19) MARKED ON 1/10/93. SKD 1/10/93
- GRIND ABOVE SPOTS CAREFULLY AS NOT TO REDUCE SHELL THICKNESS EXCESSIVE
- UT ALL SPOTS (1 THRU 19) FOR REMAINING SHELL THICKNESS
