UNITED STATES OF AMERICA
NUCLEAR REGULATORY COMMISSION

In the Matter of:	)	July 20, 2007
AmerGen Energy Company, LLC	)	Docket No. 50-219
(License Renewal for Oyster Creek Nuclear Generating Station)	)

AMERGEN'S PRE-FILED DIRECT TESTIMONY EXHIBITS

VOLUME 1 OF 2: EXHIBITS 1-19

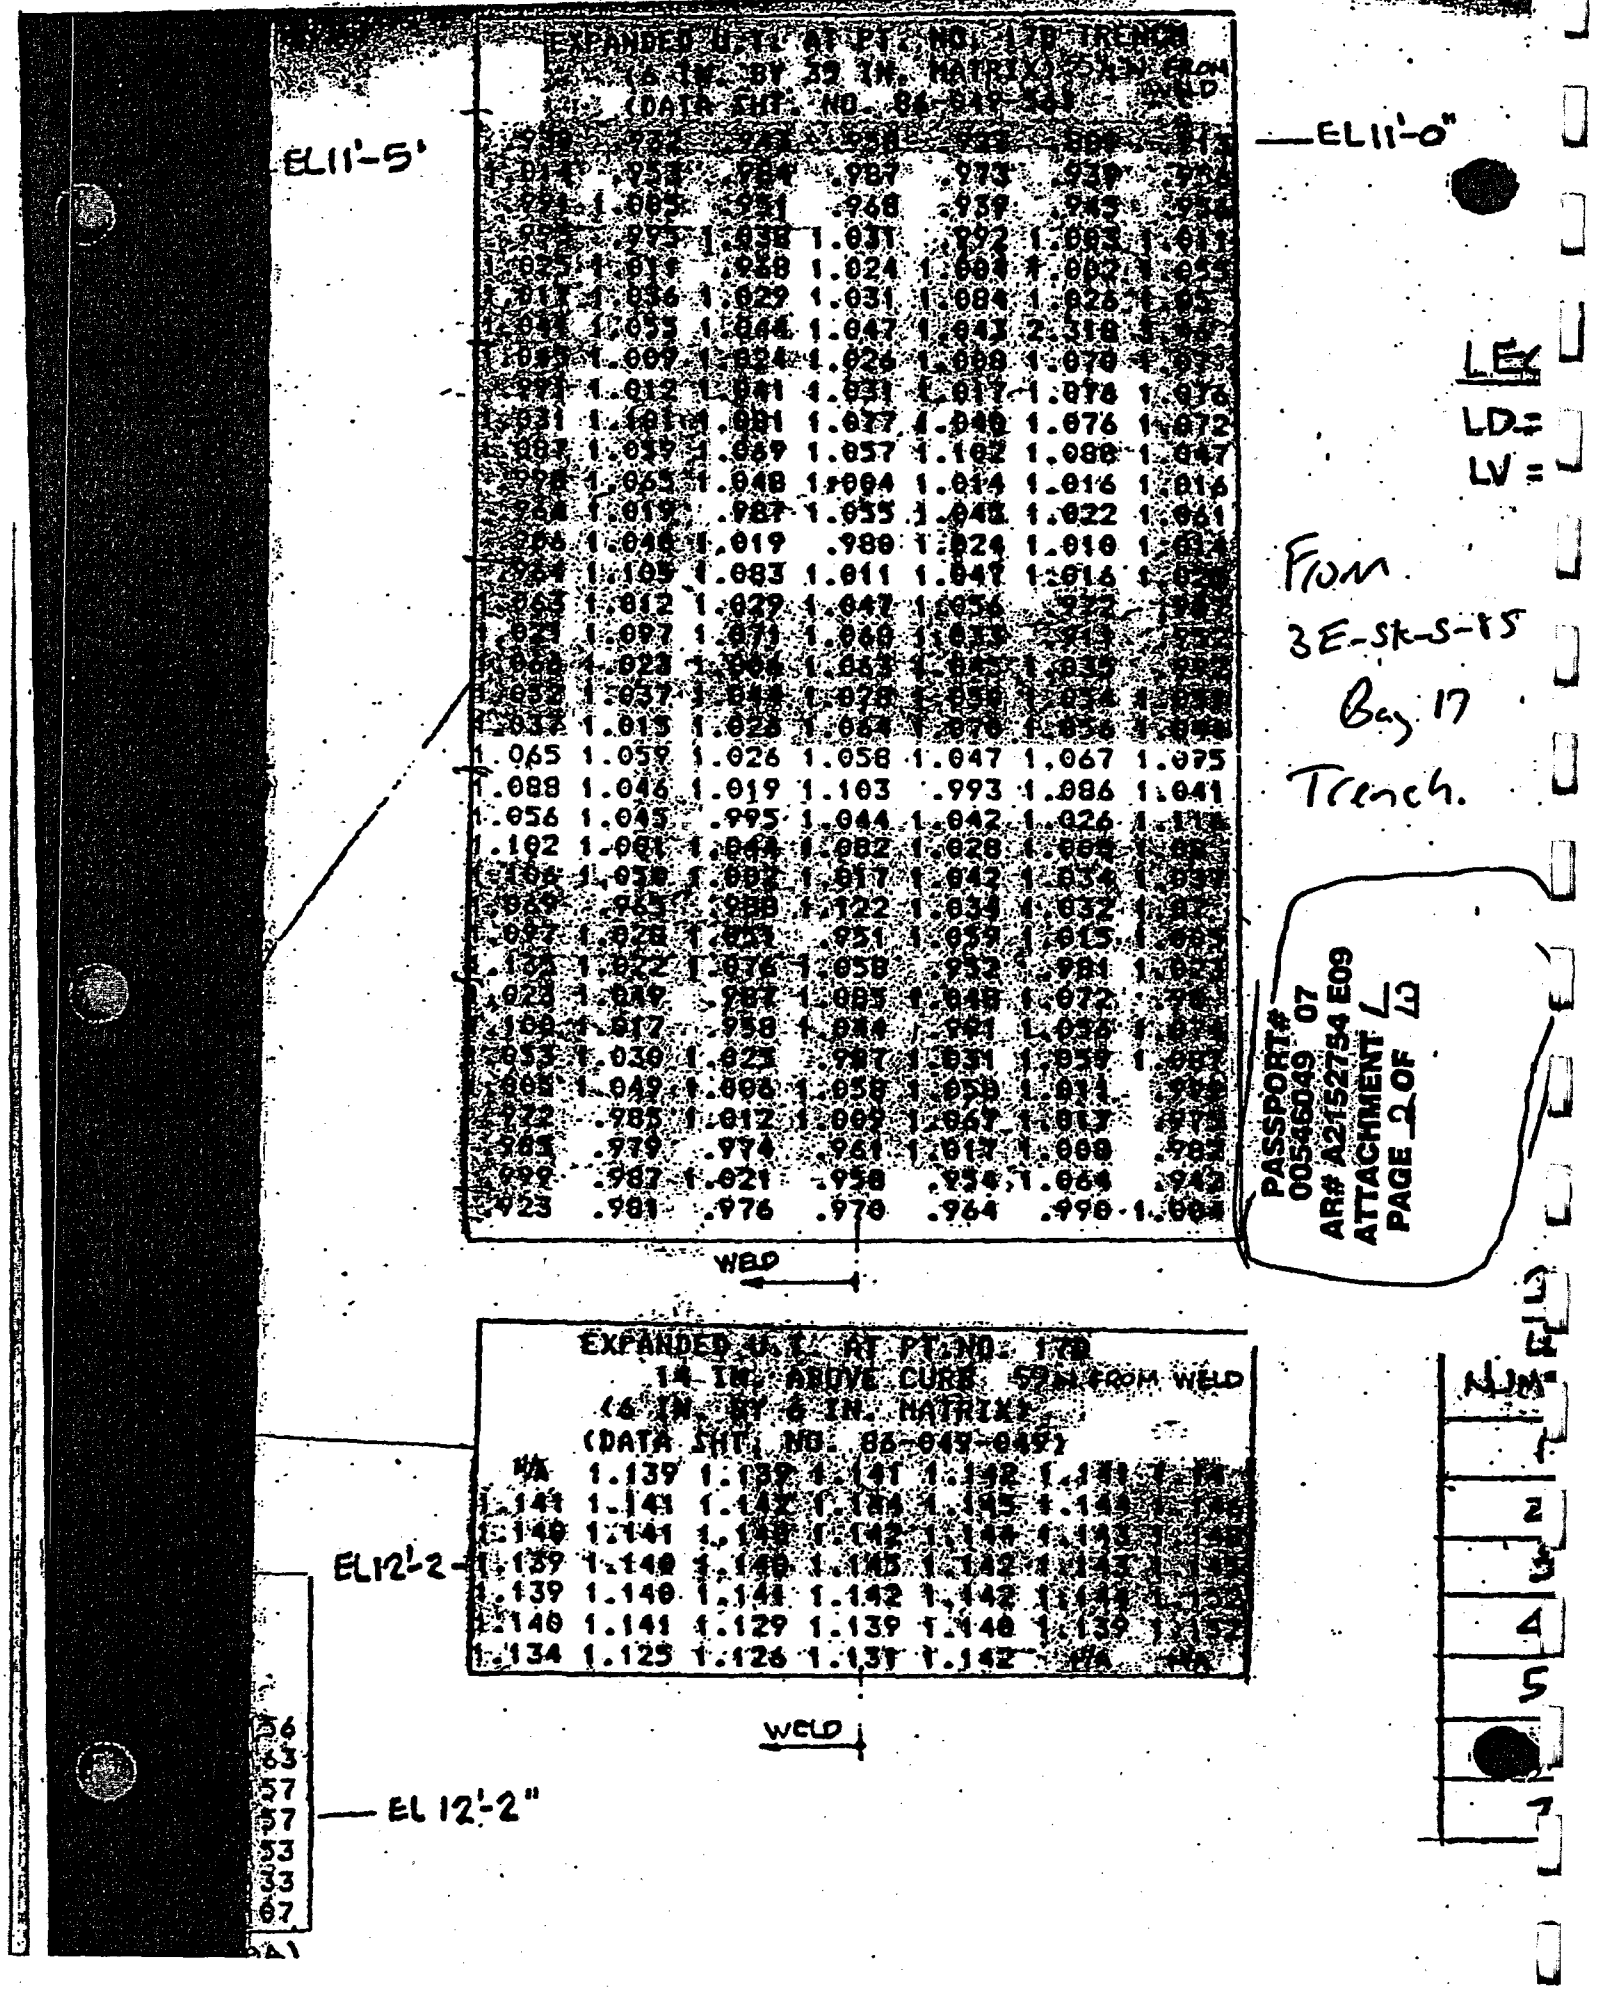
Note circled values were discounted because thes value indicate inclusions.

EXPANDED U.T. AT PT. NO. 170 TRENCH
(6 IN. BY 39 IN. MATRIX) 59 IN. FROM WELD
(DATA SHT. NO. 86-049-049)
EL11'-5"
EL11'-0"
LEK
LD=
LV=
From
3E-SK-S-15
Bay 17
Trench.
PASSPORT#
00546049 07
AR# A2152754 E09
ATTACHMENT 13
PAGE 2 OF
WELD
EXPANDED U.T. AT PT. NO. 170
14 IN. ABOVE CURB 59 IN. FROM WELD
(6 IN. BY 6 IN. MATRIX)
(DATA SHT. NO. 86-049-049)
EL12'-2"
EL 12'-2"
NUM

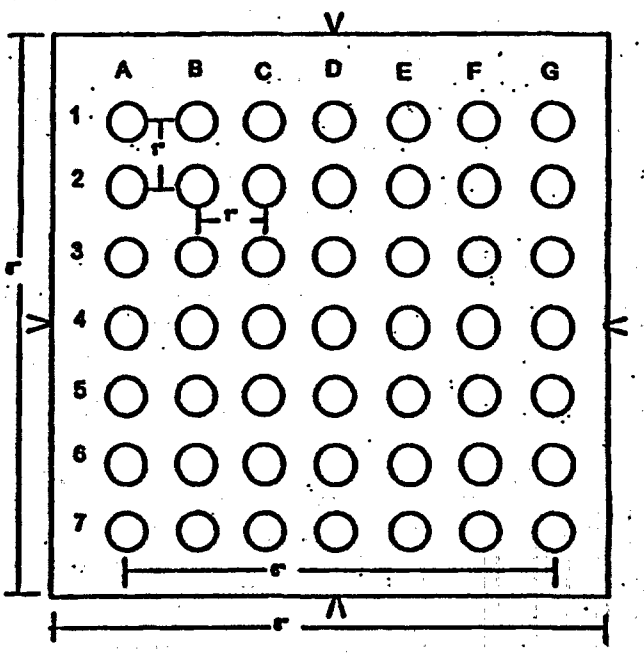
Template was placed at the bottom of the trench and forty-nine (49) points were recorded, then template was relocated above previous location with the centerline of the bottom row 1" +/- 1/16" from previous grid top row. A "V" was stamped next to each side of each template location and above and below top and bottom. A total of 294 reading were taken.

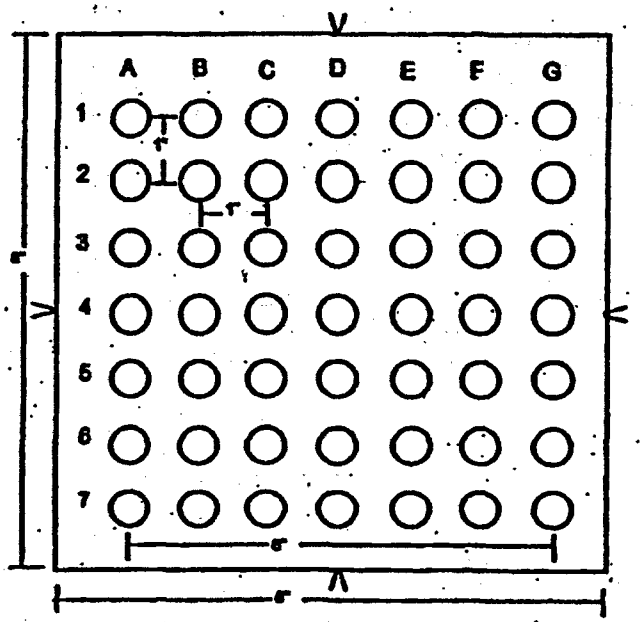
COMMENTS:
Grid Template aligned with V-stamps.
Template was placed at the bottom of the trench and forty-nine (49) points were recorded, then template was relocated above previous location with the centerline of the bottom row 1" +/- 1/16" from previous grid top row.
A total of 290 readings were taken.

All obstructions due to rough surface conditions. Some readings taken as best effort readings due to rough surface conditions.

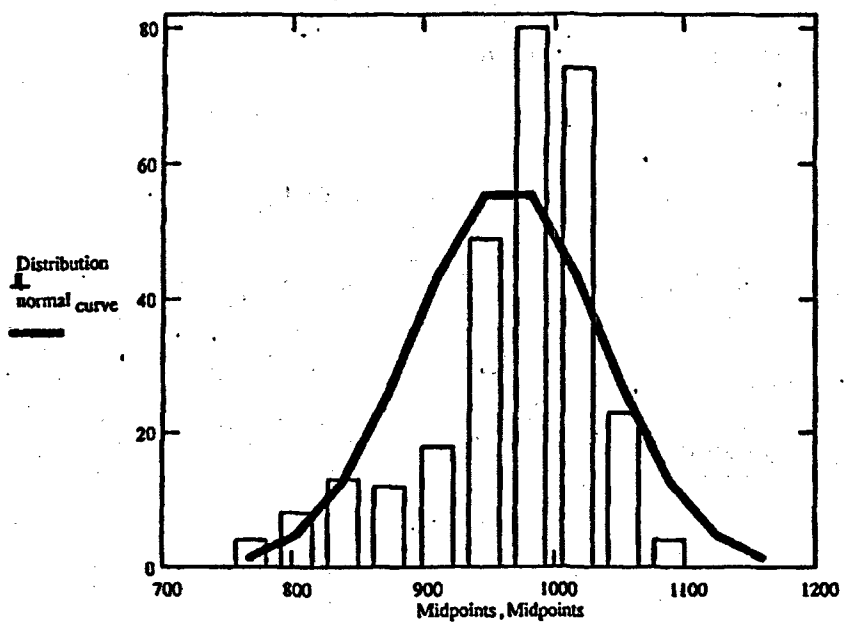
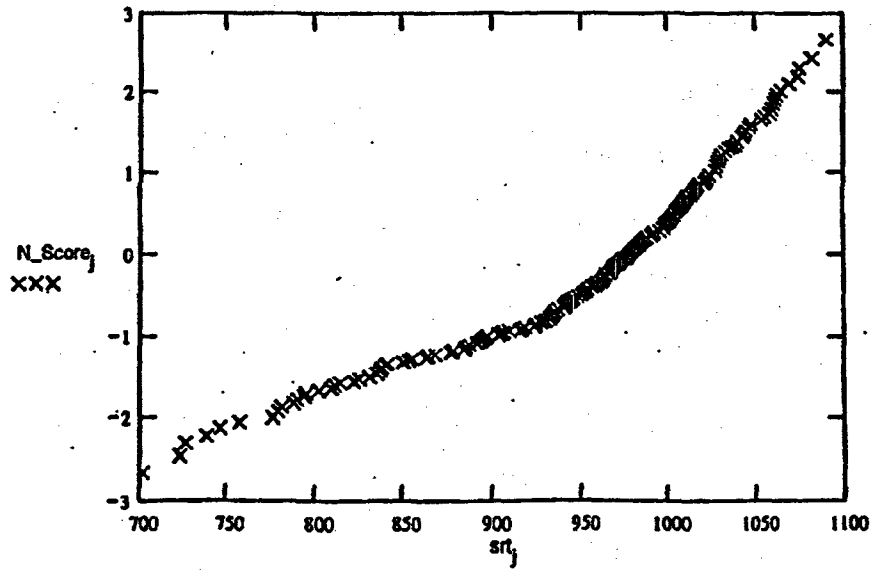
A Kurtosis value which is less than +/- 1.0 and approaches 0 is indicative of a normal distrubution. Therefore this distribution may not be completely normal. The data is skewed towards the right.

A Normal Probability Plot indicates the distrubution of this data is not completely normal

Review of the 2006 data shows that the first 49 point grid located at the top of the trench is much thinner than the remaining five 49 point grids lower in the trenchs

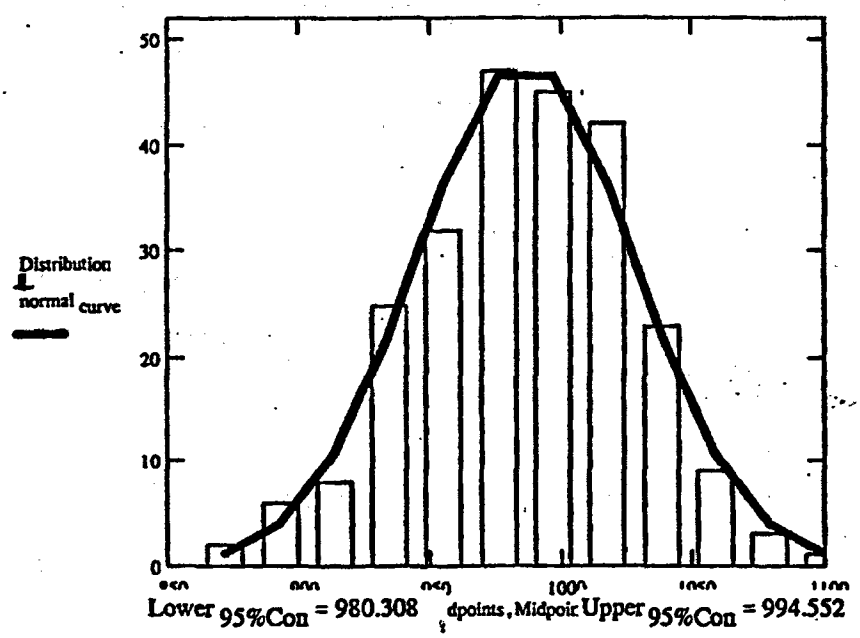
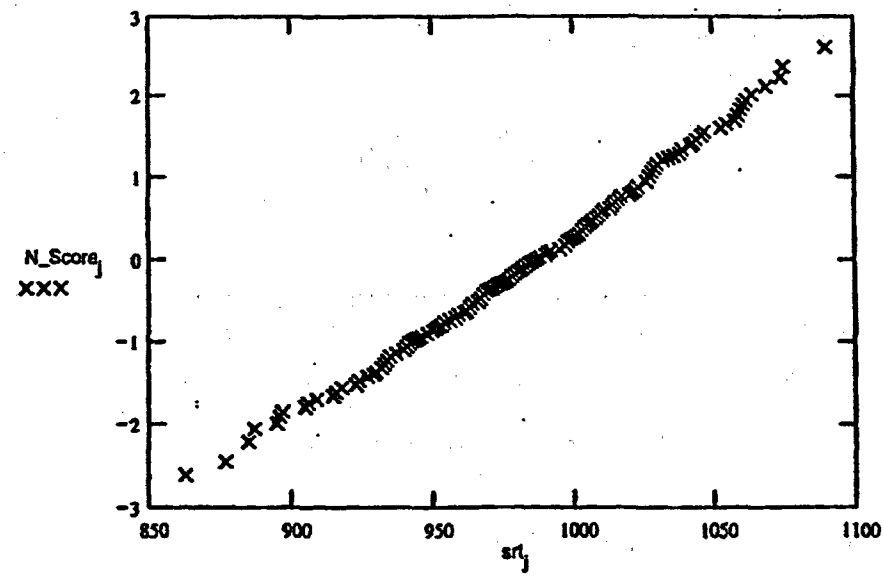
A Normal Probability Plot indicates the distrubution of this data is not completely normal

Therefore when considering the entire 2006 data (all 6 grids) set which is skewed, the corrosion rate from 1986 to 1992 was

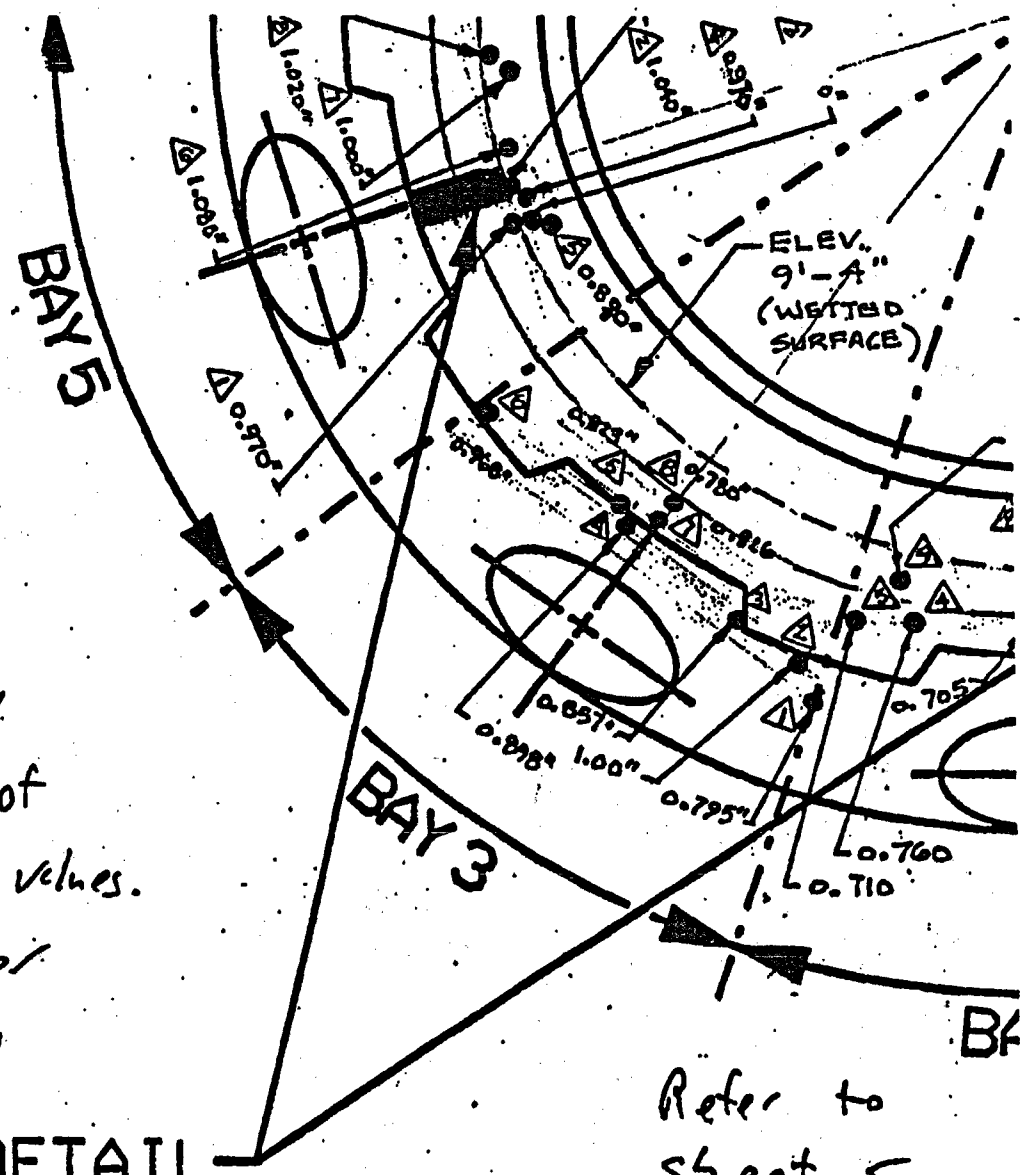
This sketch is provided only to show Location of points and not the actual values. Refer to Attachment 4 for 1992 and 2006 Thickness Readings
