VSC-24 CoC RENEWAL AGING MANAGEMENT REVIEW

ENERGYSOLUTIONS Spent Fuel Division	CALCULATION PACKAGE	Calc. Pkg No. VSC-04.3101 File No.: VSC-04.3101 Revision: 2

VSC-24 CoC Renewal Aging Management Review

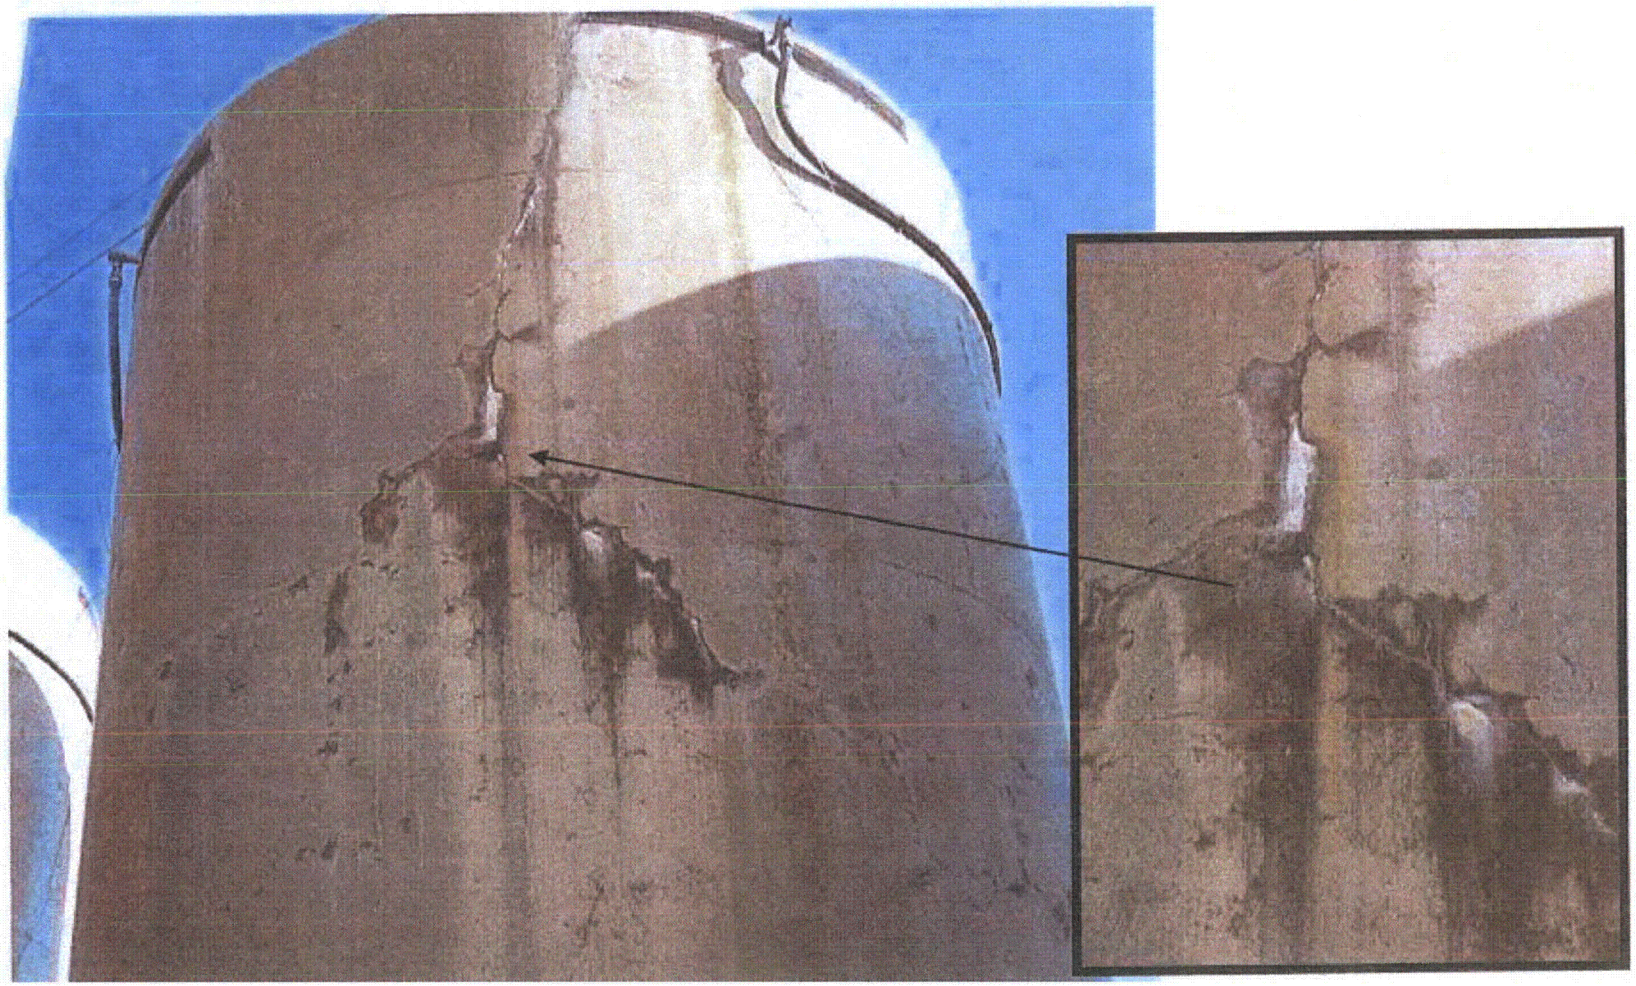
Figure 1 - VCC Surface Cracks and Mineral Deposits

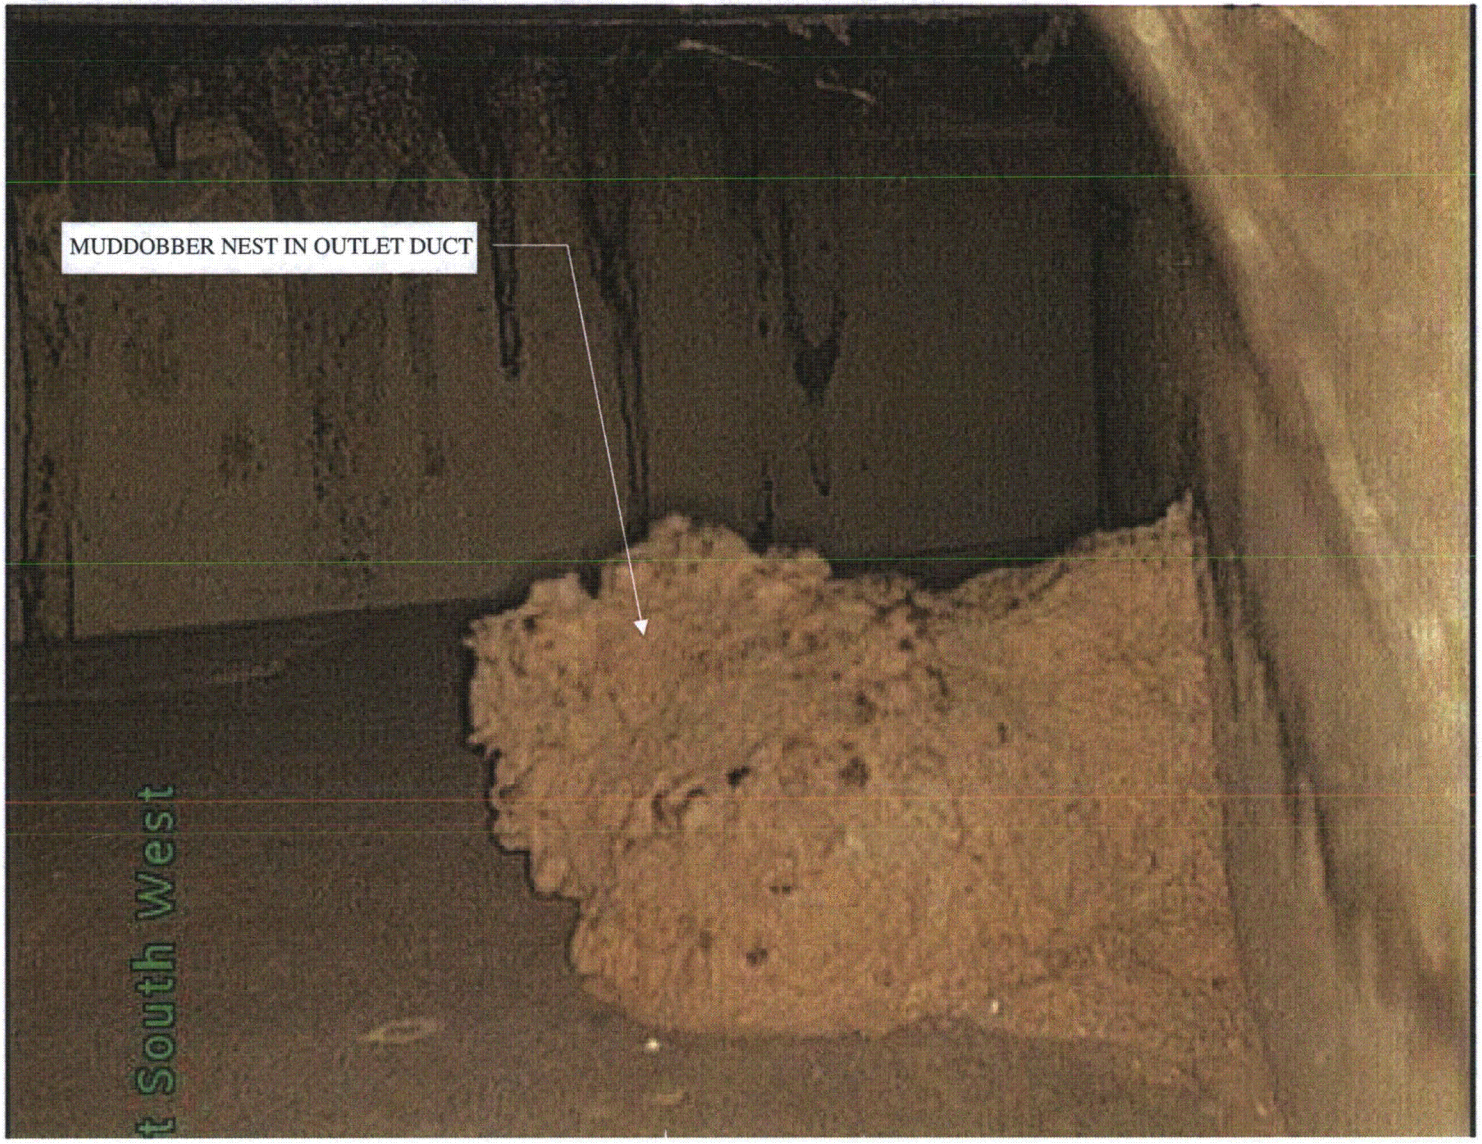
Figure 3 - Muddobber Nest in VCC Outlet Duct

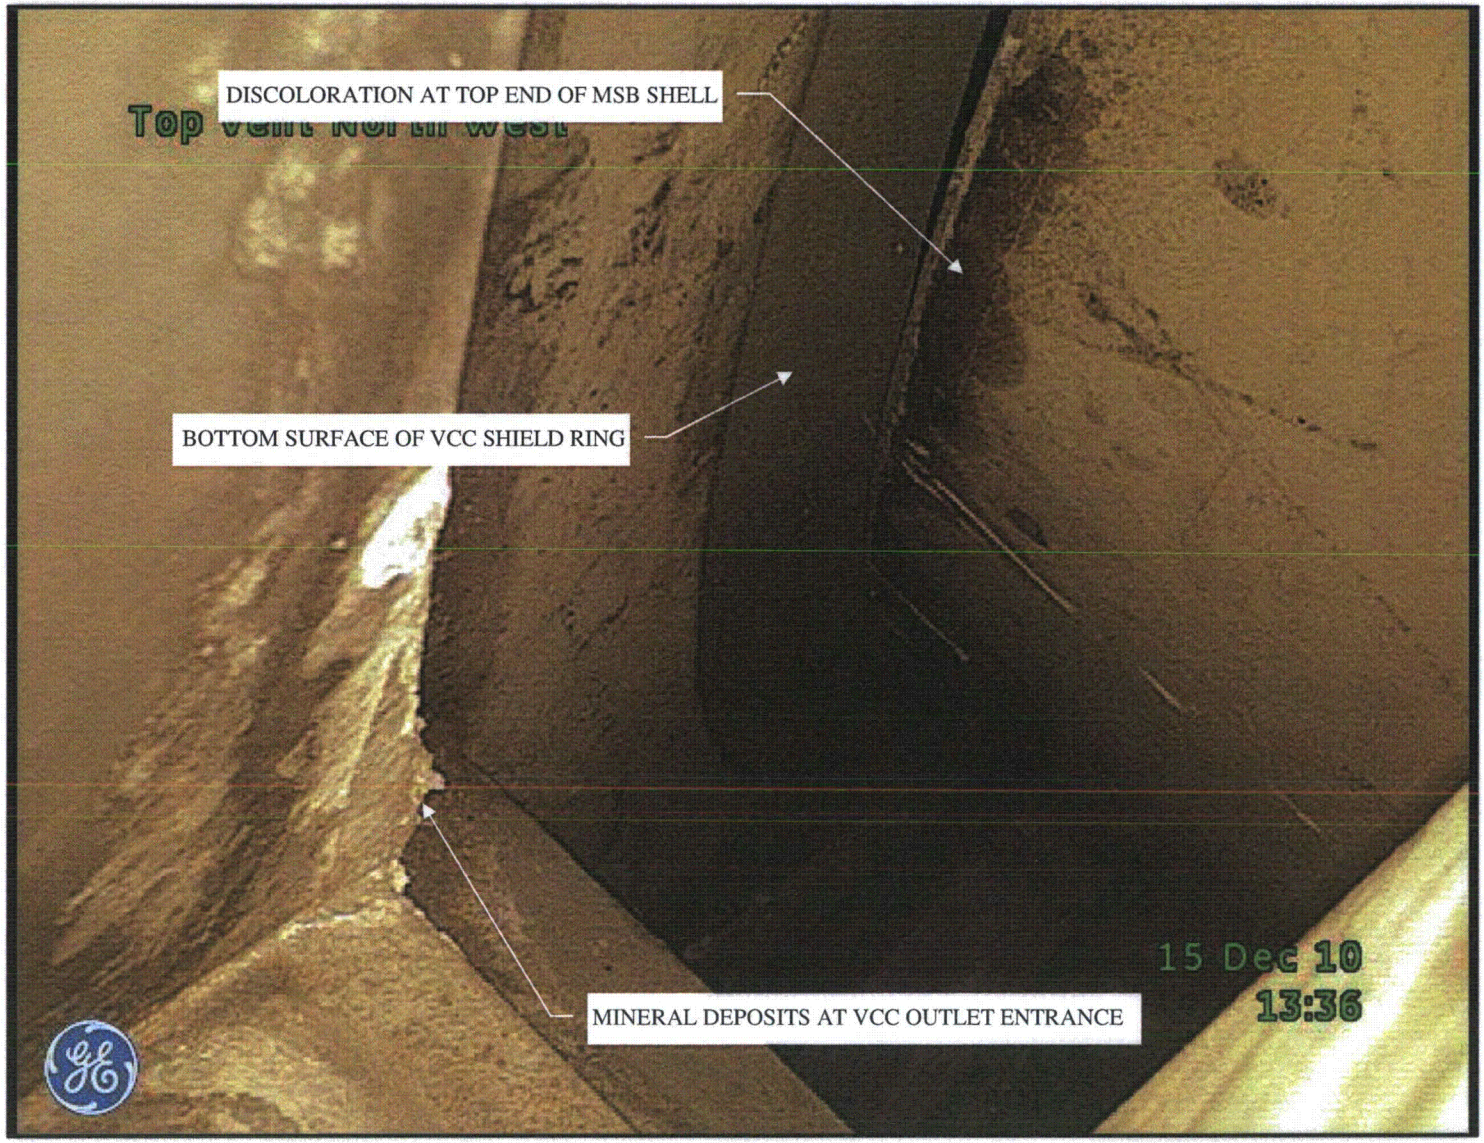
Figure 4 - Top End of VCC Annulus and MSB Assembly

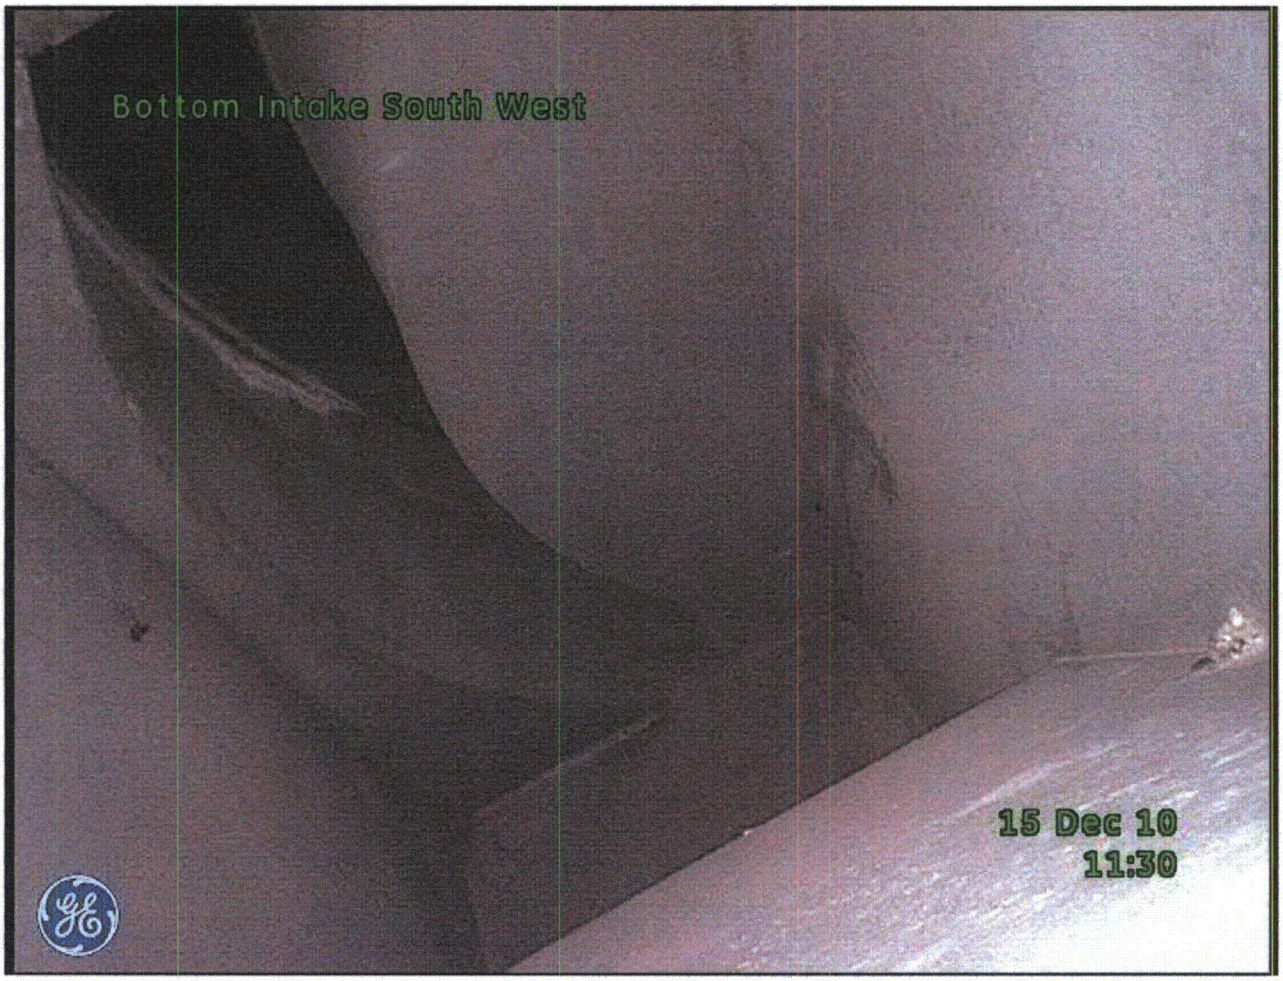
Figure 5 - VCC Air Inlet Duct (looking up into VCC annulus)

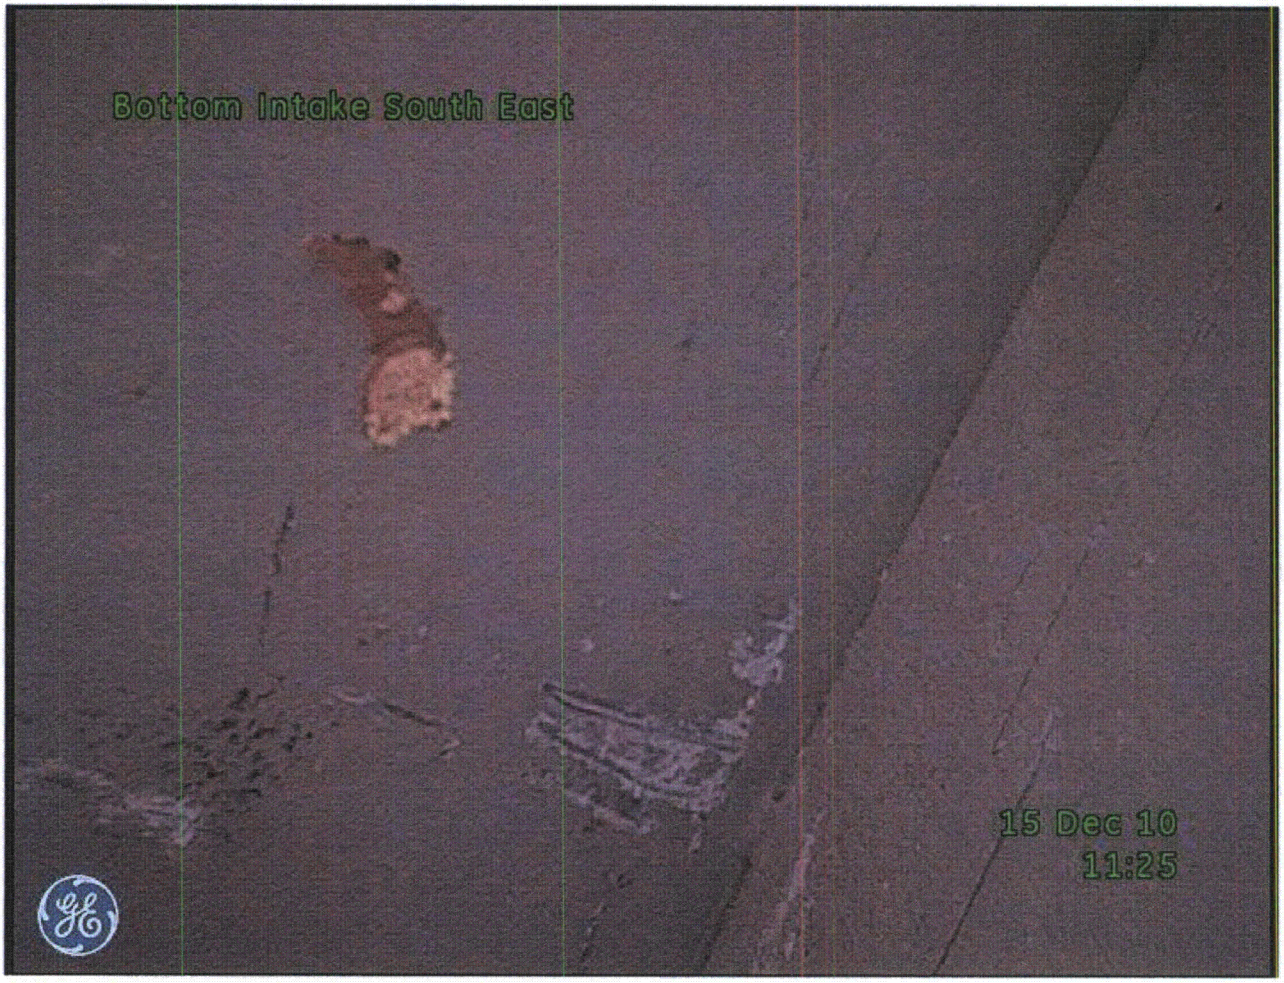
Figure 6 - Local Coating Failure and Metal Corrosion

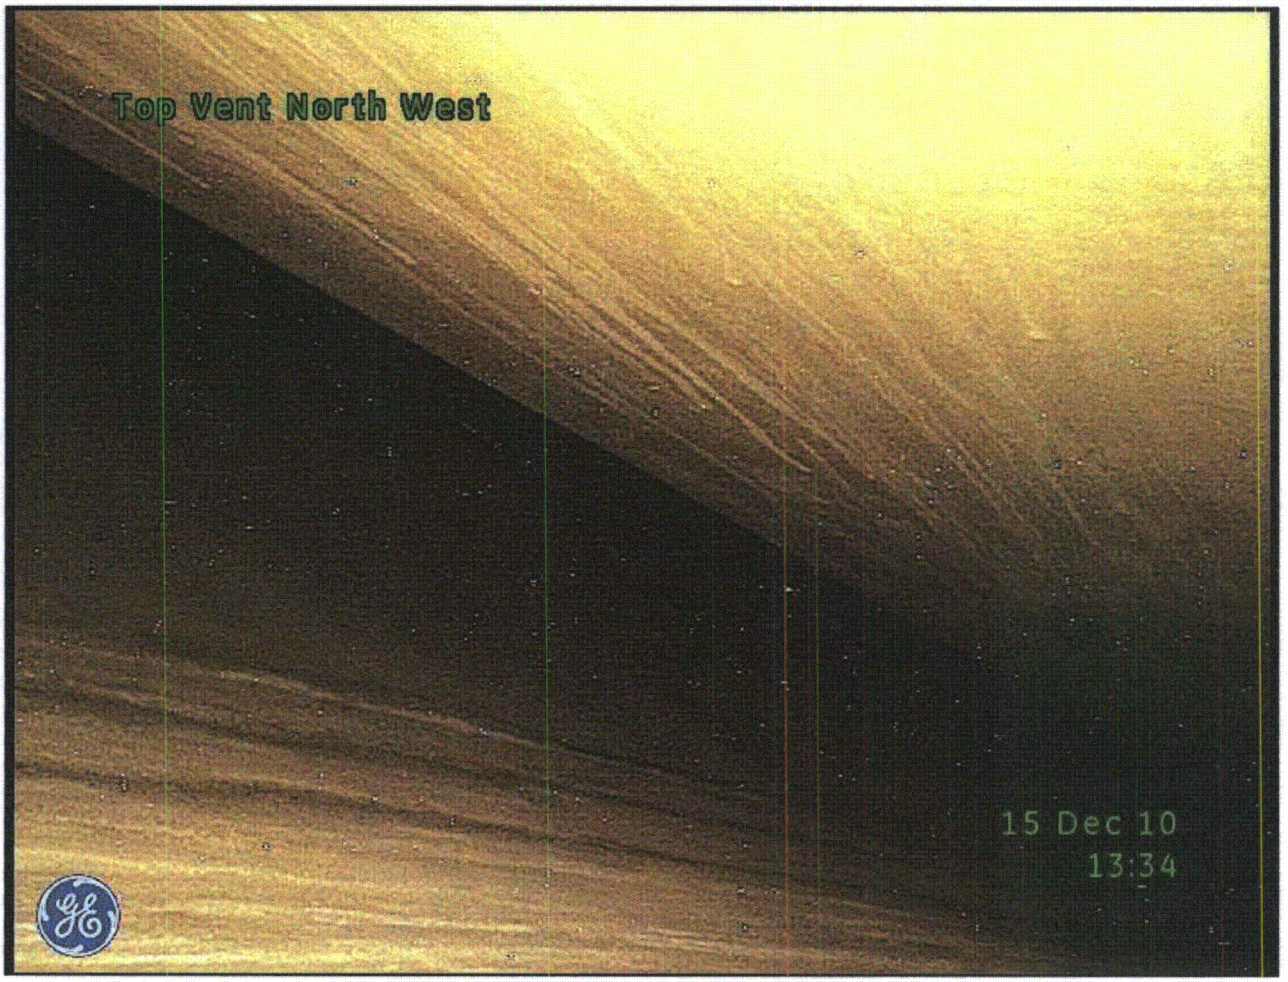
Figure 7 - Deposits on MSB Radial Surface

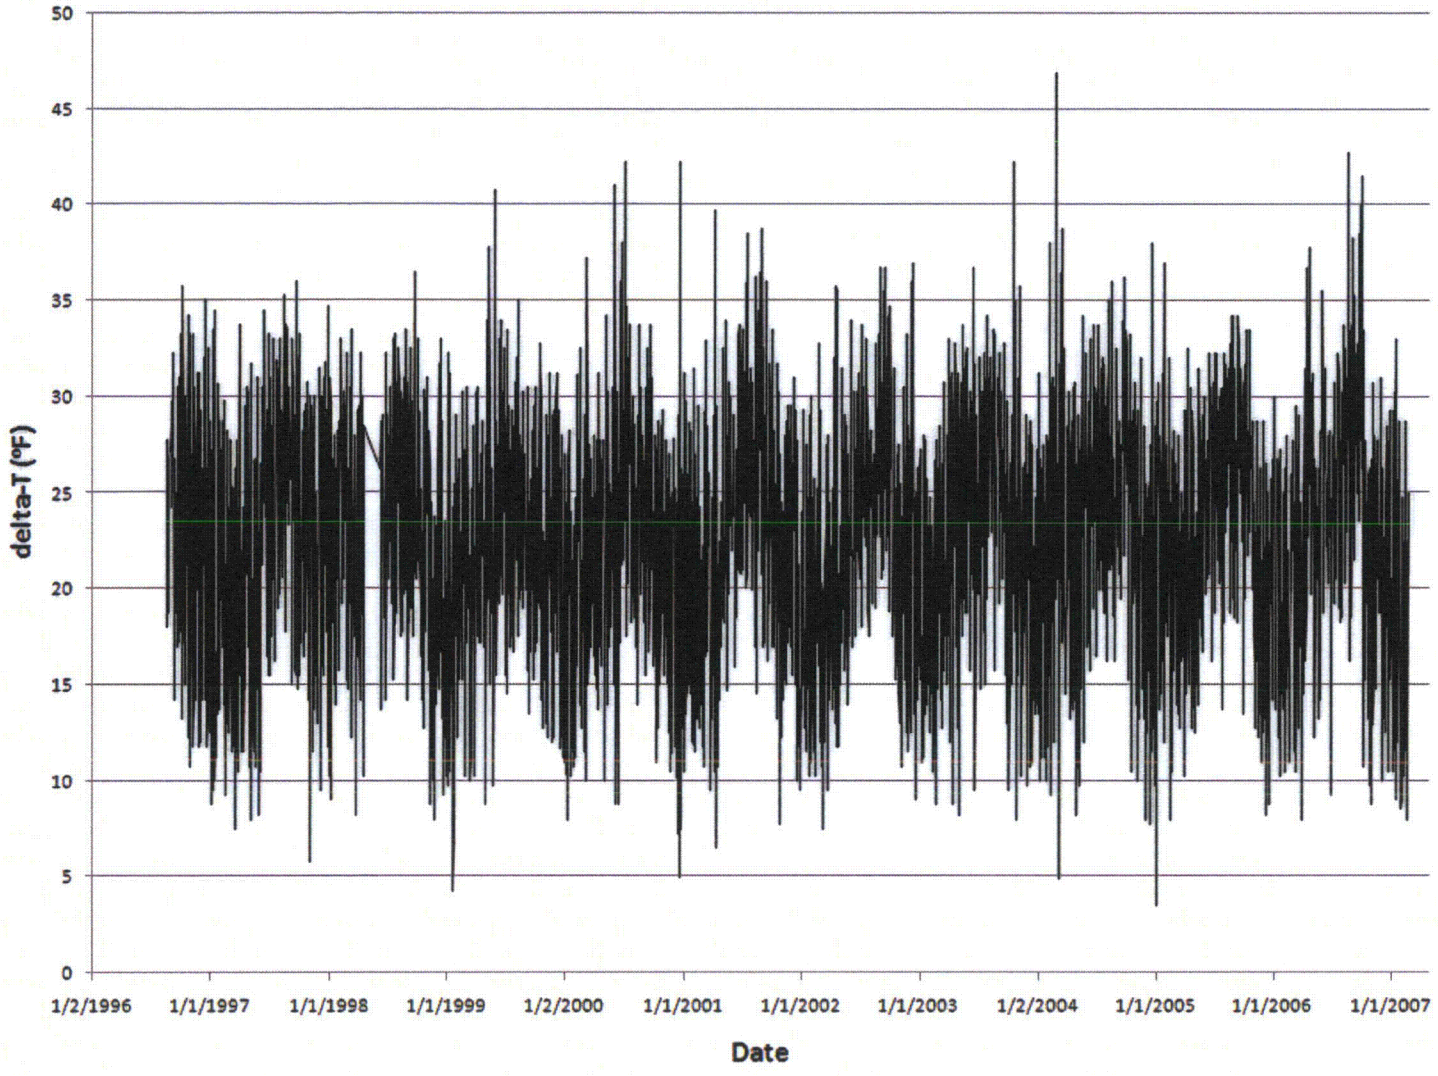
Figure 8 - Ventilation Air Temperature Rise for a Typical Cask

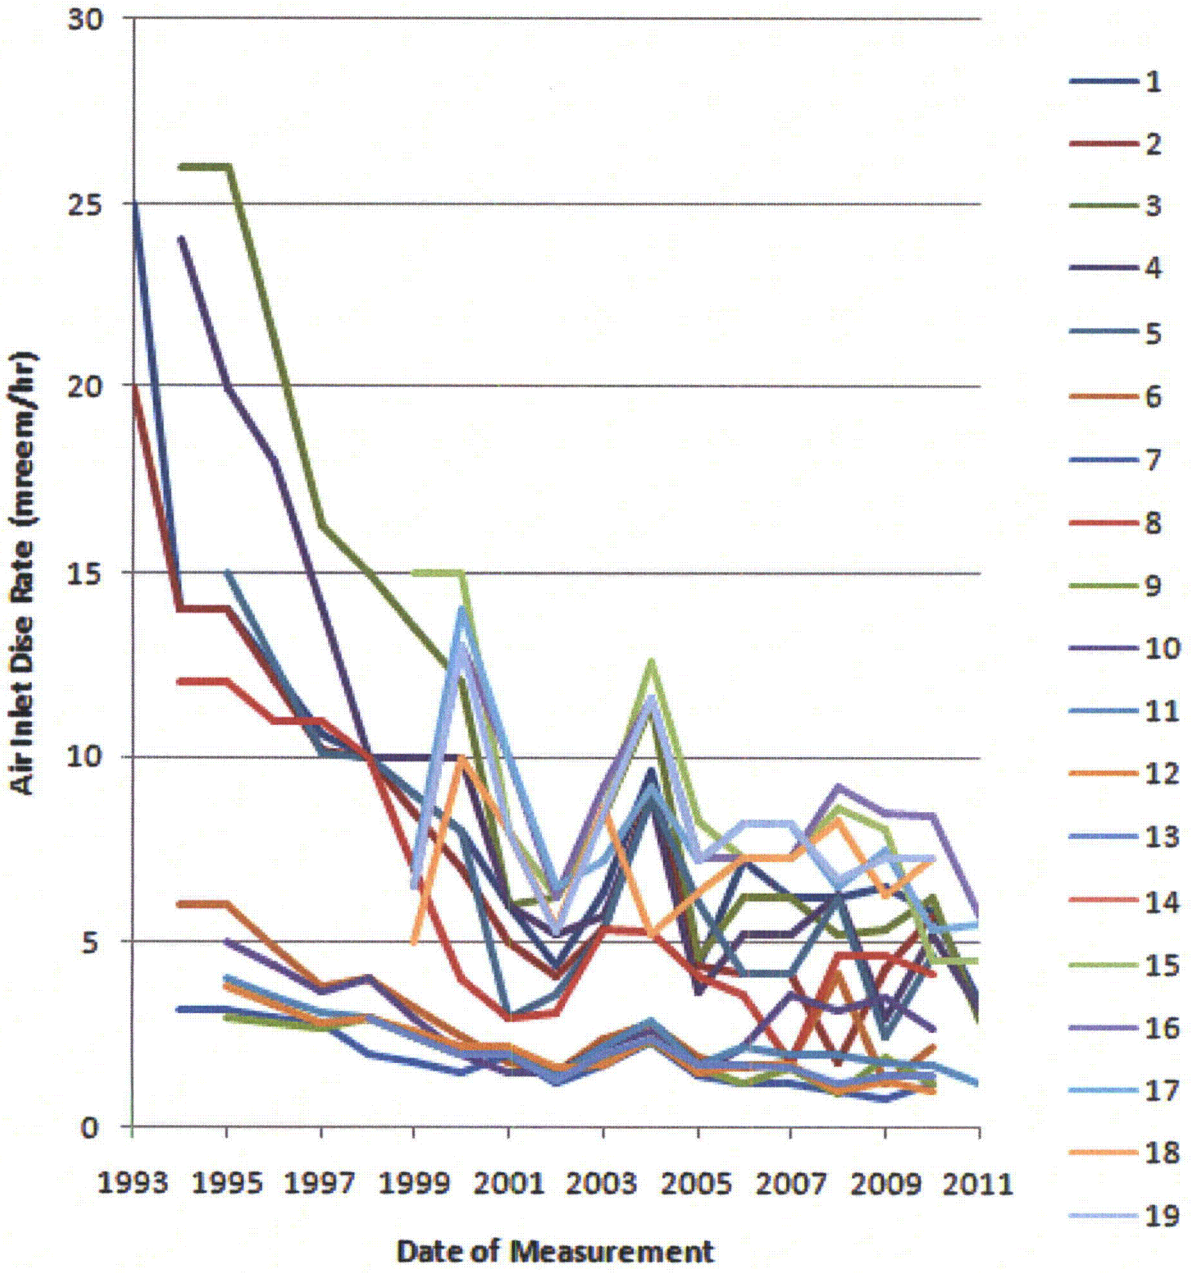
Figure 9 - Palisades Air Inlet Duct Dose Rate Trends

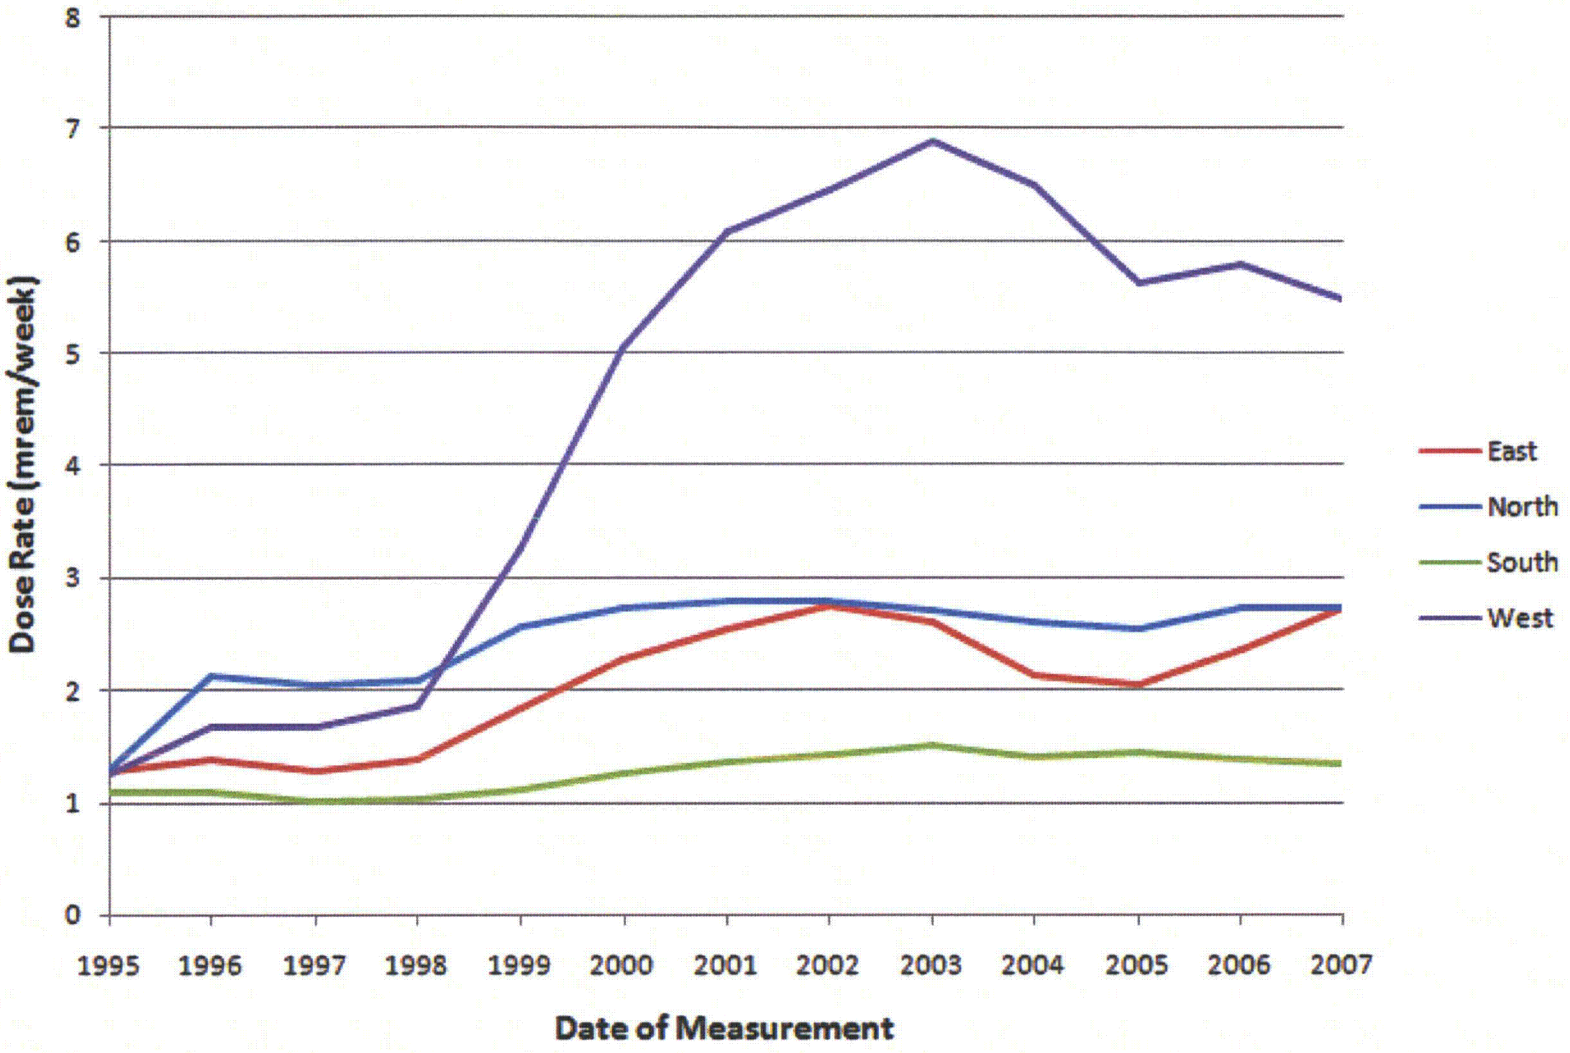
Figure 10 - Point Beach ISFSI Fence Dose Rate Trends
