CAMECO RESOURCES
CROW BUTTE OPERATION

Subject: Source Materials License SUA-1534
Docket No. 40-8943
Monitor Well Excursion – SM8-5

Monitor Well Laboratory Report

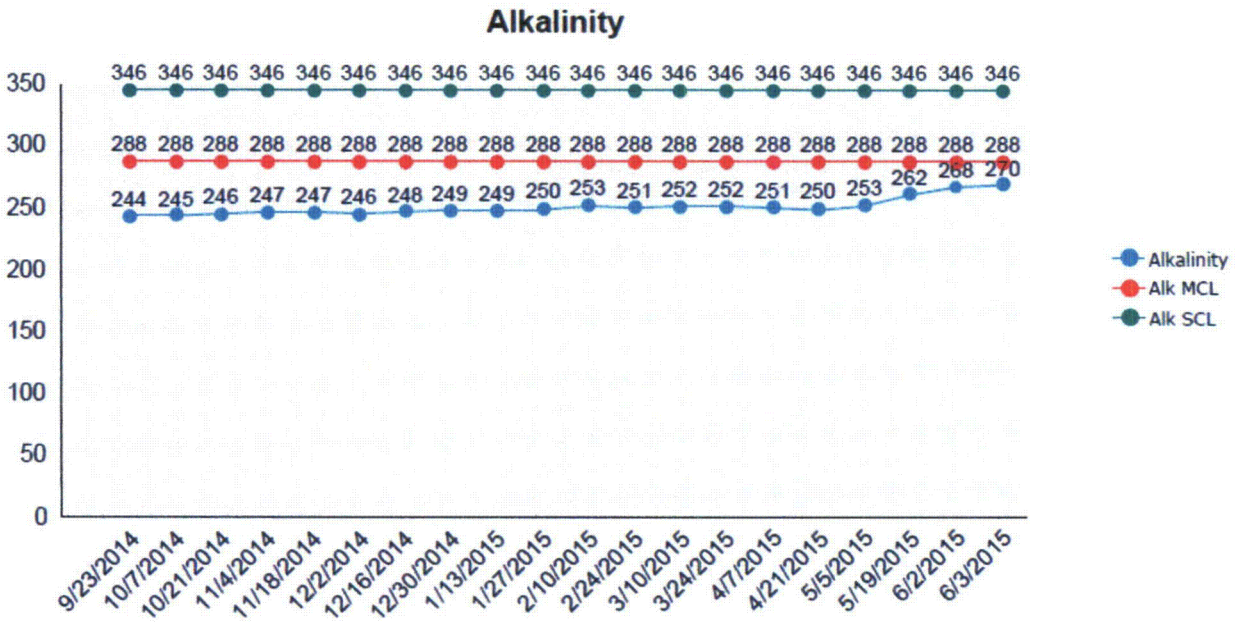
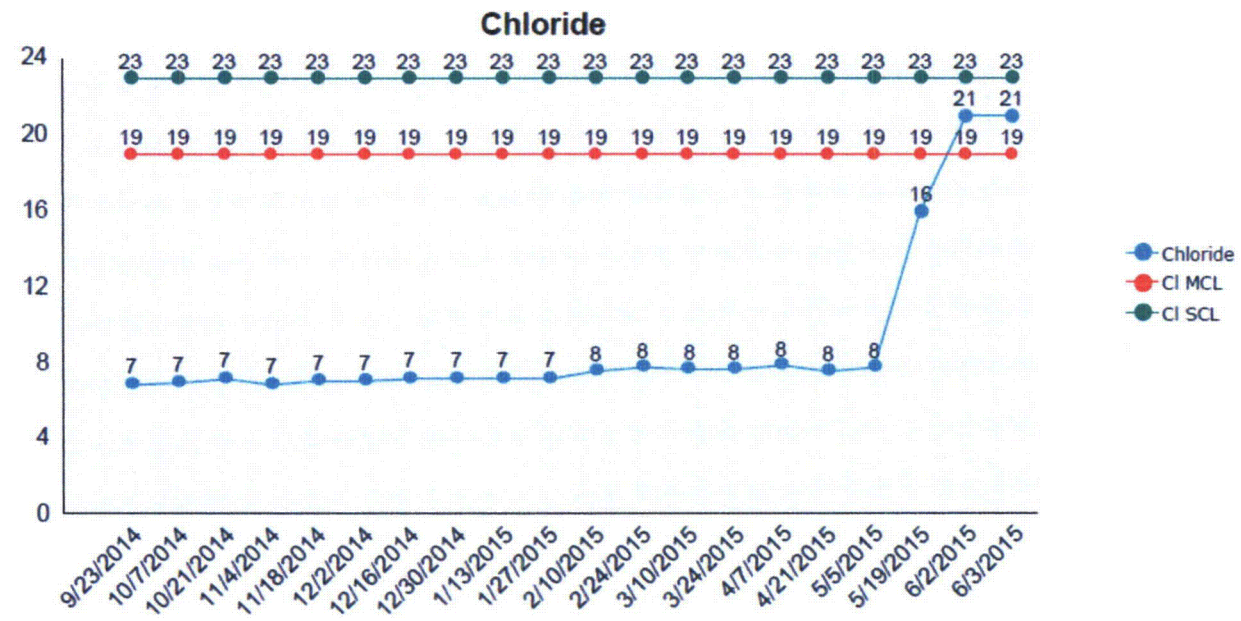
Crow Butte Resources
SM8-5

CBO notified Mr. Ron Burrows of the excursion by at 10:20 a.m. on June 3, 2015 as required in License Conditions 11.5 and 11.6. Laboratory results for the sample analysis for SM8-5 are attached. In addition, graphs are attached for the three excursion indicator parameters and water levels that cover the period from September 23, 2014, to June 3, 2015.

CBO believes that the apparent excursion is due to increased groundwater levels caused by 5+ inches of rain and 20" inches of snow received during May. This conclusion is supported by the following indications:

1. The water level has increased steadily throughout the spring, with a marked increase during the last two weeks. The well is located in an area of high groundwater near the springs that form the source of English Creek. Groundwater quality in this area is under

In accordance with License Condition 11.5, CBO has increased the sampling frequency for SM8-5 to weekly until three consecutive weekly samples are below the exceeded UCLs. Also, per the requirements of License Condition 11.12, CBO will test weekly for natural uranium. CBO will continue weekly sampling for an additional three weeks after this goal has been achieved as required by CBO's NDEQ Class III UIC Permit requirements. If the well has not exceeded the UCLs after these samples, it will be returned to normal status.
