WCAP-13188

D. C. Cook Unit-1

Steam Generator Tube Plugging Criteria for Indications at Tube Support Plates

March 1992

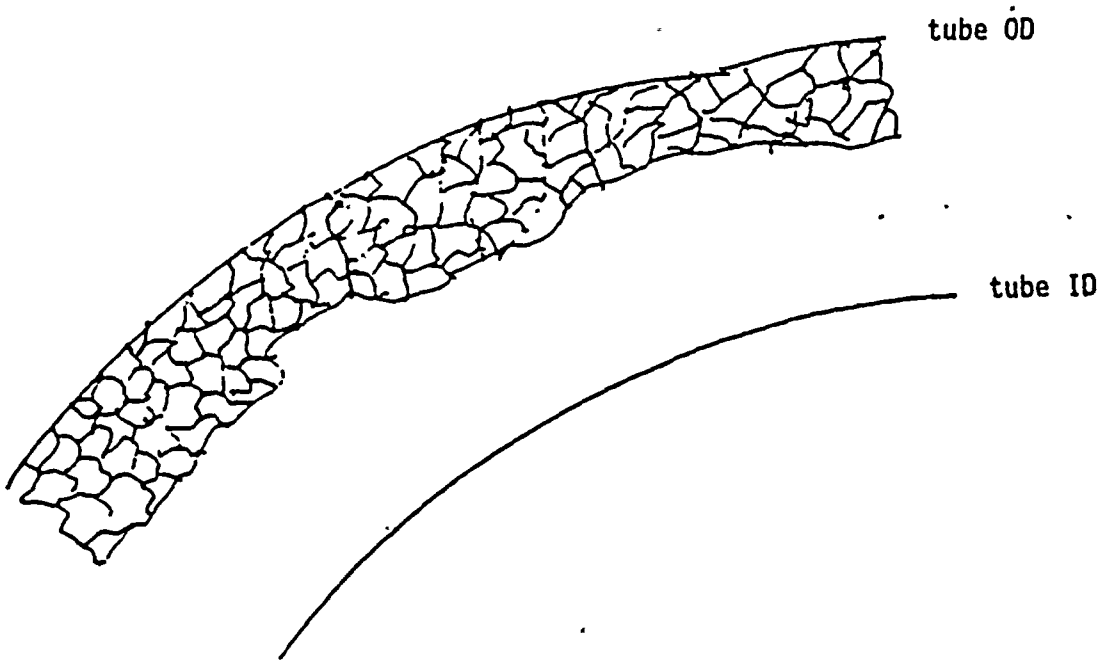
Figure 4-1 Patch and uniform IGA morphology as observed in a transverse tube section. (A similar observation would be made from a longitudinal section.)

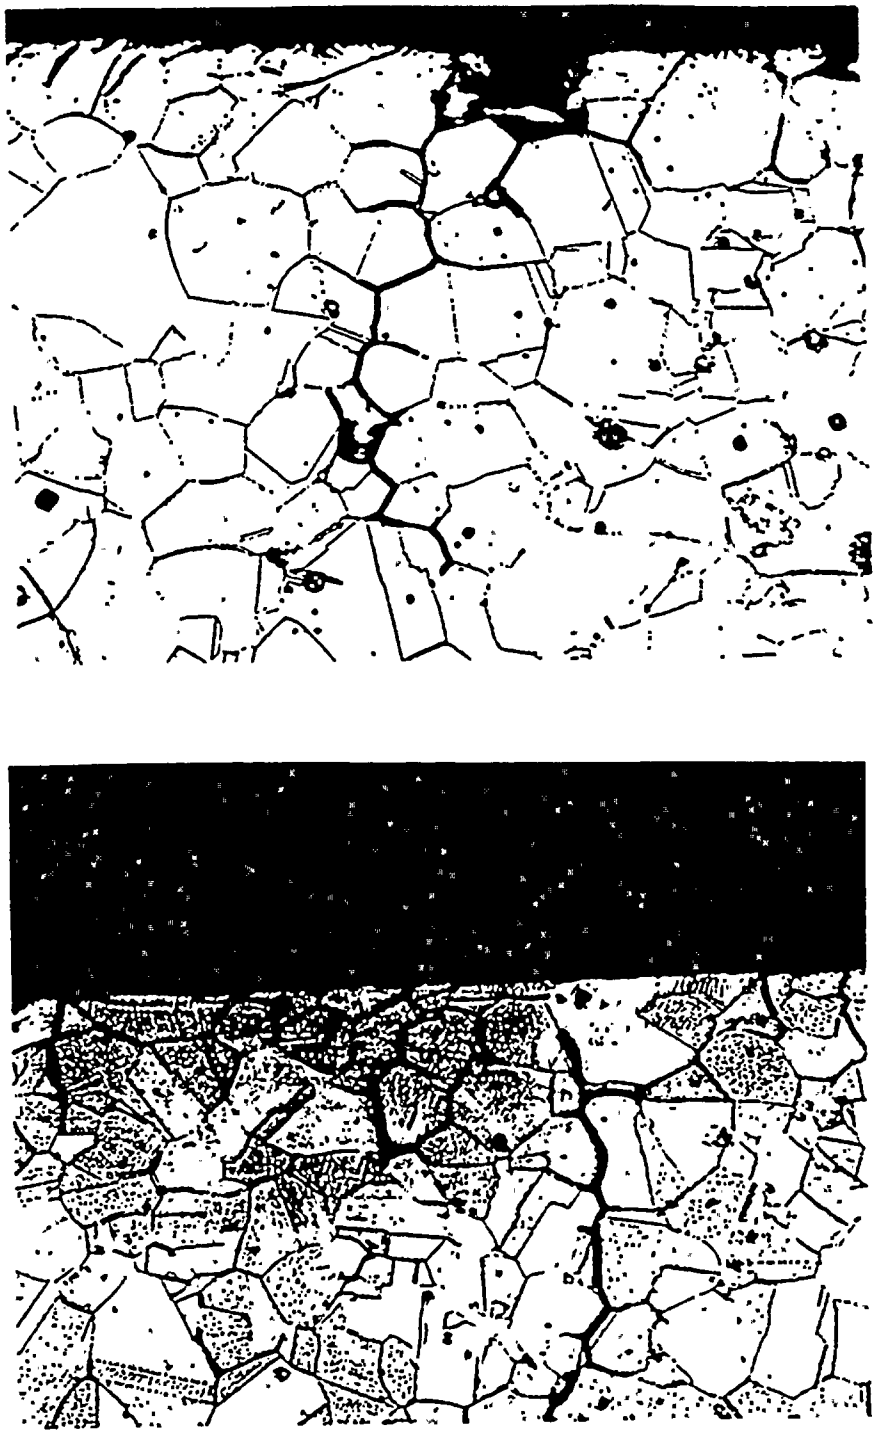
Figure 4-5 Tube R21-C31 from Cook Unit 1, first support plate region, transverse OD metallography, Mag. 500X.

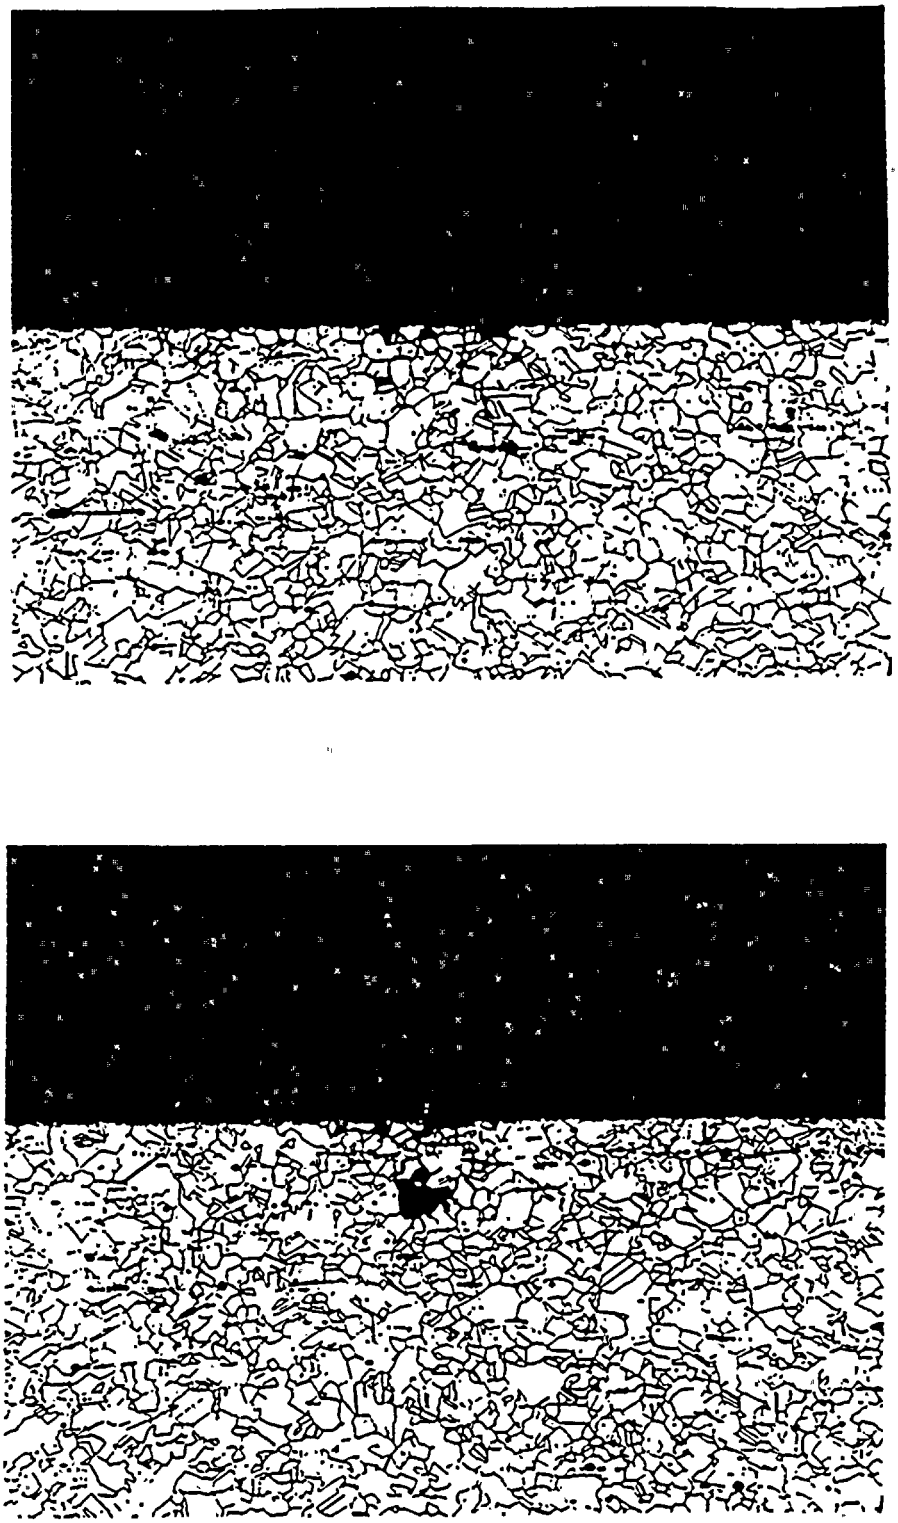
Three axial cracks were found on tube R21-C31 at three separate locations around the circumference within the mid-crevice region on the single circumferential metallographic section made and examined from within the crevice region. Their morphology was that of axial IGSCC with moderate IGA aspects (D/W = 5 for the deepest, 10% deep, crack). Some shallow (< 4% deep) intergranular penetrations, possibly IGA, existed nearby. Figure 4-5 shows photomicrographs of these cracks. An axial section through the crevice region revealed small zones with intergranular corrosion, also up to 10% deep. Figure 4-6 shows photomicrographs of two of the deeper areas.

Figure 4-6 Tube R21-C31 from Cook Unit 1, first support plate region, longitudinal OD metallography, Mag. 100X.

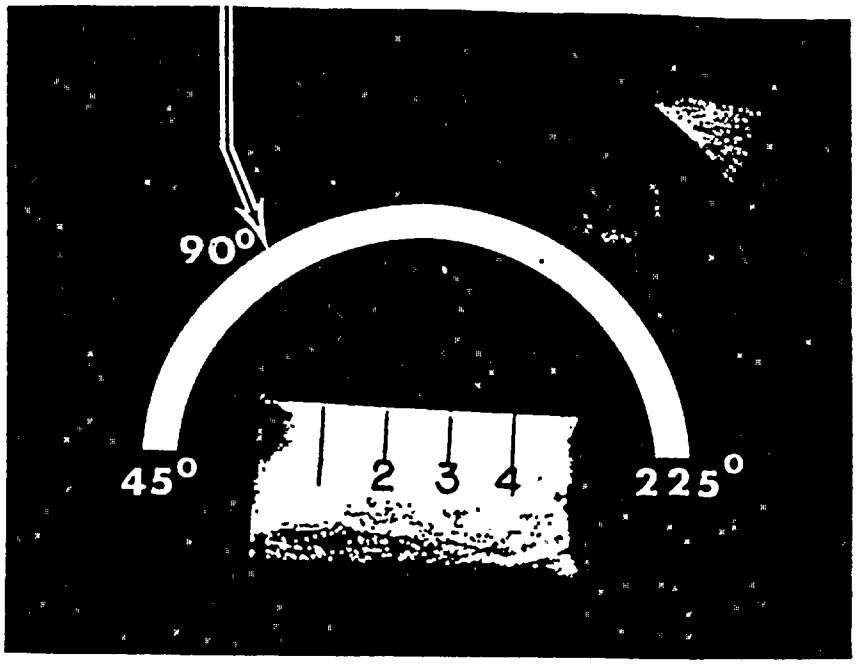
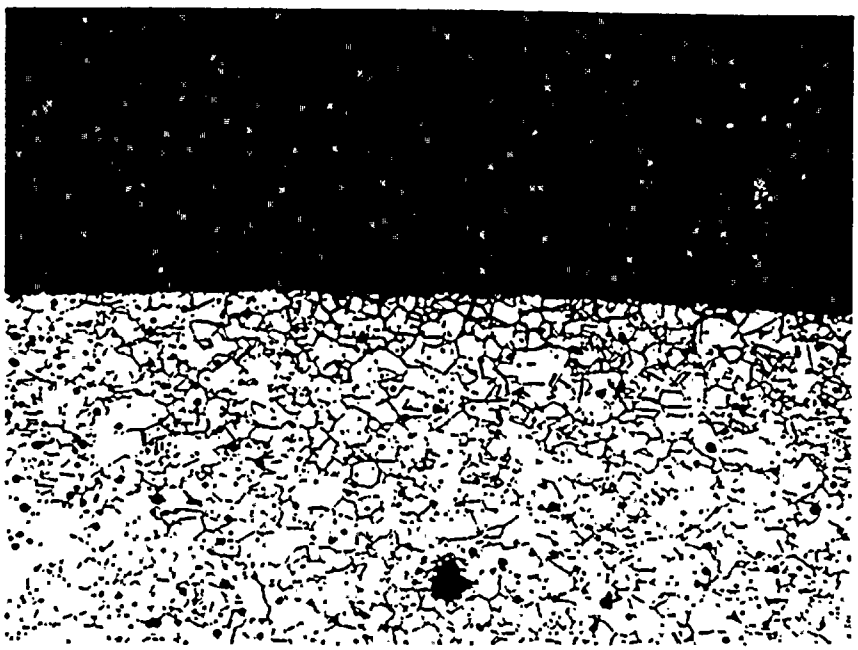
Up to 4% deep intergranular corrosion on tube R18-C33 was found at two locations on a transverse half-ring section cut from within the mid-crevice region. No axial metallography was performed. The shallow intergranular corrosion had a patch IGA morphology that may have been from the early stages of patch IGA development. Alternatively, the degradation could have been local intergranular penetrations at a location where incipient IGSCC was developing. Deeper corrosion degradation would need to have been found to separate these two possibilities. Figure 4-7 shows photomicrographs made of the deepest observed corrosion.

Figure 4-7 Tube R18-C33 from Cook Unit 1, first support plate region, longitudinal OD metallography, Mag. 100X (bottom photo).

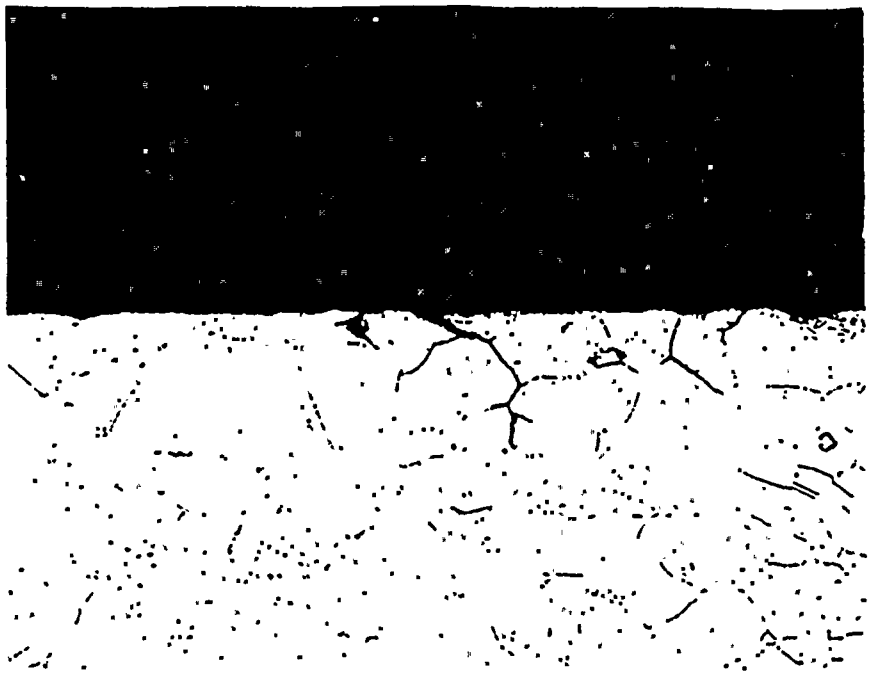
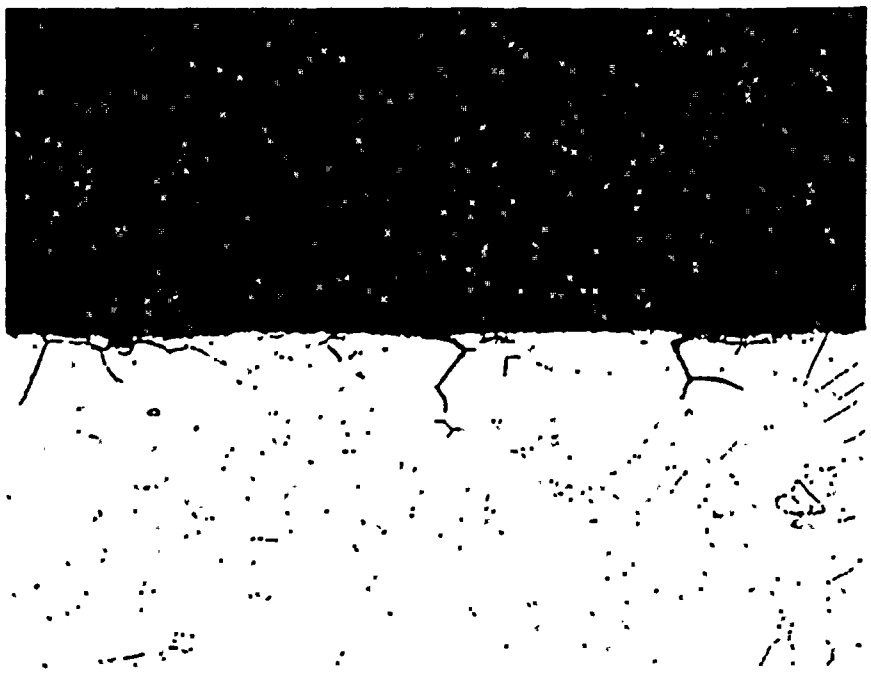
The 2% deep degradation on tube R17-C33 was found at one location on a longitudinal section cut from within the mid-crevice region of the support plate. No corrosion was found on a transverse half-ring section. Again, it is very difficult to discuss the morphology of such shallow corrosion degradation. It appeared that the morphology was that of five very shallow, close together, intergranular penetrations, possibly that of incipient axial IGSCC. Figure 4-8 shows photomicrographs of the corrosion.

Figure 4-8 Tube R17-C33 from Cook Unit 1, first support plate region, longitudinal OD metallography, Mag. 500X.

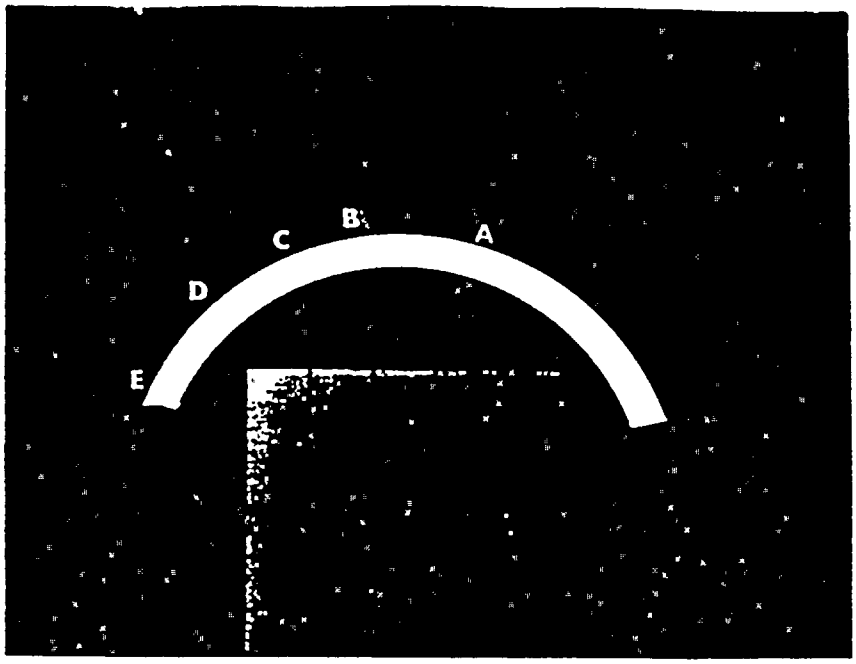
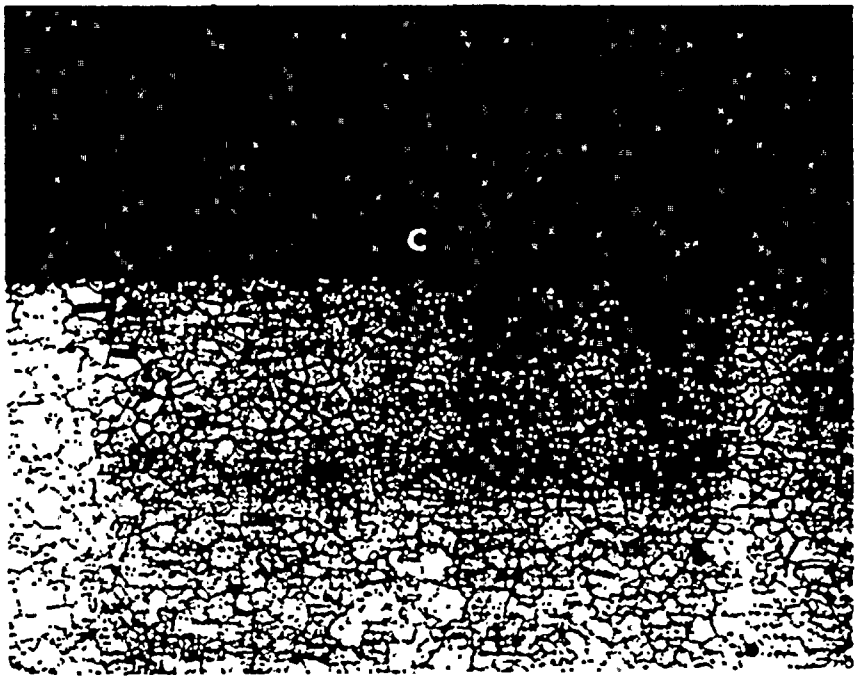
The two tubes from Steam Generator 24 had the deepest support plate location corrosion, 30% each. Tube R19-C55 was examined within the crevice region using five nearly complete transverse rings and one axial section. Axial IGSCC existed throughout the support plate crevice region. The deeper cracks had D/W ratios that typically ranged from 7 to 14 with one as low as 3. No surface IGA or IGP was present. Figures 4-9 through 4-12 show selected photomicrographs of the corrosion. The first support plate region of tube R21-C58 was examined using nearly complete transverse metallographic rings, as well as, an axial section. Axial IGSCC was found throughout the crevice region, although the corrosion was more concentrated on one half of the circumference within the crevice region. It was estimated that approximately 30 cracks existed at the mid-crevice region. D/W ratios of 5 to 20 were observed for the deeper cracks. Intermittent areas within the crevice regions had shallow intergranular penetrations on the OD surface. Figures 4-13 through 4-16 show photomicrographs of the corrosion.

Figure 4-9 Tube R19-C55 from Cook Unit 2, first support plate region, transverse OD metallography, Mag. 100X (bottom photo).

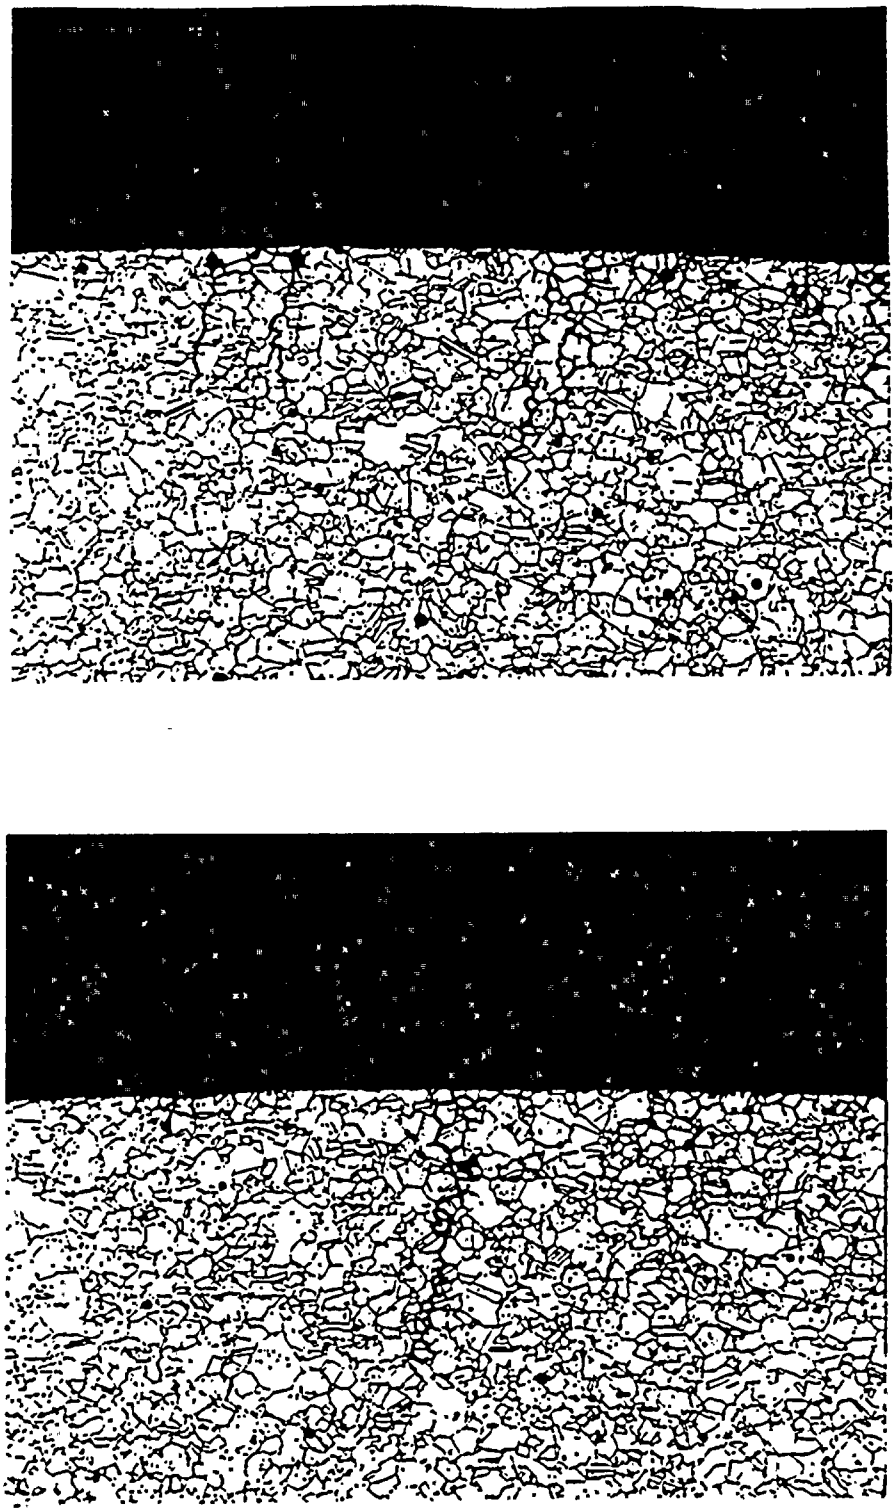
Figure 4-10 Tube R19-C55 from Cook Unit 2, first support plate region, transverse OD metallography (from a different section than the one shown in Figure 4-9), Mag. 100X.

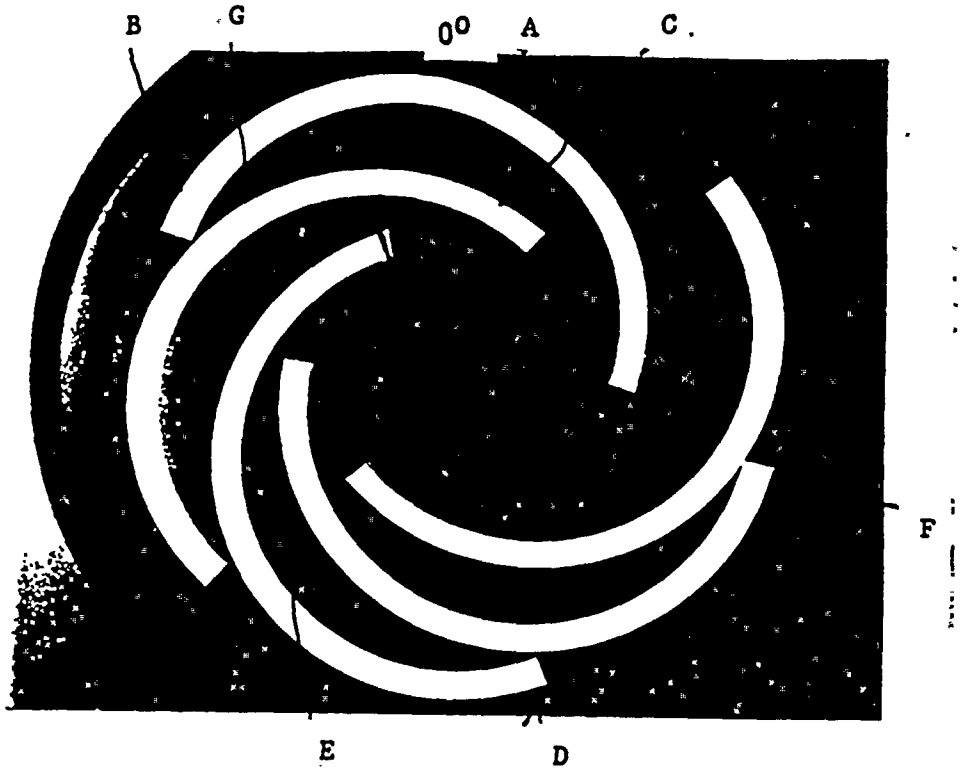
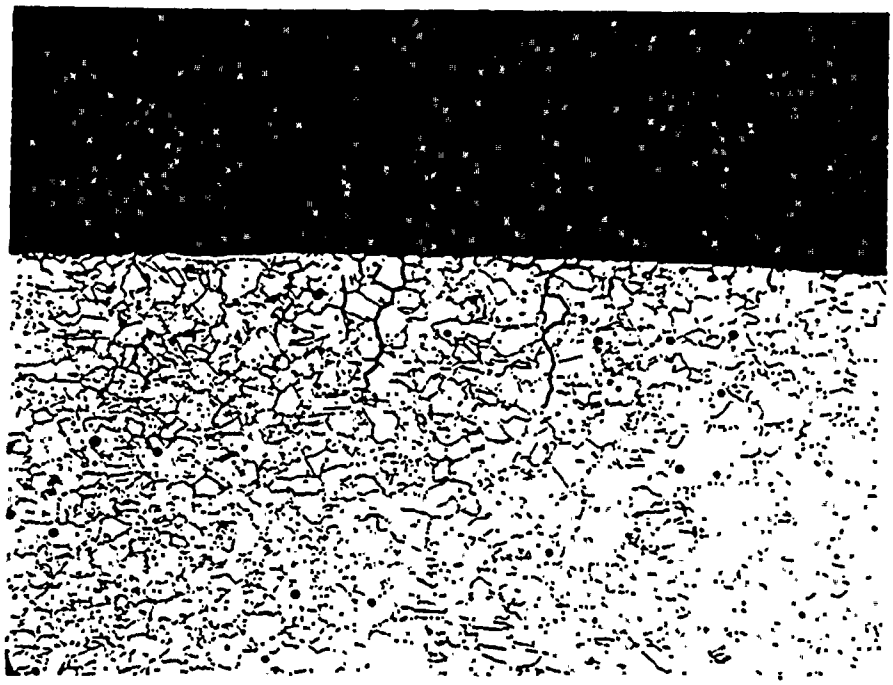
Figure 4-11 Tube R19-C55 from Cook Unit 2, first support plate region, transverse OD metallography (bottom photo is one of many areas with observed cracking on a series of transverse met. sections different than those shown in Figures 4-9 and 4-10), Mag. 100X (bottom photo).

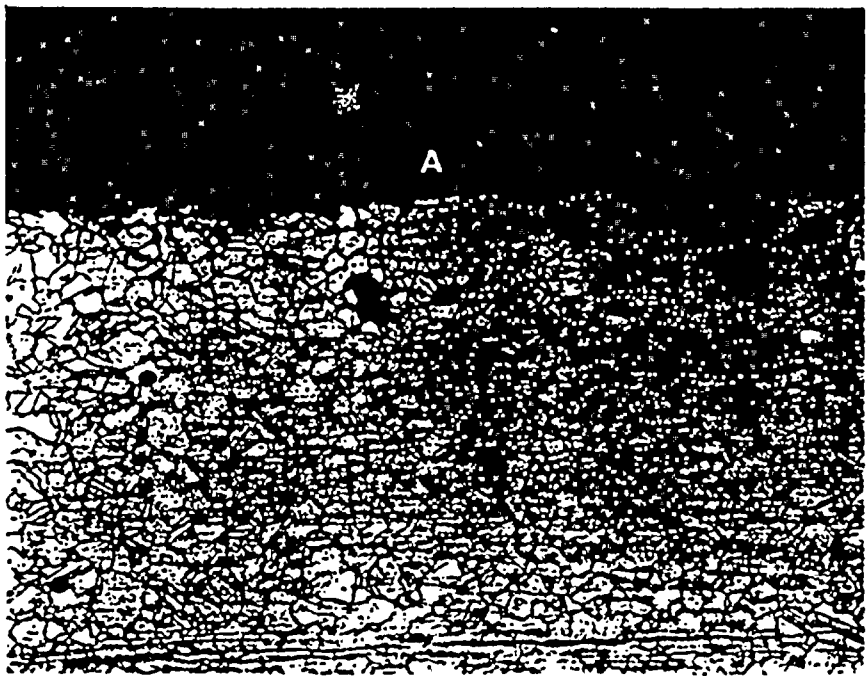
Figure 4-12 Tube R19-C55 from Cook Unit 2, first support plate region, longitudinal OD metallography, Mag: 100X (bottom photo).

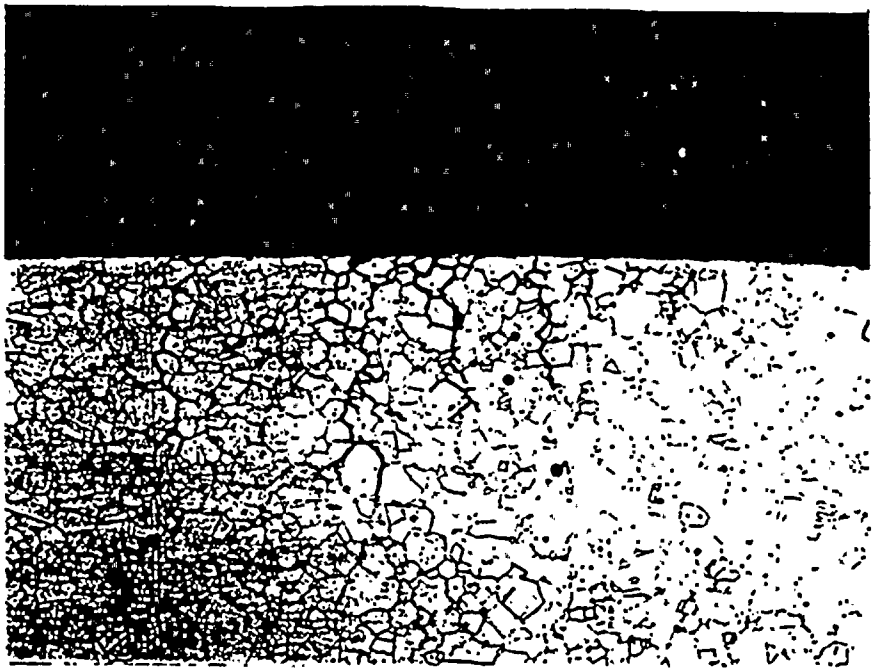
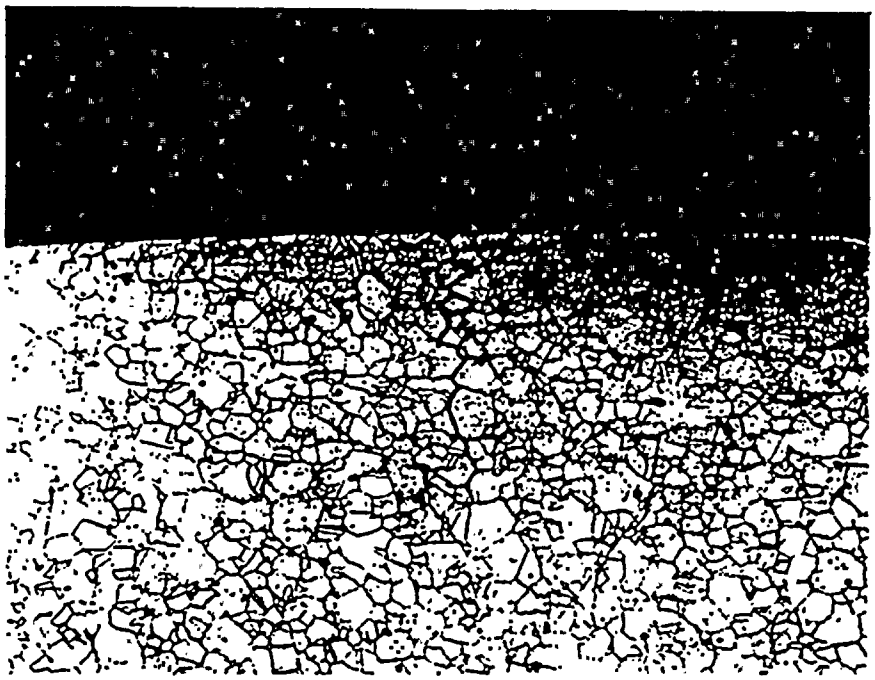
Figure 4-13 Tube R21-C58 from Cook Unit 2, first support plate region, transverse OD metallography, Mag. 100X.

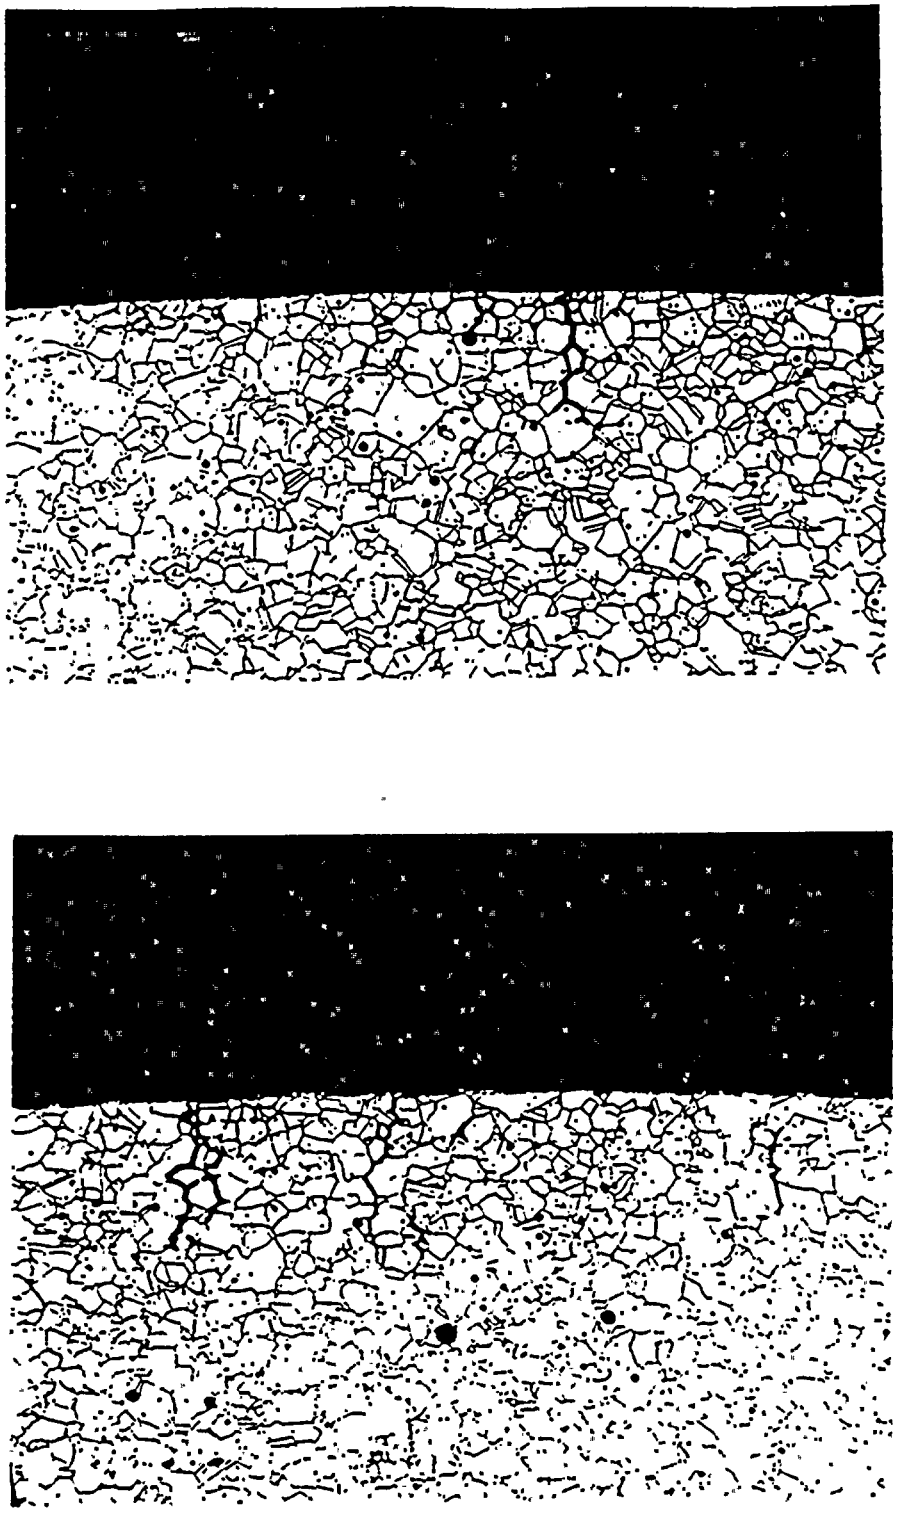
Figure 4-14 Tube R21-C58 from Cook Unit 2, first support plate region, transverse OD metallography (from a different section than the one shown in Figure 4-13), Mag. 100X.

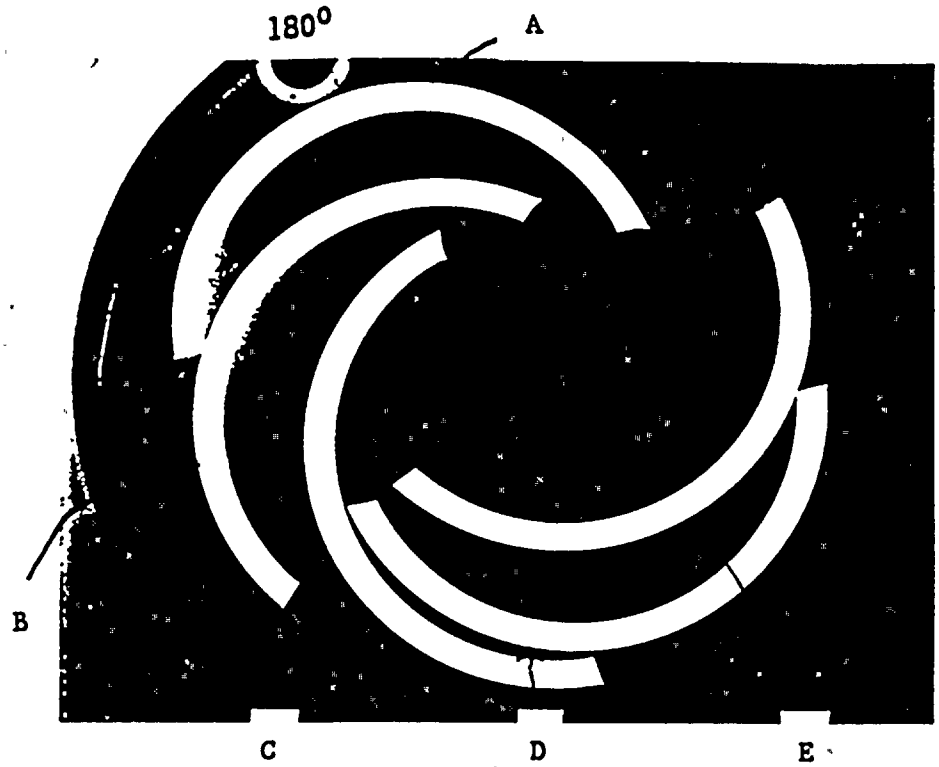
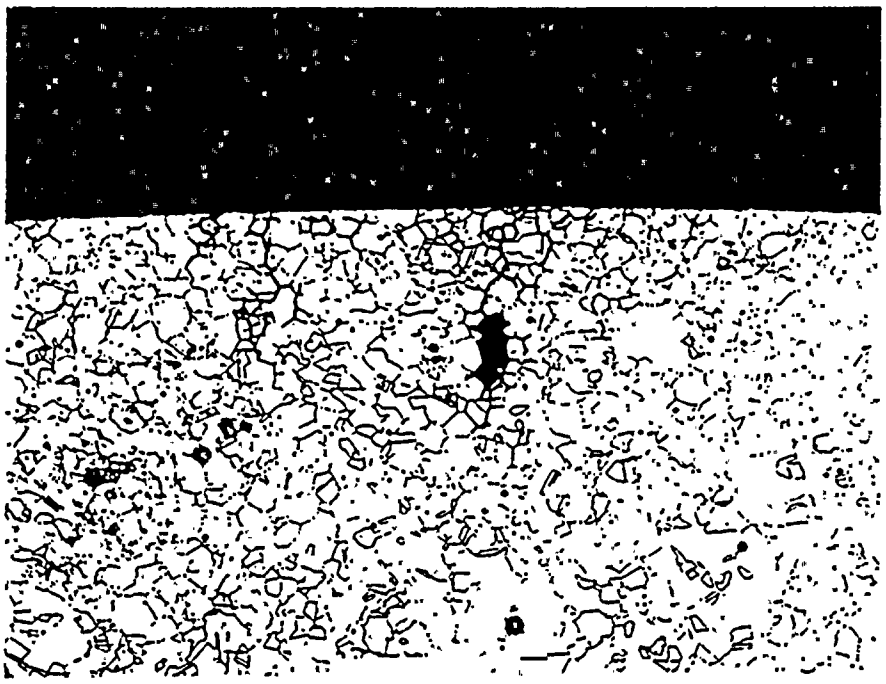
Figure 4-15 Tube R19-C55 from Cook Unit 2, first support plate region, transverse OD metallography (bottom photo is one of many areas with observed cracking on a series of transverse met. sections different than those shown in Figures 4-13 and 4-14), Mag. 100X (bottom photo).

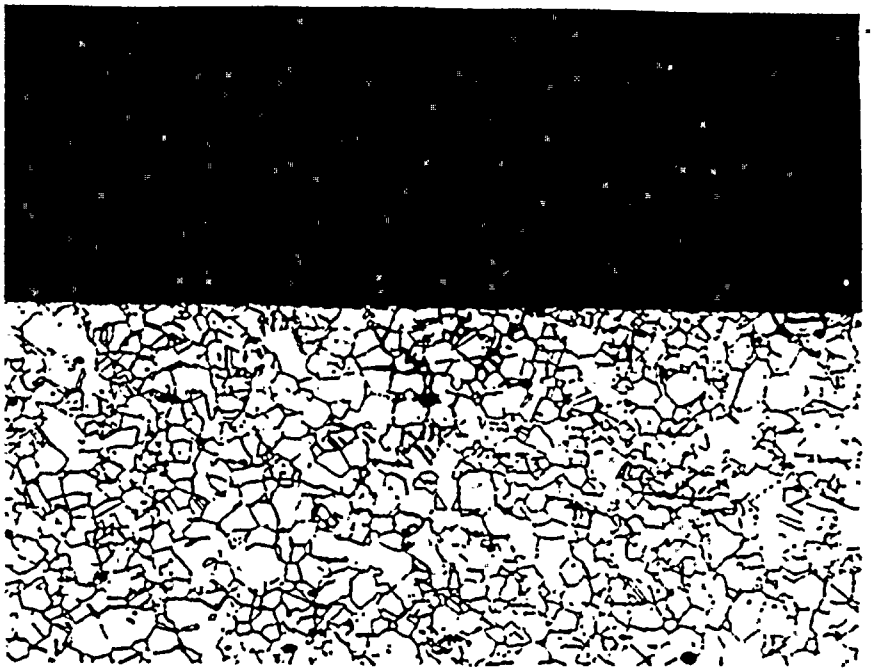
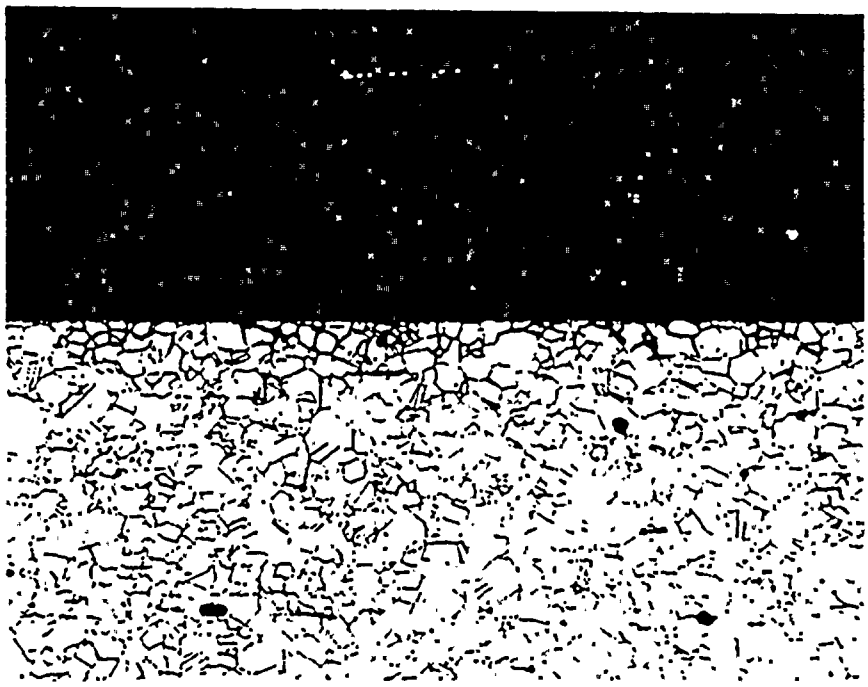
Figure 4-16 Tube R21-C58 from Cook Unit 2, first support plate region, longitudinal OD metallography, Mag. 100X.

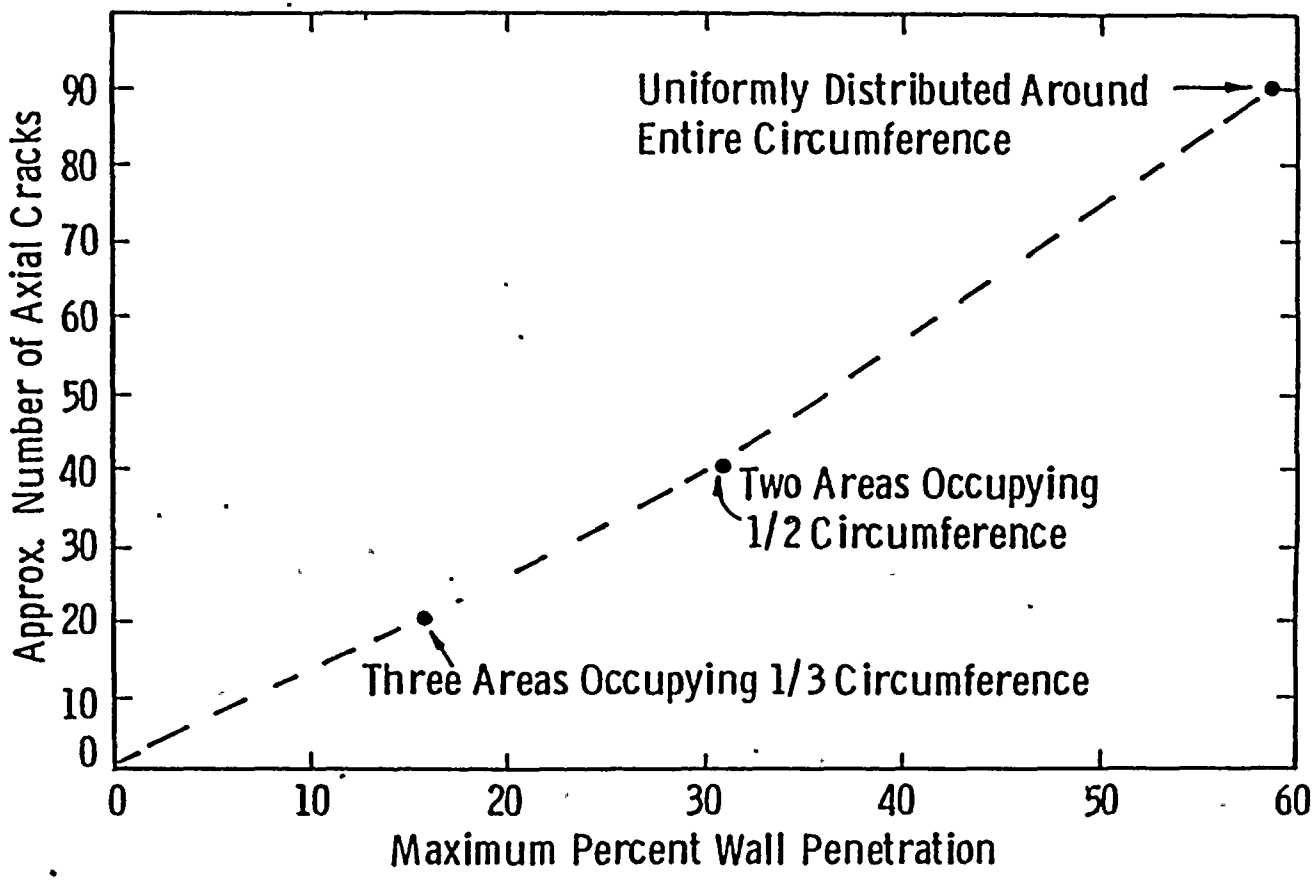
Figure 4-18 Plot of the number of cracks in a transverse plane versus maximum wall penetration for the first, second and third support plate region of tube R7-C38 from Cook Unit 2.

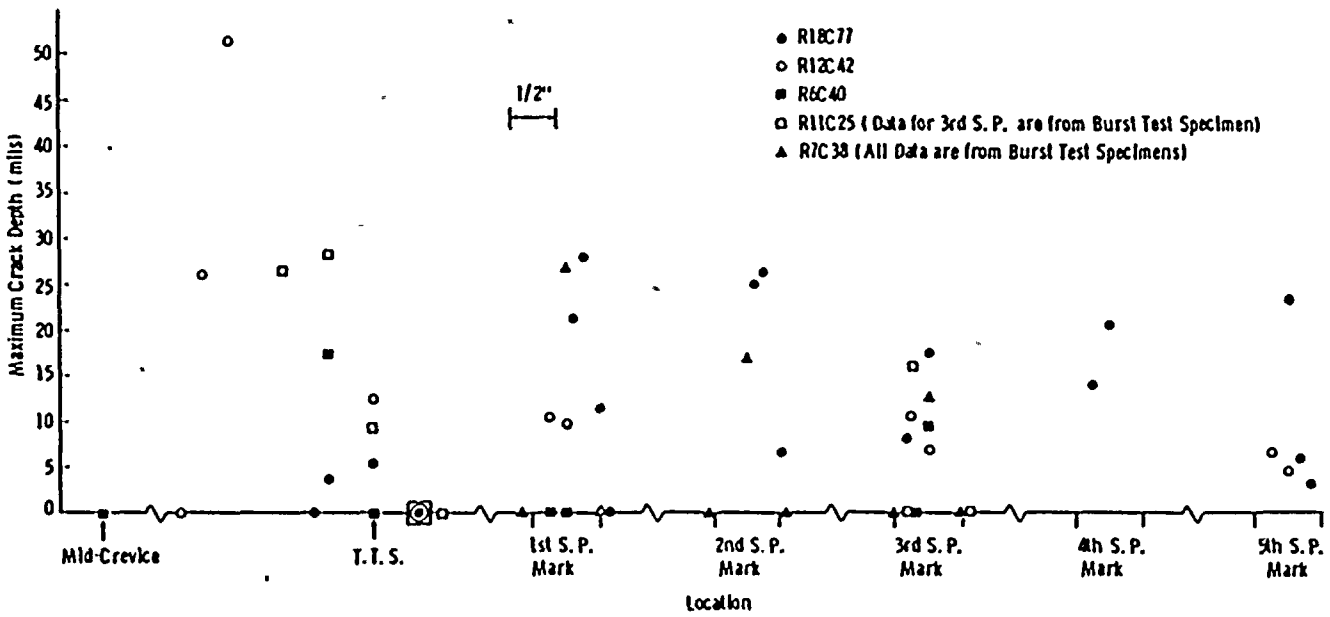
Figure 4-19 Maximum crack depth versus support plate elevation for steam generator tubes examined from Cook Unit 2.

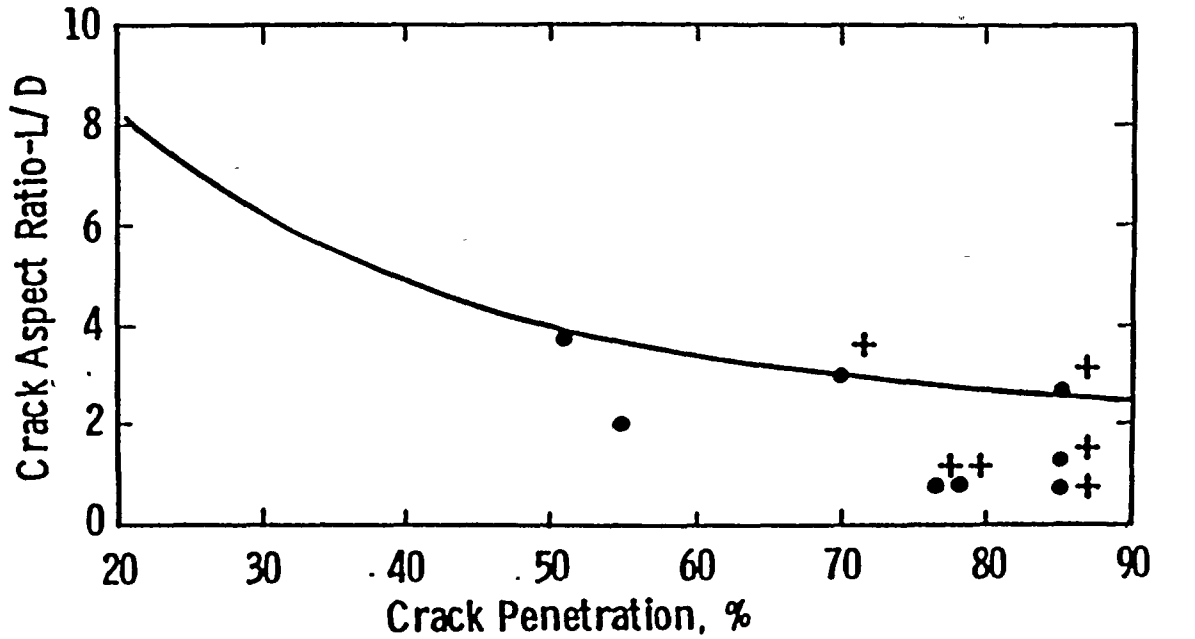
Figure 4-20 Plot of crack aspect ratios versus crack depth as measured in Cook Unit 2 tube R12-C42.

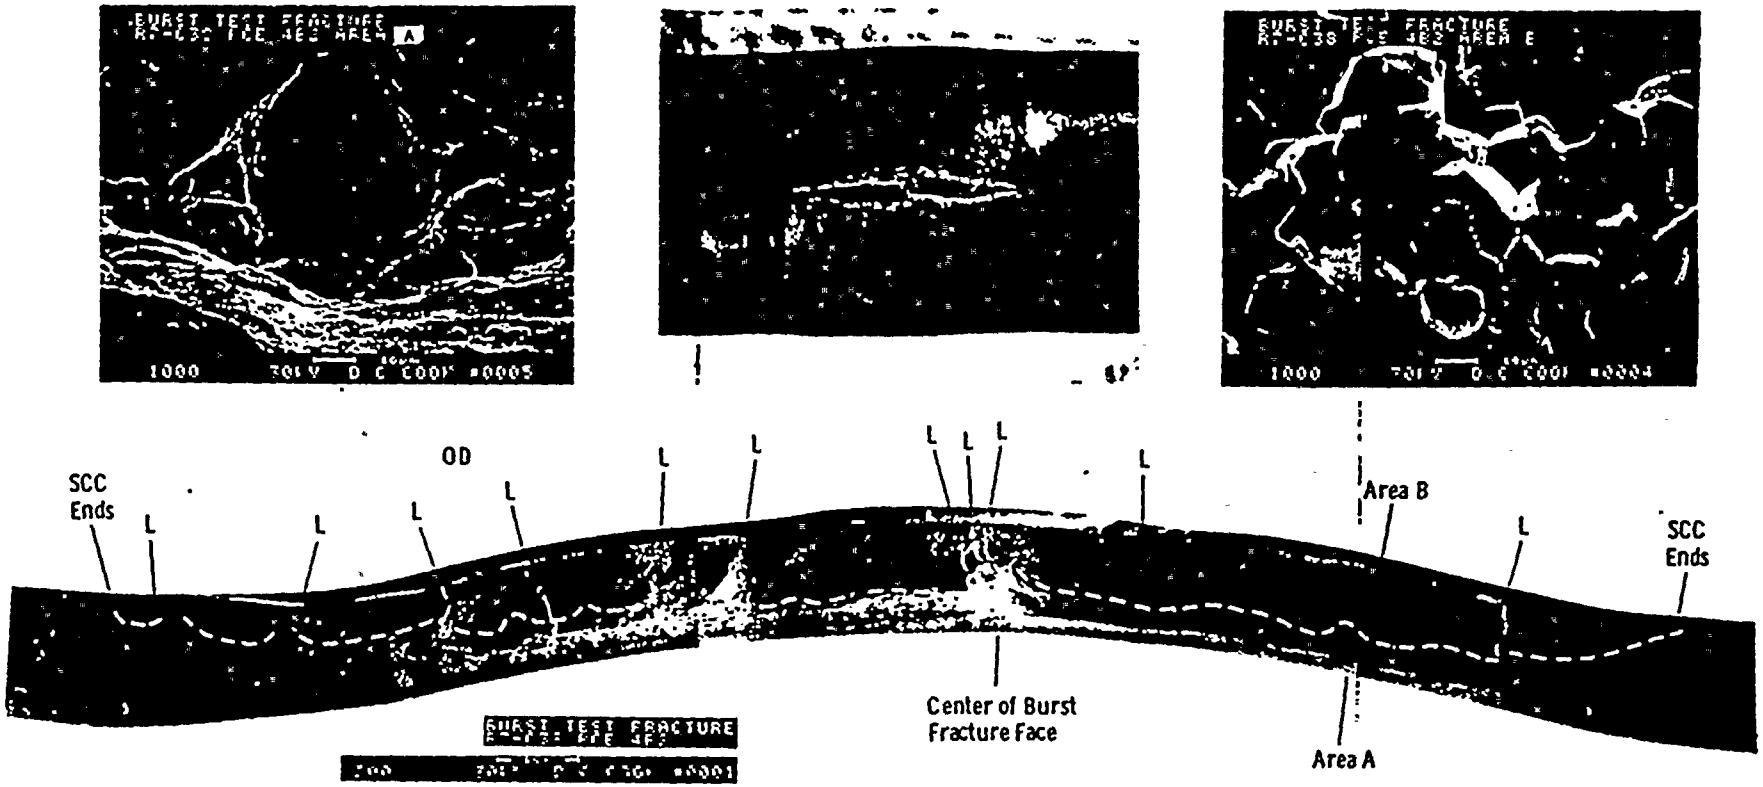
Figure 4-22 –SSM fractography of burst face of R7C38, 1st support plate location. Top center photo shows burst face. Dotted line shows intergranular corrosion boundary in fractograph. "L" shows location of tensile torn ligament

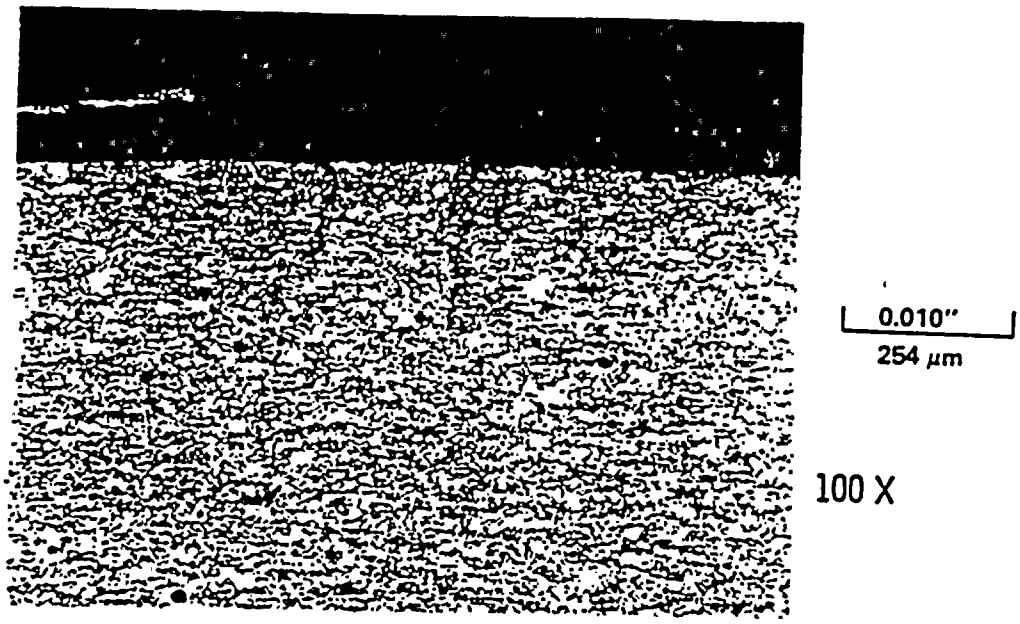
Figure 4-23 Tube R6-C40 from Cook Unit 2, third support plate region, transverse OD metallography, Mag. 100X.
