WCAP-13188

D. C. Cook Unit-1

Steam Generator Tube Plugging Criteria for Indications at Tube Support Plates

March 1992

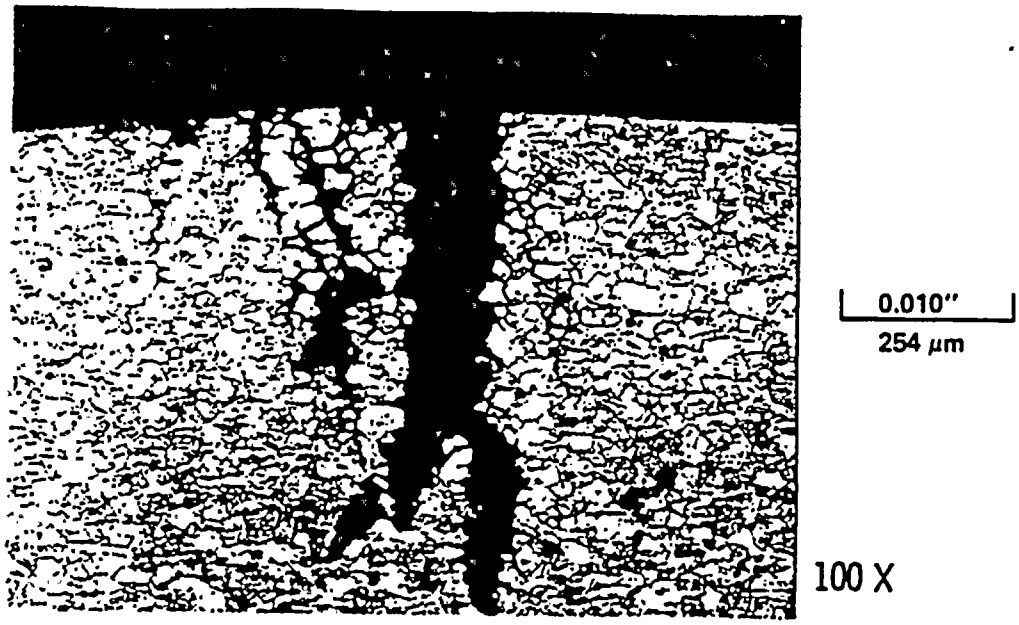
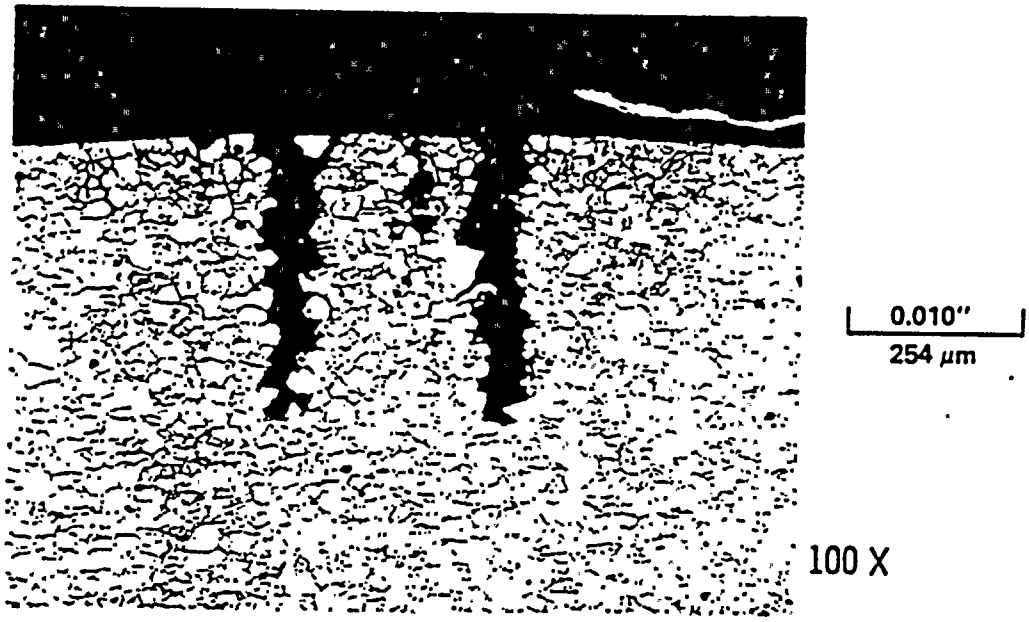
Tube R7-C38 had corrosion at the first, second, and third support plate locations (each of the crevice regions examined). The maximum depths were 60%, 34%, and 26%, respectively. The morphology was of axial IGSCC at all three locations with the first support plate location having the smaller D/W ratios (i.e, with the larger IGA components associated with the cracking). The first support plate region had 90 axial cracks uniformly distributed around the circumference at a mid-crevice location. No cracks were found at the top and bottom support plate crevice locations. Figure 4-24 shows a photomicrograph of one of the smaller D/W ratio cracks. D/W ratios typically varied from 4 to 9 although isolated ratios of greater than 40 were observed. No IGA was observed at the OD surface. The second support plate crevice region had 42 cracks at a mid-crevice region with most of the cracking located on opposite quadrants of the tube. No cracking occurred at the top and bottom crevice edges. D/W ratios were typically near 15 and no IGA was observed at the OD surface. Figure 4-24 also provides a photomicrograph of degradation located at the second crevice region. The third support plate crevice region had 23 axial cracks located at a mid-crevice region with most of the cracking again located on opposite quadrants of the tube. D/W ratios were typically near 24. Figure 4-25 shows a typical crack. The crack is opened wide due to the high burst pressure experienced by this tube section. Intergranular penetrations, approximately 1% deep, were observed at isolated locations on the OD surface.

(a) First Support Plate Crevice Region (Micro 1009, Photo D)

(b) Second Support Plate Crevice Region (Micro 1012, Photo B)

Figure 4-24 Tube R7-C38 from Cook Unit 2, first and second support plate regions, transverse OD metallography, Mag. 100X.

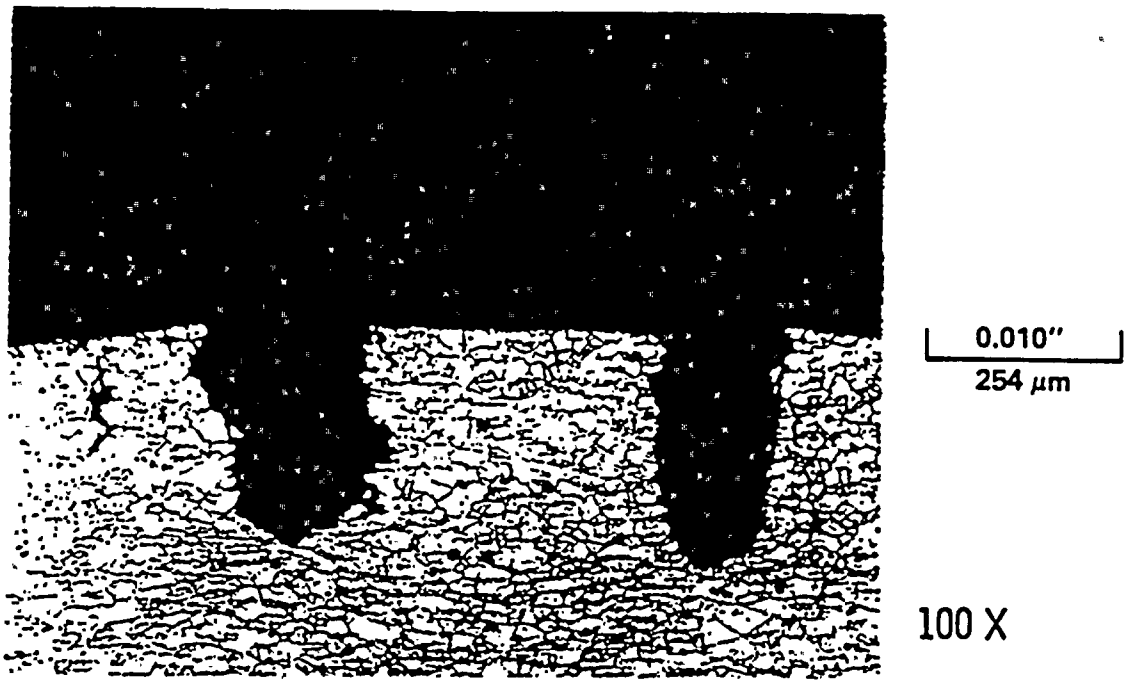
(c) Third Support Plate Crevice Region (Micro 1015,

Figure 4-25 Tube R7-C38 from Cook Unit 2, third support plate region, transverse OD metallography, Mag. 100X.

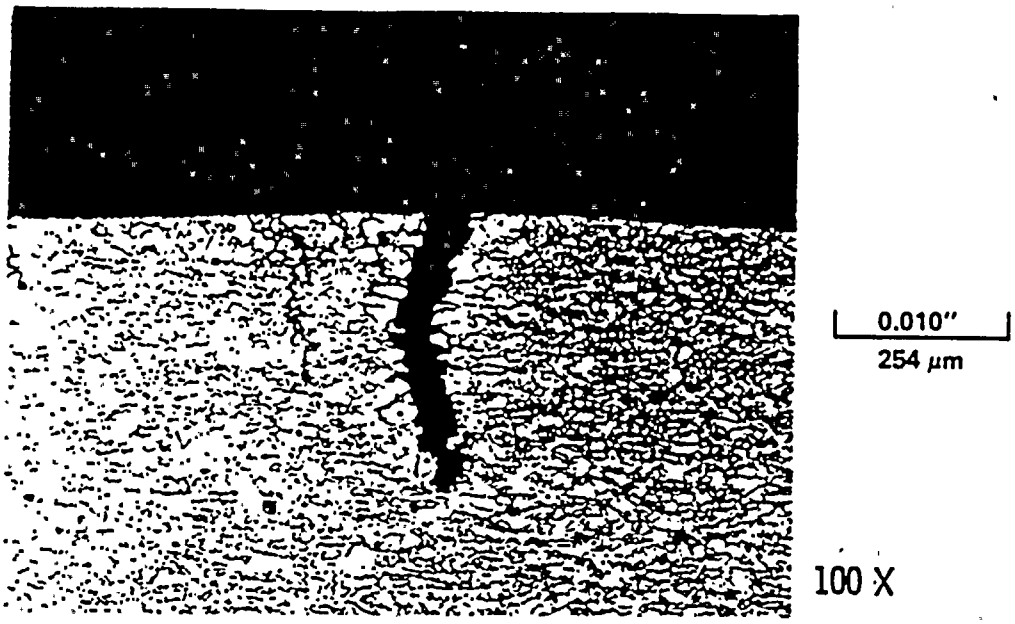
(b) Third Support Plate Crevice Region-Burst Test Specimen (Micro 1006, Photo D)

Figure 4-26 Tube R11-C25 from Cook Unit 2, third support plate region, transverse OD metallography, Mag. 100X.

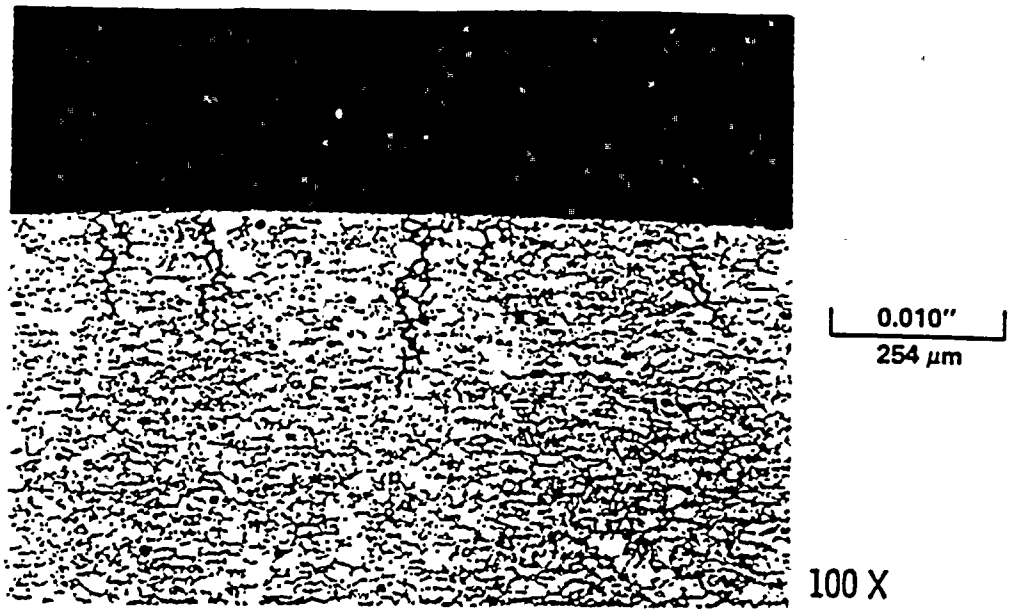
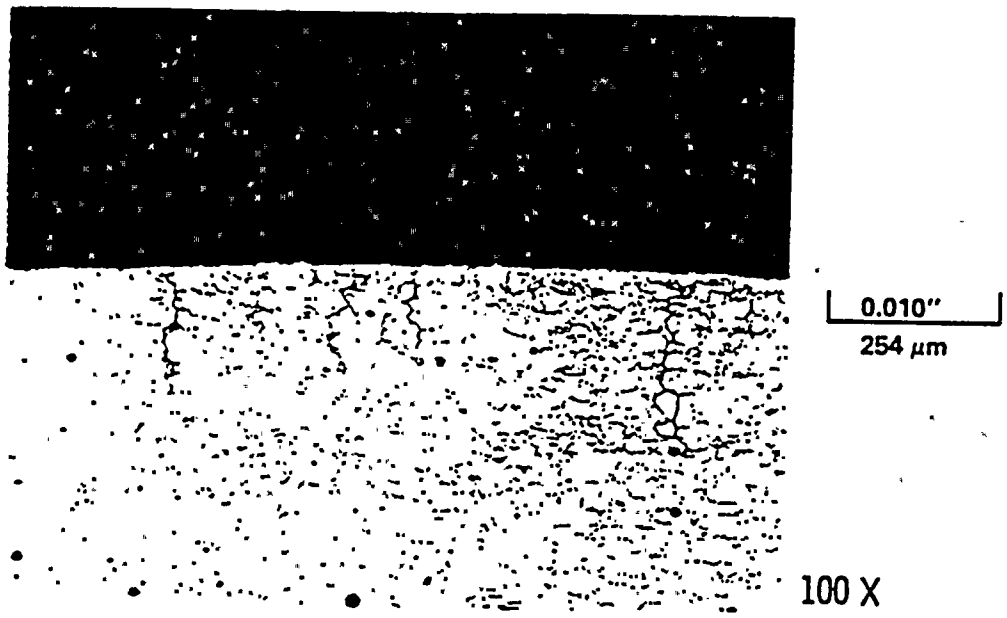
(The first and second were pulled but not examined.) The morphology of the 32% deep corrosion was that of axial IGSCC. It is believed that a moderate number of axial cracks were observed around a mid-crevice location, but only 14 were documented by photography and only three of these were included in the final report with attendant photomicrographs. Figure 4-26 presents this data. The D/W ratio of the major crack is approximately 14 and little or no OD surface IGP is observed. Tube R12-C42 had corrosion at the first, third, and fifth support plate locations. The maximum depths of corrosion were 21%, 21%, and 13%, respectively. The first and third support plate locations had an axial IGSCC morphology while the fifth support plate location degradation was difficult to observe in the single photomicrograph reproduction in the final report. It is believed that moderate to minor numbers of axial cracks were present in these three crevice regions based on the text of the final report, but no mention was made of a measurement of the total number of cracks being obtained from the metallographic mounts. Figure 4-27 includes the single photomicrographs of the corrosion documented for the first and third support plate crevice regions. The D/W ratios were 6 and 9, respectively.

(b) First Support Plate Crevice Region (Micro 999, Photo B)

(c) Third Support Plate Crevice Region (Micro 997, Photo B)

Figure 4-27 Tube R12-C42 from Cook Unit 2, first and third support plate regions, transverse OD metallography, Mag. 100X.

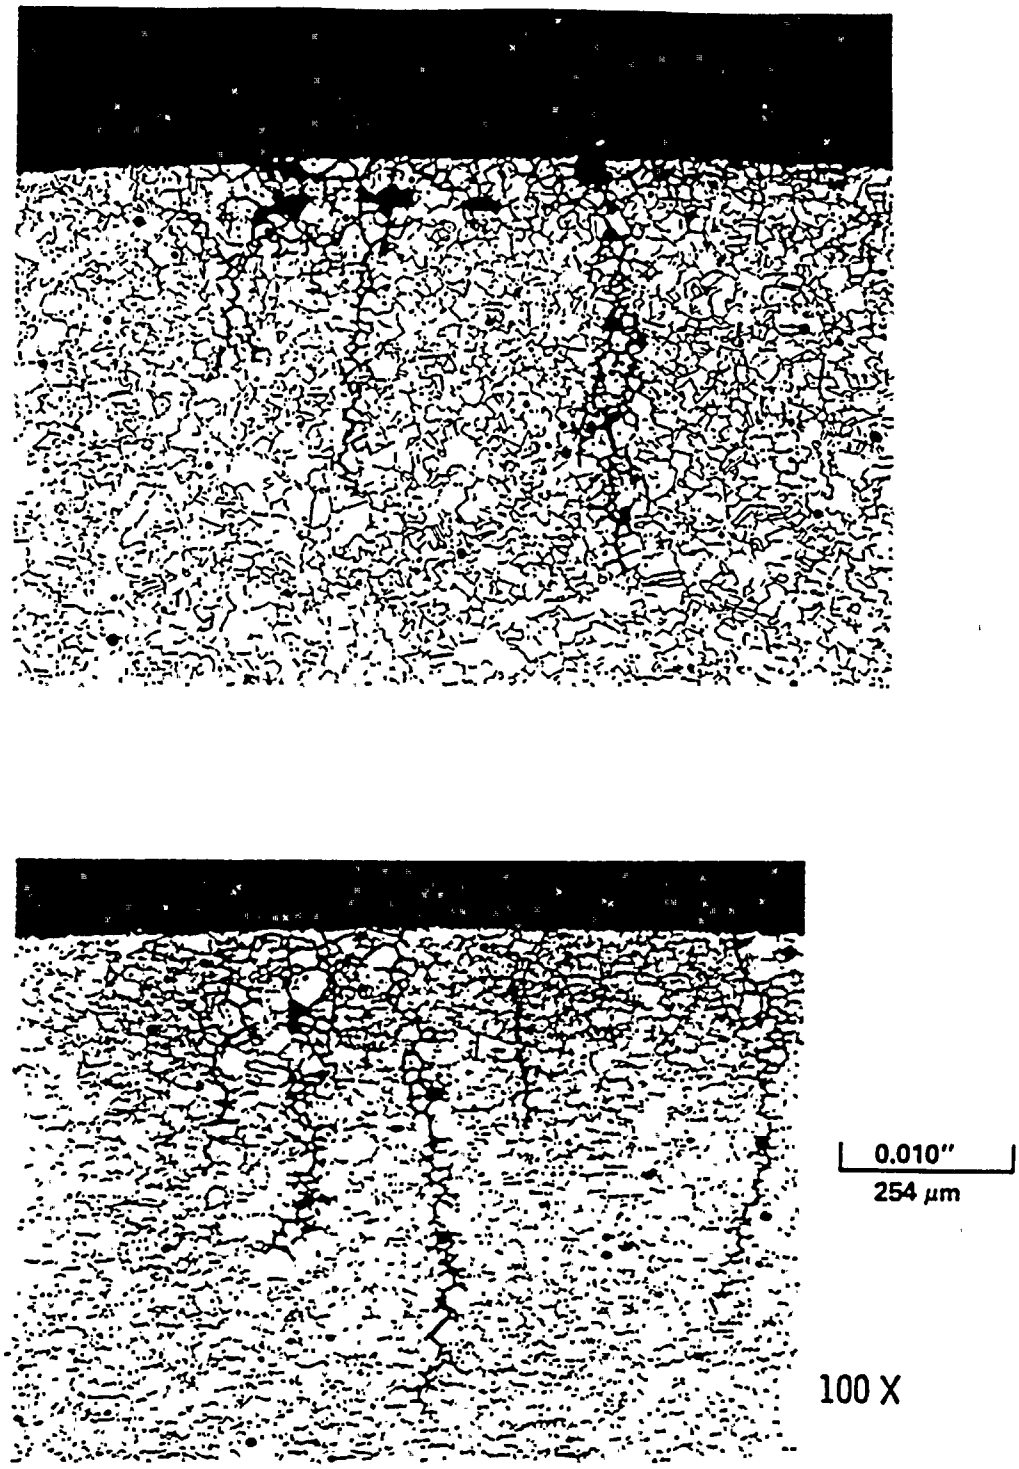
Tube R18-C77 had corrosion at the first, second, third, fourth, and fifth support plate locations. The maximum depths of corrosion were 56%, 53%, 35%, 41%, and 47%, respectively. All locations had an axial IGSCC morphology although some locations (particularly the second and fourth support plate crevice regions) had isolated regions with patch IGA, usually at locations where two or three axial cracks were particularly close together. The depth of the patch IGA was less than, but approaching, half the depth of the penetrating axial cracking. A count of the number of cracks observed around a mid-crevice region was made at the first support plate crevice region. Ninety-two (92) cracks were observed and photographs of 43 were taken. The other four TSP regions did not have a total count performed on the original metallographic mounts; however, photomicrographs taken showed 35, 23, 31 and 16 cracks, respectively, at the second, third, fourth and fifth mid-crevice locations. Figures 4-28 through 4-30 show photomicrographs of typical cracks. D/W ratios were obtained from these figures, as well as from the original data records. The ratios for the deeper cracks typically ranged from 6 to 19, 9 to 13, 11 to 17, 9 to 18, and 11 to 24 for the first, second, third, fourth, and fifth support plate crevice regions, respectively. Other than for the locations with IGA patches, only isolated shallow intergranular penetrations were observed on the OD surface away from the cracking.

Figure 4-28 Tube R18-C77 from Cook Unit 2, first support plate region, transverse OD metallography, Mag. 100X.

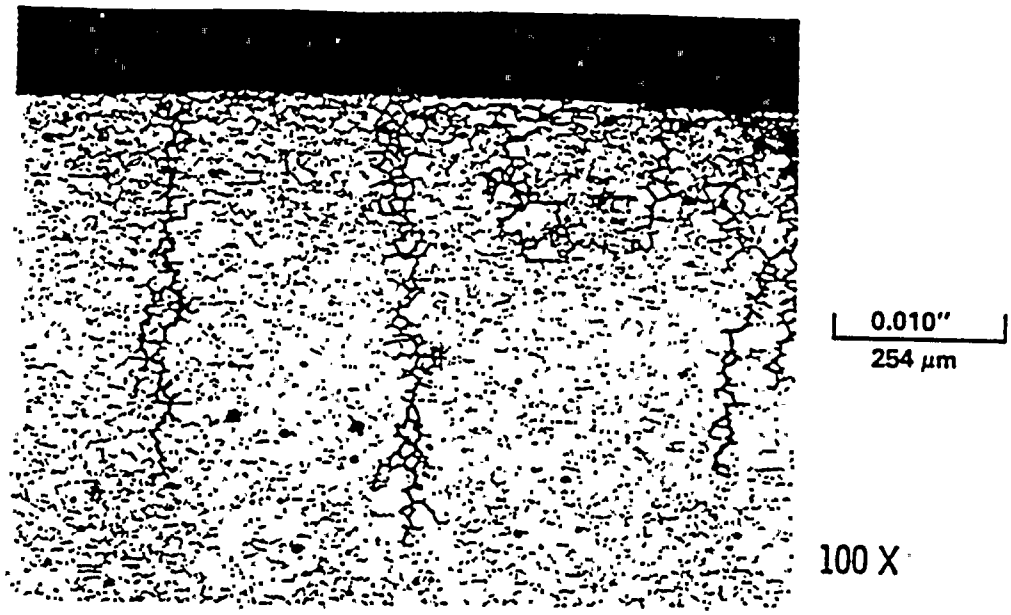
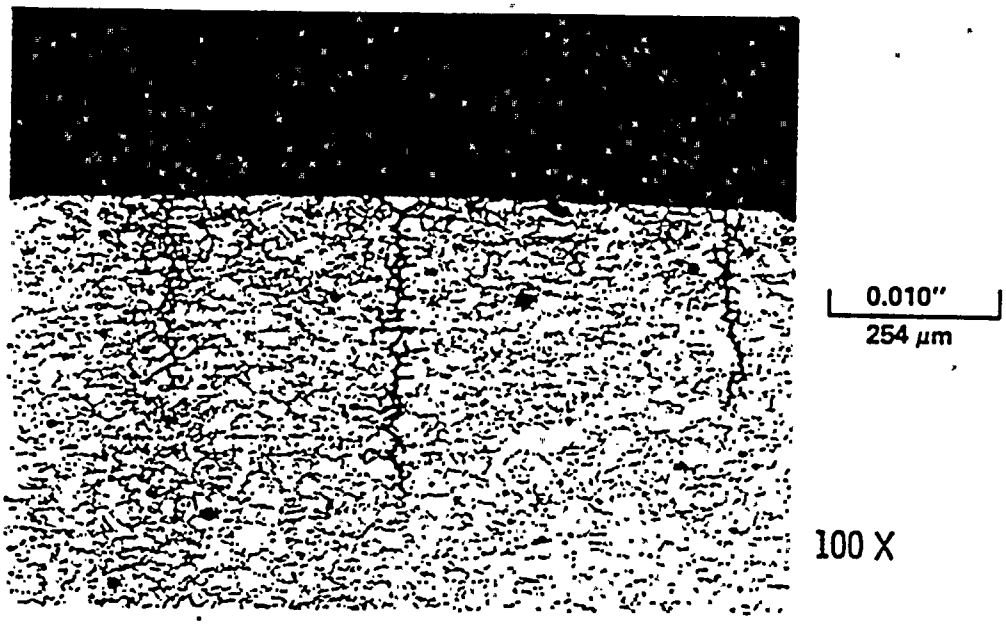
(d) Second Support Plate Crevice Region (Micro 979, Photo A)

(e) Third Support Plate Crevice Region (Micro 977, Photo C)

Figure 4 - 29 Tube R18-C77 from Cook Unit 2, second and third support plate regions, transverse OD metallography, Mag. 100X.

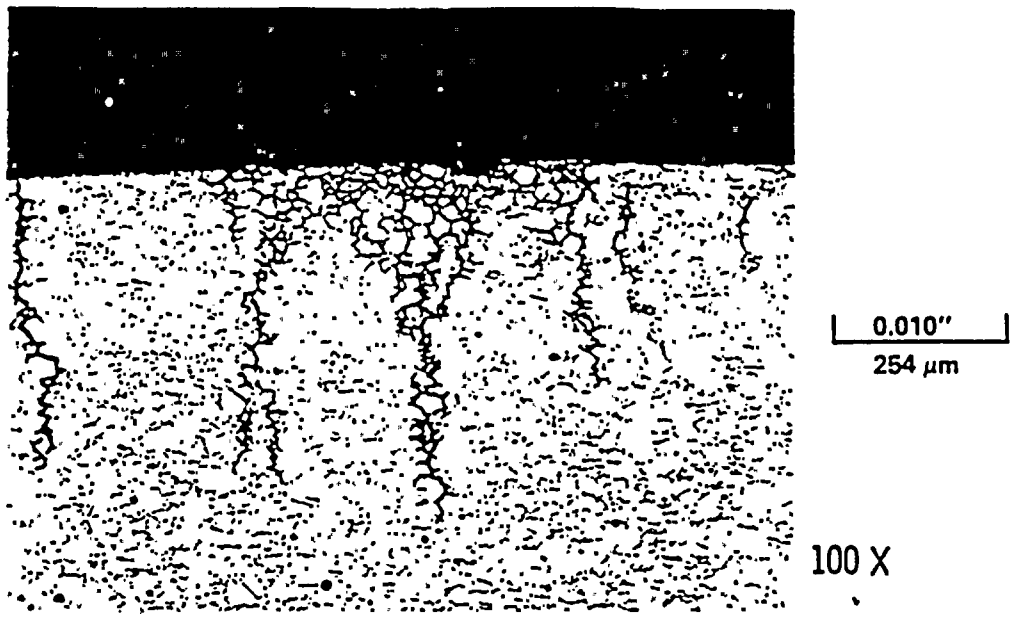
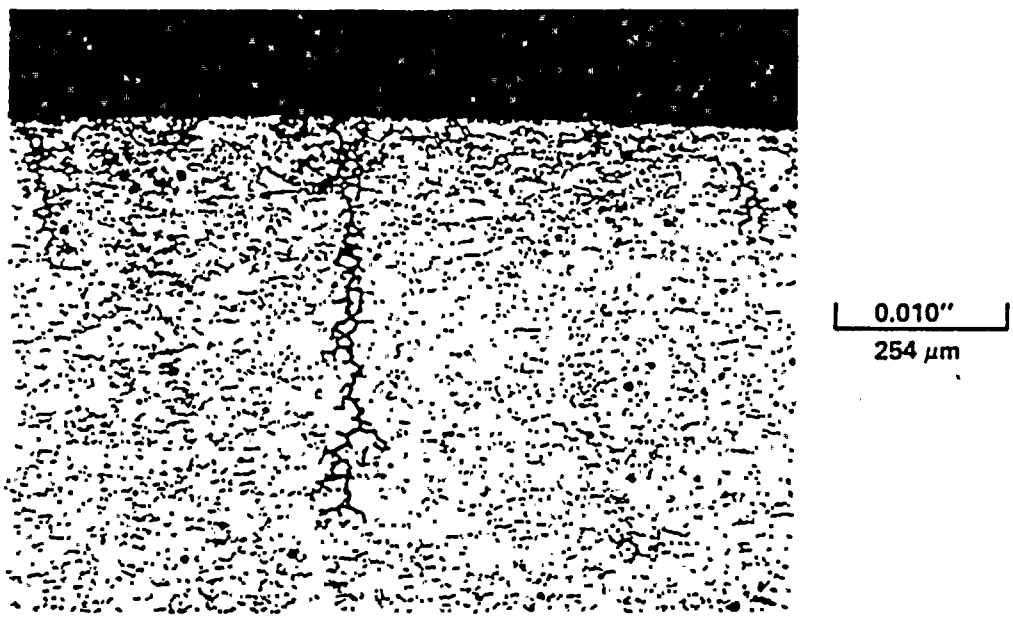
(f) Fourth Support Plate Crevice Region (Micro 975, Photo D)

(g) Fifth Support Plate Crevice Region (Micro 971, Photo A)

Figure 4 - 30 Tube R18-C77 from Cook Unit 2, fourth and fifth support plate regions, transverse OD metallography, Mag. 100X.

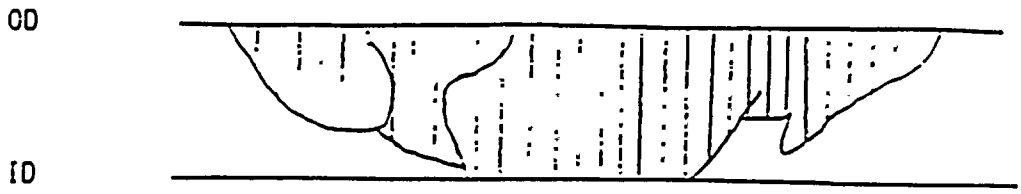
Macrocrack Length = 0.42 inches

Figure 4 - 31 Description of OD origin corrosion at the first support plate crevice region of tube R4-C73.

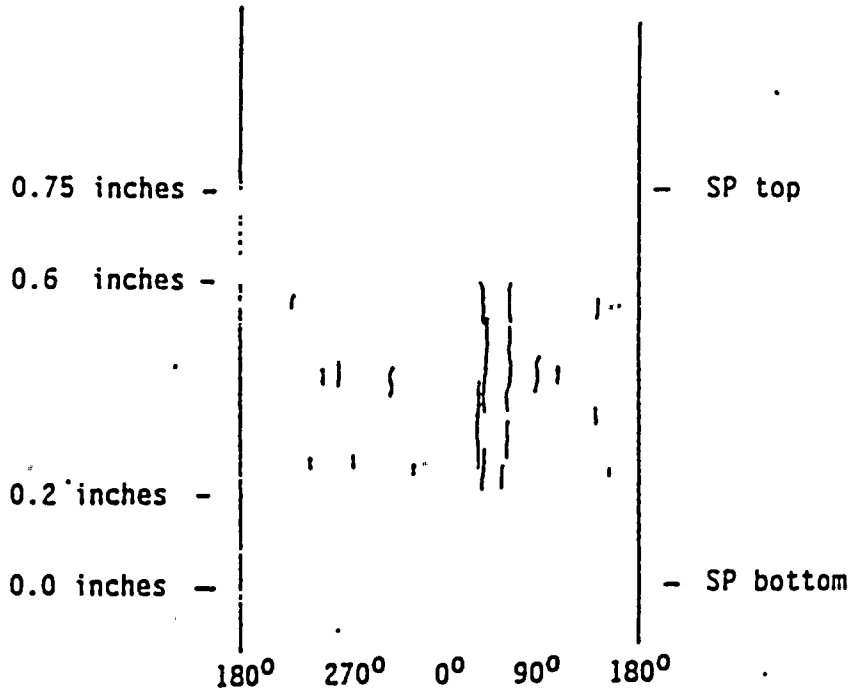
Number of Microcracks = 4 (all ligaments with intergranular features)

Morphology = Intergranular SCC with some IGA characteristics (width of IGA 0.012 inches)

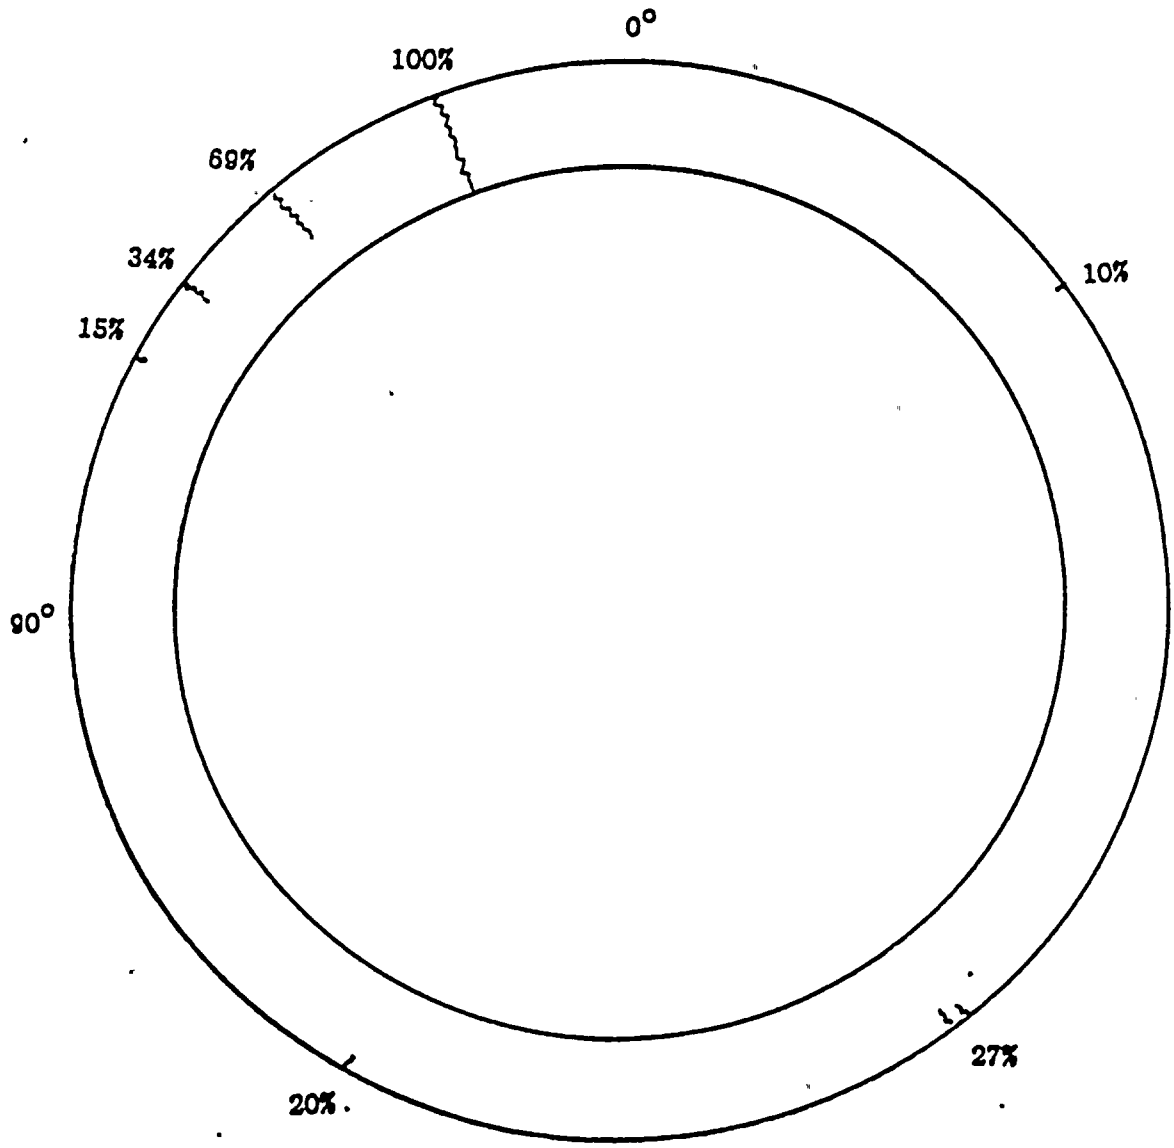
Figure 4 - 32 Sketch of crack distribution and depth within the center of the first support plate intersection in tube R4-C73.

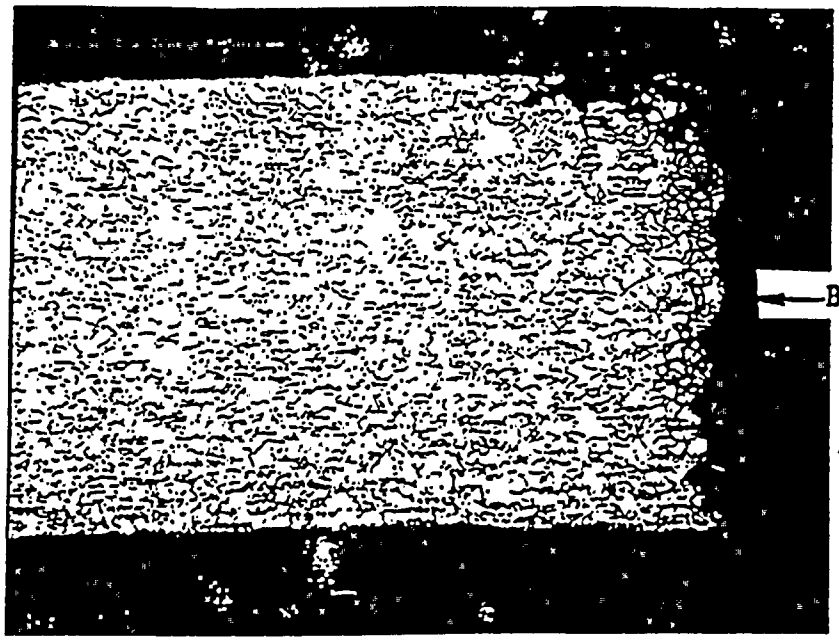
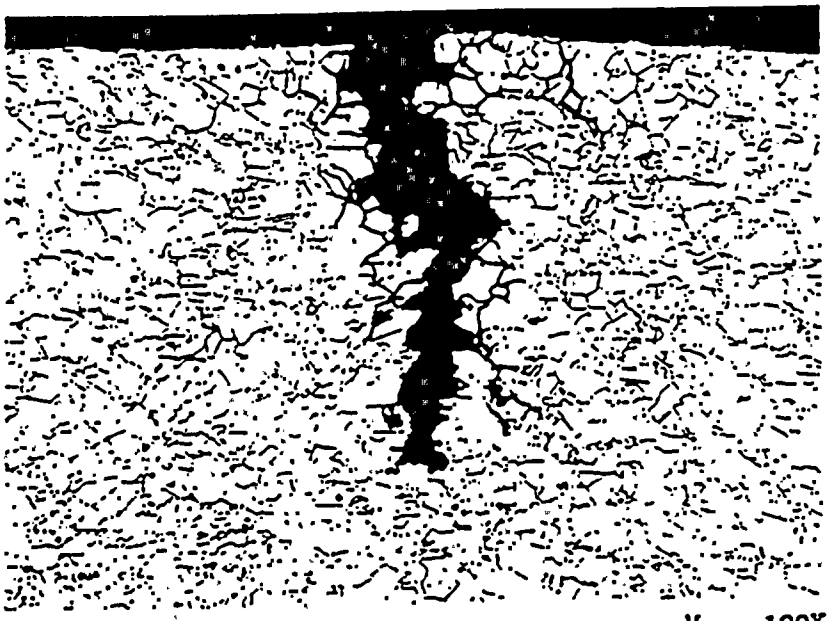
Figure 4 - 33 Top photomicrograph is from a transverse section through one half of the main burst crack. The crack morphology is that of IGSCC with some IGA characteristics (width of IGA is 0.006 inch on one side of the crack). Bottom micrograph is from a transverse section through a typical crack located near the burst crack. The morphology is that of IGSCC with only minor IGA characteristics. (Note: crack is opened wide by tube deformation).

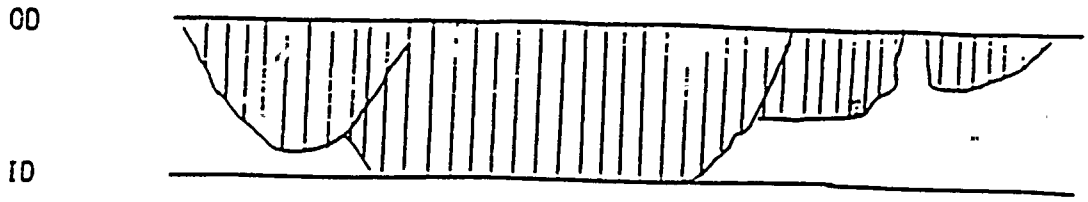
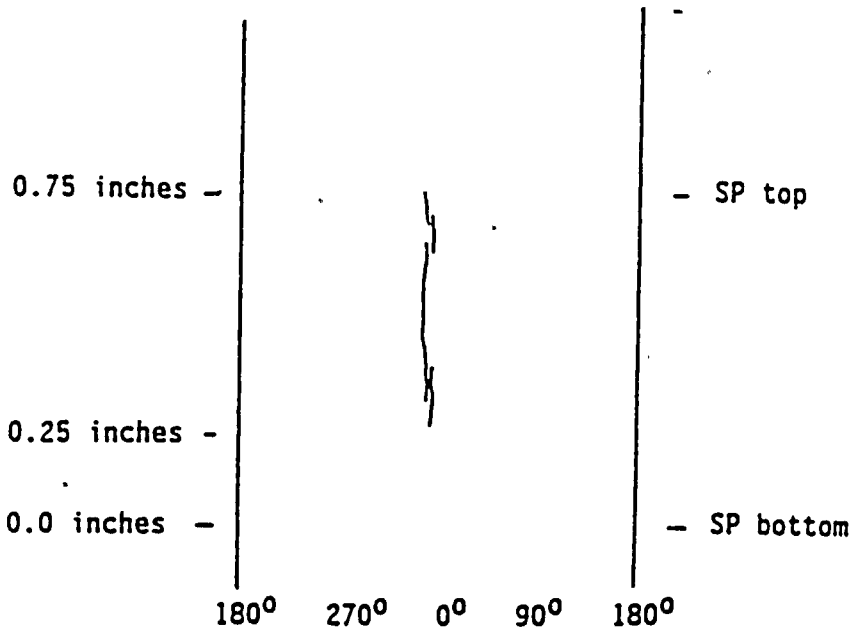
Macrocrack Length = 0.50 inches

Number of Microcracks = 4 (two ligaments with intergranular features, one with ductile overload features)

Morphology = Intergranular SCC with significant IGA characteristics (width of IGA 0.030 inches)

Figure 4 - 34 Description of OD origin corrosion at the first support plate crevice region of tube R21-C22.

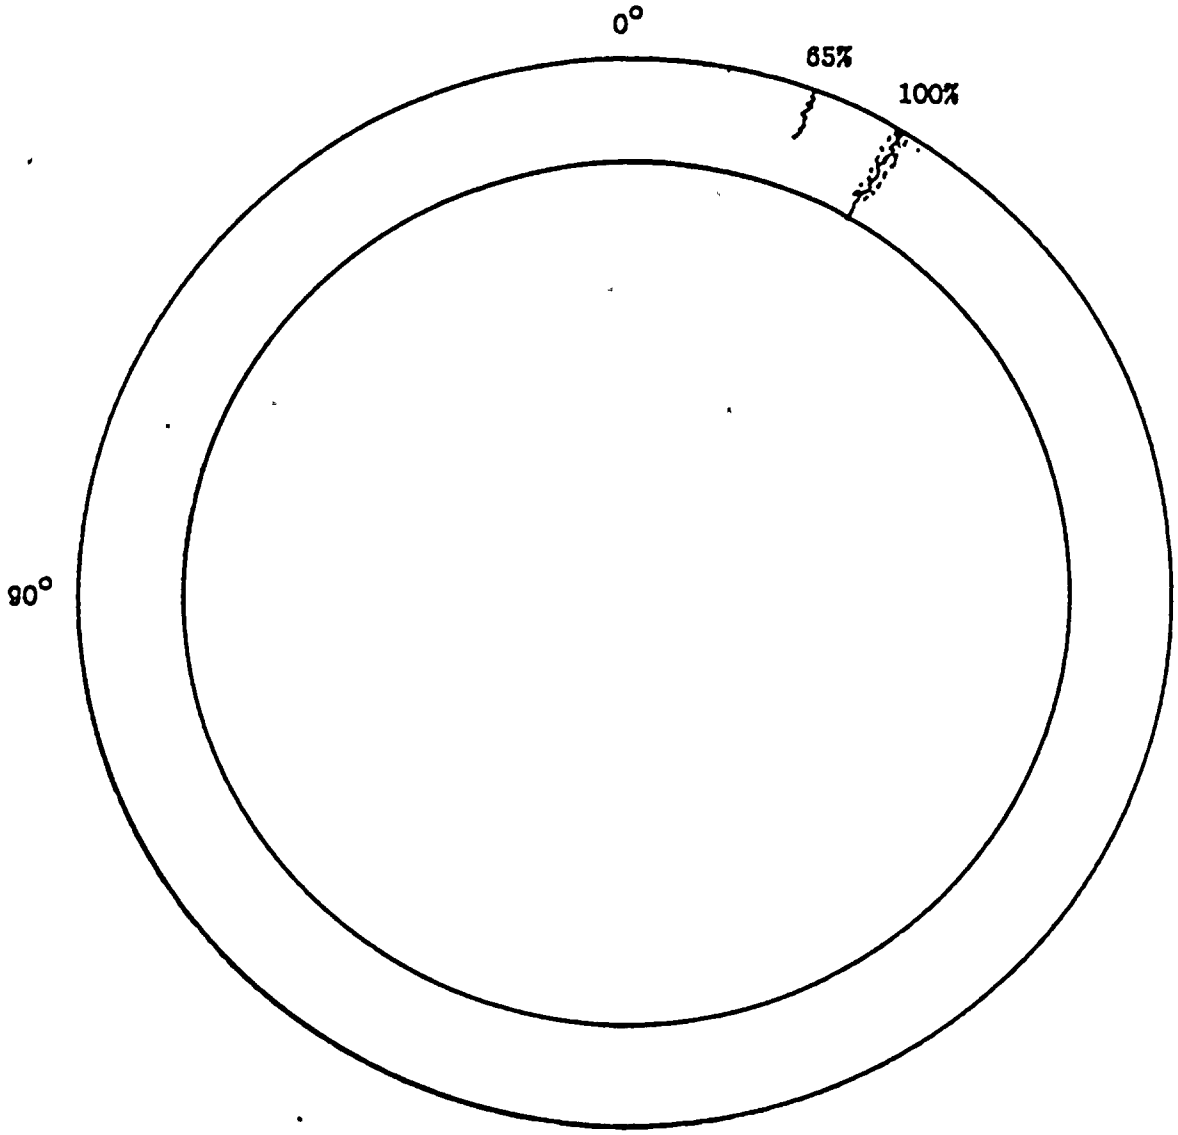
Figure 4 - 35 Sketch of crack distribution and depth within the first support plate crevice region in tube R21-C22.

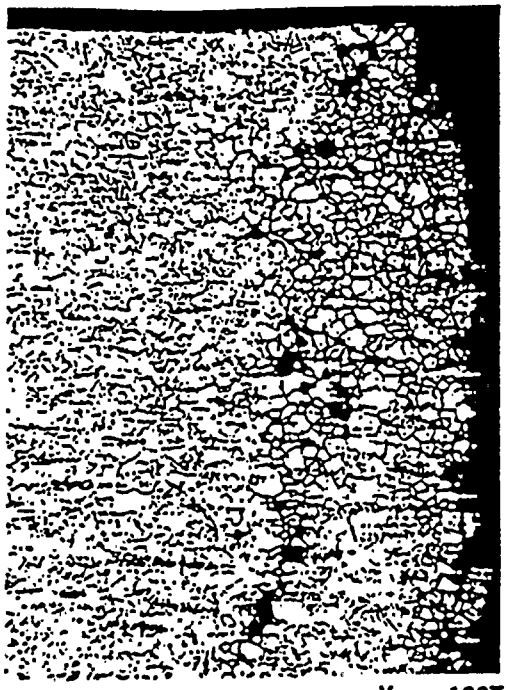
Figure 4 - 36 Top micrographs are from a transverse section through one half of the main burst crack. The morphology is that of IGSCC with significant IGA characteristics (width of IGA is 0.015 inch on one side of the crack). Bottom micrograph is from a transverse section through the only other crack found in the crevice region. Its morphology is more that of IGSCC. (Note: crack has been opened wide by tube deformation).

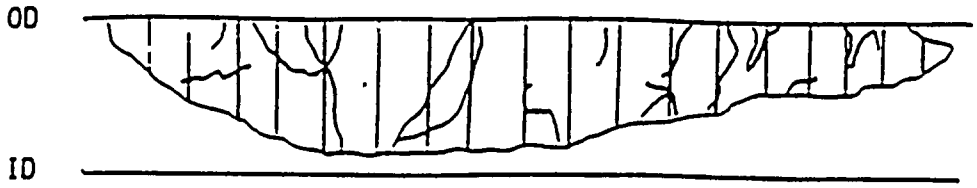
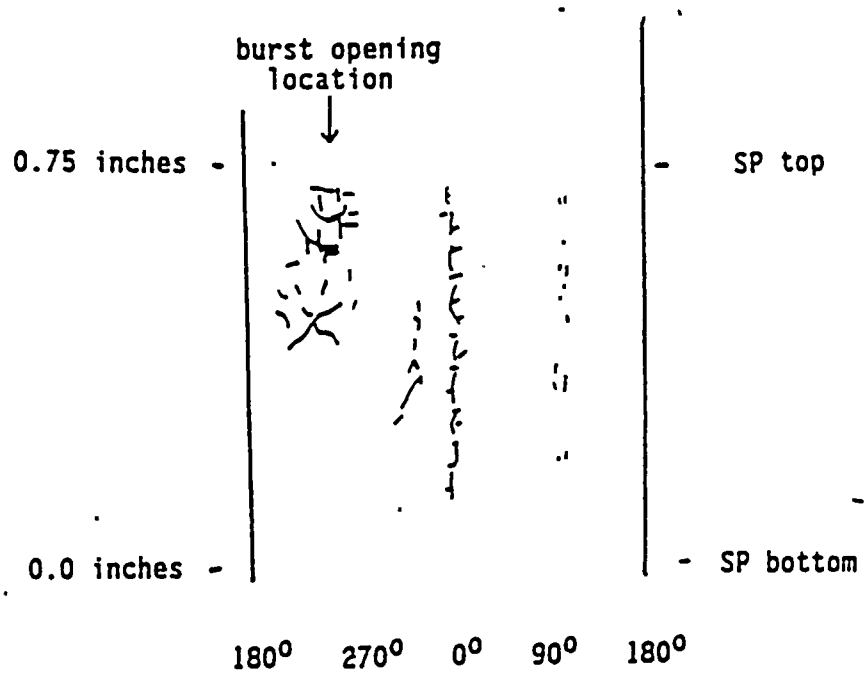
Macrocrack Length = 0.37 inches

Number of Microcracks = numerous (ligaments have intergranular features)

Morphology = Intergranular SCC with minor IGA features (Unusual spider-shaped crack distribution)

Figure 4 - 37 Description of OD origin corrosion at the first support plate crevice region of tube R38-C46.

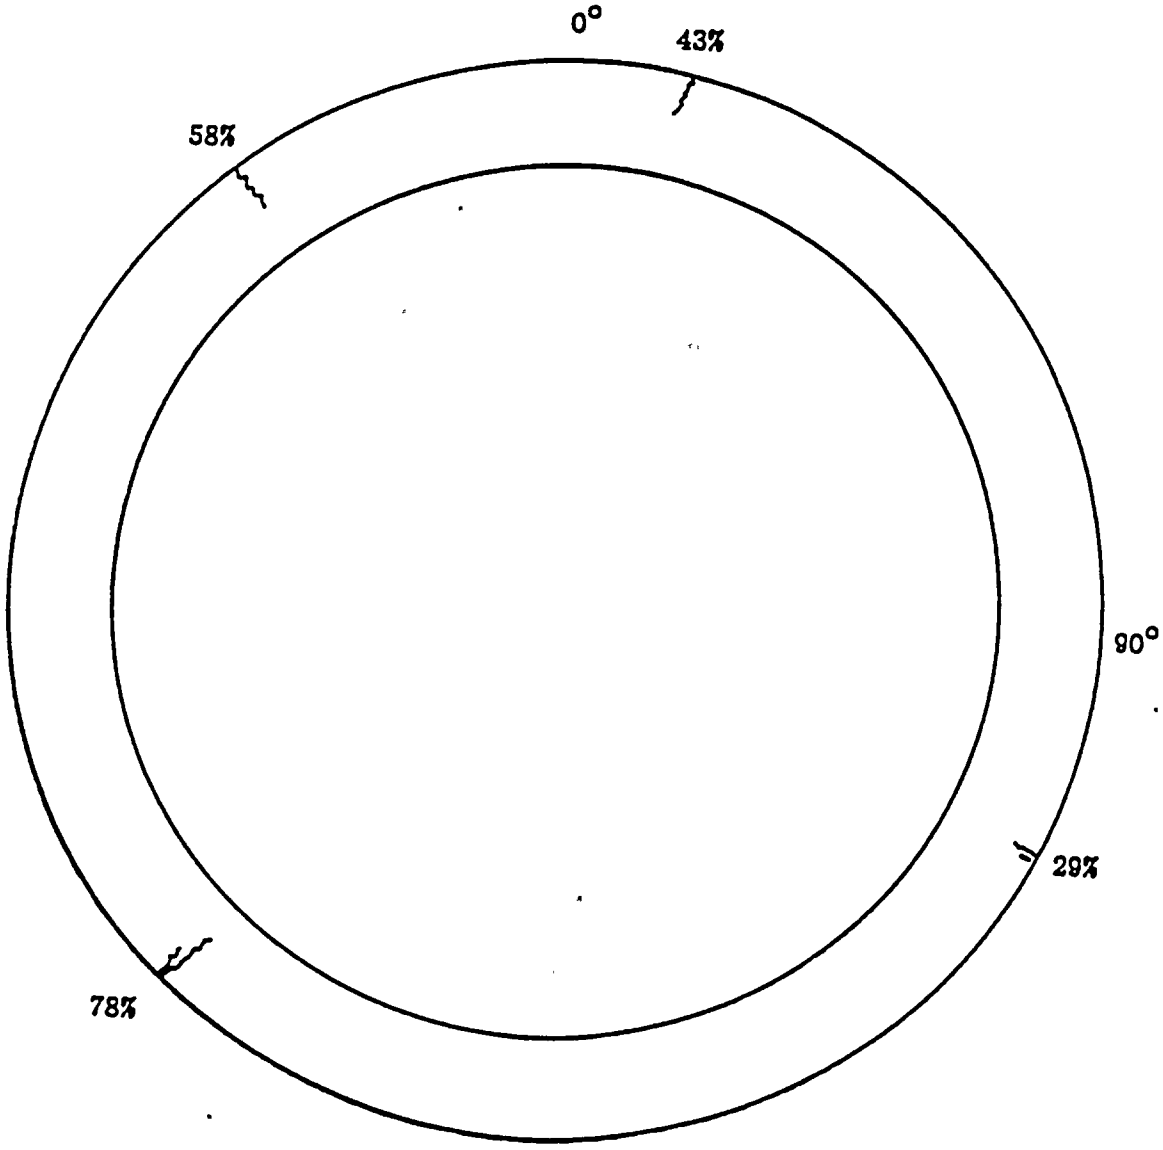
Figure 4 - 38 Summary of distribution and maximum depth of cracks found within the first support plate crevice region of tube R38-C46.

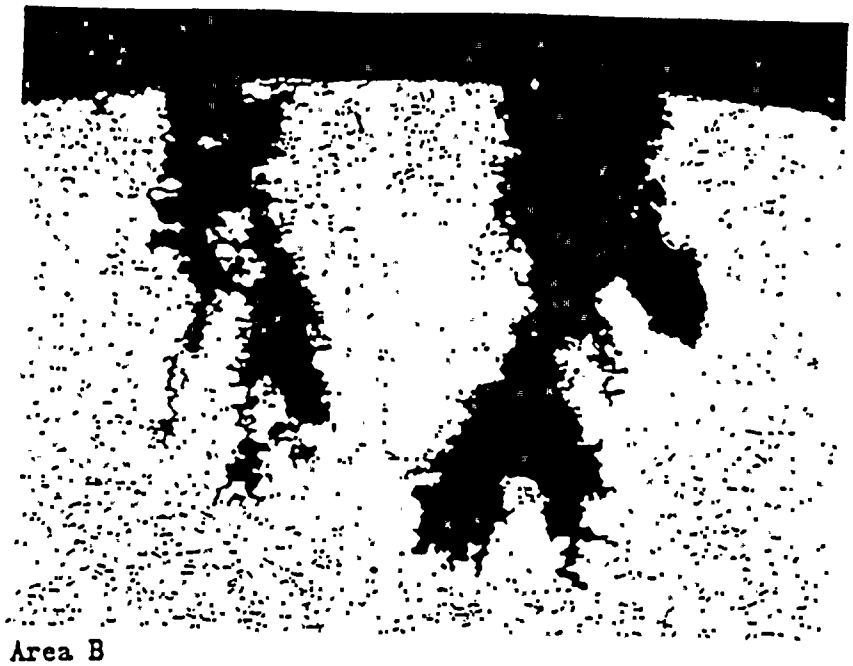
Figure 4 - 39 Photomicrographs of a transverse metallographic section through the first support plate crevice region of tube R38-C46. The crack morphology is that of IGSCC with minor IGA characteristics. Mag. 100X.

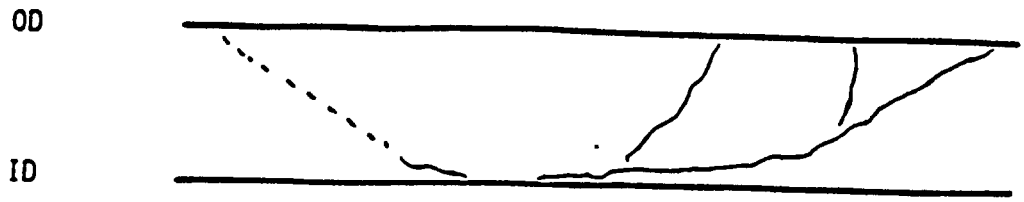
Macrocrack Length = 0.52 inch

Figure 4 - 40 Summary of crack distribution and morphology observed on the first support plate crevice region of tube R31-C46.

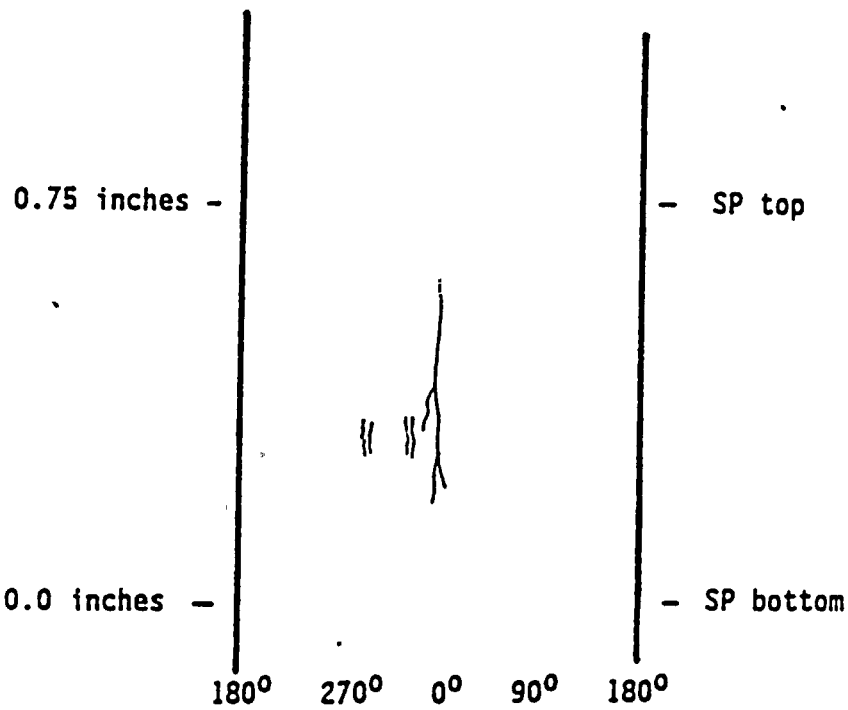
Morphology = IGSCC with moderate IGA components

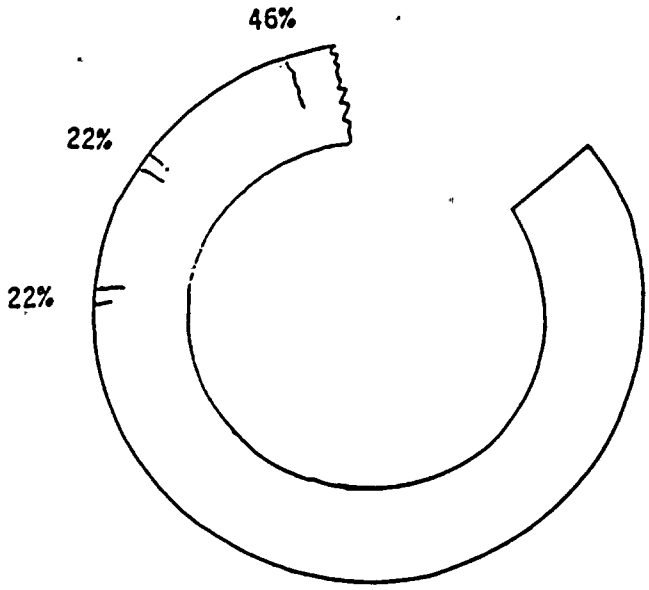
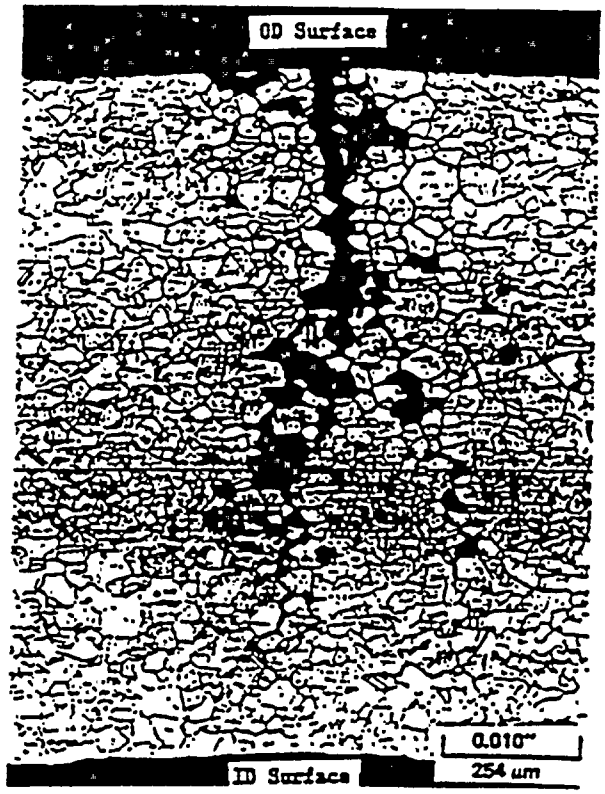
Figure 4 - 41 Secondary crack distribution and a photomicrograph of one of the cracks in a transverse metallographic section of the first support plate crevice region of tube R31-C46. The crack morphology is that of IGSCC with moderate IGA components.

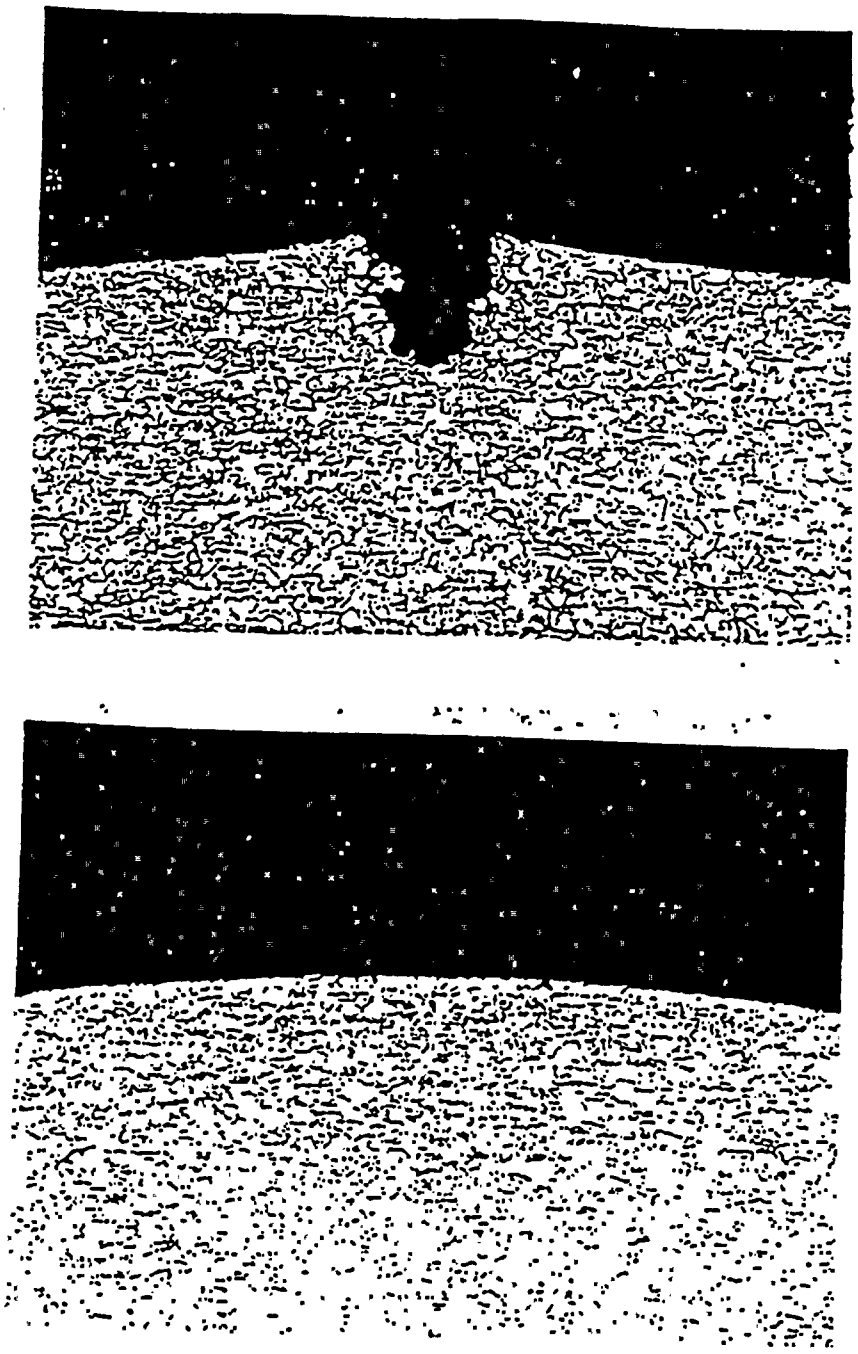
Figure 4 - 42 Cracks at the OD surface of tube R16-C50 at the first tube support plate crevice. Mag. 100X.

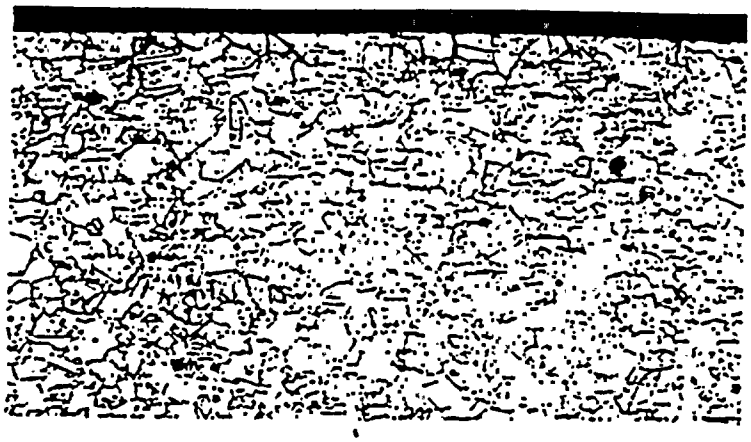
Figure 4 - 43 Photomicrographs of a transverse section from the first support plate crevice region of tube R16-C53. Mag. 100X.

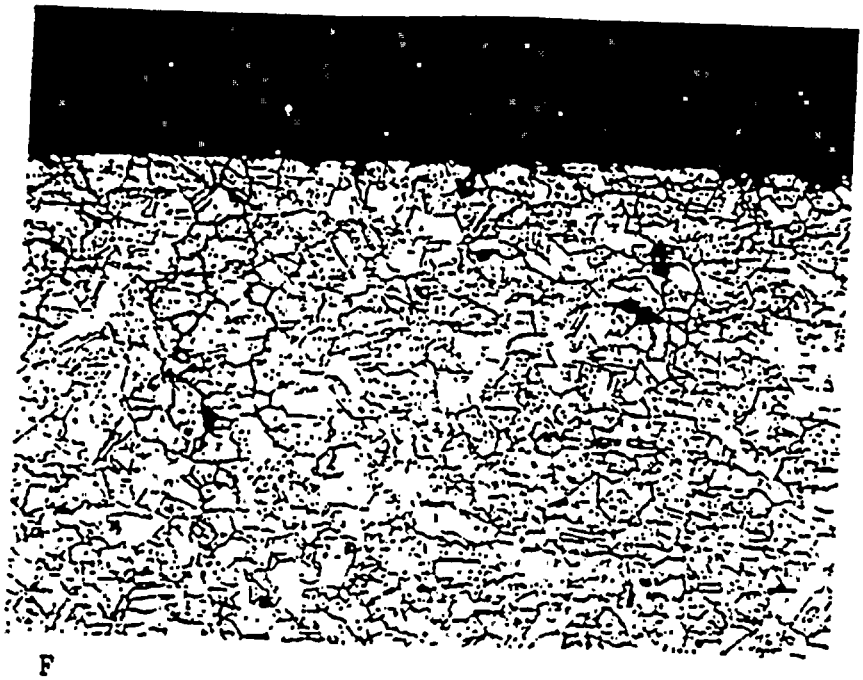
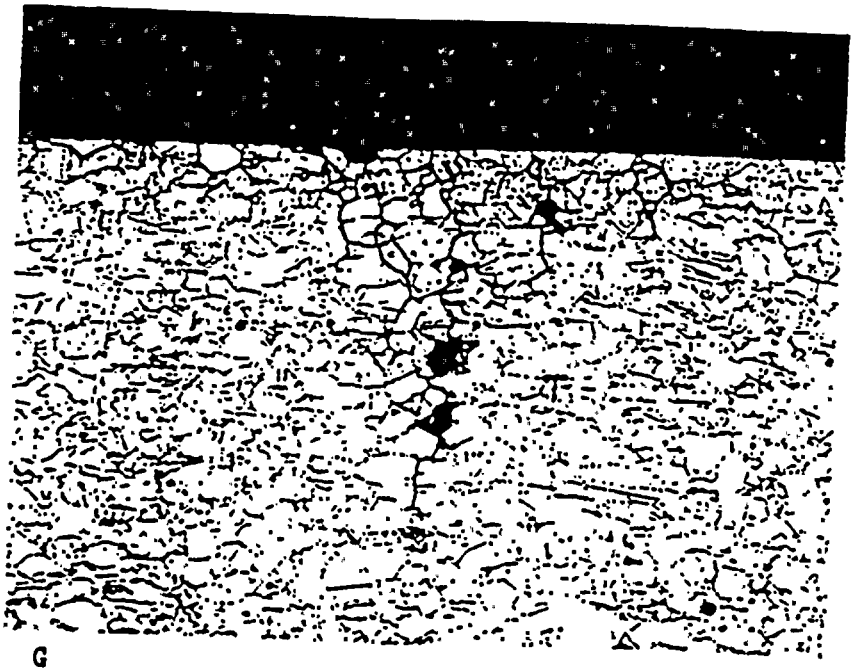
Figure 4 - 44 Additional micrographs from the same transverse section shown in Figure 4–43 tube R16-C53. Mag. 100X.
