WCAP-13188

D. C. Cook Unit-1

Steam Generator Tube Plugging Criteria for Indications at Tube Support Plates

March 1992

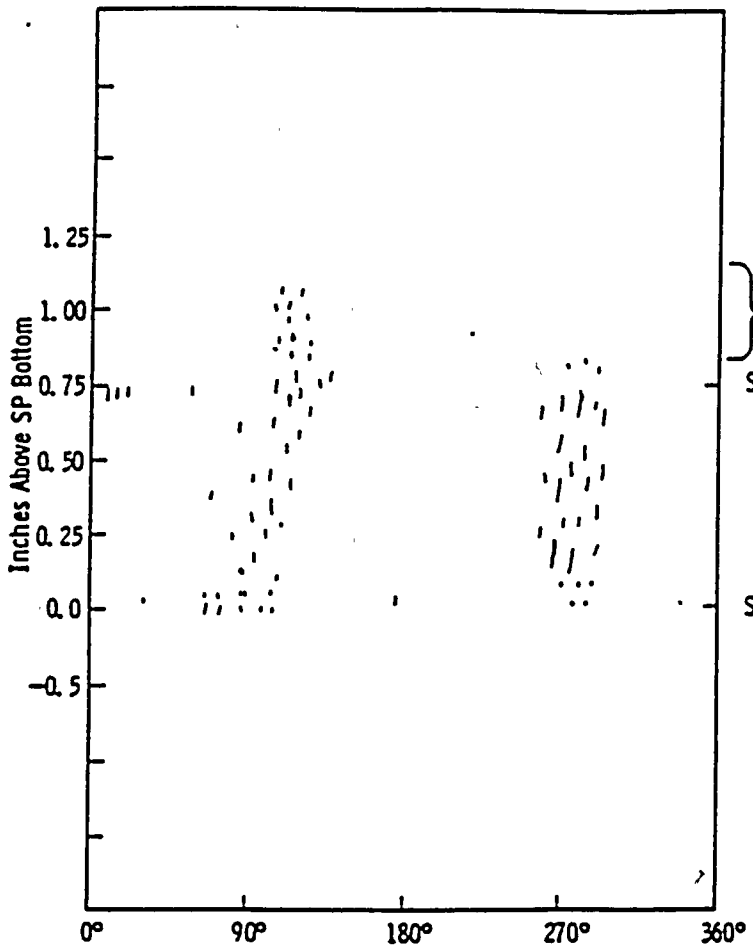
Figure 4 - 45 Crack network location at first support plate region on tube R20-C26 HL.

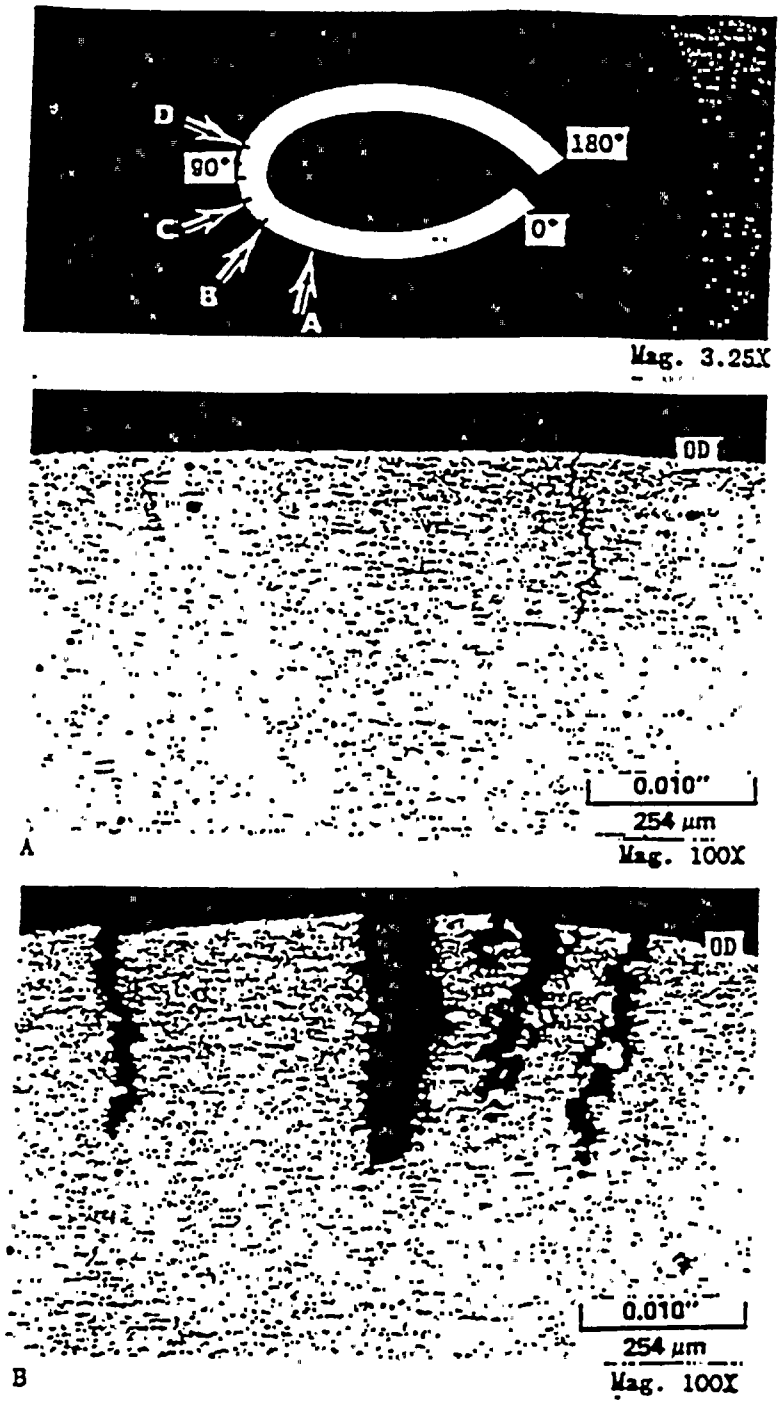
Figure 4 - 46 Transverse metallographic section through tube R20-C26 HL at the mid-point of the first support plate crevice region (90° deformed half) with crack details in Areas A and B.

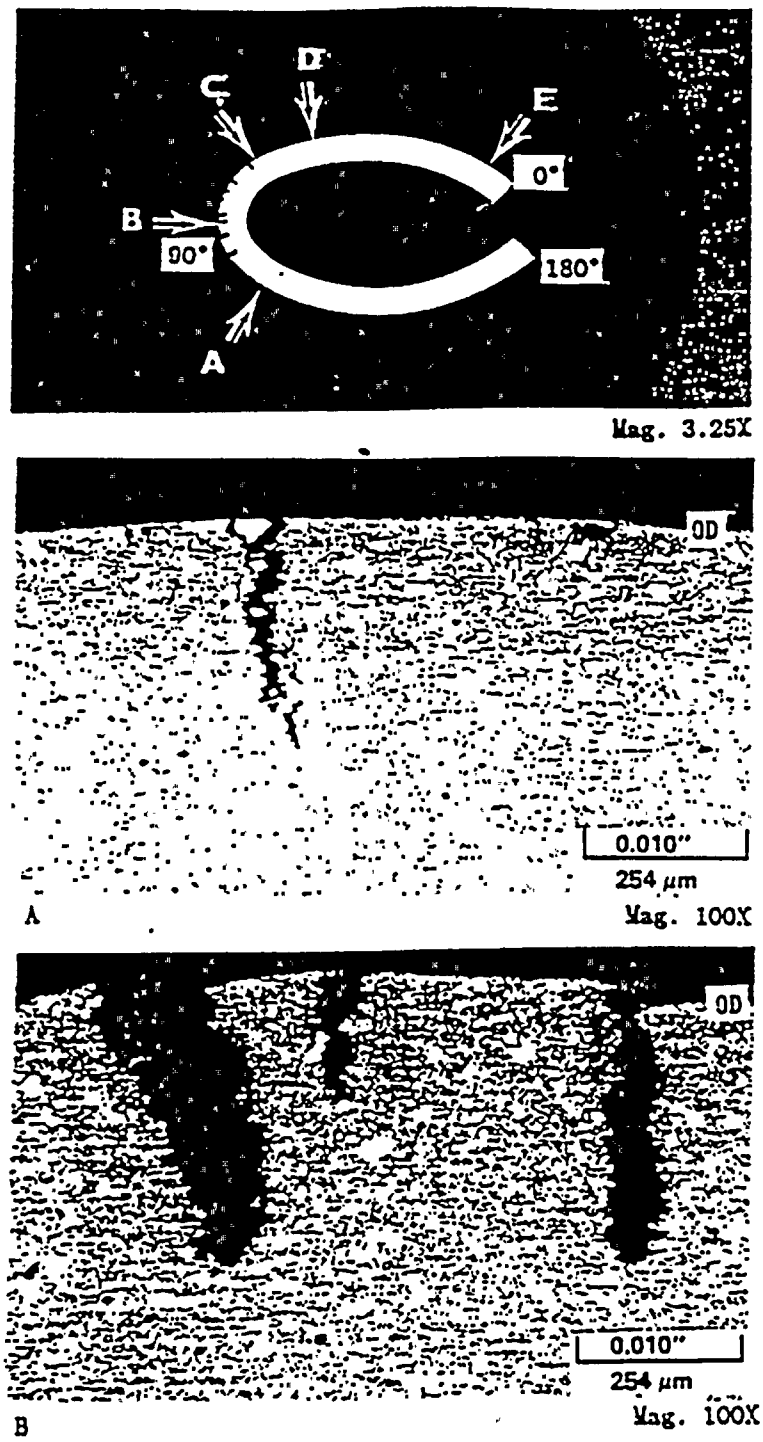
Figure 4 - 47 Transverse metallographic section through Plant A tube R20-C26 HL at the first support plate crevice region (90° deformed half) below the support plate crevice top with crack details in Areas A and B.

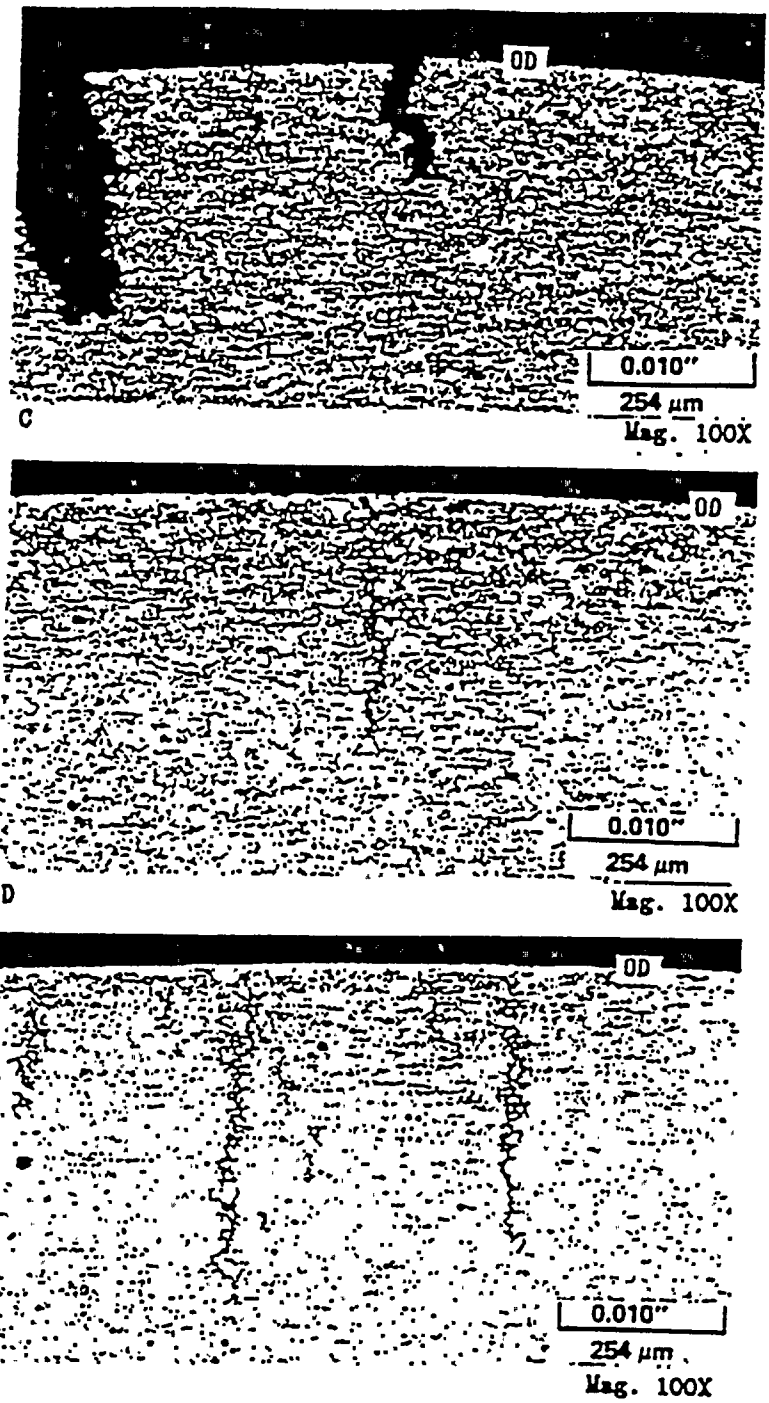
Figure 4 - 48 Crack details in Areas C, D, and E of metallographic cross section shown in previous figure, tube R20-C26 HL, Plant A.

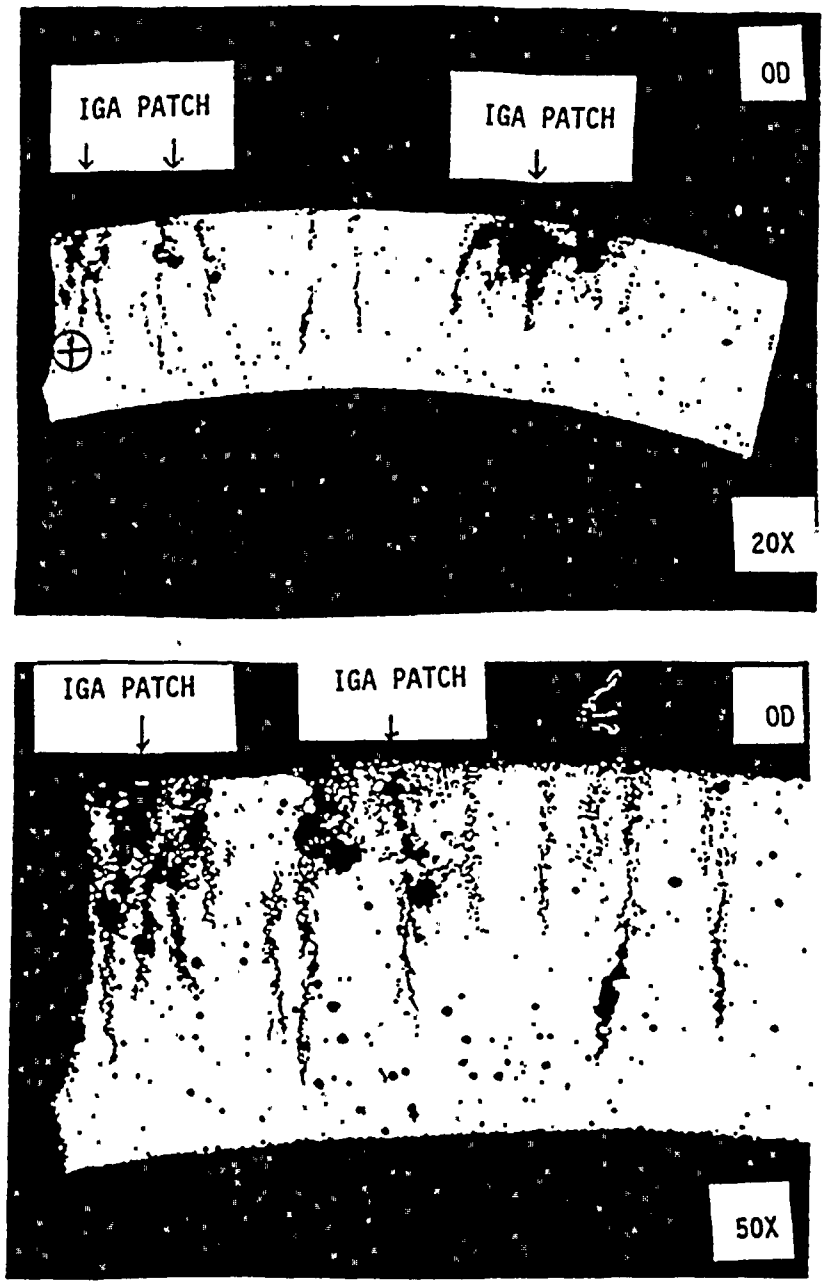
Figure 4 - 49 Transverse optical micrographs obtained just below the circumferential fracture at the center of the support plate. The circumferential location is that where the deepest corrosion was found. The deepest axial IGSCC is 85% through wall and three IGA patches are observed: one 43% through wall and 0.015 inch long, one 33% through wall and 0.05 inch long, and one 28% through wall and 0.015 inch long. The axial IGSCC had IGA aspects to individual cracks. These aspects can be characterized by ratios comparing the crack length (depth from OD surface) to IGA width at the mid-crack location. L/W ratios vary from 6 to 18. Plant L, R12C8

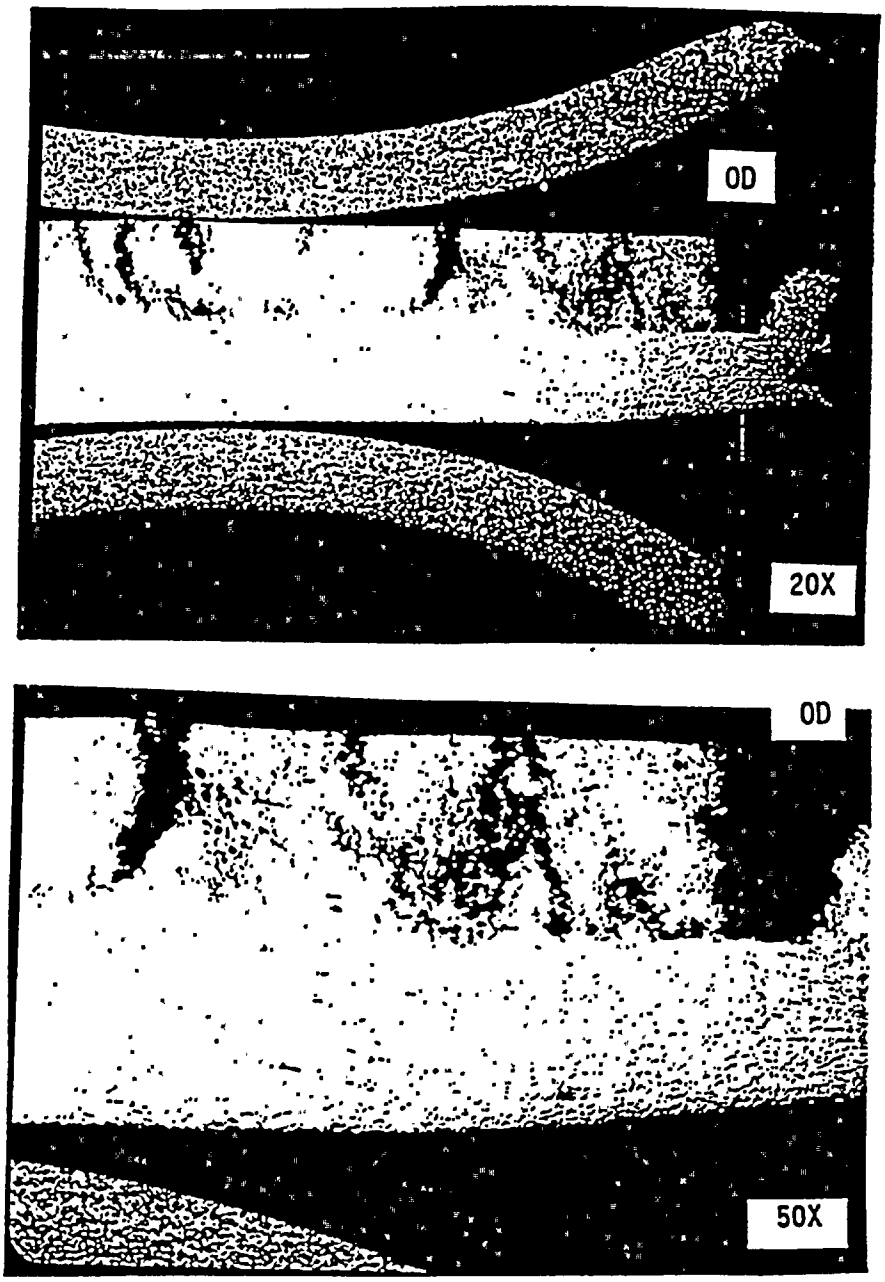
Figure 4 - 51 Axial optical micrographs obtained from the center of the support plate crevice region to the bottom edge of the crevice at a location where the deepest corrosion is believed to exist. A uniform corrosion front, approaching half way through wall, is observed within the crevice region. The section is believed to cut through a region composed of numerous axial microcracks.

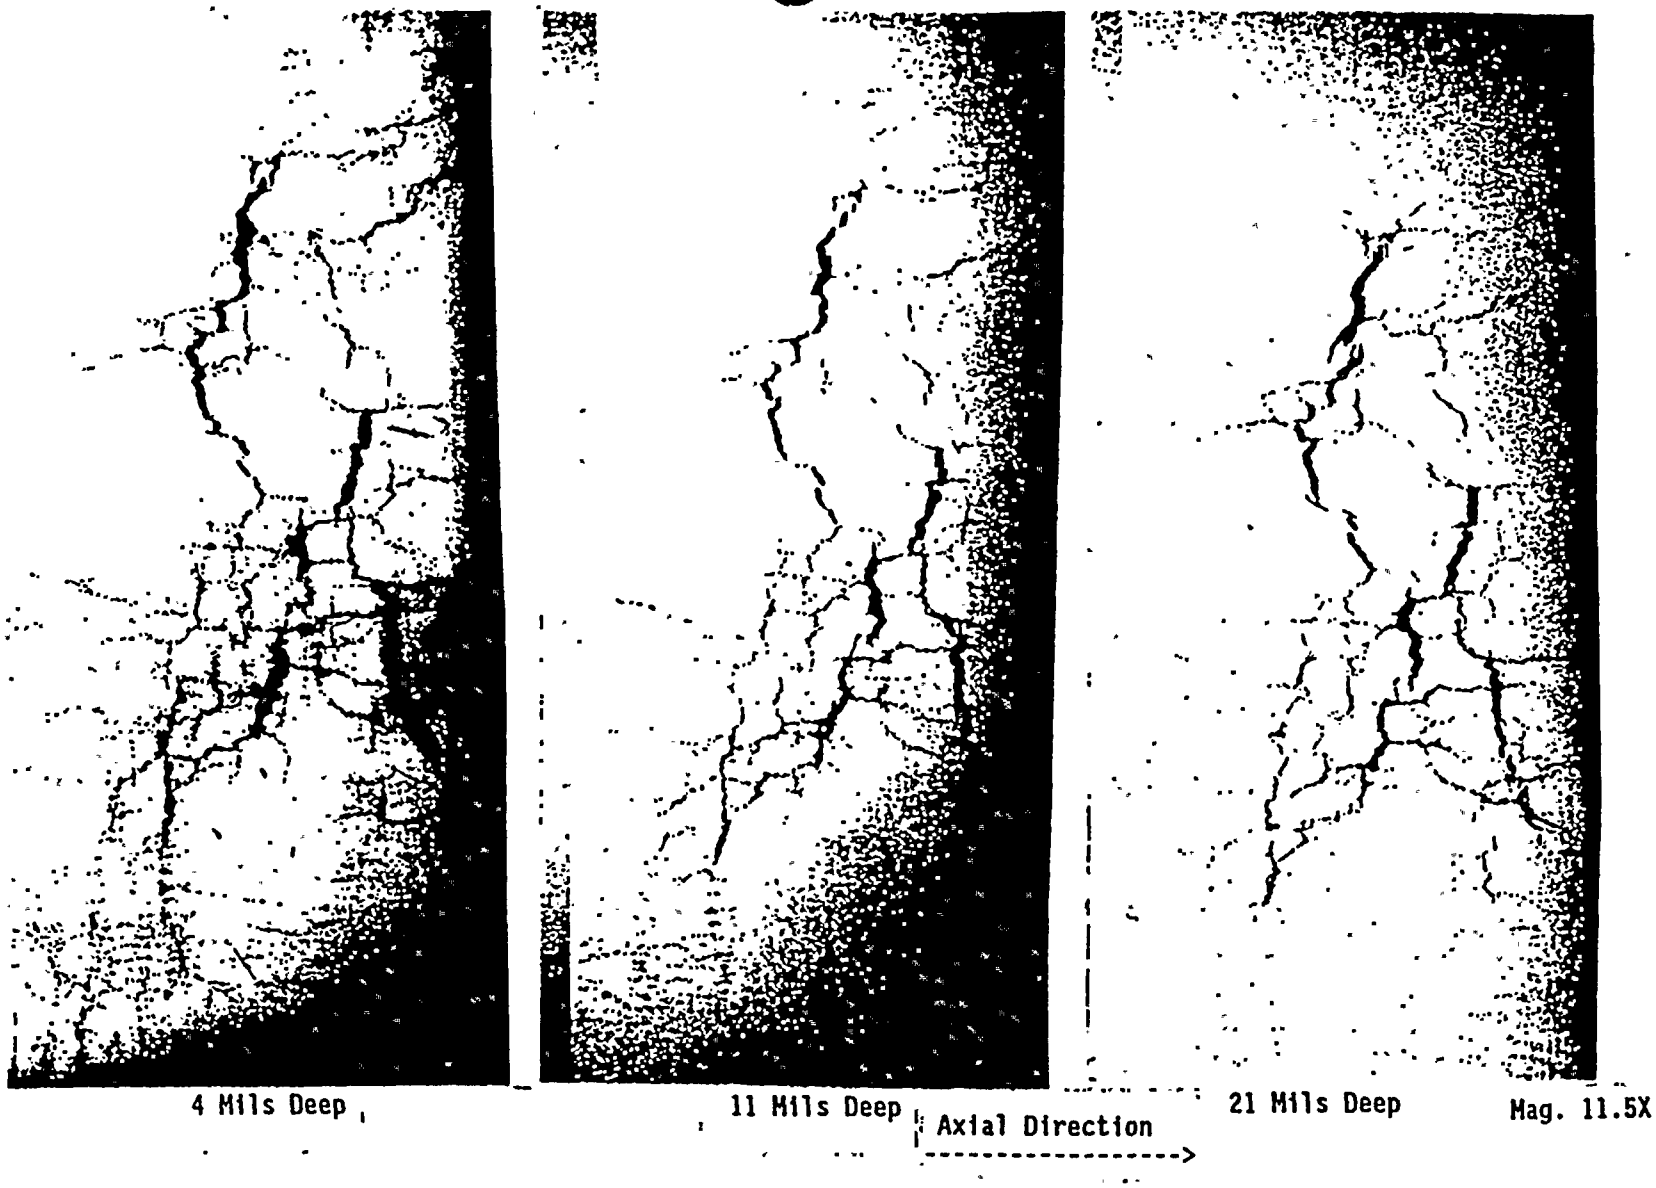
Figure 4 - 52 Photomicrographs of radial metallography performed on a region with axial and circumferential degradation on tube R16-C74, support plate 1. Cellular IGA was found with little change in the cell shape and cell wall thickness at depths of 4, 11 and 21 mils below the OD surface. Note that the cut section was flattened, preferentially opening the circumferential wall of the cells.

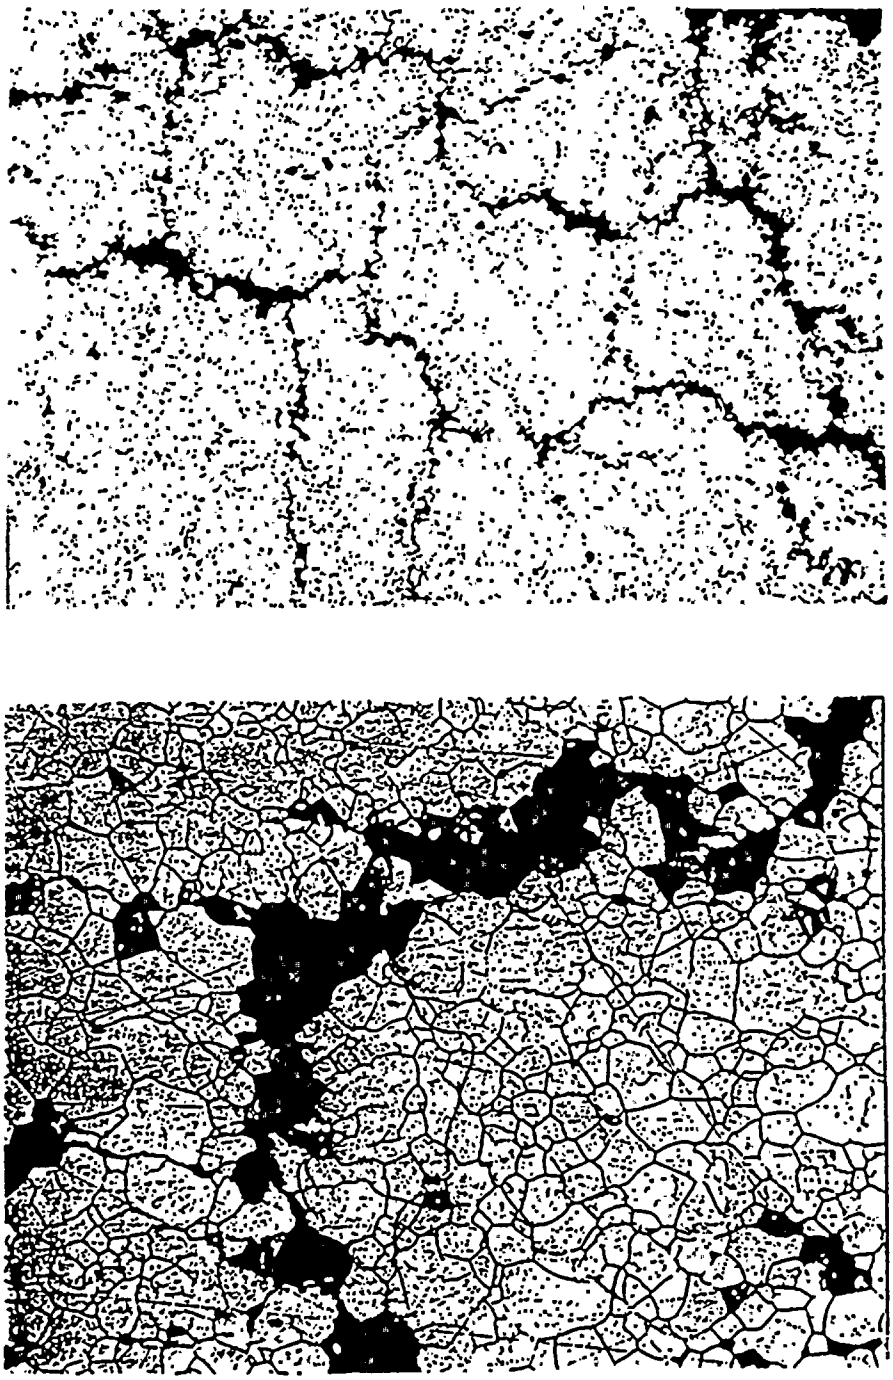
Figure 4 - 53 Higher magnification photomicrographs of the radial section shown in the previous figure. Top photo 50X, bottom 200X

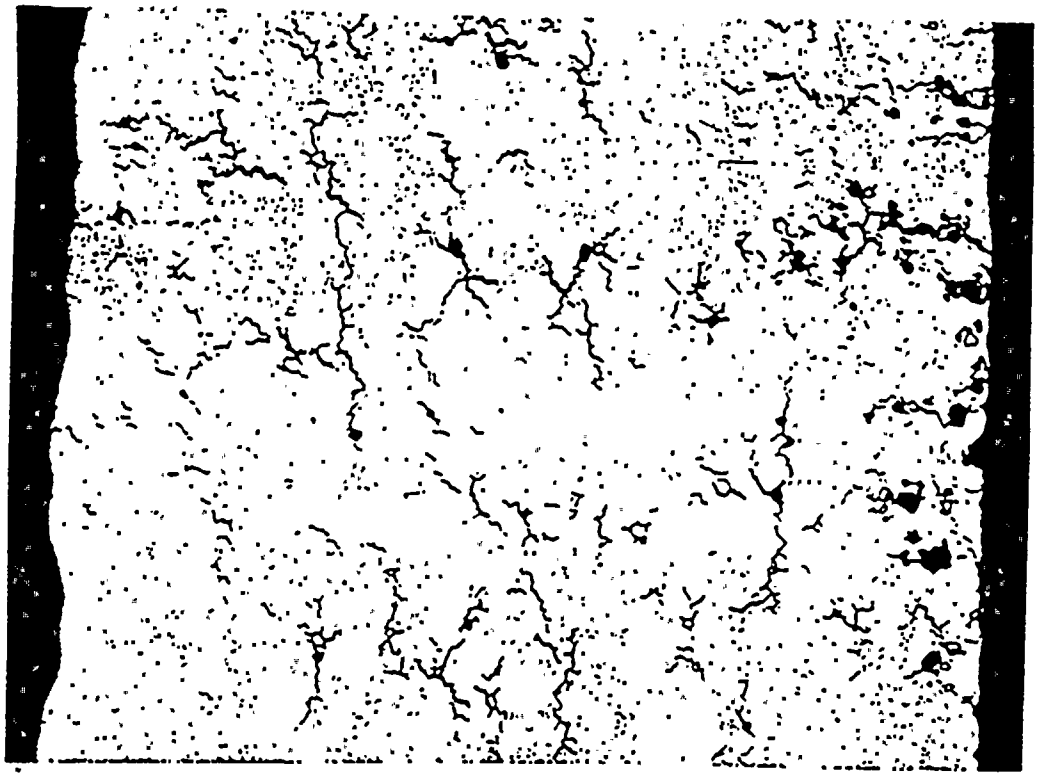
Figure 4 - 54 Radial metallographic section through a portion of the third support plate crevice region of tube R19-C35 from Plant E-4. A cellular IGA/SCC structure is observed. The depth of the section was not specified.

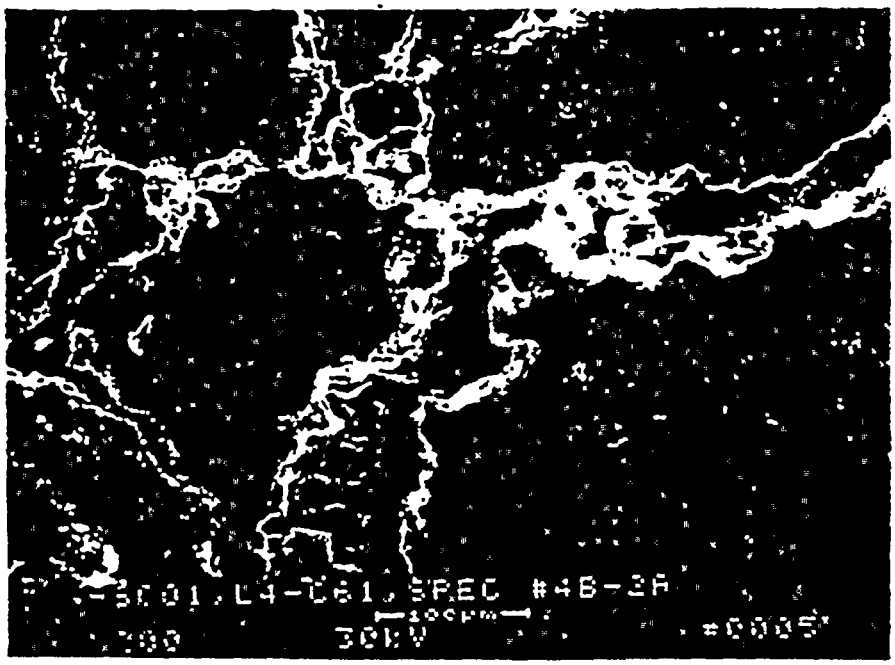
Figure 4 - 57 Network of small, mostly circumferentially oriented OD surface cracks observed in the 5th support plate region, Tube R4-C61.

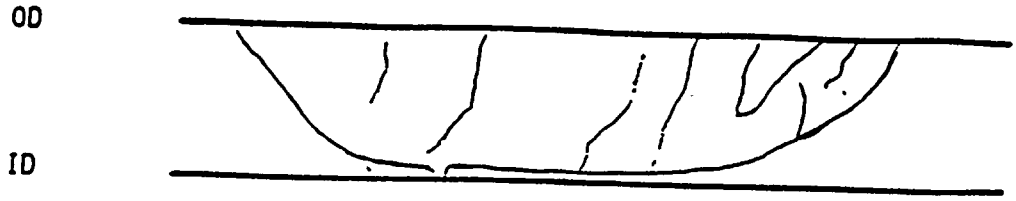
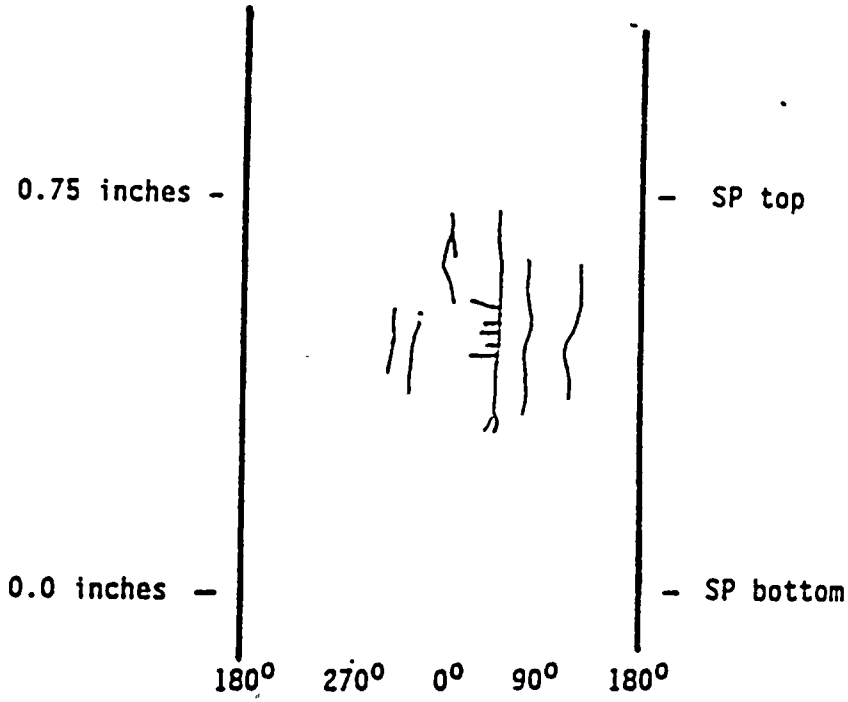
Macrocrack Length = 0.4 inch

Number of Microcracks = 7 (all ligaments have predominantly intergranular features)

Morphology = IGSCC with some IGA aspects (circumferential cracking has more IGA characteristics)

Figure 4 - 56 Description of OD origin corrosion at the fifth support plate crevice region of tube R4-C61, Plant B-1

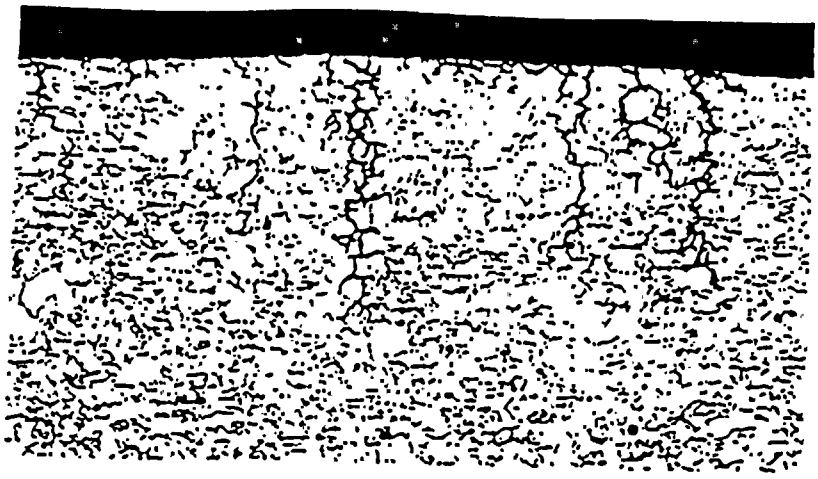
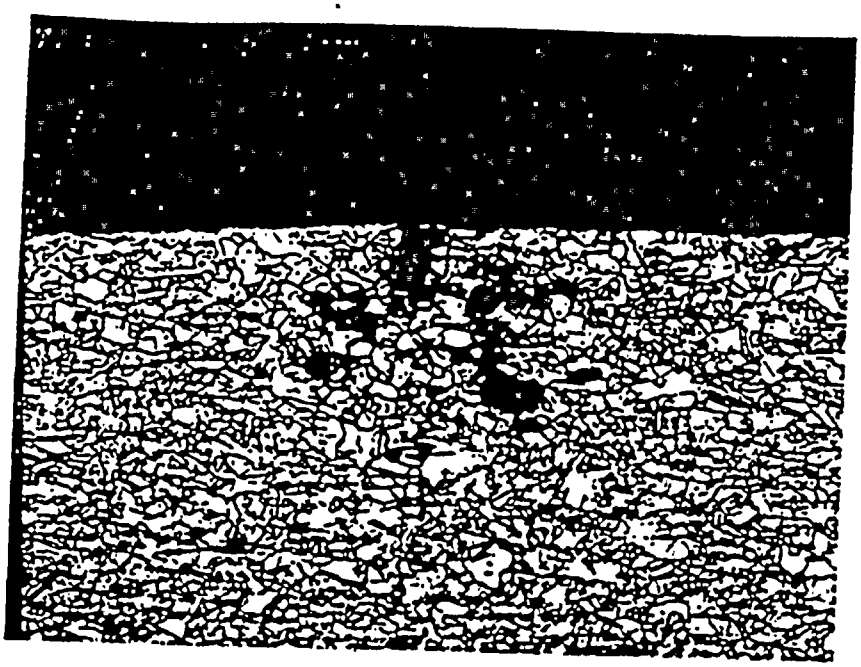
Figure 4 - 58 Photomicrographs of tube R4-C61 corrosion degradation. Top photo shows axial crack morphology (transverse section) at the eighth support plate location (no transverse metallography was performed at the fifth support plate region). Bottom photo shows circumferential crack morphology (axial section) at fifth support plate region.

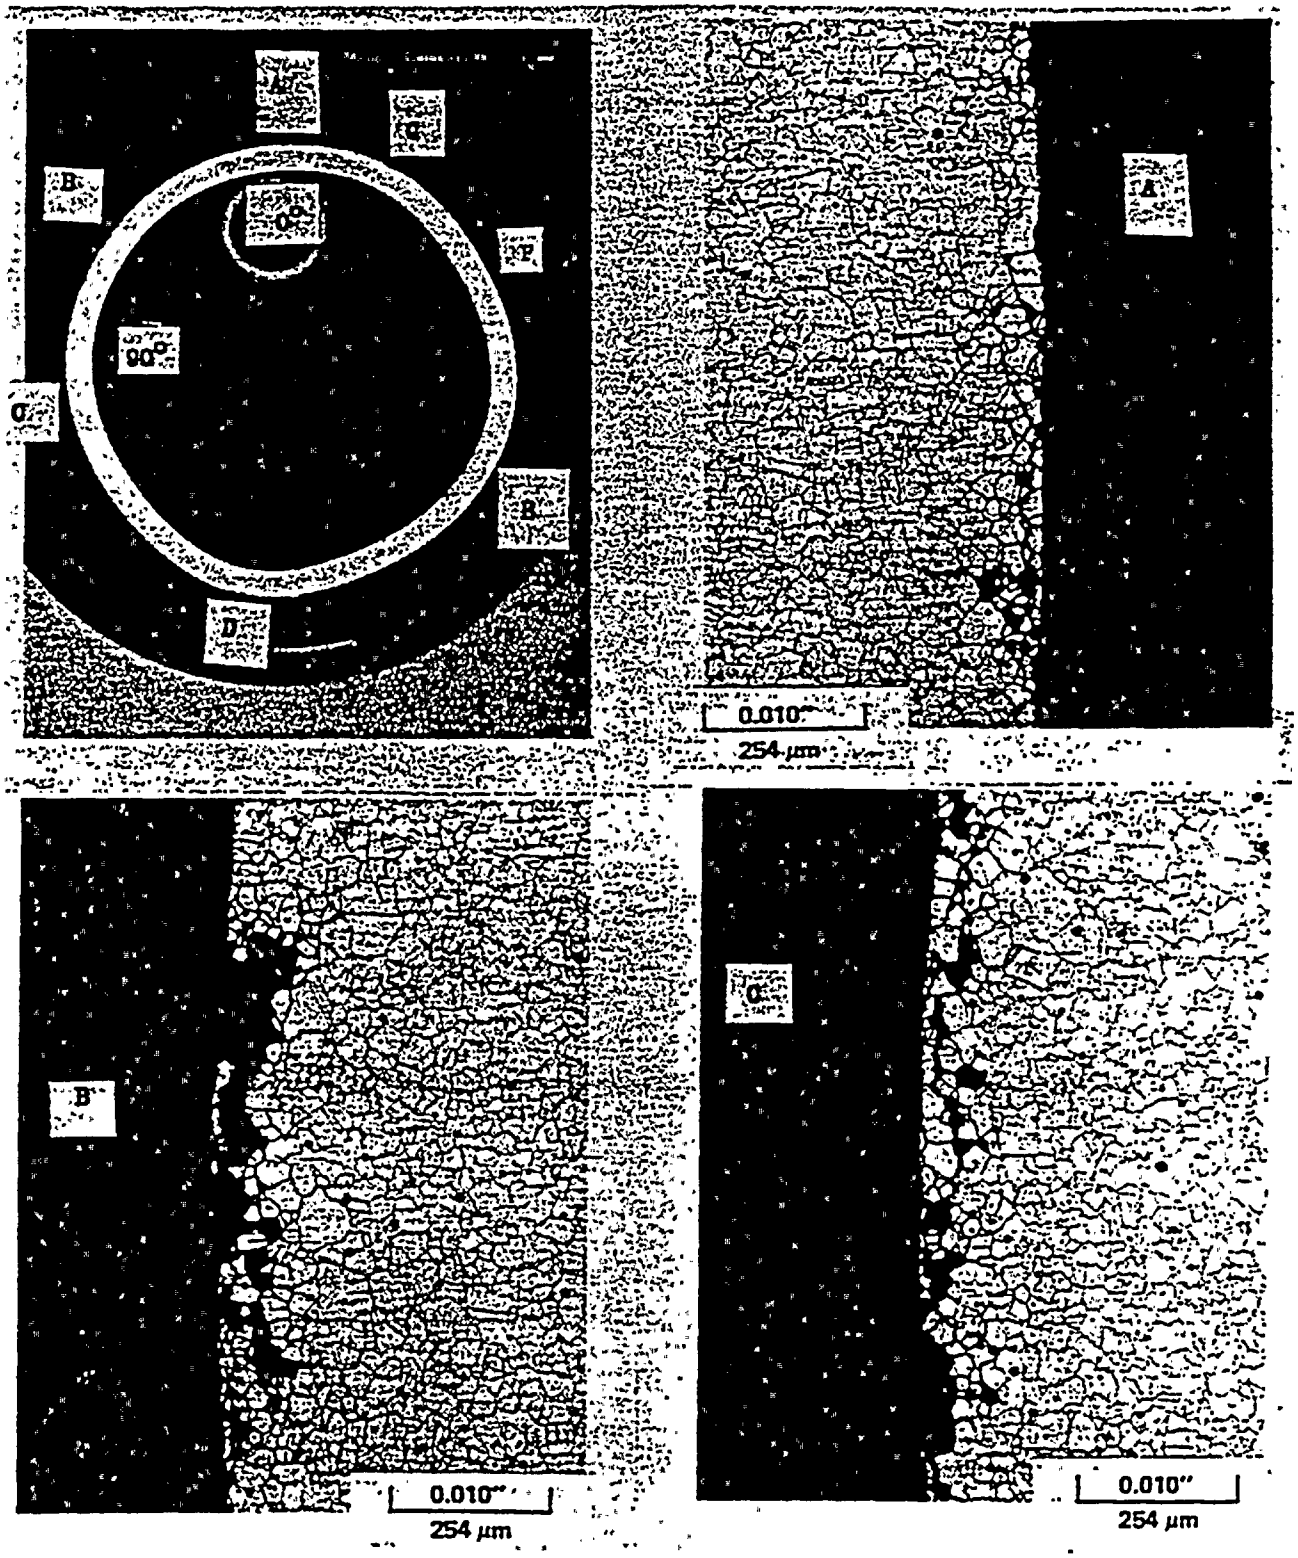
Figure 4 - 59 Transverse metallography at 0.2 inches above first support plate bottom edge showing almost continuous OD IGA around circumference. Maximum depth is 24%.

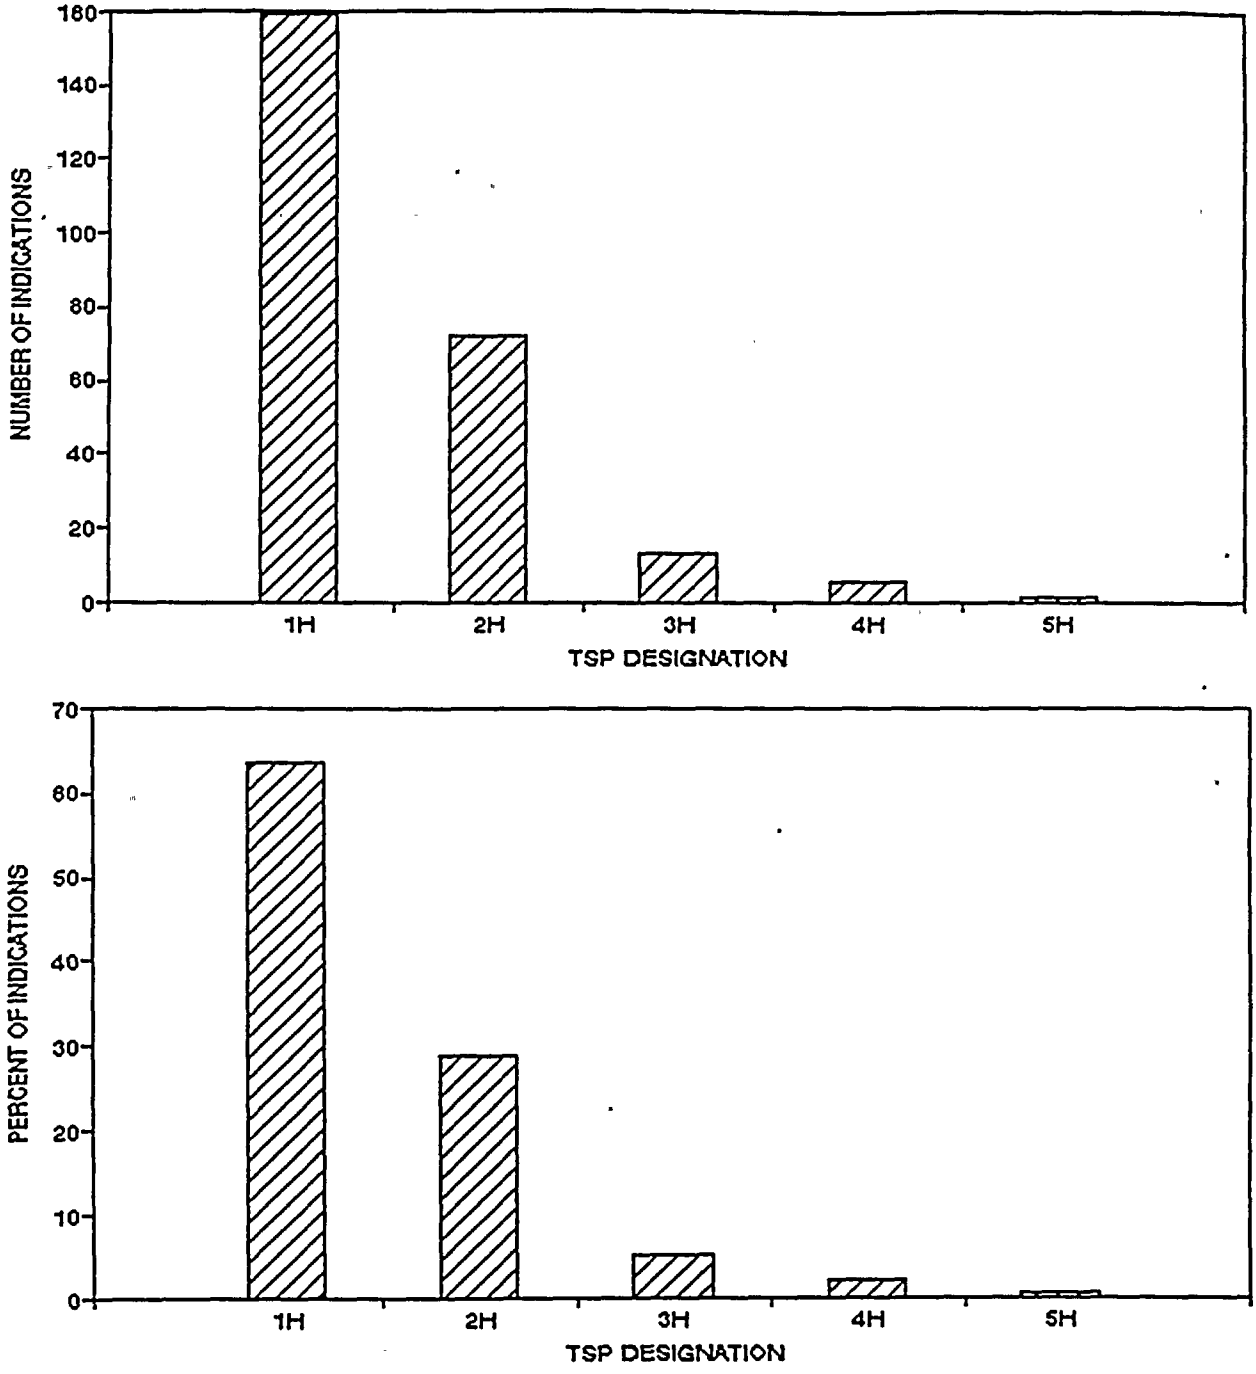
The tube support plate indications from the 1990 inspection were distributed among the four steam generators as follows. There were 83 indications in steam generator 11, 47 in S/G-12, 29 in S/G-13, and 91 in S/G-14. All indications were in the hot leg. Figure 5-1 displays the frequency distribution of TSP indications by support plate locations. The upper figure shows the number of observations at a TSP while the lower figure shows the percent of all TSP indications falling within a given support plate location. It may be noted that over 60% of the indications were at the first TSP in the hot leg (1H).

Figure 5-1. Frequency Distribution of TSP Indications by Location (1990 Inspection)

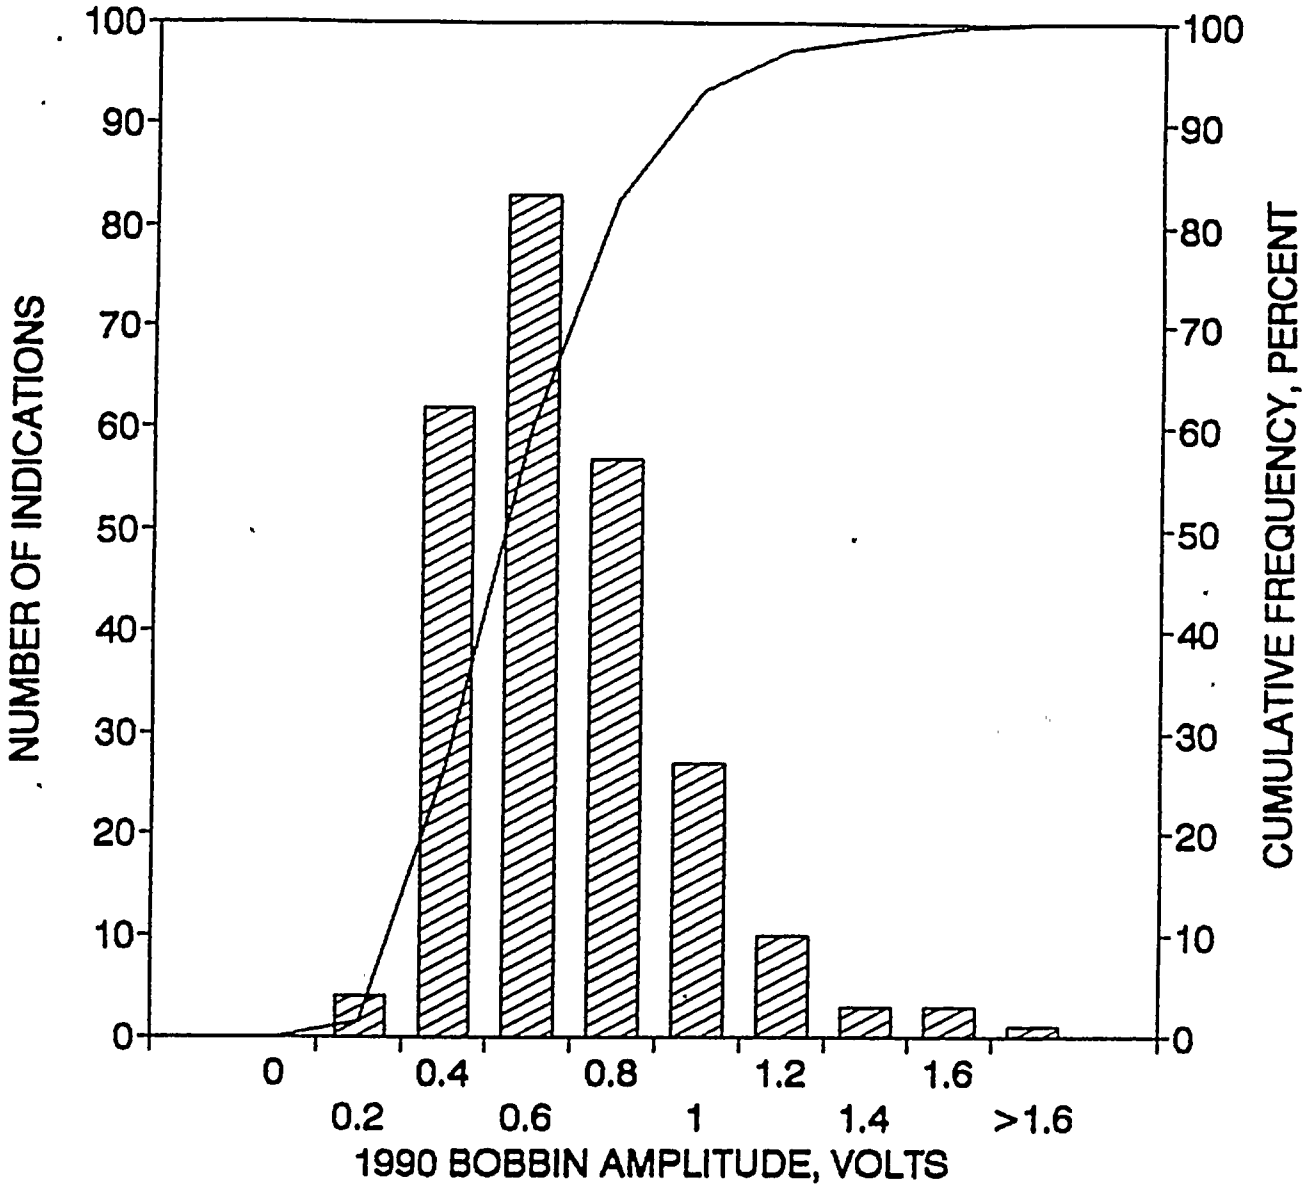
In general, the TSP indications at D. C. Cook Unit 1 had very low amplitudes. A frequency distribution of the 1990 voltage amplitudes from the TSP indications is displayed in Figure 5-2. The upper ends of the voltage ranges are shown on the X-axis scale. Thus the first bar at 0.2 volts represents indications of amplitudes between 0 and 0.2 volts. The cumulative percent frequency is also plotted and is shown as a curve. Over 90% of the indications had amplitudes of less than 1 volt (400/100 kHz mix channel). With the exception of a 2.15 volt indication in S/G-14, all TSP indications were less than 2 volts in amplitude. A histogram of the bobbin voltages in each S/G is shown in Figure 5-3. As in Figure 5-2, the X-axis scale displays the upper ends of the voltage ranges.

Figure 5-2. Frequency and Cumulative Percentage Distribution of Bobbin Amplitudes (December 1990 Inspection)

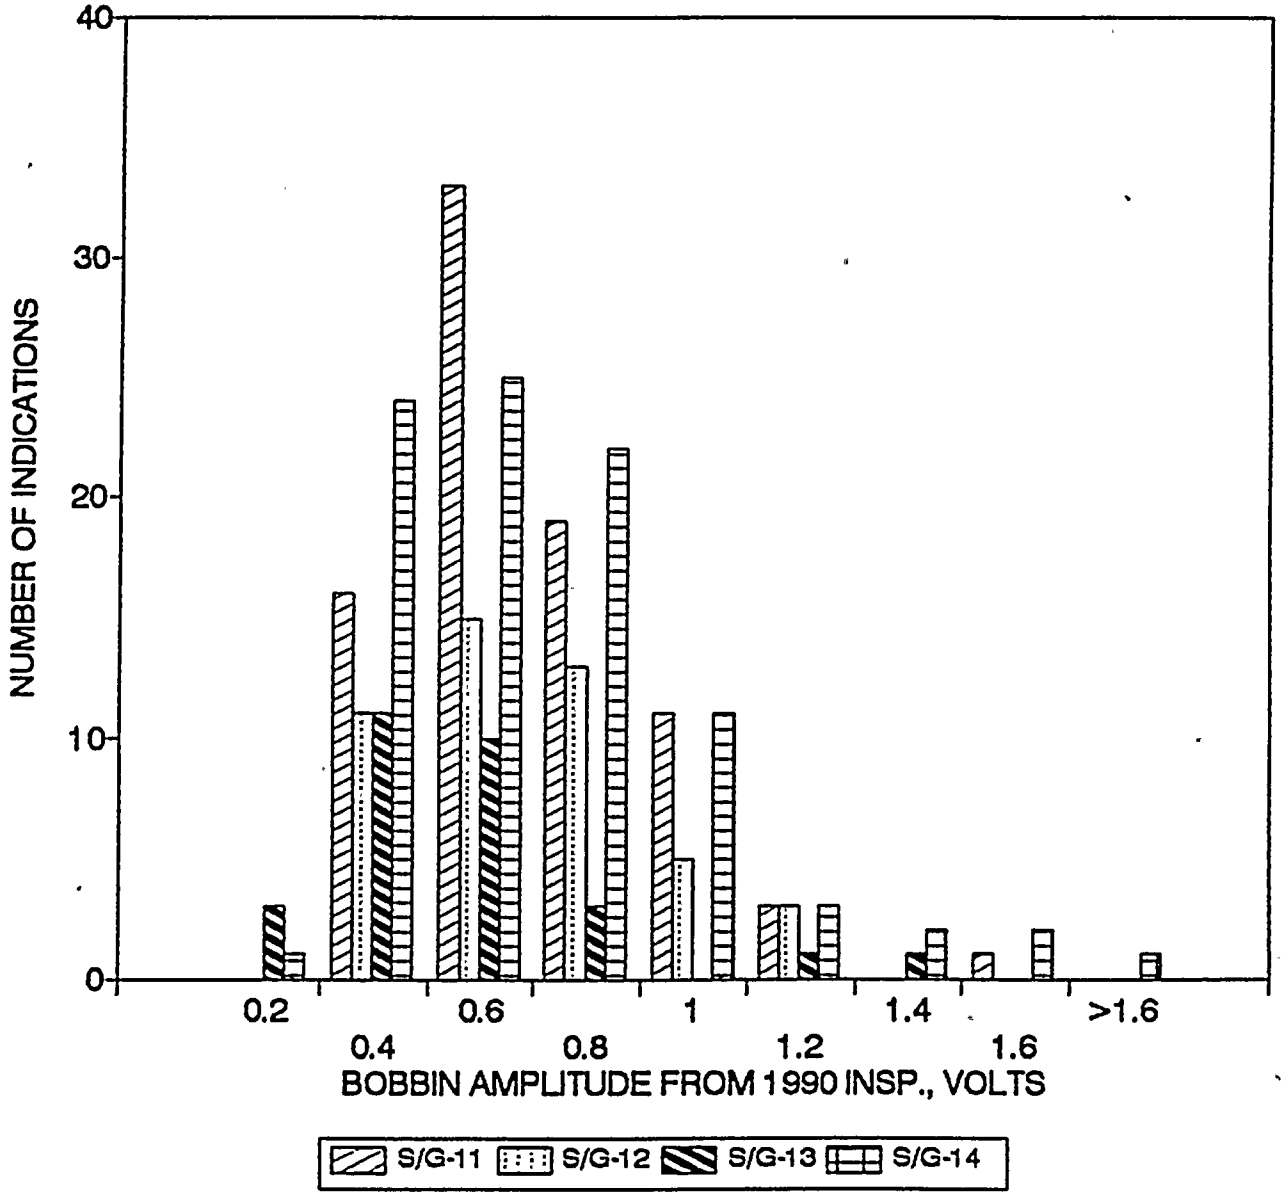
Figure 5-3. Histogram of Bobbin Voltage Distribution in each Steam Generator (1990 Inspection)

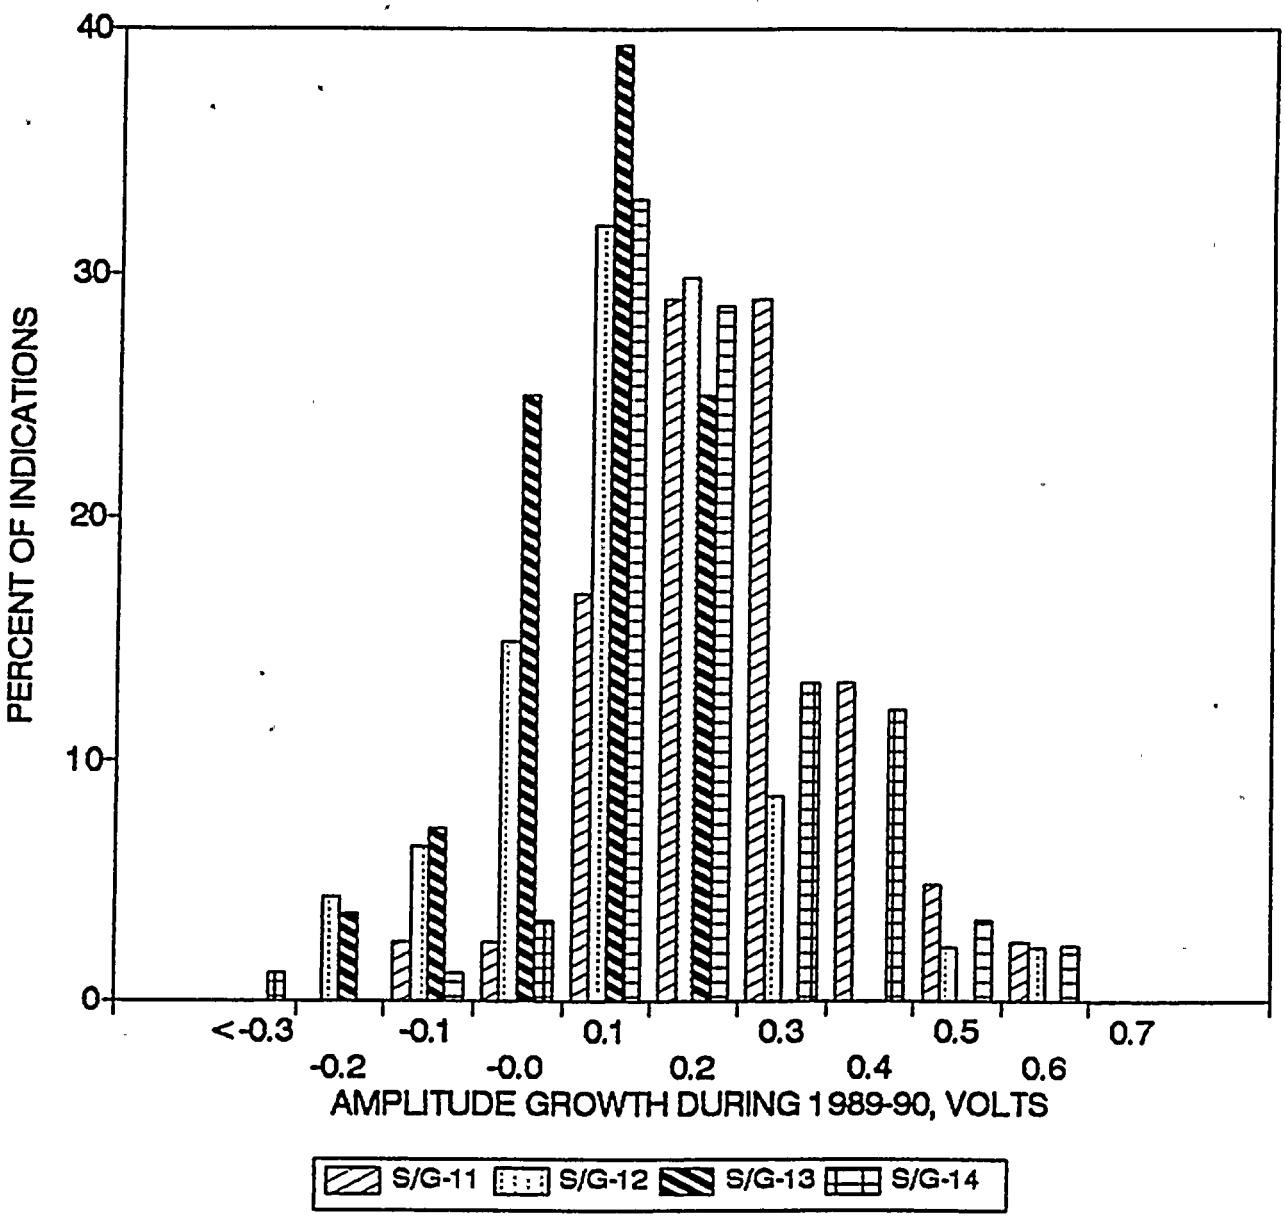
The bobbin voltage amplitudes of the TSP indications during the 1989 inspection ranged from 0.14 to 1.43 volts with an average value of 0.45 volts. Growth in amplitude for each of the last two cycles was determined from the data. Growth estimates were calculated only for the cases where bobbin signal voltage data were available for at least two consecutive inspections; i.e., no assumption about the signal voltage for prior years was made if a flaw indication was not available. As a result, growth estimates for the 1989-90 cycle were made for only 249 of the 250 indications (one indication was not detectable during the reevaluation of the 1989 inspection data). Similarly, growth during the 1987-89 cycle could be estimated for only 234 of the 250 indications from 1990. A frequency distribution (in percent) of voltage growth in each of the four S/Gs during the 1989-90 operating cycle is shown in Figure 5-4. It may be noted that the mode (interval of highest frequency) of the amplitude growth is near 0.1 volt. No significant variation between S/Gs is apparent.

Figure 5-4. Percentage Distribution of Voltage Growths in each Steam Generator (1989-90 Cycle)
