WCAP-13188

D. C. Cook Unit-1

Steam Generator Tube Plugging Criteria for Indications at Tube Support Plates

March 1992

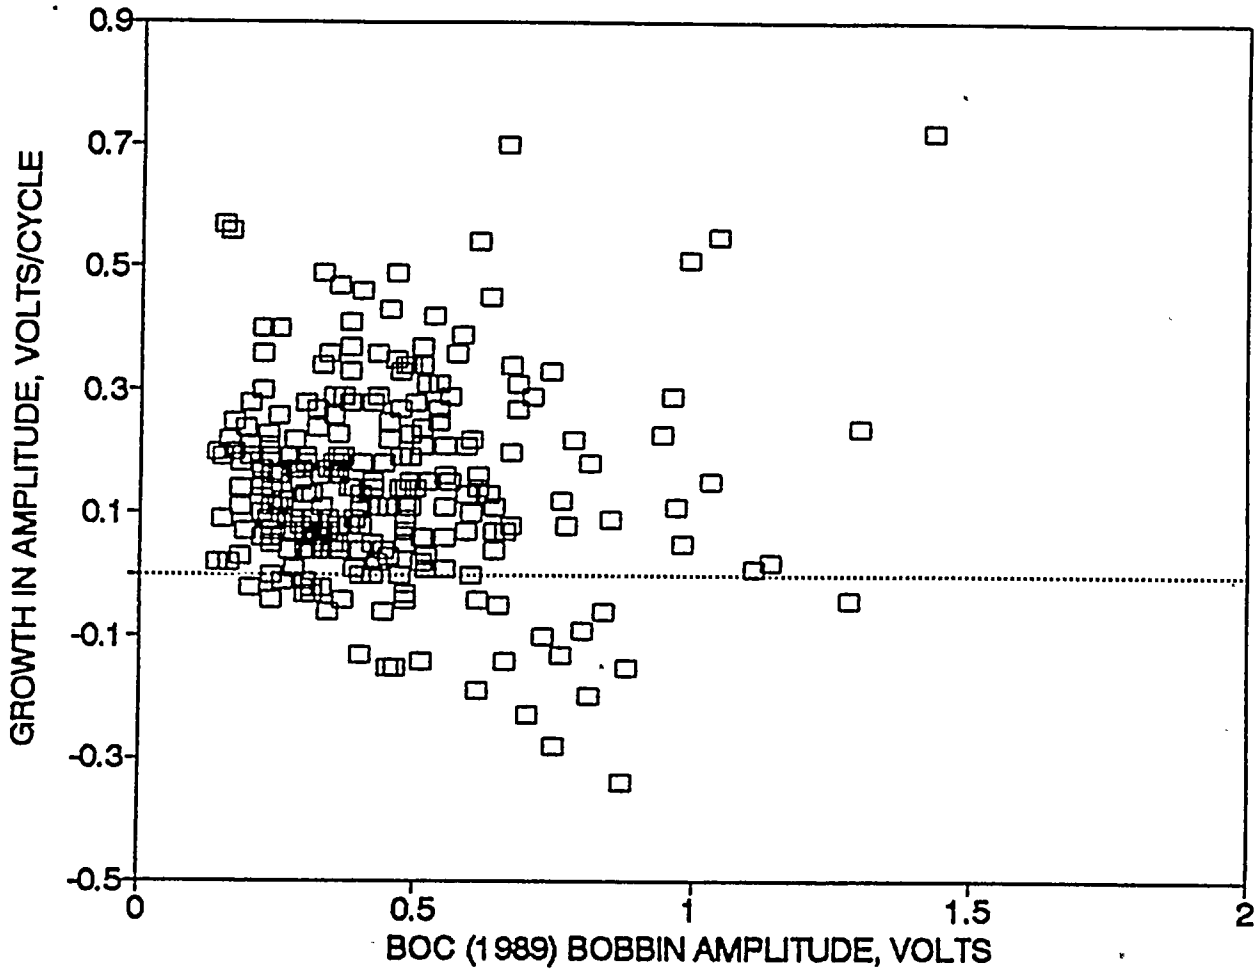
Figure 5-5 shows a plot of the growth in amplitude from 1989 to 1990 as a function of the 1989 amplitude for the TSP indications in all S/Gs. It may be noted that the amplitude growth ranged from about -0.4 to +0.7 volts. The negative growths (and possibly some of the high positive growth values) result from the uncertainties in the eddy current inspection and data evaluation discussed above. Overall, the distribution of amplitudes and their growths appear reasonable, based on experience with data from other plants. Figure 5-6 shows the growth in amplitude during the 1987-89 cycle as a function of the beginning of cycle (BOC) bobbin amplitude. The data from the two cycles appear quite similar.

Figure 5-5. Growth in Bobbin Amplitudes During the 1989-90 Cycle

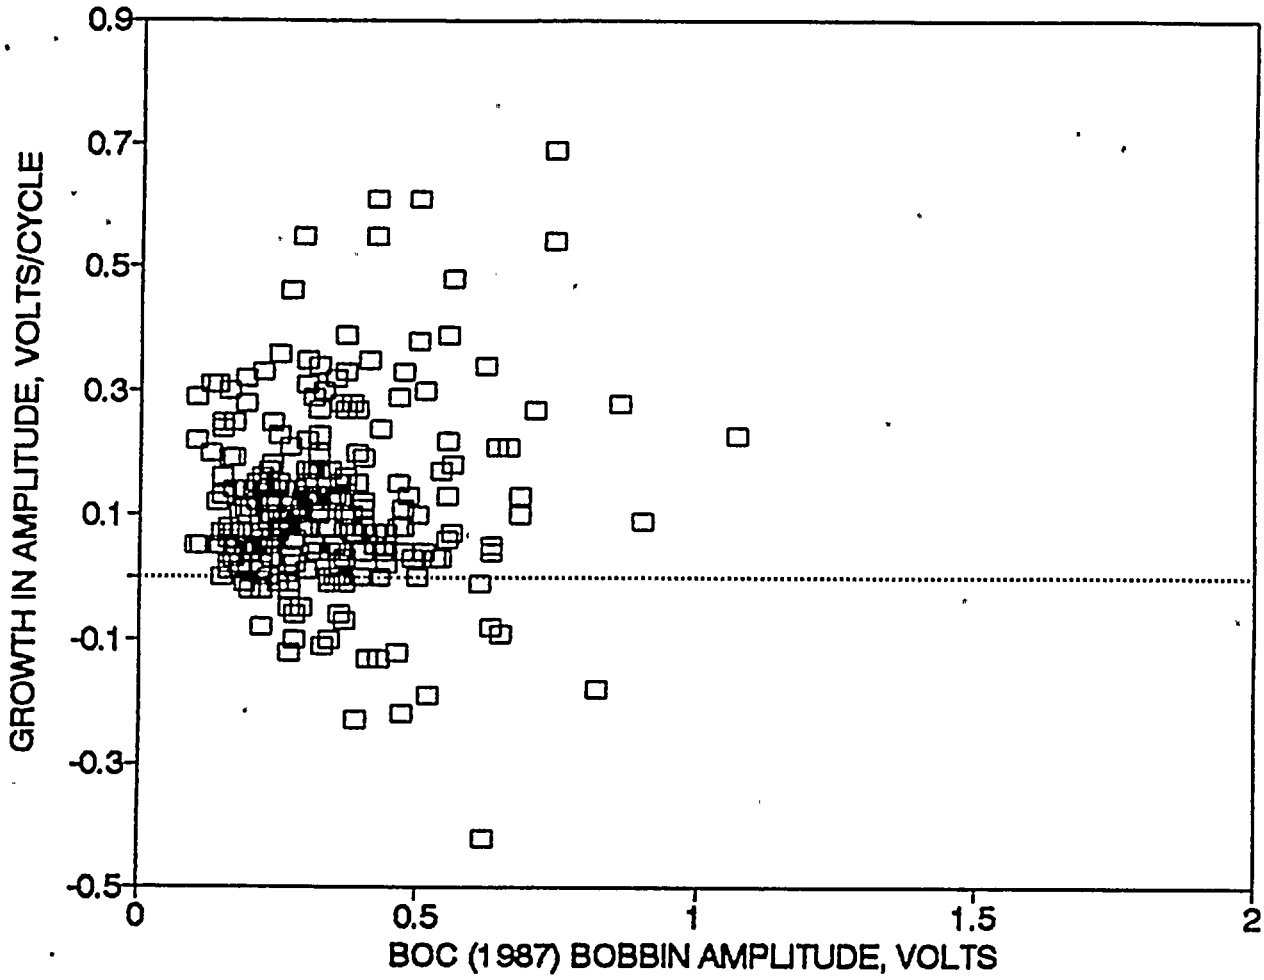
Figure 5-6. Growth in Bobbin Amplitudes During the 1987-89 Cycle

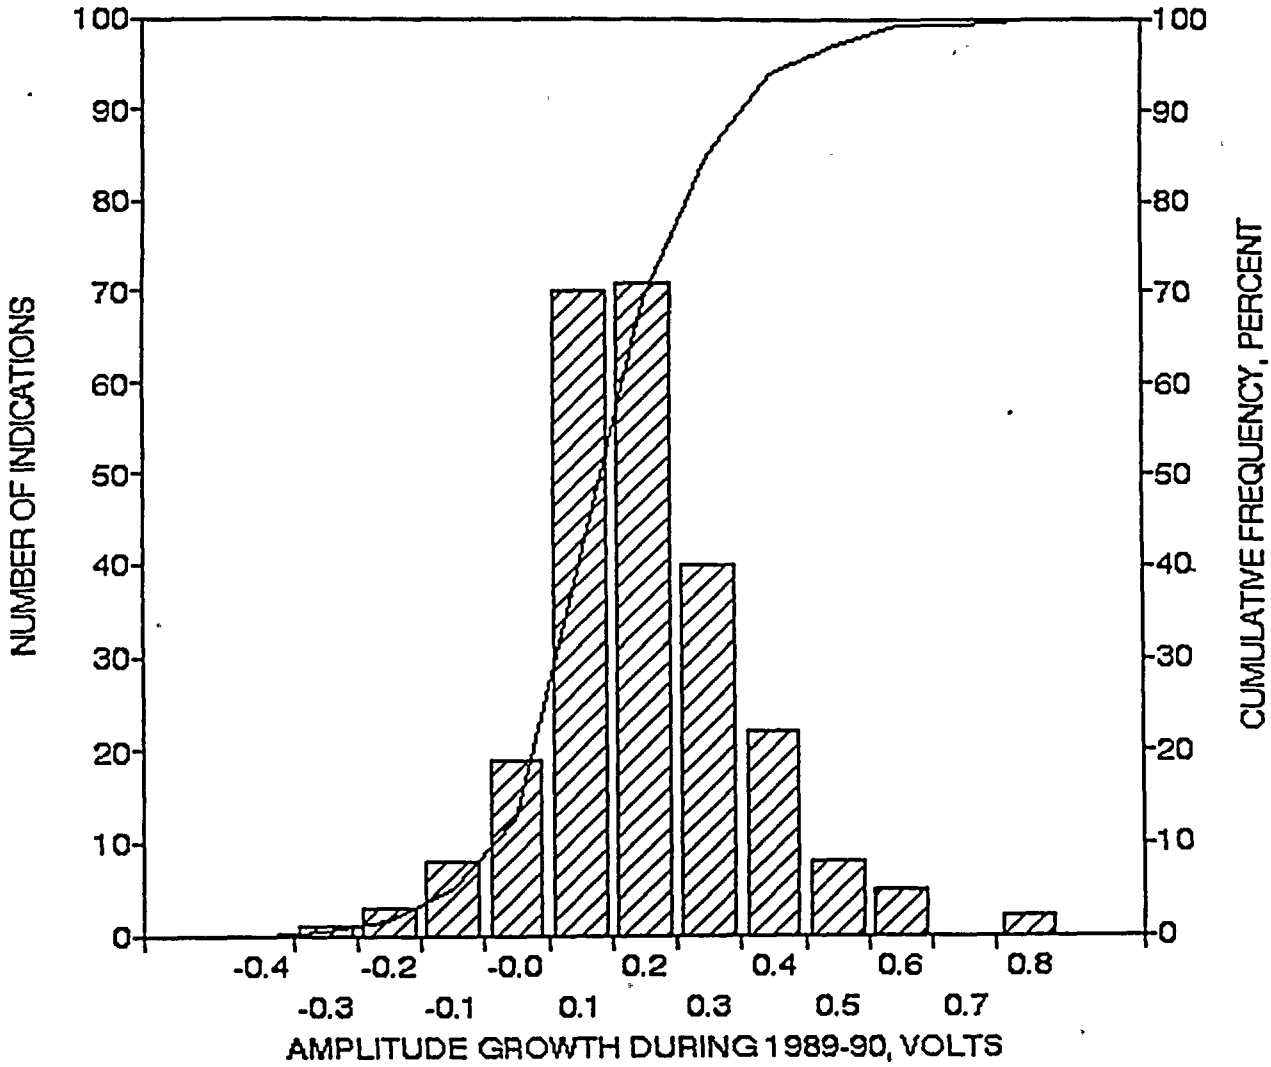
Figure 5-7 shows a frequency distribution of voltage growths during the 1989-90 cycle. The upper ends of the ranges are displayed on the X-axis. The cumulative frequency distribution in percent is also displayed in the figure, as an "S" curve. It may be noted that most of the indications had growth rates between 0.0 and 0.2 volt per cycle and that all (100%) of the indications had growth rates less than 0.8 volt per cycle. This data (growth rate distribution) is used in the Monte Carlo analyses described in Sections 11 and 12. The frequency distribution of voltage growth during the 1987-89 cycle is shown in Figure 5-8. These results are quite similar to those from the 1989-90 cycle.

Figure 5-7. Histogram and Cumulative Probability Distribution of Voltage Growth During the 1989-90 Cycle

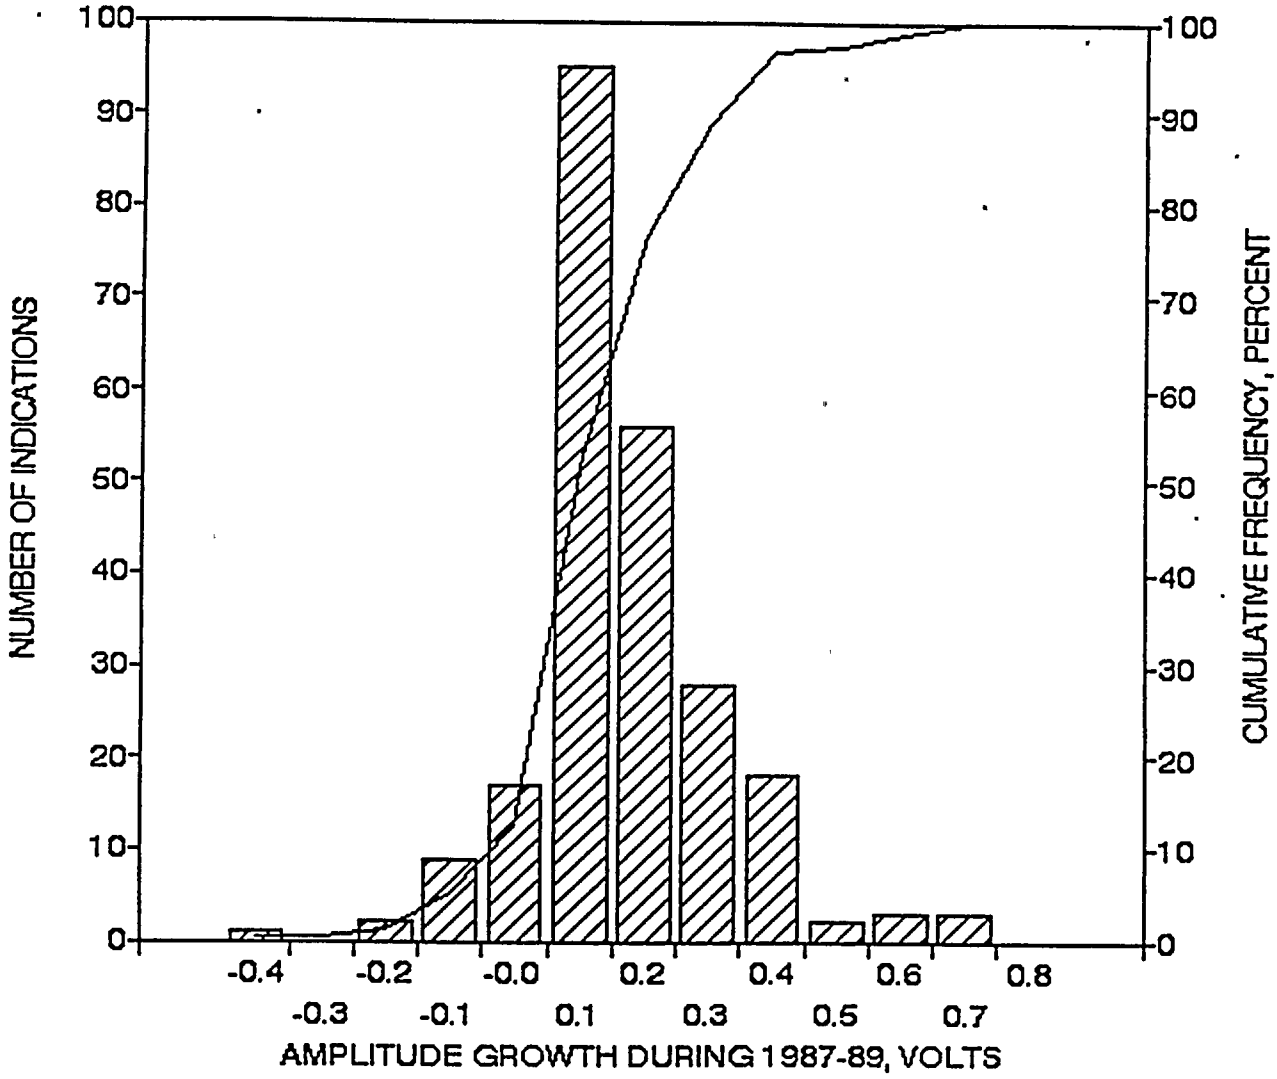
Figure 5-8. Histogram and Cumulative Probability Distribution of Voltage Growth During the 1987-89 Cycle

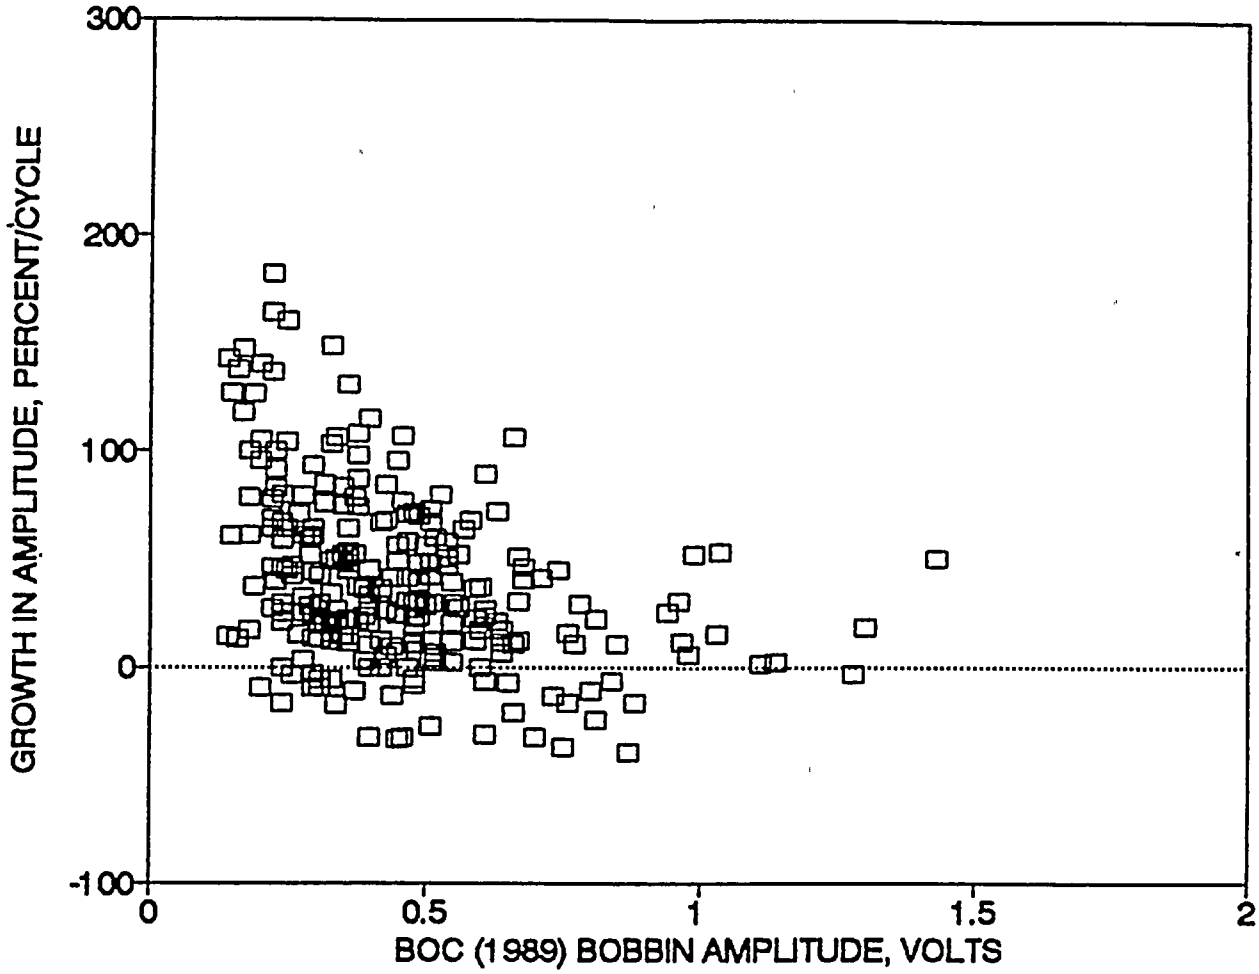
It was noted before that the percent growth rate of amplitude is lower at higher BOC amplitudes (see Figures 5-9 and 5-10). This observation is typical of all domestic plants evaluated by Westinghouse to date. Thus an overall average of percent growth rate may have a strong upward bias due to the small amplitude signals. To assess the impact of this factor, average percent growth rates were calculated for two different BOC amplitude ranges above and below 0.75 volts. The results are displayed in Table 5.2. For BOC amplitudes below 0.75 volts, the average percent growth rate for the 1989-90 cycle was 46% whereas the average for BOC amplitudes equaling or exceeding 0.75 volts was 8%. Similar difference is noted for the 1987-89 cycle when the averages of the two ranges were 43% an 11 %, respectively. This significant difference must be taken into account in the development of the plugging criteria. The standard deviations associated with the averages are listed in Table 5.3.

Figure 5-9. Percent Growth in Bobbin Amplitudes During the 1989-90 Cycle

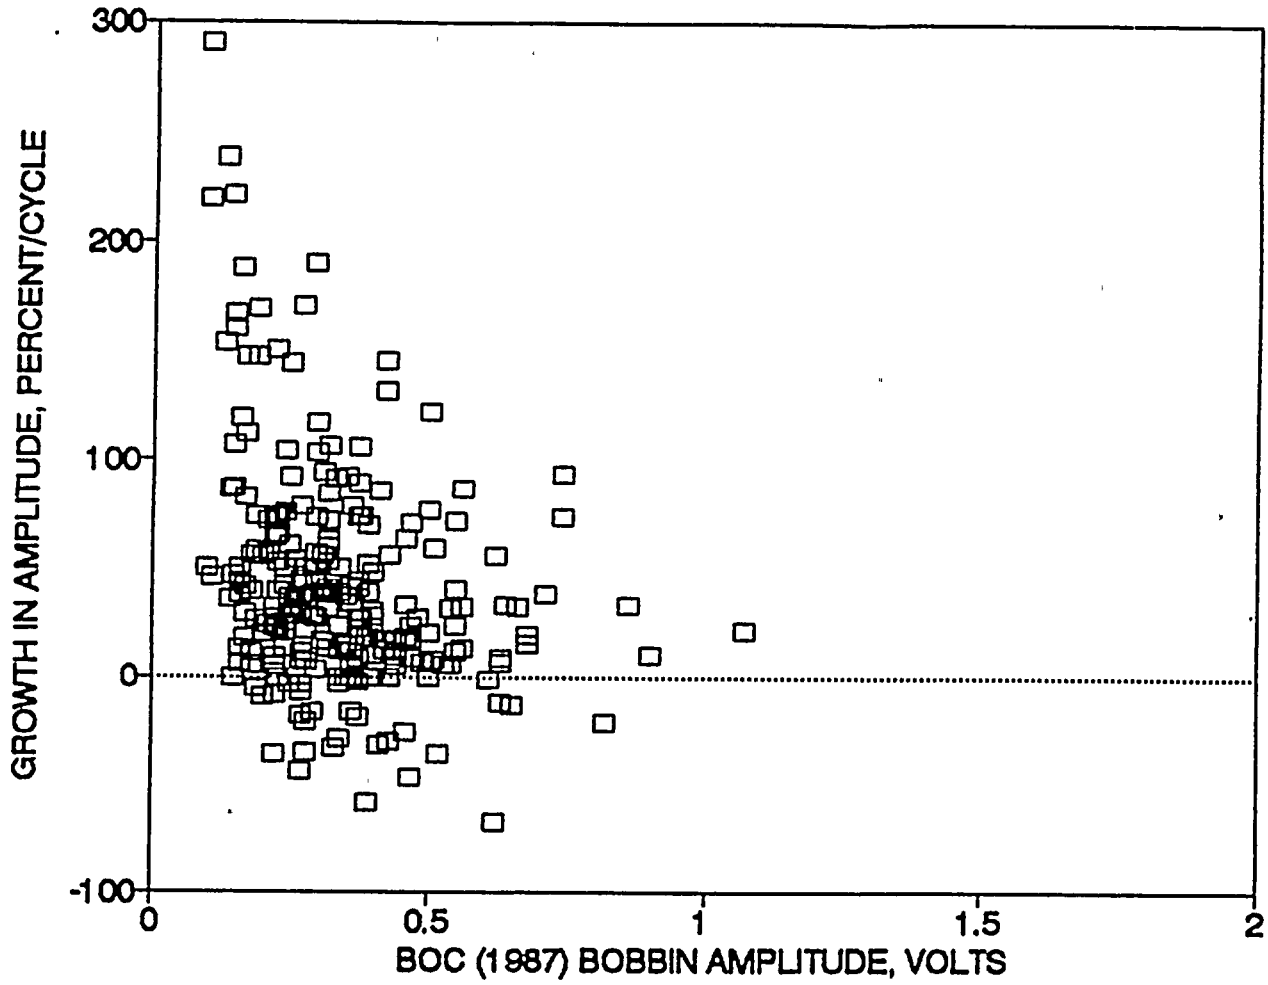
Figure 5-10. Percent Growth in Bobbin Amplitudes During the 1987-89 Cycle

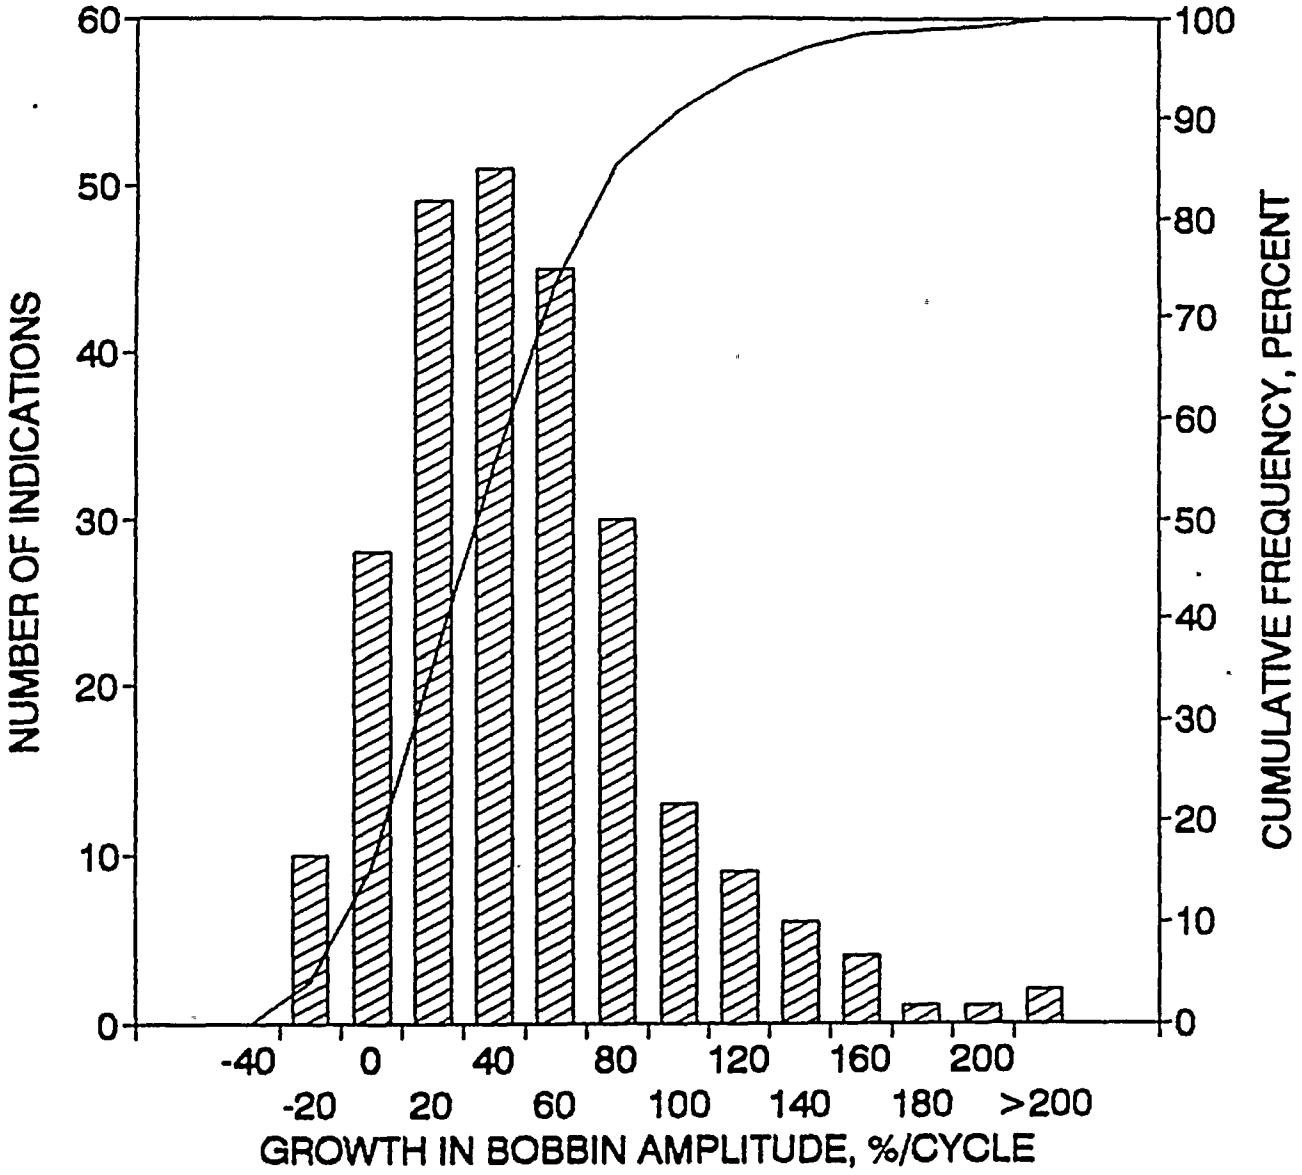
Figure 5-11 shows a frequency distribution of the percent growth rates from the 1989-90 cycle. The scale on the X-axis shows the upper value of the range whose frequency is displayed on the Y-axis. The mode is 20 to 40% growth per cycle. The cumulative frequency distribution (in percent) is also plotted in the figure as a curve. It shows that 90% of the percent growth values are below 100%/cycle. A similar plot for the 1987-89 cycle is shown in Figure 5-12. The distributions are very similar between the two cycles.

Figure 5-11. Histogram and Cumulative Probability Distribution of Percent Growth During the 1989-90 Cycle

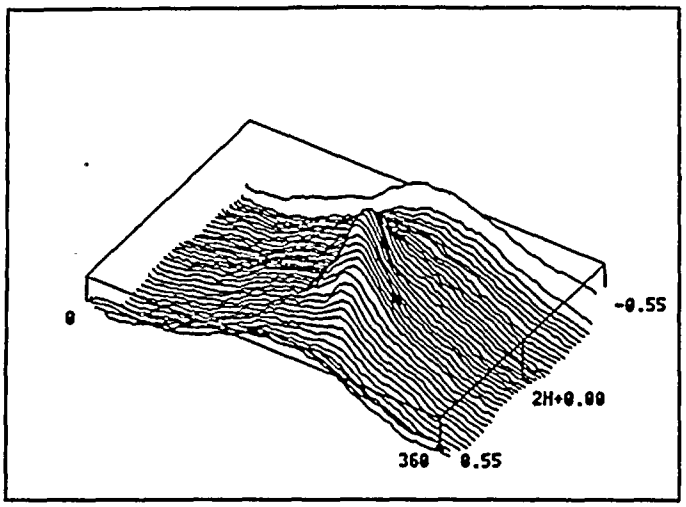
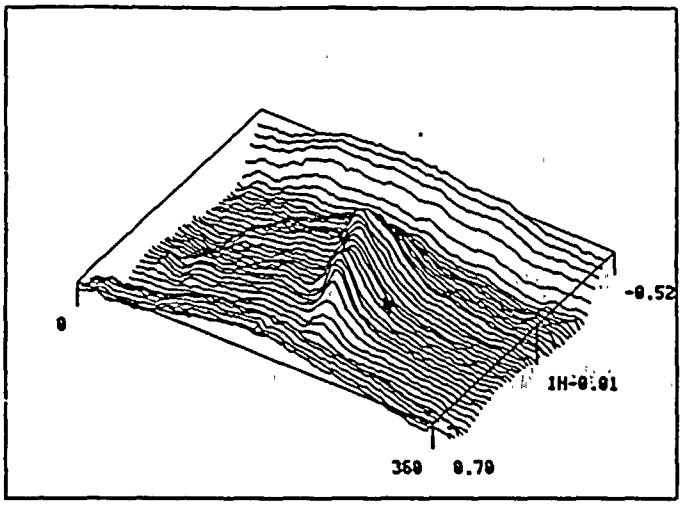
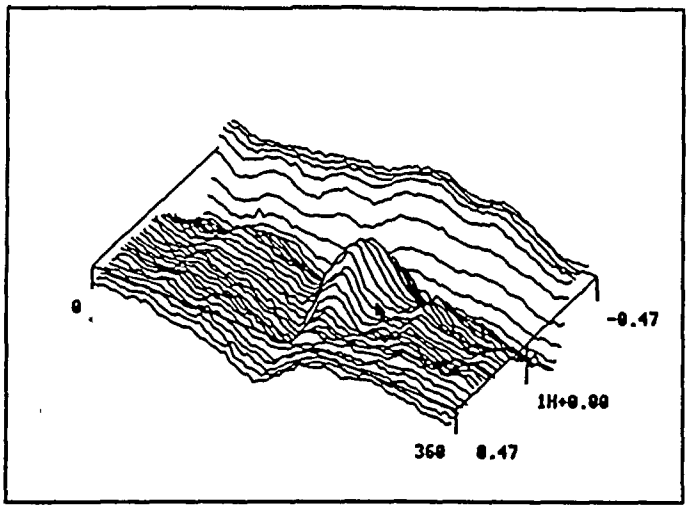
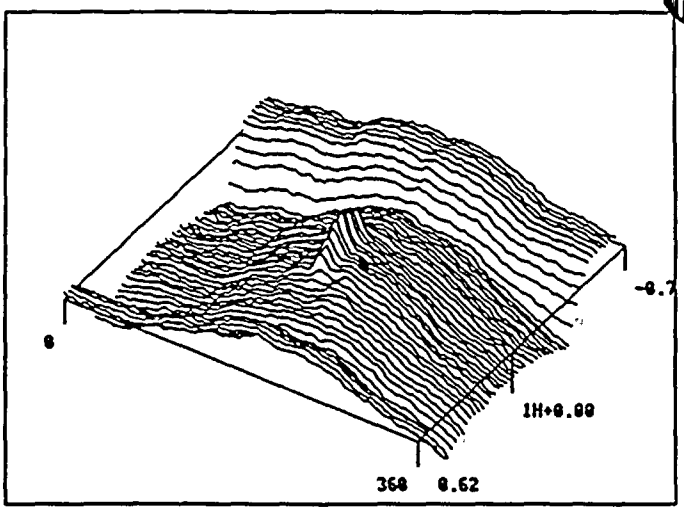
Figure 5-13. Example RPC Traces from Hot Leg Support Plate Locations in S/G-12 (April 1989 Inspection)

a) R8 C20, Location 2H

b) R2 C14, Location 1H

c) R18 C16, Location 1H

d) R20 C24, Location 1H

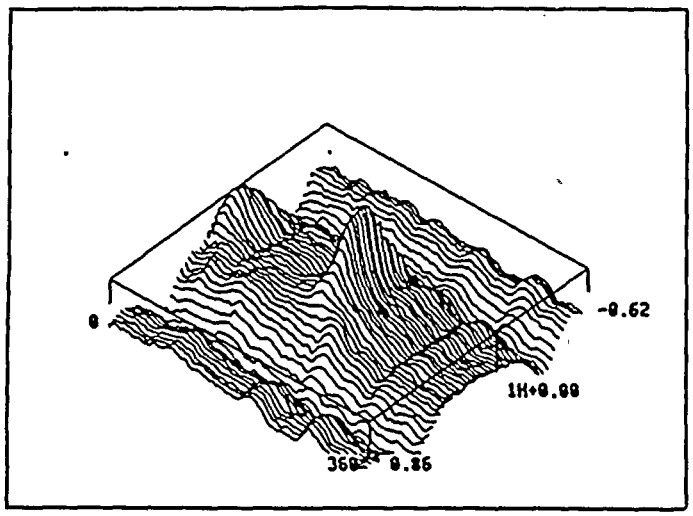
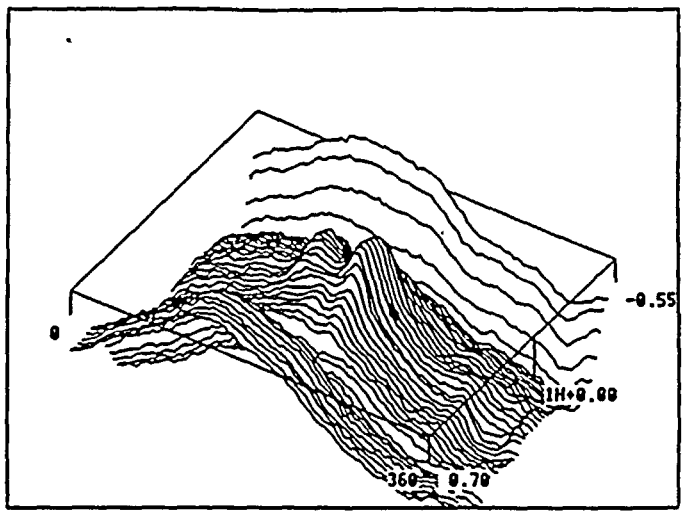
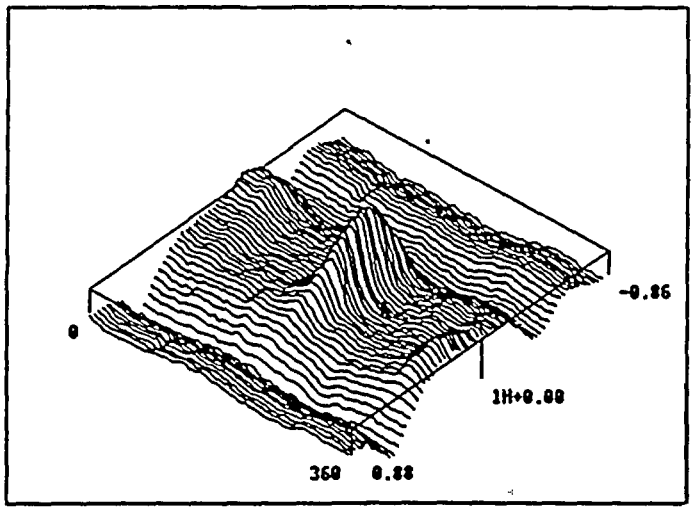
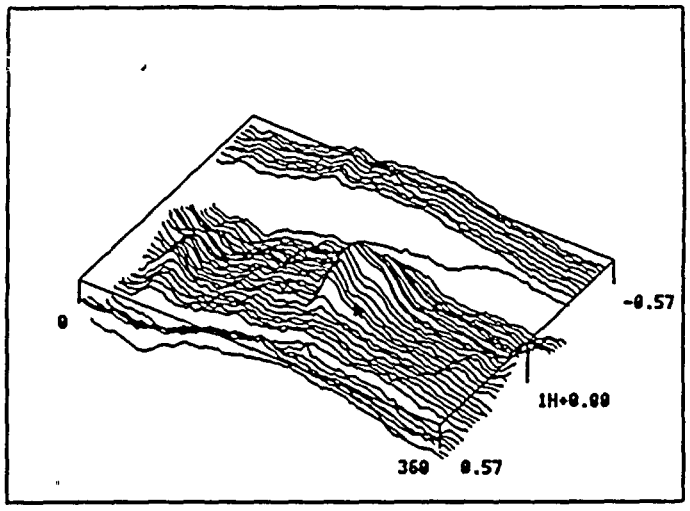
Figure 5-14. Example RPC Traces from Hot Leg Support Plate Locations in S/G-12 (April 1989 Inspection)

a) R8 C5, Location 1H

b) R12 C14, Location 1H

c) R9 C7, Location 1H

d) R23 C13, Location 1H

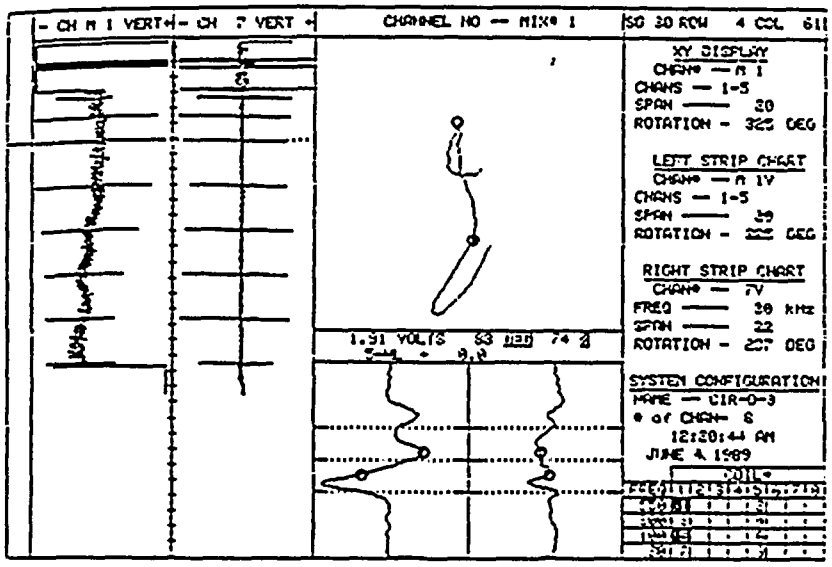
Figure 6-3. Field Bobbin Coil and RPC Traces for 3/4 inch Tube

Field bobbin probe data for Plant B-1, tube R4-C61
at TSP 5, using 550/100 kHz differential mode mix.
A 1.91 volt indication with 74% depth is observed.

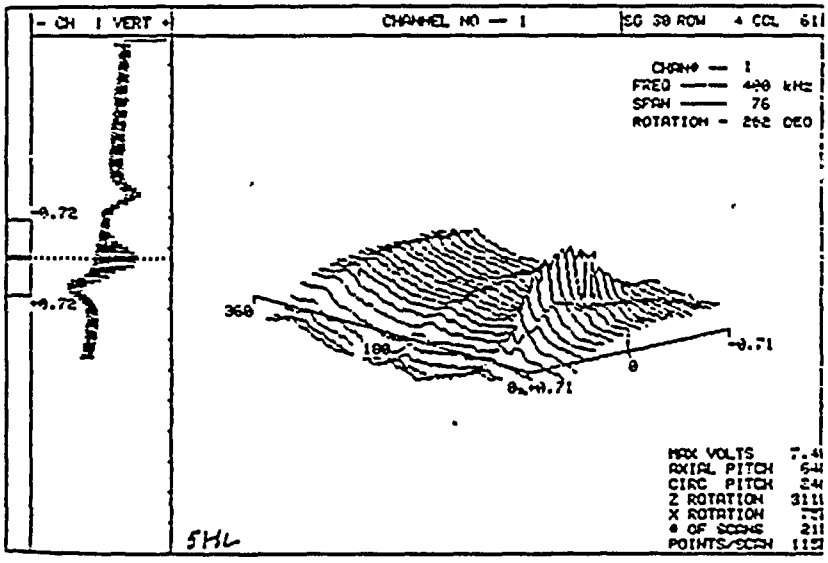
Field RPC data for Plant B-1, tube R4-C61 at TSP 5.
A 0.4 inch long axial indication is observed.

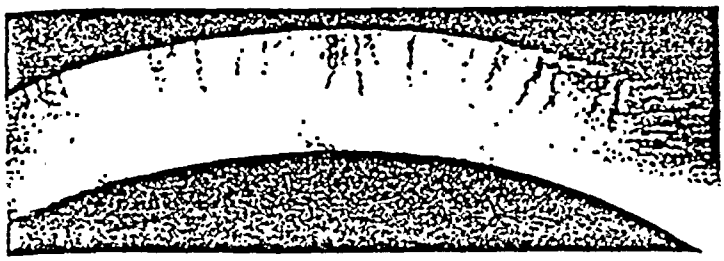
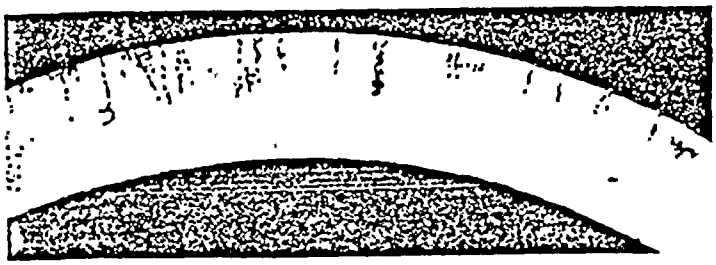
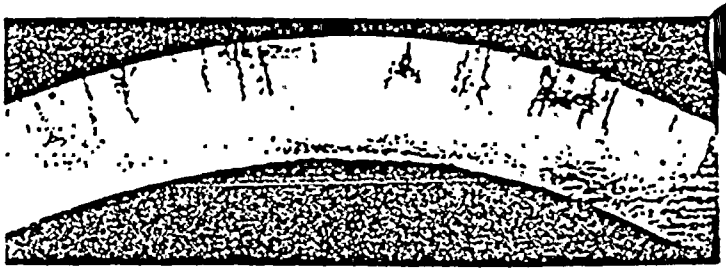
Figure 6-8. Crack Morphology for Pulled Tube from French S/G

Fourteen tubes have been removed from French units with destructive examination results currently available. Figure 6-8 shows the crack morphology for a tube with a 0.7 volt (~3.7 U.S. volts) indication. The tube exams indicate many axial cracks of comparable depth around the tube circumference. The cracks are dominantly ODSCC with somewhat more IGA participation than seen in most domestic pulled tube data such as the Plant A data. The multiple crack networks would be expected to increase bobbin coil voltage compared to one or only a few deep cracks as typical of the domestic data.

Coupe transversale 2 (cf. annexe 8)
Aspect de la fissuration sur différents plans de polissage

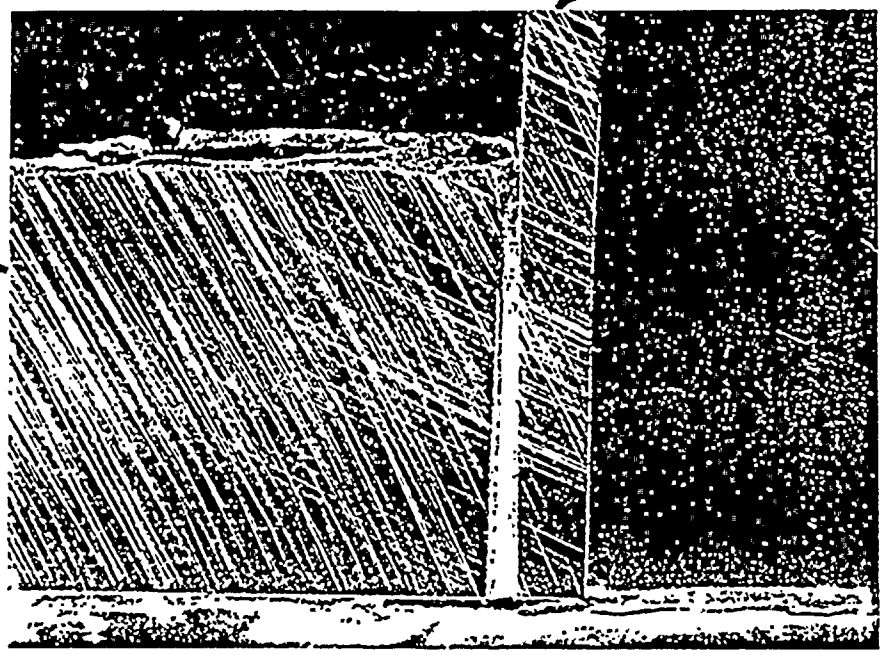
Figure 7-3. Section Through a Dented Tube Support Plate Intersection

A section through the tube and collar of specimen Trial-1 is shown in Figure 7-3. The packed

magnetite and the corrosion products in the crevice are clearly evident. A scanning electron photograph of the polished section in Figure 7-3a shows several layers of corrosion products along with the starting layer of packed magnetite. The EDS (energy dispersive spectrometry) nickel and iron maps of Figure 7-4 show that the corrosion product adjacent to the Alloy 600 tube is enriched in nickel and some what depleted in iron. The corrosion product adjacent to the carbon steel collar appears to have the same iron content as the packed magnetite layer. The corrosion product layers in general appear to be relatively dense and any leakage path would be highly tortuous.

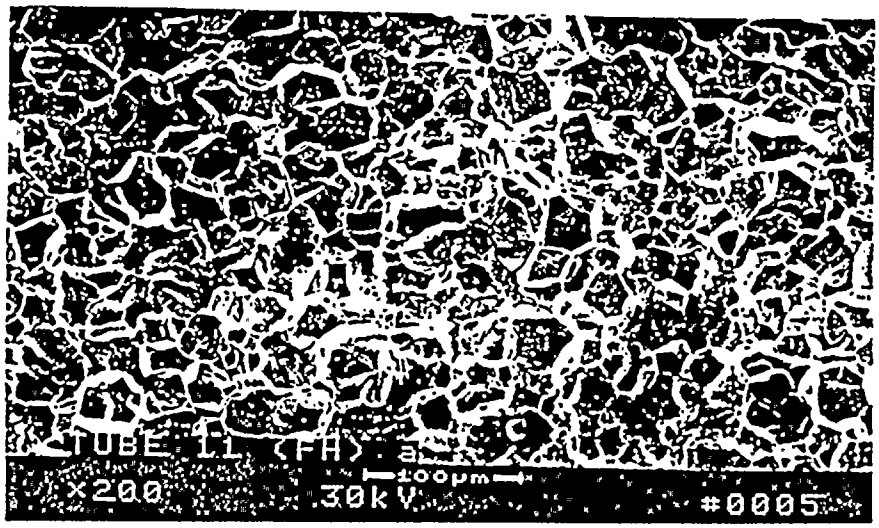
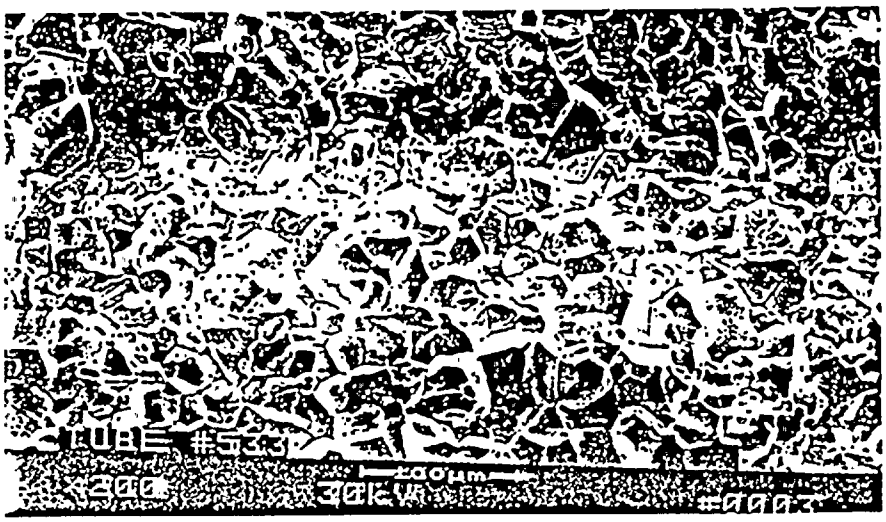
Figure 7-5. SEM Fractographs of Cracks in Doped Steam Specimen, Model Boiler Specimen and Service Tube

Doped Steam Specimen

Model Boiler Specimen

Pulled Tube (Field)

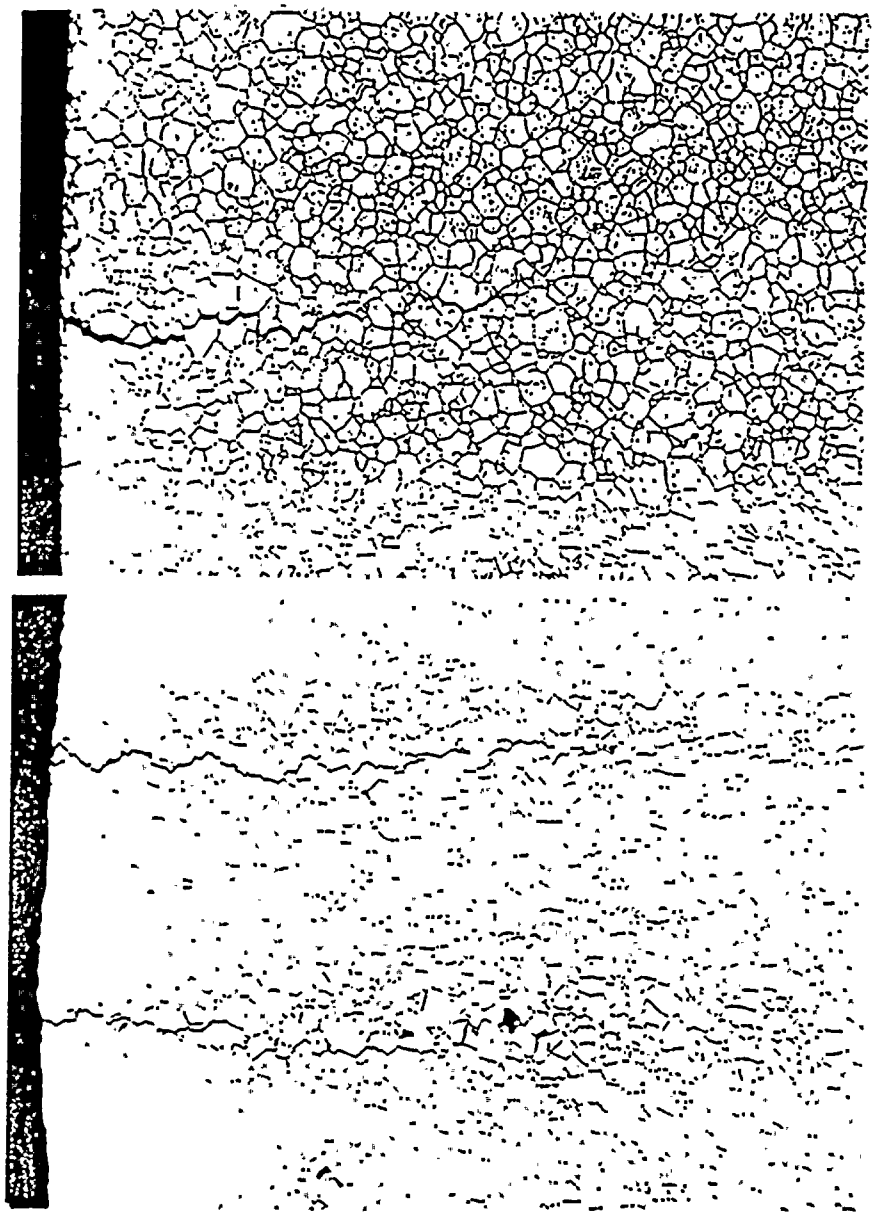
Figure 7-6. Metallograph of Cracked Specimens

Plugging criteria which are partially based upon eddy current characterization, leak rate and burst strength testing of laboratory specimens depend upon a reasonable simulation of actual service produced cracks. The crack morphologies of service tubes, doped steam test specimens and model boiler test specimens are presented in this section. An intergranular mode of cracking is common to cracks produced in these three environments. Figure 7-5 illustrates this fact with scanning electron fractographs. A further illustration of intergranular cracking is provided by the metallographic details shown in Figure 7-6.

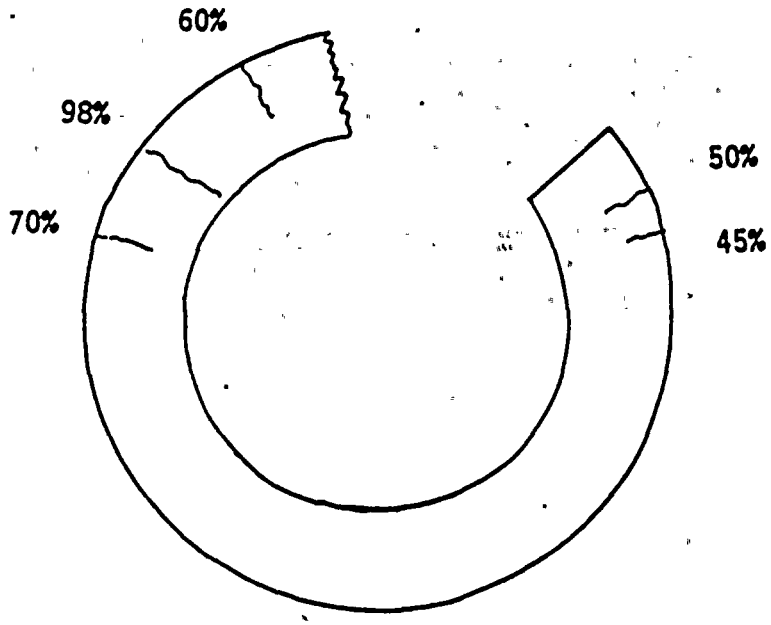
Figure 10-1. Sketch of a metallographic tube cross section through secondary cracks in crevice at support plate intersection for specimen 543-4. A typical crack micrograph is also shown.

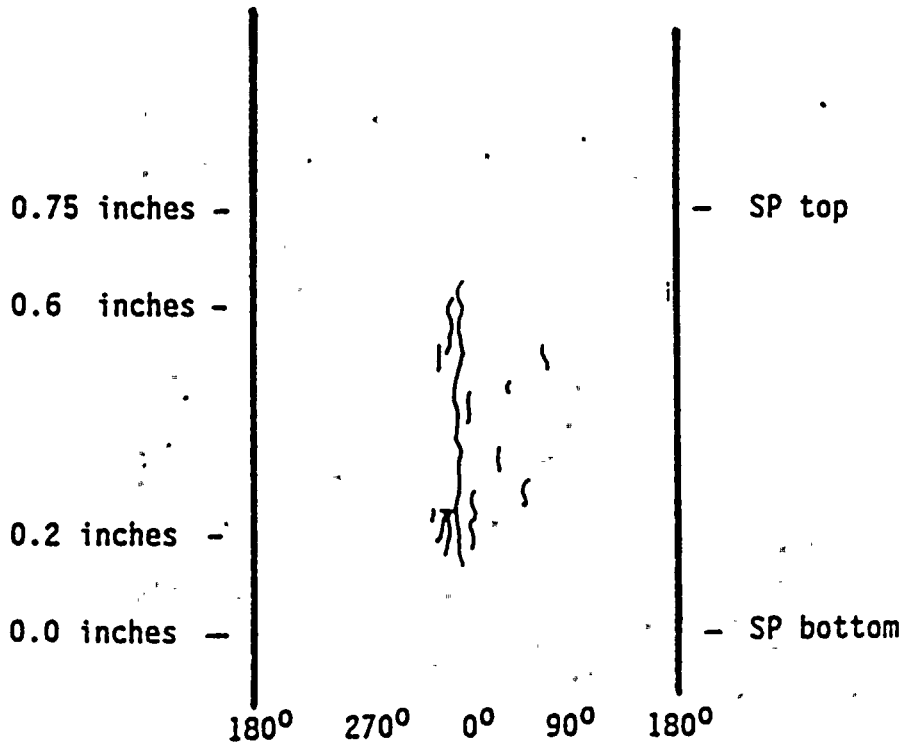
Number of Microcracks = 6 (all ligaments with intergranular features)

Morphology = IGSCC

Figure 10-2 Summary of crack distribution and morphology observed on Tube 543-4.

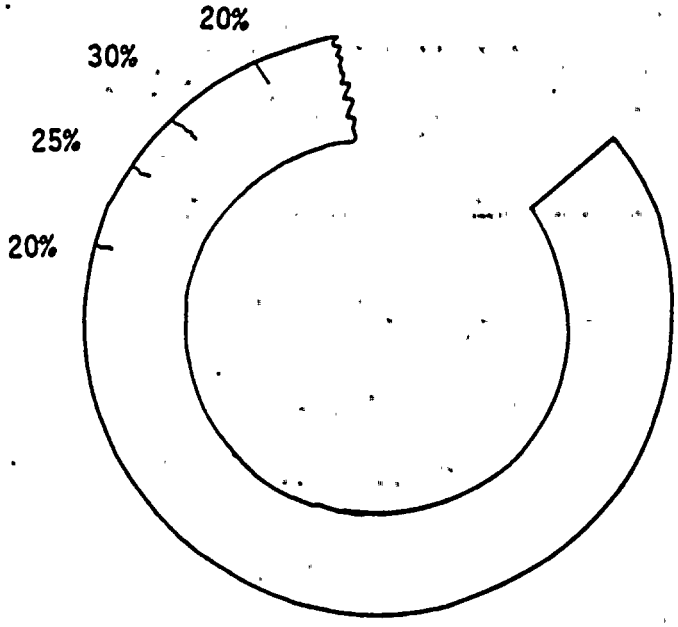
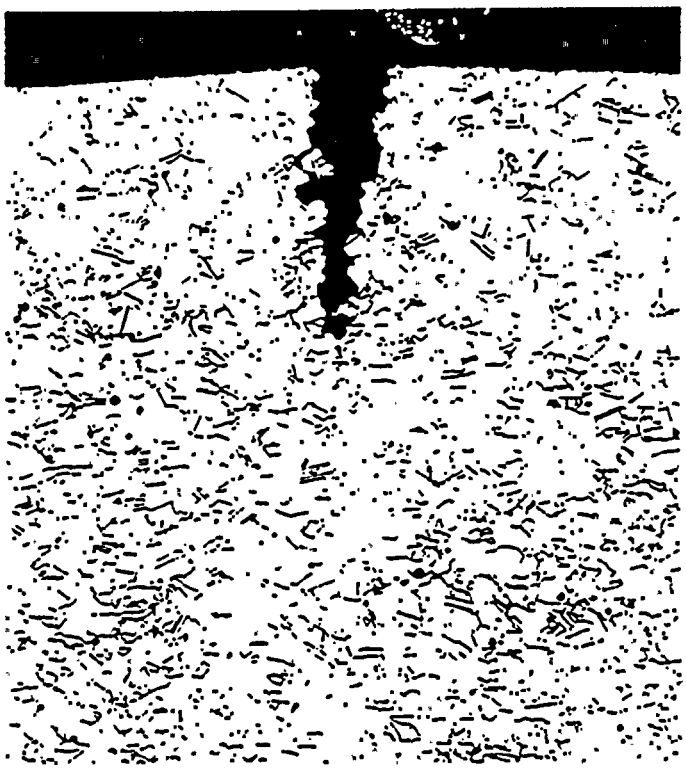
The burst crack was relatively short (0.16 inch long) but deep, 95% through wall. The secondary cracks were all short and axially orientated. A summary of the shape, morphology and distribution of cracks found in Tube 525-1 is presented in Figures 10-3 and 10-4.

Figure 10-3 Secondary crack distribution in a metallographic cross section of Tube 525 in the support plate crevice region. A micrograph of one of the cracks is also shown.

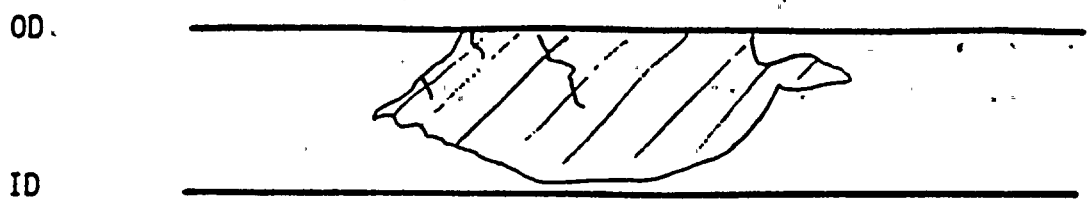
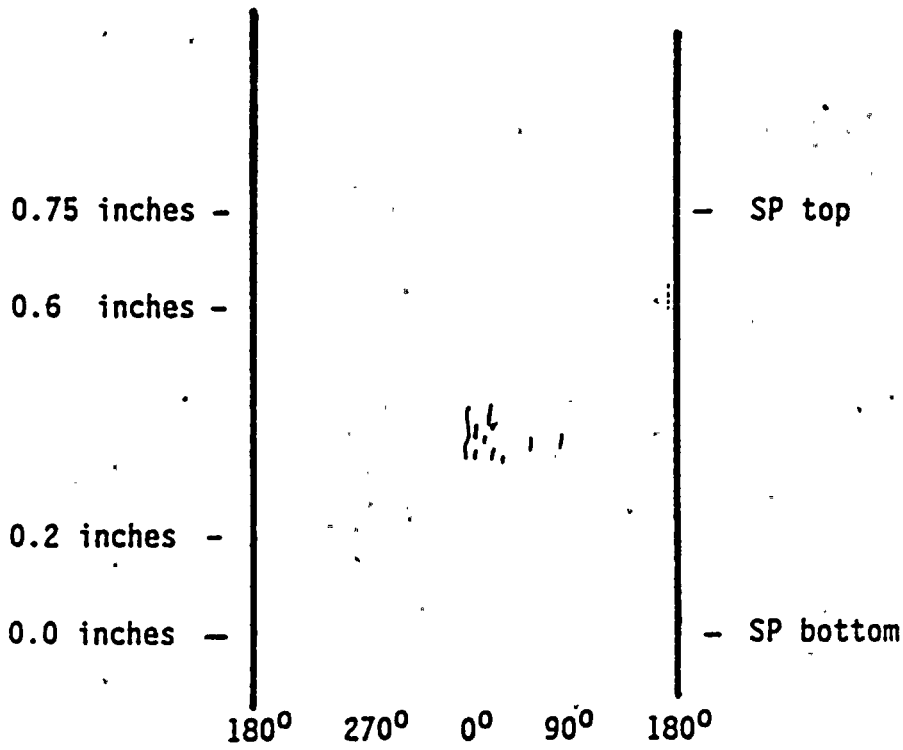
Macrocrack Length = 0.16 inches

Number of Microcracks = 3 (all ligaments with intergranular features)

Morphology = IGSCC

Figure 10-4 Summary of crack distribution and morphology observed on Tube 525.

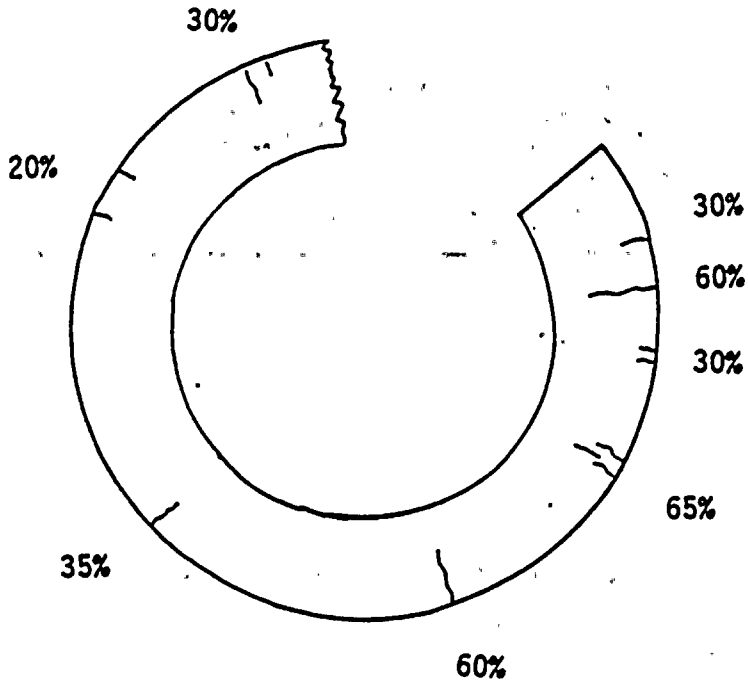
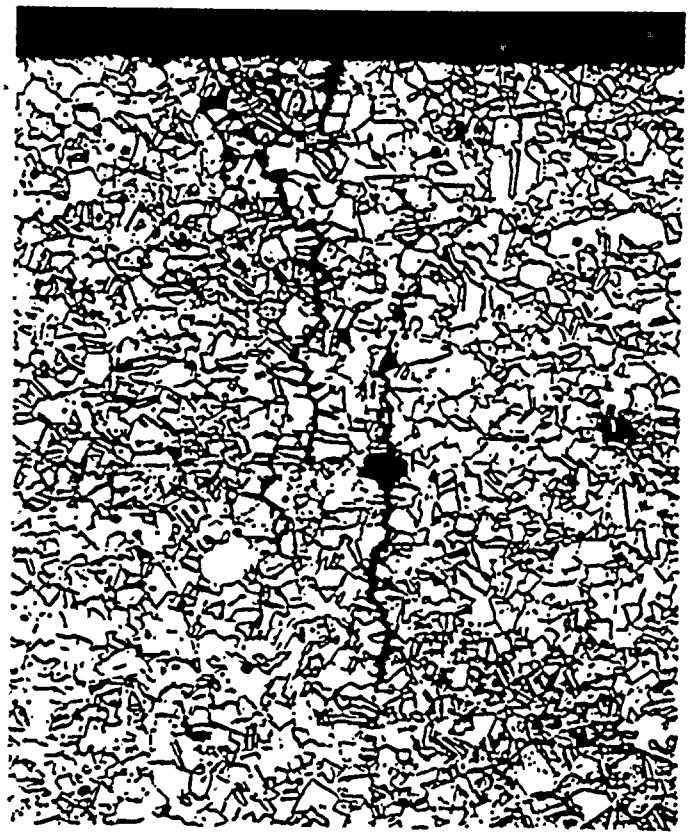
Figure 10-5 Secondary crack distribution and a micrograph of one of these cracks in a metallographic cross section of Tube 533-4.
