WCAP-13188

D. C. Cook Unit-1

Steam Generator Tube Plugging Criteria for Indications at Tube Support Plates

March 1992

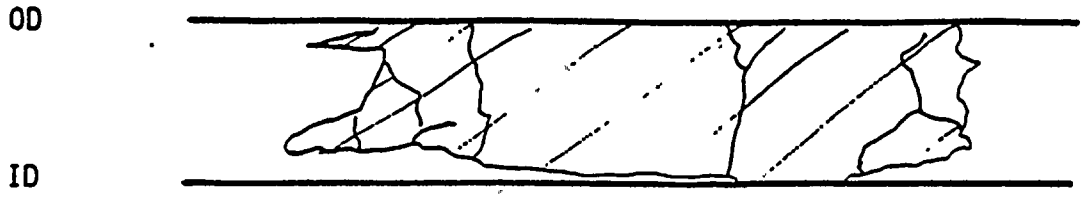
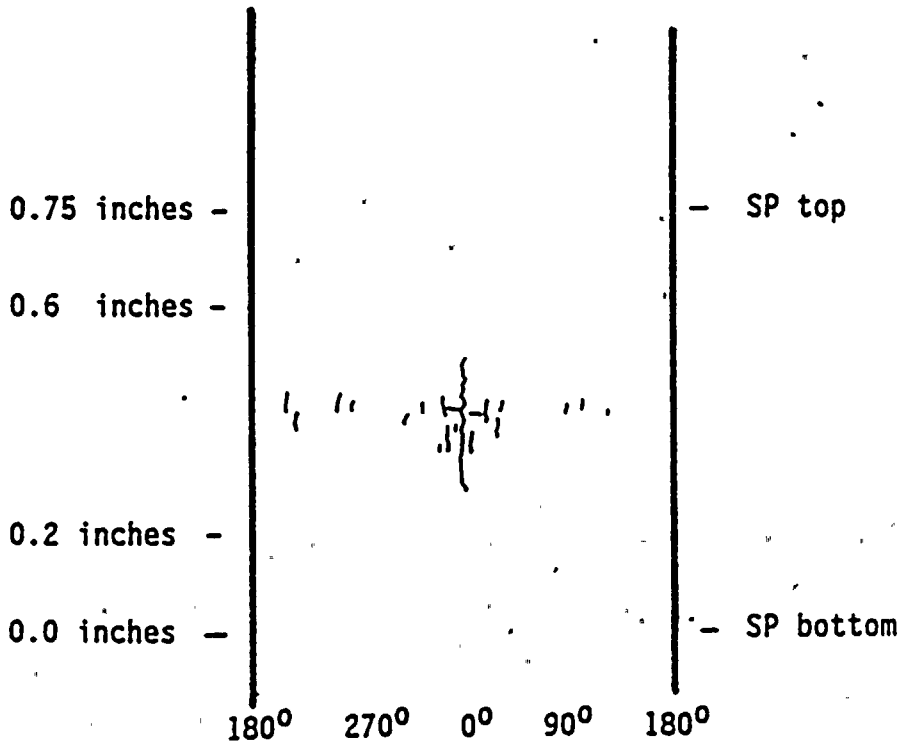
A network of axial and circumferential secondary cracks was observed near the burst crack. The axially orientated burst crack was composed of at least five microcracks which joined to form the macrocrack. Ledges separating these microcracks showed partially ductile features (shear dimples) while the crack face was entirely intergranular. The OD origin major crack was 0.34 inch long and penetrated the ID wall for a length of 0.14 inch. The secondary crack distribution found in the metallographic cross section is shown in Figure 10-5, and a summary of the cracks observed in the support plate region of the tube is presented in Figure 10-6.

Macrocrack Length = 0.34 inches

Number of Microcracks = 5 (3 ligaments have ductile features)

Morphology = IGSCC

Figure 10-6 Summary of crack distribution and morphology observed on Tube 533-4.

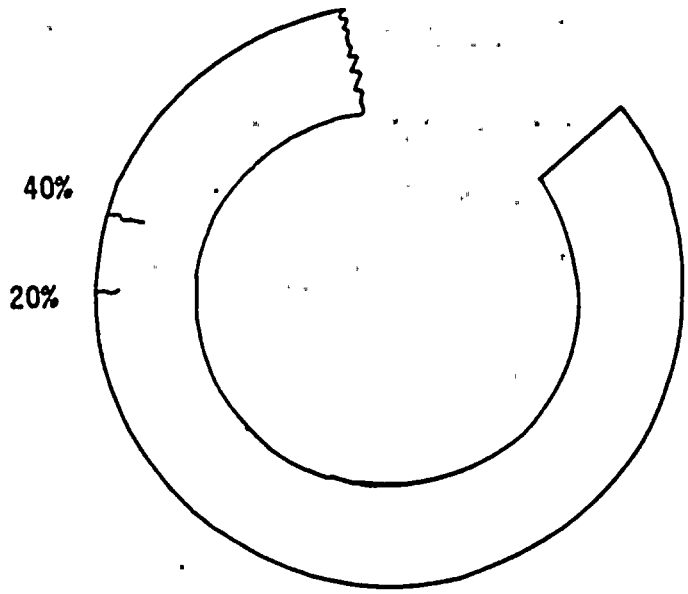
Many secondary cracks were observed clustered around the burst opening. Other larger secondary cracks were found at a location 95 and 145 degrees from the burst opening. The main burst crack and the largest of the secondary cracks located at 95 degrees were opened and examined by SEM. In both cases the OD origin cracking morphology was intergranular and typical of SCC. The burst crack was 0.4 inch long and 90% through wall. The macrocrack consisted of at least five microcracks which joined to form the macrocrack. The largest secondary crack was 0.3 inch long and 95% through wall. It was also formed by several microcracks. A metallographic cross section through the remaining piece of the tube at the support plate intersection showed two intergranular OD origin stress corrosion cracks (Figure 10-7). The larger of these two cracks was 40% through wall. A summary of crack observations on Tube 536-1 is shown in Figure 10-8.

Figure 10-7 Secondary crack distribution and a micrograph of one of these cracks in a metallographic cross section of Tube 536-1.

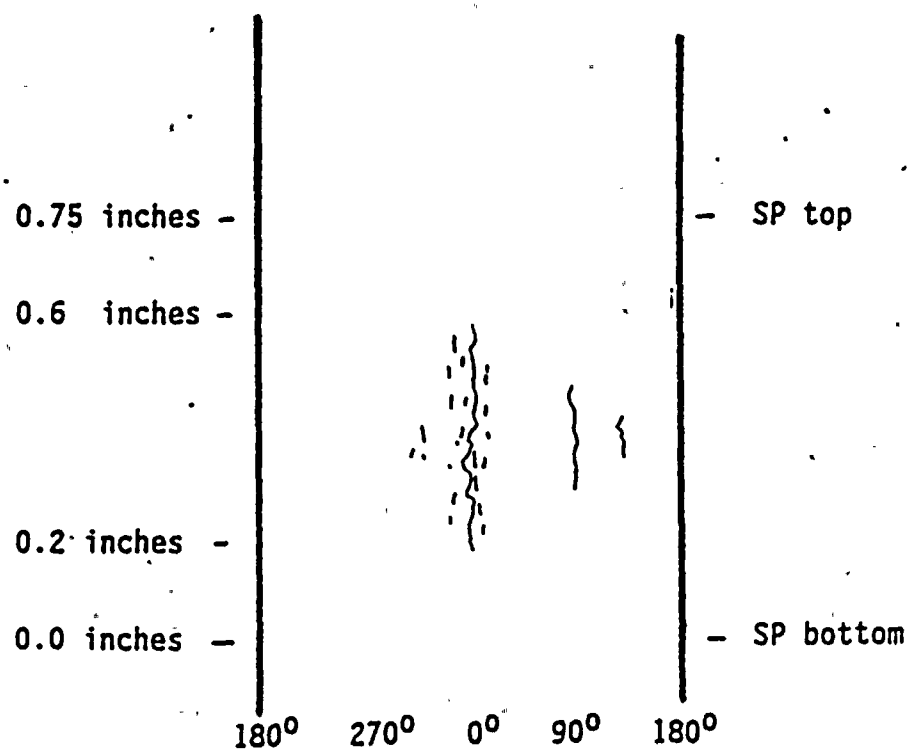
Number of Microcracks = 5 (ligaments have mostly ductile features)

Morphology = IGSCC

Figure 10-8 Summary of crack distribution and morphology observed on Tube 536-1.

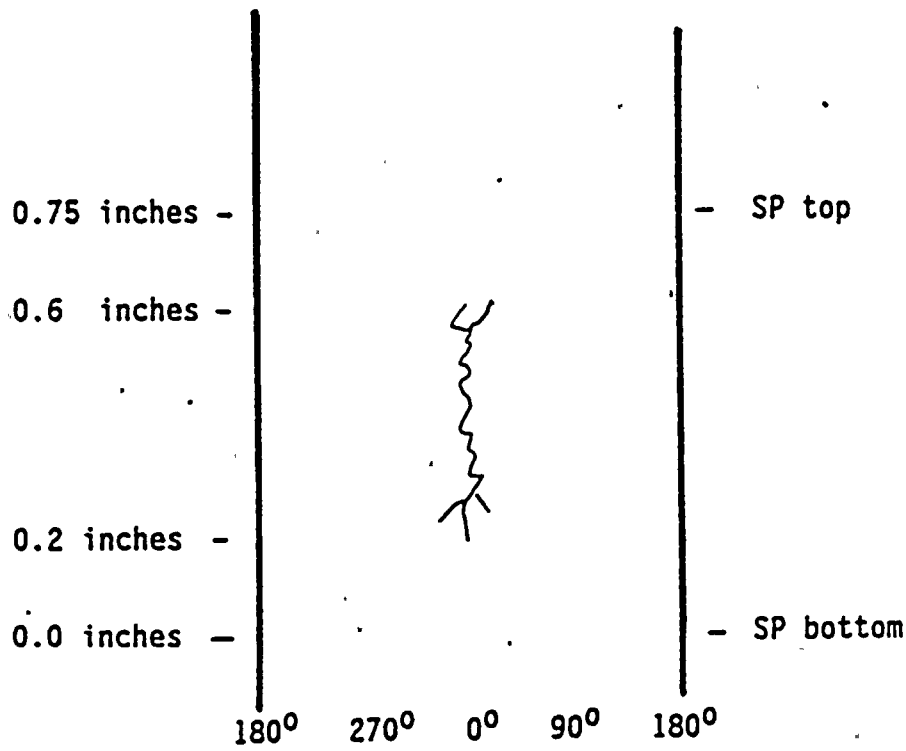
Number of Microcracks = 6 (ligaments have mostly intergranular features with some ductile features)

Morphology = IGSCC

Figure 10-9 Summary of crack distribution and morphology observed on Tube 558-1.

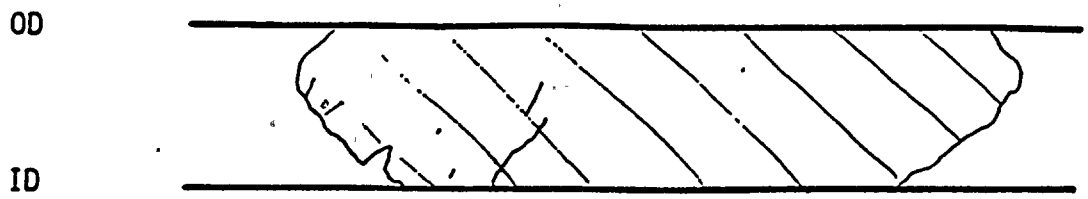
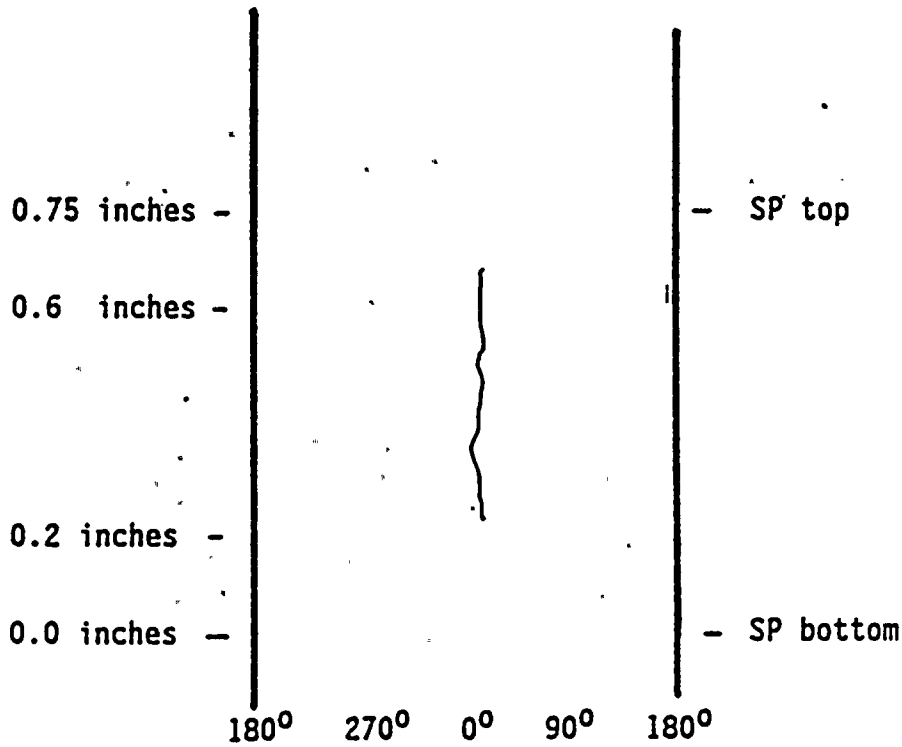
Macrocrack Length = 0.44 inches

Number of Microcracks = 1 to 4

Morphology = IGSCC

Figure 10-10 Summary of crack distribution and morphology observed on Tube 571-1.

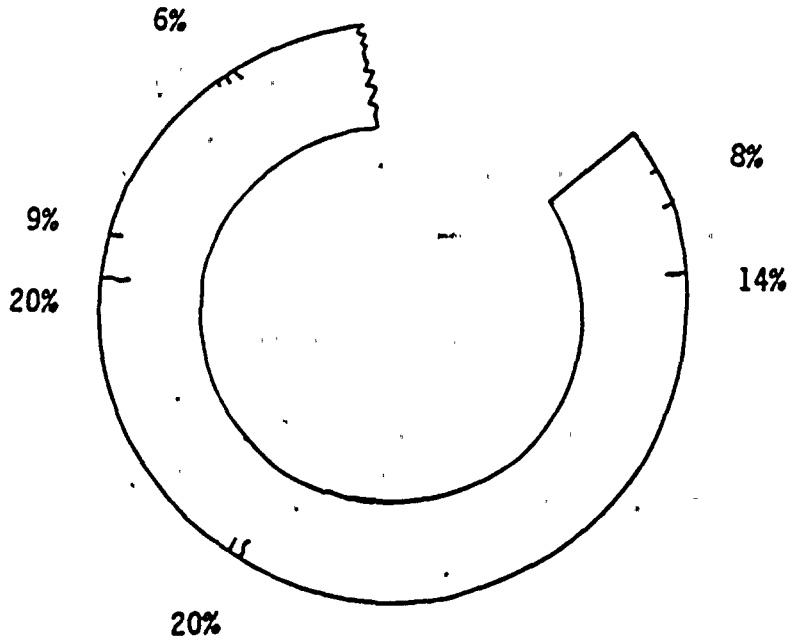
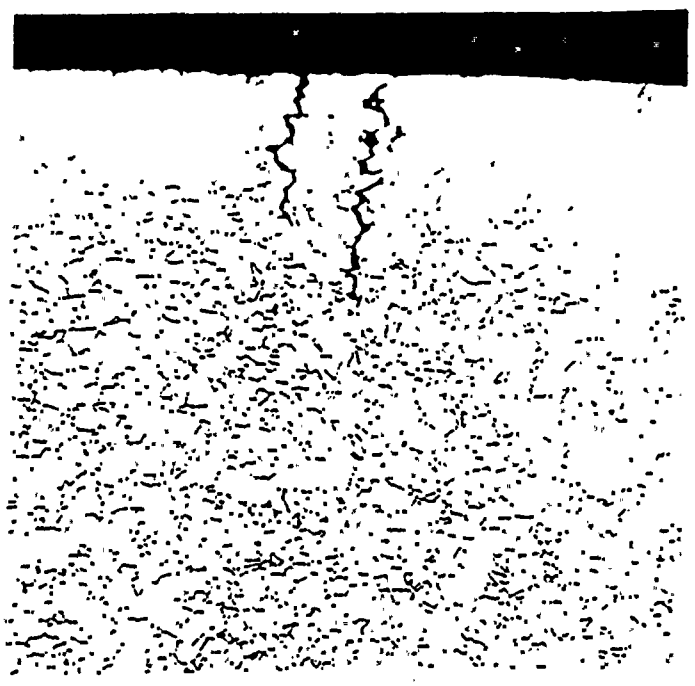
Figure 10-11 Secondary crack distribution and a micrograph of one of these cracks in a metallographic cross section of Tube 533-3 within the Teflon support plate region.

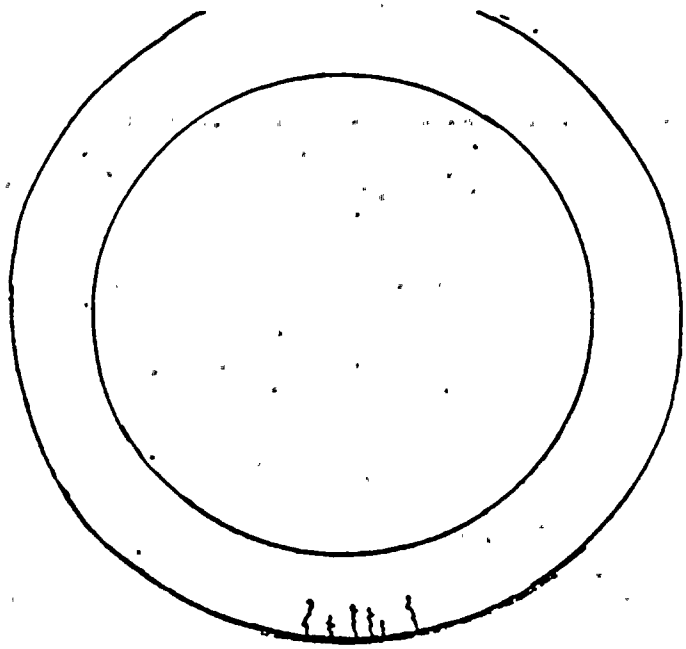
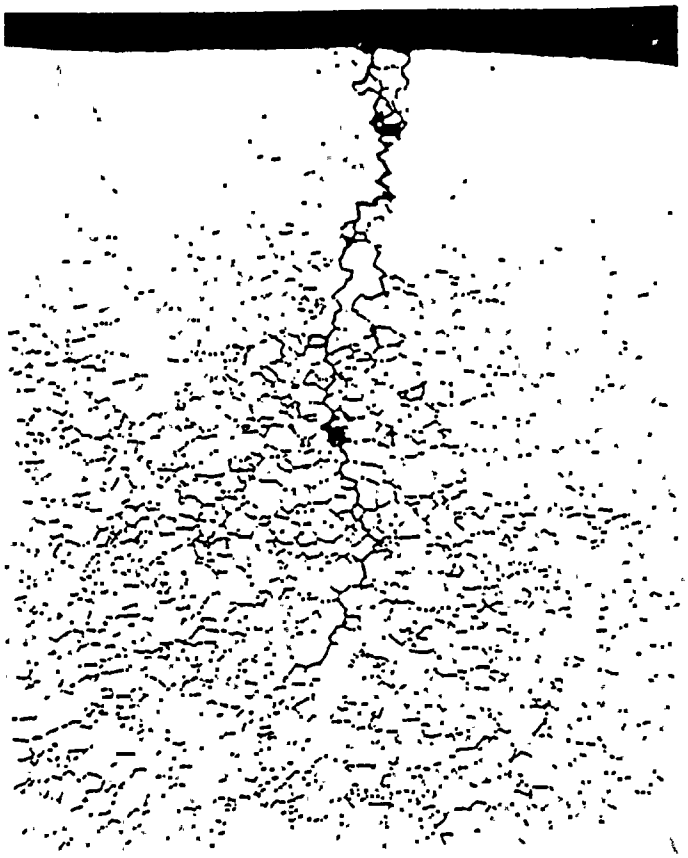
Figure 10-12 Crack distribution and a micrograph of one of these cracks in a metallographic cross section of Tube 533-3 within the steel collar region.

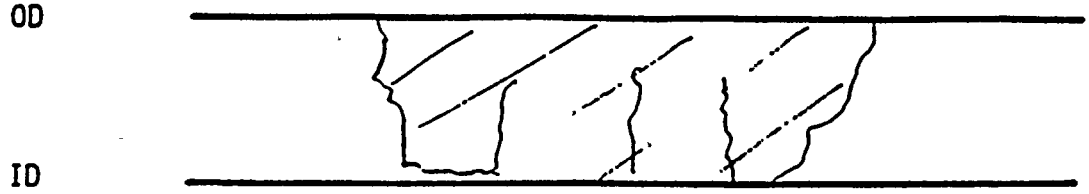
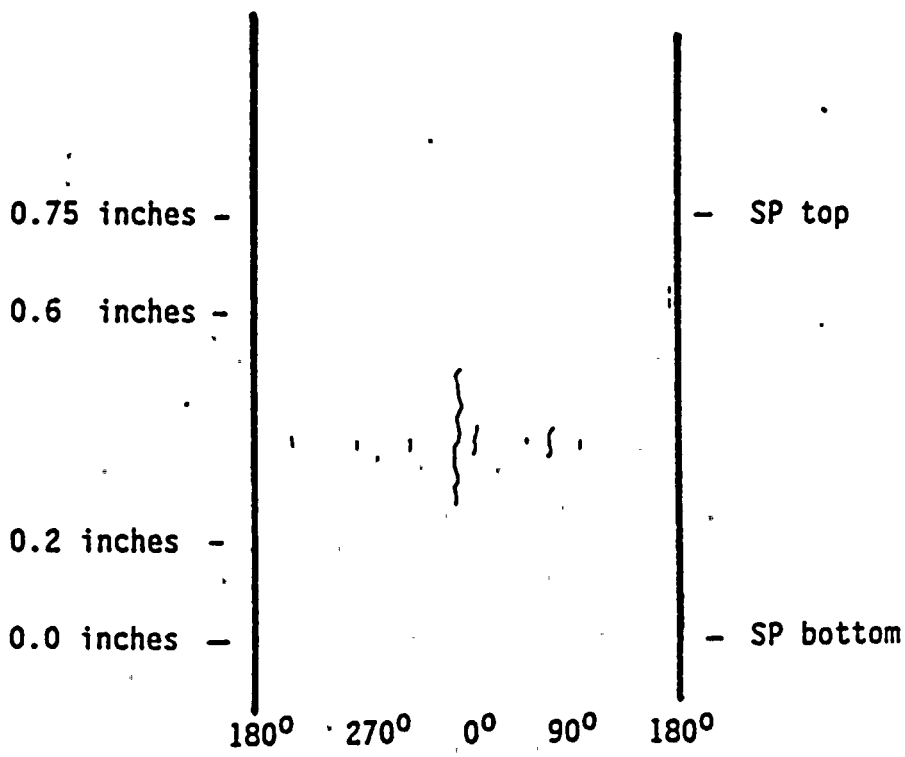
Macrocrack Length = 0.27 inches

Number of Microcracks = 4 (2 ligaments with intergranular features; 1 with ductile features)

Morphology = IGSCC

Figure 10-13 Summary of crack distribution and morphology observed on Tube 533-3 at the Teflon intersection.

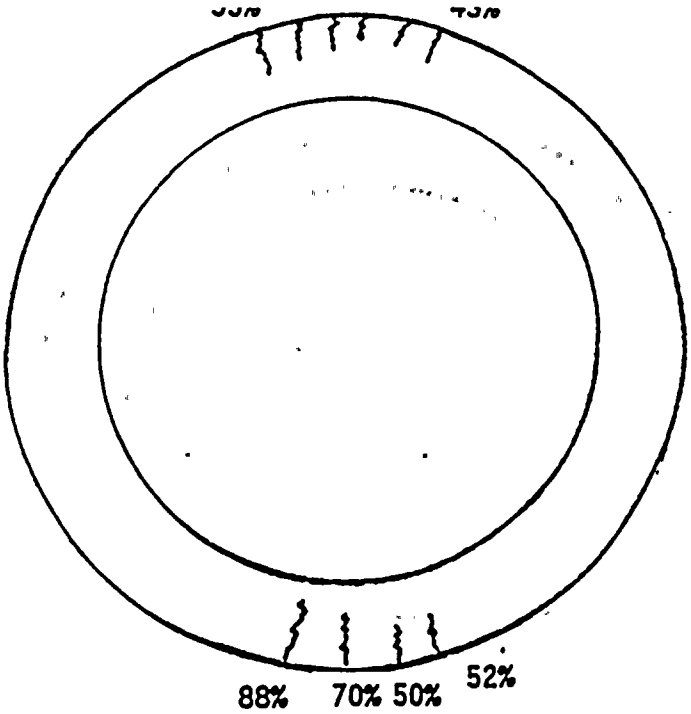
Doped steam specimen SL-FH-11 developed a large number of OD origin cracks. The largest agglomeration of these cracks was opened for fractographic examinations and cross sectional cuts made above (A) and below (B) the opened section of the macrocrack for metallographic examinations. The opened section of the tube showed an intergranular macrocrack, 0.37 inch long. The ligaments separating the 4 microcracks of the macrocrack had only intergranular features. The crack penetrated the ID wall for a length of 0.23 inch. The cross sectional cuts made through planes A and B produced the crack distributions and typical crack morphologies depicted in Figures 10-14 and 10-15. A summary of the crack observations made at this location is shown in Figure 10-16.

Figure 10-14 Crack distribution and a micrograph of one of these cracks in a metallographic cross section of Tube SL-FH-11 in Plane A.

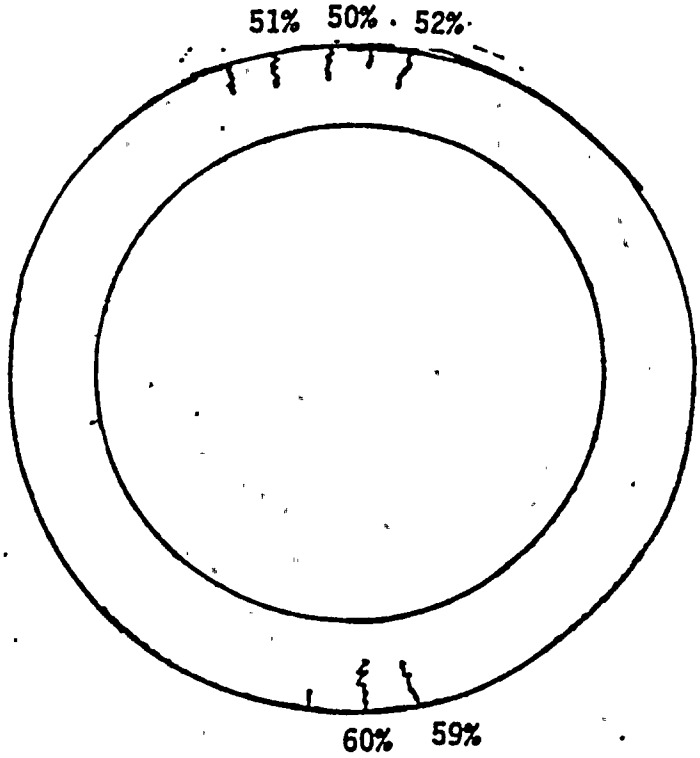
Figure 10-15 Crack distribution and a micrograph of one of these cracks in a metallographic cross section of Tube SL-FH-11 in Plane B.

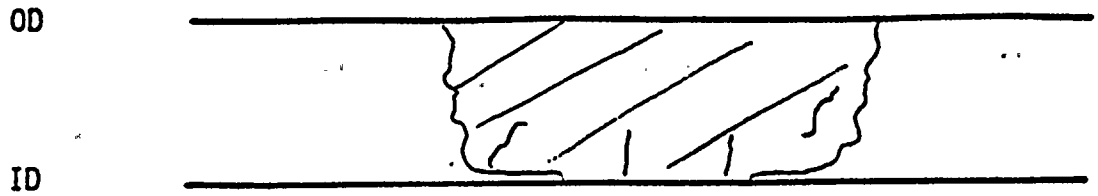
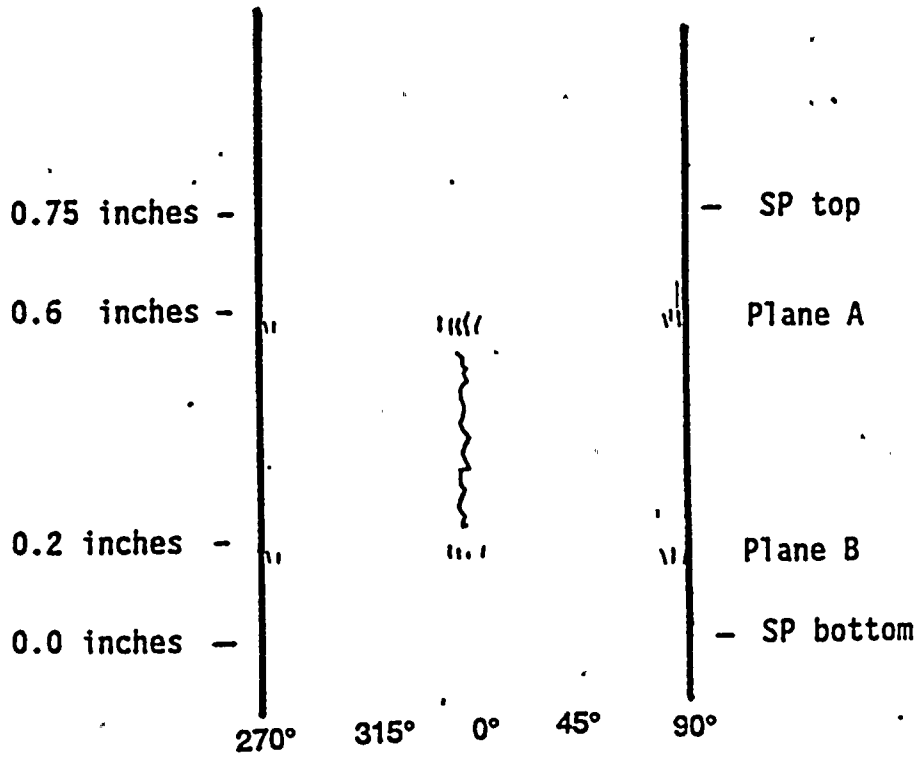
Macrocrack Length = 0.37 inches

Number of Microcracks = 4 (all ligaments with intergranular features)

Morphology = IGSCC

Figure 10-16 Summary of crack distribution and morphology observed on Tube SL-FH-11.

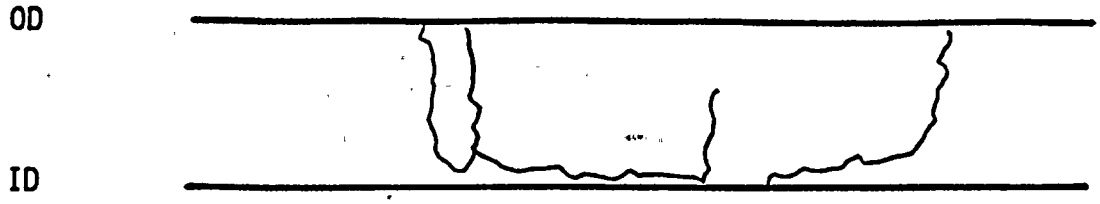
Macrocrack Length = 0.46 inches

Figure 10-17 Summary of crack distribution and morphology observed on second crack opened in the laboratory on Tube SL-FH-11.

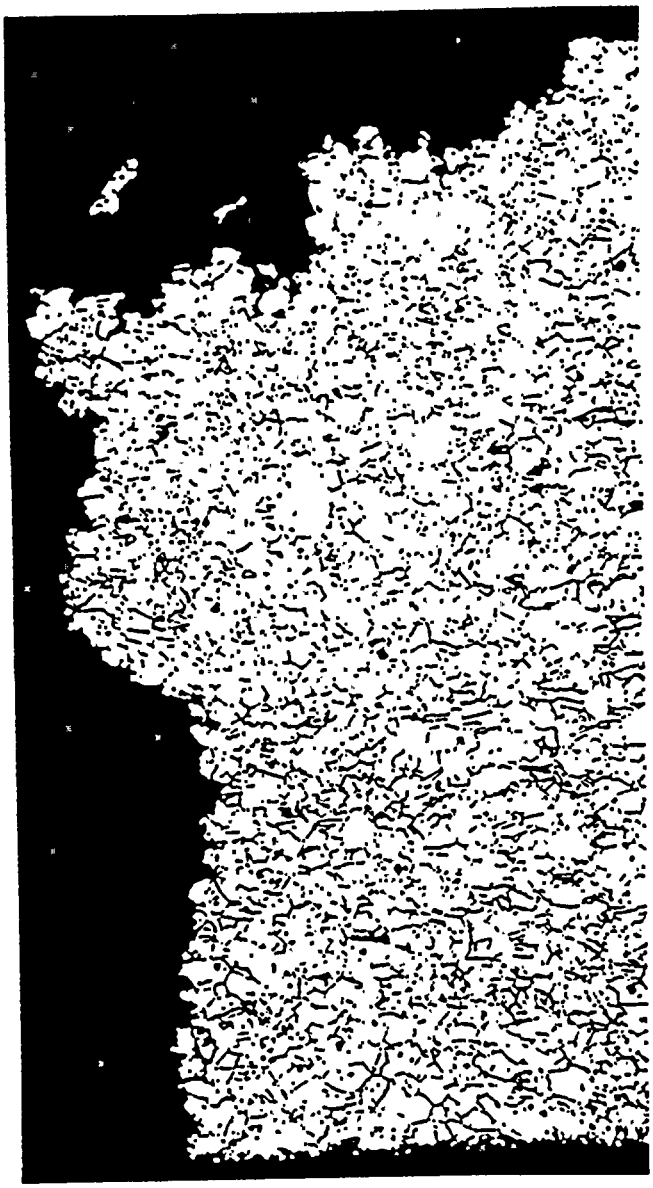
Figure 10-19 Crack morphology of the major burst opening crack (transverse section) showing it to be IGSCC with circumferential extension. Mag. 100X

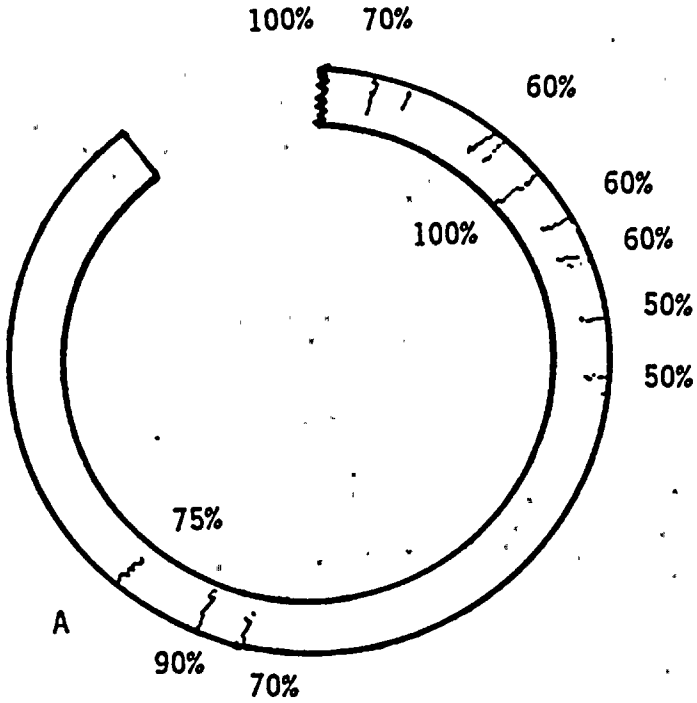
Figure 10-20 Crack distribution found by a metallographic cross section through the center of the crevice (top) and a photomicrograph of one of the secondary cracks (bottom) showing IGSCC with negligible IGA aspects. Mag. 100X

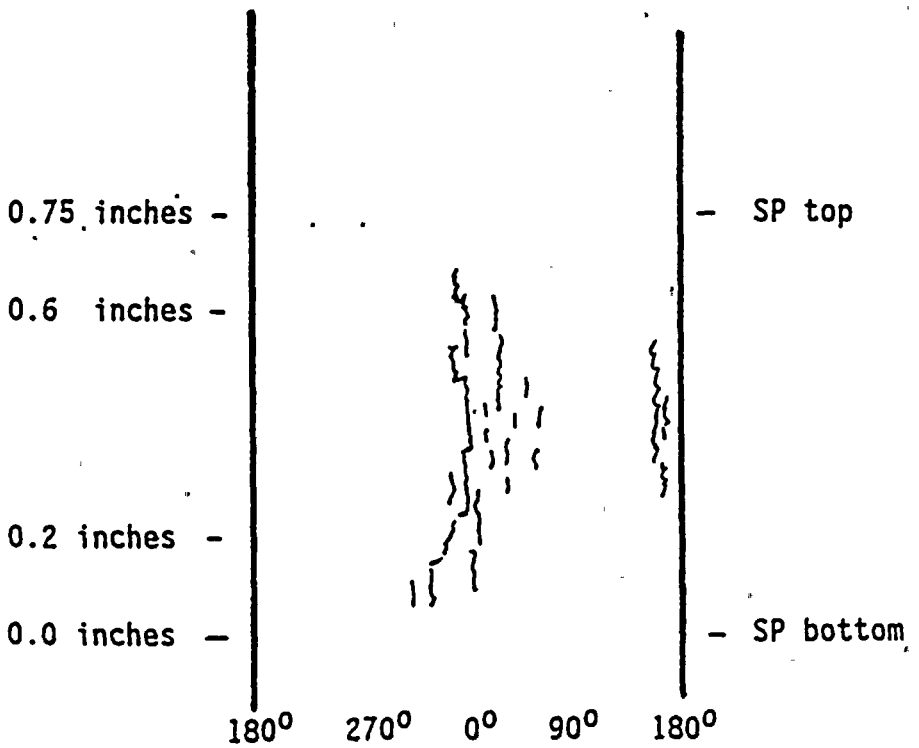
A grouping of many small, OD origin, axial cracks, interconnected by ligaments and by circumferential extensions, formed the curved major burst opening shown in Figure 10-18. Other small axial cracks with circumferential involvement were observed in other areas of the simulated tube support plate crevice region. Fractographic observations of the major burst opening revealed that the corrosion crack consisted of at least six microcracks with intergranular ligaments. These ligaments often ran in the circumferential direction. The combined length of the microcracks that formed the macrocrack was 0.67 inch. Through wall cracking extended for 0.50 inch. The morphology of the macrocrack was IGSCC with no IGA or with negligible IGA components, as shown in Figure 10-19. Circumferential, intergranular extension of the axial crack can be observed in this figure. Transverse metallography through the center of the crevice region revealed the crack distribution shown by a sketch in Figure 10-20. An example of the morphology of one of the secondary OD cracks is also shown in this figure; the morphology is again that of IGSCC with negligible IGA aspects. A summary of the major crack shape and corrosion morphology and the distribution of OD cracks observed within the crevice region of tube 528-2 is shown in Figure 10-21.

Number of Microcracks = at least 6 (ligaments have intergranular features)

Morphology = IGSCC

Figure 10-21 Summary of overall crack distribution and morphology observed on tube 528-2.

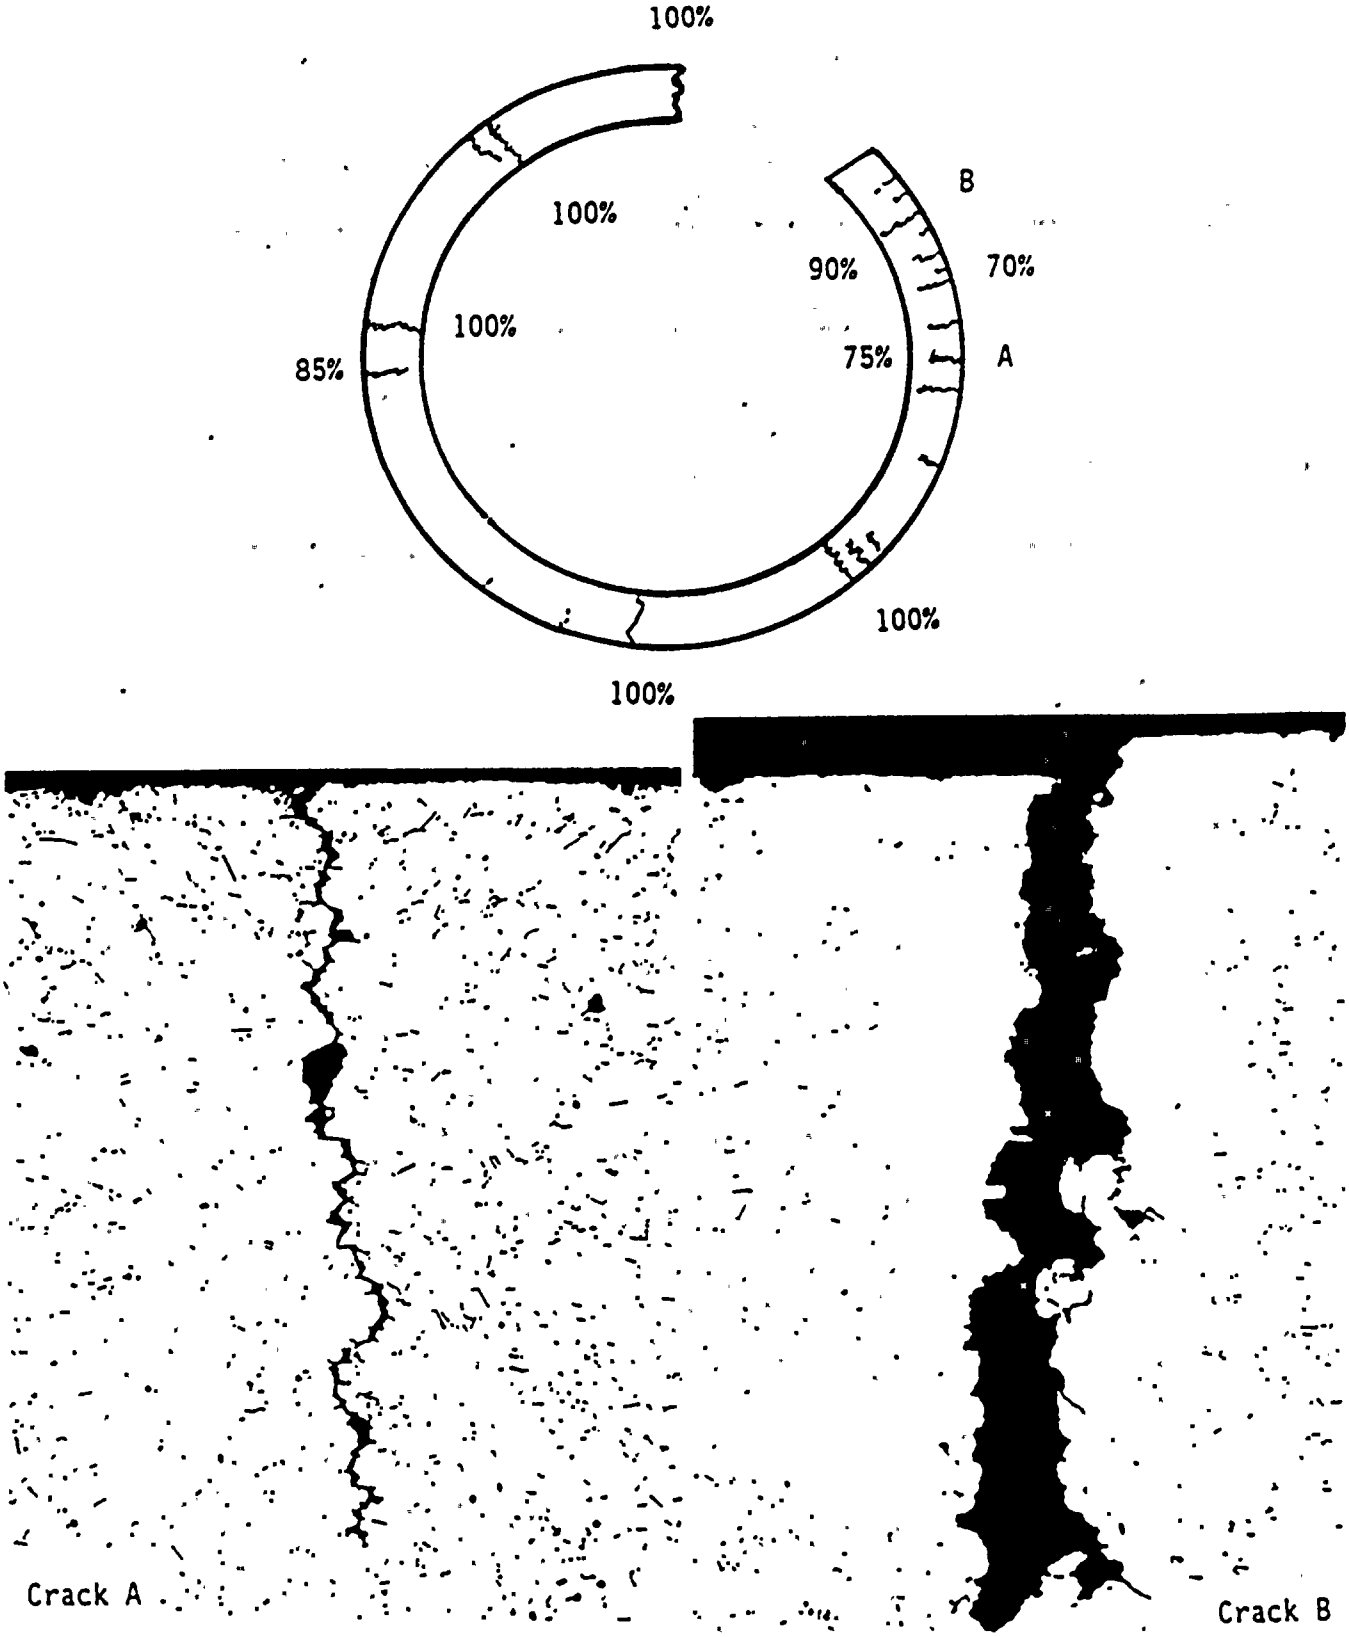
Figure 10-24 Sketch of crack distribution found by a metallographic cross section through the center of the crevice region of tube 532-1 and two photomicrographs of secondary cracks.
Mag. 100X

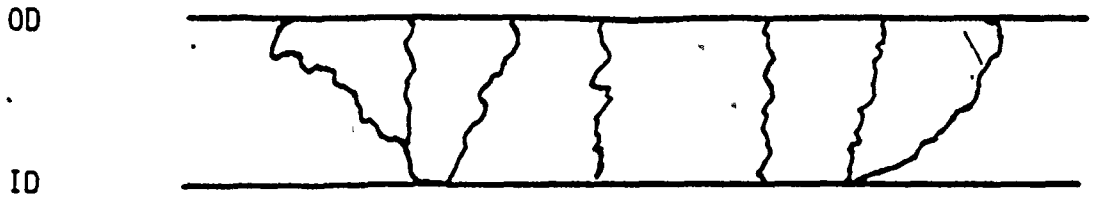
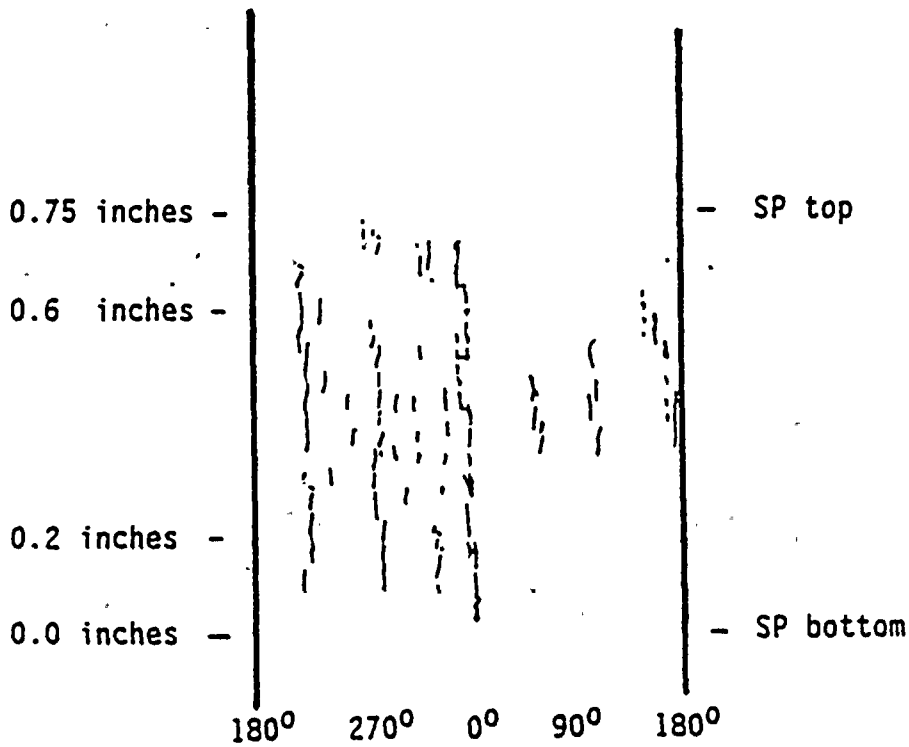
A large number of long and short, OD origin, axial cracks were observed in the simulated tube support plate crevice region of tube 532-1, many of which were through wall. Figures 10-22 and 10-23 show photographs of the burst tube and convey the extensive cracking around the tube within the crevice region. A grouping of small axial cracks combined to form two of the burst crack openings which were examined in some detail. The longer of the two was 0.70 inch long and was formed from five microcracks interconnected with ledges having intergranular features. The length through wall was 0.52 inch. The crack morphology was IGSCC. Cracks seen on a metallographic cross section through the center of the crevice are depicted in a sketch in Figure 10-24 together with two micrographs showing typical crack morphologies of secondary cracks. A summary of the major burst crack and its morphology together with a distribution of cracks seen the crevice region is shown in Figure 10-25.

Macrocrack Length = 0.70 inch

Number of Microcracks = 5 (ligaments have intergranular features)

Morphology = IGSCC

Figure 10-25 Summary of overall crack distribution and morphology observed on tube 532-1.

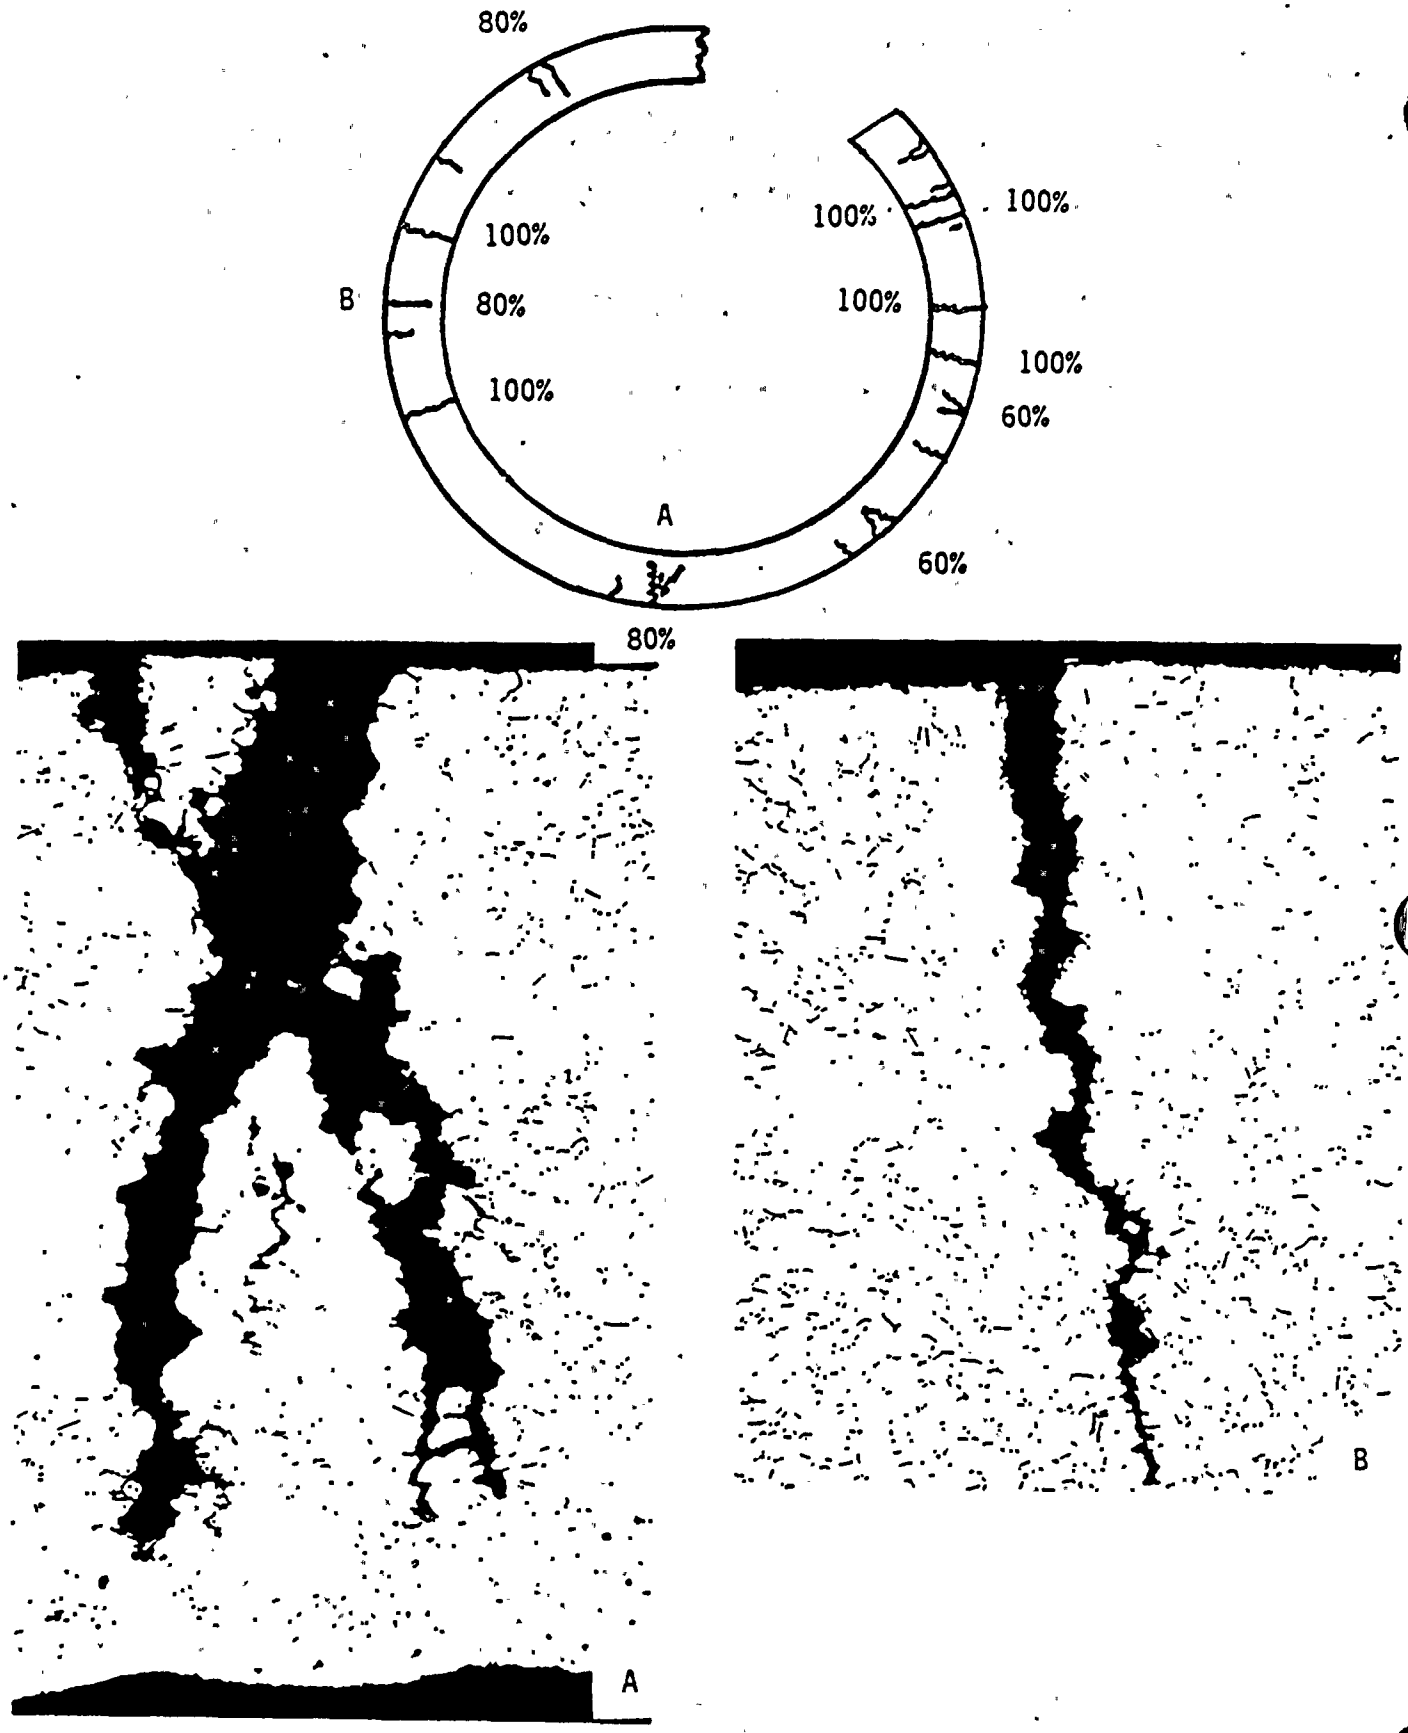
Figure 10-28 Crack distribution as revealed by a metallographic cross section through the center of the crevice of tube 532-2 and photomicrographs of secondary cracks A and B. Mag. 100X

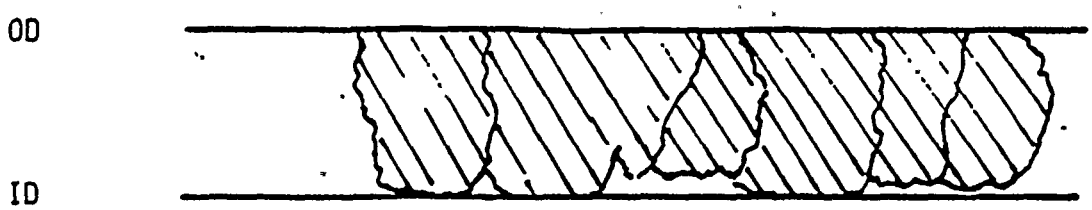
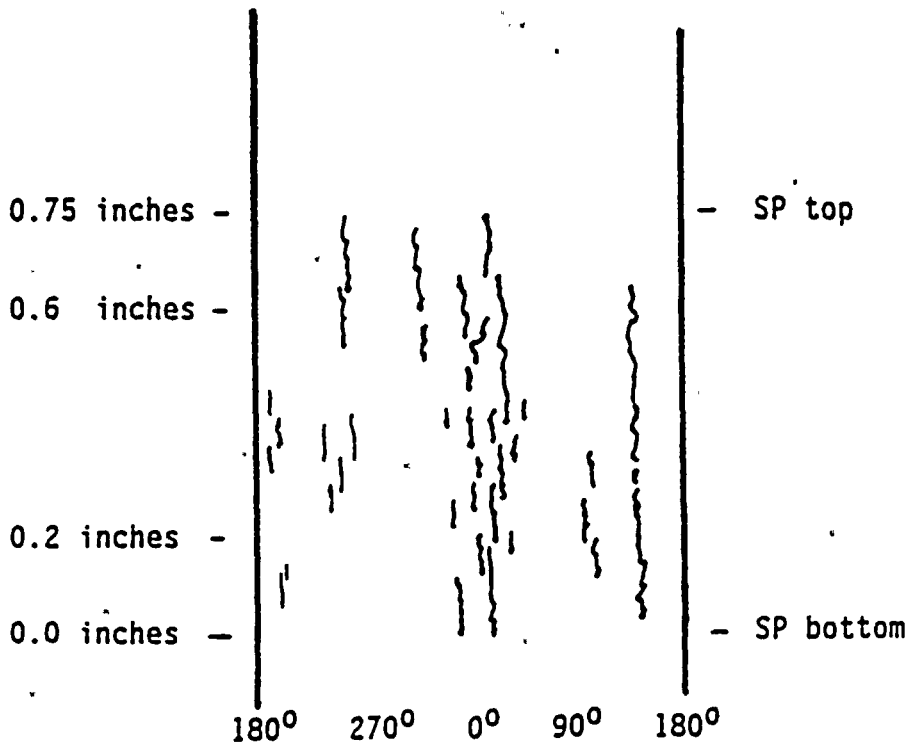
OD origin cracking within the simulated tube support plate crevice region of tube 532-2 can be seen in the post-burst test photographs of the tube in Figures 10-26 and 10-27. Many of the axial cracks were through wall. A group of many through wall microcracks formed the weakest area in the tube where the main burst fracture occurred. Fractography of this macrocrack showed at least six microcracks combined to form the main burst fracture. The total length of the macrocrack was 0.75 inch and it was through wall for 0.58 inch. While most ligament features were intergranular, occasional areas had ductile features, indicating that the ligaments had not completely interconnected by intergranular corrosion. The corrosion crack morphology of the main burst crack was that of IGSCC. A metallographic cross section through the center of the crevice region revealed many cracks shown by a sketch in Figure 10-28. Typical crack morphologies are also shown in photomicrographs for two secondary cracks in this figure. A summary of the main burst crack description and morphology are given in Figure 10-29.

Macrocrack Length = 0.75 inch

Number of Microcracks = at least 6 (ligaments have mostly intergranular features)

Morphology = IGSCC

Figure 10-29 Summary of the burst crack and overall crack distribution in the crevice region of tube 532-2.

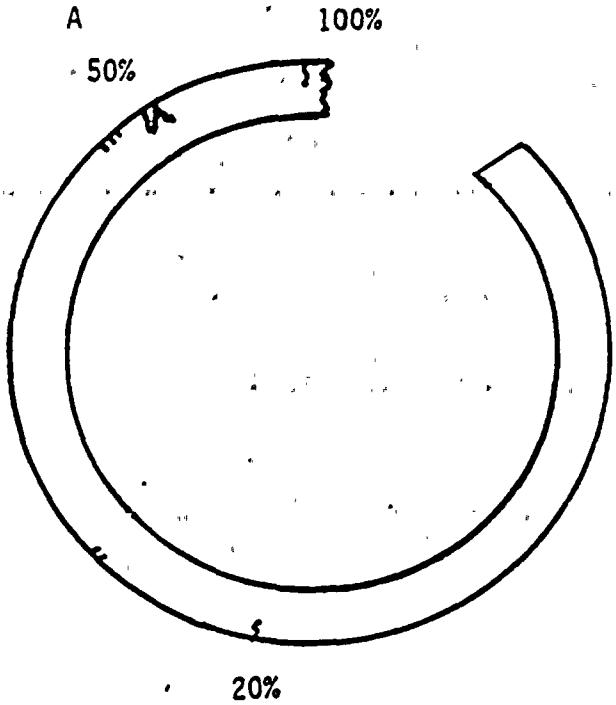
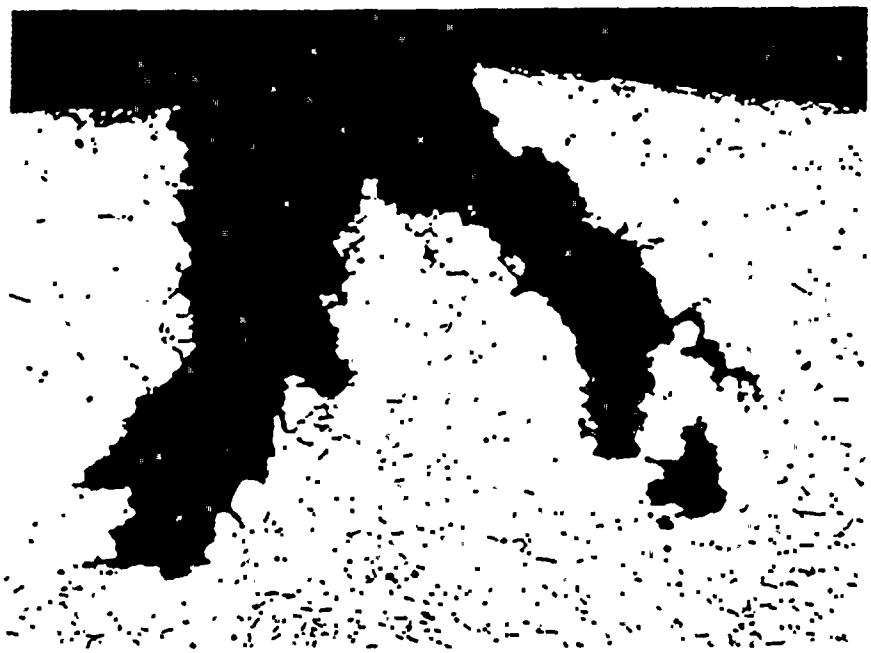
Figure 10-30 Sketch of crack distribution in a metallographic cross section of tube 535 through the center of the crevice and a photomicrograph of crack A. Mag. 100X

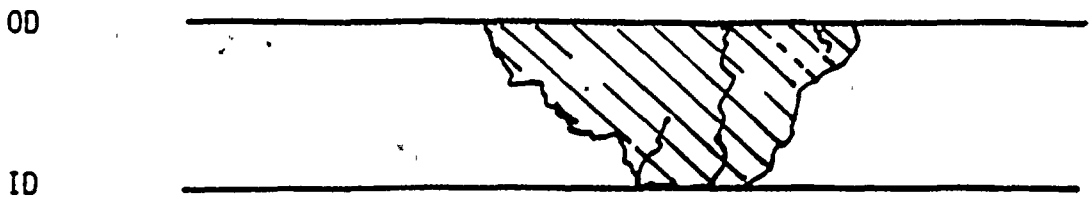
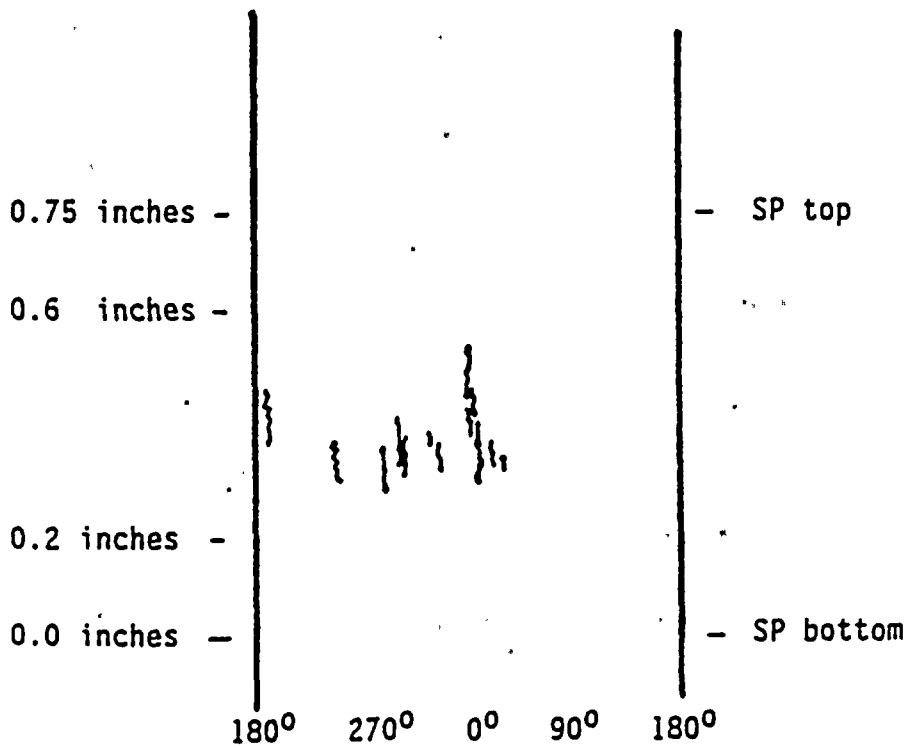
Numerous secondary, but small, microcracks were observed around the circumference within the crevice region. Fractography of the burst crack showed that it was composed of three microcracks which joined together by intergranular corrosion to form the macrocrack. The morphology of the macrocrack was IGSCC with negligible IGA aspects. The macrocrack was relatively short (0.28 inch in length) and penetrated through wall for 0.11 inch. A metallographic cross section through the center of the crevice showed numerous secondary cracks, some of which had negligible to minor IGA aspects. The distribution of cracks from the cross section is shown in Figure 10-30 along with a photomicrograph of a secondary crack. A summary of the of burst crack description and of the overall crack distribution is given in Figure 10-31.

Macrocrack Length = 0.28 inch

Number of Microcracks = 3(ligaments have intergranular features)

Morphology = IGSCC

Figure 10-31 Summary of the burst crack and overall crack distribution in the crevice region of tube 535-1.
