WCAP-13188

D. C. Cook Unit-1

Steam Generator Tube Plugging Criteria for Indications at Tube Support Plates

March 1992

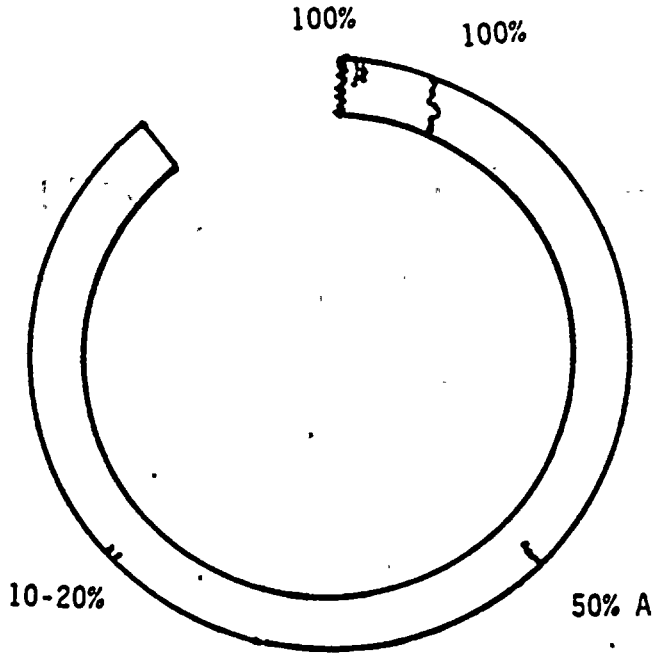
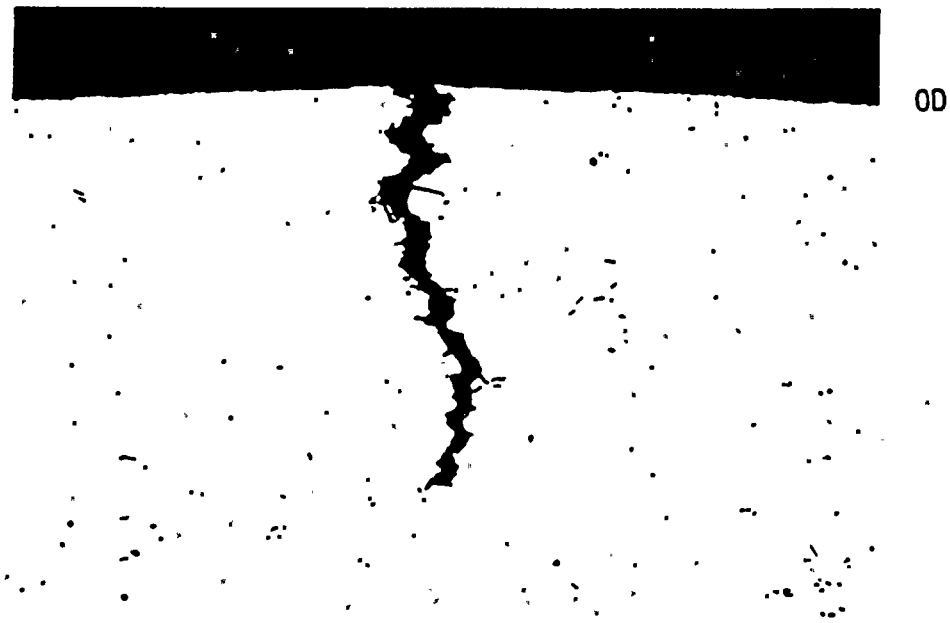
The most degraded area in tube 555-3 was confined to one location within the crevice region, the location where the burst opening occurred. The crack distribution was complex in this region, with numerous parallel axial cracks with short circumferential branches. All cracks were of OD origin. Fractography showed the major macrocrack to be composed of two or three microcracks which joined in an irregular pattern to form the burst crack. The connecting ledges showed a ductile fracture features, while the individual microcracks had intergranular features. The macrocrack was 0.75 inch long with a through wall length of 0.42 inch. Metallography of a tube cross section through the region with the highest crack density showed a morphology of IGSCC with some IGA or SCC branch characteristics near the main fracture. A photograph of the burst opening and a photomicrograph of the fracture face at the burst opening is shown in Figure 10-32. Other crack details are summarized in Figures 10-33 and 10-34.

Figure 10-33 Sketch of the metallographic cross section through secondary crevice region cracks in tube 555-3. A photomicrograph of Crack A is also shown. Mag. 100X

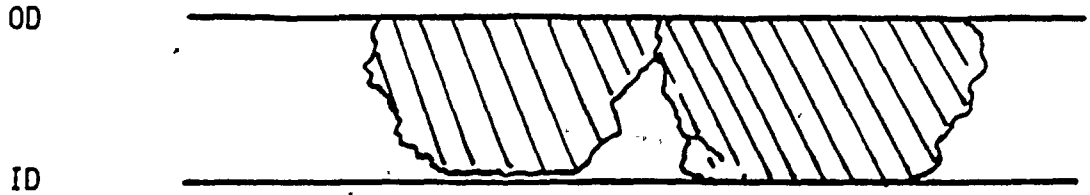
Macrocrack Length = 0.75 inch

Figure 10-34 Summary of burst crack observations and the overall crack distribution observed at the crevice region of tube 555-3.

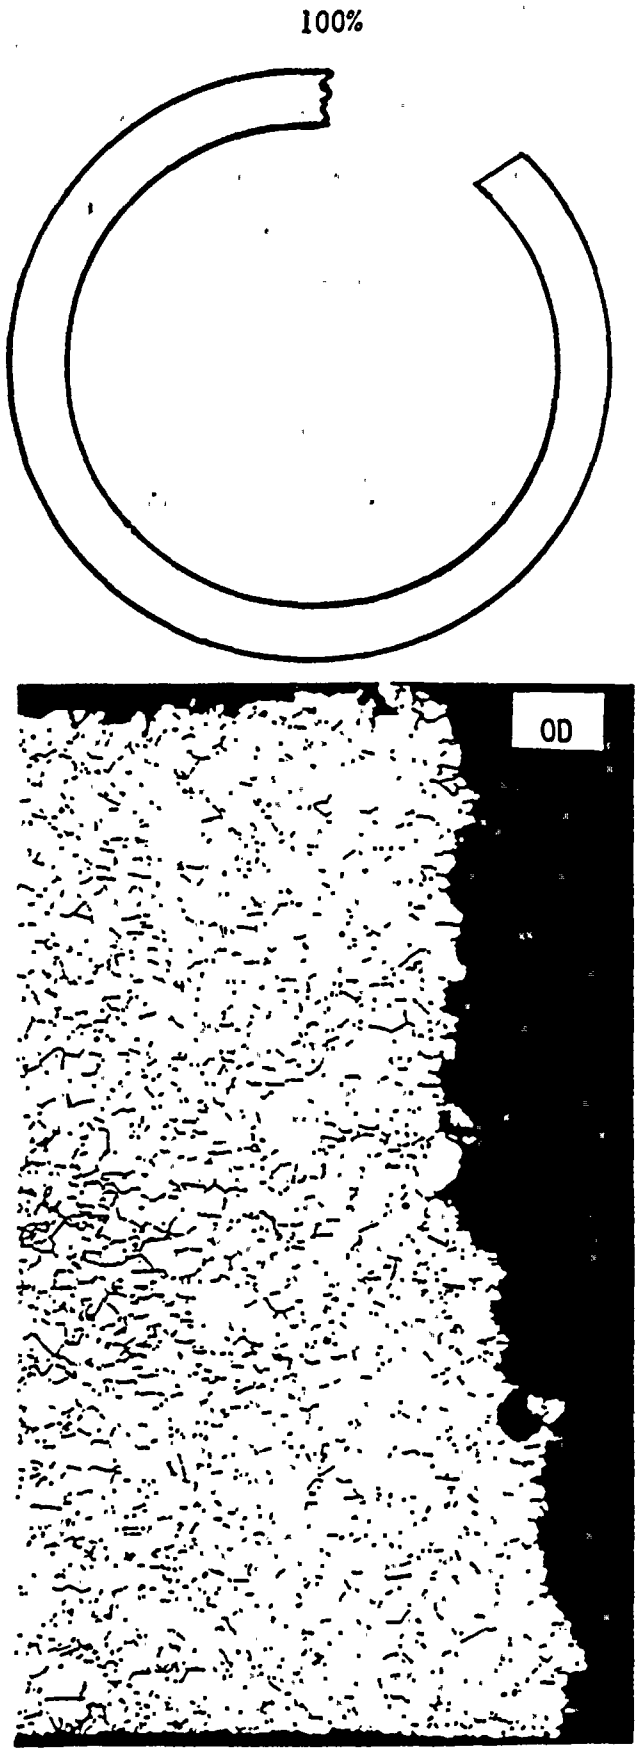
Figure 10-35 Sketch of a metallographic cross section through the center of the crevice region of tube 576-2, showing only the single burst crack, and a photomicrograph of the burst crack.
Mag. 100X

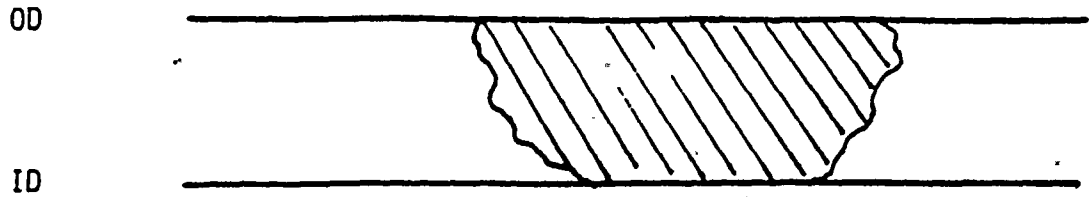
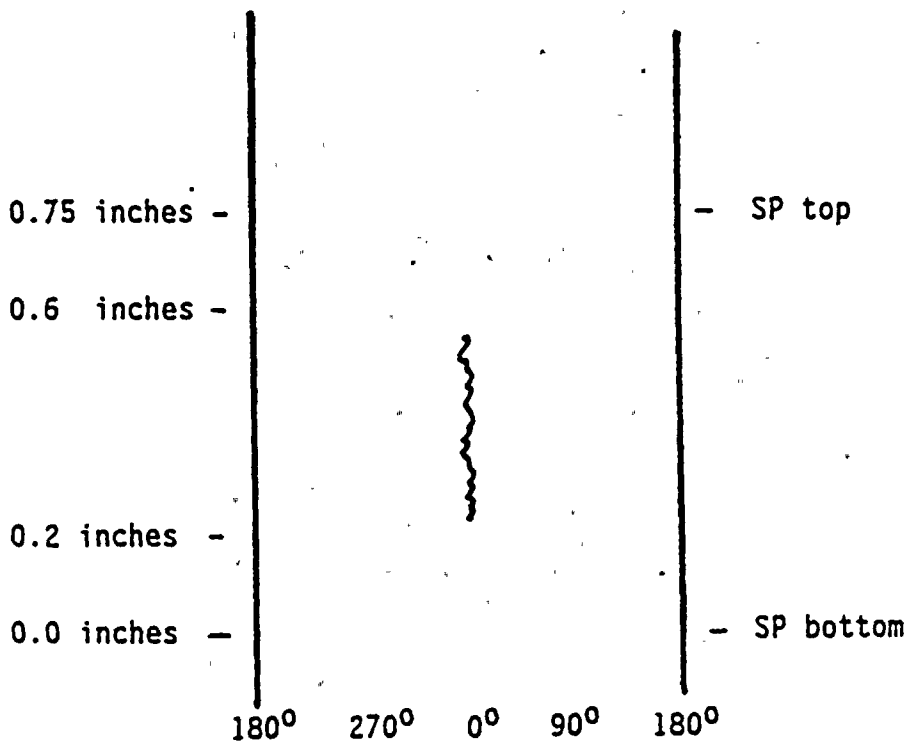
Only one, OD origin, single axial crack was observed after burst testing of tube 576-2. Fractography showed the crack to be 0.30 inch long and it was through wall for 0.22 inch. The macrocrack appeared to be composed of a single microcrack and its morphology was that of IGSCC. A metallographic cross section through the center of the crevice region found no secondary cracks around the circumference. Crack details and crack morphology data are shown in Figures 10-35 and 10-36.

Macrocrack Length = 0.30 inch

Number of Microcracks = 1 (no ligaments)

Morphology = IGSCC

Figure 10-36 Summary of burst crack observations and the overall crack distribution observed within the crevice region of tube 576-2.

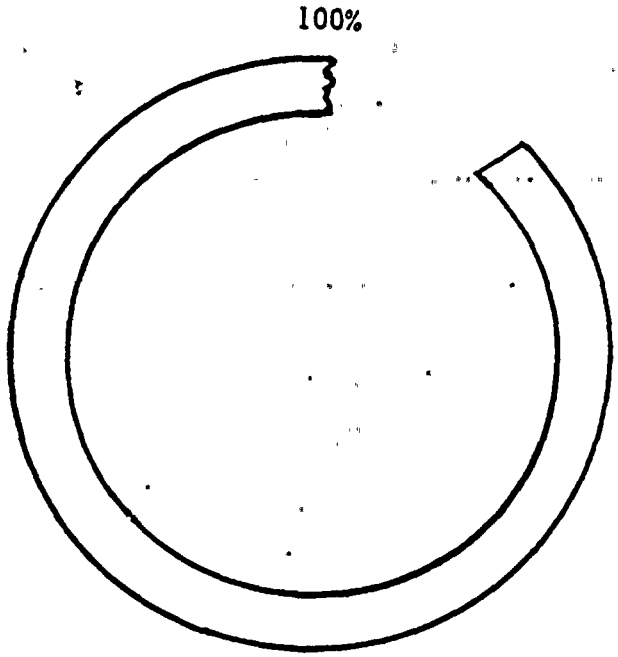
Tube 576-4 also burst with a single crack. Fractography showed the crack to be 0.60 inch long and it was through wall for 0.43 inch. The OD origin intergranular macrocrack was composed of three axial microcracks joined together by ligaments with intergranular features. Visual examination showed a few small axial cracks nearby the burst crack. The morphology of the burst crack was IGSCC with negligible IGA aspects. A metallographic section cut through the center of the crevice found only the burst crack. Crack details and crack morphology data are shown in Figures 10-37 and 10-38.

Figure 10-37 Sketch of a metallographic cross section through the center of the crevice region of tube 576-4, showing only the single burst crack, and a photomicrograph of the burst crack.
Mag. 100X

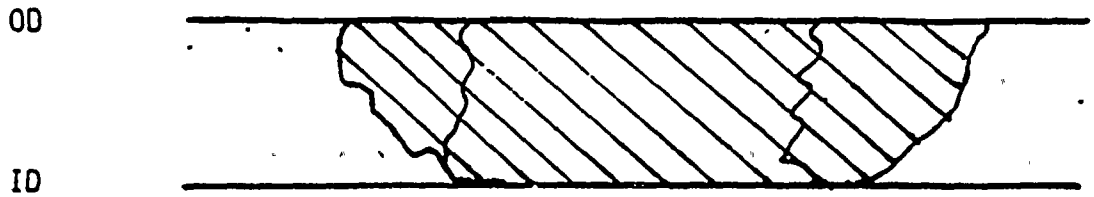
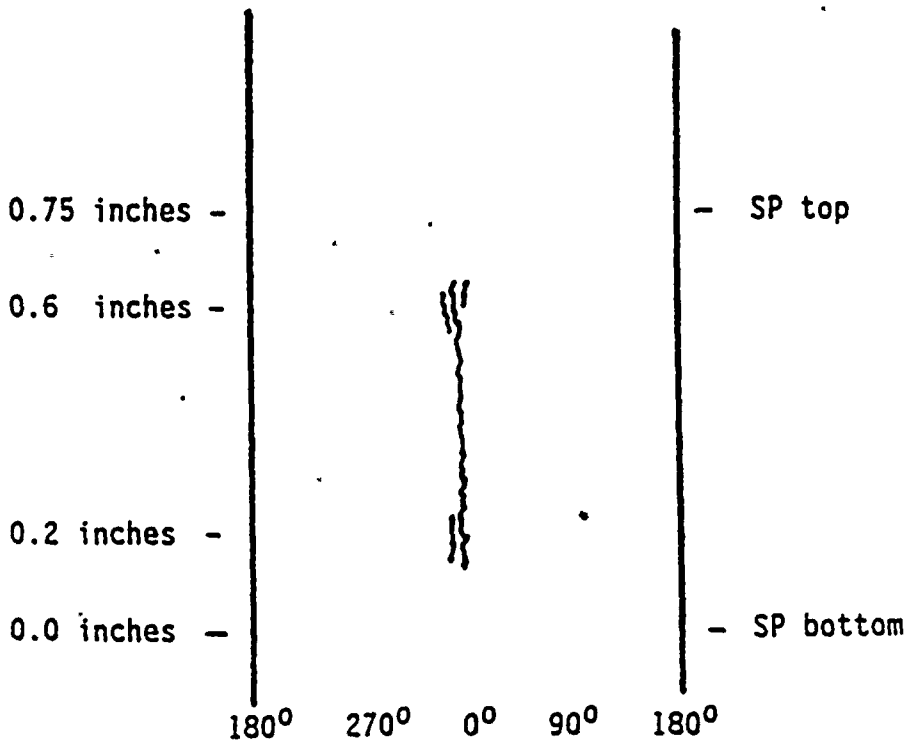
Macrocrack Length = 0.60 inch

Number of Microcracks = 3 (ligaments have intergranular features)

Morphology = IGSCC with negligible IGA features

Figure 10-38 Summary of burst crack observations and the overall crack distribution observed at the crevice region of tube 576-4.

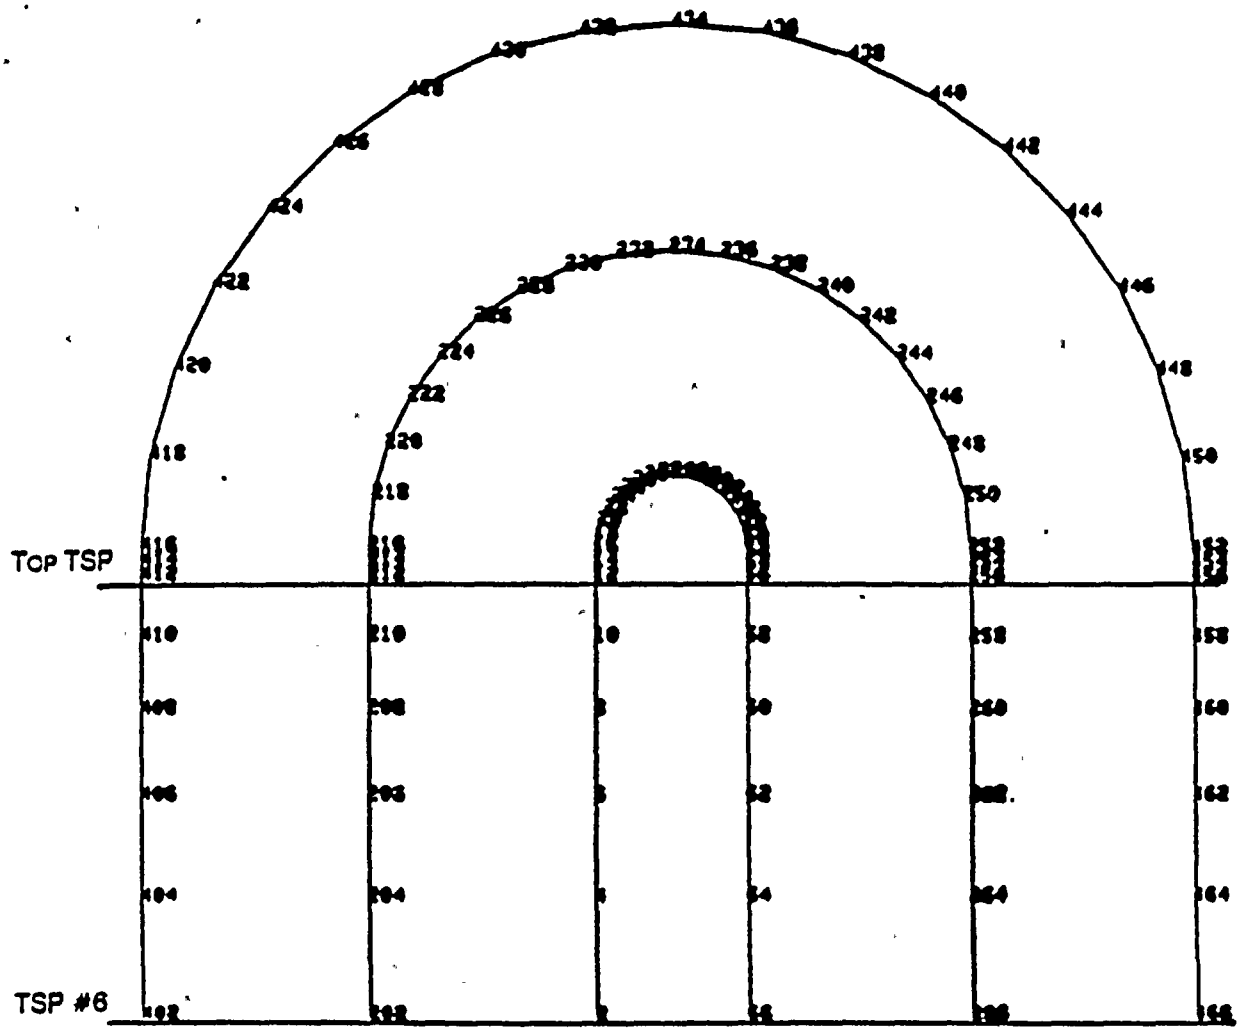
For the rarefaction wave induced loadings, the predominant motion of the U-bends is in the plane of the U-bend. Thus, the individual tube motions are not coupled by the anti-vibration bars. Also, only the U-bend region is subjected to high bending loads. Therefore, the structural analysis is performed using single tube models limited to the U-bend and the straight leg region over the top two TSPs. The LOCA rarefaction pressure wave imposes a time varying loading condition on the tubes. The tubes are evaluated using the time history analysis capability of the WECAN computer program. The structural tube model consists of three-dimensional beam elements. The mass inertia is input as effective material density and includes the weight of the tube as well as the weight of the primary fluid inside the tube, and the hydrodynamic mass effects of the secondary fluid. The geometry of the three tube models used for the LOCA analysis are shown in Figure 11-5, with the node numbers identified.

Figure 11-5. Finite Element Model for Structural LOCA Time History Analysis

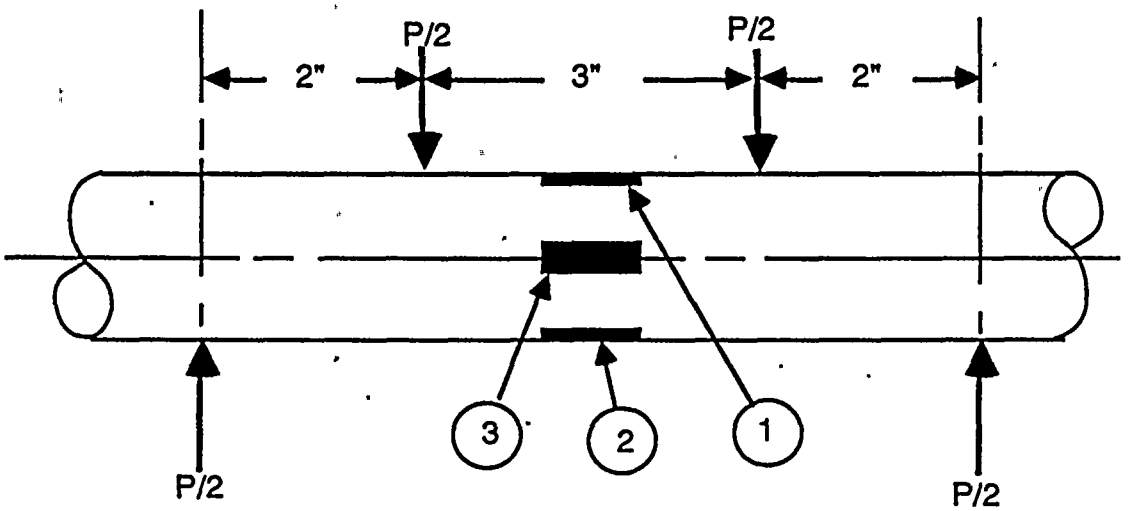
Figure 11-11. Externally Applied Bending Load and Locations of Through Wall Slots

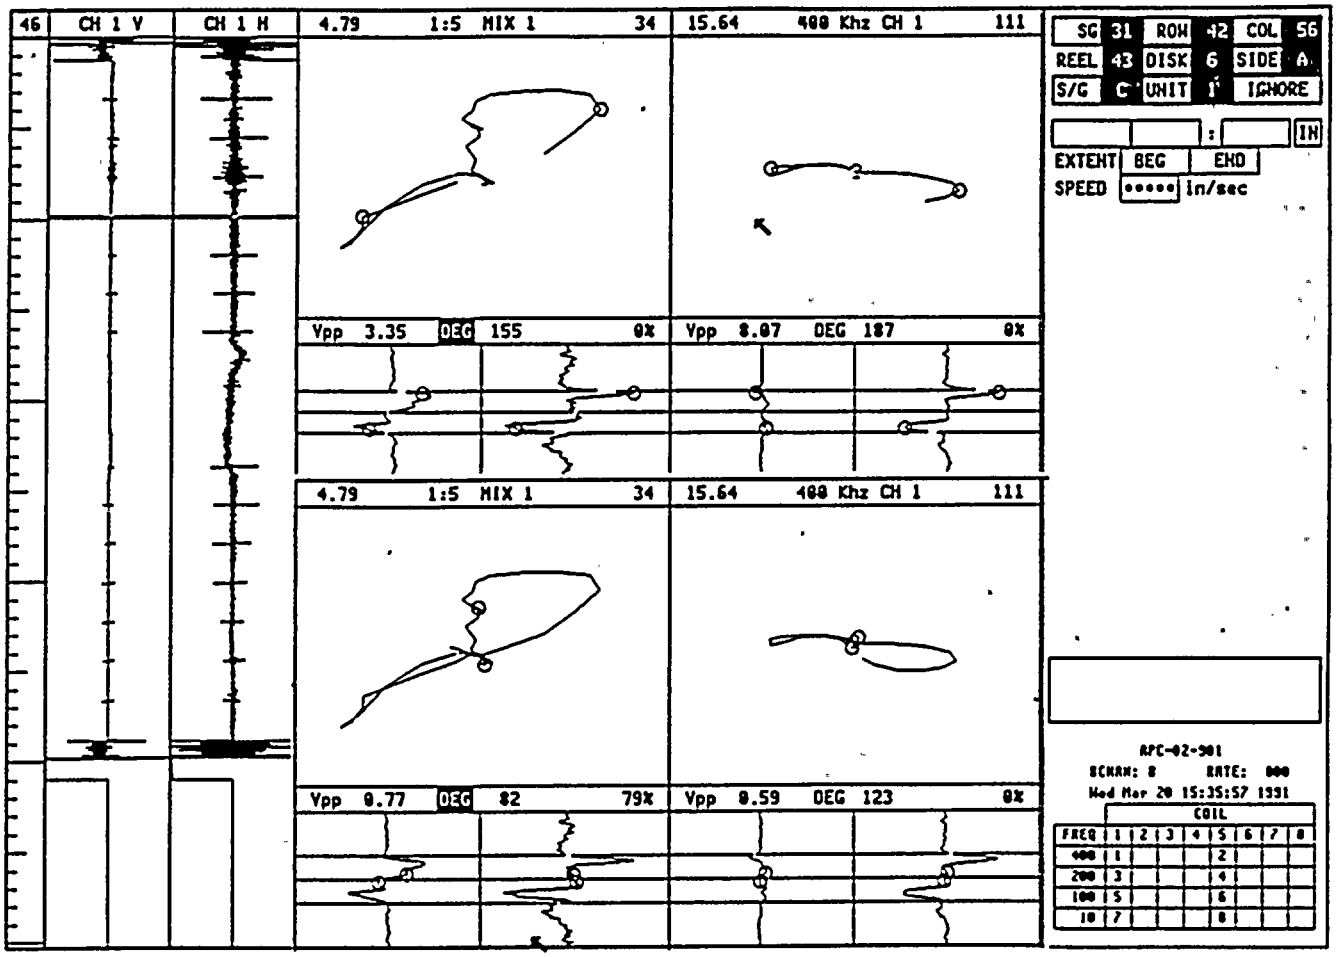
Figure A-14. Example of Bobbin Coil Field Data - Flaw Signals for ODSCC at Dented TSP Intersection

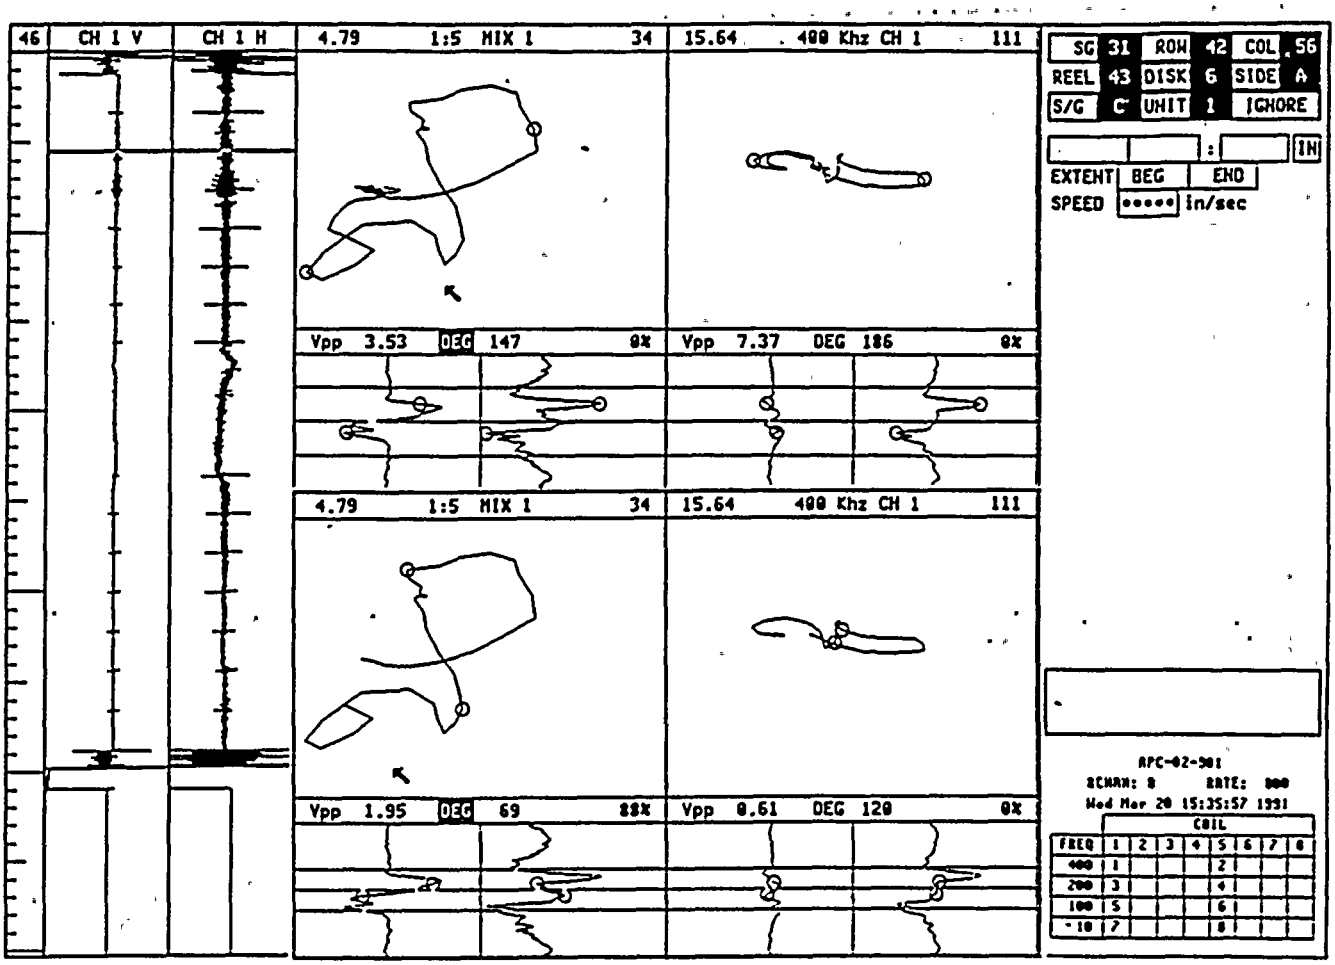
Figure A-15. Example of Bobbin Coil Field Data - Flaw Signals for ODSCC at Dented TSP Intersection

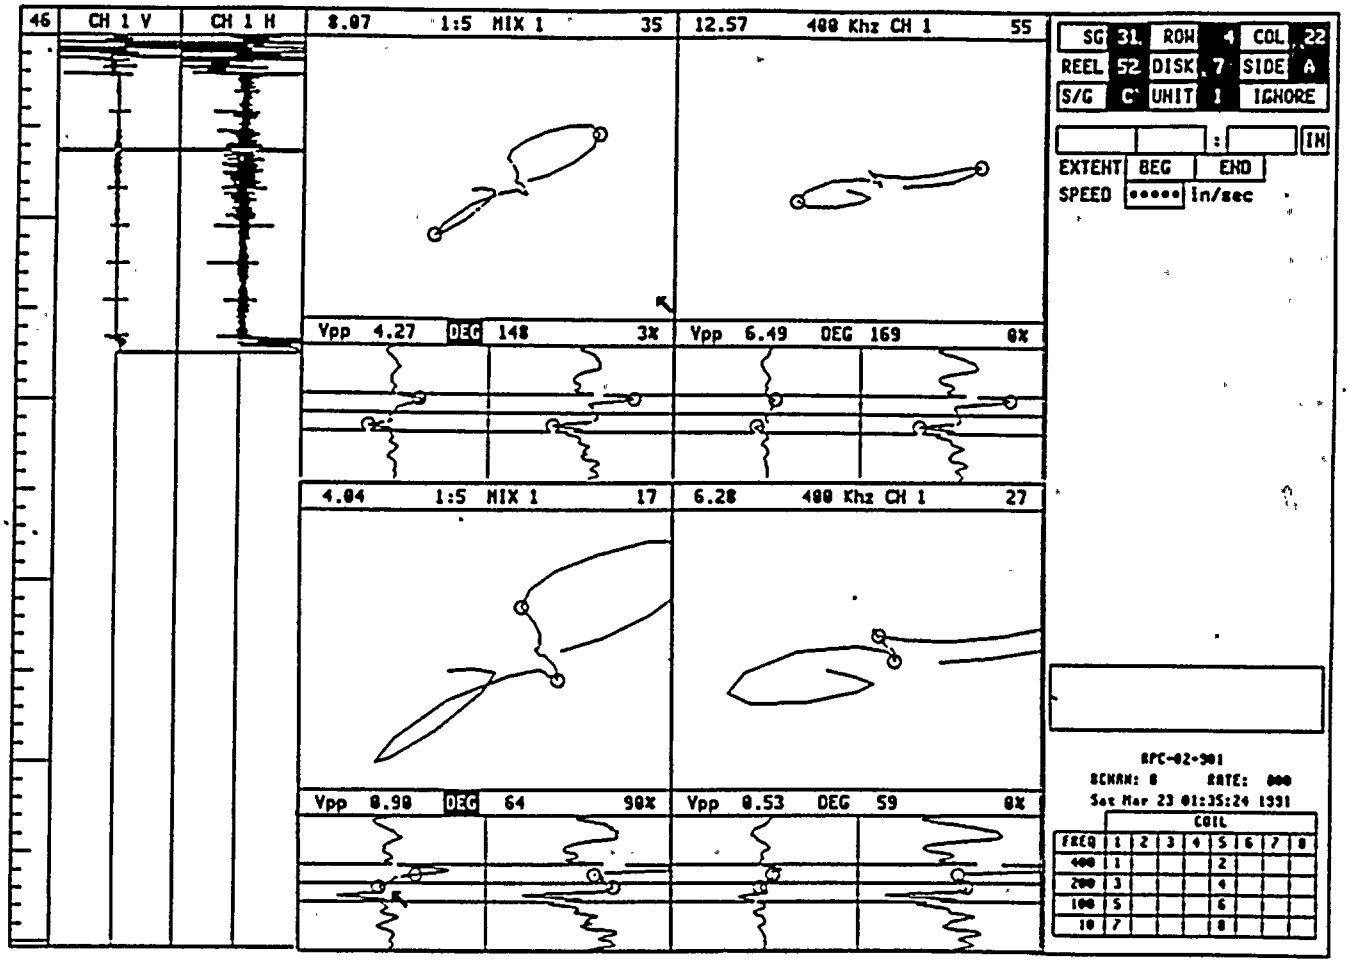
Figure A-16. Example of Bobbin Coil Field Data - Flaw Signals for ODSCC at Dented TSP Intersection

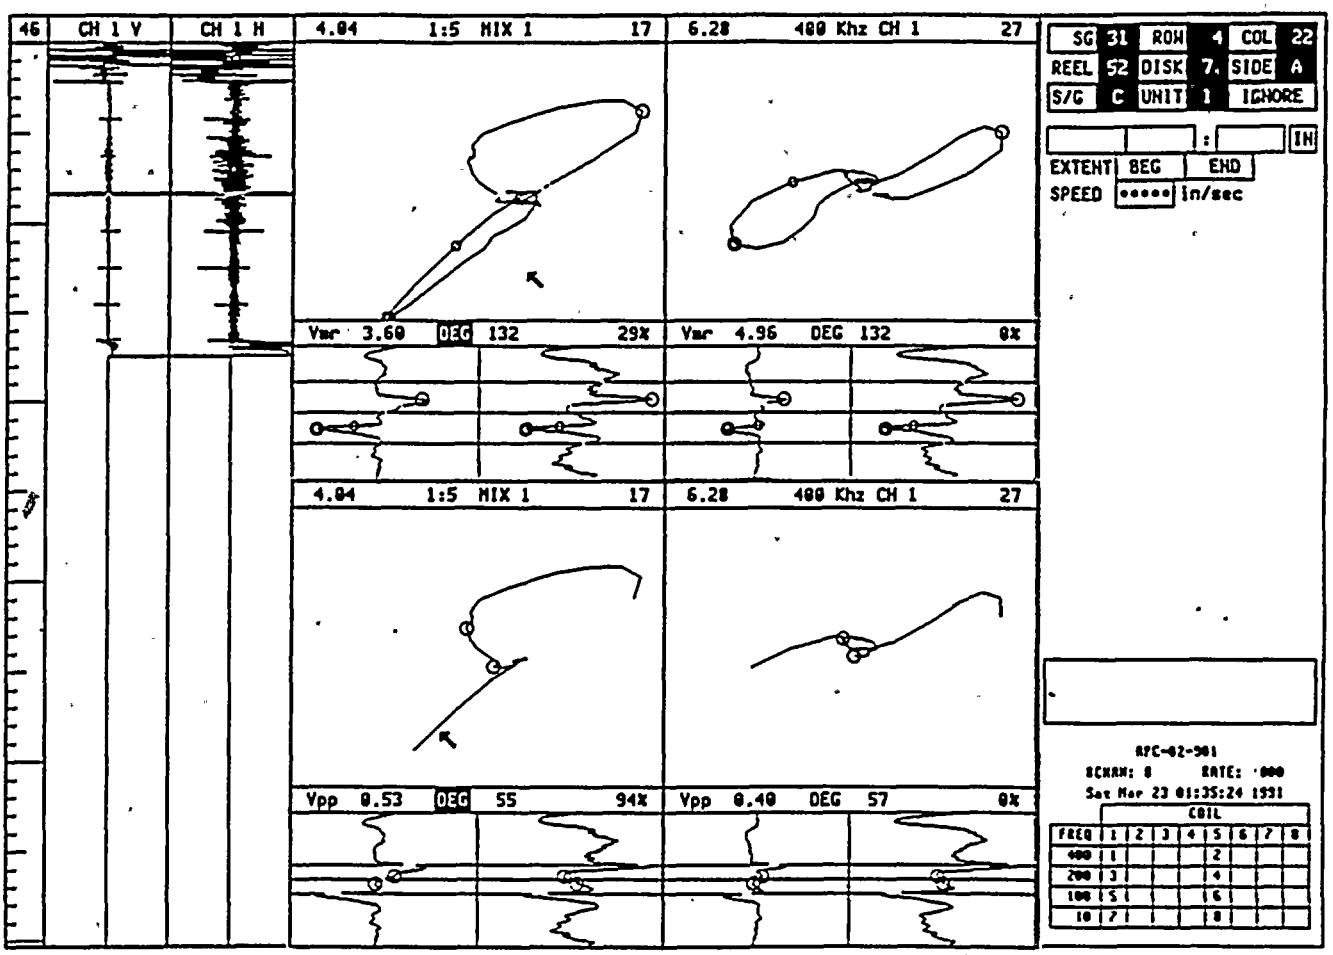
Figure A-17. Example of Bobbin Coil Field Data - Flaw Signals for ODSCC at Dented TSP Intersection

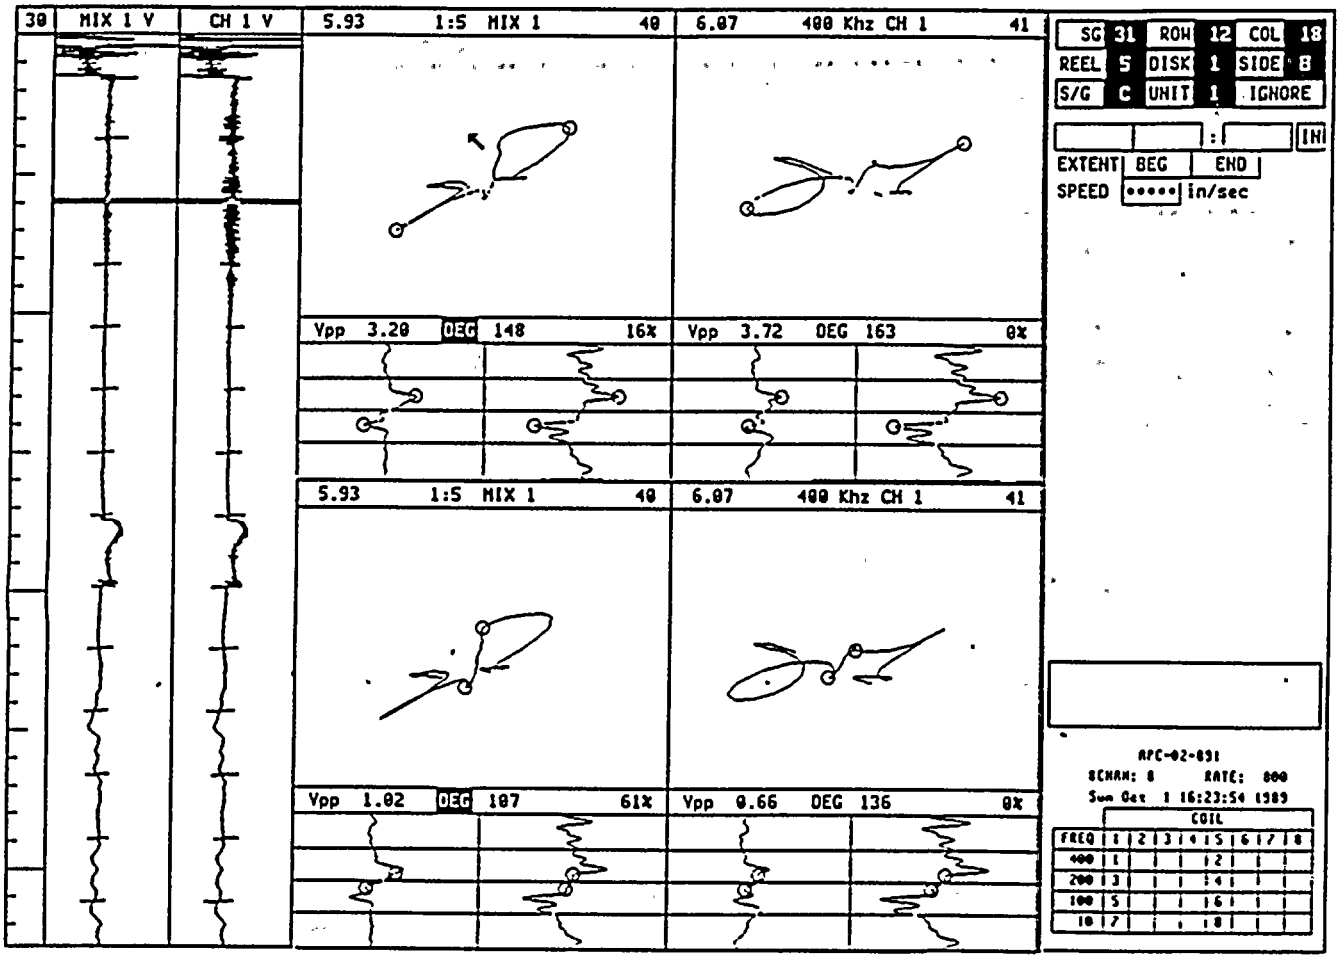
Figure A-18. Example of Bobbin Coil Field Data - Flaw Signals for ODSCC at Dented TSP Intersection

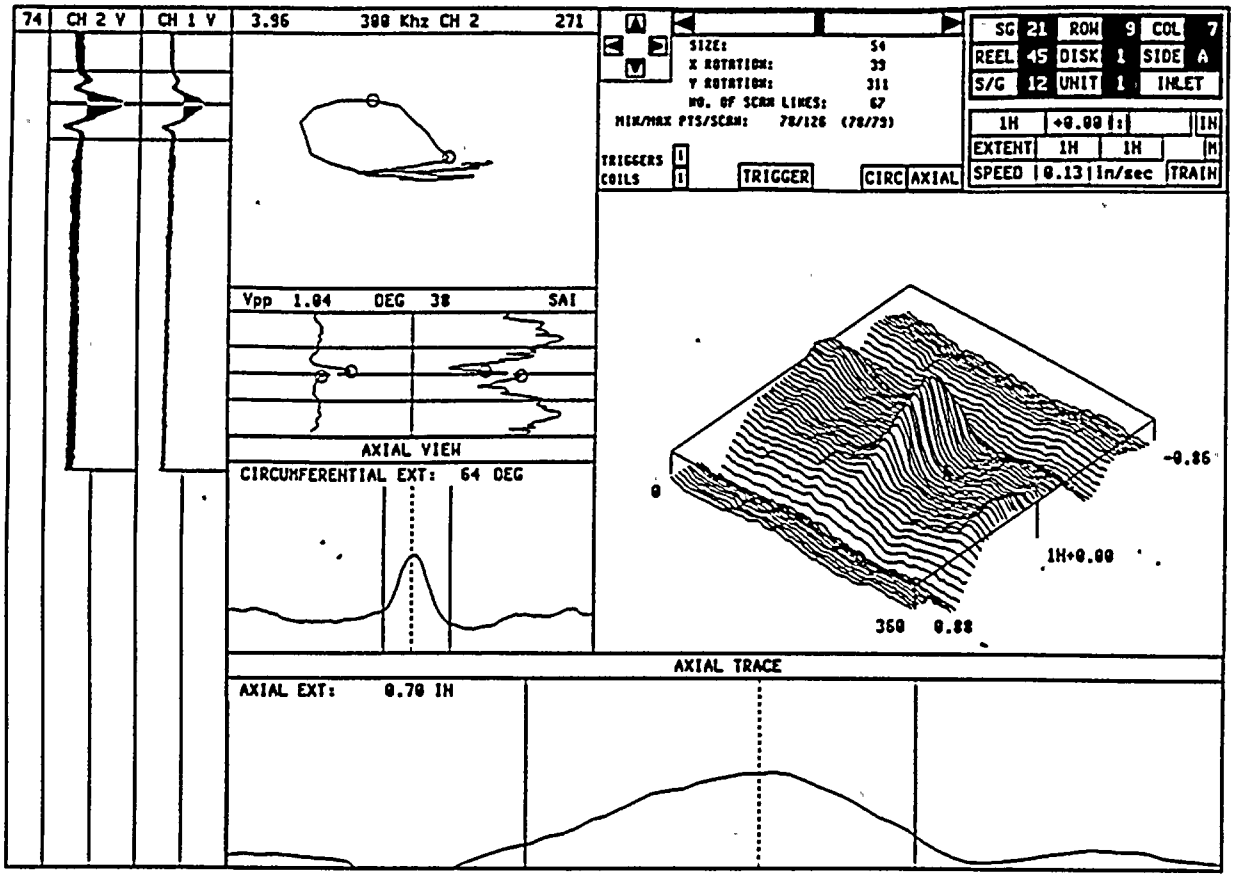
Figure A-19.Example of Bobbin Coil Field Data - Flaw Signals for ODSCC at Dented TSP Intersection

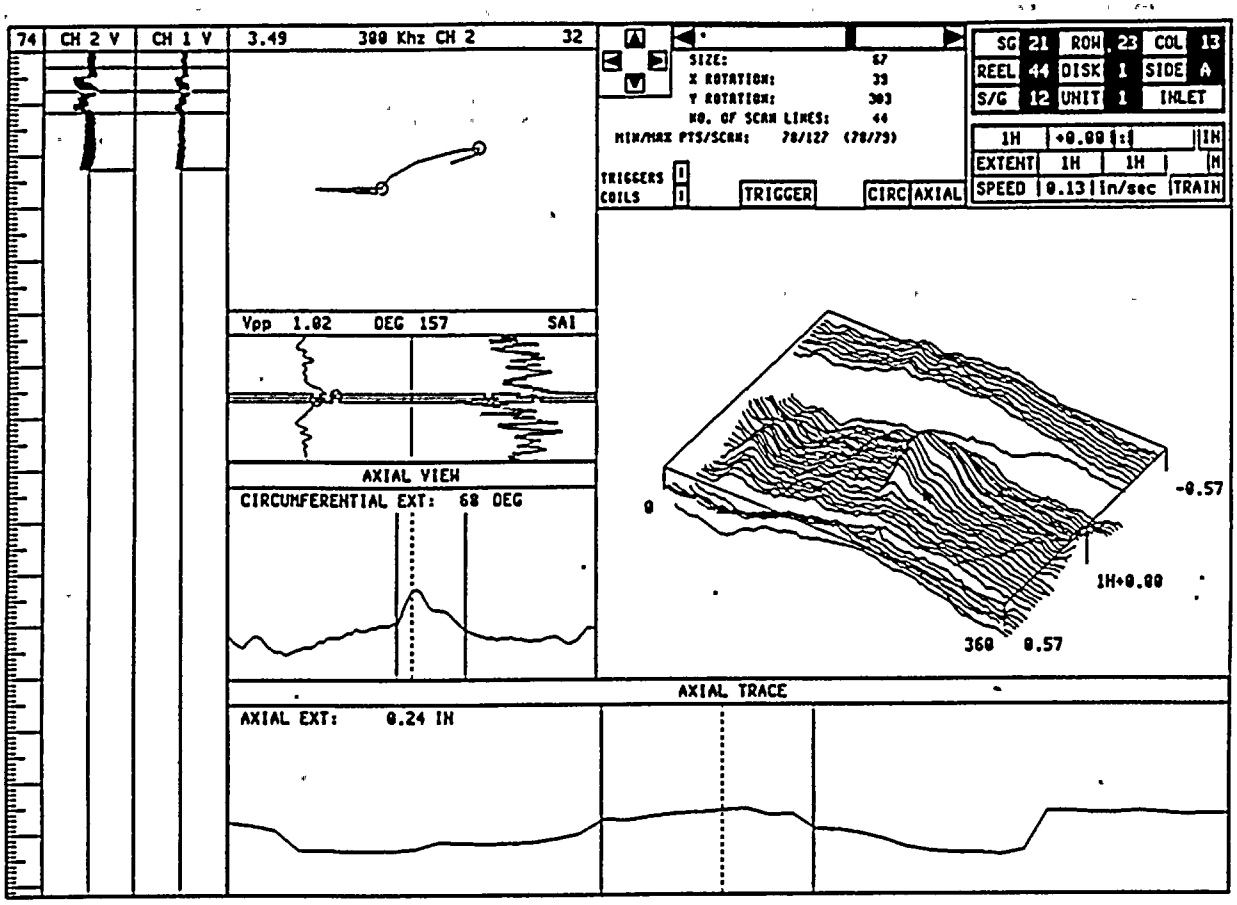
Figure A-20. Example of Axial ODSCC Indication at TSP 1 - Cook Unit 1

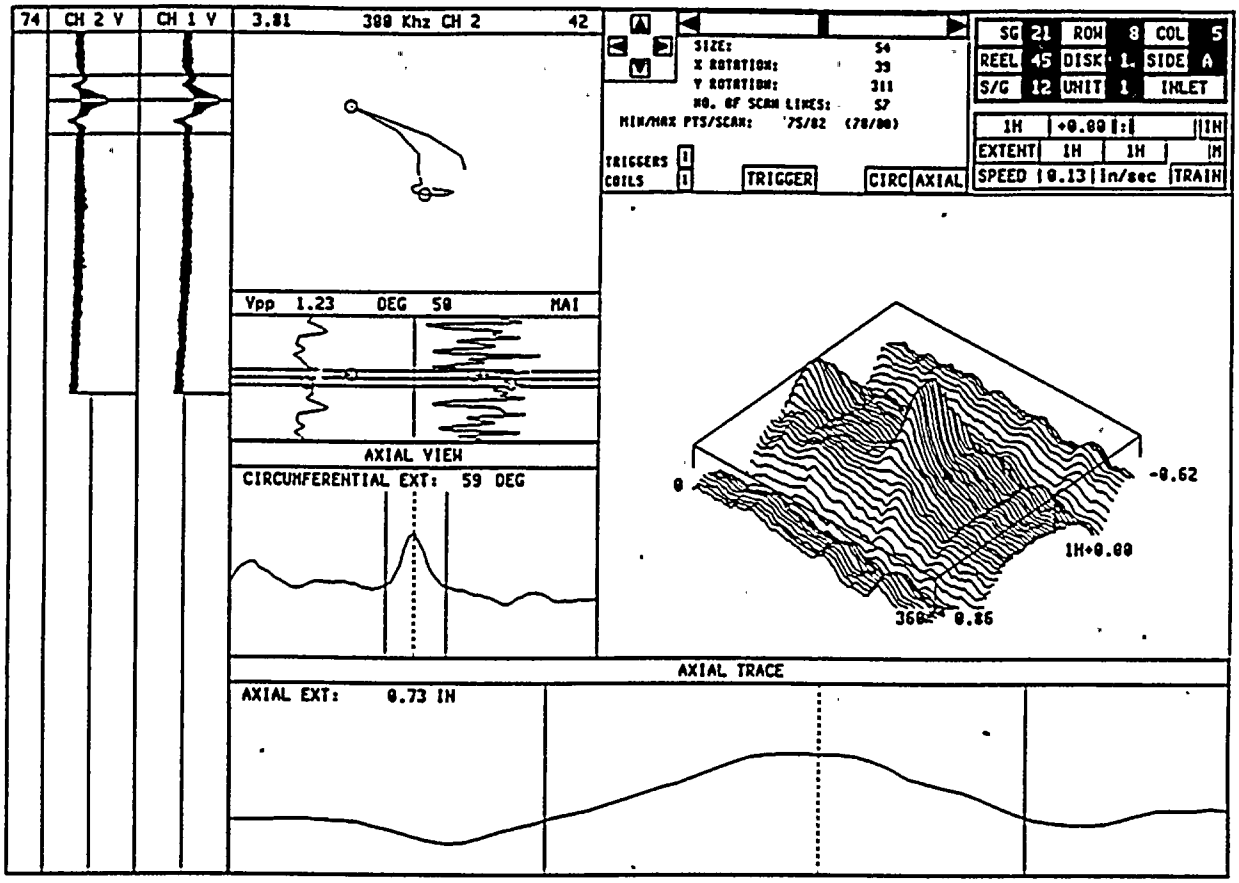
Figure A-21. Axial ODSCC Indication at TSP - Cook Unit 1

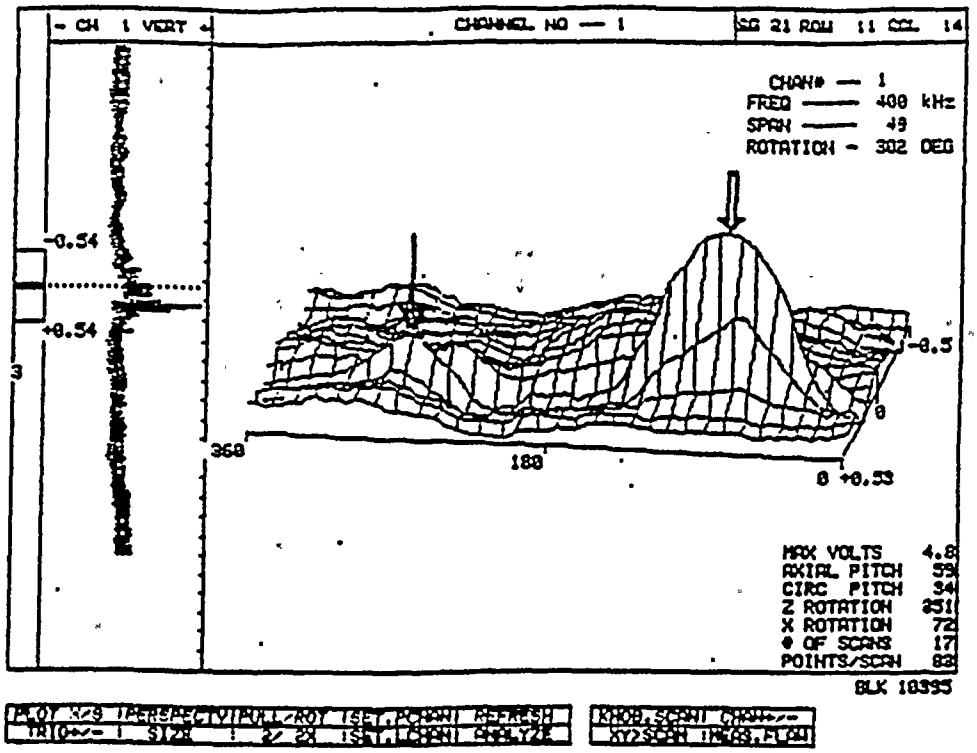
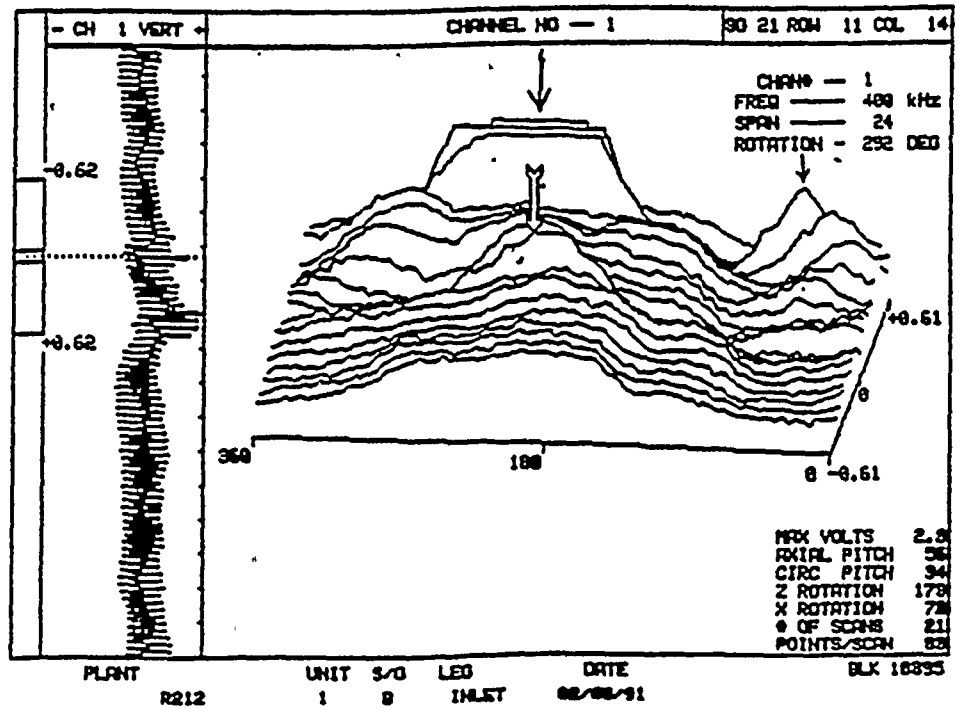
Figure A-22. Axial ODSCC Indications (MAI) at TSP - Cook Unit 1

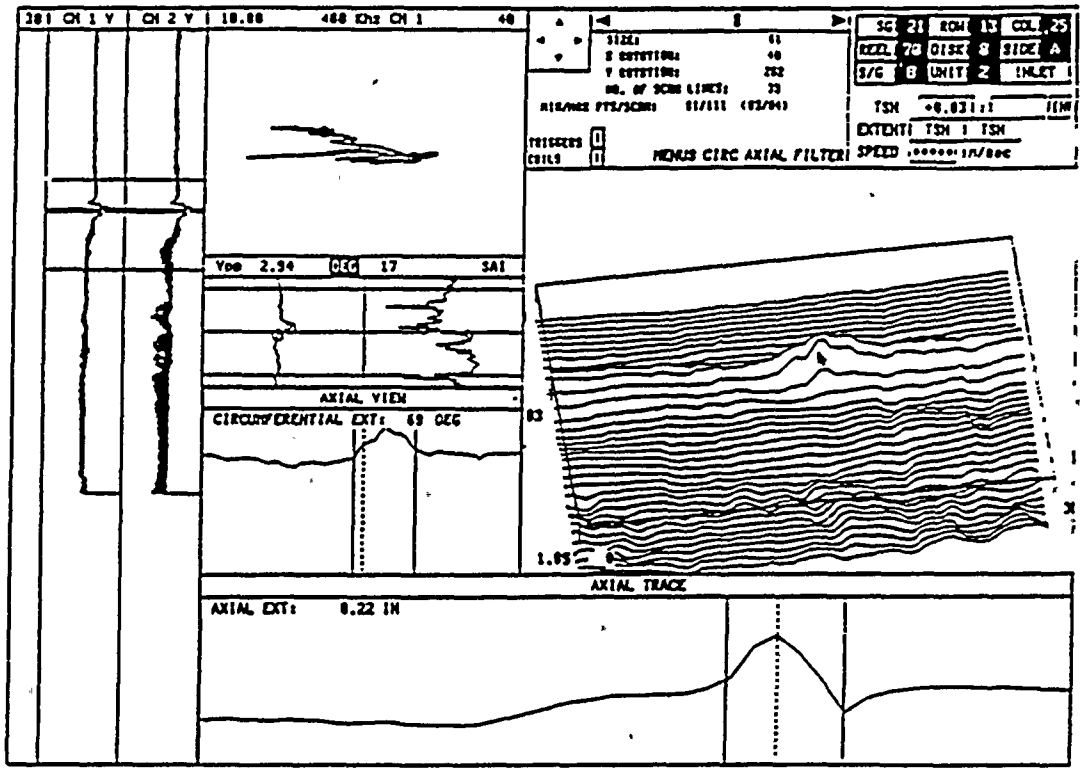
Figure A-23. Circumferential ODSCC Indications at Support Plates
