February 11, 1987

RESULTS OF BORAFLEX EXAMINATION
POINT BEACH NUCLEAR PLANT

Full-length Boraflex Sheet Examination - August 1986

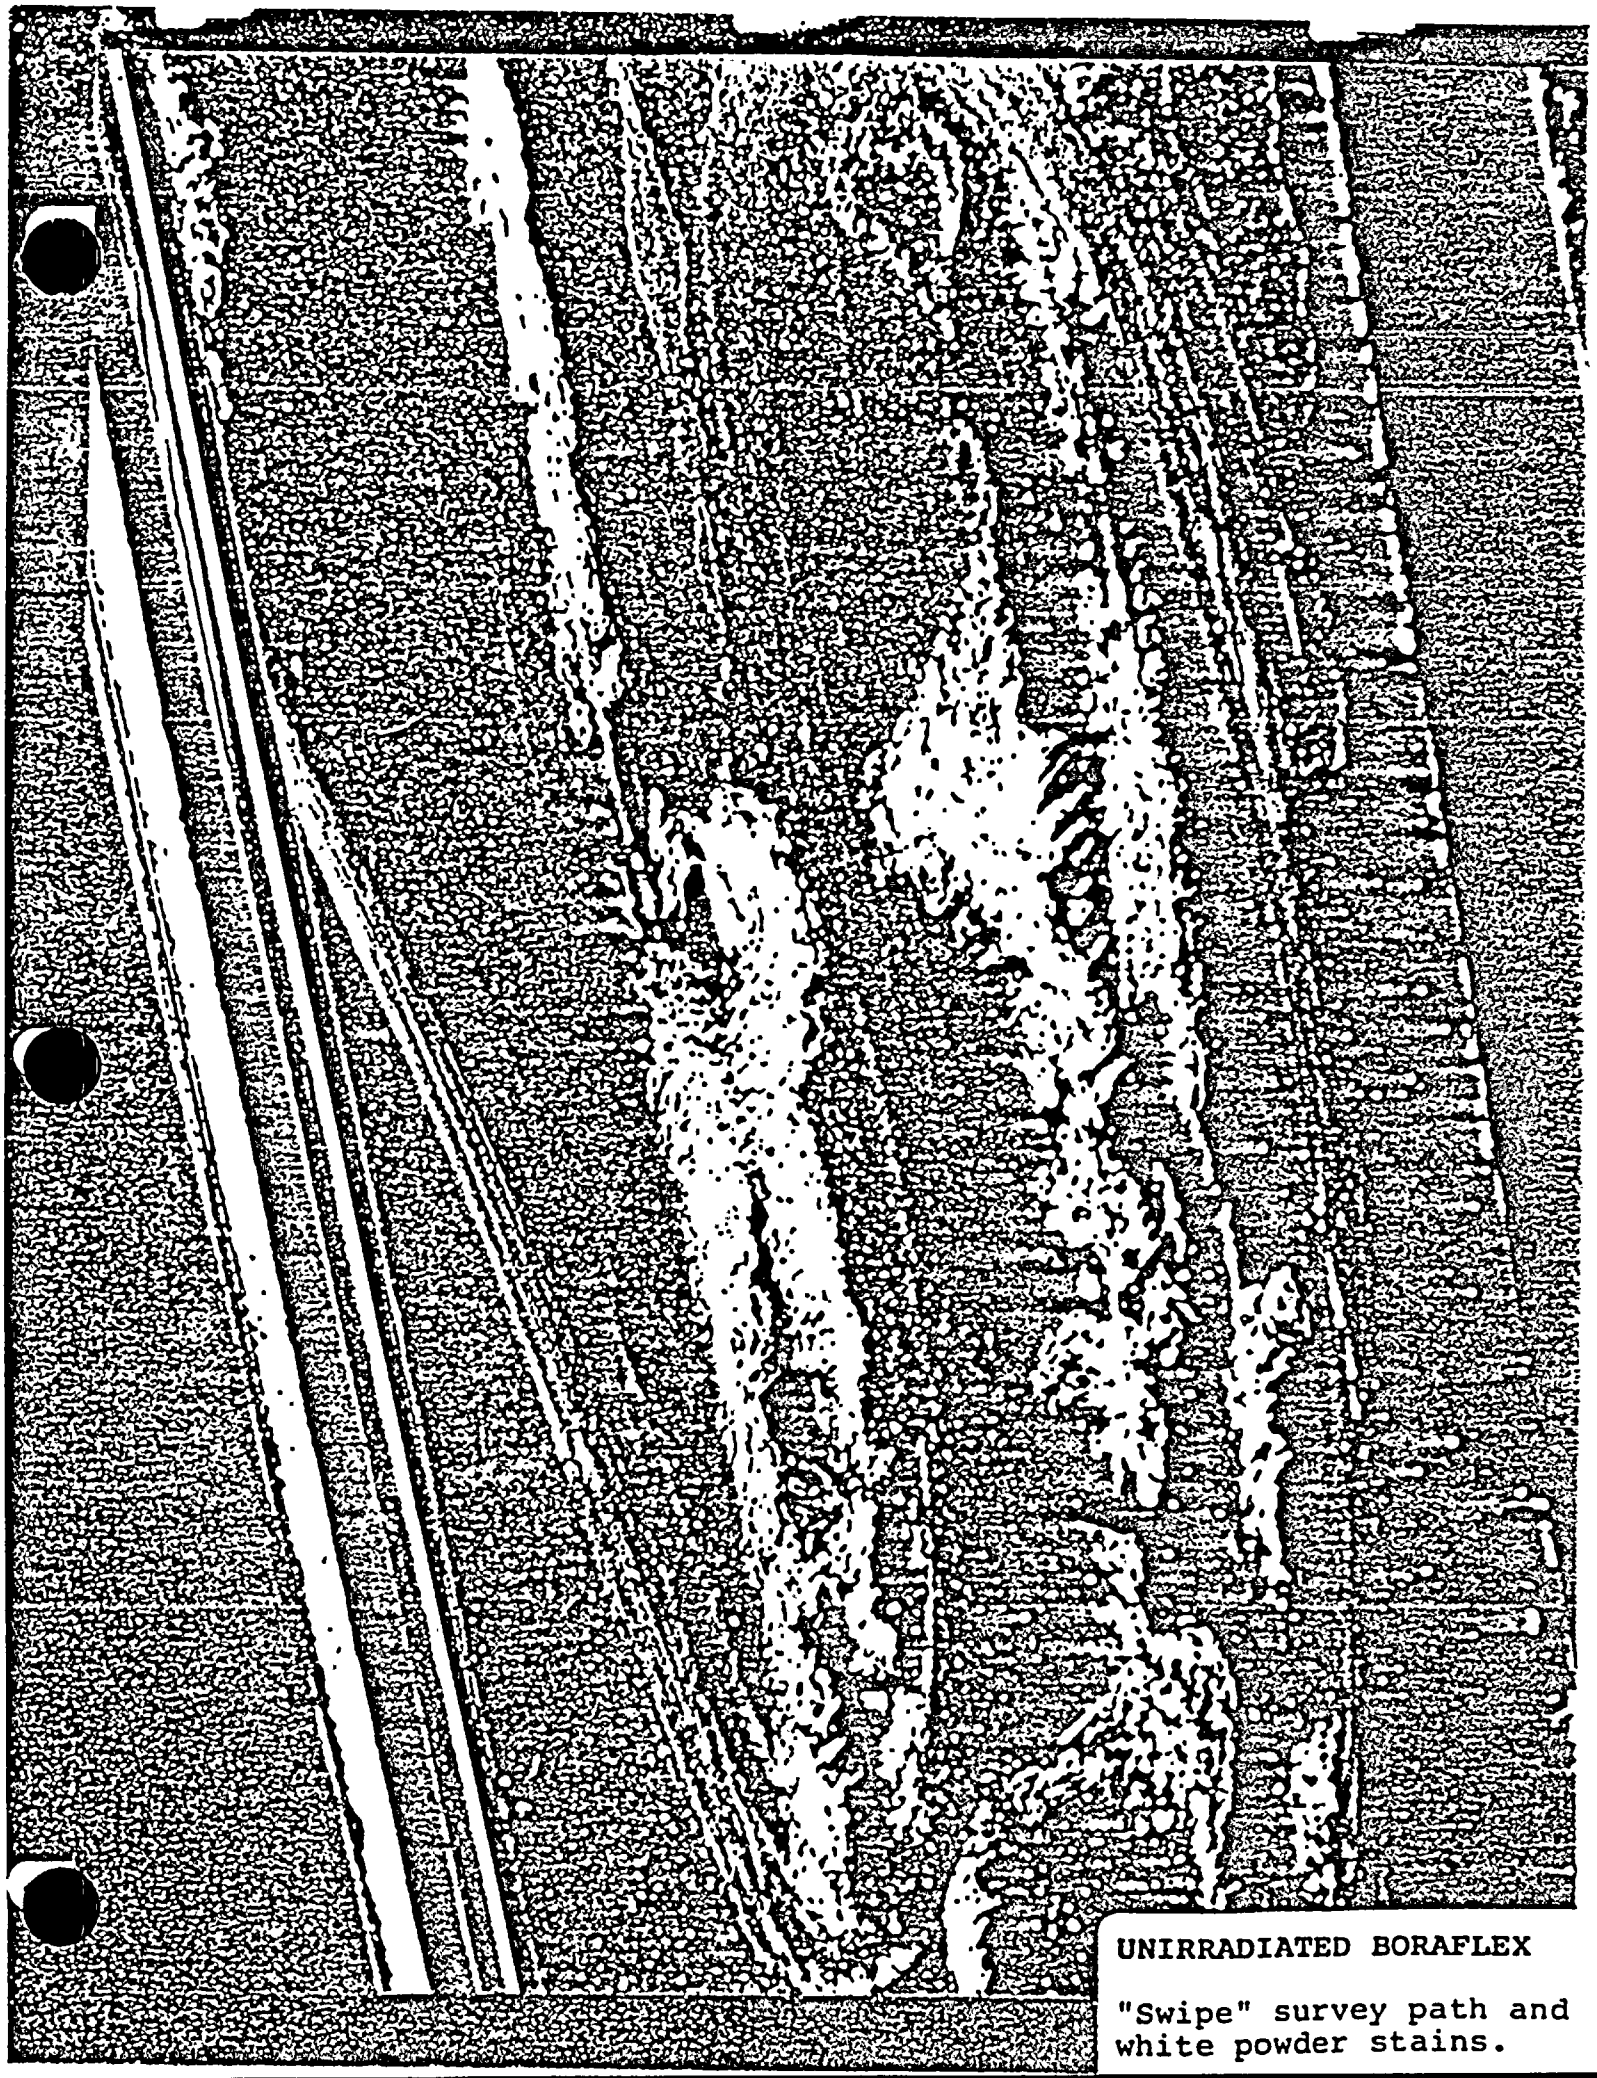
UNIRRADIATED BORAFLEX

"Swipe" survey path and white powder stains.

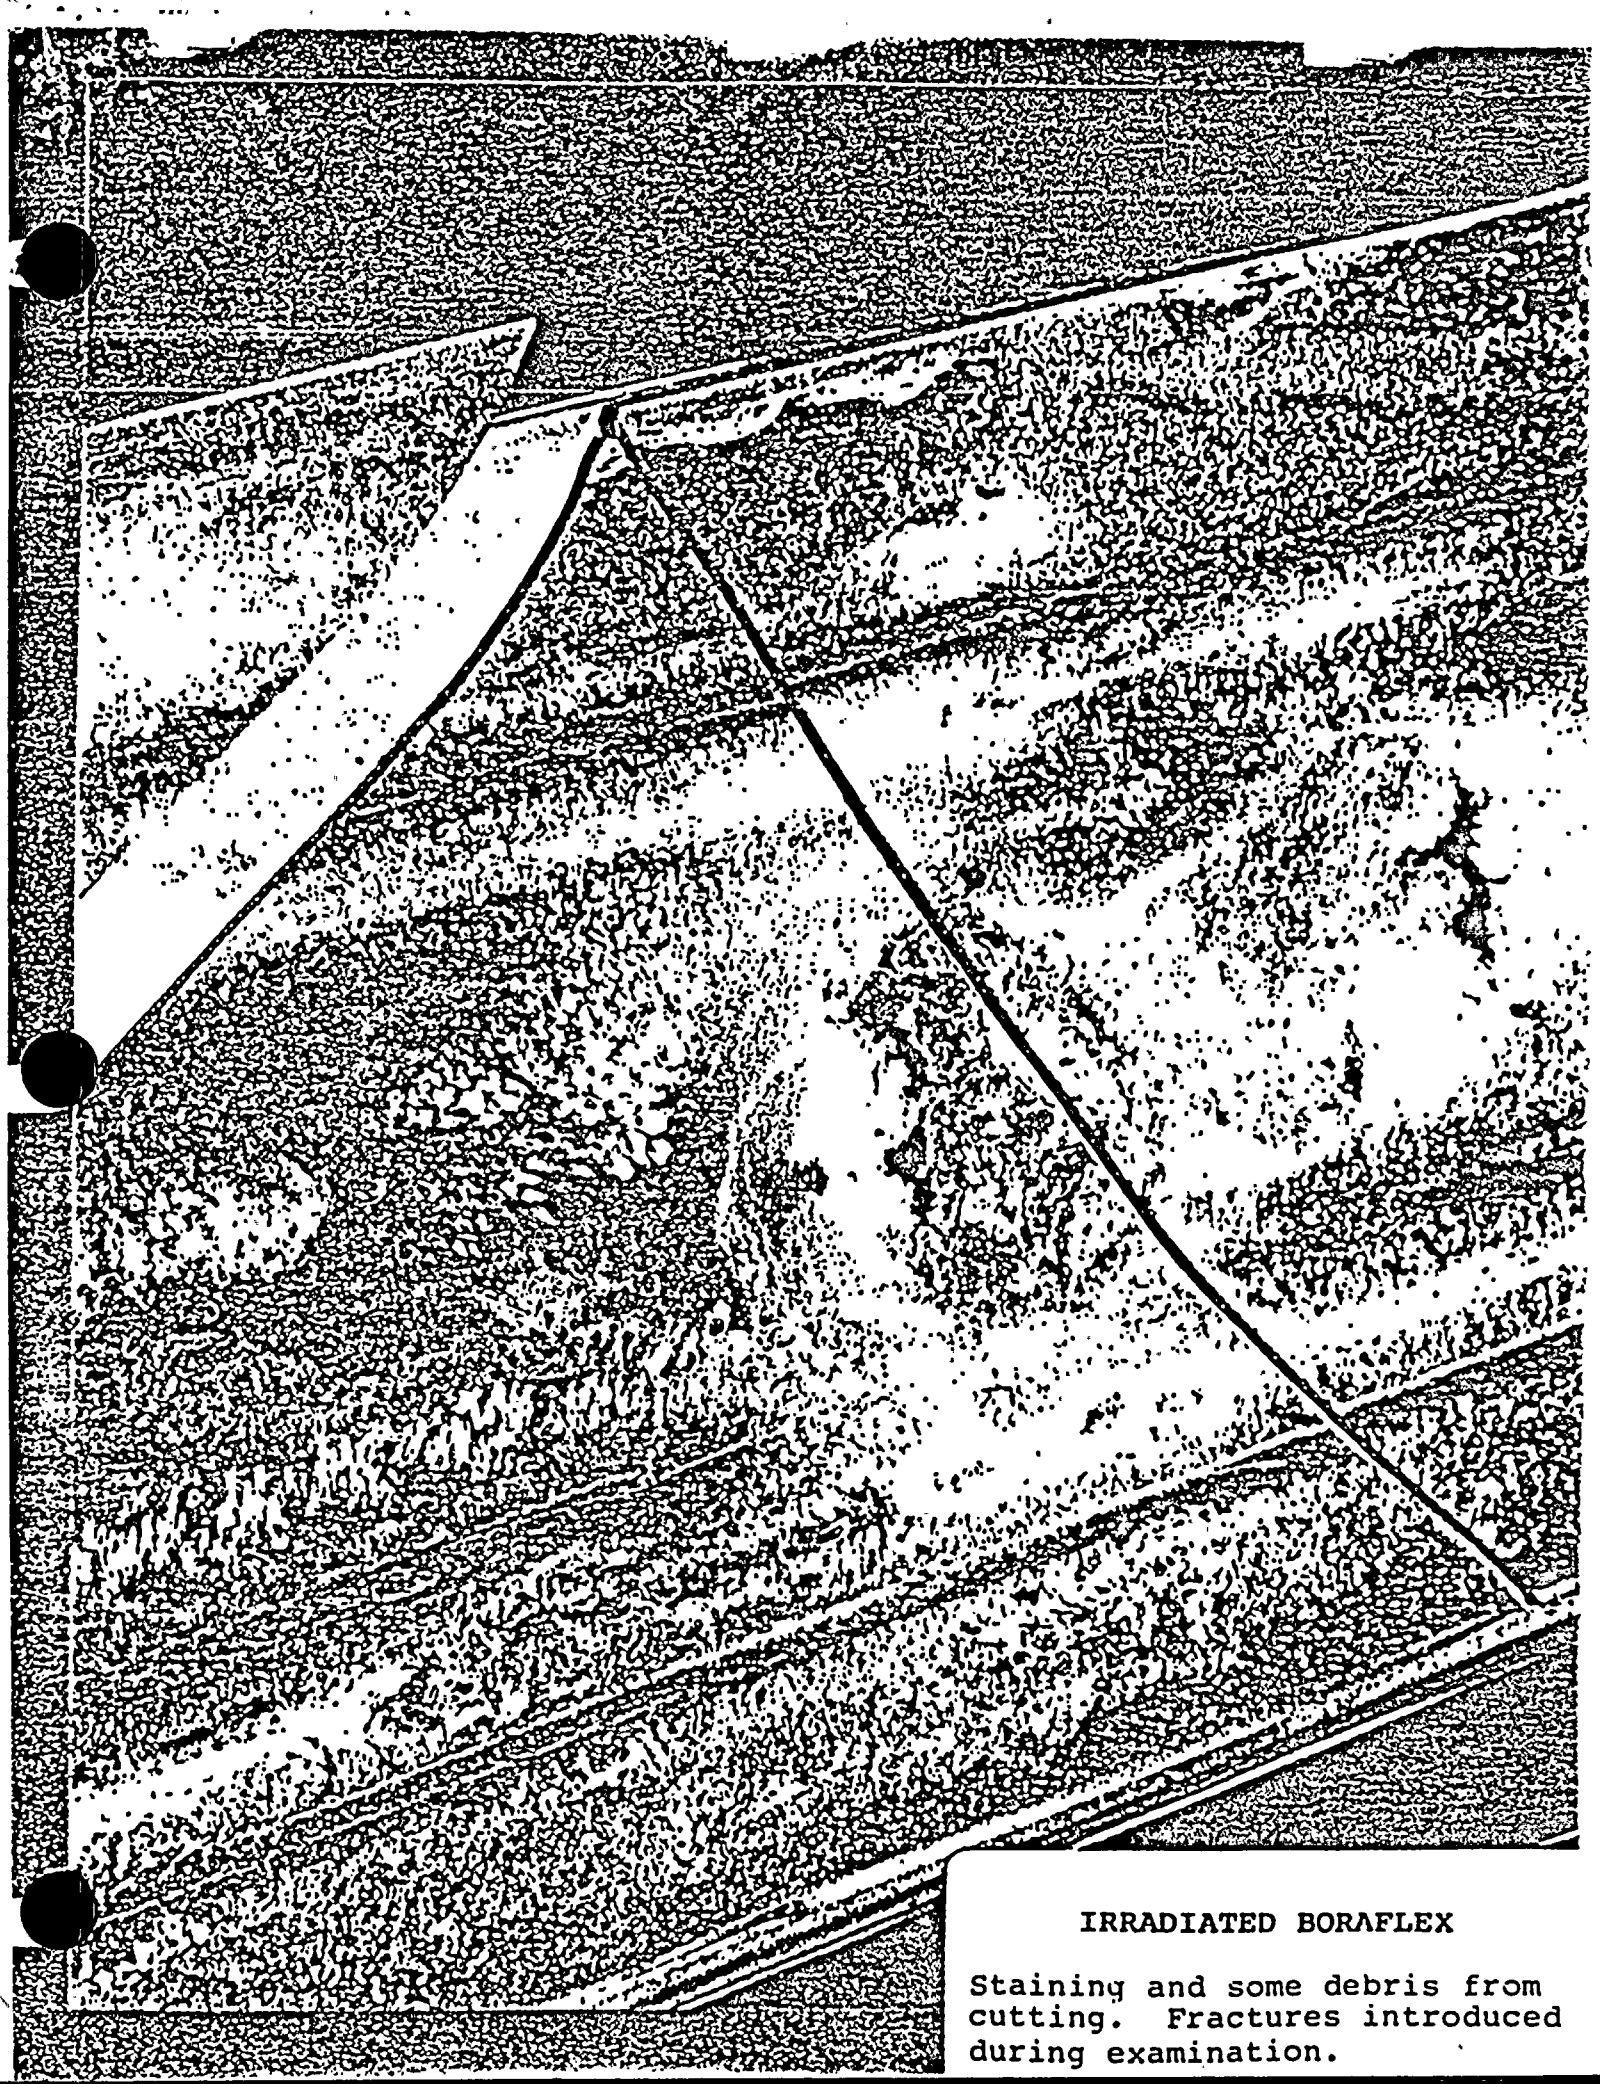
IRRADIATED BORAFLEX

Staining and some debris from cutting. Fractures introduced during examination.
